# Seismic Performance of Buried Cables and Pot Heads

John Eiding

G&E Engineering Systems Inc.

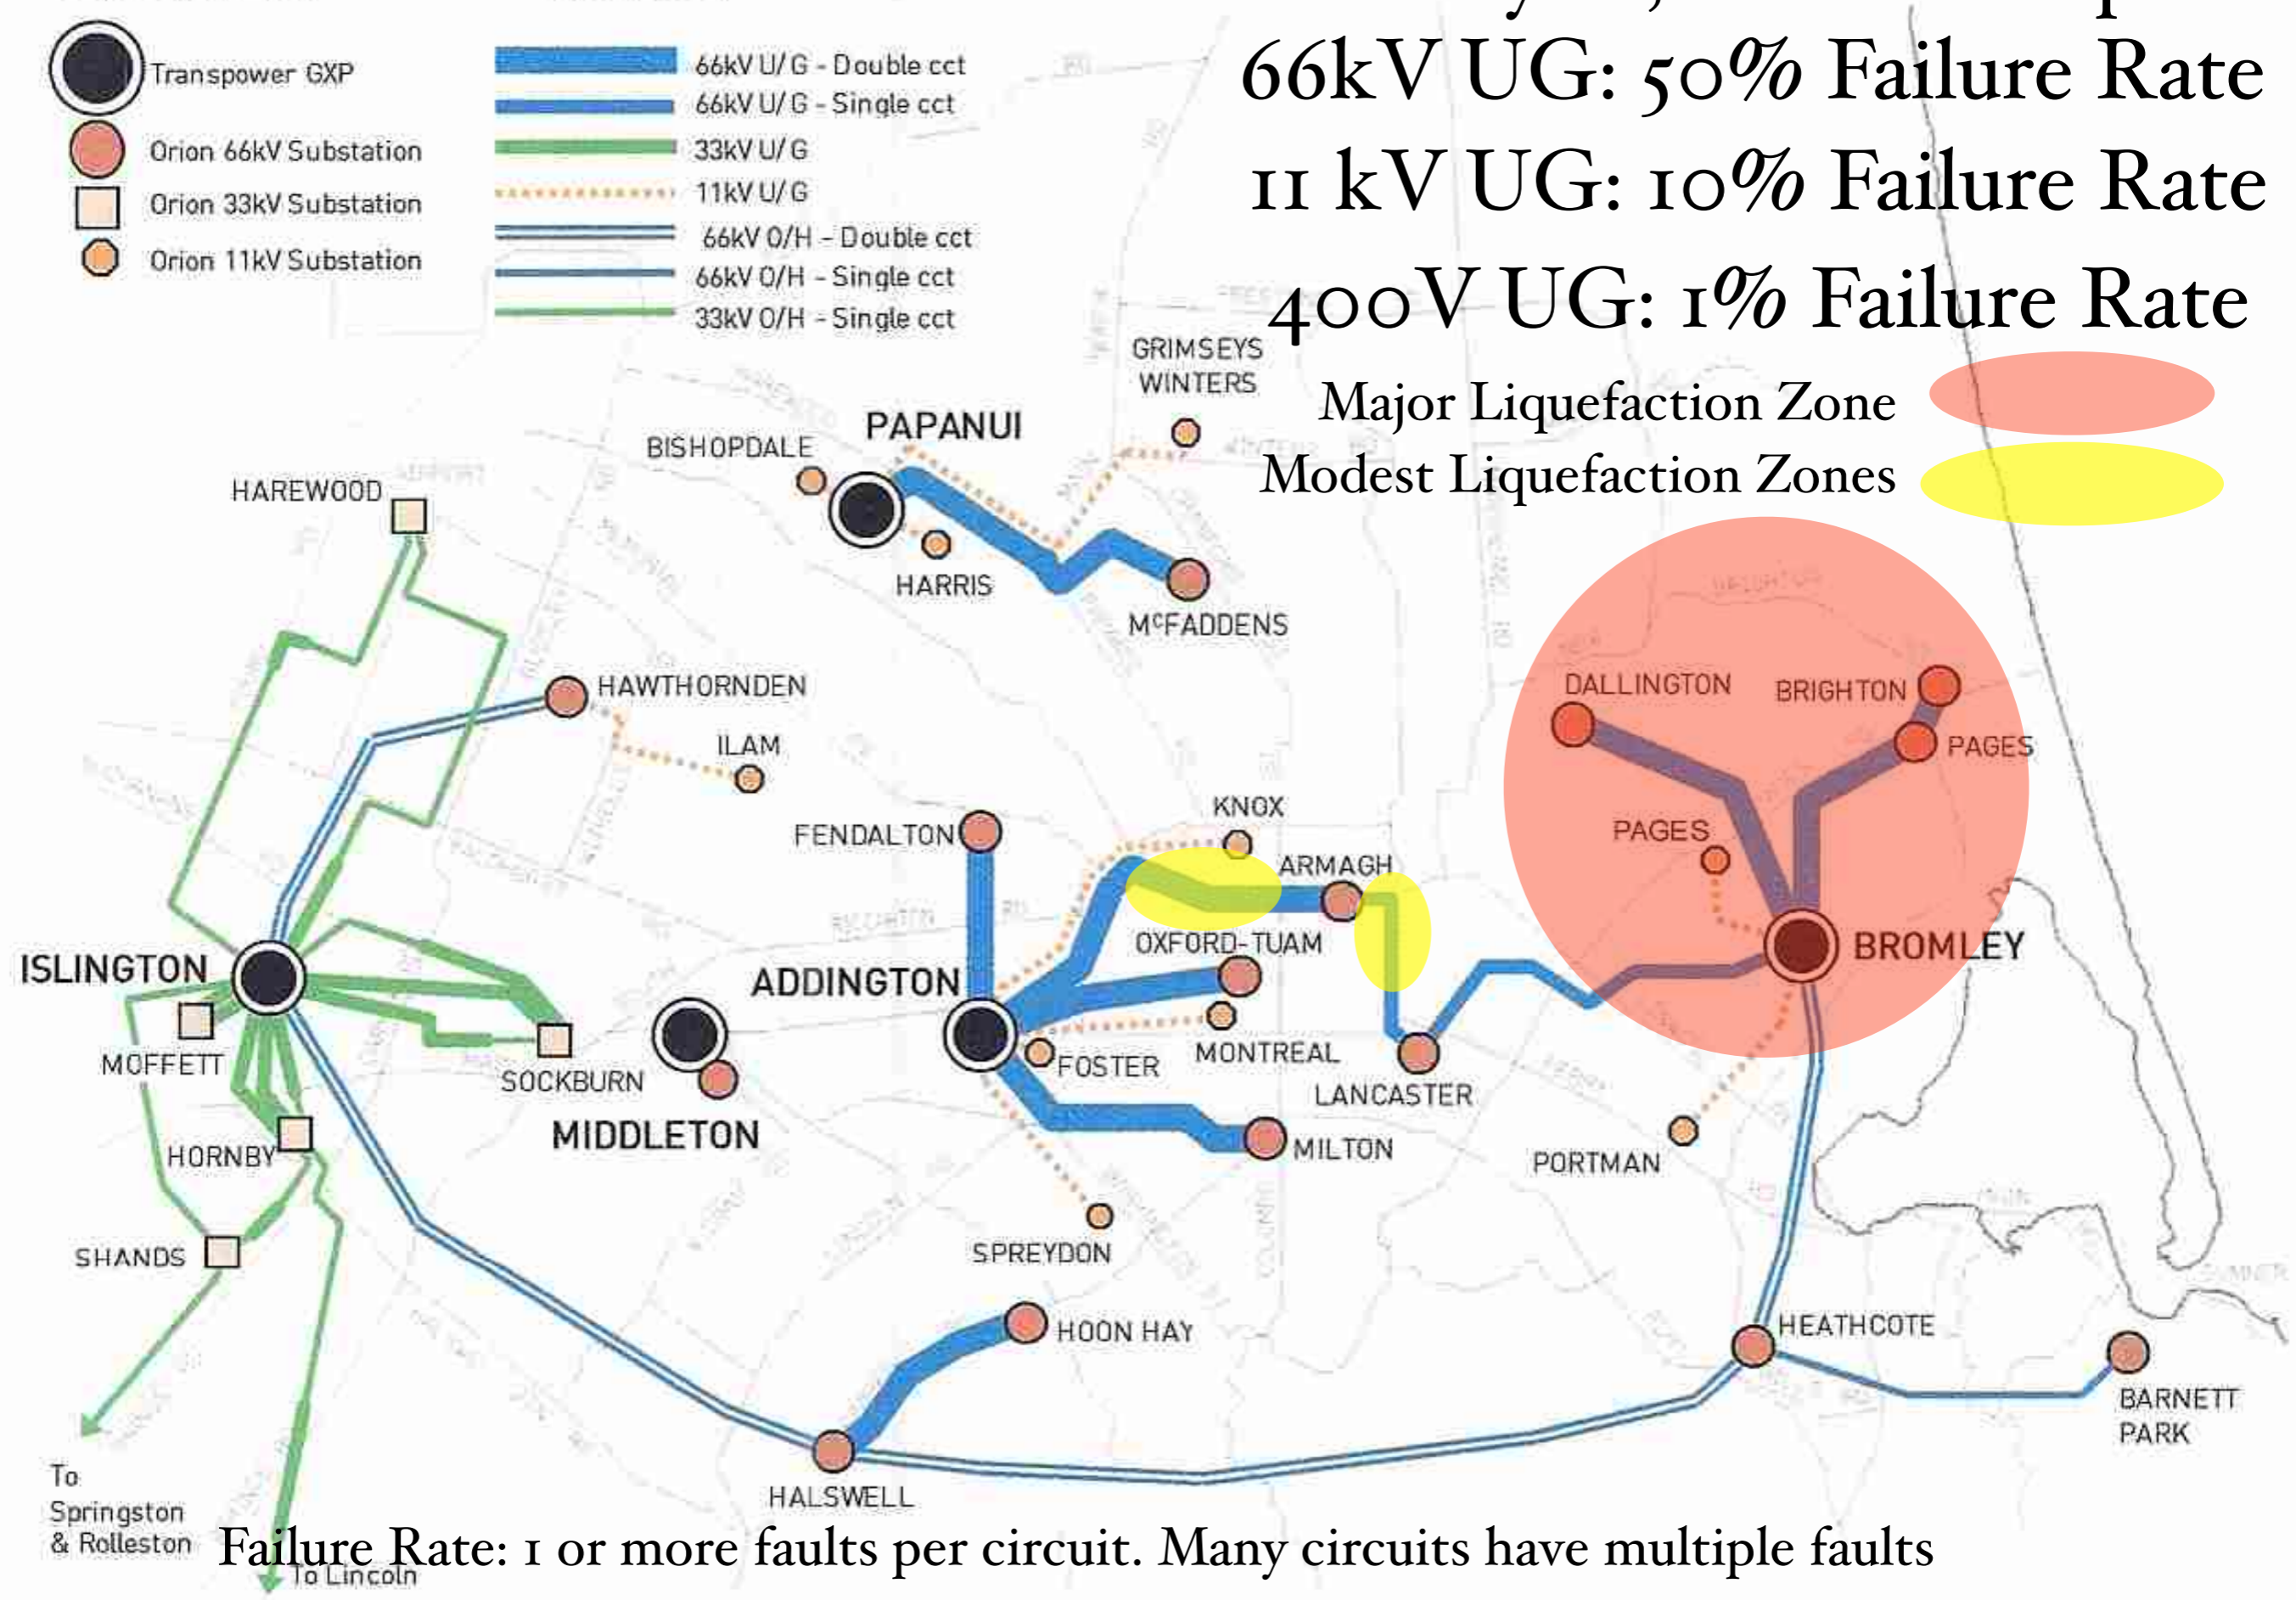
## Orion Inventory 11 kV

February 22, 2011 Earthquake  
 66kV UG: 50% Failure Rate  
 11 kV UG: 10% Failure Rate  
 400V UG: 1% Failure Rate

Failure Rate: 1 or more faults per circuit. Many circuits have multiple faults

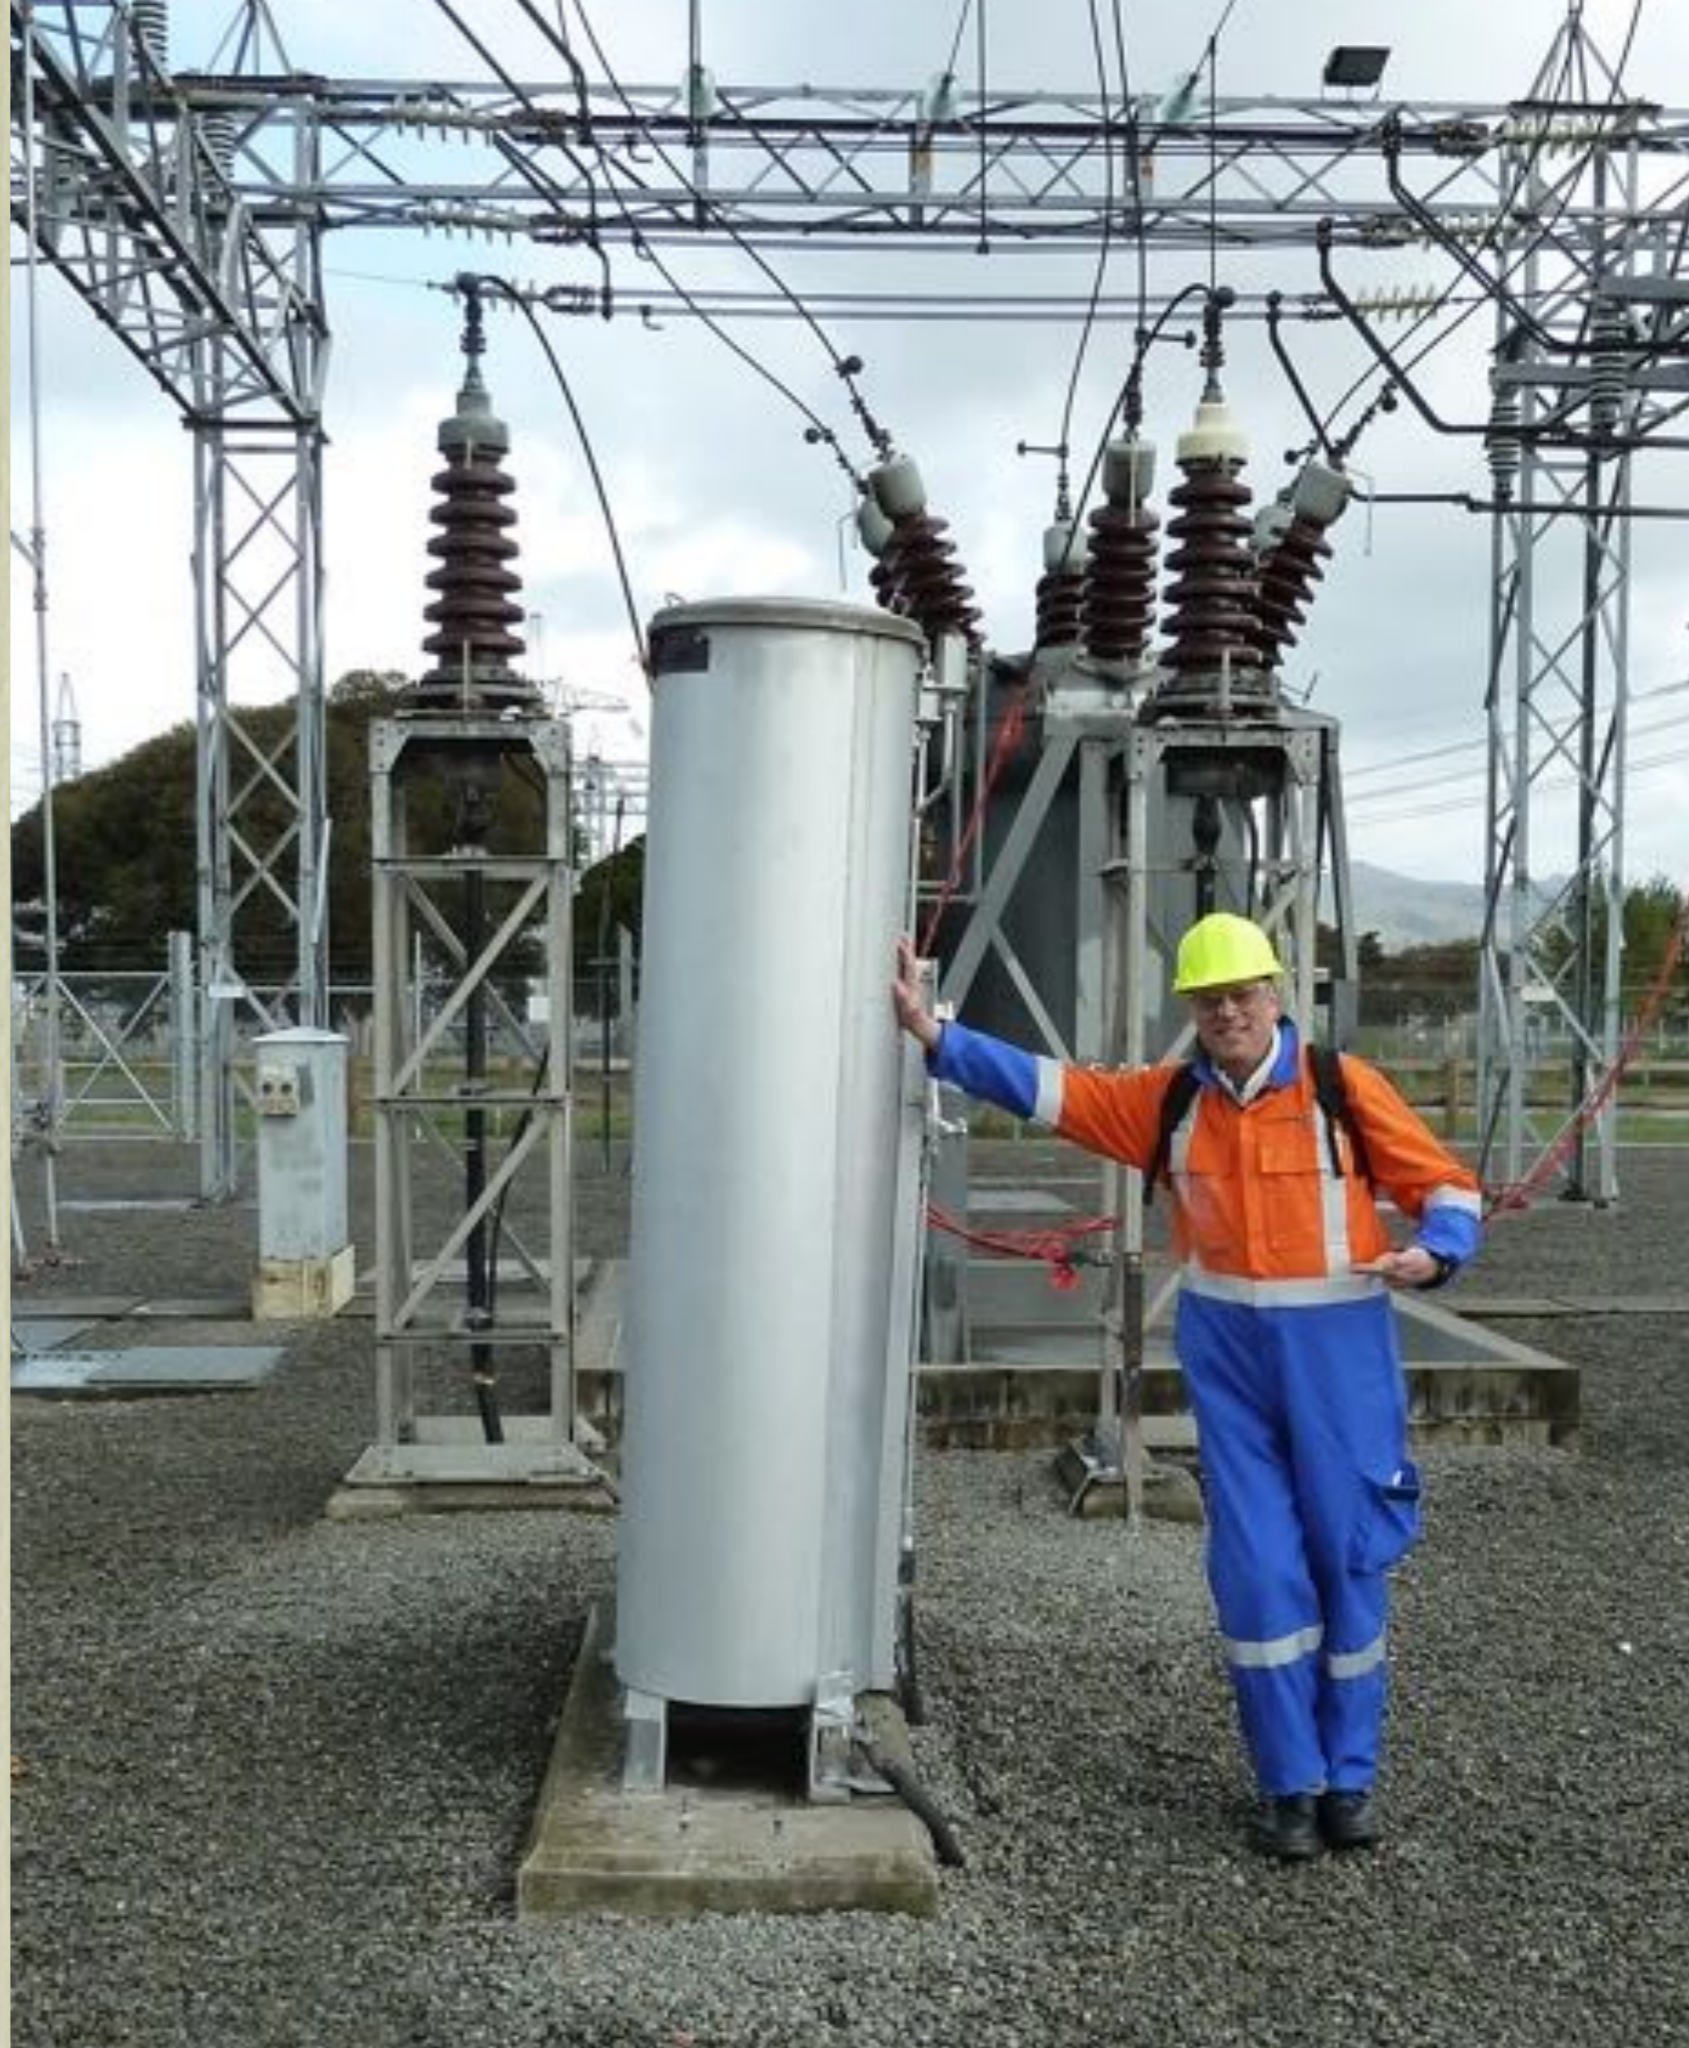
DALLINGTON No.2

2 of 3 were tilted  
on their  
foundations, one  
spalled concrete  
foundation....

but that is not the  
real problem....

0 psi pressure to buried oil-filled cables  
(3 cables from this substation)

This is the  
real problem!

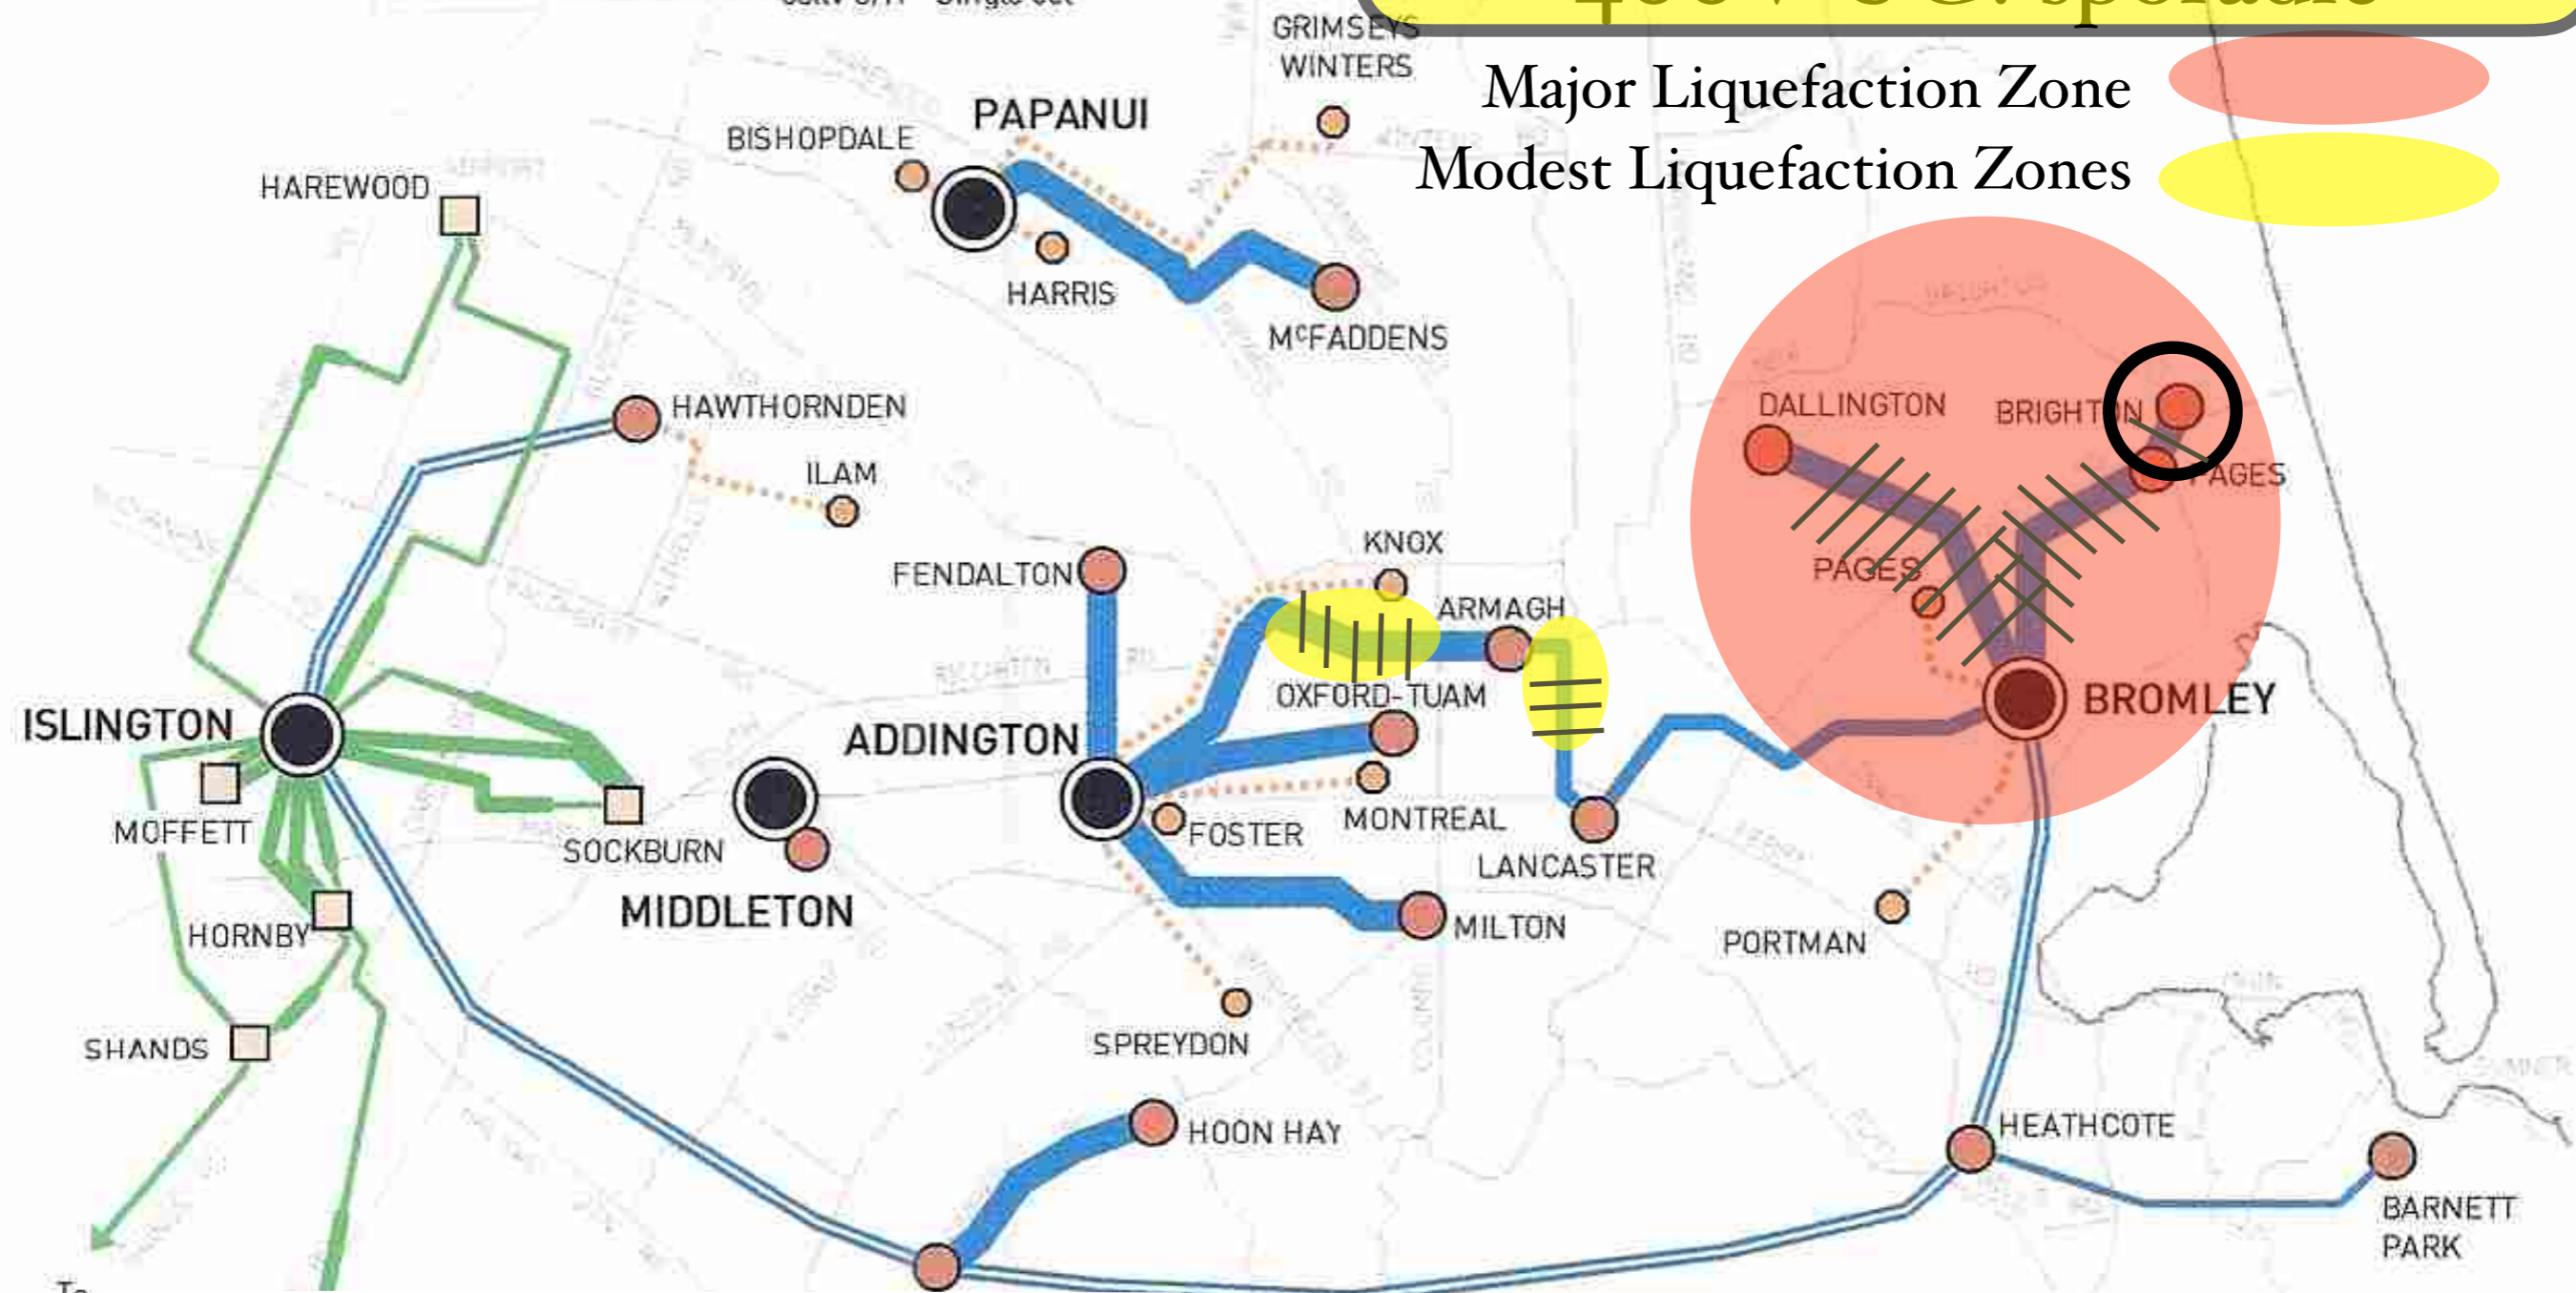
66kV UG: 6 faults, 4 cables  
 11 kV UG: 433 cables  
 400V UG: sporadic

To Spr & F  
 Failure Rate: 1 or more faults per circuit.  
 Many circuits have multiple faults

Substation destroyed due to liquefaction  
 Faulted buried 66 kV Circuit

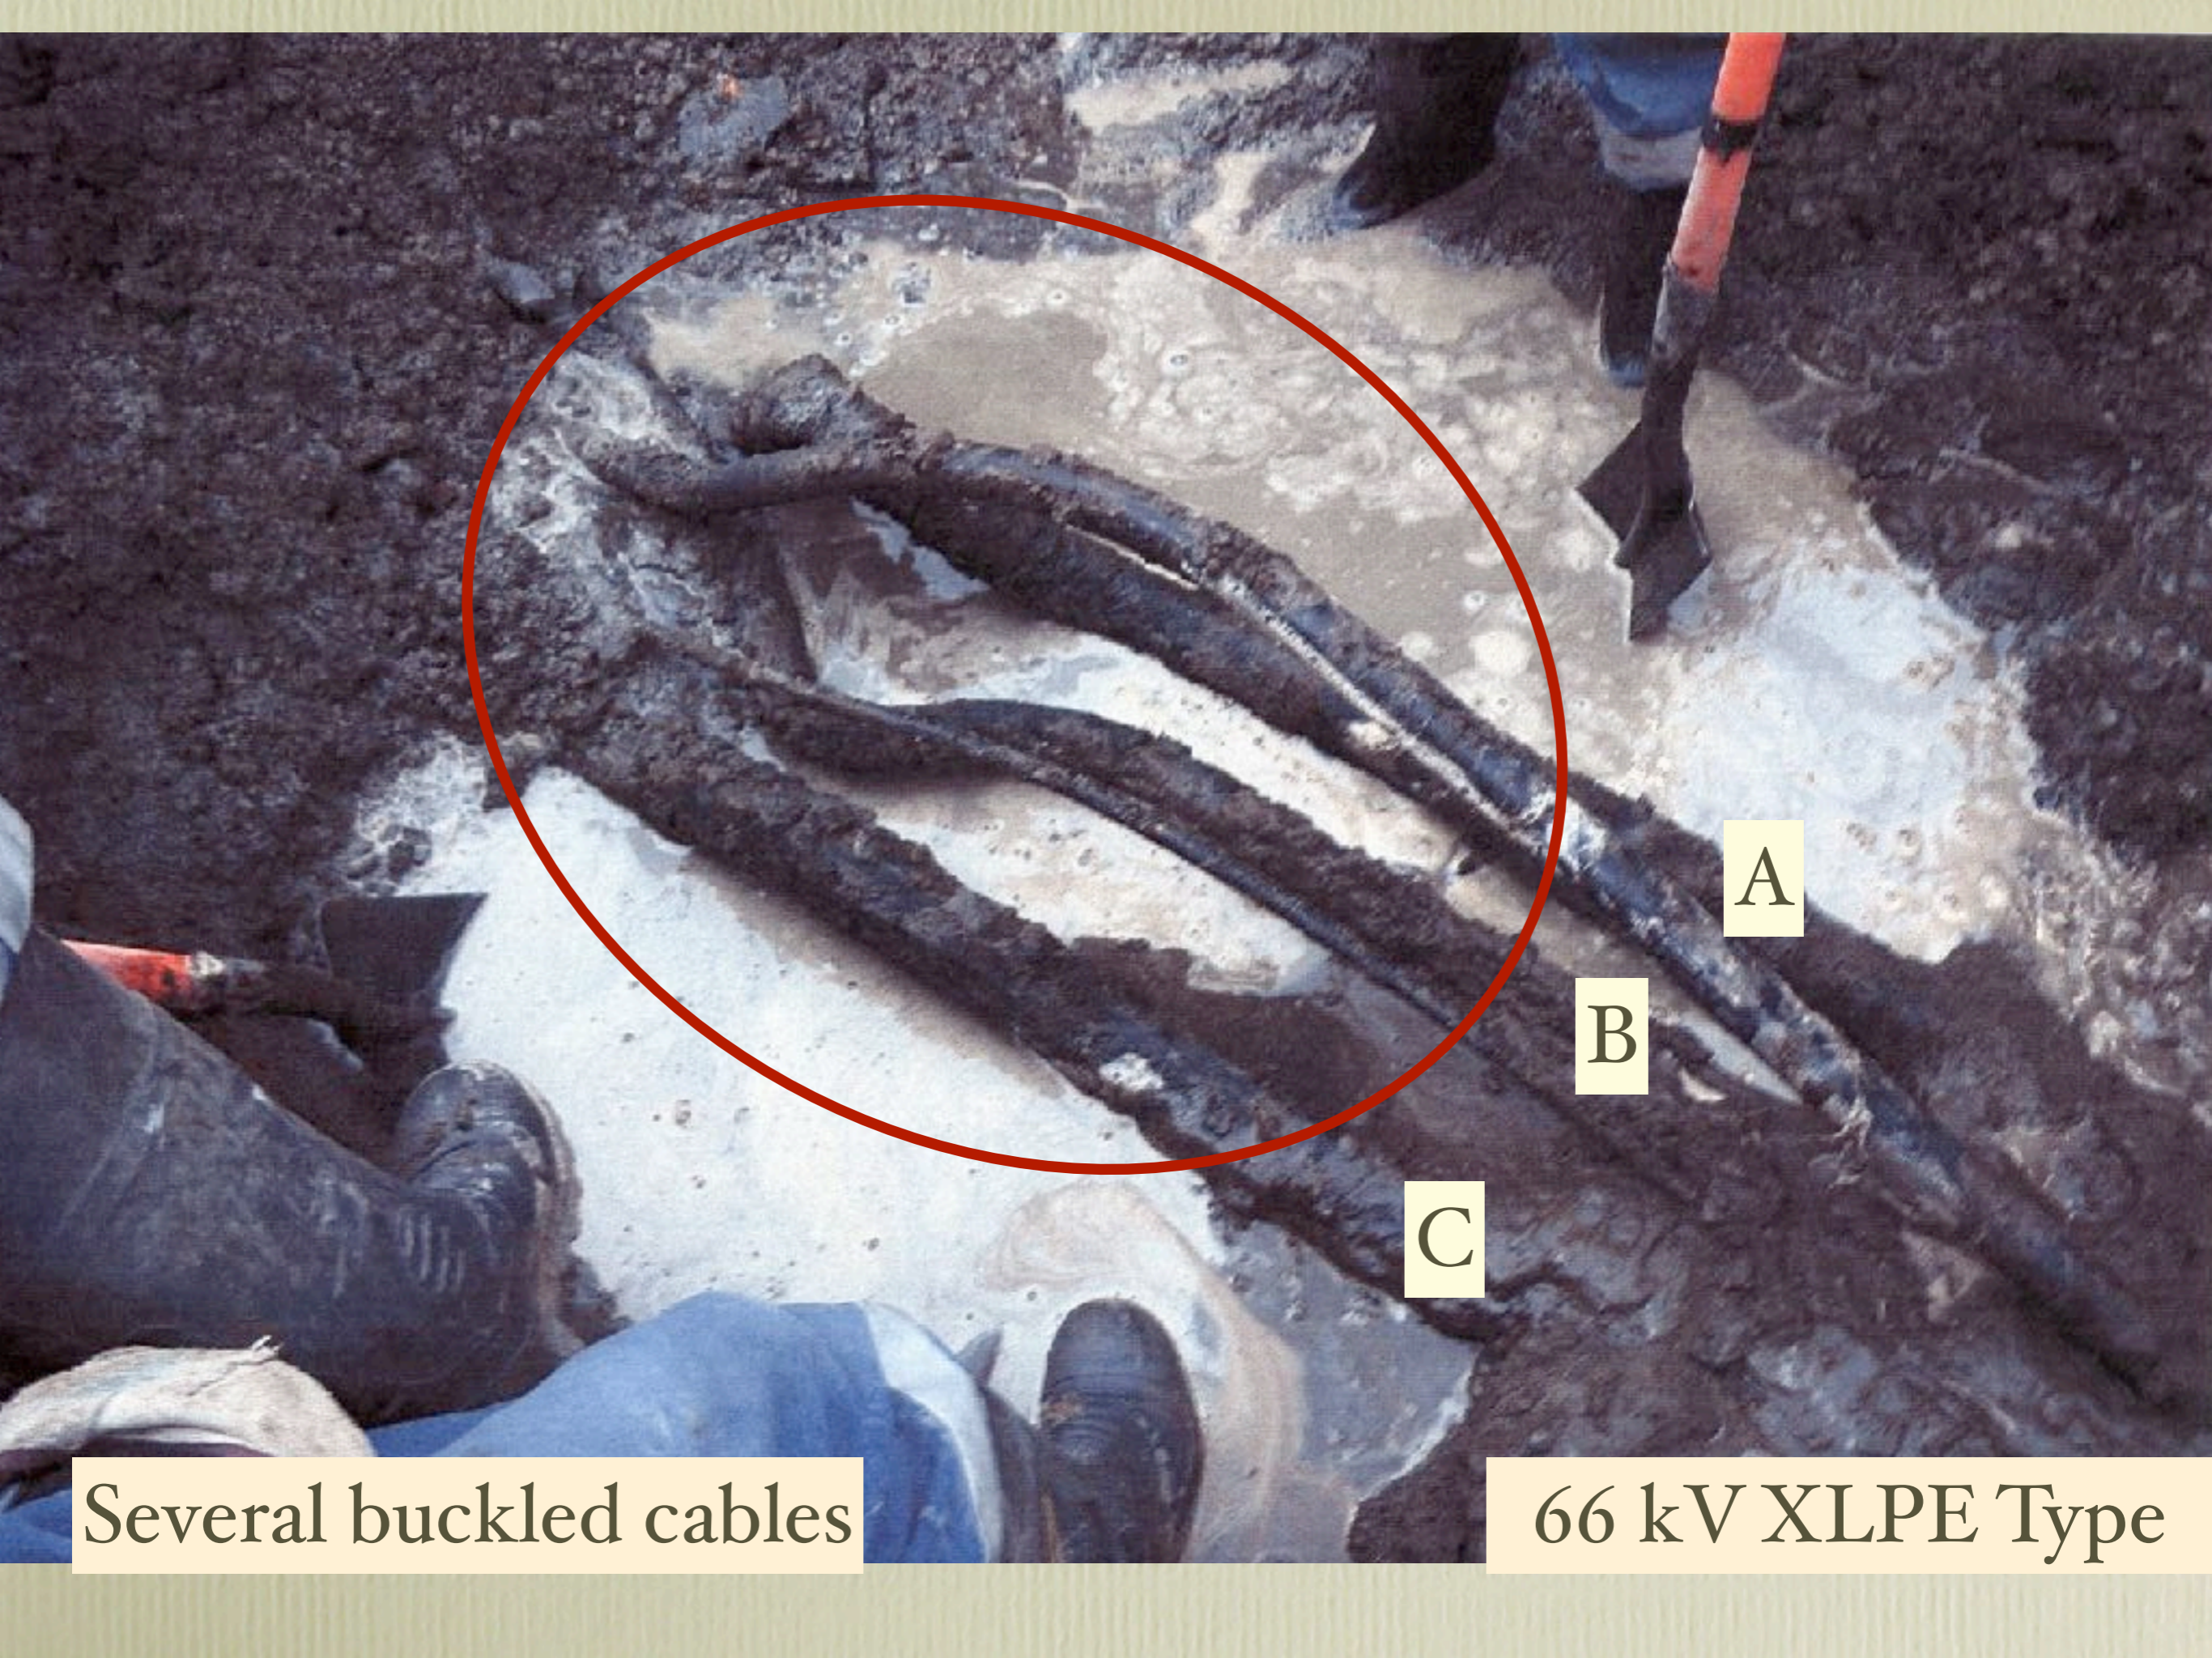
66 kV XLPE Type

Several buckled cables

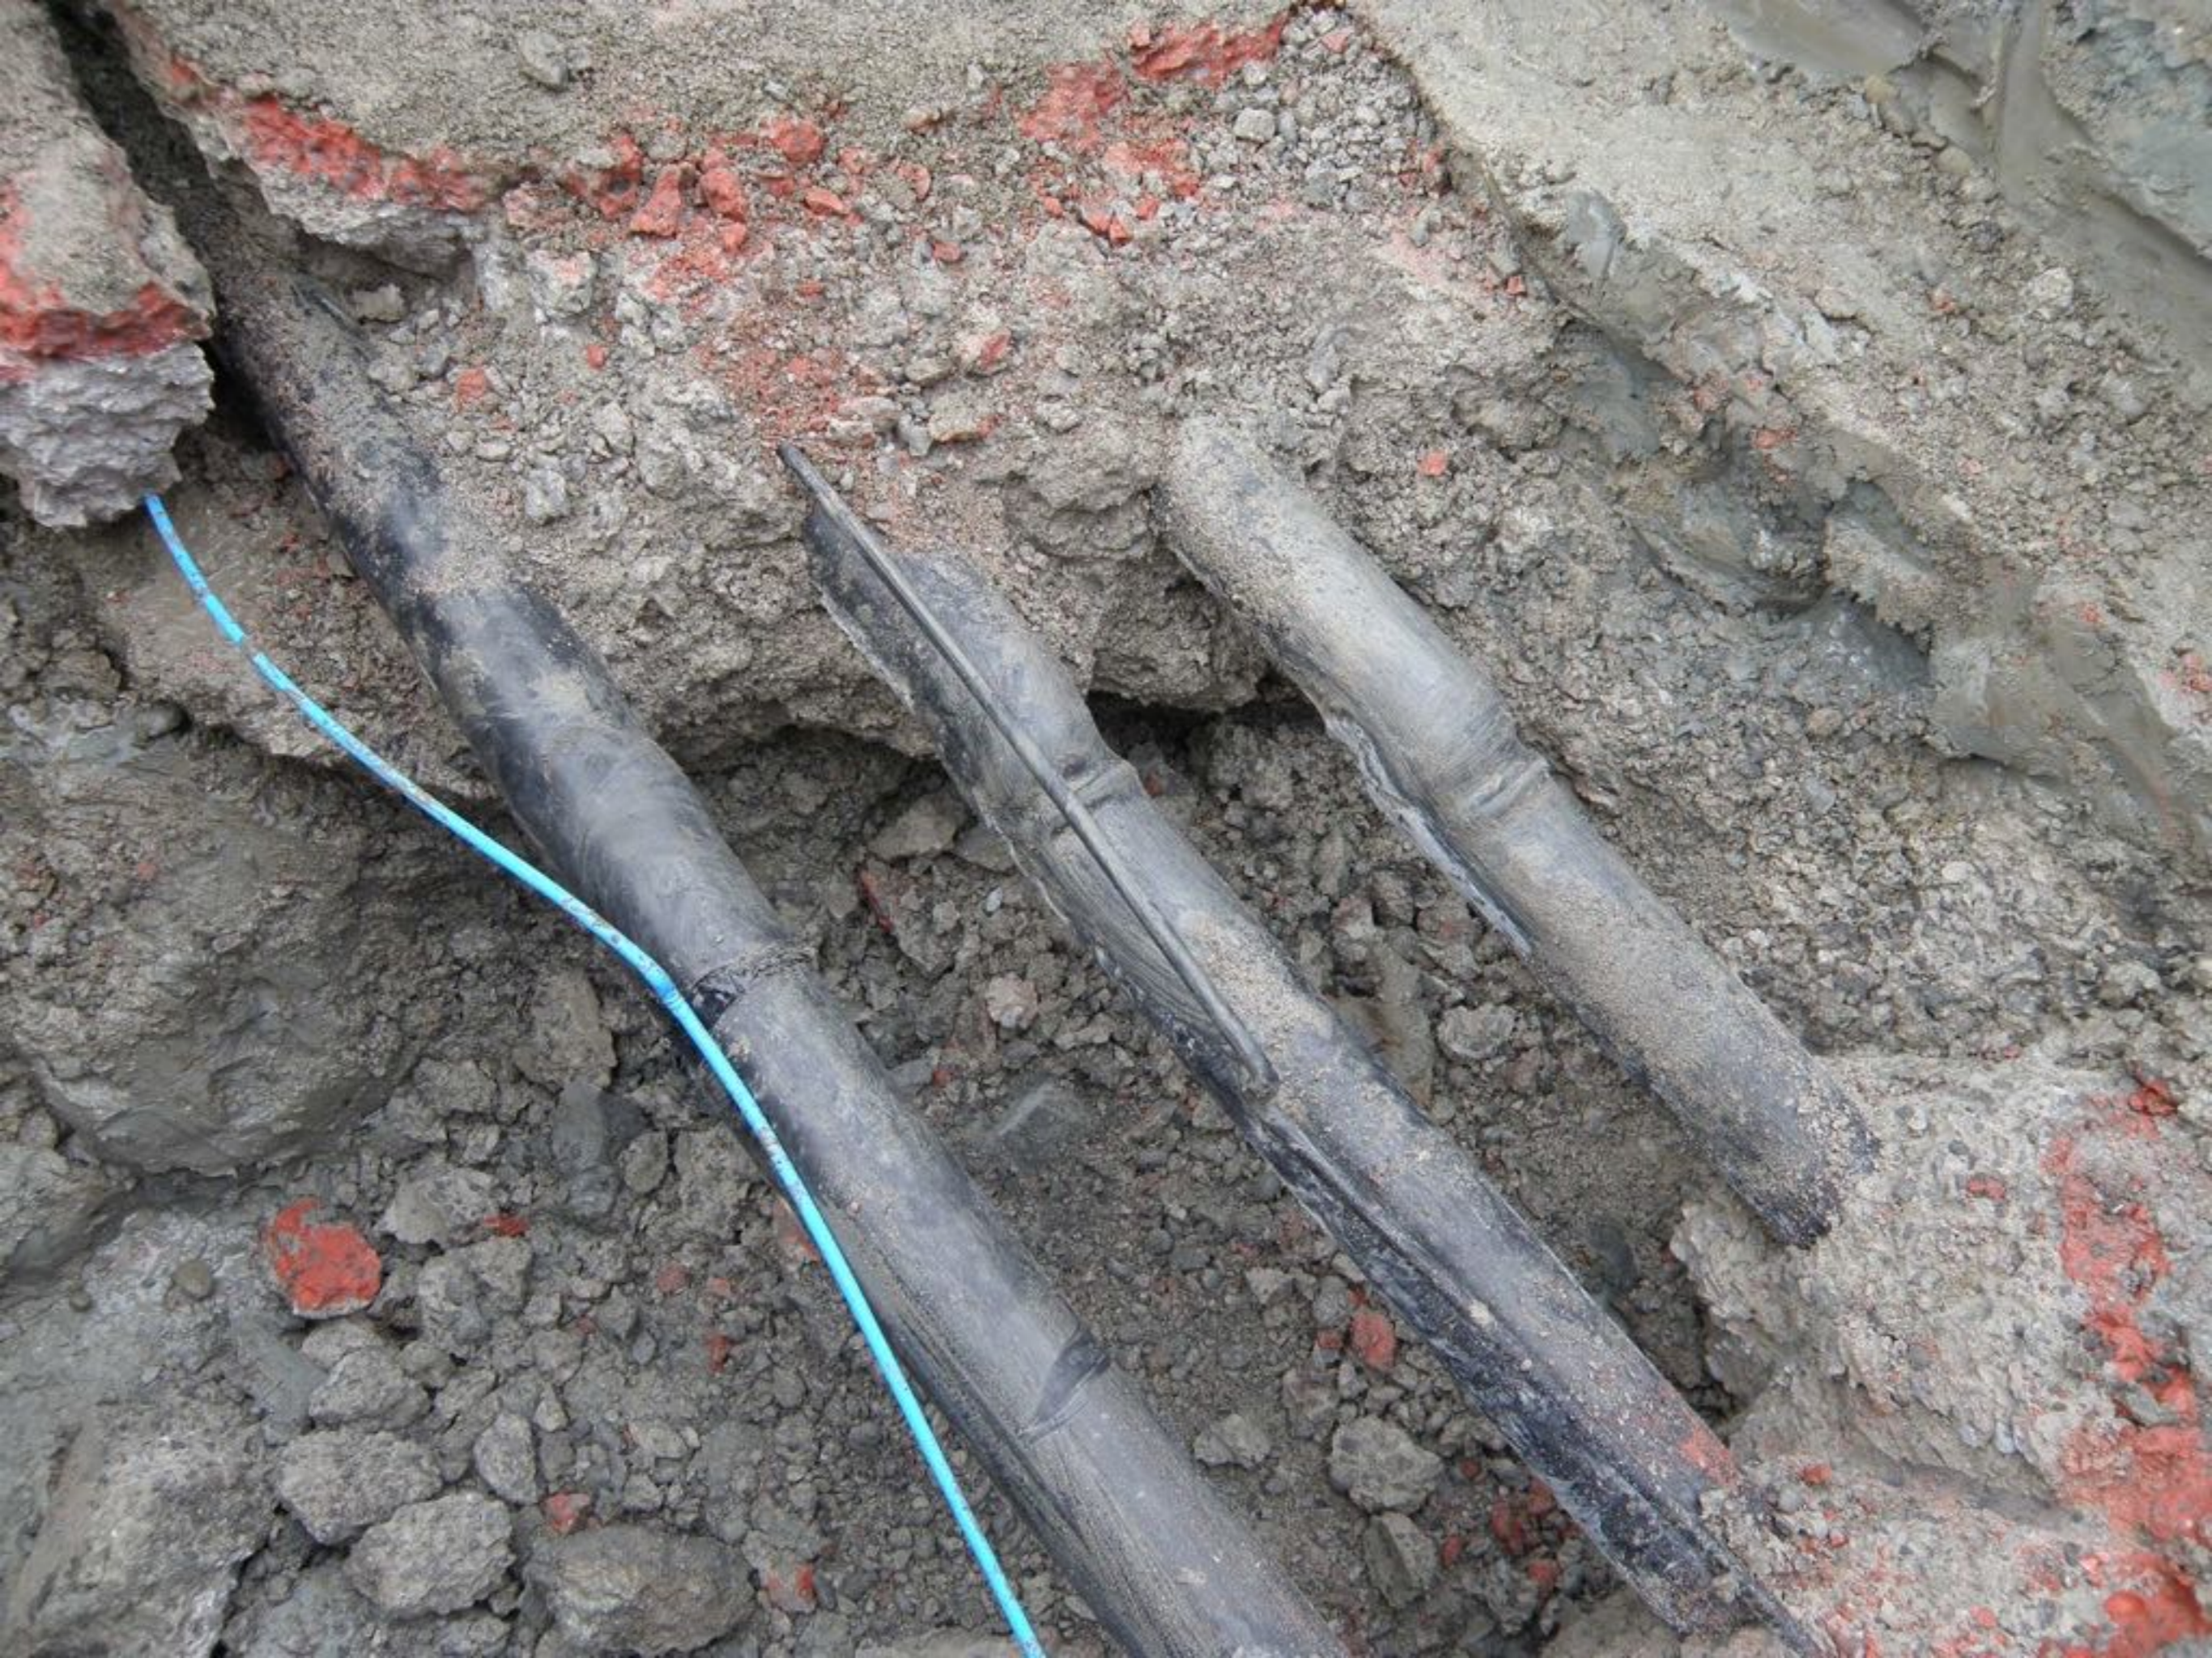
11 kV - Transition from direct burial to conduit

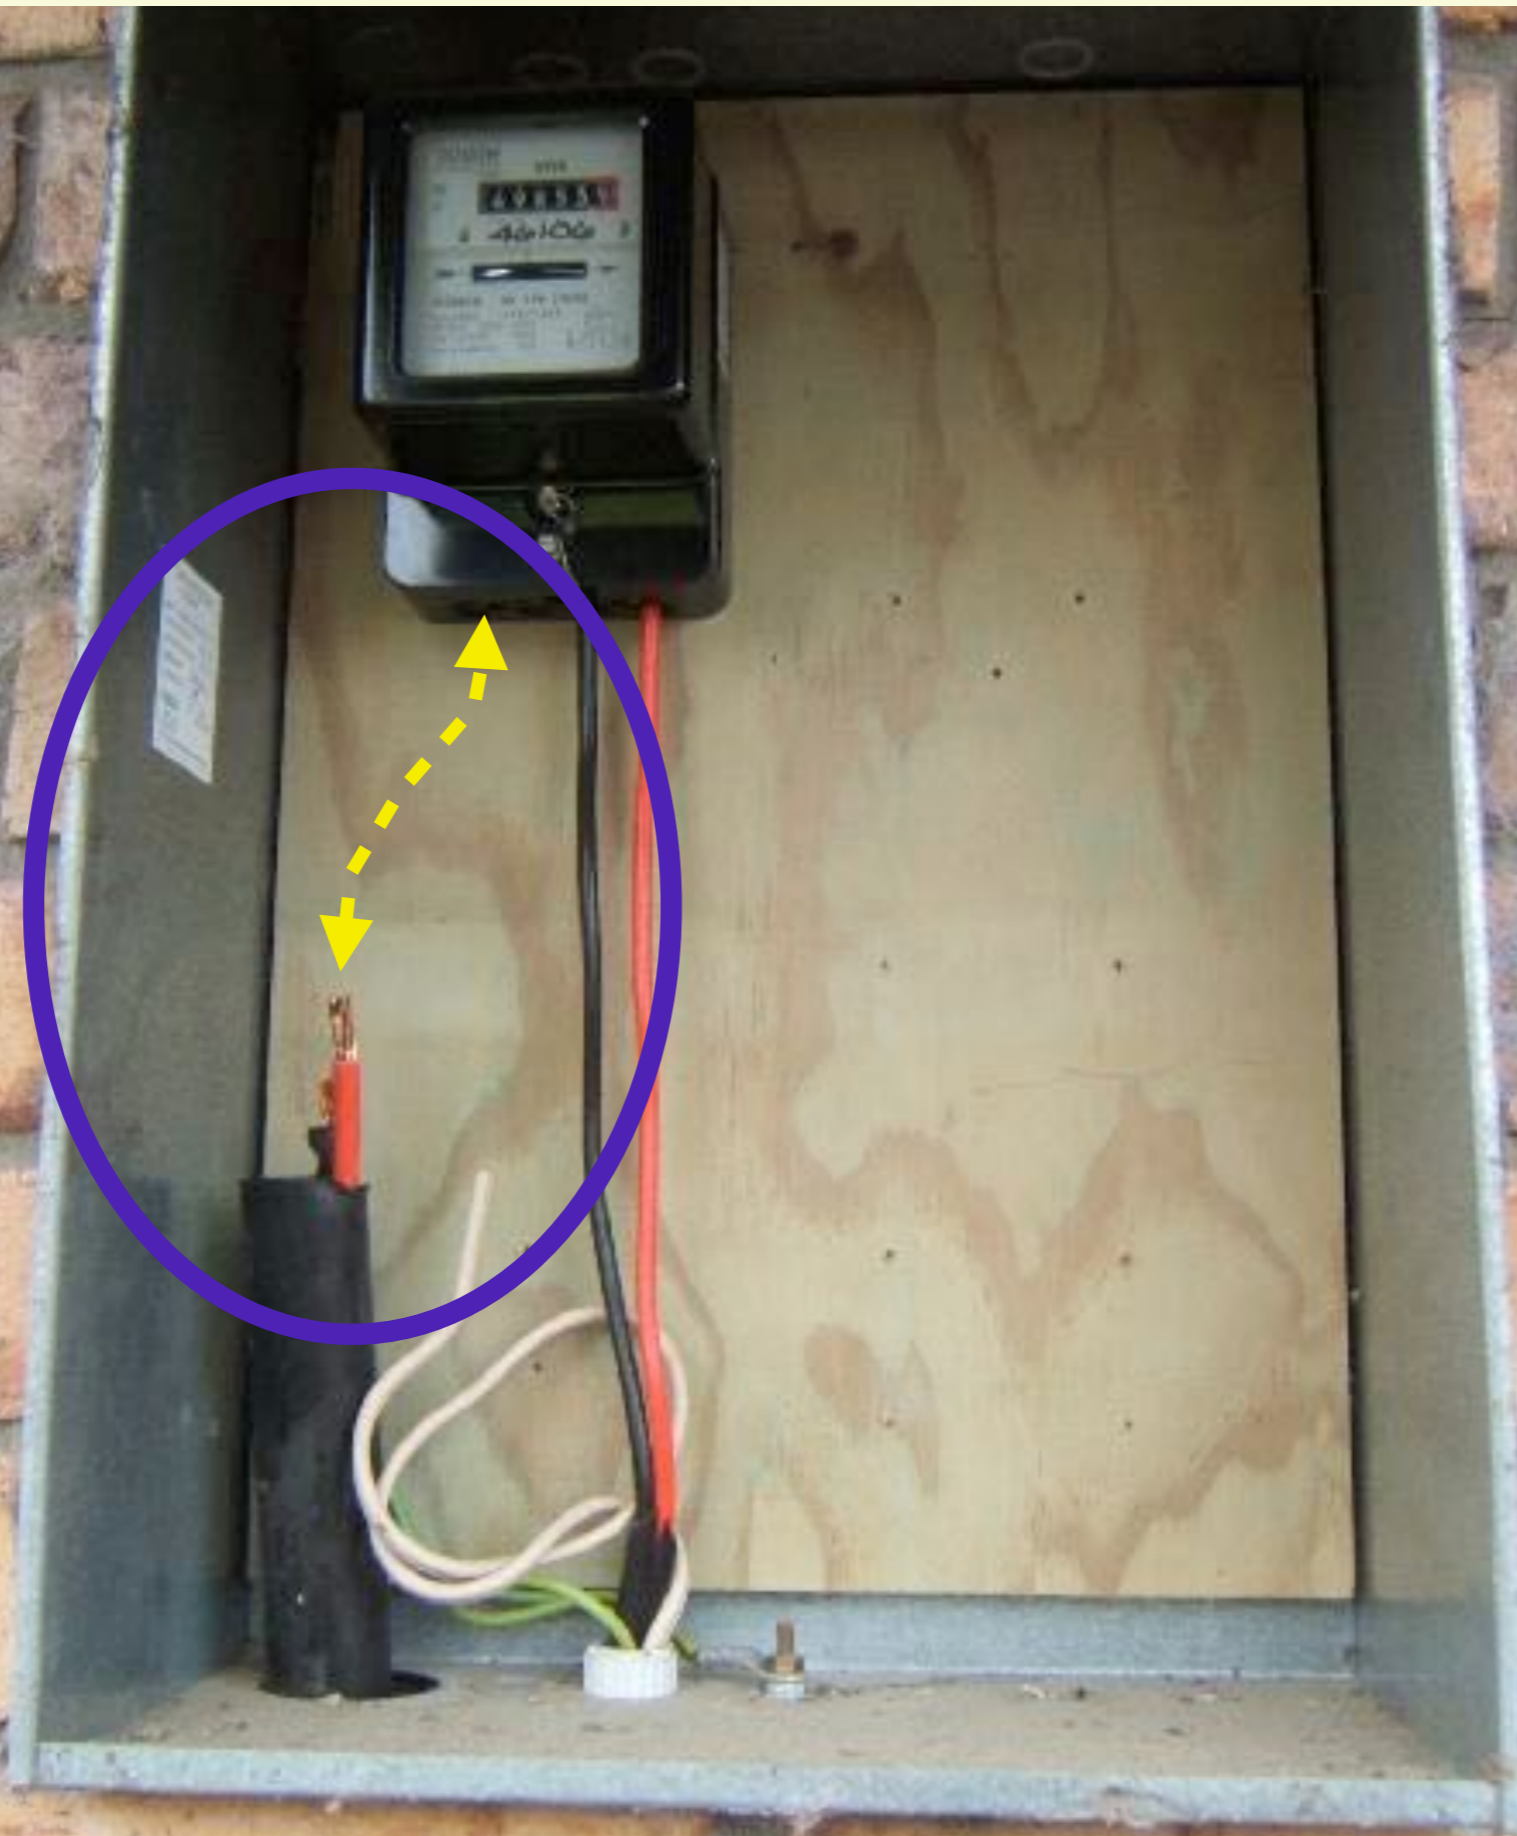
# Failed Meter Service to House (Liquefaction)

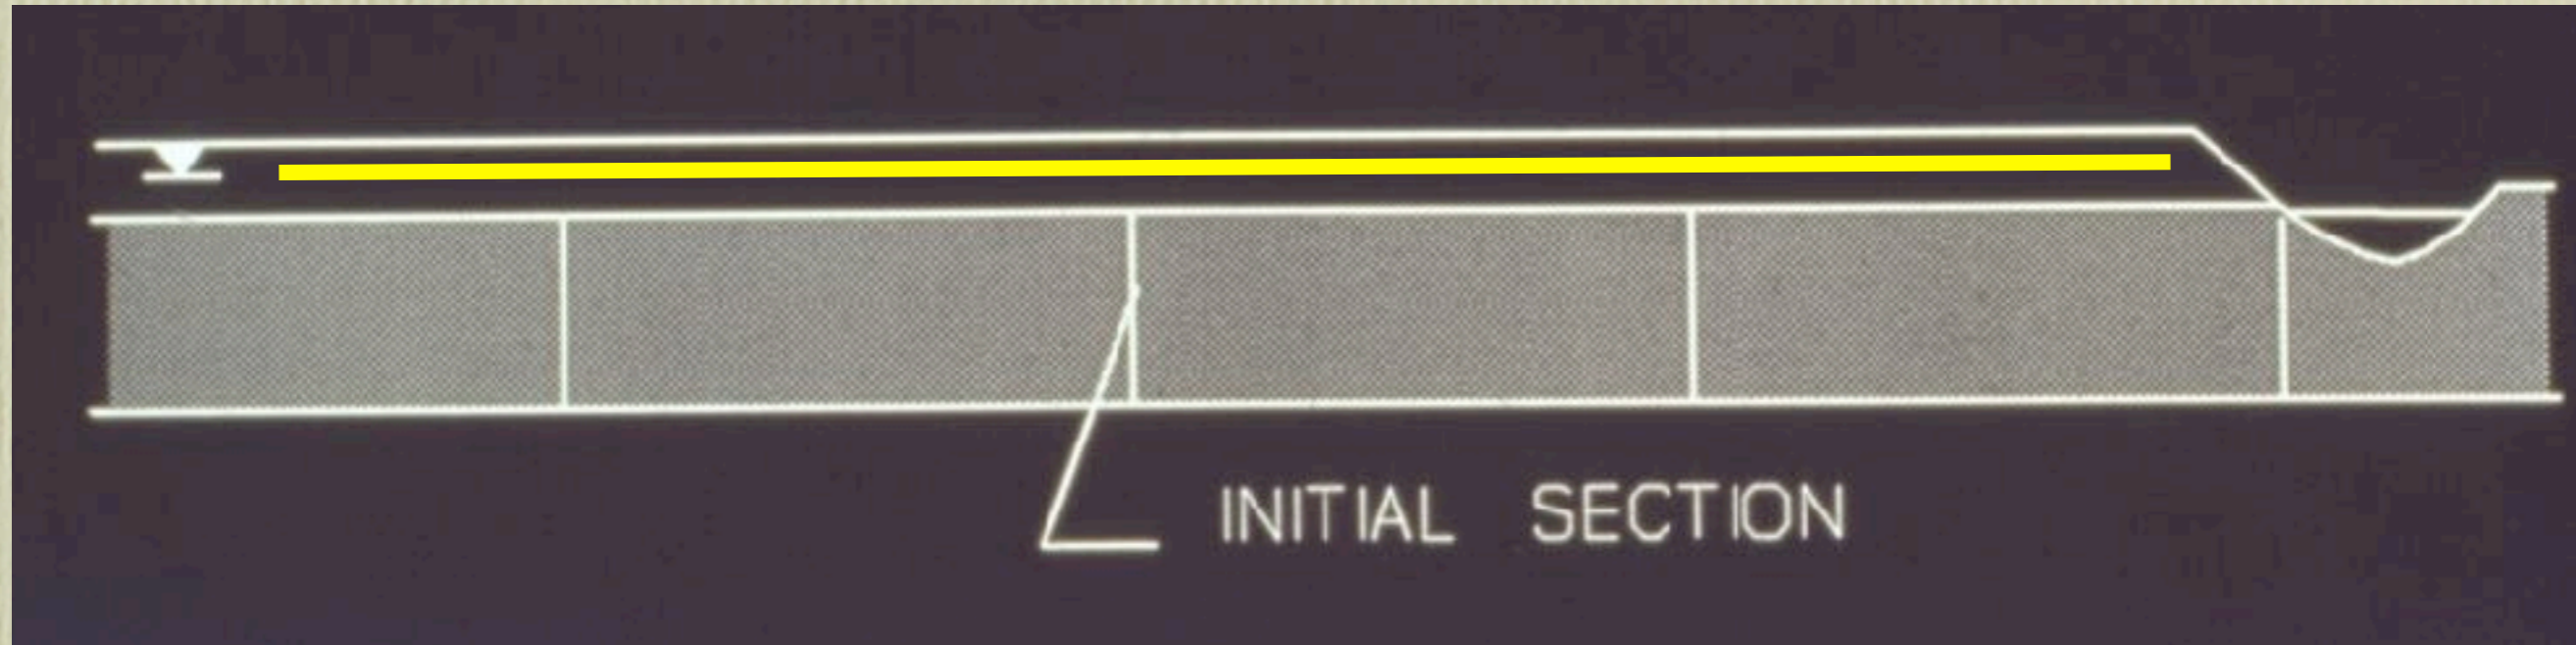
High Voltage Buried Cable
