# Seismic Performance of Buried Cables and Pot Heads

John Eiding

G&E Engineering Systems Inc.

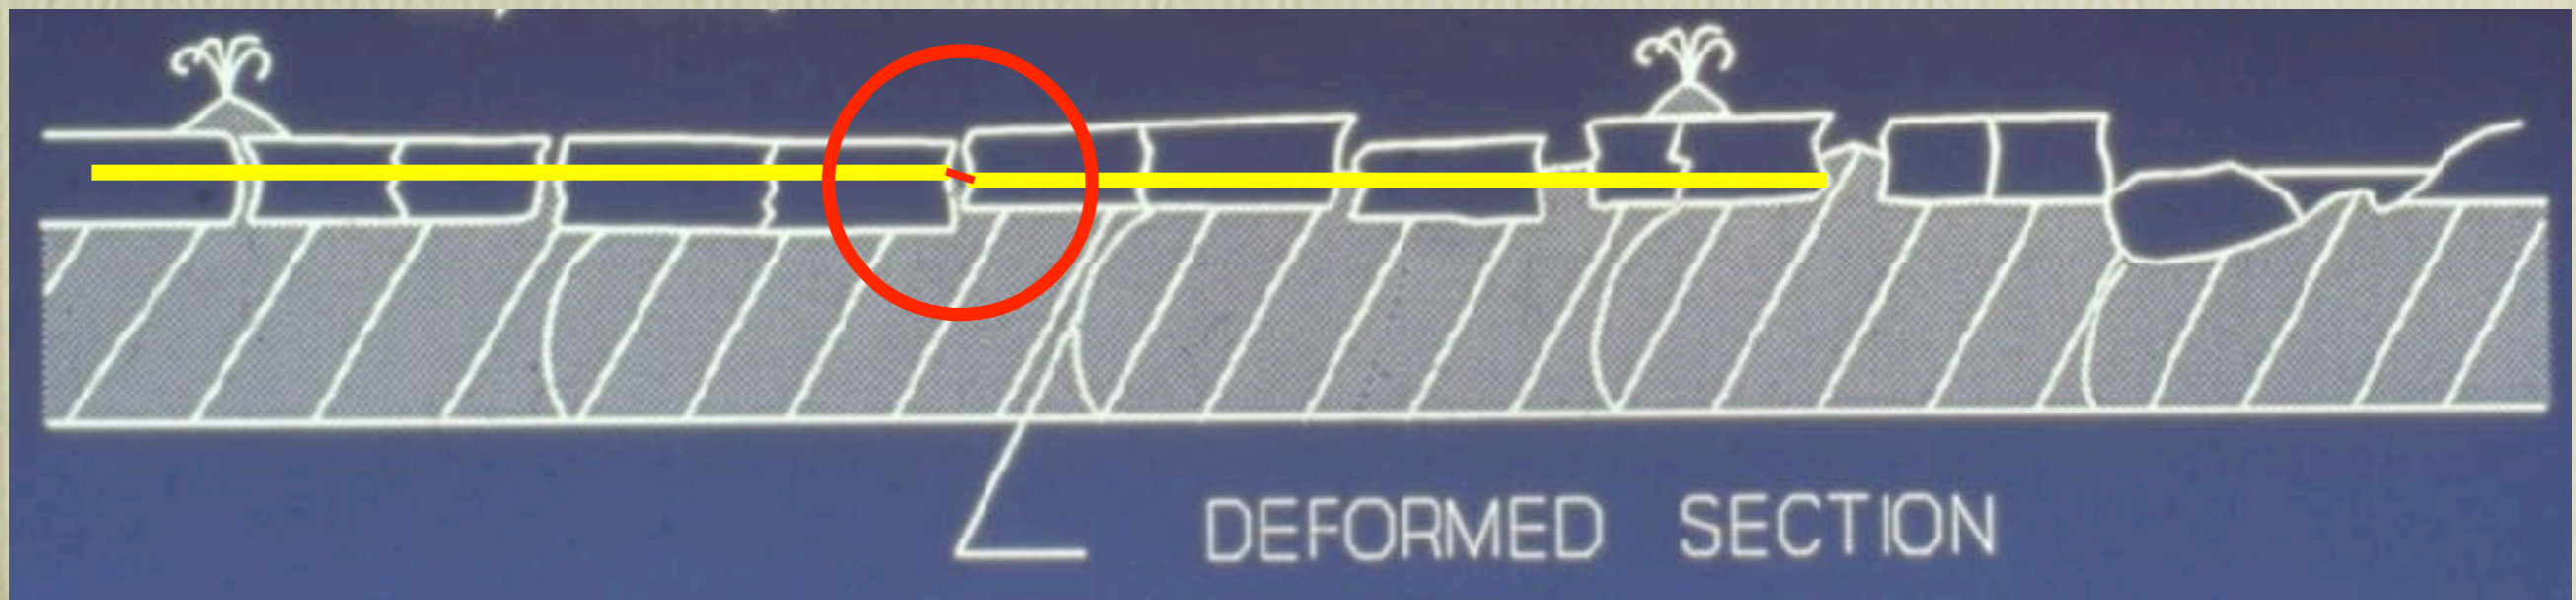
Soil cap blocks continue to vibrate back and forth

Cable Compresses, High Curvature, Buckles and Fails

- Never use direct burial cables in thermal concrete in liquefaction zones.
- Use overhead (if possible)
- User buried cables in PVC or HDPE conduits within reinforced thermal concrete duct banks
