Christchurch, Feb 22 2011 and Sept 4 2010

John Eiding  
G&E Engineering Systems Inc.  
[eidinger@geEngineeringSystems.com](mailto:eidinger@geEngineeringSystems.com)

## Impact to Electric Power Systems

ASCE - Structural Congress

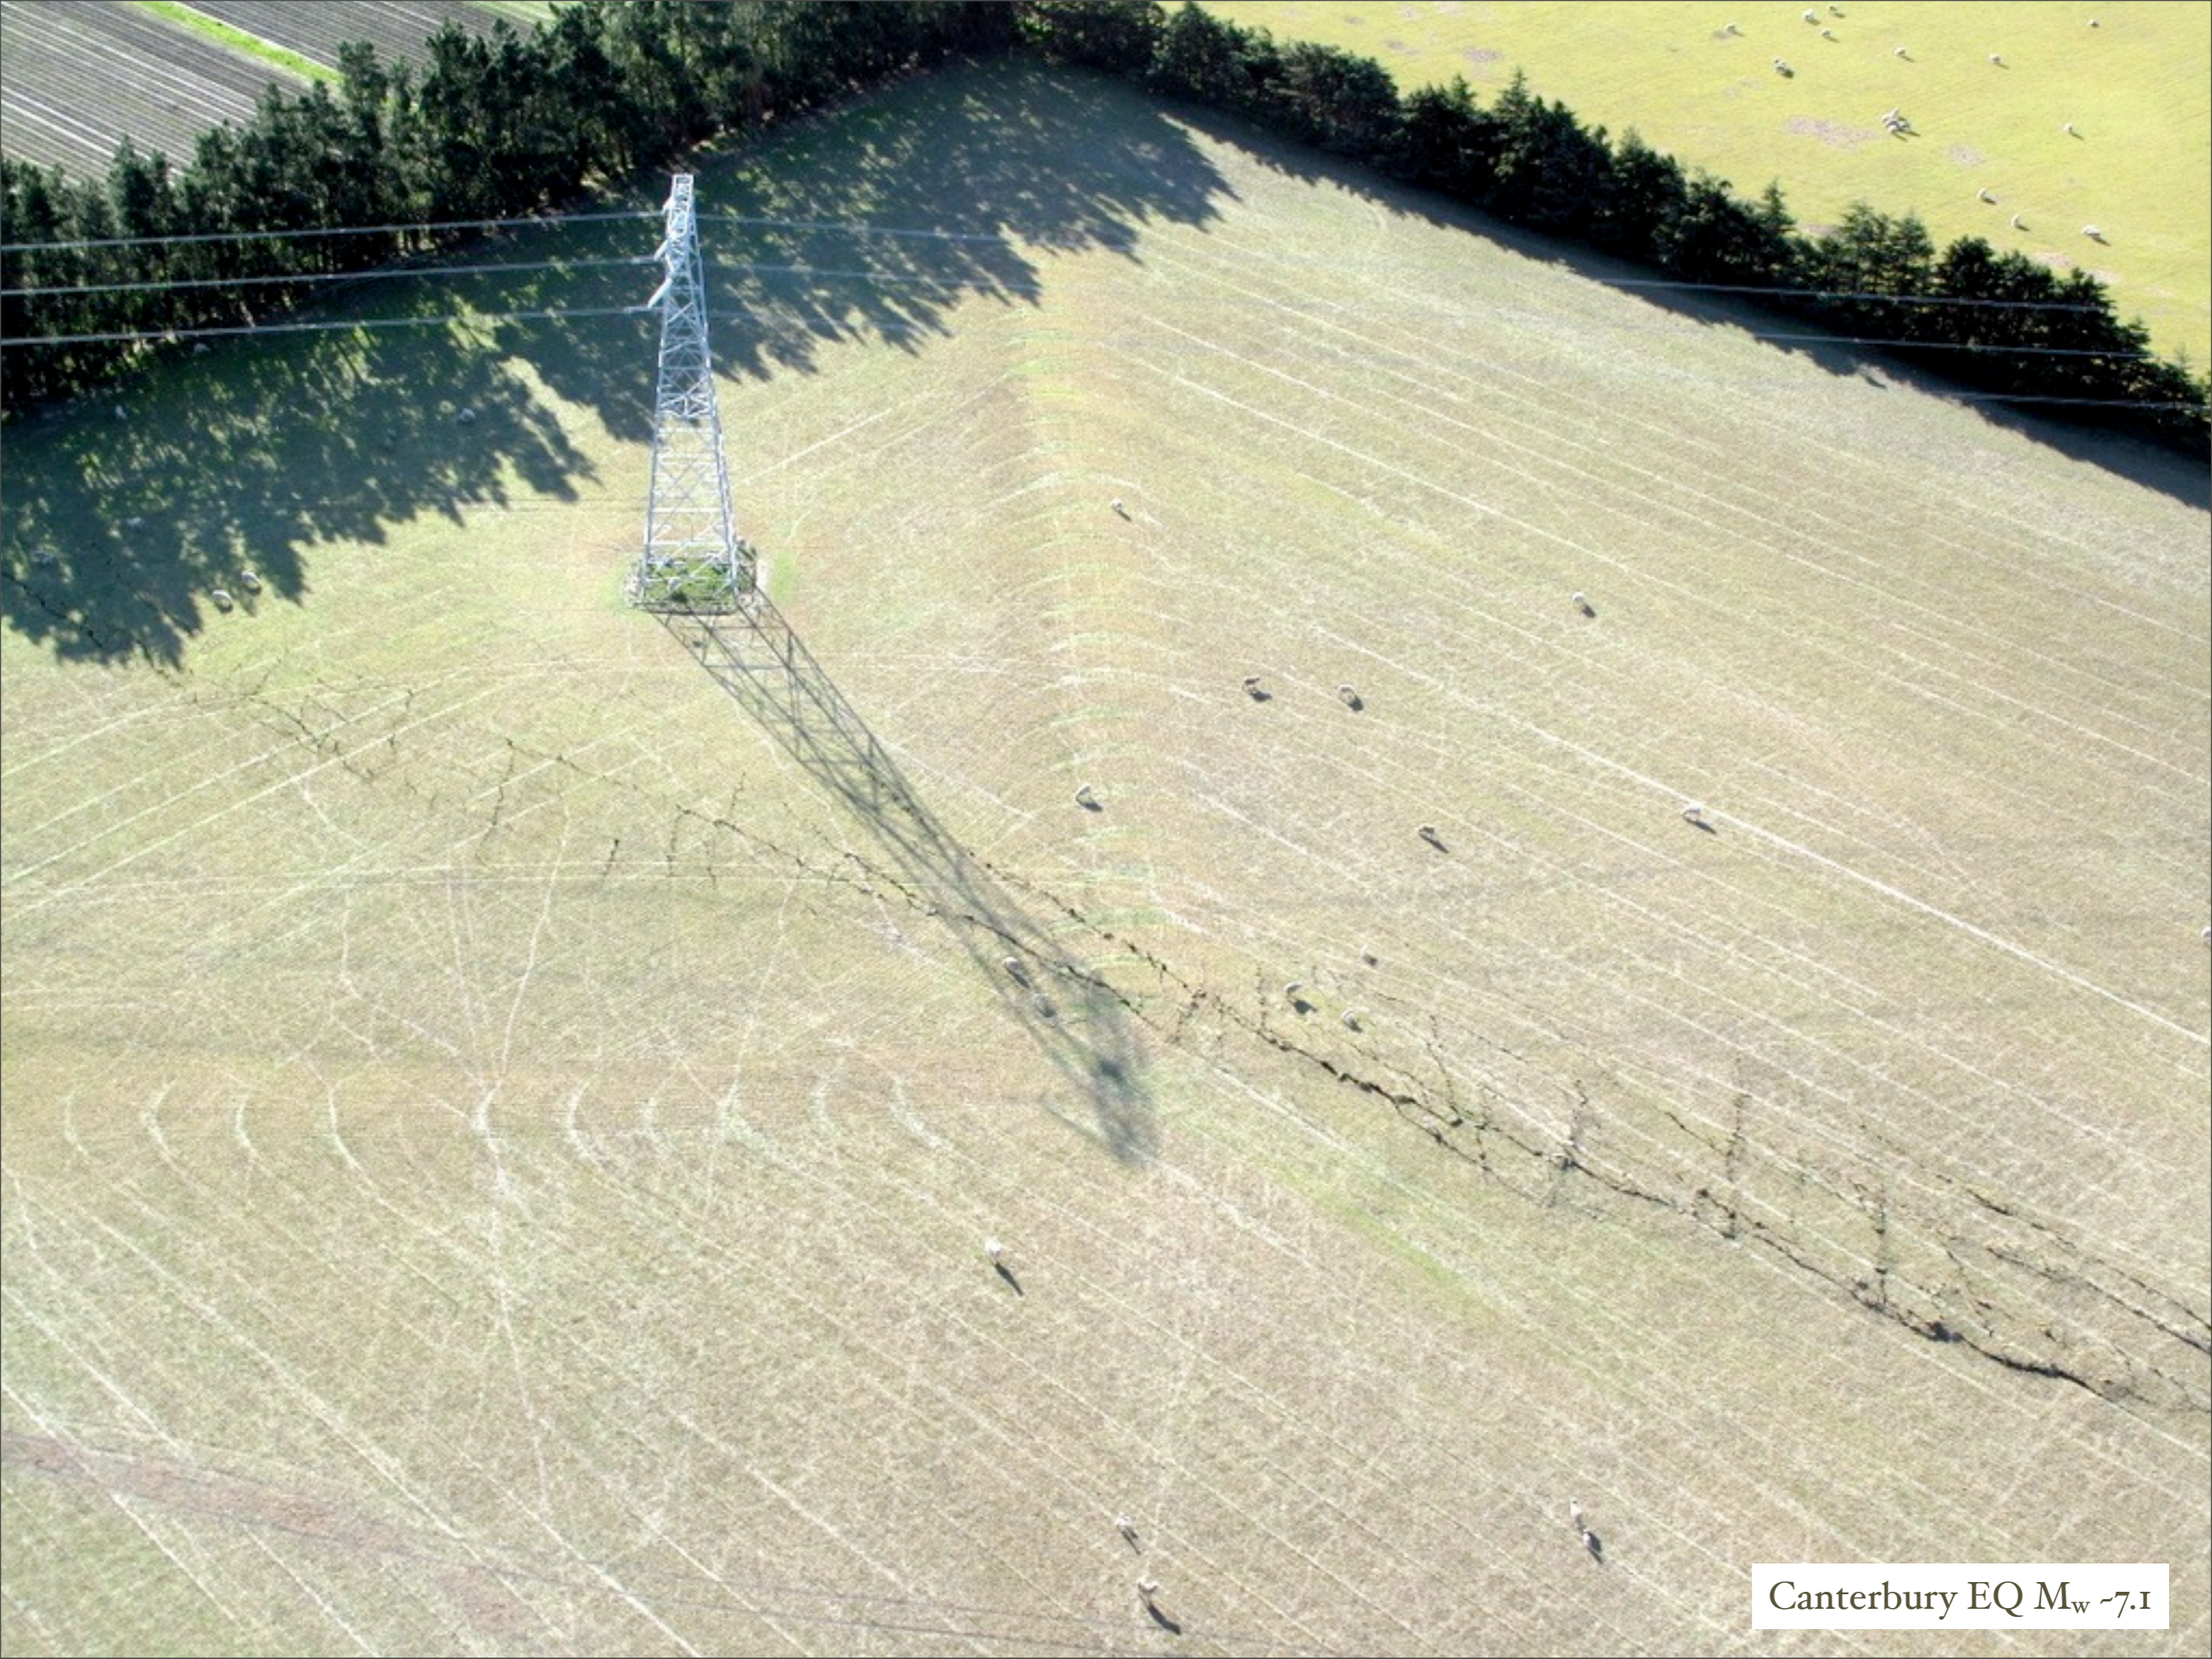
Roxburgh-Islington  
220 kV Fault Offset  
Two-bundle. No  
ground wire.  
Insulators remain  
stretched as of  
October 14, 2010,  
awaiting a suitable  
outage. Line Tensions  
are unbalanced but  
tolerable

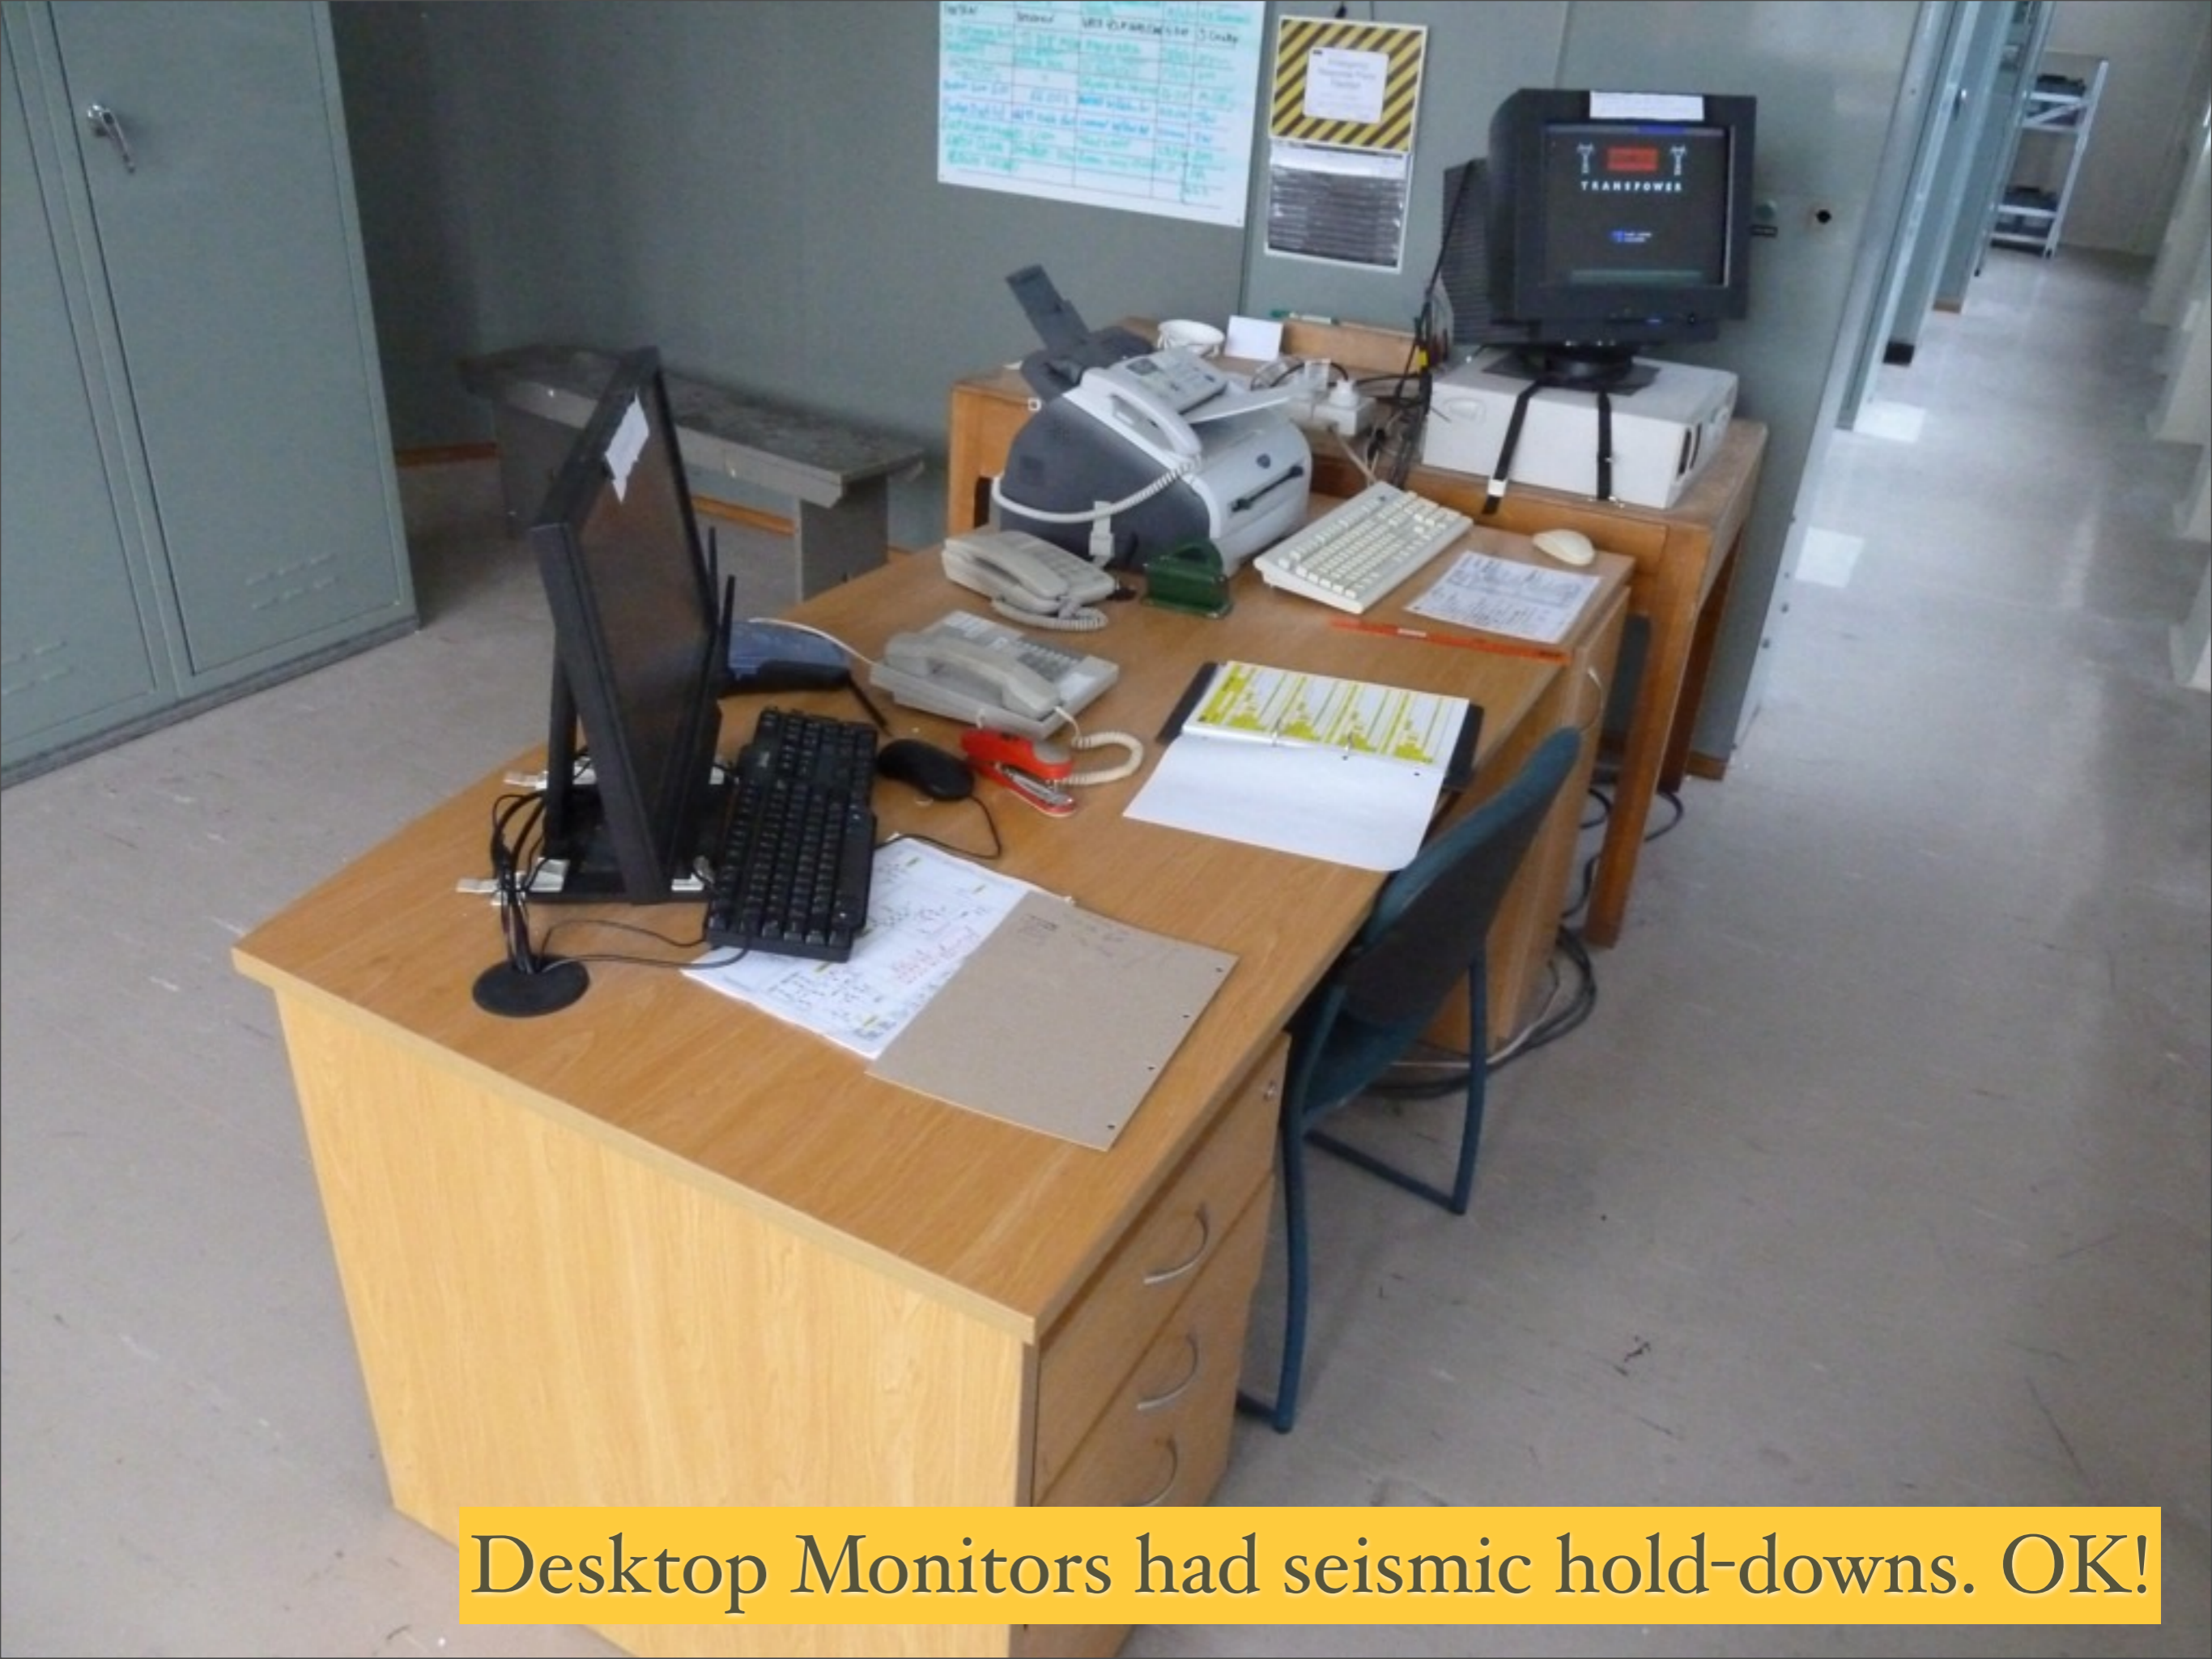
Desktop Monitors had seismic hold-downs. OK!

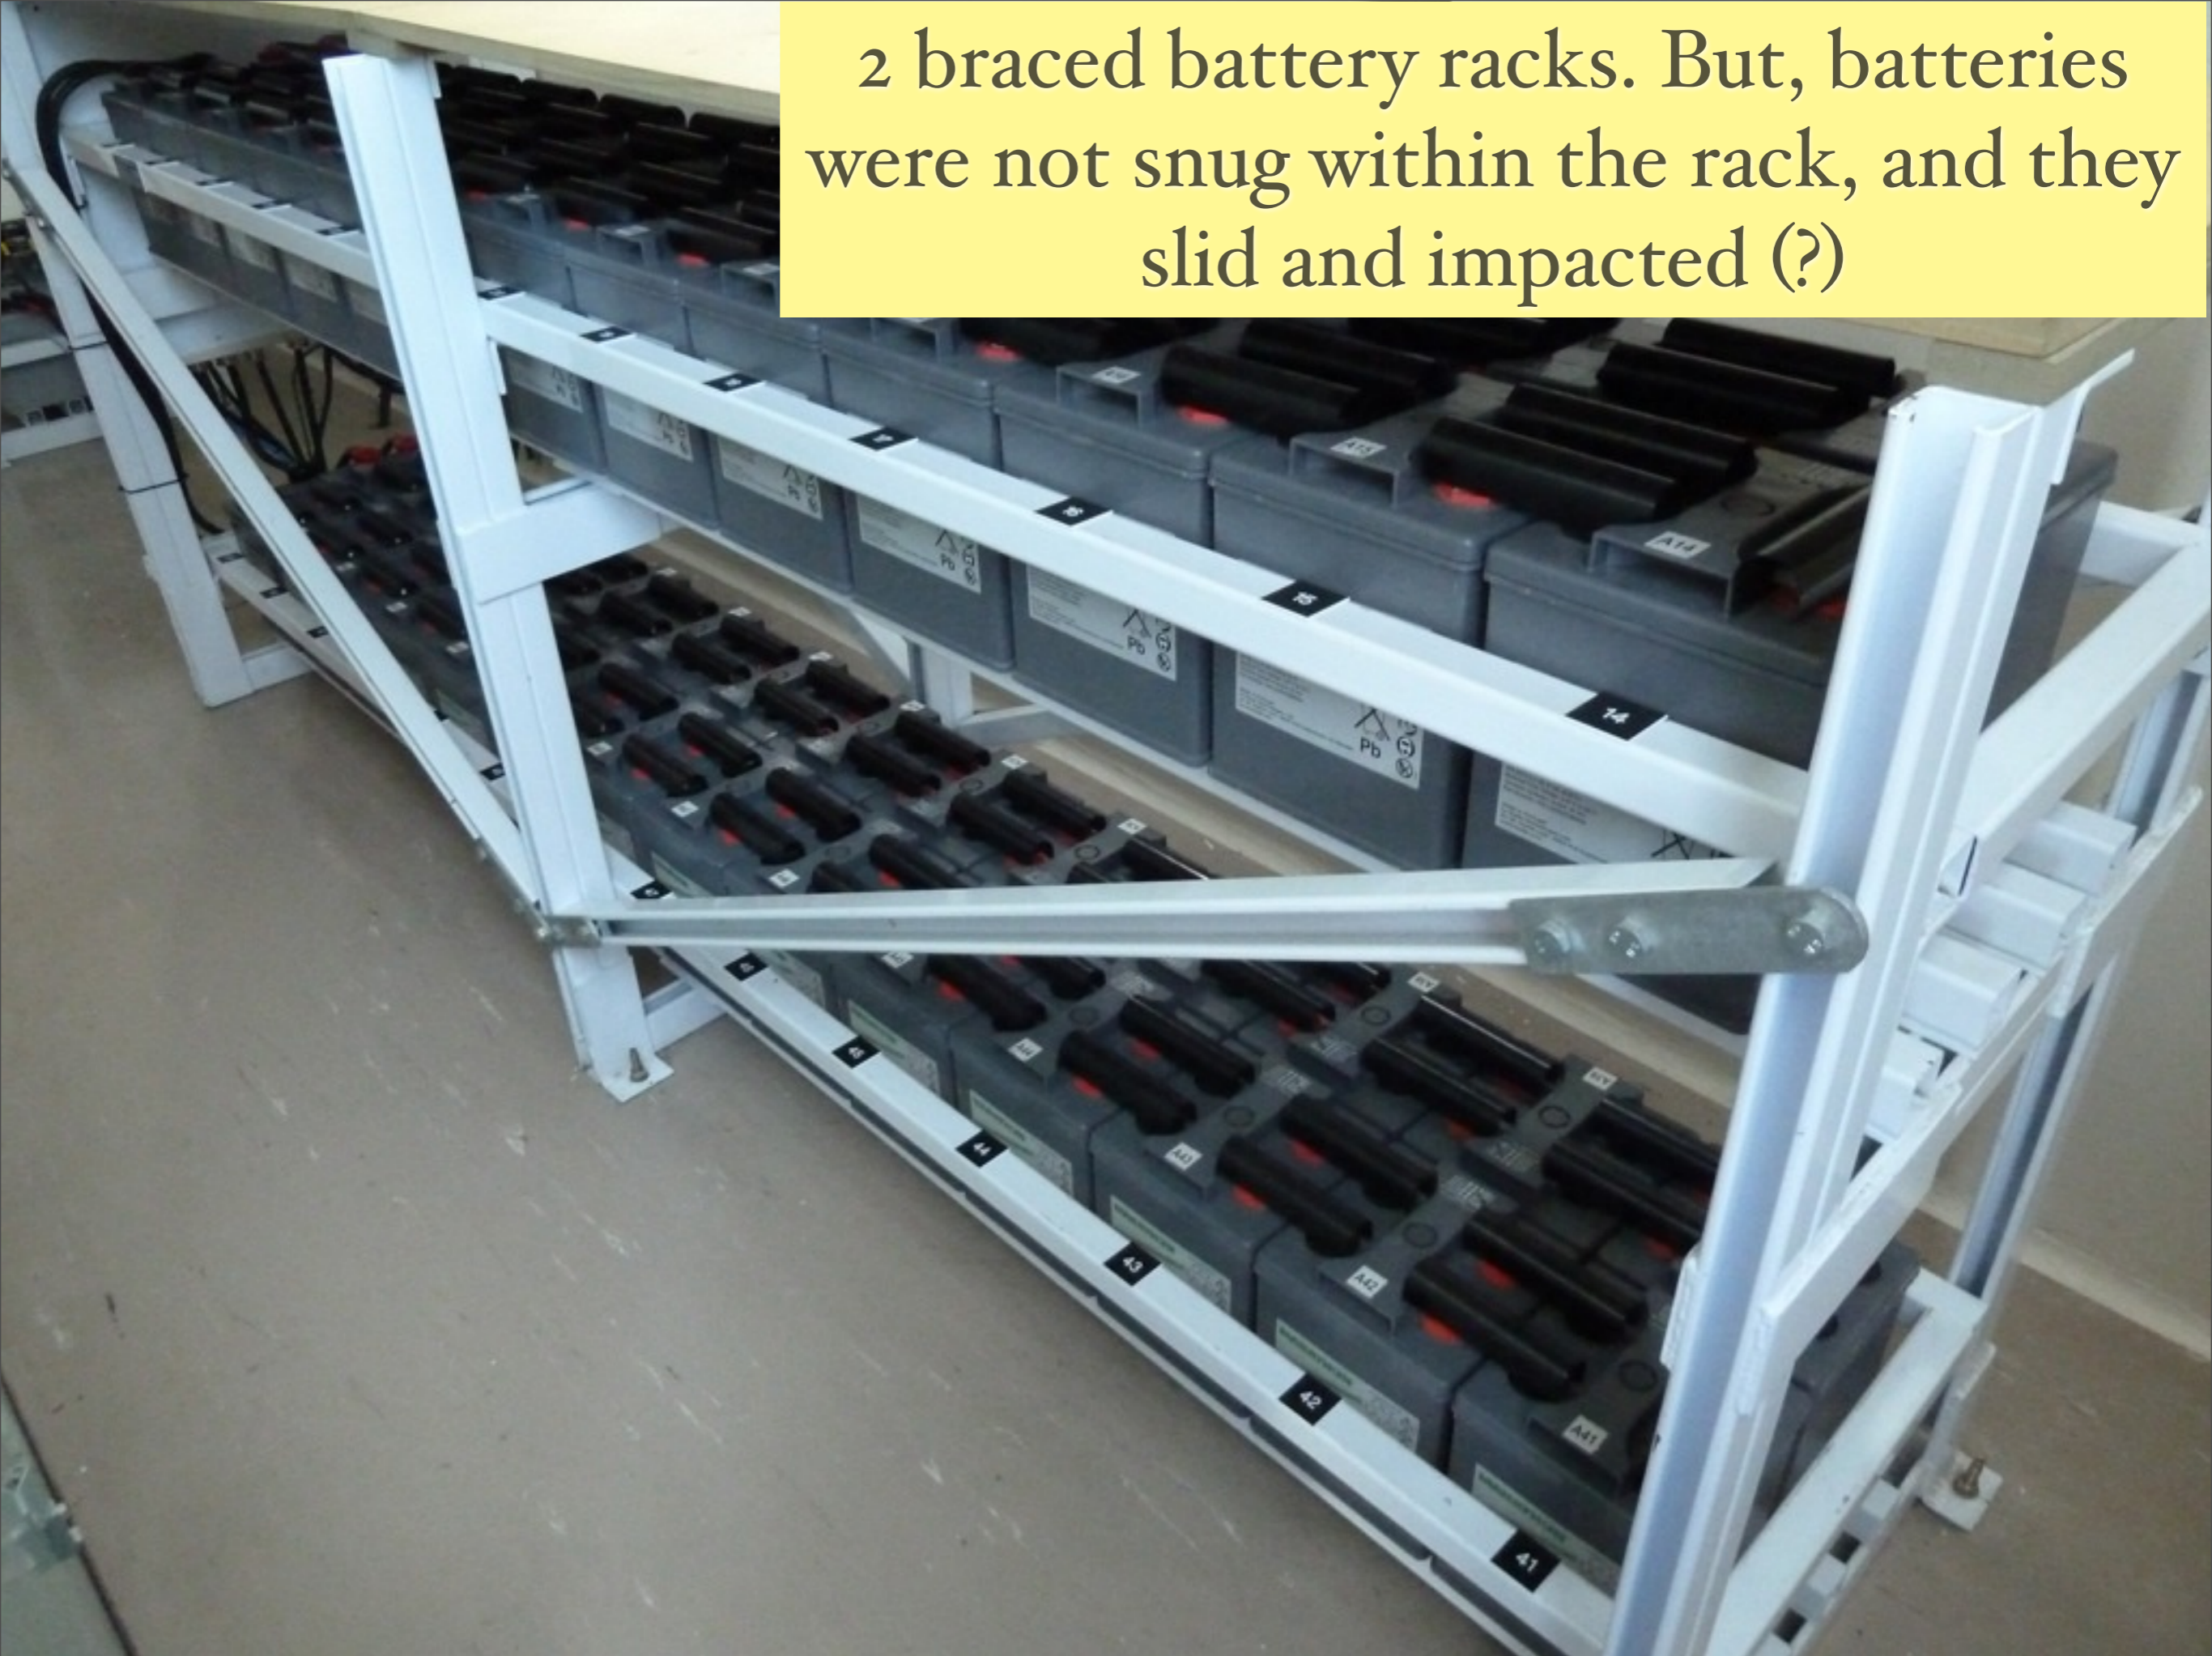
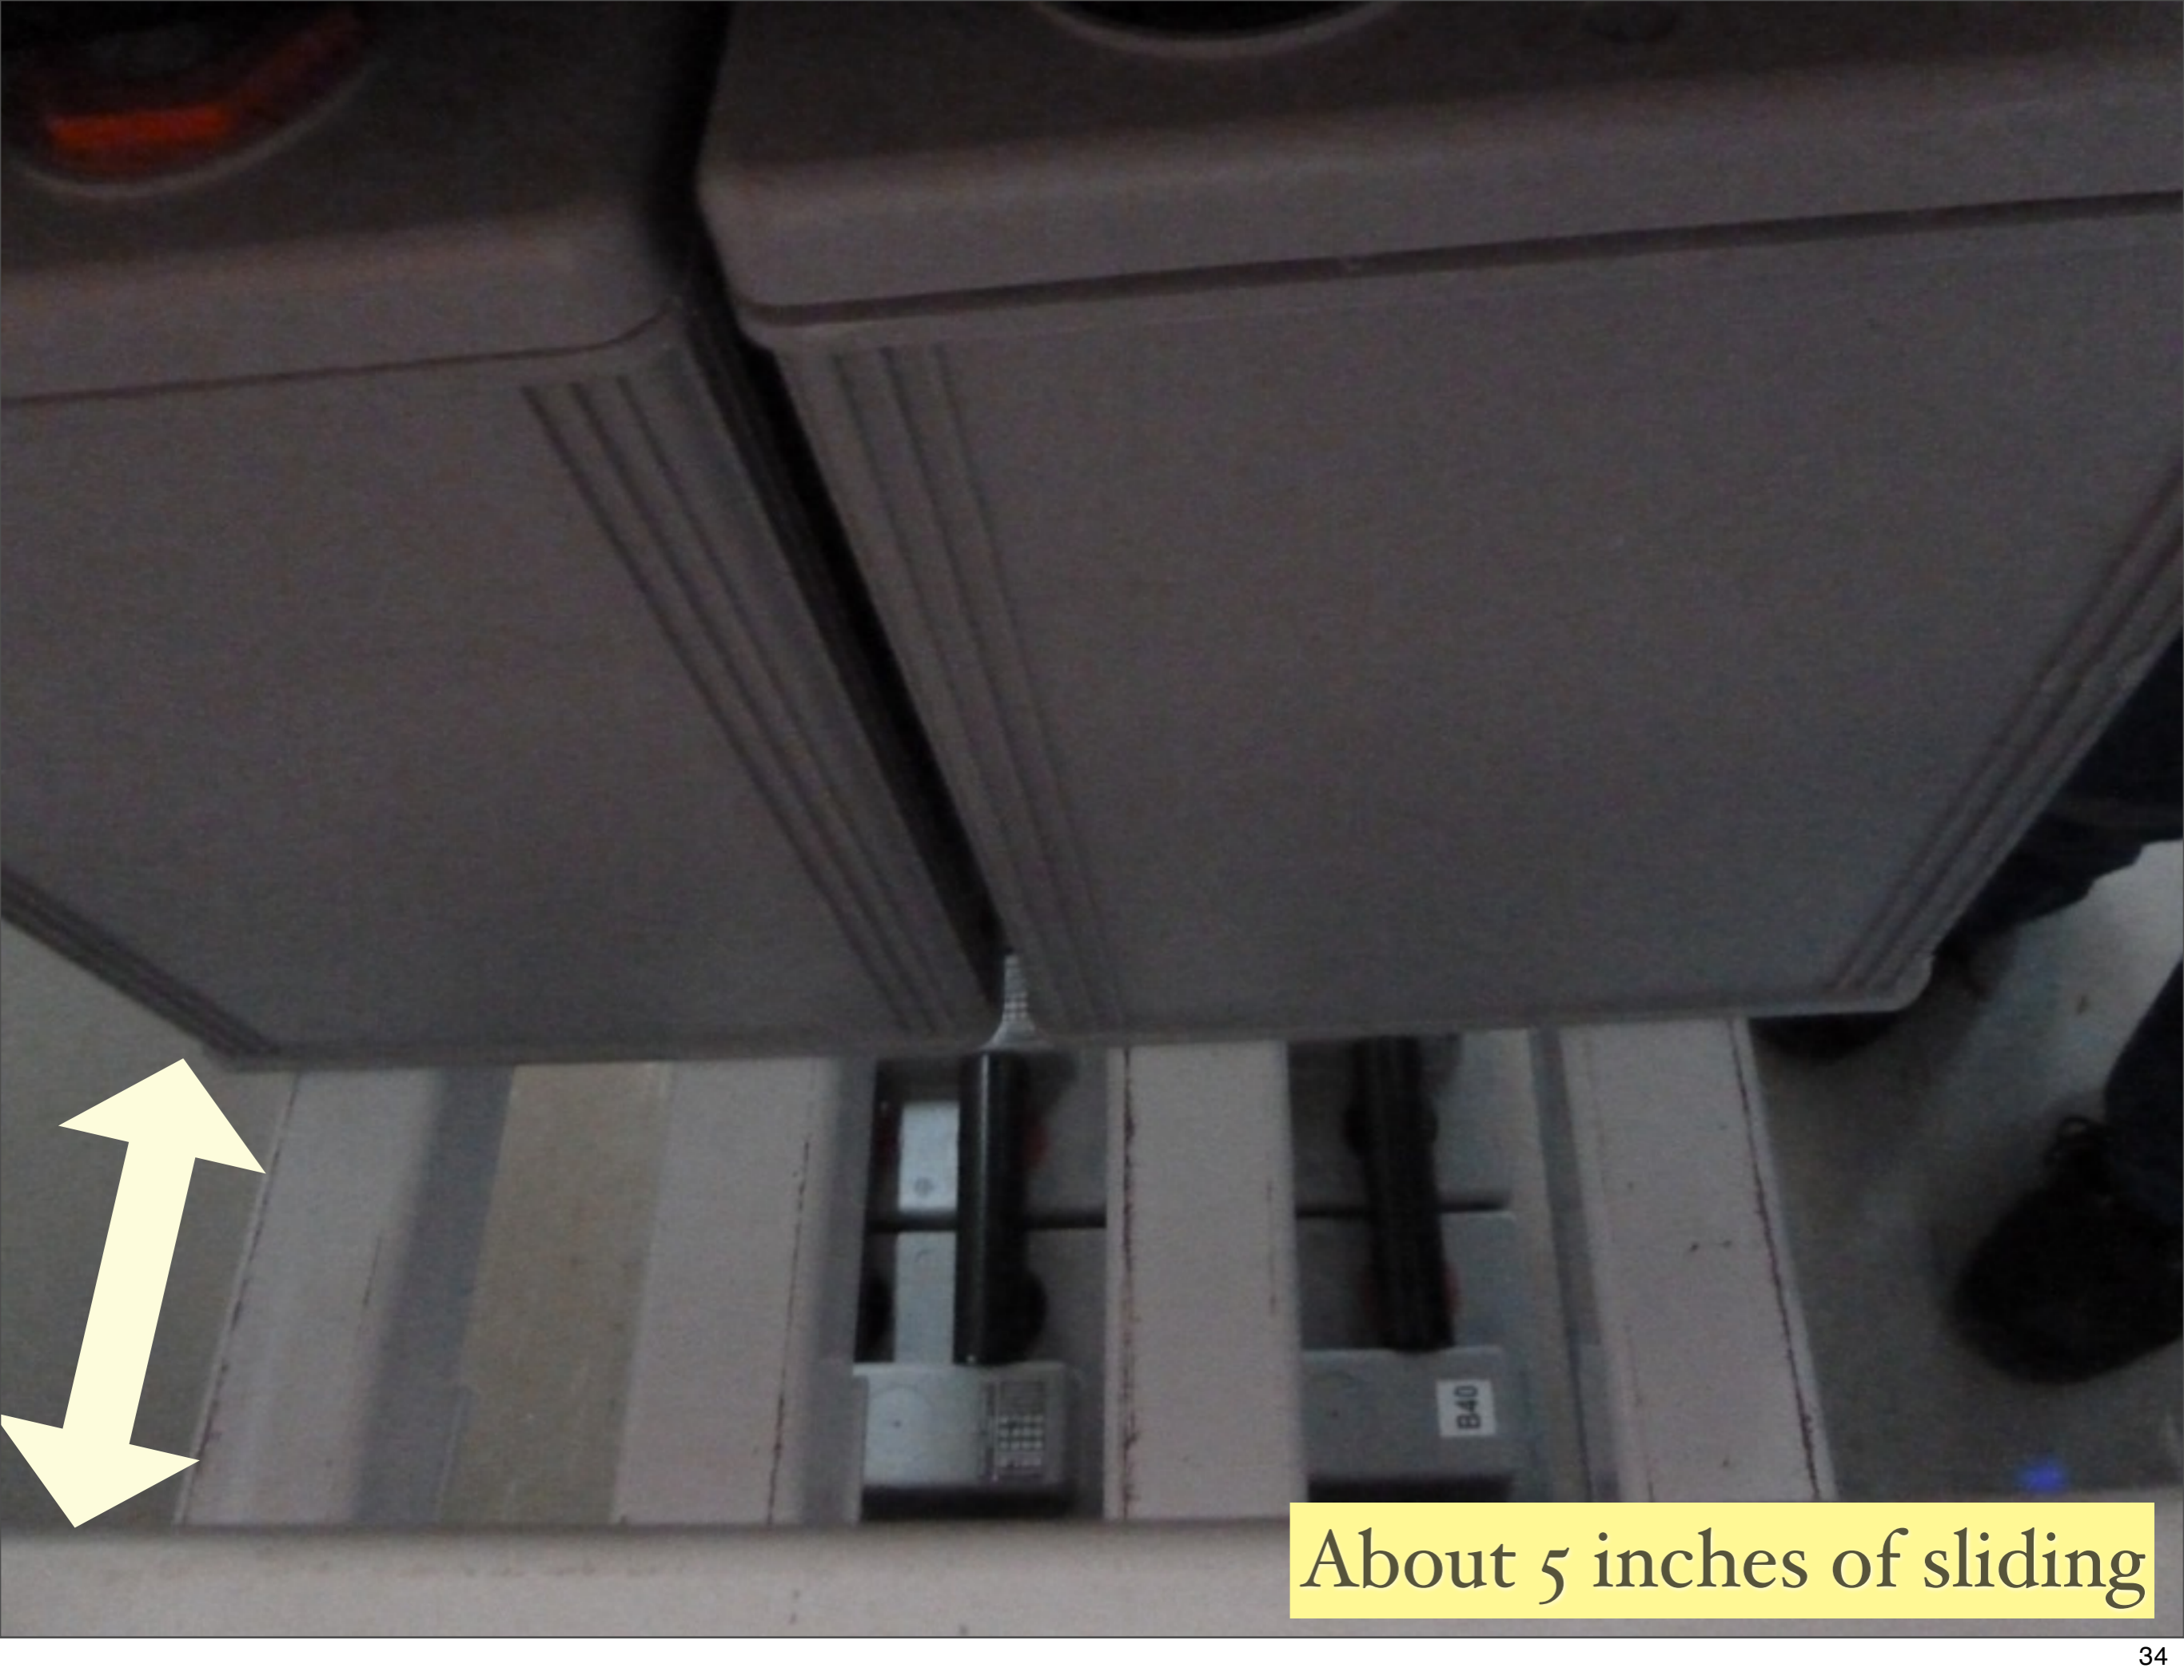
2 braced battery racks. But, batteries were not snug within the rack, and they slid and impacted (?)

About 5 inches of sliding

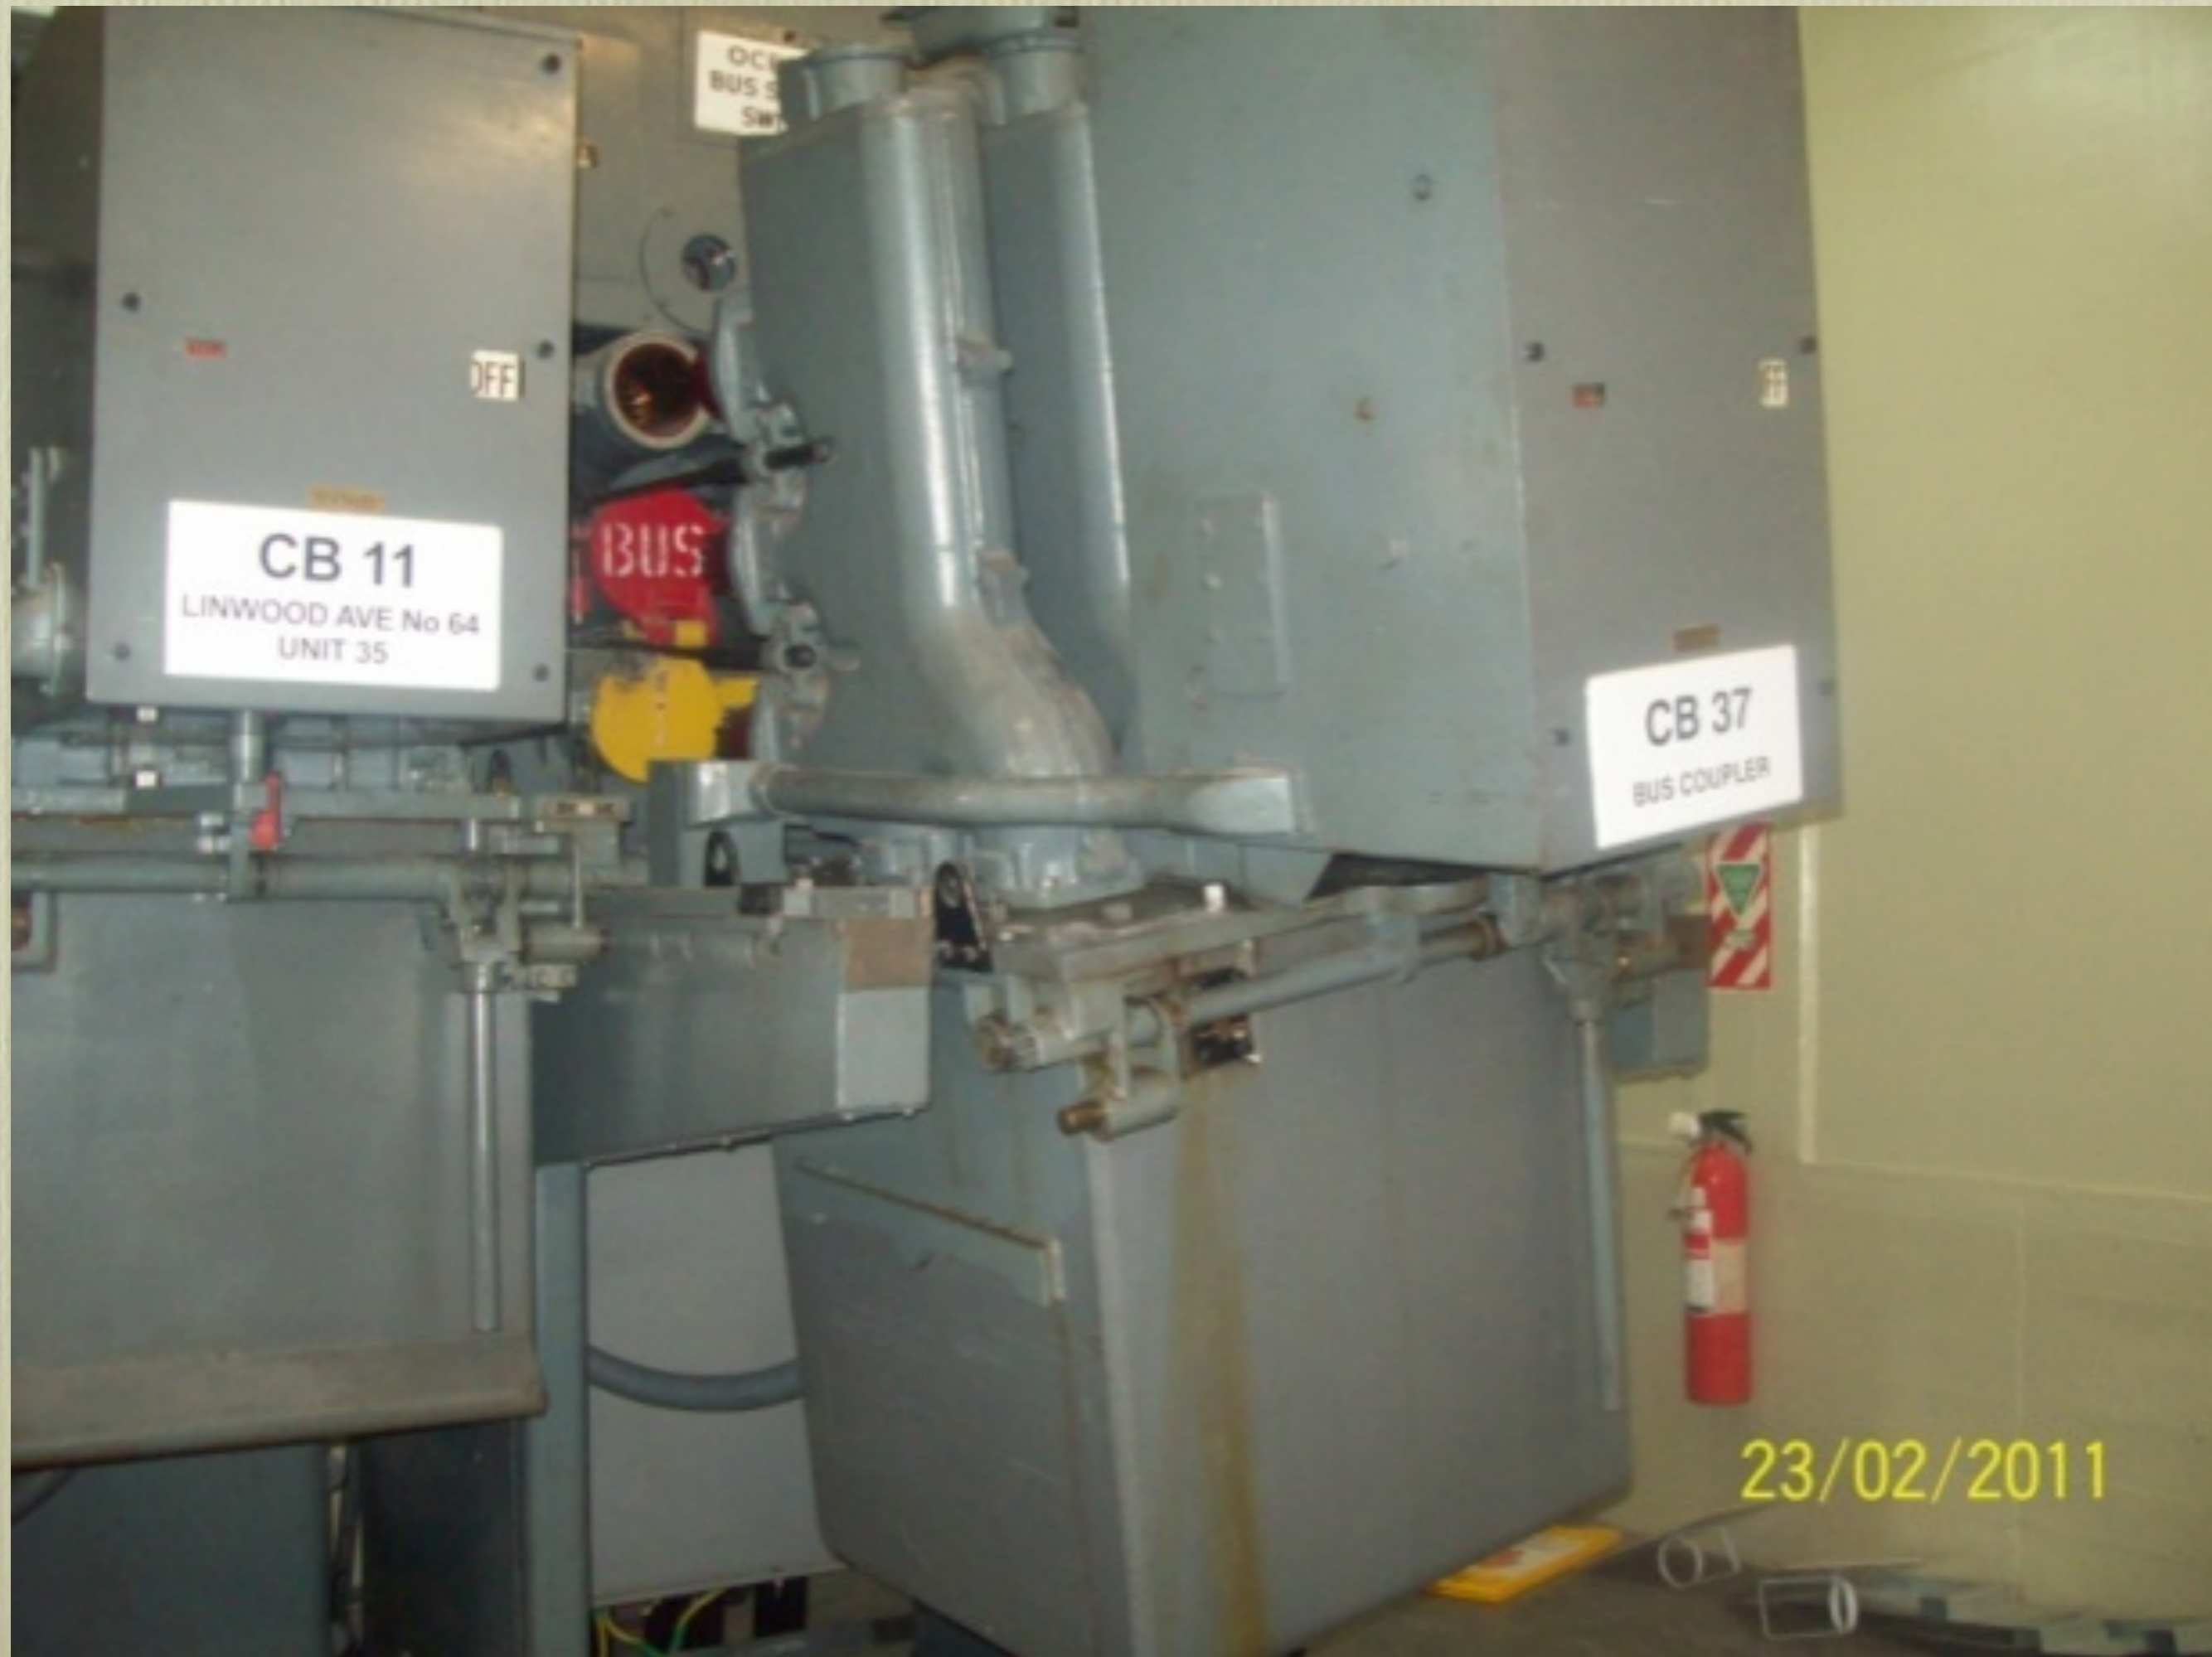
OCBs had high forces, cracked castings. One OCB in disengaged position fell to the ground. In-service OCBs remained functional, although lots of evidence of anchorage overloads

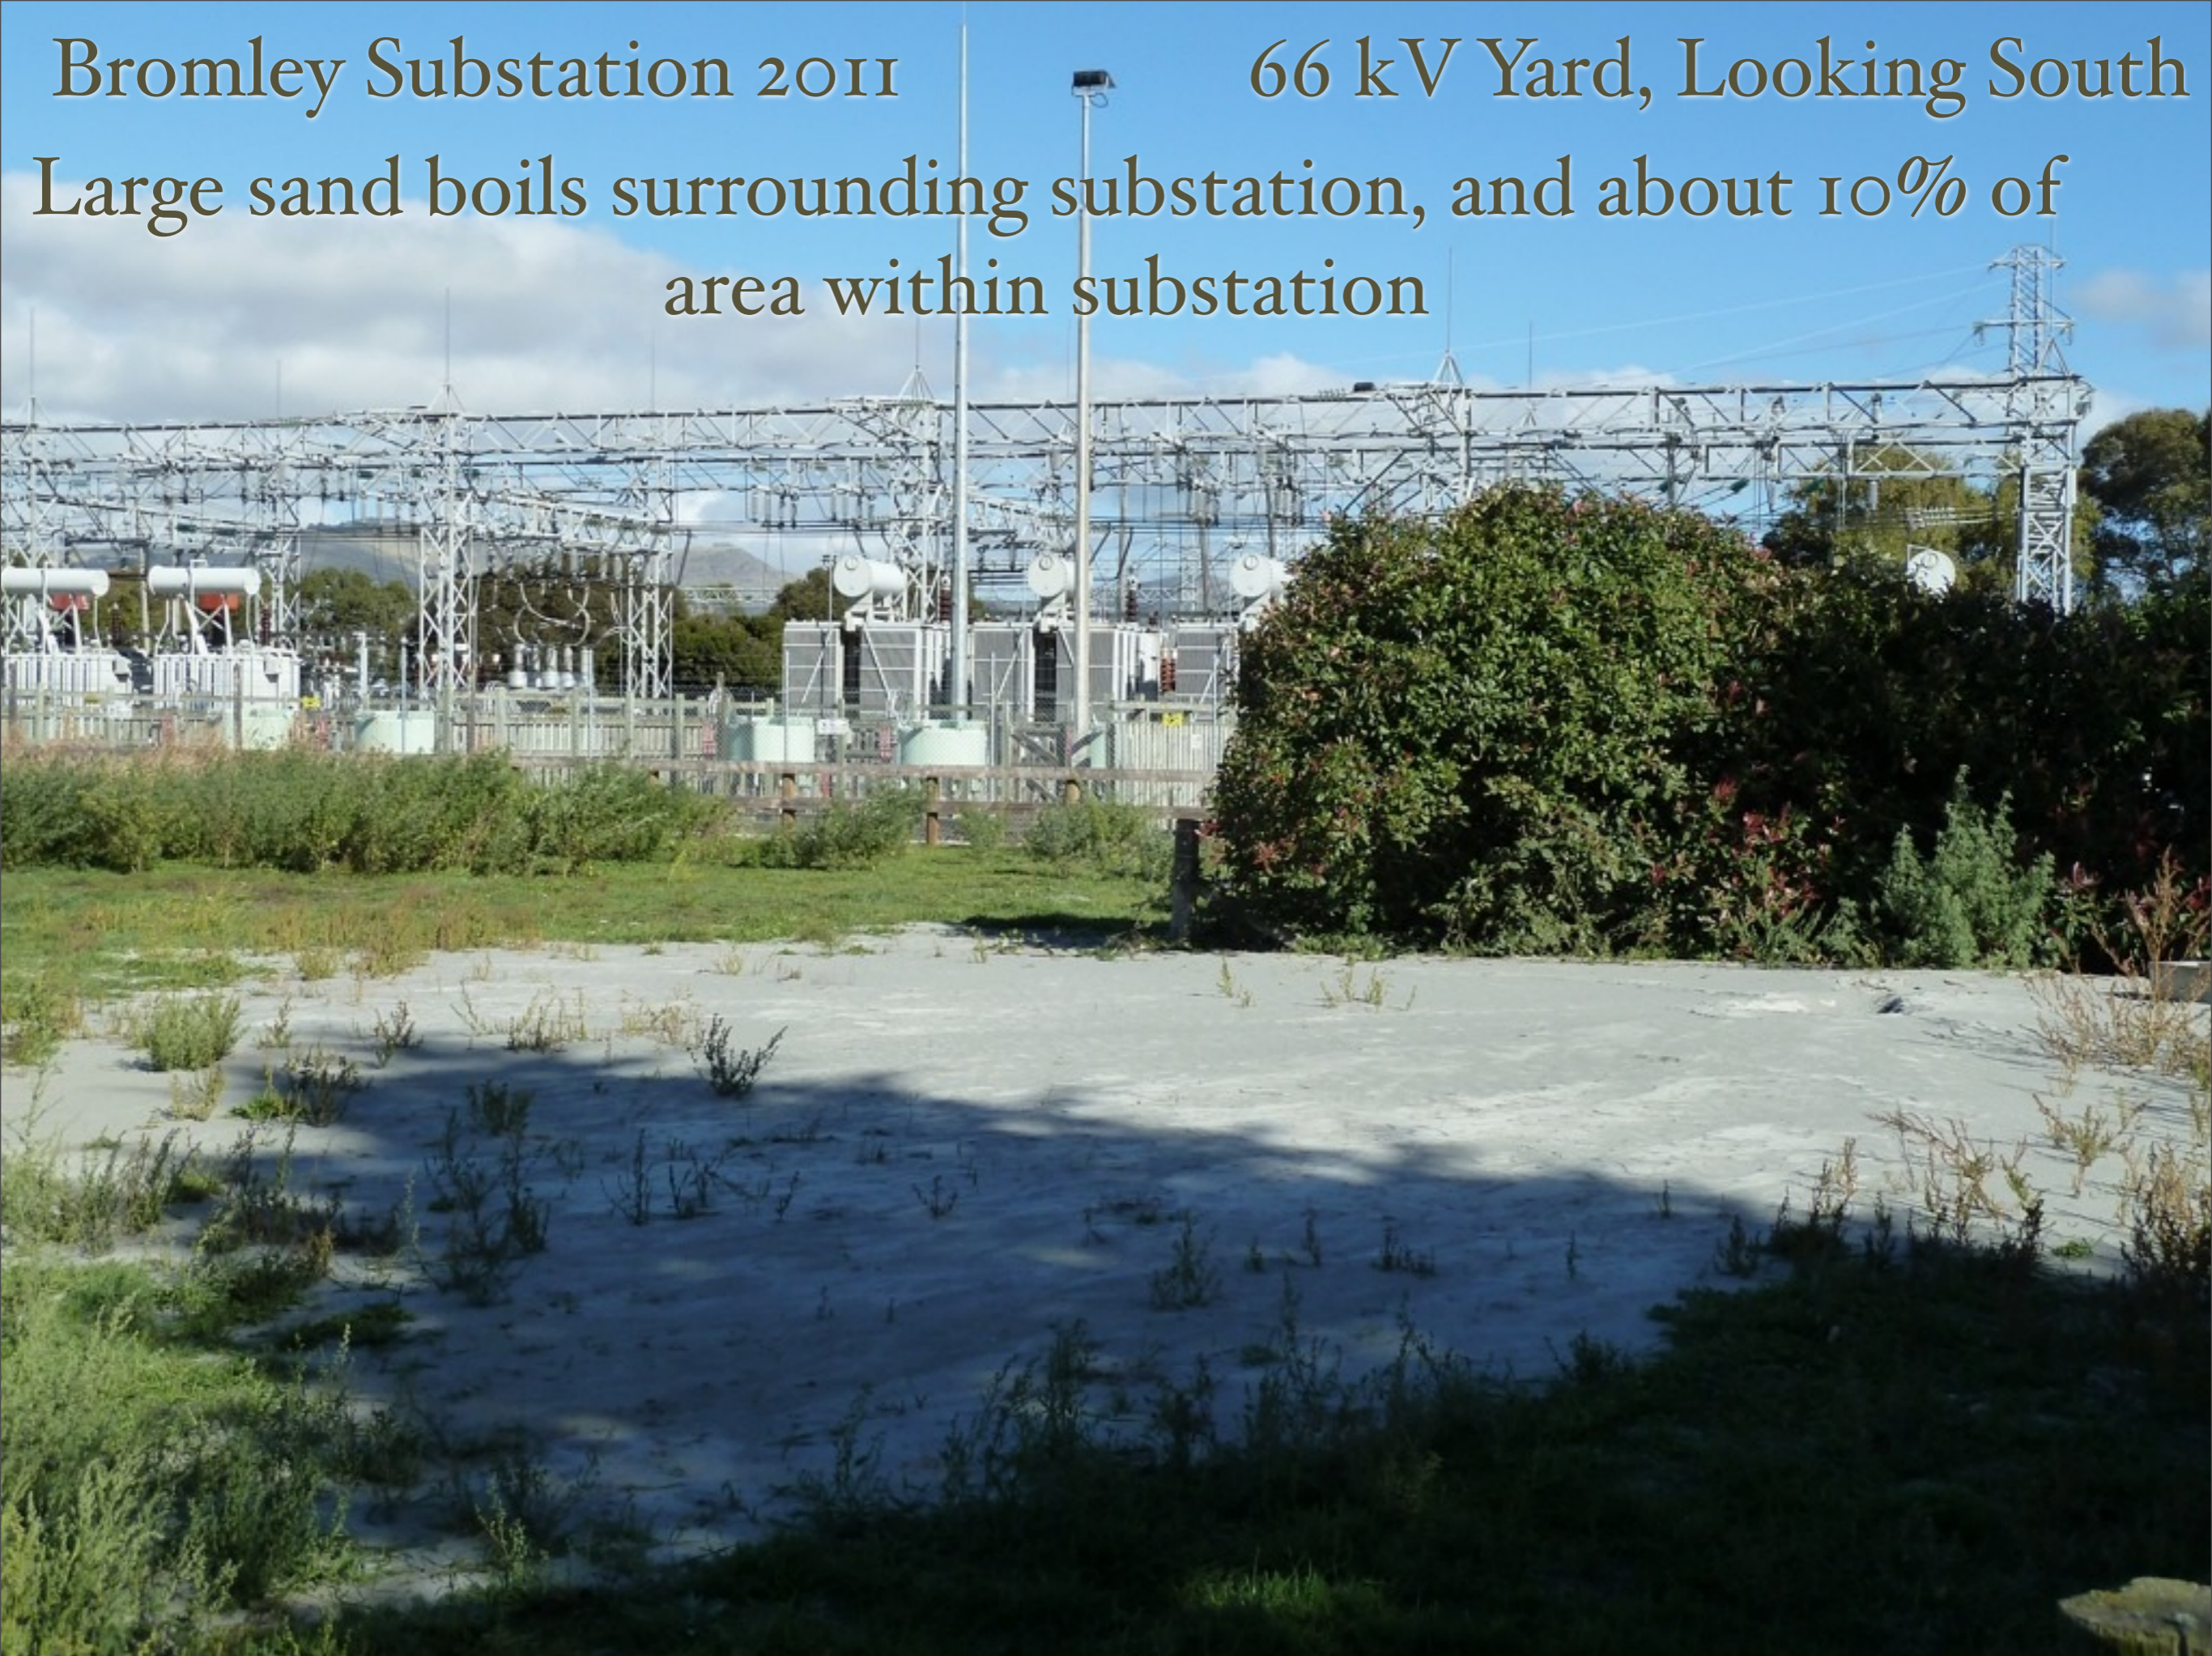
66 kV Yard, Looking South

Large sand boils surrounding substation, and about 10% of area within substation
