Christchurch, Feb 22 2011 and Sept 4 2010

John Eiding  
G&E Engineering Systems Inc.  
[eidinger@geEngineeringSystems.com](mailto:eidinger@geEngineeringSystems.com)

## Impact to Electric Power Systems

ASCE - Structural Congress

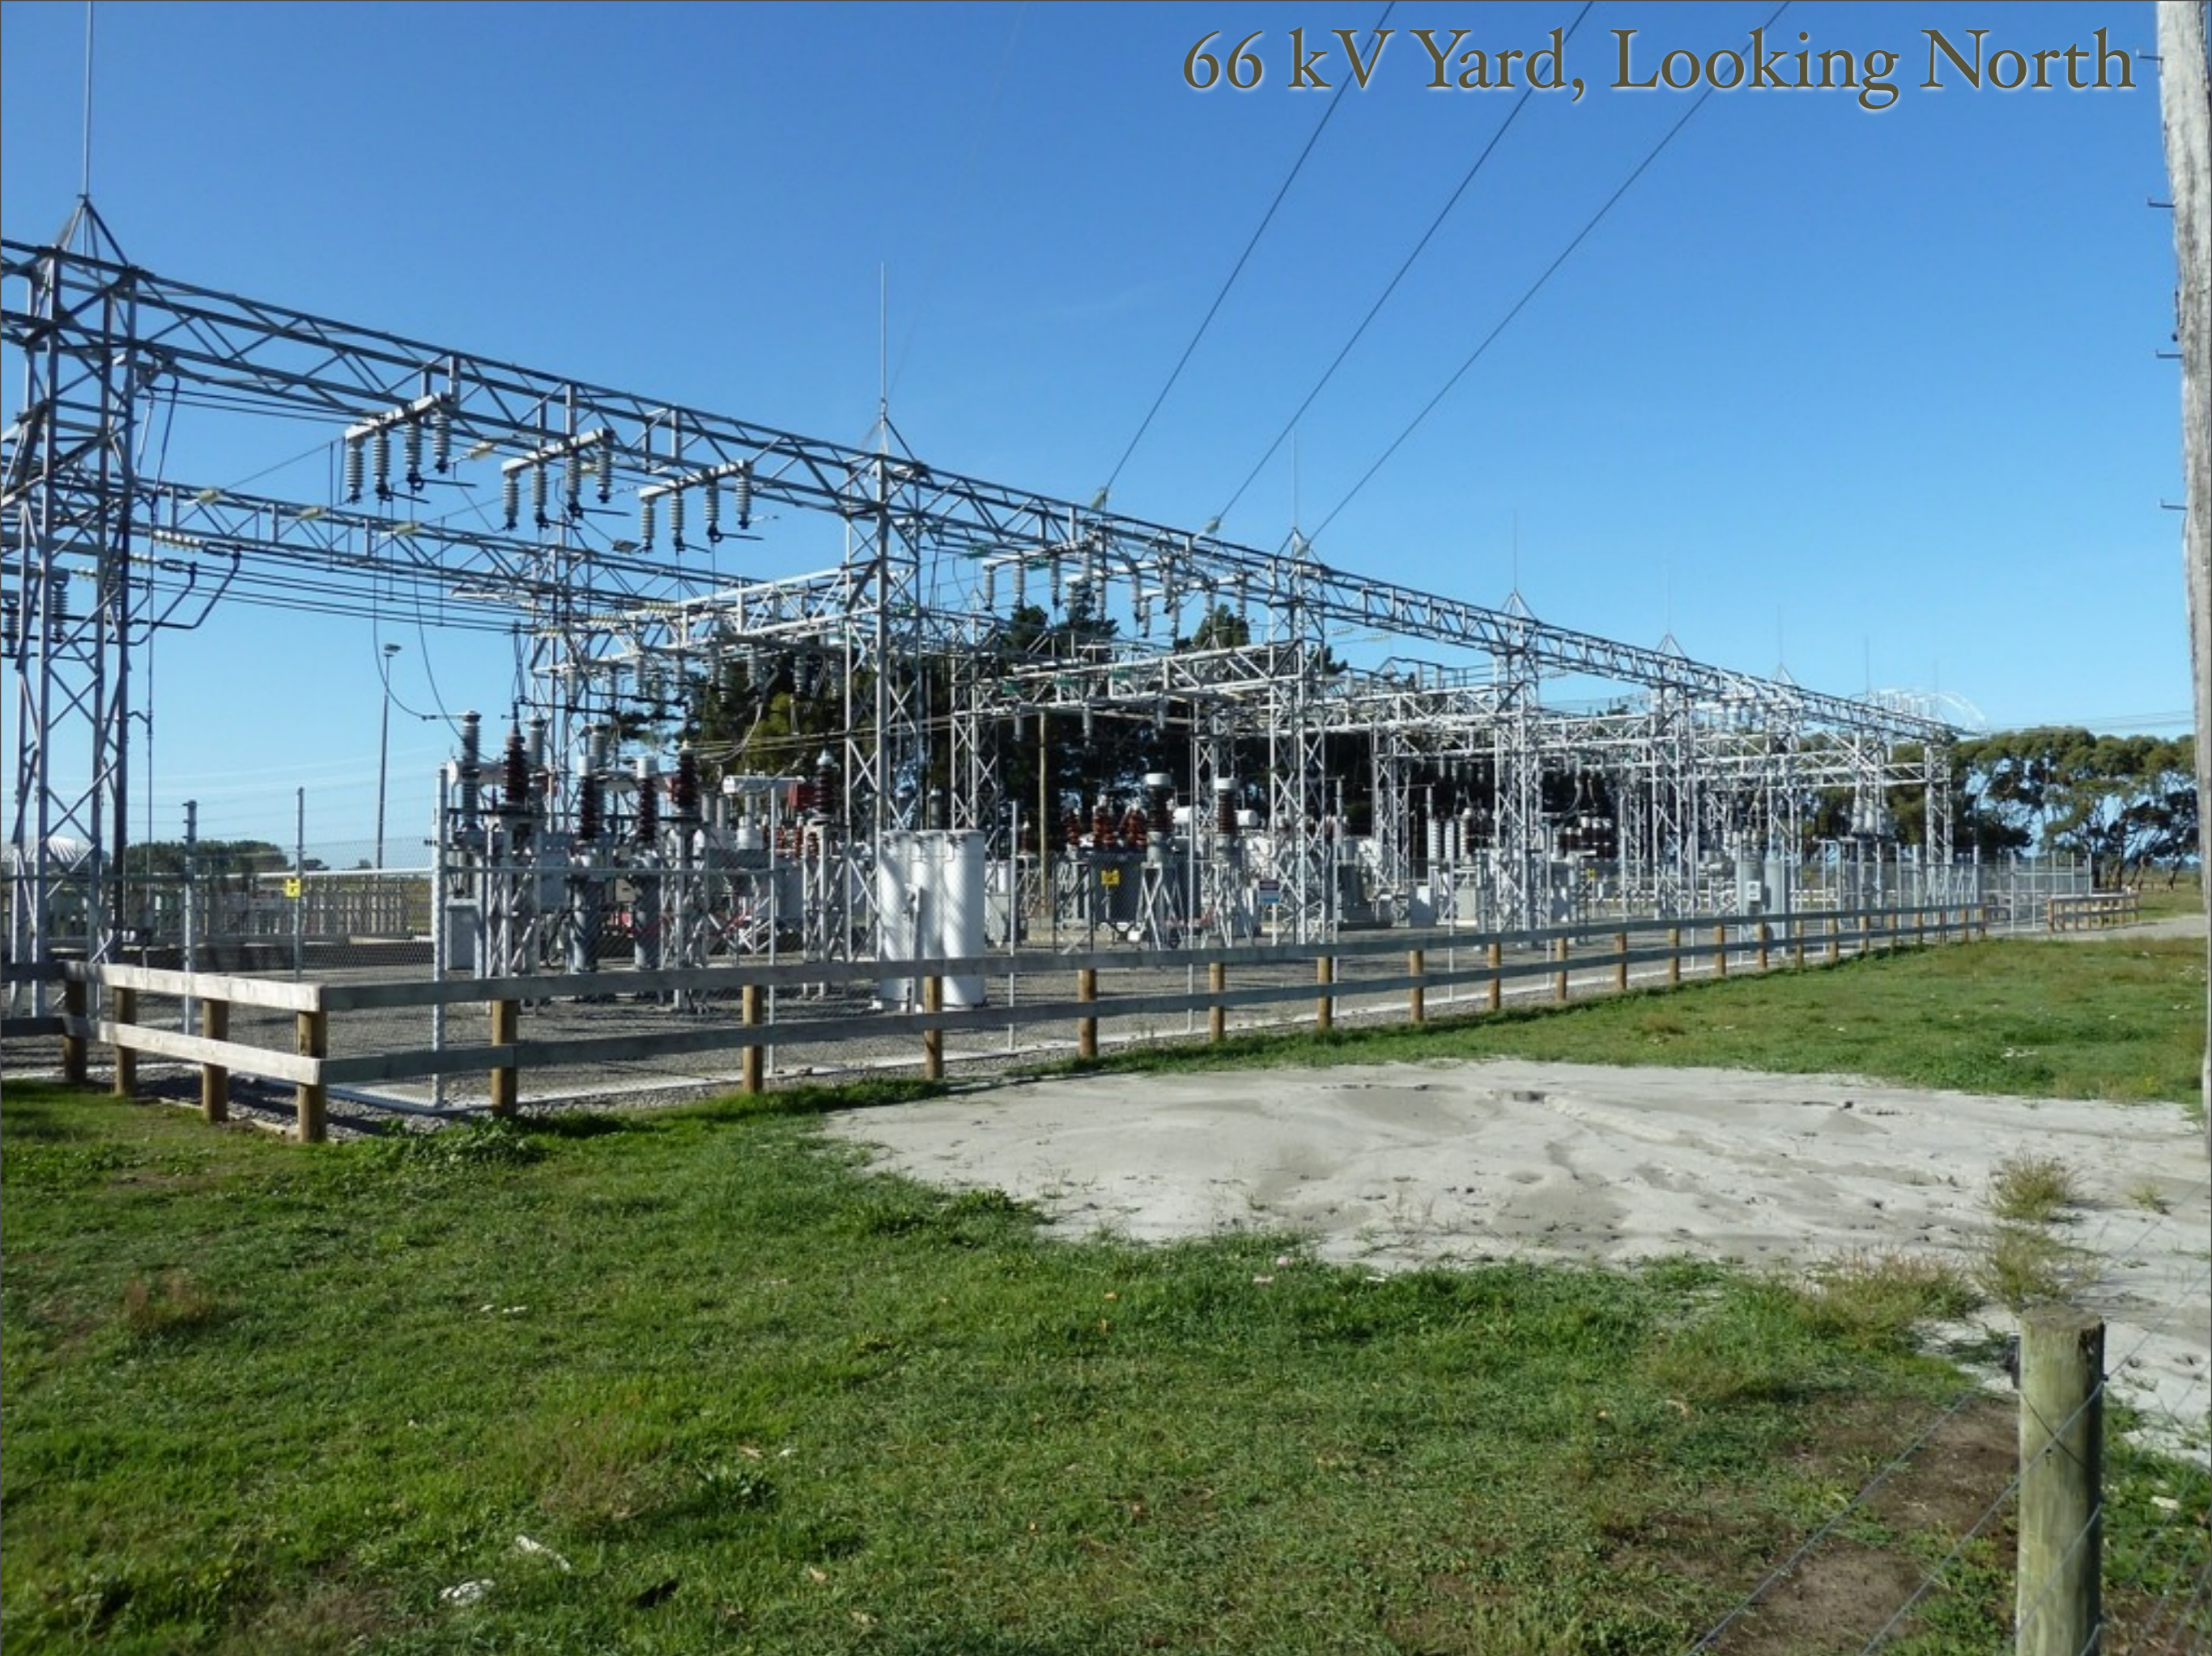
# 66 kV Yard, Looking North

Large sand boil in 220 kV Yard

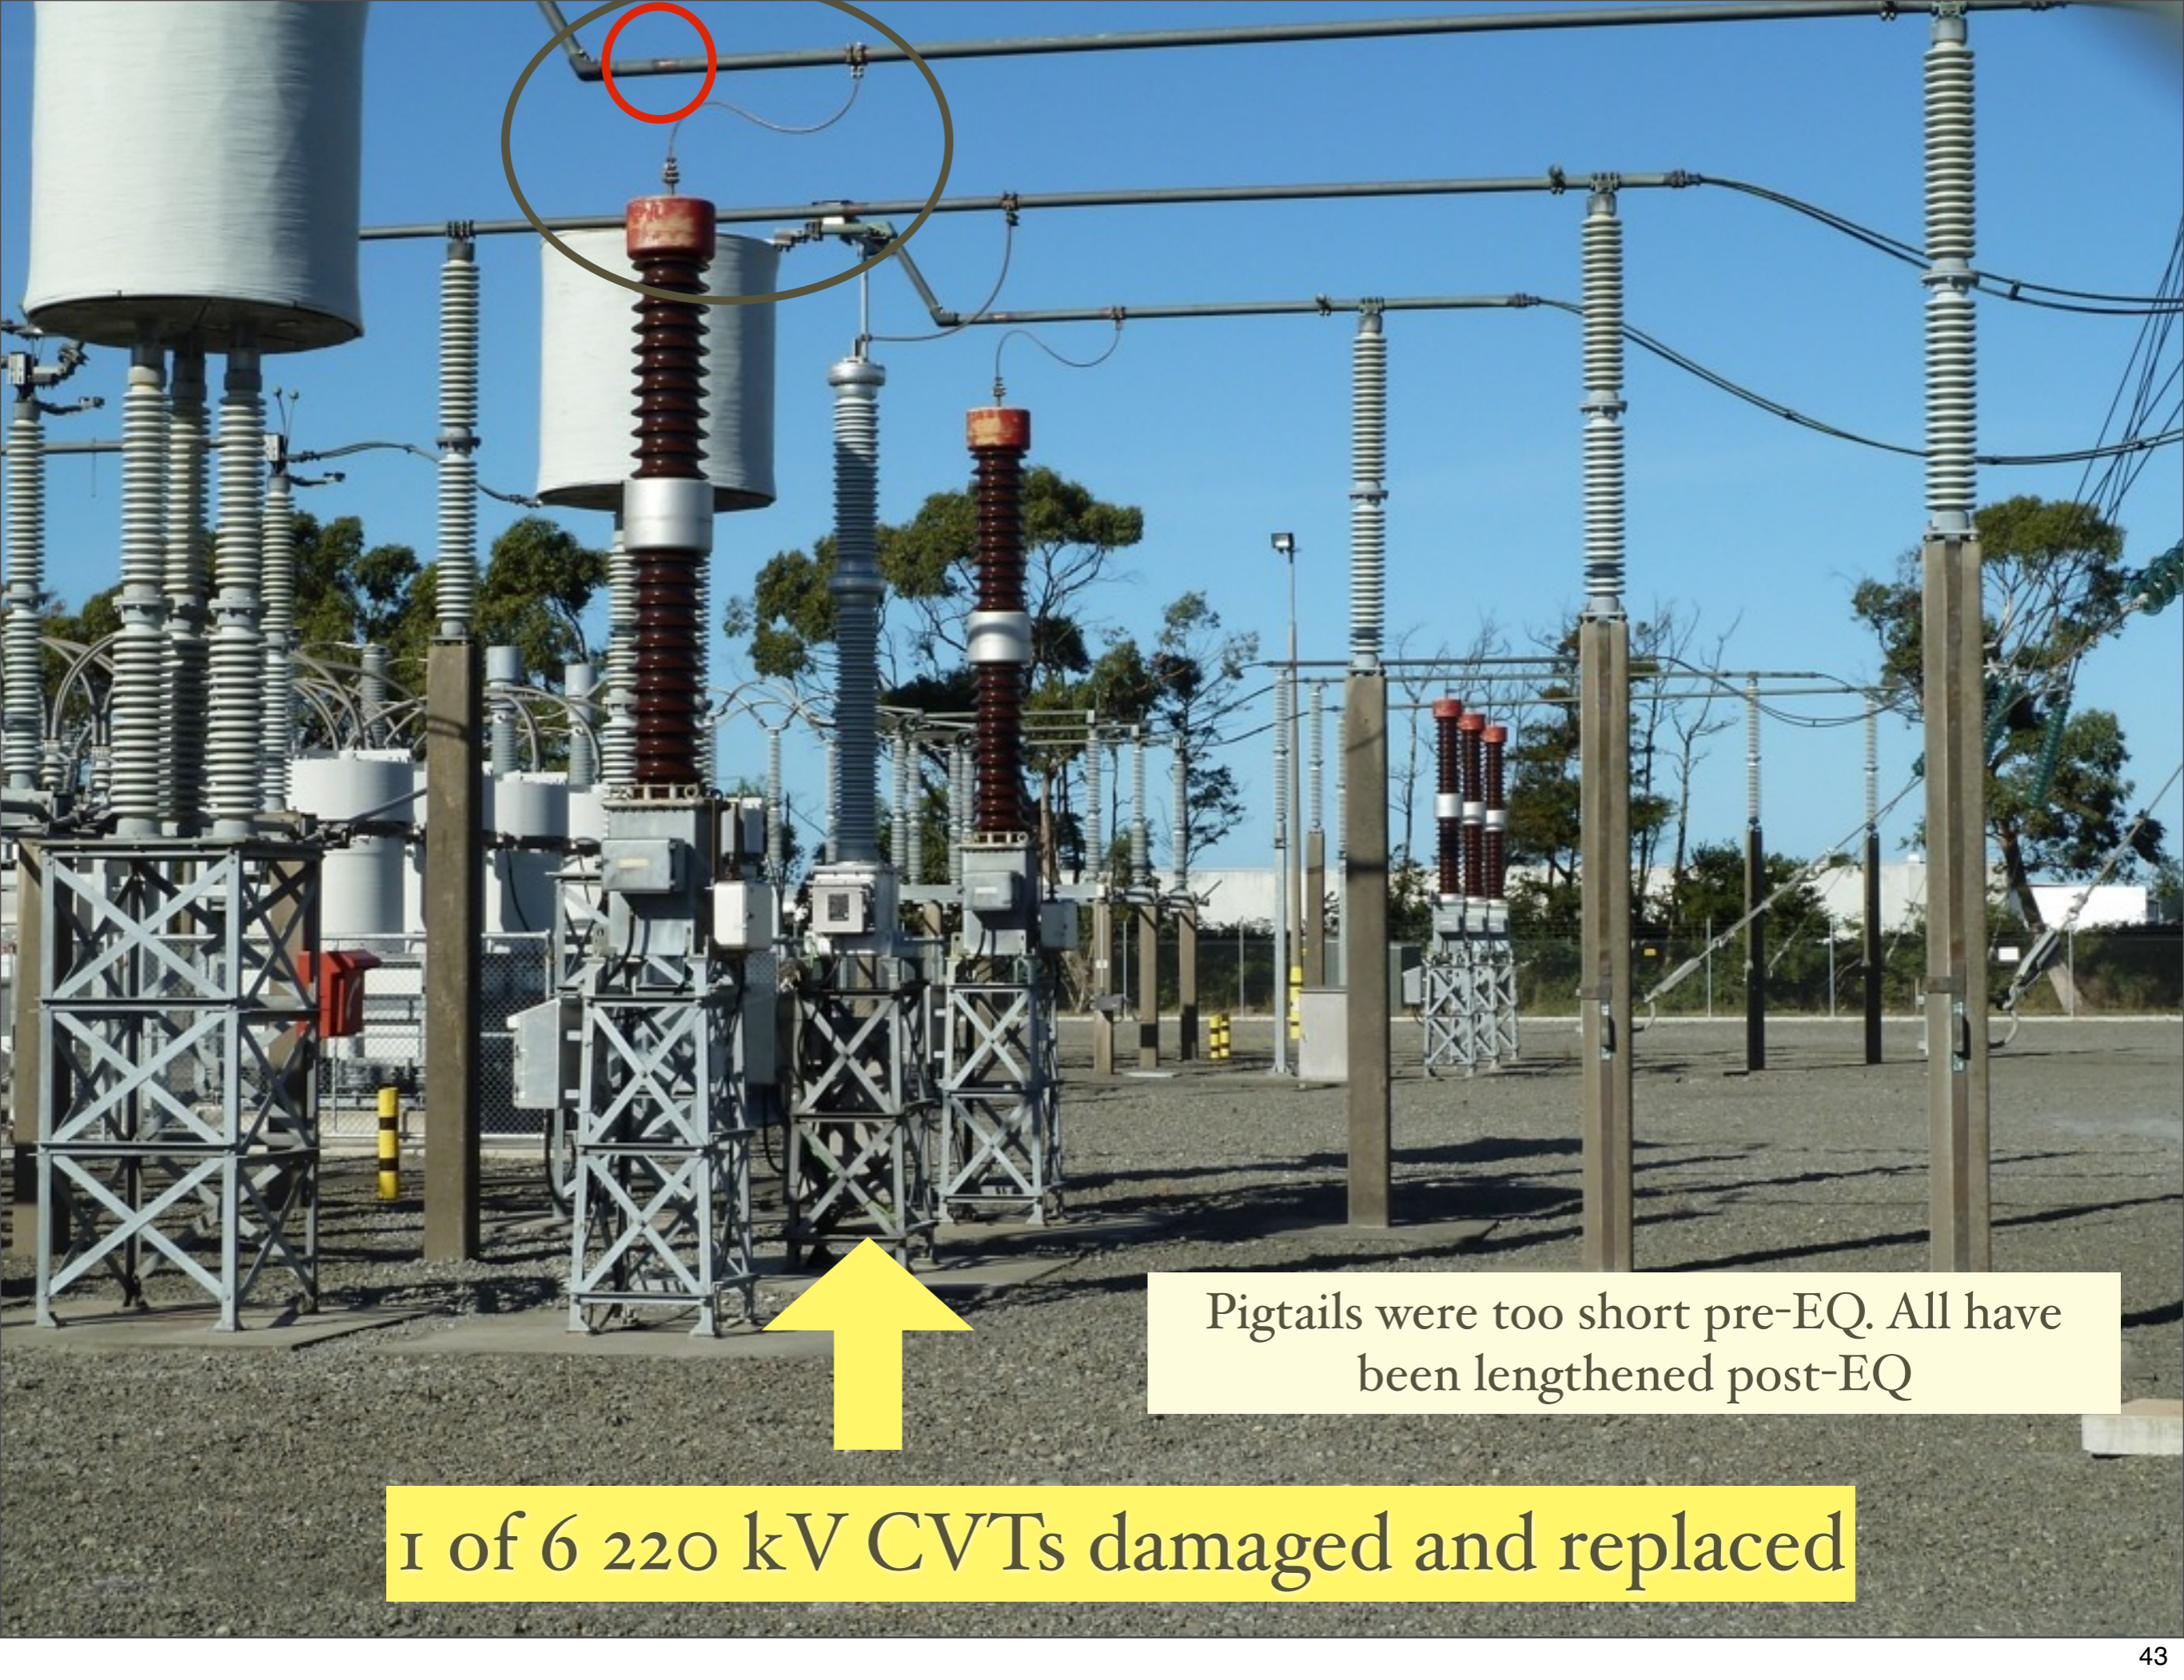
Pigtails were too short pre-EQ. All have been lengthened post-EQ

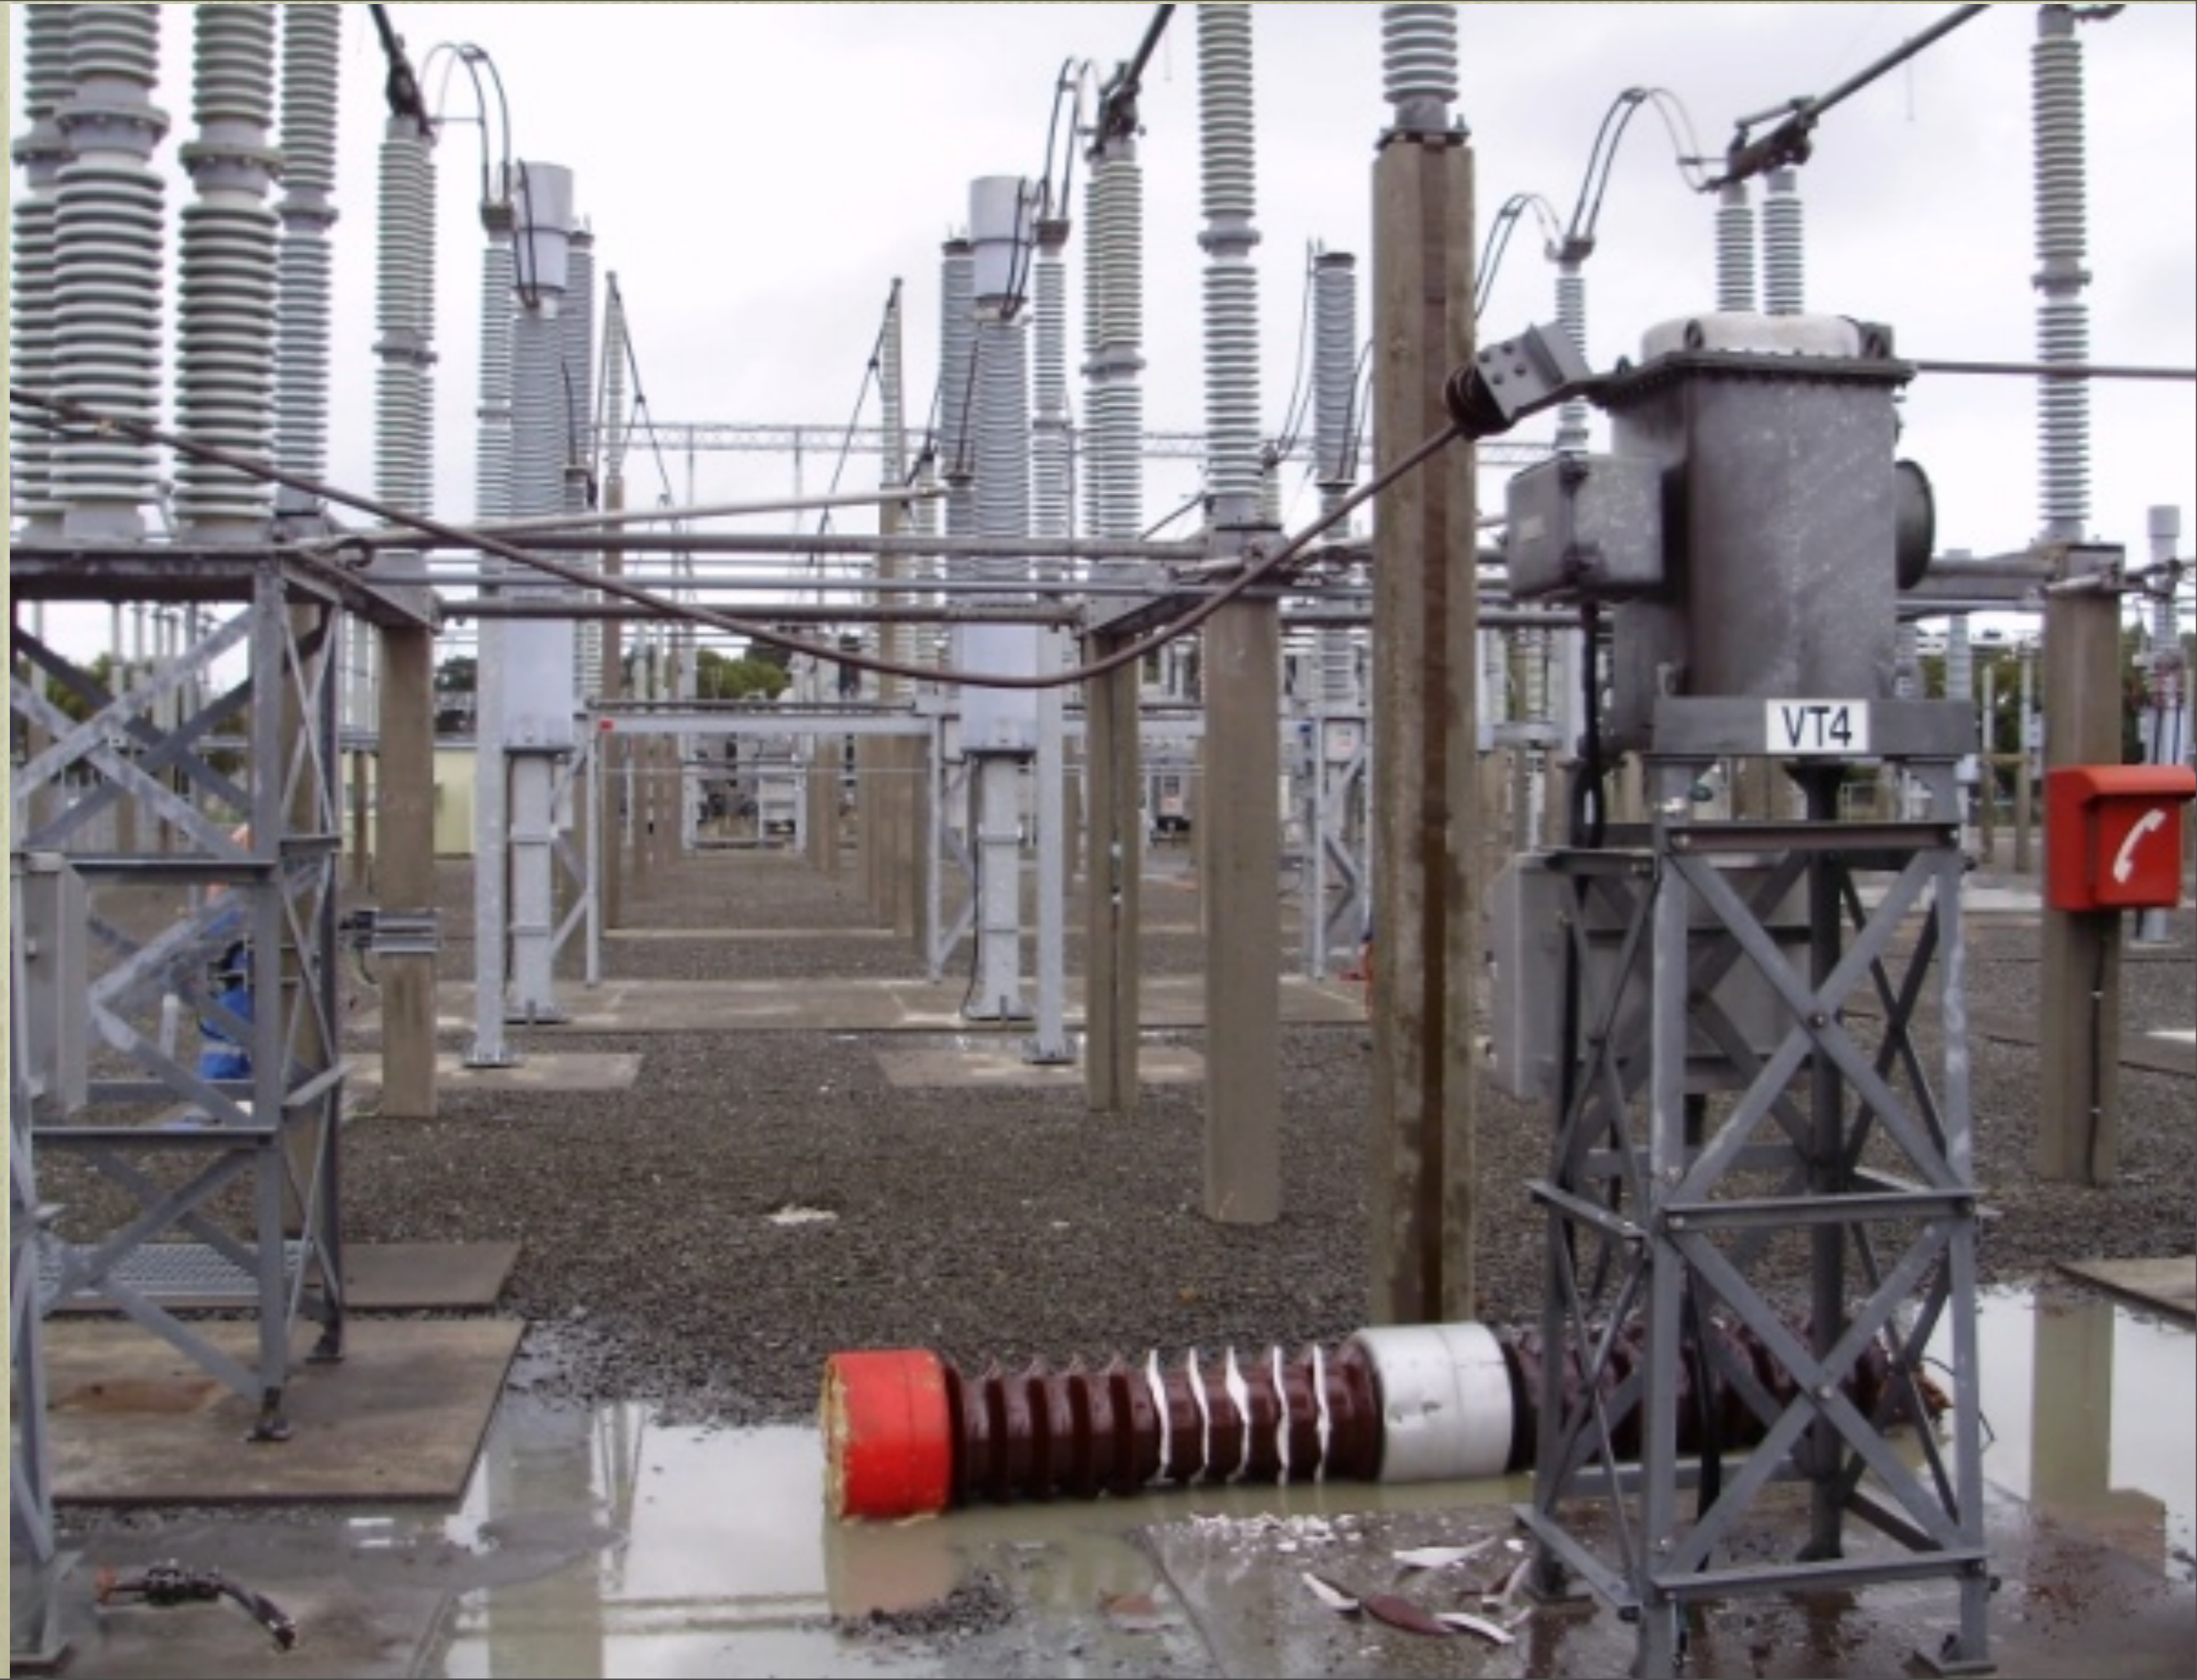
1 of 6 220 kV CVTs damaged and replaced

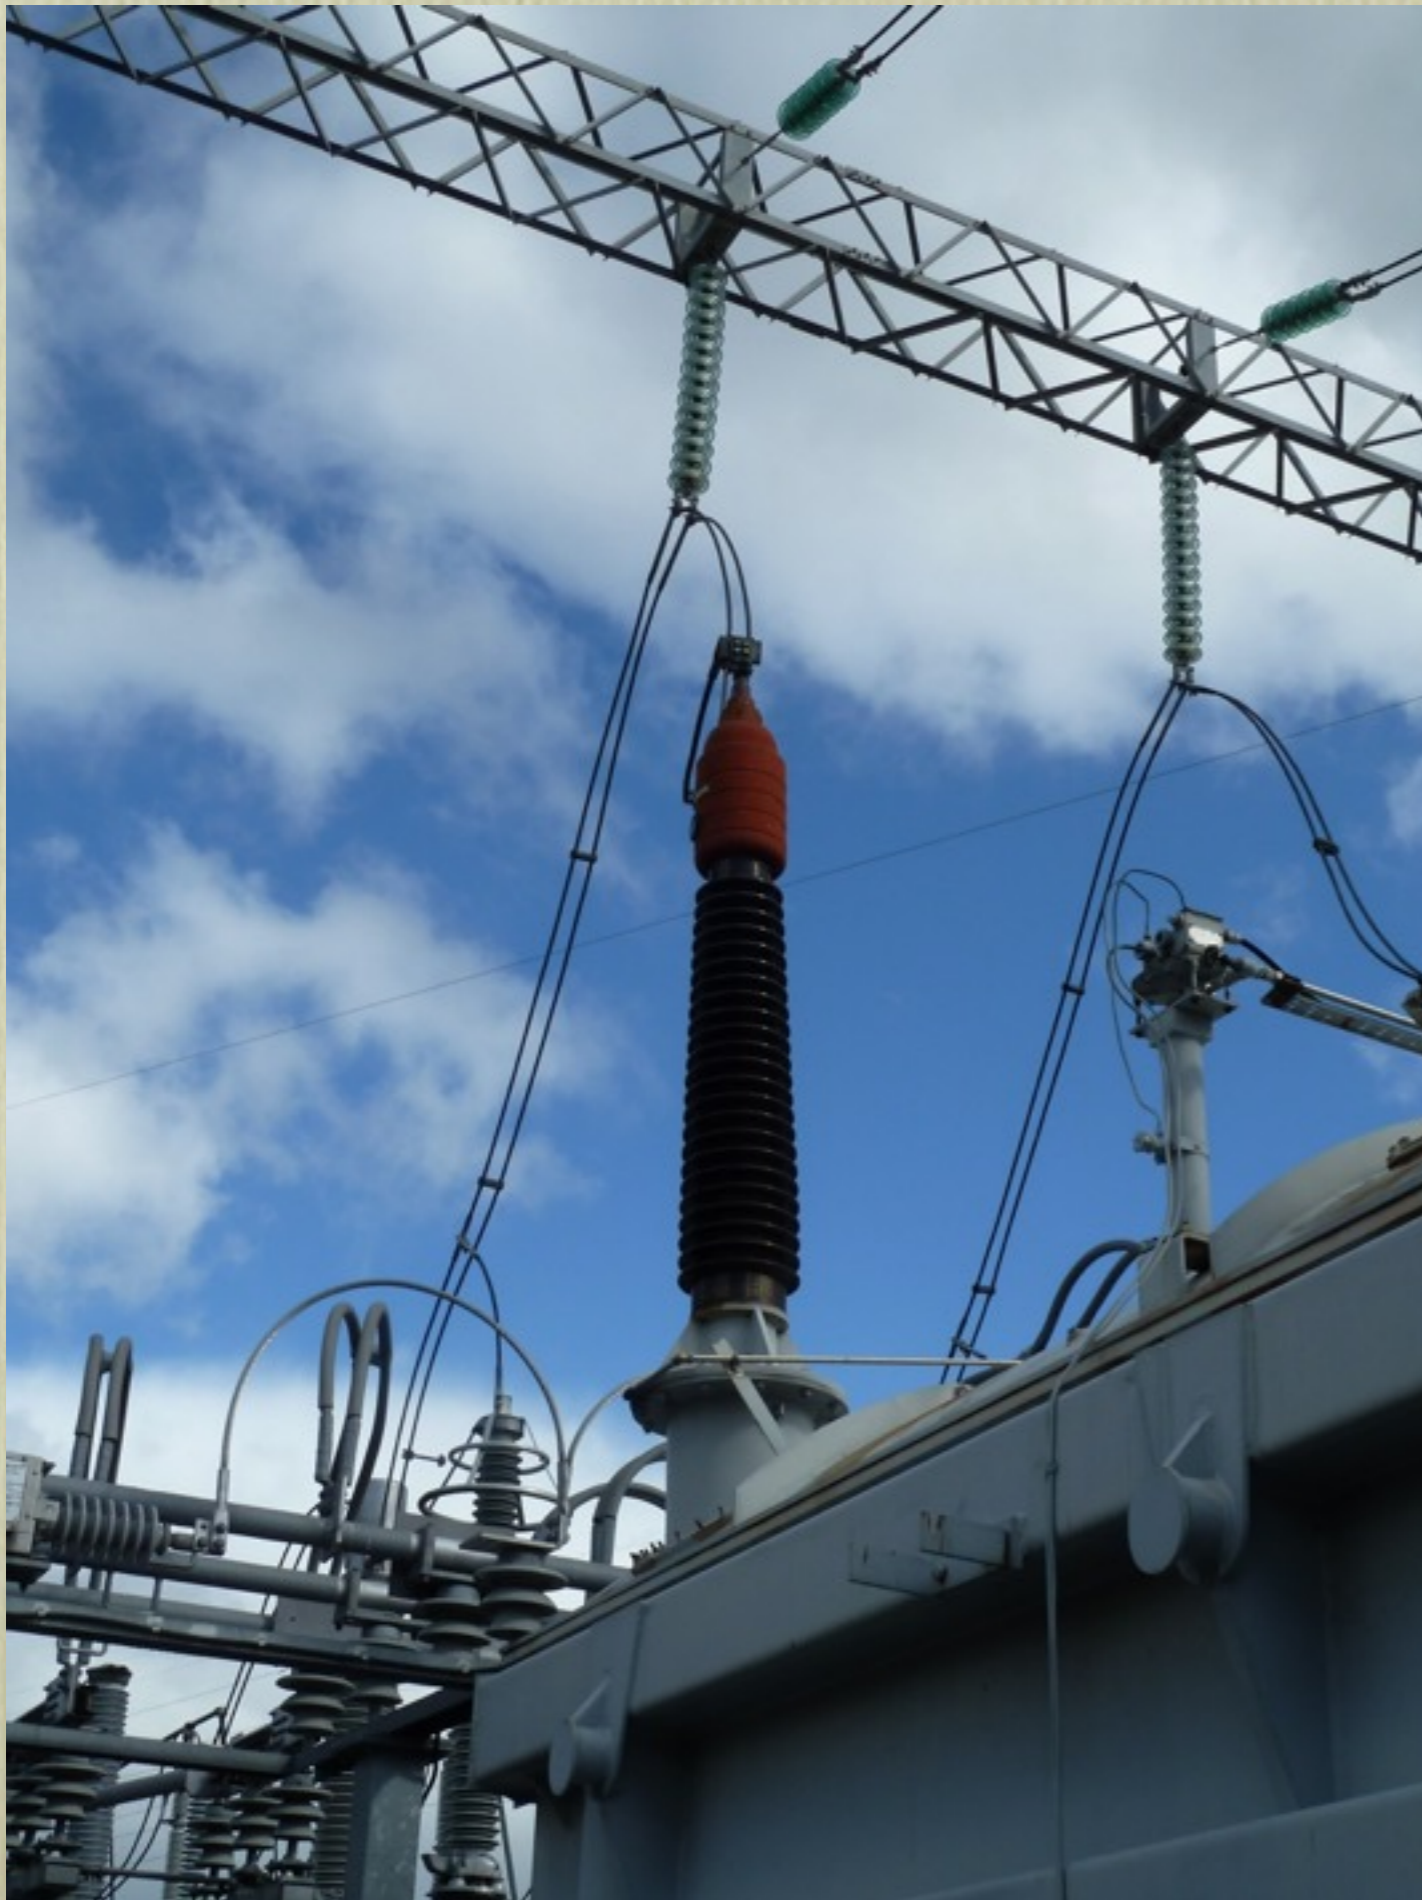
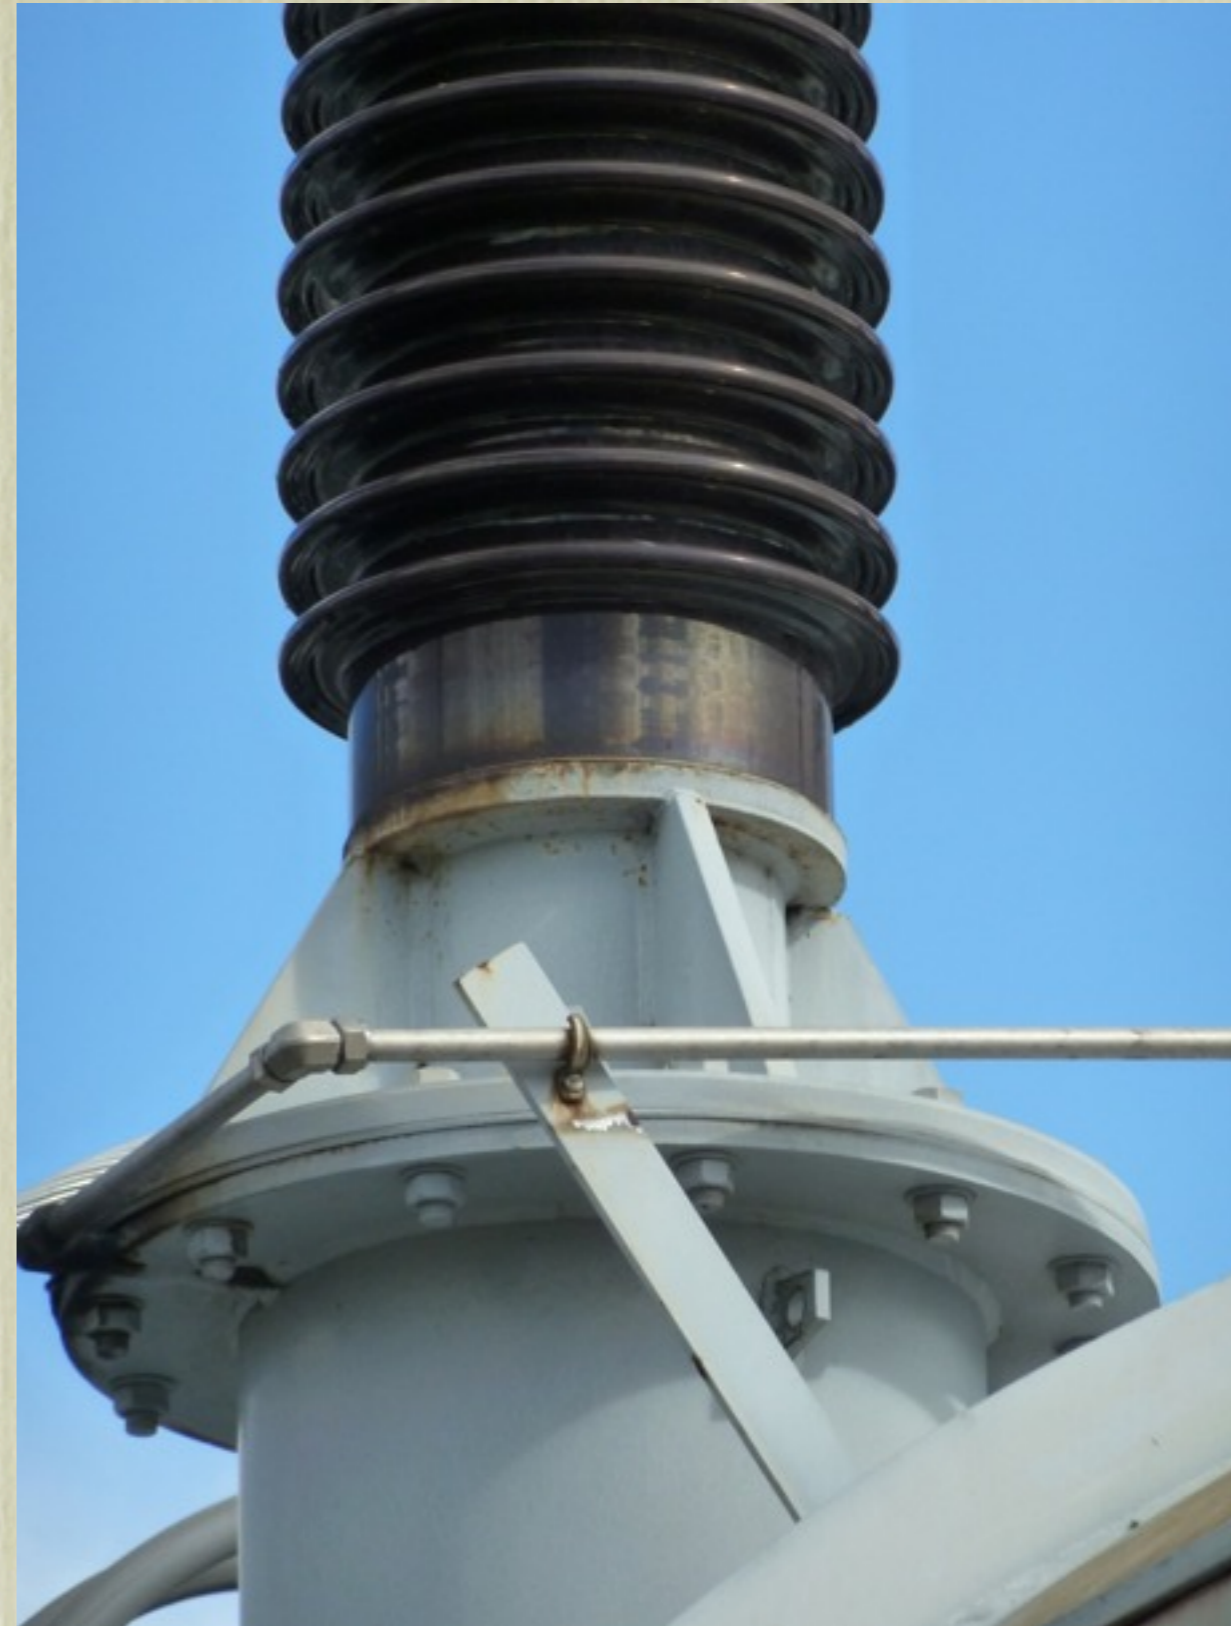
# Cemented bushing

Cracked paint  
suggests yielding?

Very minor oil  
leakage

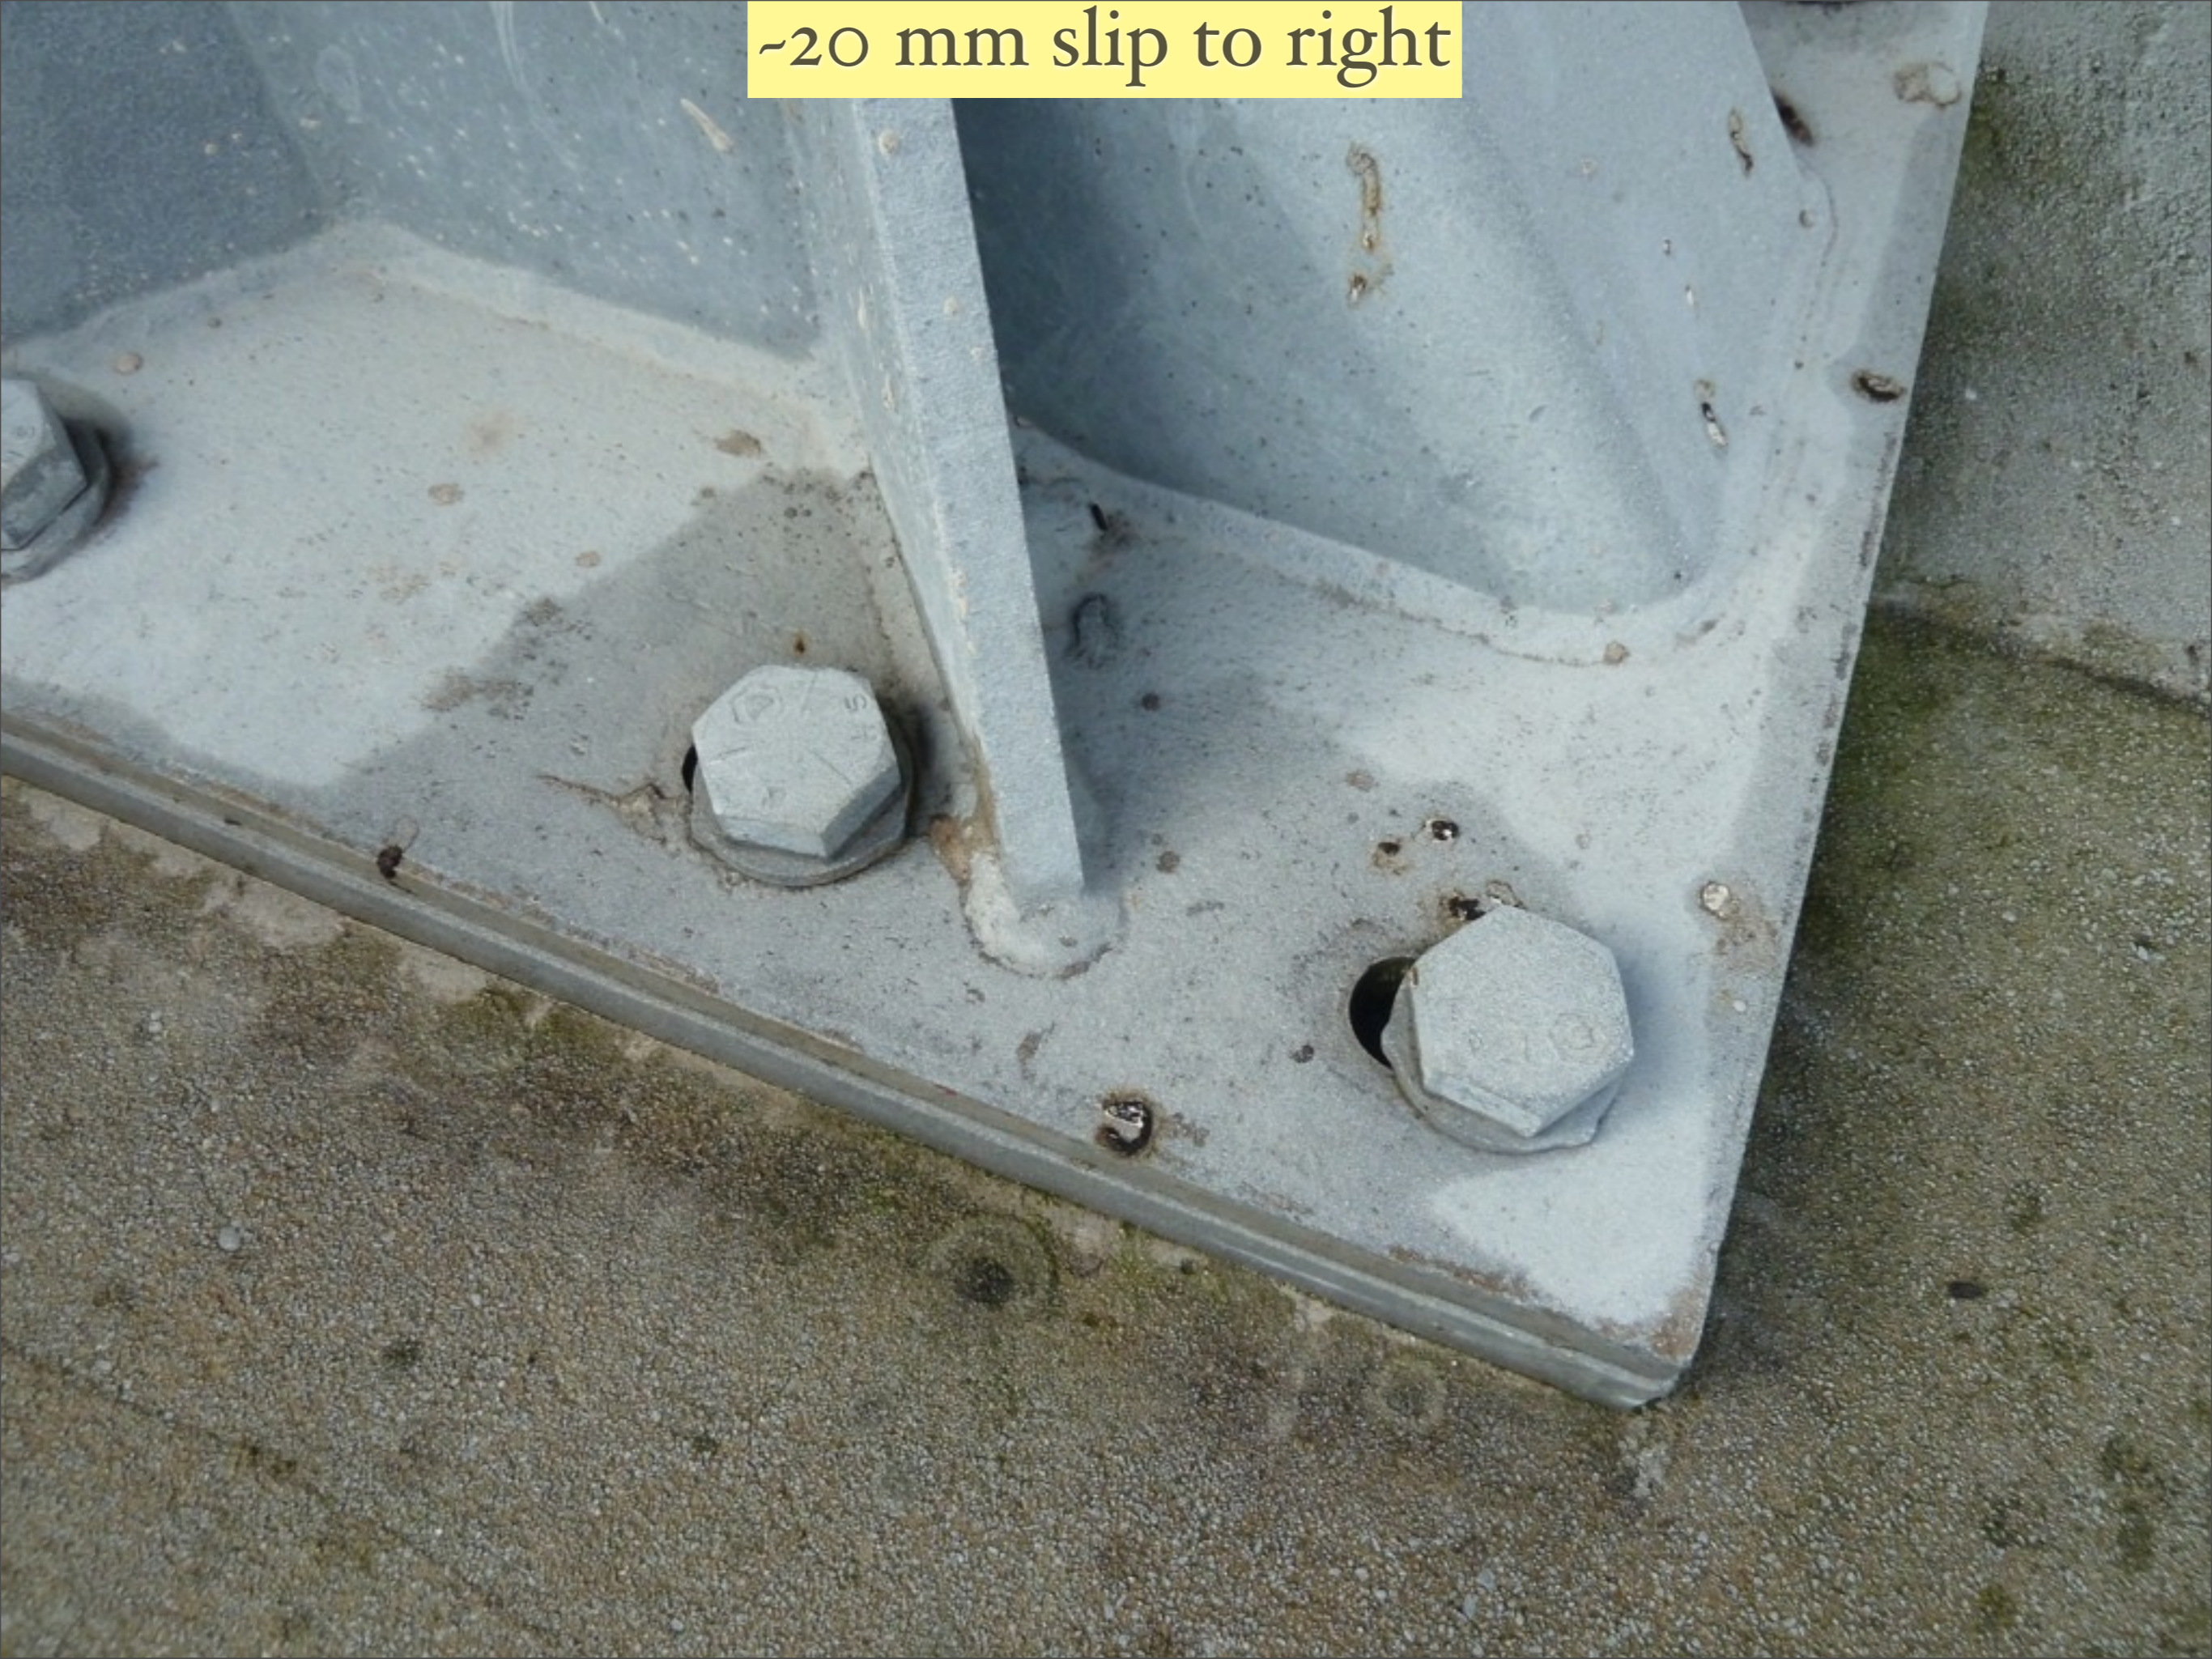
# Bolted Connections: slight slip in 220 kV yard

~20 mm slip to right
