Christchurch, Feb 22 2011 and Sept 4 2010

John Eiding  
G&E Engineering Systems Inc.  
[eidinger@geEngineeringSystems.com](mailto:eidinger@geEngineeringSystems.com)

## Impact to Electric Power Systems

ASCE - Structural Congress

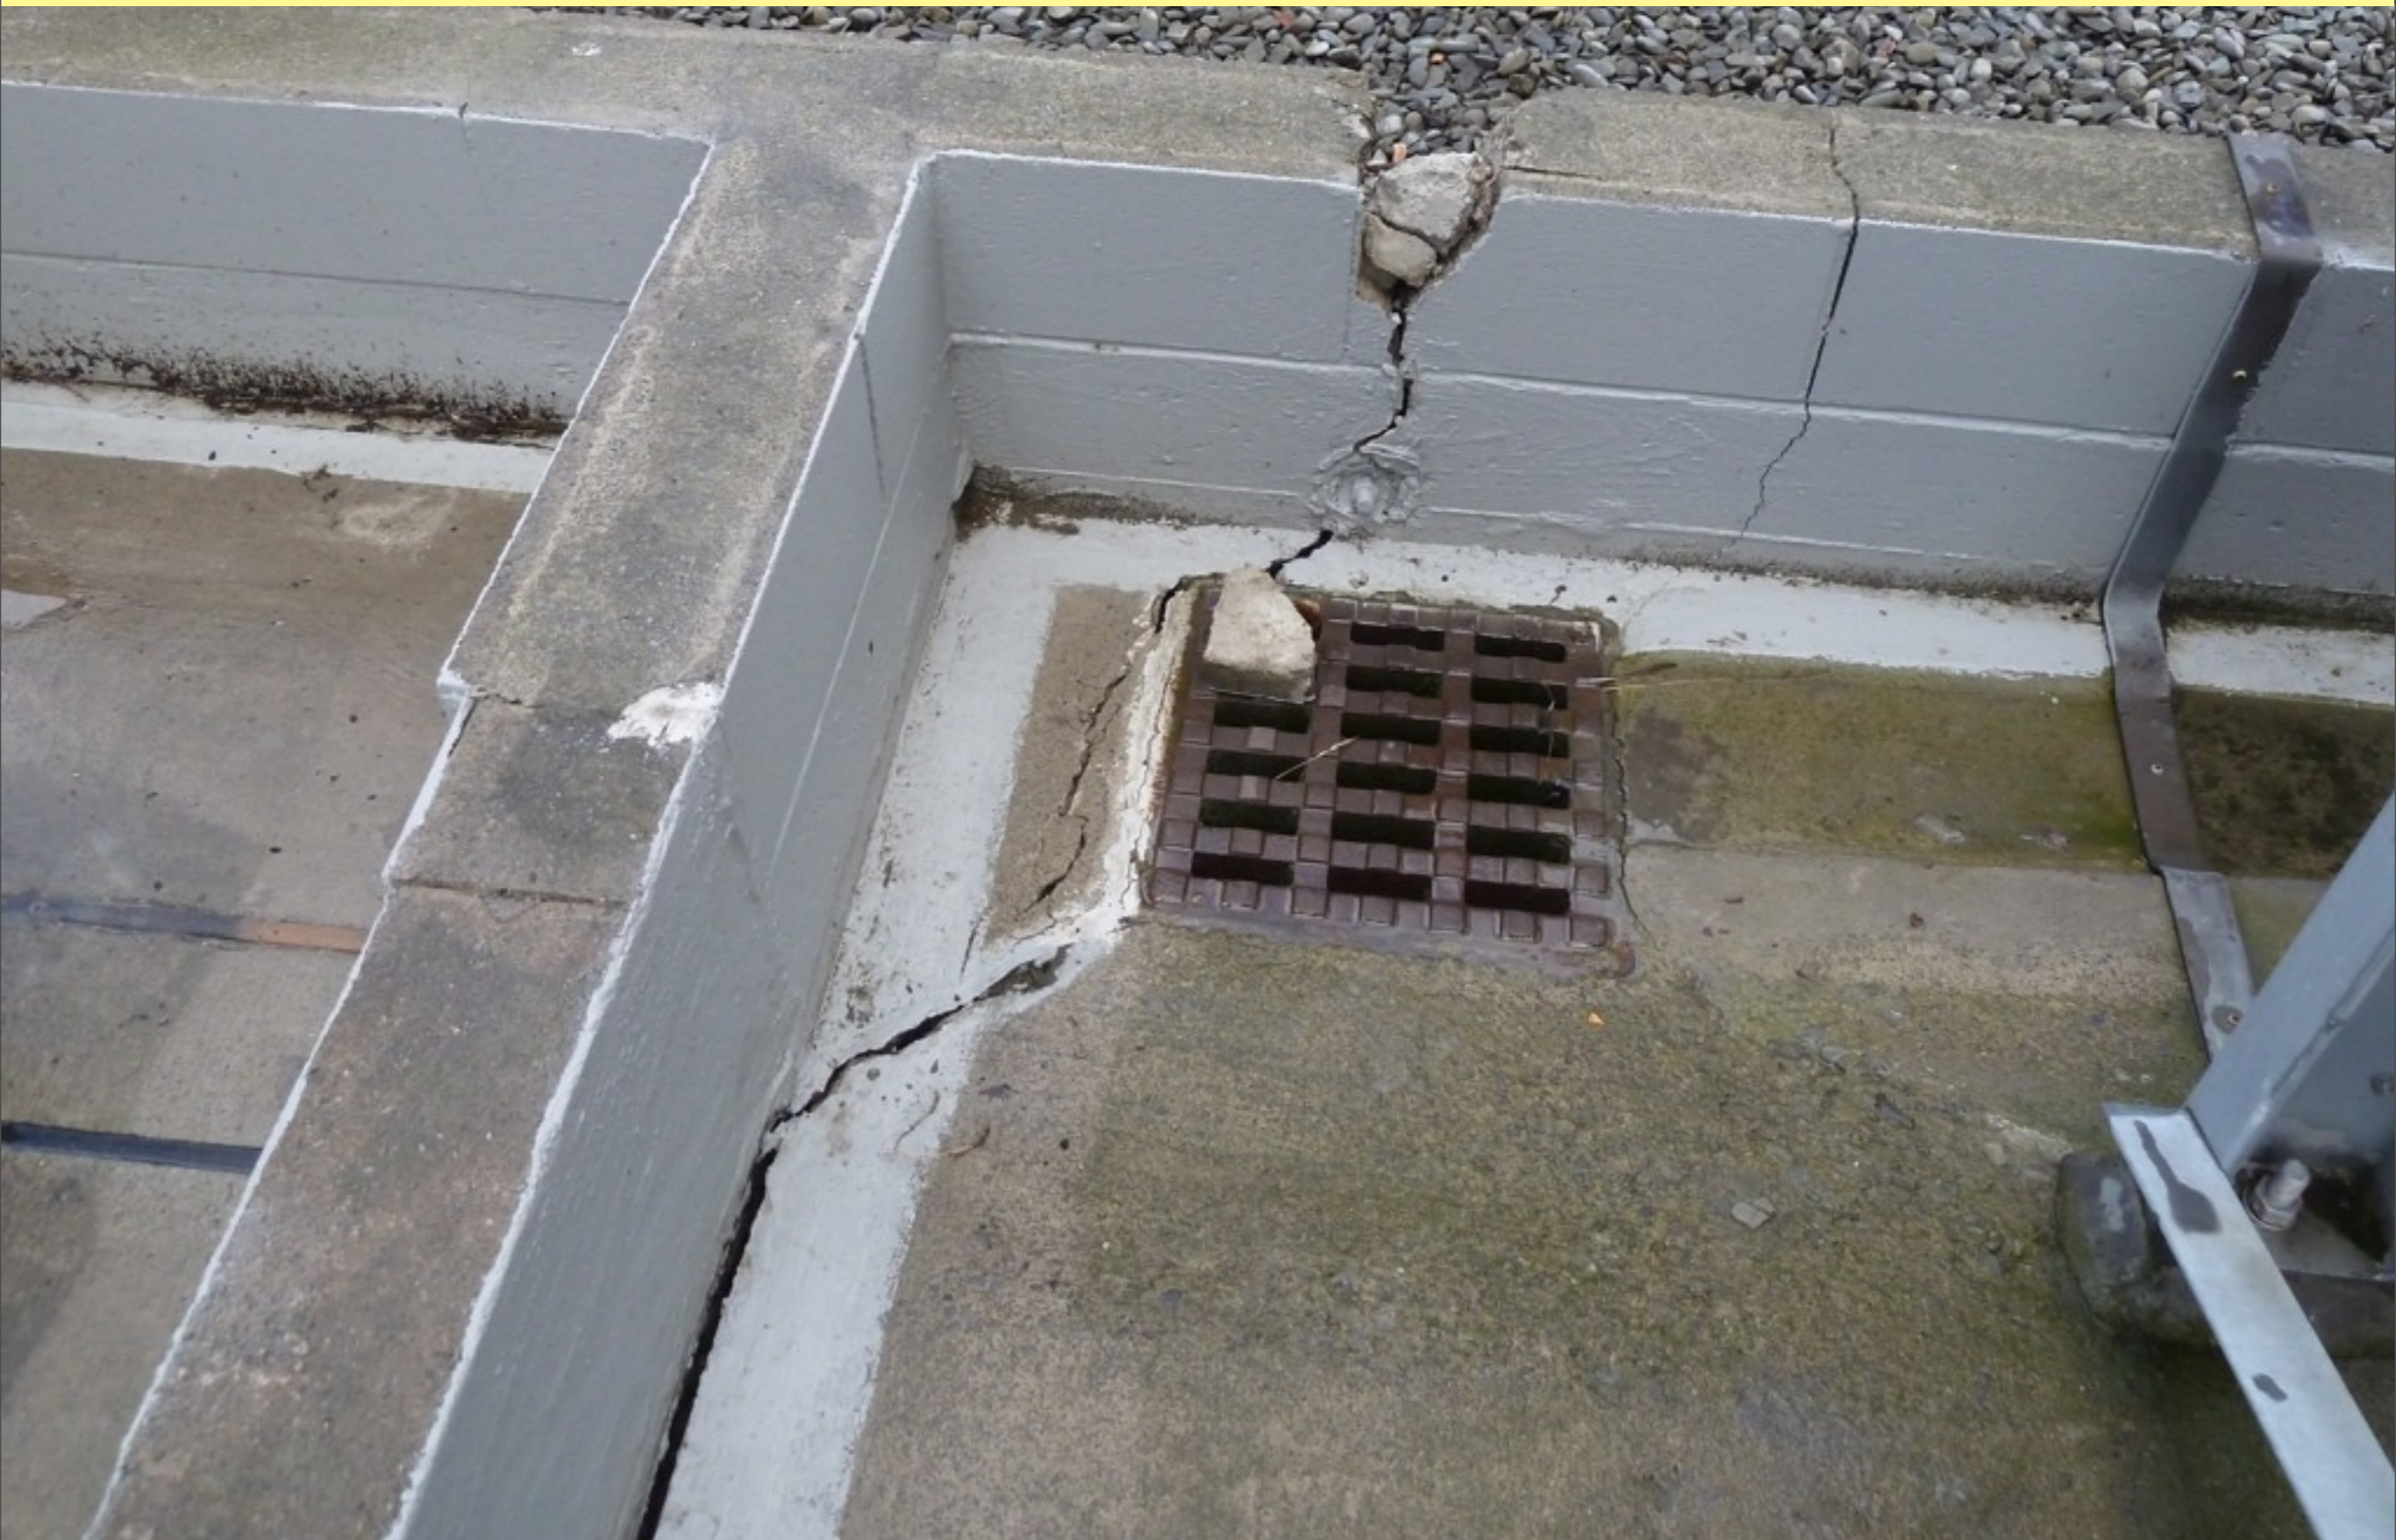
# Spill Prevention Containment Walls, Drain Damage (liquefaction ?)

220 kV center break DS. Some contact problems, misalignments. No contact burns. Needed to be manually reset.

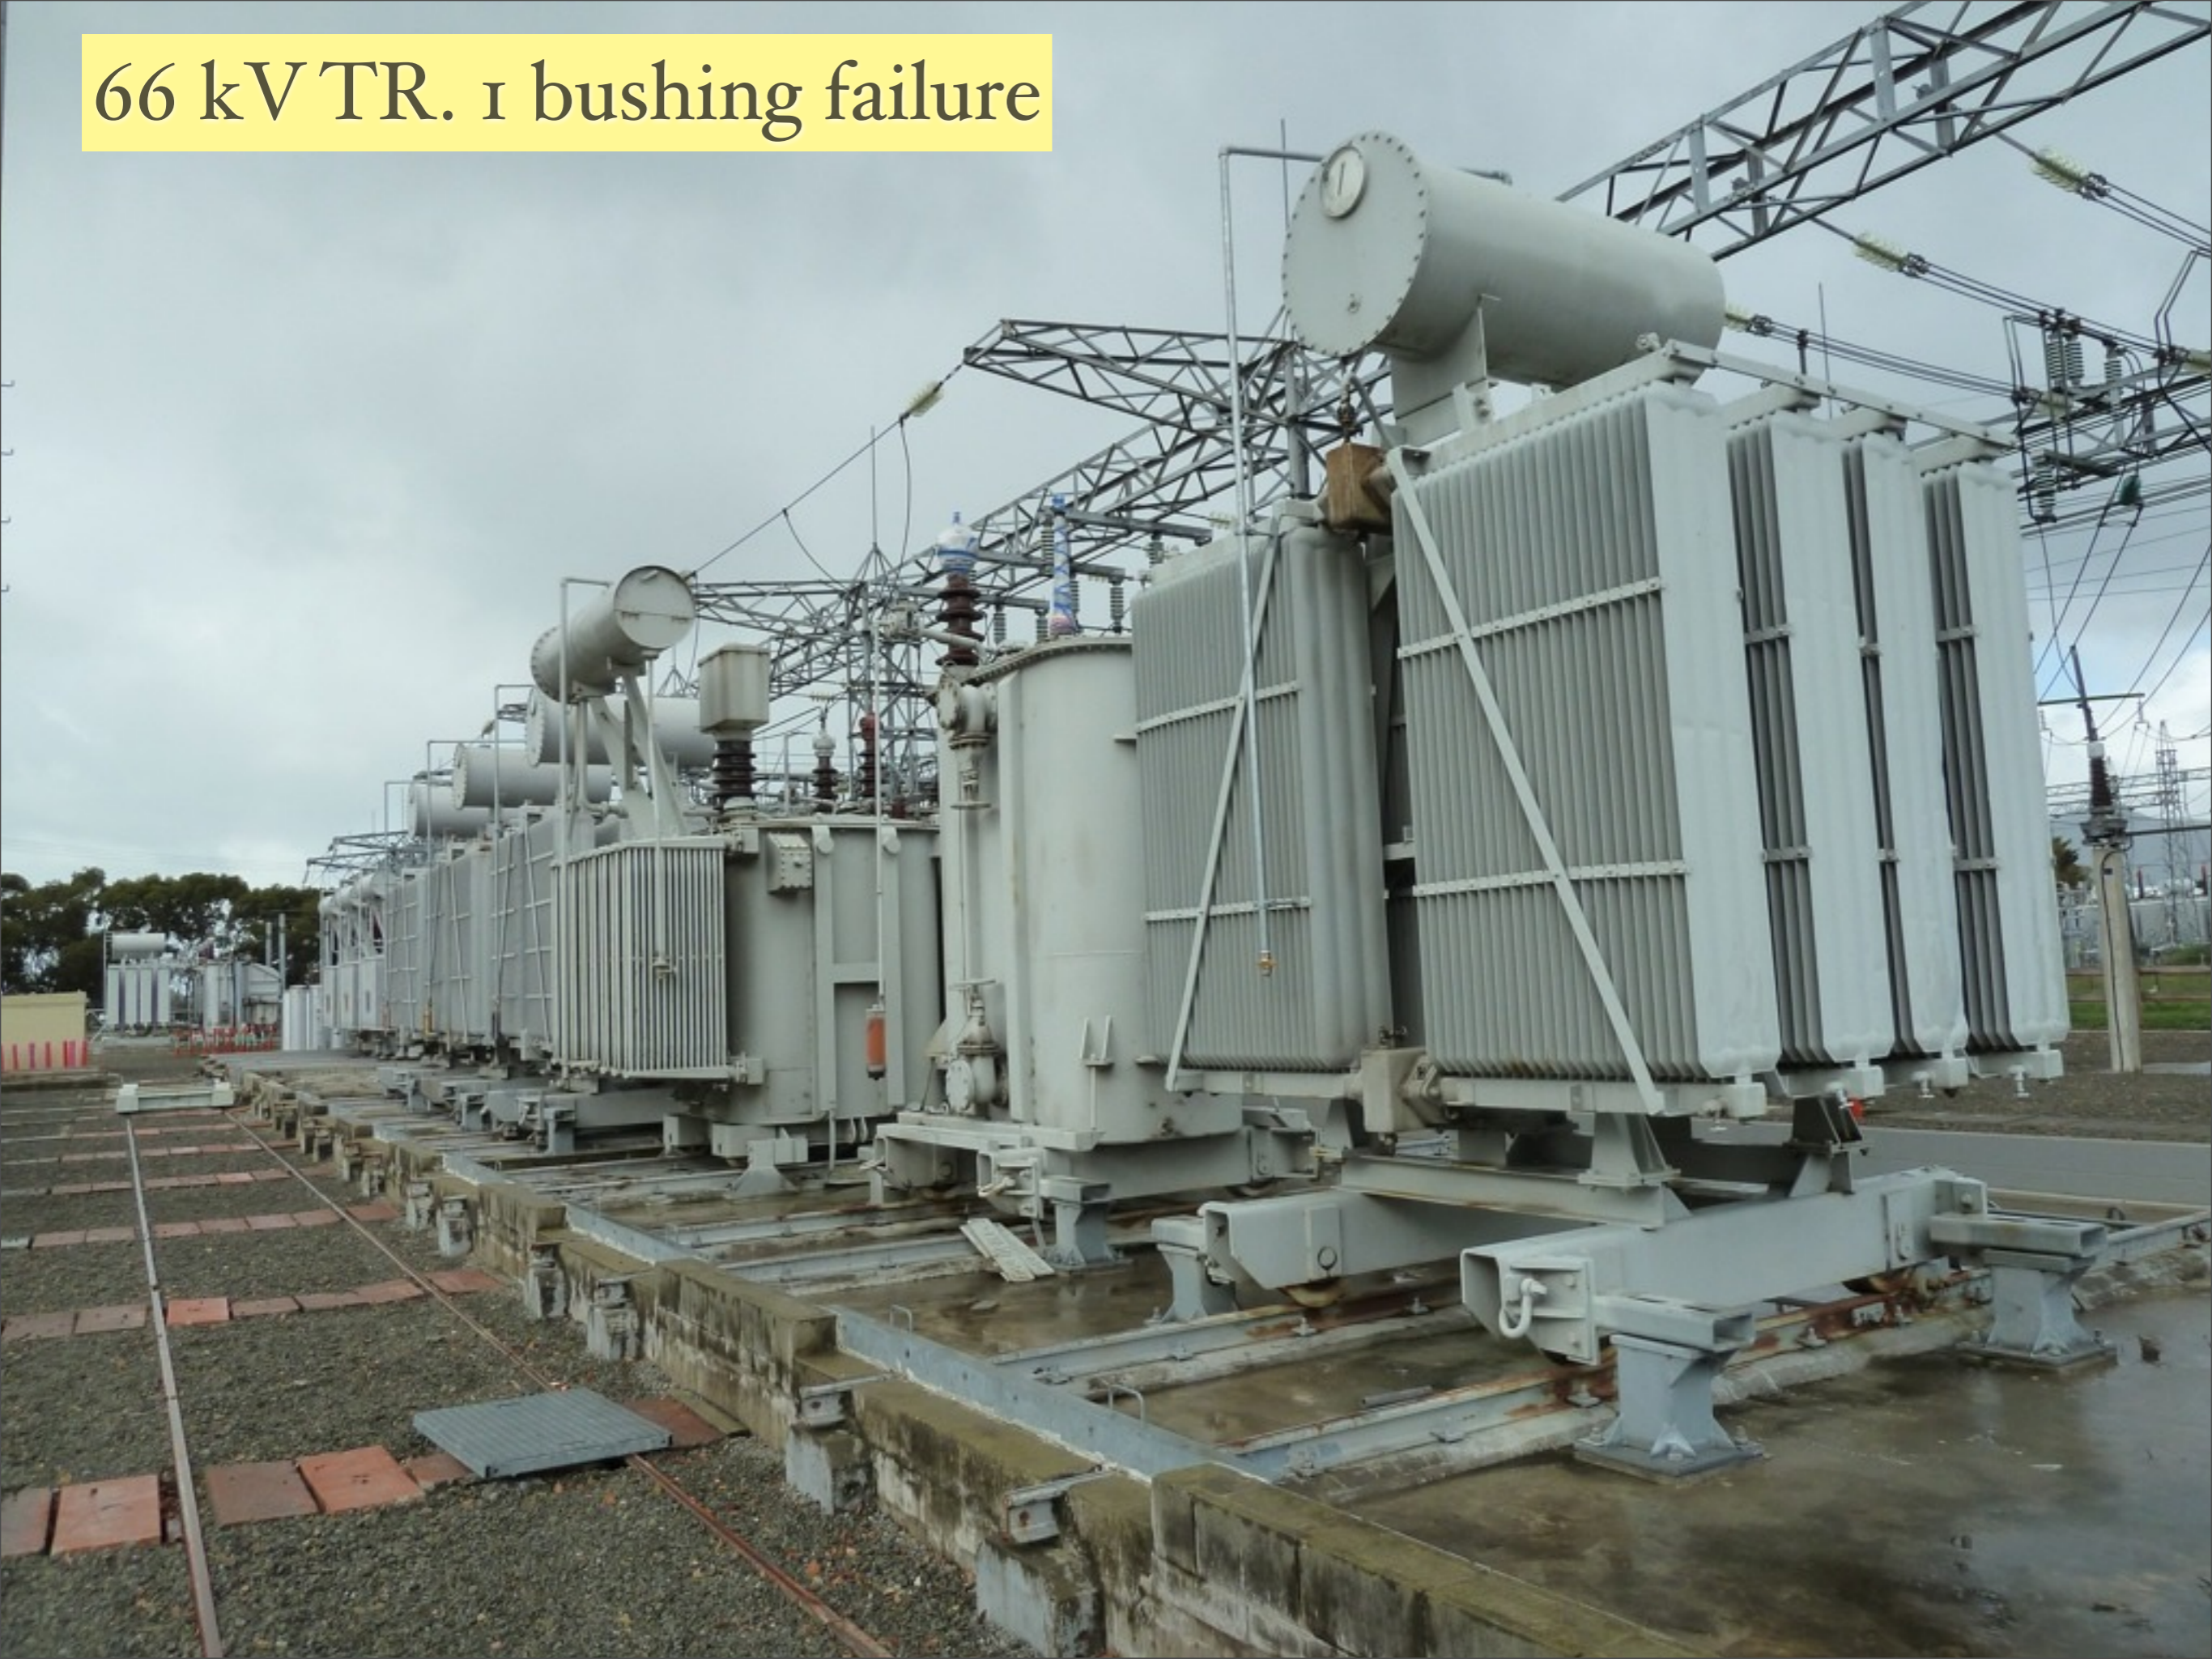
# 66 kV TR. 1 bushing failure

Bus Structure (1951-  
vintage) showed no  
signs of yielding,  
slight spalling in  
concrete  
foundations

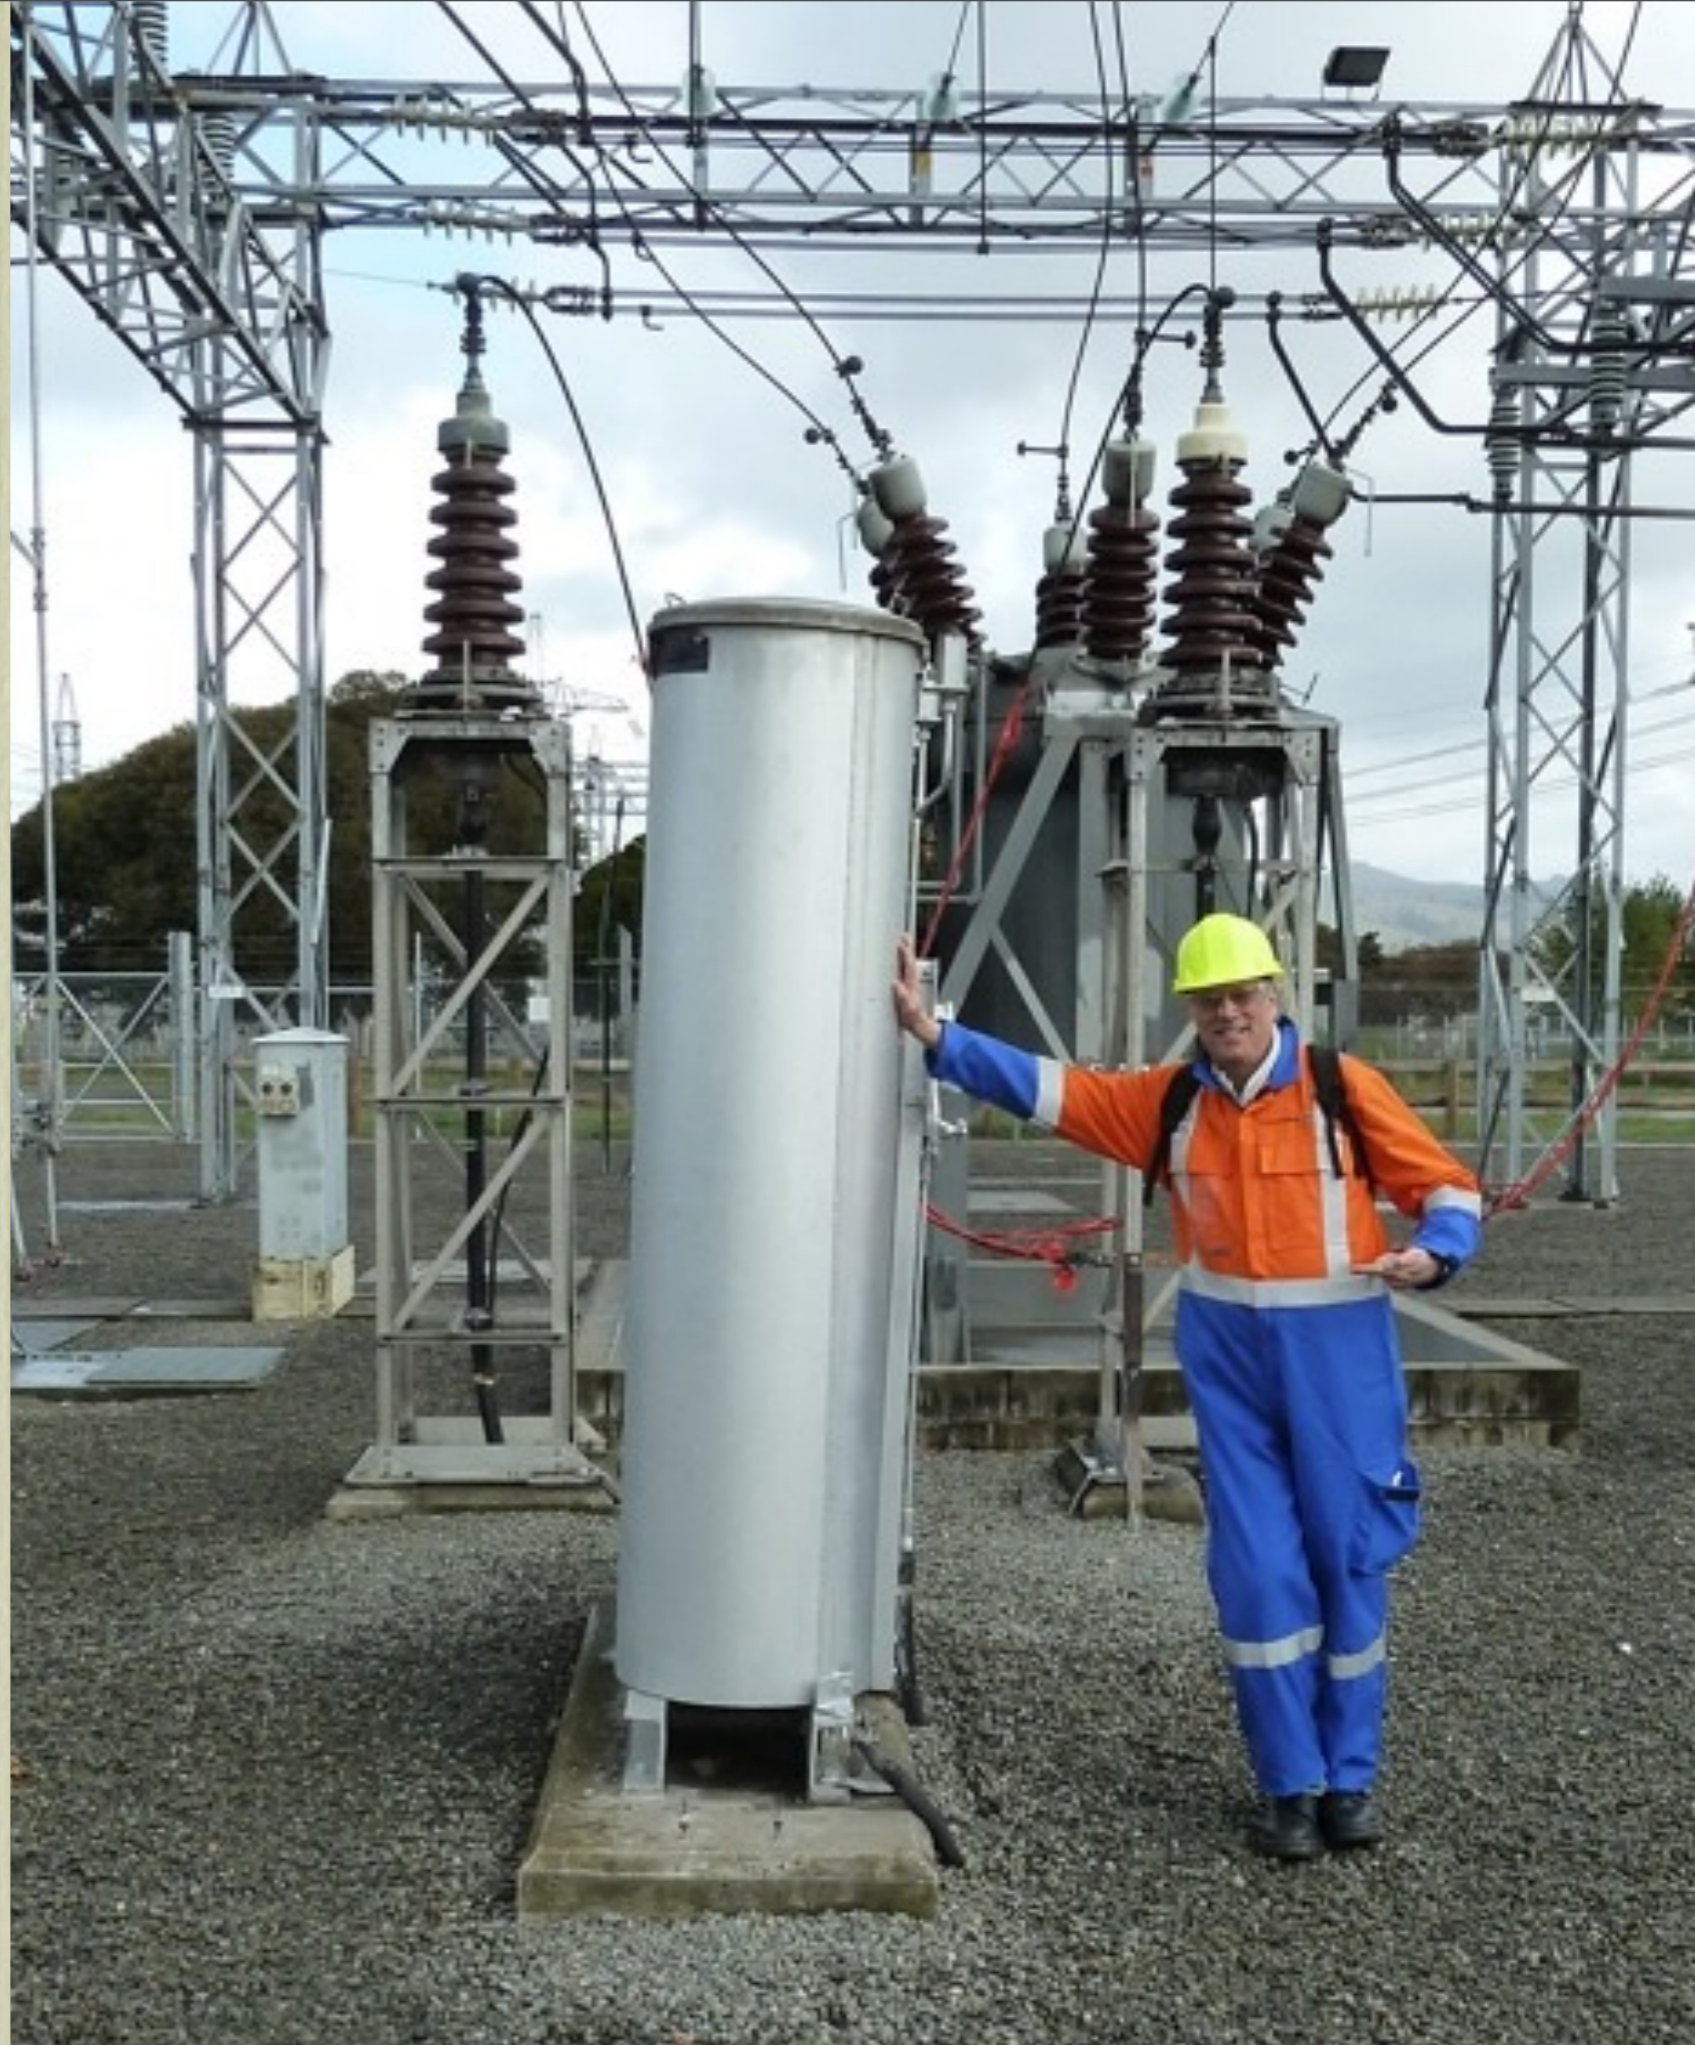
Oil Tanks for  
Buried 66 kV  
Cables. 2 of 3 were  
tilted on their  
foundations, one  
spalled concrete  
foundation

0 psi pressure to buried oil-filled cables  
(3 cables from this substation)

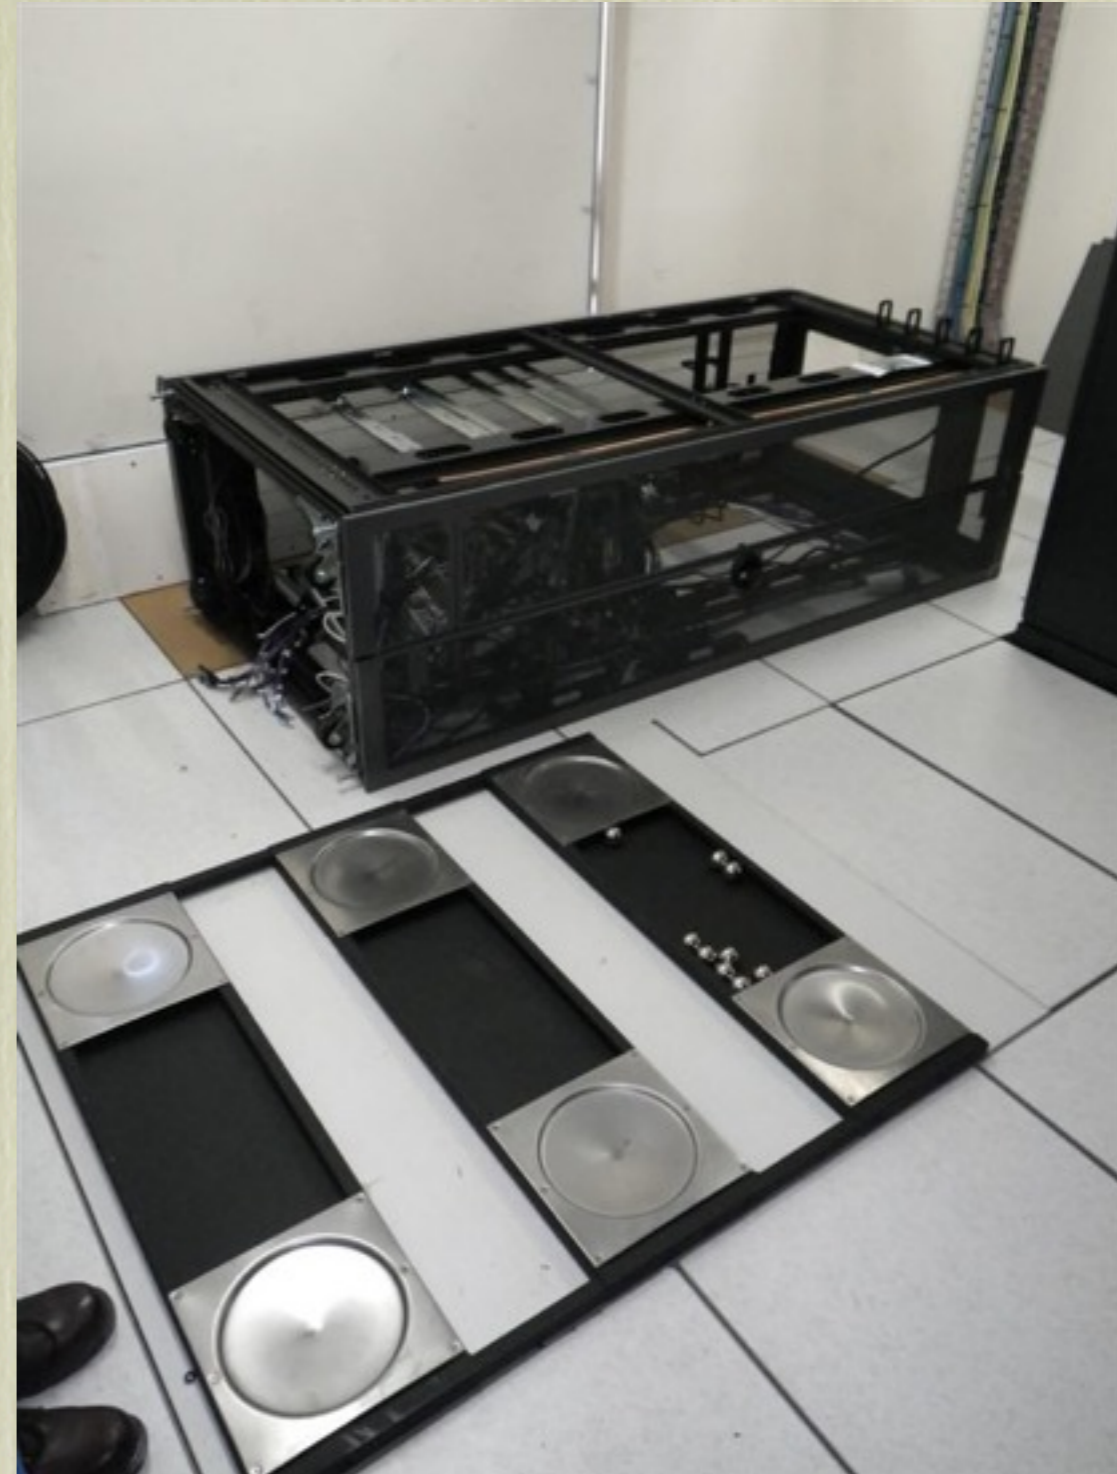
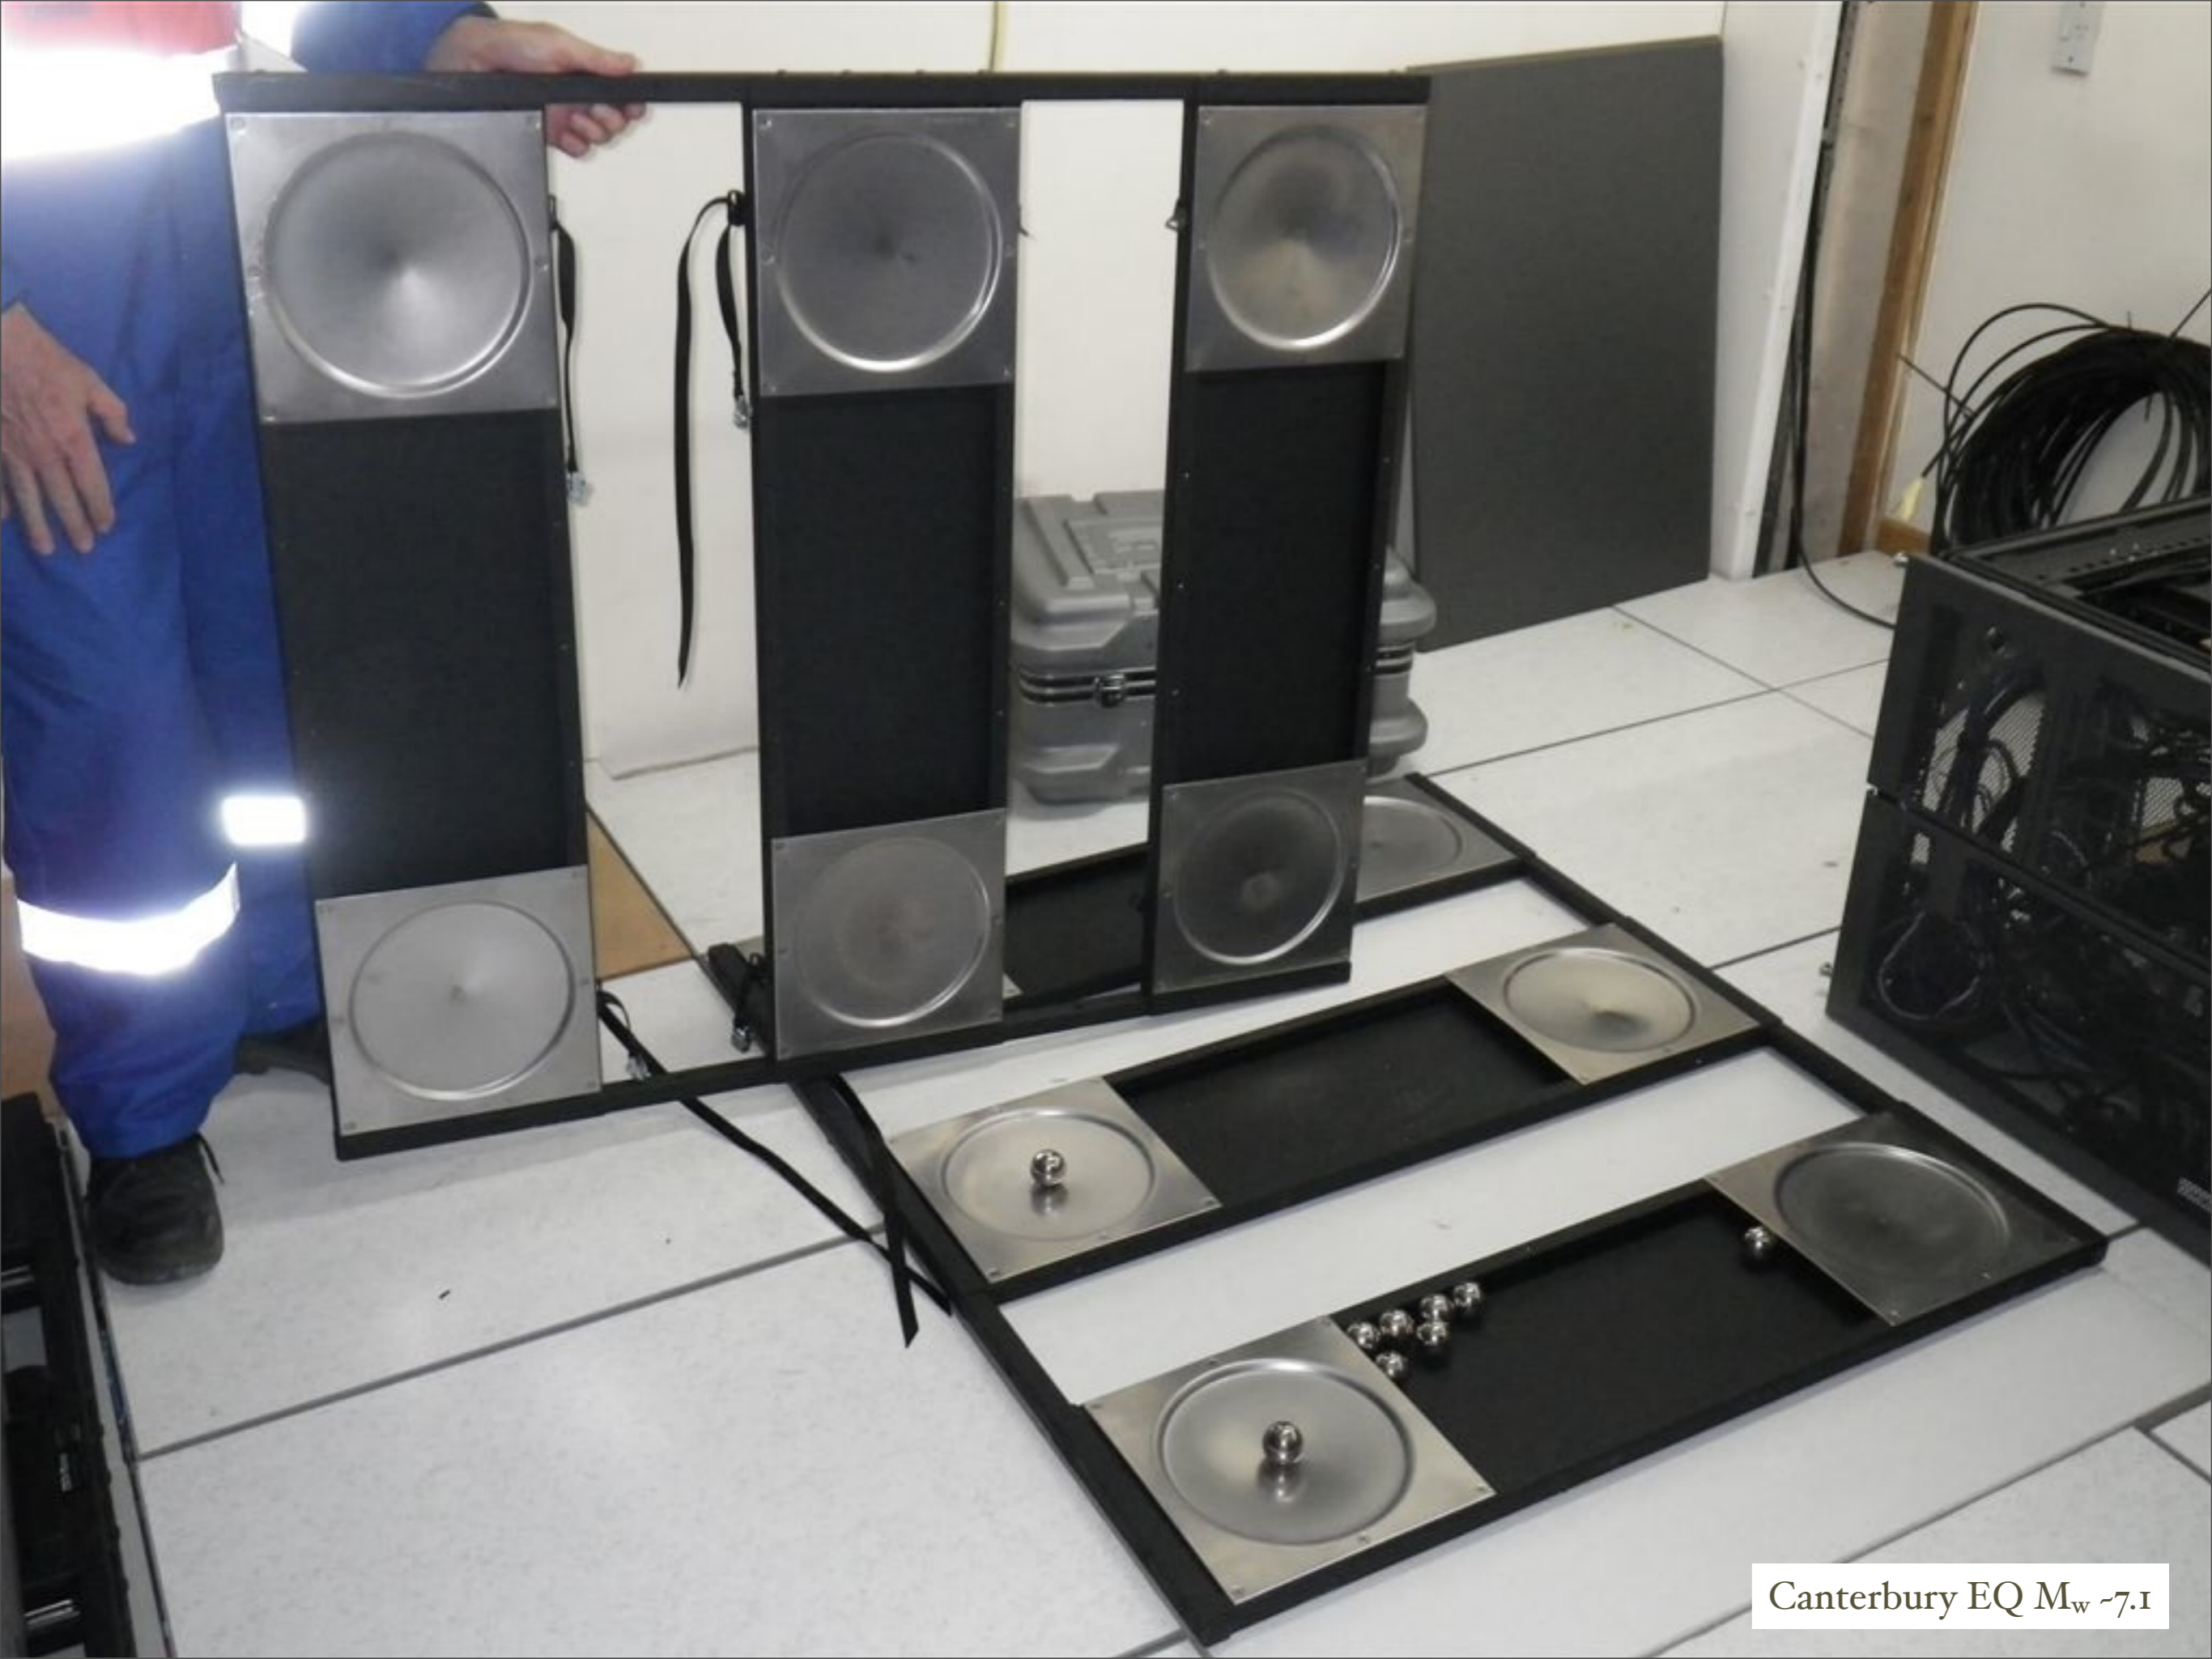
# Regional Operations Center

- Cabinet dislodged in computer room. Removed.
- Seismic isolators under cabinet failed (ball bearings came out). No longer seismically free to move
- Suspended ceiling tiles fell down in lunch room, near entrance.
- Lighting diffusers in ceiling fell down in the control room

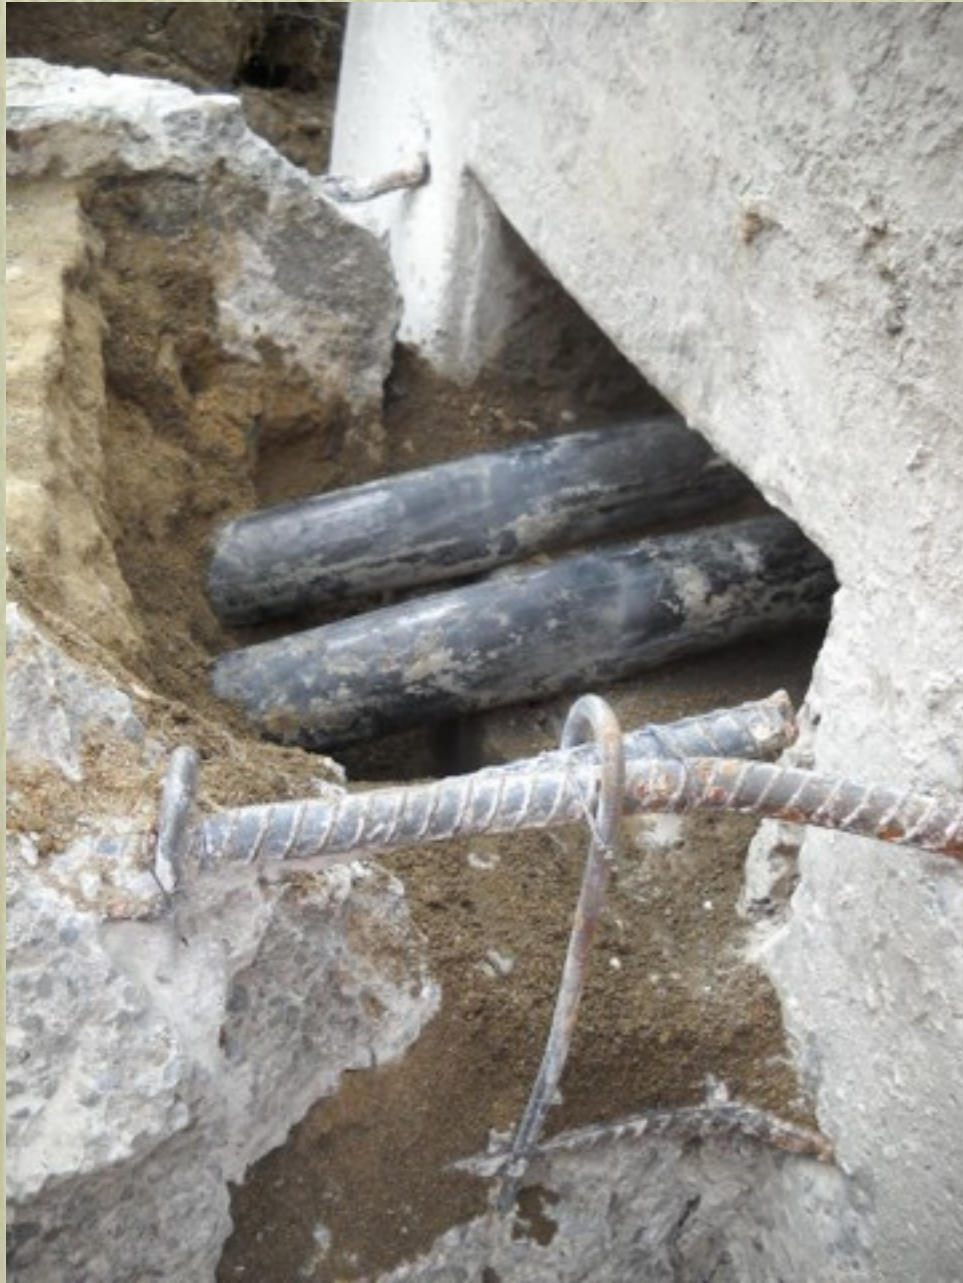
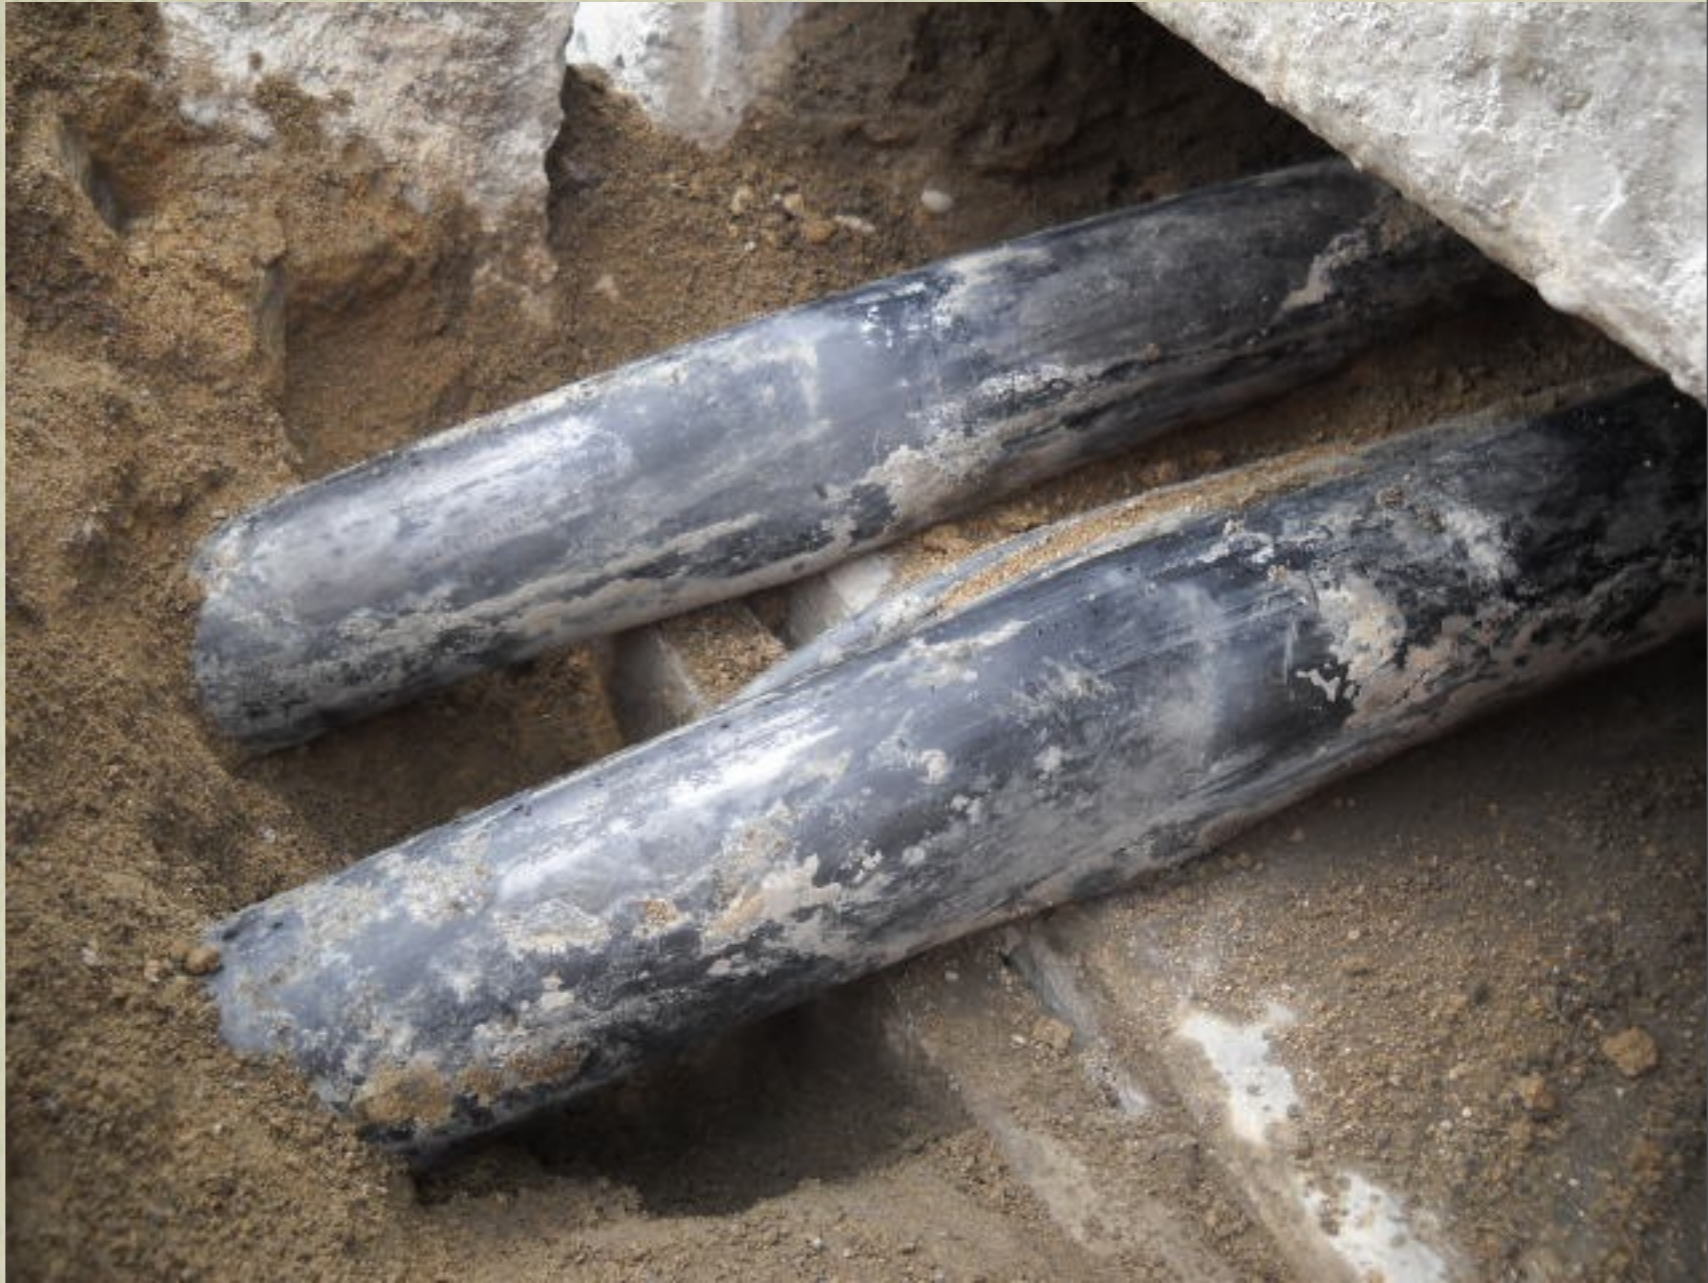
(2010) Two 66 kV cables, Buckled, pinched, not faulted (2010)
