Christchurch, Feb 22 2011 and Sept 4 2010

John Eiding  
G&E Engineering Systems Inc.  
[eidinger@geEngineeringSystems.com](mailto:eidinger@geEngineeringSystems.com)

## Impact to Electric Power Systems

ASCE - Structural Congress

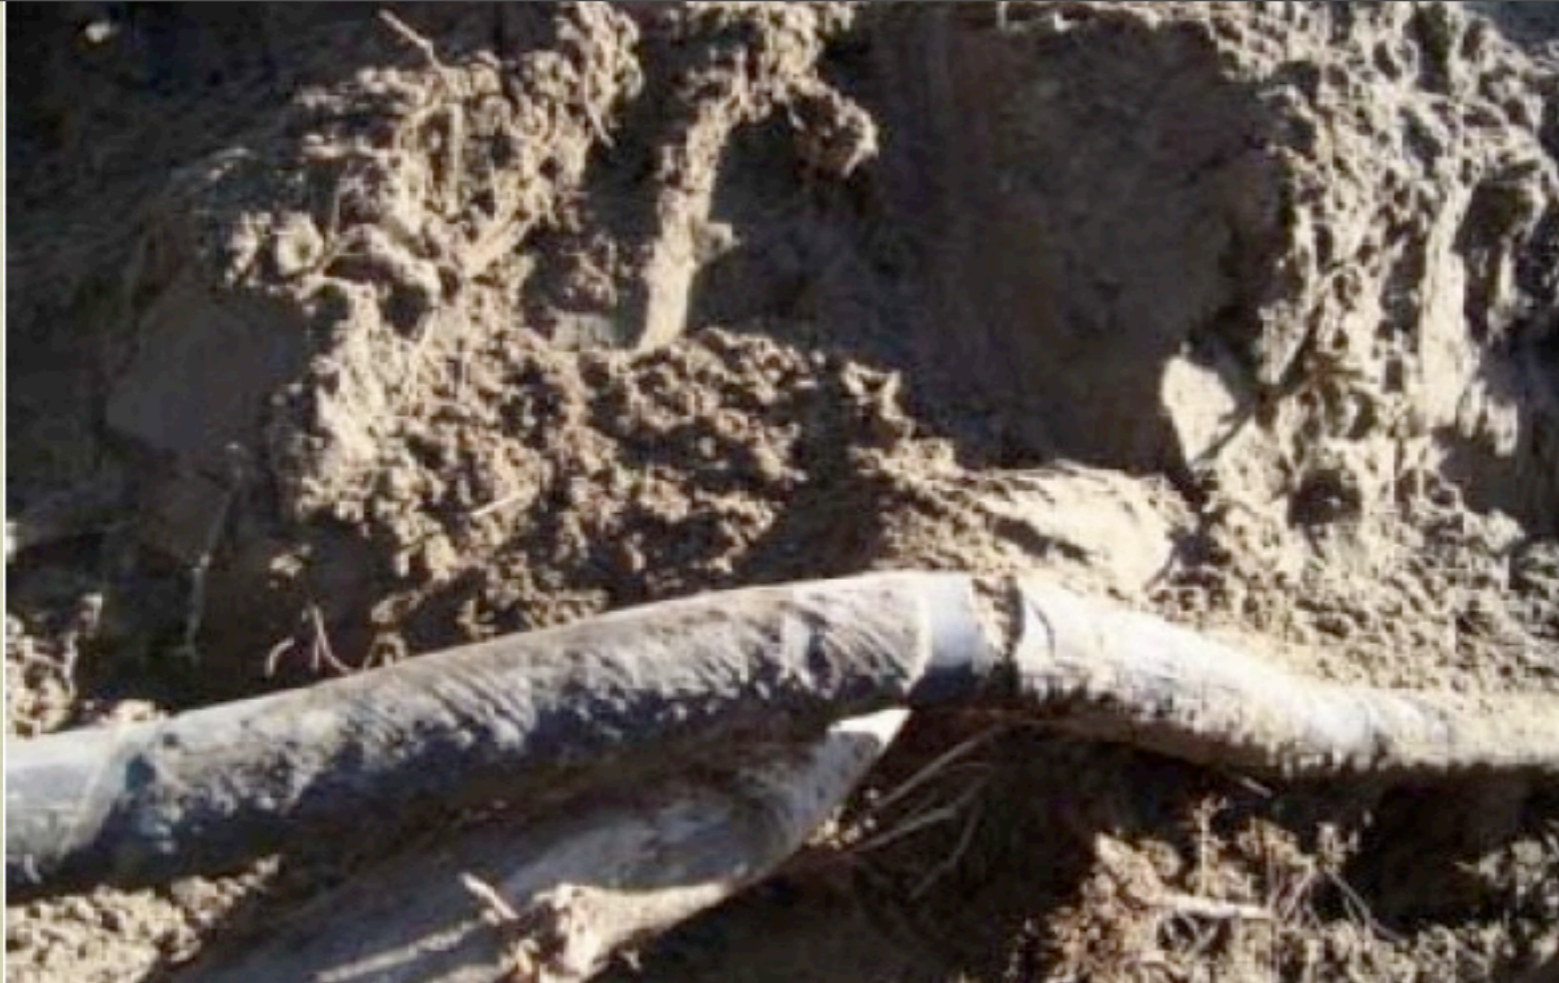
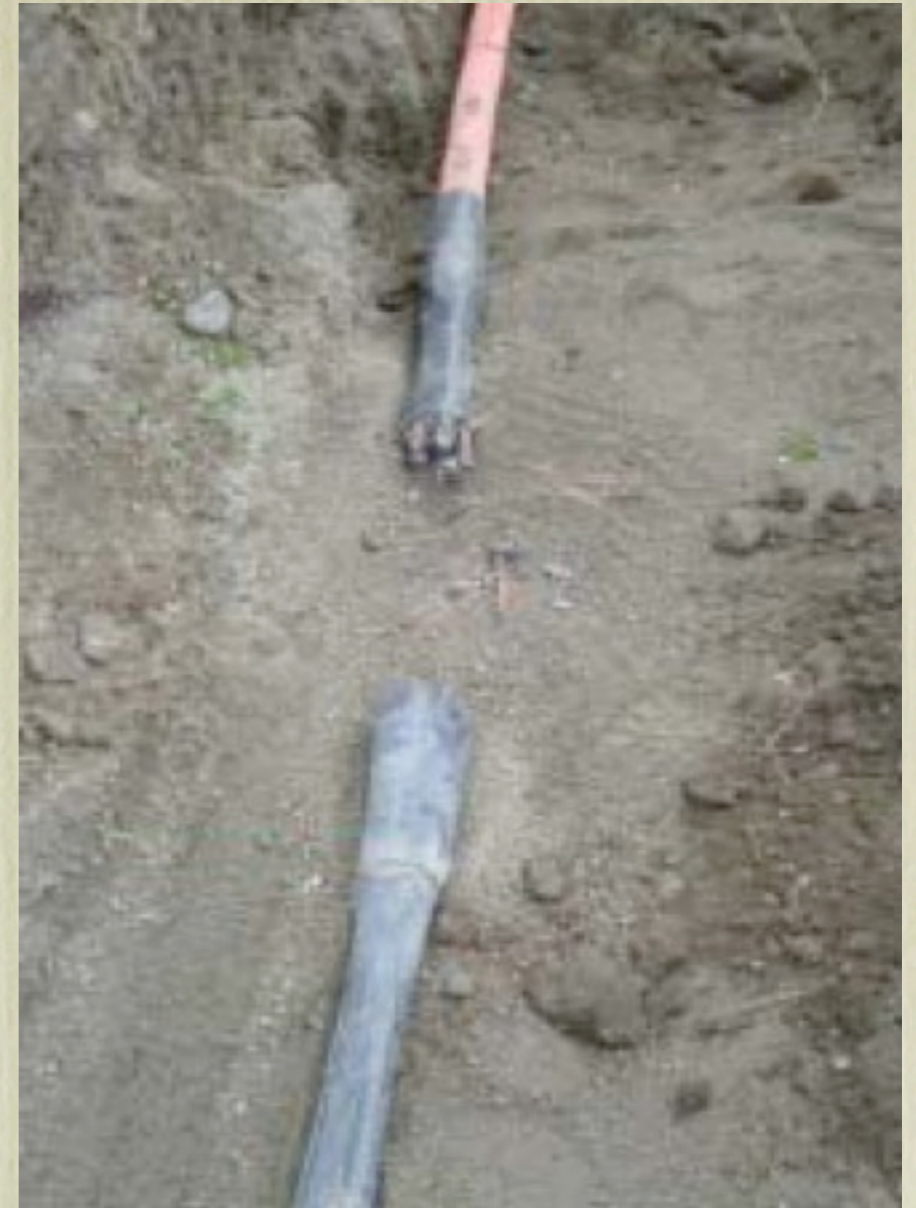
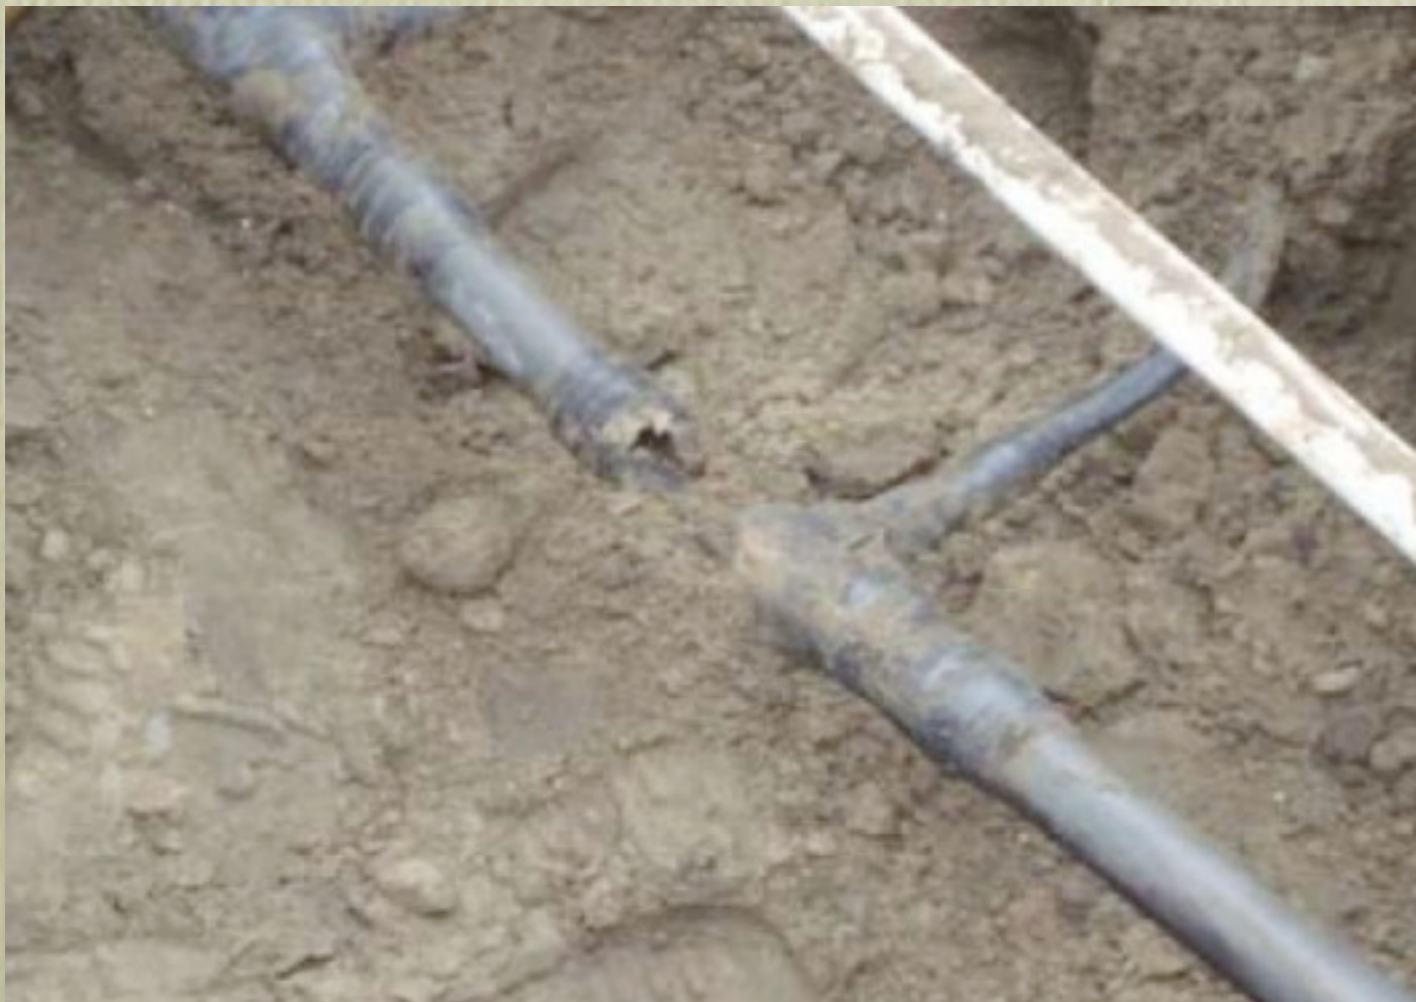
2011: More lateral Spreading, now forming a 3-pin arch

(2011) Same cables faulted, not yet dug up or repaired (as of April 5 2011)

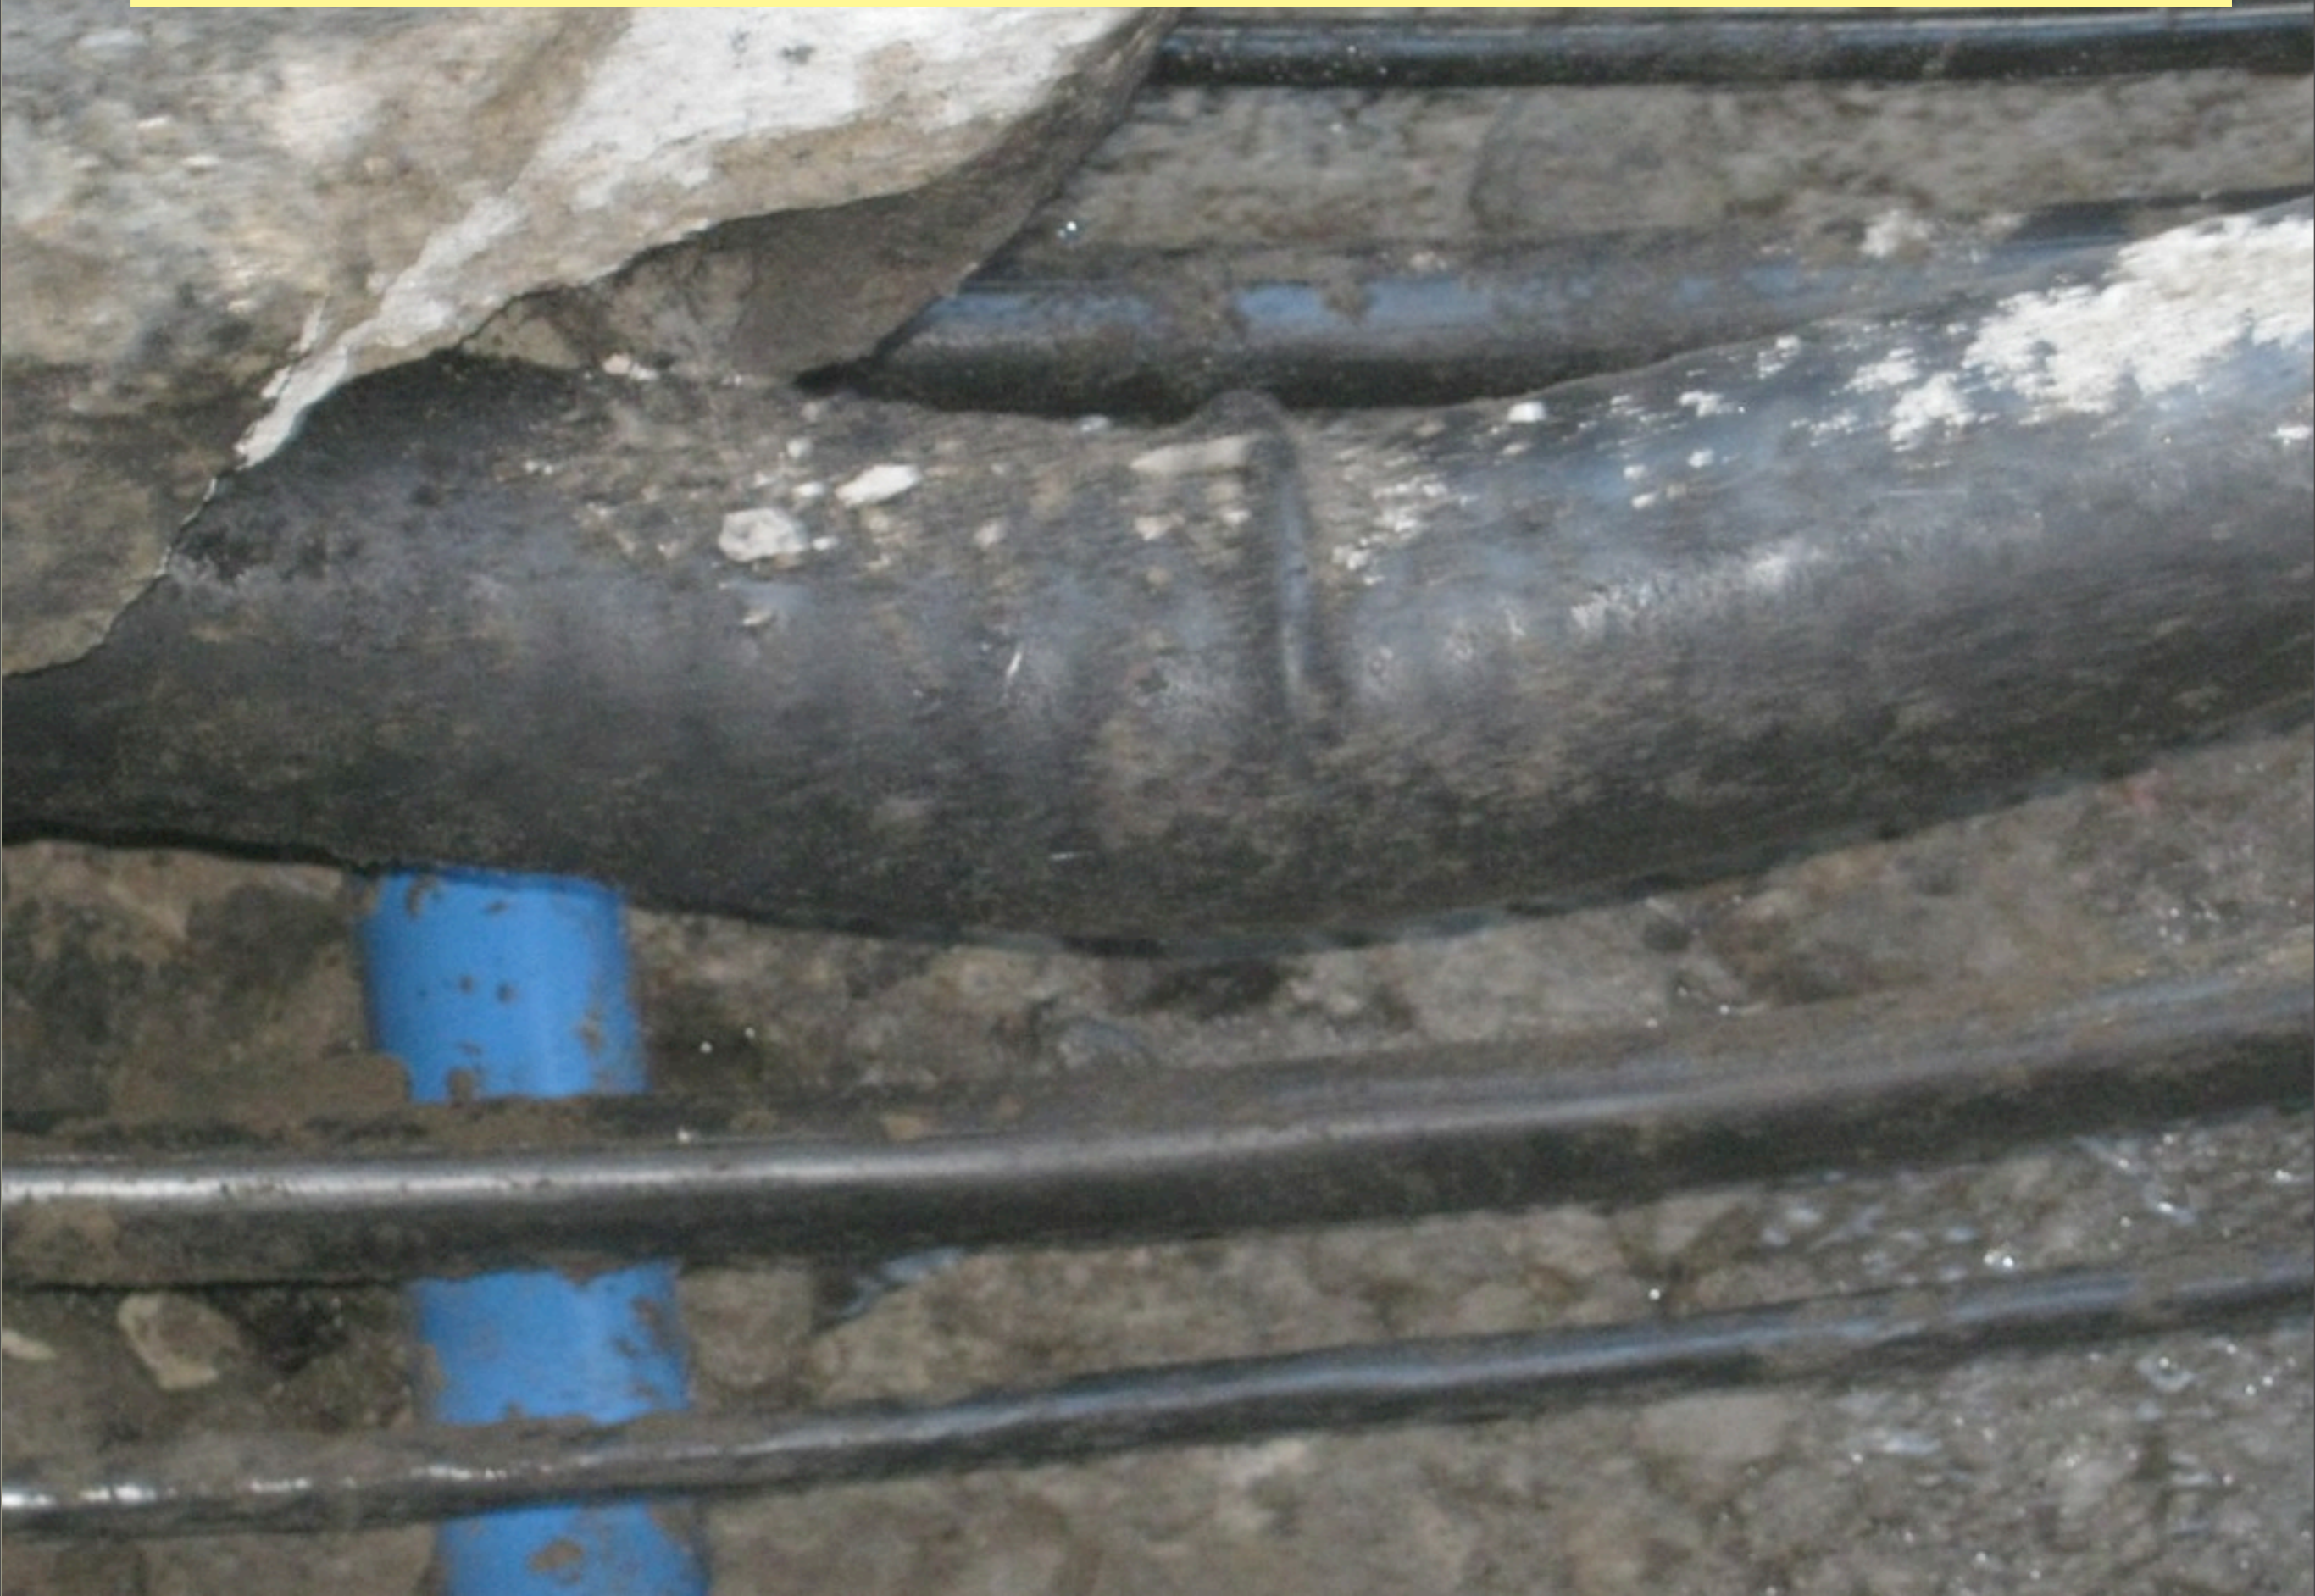
Armagh Street - failed 66 kV cables (multiple)  
Similar damage for Brighton, Dallington

66 kV Cable - Buckled, but remains operational (for now)

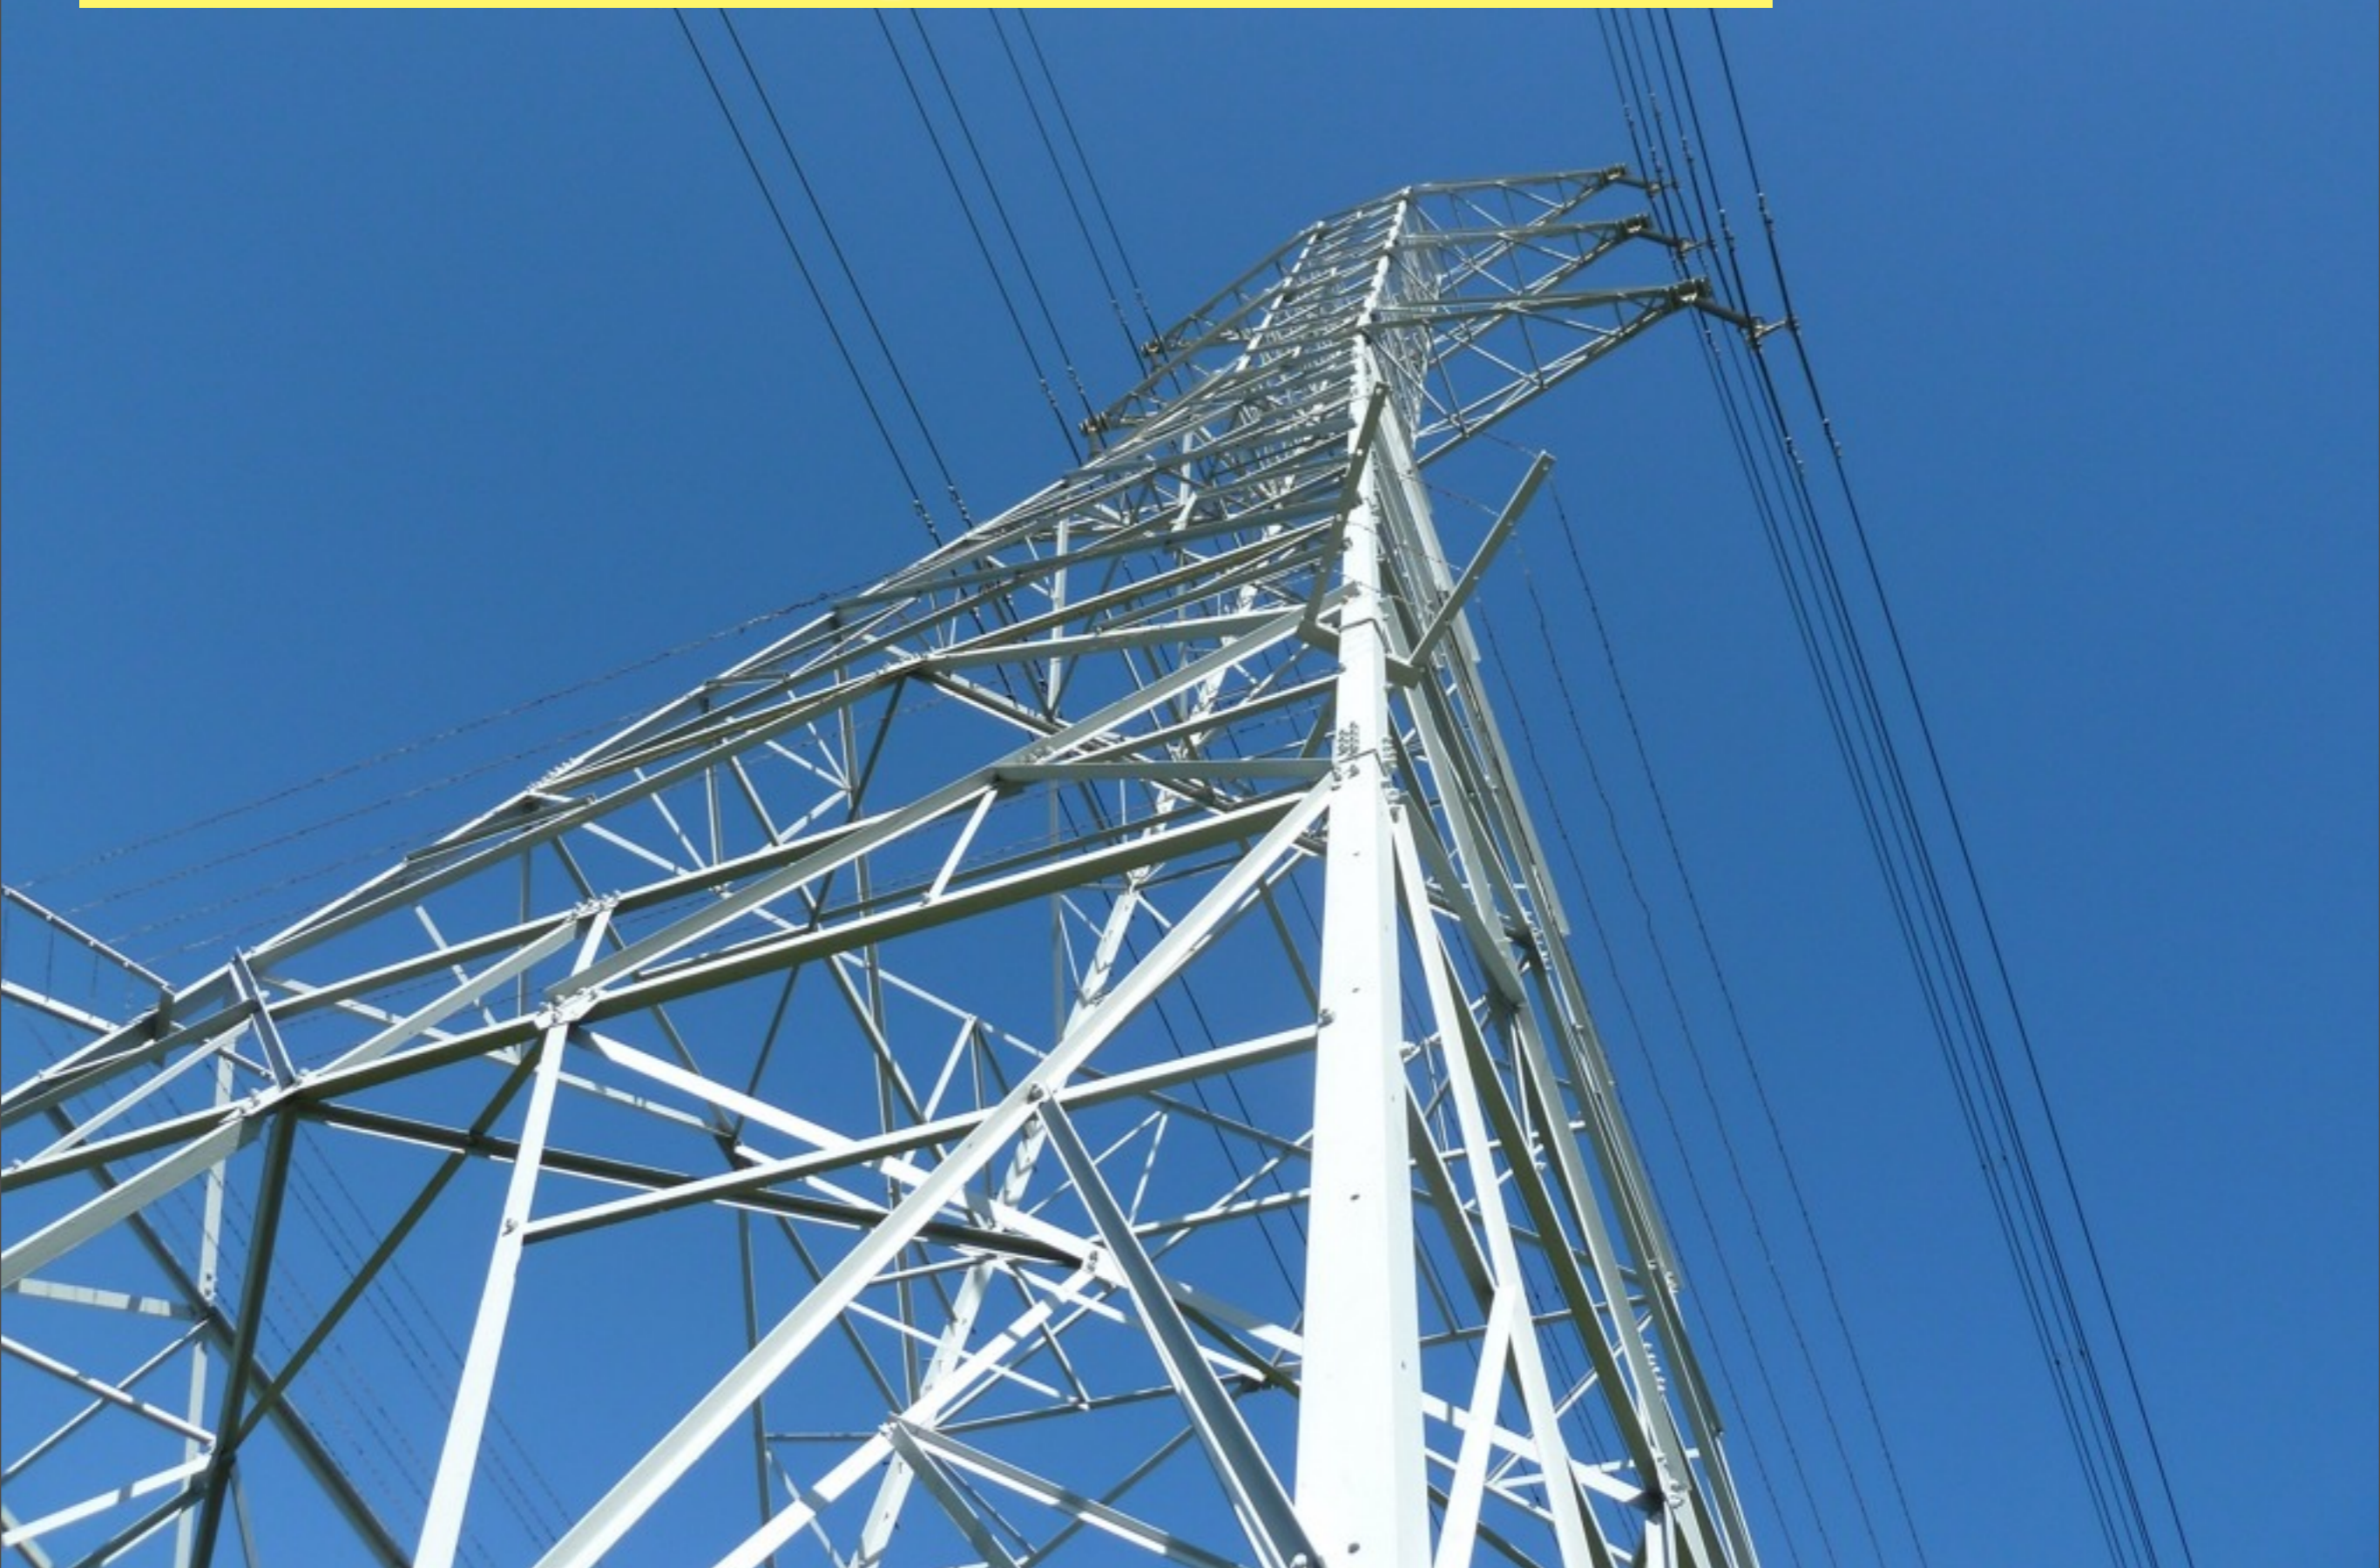
220 kV - Displaced sideways or slightly tilted  
No observed panel distortion

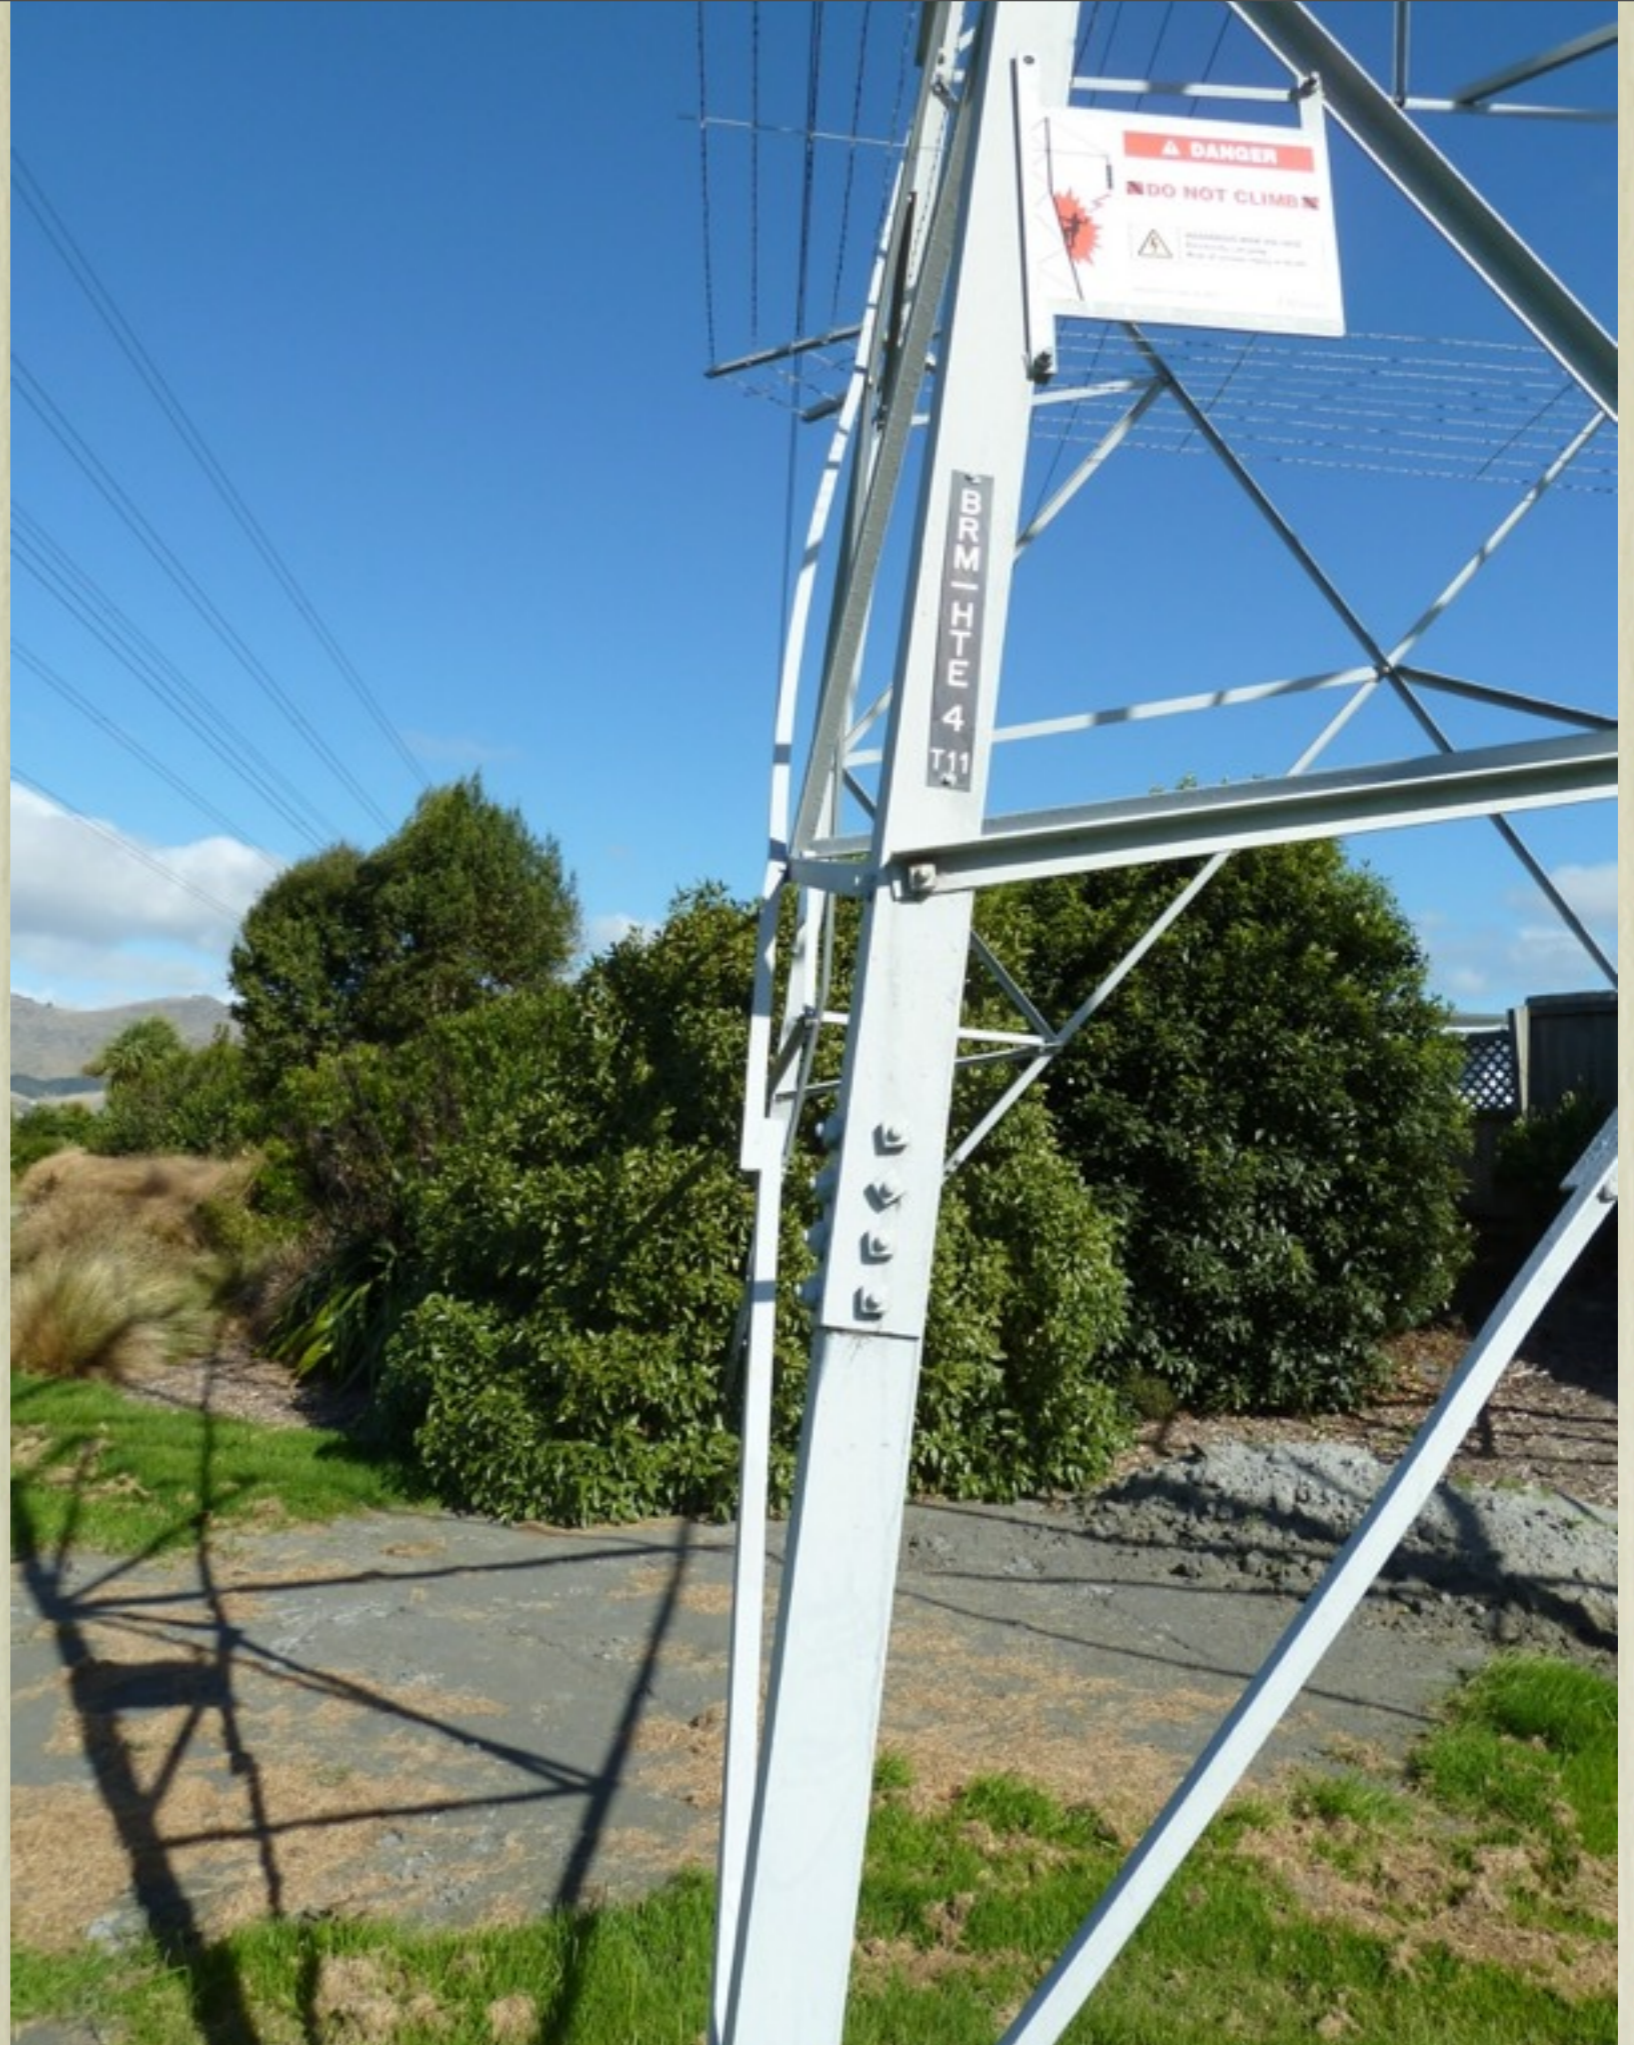
66 kV - Displaced sideways or slightly tilted  
Some observed panel distortion

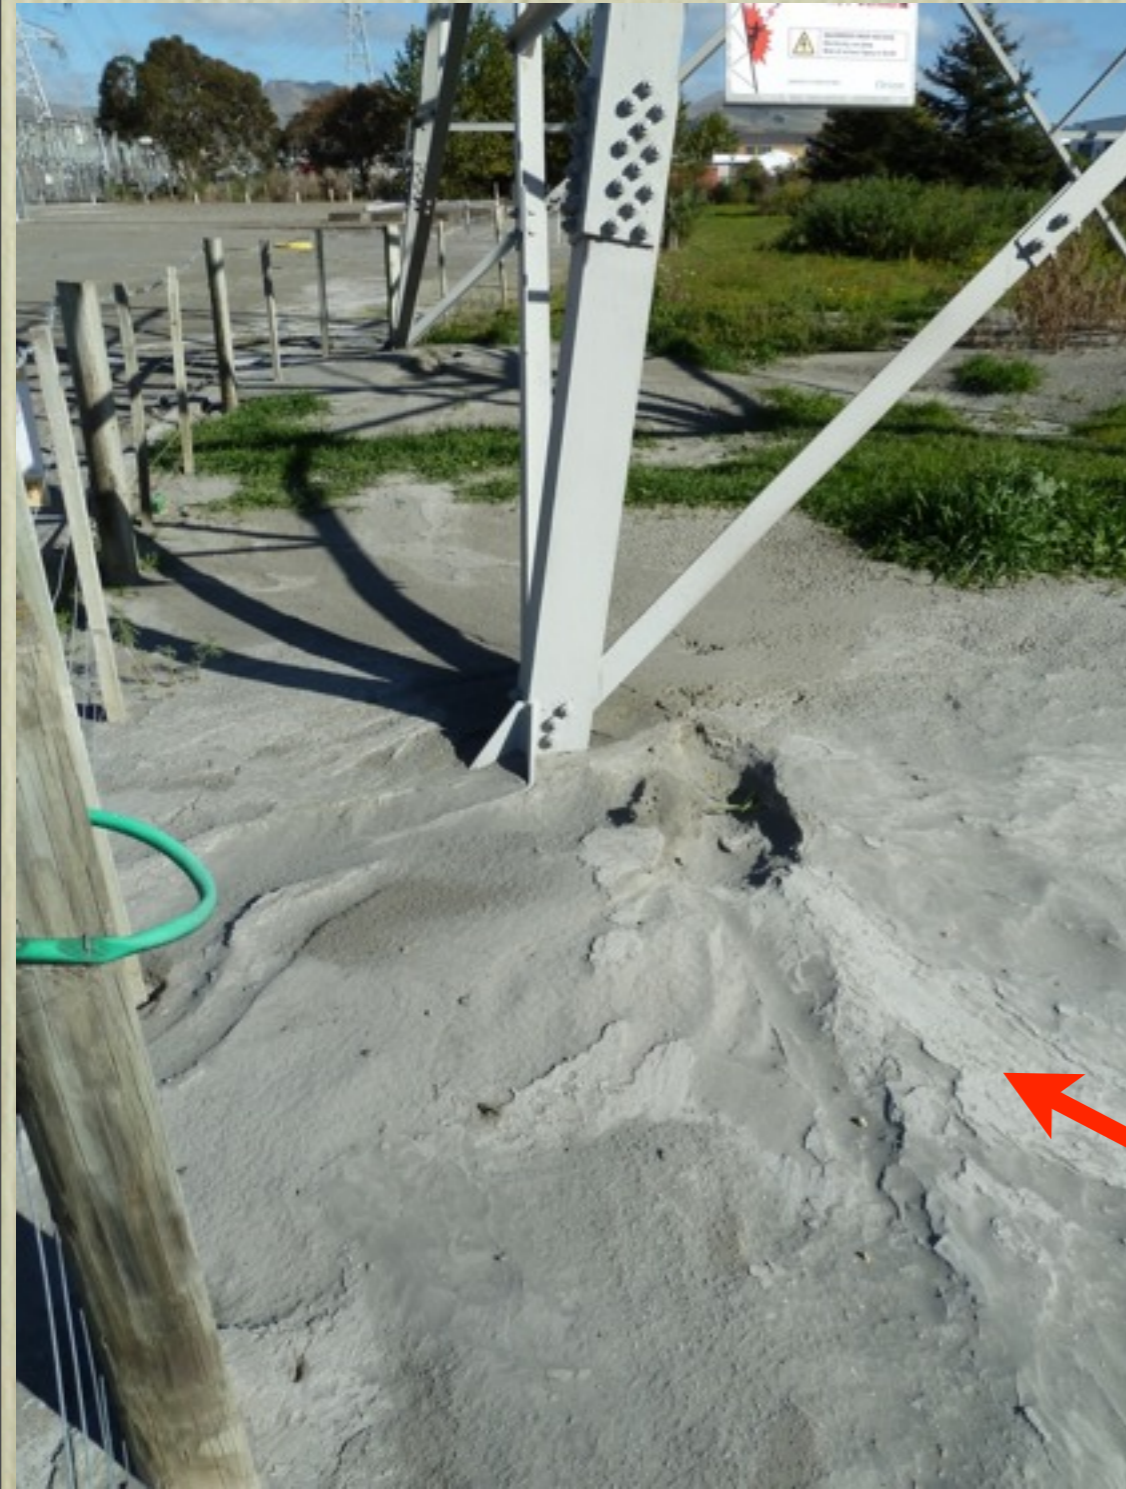
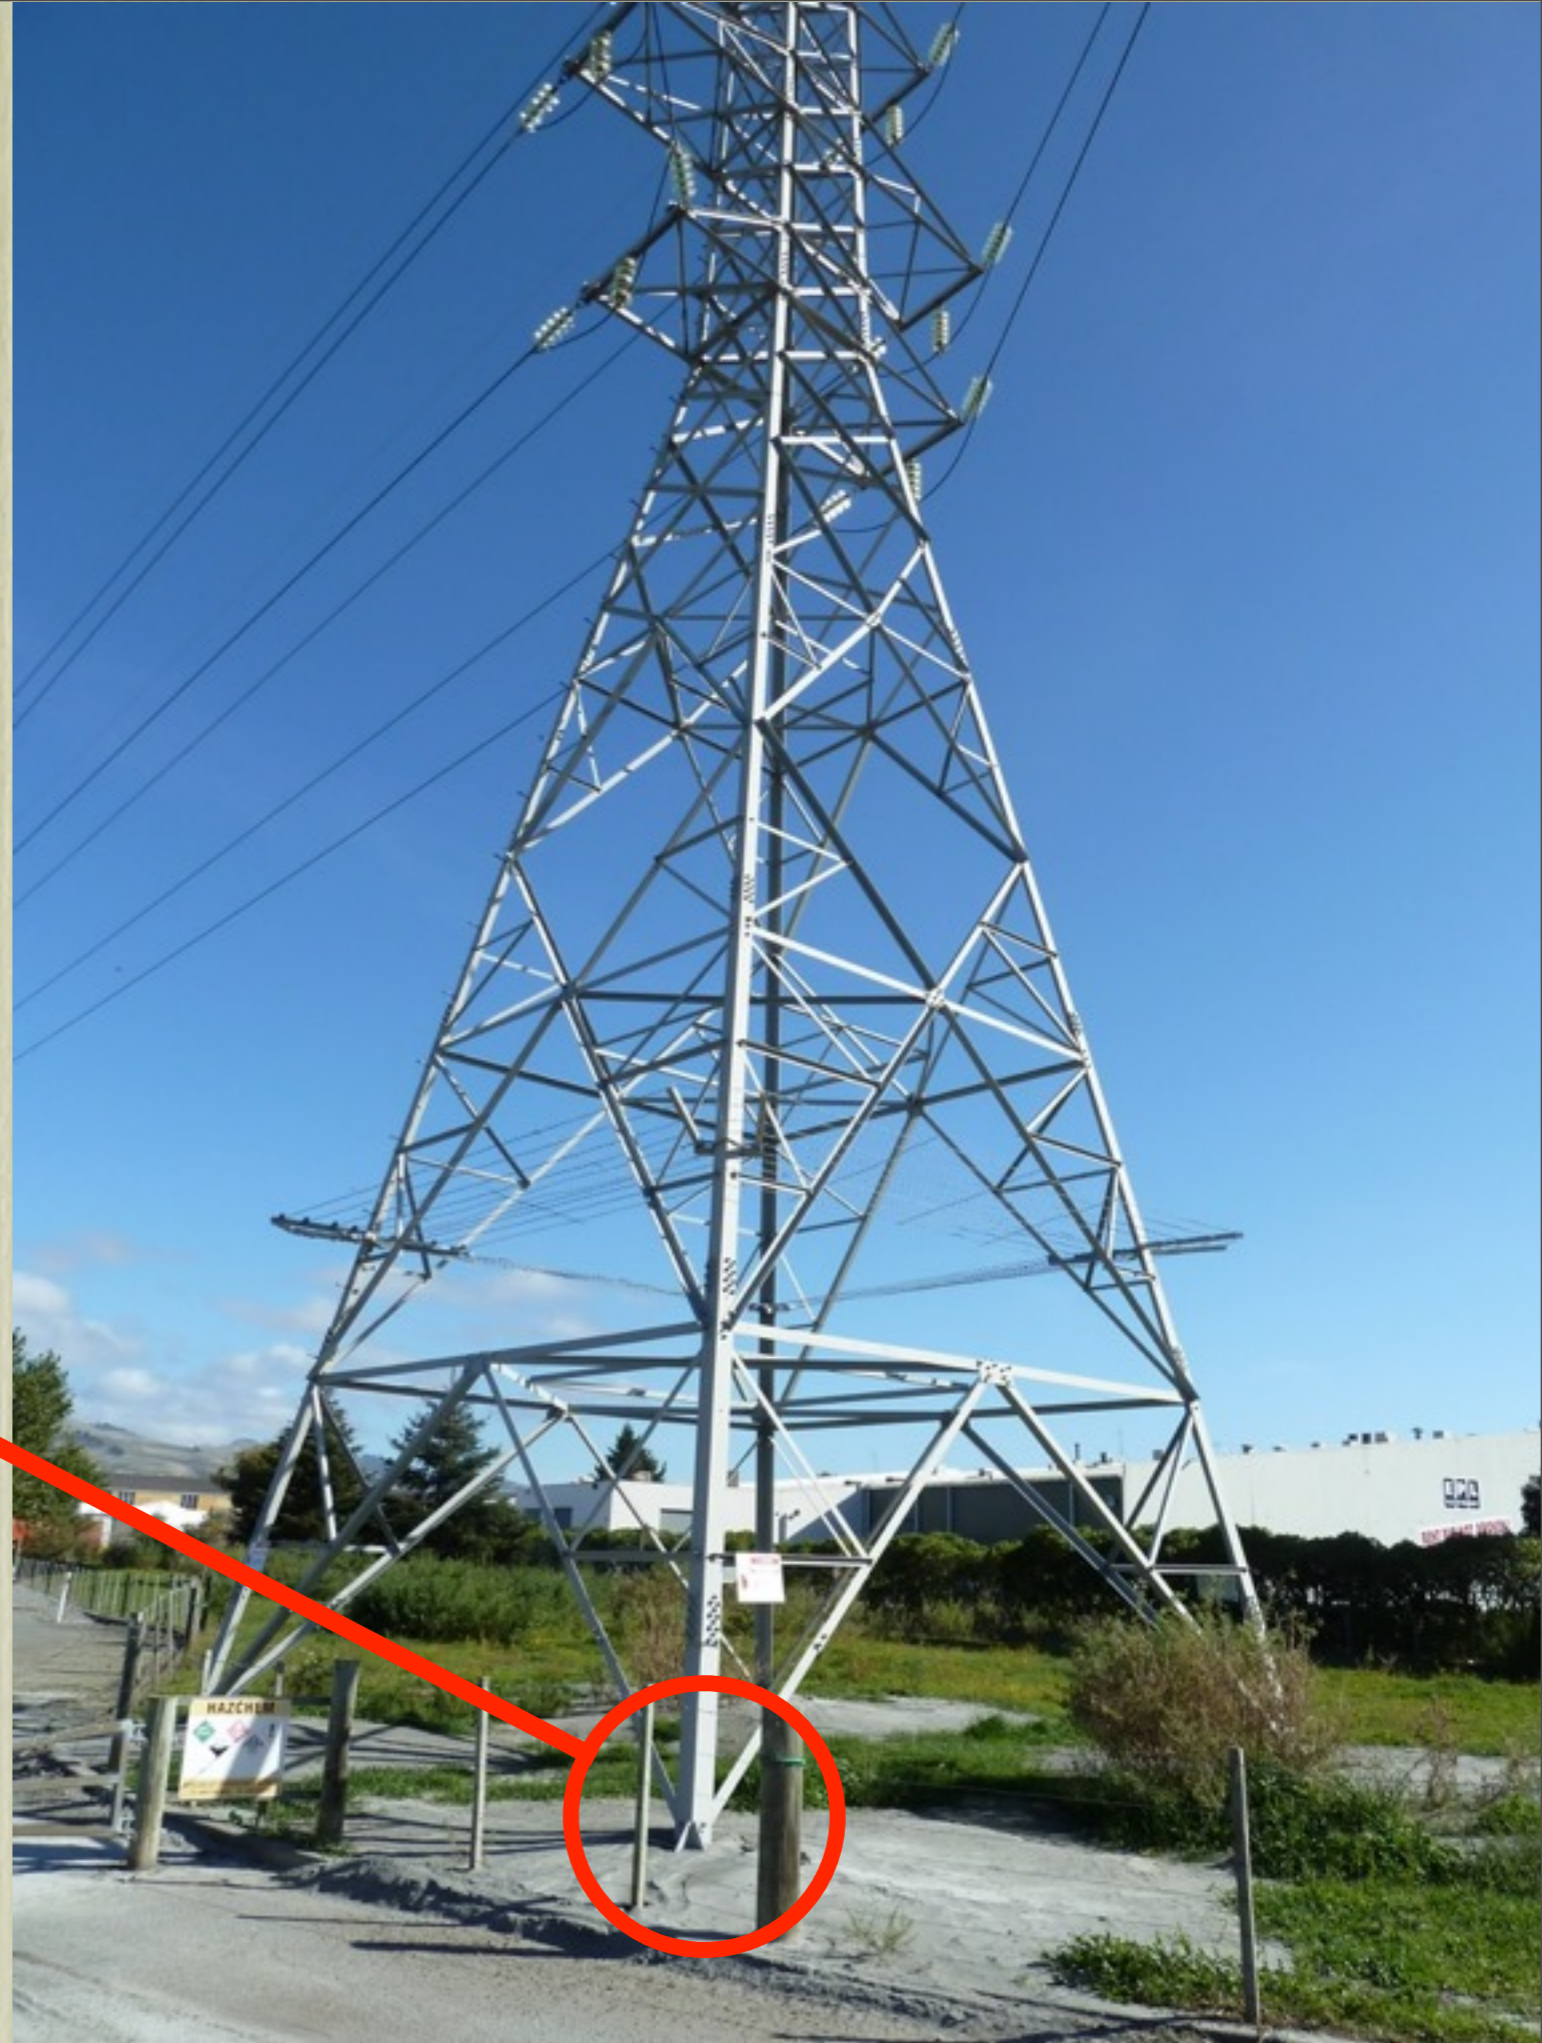
# Bromley-Heathcote 4T1

None-slight observed permanent distortions
