Christchurch, Feb 22 2011 and Sept 4 2010

John Eiding  
G&E Engineering Systems Inc.  
[eidinger@geEngineeringSystems.com](mailto:eidinger@geEngineeringSystems.com)

## Impact to Electric Power Systems

ASCE - Structural Congress

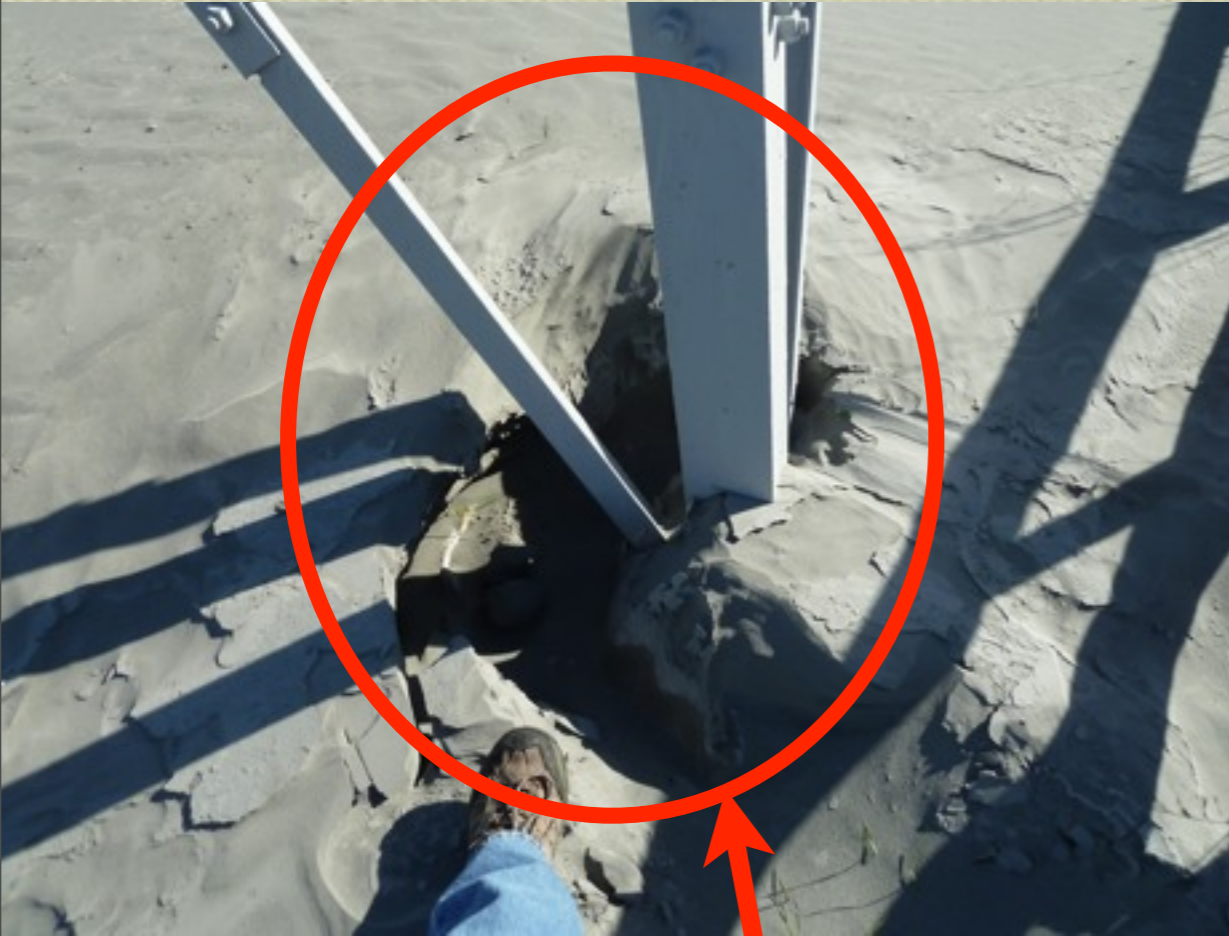
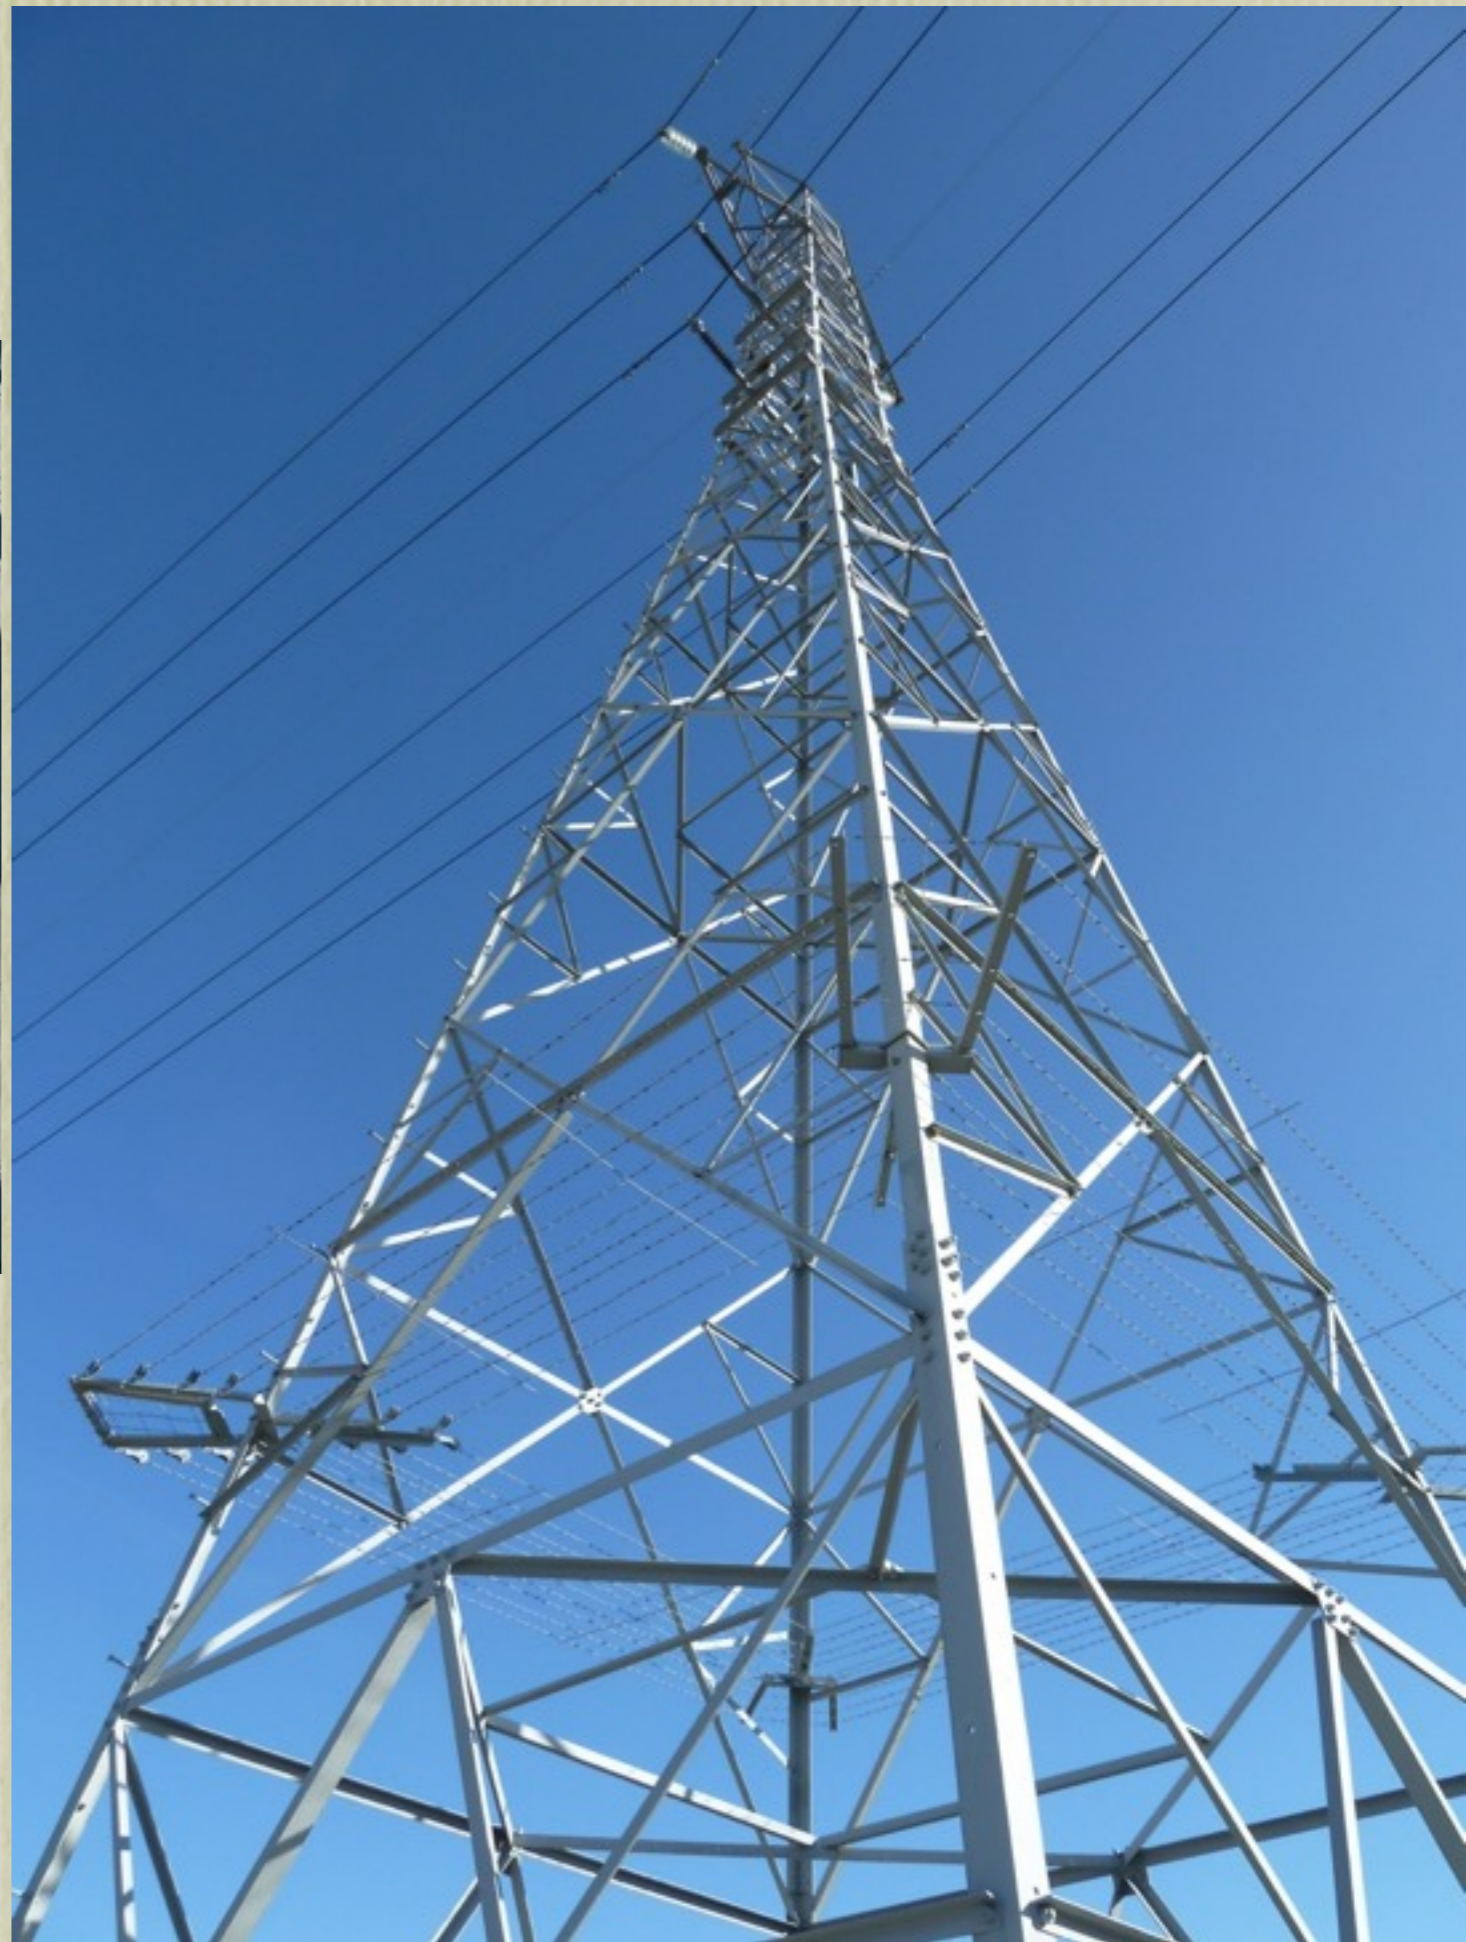
# Bromley-Heathcote 4T2

Sand Boils 1 foot deep.  
No observed  
permanent distortions

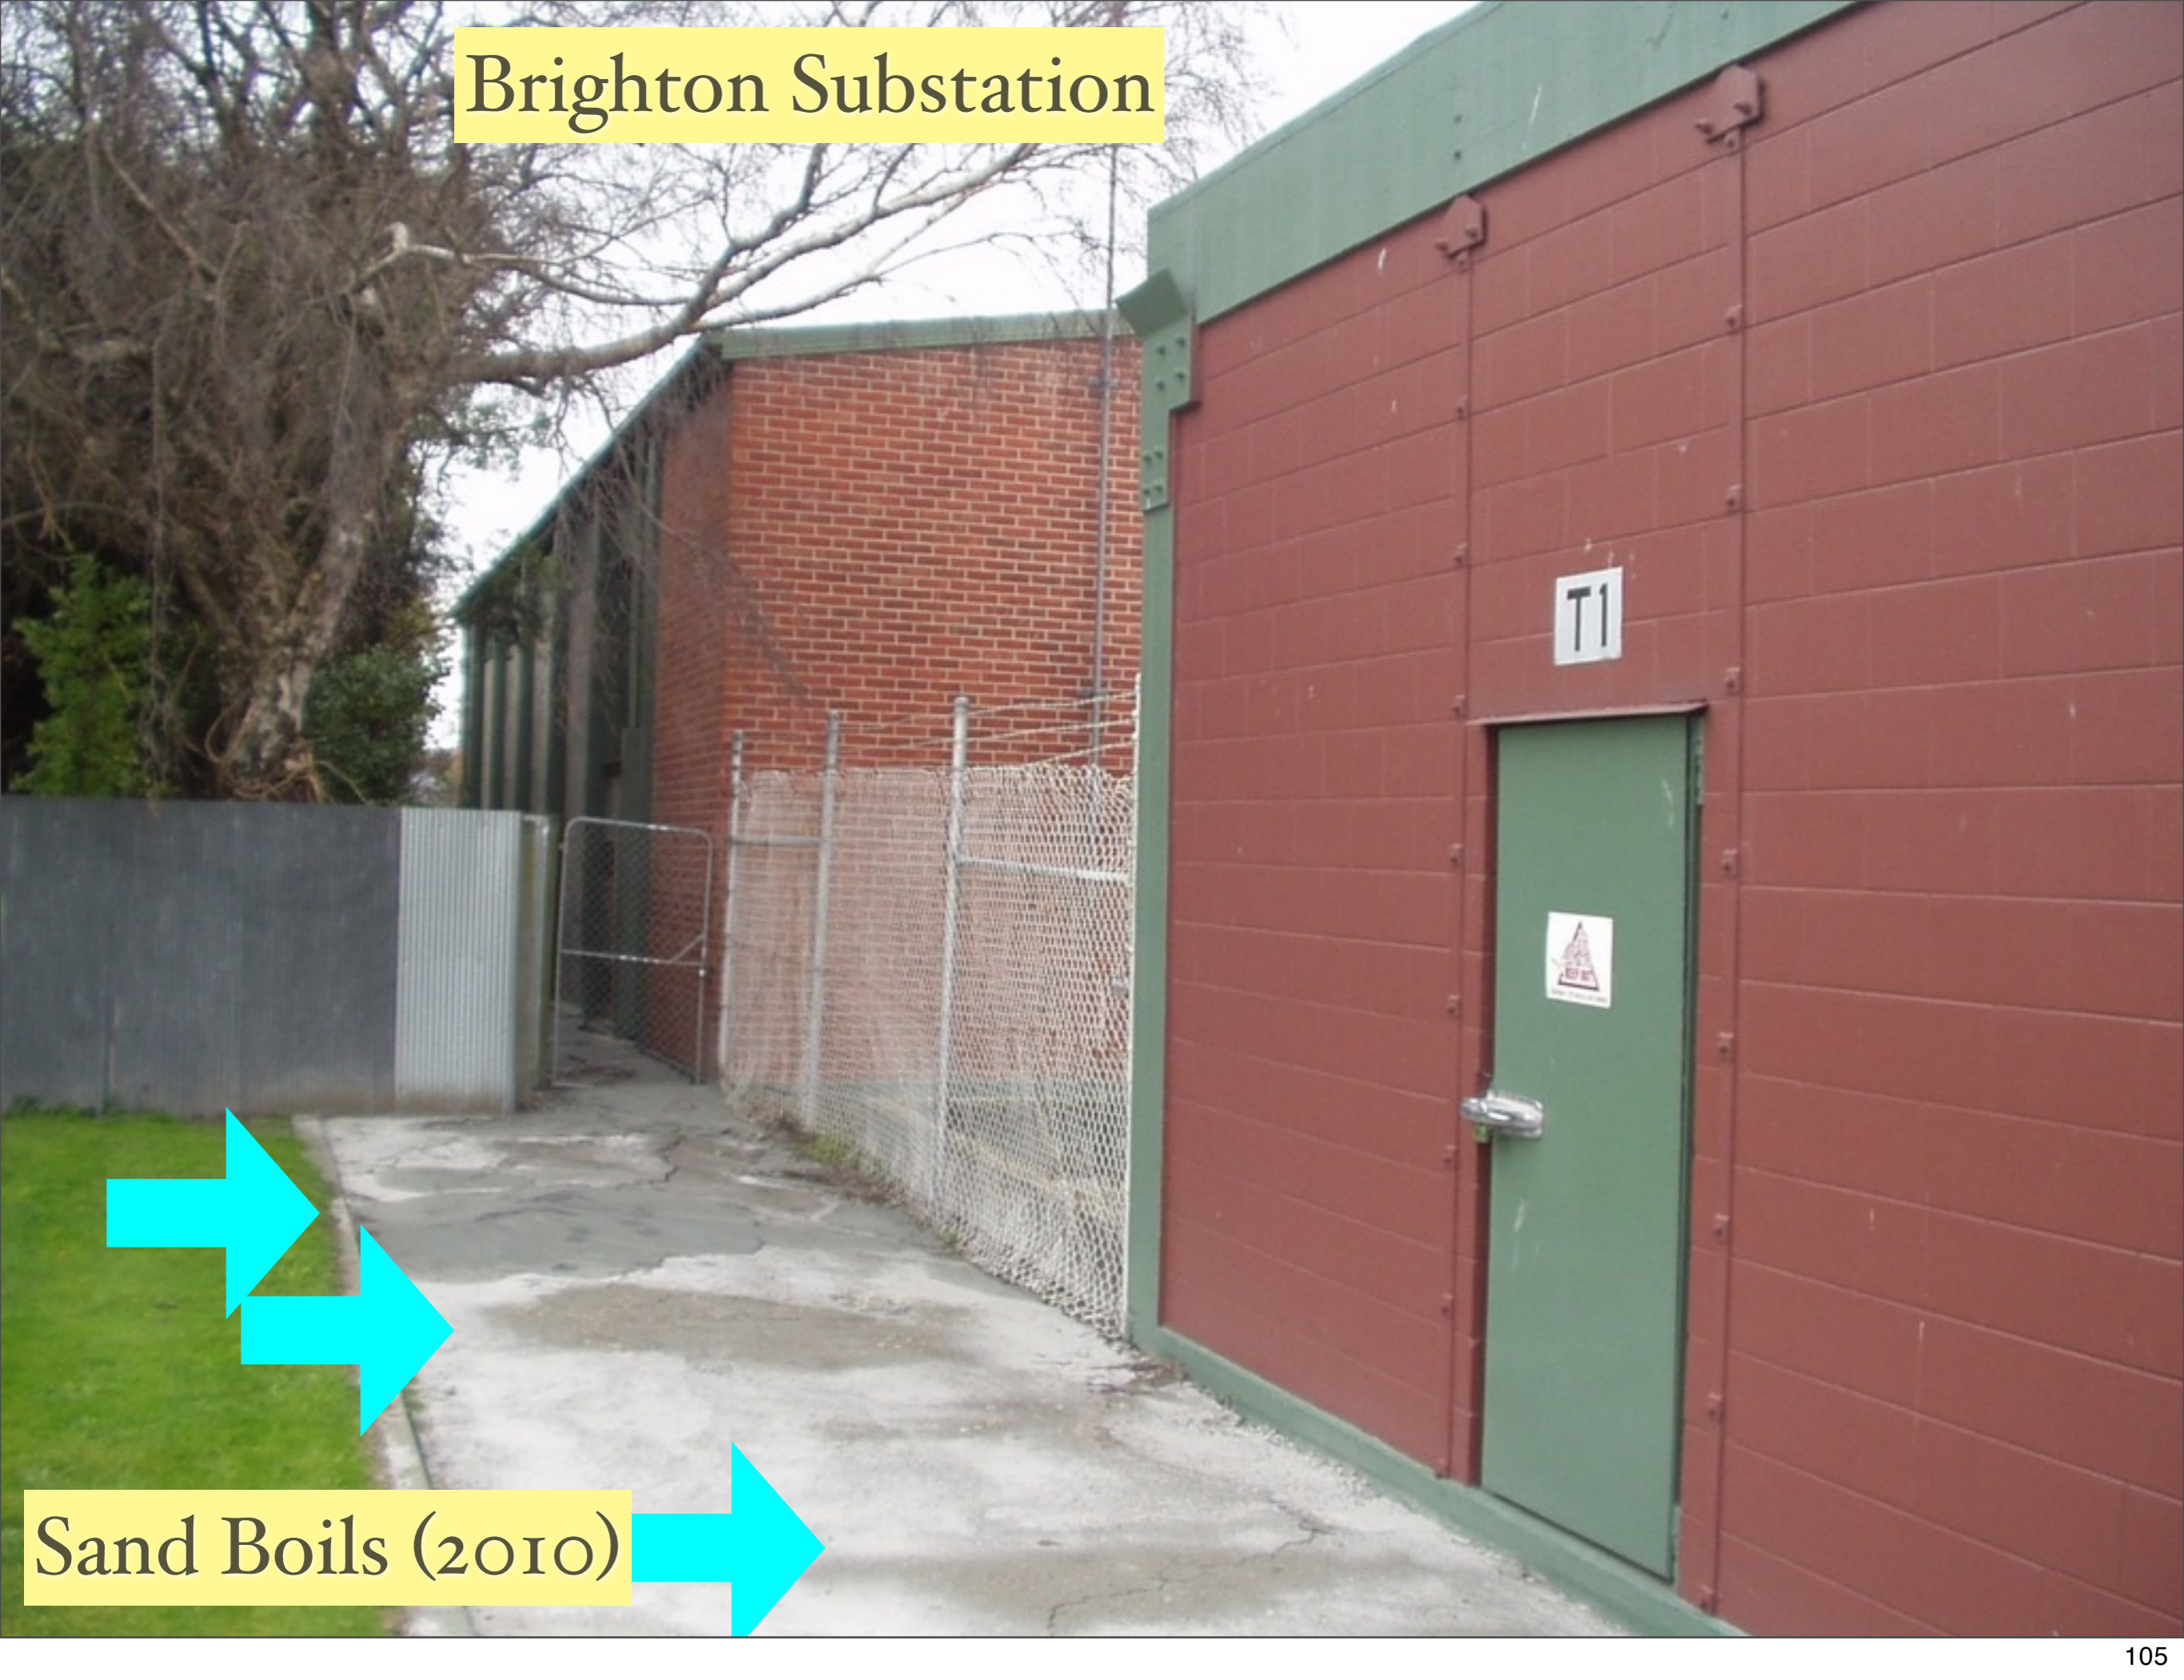
# Brighton Substation

Sand Boils (2010)

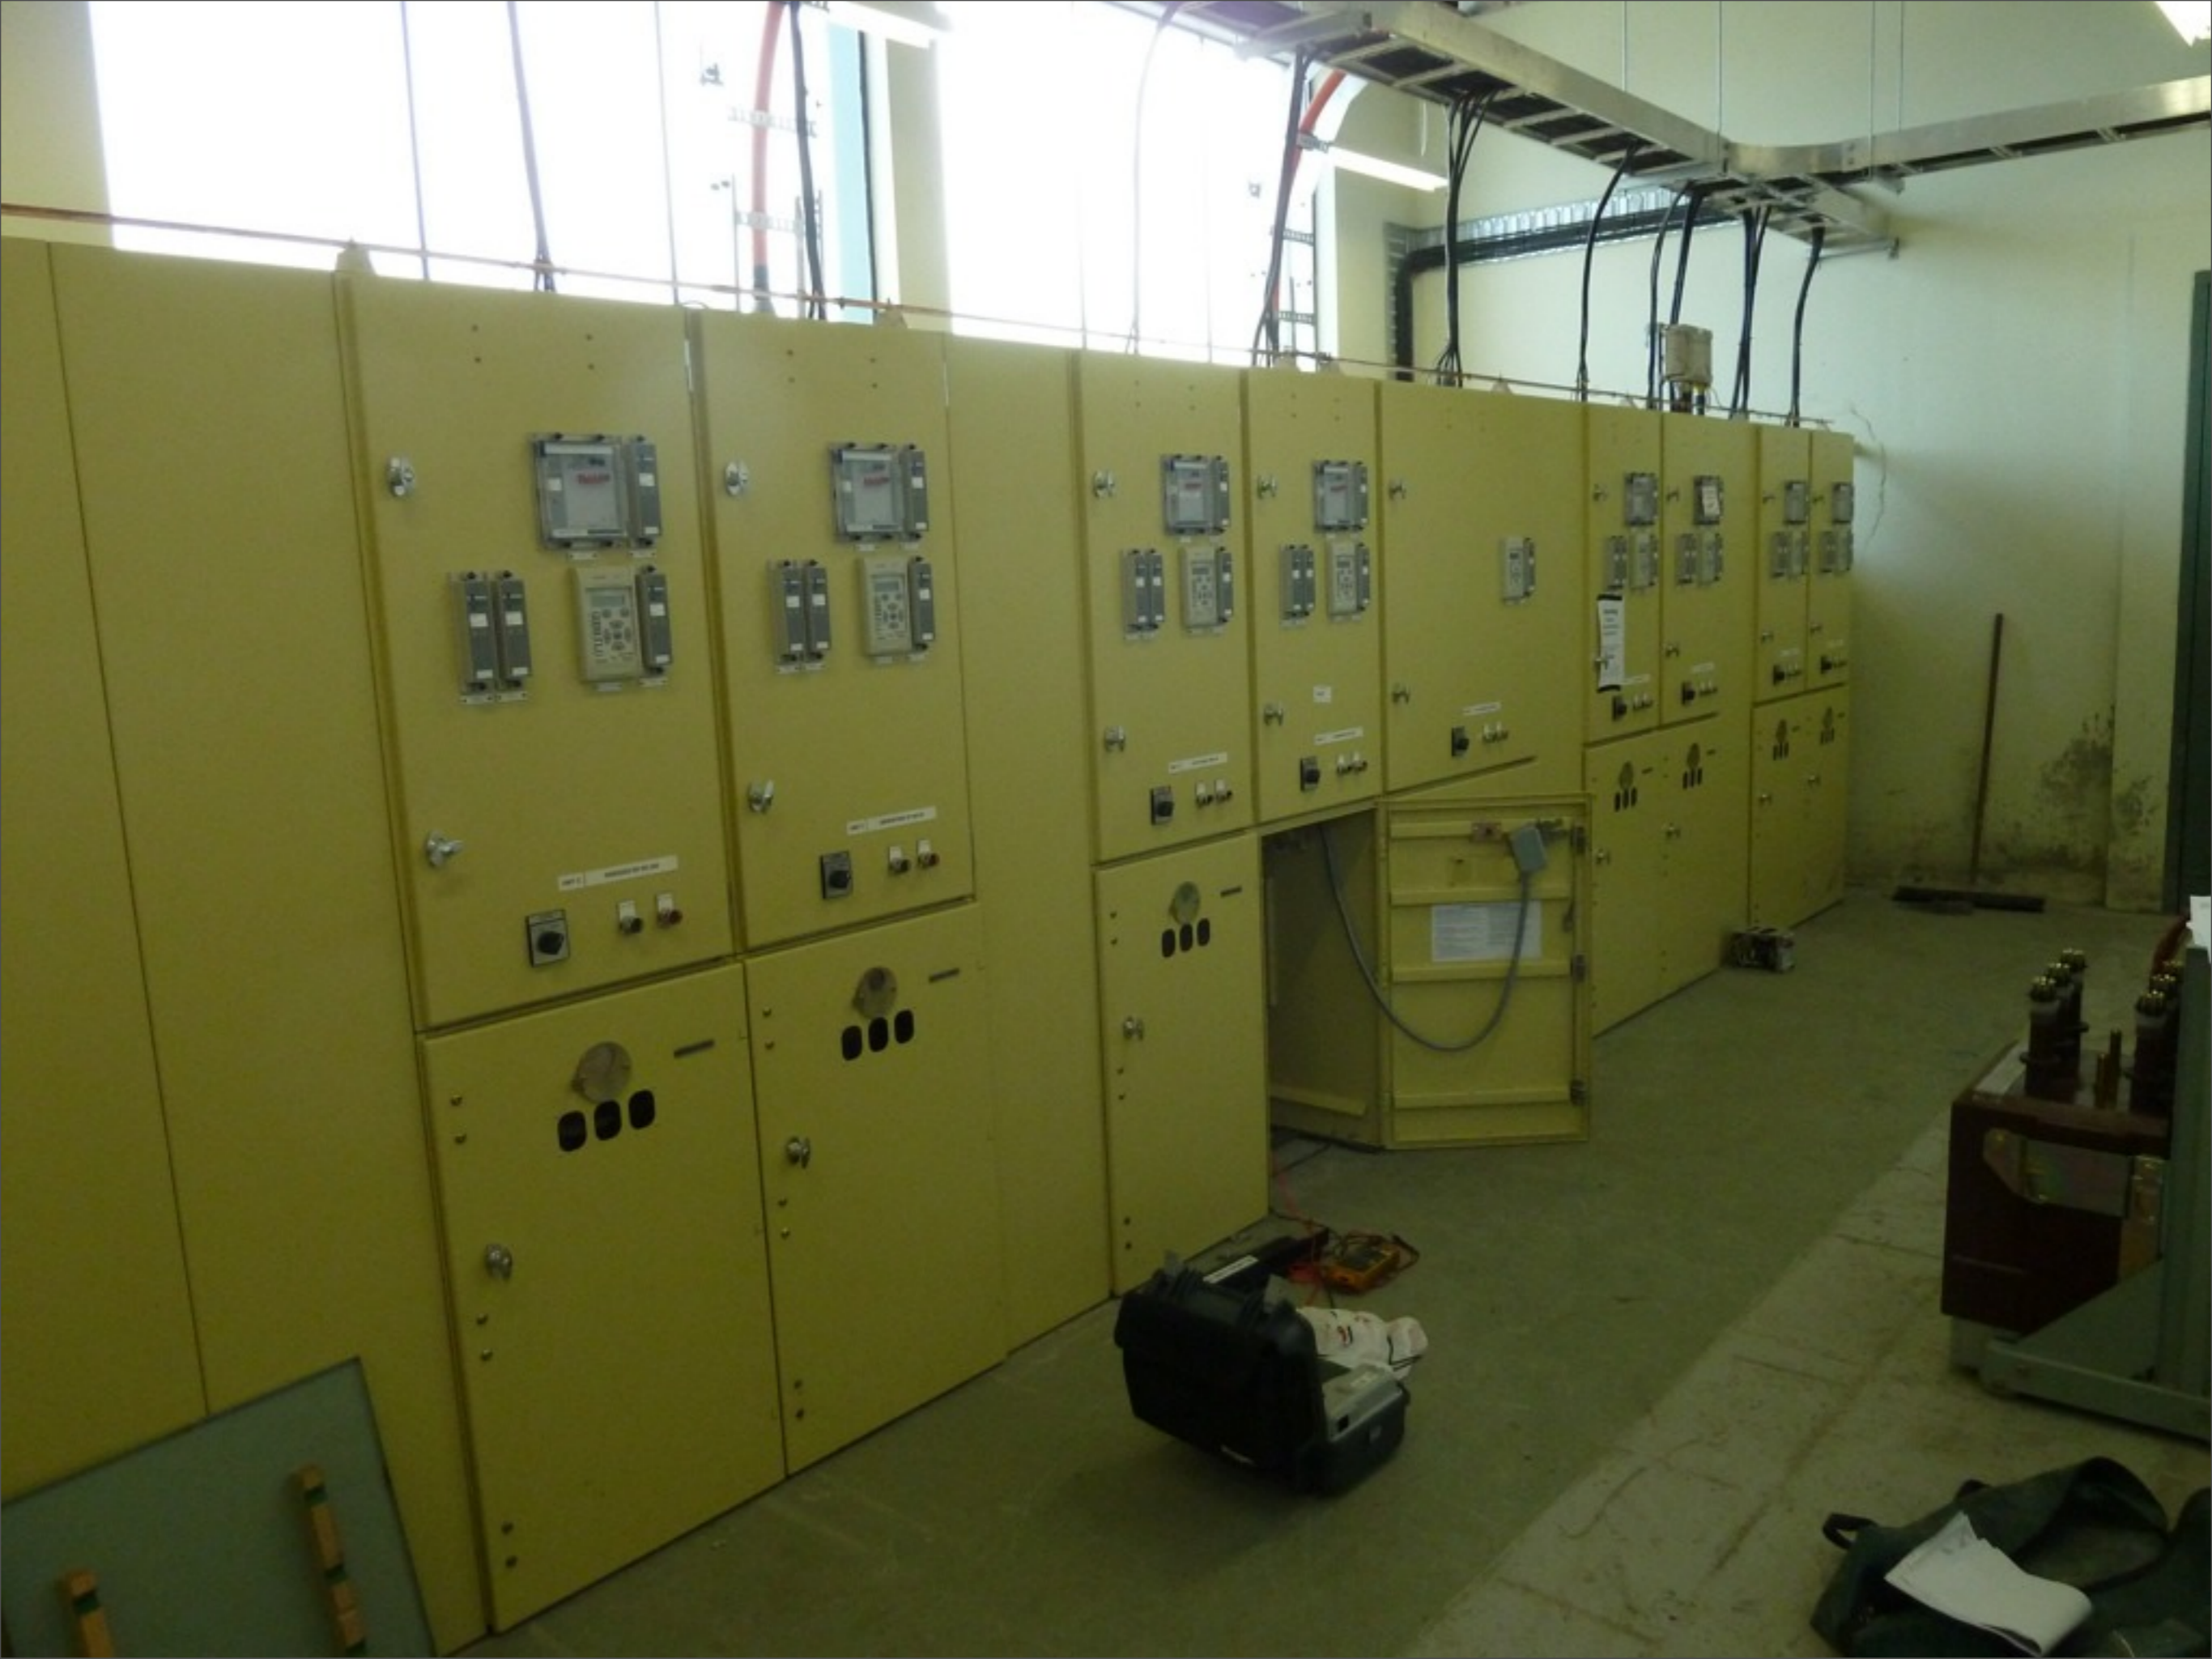
Water Depth, 0.5 meters  
Brighton Substation (2011)

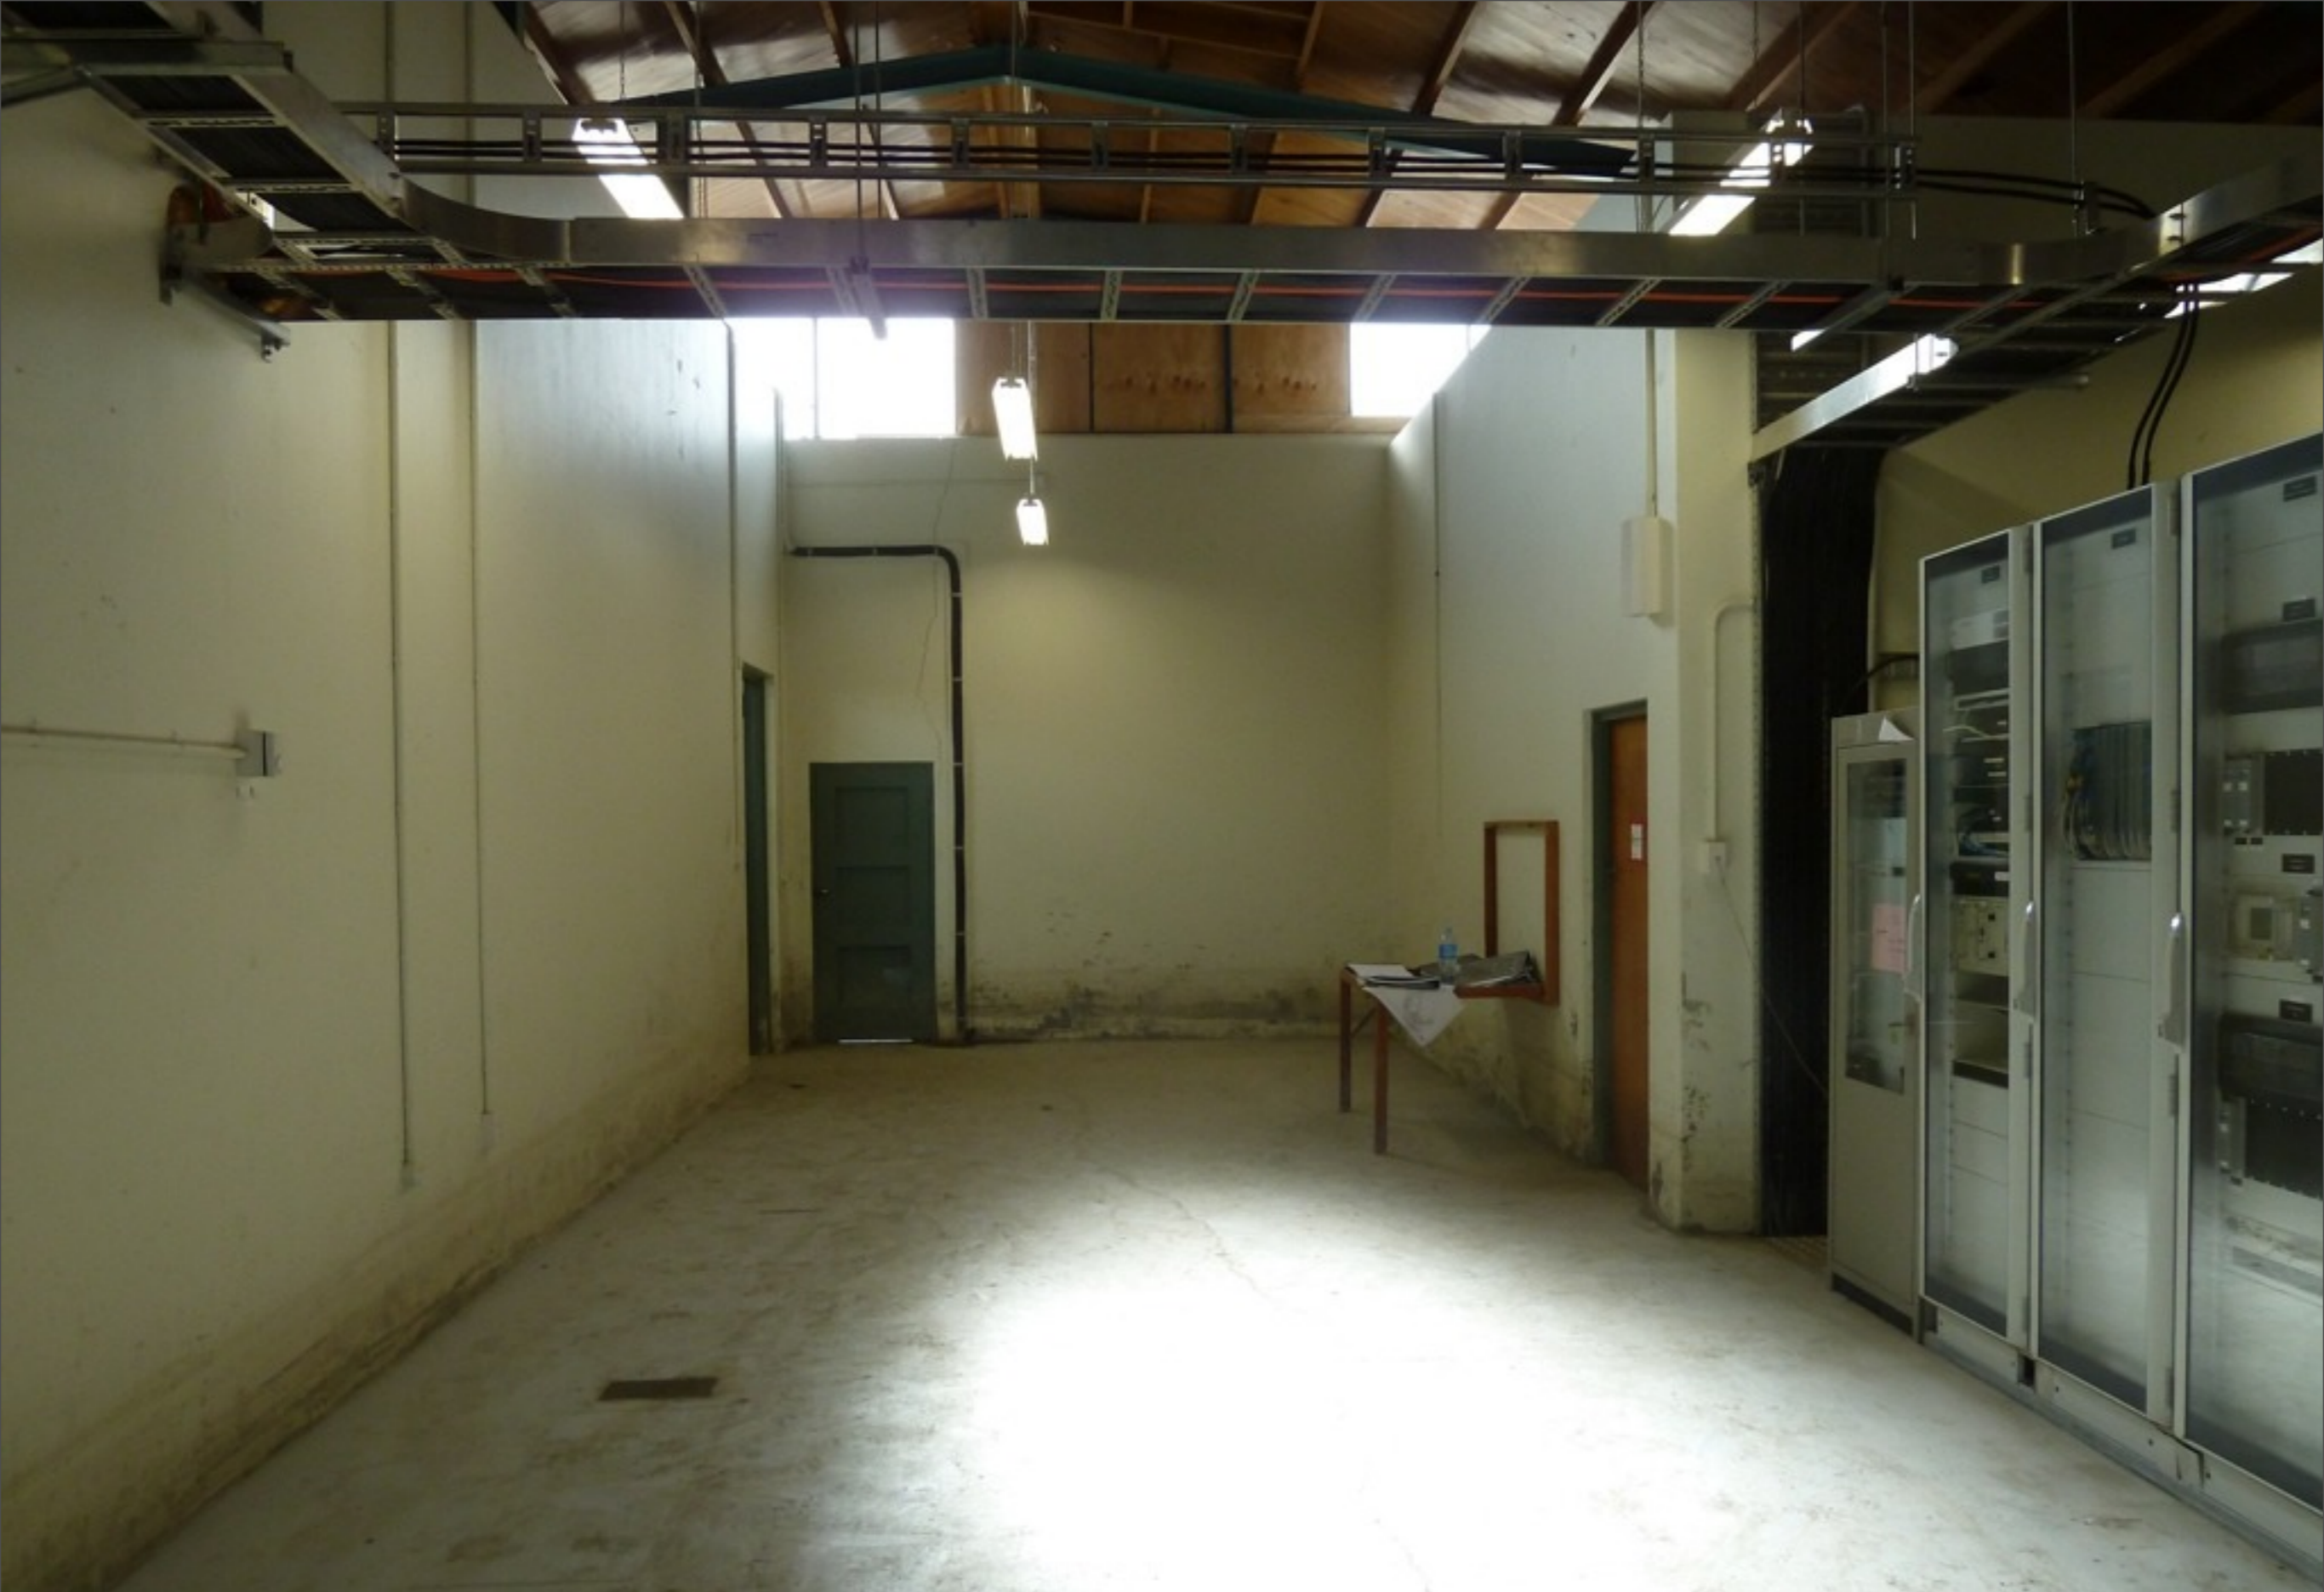
Mud Damage
