Water and Sewer Systems

John M. Eiding, M. ASCE¹

1.0 Introduction

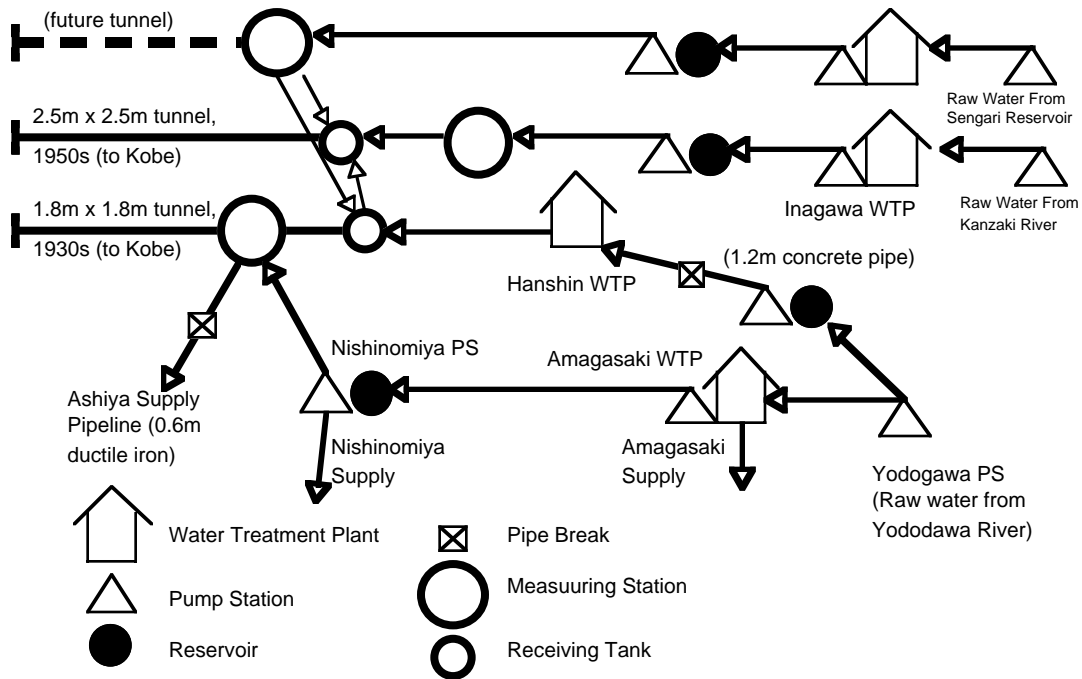
Figure 12. Hanshin Water Supply Authority

Figure 12 shows a schematics of the Hanshin Water Supply Authority, as well as points of major pipeline damage in this transmission system.

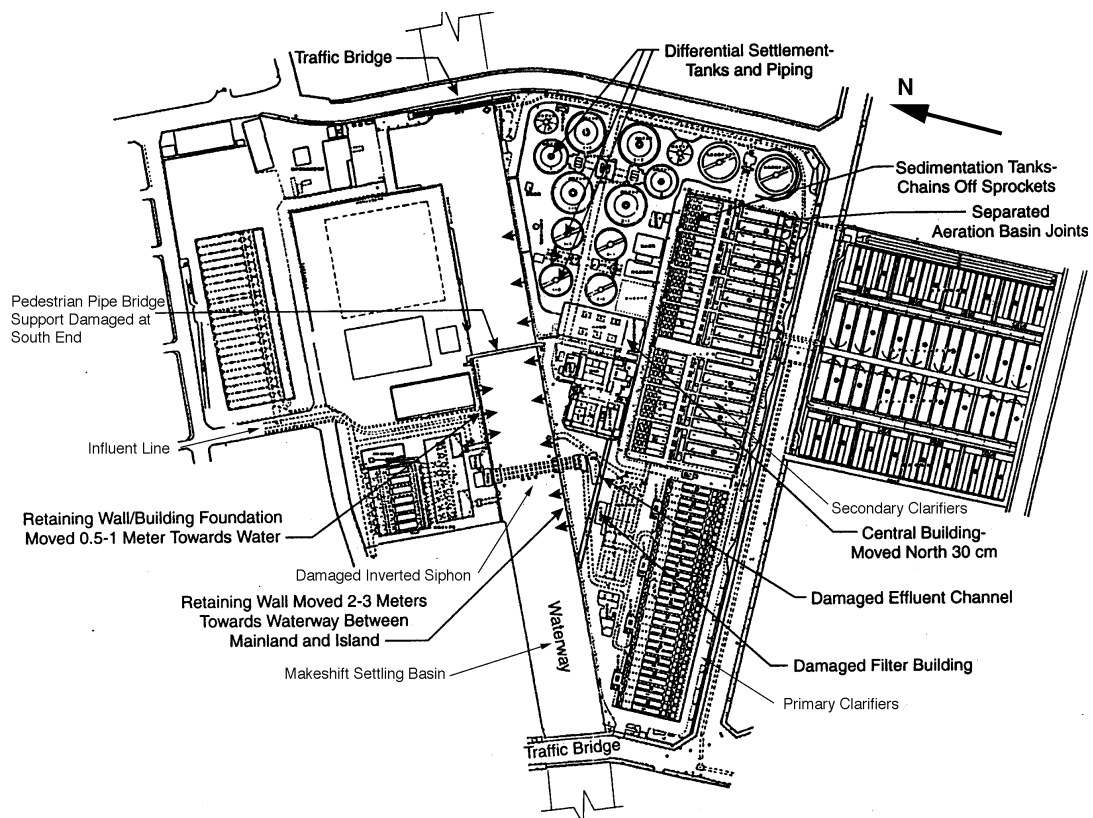
Figure 21. Higashinada Wastewater Treatment Plant

The facility was heavily damaged when the retaining wall along the north side of the plant adjacent to the waterway moved two to three meters towards the water as a result of liquefaction. As a result of the movement, much of the site settled an average of one meter. Figure 21 shows the plant layout and notes damage locations.
