Seismic Performance of Water Pipelines in the August 24 2014 Napa Earthquake

John Eiding
eidinger@geEngineeringSystems.com

JWWA-WRF-CTWWA Workshop, Sendai, October 2015

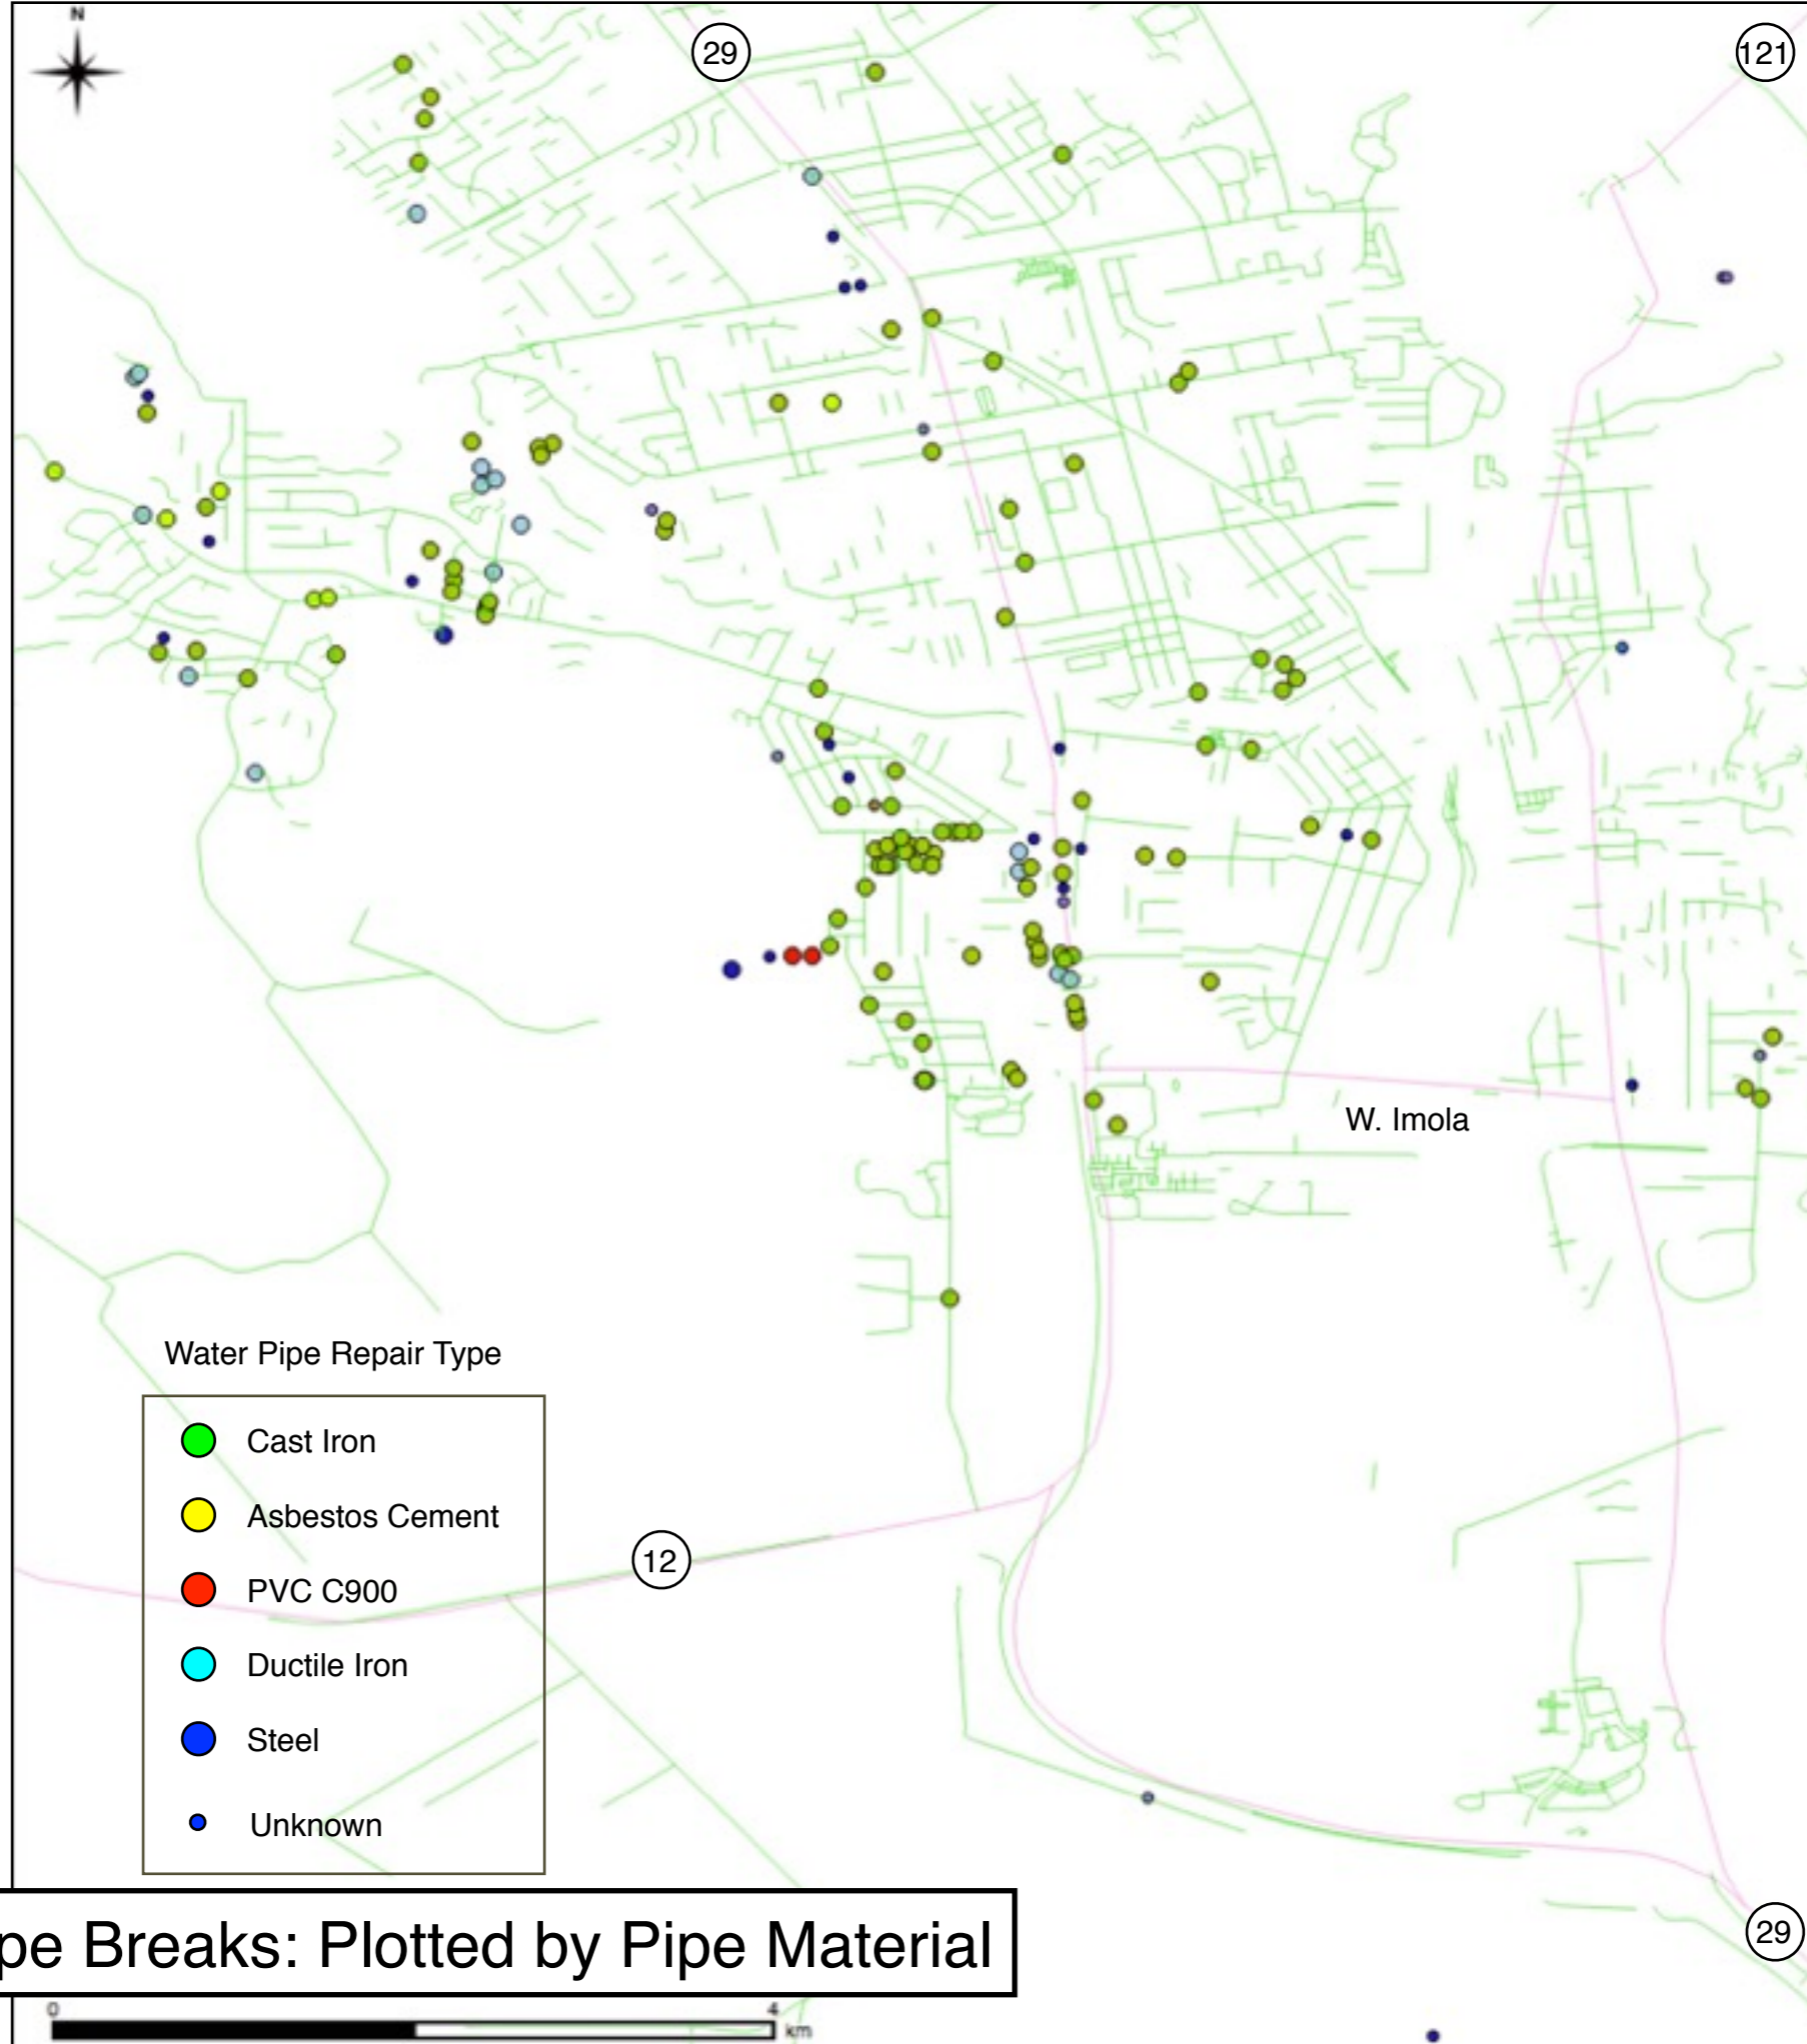
164 Water Pipe Breaks: Plotted by Pipe Material

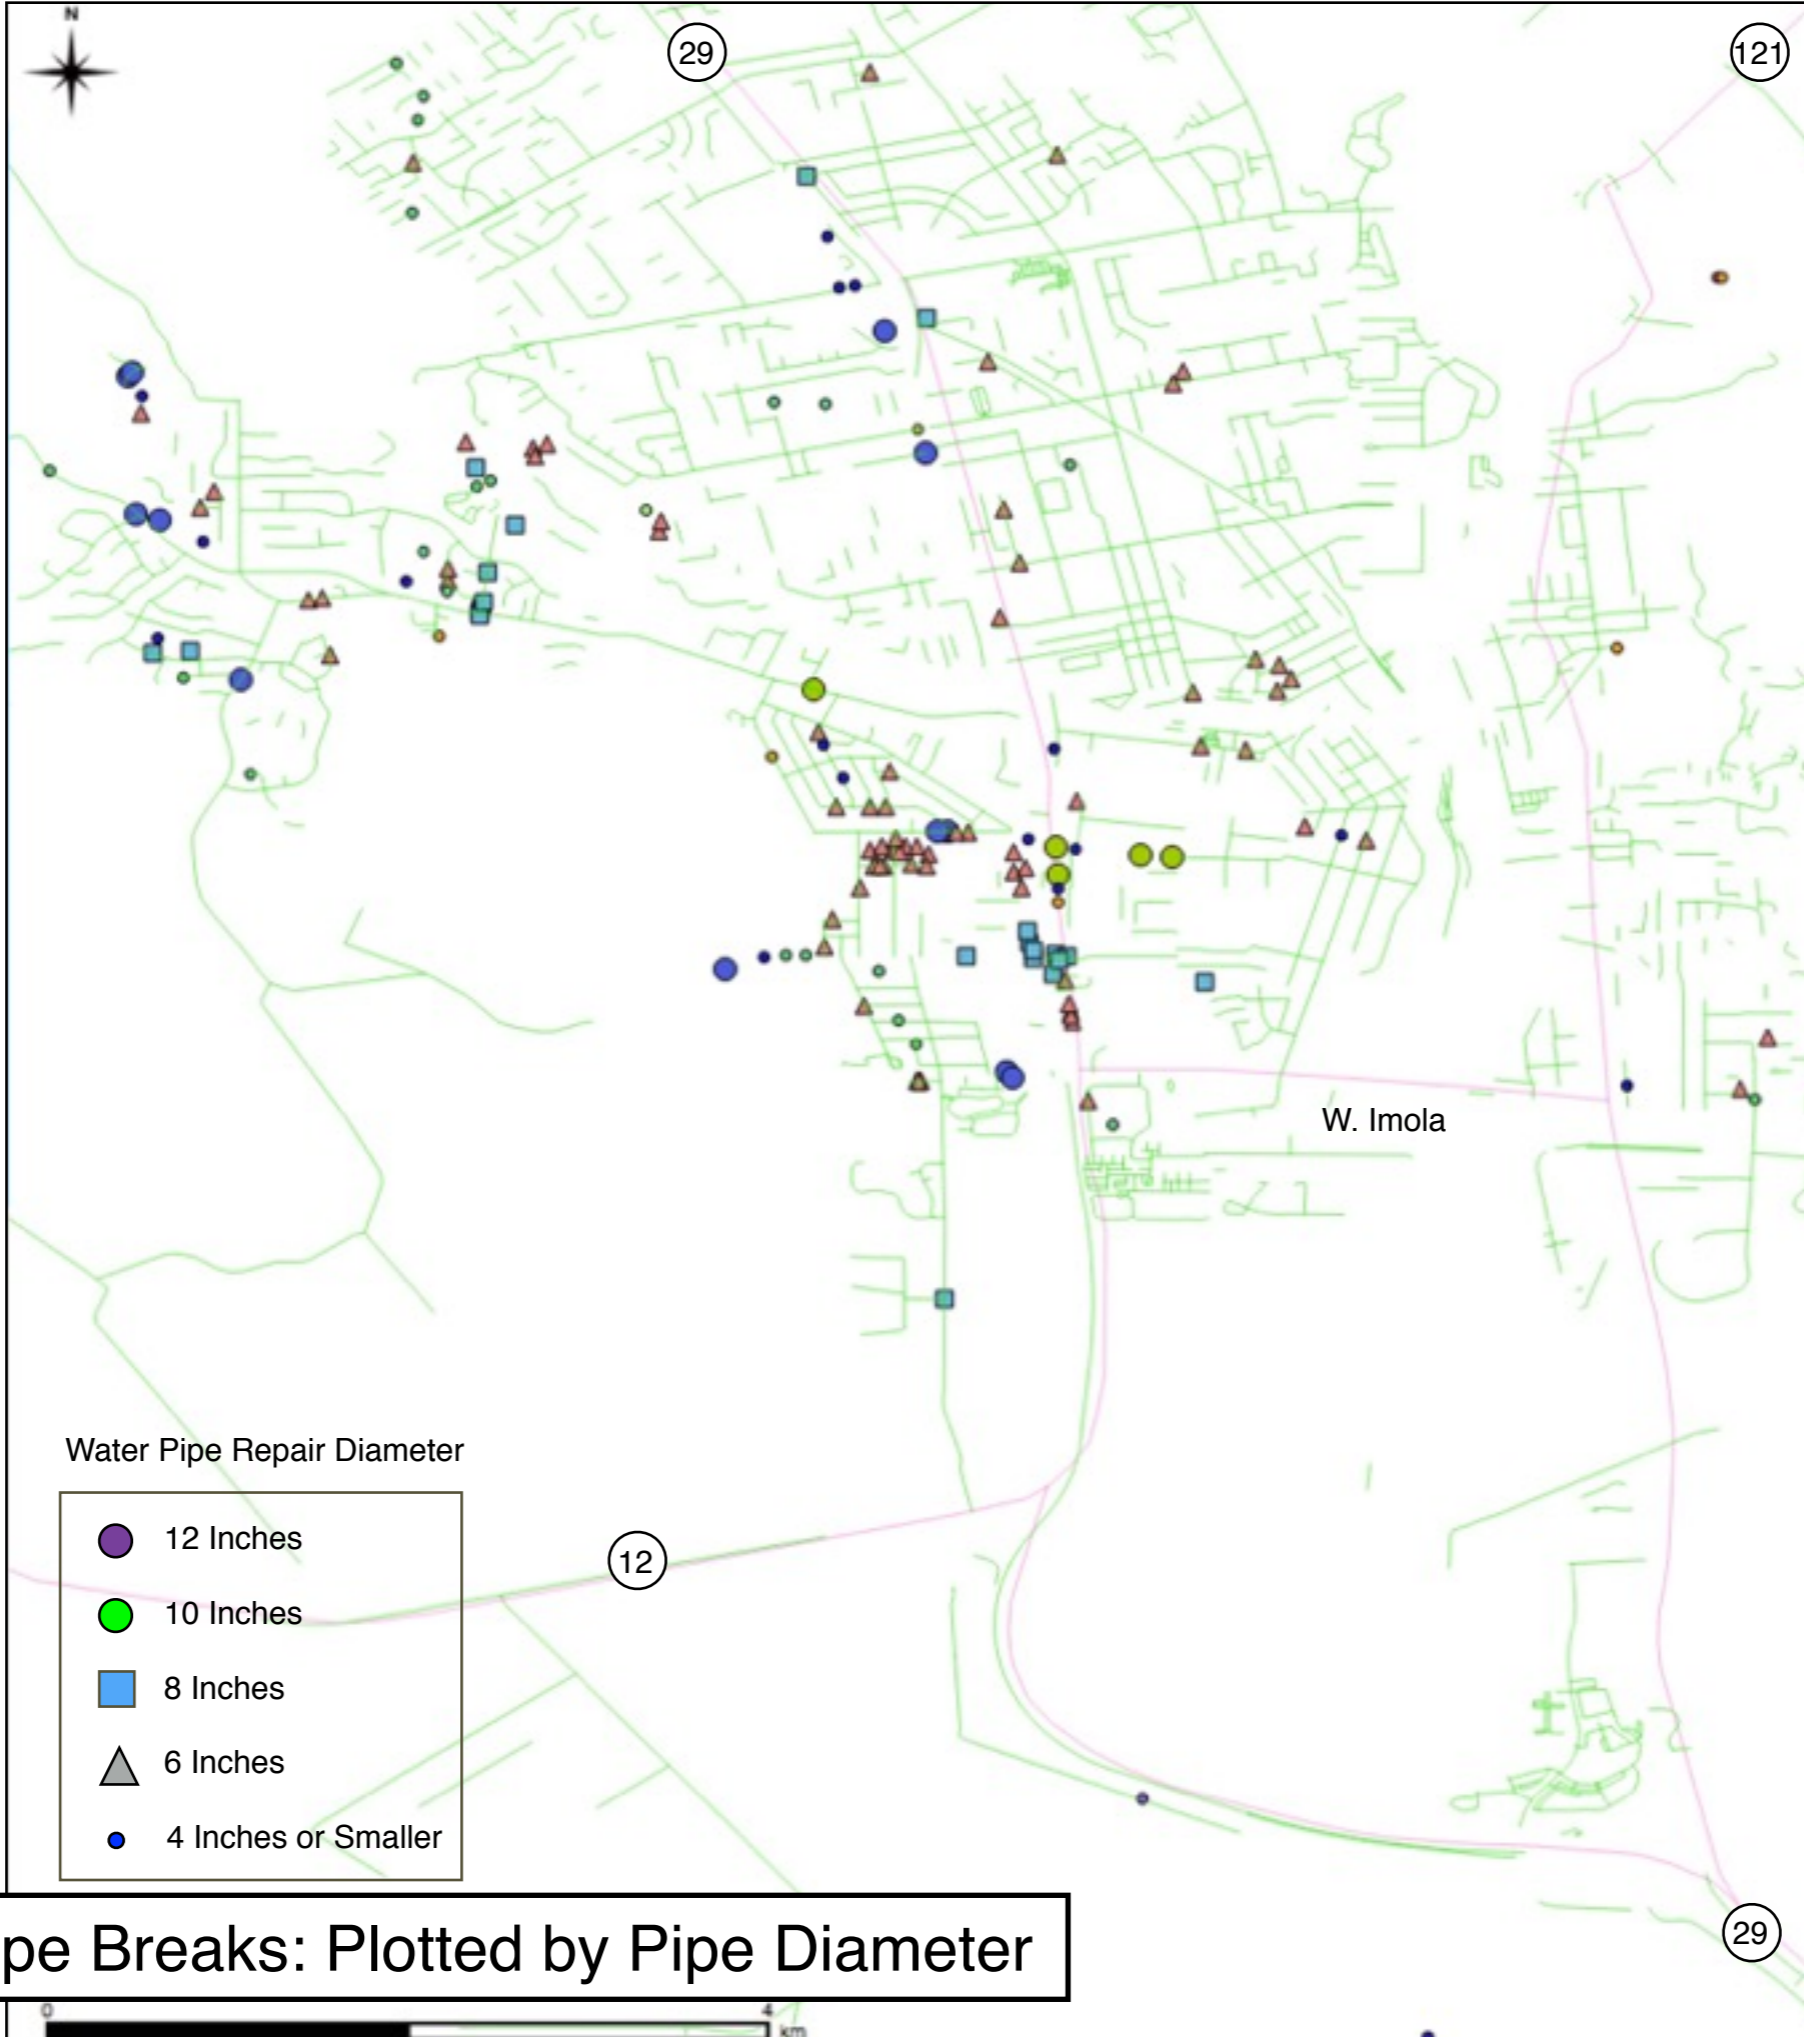
164 Water Pipe Breaks: Plotted by Pipe Diameter

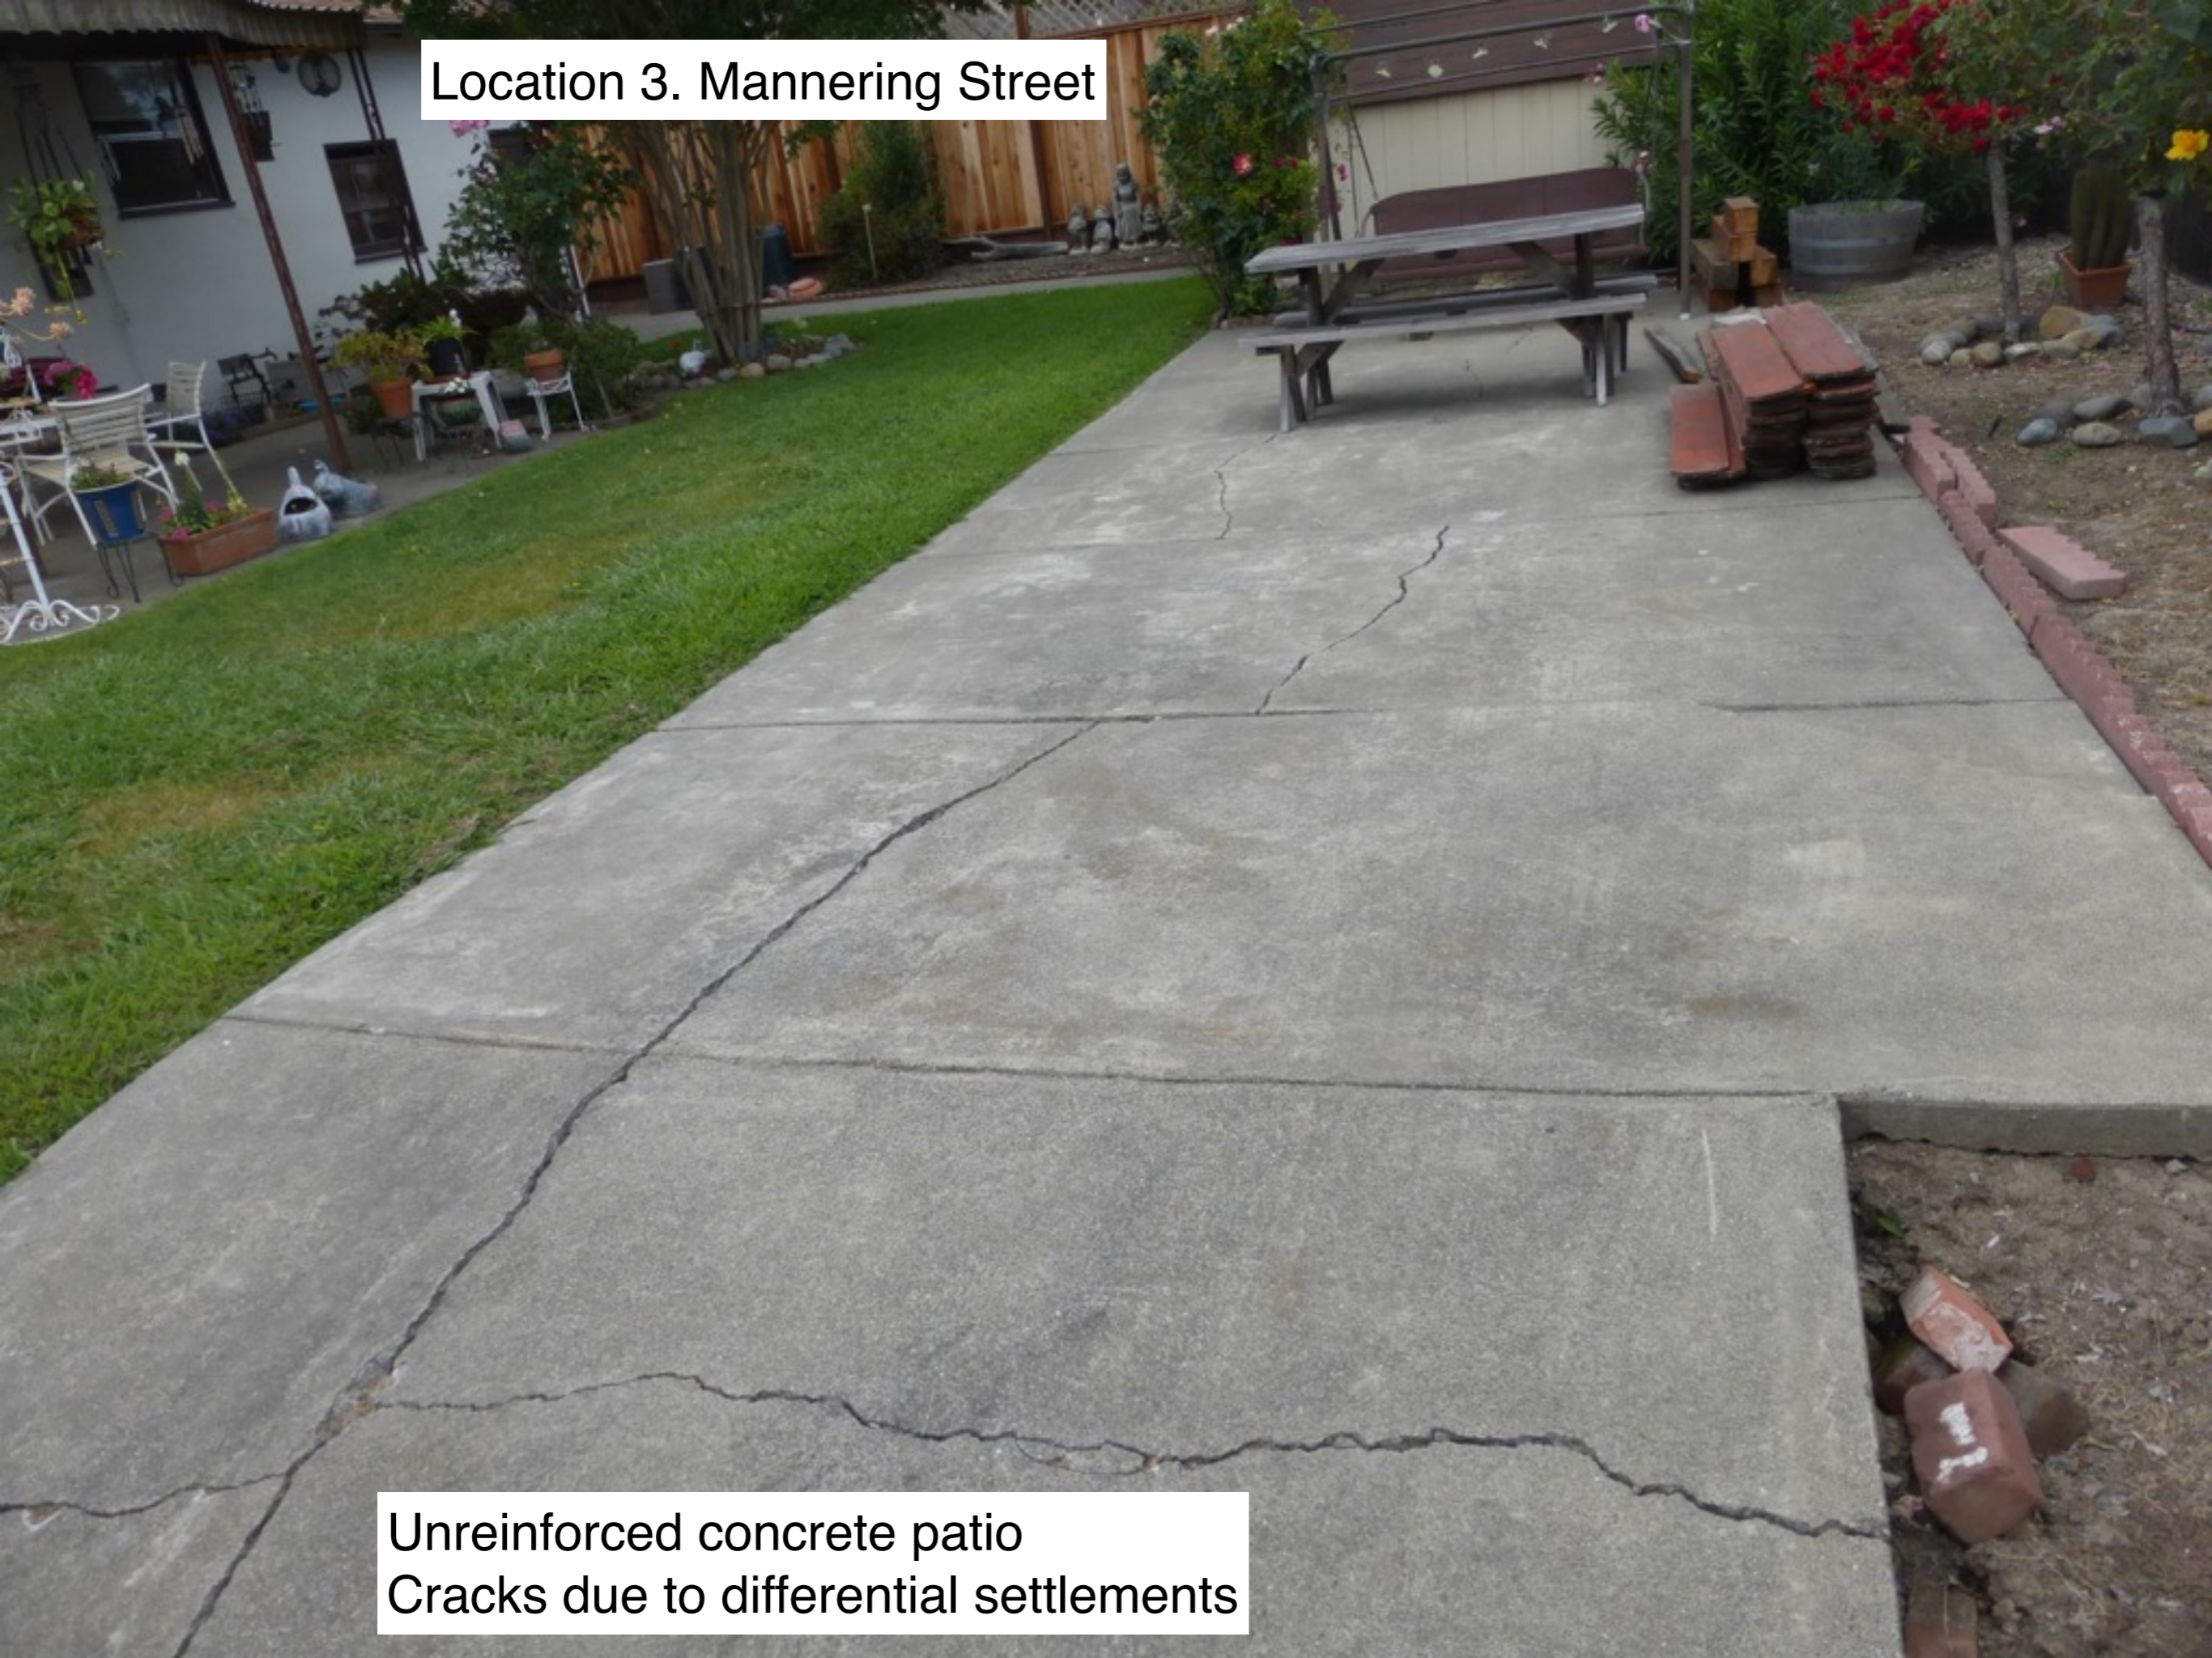
Location 4. Mannering Street

Unreinforced concrete patio
Cracks due to differential settlements

Unreinforced concrete driveway
Cracks due to differential settlements
Water table confirmed, <5 feet
(Tree in planter box is about to be moved)

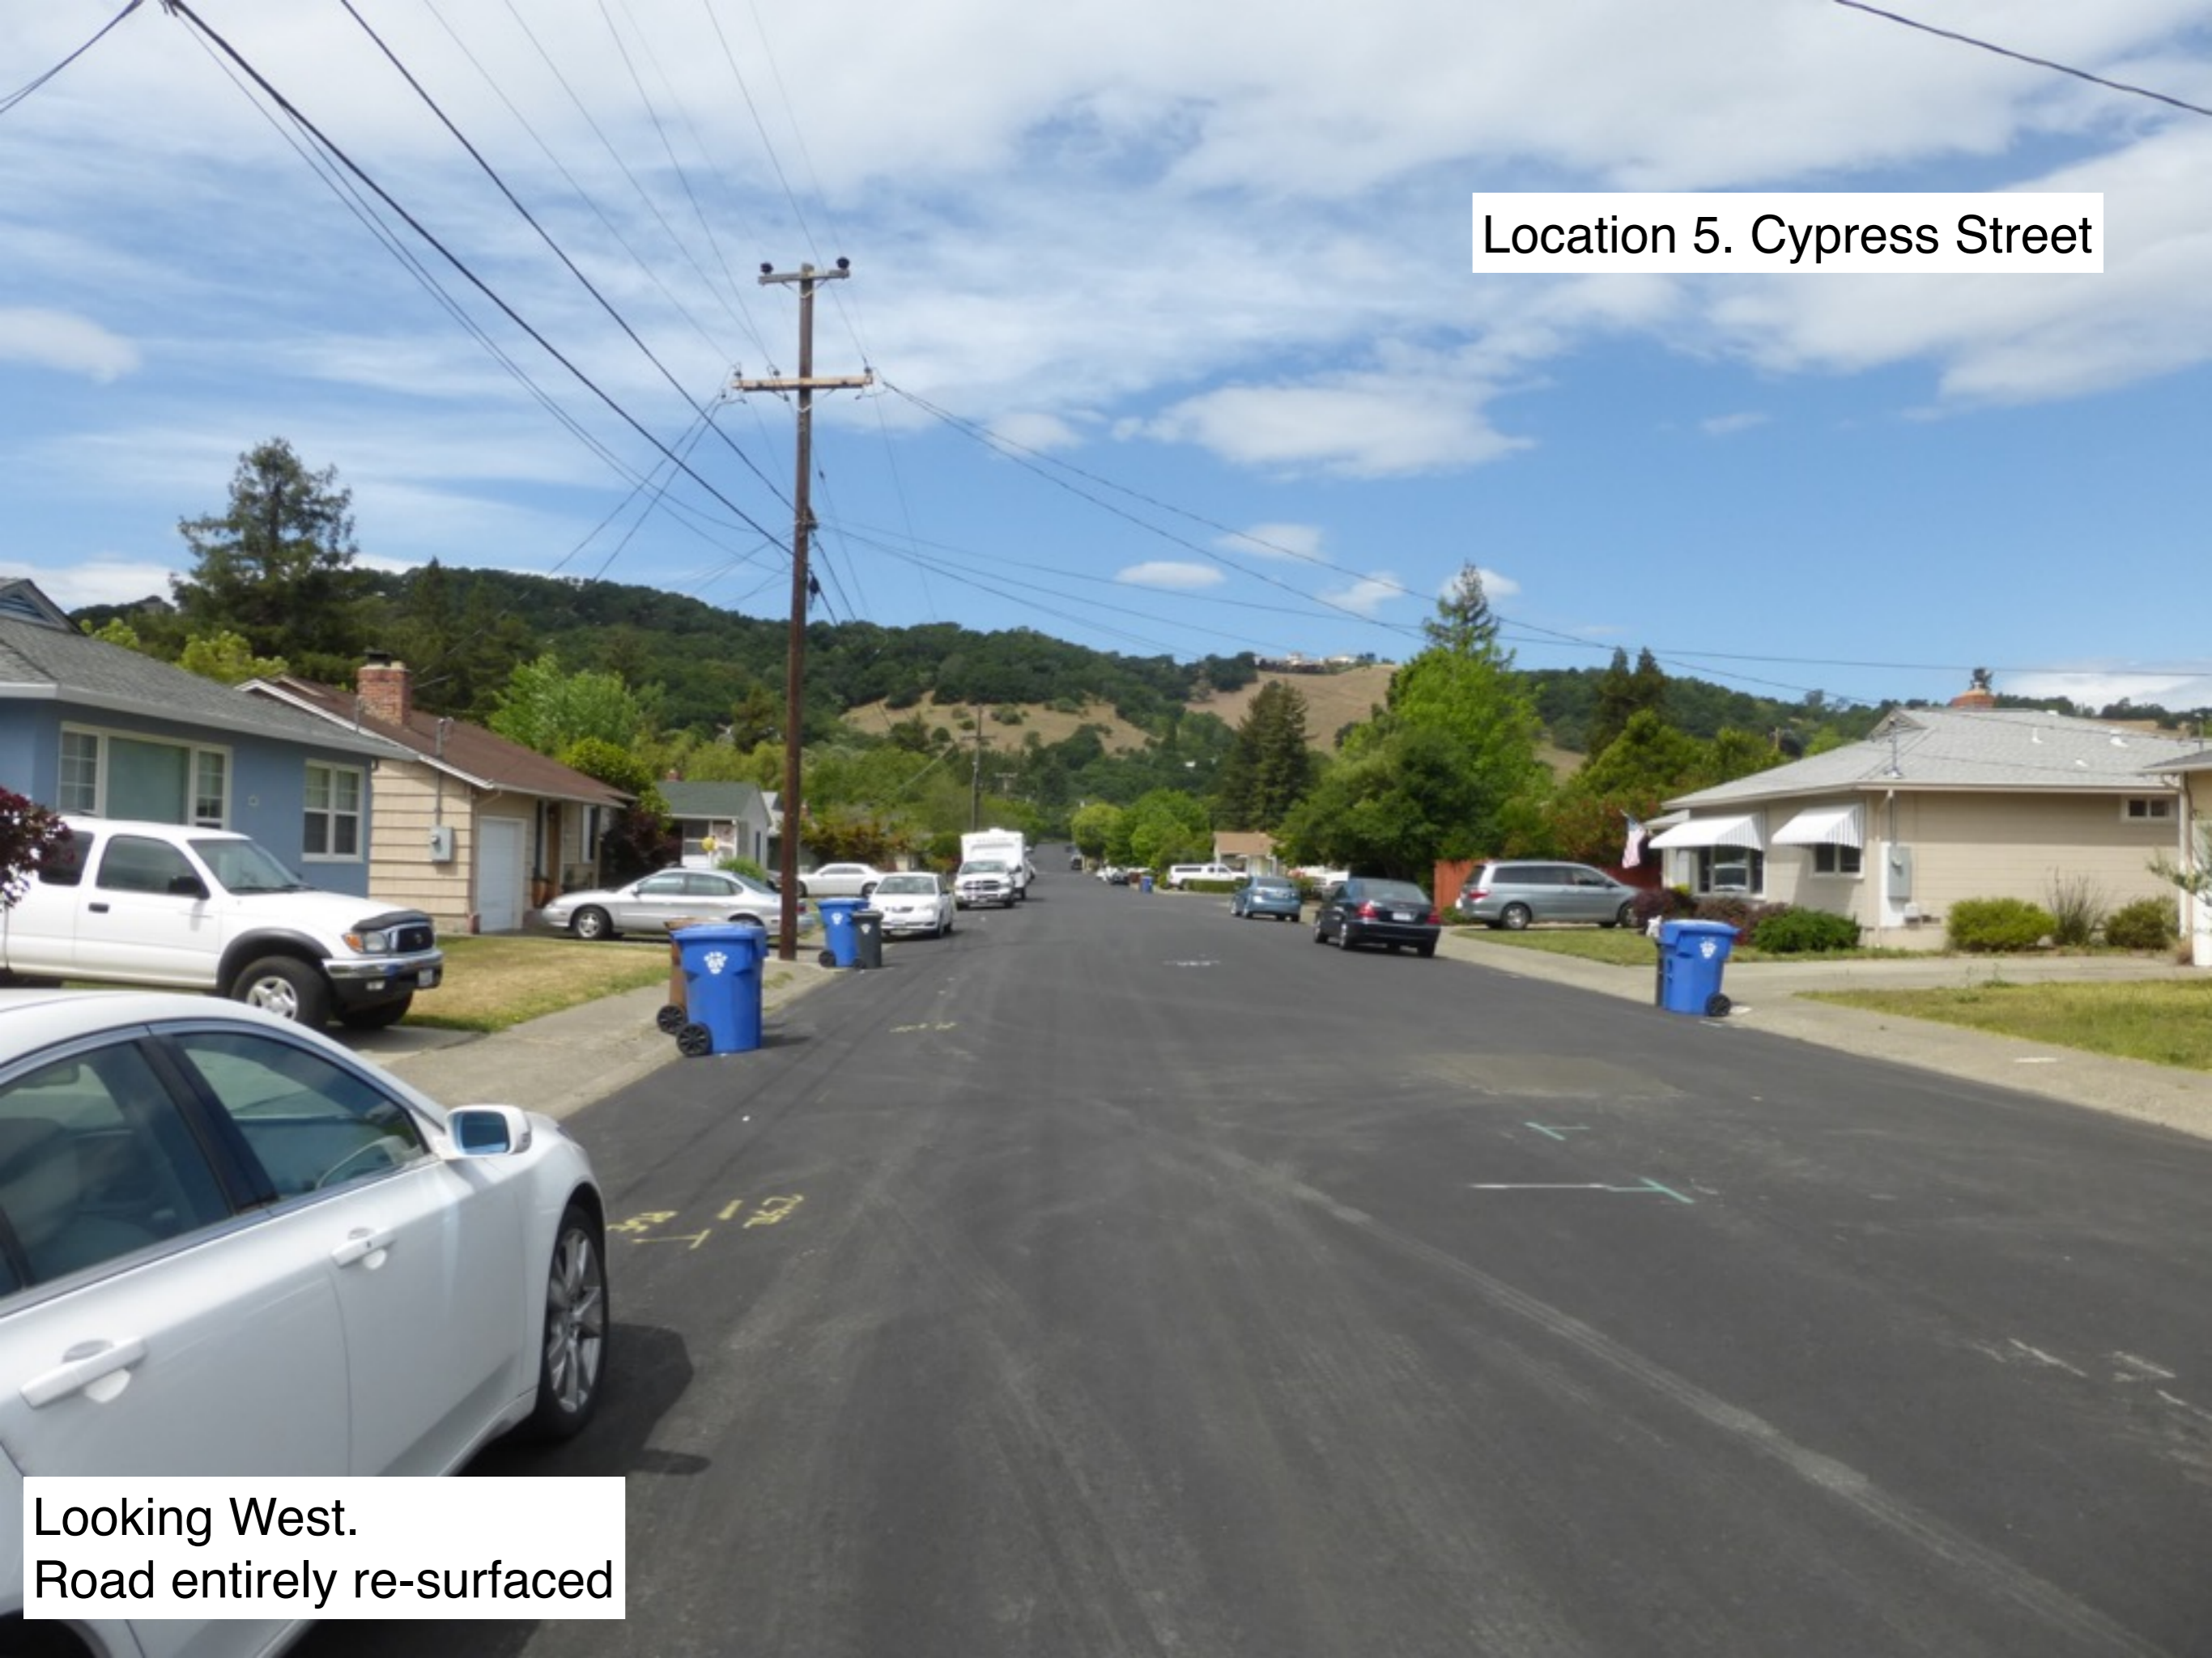
Location 5. Cypress Street

Looking West.
Road entirely re-surfaced

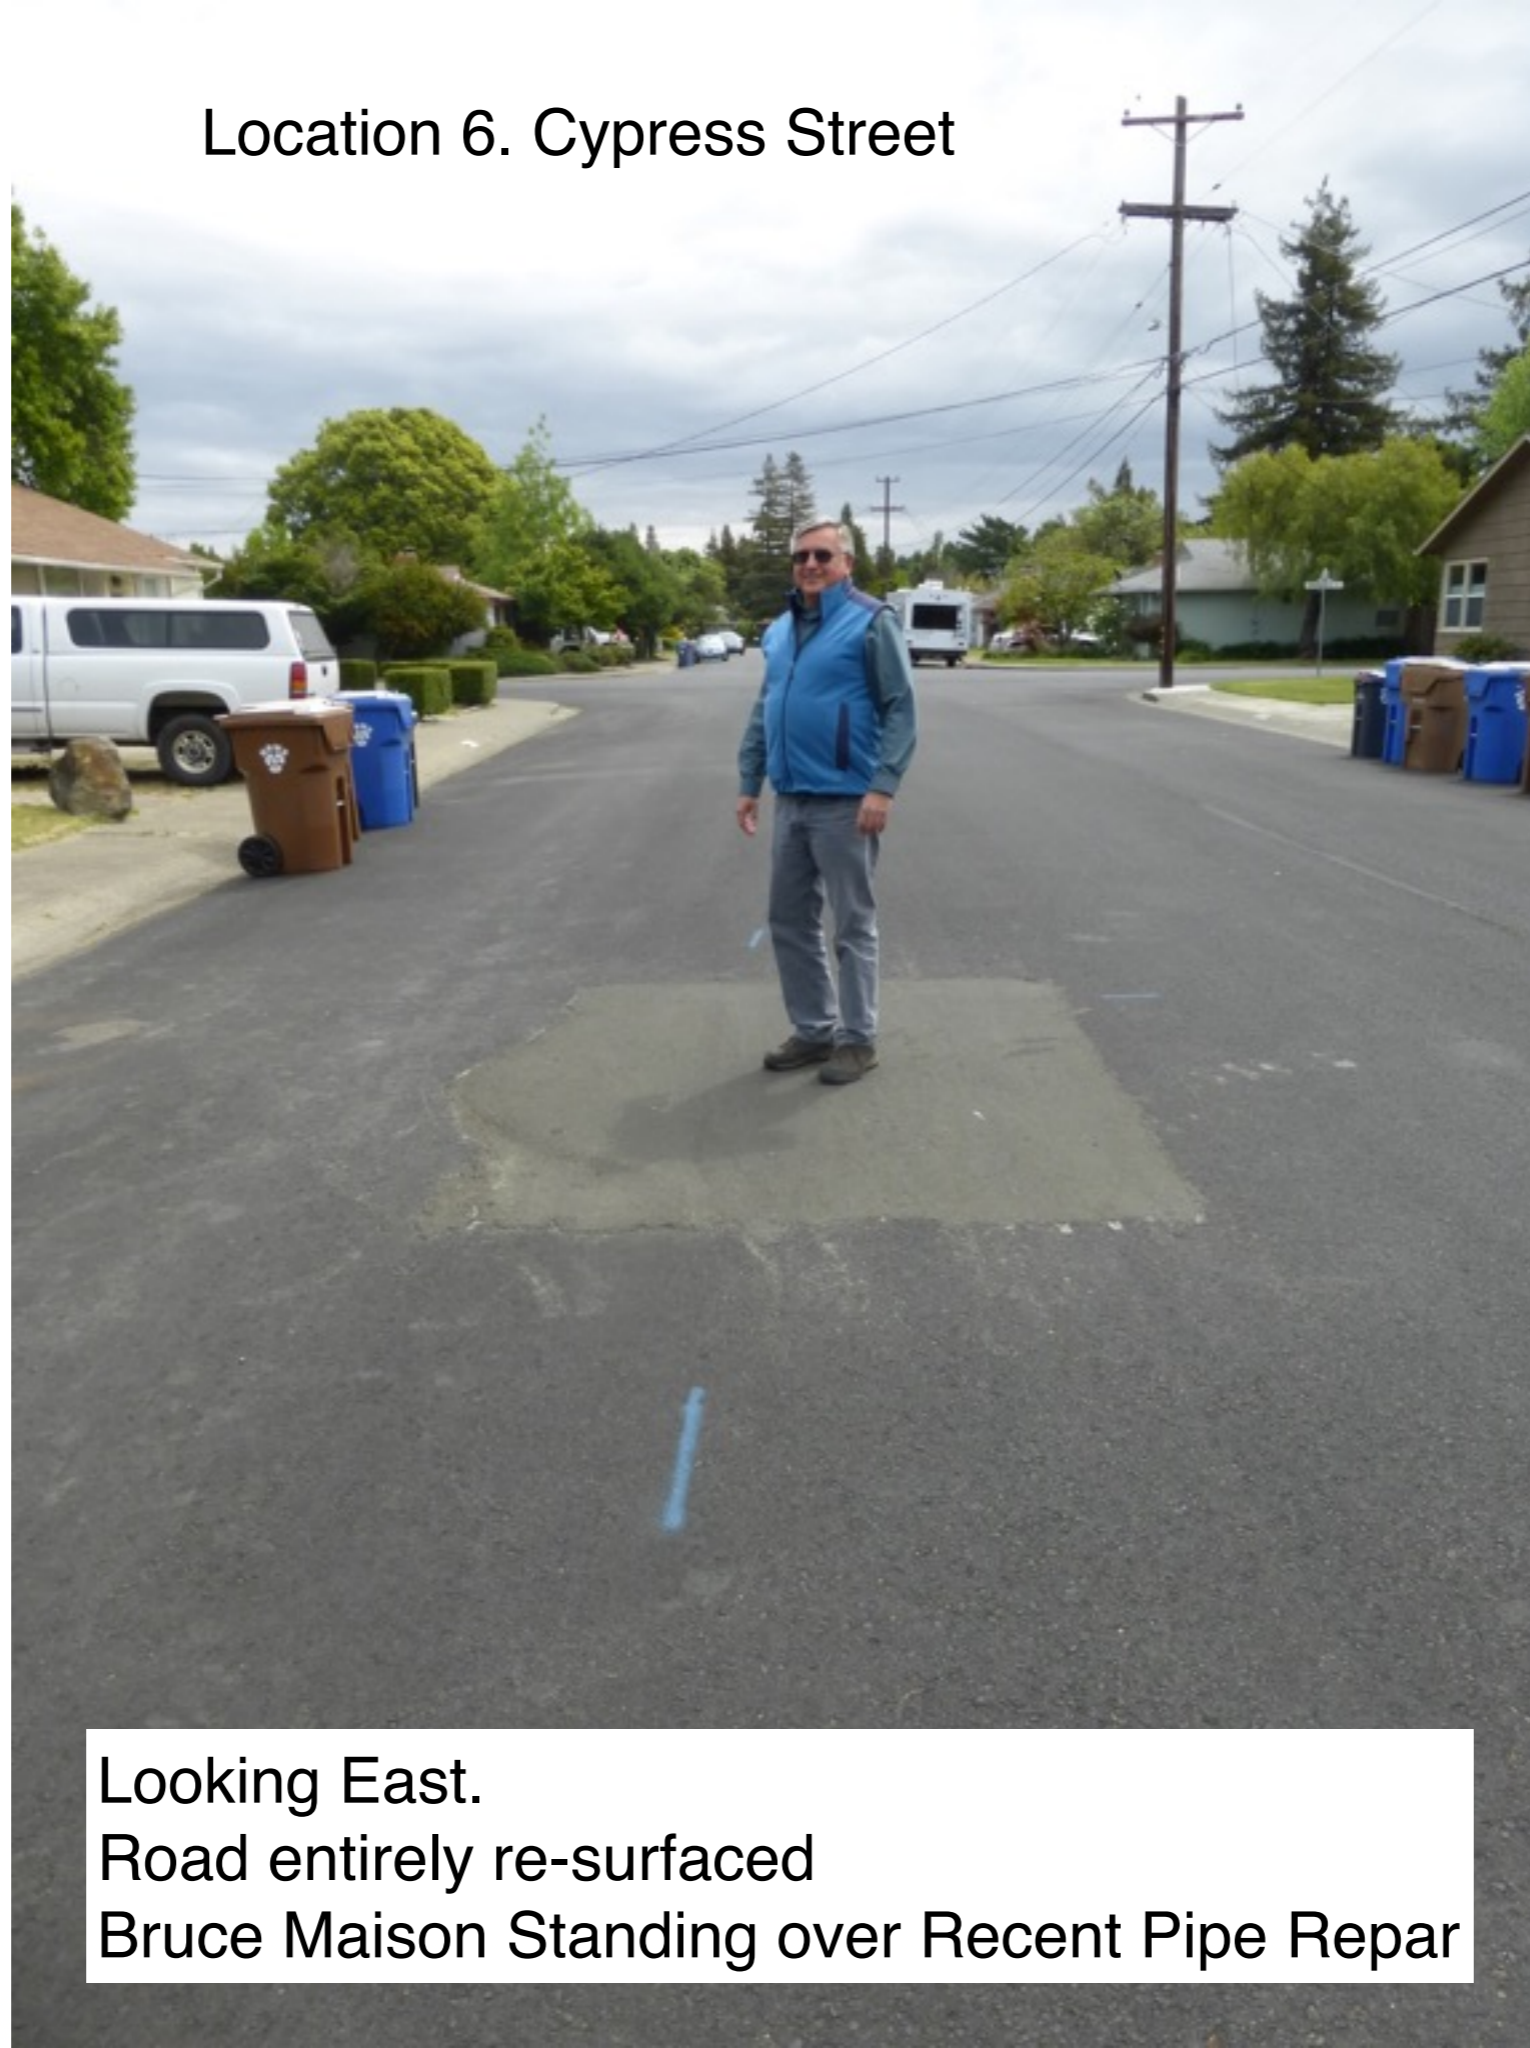
Location 6. Cypress Street

Looking East.
Road entirely re-surfaced
Bruce Maison Standing over Recent Pipe Repair
