Performance of Buried High Voltage Cables due to Liquefaction (Christchurch)

May 29, 2013

Sixth China-Japan-USA
Trilateral Symposium on
Lifeline Earthquake Engineering

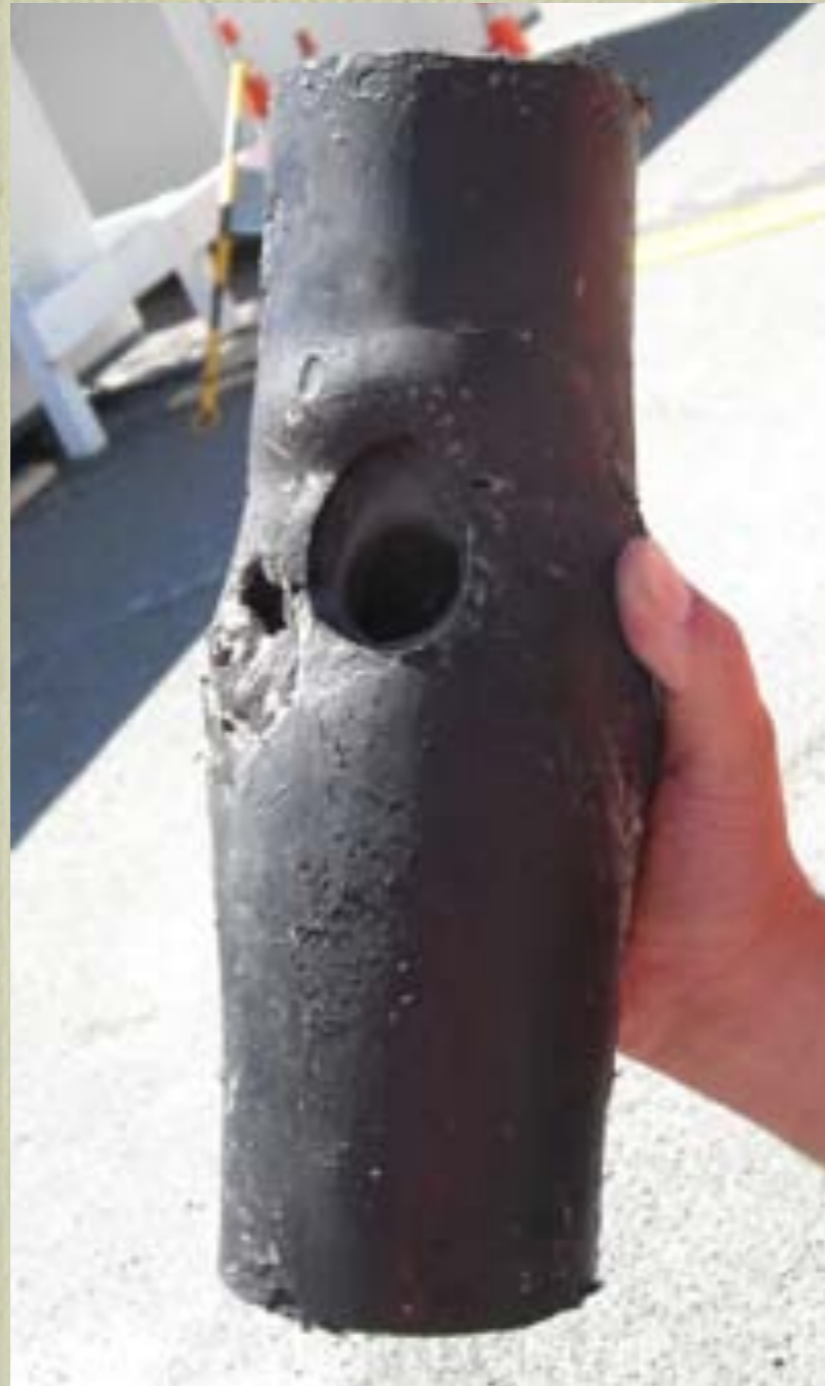
Answer: Earthquake - destroyed 66 kV Power Cable (XLPE)..... 400 similar cable failures.... Why did they fail?

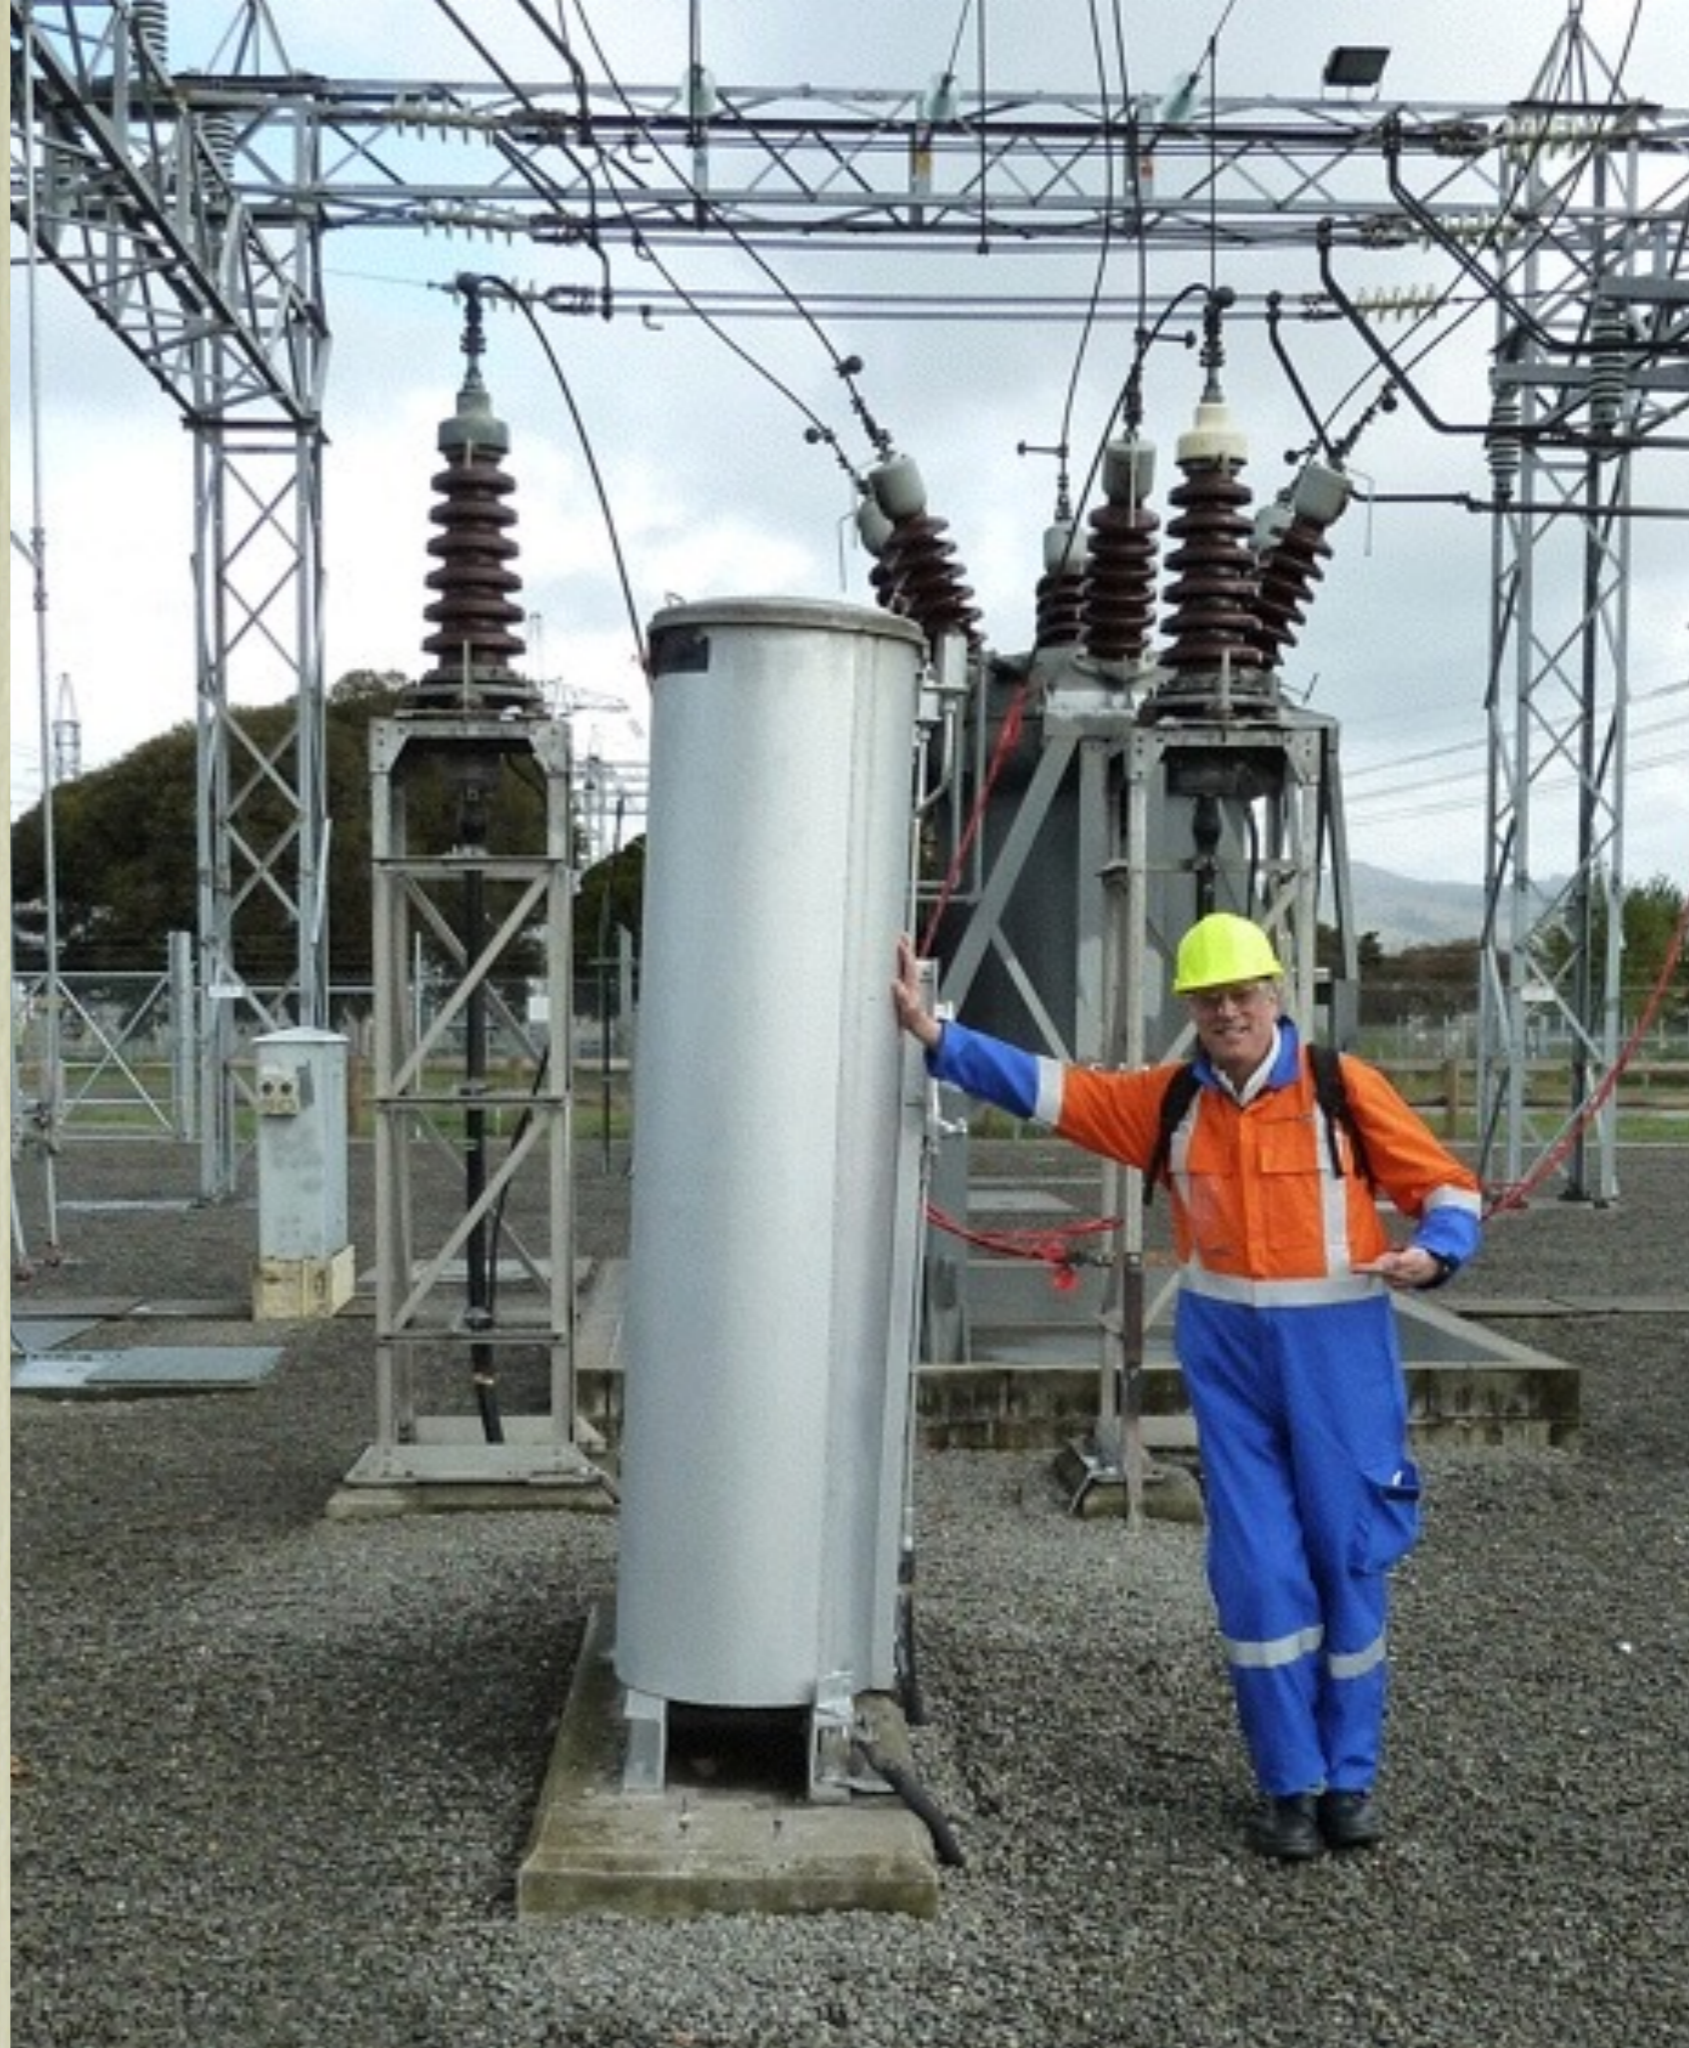
Oil Tanks for
Buried 66 kV
Cables. 2 of 3 were
tilted on their
foundations, one
spalled concrete
foundation

0 kPa pressure to buried oil-filled cables (3 cables from this substation)

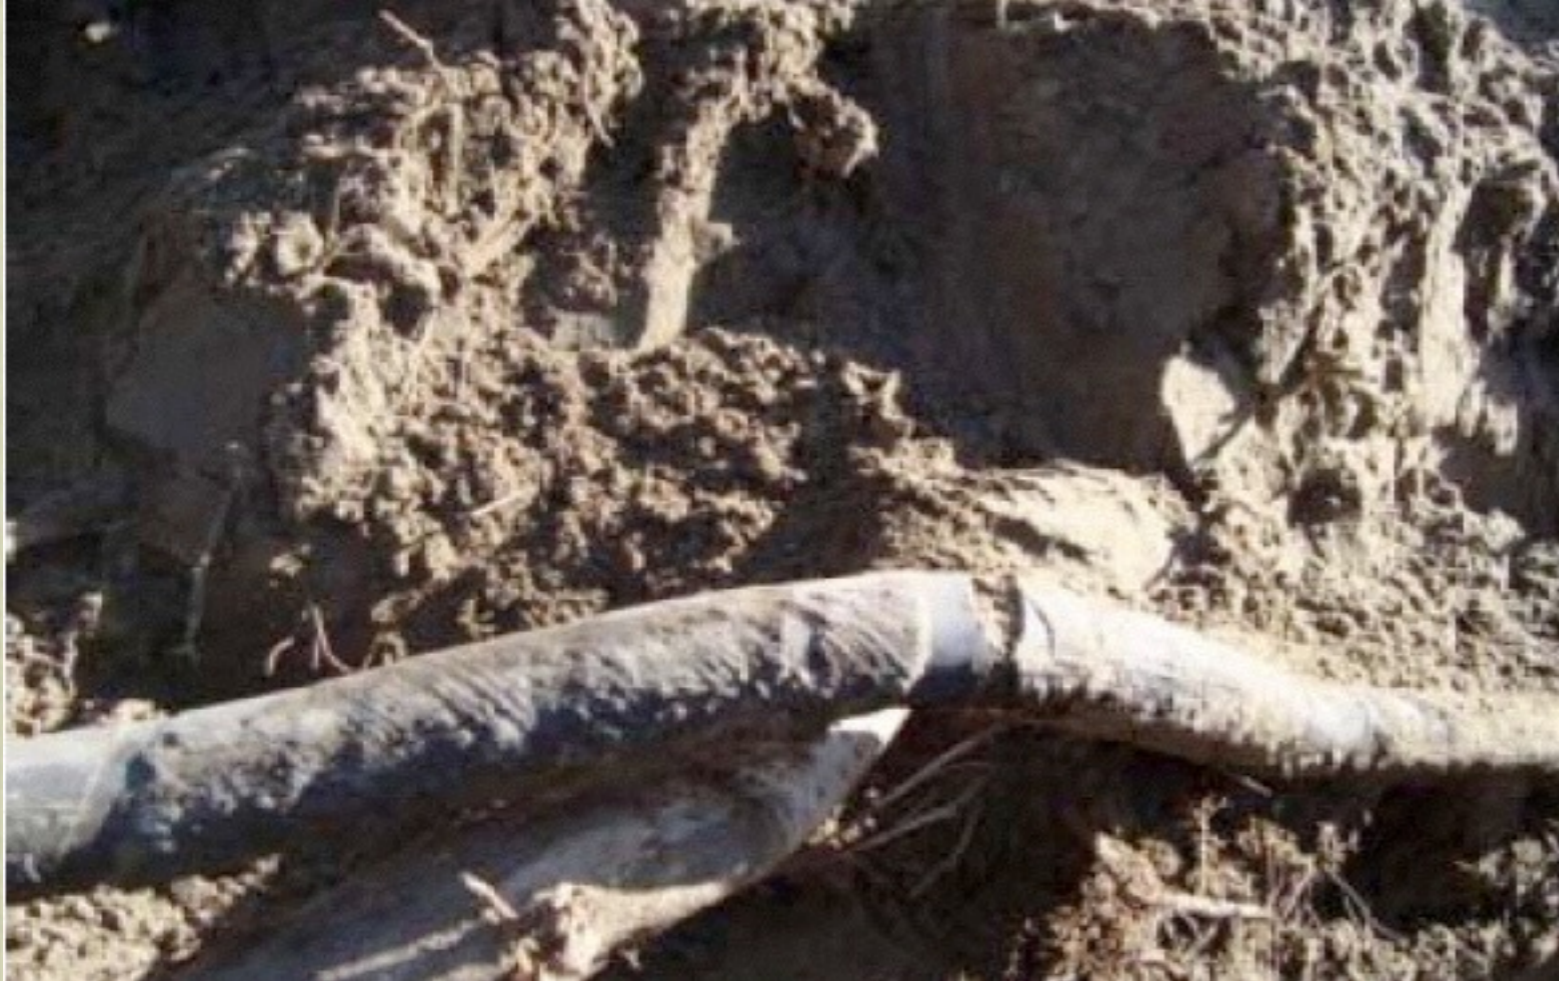
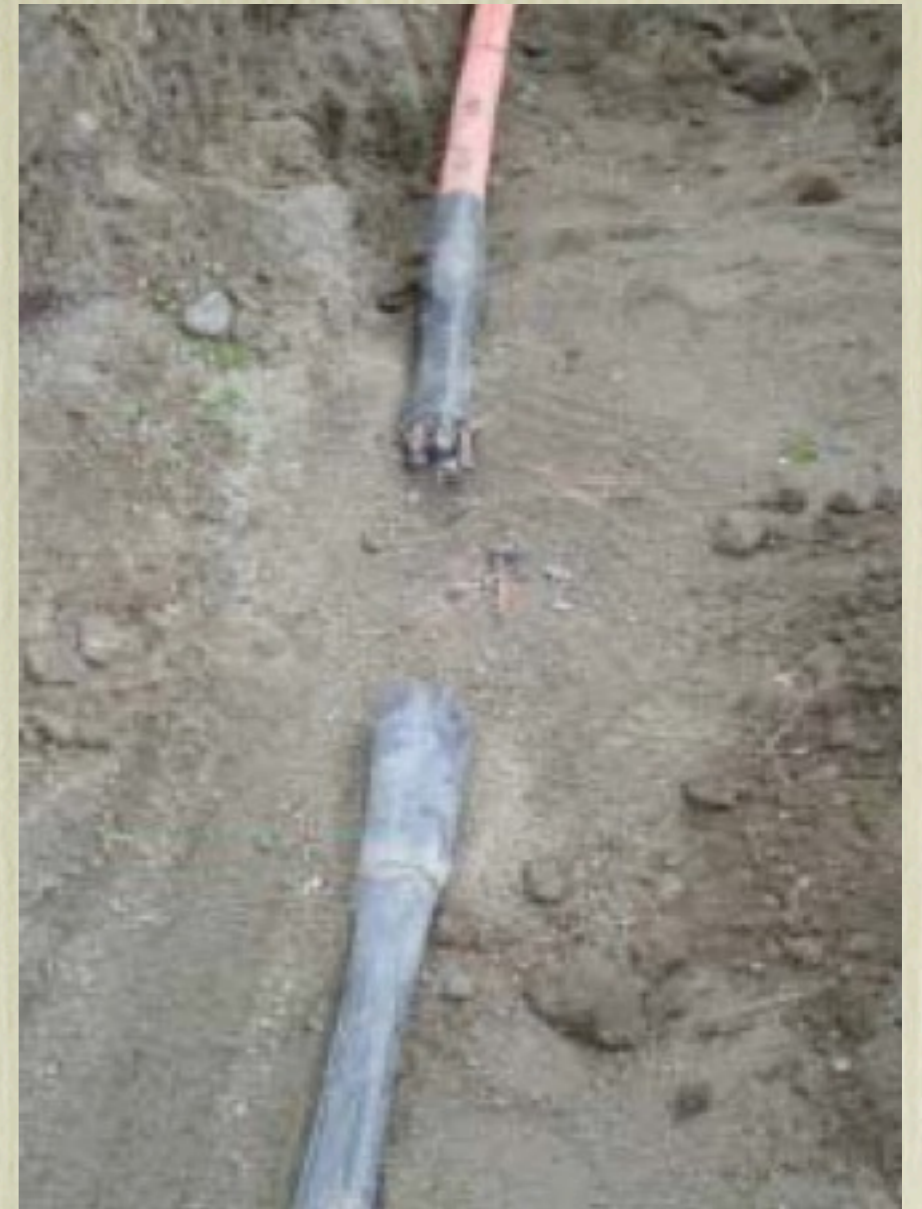
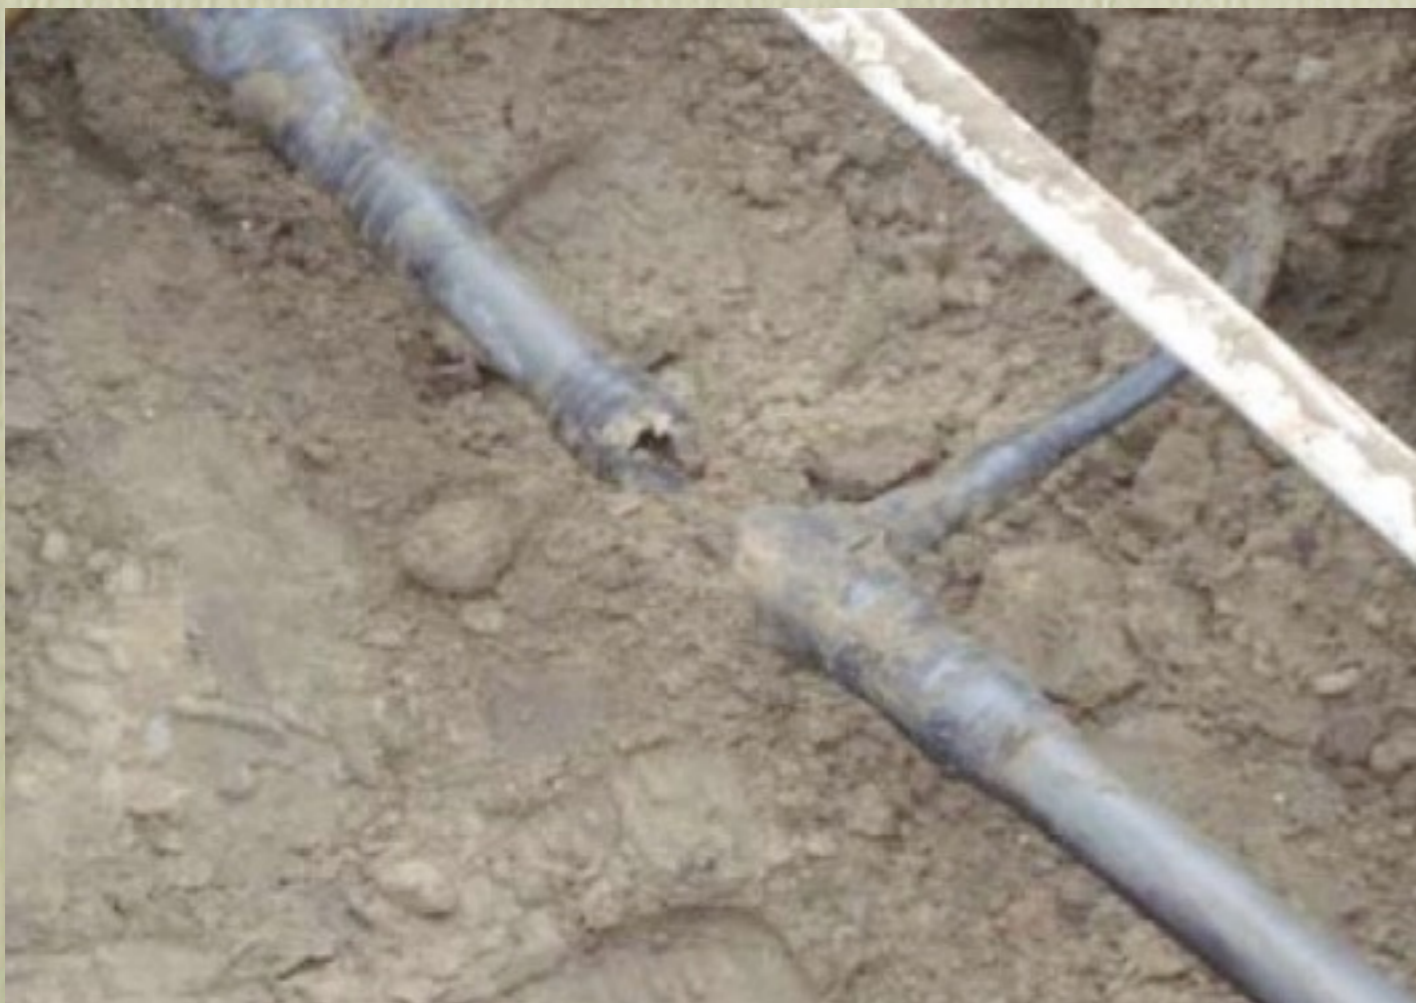
Faulted 11 kV Cables

Typical 11 kV cable damage

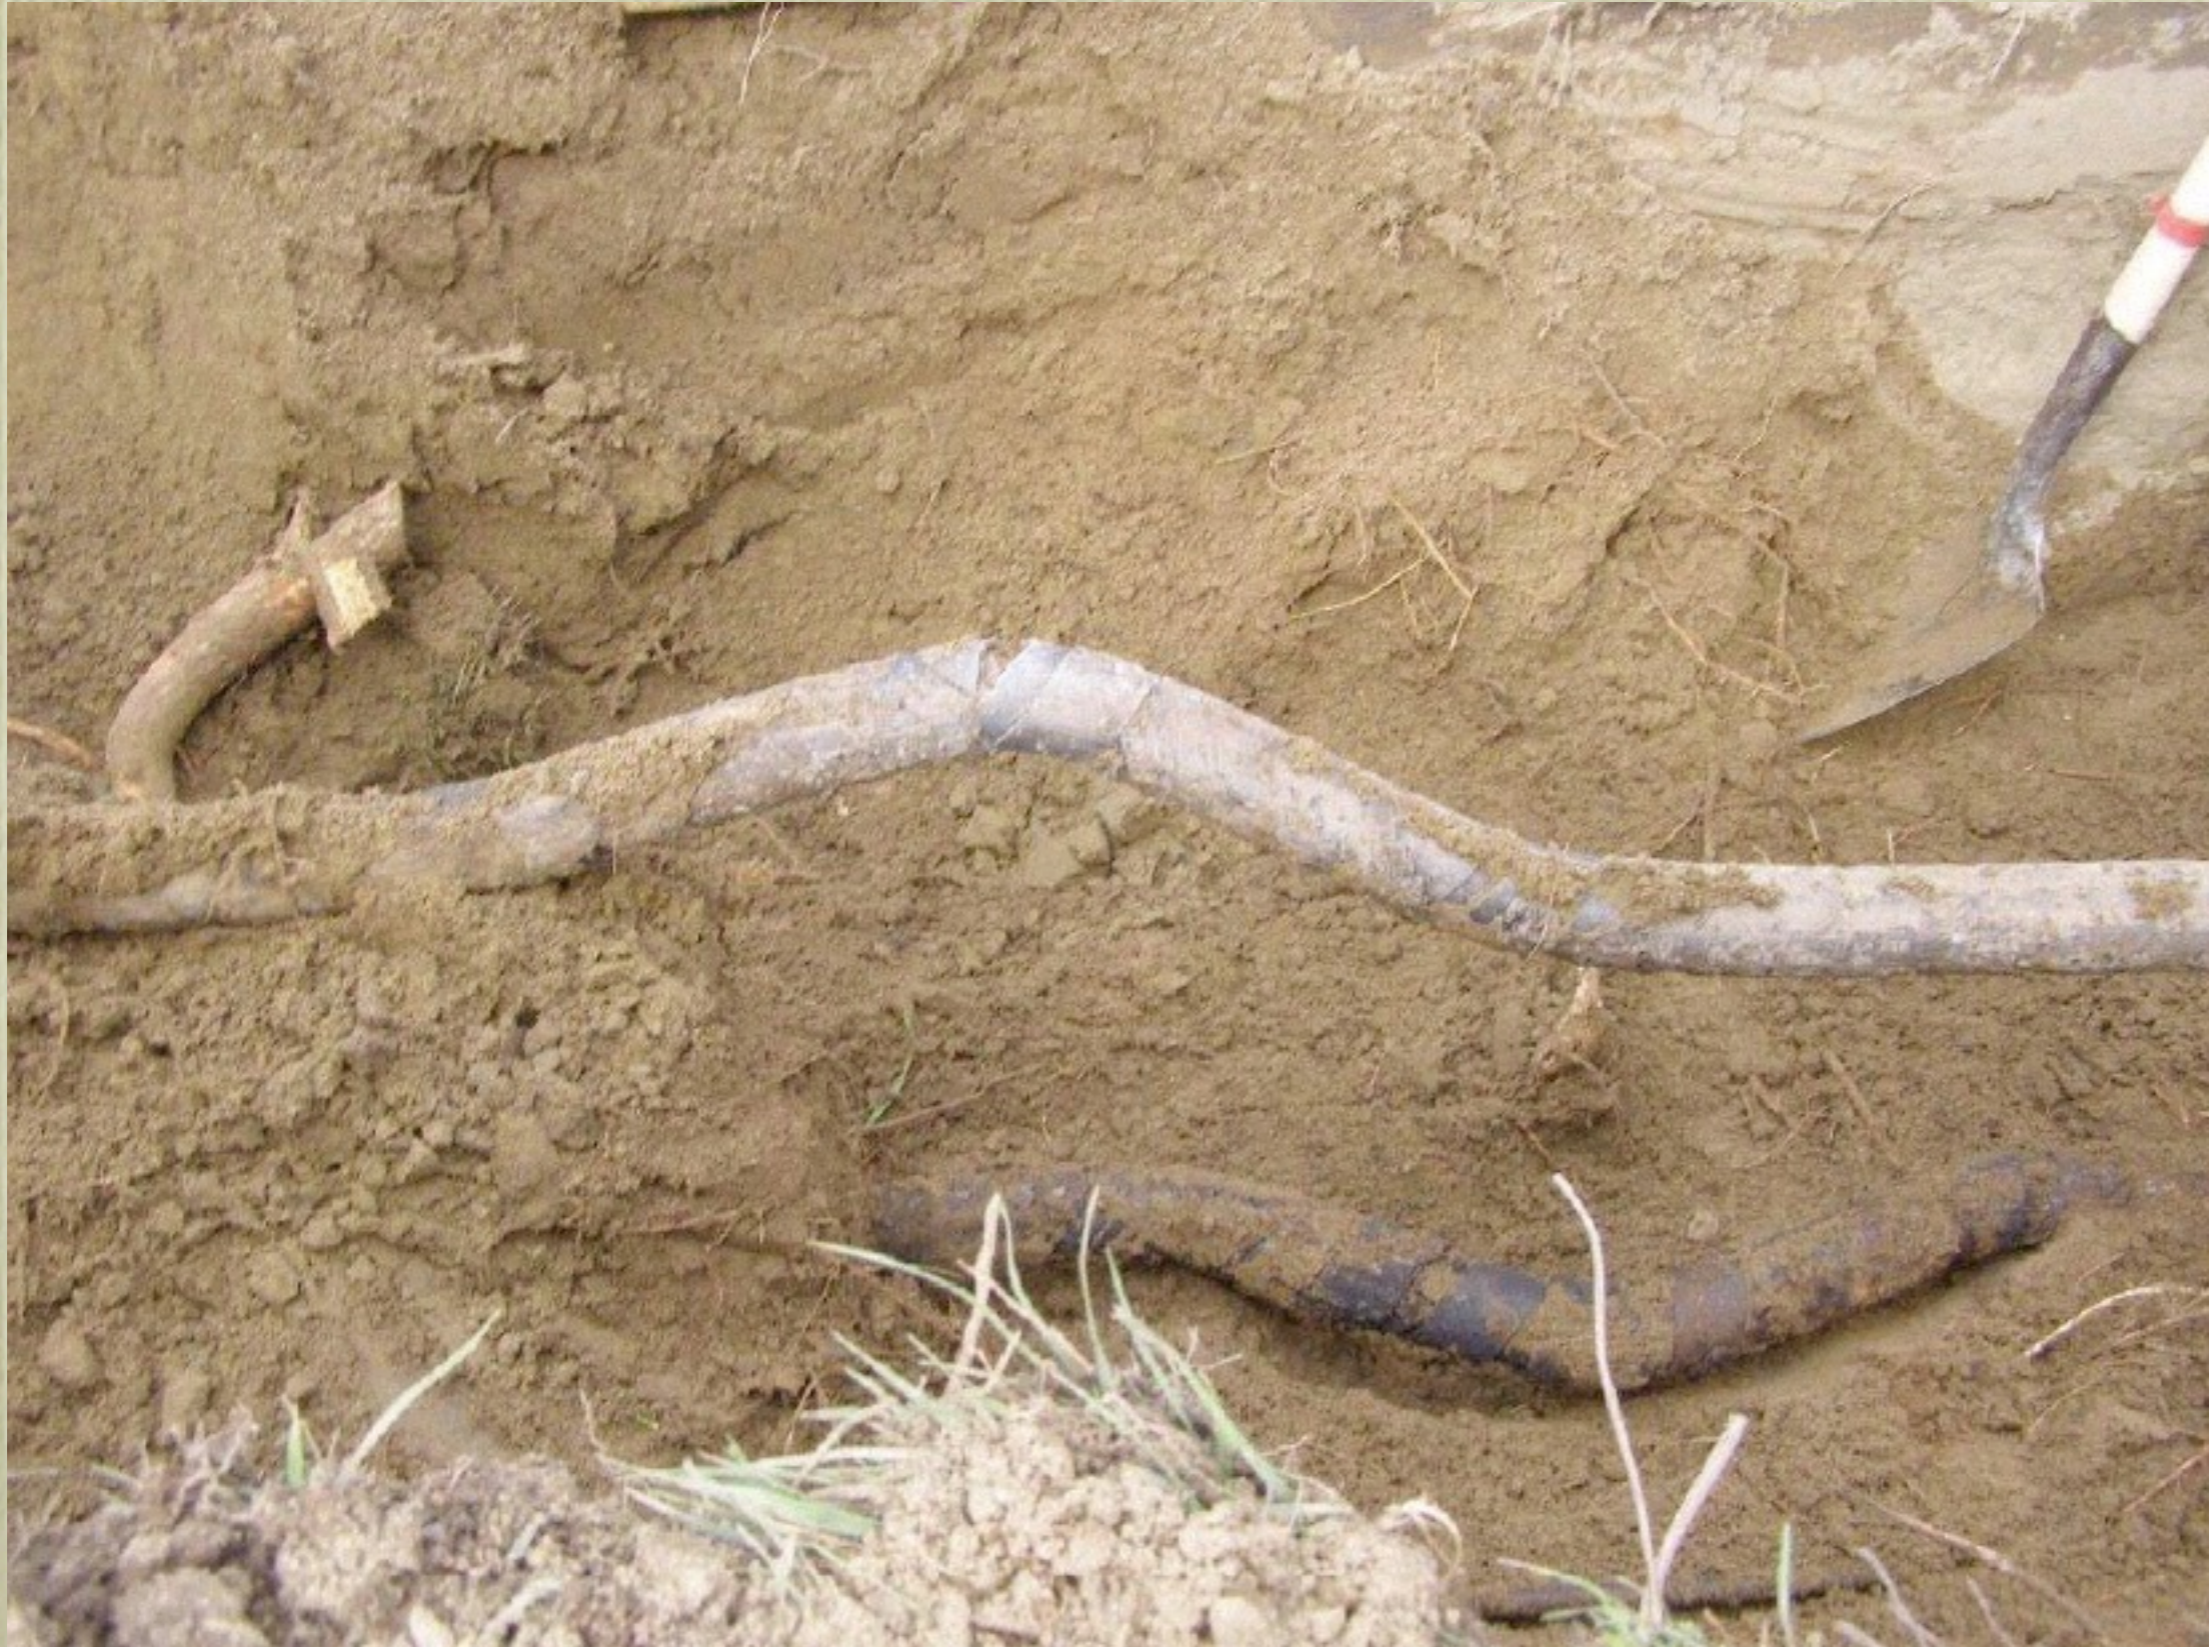
Typical 11 kV Cable Damage

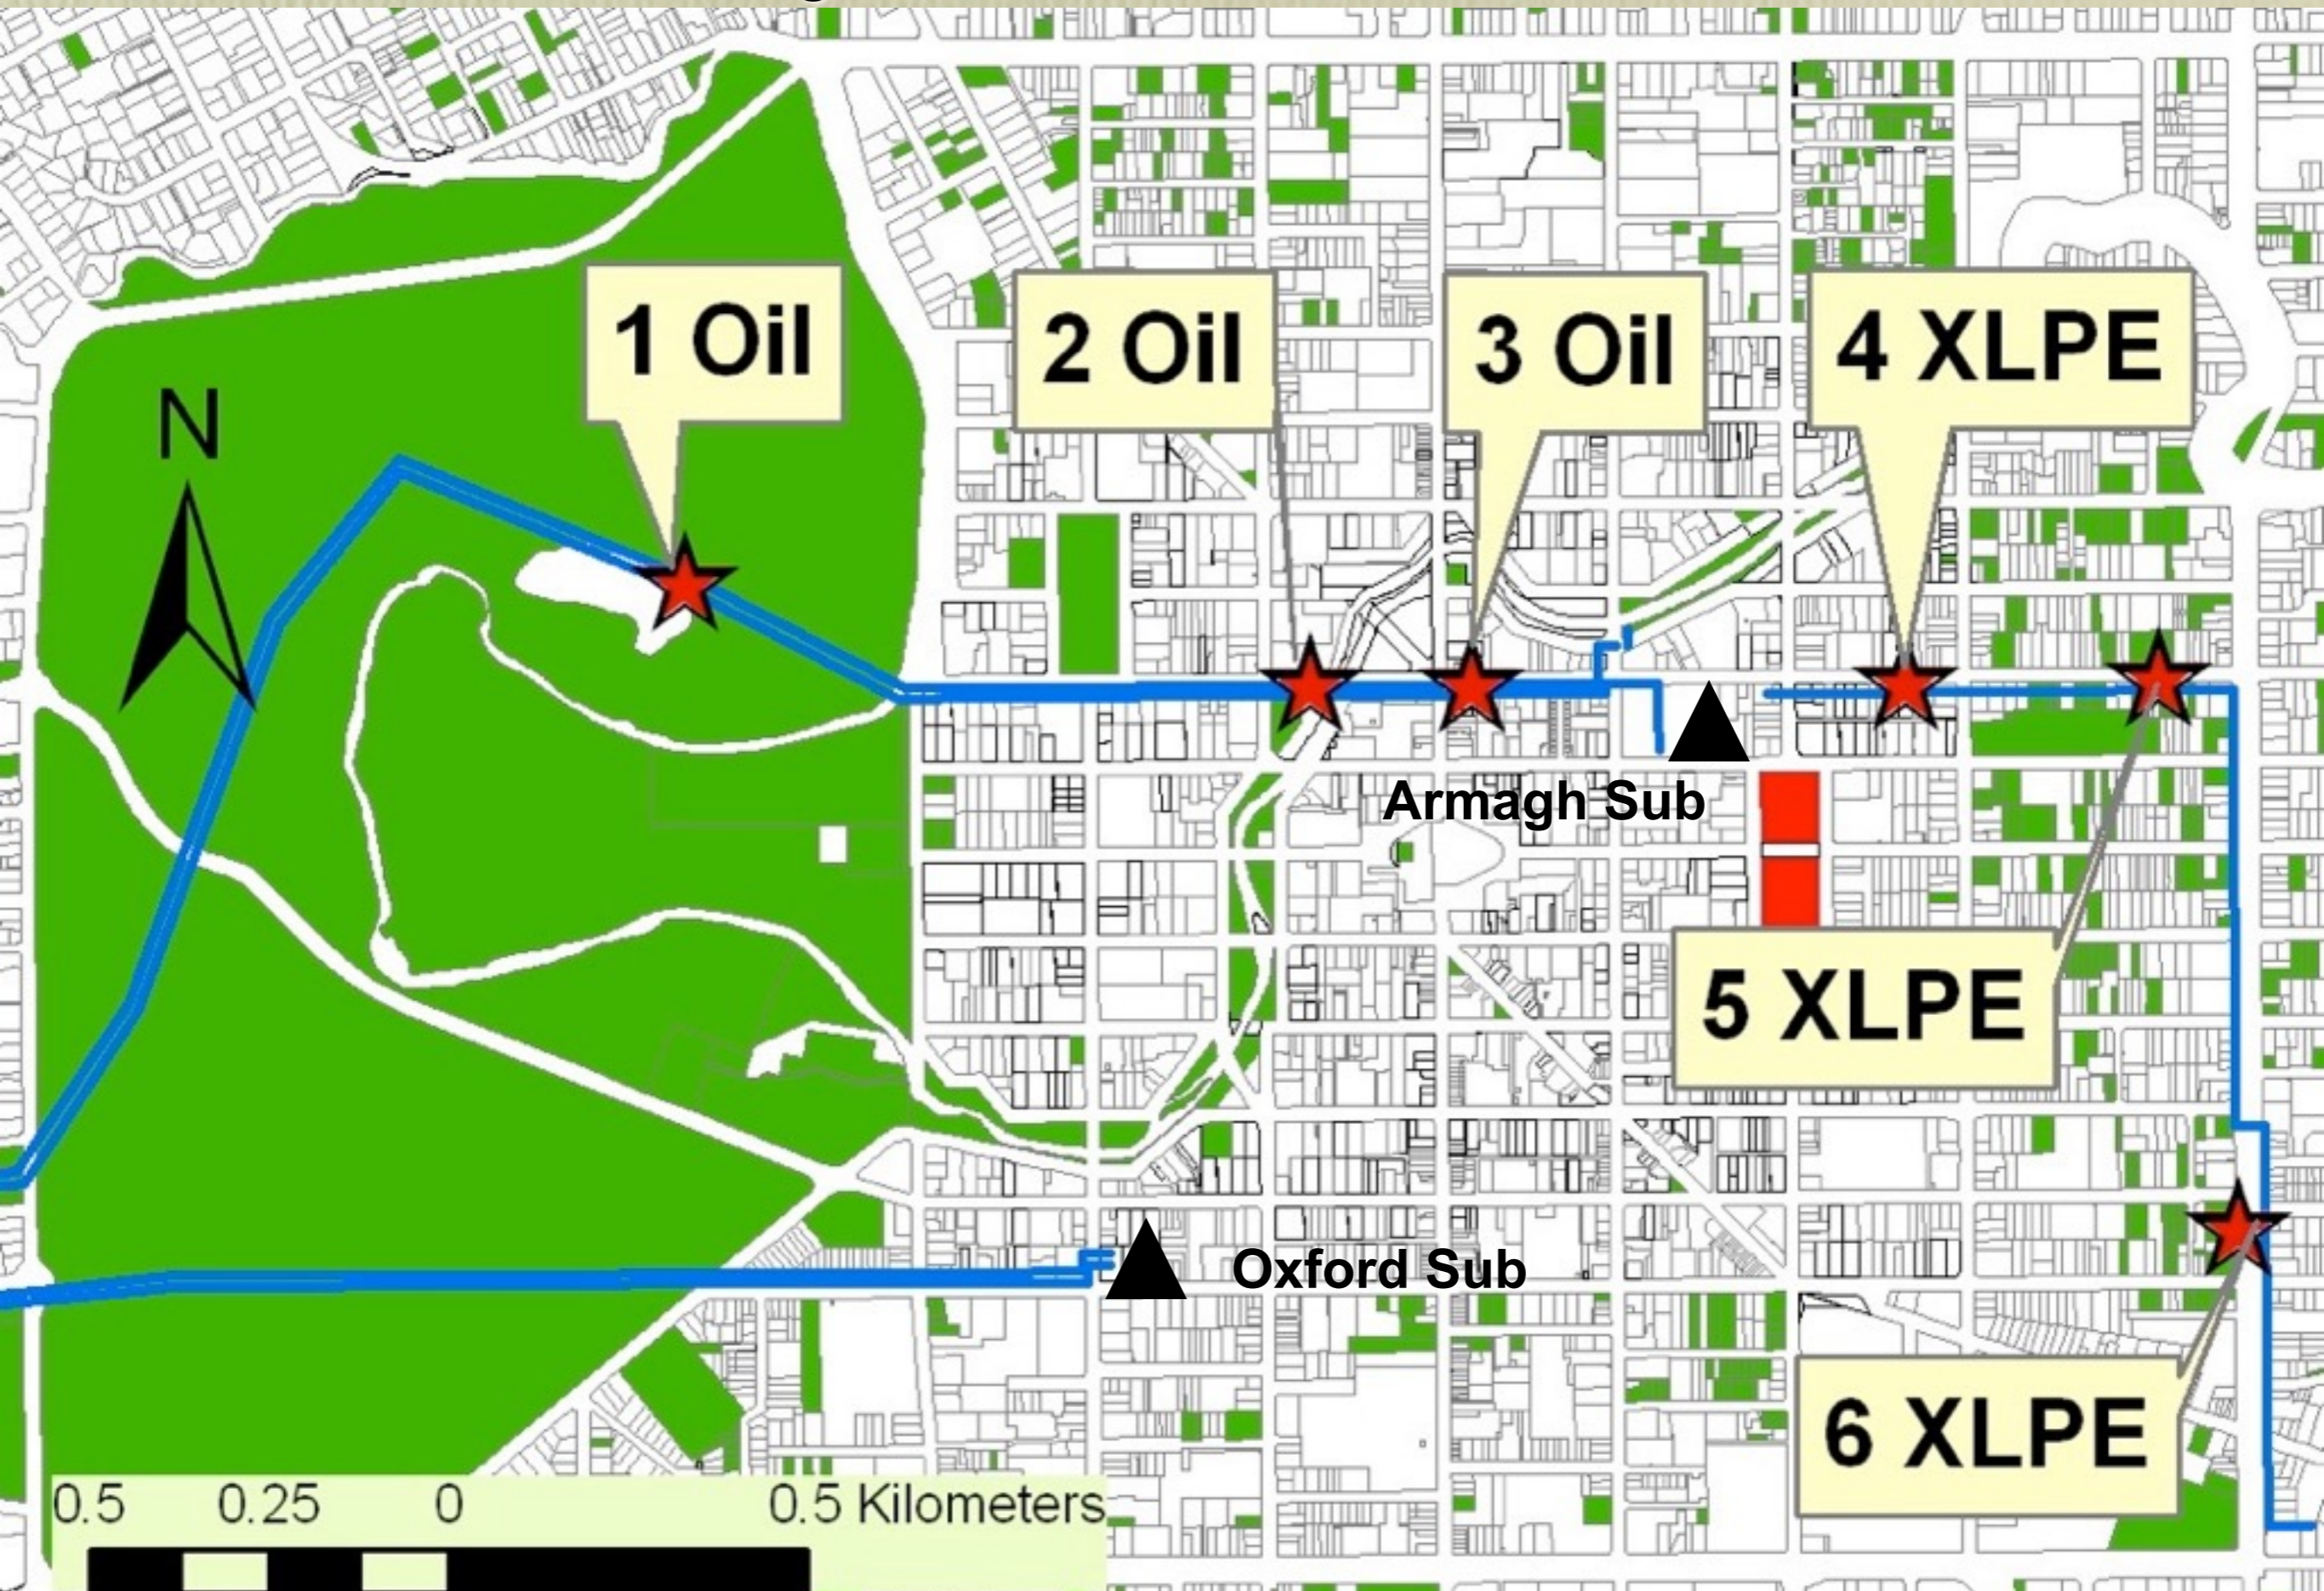
Locations of 66 kV Underground Cable Failures in Central Business District

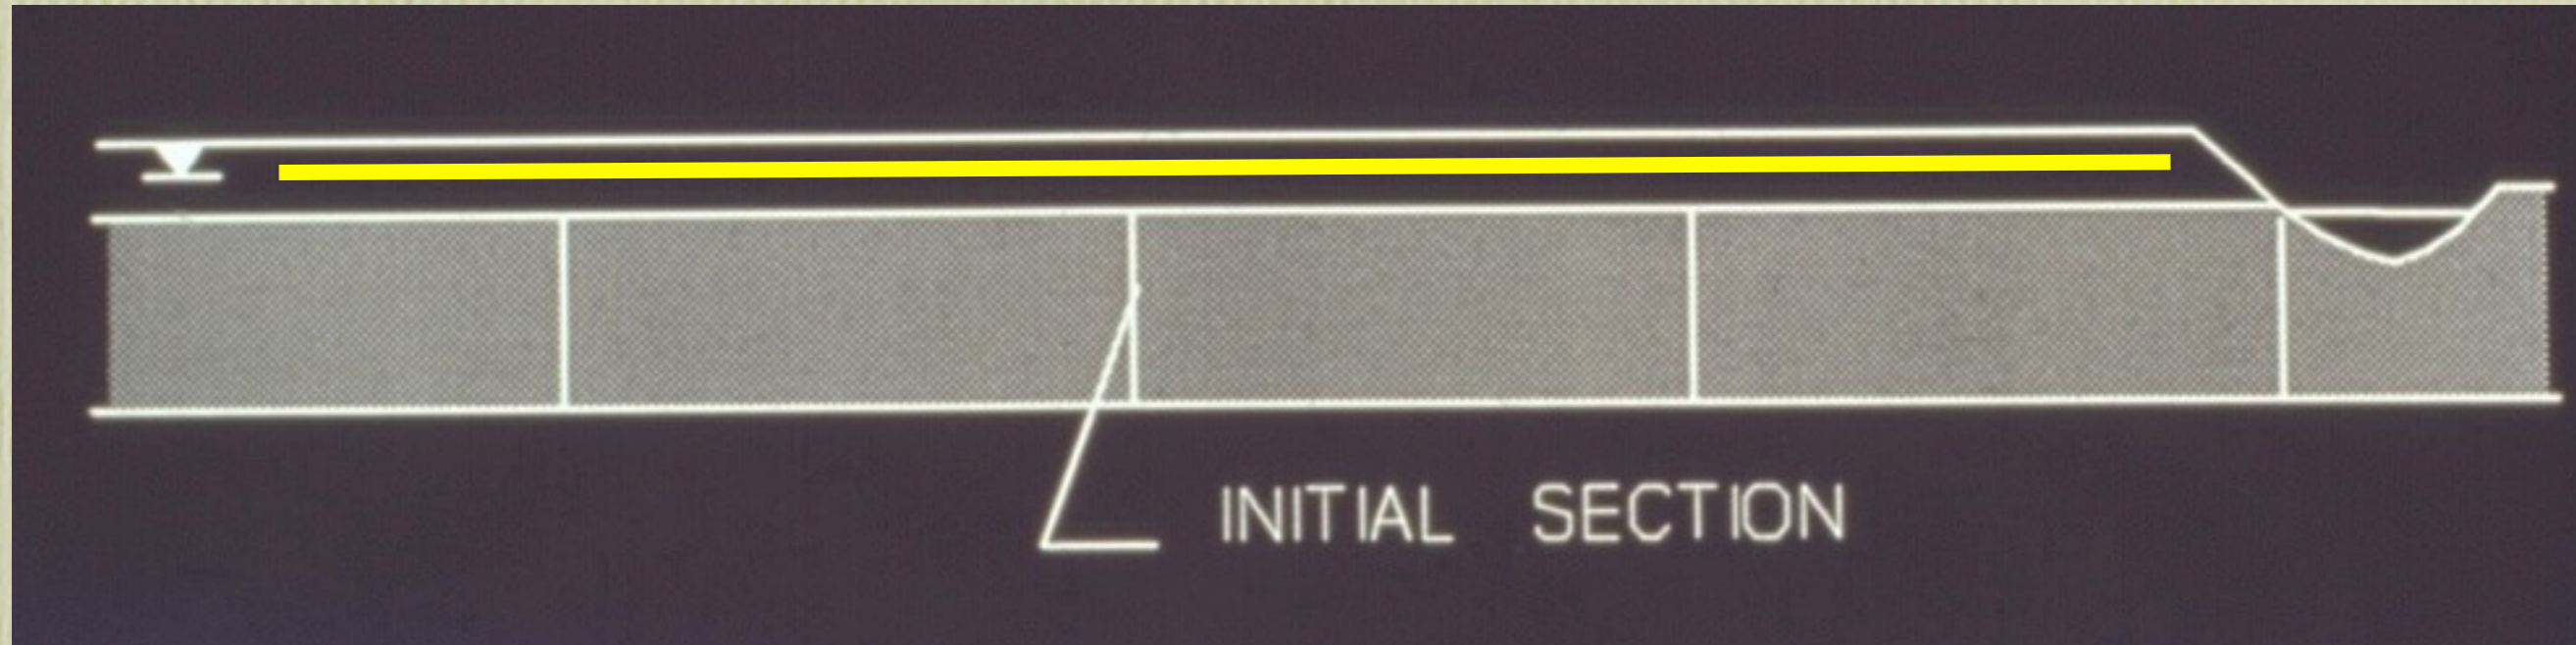
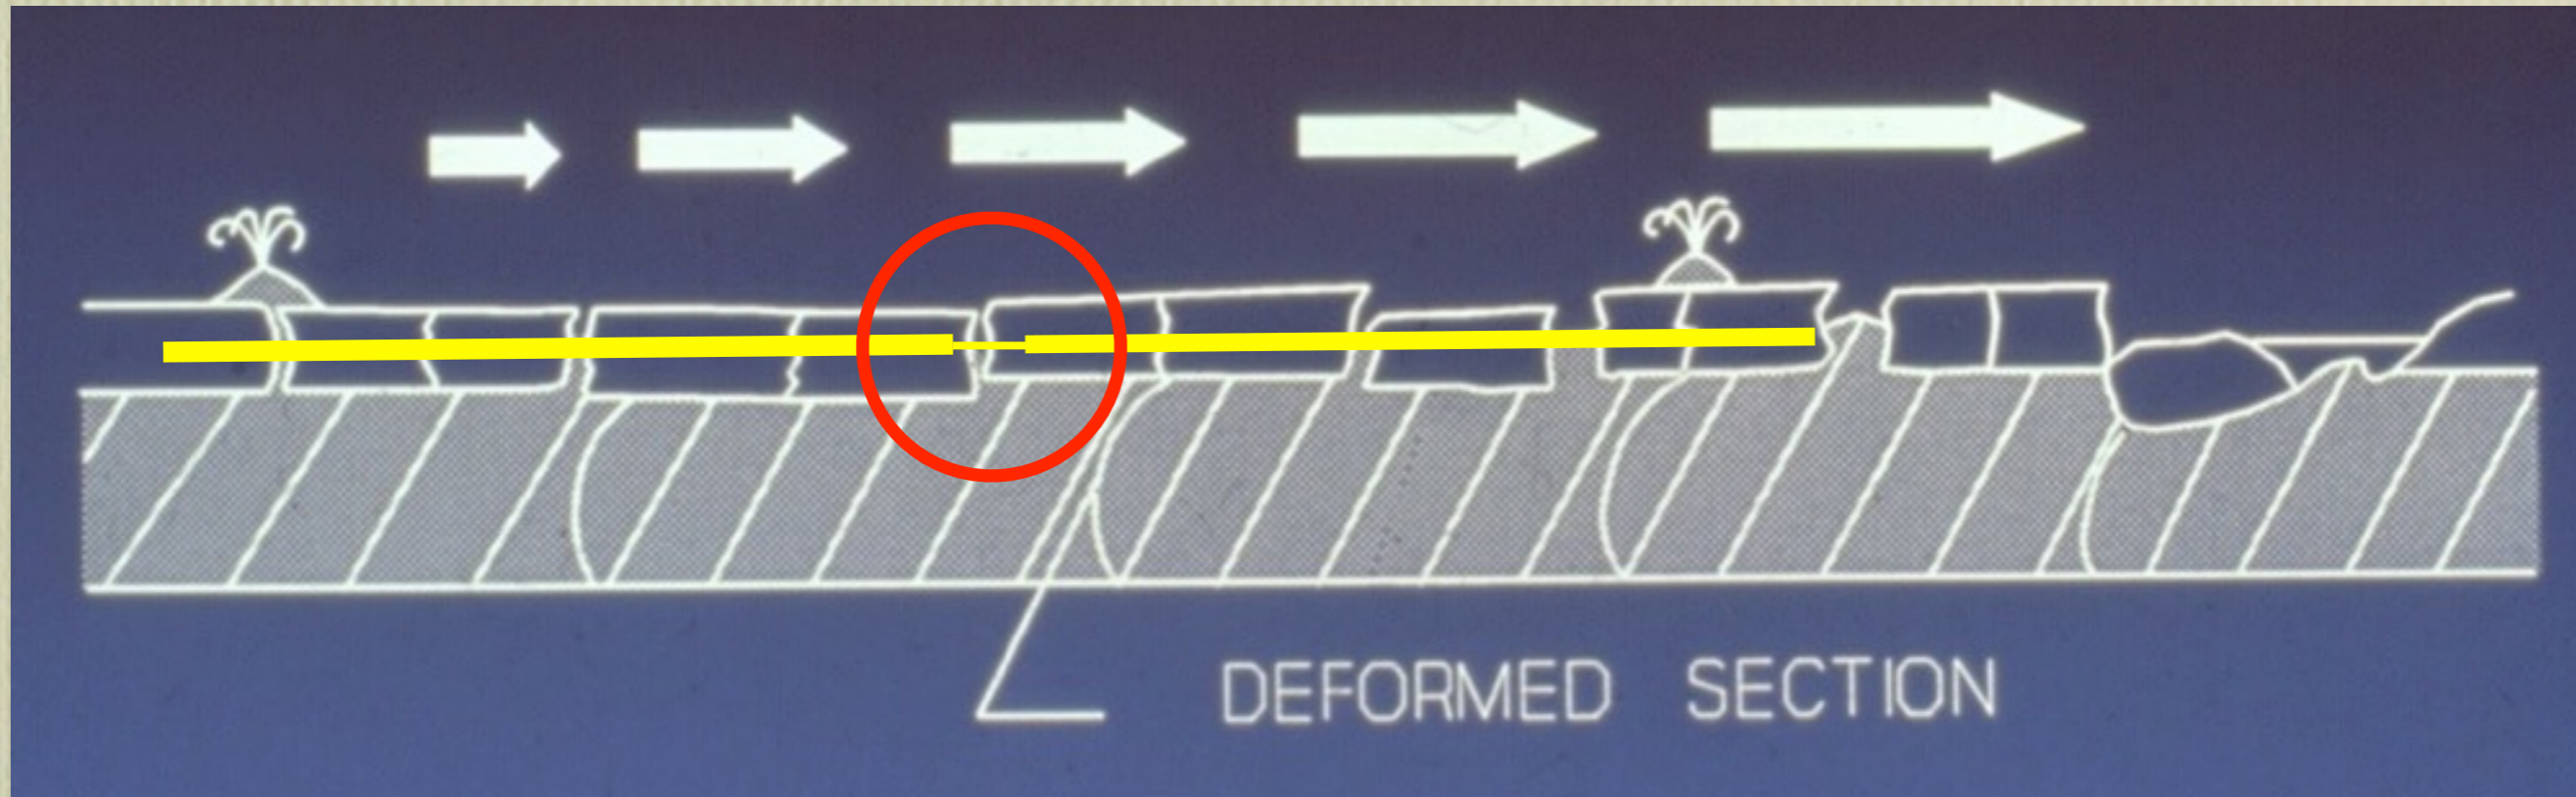
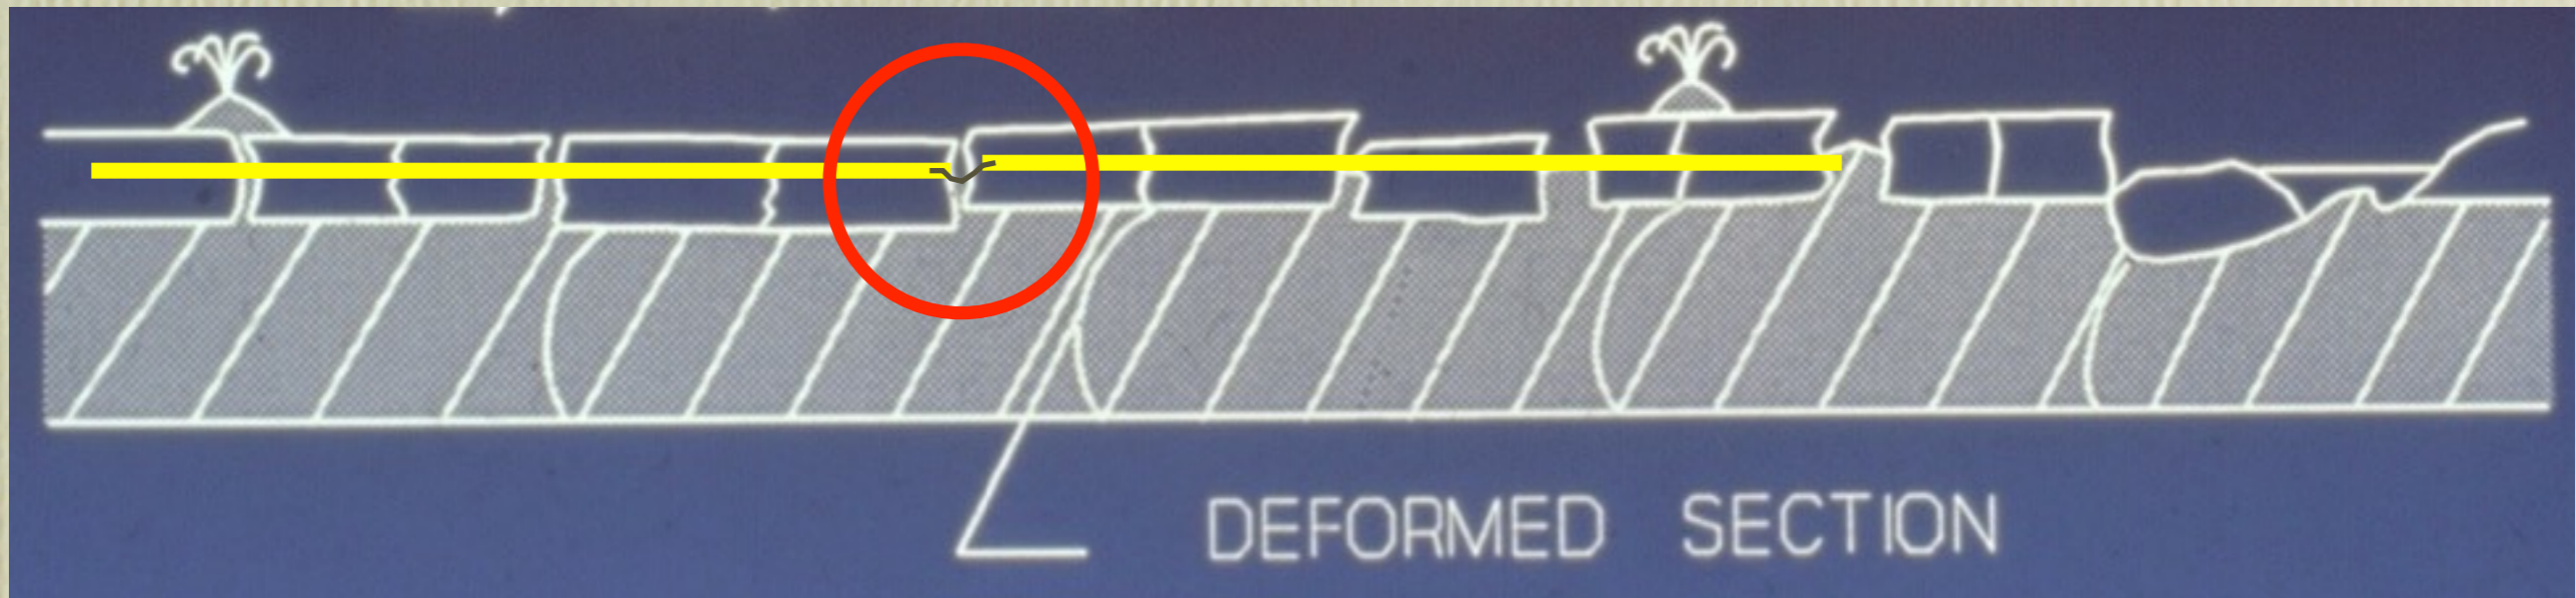
Soil cap breaks into independent blocks and begin to slosh around, tending towards free face

Cable Stretches

Soil cap blocks close into their final position

1. Concrete cracks in tension ($t_u * L > f'_t * A$)
 2. Pipe-Type Cable Stretches
 3. Pipe-Type Cable Buckles in Compression
 4. Oil Pressure Lost (as observed at substation gage, 2-3 hours post-earthquake)

- NEVER use direct burial cables in thermal concrete in liquefaction zones.
- In liquefaction zones:
 - Use overhead (if possible)
 - Use buried cables in PVC or HDPE conduits within reinforced thermal concrete duct banks
