Seismic Performance of Water System – M 6.6 Lushan, China Earthquake of April 20 2013

John Eiding, President, G&E Engineering Systems Inc., Olympic Valley, CA 96146
eidinger@geEngineeringSystems.com

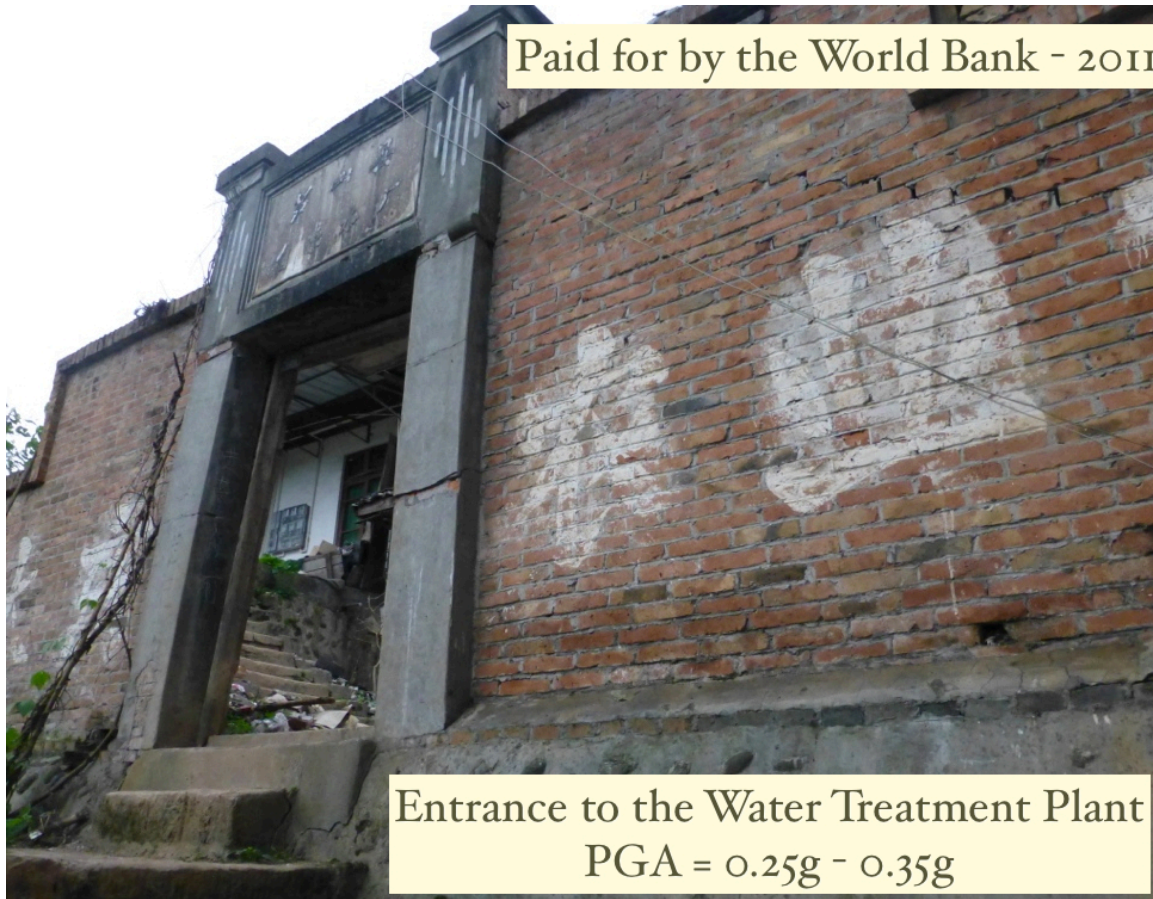
Figure 6. Entrance to Water Treatment Plant

A new (2011 vintage) water treatment plant had just been completed prior to the 2013 earthquake, using funding from the World Bank. Figure 6 shows the entrance, using a unreinforced masonry wall (the wall was damaged, but this did not impact the plant's performance).

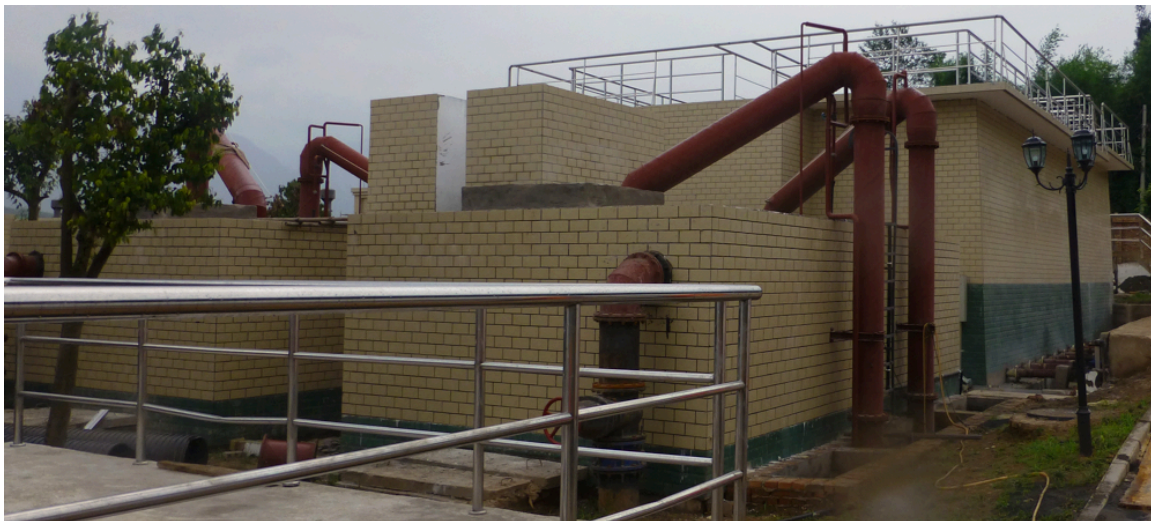
Figure 7. Settling and Filter Basin Structures

Raw water enters two sets of settling basins, flocculation basins and tube settlers, all in rectangular reinforced concrete structures, Figure 7. There was no evidence of damage to any part of these structures. Launderers over the filters were steel, anchored to the reinforced concrete walls; the launderers were undamaged.

It appears that all the water-retention structures of this 2011-vintage-designed plant worked well. Whether this good performance is due to minimum requirements for water leak-tightness; or if these facilities were designed per modern seismic codes (or both), is an area for investigation.

- There was good performance of the water retention structures at the newly constructed water treatment plant. Why did this occur? Possibly due to the requirement to make water-retaining reinforced concrete structures to be leak tight (lots of reinforcing steel at small bar spacing).

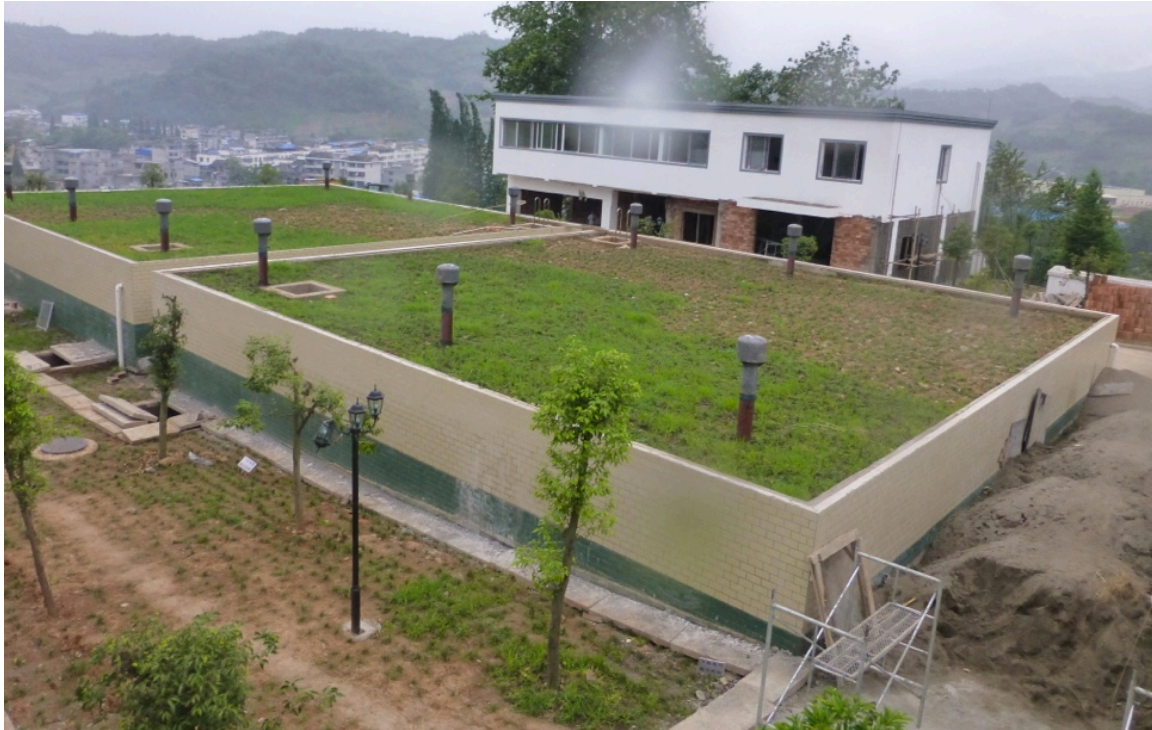
Figure 8. Two Partially Buried Clearwells

Water leaves the filters and enters two partially-buried rectangular reinforced concrete clearwells, Figure 8. The two clearwells appeared to be undamaged.

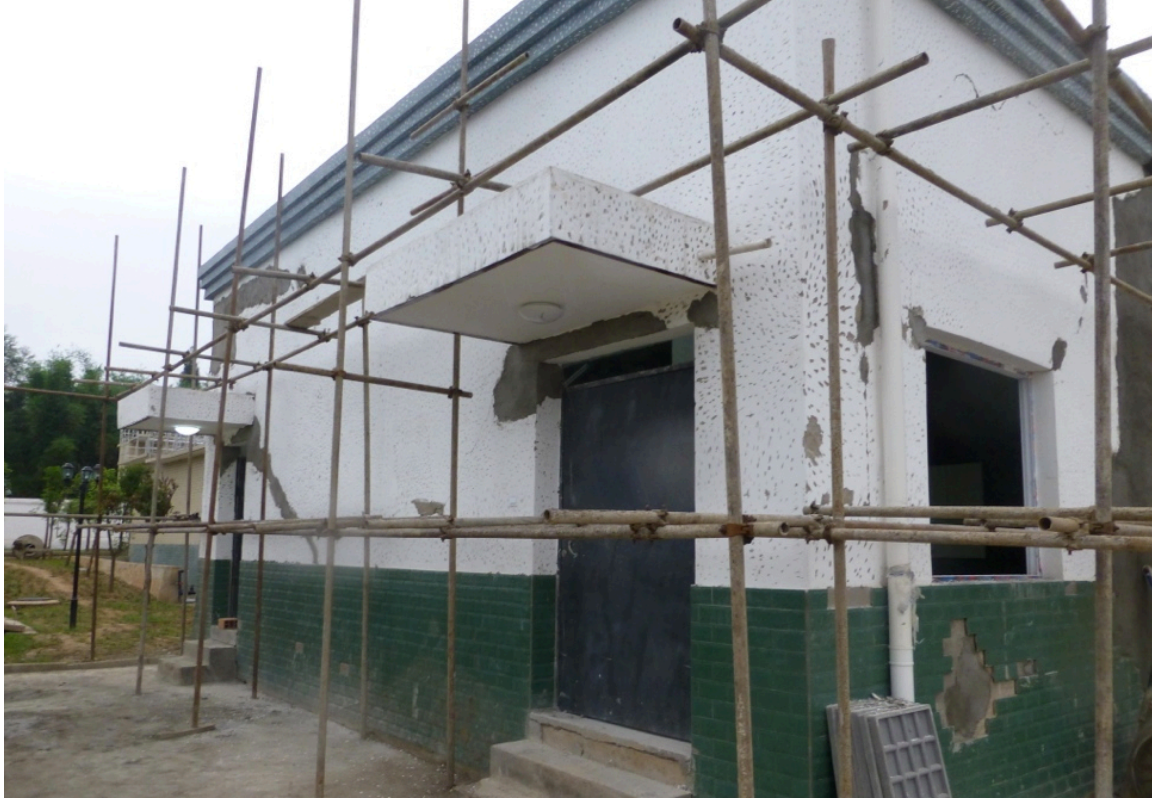
Figure 9. Damaged Control Building

Several other facilities at the water treatment plant were damaged. The control building is unreinforced, and suffered large cracks (but did not collapse), Figure 9. There were several large diagonal cracks through the exterior walls; these were repaired post-earthquake by inserting grout.

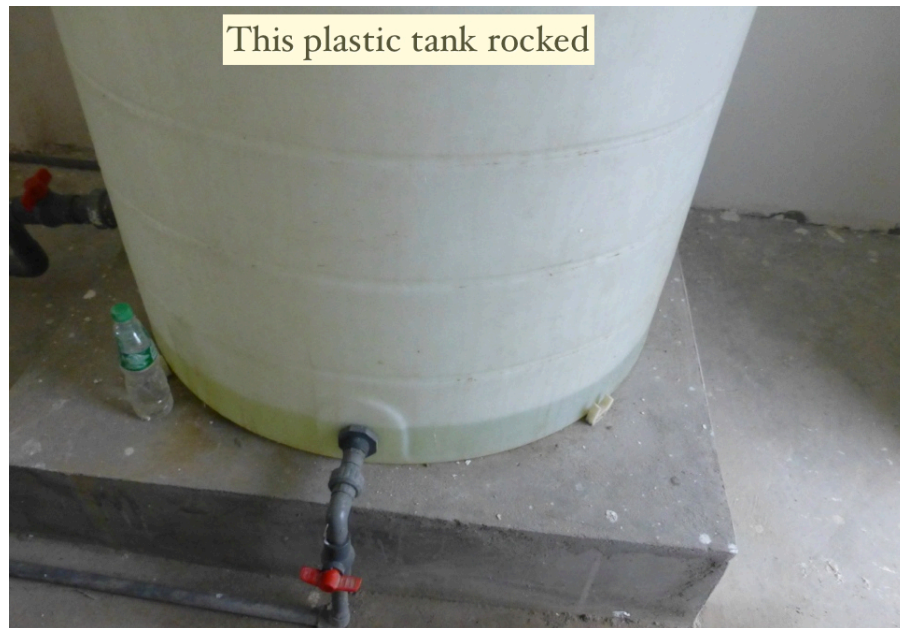
Figure 10. Plastic Tank for Chlorine Dioxide Disinfectant

The chemical tanks rocked, Figure 10, damaging the attached PVC pipes, Figure 11. The small plastic "seismic stops" (4 of them) did restrain the tank from sliding, but not rocking. The rocking led to damage of the attached restrained PVC pipe.

- The minimal attempt to "anchor" chemical tanks at the water treatment plant failed, entirely. Seismic anchors / restraints for such equipment need to be robust,

taking the full seismic loads, and ensuring that rocking of tanks / equipment does not impose differential movements on attached pipes and pumps.

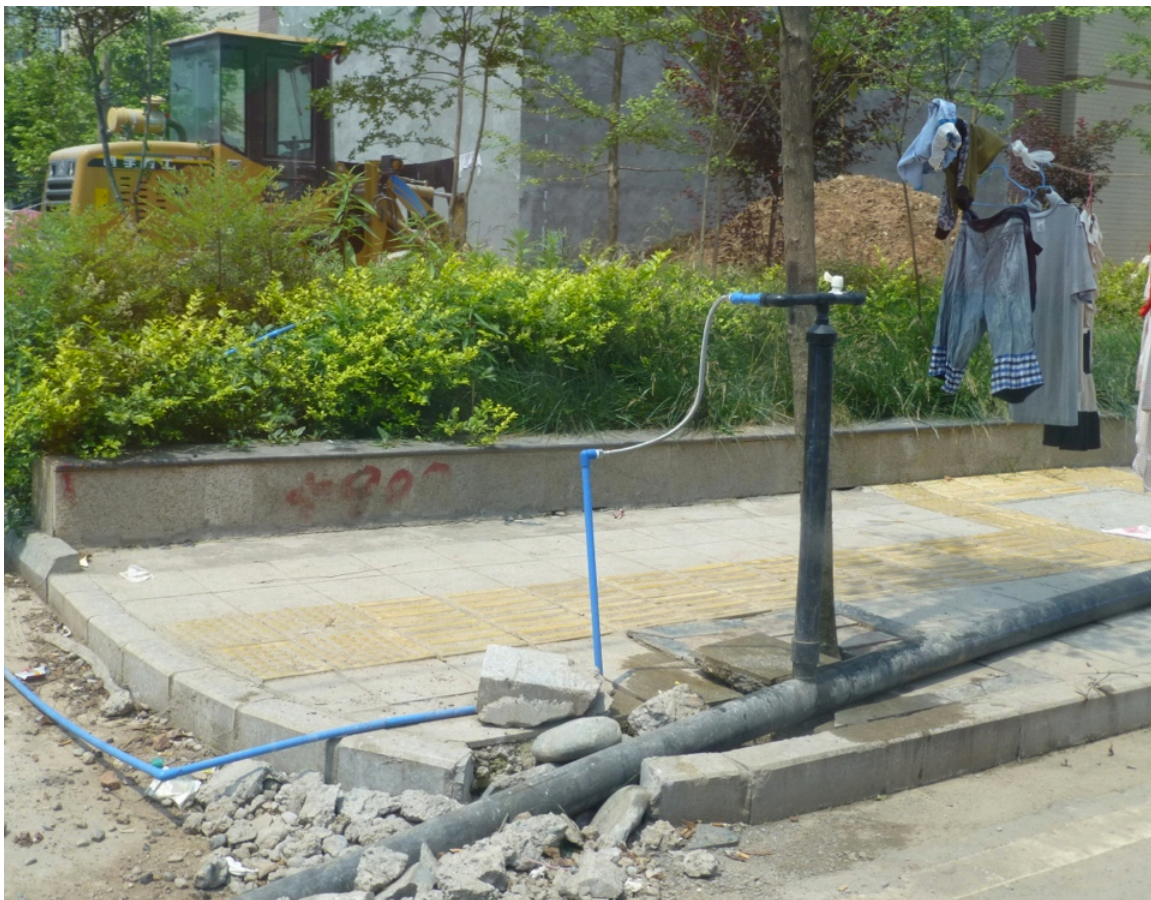
Figure 13. Above Ground Temporary Water Pipe

The People's Liberation Army (PLA) installed the above-ground water pipe network for most of the city immediately post-earthquake. Figure 13 shows a typical above ground pipe with hose bib; these were located on nearly every city street that the author visited during three days in Lushan. Note the damage to the sidewalk curb; this was repeated in many locations, in an attempt to bury the above ground pipes in shallow trenches through streets, to allow for vehicle traffic. It took the PLA one week to place the temporary water lines for the majority of the city and an additional week to complete the temporary network; the outskirts of the city have fewer people but took longer to place the system.
