History of the Water Works of San Francisco, Its Performance in the 1906 Earthquake and Aftermath

John M. Eiding and N. Timothy Hall

December 19, 2023

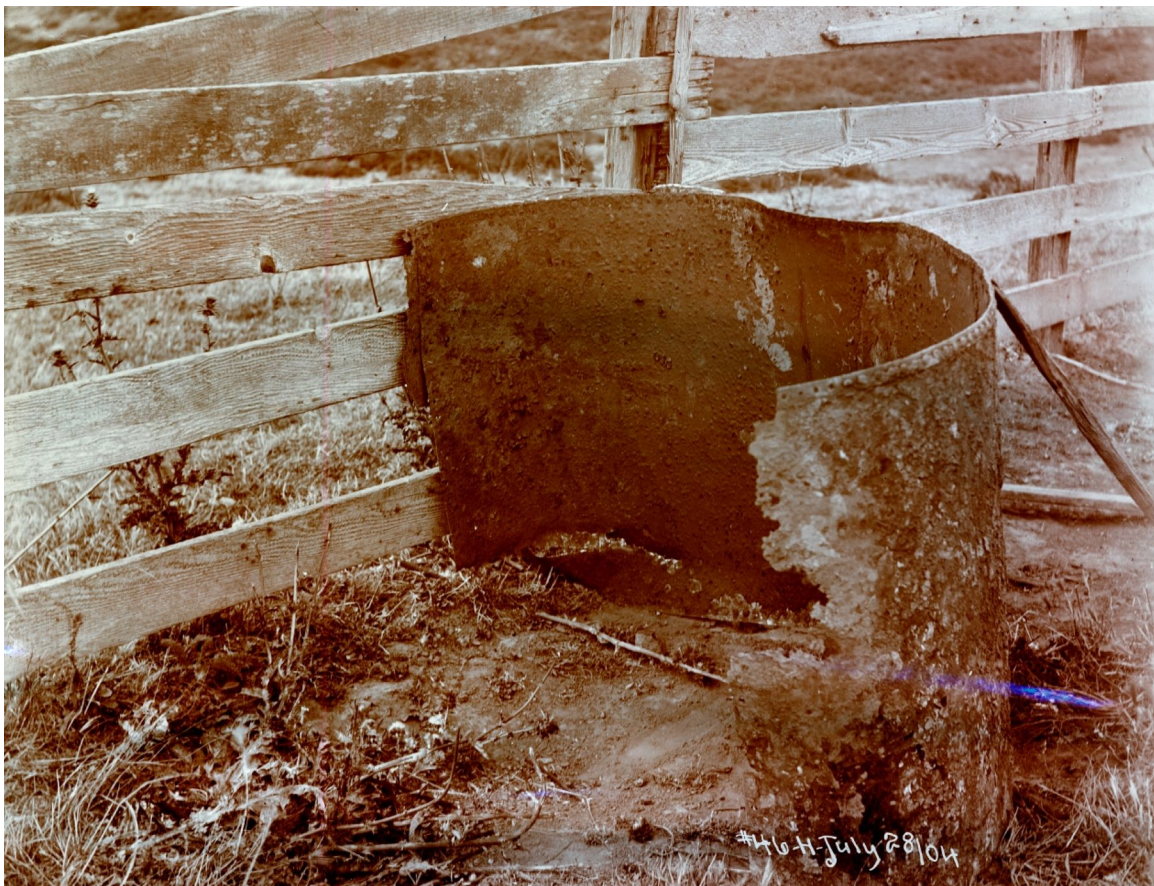
This pipe segment failure mode was due to an excess of internal pressure that overcame the corrosion-weakened pipe. The water pressure at this location was about 40 to 50 psi, suggesting that the pipe wall thickness at the time of failure had thinned to be on the order of 0.025 inches or so. This is much thinner than the original installed wall thickness of 0.104 inches. At the time of failure, the pipe has been in the ground for about 39 years. This suggests a wall-thinning process of about $(0.104 - 0.025 \text{ inches}) / 39 \text{ years} = 0.002$ inches per year. A not uncommon approximation of wall thinning in corrosive soils is on the order of 1 mil per year (0.001 inches per year).

Figure 4-3. Failure of Pilarcitos 30" Low Pressure Pipe (WI-thin), July 28 1904 (Photo: SVWC 1904)

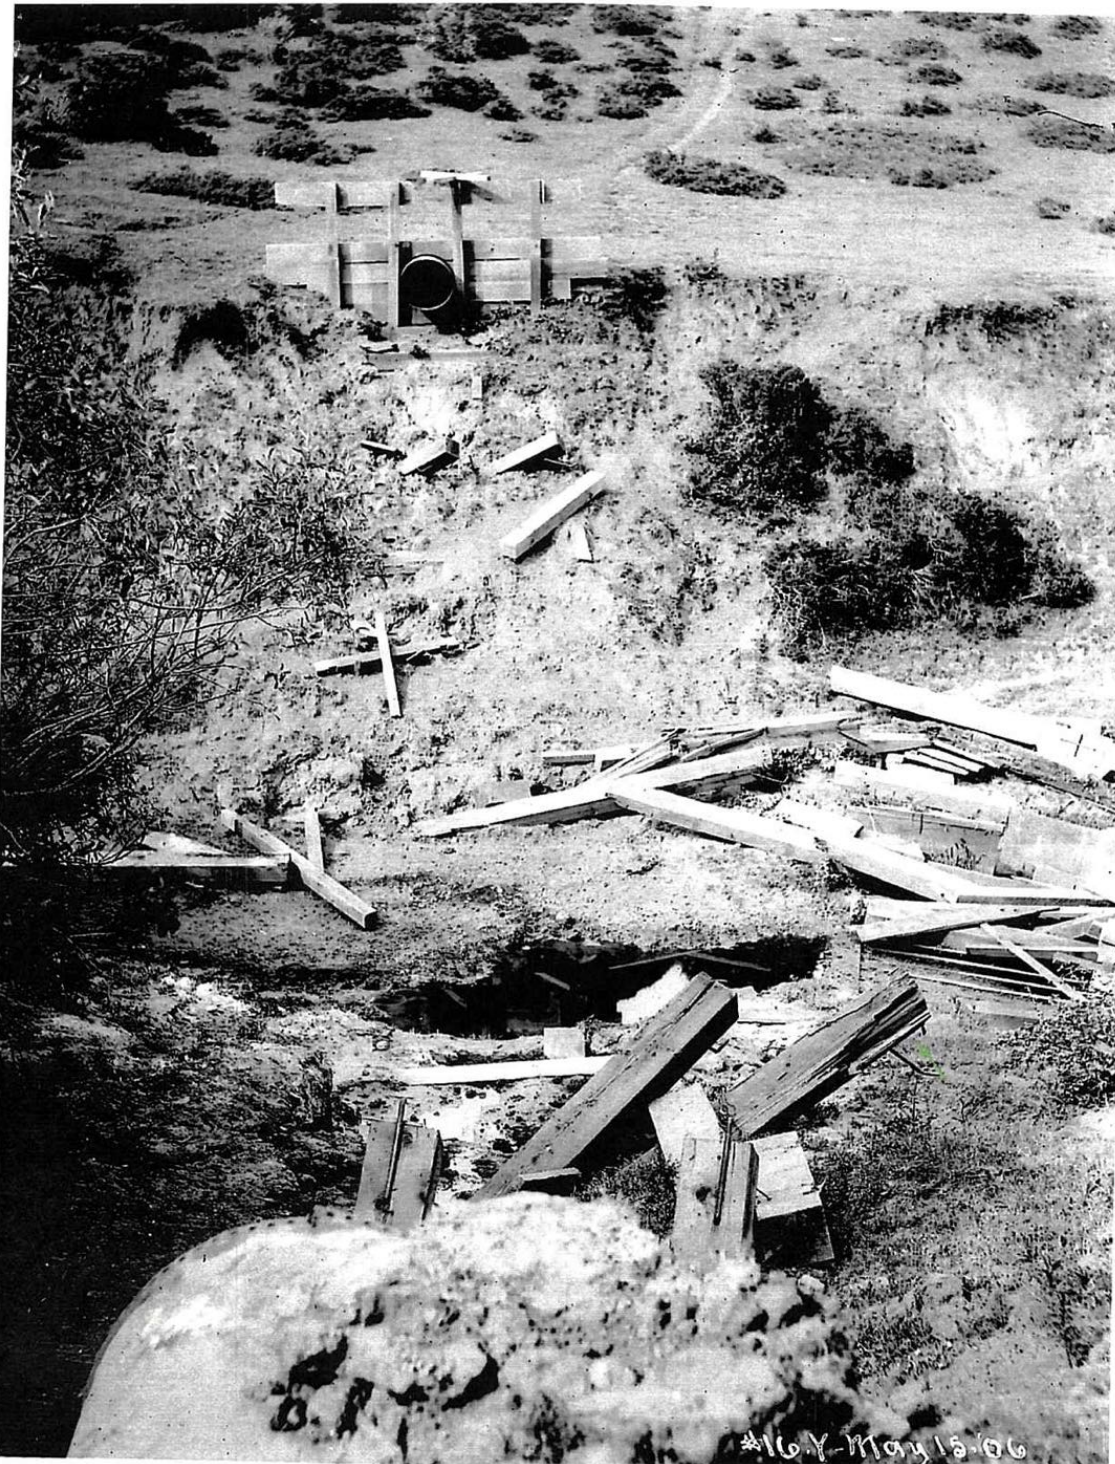
Figure 4.1.1-1 shows the pipe alignment from the south edge of the canyon, looking northwards. The wooden trestle collapsed in its entirety.

Figure 4.1.1-1. Large Frawley Canyon. Destruction of heavy bridge and 30-inch Pilarcitos pipe over Large Frawley Canyon. The pipe was torn in three locations and thrown sideways over 50 feet to the east into the canyon below. View looking northerly. (Photo: Schussler 1906, HS8)

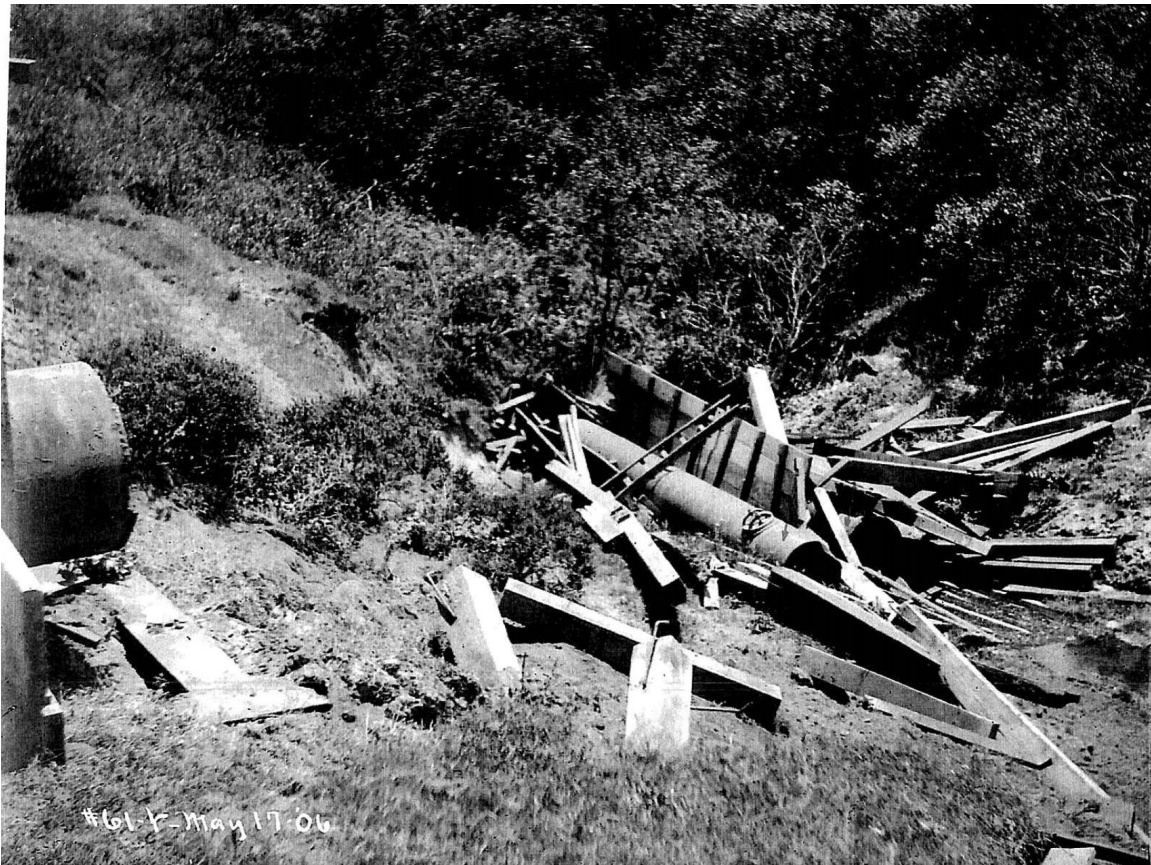
The left side of Figure 4.1.1-2 shows a complete failure through the girth riveted joint where the pipe enters the ground at the northern abutment.

Figure 4.1.1-2. Large Frawley Canyon. View downstream, looking easterly. Pipe on left side is original Pilarcitos pipe at the north edge of the canyon. (Photo: Schussler 1906, HS9)

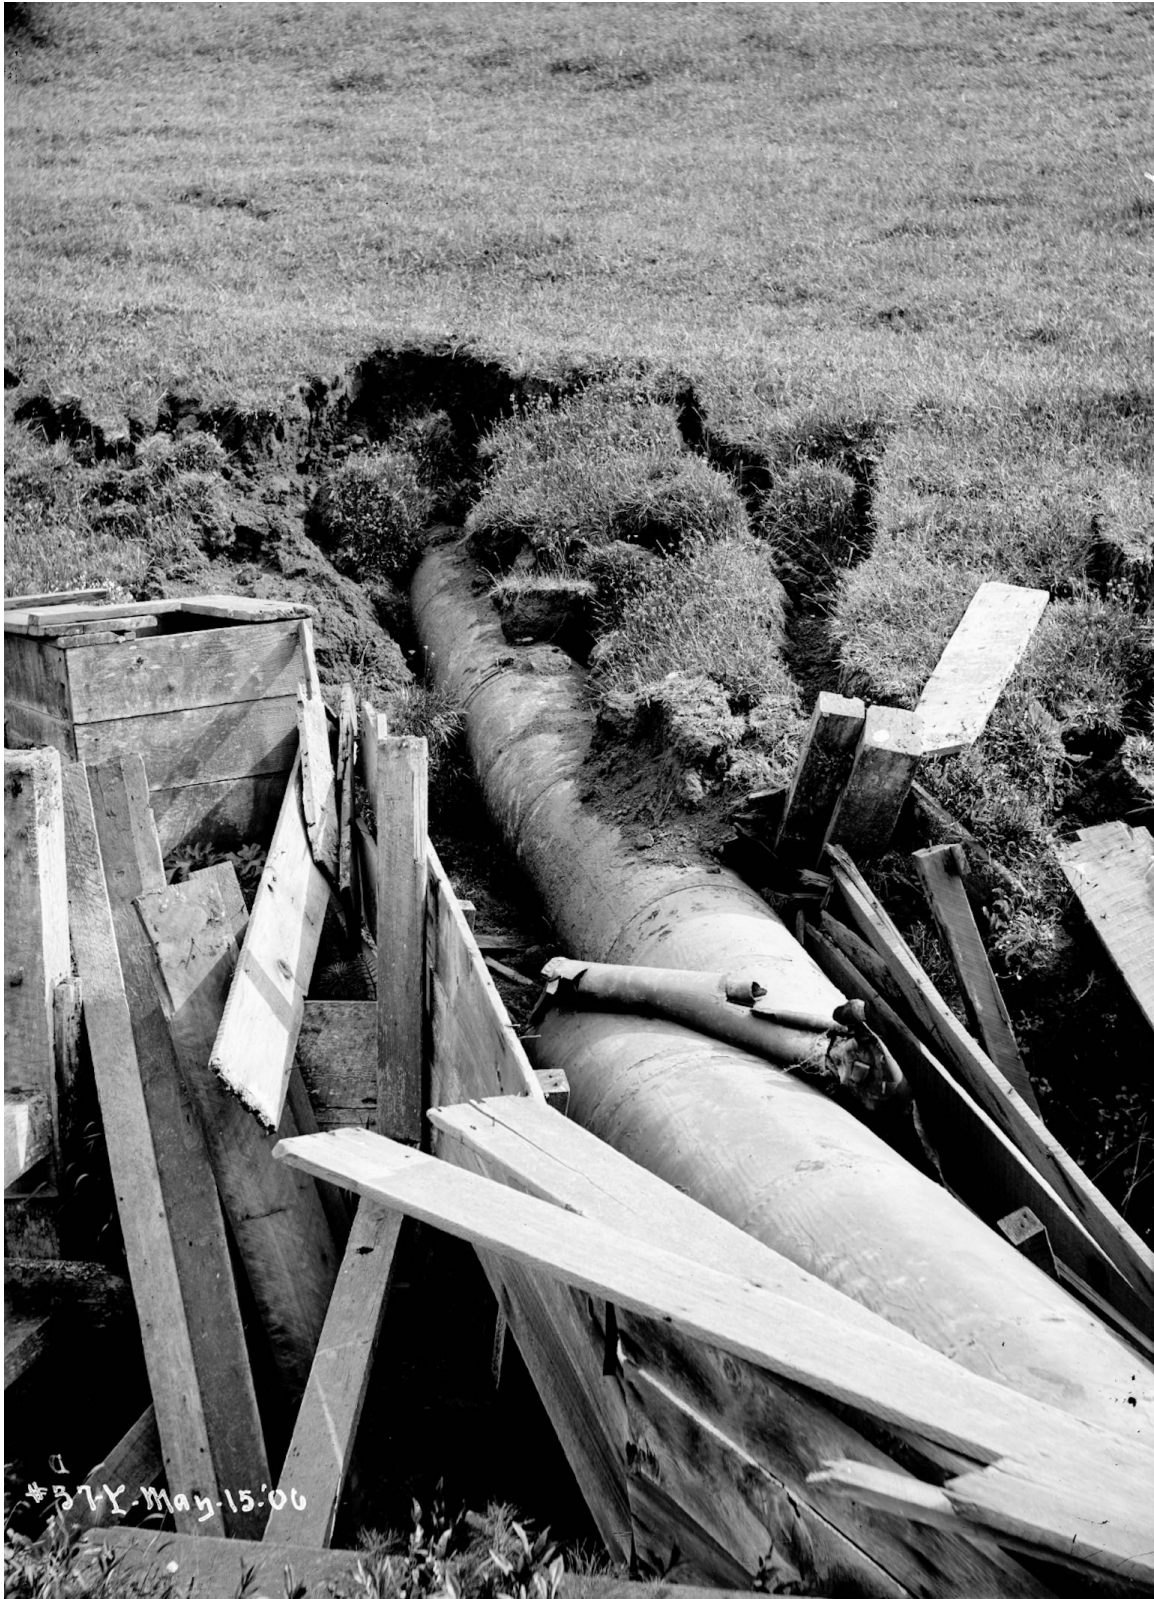
The light-colored lineament at the top of Figure 4.1.2-1 (about 25-30 feet from the exposed pipe) suggests some type of right lateral secondary shearing fault movement.

Figure 4.1.2-1. Small Frawley Canyon. Failure of Pilarcitos 30 inch pipe. Pipe is telescoped and thrown sideways on bridge over Small Frawley Canyon. View looking south. (Photo: Schussler 1906, HS5)

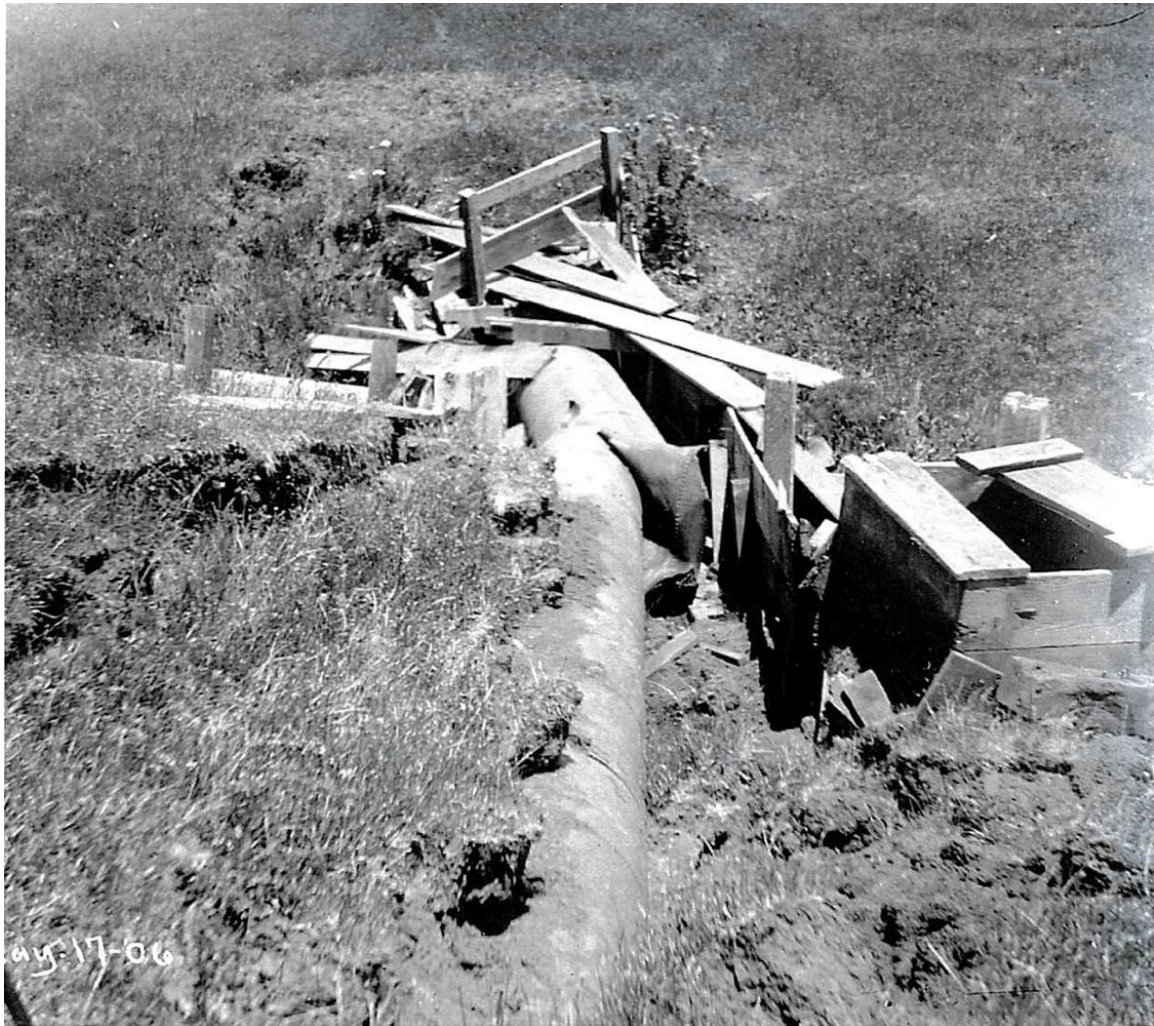
Figure 4.1.2-3. Failure of Pilarcitos 30 inch pipe. Pipe telescoped and was thrown sideways off the wooden bridge crossing Small Frawley Canyon. View looking north. (Photo: Schussler 1906)

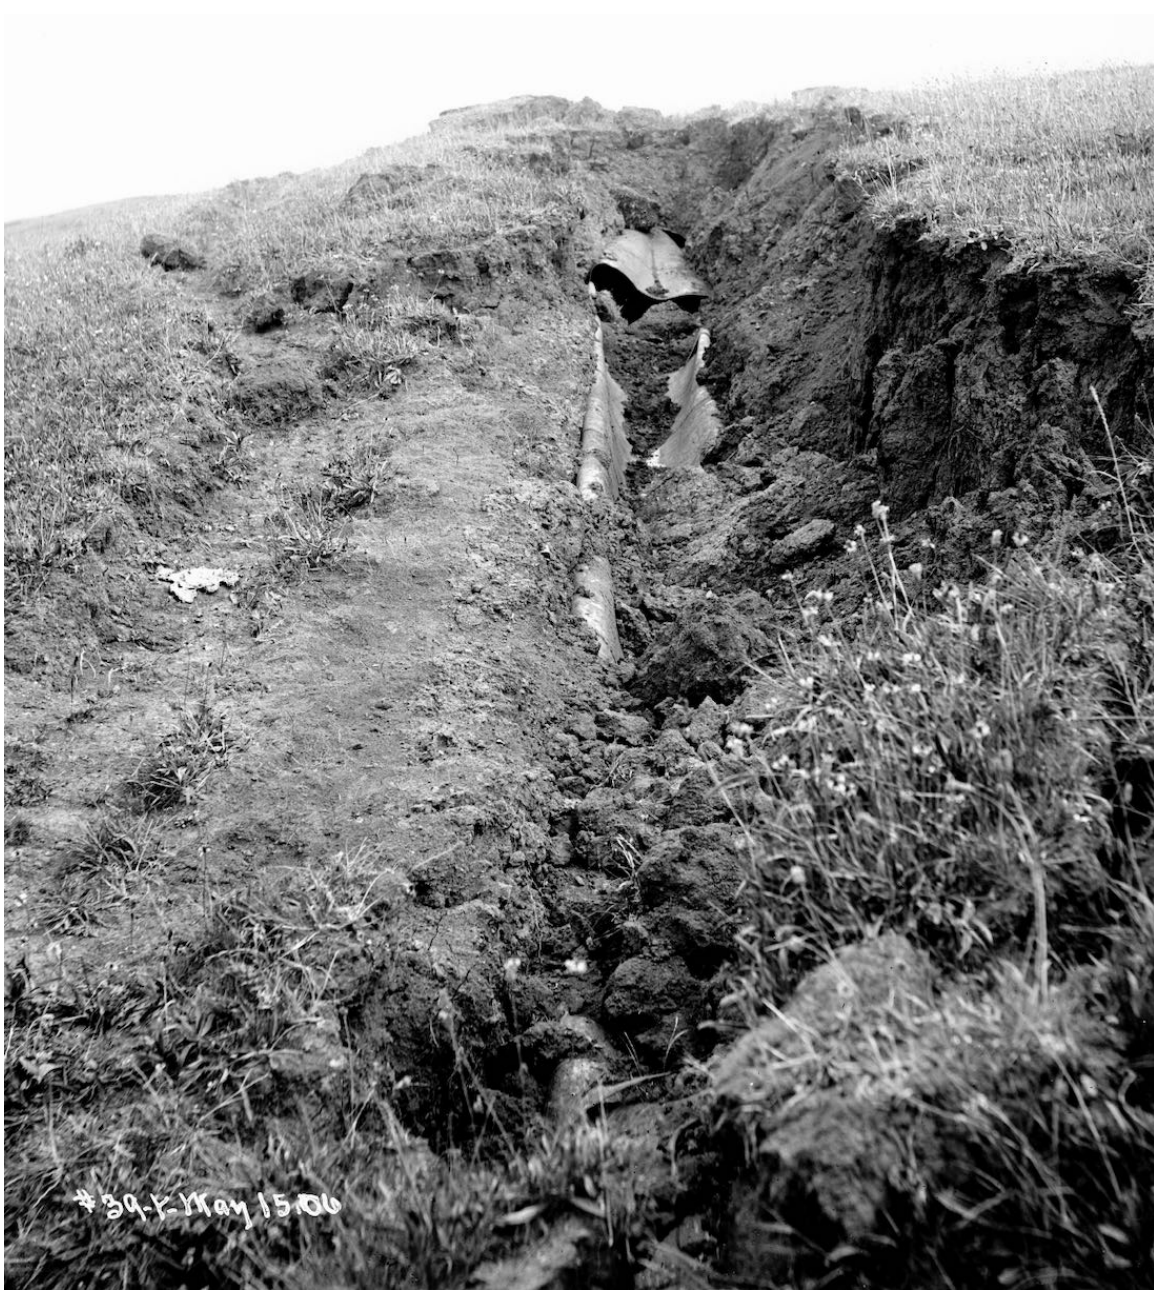
Figure 4.1.3-1. Failure of Pilarcitos 30 inch pipeline about 220 yards south of FX-1. Pipe is collapsed on itself. Looking southerly. (Photo: Schussler 1906, HS-4)

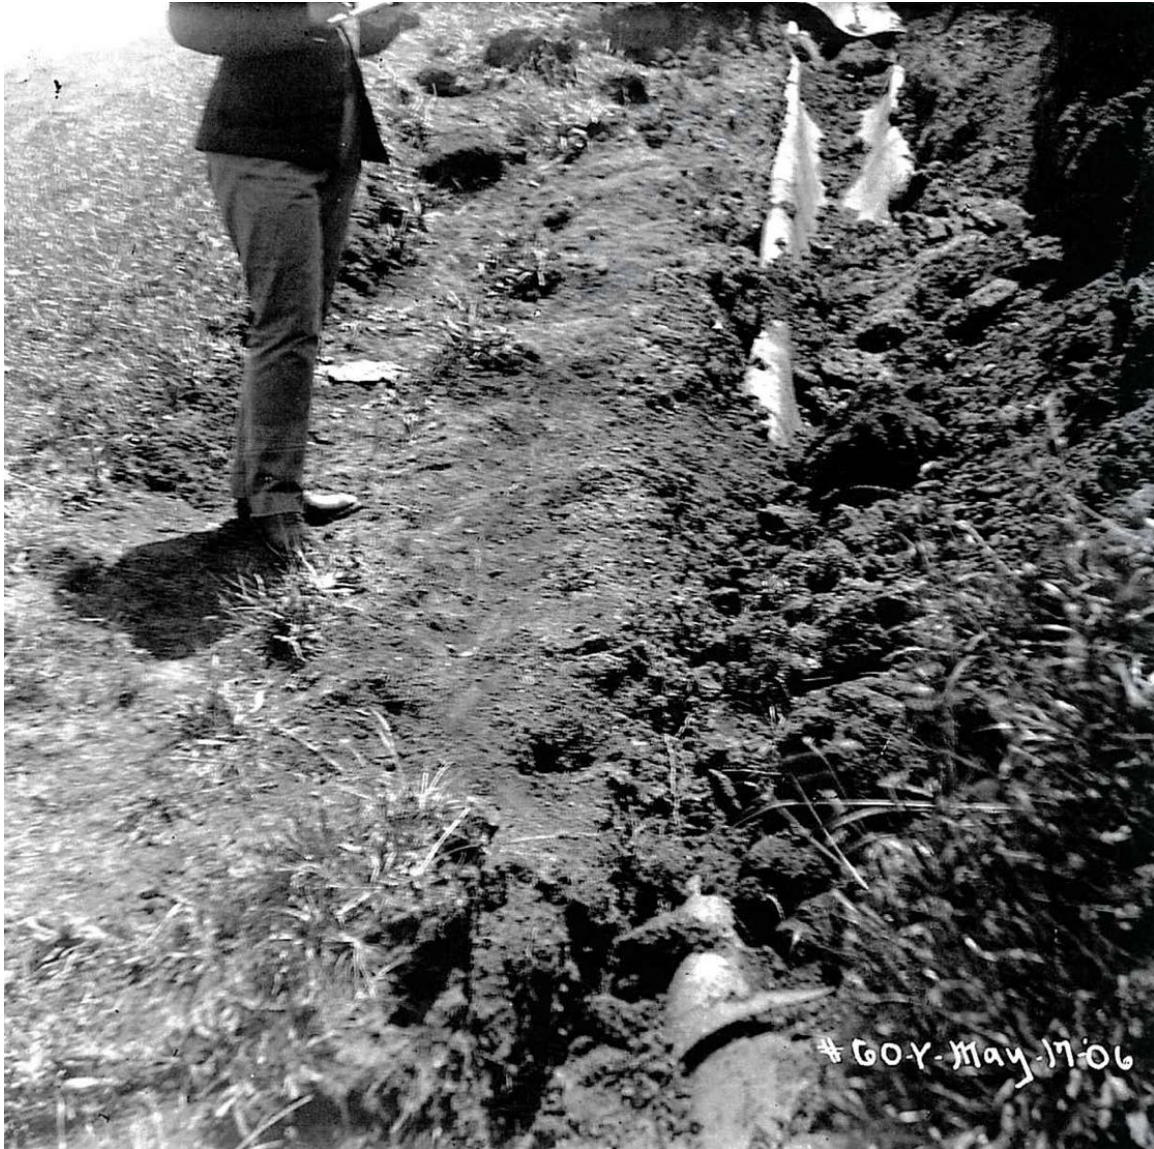
Figure 4.1.3-2. Failure of Pilarcitos 30 inch pipeline about 220 yards south of FX-1. Pipe is collapsed on itself. Looking southerly. (Photo: Schussler 1906)

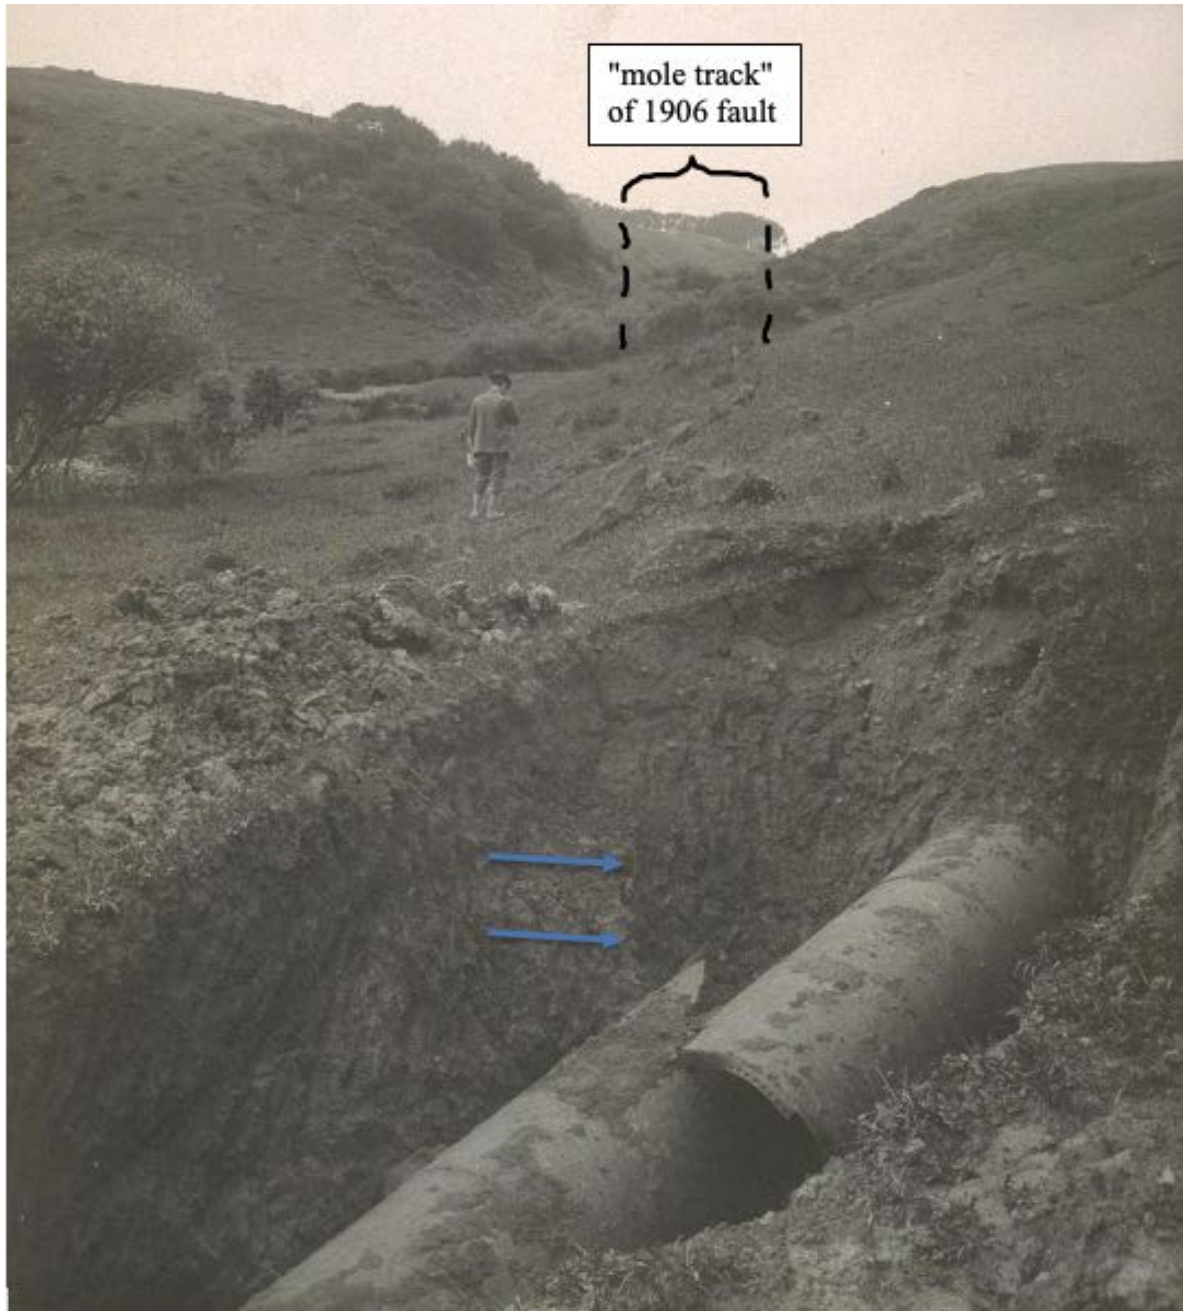
Figure 4.1.6-5. Crossing FX-3. Looking northwesterly along trace of 1906 fault rupture. Failure of Pilarcitos 30 inch pipeline. (Photo: ASCE 1907, p 16)

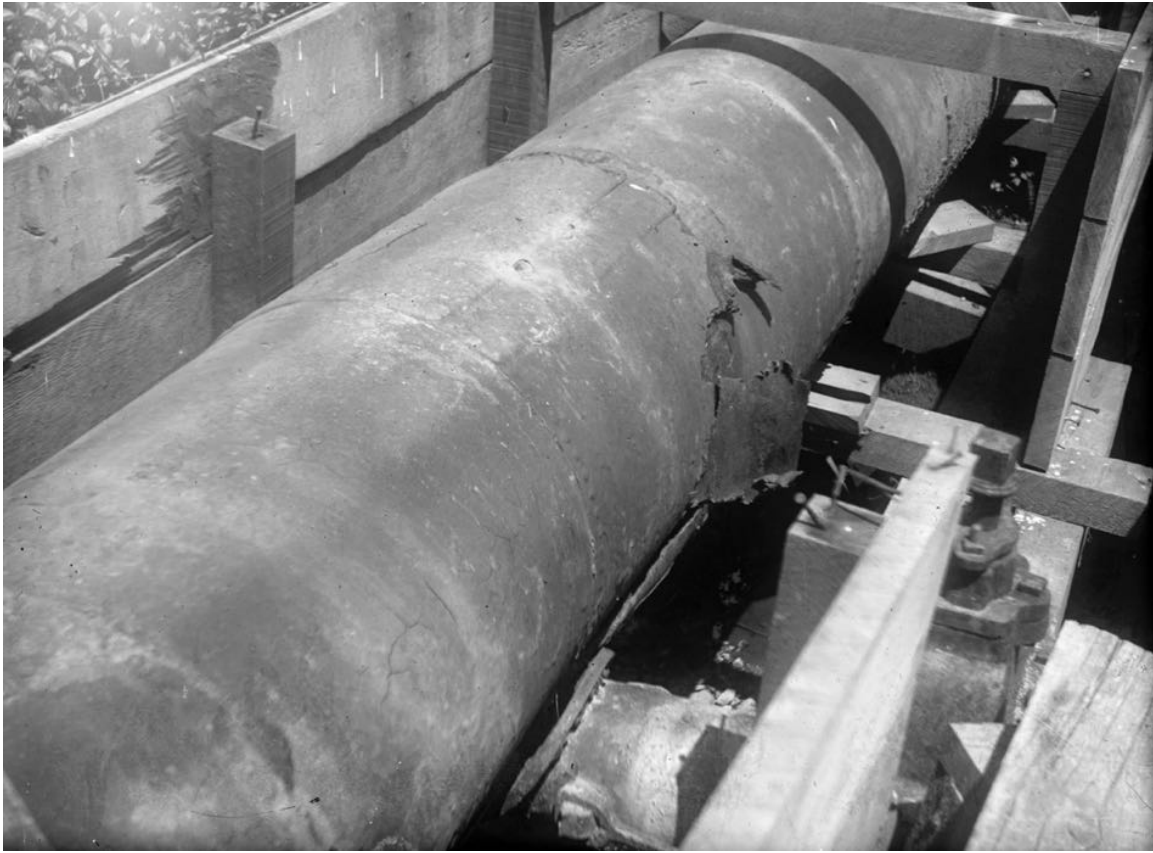
*Figure 4.1.7-3. South of FX-3. Pipe has telescoped on the bridge. Looking southerly.
(Photo: SVWC 1906)*

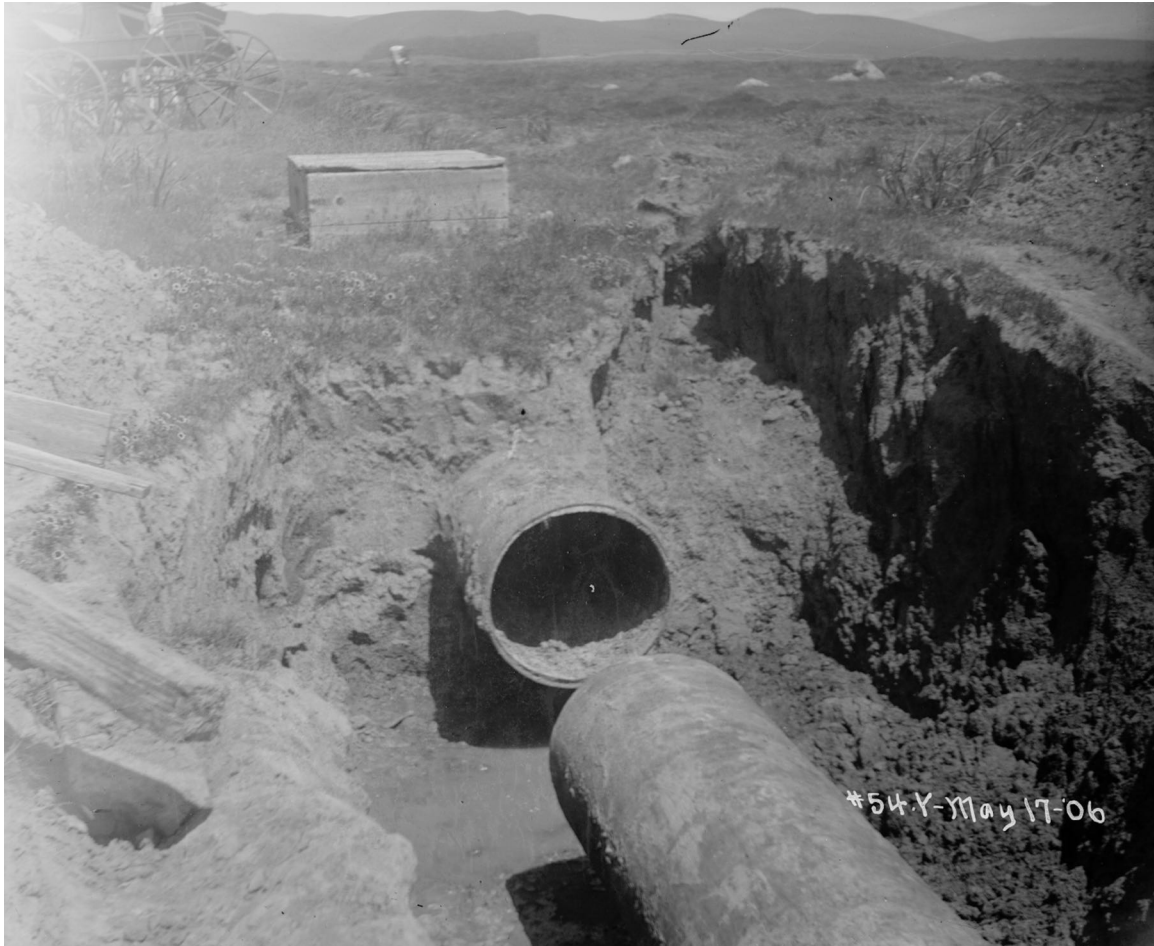
Figure 4.1.8-1. FX-4. Failure of Pilarcitos 30 inch pipeline. At north end of San Andreas Reservoir. Looking Northwesterly. Pull Apart ~59". North segment of pipe is ~4" to the right (transverse) of the south segment. (Photo: Schussler HS7 1906)

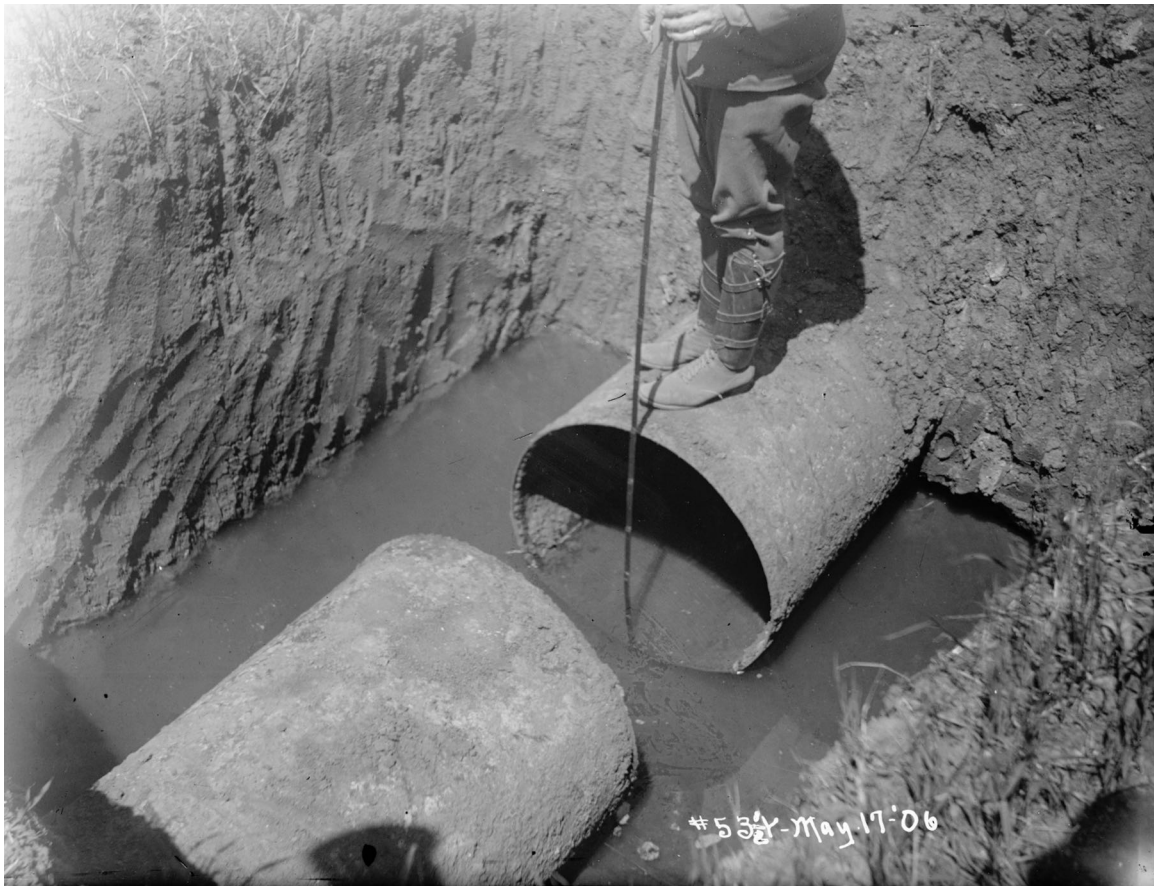
Figure 4.1.8-5. Site 8. Failure of Pilarcitos 30 inch pipeline. Pull Apart ~ 21.5 inches. (Photo Credit Schussler HS3 1906)

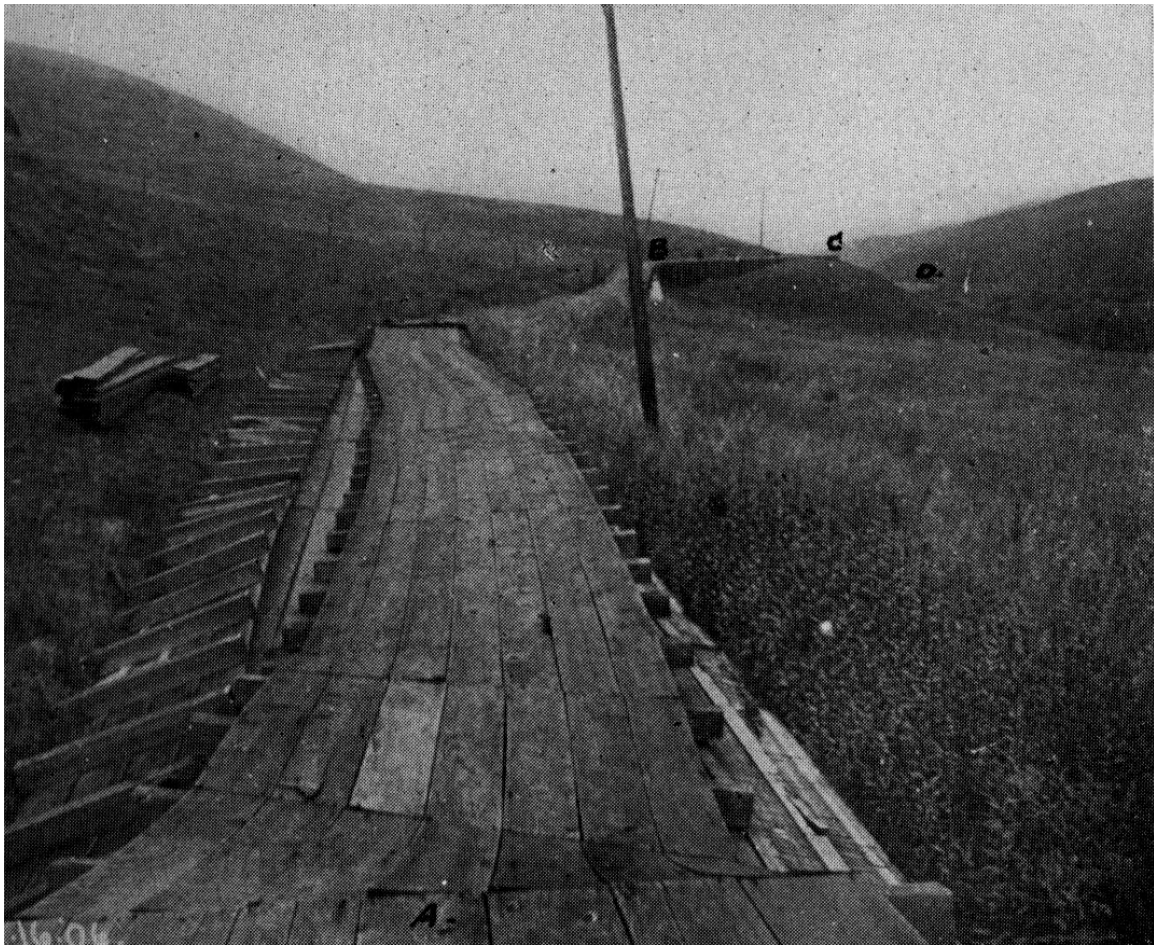
Figure 4.1.12-10. Failure of Stone Dam Flume, Looking Southerly (Photo: Schussler 1906 HS49)

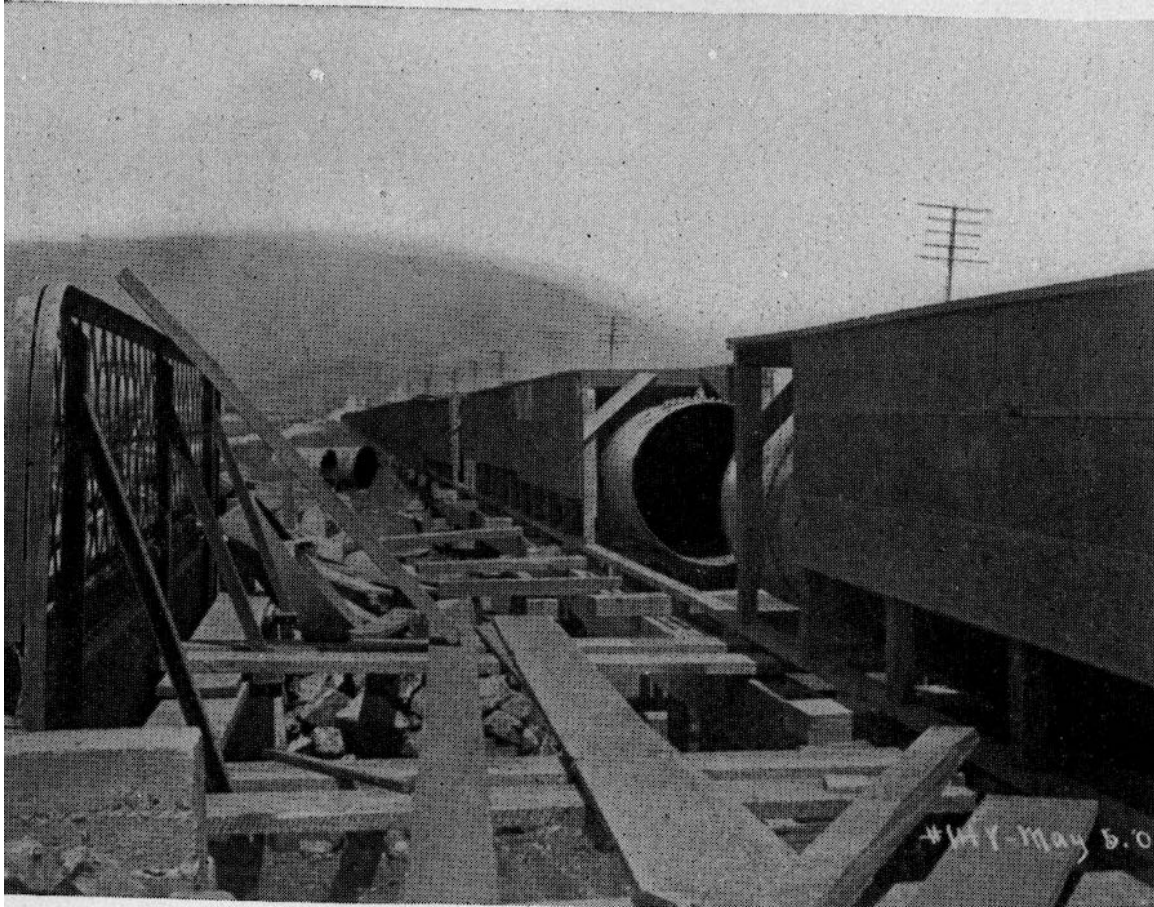
Figure 4.3-10. Crystal Springs 44" at San Bruno Marsh (Colma Creek), showing repair process. View looking northeasterly. (Photo: Schussler HS20)

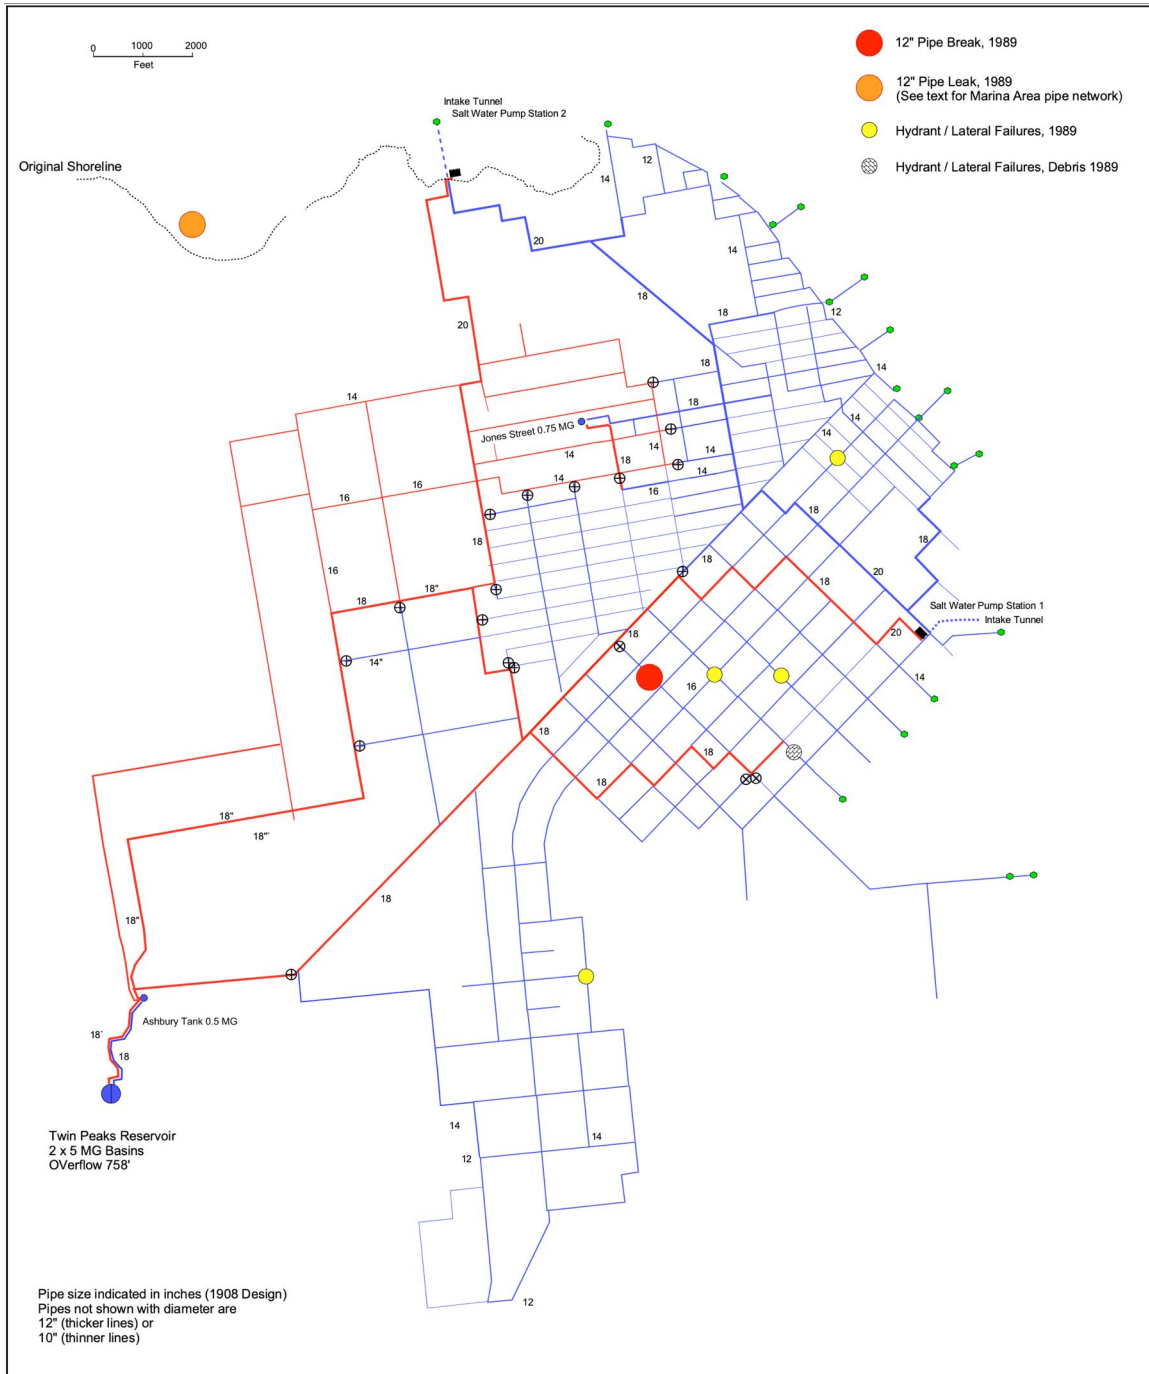
Figure 8-7. Damage to AWSS Pipe Network, 1989 Loma Prieta Earthquake
