History of the Water Works of San Francisco: Its Performance in the 1906 Earthquake and Aftermath

John M. Eidinger and N. Timothy Hall

Revision 2

August 2024

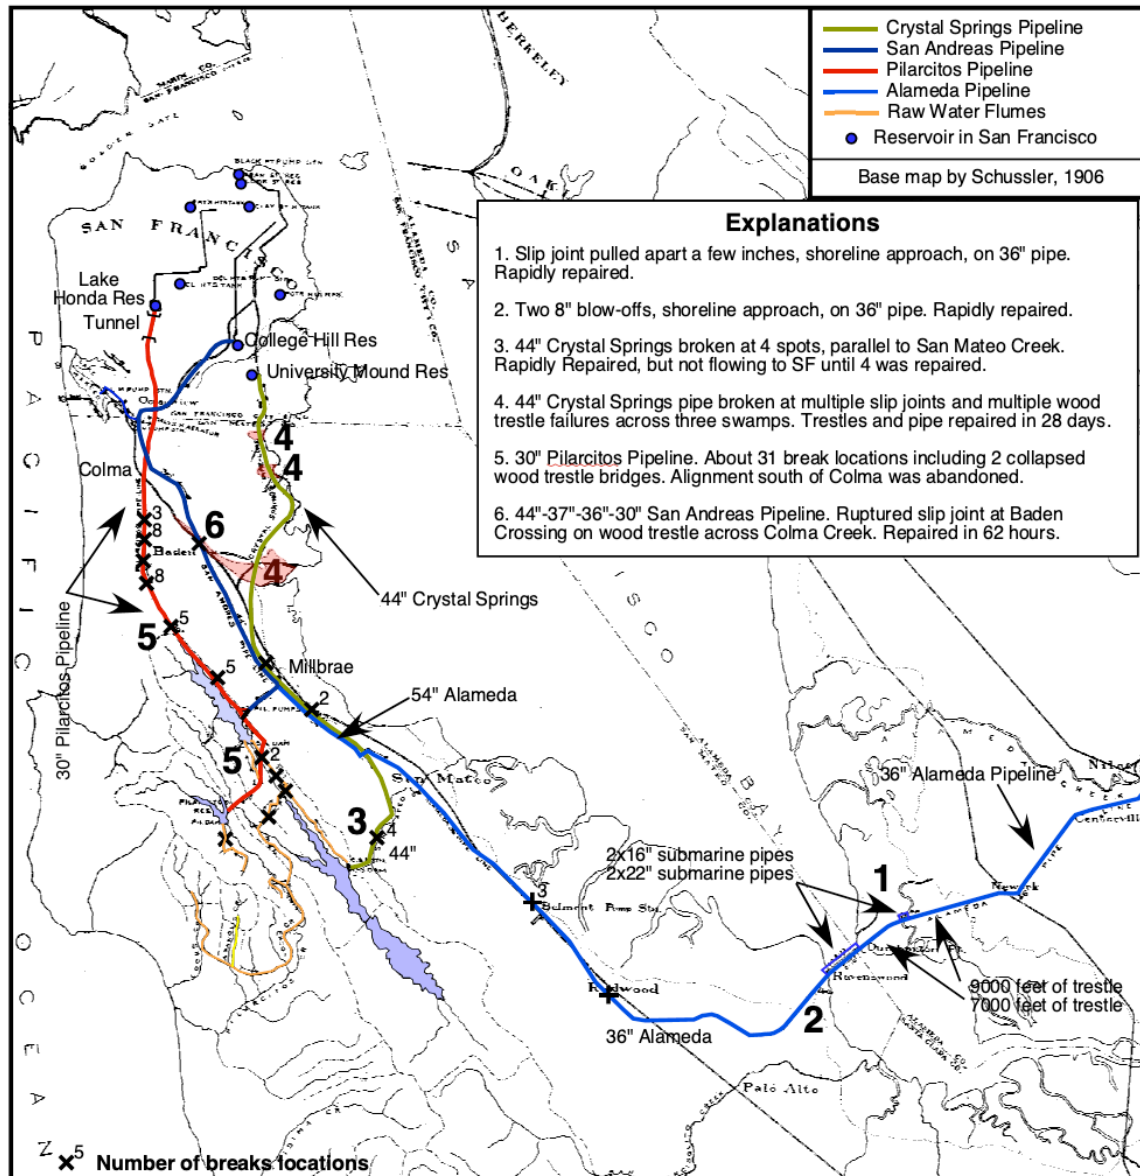
Figure 4-1. Damage to the Transmission Pipelines Serving San Francisco, 1906

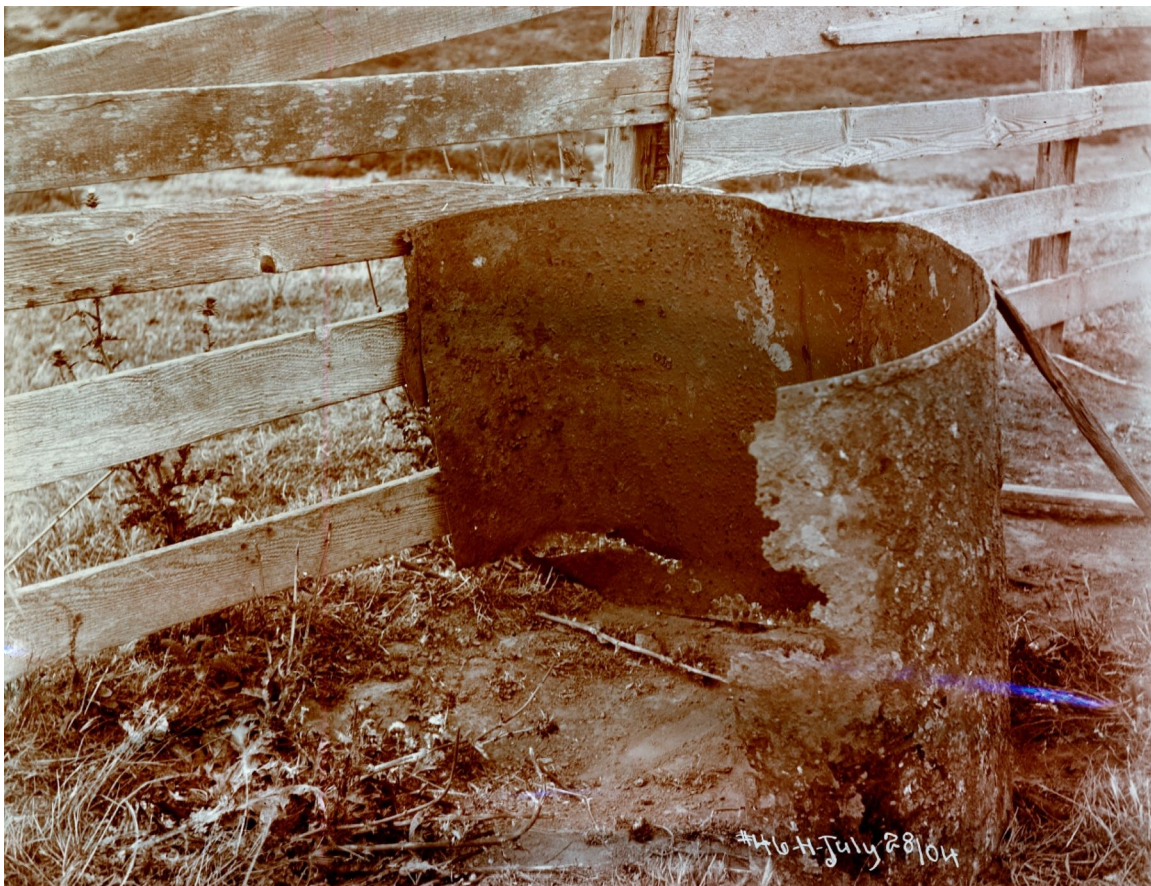
This pipe segment failure mode was due to an excess of internal pressure that overcame the corrosion-weakened pipe. The water pressure at this location was about 40 to 50 psi, suggesting that the pipe wall thickness at the time of failure had thinned so as to be on the order of 0.025 inches or so. This is much thinner than the original installed wall thickness of 0.104 inches. At the time of failure, the pipe has been in the ground for about 39 years. This suggests a wall-thinning process of about $(0.104 - 0.025 \text{ inches}) / 39 \text{ years} = 0.002$ inches per year. A not uncommon approximation of wall thinning in corrosive soils is on the order of 1 mil per year (0.001 inches per year).

*Figure 4-3. Failure of Pilarcitos 30" Low Pressure Pipe (WI-thin),
July 28, 1904 (Photo: SVWC 1904)*

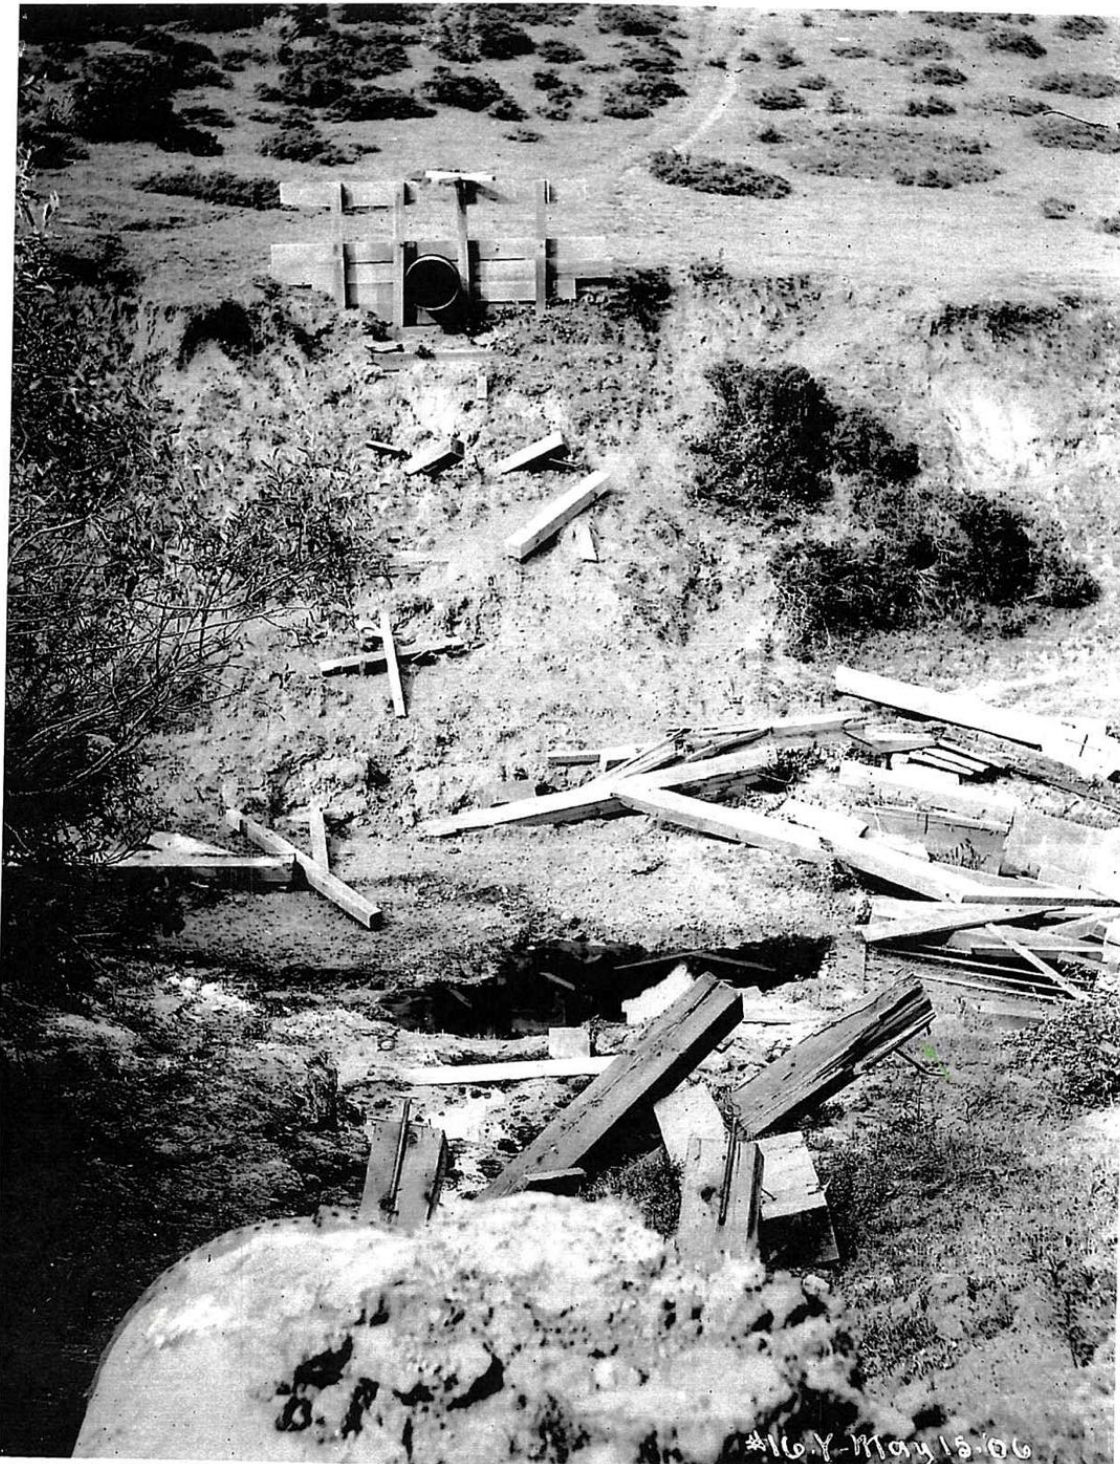
Figure 4.1.1-1 shows the pipe alignment from the south edge of the canyon, looking northwards. The wooden trestle collapsed in its entirety.

Figure 4.1.1-1. Large Frawley Canyon. Destruction of heavy bridge and 30-inch Pilarcitos pipe over Large Frawley Canyon. The pipe was torn in three locations and thrown sideways over 50 feet to the east into the canyon below. View looking northerly. (Photo: Schussler 1906, HS8)

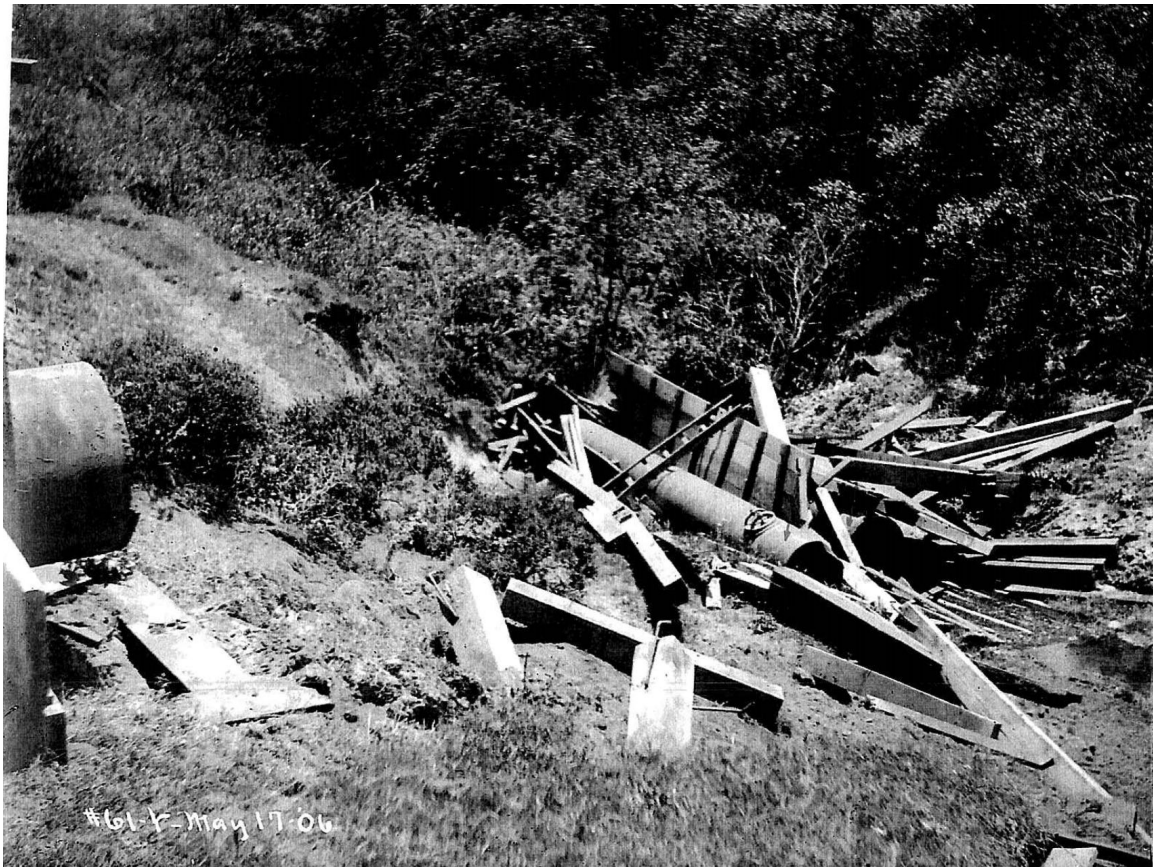
Figure 4.1.1-2. Large Frawley Canyon. View downstream, looking easterly. Pipe on left side is original Pilarcitos pipe at the north edge of the canyon. (Photo: Schussler 1906, HS9)

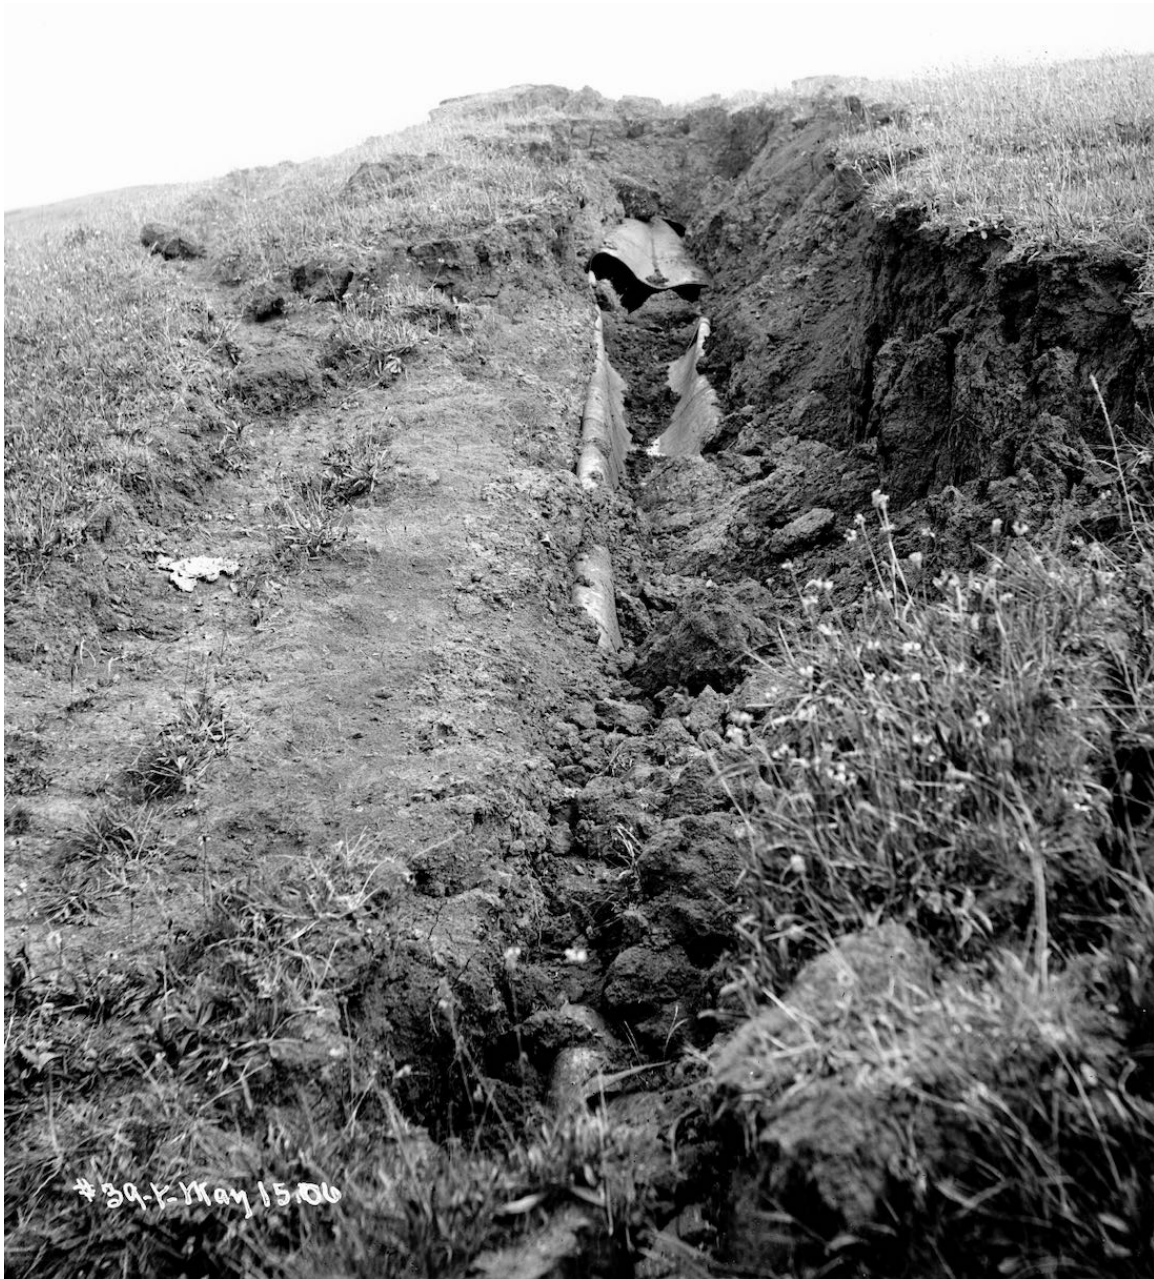
Figure 4.1.3-1. Failure of Pilarcitos 30 inch pipeline about 220 yards south of FX-1. Pipe is collapsed on itself. Looking southerly. (Photo: Schussler 1906, HS-4)

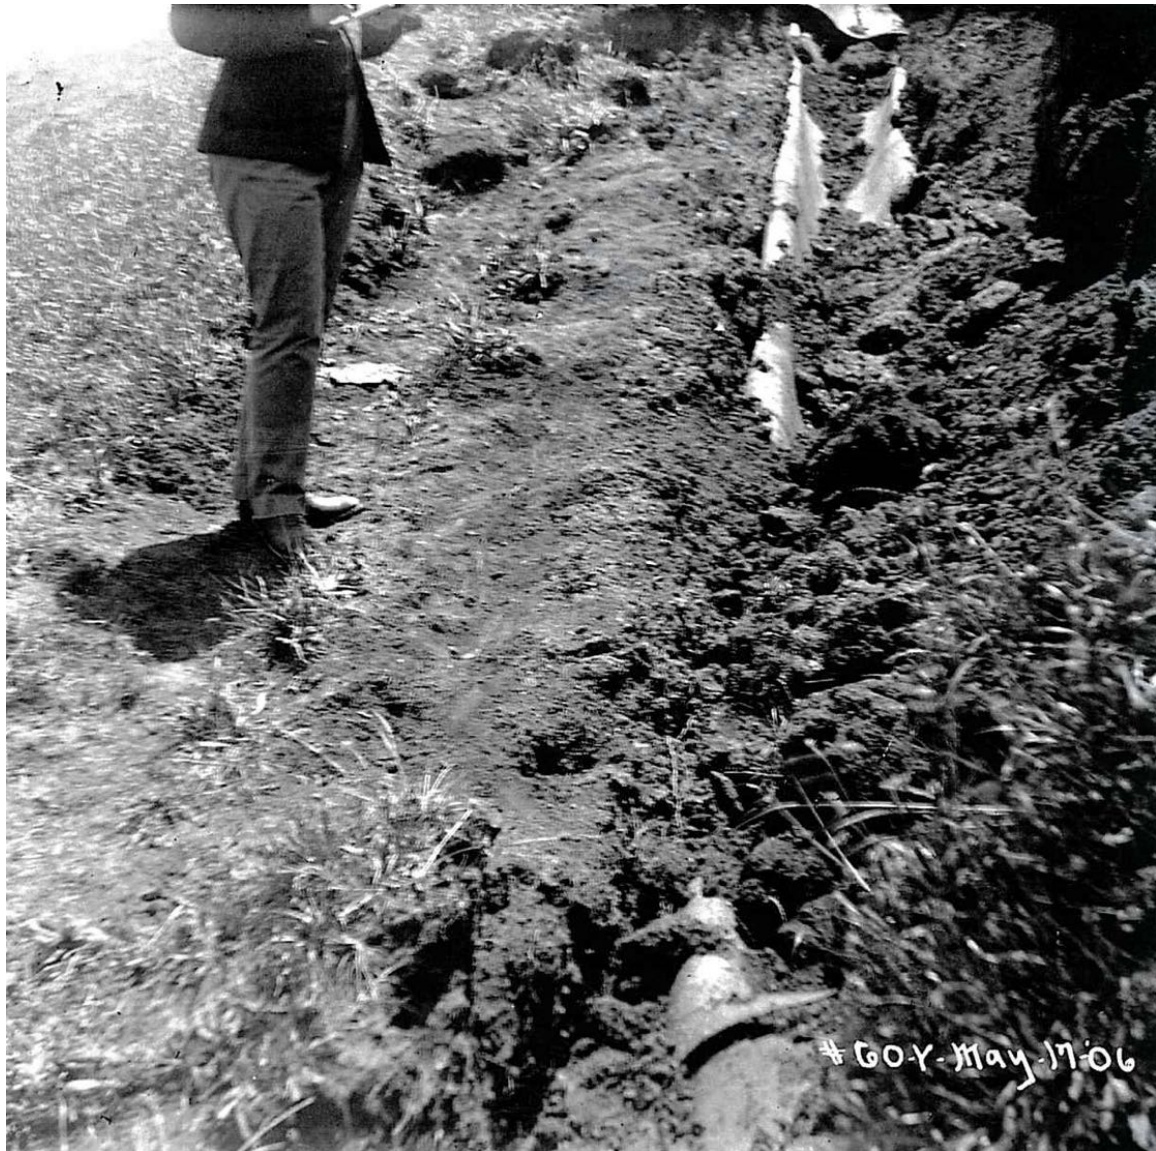
Figure 4.1.3-2. Failure of Pilarcitos 30 inch pipeline about 220 yards south of FX-1. Pipe is collapsed on itself. Looking southerly. (Photo: Schussler 1906)

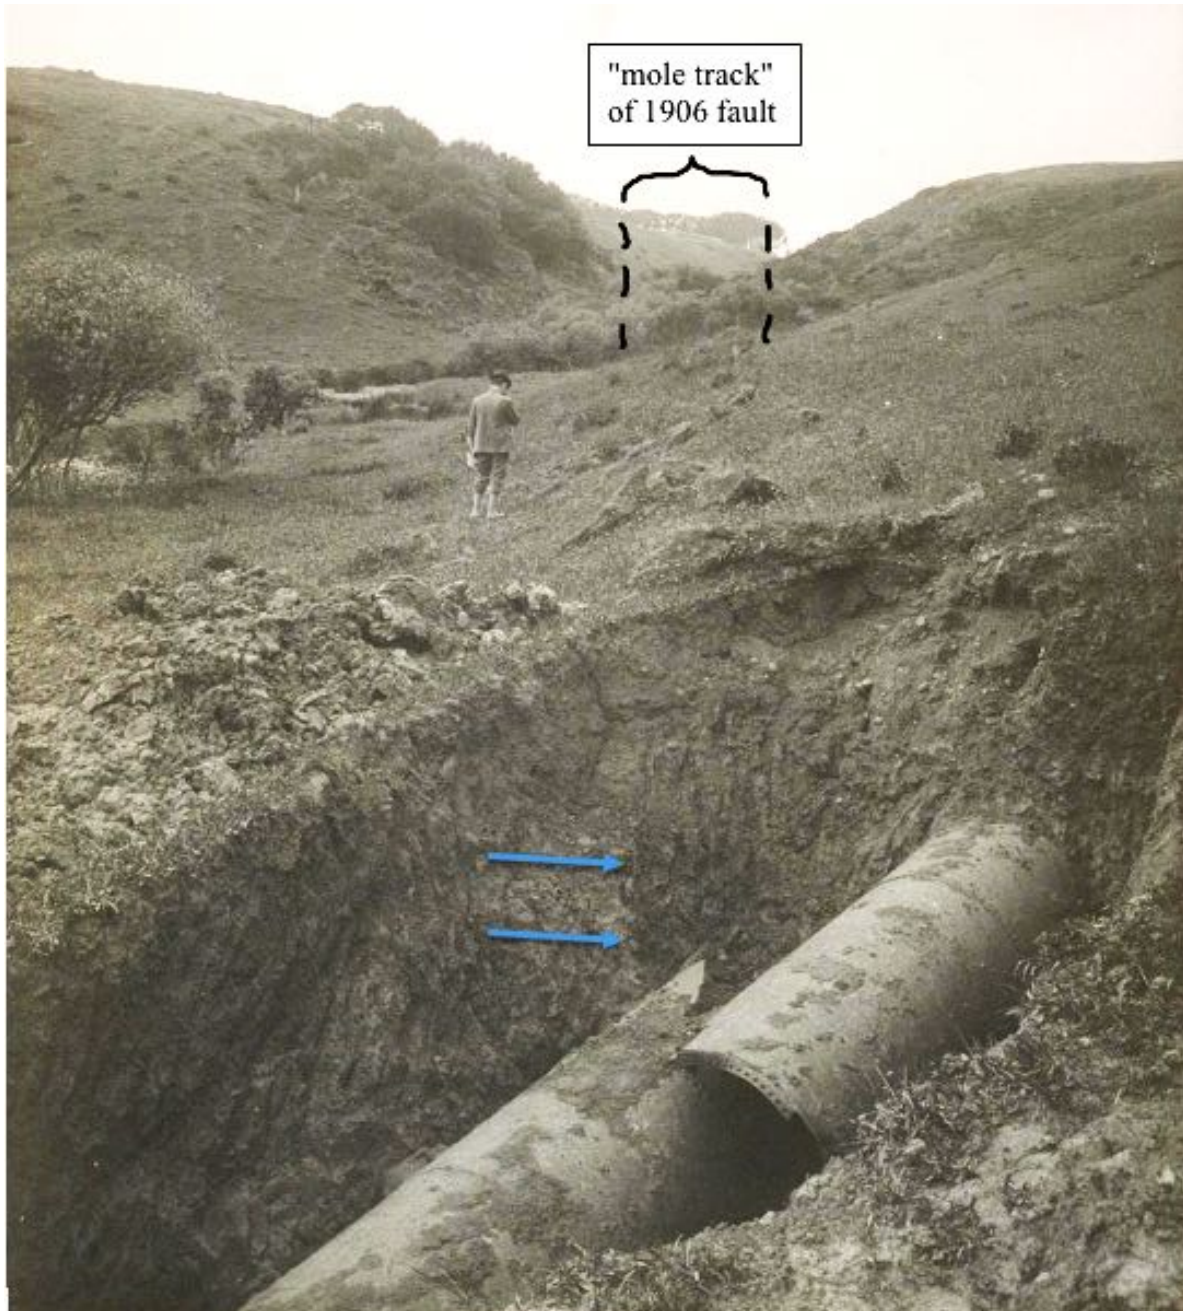
Figure 4.1.6-5. Crossing FX-3. Looking northwesterly along trace of 1906 fault rupture. Failure of Pilarcitos 30 inch pipeline. (Photo: ASCE 1907, p 16)

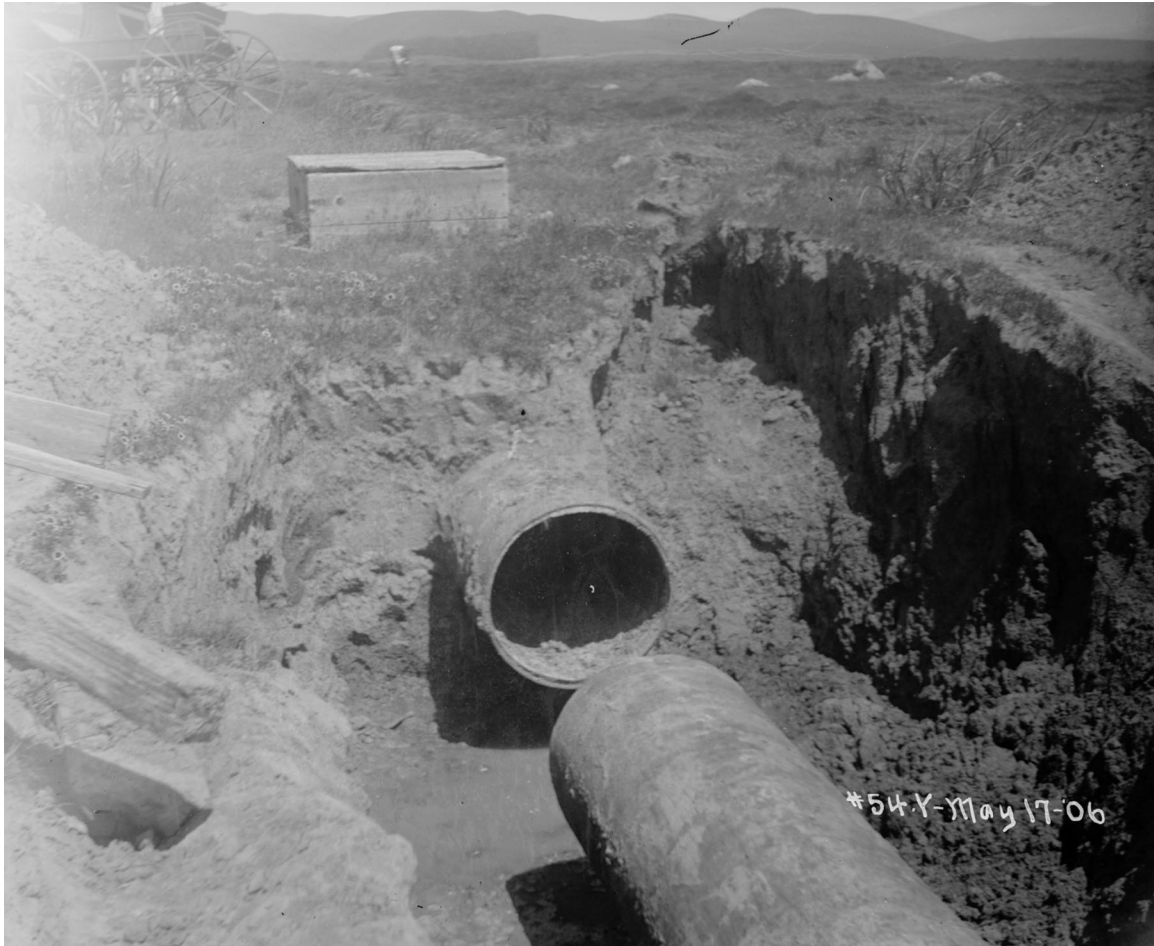
Figure 4.1.8-2. FX-4. Failure of Pilarcitos 30 inch pipeline. At north end of San Andreas Reservoir. Looking Northwesterly. Pull Apart ~59". North segment of pipe is ~4" to the right (transverse) of the south segment. The wood box seen in this photo encapsulates a valve, and is so-marked in Figure 4.1.8-3; it is the same wood box seen in Figures 4.1.9-4 and -5. (Photo: Schussler HS7 1906)

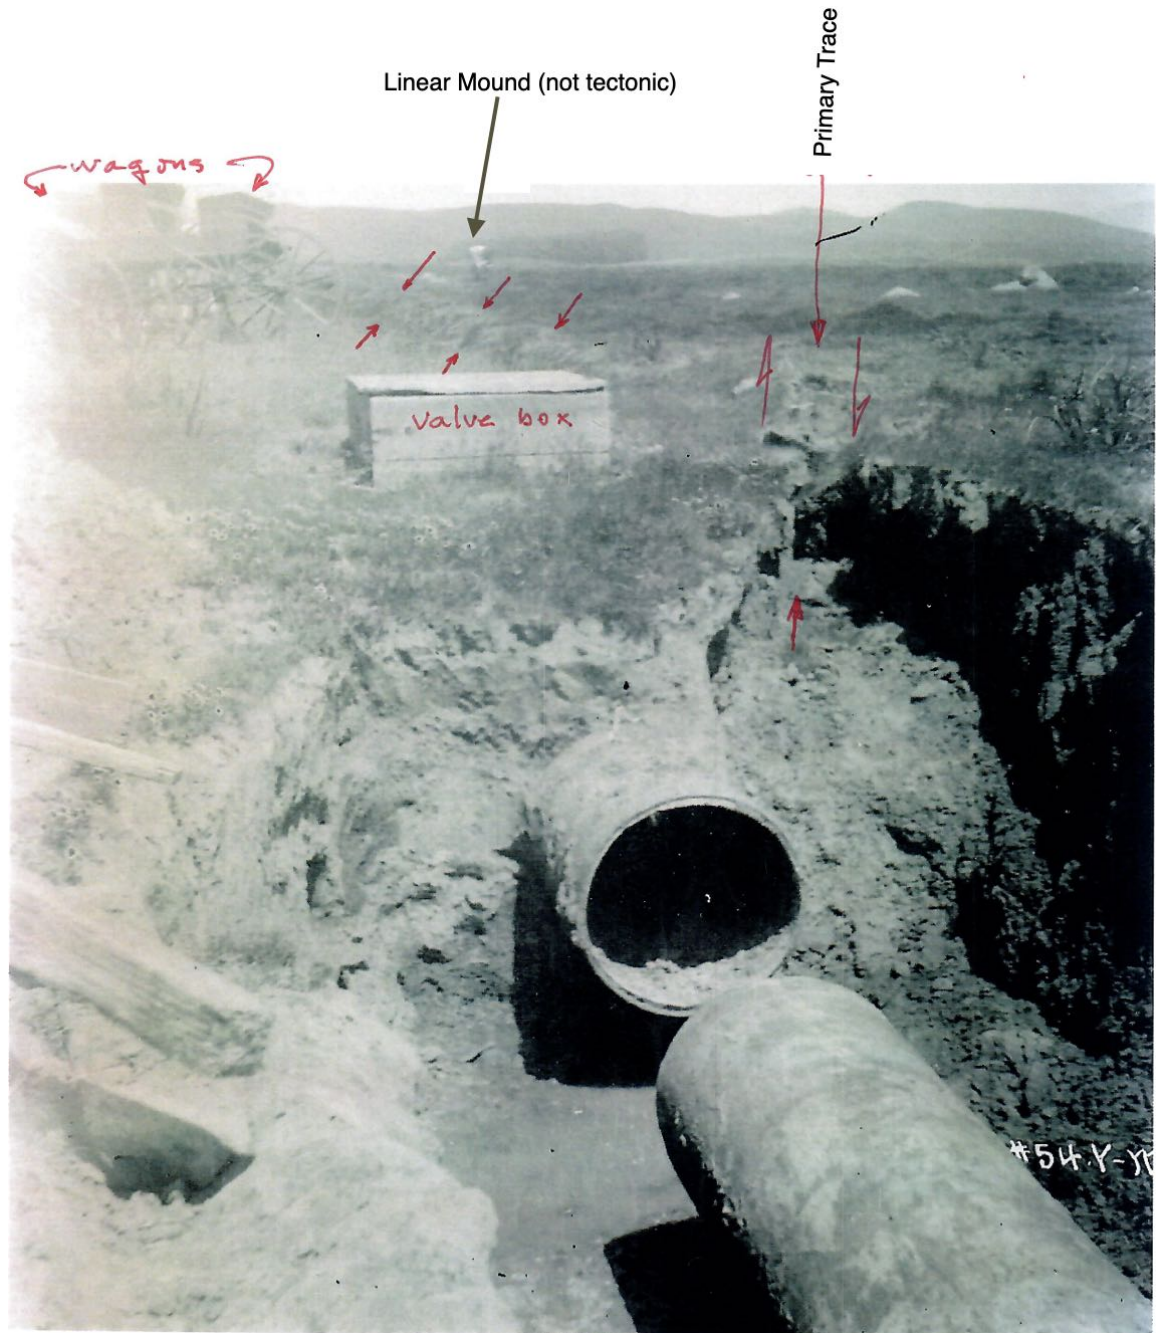
Figure 4.1.8-3. FX-4. Same as Figure 4.1.8-2, with Author's notes

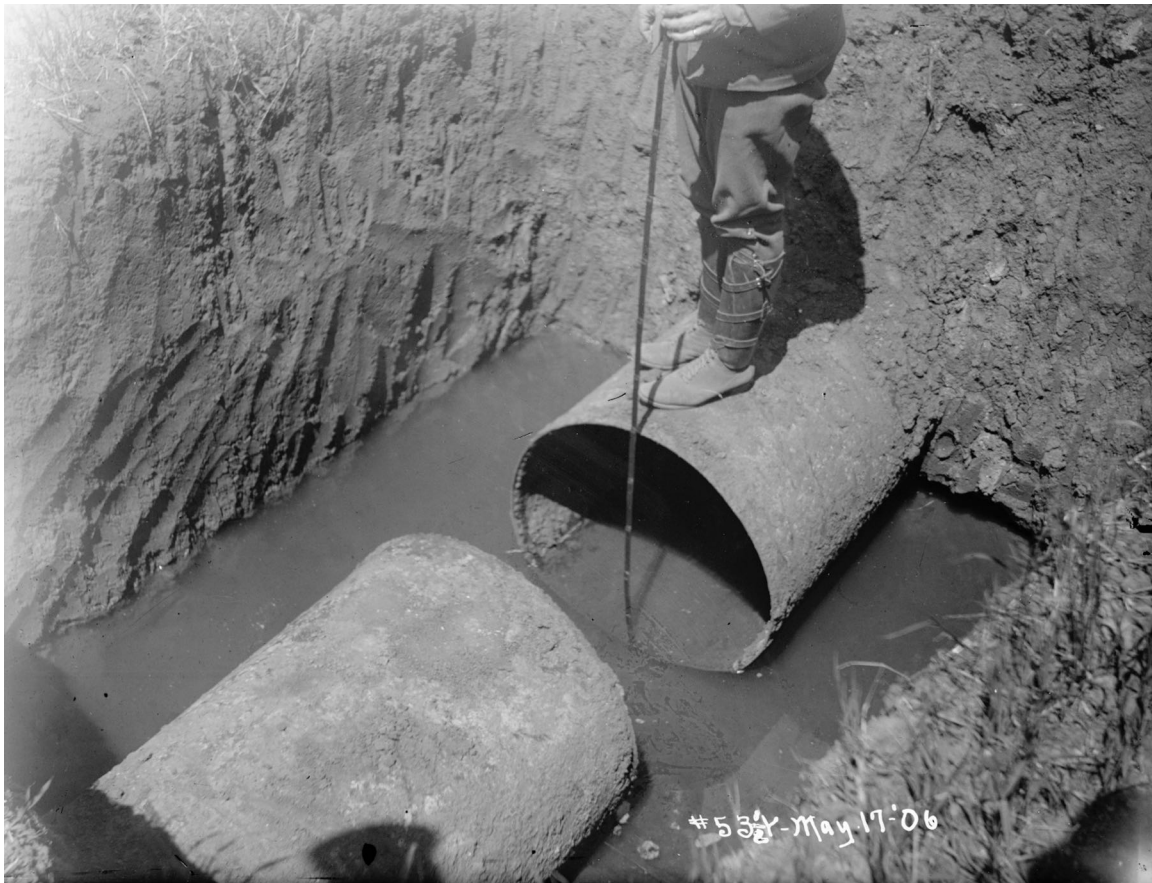
*Figure 4.1.8-6. Site 8. FX-4N. Failure of Pilarcitos 30 inch pipeline. Pull Apart ~ 21.5 inches.
(Photo: Schussler HS3 1906)*

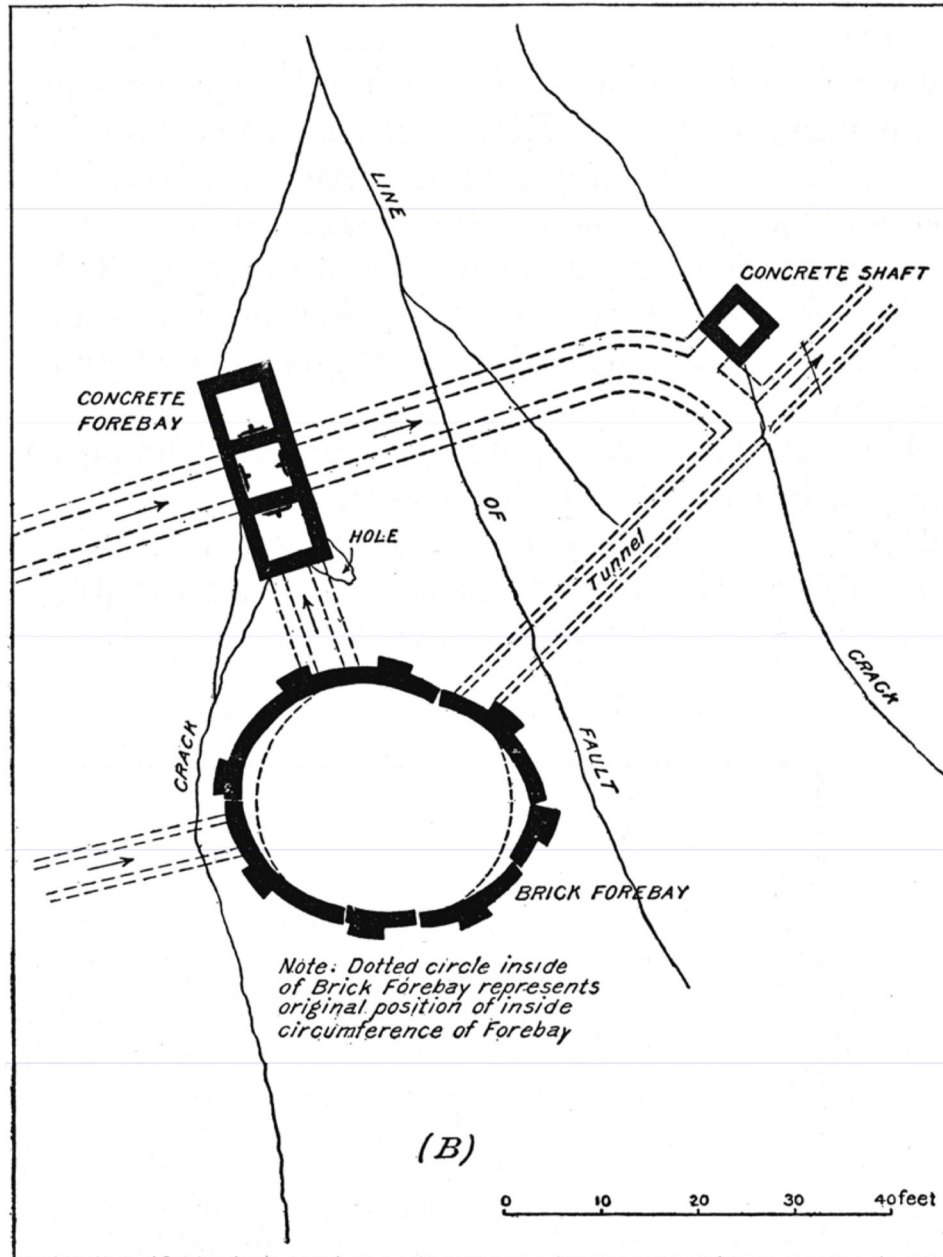
Figure 4.1.10-5. San Andreas Reservoir Outlet Works with Damage (Credit: Schussler)

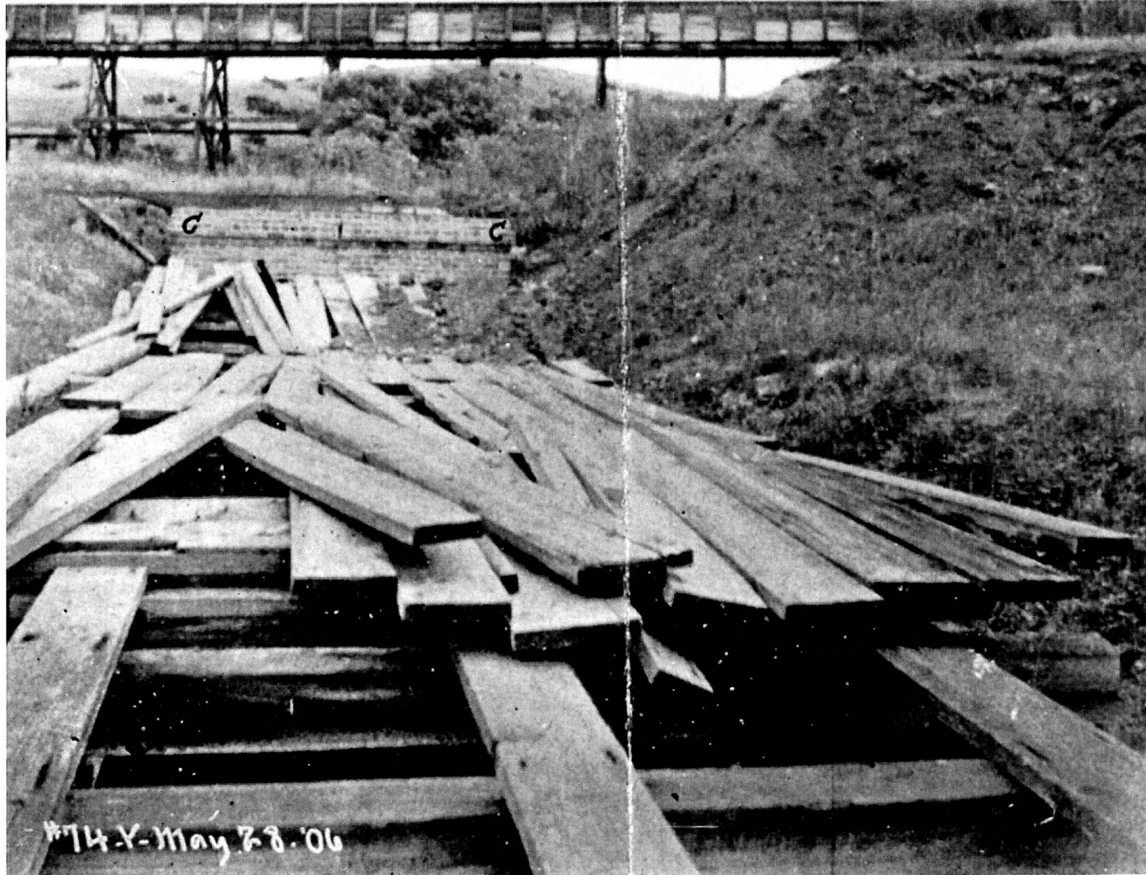
Figure 4.1.12-8. Damaged Exterior of Wastewater Exit Flume, Looking Northeasterly. Undamaged Portion of Elevated Stone Dam Flume in Distance (photo: Schussler HS52)

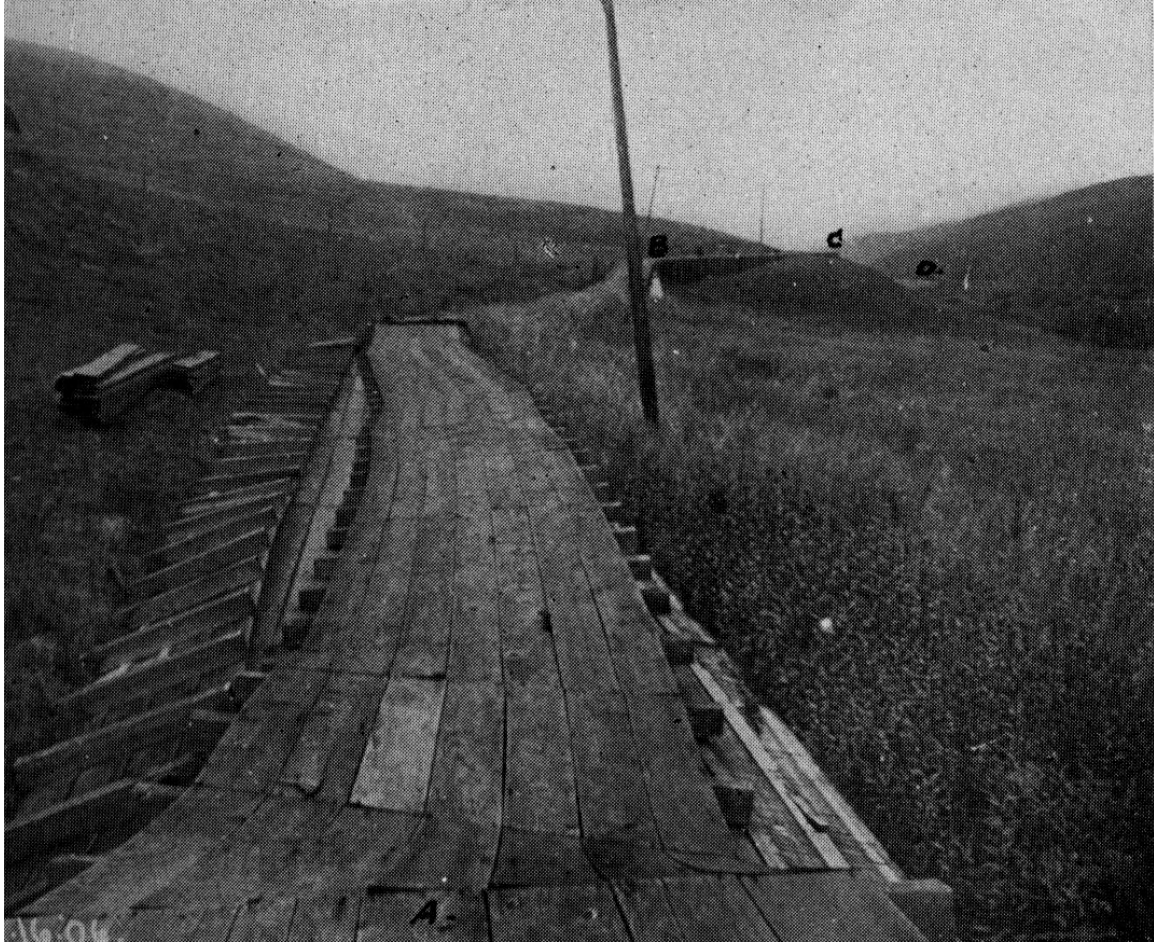
Figure 4.1.12-12. Failure of Stone Dam Flume, Looking Southerly (Photo: Schussler 1906 HS49)

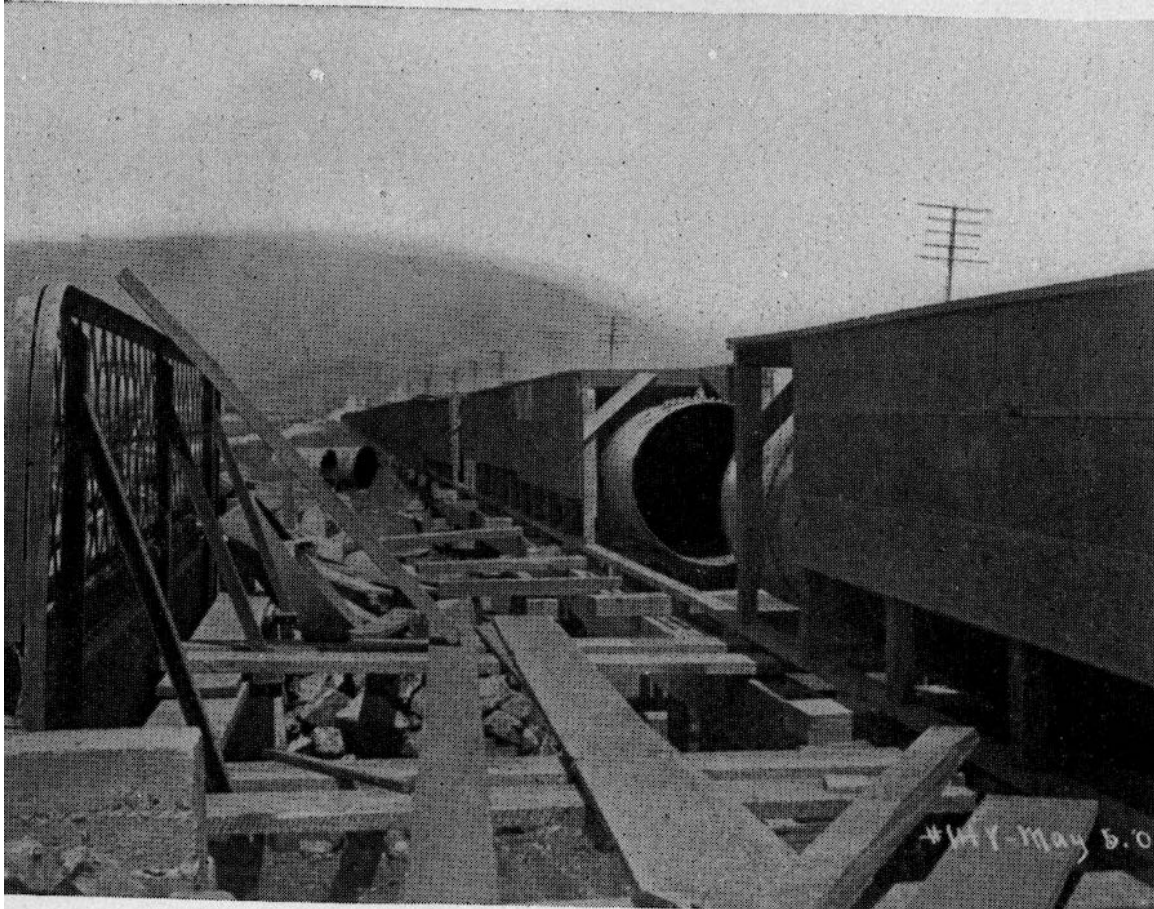
Figure 4.3-10. Crystal Springs 44" at San Bruno Marsh (Colma Creek), showing repair process. View looking northeasterly. (Photo: Schussler HS20)

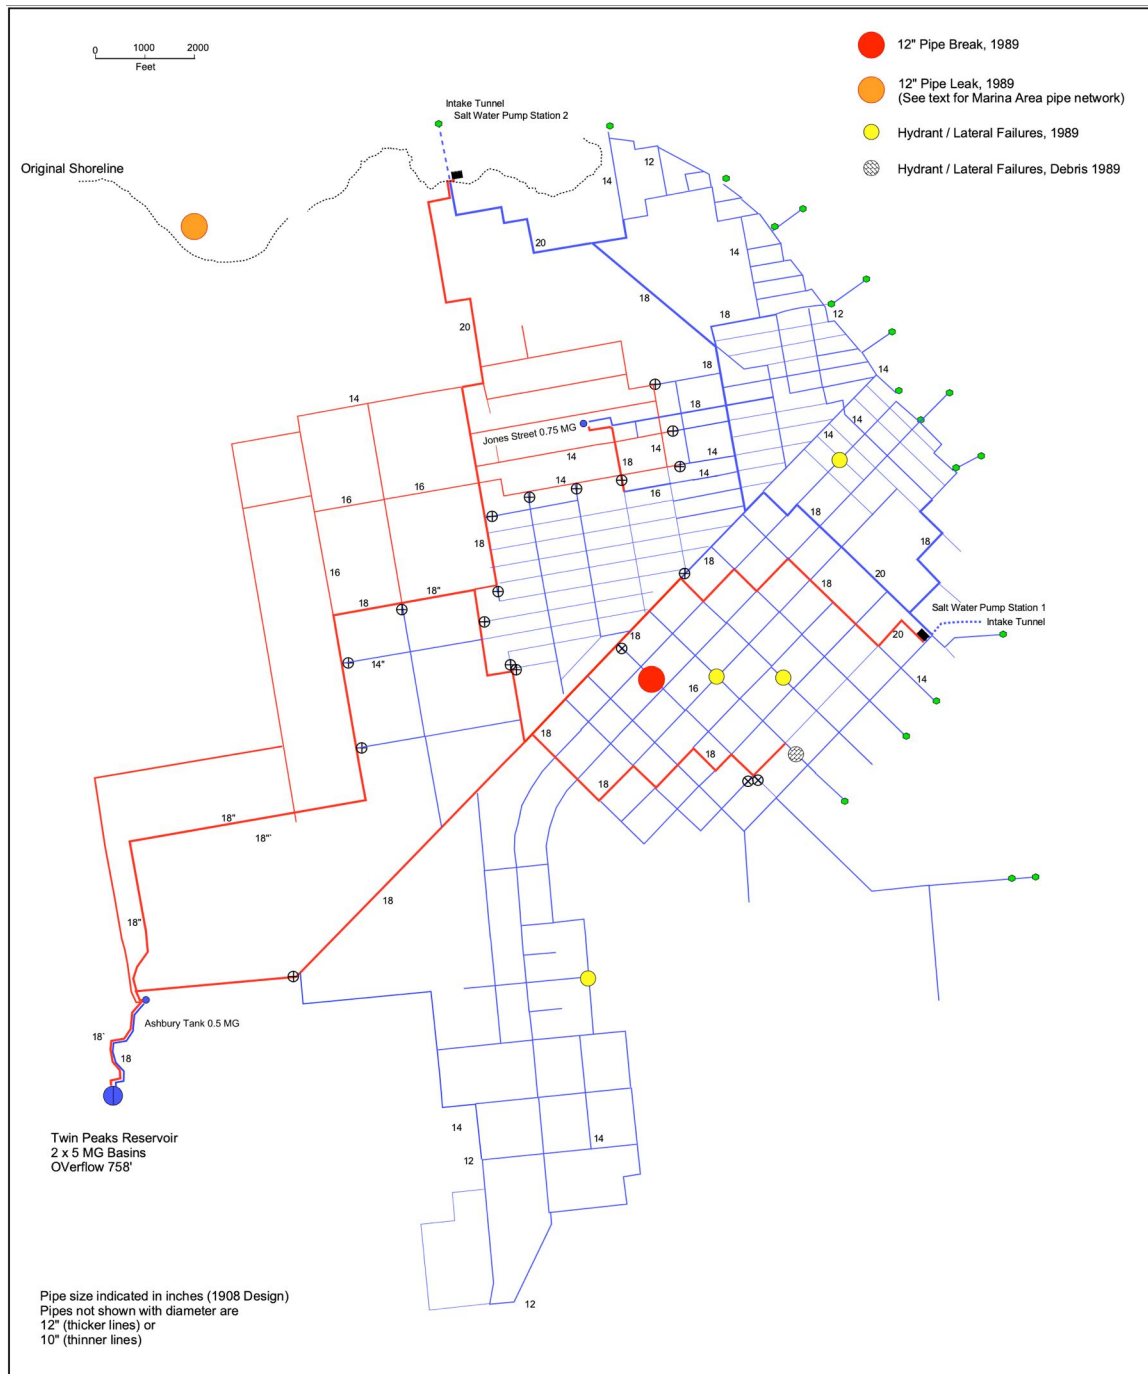
Figure 8-7. Damage to AWSS Pipe Network, 1989 Loma Prieta Earthquake
