The 1906 Earthquake Impacts on the San Francisco and Santa Clara Water Systems - What We Learned, and What We are Doing About It

John Eidinger¹, M.EERI, Lota de Castro², Dennis Ma³

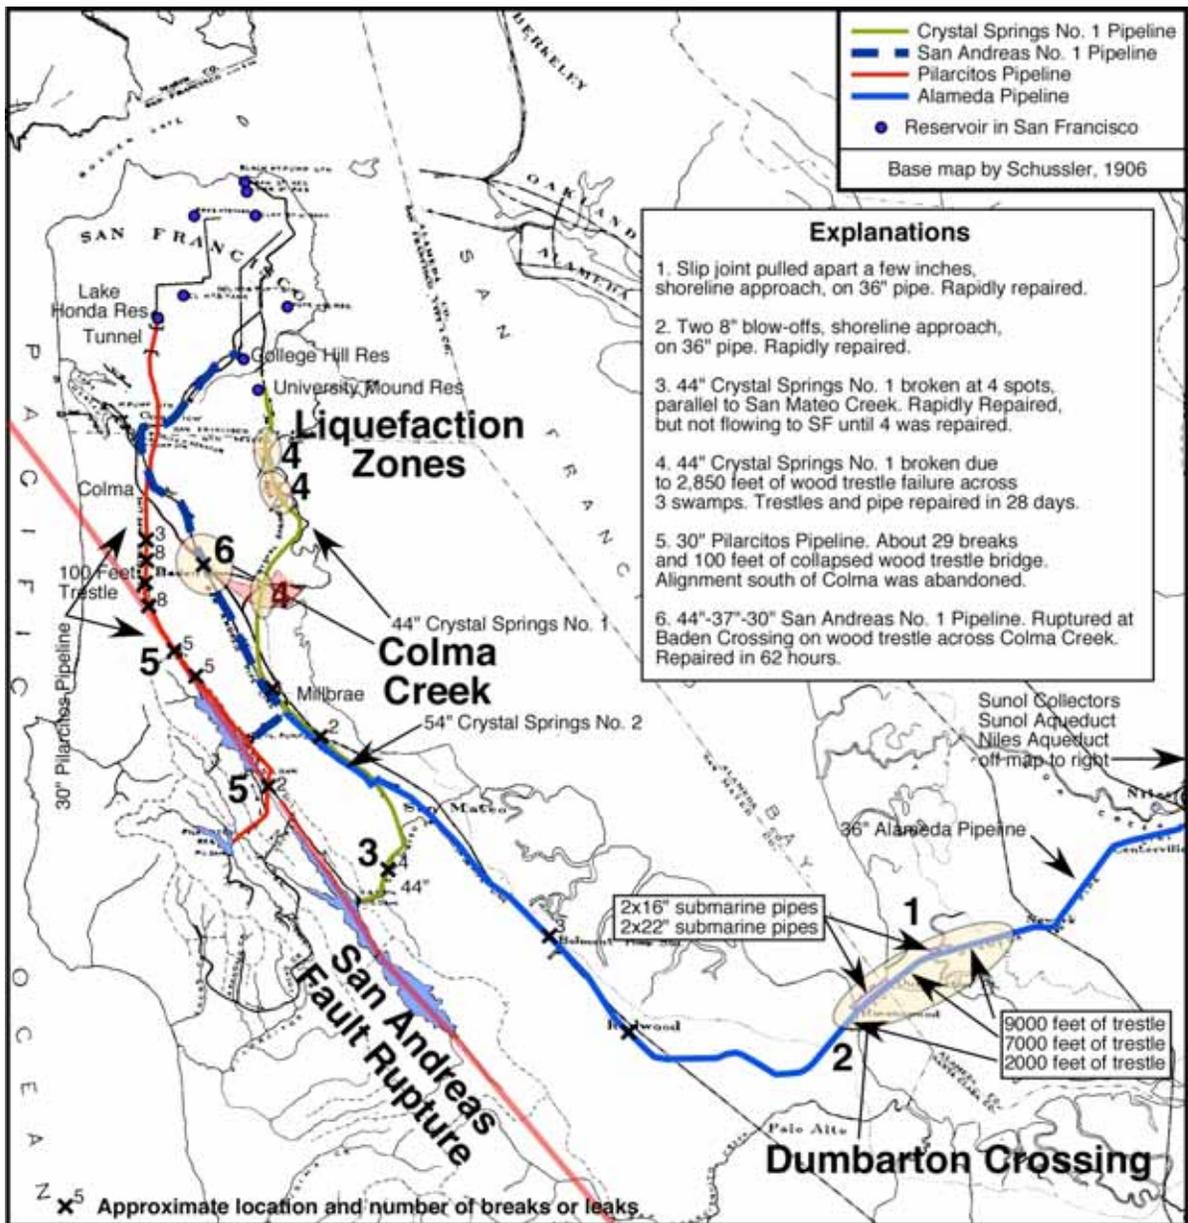
Figure 3. Damage to SFPUC (then SVWC) Transmission System, 1906 Earthquake

Major components that were damaged or had good performance of the SVWC system as reported by Schussler (1906) and mapped in Figure 3 and are described in the following sections. In hindsight, if one were aided by the geologic hazard maps now available and a modern understanding of earthquake vulnerability of water components, one could have forecasted some (but probably not all) of the damage that actually occurred. If one were to try to pinpoint the most important items of damage that led to the loss of water supply for fire fighting in San Francisco, the answer would be the simultaneous failure of all three supply pipelines: Pilarcitos pipeline (due to multiple failures due to fault offset and a few inertial overloads on weakly installed wood trestles at canyon crossings), San Andreas pipeline (due to inertial overload of a weakly installed pipe on a short bridge over Colma Creek), and Crystal Springs pipeline (due to landslide-induced pipe failures along San Mateo Creek and three inertial-induced wood trestle failures at crossings over three long "swamps" (now called very high liquefaction zones). Most of the other transmission system damage had little or no effect on transmission of water for fire flows, but impacted only longer timer water supply. It could be argued now that had any of these three transmission pipelines survived intact, then the resulting spread of fire within the City of San Francisco could have been somewhat reduced, possibly by a third or so (⁴). However, the primary reasons for fire ignitions and fire spread had more to do with the damage to structures, wind, failure of the local distribution pipe system and hampered fire department response, so even had the transmission system remained completely intact, fire losses in the City would still have been great. Recognizing that an intact transmission system does not entirely solve seismic vulnerability or even eliminate the bulk of the risk of fire spread, this paper also deals with what the City of Santa Clara (one of the SFPUC's wholesale customers) is doing to upgrade its own water distribution system.

Locks Creek Line. This aqueduct was one of the main feeders of raw water from the west into San Andreas reservoir. It diverted water from San Mateo Creek. Damaged due to landslides and repaired. It no longer exists.

Crystal Springs Flume and Pipeline to San Andreas Reservoir. The flume portion of this conduit, located near the east abutment of the San Andreas dam, completely collapsed where it crossed the fault. This flume no longer exists. The pipeline portion was replaced; and is scheduled to be replaced again in order to increase the hydraulic capacity of moving water from Crystal Springs reservoir to San Andreas reservoir.

San Andreas Dam. Located within 10s of feet of the fault offset. The Dam, built from selected clay and with a puddle core, was left uninjured, only showing a few small cracks in the macadam pavement on the top of the dam and above the puddle core. A brick outlet tunnel was offset by the fault, but not so severely that water could not continue to flow.

Fissures in the brick lining were repaired with cement. Another brick-lined tunnel was sharply offset by the fault and was cut in two. The heavy timber chute connected to this tunnel was partly destroyed.

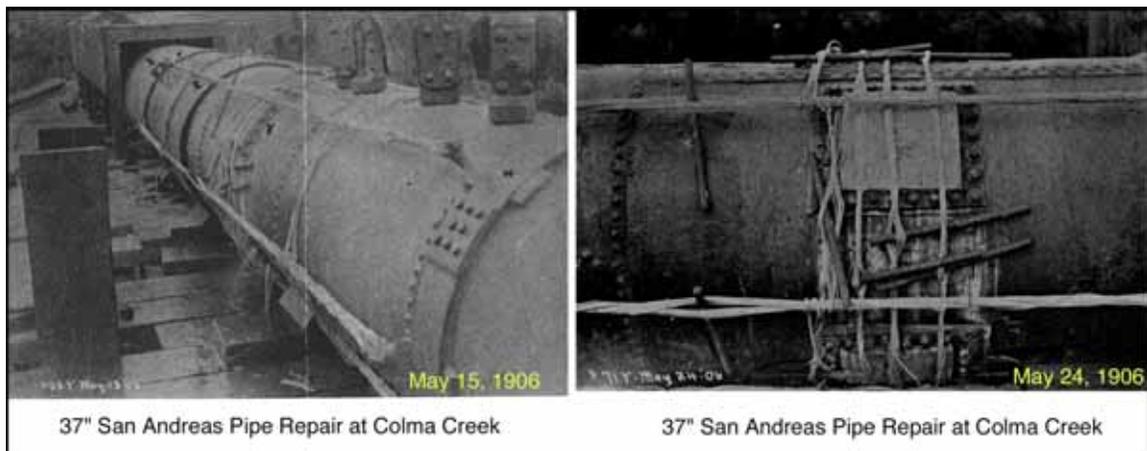
Figure 4. Damage to San Andreas Pipeline

San Andreas Pipeline. A 44" diameter pipeline from the Pilarcitos pumps east to the Millbrae pump station, then north to Baden pump station, then northwest as a 30" diameter pipeline to Lake Merced pump station. Portions of this pipeline are still in use in 2005. The 44", 37" and 30" San Andreas No. 1 pipeline was badly ruptured at one location near Baden Pump Station, and suffered some other minor damage at other locations. The damage near Baden pump station consisted of four large lugs being torn off the pipe near an expansion joint on the pipe bridge at Baden. The repair of this break was high priority, with a temporary repair being made in about 2 days (Figure 4). By the 7 pm on April 20, 1906, 62 hours after the earthquake, water from San Andreas reservoir was again being delivered via San Andreas No. 1 pipeline to College Hill reservoir in San Francisco at an 8 MGD rate.

The cause of the damage appears to be the above-ground trestle-supported pipeline crossing near Baden pump station through a "swamp" (zone mapped in Figure 1 as having a very high liquefaction susceptibility). This demonstrates the vulnerability of above-ground pipes with dresser-type couplings and harnesses, if not properly designed for seismic forces.

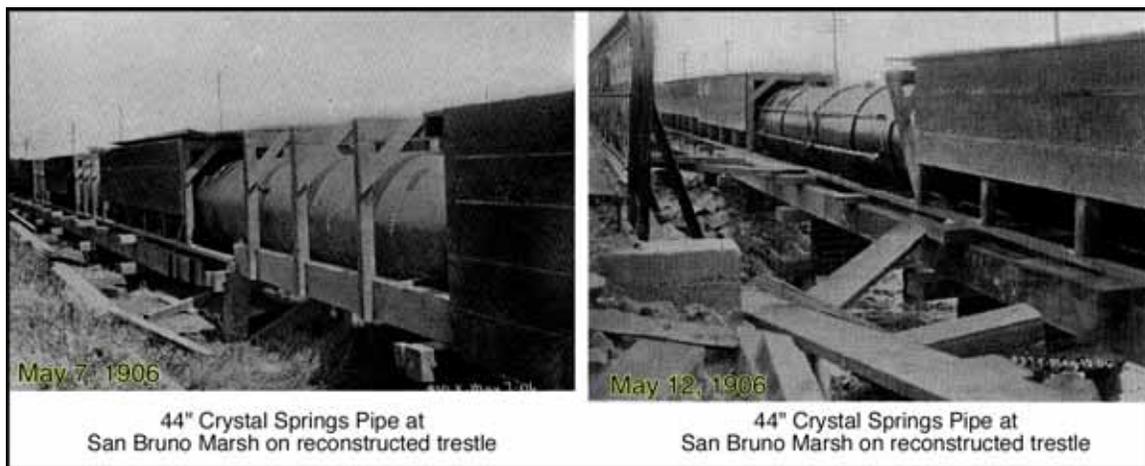
Figure 5. Damage to Crystal Springs Pipeline

Crystal Springs Pipeline from Millbrae to University Mound reservoir. The Crystal Springs 44" No. 1 pipeline (laminated wrought iron, $t=1/4"$, girth joints made from a single line of 0.5" diameter rivets) was ruptured in seven places between the Crystal Springs

concrete dam outlet works and the (modern) Millbrae valve lot. Several miles north, the pipe was also severely damaged where it was supported on substantial wooden trestles across the "swamps" or "marshes" across three valleys: San Bruno Valley (Colma Creek, Figure 5); Guadalupe Valley (near City Hall location of modern Brisbane) and Visitacion Valley; the wooden bridges failed, and in locations the pipeline was thrown off the trestle.

The several damage points on the pipeline between the dam and Millbrae were rapidly repaired. However, since the downstream pipeline was still damaged, no water from Crystal Springs reservoir was then available to San Francisco.

The wooden trestles at these three crossings were overloaded due to strong horizontal and vertical inertial loading of the pipe, possibly aggravated by longer duration shaking due to localized deeper soft soil profiles. The modern CS-No. 1 pipeline still traverses these three valleys along the same alignment, but is now a buried pipeline (i.e., no more wooden trestles). Between Crystal Springs concrete dam and Millbrae, the original 44" pipeline has been abandoned in place; the reasons for the damage might have been a combination of strong ground shaking, coupled with some hillside movements.

The repair of the three trestles took substantial time. Once the trestles were repaired, the original pipeline was jacked back into place, various joints were repaired, and the pipe was put into service on May 16, 1906 (28 days after the earthquake).

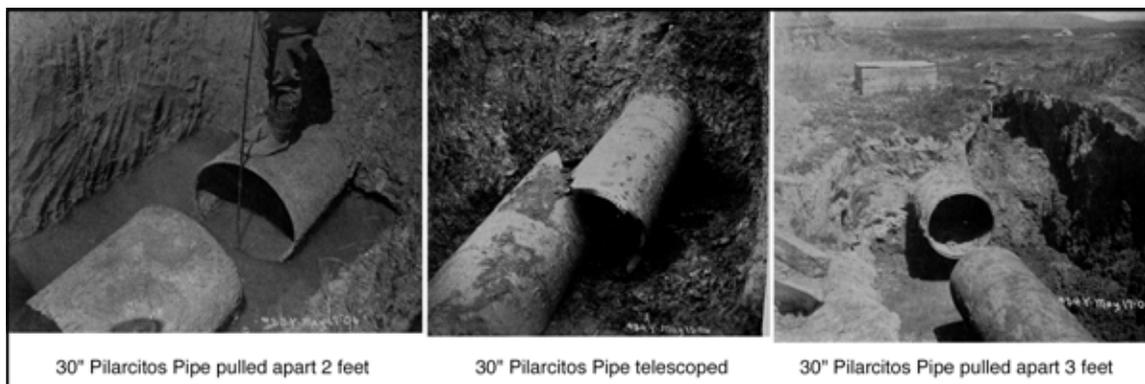
Figure 6. Damage to Pilarcitos Pipeline

Pilarcitos Pipeline from Pilarcitos reservoir to Lake Honda. The upper elevation reaches of this conduit (southern portion) was a 30" diameter riveted steel pipeline

(laminated wrought iron, $t=3/16"$, girth joints made from a single line of rivets) that paralleled the San Andreas fault from the north end of San Andreas reservoir. This pipe was torn and telescoped at several places (Figure 6) and practically destroyed. Initial estimates suggested it would take many months to repair and put this pipeline back in service. Ultimately, the pipe was not repaired, and it was removed from service. The northern portion of the 30" pipeline, from about the modern location of the San Pedro valve lot to Lake Honda, was only slightly damaged, and was quickly (16 hours) restored to service, drawing water from the Lake Merced pumps and delivering water at a 6 to 7 MGD rate to Lake Honda and beyond. This water, coupled with local storage in Lake Honda, helped control the spread of the conflagration within the City of San Francisco.

The cause of the damage to the southern part of the Pilarcitos conduit included fault offset at several places, and inertial overload of the 100-foot long wooden trestle bridge supporting the pipe across Frawley Canyon. The southern alignment is no longer part of the modern SFPUC system. The northern alignment of the pipeline is also no longer in service, but roughly parallels the modern San Andreas No. 2 pipeline east of Lake Merced.

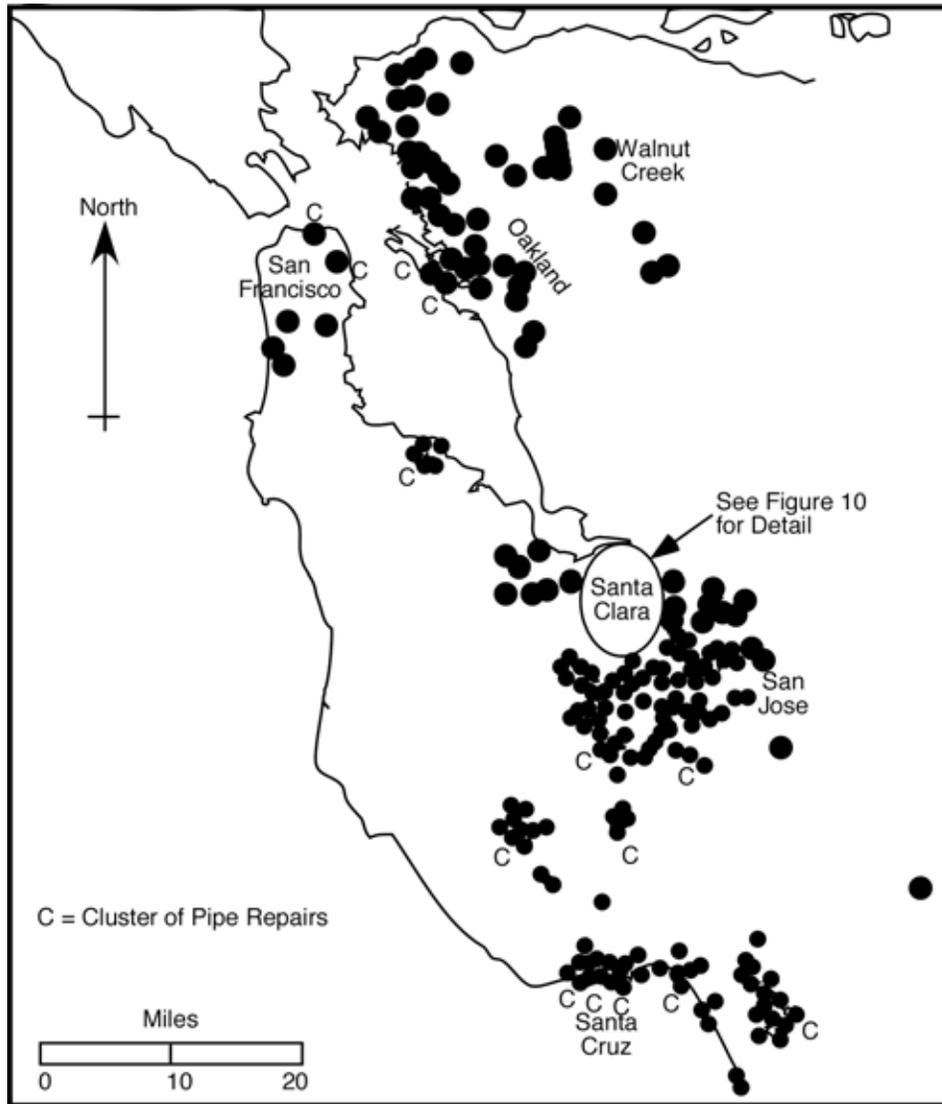
Figure 7. 1989 Loma Prieta Earthquake – Locations of Pipe Damage

Figure 7 shows a regional map with the bulk (but not all) of recorded water pipeline breaks and leaks. Figure 8 shows a close up of water distribution system pipe damage in the City of Santa Clara. Unlike the damage pattern to the San Francisco distribution pipes in 1906, almost all of the damage in the City of Santa Clara in 1989 occurred at locations mapped as having essentially no liquefaction susceptibility; further, in portions of the City of Santa Clara that are mapped as having high liquefaction susceptibility, where the predominant type of pipeline is asbestos cement, essentially no damage occurred.

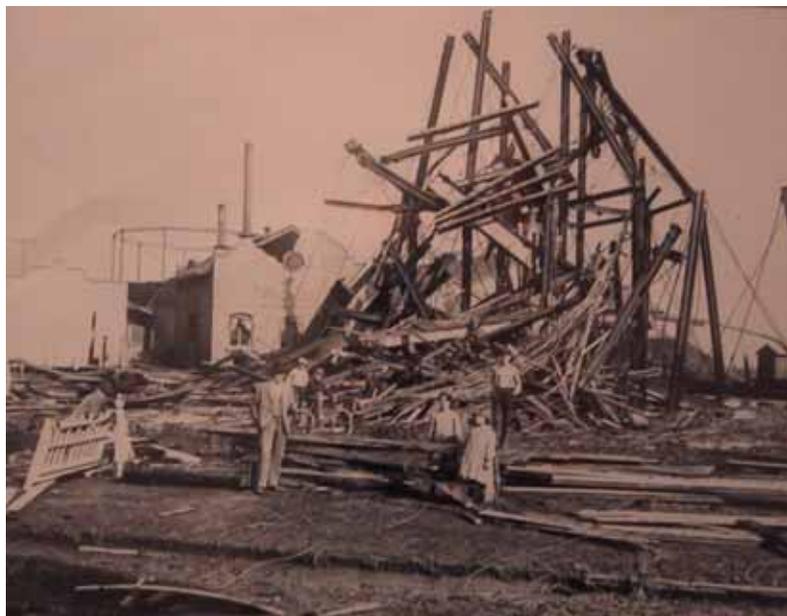
Figure 9. Collapsed Water Tanks in Santa Clara (c. April 1906)

The 1906 earthquake exposed the then considerably smaller City of Santa Clara water system to moderate to strong ground shaking. Recorded damage to the Santa Clara water system included the collapse of its water tanks. Figure 8 shows the four elevated wood tanks then in use in the City (pre-earthquake). Figure 9 show the same tank structure, collapsed by ground shaking in the 1906 earthquake.

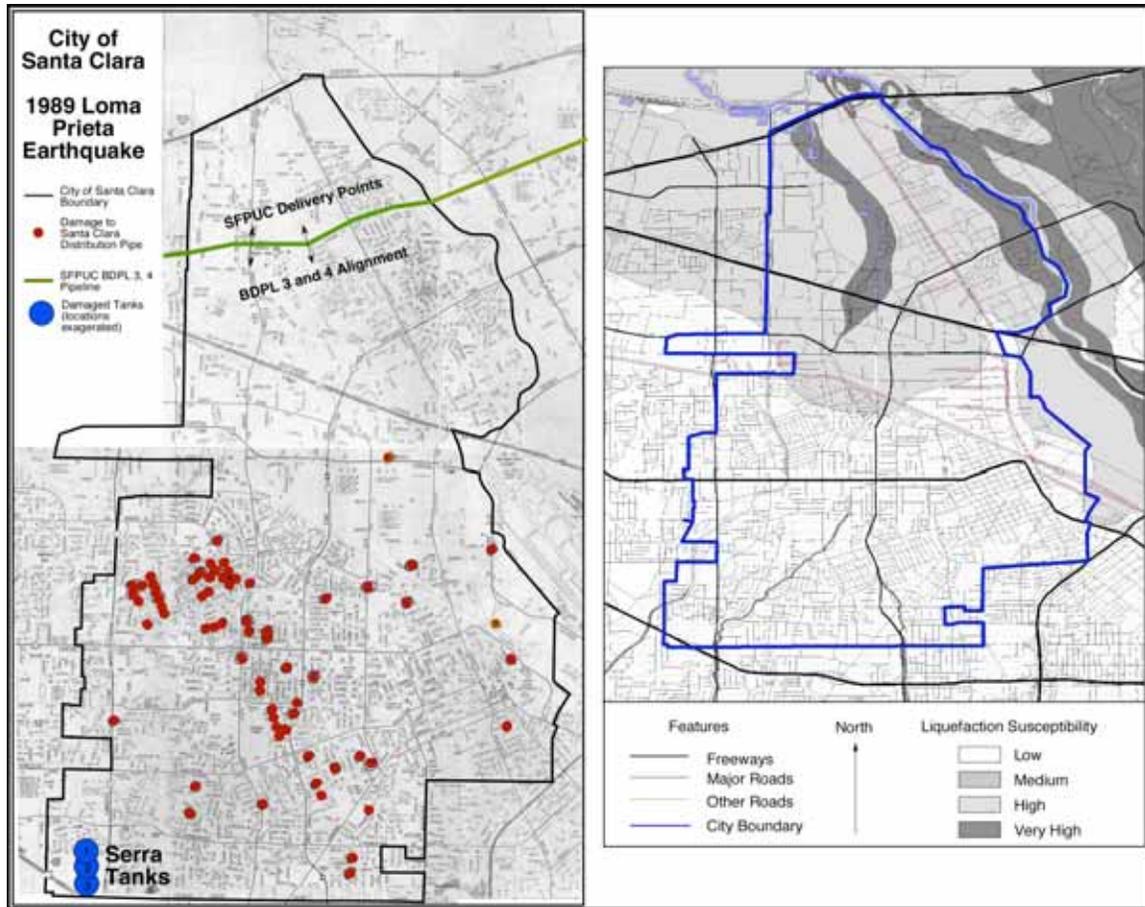
Figure 10. 1989 Loma Prieta Earthquake – Locations of Pipe Damage in Santa Clara

The 1989 Loma Prieta earthquake again damaged tanks and pipelines in the City of Santa Clara. The left side of Figure 10 maps the location of distribution system damage in Santa Clara in the 1989 earthquake; the right side shows the geologic hazards for the city. Three of the six 4 MG unanchored steel tanks in the City suffered roof damage, likely due to wall uplift. The three remaining tanks did not suffer damage; but were located in the northern parts of the city where ground motions were lower.

Figure 10 shows a map of the 66 pipe repairs (left side) and liquefaction susceptibility (right side). Some key observations:

- 64 of the 66 repairs were to Cast Iron (CI) pipe or the service connections attached to CI pipe. All of these repairs were located south of the Central Expressway.
- 1 (or 2) of the 66 repairs were to Asbestos Cement (AC) pipes (the repair location near the Downtown tank might have been to other than a AC pipe). One of these repairs was located south of the Central Expressway.

- Essentially none of the pipe damage occurred in zones mapped as having either high or very high liquefaction susceptibility. This is the opposite of what happened in the 1906 earthquake in the City of San Francisco distribution system.
- There are about 295 miles of pipe in the Santa Clara water system. South of the Central Expressway, where the bulk of the pipeline damage occurred, about 90% are cast iron.

The actual pattern of damage in Figure 10 shows a concentration along a northwest trending alignment. The damage rate within this 0.75 mile wide by 3.5 mile band was much higher than outside this band. This suggests that the actual highest levels of ground motions in the City of Santa Clara were concentrated along this narrow alignment., but this unusual band of damage might also be attributed to any of the following reasons:

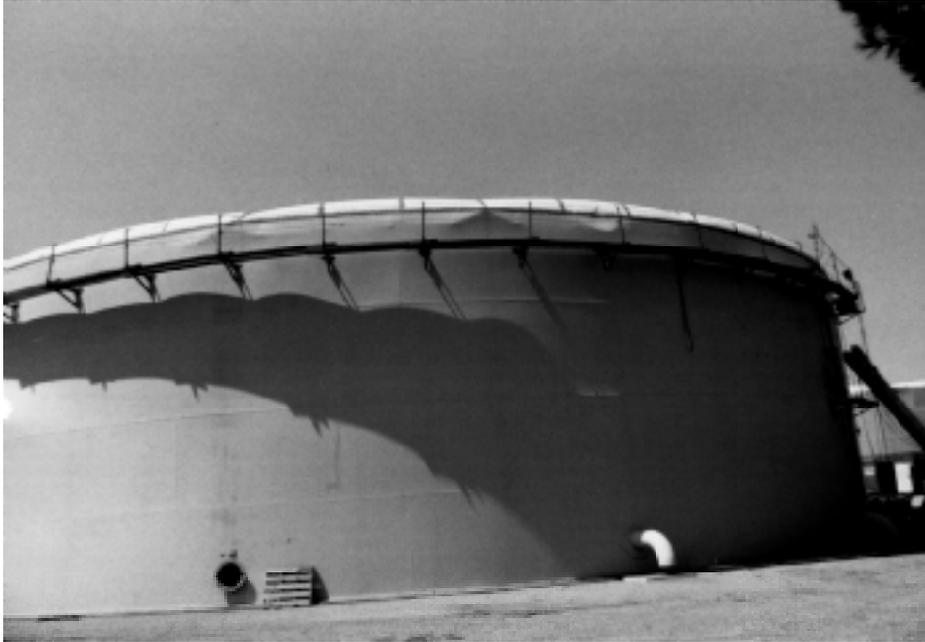
Figure 11. Damage to Serra Tank No. 3

Figure 11 shows one of the three damaged tanks. This tank is located at a site in the southwest corner of the city, where there are 3 similarly-built tanks; each suffered similar damage. This view shows the southern face of the tank. The damage seen reflects the lateral buckling of the roof rafters which in turn caused the buckling of portions of the roof and knuckle shell (the scaffolding seen is part of the repair effort).

The three damaged tanks are all welded steel tanks resting on concrete ring beam foundations. All the tanks were unanchored, with side entry pipes. At the time of the earthquake, there was more than 10 feet of freeboard above the water line to the roof rafters. Nearest strong ground motion instruments suggest that the tanks experienced about $PGA = 0.30$ to $0.35g$ shaking. The damage to all three tanks was nearly identical in terms of location, suggesting that the damage was due to incipient wall uplift, and not water sloshing. Very similar damage has since been seen in Paso Robles at similar sized unanchored welded steel tanks in the 2003 San Simeon earthquake. While the roof damage did not cause loss of water contents for fire fighting purposes, it was expensive to fix. More troubling is the fact that the tanks could be exposed to considerably higher levels of shaking in a future earthquake on the nearby San Andreas fault, and the resulting uplift would damage the inlet-outlet pipes, as well as damage (again) the roof. The modern AWWA code for steel tank design remain deficient in providing guidance as to avoiding this type of damage, and

similar types of damage can be expected for unanchored steel tanks that are constructed to code minimums, should they experience an earthquake that causes wall uplift.

The City of Santa Clara will upgrade its six largest water tanks (all unanchored steel tanks) with flexible couplings, to prevent pipe failures due to tank wall uplift possible under very large earthquakes; anchor one of the tanks; and anchor various pieces of electrical and mechanical equipment at its various pumps stations. The cost of this upgrade program is envisioned to be less than \$2,000,000. The City has already installed many local wells, some with permanent backup power supplies, so that it can provide winter time flows to the community even with complete disruption of supply from its two surface water suppliers, the SFPUC and SCVWD. Once these upgrades are complete, the City should have higher reliability of providing fire flows to the community in the first hours after any large earthquake, even if there is a service disruption from wholesale supplies from the SFPUC or SCVWD; and be able to provide sufficient water to the community to sustain rapid economic restoration, while repairs are made to the City's distribution pipelines, as well as SFPUC's and SCVWD's transmission pipelines and tunnels.

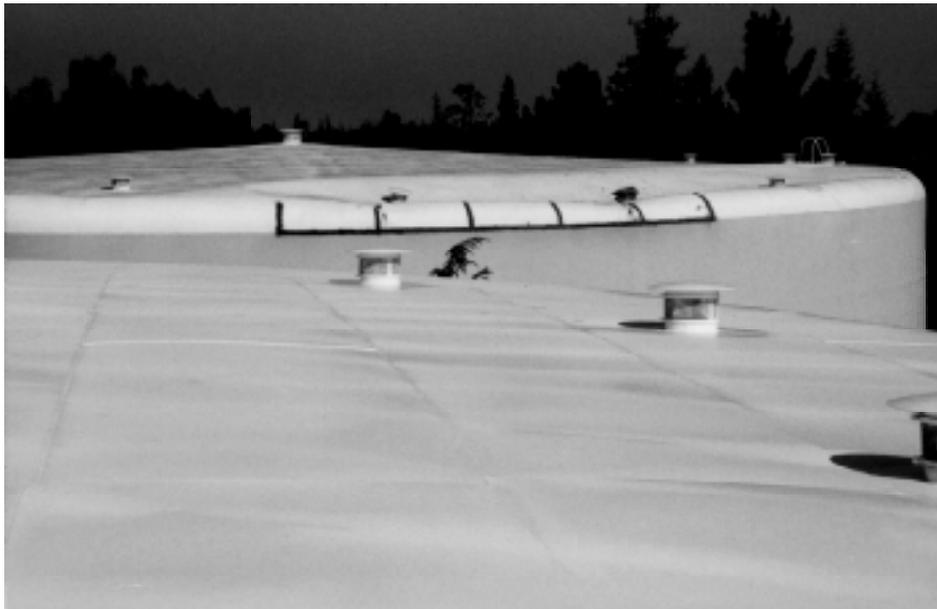
Figure 12. Damage to Serra Tank No. 1 (Background)

Figure 12 shows the roof lines of Serra Tanks 1 (background) and 2 (foreground). At the time this photo was taken, the roof for Tank No. 2 was already repaired (November 1991); Tank 1 had not been repaired. A large buckle can be seen in the roof of Tank No. 3, indicative of the damage to the roof beams below.

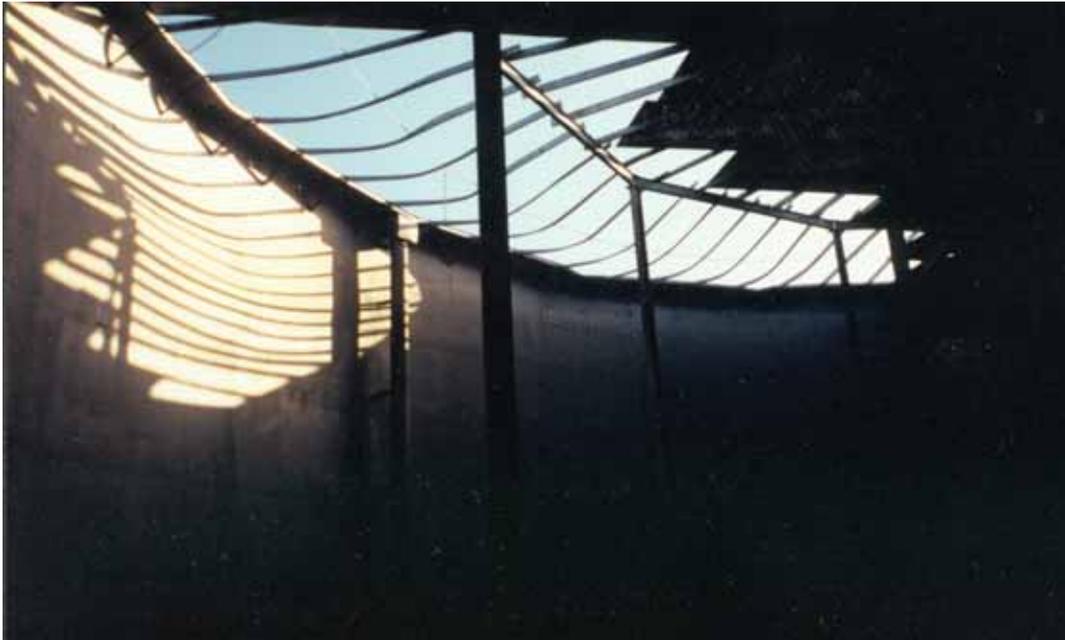
Figure 13. Damaged Roof Rafters

Figure 13 shows the damaged roof rafters of Tank No. 1. At the time this photo was taken, the tank had been drained and the damaged roof plate had been removed. The photo is taken looking up at the damaged roof rafters and knuckle. Lateral buckling of the roof rafters is readily observed.

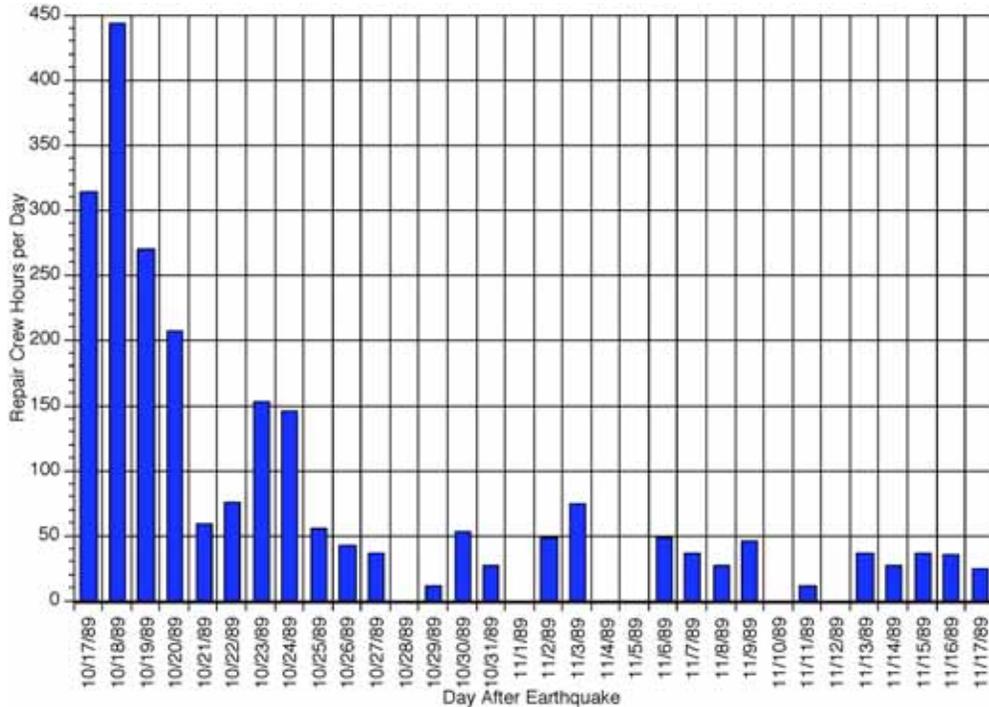
Figure 14. Pipe Repair Effort, October 17, 1989 through November 17, 1989

- A total of 66 pipe repairs were made in the period Oct 17 to Nov 17 1989. The "normal" number of pipe repairs in the City are about 1 or 2 per week, which would be about 6 or so for this same time period had there been no earthquake.

- The bulk of the pipe repairs were made from Oct 17 1989 to Oct 24 1989. In this time period, there were 45 pipe repairs made. During this time period, the average effort was 32 manhours per repair, with most repairs made to 6" mains and service lines up to the meter.

- The bulk of the repair work was for leaking pipes. By "leaking", it is meant to say that the pipe suffered a pin hole leak, a slight opening of the joint, or a failure of the service connection. By service connection, it is meant that the repair was made up to the water utility's side of the meter; and not damage to the customer's service pipe.

- In only a few cases were repairs made to "broken" pipes, where "broken" means total loss of flow capability. For example, the pipe may have pulled apart completely, or suffered a large split.
