# PERFORMANCE OF BURIED HIGH VOLTAGE POWER CABLES DUE TO LIQUEFACTION

John M. EIDINGER<sup>1</sup>

**ABSTRACT:** Buried high voltage power cables failed in many locations in the February 22, 2011 M 6.3 Christchurch earthquake, due to liquefaction. The empirical evidence of these failures is presented. The original design of the cables is considered, and what made the cables so vulnerable. Nonlinear analyses of buried cables are presented to see how they "theoretically" should perform due to liquefaction. Full scale tests are conducted for unreinforced and reinforced buried cable duct banks to examine their relative capability to absorb the effects of liquefaction. Recommendations are made for the design of new buried cables in liquefaction zones.

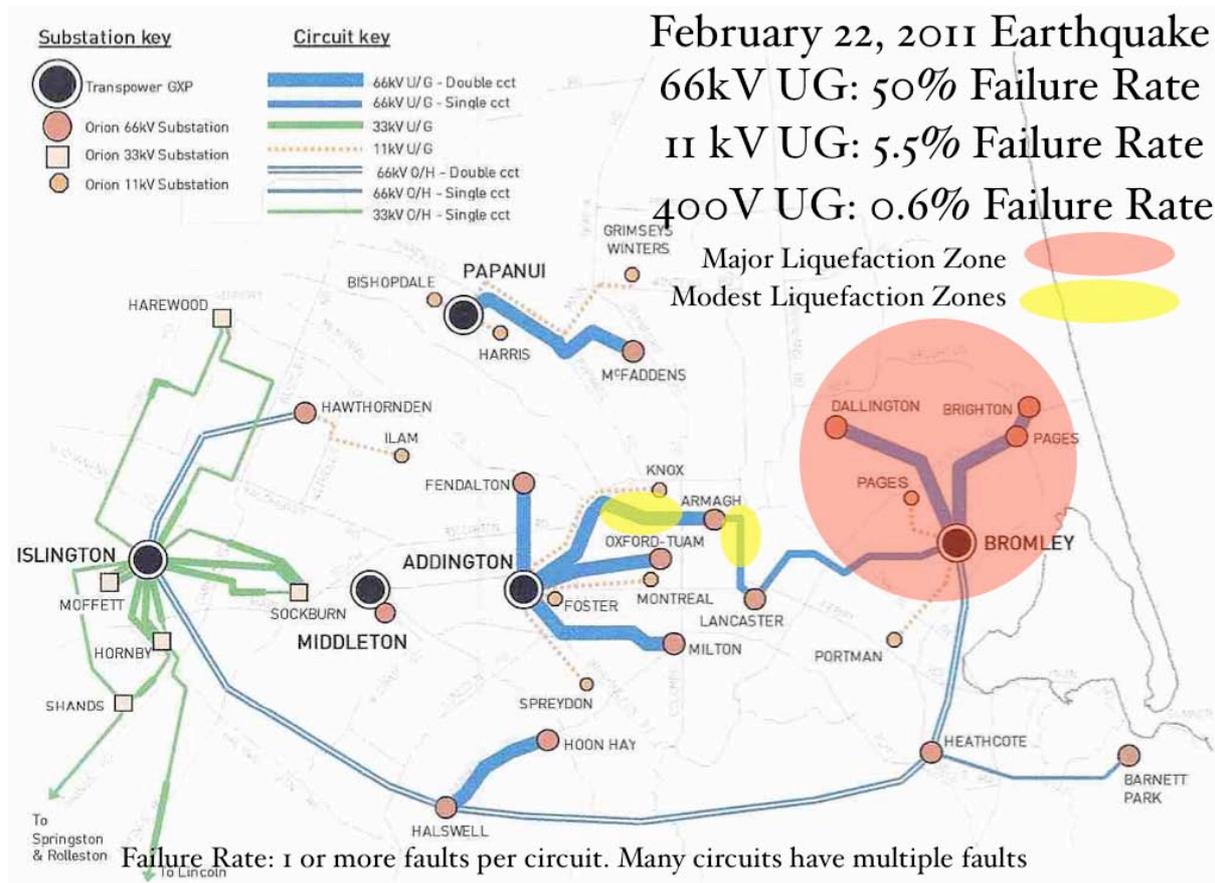
Figure 1. Location of Orion 33 kV to 66 kV Distribution System and Liquefaction Zones (Feb 22 2011)

This paper examines just one aspect of the overall power system damage, namely the failure of buried 66 kV power cables in the Orion system. Figure 1 shows a map of the Orion power system, highlighting the liquefaction zones in red (major liquefaction, settlements often 5 to 10 cm, with lateral spreads locally up to 1 meter) and yellow (moderate liquefaction, with settlements commonly 2 to 5 cm).

In Figure 1, the red zone in the eastern part of the city suffered the most widespread concentration of liquefaction, and the worst impact to buried power cables. The eastern part of the city is primarily residential. From the Bromley 220 kV – 66 kV substation, there are 5 underground (UG) 66 kV circuits that branch out to 66 kV substations: all these circuits had more than 1 faults; short term emergency repair was to deploy emergency generators at low voltage substations; moderate term repair was to re-energize substations with temporary above-ground cables; the long term permanent strategy (2012 and beyond) is to install new end-to-end 66 kV buried cables, with some seismic design provision. Exactly what will constitute the seismic design for the new buried cables remains to be determined.

In Figure 1, the two yellow zones are drawn over the single Lancaster-to-Armagh 66 kV XLPE-type circuit and the double Addington-to-Armagh 66 kV oil-type circuits. These failed at six locations, were repaired with new splices at those six locations, and put back into service.

In Figure 1, the statistics for the February 22, 2011 earthquake are presented. If one counts by circuit, including all of Orion's system, then 50% of 66 kV underground cables had one-or-more

faults; 5.5% of 11 kV and 0.6% of 400 Volt. If one counts only those circuits located within liquefaction zones, essentially all the 66 kV buried cables failed.

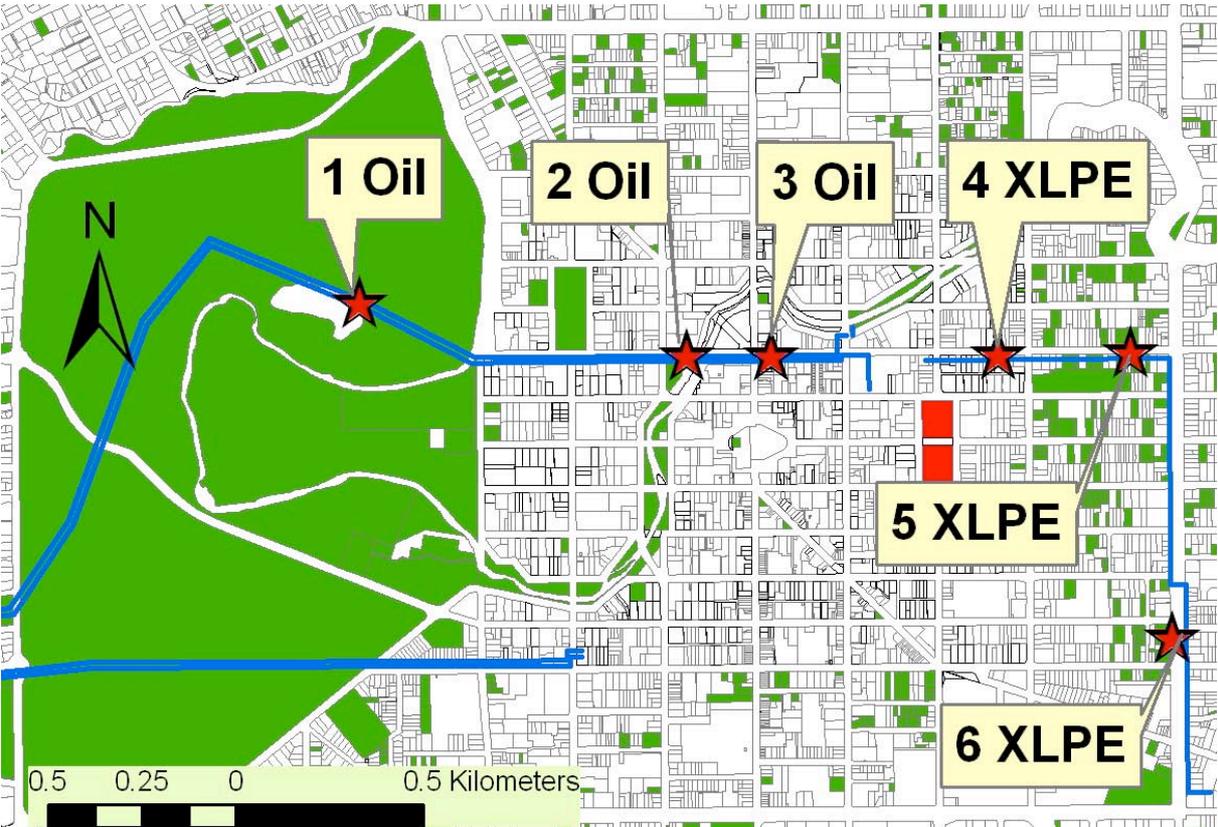
Figure 2. Location of 66 kV Buried Circuit Faults, Central Business District, Christchurch (Feb 22 2011)

Figure 2 shows the alignment of 66 kV buried circuits in and around the central business district (CBD) of Christchurch, New Zealand. The red stars show the locations where the circuits failed. The blue lines show the circuit alignments. Green areas are parks. The meandering Avon River is highlighted by green parks along either bank. The six circuit failure locations are noted "1, 2, 3, 4, 5, 6". The type of cable at each faulted location is listed as either Oil, or XLPE. Each blue line represents a three-phase circuit. Oil-type cables have all three phases within pipe. XLPE-type cables have three separate cables.

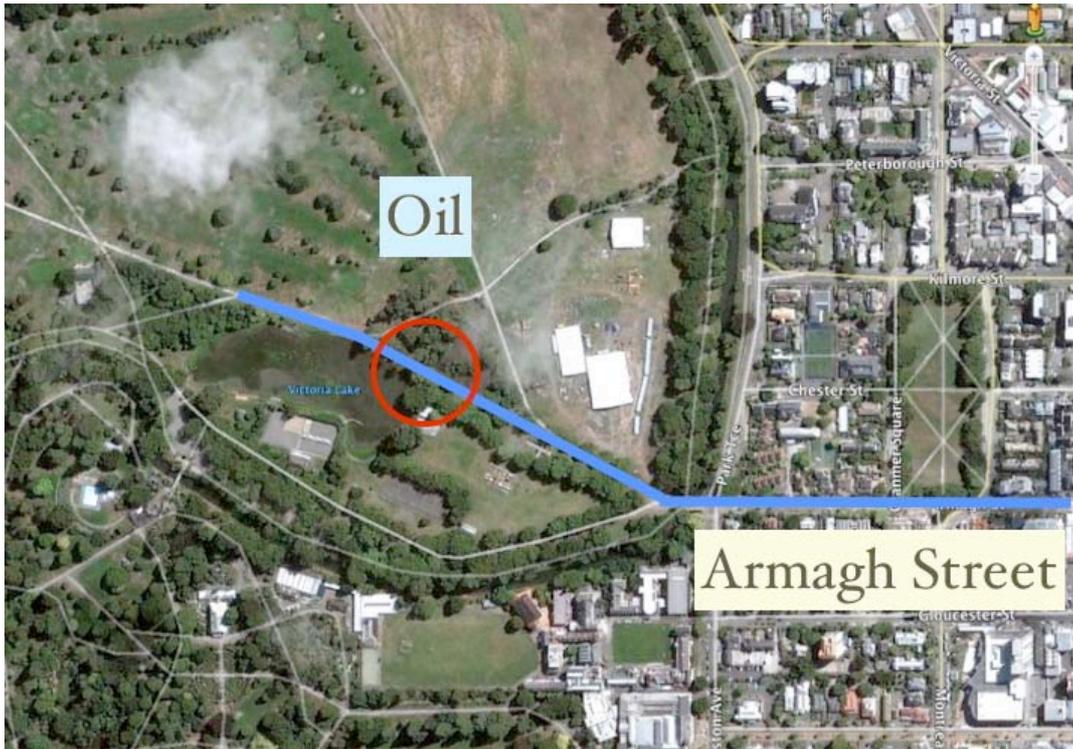
Figure 3. Location 1 – 66 kV Oil-filled Cable

Figure 3 shows failure Location 1. Figure 4 shows the cross section of the trench design used at Location 1, same as used at Locations 2 and 3. In the field, we observed the actual "230 mm cement-bound sand" and "80 mm red concrete cap" to have the consistency of a moderate strength concrete. Native soil in the top 3 meters, surrounding the cables, are typically moderate strength clays / silts, able to withstand a vertical-cut trench wall. Figure 5 Shows the buckled cables, as crews dig them up after the earthquake. Figure 6 shows the cable cross section, comprised of three aluminum phases (300 mm<sup>2</sup>), paper wrapped, with three oil-ducts; all housed within a corrugated aluminum pipe and then with protective plastic outer sheath.

Post-earthquake inspection at Location 1 revealed that the cable alignment was parallel and about 6 meters from the edge of Lake Victoria. Liquefaction occurred under the lake, inducing some settlements, and possibly a very slight lateral spread, as indicated by damage to the retaining wall at the edge of the lake. One buried storm culverts goes under power cable, another over the power cable one installed likely before, and one after, the cable installation. Surface level ground deformations in the zone where the cable failed show sudden "knife edge" settlements on the order of 2 cm, gradual lateral soil movements of perhaps 3 cm.

The damage pattern of the cable shows a classic "nonlinear beam on nonlinear soil" pattern, expressed mostly of vertical settlement. The actual damage to the cable occurred due to high curvature on the exterior aluminum pipe, leading to local wrinkling of the corrugations, pushing inward on the oil tubes / paper wrap. The aluminum pipe tore, releasing the oil and allowing air into the cable. The actual aluminum cores did not appear worse-for-wear.

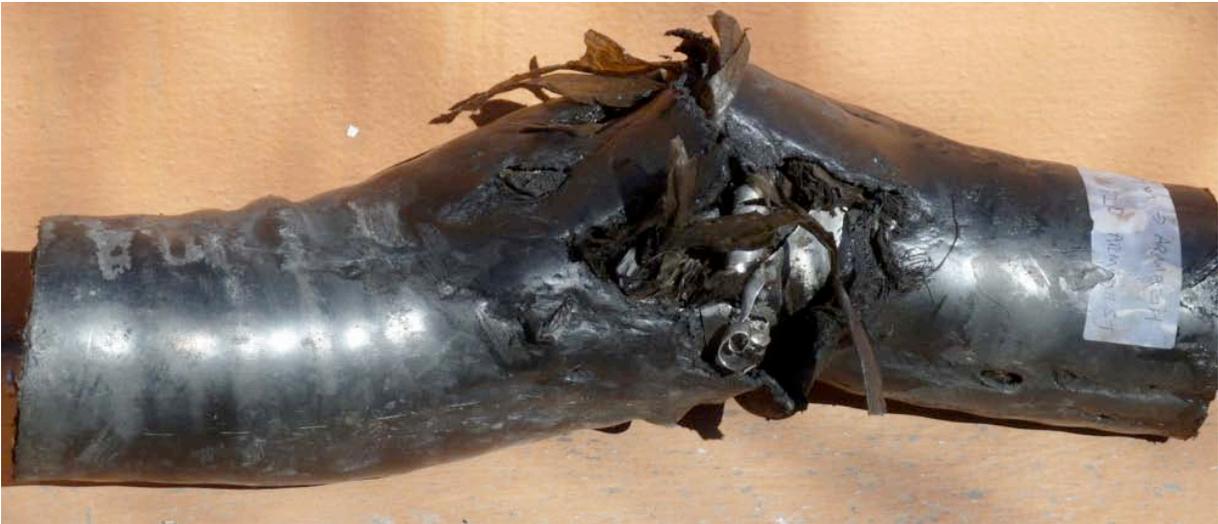
Figure 7. Oil-Type Cable (Location 3)

Figure 7 shows the cut-out section of a oil-type cable, from Location 3. The final deformed shape shows that the cable tried to deform in sharp double curvature, to accommodate a shear across the cracked thermal concrete cross section. The high curvature lead to high strain in the aluminum pipe, tearing it. Post-earthquake inspection of the roadway surface at Location 3 showed street-level knife-edge type vertical settlements on the order of 2 cm; no lateral spreads.

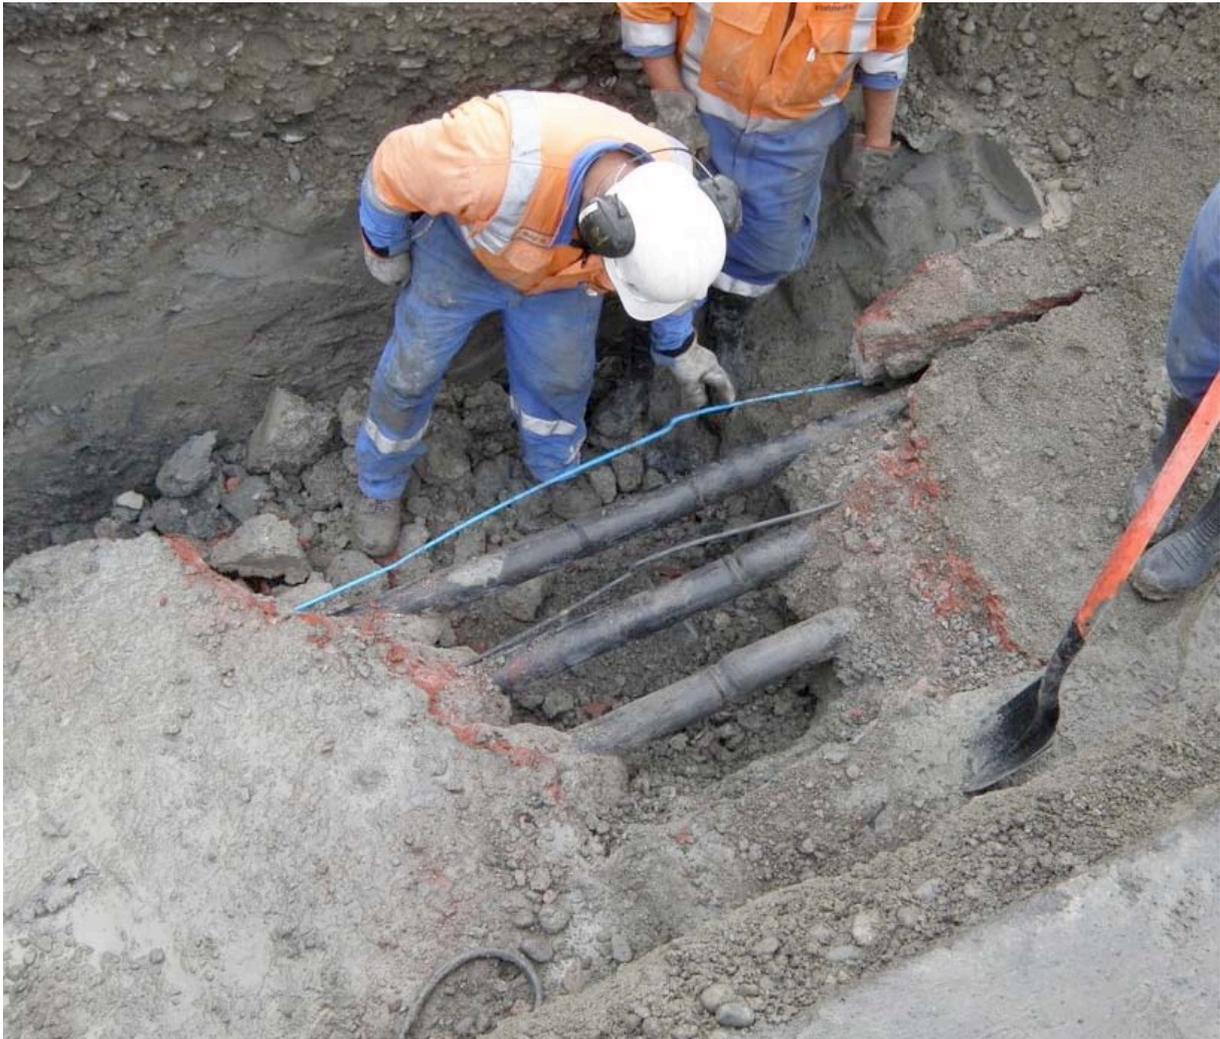
Figure 10. Exposing the Damaged XLPE-Type Cables, Location 6

Figure 10 shows work crews exposing the fault cable at Location 6.

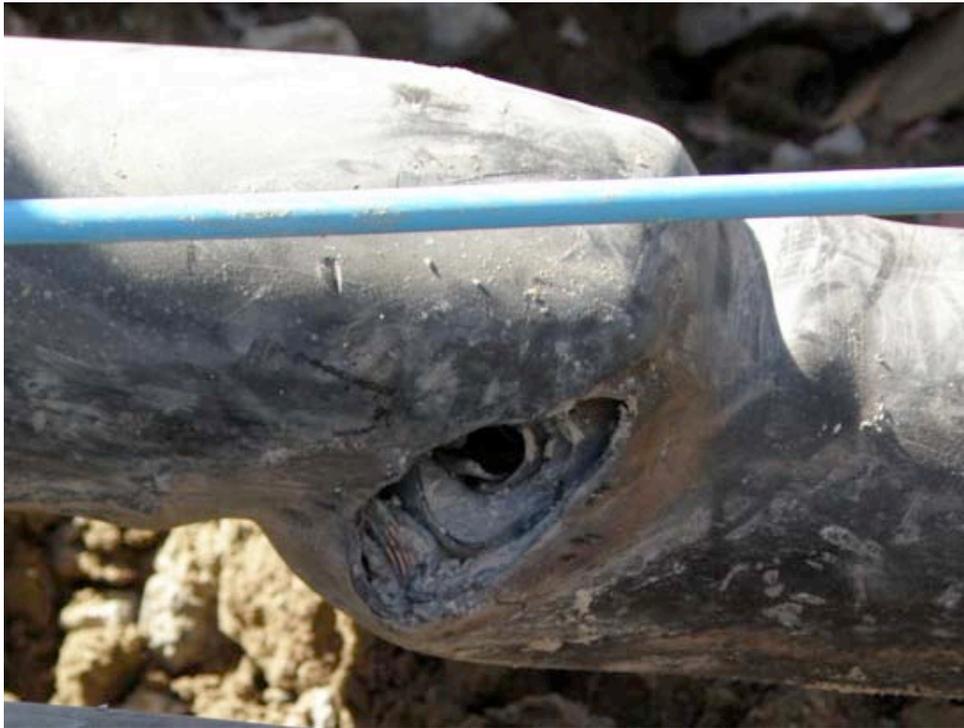
Figure 11. Failed XLPE-Type Cable, Location 4

Figure 11 shows the tell-tale reverse-curvature bend in the XLPE cable from Location 4, with a blow-out hole caused when the cable faulted. Each of the three cables had similar reverse curvature at this location. Figure 12 shows this cable after the outer HDPE coating is removed. The high reverse curvature has caused the XLPE insulation around the copper core to wrinkle outwards, tearing the outer copper sheath.

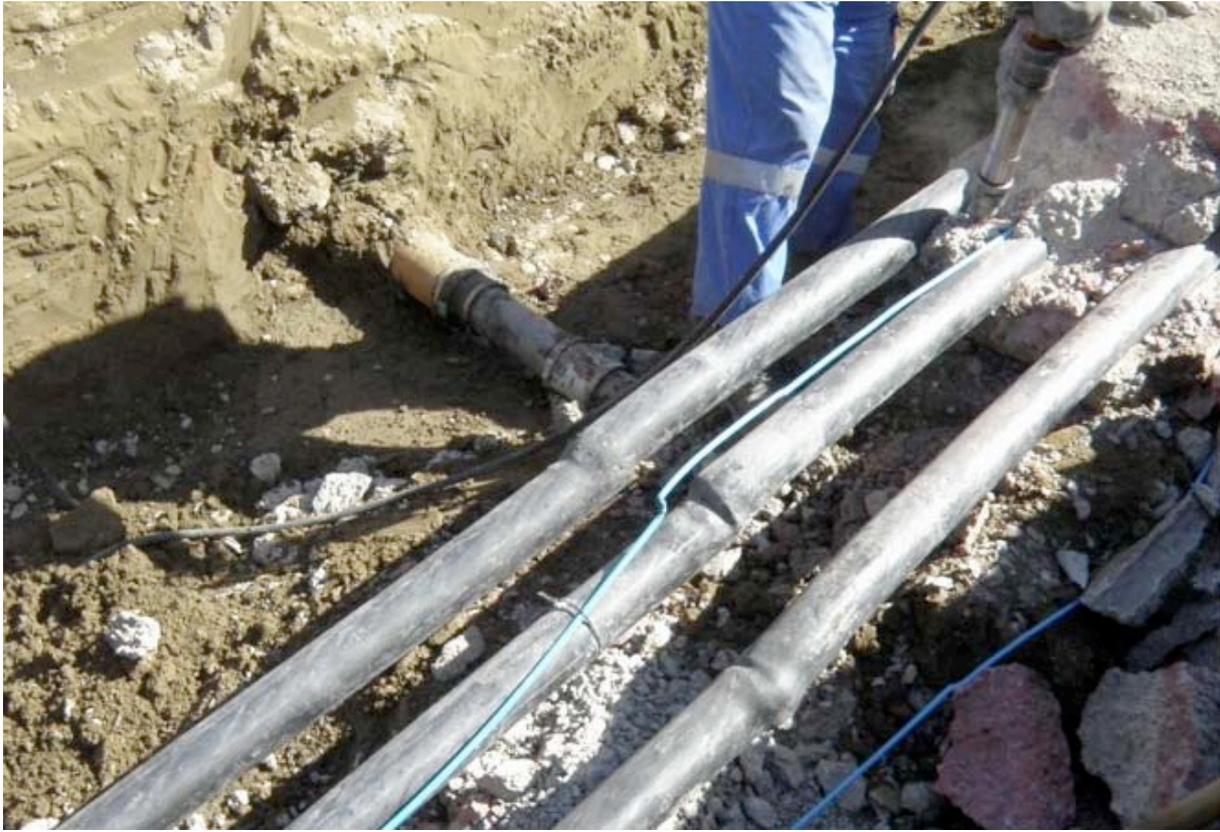
Figure 13. Failed XLPE-Type Cable, Location 5

At none of the six locations was the ground deformation "huge", and there were no major ground cracks. Figure 13 shows Location 5; the remaining locations are not all that much different with respect to damage to the streets / sidewalks.

Figure 13 shows the buckling of the XLPE-type cables at Location 5.

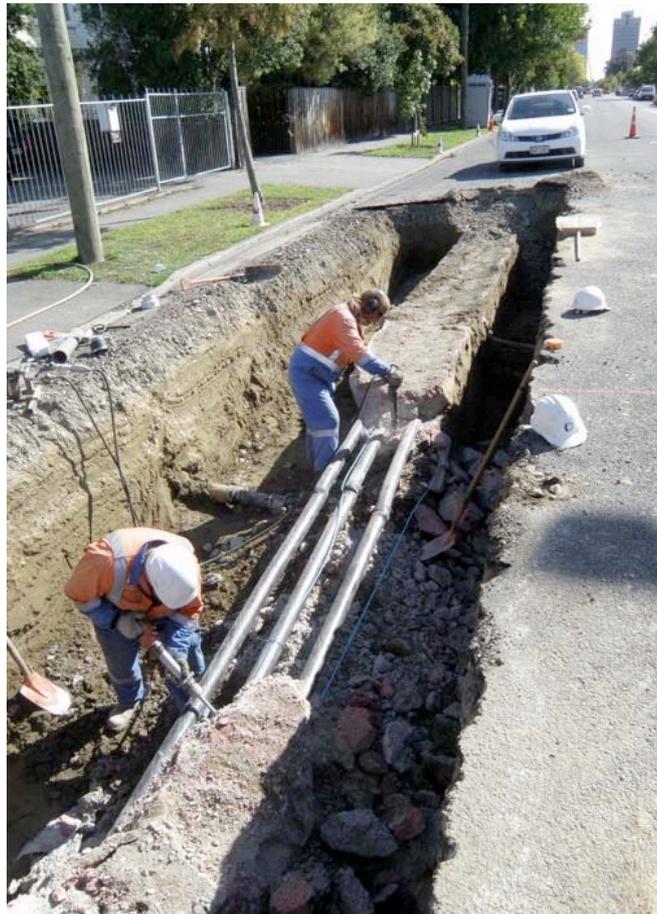
Figure 14. Street at Location 5

In discussions with Orion, it was observed that multiple people who looked at the damage locations could not discern any particular reason why the cables broke at those specific locations. Figure 14 shows the street in the vicinity of Location 5: no major ground deformations are observed.
