Maule, Chile M_w 8.8 Earthquake of February 27, 2010

By: John Eidinger, G&E Engineering Systems Inc. Copyright 2010.

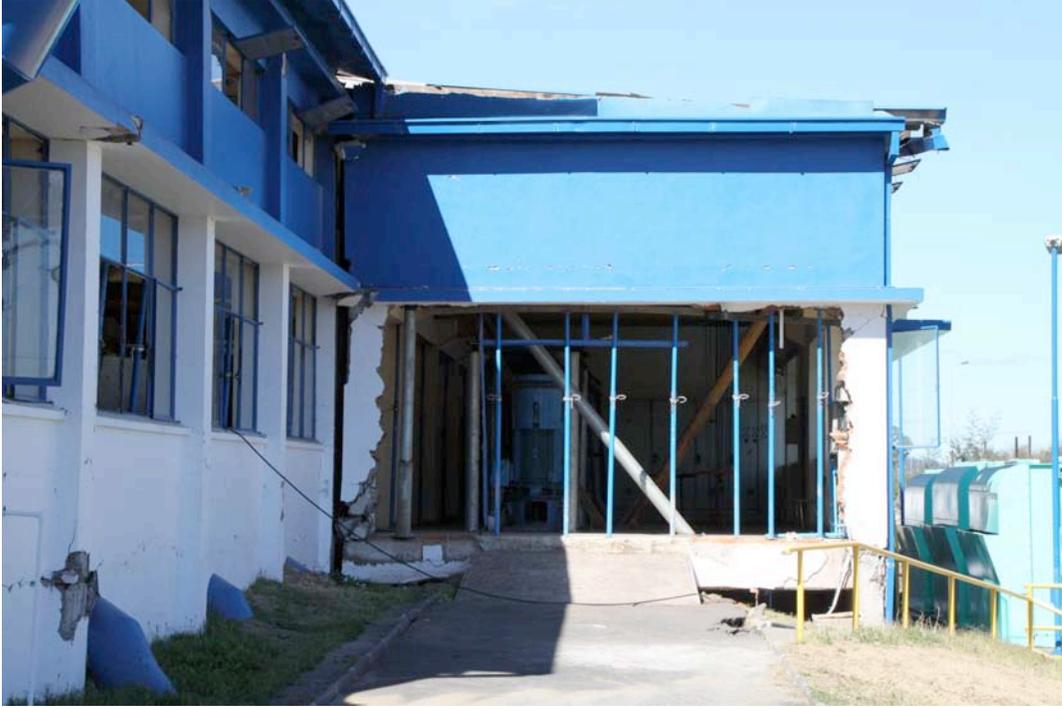
The raw water pump station includes a reinforced concrete structure supporting trash racks, and a reinforced concrete wet well that is below the pump station floor, housed in a reinforced concrete frame structure with some infill unreinforced brick panels (several damaged, Figure 8). The trash rack structure underwent about 1 foot of lateral spread and 1 inch of settlement, due to liquefaction at the shore of the river inlet. The wet well and pump station structure above did not move permanently, thereby resulting in a 13-inch wide space between the buildings. The pump station building suffered extensive damage, but did not collapse; to protect the pumps, steel "catch" structures were built after the earthquake to protect the pumps, and the pump station building was shored up and laterally braced after the earthquake.

Figure 8. Collapsed Wall at Mochita WTP Raw Water Pump Station.

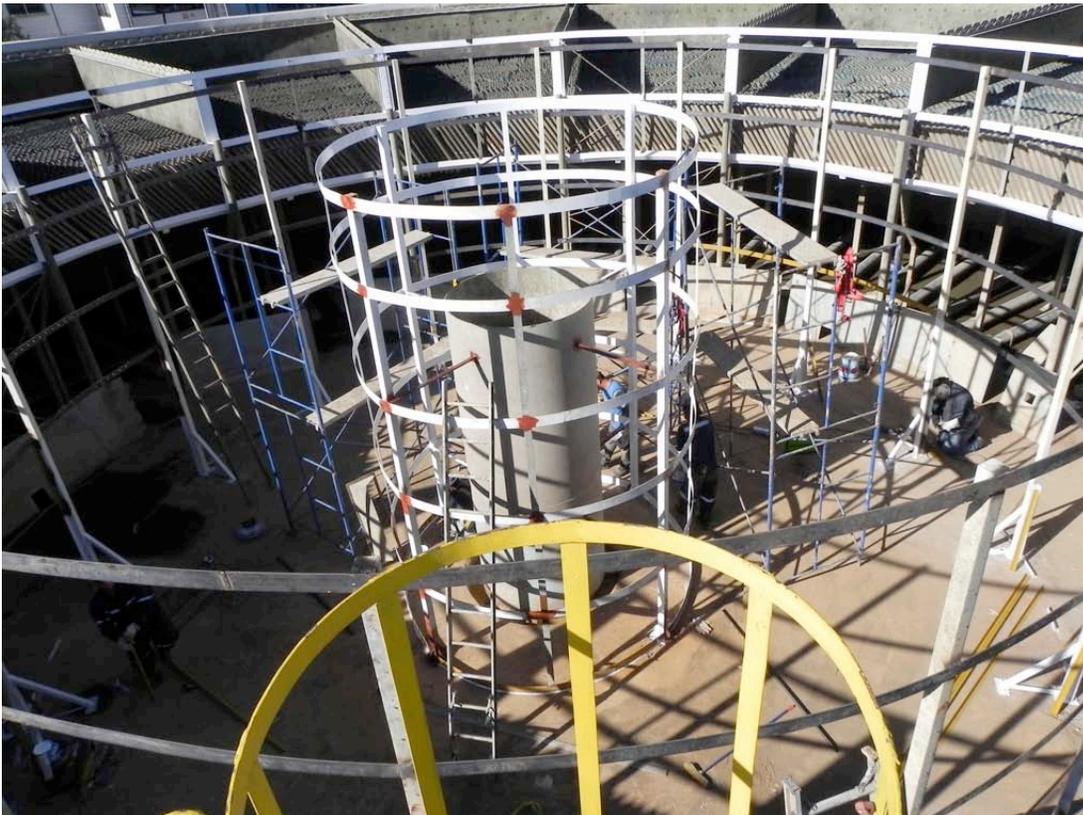
Water leaves the pump station to one of four circular clarifiers. For all four clarifiers, the center post, each set of baffle rings and many tube settlers were damaged or dislodged by sloshing / water loads (Figure 9). As of 6 weeks after the earthquake, one of the four clarifiers was being repaired; while the three others remained in service (albeit with short-circuits and lower efficiency).

Figure 9. Repairs being made to Clarifier at Mochita WTP

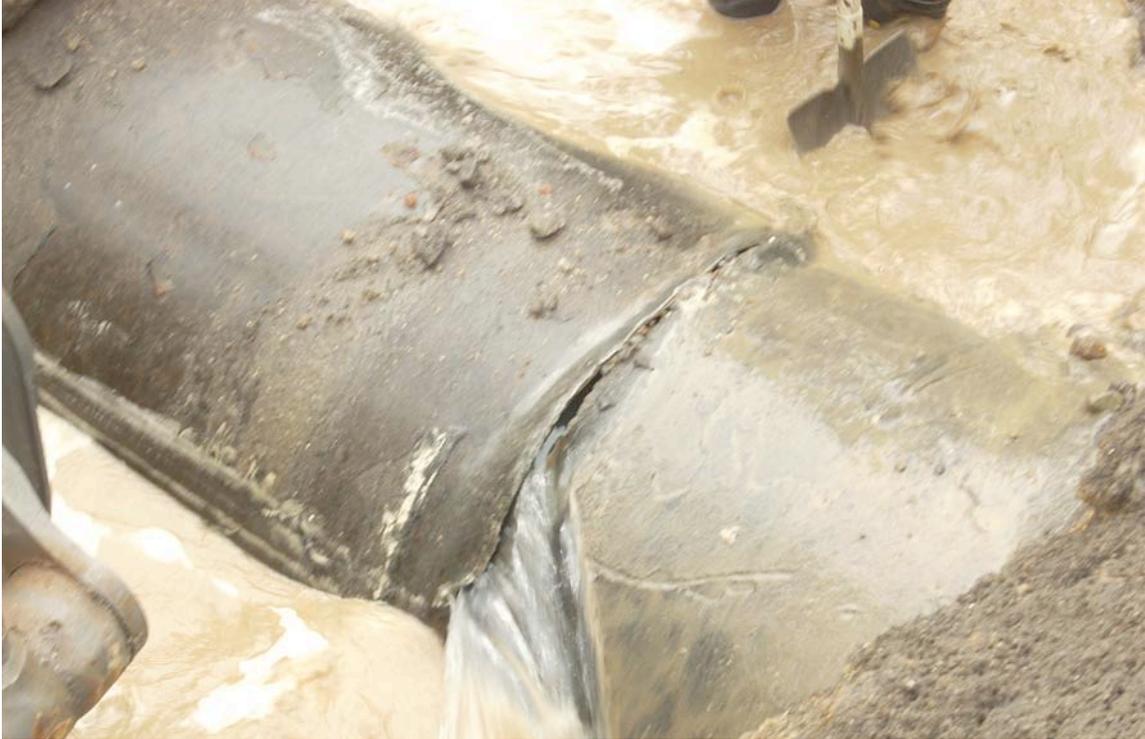
The treated water transmission lines leaving the WTP are welded steel, commonly 500 mm to 1000 mm diameter. There were 72 failures in these pipes; Figure 10 shows one such example, showing a wrinkled steel pipe with tear and leaking water. Most of the failures appear to be attributed to settlements and lateral spreads. See Figures 27 to 33 for additional examples of damage to large diameter transmission pipes.

Figure 10. Damaged Large Diameter Welded Steel Water Pipe

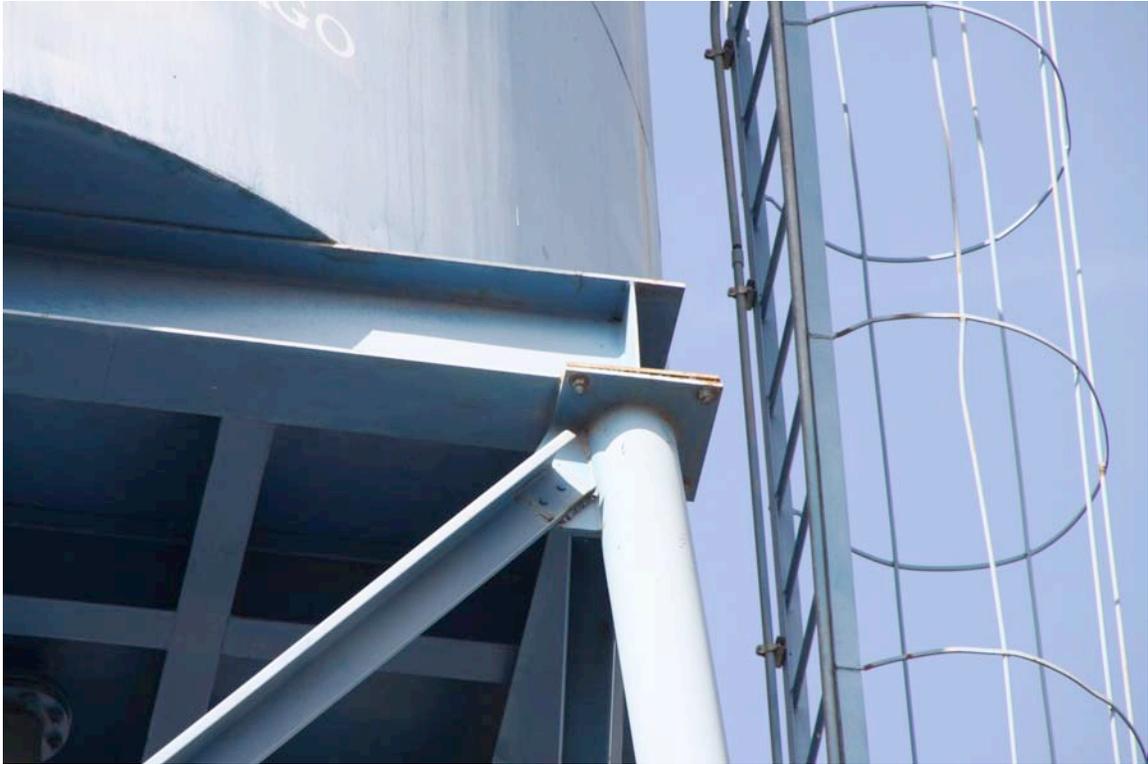
Figure 11 shows a common elevated steel tank (undamaged). It is estimated that there are more than 1,000 nearly identical tanks situation throughout rural Chile. Figure 12 shows the steel tank resting (it is welded, but the welds cannot be seen in the photo) on a steel beam; and one of the four tubular column-upper frame connections; it is suspected that this bolted beam-to-column connection was the weakest link that led to the many collapses. Figure 13 shows one of the 73 collapsed tanks. It was reported that in a few cases the collapsed tank damaged nearby structures with casualties due to the impacts. We obtained conflicting data as to the total number of such tanks that collapsed; we verified 73, but one official indicated the total was over 400. In any case, we estimate that most (more than 75%) of these types of elevated steel tanks collapsed, if they experienced ground motions of PGA much over 0.25g.

Figure 12. Column – Frame Connection (Constructed 2006)

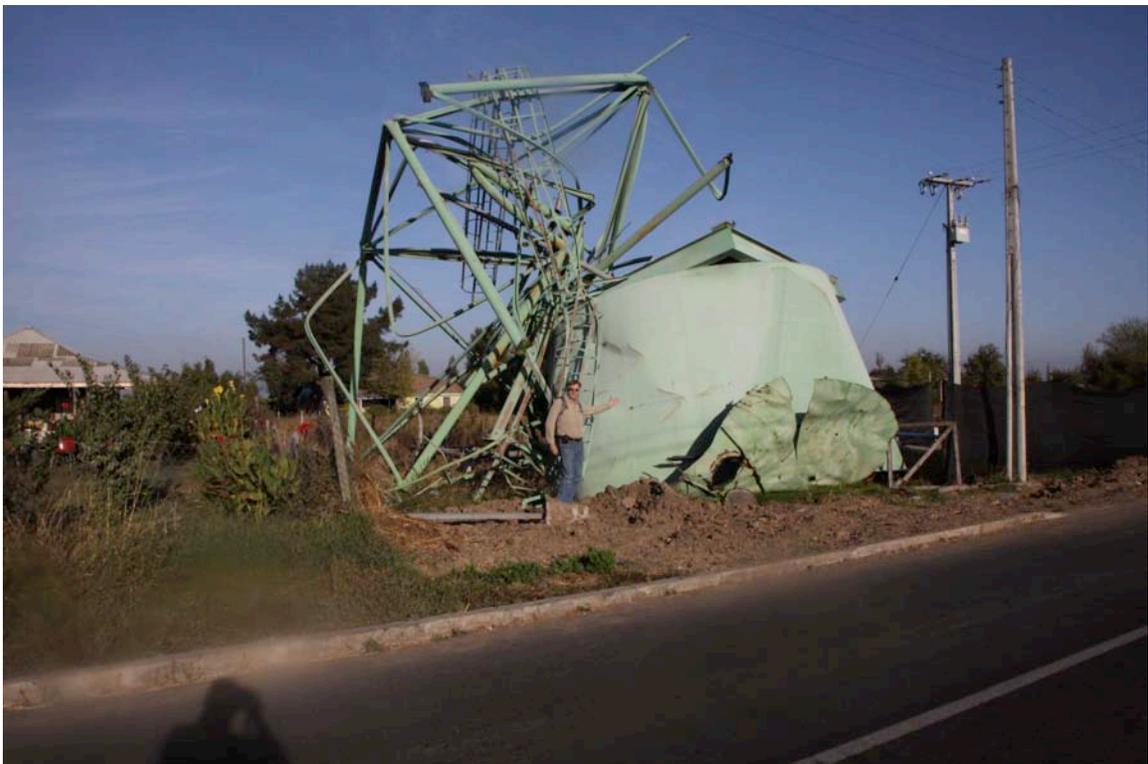
Over the past 50 years, the federal government of Chile has constructed nearly 2,000 small rural potable water systems country-wide, of which about 420 were in the strong earthquake-shaking areas. The common system uses a well with submersible pump (about 100 to 600 feet deep, depending on the local aquifer), an elevated water tanks (commonly a steel tank atop steel braced structure, with tank storage volume of about 10,000 gallons), and PVC distribution pipe. In Regions VI, VII and VIII, at least 73 of the elevated tanks completely collapsed. Tank failures were due to inertial overloads.

Figure 13. Typical Collapsed Elevated Small Steel Tank (Constructed 1999)

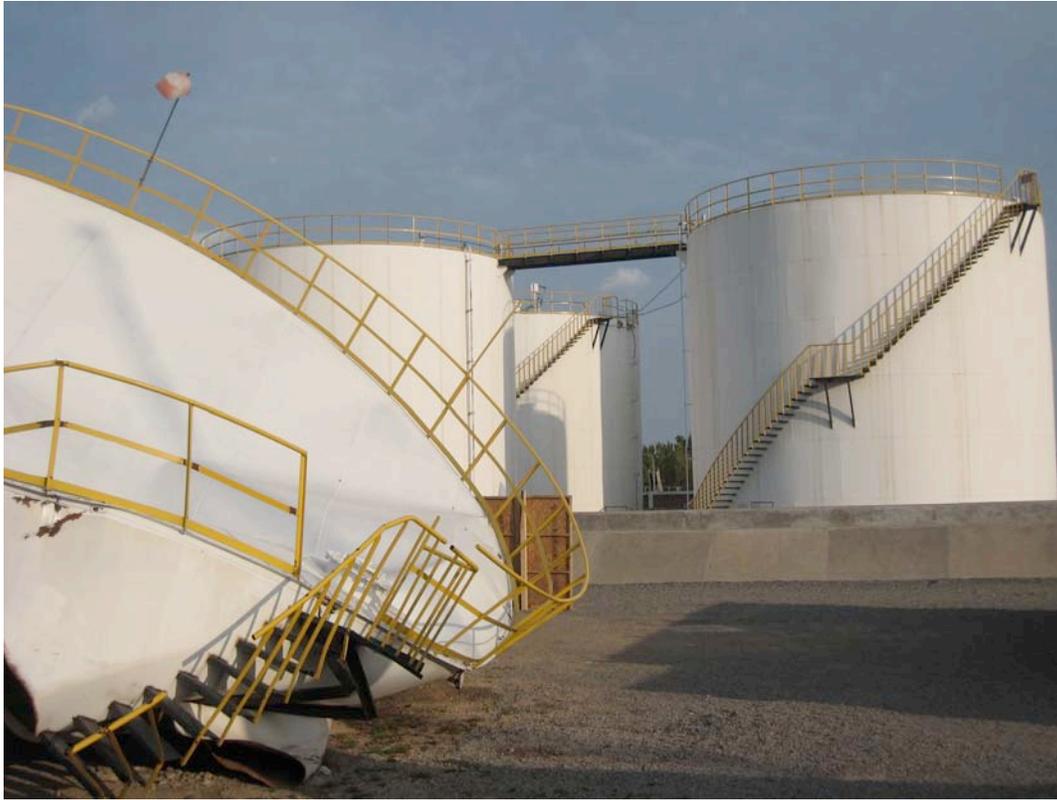
- Very high local ground motions (say $PGA > 0.8g$ or so). We have no local site instrument to provide this information, but the apparent modest levels of damage to four (partially filled) liquid fuels tanks and pump station building suggests that the local level of ground motion was not more than $PGA = 0.25g$ to $0.35g$.

We were unable to gain access to carefully inspect the performance of the nearby liquid fuels tanks. However, their observed (from the site boundary, about 100 feet from the tanks) minimal damage suggests that they were designed at the same time as the water tank, using the same paint system and same staircase designs. The lack of damage to the somewhat larger (taller) liquid fuel tanks to the water tanks suggest that possibly they were no more than 50% full at the time of the earthquake, a not uncommon practice.

Figure 14. Collapsed Water (Foreground Left) and Nearby Liquid Fuels Tanks at Santiago Airport

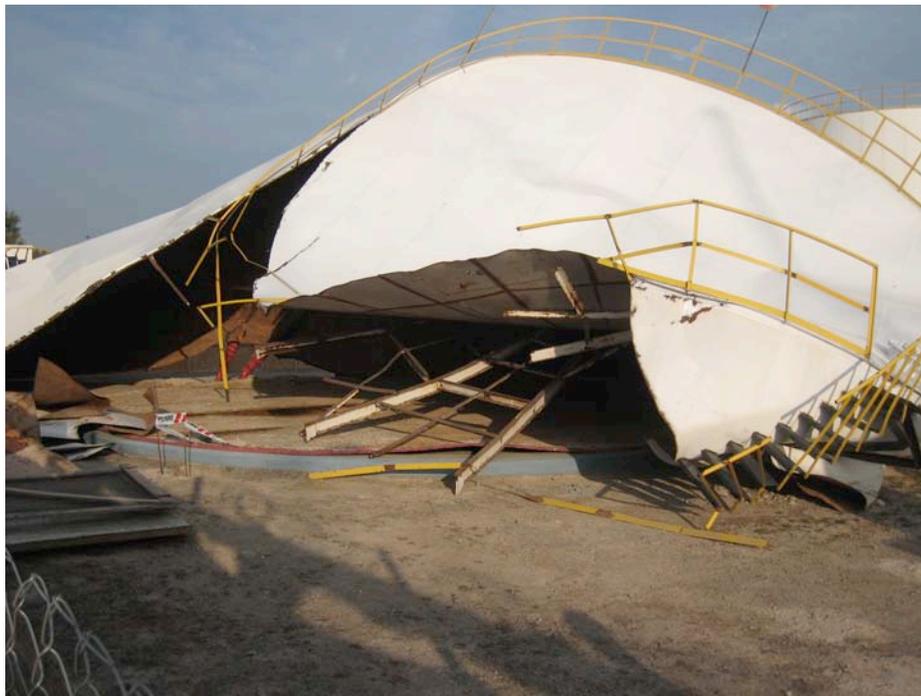
- Tank wall uplift leading to tearing of the bottom course – floor plate welds. This is the most likely cause of failure. This clearly demonstrates the fallacy of assigning $R = 3.5$ to 4.5 for unanchored steel tanks (implied by all AWWA D100 code versions since the early 1970s) coupled with long duration of ground shaking.

- Accumulating corrosion could have weakened welds and steel plates. We observed a modest amount of corrosion on the exterior of the tank. The interior of the tank appeared to have a fair amount of corrosion below the water line, and major corrosion above the water line.

- Once the tank wall-floor plate tore due to a combination of wall uplift (repeated cycles) and wall buckling, the tear likely propagated up a vertical full penetration weld. With the tearing of the tank wall, the high rate of release of water through the vertical tear would have caused the gross opening up and movement of the wall, leading to further tearing of the wall-floor plate around much of the circumference (Figure 15).

Figure 15. Collapsed Water Tank at Santiago Airport

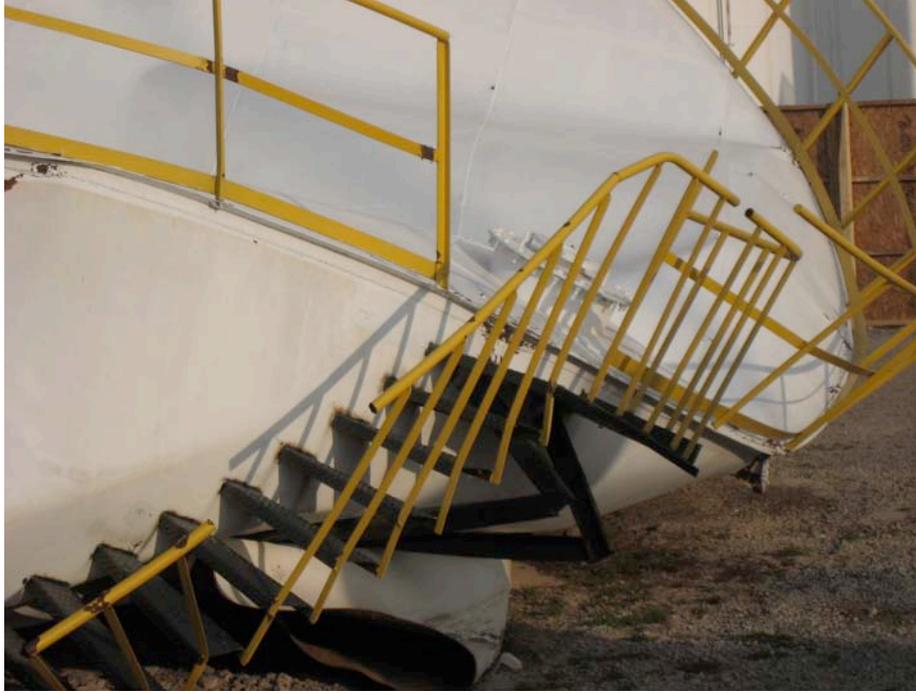
The observed failure modes appeared to be tearing of the bottom course from the steel floor plate, with a nearly uniform tear vertically along one of the vertical seam welds in the lower courses (Figure 16). This led to collapse of the tank, with subsequent buckling and tearing of the steel.

Figure 16. Roof-Wall-Staircase Connection of Collapsed Water Tank at Santiago Airport

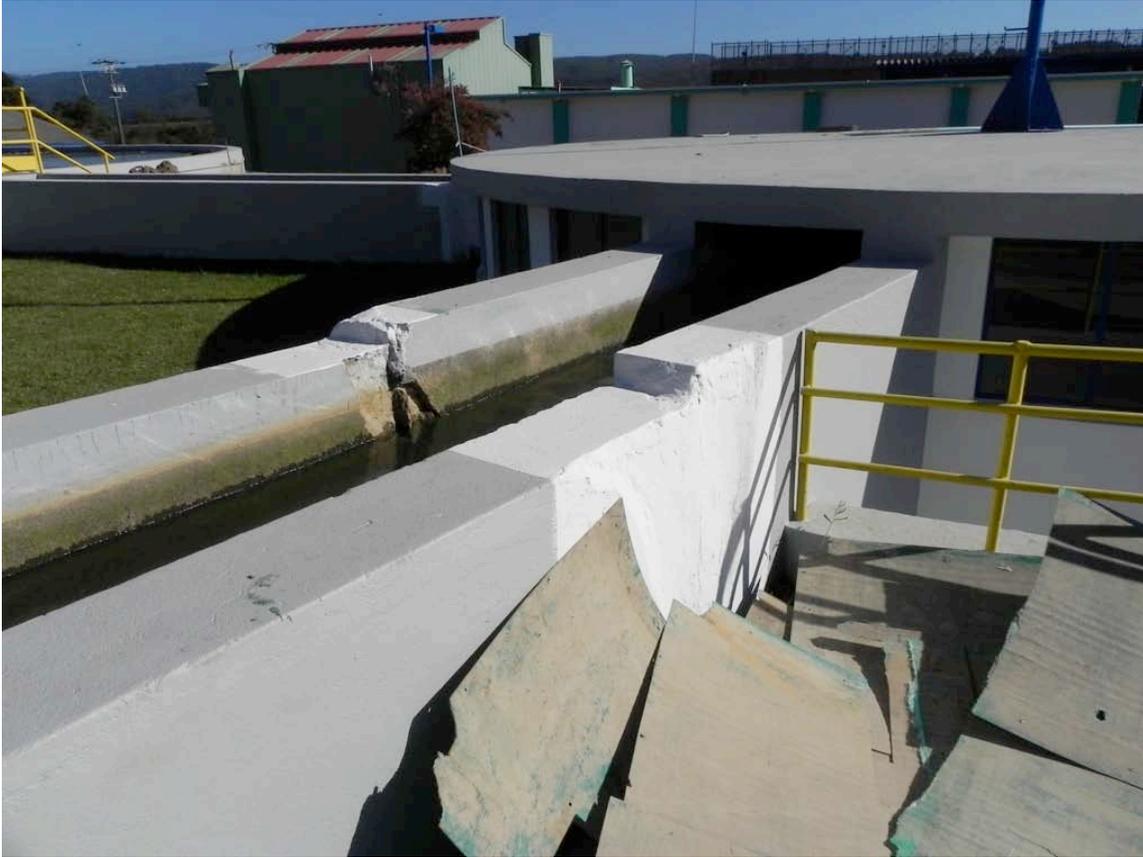
Figure 17 shows settlement at the Mochita WTP that led to damage of a u-shaped concrete water channel.

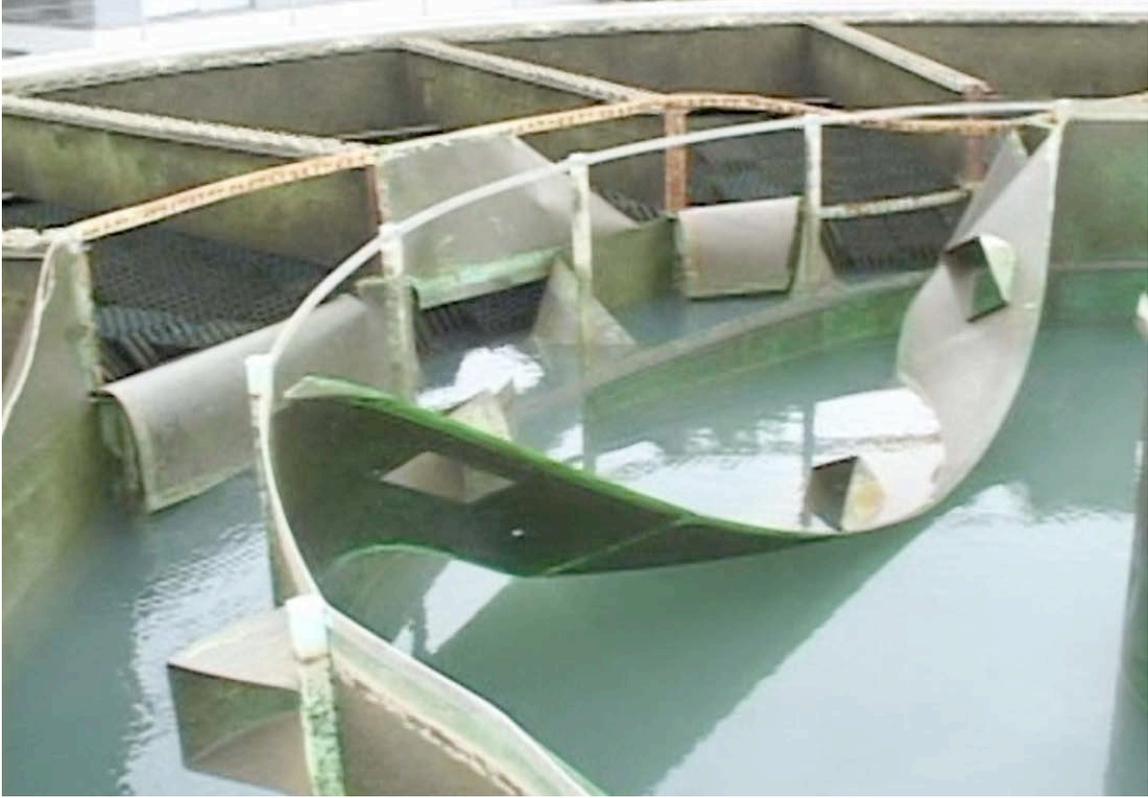
Figure 18 shows damage to the baffles at one of the four clarifiers at the Mochita WTP. Some tube settlers are displaced in the background. There was similar damage to all four clarifiers.

Figure 18. Damaged Baffles at Mochita WTP

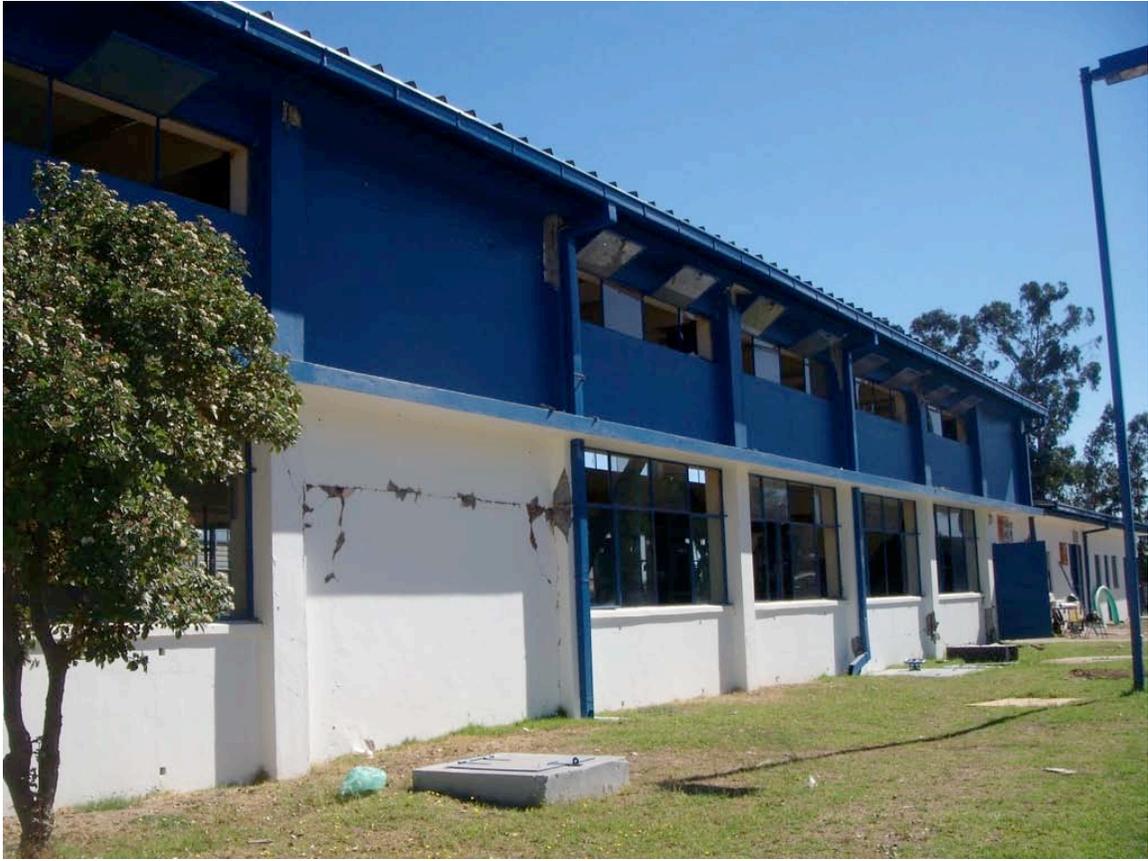
Figure 19 shows the damage to the pump station at the Mochita WTP. The building uses non-structural infill walls (some cracked) and has non-ductile concrete columns. While the building did not collapse, there was much concern that it might subsequently collapse in an aftershock. Should the building collapse, it would damage the motors and pumps within, leaving Concepcion without any source of water. Accordingly, Essbio installed steel braces and "catchers" around all the motors (Figure 20) to assure that a subsequent building collapse would not impact the equipment.

Figure 19. Damage to the Pump Station at Mochita WTP

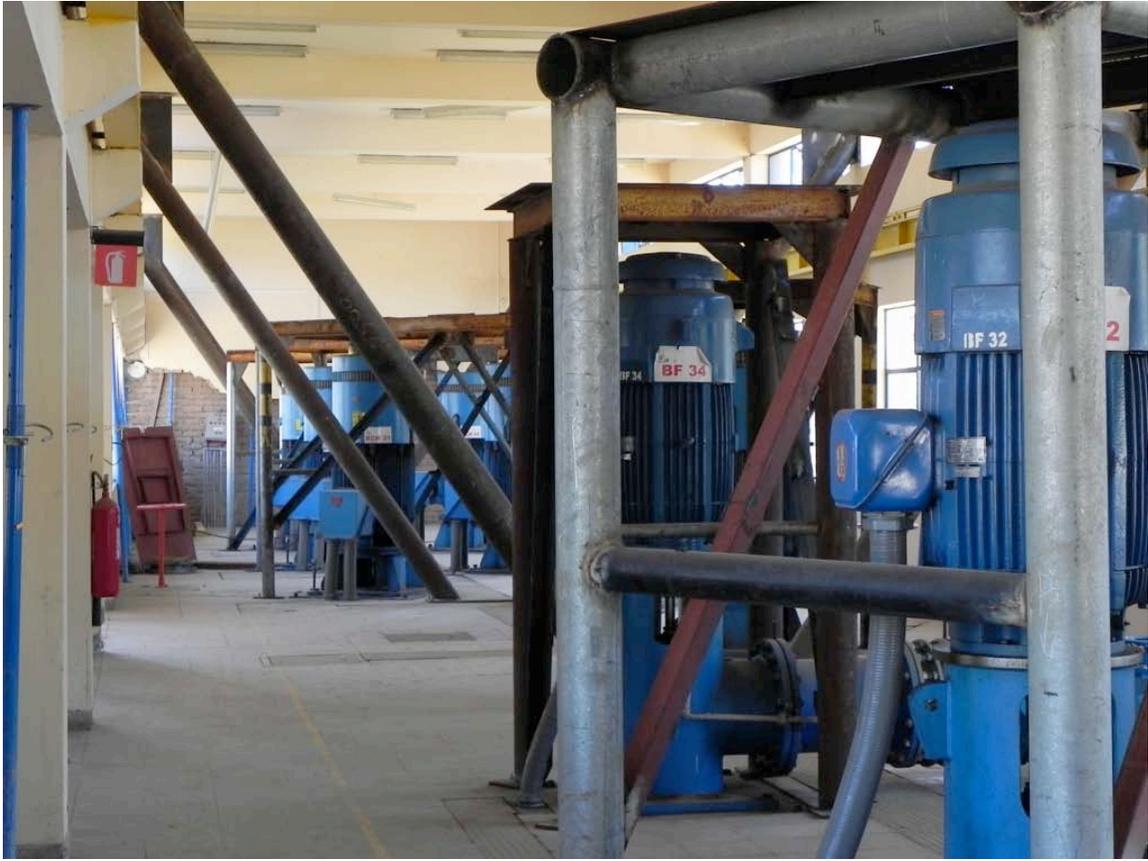
Figure 20. Installed Steel Braces and "Catchers" over Pump Station Motors

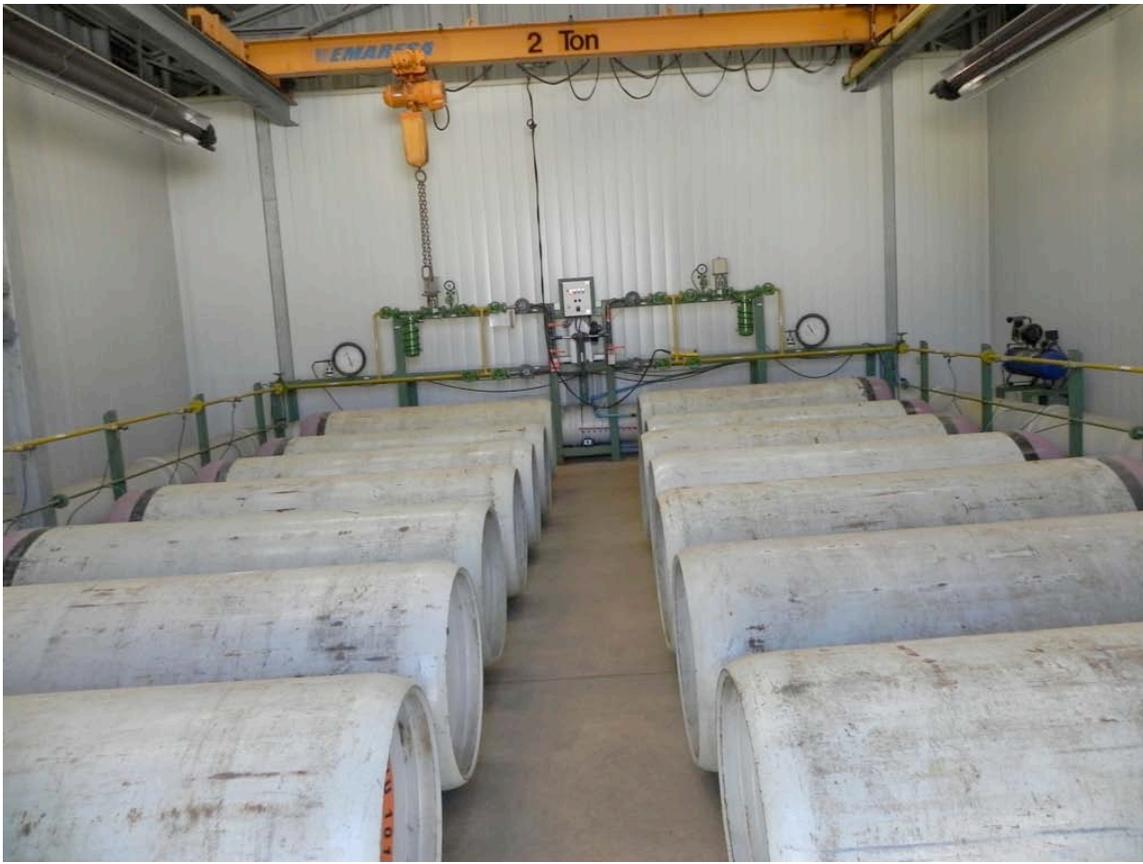
Figure 21 shows 14 "one ton" chlorine tanks at the Mochita WTP. These are located within a steel building. None of the tanks were anchored, and we could observe no evidence of sliding of the tanks on their wood skid supports. Plant staff confirmed that there was no sliding of the tanks. Had ground motions been PGA of 0.60g or larger, there would almost certainly have been some sliding of the tanks. While there was no strong motion instrument near the WTP, we relied on observed evidence to estimate the actual motions. Given the various levels of damage to non-structural items (like bookcases, windows, suspended ceilings, etc.) we estimate the actual horizontal PGA at the site to have been about 0.30g to 0.45g.

Figure 21. Chlorine Tanks at Mochita WTP

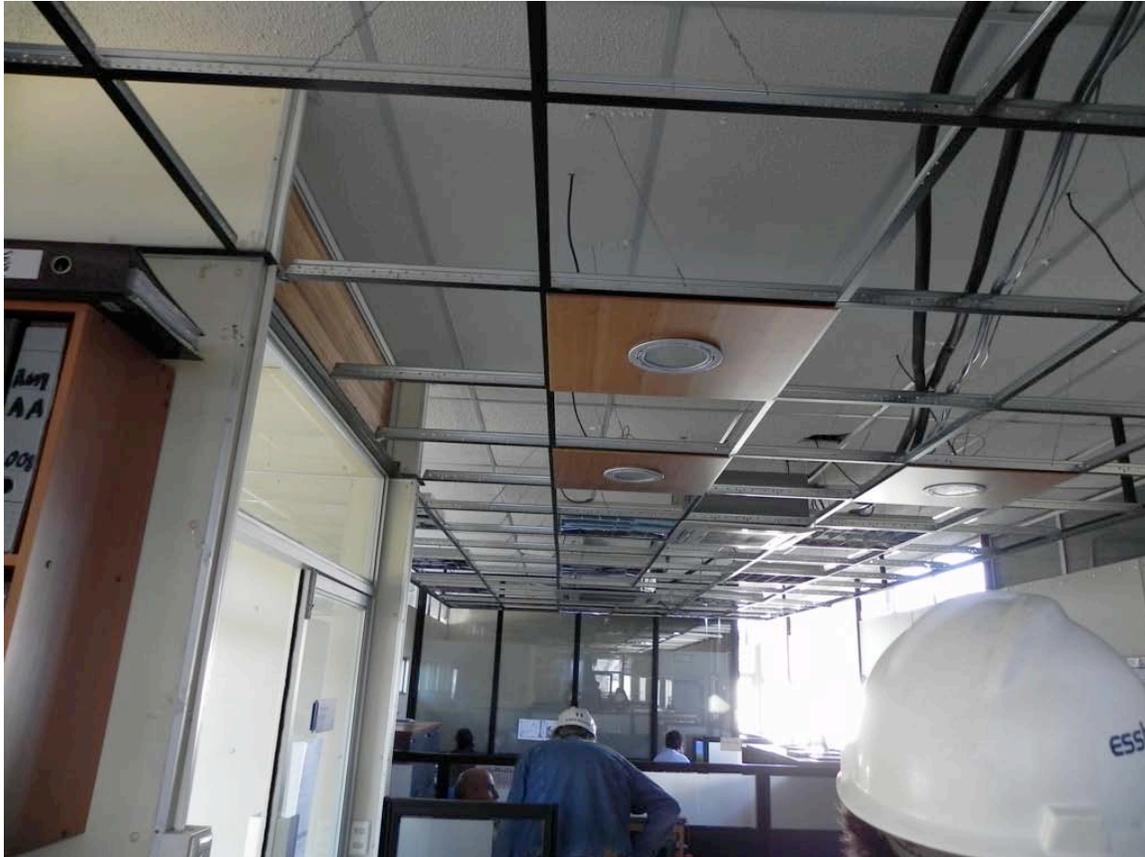
Figure 24 shows a partially fallen suspended ceiling at the WTP. The fallen tiles and materials had no life safety consequences, and the plant operators who were on shift at the time of the earthquake reported no egress issues. This suggests that code provisions to require "seismic design" for suspended ceilings as a "life safety" requirement are not entirely logical. Instead, it would make some sense to improve these types of ceilings over critical areas (such as control rooms, and using proper seismic detailing), while accepting lower cost suspended roof installations in other areas (warehouses, etc.). For "life safety", it would appear sufficient to add wires to heavier items in roofs to prevent them from falling on people below. For locations where there are potential sprinkler pipes that have sprinkler heads through the suspended ceiling, the pipe-ceiling interaction needs to be considered, as impacts of the ceiling with some types of sprinkler heads can snap off the heads leading to unwanted water release and damage. In the USA, a wire-hung suspended ceiling might cost about \$3 per square foot to install; test data shows that modern code provisions for "seismic" suspended ceilings (wire diagonals plus compression struts) provides little or no capacity much beyond $PGA = 0.4g$ or so. The cost to build truly "seismic" suspended ceilings with complete lateral load paths with load rated components can easily cost 10 times the basic cost of a suspended ceiling. Given the cost and performance issues, and the common observation that suspended ceilings tend to fall apart at about $PGA = 0.30g$ to $0.40g$ or so, suggests that the current codes and

Figure 24. Damaged Suspended Ceiling

state of practice in the USA are resulting in extra cost for "seismic bracing" without delivering much in the way of extra seismic performance; for those interested in good performance of suspended ceilings, it is suggested that a qualified engineer verify the complete load path of the ceiling system.

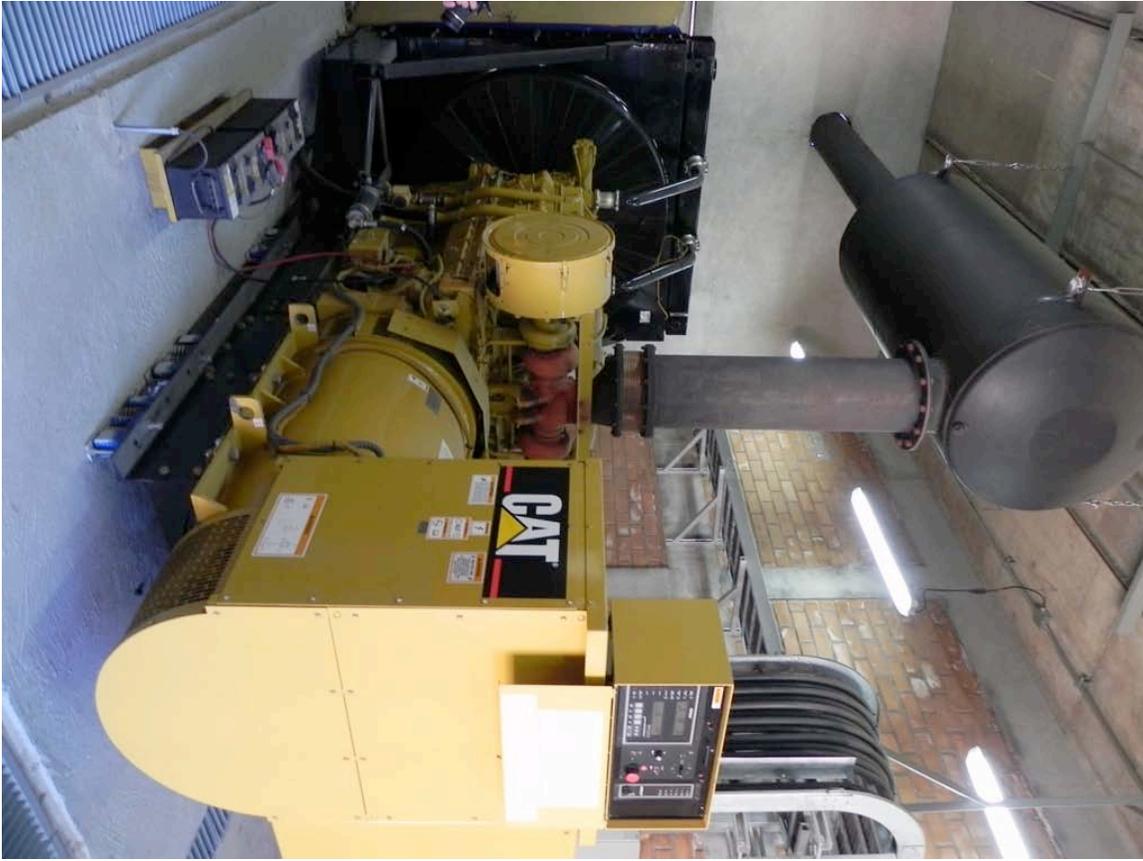
The diesel generator for the WTP is shown in Figure 24. Note the unrestrained startup batteries on the left. The steel skid rests on spring isolators, one of which became dislodged during the earthquake. According to plant staff, the offsite power went out almost immediately after the earthquake; the plant operator turned on the emergency generator 45 minutes after the earthquake; the generator started on demand.

Figure 25. Emergency Generator at Mochita WTP

In the USA, we would recommend that the startup batteries be properly restrained (there were not for this generator), and put in suitable "snubbers" to restrain the isolated generator. Neither of these improvements were in place at the time of the earthquake, yet the generator performed as required, even if a isolator was damaged. This suggests that the level of ground motion was not over $PGA = 0.50g$, as the batteries would almost certainly have slid / toppled. Still, the relative low cost to restrain batteries (usually under \$200) and snub a generator (usually under \$2,000) seems like a good practice for such a vital piece of equipment at a WTP.

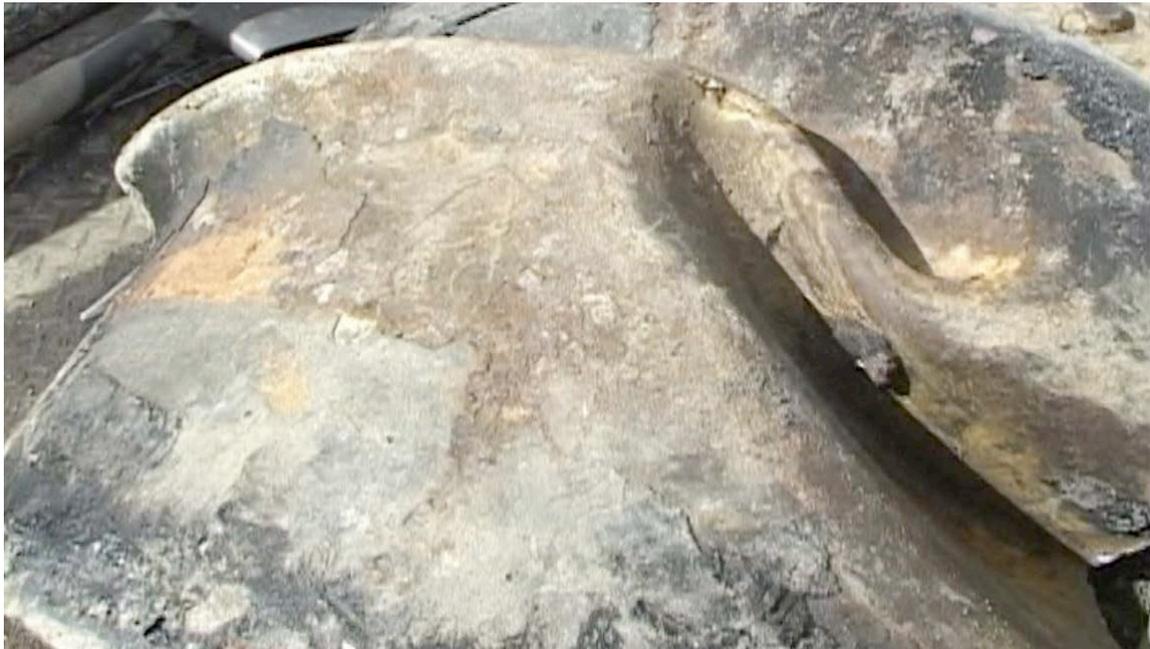
Figure 27. Wrinkled Steel Pipe

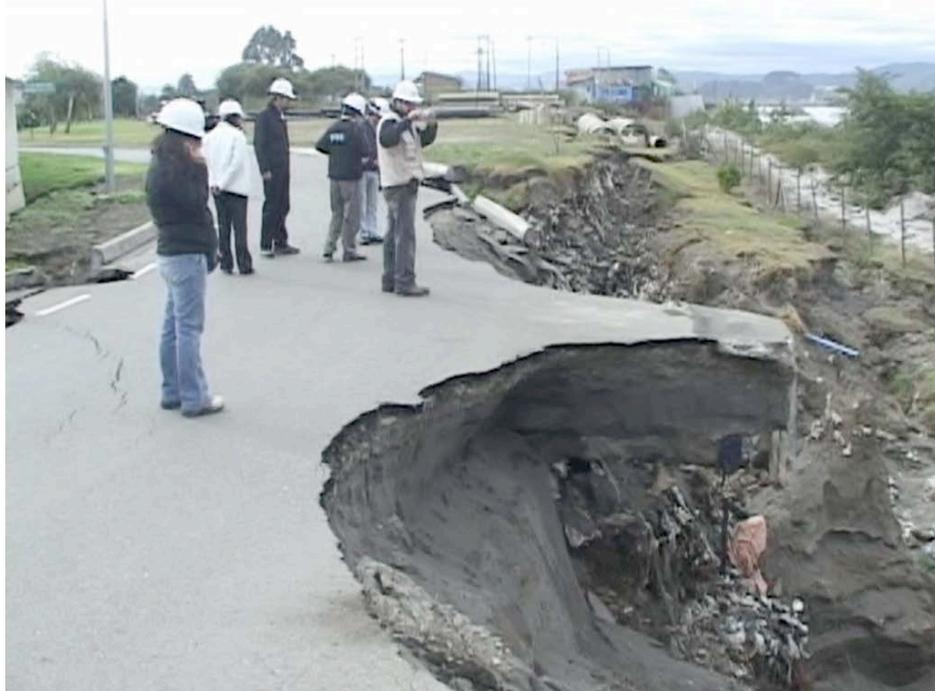
Figure 28. Erosion due to Large Diameter Pipe Failure

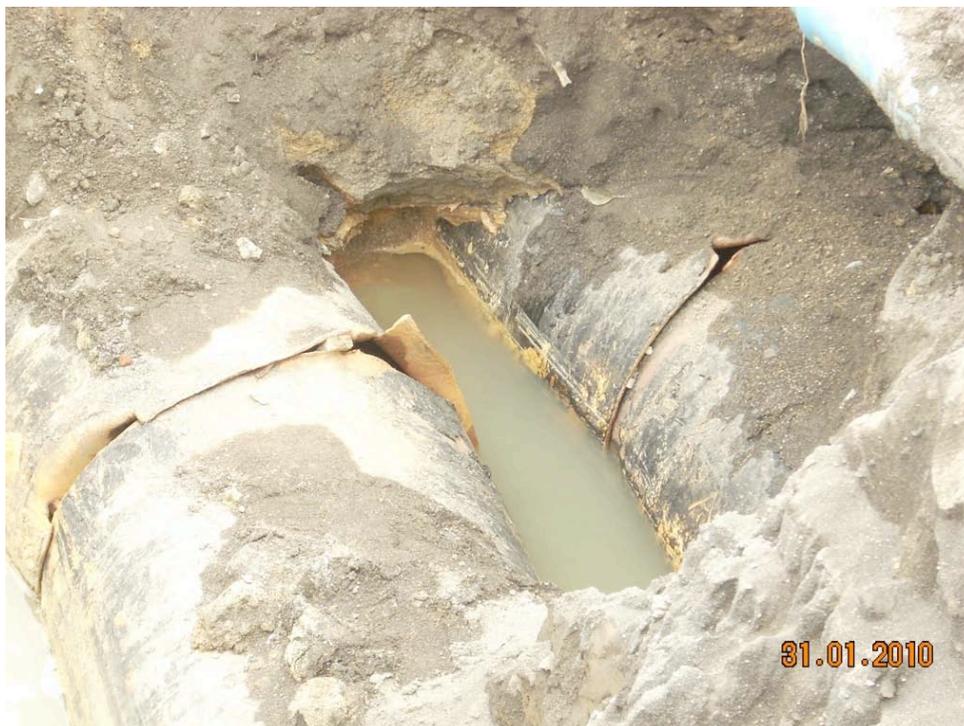
Figure 29. Failure of two Parallel Steel Pipes at Same Location (date stamp incorrect)

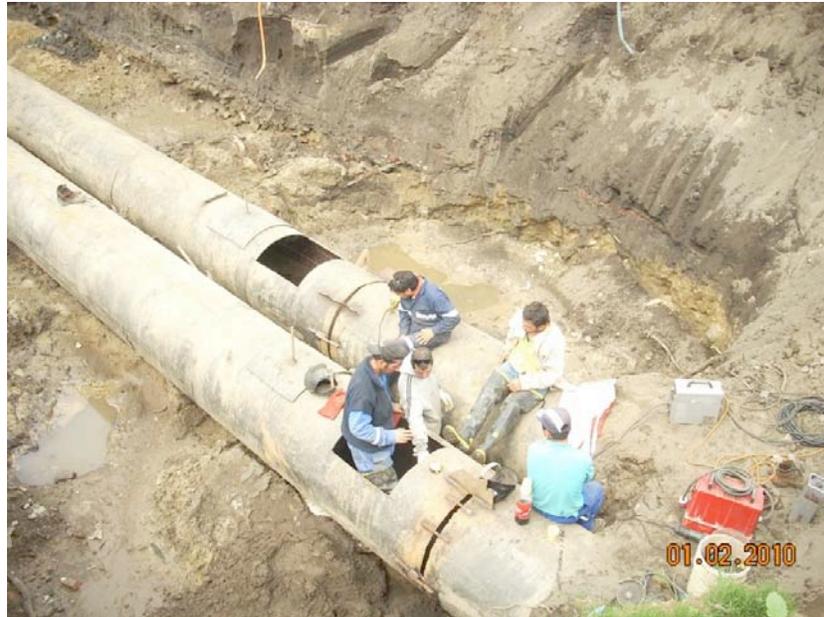
Figure 30. Repair Effort for Two Parallel Failed Steel Pipes (date stamp incorrect)

Repairs are being made to two steel pipes. Temporary manholes are cut; the pipes aligned with external bars; and then custom-made butt straps installed. Common repair times for a crew, per steel pipe were on the order of 48 hours (working 24 hours shifts) (not including disinfection or repairing the road).

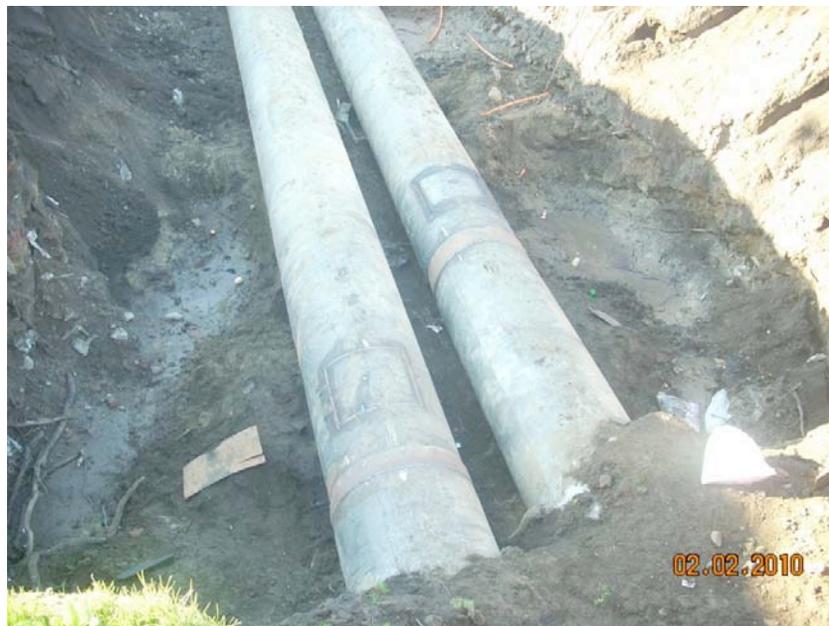
Figure 31. Repairs Completed (date stamp incorrect)

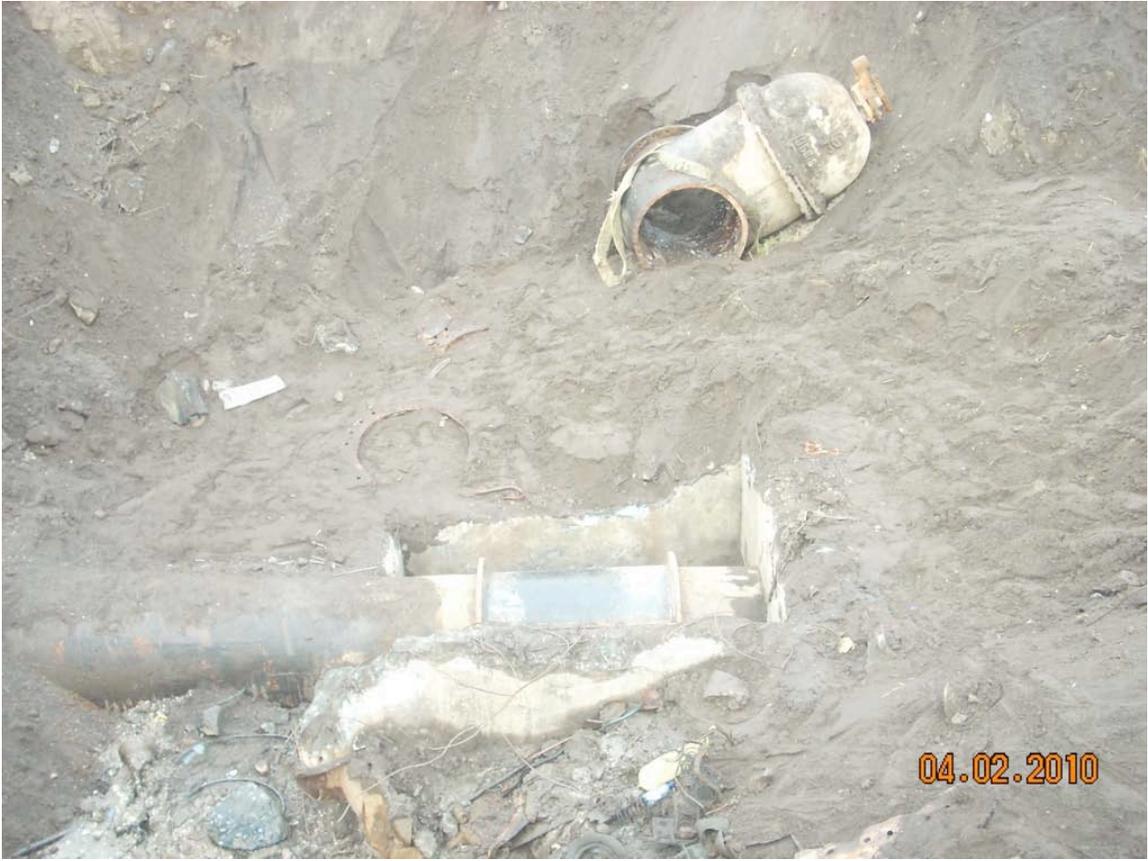
Figure 32. A broken ~36" diameter gate valve (flange failure) within a concrete vault was resolved by removing the valve and replacing it with a straight piece of pipe. The lack of spare valves, parts and the urgent need to restore water supply led to this type of repair.

Figure 32. Broken Gate Valve and Pipe Repair in Vault Remnants

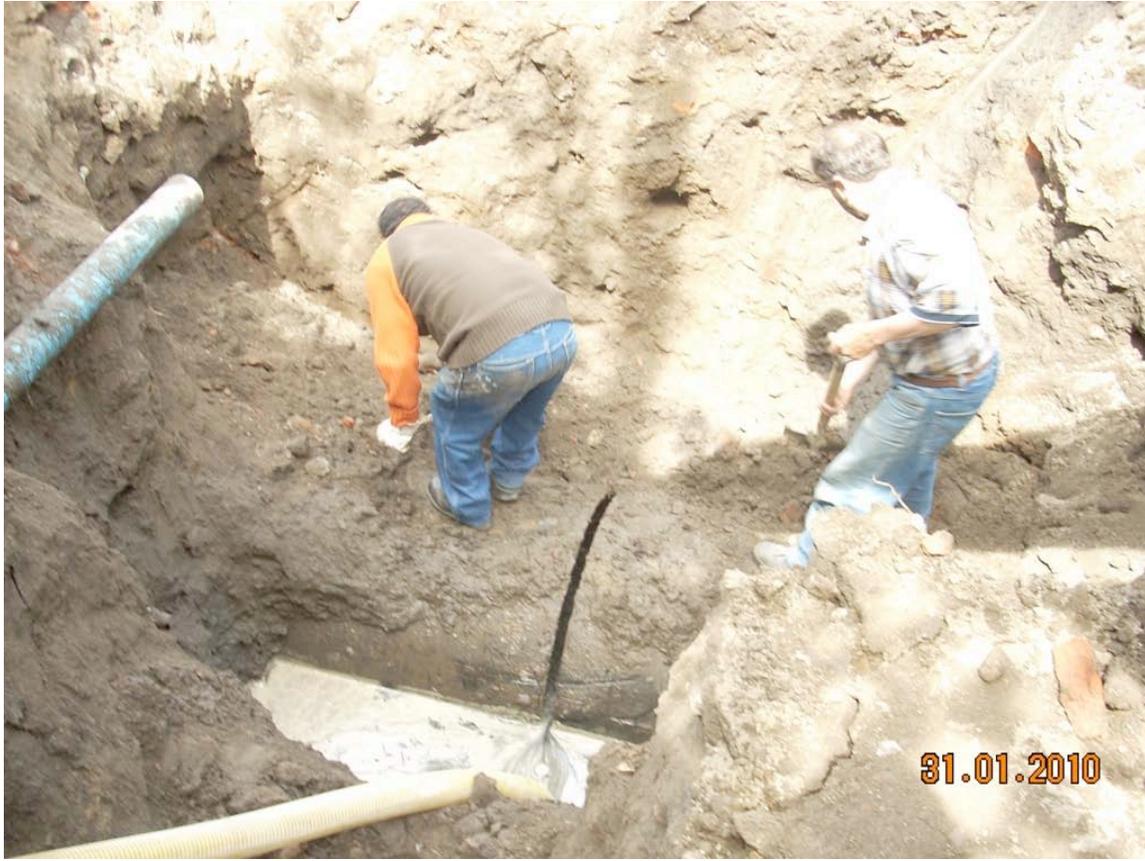
Figure 33. Another Pipe Break (date stamp incorrect)

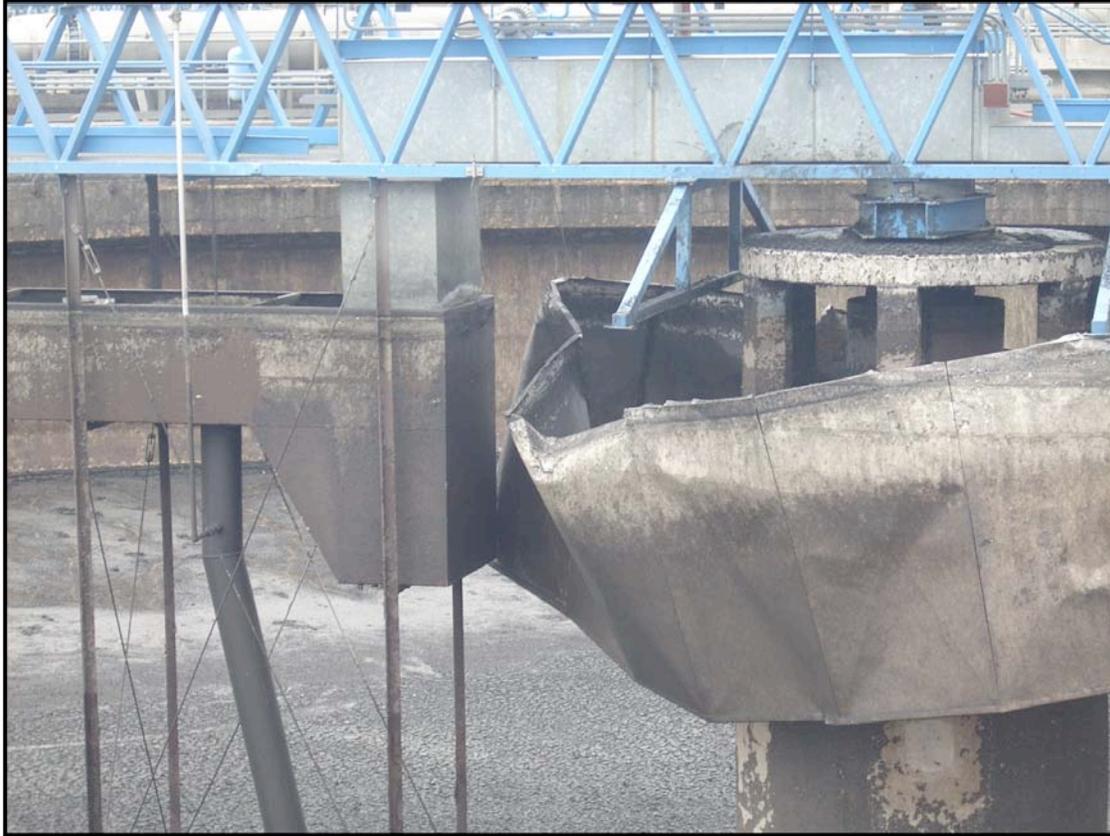
Figure 34 shows damage to the baffles at a clarifier at the Concepcion Wastewater Treatment Plant (WWTP). Figure 35 shows damage to the external concrete walls of the clarifier.

Figure 34. WWTP Clarifier Damage
