Maule, Chile M_w 8.8 Earthquake of February 27, 2010

By: John Eidinger, G&E Engineering Systems Inc. Copyright 2010.

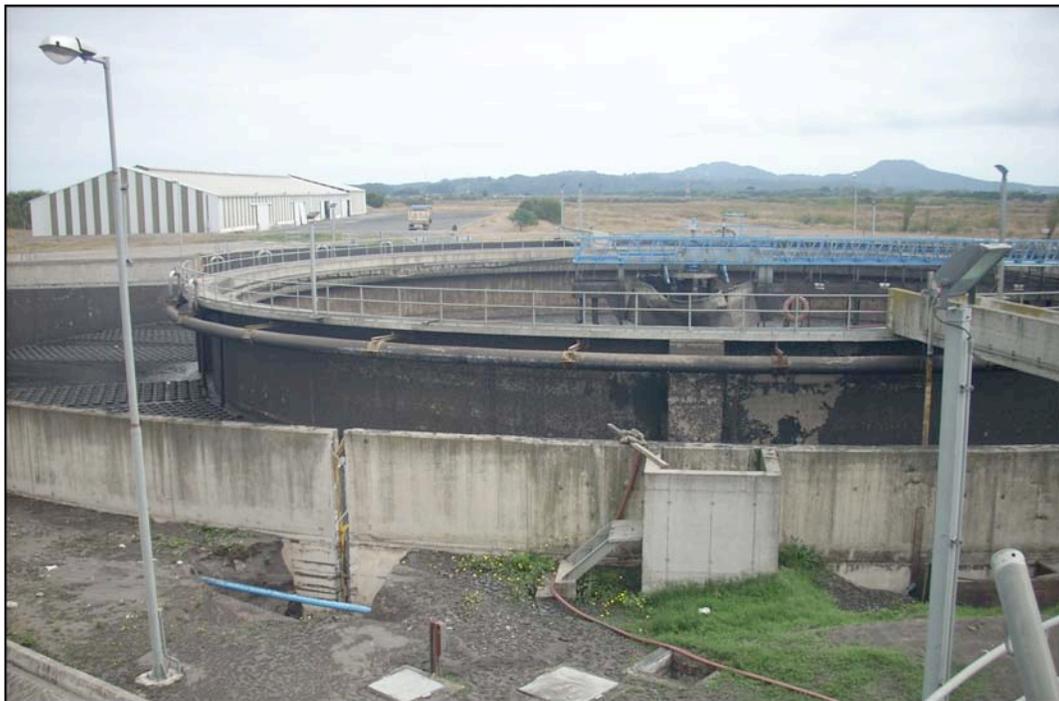
Figure 35. WWTP Clarifier Damage

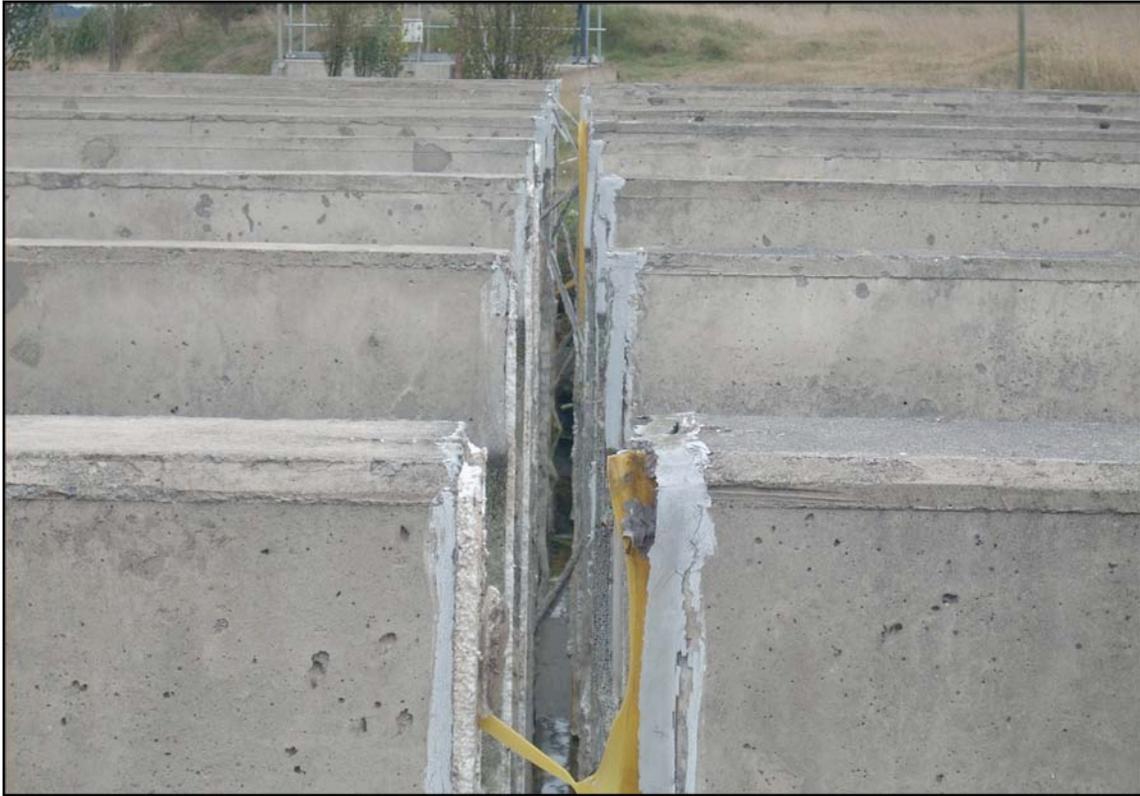
Figure 36 shows the pull-apart of the concrete walls in the chlorine contact tank at the WWTP. There were liquefaction-caused PGDs at the WWTP. The level of damage at the WWTP suggested that it would take about 6 months to bring the plant back in service. One of the main sewers bringing raw sewage to the plant was broken, near the Bio Bio river, so there was no influent to the WWTP, and raw sewage was flowing into the river.

Figure 36. WWTP Chlorine Contact Tank Failure

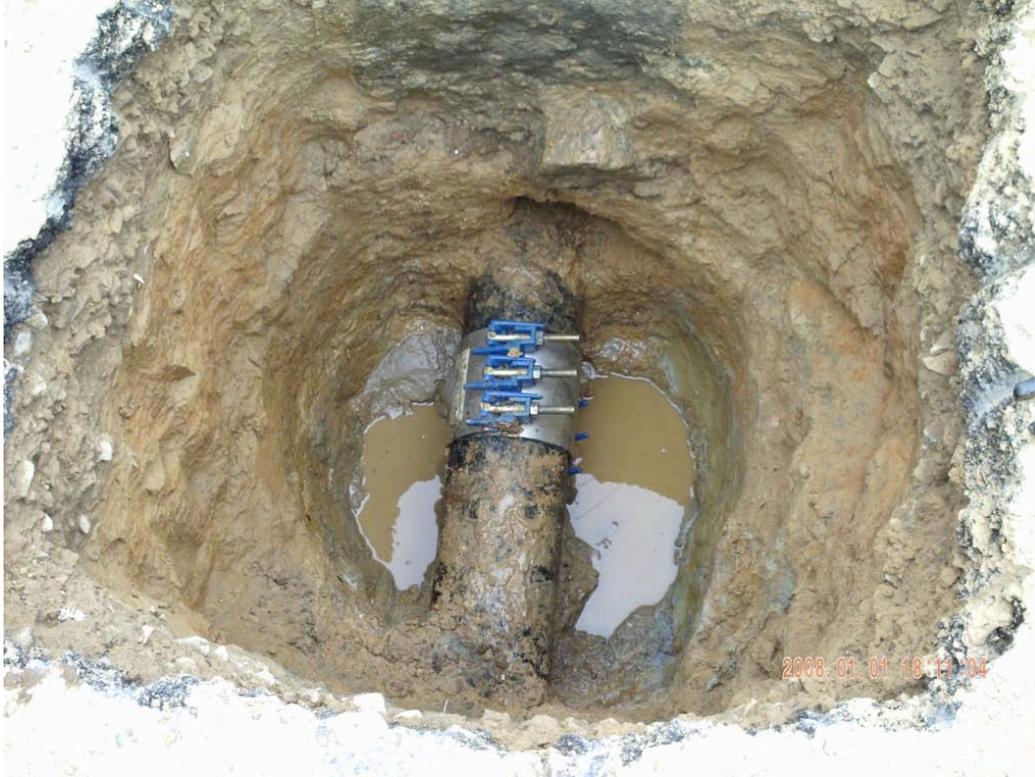
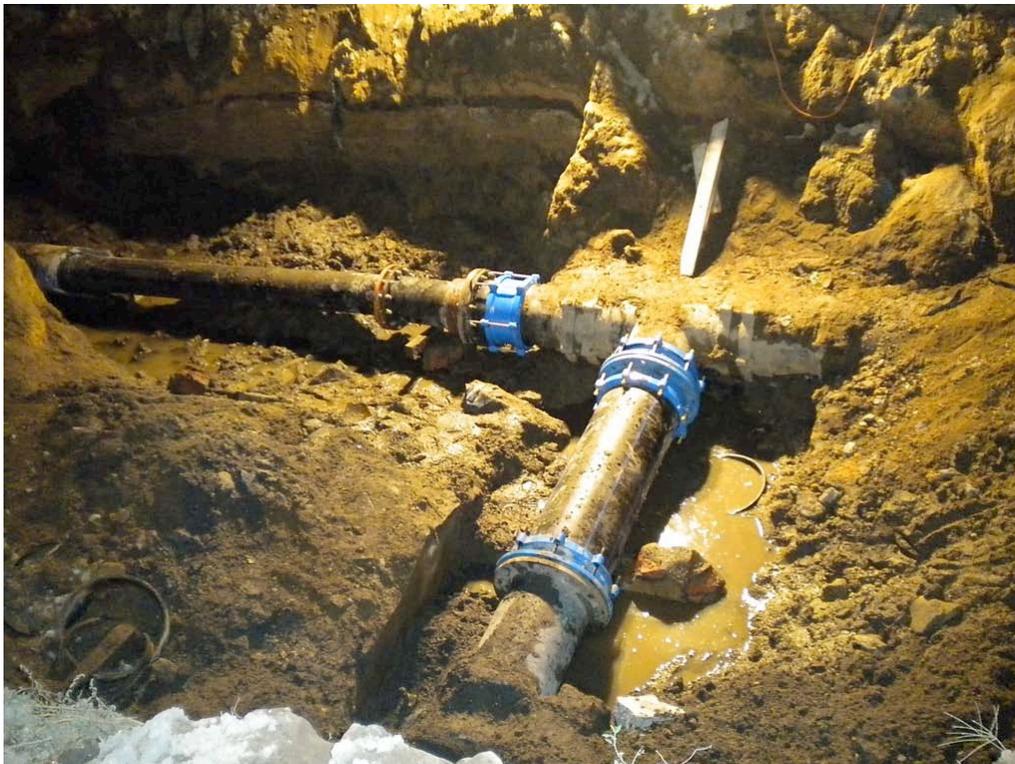
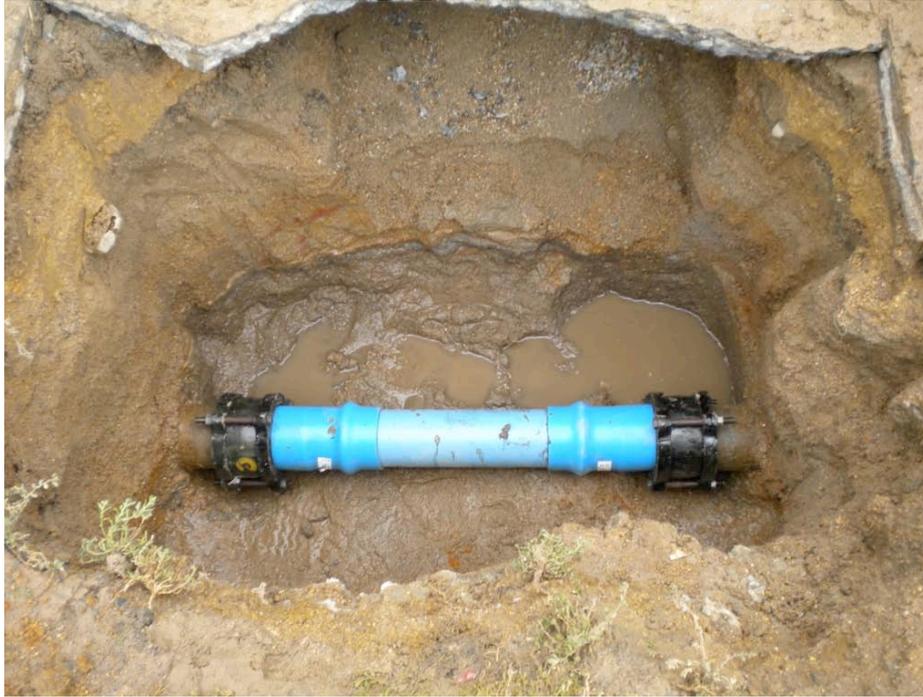
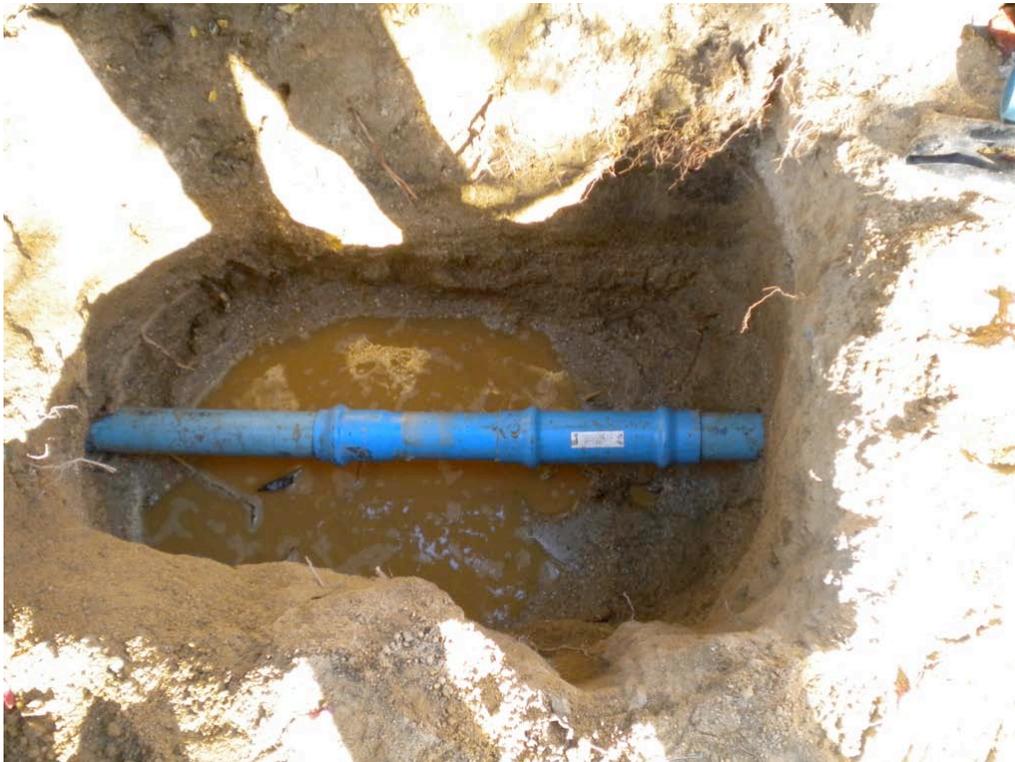
Figure 37 to 40 show typical repairs to common distribution pipes (6" to 8" common). The style of repair of using pipe clamps, inserting PVC pipes, etc., shows the range of damage and repair strategies.
