Technical Council on Lifeline Earthquake Engineering (TCLEE)
Report of the
4 September 2010 M_w 7.1 Canterbury (Darfield), New Zealand Earthquake
By: John Eidinger, Alex Tang, Thomas O'Rourke

Summary

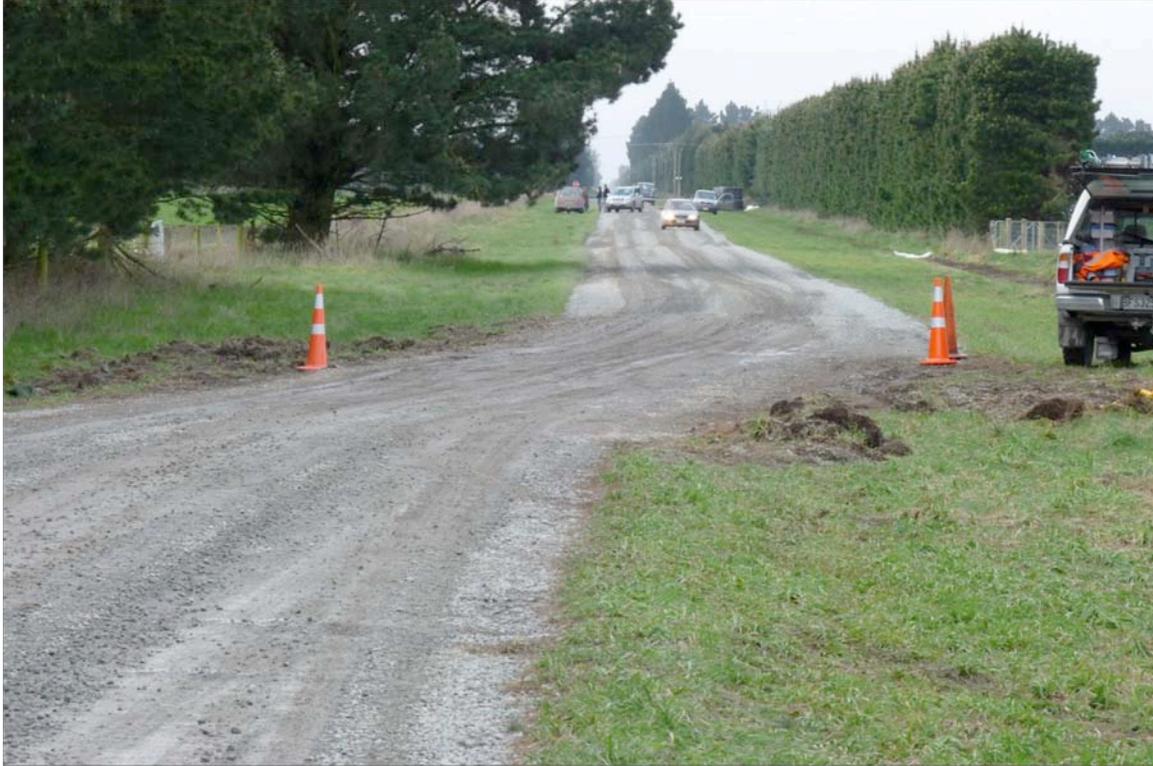
Figure 8. Fault Offset Through a Road

Figure 8 shows the right lateral offset of a country road. The road was straight prior to the earthquake. Figure 9 shows a paved road that crossed the fault; the right lateral offset of the fault appears to have forced the road to shorten, resulting in many pavement buckles.

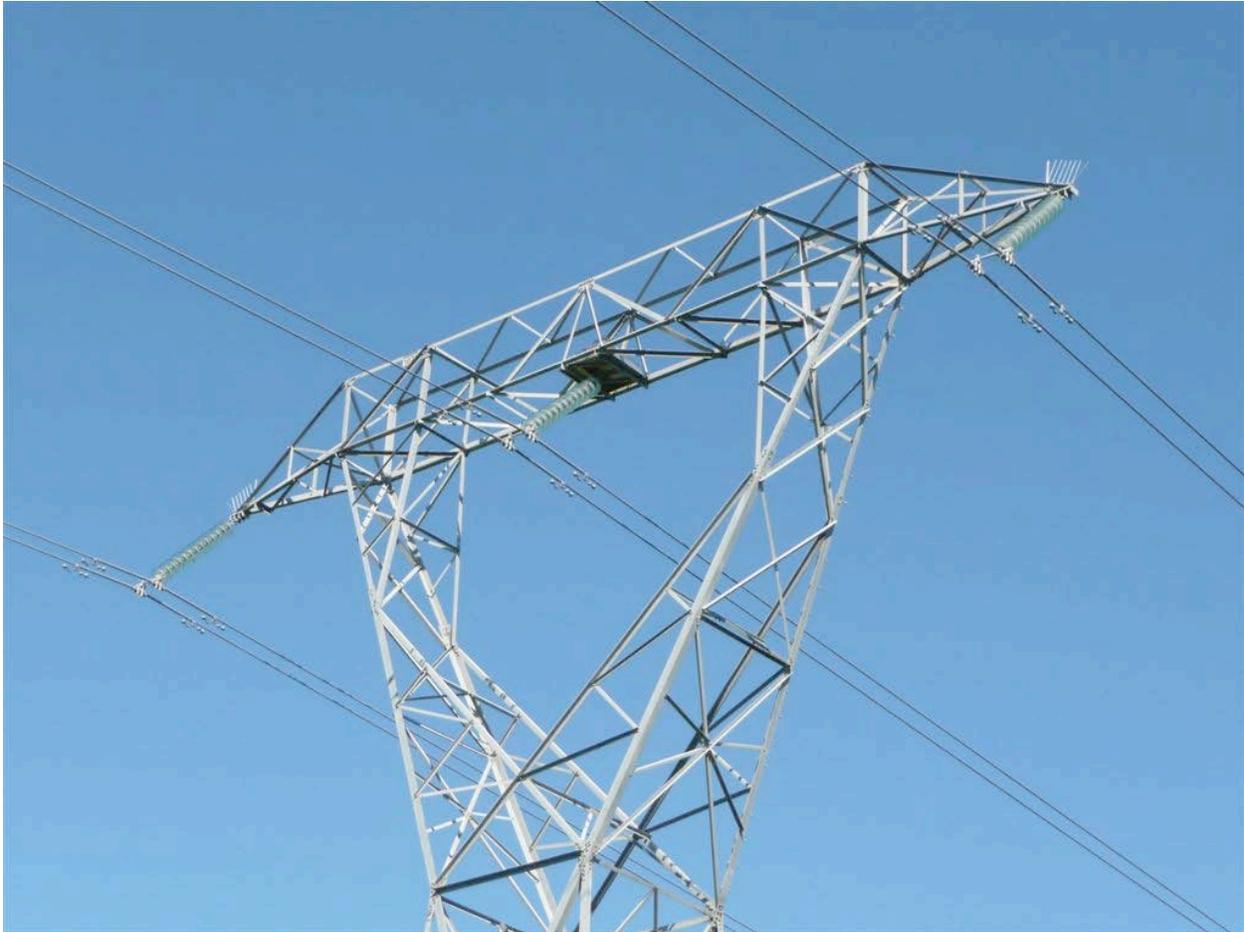
Two single-circuit 220 kV overhead transmission lines crossed the rupture zone. The fault rupture passed nearby the legs of the steel lattice towers, but not through them. There was no observed damage to any towers due to inertial shaking. Due to the fault offset, on the order of 4 meters, the conductor sags on either side of the fault became unbalanced. On the ROX-ISL-A line, the unbalanced sag is indicated by the diagonally-swung insulators (normally they would be straight down) in Figure 15; this sag remains unbalanced 6 weeks after the earthquake; Transpower reported that they would adjust the sag during some future outage. On the Benmore-Islington line, the fault offset resulted in high tension loads in a ground wire, which bent the tower extension that supported the ground wire; again, this did not lead to an outage, but could be repaired during a future outage.

Figure 15. Displaced Insulators on Suspension Tower Adjacent to Fault Offset

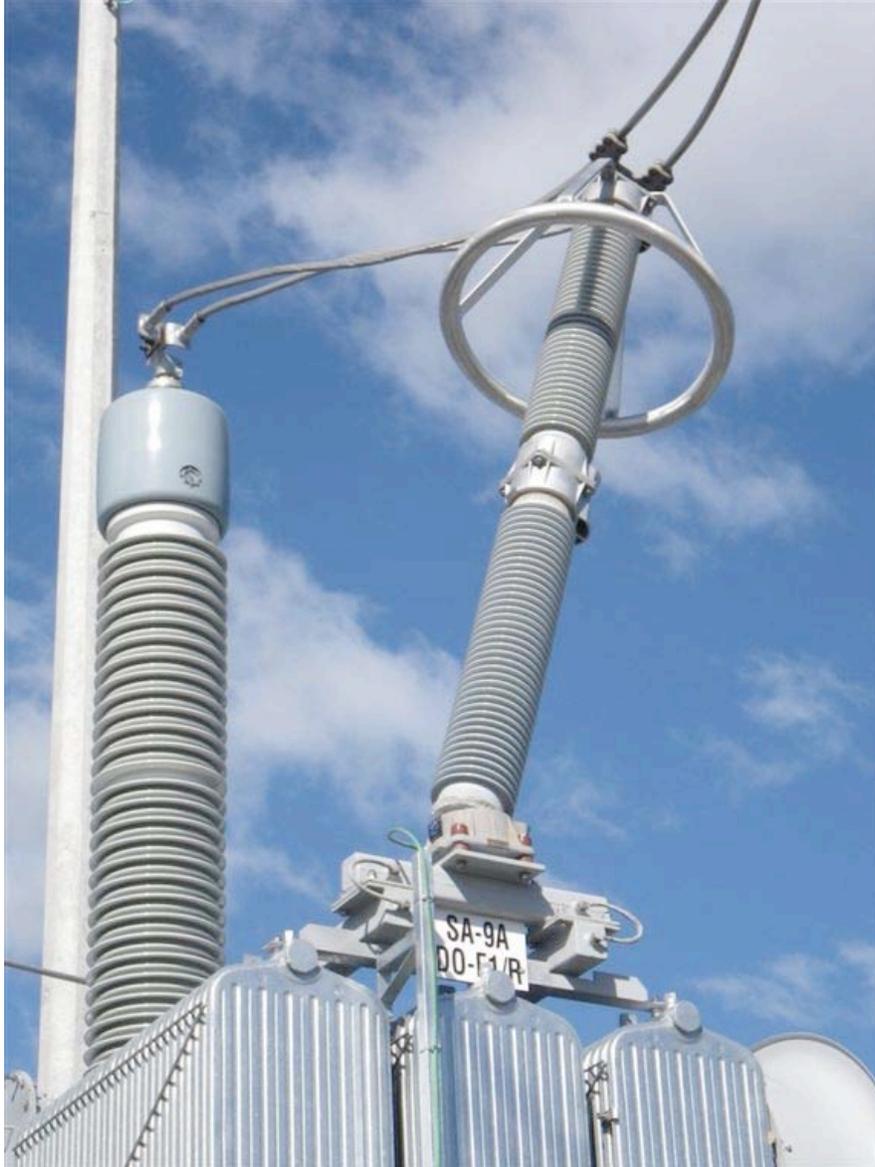
Figure 16. Broken Lightning Arrester

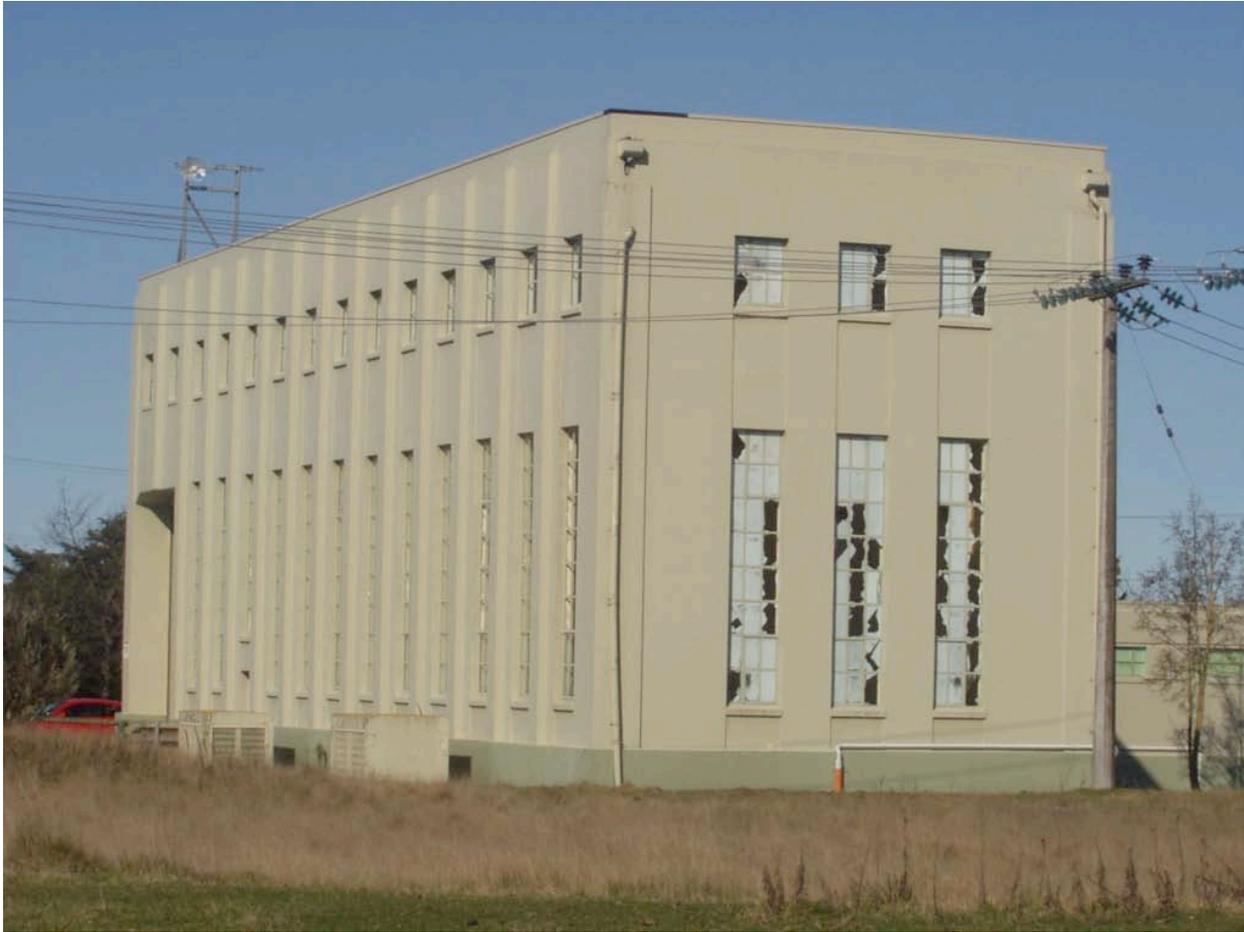
Older style multi-level reinforced concrete building had broken windows (Figure 17). Three spare (unanchored, in process of relocation) current transformers toppled. A desk collapsed. Florescent lights on chains, hanging from the ceiling, became loose; florescent tubes fell out. Some data cable tray tie rods ripped out of the ceiling. Lightning poles swayed and loosened their foundations.

Figure 17. Hororata Control Building

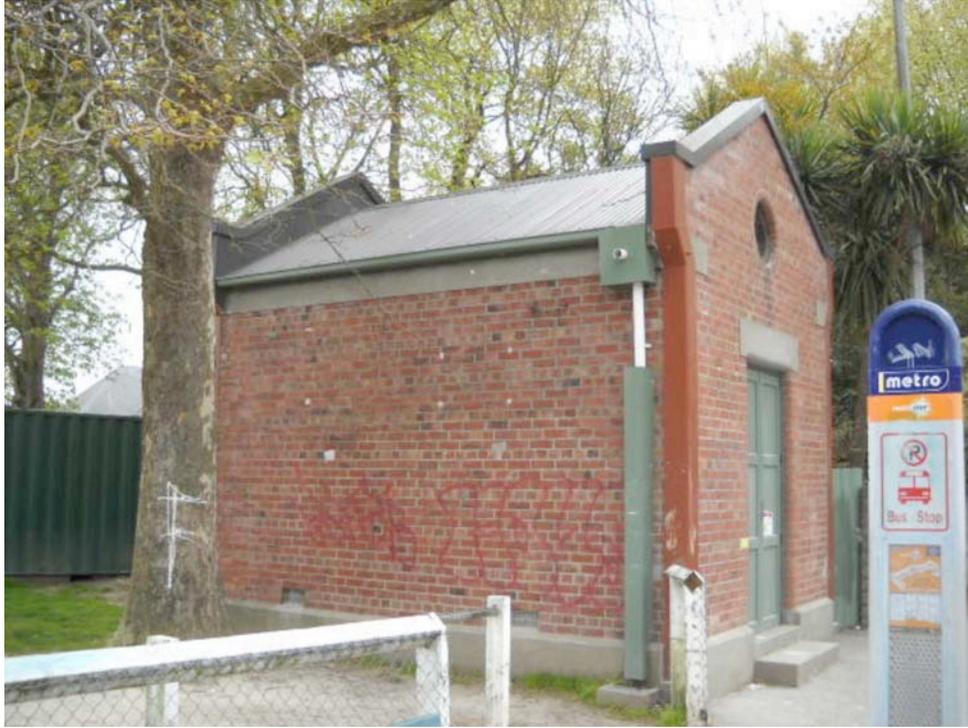
Figure 20 shows one of Orion's seismically upgraded small URM substations. Note the steel supports outside the building, that had been installed as part of the seismic upgrades instituted over the prior years. Figure 21 shows another URM and non-retrofitted building; instead of upgrading this building, Orion abandoned it; the amount of damage observed is common to that observed at other URM buildings in Christchurch.

Figure 20. Orion URM Upgraded Small Substation

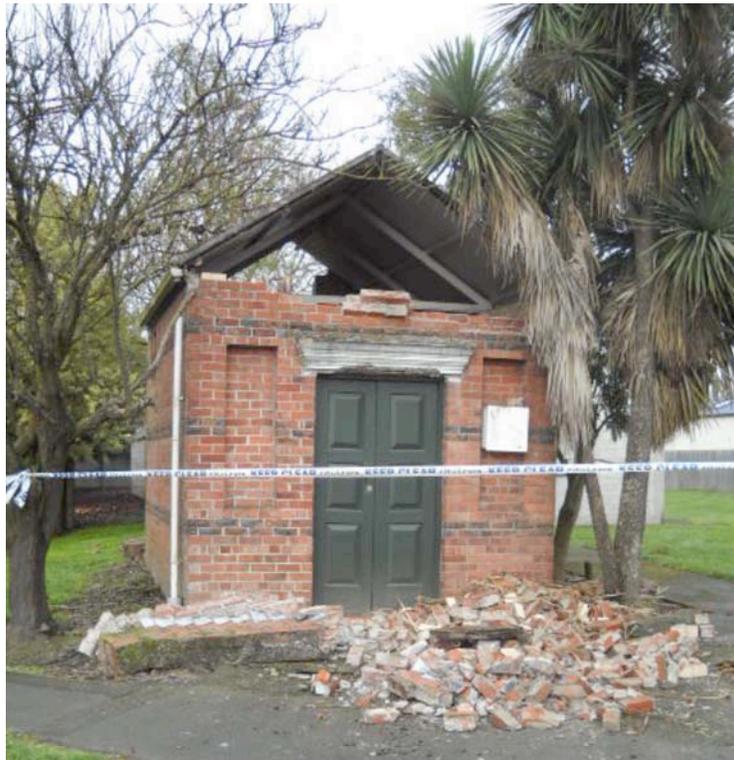
Figure 21. Orion URM Non-Upgraded Former Small Substation

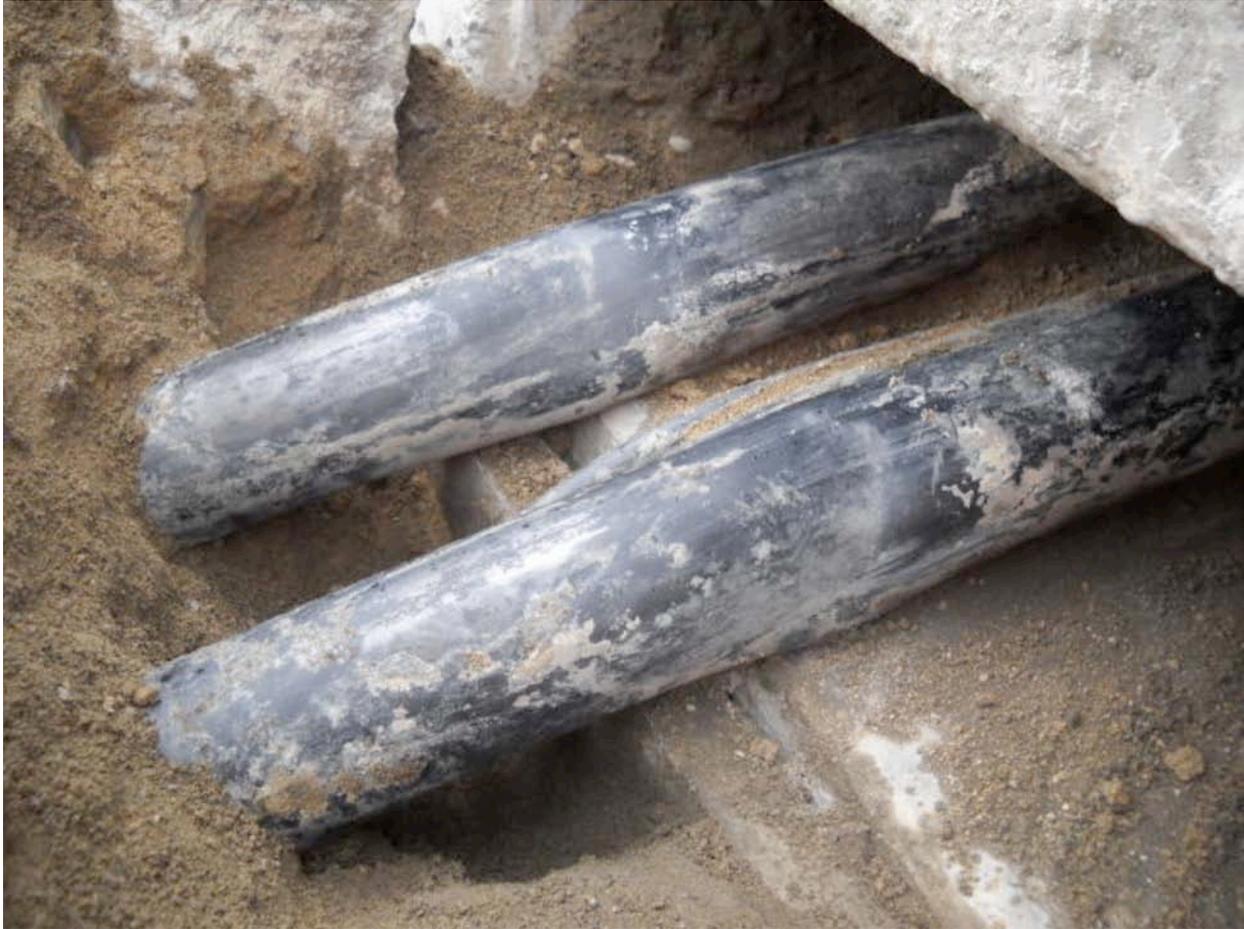
Figure 22 shows two partially crushed 66 kV oil-filled low pressure cables. This occurred where the buried cables transitioned from a buried condition, and went onto a pile-

supported bridge across the Avon river. While the cables remained functional after the earthquake, they will ultimately need to be replaced or otherwise bypassed; as part of a temporary measure after the earthquake, Orion braced the bridge on which the cables are located. There were several other 11 kV buried cables that were completely broken; we believe all of the broken cables were in the areas with lateral spreads and/or settlements.

Figure 22. 66 kV Cables

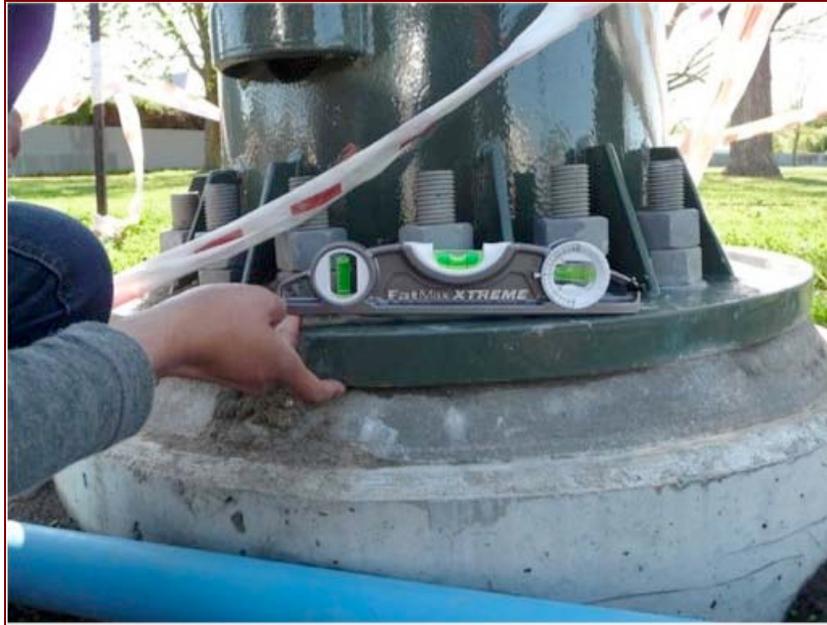
At two cell phone tower sites, liquefaction resulted in rotation of the tower (see Figure 23). The towers were out-of-plumb by 2° to 5°. These rotations did not affect service, and no effort to restore the towers to vertical had been made within the first 6 weeks after the earthquake.

Figure 23. Cellular antenna tower out of plumb due to ground deformation.

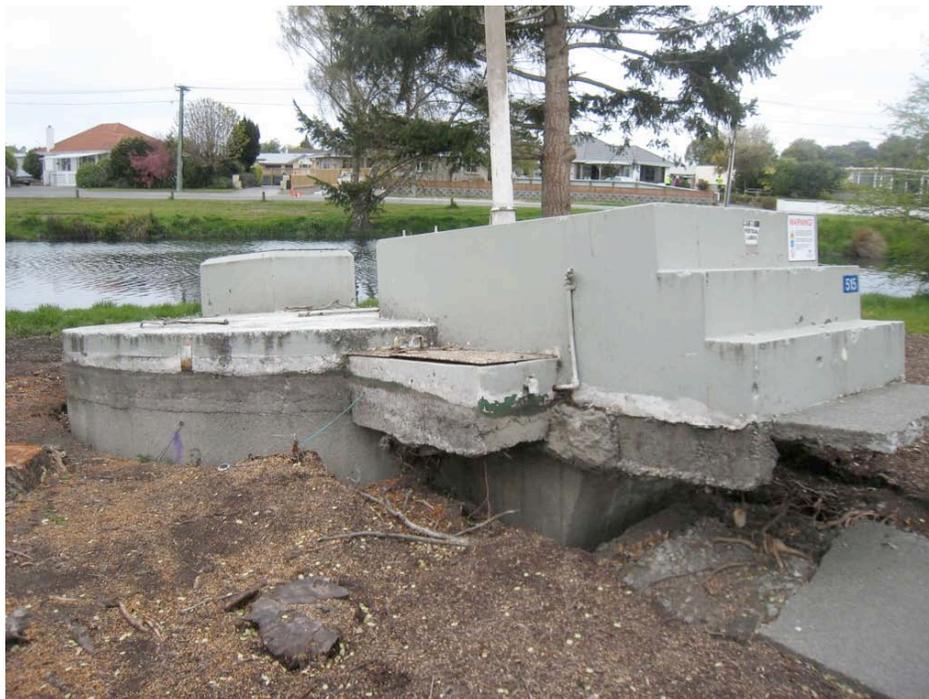
Figure 27. Floated and Tilted Wastewater Life Station 26, Porritt Park, Avonside

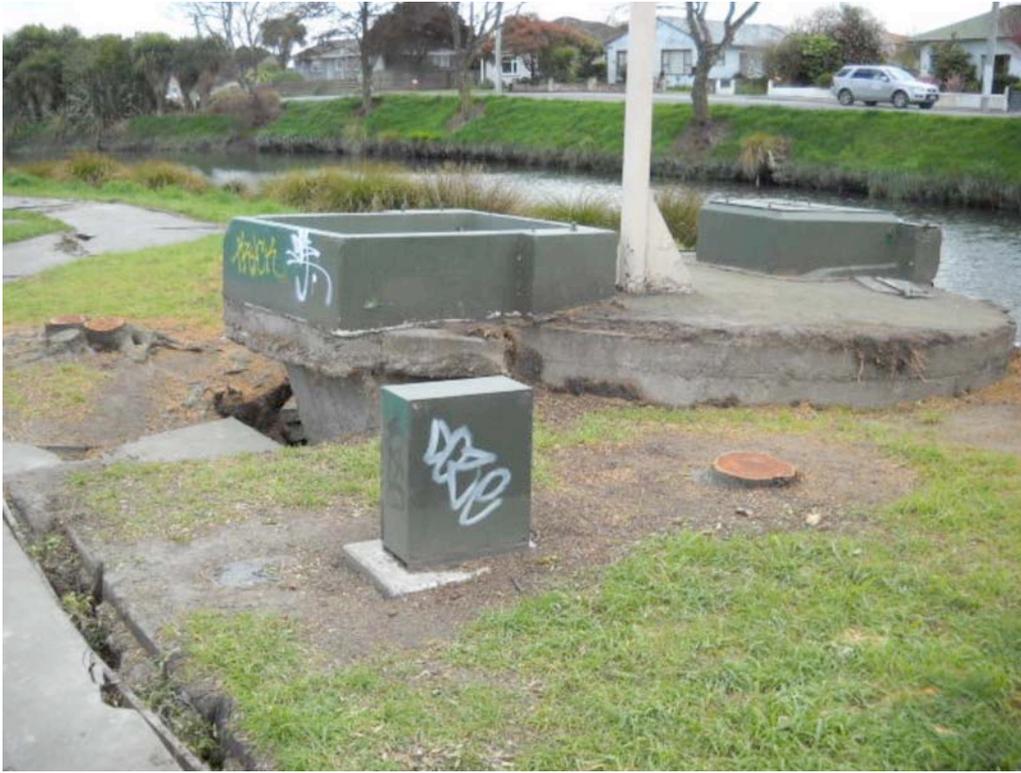
Figure 28. Floated and Tilted Wastewater Life Station 27, Avonside

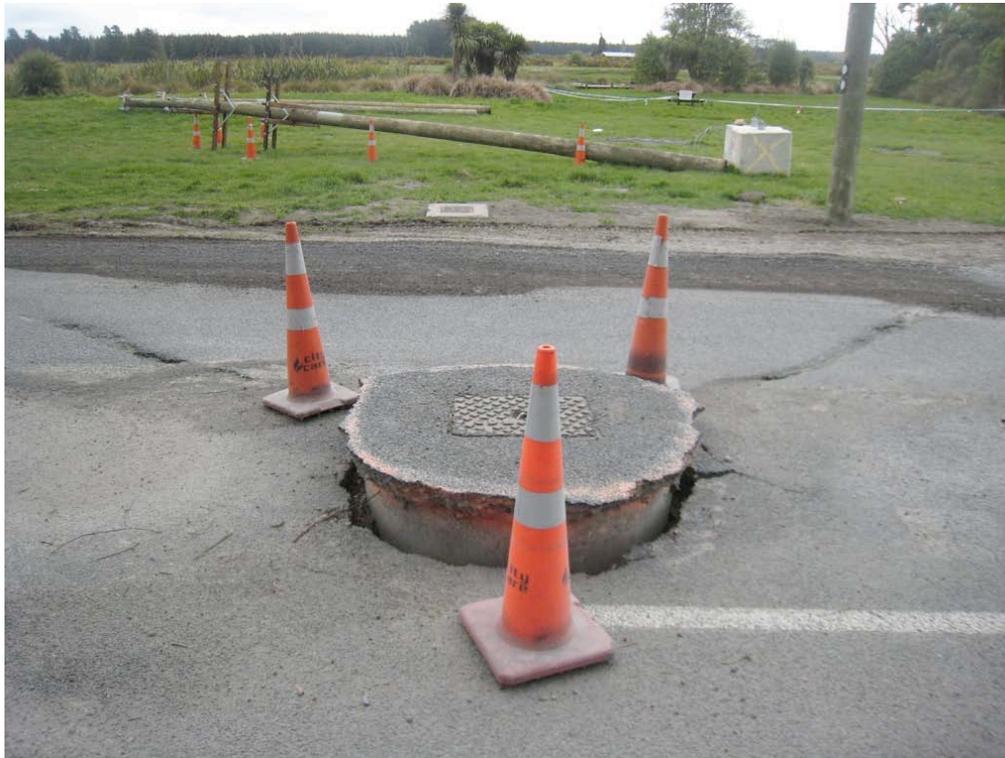
Figure 29. Floated Sewer Manhole, Brooklands (one of fifteen)

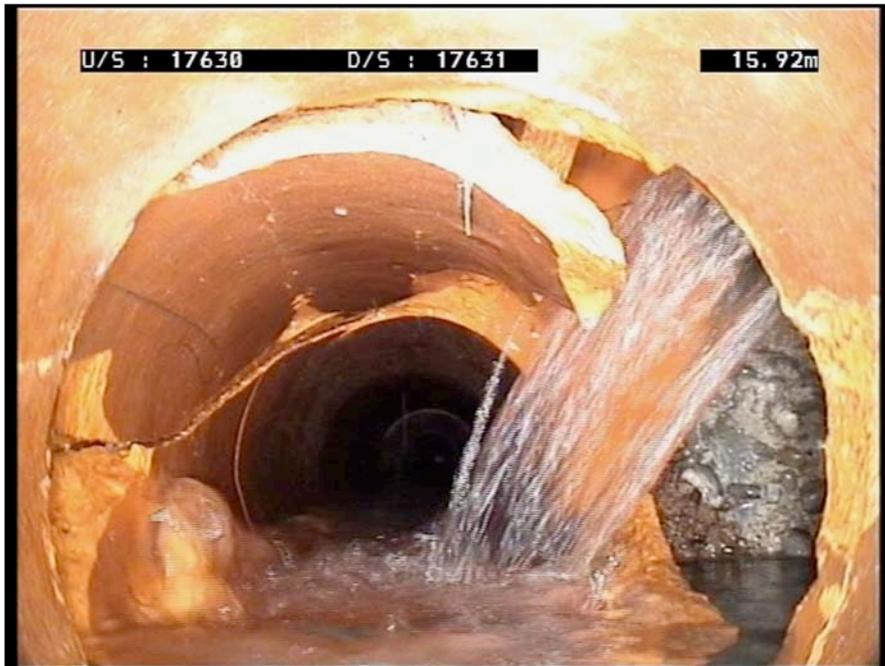
Figure 30. CCTV picture of Broken Sewer, MDC

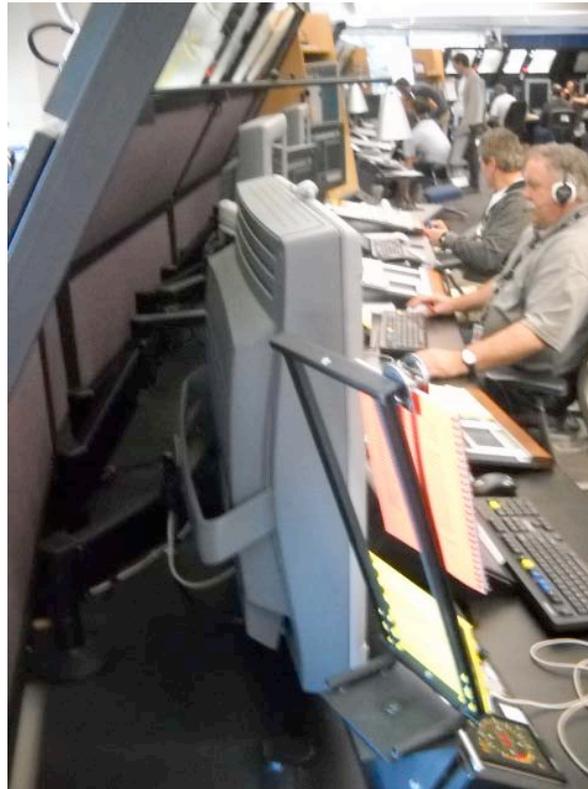
nearby air traffic control facility sustained limited structural damage, but with no material non-structural damage (Figure 34), and it was in service shortly after the earthquake.

Figure 34. Air Traffic Control

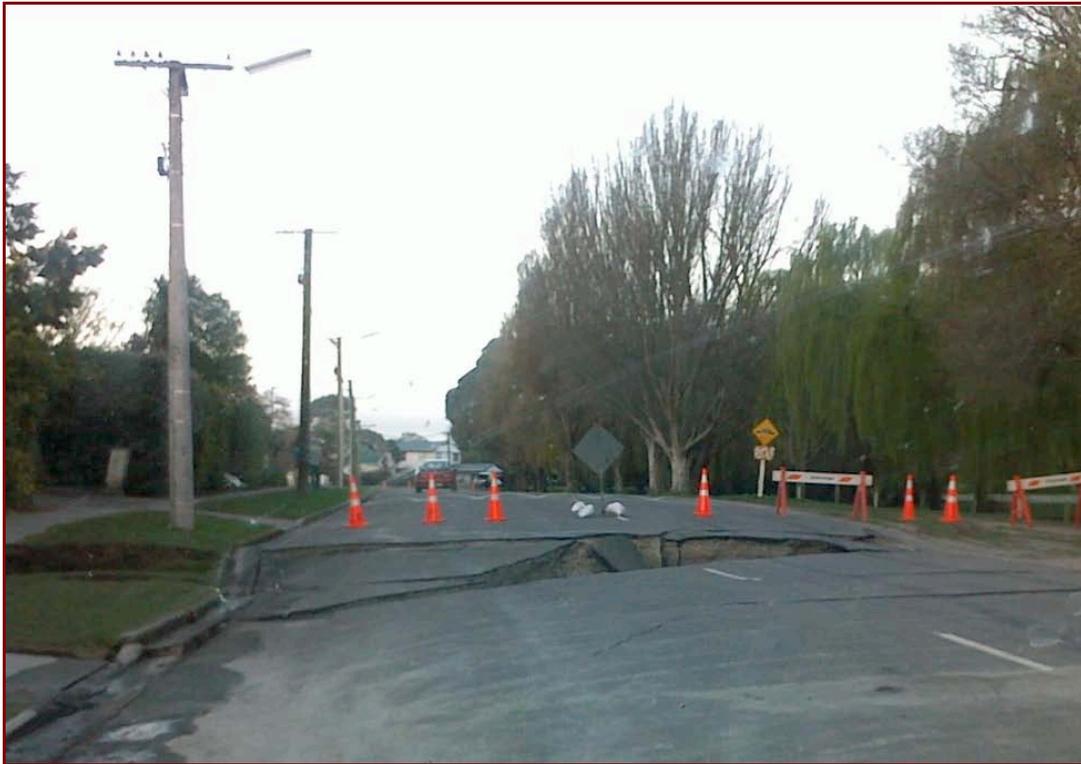
Figure 35. Road surface up heaving due to permanent ground deformation

Final repair of damaged roads may take many months to complete. Repairs of damaged roads need to be coordinated with final repairs or replacements of buried water and wastewater pipes and other buried utilities. Complete re-builds of roads may take a year or more to complete, covering more than about 60 km of roads.

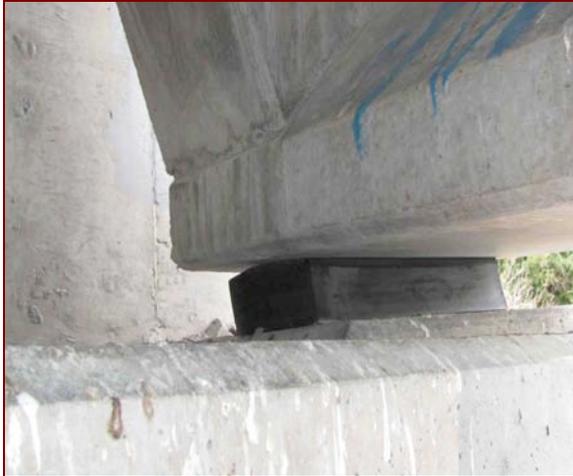
Figure 36. Rubber bearing deformed

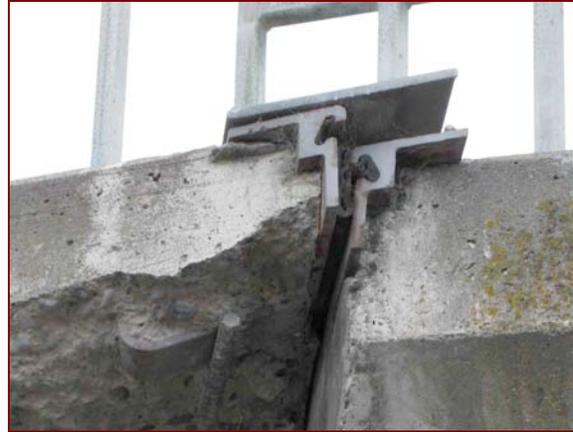
Figure 37. Deck and abutment impact damage

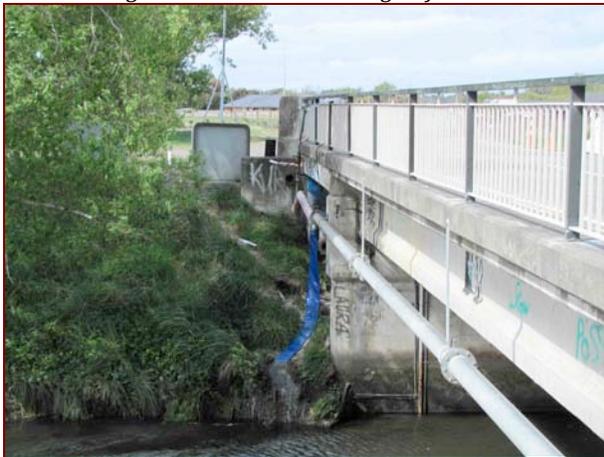
At most of the bridges that we visited that suffered abutment damage, if there were pipes hanging from the bridge, then the pipes were broken. Figures 38 and 39 show a broken sewer pipe crossing a bridge; the broken pipe remained in service and was discharging into the creek below.

Figure 38. Plastic hose connected to broke pipe to discharge wastewater to stream

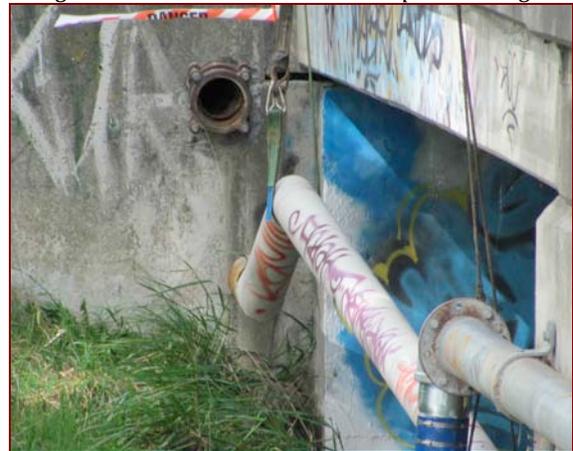
Figure 39. Close up of the damaged wastewater pipe

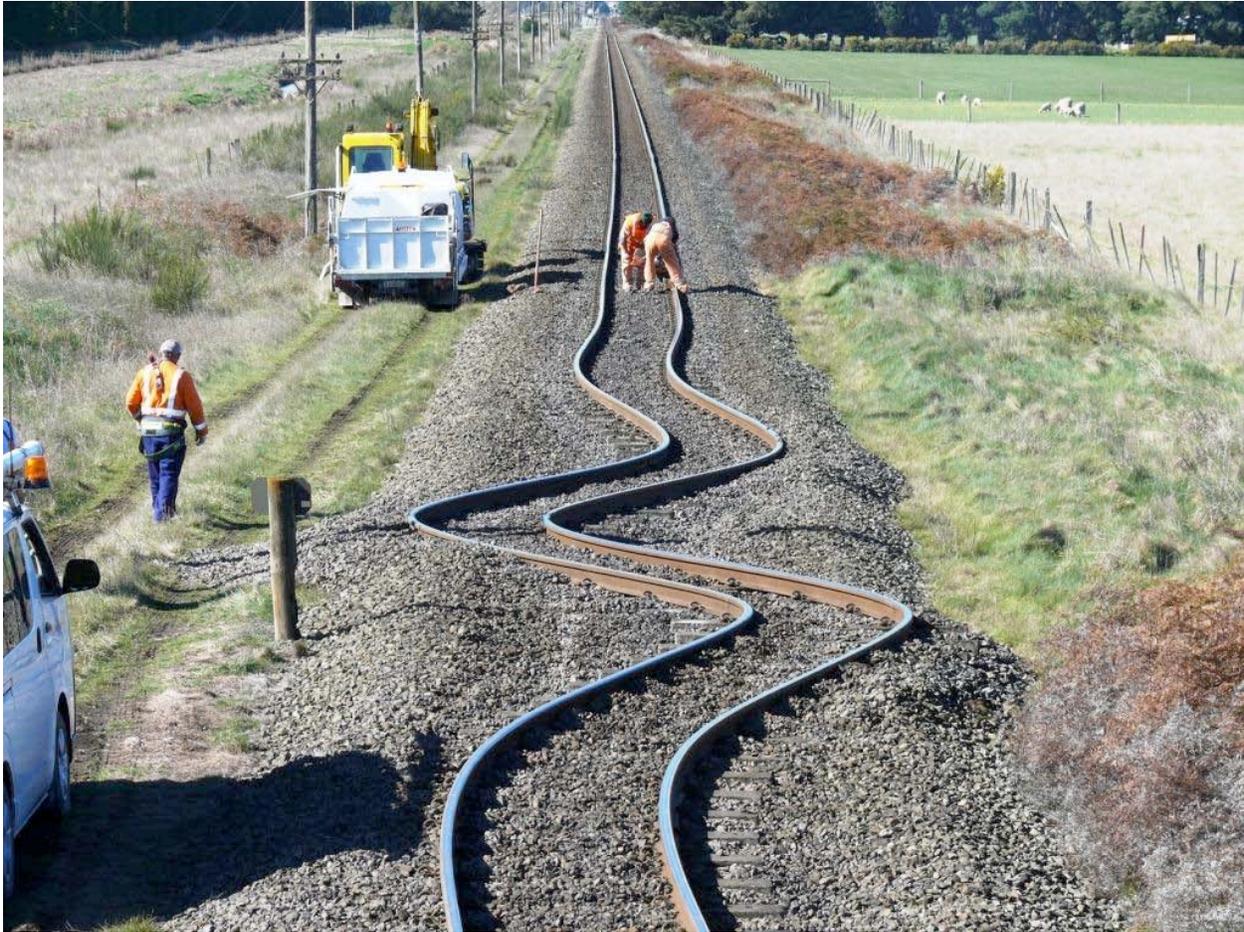
Figure 41. Buckling of Rails at Fault Offset Location

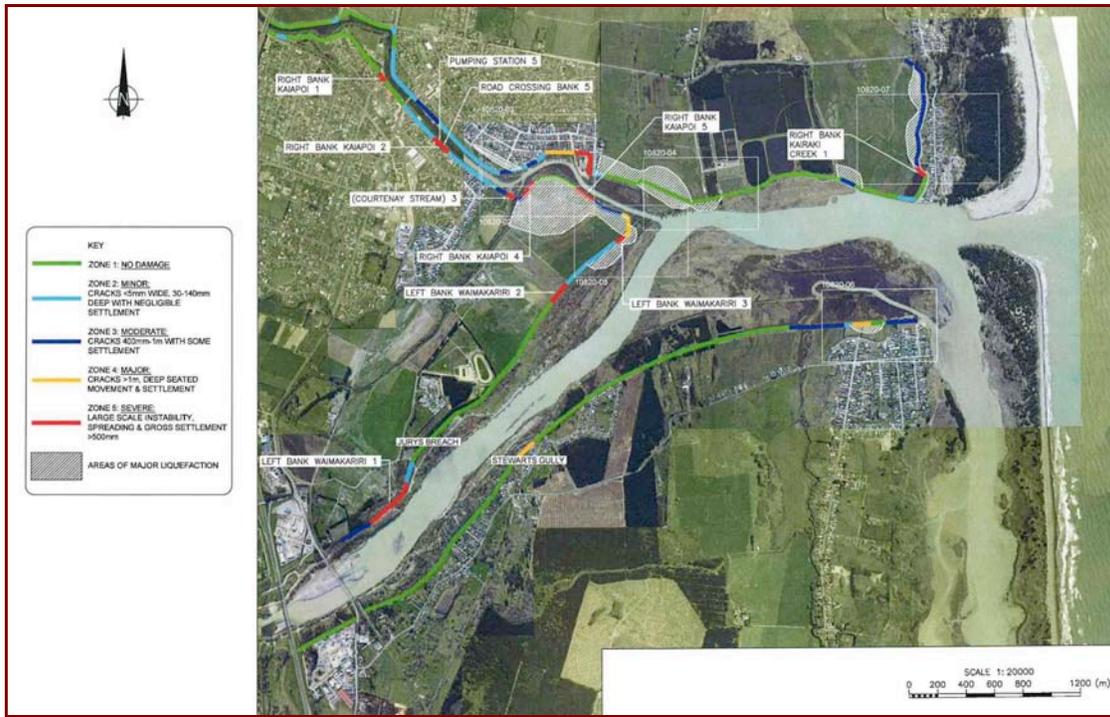
suffered severe to major damage. Severe damage included cracks greater than 1 m in width, with deep seated movement and settlement. Major damage included large scale instability, with lateral spreading and settlement exceeding 0.5m.

Figure 43. Stopbank damage surveyed by Riley Consultants

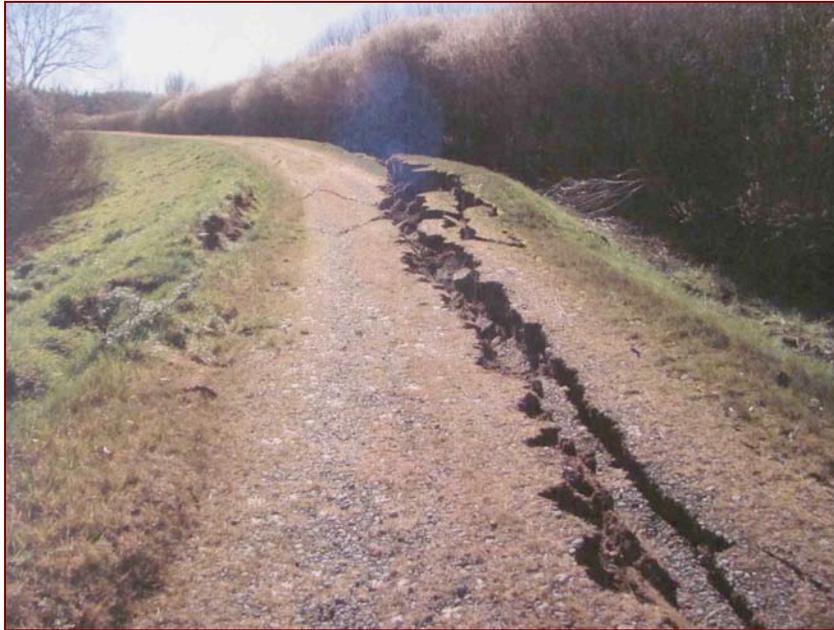
A survey reported by Riley Consultants indicated the following damage to stopbanks: 10 severe, 4 major, 11 moderate, and 14 minor damage: see Figures 45 to 47.

Figure 45. Severe Damage – Stopbank

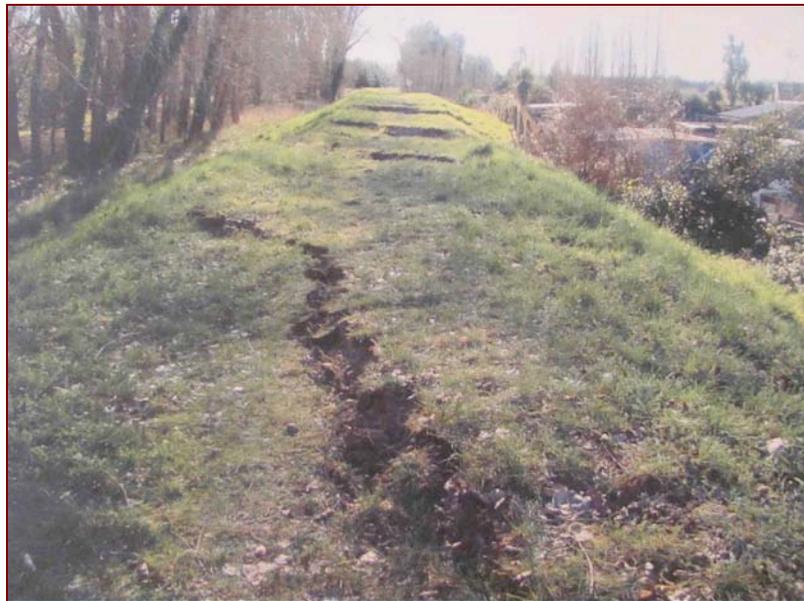
Figure 46. Major Damage – Stopbank

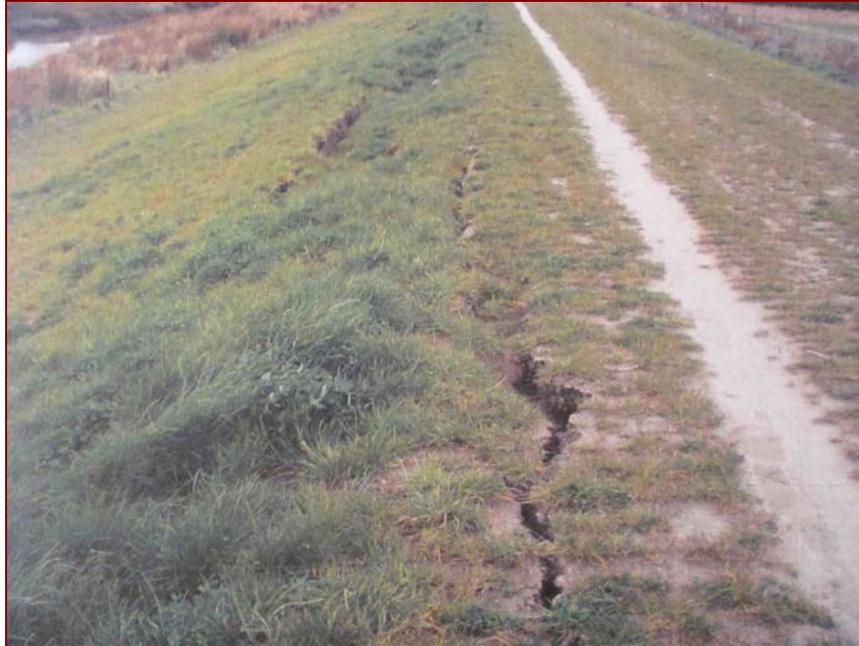
Figure 47. Moderate Damage - Stopbank
