# Seismic Fragility of Power Distribution Systems

John Eiding<sup>1</sup>, Eric Fujisaki<sup>2</sup>, Joseph Sun<sup>2</sup>, Raymond Trinh<sup>2</sup>

## ABSTRACT

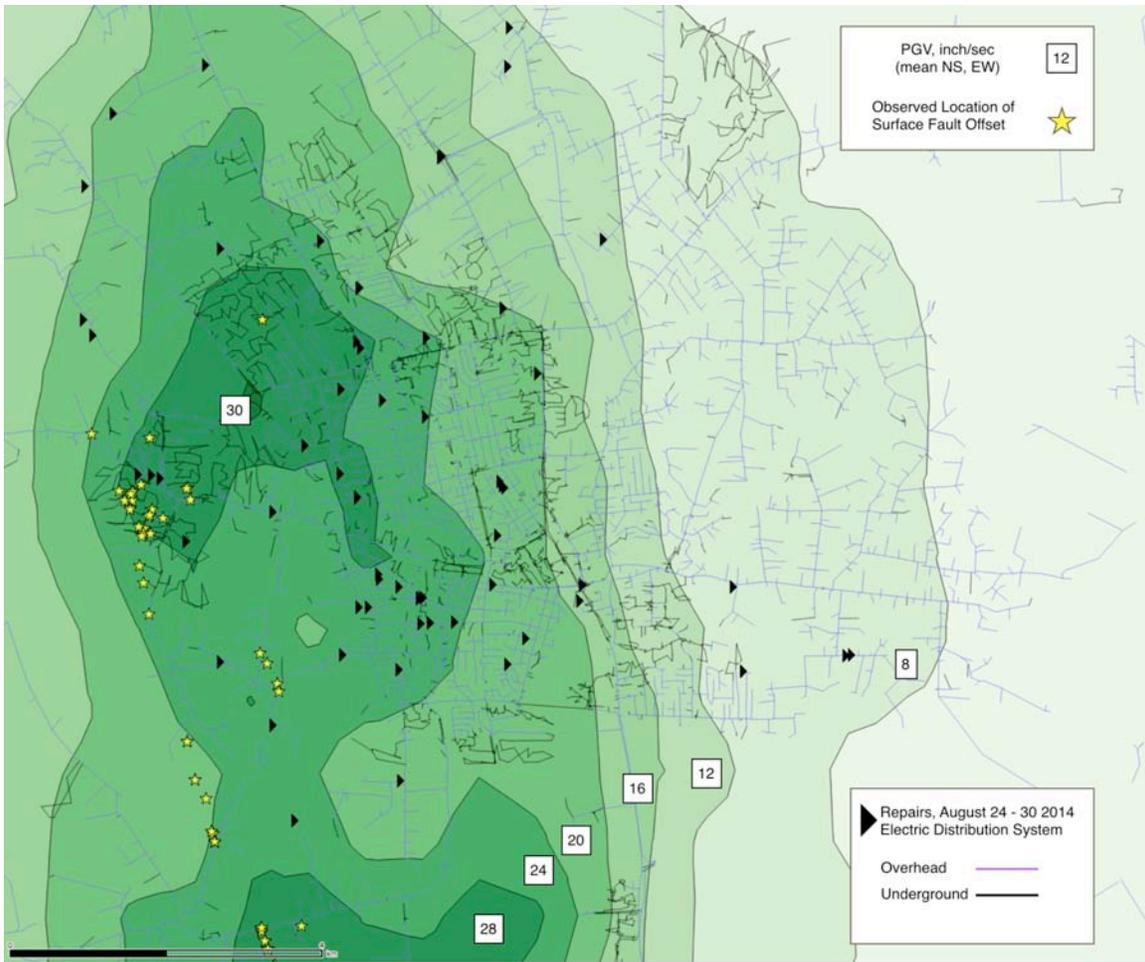
Figure 4. Repairs, City of Napa

Figure 4 highlights the location of repairs (black triangles) in the City of Napa with respect to overhead (purple lines) and underground (black lines), along with the PGV levels (green shaded contours) and locations of surface faulting (yellow stars). There is a strong correlation of overhead repairs with higher PGV; and very little (if any) correlation of damage of overhead or buried circuits with surface faulting location. There was no damage to buried feeders due to surface faulting that was on the order of 3 to 9 inches of right lateral offset, indicated by the yellow stars in Figure 4; this strongly indicates that PG&E's design practice to place buried feeders in PVC (or similar) ducts, leaves enough slack in between the conductor cable and the PVC duct to accommodate a few inches of fault offset, or, for that matter, a few inches of PGD due to liquefaction or landslide.

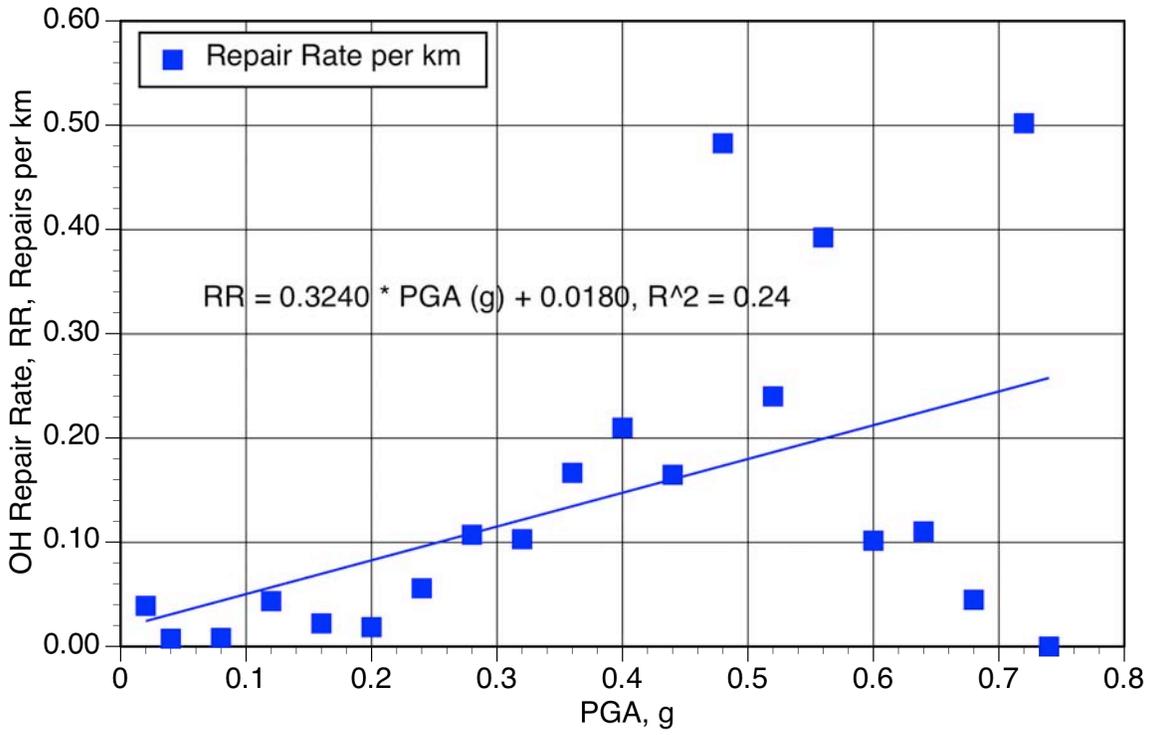
Figure 5. Repair Rate, Overheads, Using PGA

The results using PGA, PGV and SA(T=3.0 seconds) and PGV are presented in Figures 5 and 6. Some observations from Figures 5 and 6:

- There is a clear trend of increasing repairs with increasing seismic hazards. The  $R^2$  values for PGA (0.24) is much lower than for SA(T=3) (0.96). This suggests that PGA is not a good predictor. The  $R^2$  value for SA (3.0 seconds) (0.96) is very high. Mostly, we think that the better correlation for long period motion is because the poles and wire systems are long period structures.

- At the highest levels of PGA (0.6g or higher), there appears to be a decreasing rate of damage. This seems "counter-intuitive", but in fact, if we assume that long period motions drive motion of the conductors, and hence loads due to insufficient slack issues, or wire-slapping issues, this trend might not be unexpected.
