## Evolution of Electrical Grid Seismic Resiliency

John Eidinger<sup>1</sup> and John Dai<sup>2</sup>, Florizel Bautista<sup>2</sup>, Roderick Dela Cruz<sup>2</sup>

### ABSTRACT

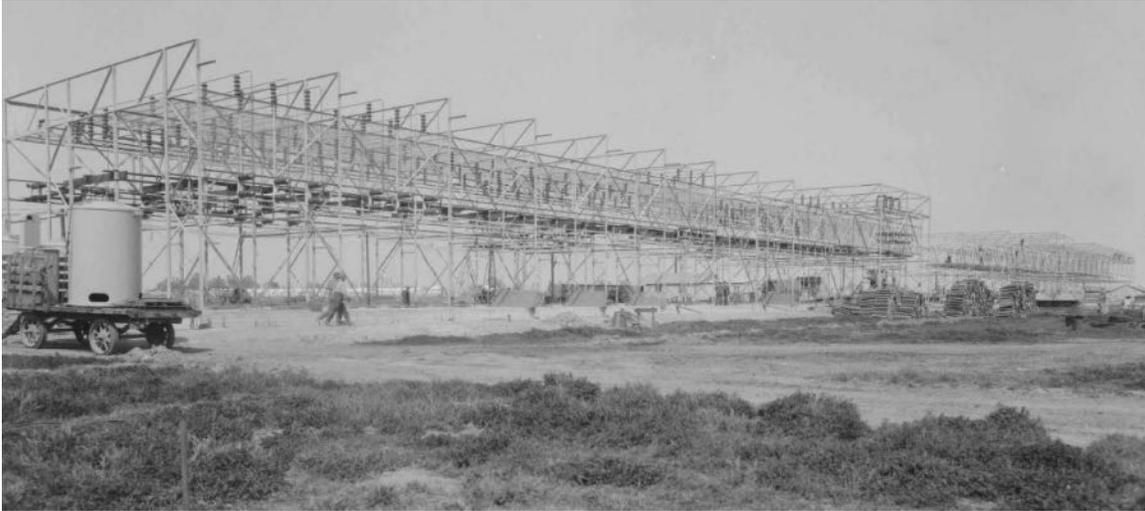
*Figure 2. Lighthipec Steel 66 kV Switchrack (photo dated 1927)*

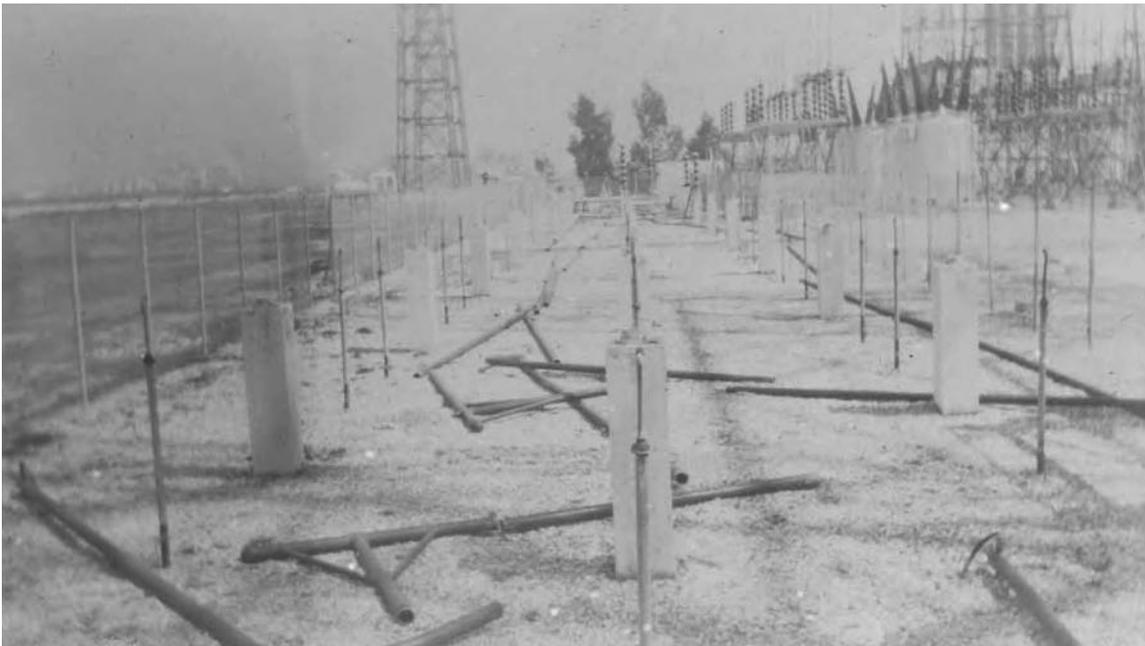
both in Long Beach (Lighthipec substation and the step-up switchyard at the Long Beach power plant). The March 10, 1933 Long Beach earthquake heavy damaged both of these 220 kV yards. The estimated motions were about  $PGA = 0.30g$  at both yards. The 66 kV switchrack at Lighthipec, Figure 2, apparently suffered little damage, and much of this 800-foot long structure remains in service today (2018); back-calculation suggests this 1920s-era steel switchrack can sustain about  $PGA = 0.5g$  near yield. However, a variety of rigid bus connections were used to connect 220 kV circuit breakers with disconnect switches and electrical bus, and these failed badly; about 600-feet of rigid bus collapsed entirely, Figure 3.

*Figure 3. Long Beach 220 kV Rigid Bus (photo dated March 10 1933)*

A major finding from the 1933 earthquake was that "220 kV rigid bus" was no longer to be used for new construction. Today (2018), all transmission level substations use "flexible bus"; nearly all of the rigid bus (like Figure 3) has been removed and replaced over the past 85 years, with just a few remnants left at lower voltage substations; eventually, those too will be replaced.
