Power Outages,
December 20 2022 M 6.4 Fortuna Earthquake

John Eiding, S.E.

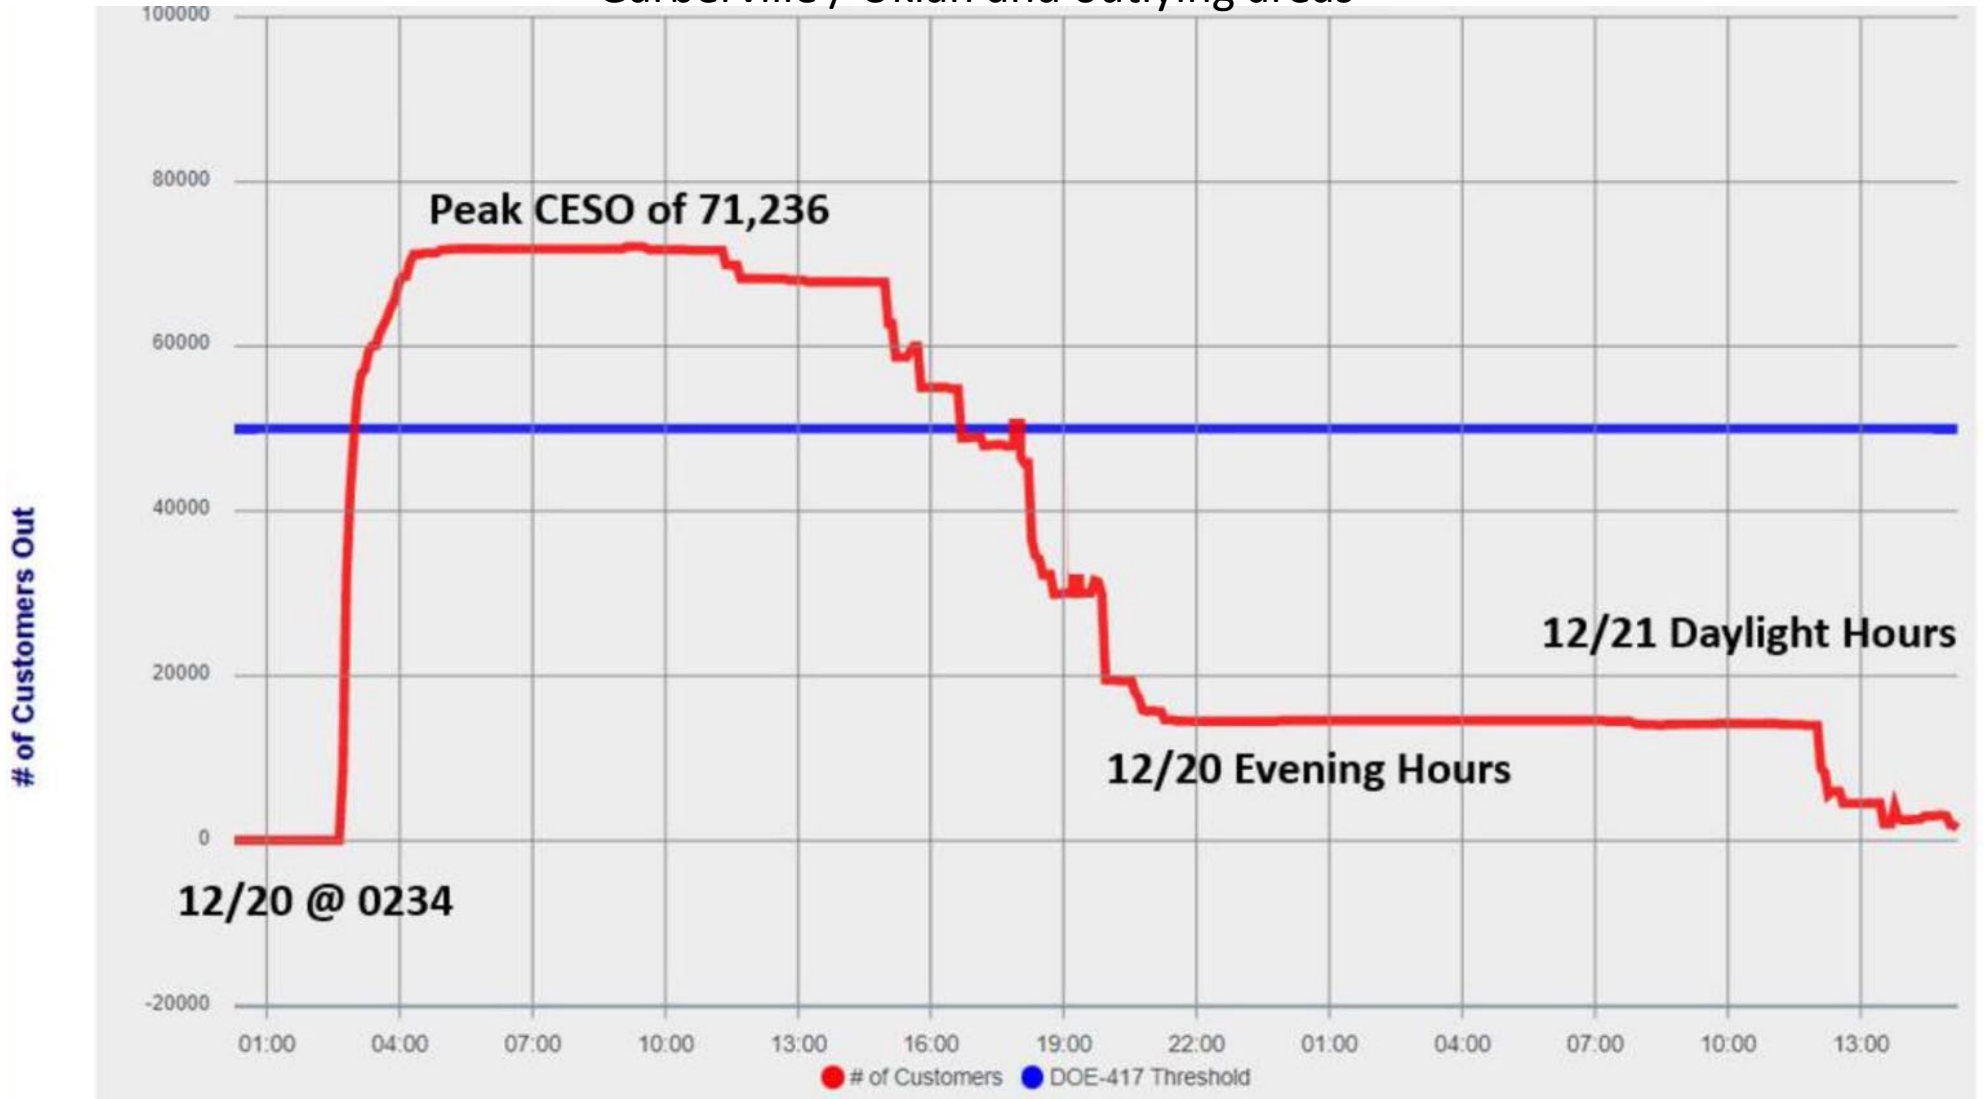
71,236 Customers \approx 100% of PG&E electric customers in Eureka, Arcata, McKinleyville, Samoa Peninsula, Fortuna, Rio Dell, Trinidad, plus some in Garberville / Ukiah and outlying areas

Area under red curve: \sim 79,000,000 Customer-Minutes

This is similar to outages that happen 2-5 times per year due to winter storms in Northern California

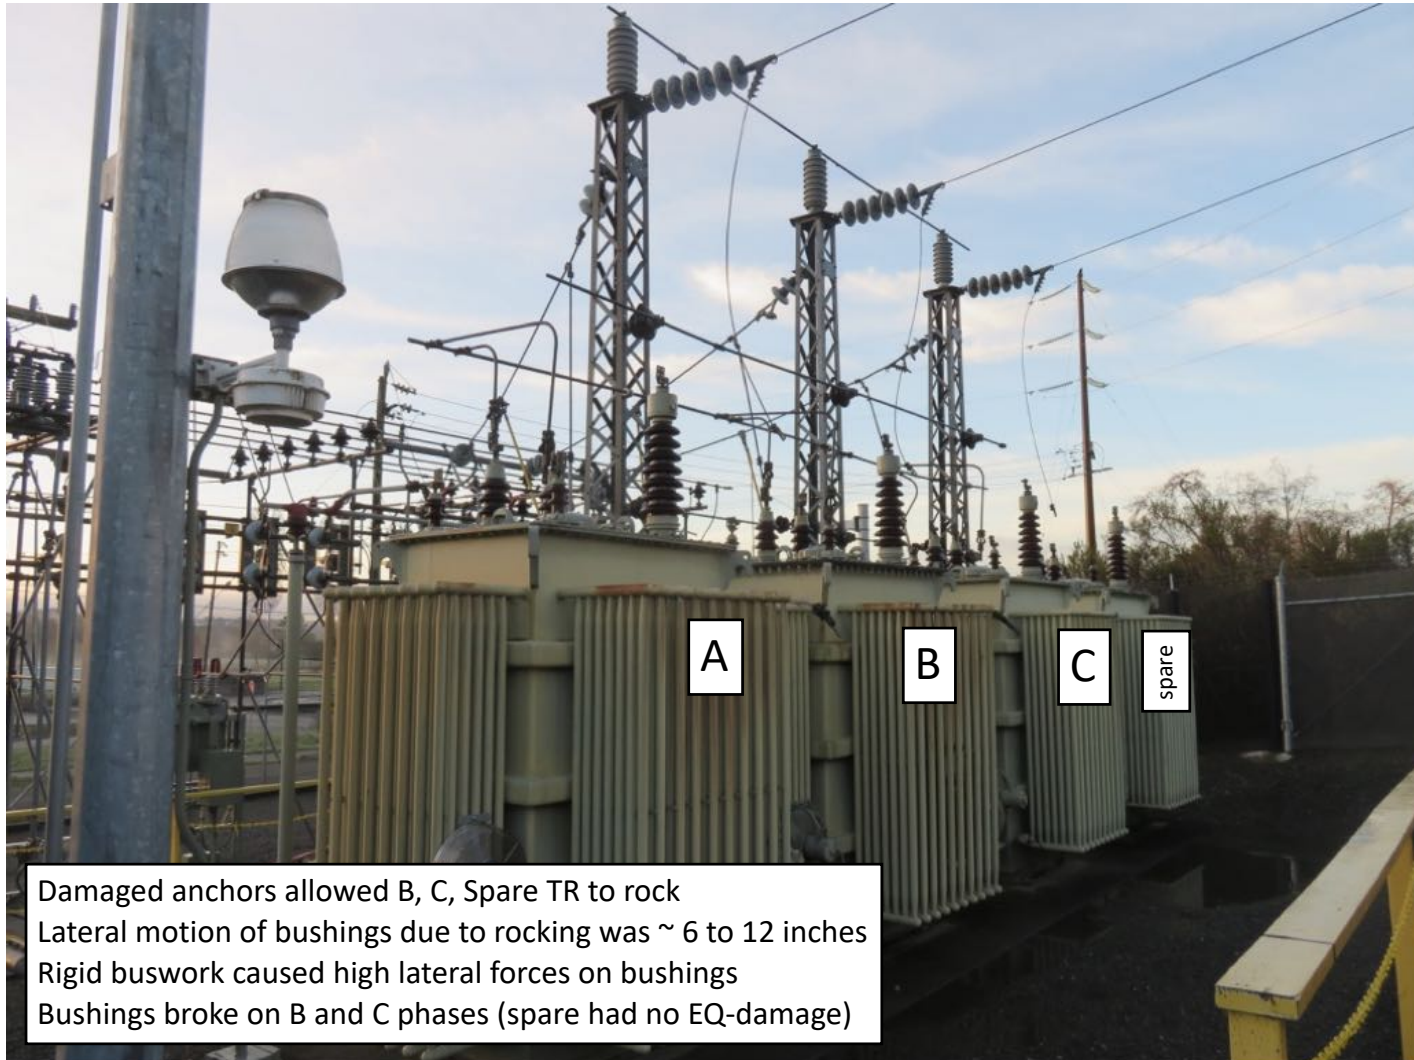
60 kV - 12 kV Transformers (TR). B, C, Spare had failed anchorage.
PGA (median) = 0.50g (attenuation based).
PGA (range) = 0.32g to 0.77g; 16th to 84th.
These transformers were installed in 1949.
1949-era anchorage design $V \approx 0.25W$.

Modern (IEEE 693 1997 and later) anchorage design is $V \sim 1.0W$ (elastic).
No modern designs failed at 18 substations with $0.10g \leq PGA \leq 0.50g$.
Adjacent transformer bank had no damage, and carried all the load.
Due to redundancy, this damage caused zero power outages.

SOME OF YOU MAY STILL HAVE
WEAKLY-ANCHORED OR UNANCHORED TRANSFORMERS.
GET THESE UPGRADED!

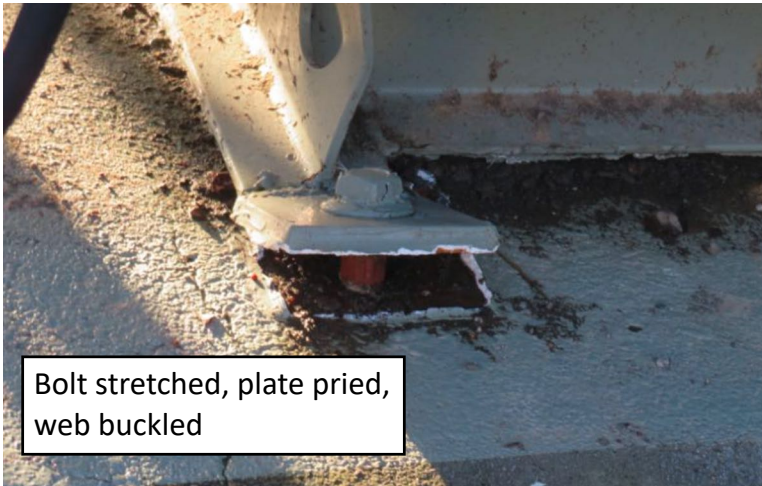
Bolt stretched, plate pried,
web buckled

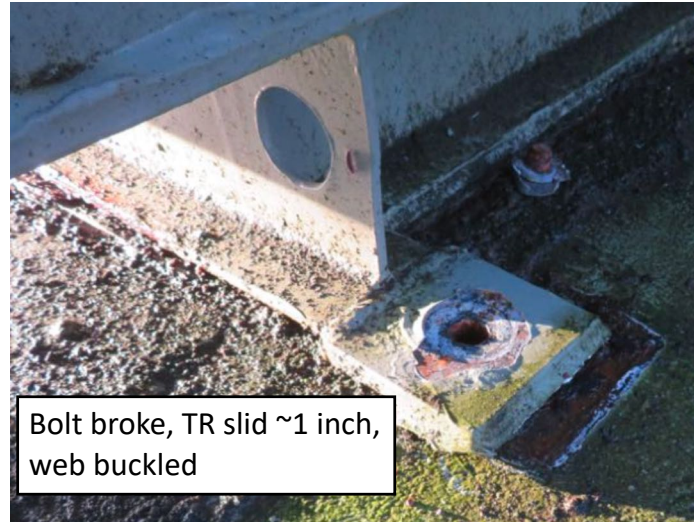
Bolt broke, TR slid ~1 inch,
web buckled

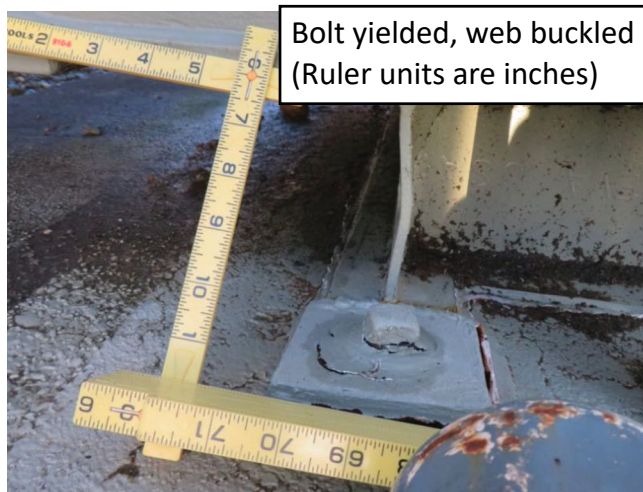
Bolt yielded, web buckled
(Ruler units are inches)
