Fragility of the Electric Power Grid

J. Eiding

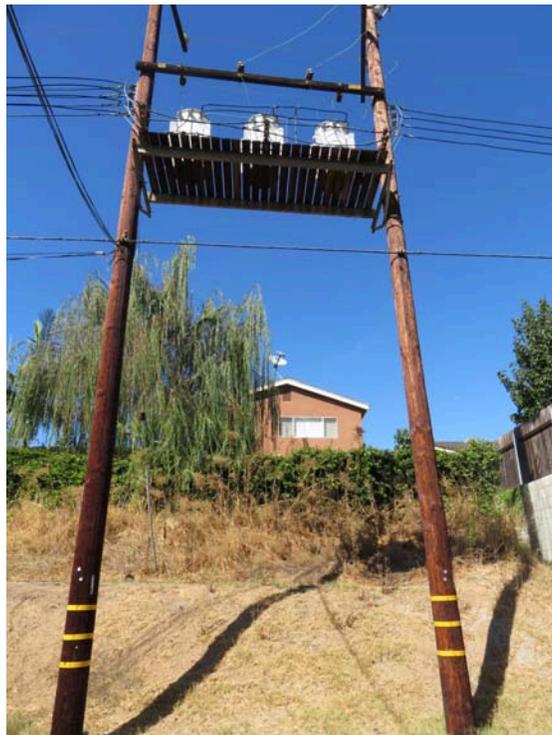
Figure 3. Unanchored Pole Top Transformers, Orange County

circuit faulted, serving perhaps 3,000 customers. That circuit was located in the epicentral area, where shaking likely exceeded $PGA > 0.3g$. The circuit outage was possibly (?) caused by rocking of an unanchored platform-mounted transformer, Figure 3. SCE currently has a program to identify all remaining unanchored platform-mounted transformers, with the intent to seismically strengthen them. In the 1952 Taft M 7.7 earthquake, more than 200 PG&E unanchored pole top transformers fell off their platforms, and the reason the ones in Figure 3 did not, even though exposed to high PGA, is attributed to the short duration of shaking (under 4 seconds) in this M 5.1 event. The actual shaking was likely high enough to initiate rocking and sliding of these transformers, possibly leading to a fault, but not long enough in duration to allow the transformers to slide far enough to fall.

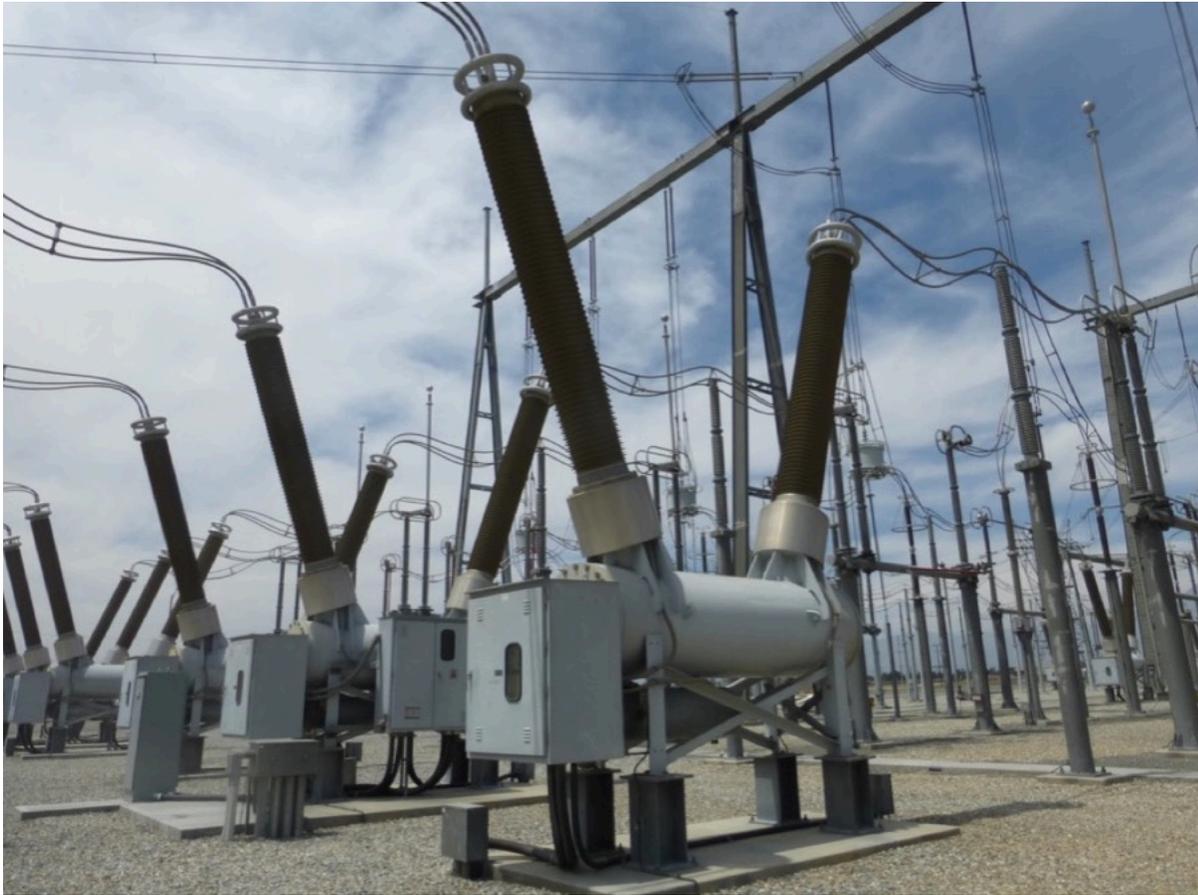
Figure 4. 500 kV SF6 Dead Tank Circuit Breaker

- The most common 500 kV circuit breaker in this inventory is Mitsubishi, 500 kV SF6 dead tank type, Figure 4, with 2,349 exposures. Of these 2,349 exposures, 4 were at $PGA = 0.16g$; 12 at $PGA = 0.14g$; 25 at PGA between 0.06g and 0.10g; etc.

- This information establishes that this type of circuit breaker is seismically rugged up to at least $PGA = 0.16g$; probably much higher. Dead tank 500 kV breakers have been shake table tested and qualified per IEEE 693 for $PGA = 0.5g$, so these empirical observations are not surprising; but are reassuring. With time, as more earthquakes occur and produce strong shaking at equipment, these results can calibrate the various fragility models.
