Seismic Fragility of Natural Gas Transmission Pipelines and Wells

G&E Engineering Systems Inc.

November 14 2021 | Revision 4

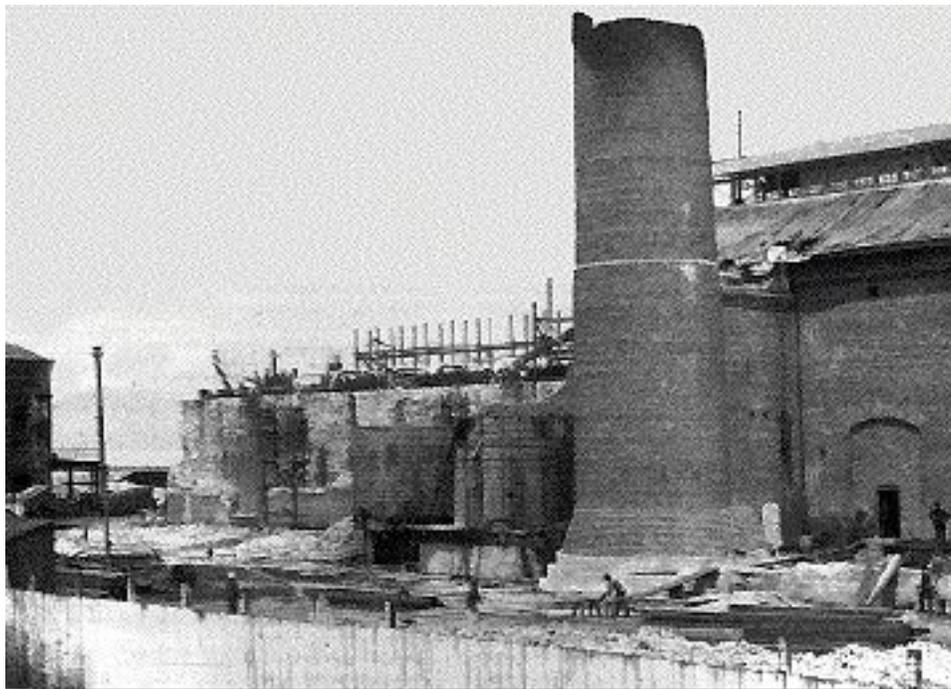
Figure 6.1-2. Damage to SFG&E North Beach Gas Plant, San Francisco 1906

The earthquake damaged the North Beach Station (Figures 6.1-2, 6.1-3), where liquefaction resulted in settlements locally on the order of 2 to 3 feet. A gas holder station and storehouse at Fifth and Tehama Streets were destroyed by the fire (this gas holder was located within Sullivan Marsh, and probably also subject to liquefaction). The gas plants at Potrero and Martin were subject only to ground shaking, and had little damage.

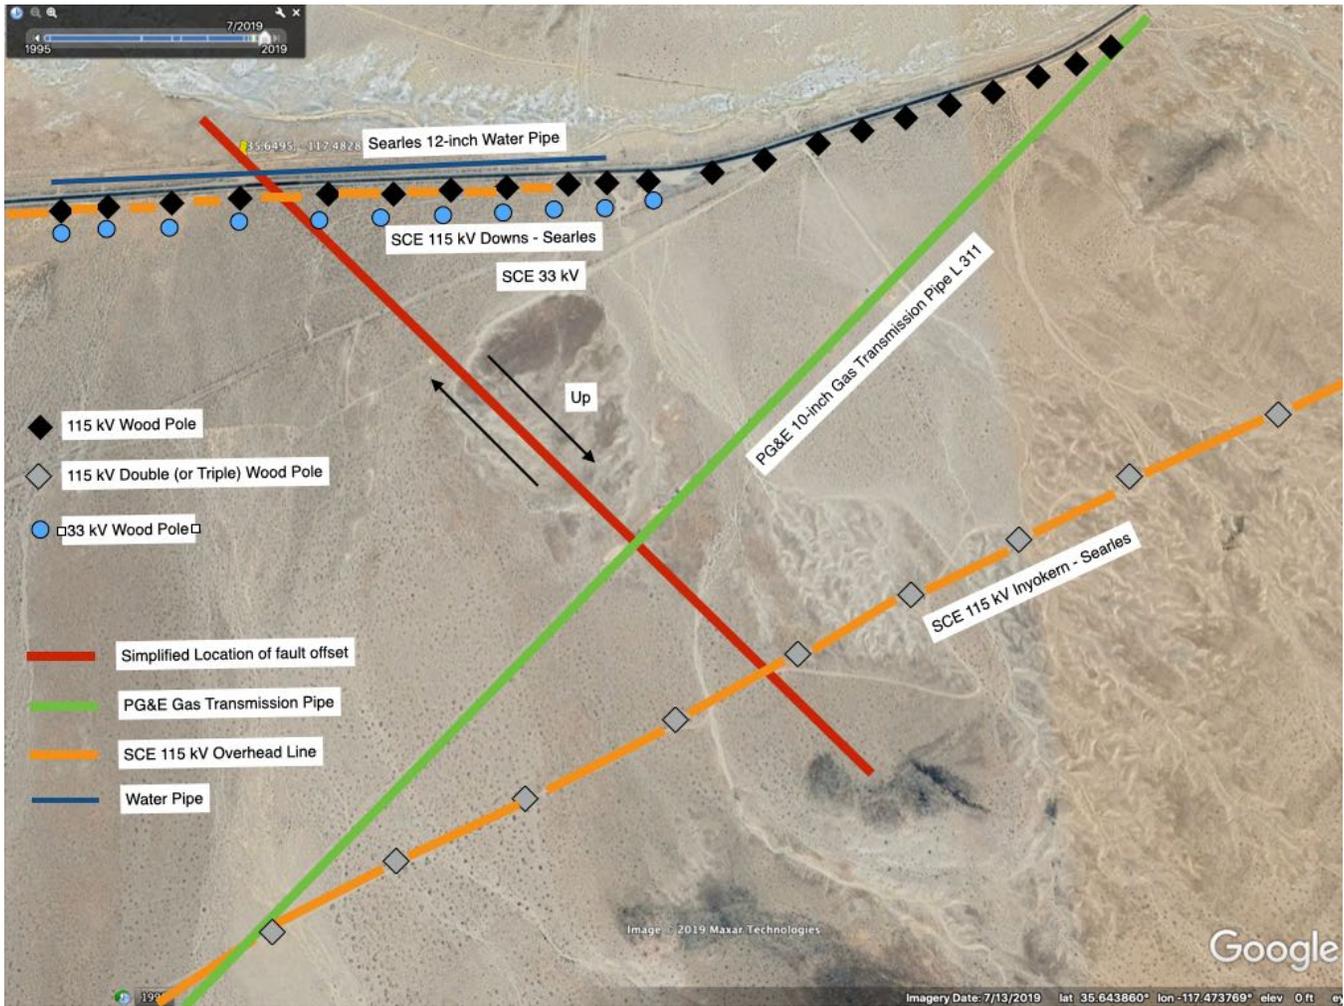
Figures 6.18-2 and 6.18-3 show aerial photos of the two fault crossing locations. The Searles 12-inch water pipe broke at the fault crossing in Figure 6.18-2 in the M 7.1 event.

Figure 6.18-2. M 7.1 Offset Location Showing Line 311 and Nearby Lifelines

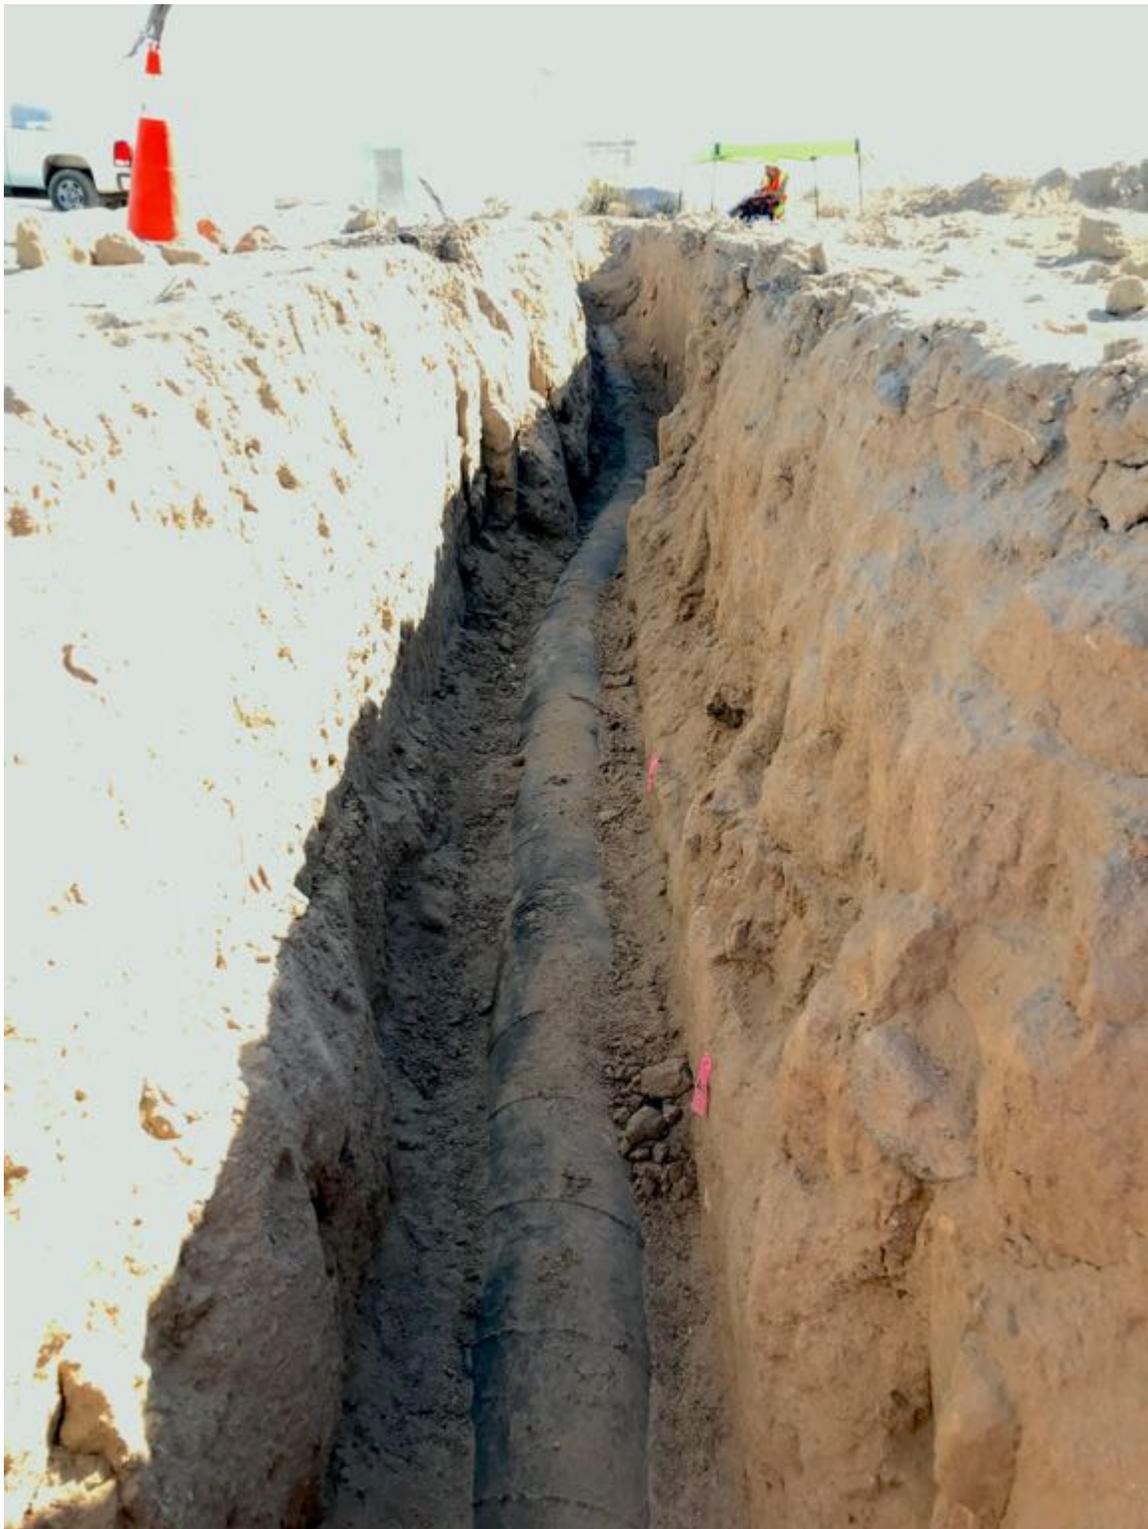
Within a week after the earthquakes, PG&E crews dug trenches along the two transmission pipes at the crossing zones, with the intention to observe the condition of the pipes, as well as to replace the stressed pipes with new unstressed pipes. Figure 6.18-4 shows Line 311. Figure 6.18-5 shows Line 372. At the stage of excavation shown in these figures, the pipes are still mostly buried. Lines 311 (10.75" OD) and 372 (6.625" OD) were both replaced where each crossed the faults.

Figure 6.18-4. Line 311 after Trench and Pipe were Partially Exposed (Courtesy PG&E)

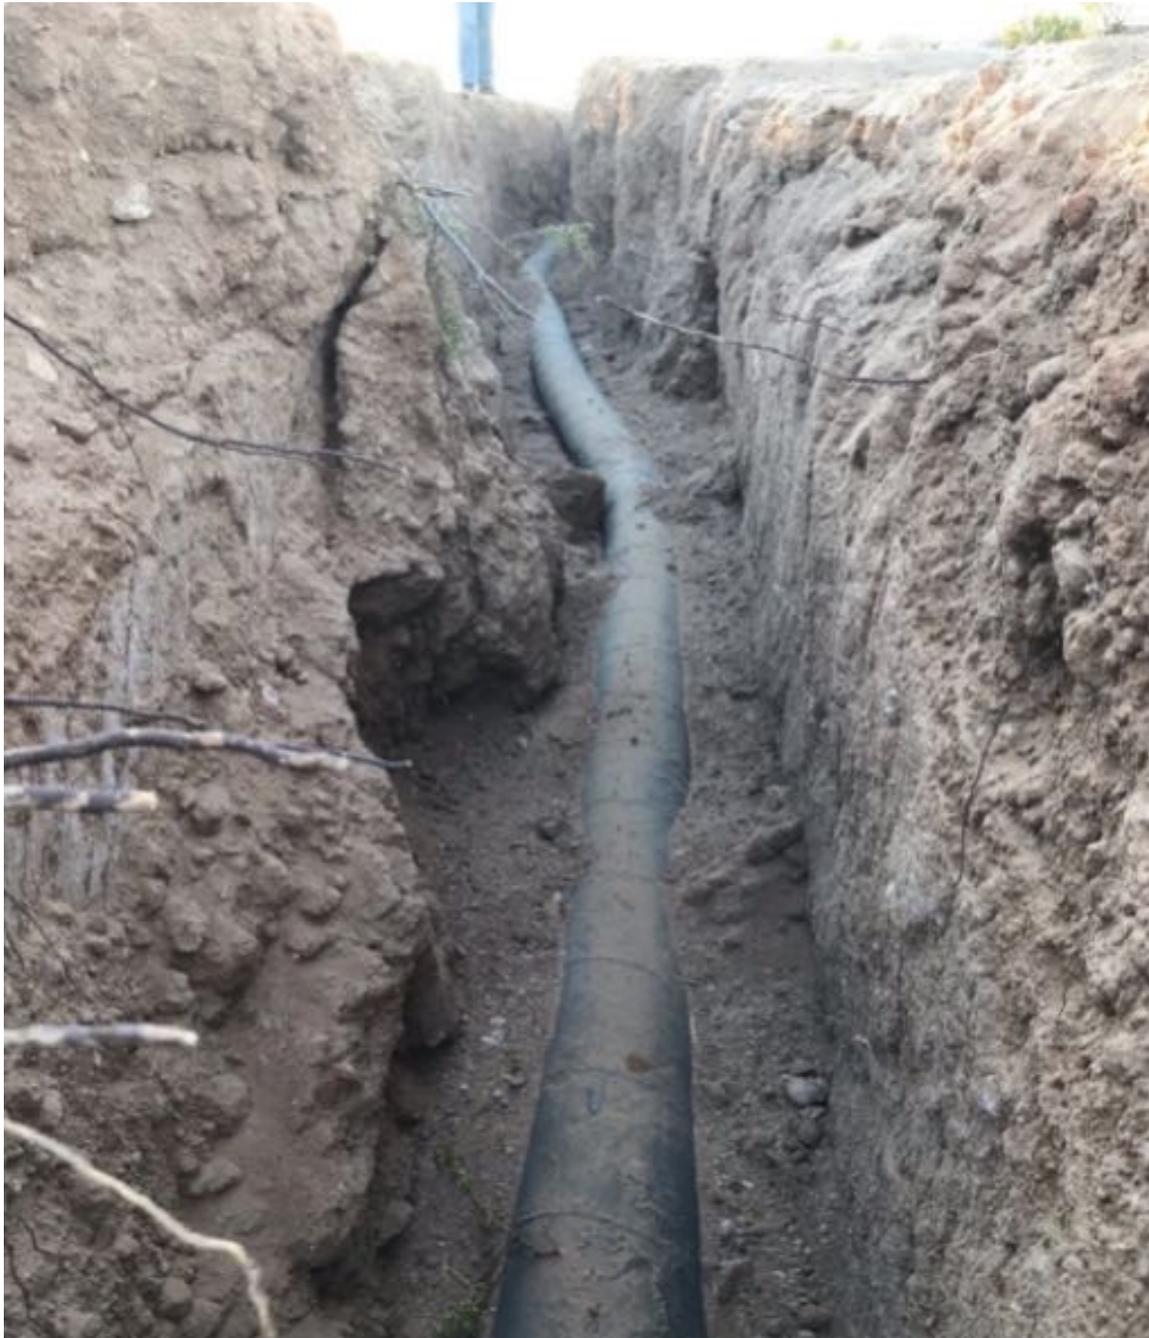
Figure 6.18-5. Line 372 after Trench and Pipe were Partially Exposed (Courtesy PG&E)

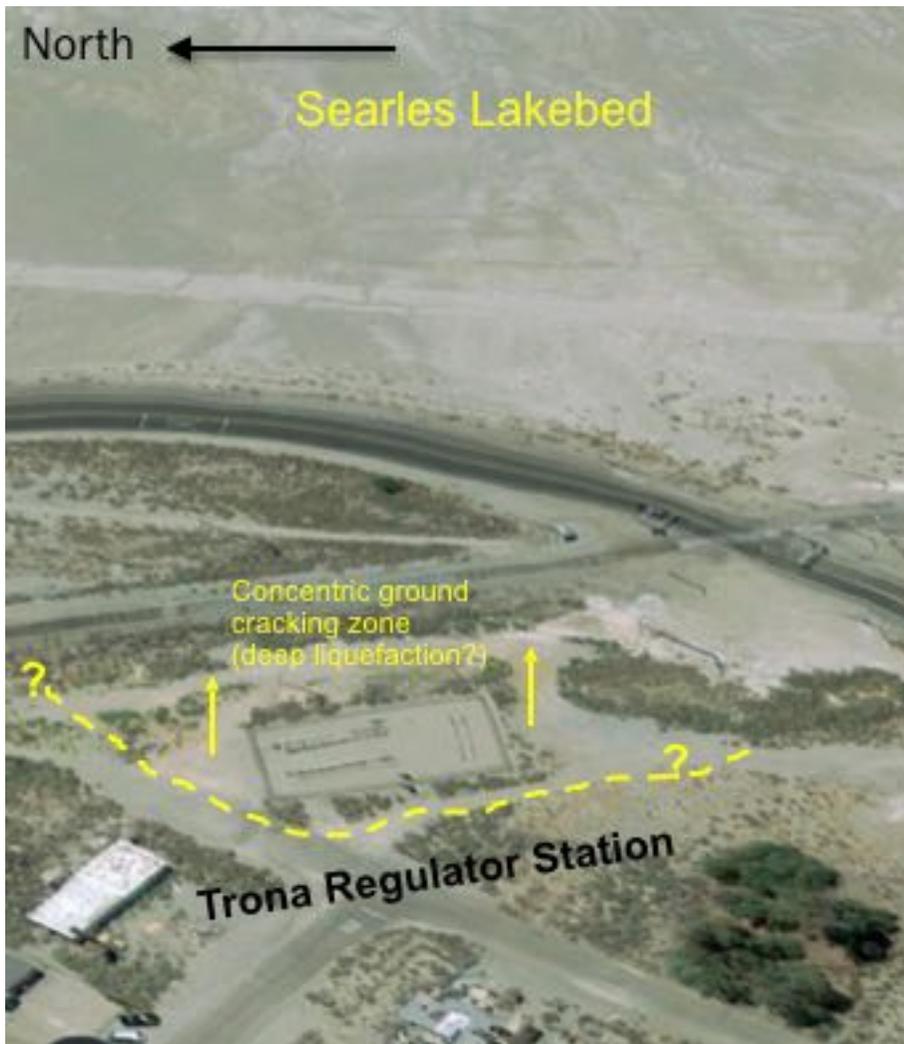
There was liquefaction in the Argus area. Figure 6.18-8 shows an aerial view, looking easterly, of the PG&E gas regulator station at the north terminus of Line 372. The yellow dashed line is an approximate location of the western extent of ground cracking at this location. The sense of movement is indicated by the yellow colored arrows, towards the Searles lakebed. Observations of excavations in this area suggest that the top layer of soil is granular, underlain by hard clay, underlain by rock. The thickness of the top layer would be thicker towards the Searles lake bed, thinning out or disappearing entirely toward the mountainous terrain to the immediate west of Argus, Trona and Pioneer Point. Where the water table was high, liquefaction occurred in the top soil layer. Many ground cracks were observed along Trona Road through the communities of Argus and Trona, but none was observed in Pioneer Point.

Figure 6.18-8. Trona Gas Regulator Station

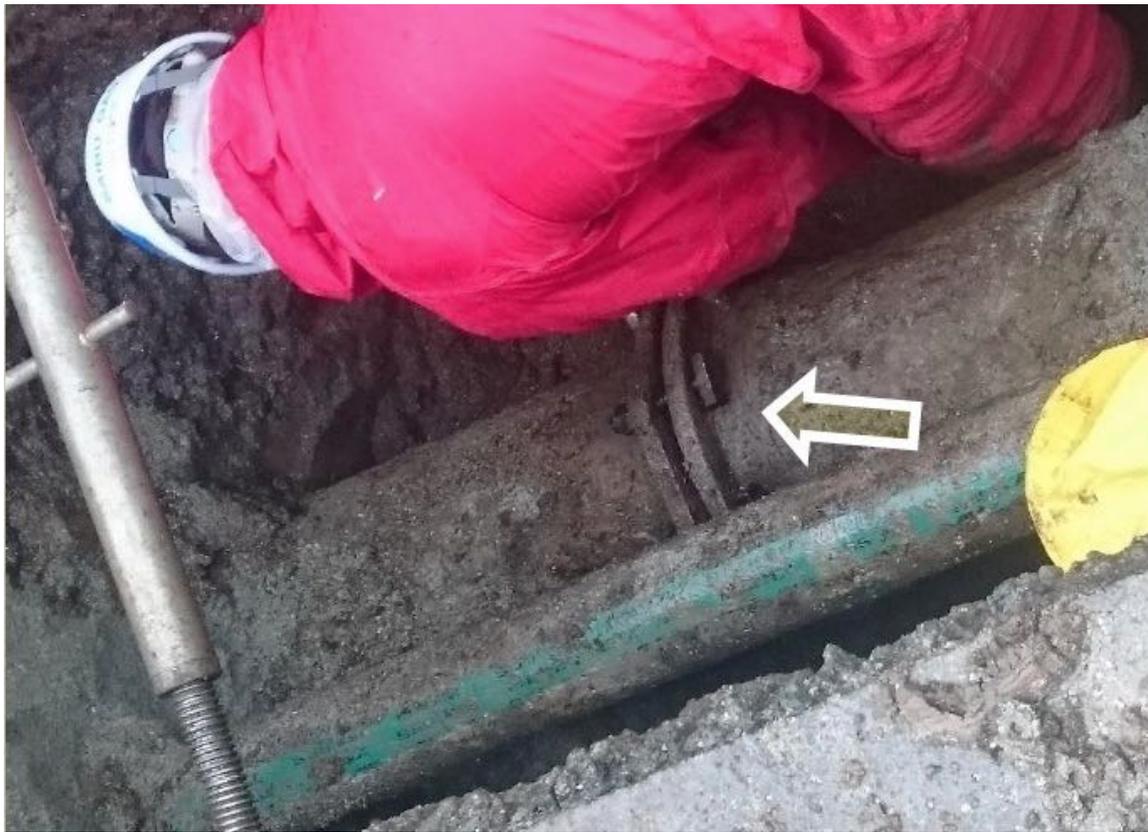
Figure 6.34-1. Repair to medium pressure steel pipe; repair was to tighten the mechanical joint (typical of 9 locations)

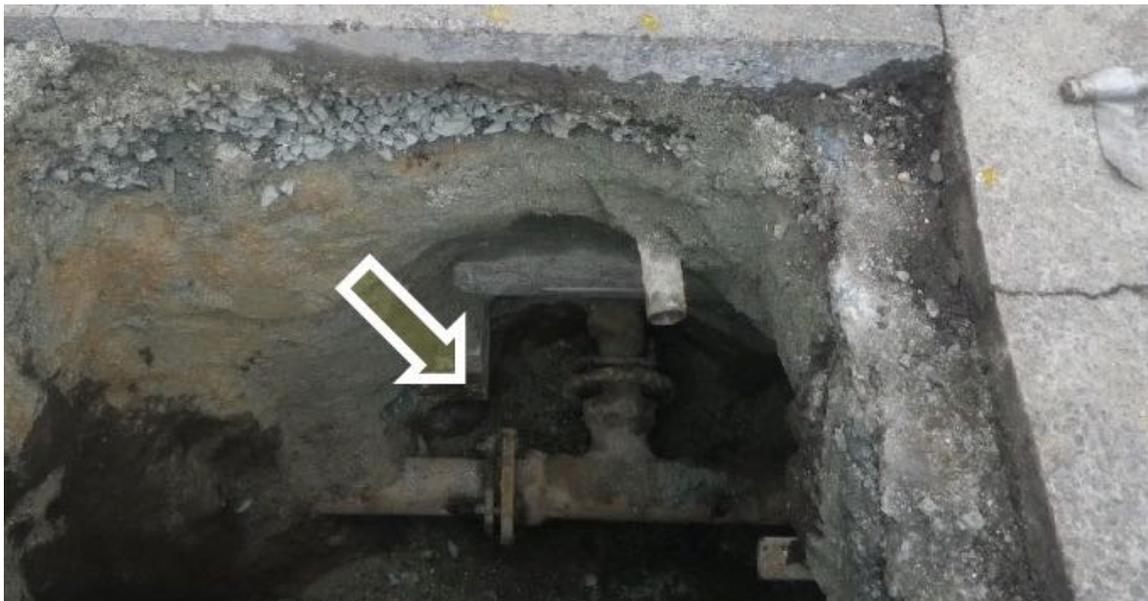
Figure 6.34-2. Repair to low pressure distribution steel pipe; repair was to tighten the mechanical joint (typical of 23 locations)

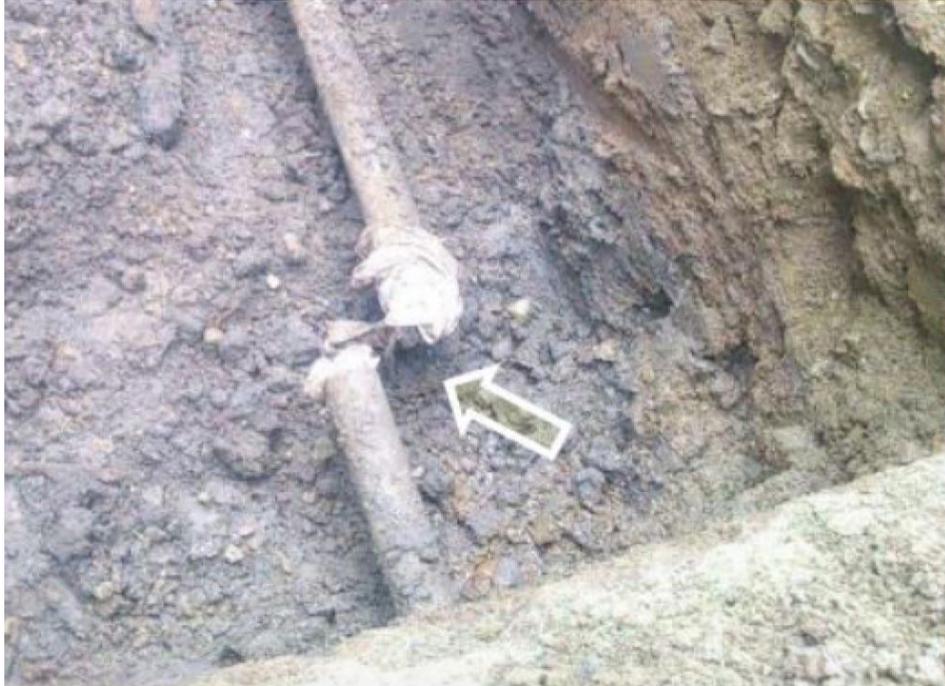
Figure 6.34-3. Repair to low pressure distribution steel screwed joint pipe; repair was to tighten the mechanical joint

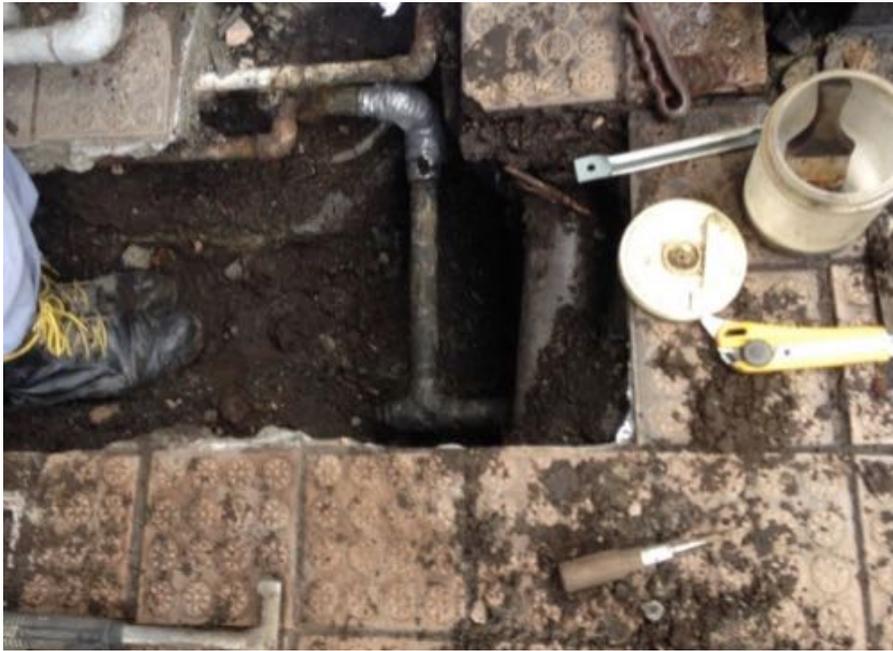
Figure 6.34-4. Repair to low pressure service lateral

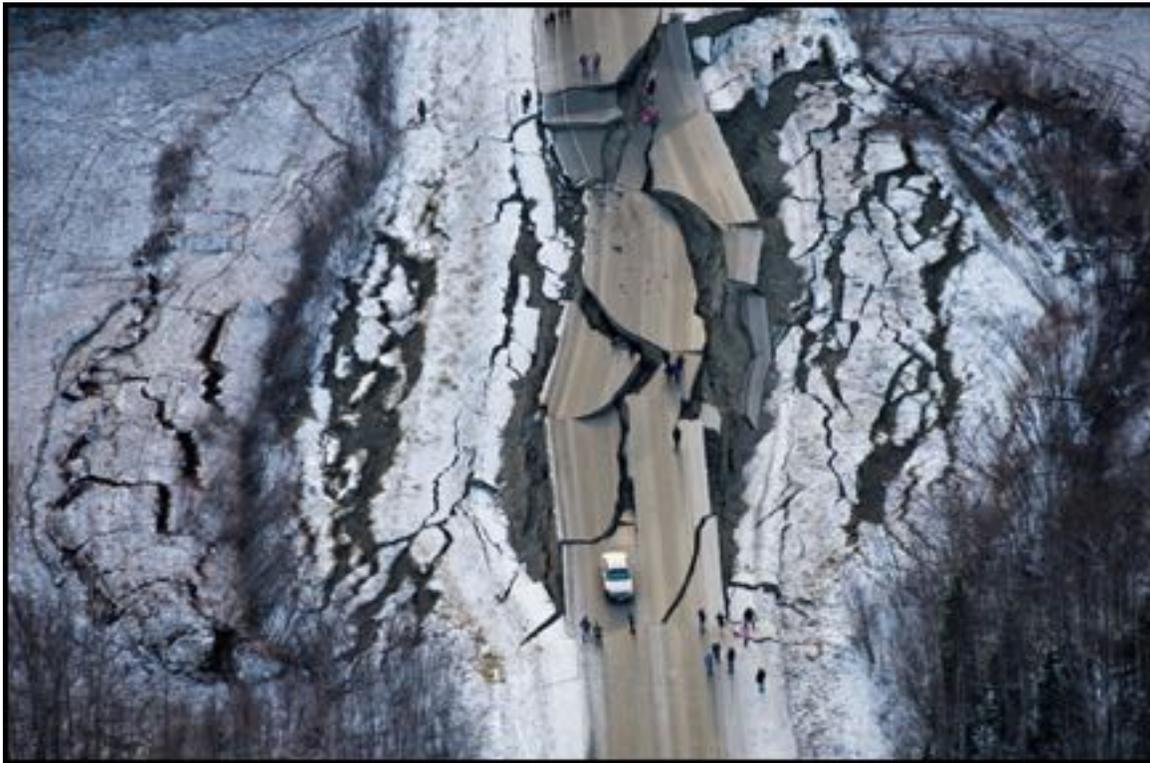
Figure 6.36-2. Roadway Deformations (December 1 2018)
