PERFORMANCE OF POWER, GAS AND WATER LIFELINES IN THE 2018 HOKKAIDO EARTHQUAKE

J. Eidinger⁽¹⁾

Abstract

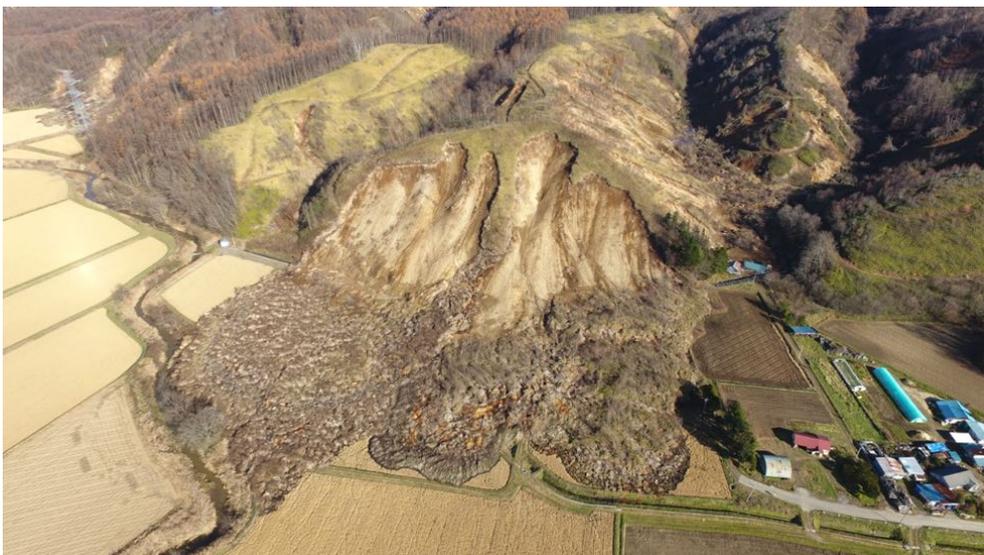
The earthquake triggered a large number of shallow- and deep-seated landslides in areas with $PGA > 0.5g$, see Fig. 2. The depth of the moving landslide masses from the mainshock was commonly over 2 meters deep (in some cases, over 10 meters deep), and the downslope movement of these slides was commonly more than 5 meters (in many cases, the downslope movement exceeded 20 meters with horizontal run-out of debris extending another 50 meters, in some cases, the horizontal movement exceeded 350 meters).

Fig. 3. Landslides east of Atsuma (credit: Shiga)

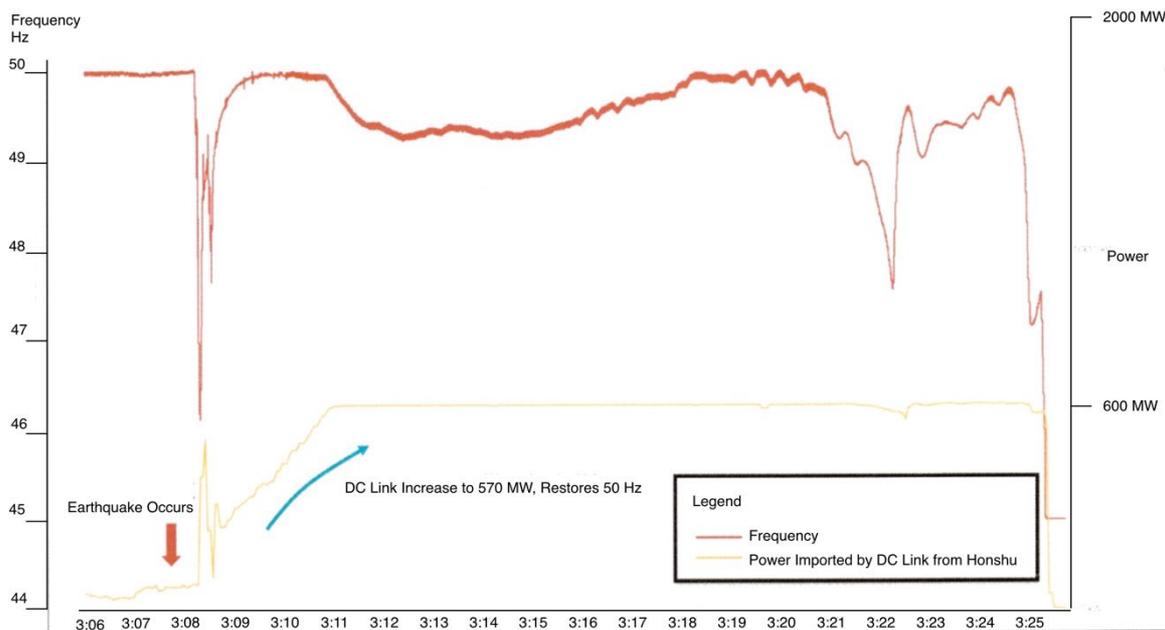
Fig. 5. System Frequency and DC Link Power Flow

Immediately after the earthquake, the coal-powered Tomatoh-Atsuma Units 2 and 4 tripped offline. This was caused by various damage to the boilers, detection of excessive vibration in the turbines, and a fire. This dropped 1,160 MW of generation supply. Two 275 kV transmission lines from the east also faulted (due to conductor dynamics leading to line faults), dropping another 600 MW of supply from remote hydro and wind and other power plants. System frequency immediately began to drop. When the frequency reached 48.5 Hz, under-frequency relays shed 1,300 MW of load. The eastern part of Hokkaido Island underwent a blackout, probably due to the rapid drop of the transmission lines that led to local frequency / voltage imbalances in that area. The Kita-Hon DC link was triggered when frequency dropped to 49.62 Hz. Over the course of a few seconds, the DC link ramped up to over 500 MW from south to north, and with the drop of load, system frequency began to recover towards 49 Hz. The DC link dropped load at about 3:08 am + 30 seconds, leading to a second drop in system frequency. The DC link quickly recovered in a few seconds, and system frequency increased, reaching 50 Hz by 3:10 am. By 3:10 am, about 1,760 MW of supply had been lost, of which about 500 MW had been "made up" by the ramp-up of the DC link from 72 MW to nearly 570 MW. At the same time, about 1,300 MW of demand had been shed. Therefore, by 3:10 am, the system was "more-or-less" in balance, and system frequency was restored to 50 Hz. Up to this point, the system had sustained about a "N-4" event (loss of two large generators and loss of two large transmission lines). The loss of the transmission lines due to "phase-to-ground" faults should have been only for a short amount of time, allowing time inspect the cause(s) of the fault and then clear the fault. After 3:11 am, power demand increased (in the portion of the grid that was not already cut-off), as people had been awoken by the earthquake and were then turning on lights, etc. This lasted a few minutes, during which time the power output from two undamaged power plants on undamaged parts of the transmission grid was ramped up (138 MW ramping up to 525 MW). Between 3:11 am and 3:14 am, this demand load increase resulted in system frequency dropping from nearly 50 Hz to about 49.2 Hz, but as two undamaged power plants ramped up, system frequency again increased to about 50 Hz by 3:20 am. At around 3:21 am, damage at Unit 1 of Tomatoh-Atsuma resulted in unstable power, and output from Unit 1 was decreased by about 200 MW. System frequency then dropped to about 48 Hz. At around 3:22 am, an additional 160 MW of load was shed, and the system frequency quickly increased to about 49.5 Hz. Between 3:24 am and 3:25 am, the damage at Tomatoh-Atsuma Unit 1 resulted in the entire unit tripping off line, a drop of another 138 MW in supply. System frequency declined rapidly to about 47.8 Hz. Another 60 MW of load was then shed, and system frequency briefly increased to about 48 Hz for a few seconds. Then, three other un-damaged operating power plants all tripped, resulting in a further loss of 340 MW in supply. System frequency rapidly dropped to about 45 Hz. At about 3:24 + 40 seconds, due to the drop to 45 Hz, the DC – AC inverter station

on the DC link relayed out, and the 570 MW supply was immediately lost. At this point, at about 3:25 am + 10 seconds, an Island-wide outage occurred.

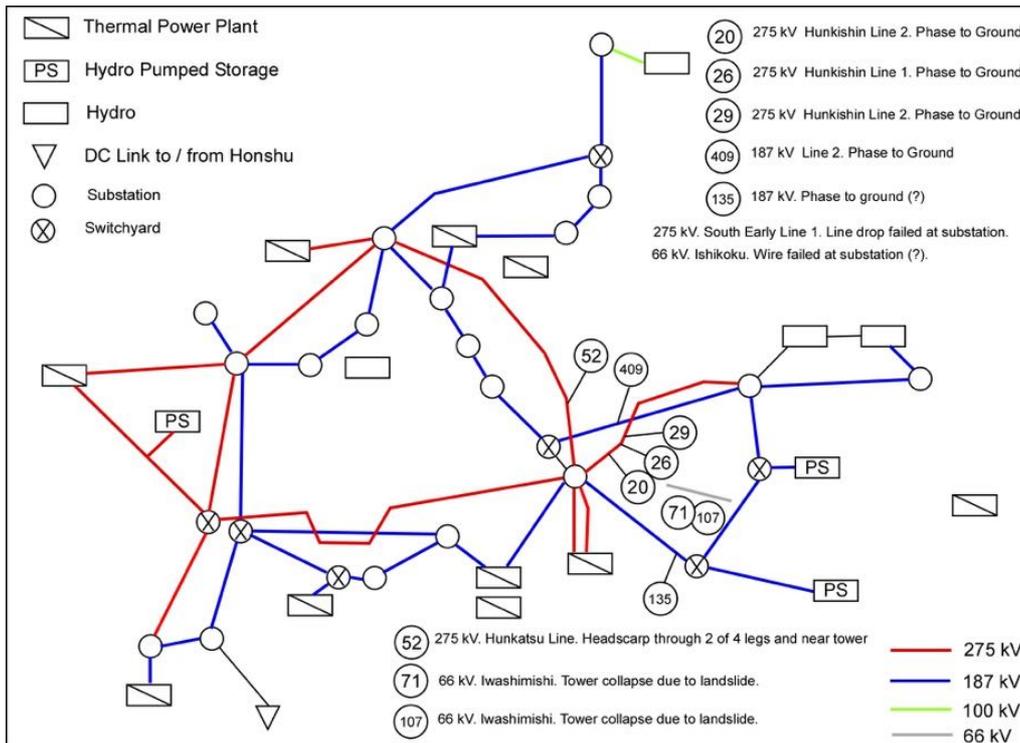
Sapporo. In the area highlighted in green (Otaru and Ishikari port areas), the ground shaking was commonly 0.03g to 0.05g. In the areas without color boxes, the ground shaking was commonly 0.01g to 0.03g. The bulk of the physical damage to the power grid occurred in the red and orange areas. This includes damage to the Tomatoh-Atsuma coal power plants, collapsed transmission towers, faulted transmission lines due to the "galloping" of jumpers that resulted in phase-to-ground faults, some damage to equipment within substations, and many collapsed distribution poles due to landslides. There was also some damage in the yellow zones due to landslide and liquefaction effects on distribution lines. Fig. 7 shows locations of damage at 8 transmission towers; 2 other transmission lines were faulted due to damage of equipment at substations. A portion of the single circuit 66 kV Iwashimishi line is shown, to highlight the relative locations of collapsed towers due to landslides. All the damaged towers are located in the red zone from Fig. 6. Five lines faulted due to high inertial loading on the conductors (20, 26, 29, 409, 135). Three towers were damaged due to landslides (52, 71, 107).

Fig. 7. Locations of Transmission Tower Damage

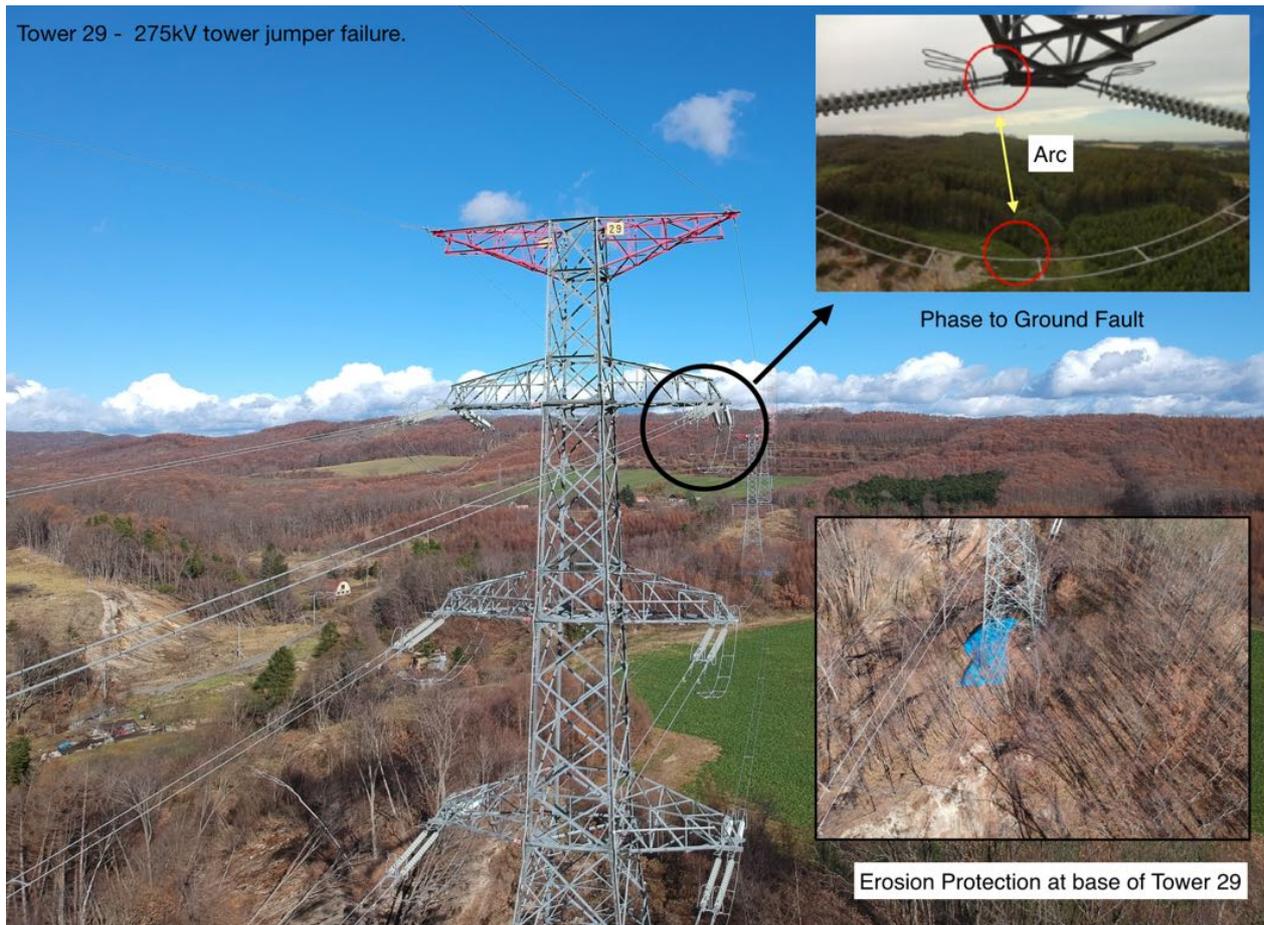
Fig. 8 show Tower 29 on the 275 kV lines (see Fig. 7 for location). The line jumpers and string insulators in the black circles moved during sufficiently during the earthquake to cause phase-to-ground faults.

Fig. 8. Tower 29, Line Fault

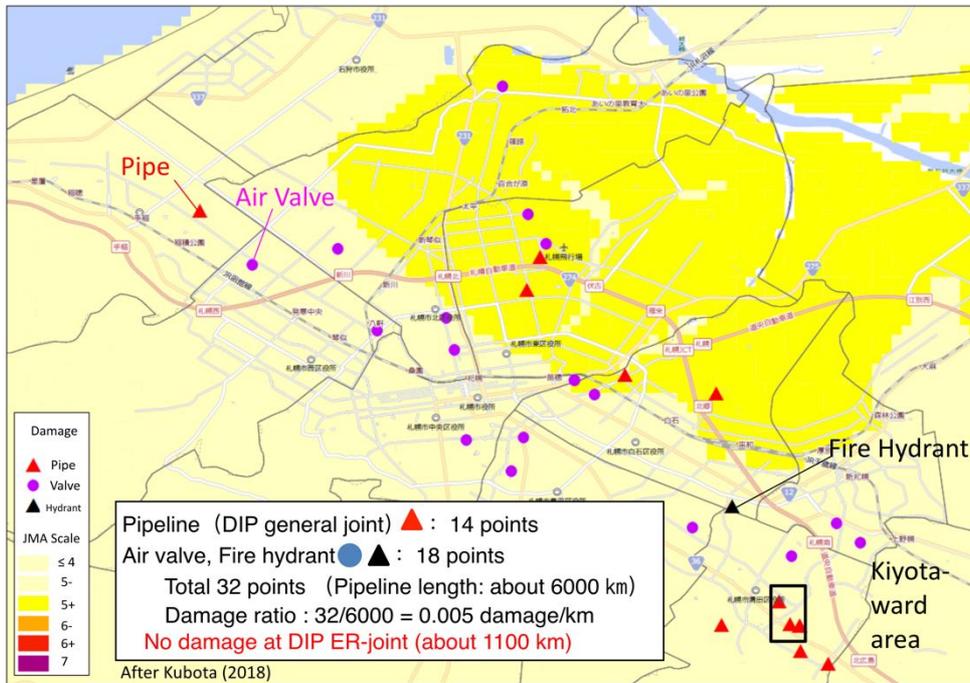
The most concentrated pipeline damage location was in the area called Kiyota Ward, (heavy black rectangle in Fig. 9) where significant liquefaction resulted in 3 broken water mains. City-wide, the number of damaged appurtenances was 17 air valves and 1 fire hydrant. Fig. 10 shows photos of a damaged pipe in the Kiyota-ward area. The exact number of damaged service laterals (commonly 25 mm or smaller) is uncertain.

Fig. 9. Location of Water Pipeline Damage

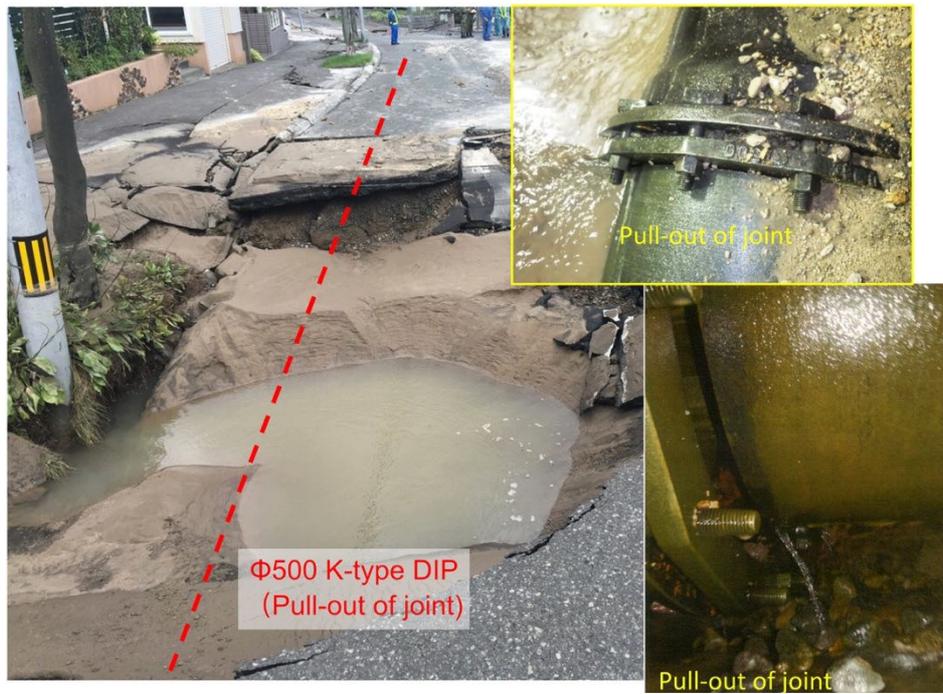
Fig. 10. Pipe Damage in the Liquefaction Zone (credit: Kubota)
