KUMAMOTO, KYUSHU, JAPAN, EARTHQUAKES OF M_w 6.0 April 14, 2016 M_w 7.0 April 16, 2016 LIFELINE PERFORMANCE

ALEX K TANG and JOHN M EIDINGER

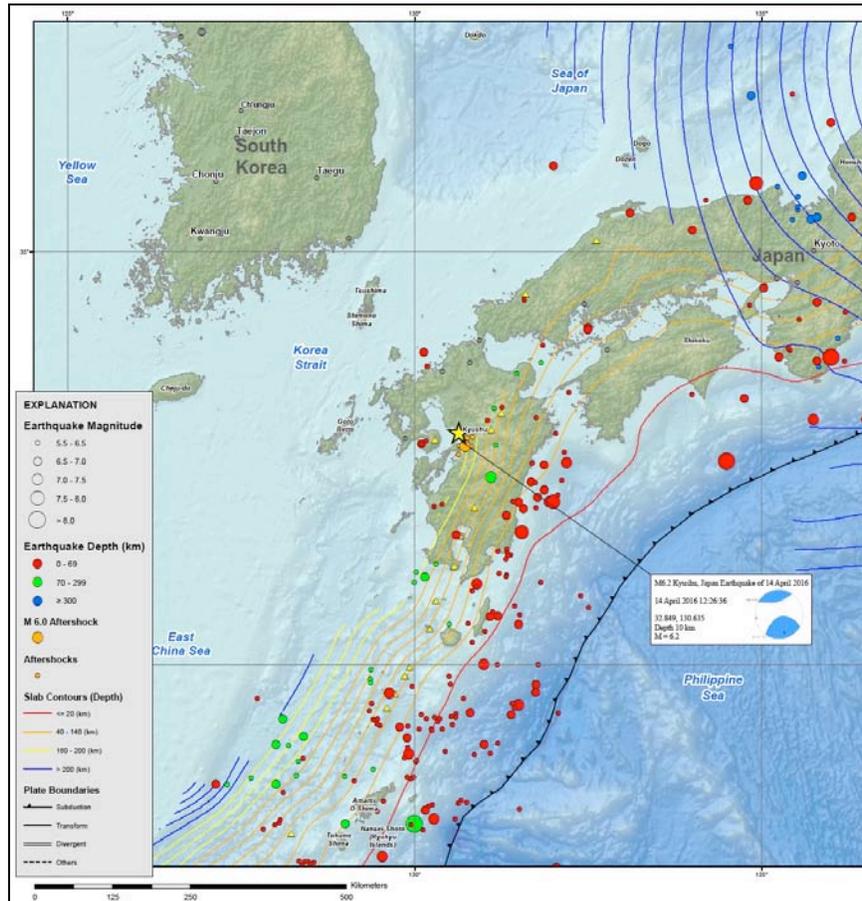
Figure 1-1. Epicenter of M=6.0 Kumamoto Earthquake (Foreshock), 14 April 2016 (USGS)

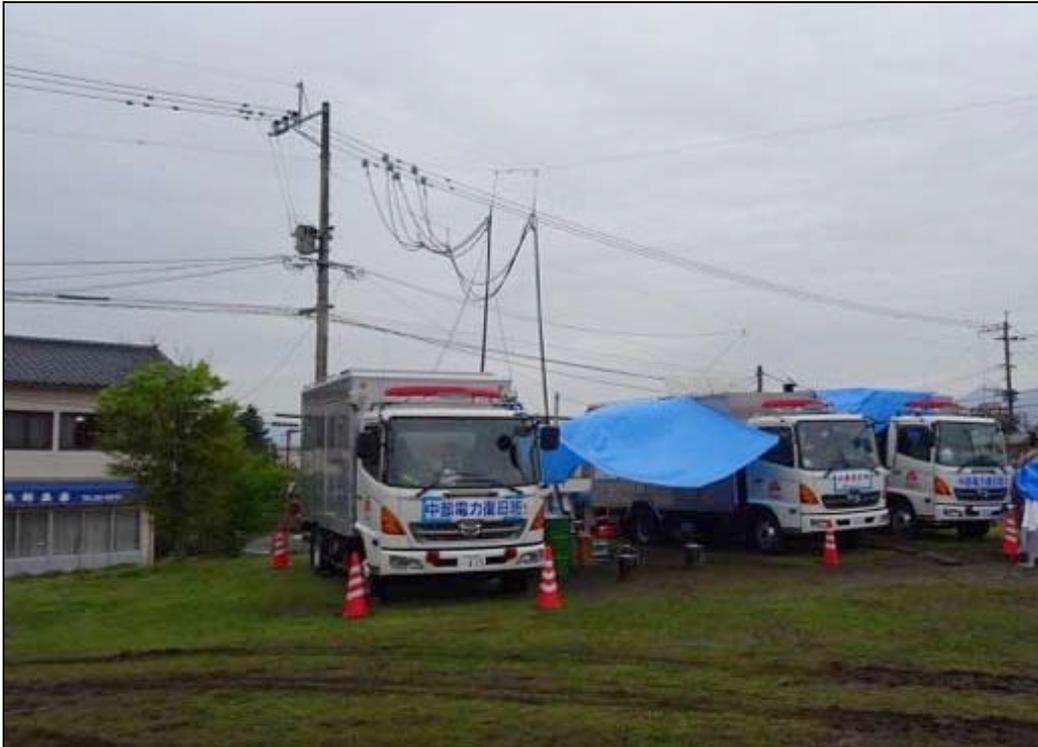
Figure 1-3. High power generating truck provided power to circuits that were disconnected from power source (MLIT)

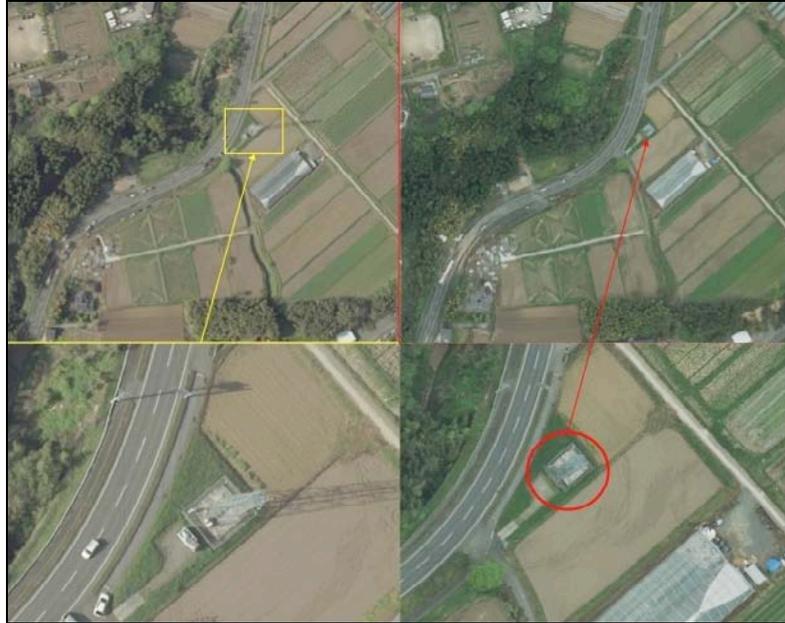
Figure 1-4. The aerial photo on the left was taken on 15 April 2016, while the one on the right was taken on 16 April 2016 after the main shock. Note the crumbled tower on the lower right, within the red circle. (Photos from Aero Asahi Corporation)

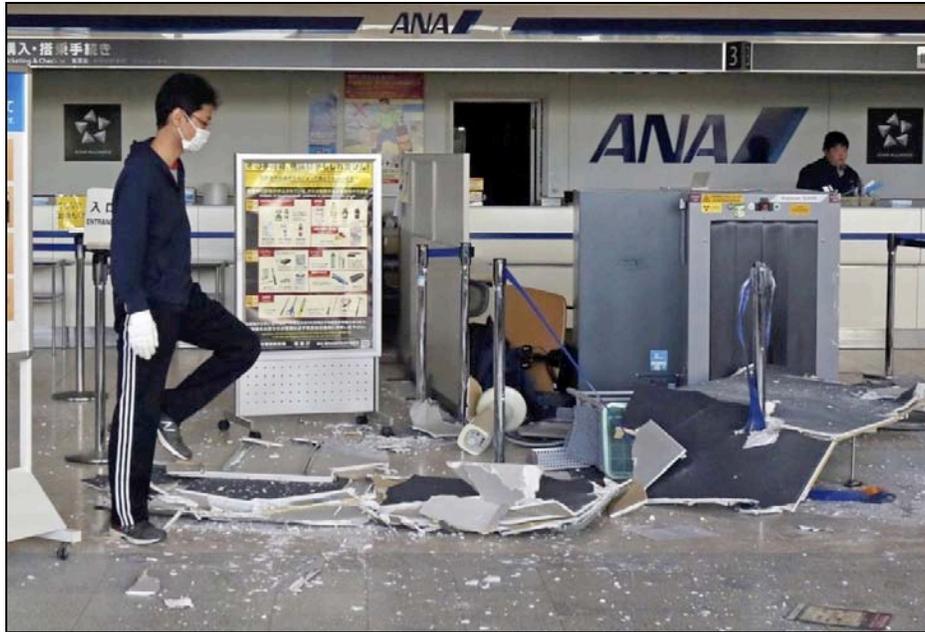
Figure 1-6. Kumamoto Airport domestic terminal the morning after the main shock in front of ANA service counter. (Courtesy Guardian News & Media Ltd)

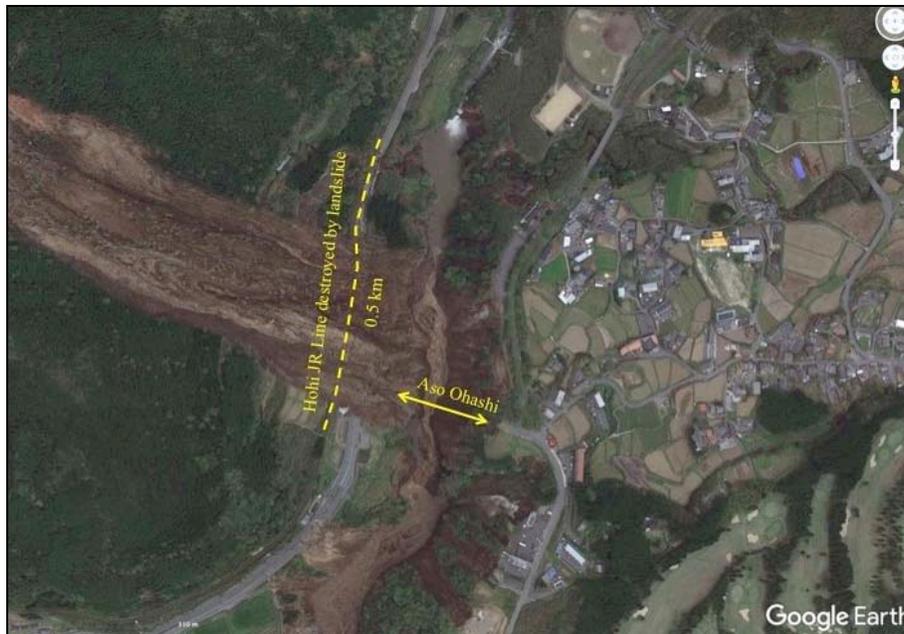
Figure 1-7. Hoho JR Line destroyed by landslide

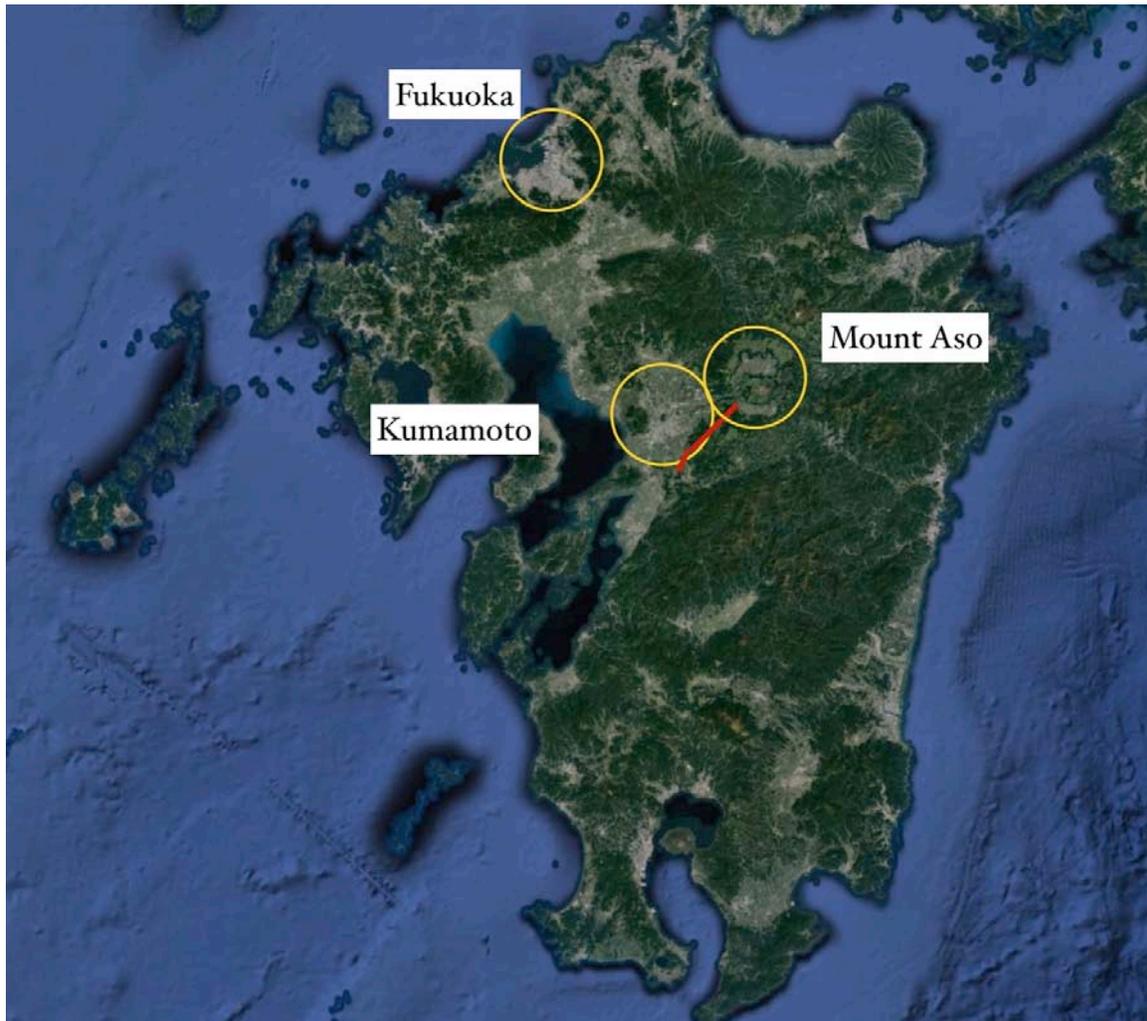
Figure 2-2. Kyushu Island

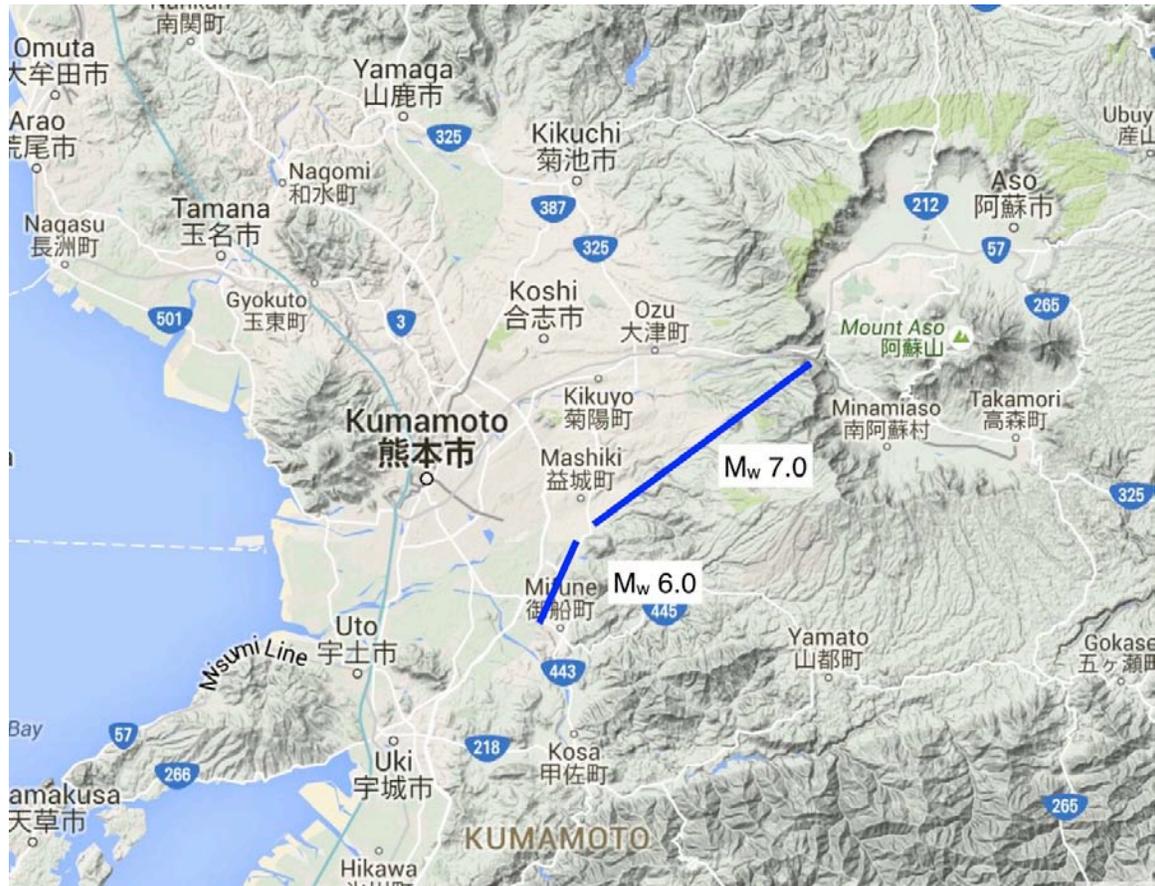
Figure 2-3. Kumamoto and Mount Aso Area

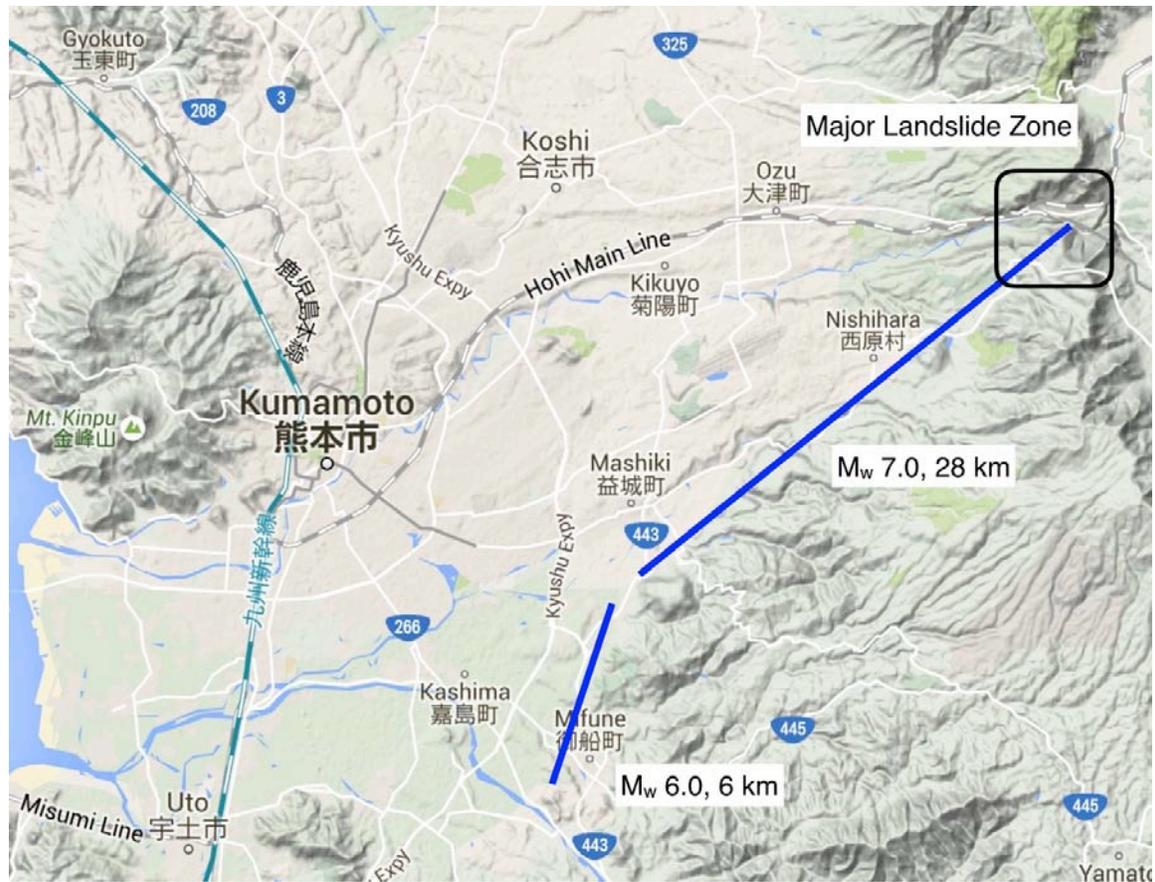
Figure 2-4. Kumamoto, Mount Aso and Landslide Area

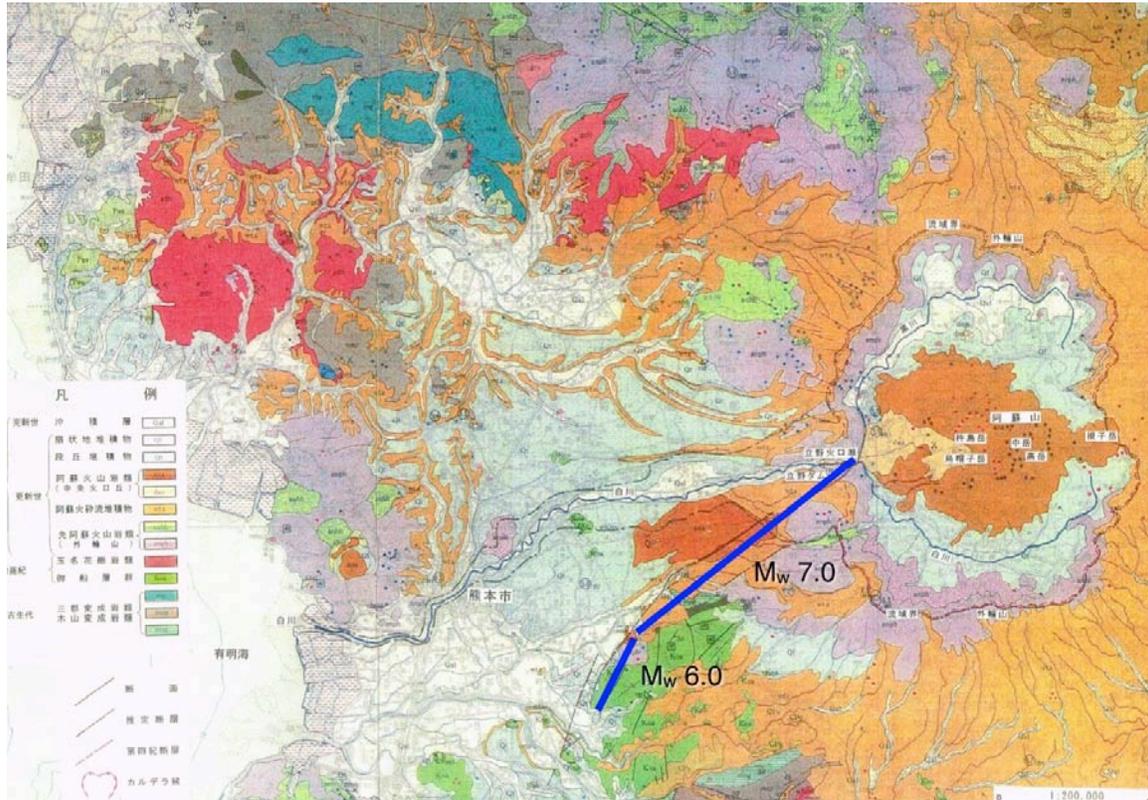
Figure 2-5. Geologic Map

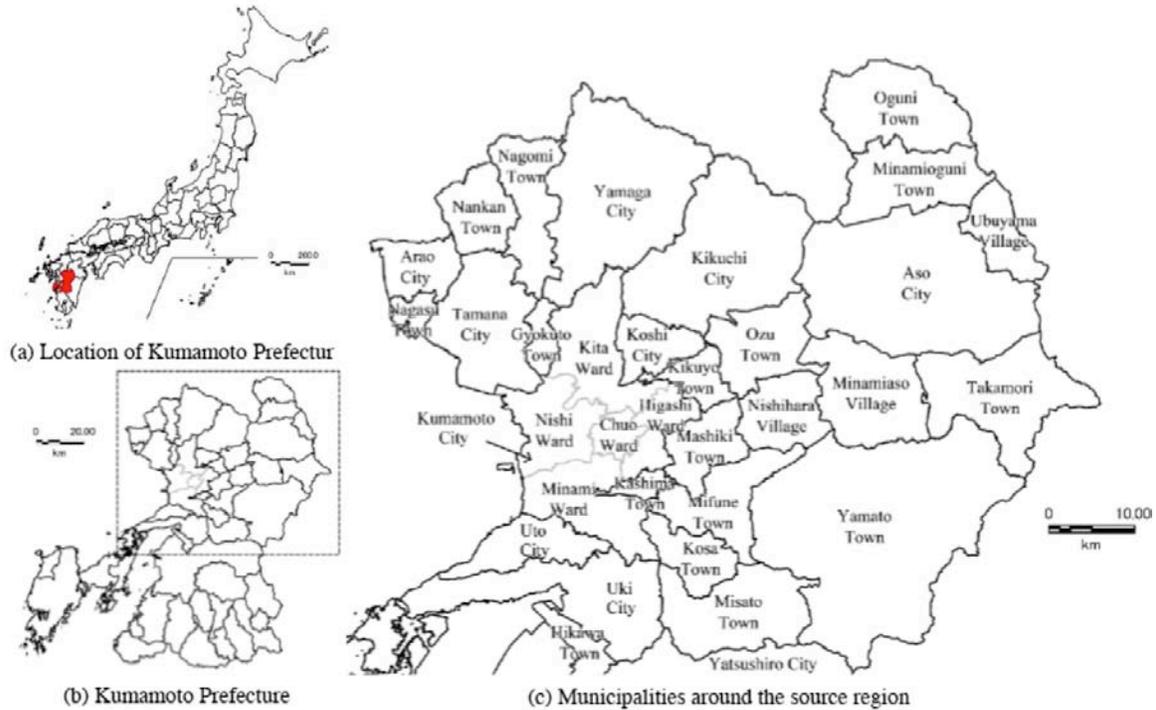
Figure 2-6. Place Names

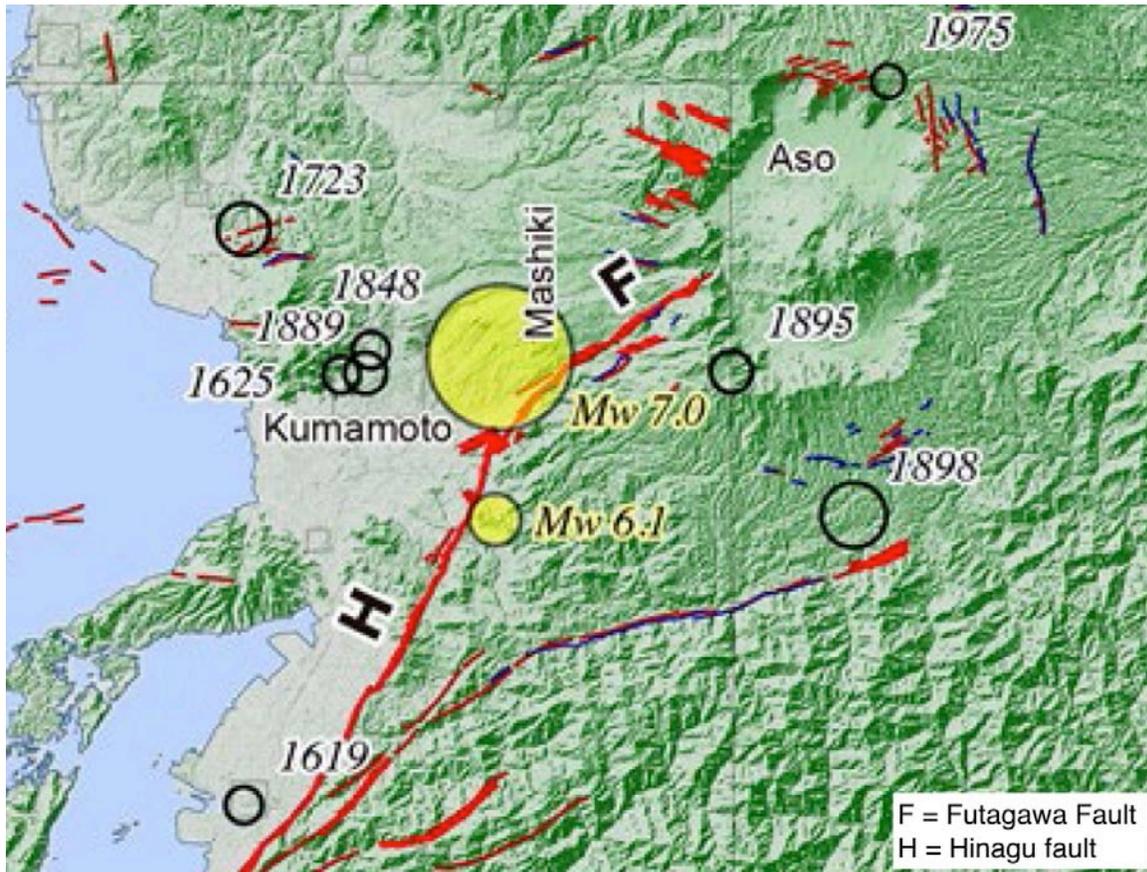
Figure 2-7. Historical Seismicity

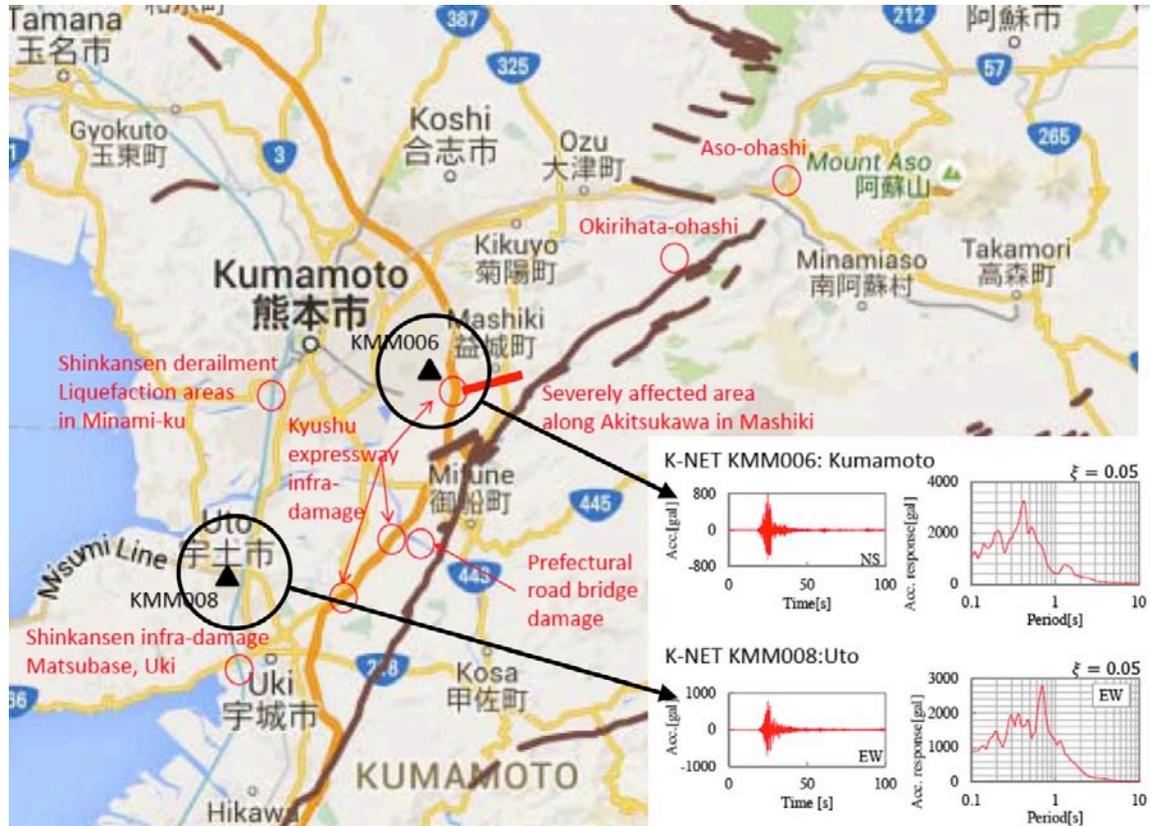
Figure 2-8. Strong Motions

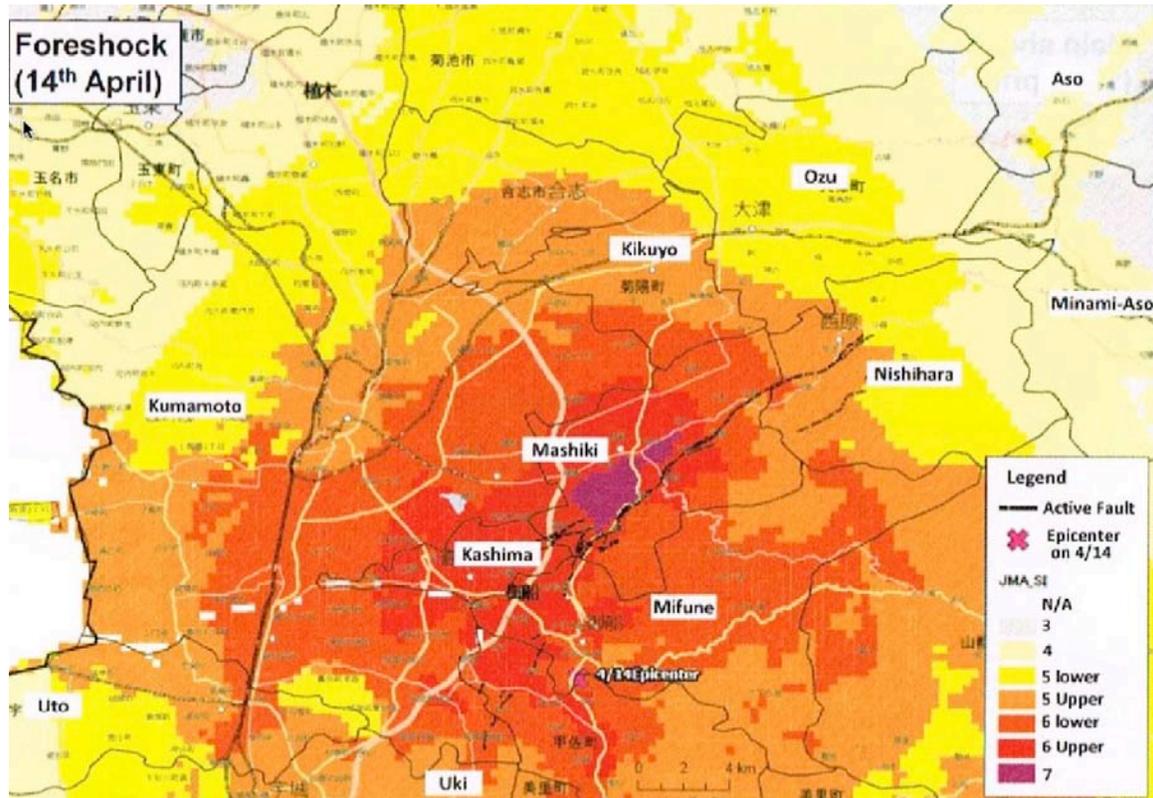
Figure 2-9. JMA SI Scale – April 14 2016 Fore Shock Earthquake

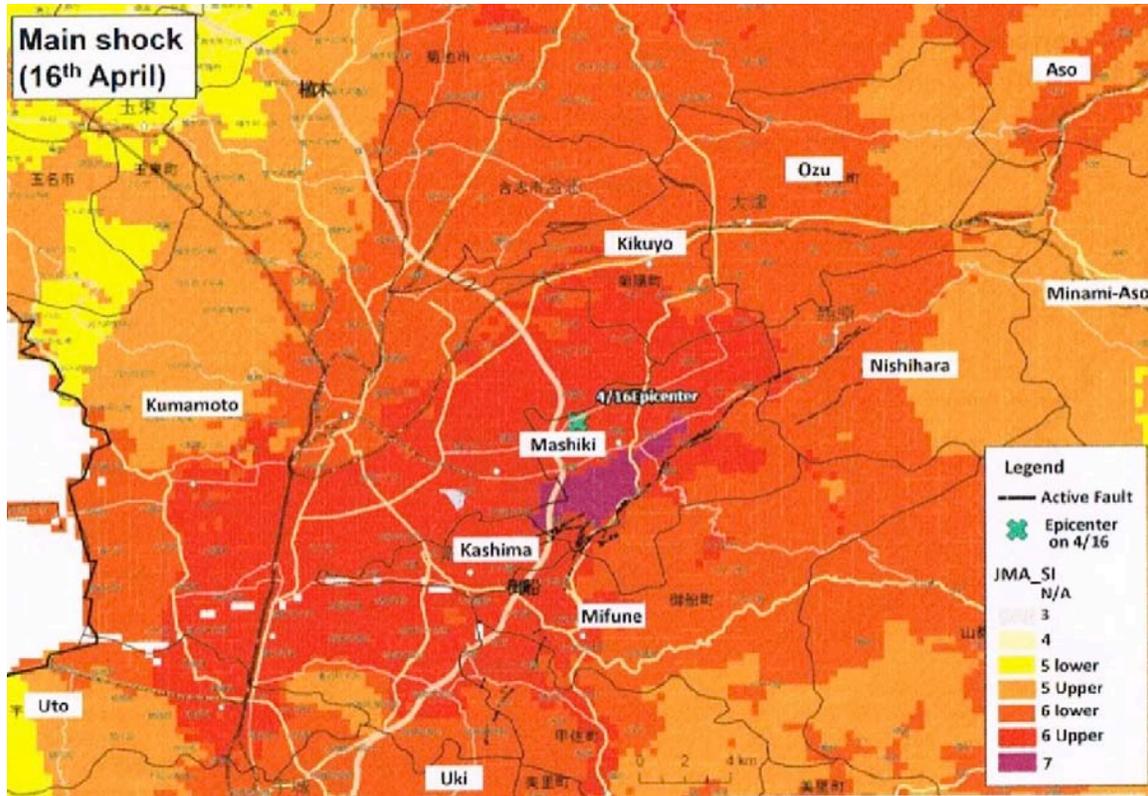
Figure 2-10. JMA SI Scale – April 16 2016 Main Shock Earthquake

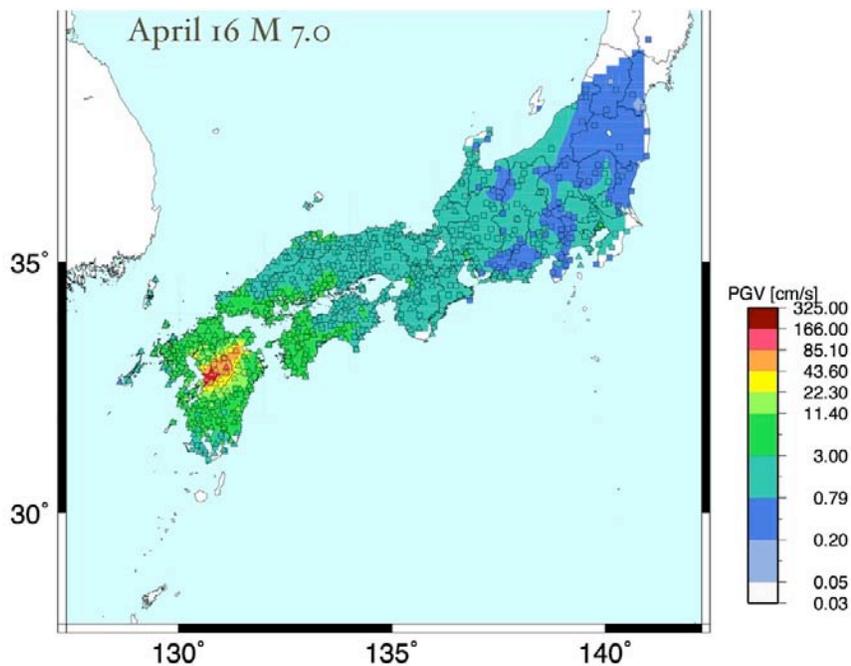
Figure 2-12. PGV Map - Japan – April 16 2016 Main Shock Earthquake

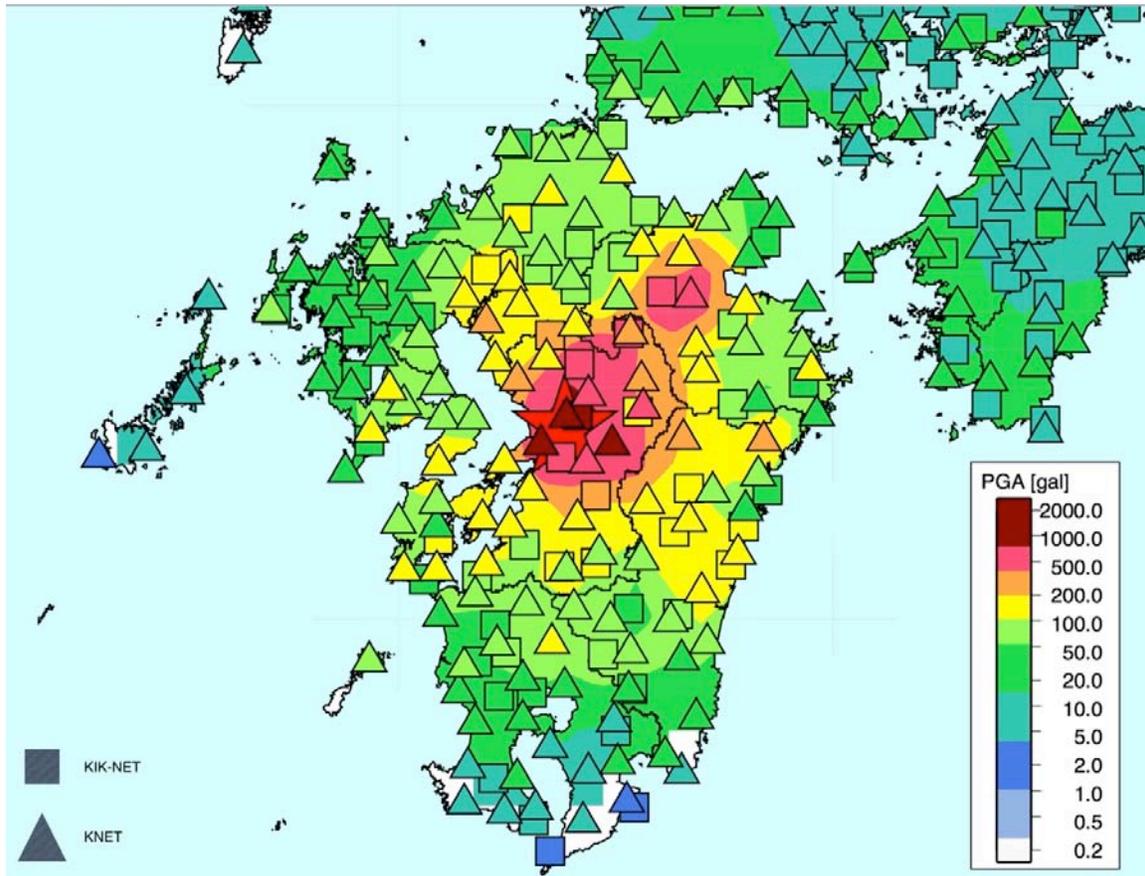
Figure 2-13. PGA Map - Kyushu – April 16 2016 Main Shock Earthquake

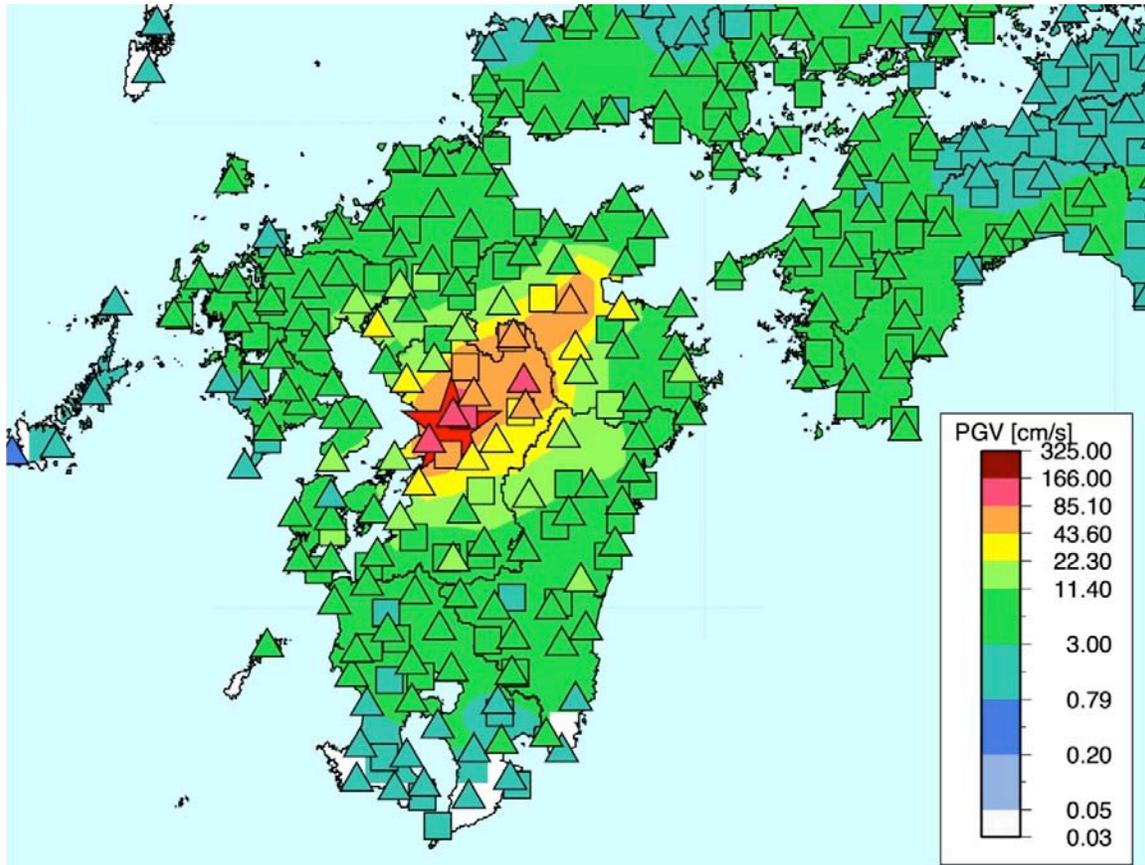
Figure 2-14. PGV Map - Kyushu – April 16 2016 Main Shock Earthquake

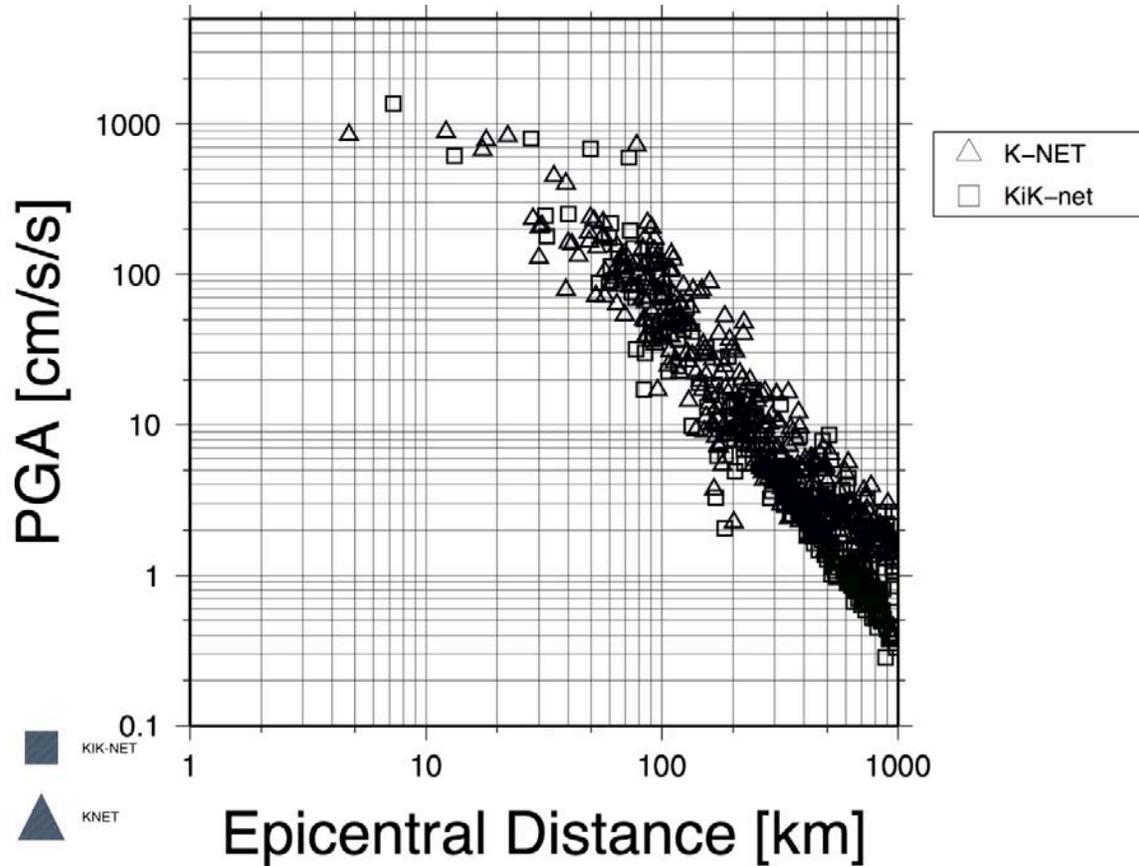
Figure 2-15. PGA versus Epicentral Distance Main Shock

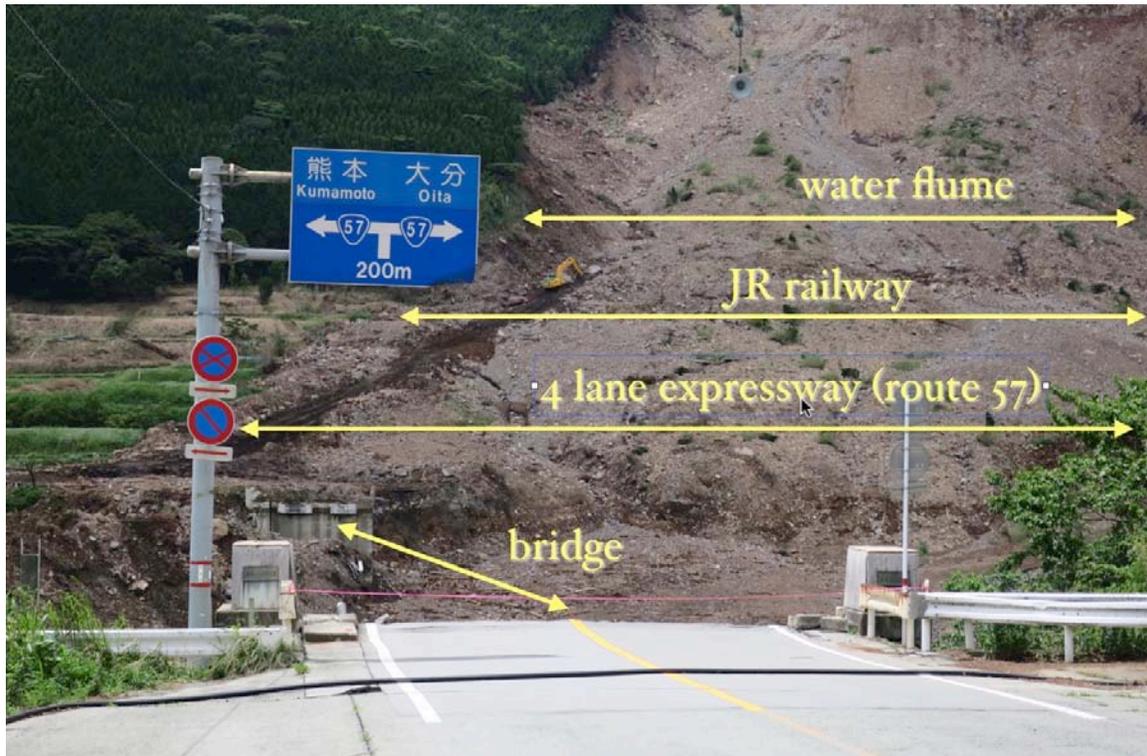
Figure 2-23. Landslide and Failed Infrastructure – East Facing Slope

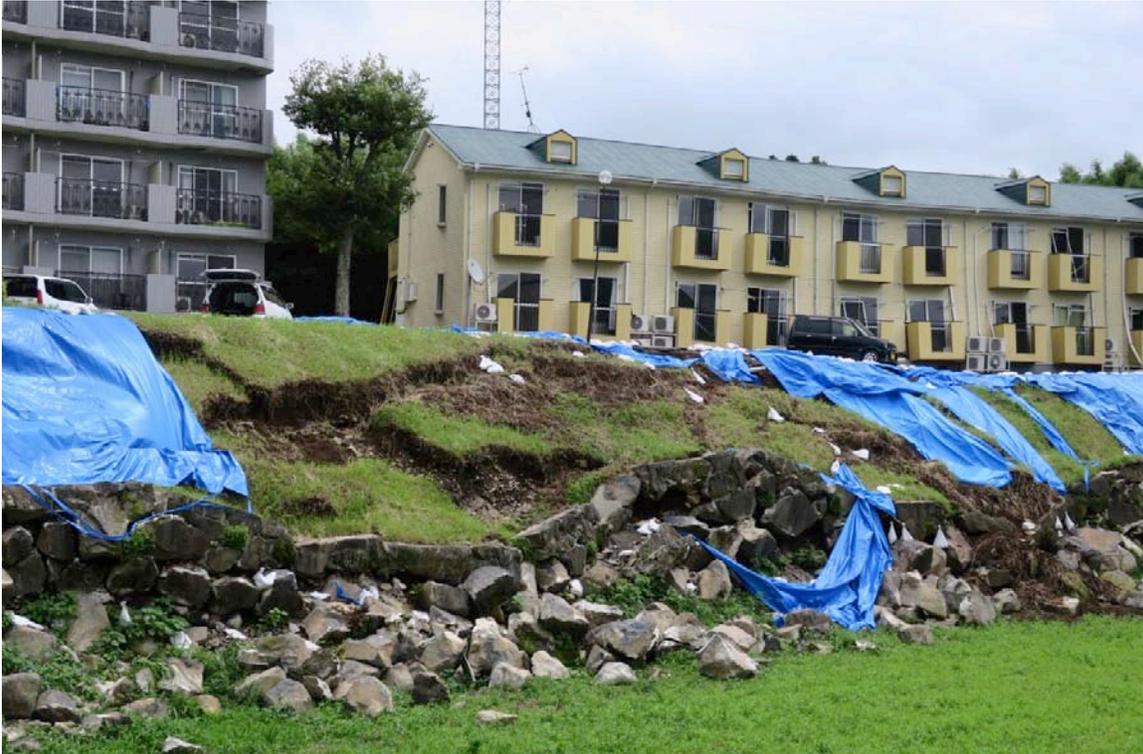
Figure 2-24. Embankment Slope Failure

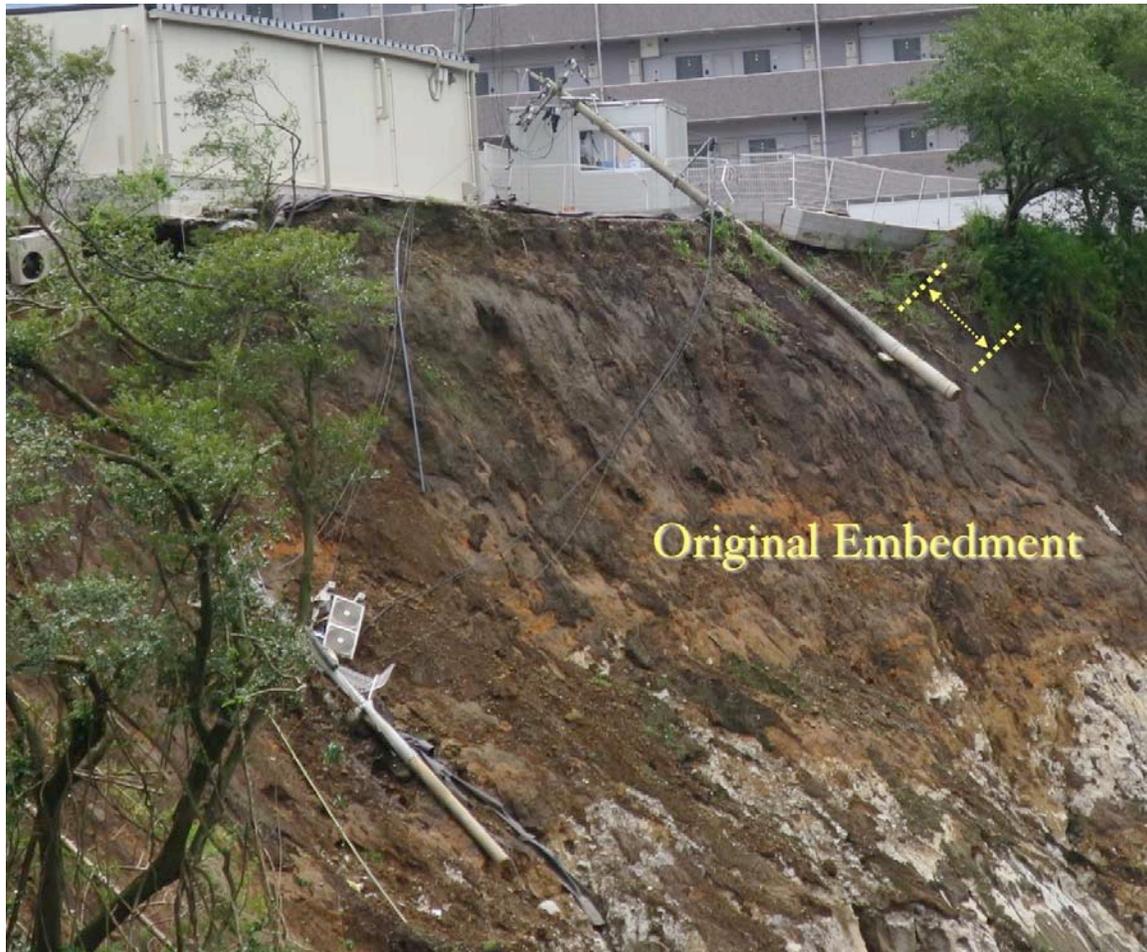
Figure 2-25. Slope Failure with Distribution Pole

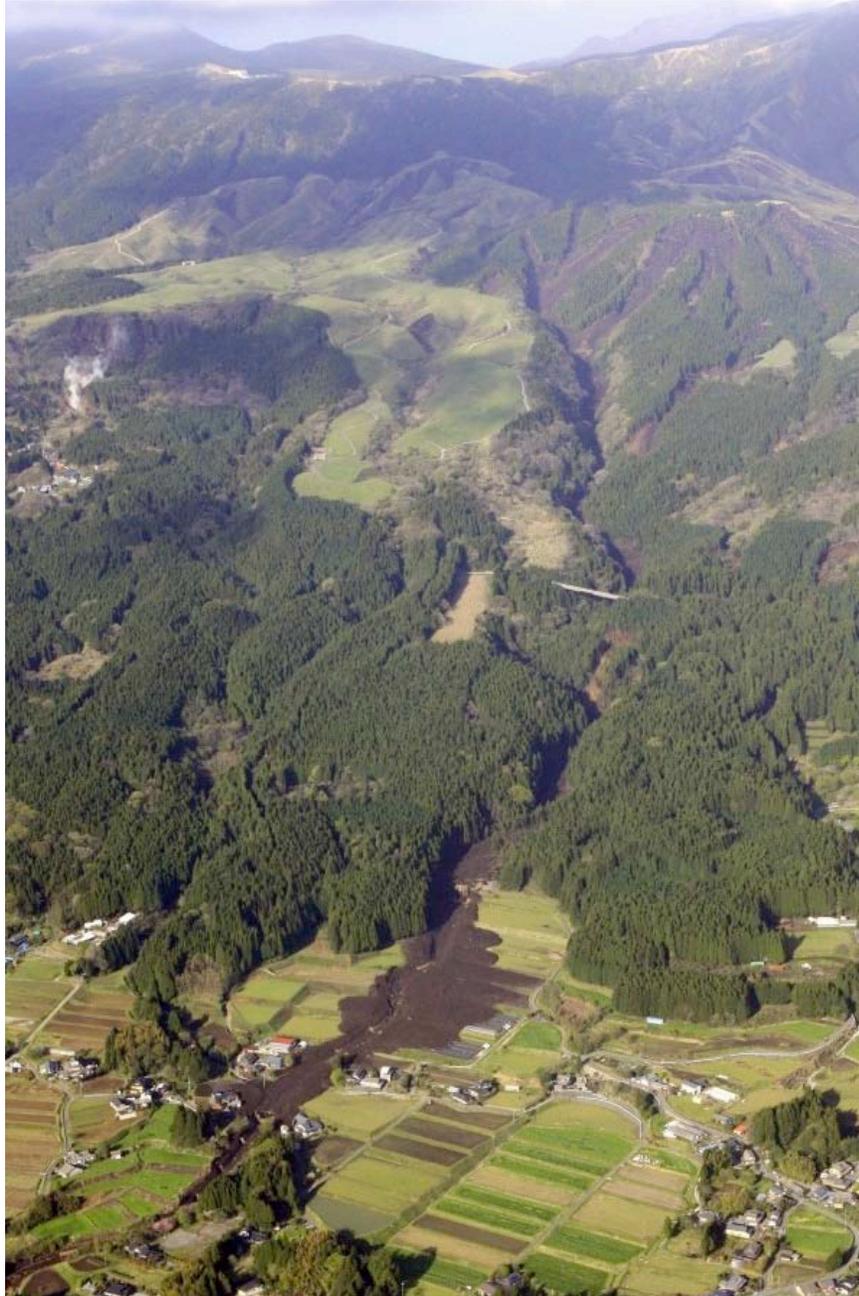
Figure 2-26. Mud Flow (32.8644° 131.0232°) Courtesy Geospatial Institute of Japan

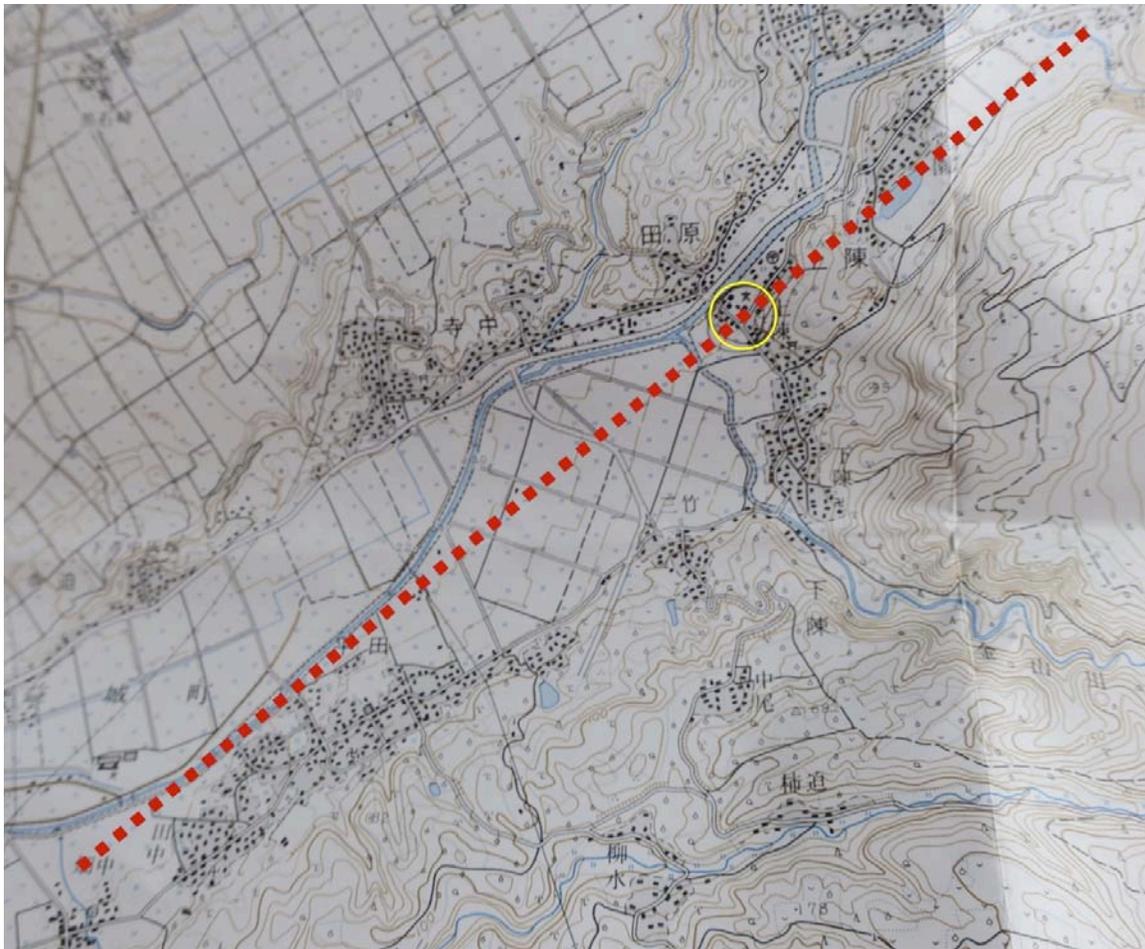
Figure 2-27. Location of Surface Faulting in Farming Area

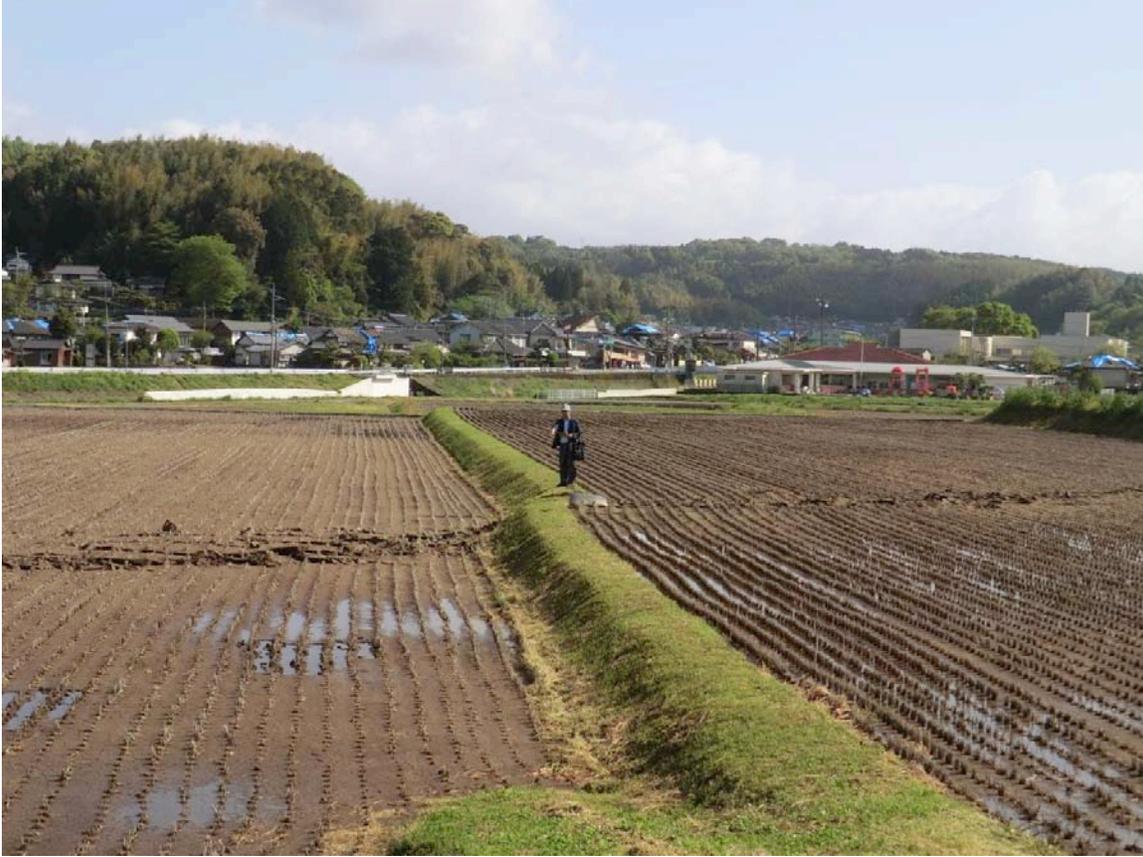
Figure 2-32. Surface faulting (photo taken ~April 20 2016) (Courtesy Prof. Maruyama)

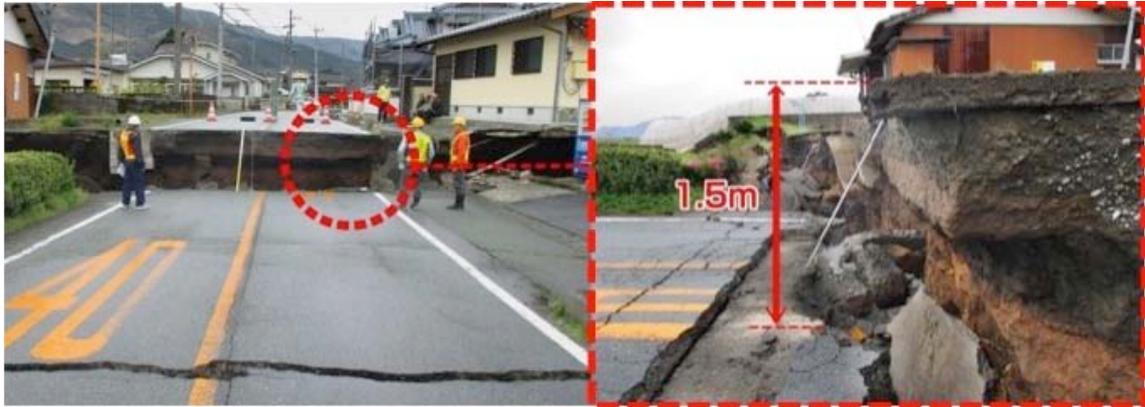
Figure 2-33. Graben formation (surface faulting) in Aso Town (Courtesy MLIT)
