KUMAMOTO, KYUSHU, JAPAN, EARTHQUAKES OF M_w 6.0 April 14, 2016 M_w 7.0 April 16, 2016 LIFELINE PERFORMANCE

ALEX K TANG and JOHN M EIDINGER

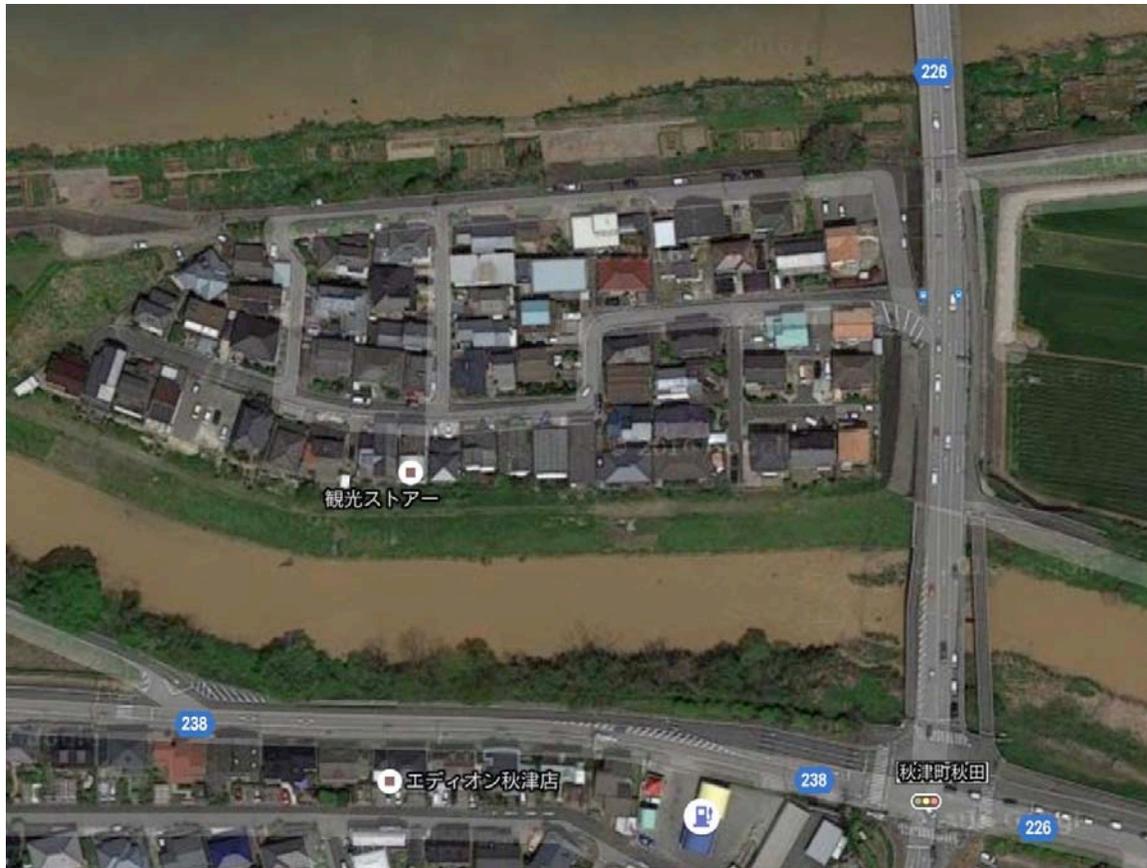
Figure 2-34. Island Subjected to Liquefaction (Photo Taken Prior to Earthquake)

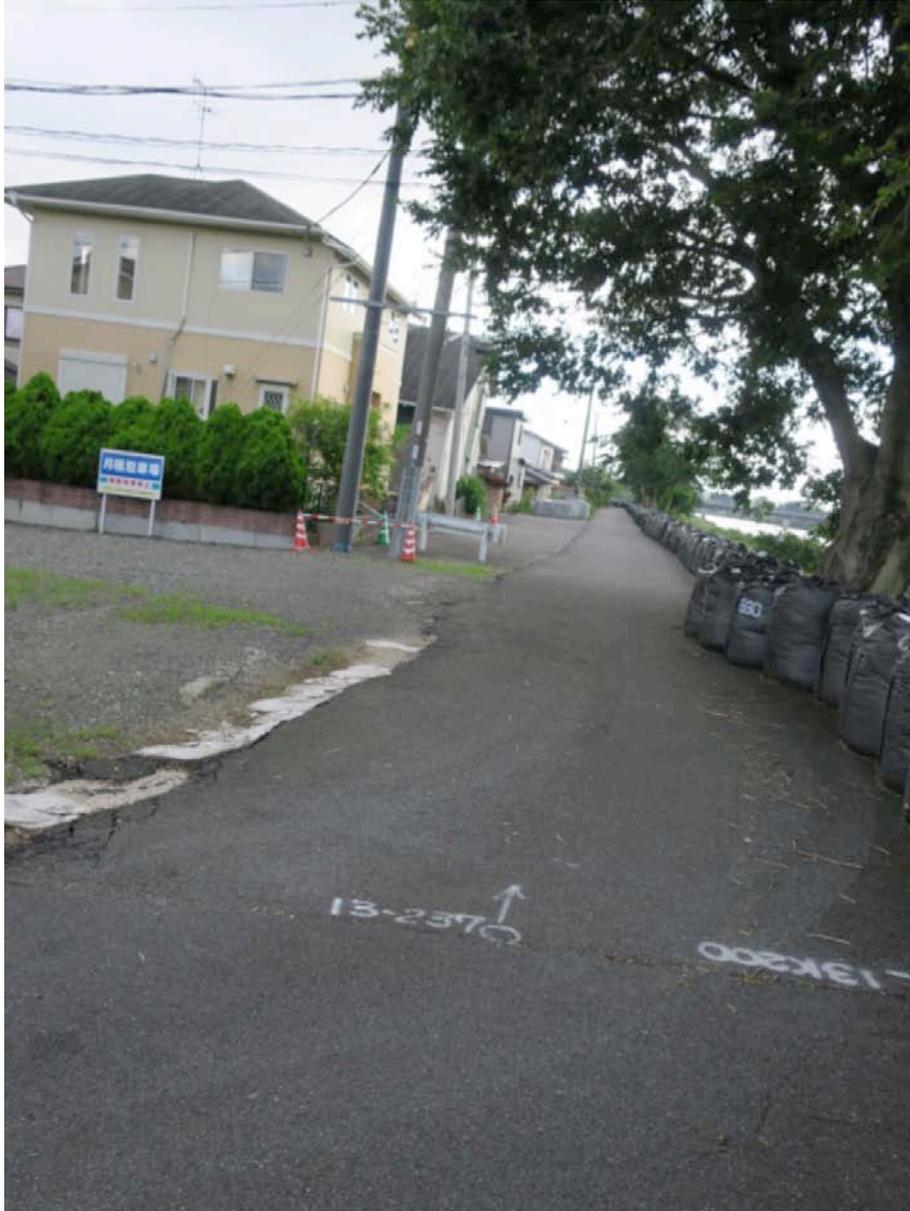
Figure 2-35. Levee Protection, North Side of Island

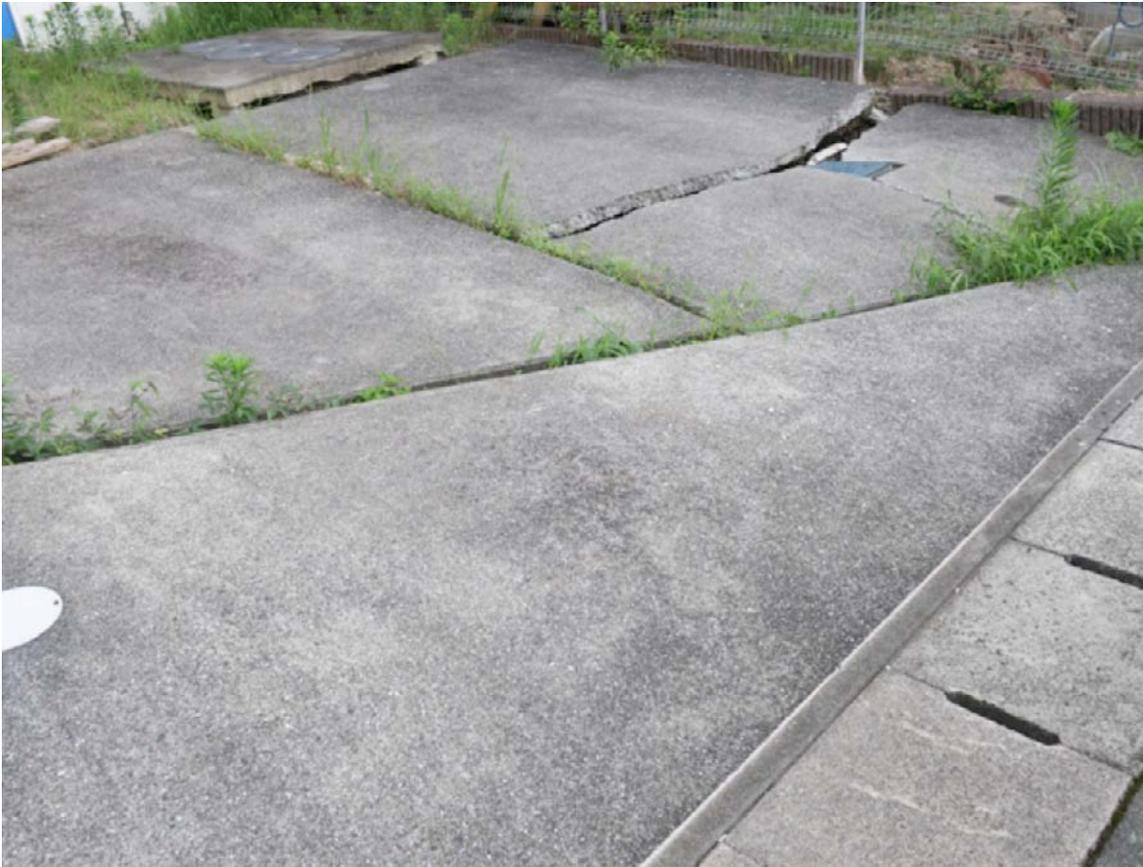
Figure 2-36. Driveway damaged by liquefaction

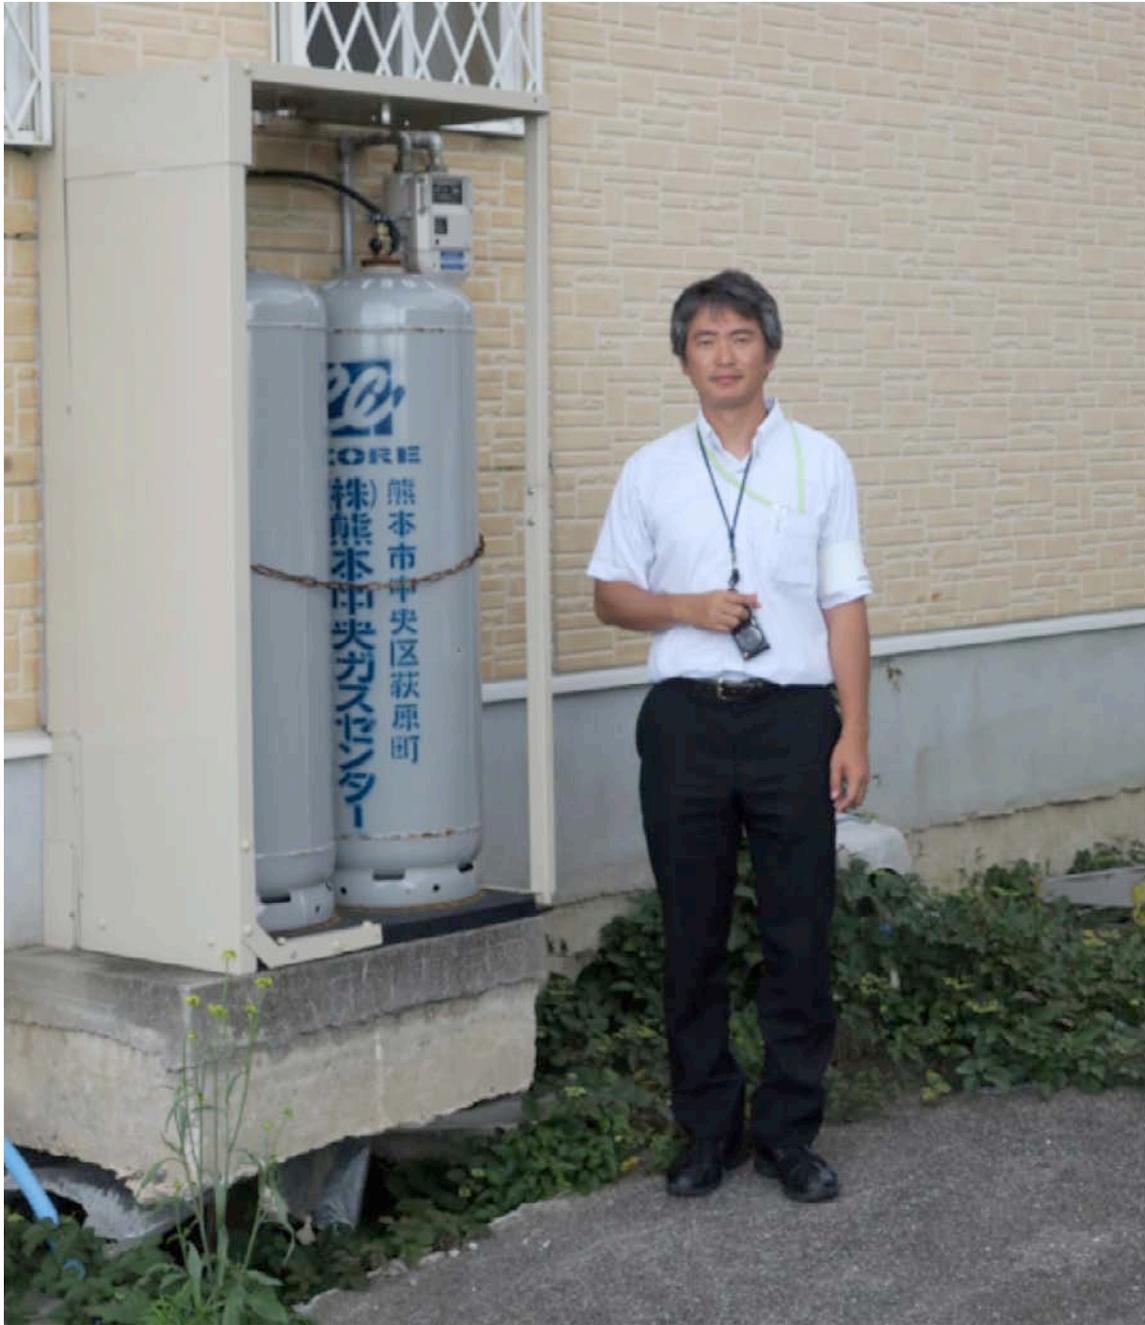
Figure 2-37. Differential settlement between pile supported house and propane tank pad and driveway (Prof. Shoji)

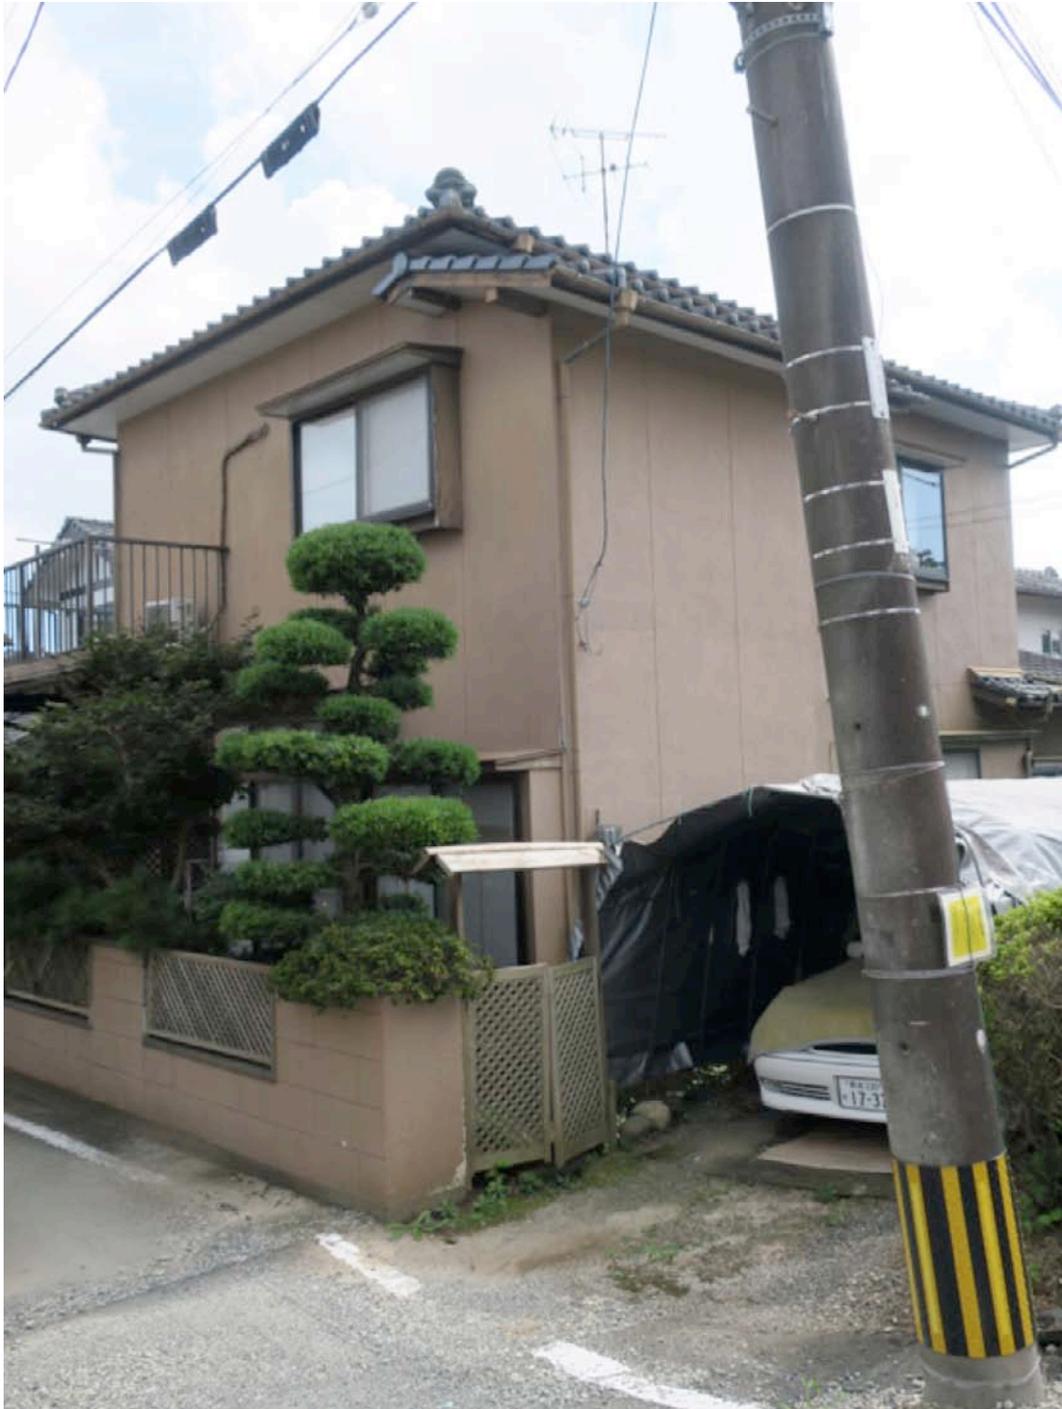
Figure 2-38. Tilted Power Pole

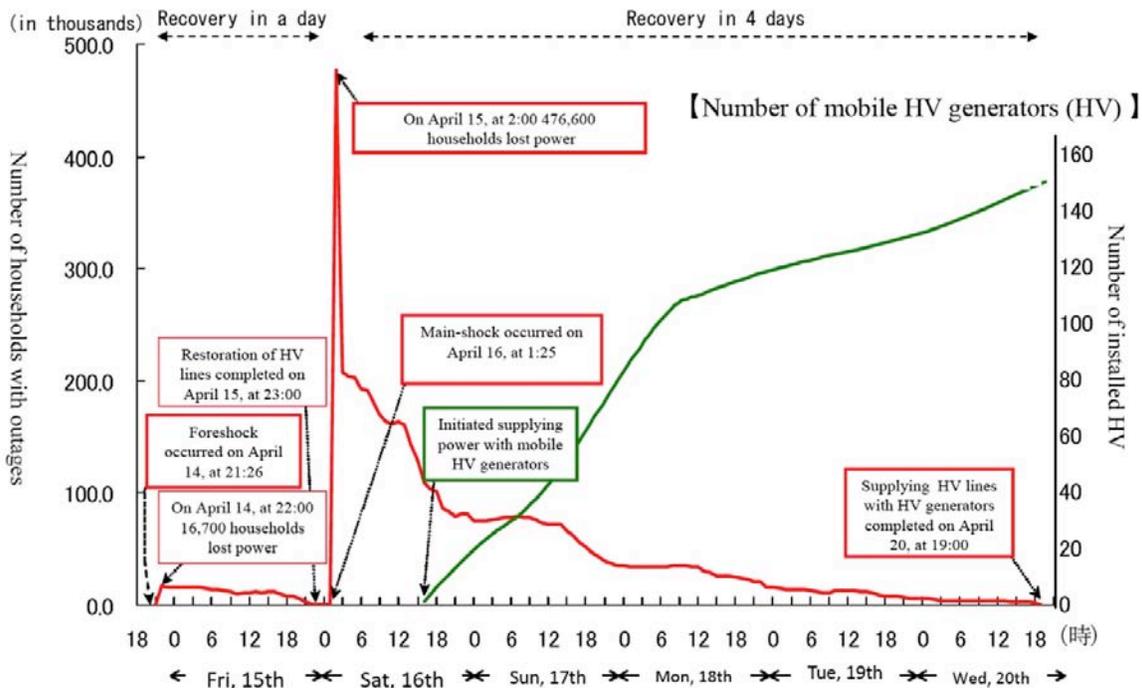
Figure 3-1. Electric Power Restoration

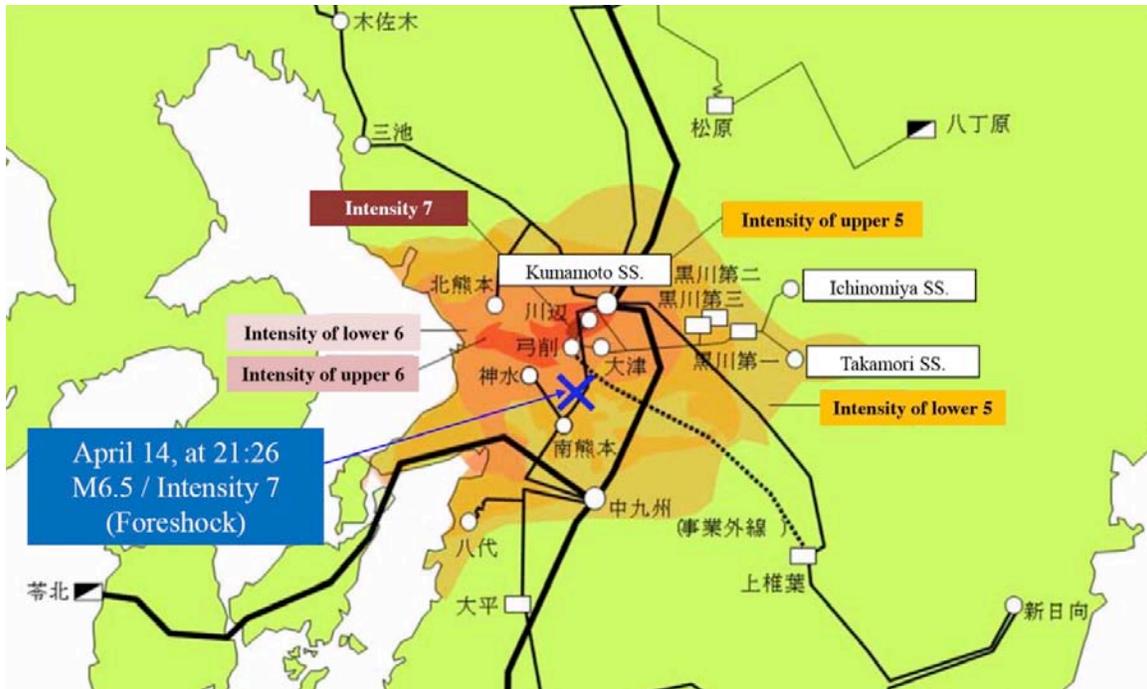
Figure 3-3. Power Grid in Kumamoto and Mount Aso Region, Main Shock

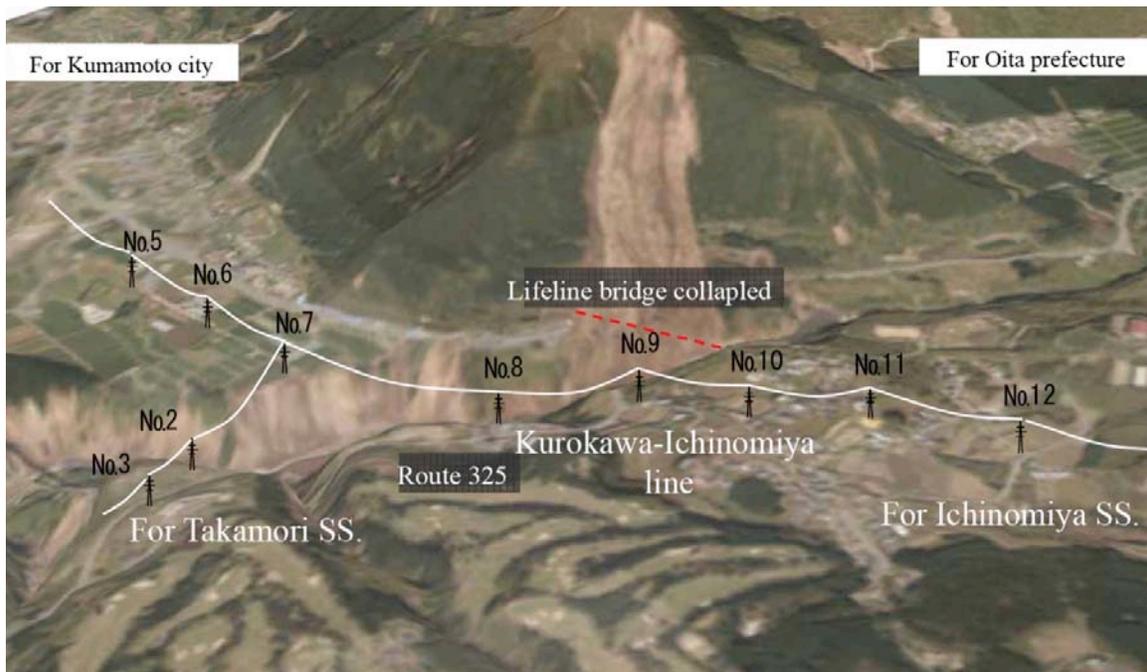
Figure 3-4. 66 kV Transmission Lines Near Major Landslide

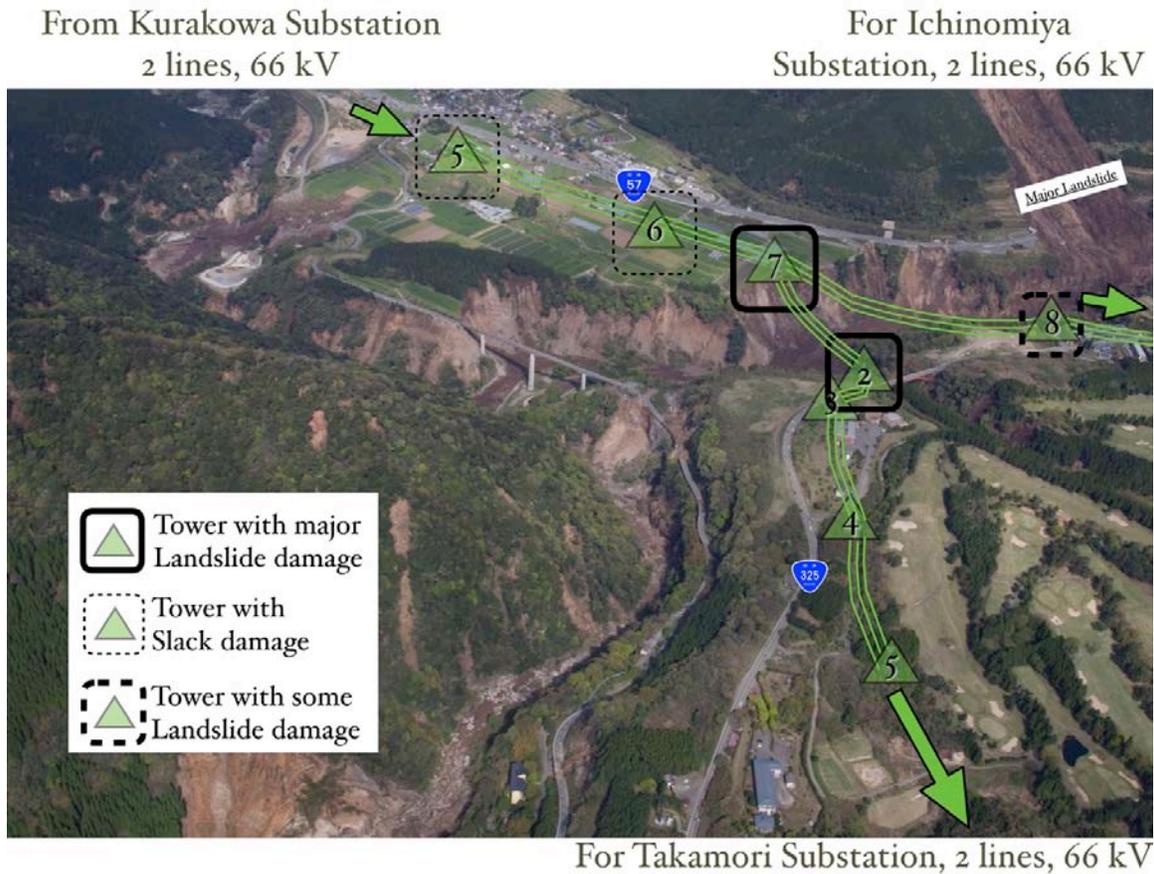
Figure 3-5. 66 kV Transmission Lines Near Major Landslide

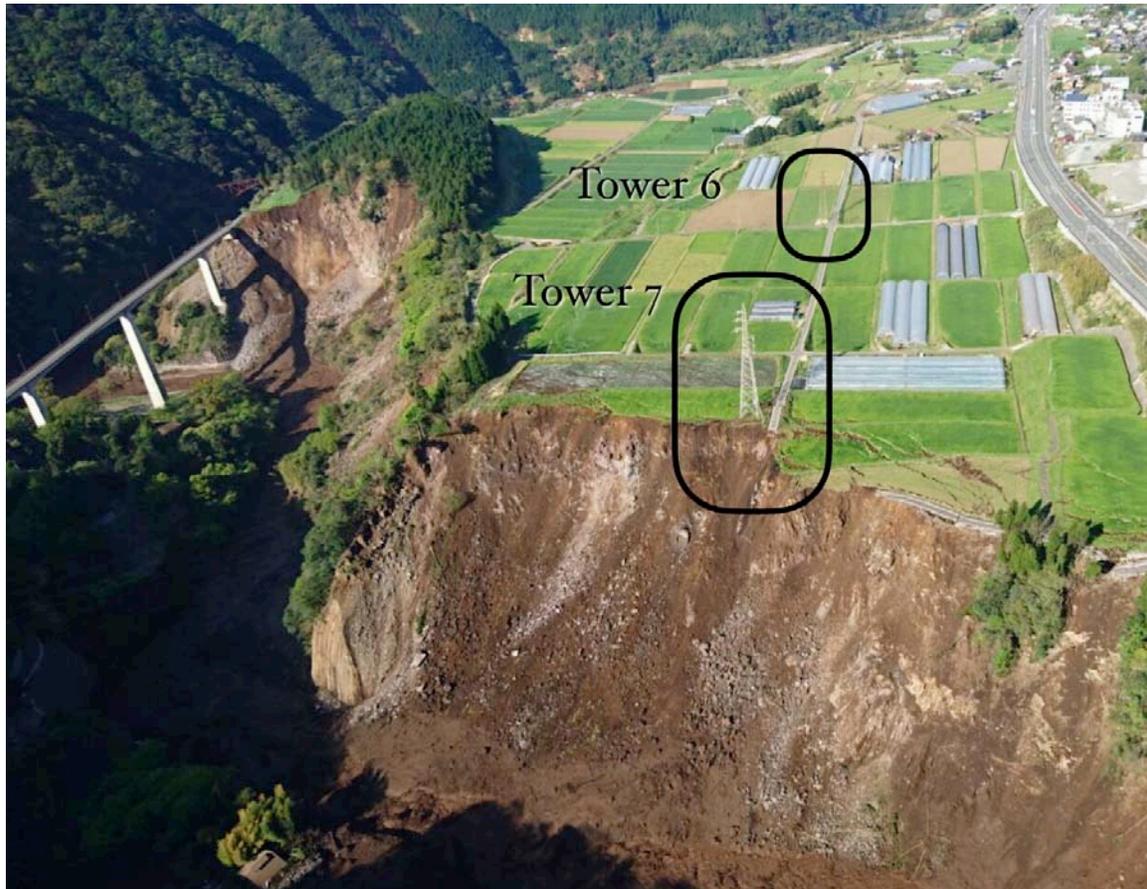
Figure 3-6. Towers No. 6 and No. 7

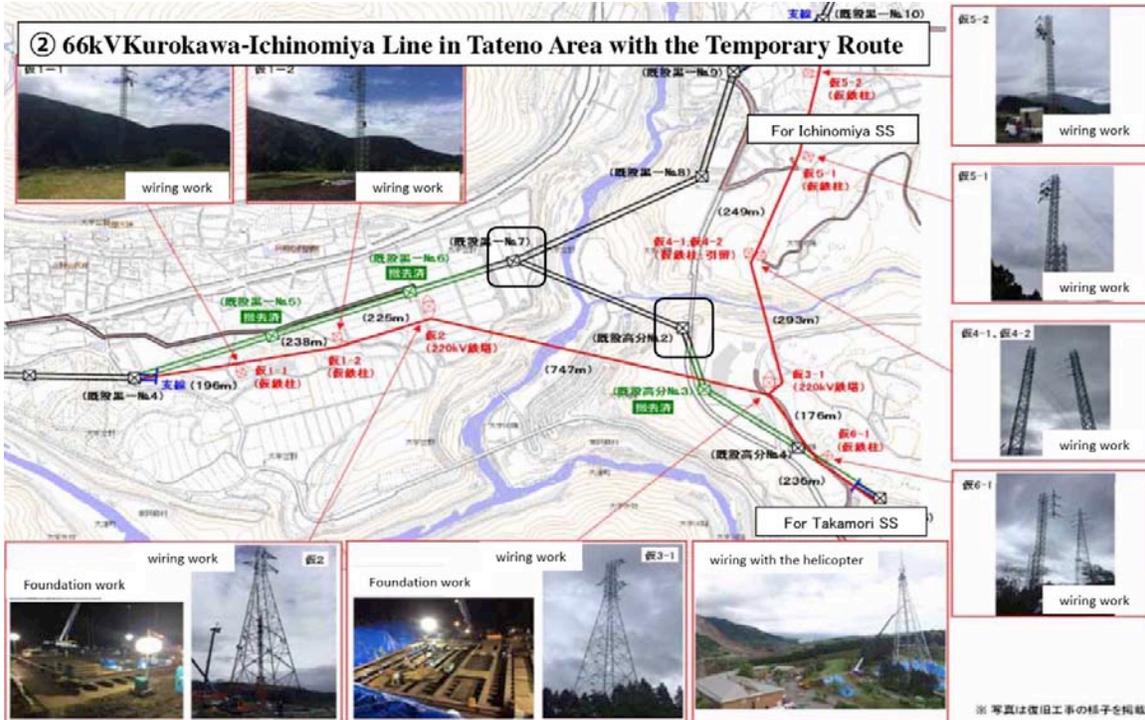
Figure 3-7. Replacement Towers

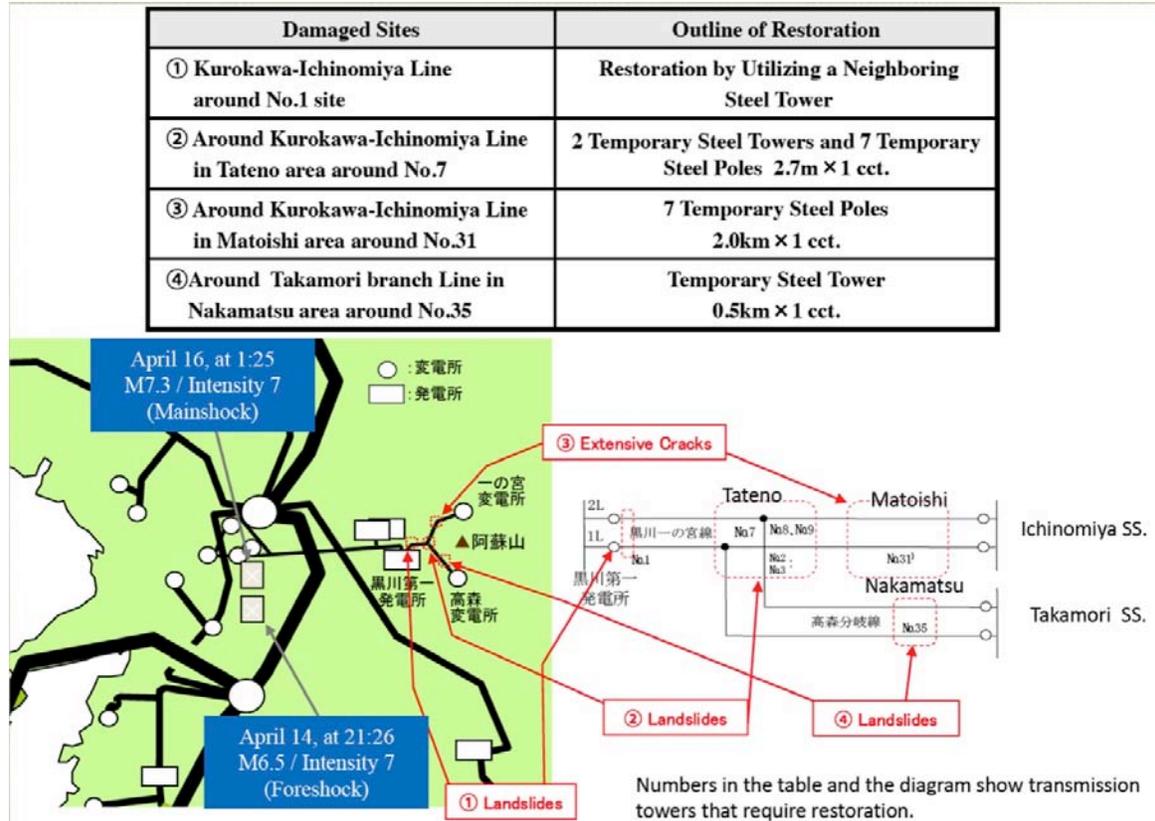
Figure 3-8. 66 kV Transmission Lines Affected by Ground Deformations

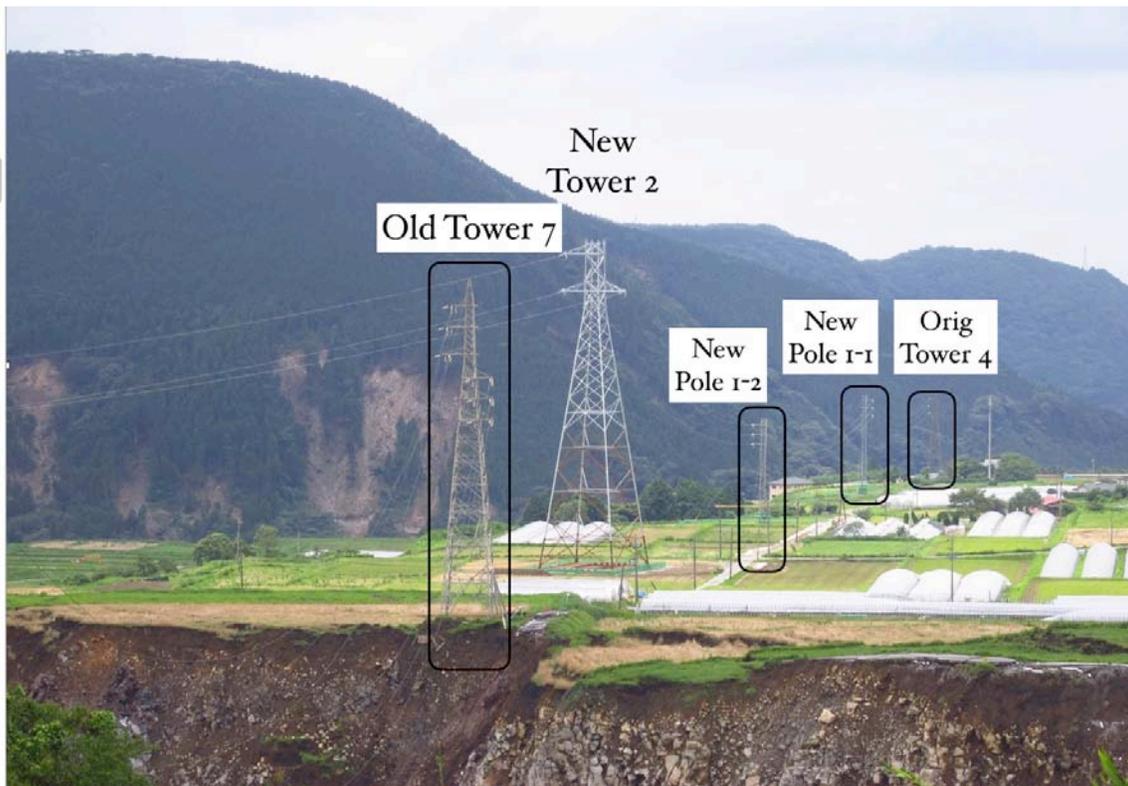
Figure 3-9. Towers 4, 5, 6, 7

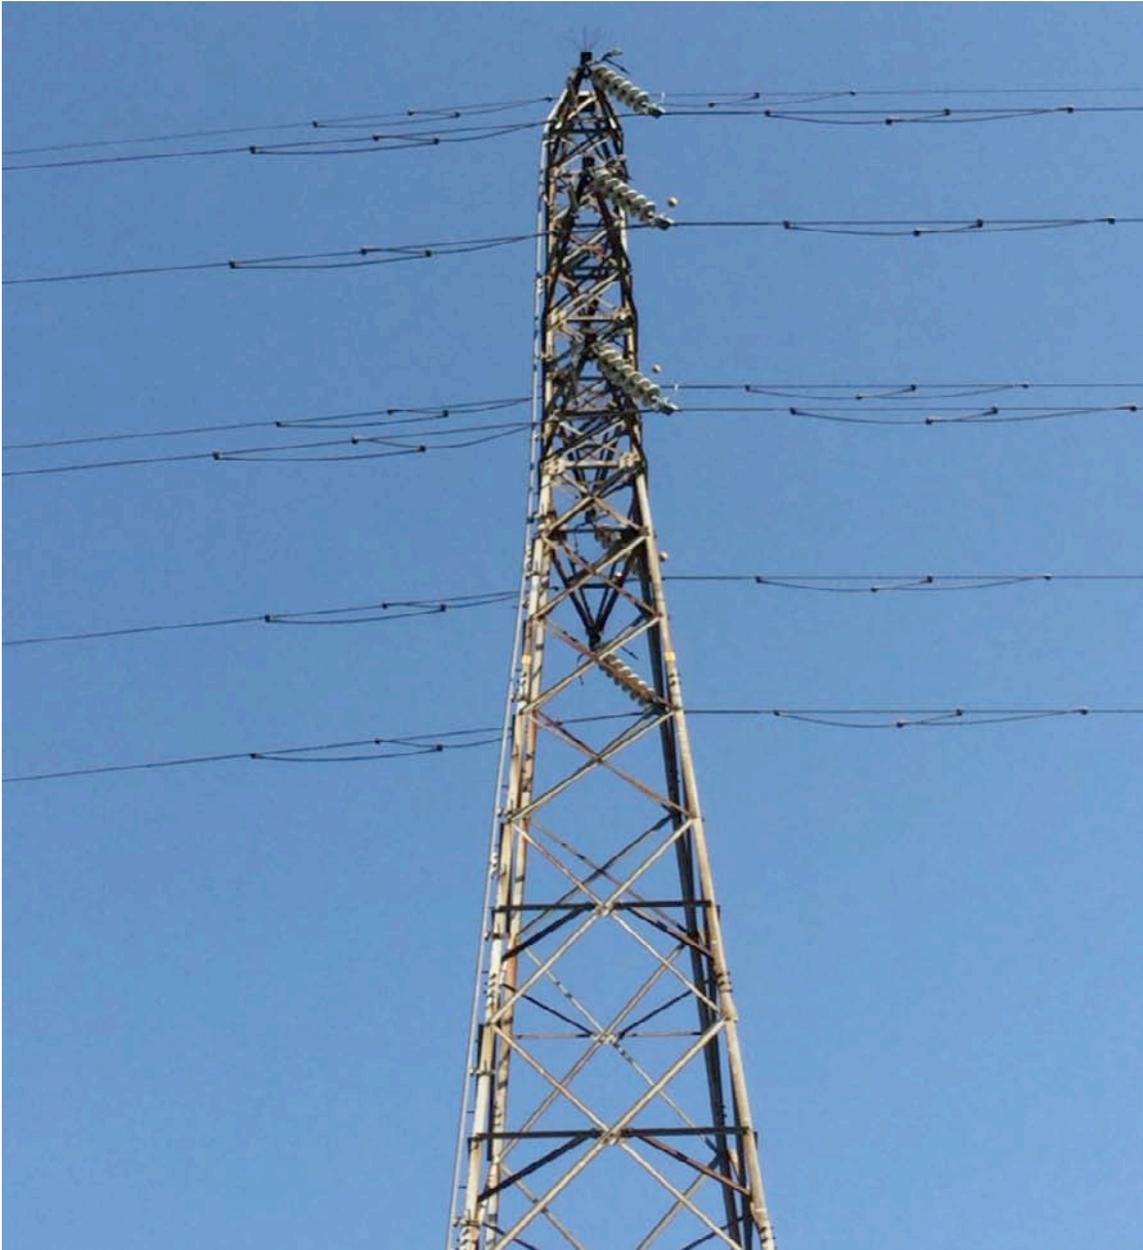
Figure 3-10. Tower 5 with Suspension Strings Displaced due to Tilt of Tower 7

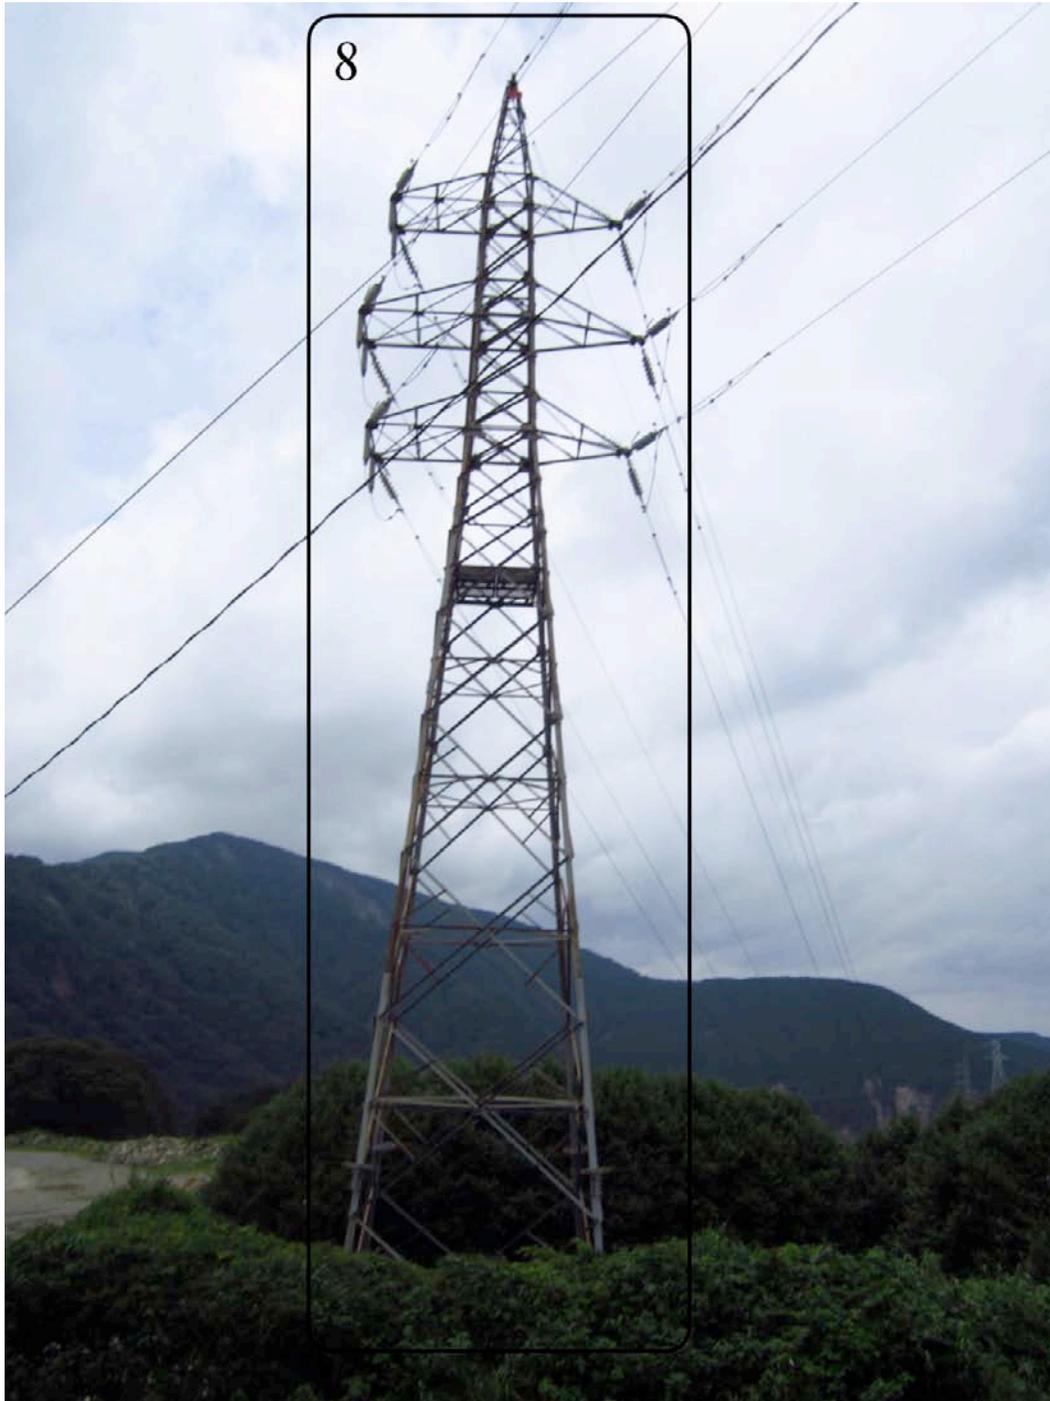
Figure 3-11. Old Tower 8

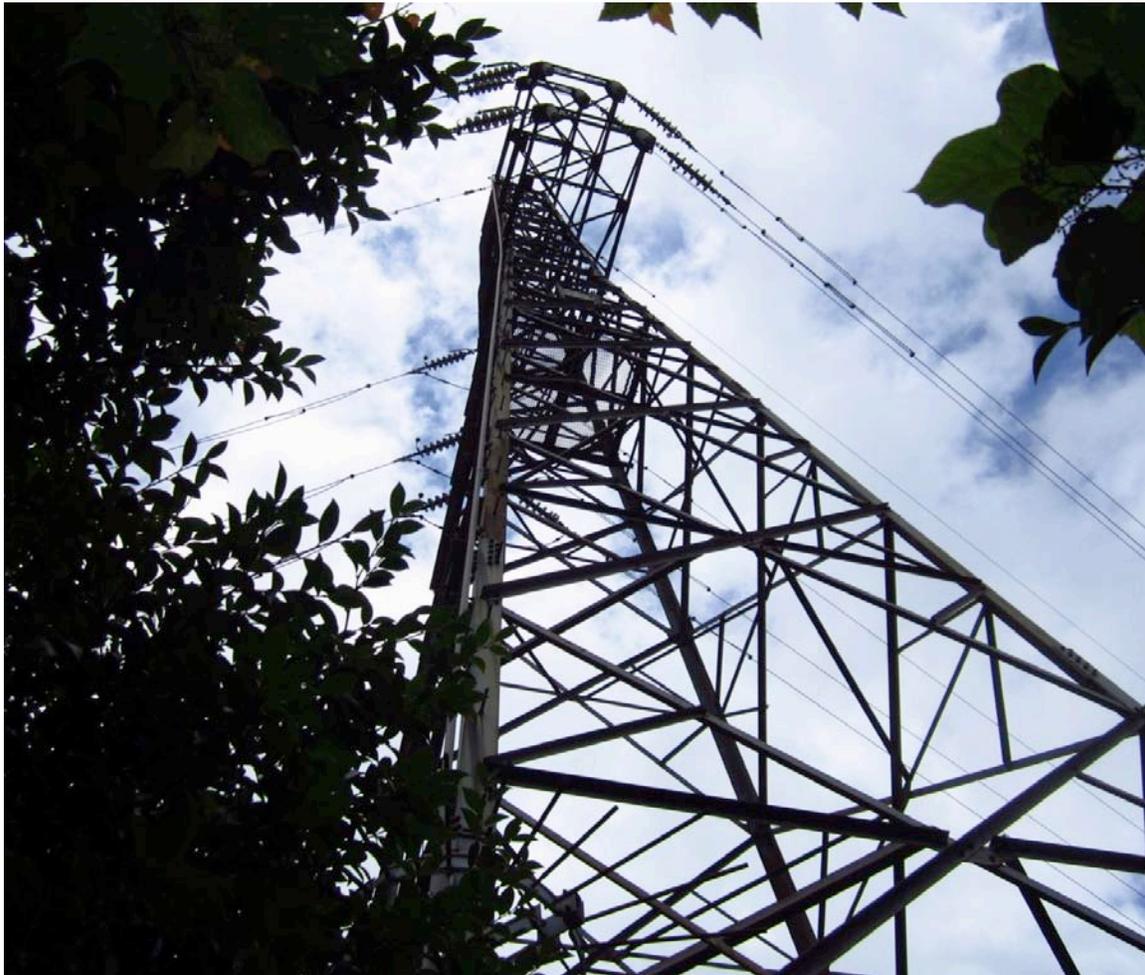
Figure 3-12. Old Tower 8

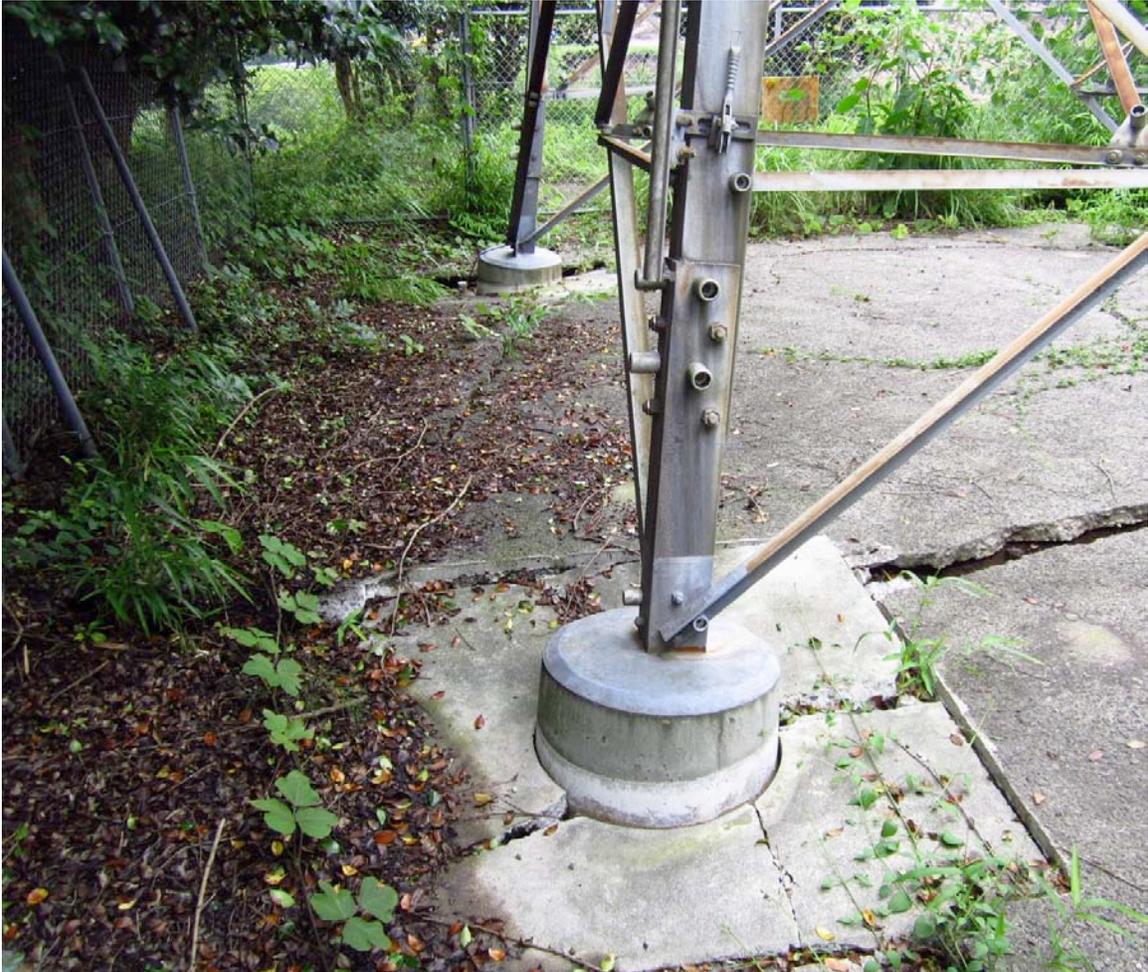
Figure 3-13. Old Tower 8 Foundation

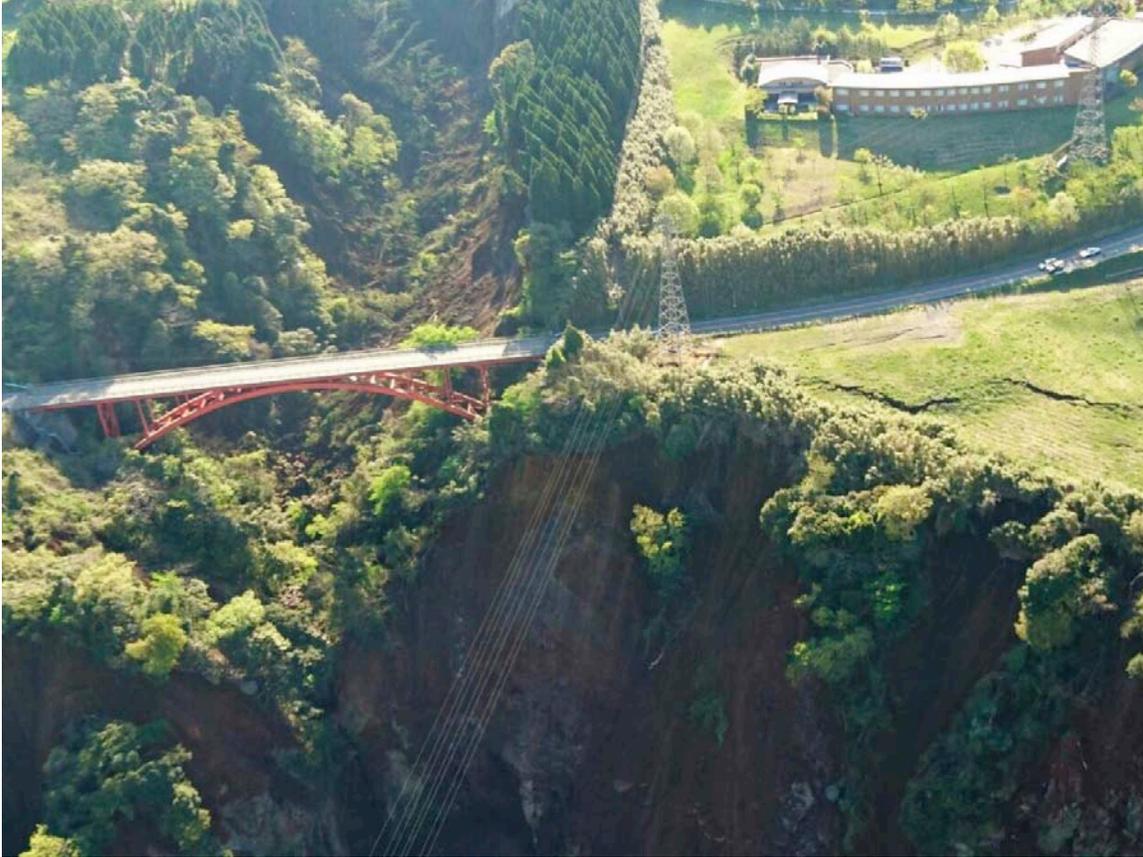
Figure 3-14. Old Tower 2 (foreground) and Old Tower 3 (background right)

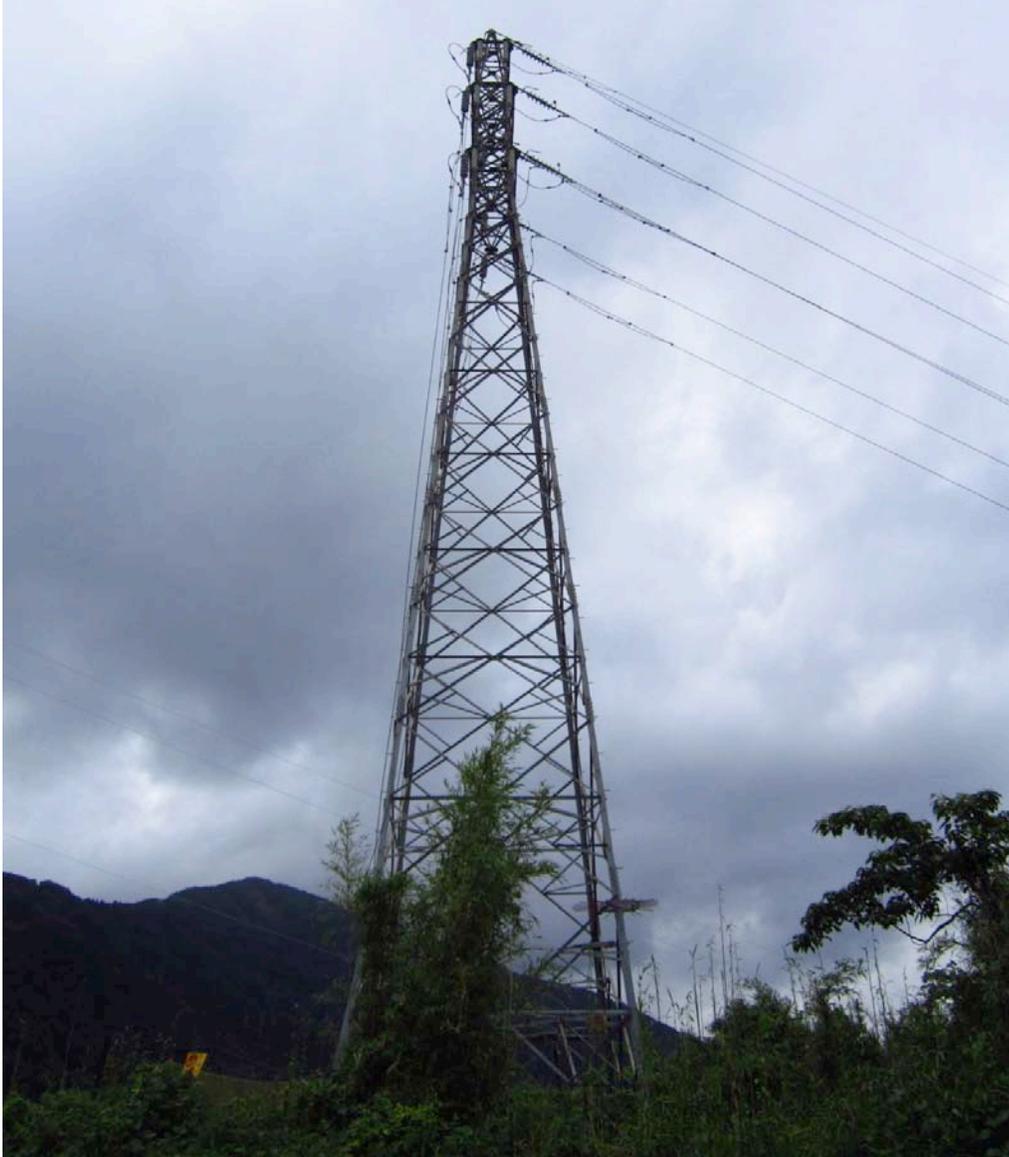
Figure 3-15. Old Tower 2

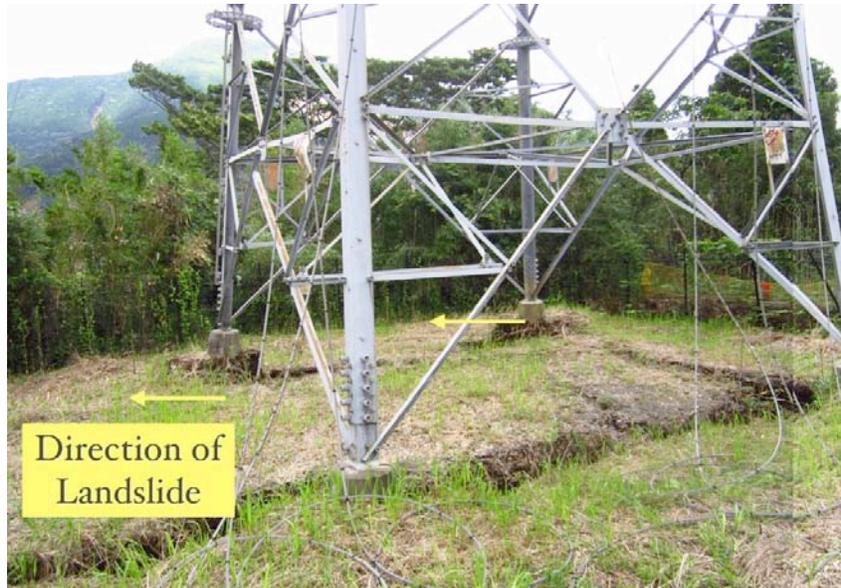
Figure 3-16. Old Tower 2 Foundation Level

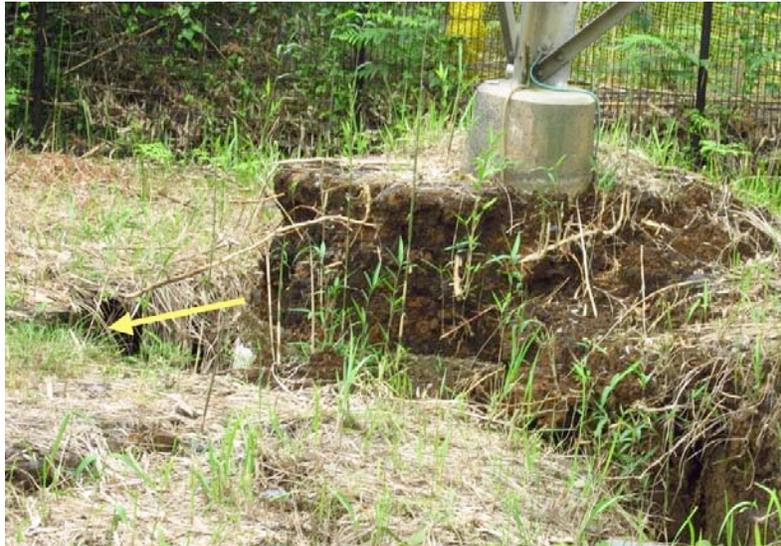
Figure 3-17. Old Tower 2 Ground Deformation

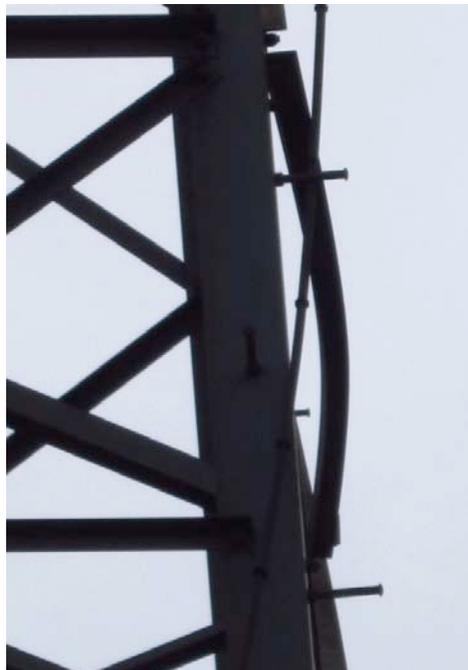
Figure 3-18. Old Tower 2 Buckle in Secondary Member

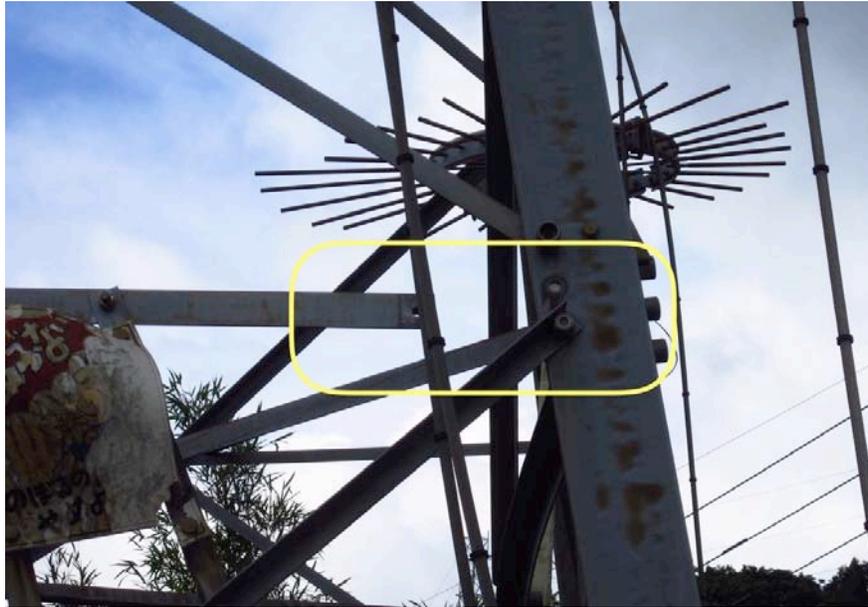
Figure 3-19. Old Tower 2 Unbolted Connection

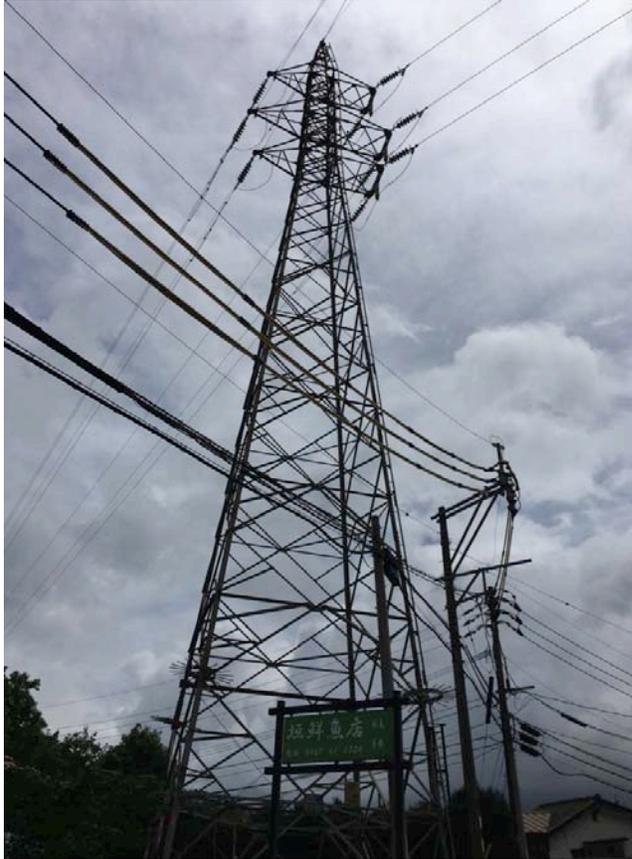
Steel Tower 10
Buckled Brace
