KUMAMOTO, KYUSHU, JAPAN, EARTHQUAKES OF M_w 6.0 April 14, 2016 M_w 7.0 April 16, 2016 LIFELINE PERFORMANCE

ALEX K TANG and JOHN M EIDINGER

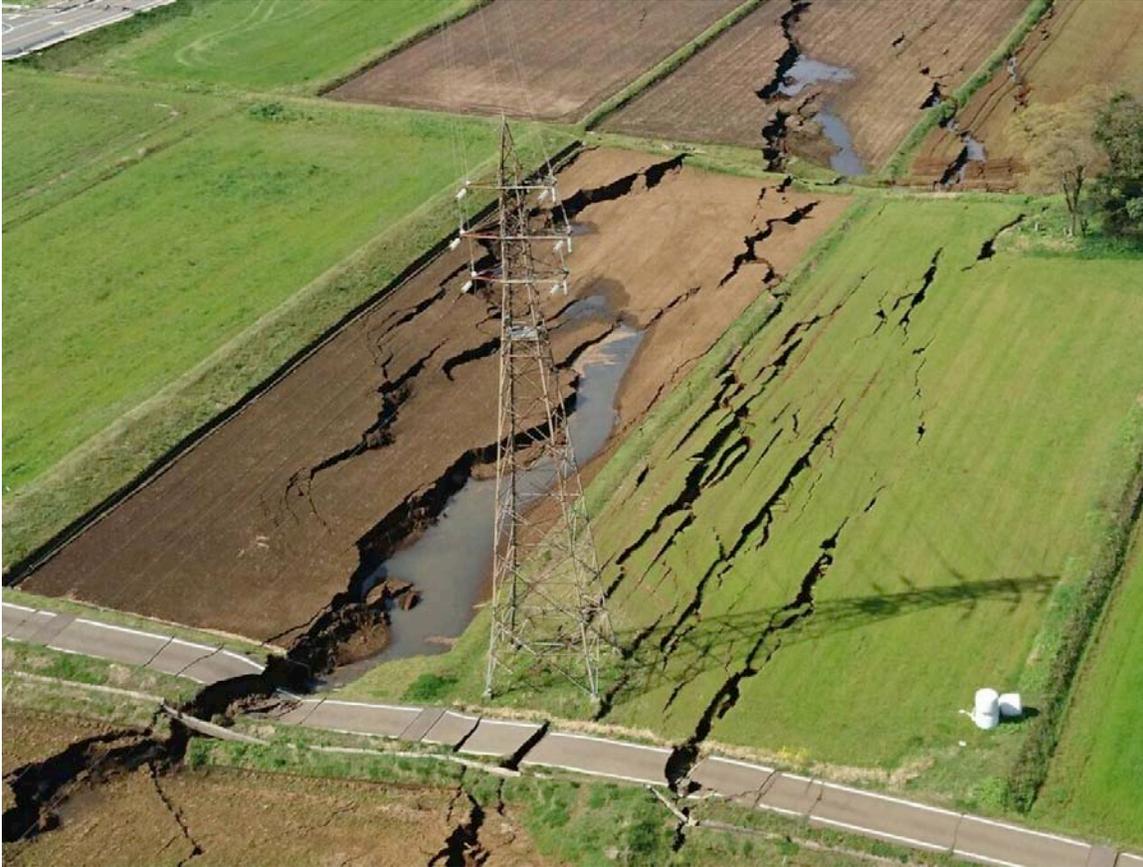
Figure 3-23. Tower 30

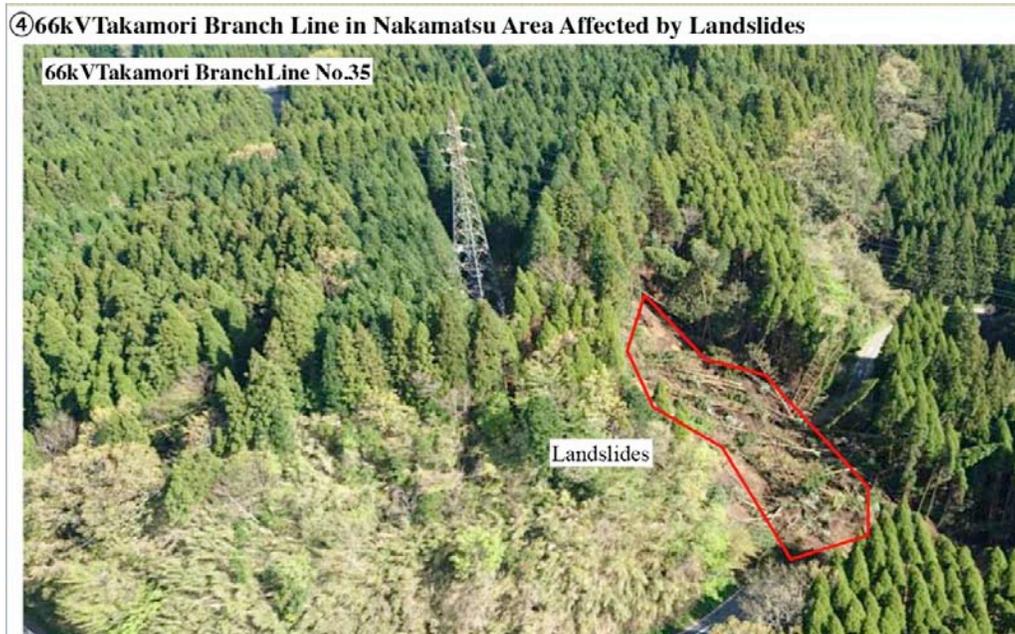
Figure 3-25. Tower 35

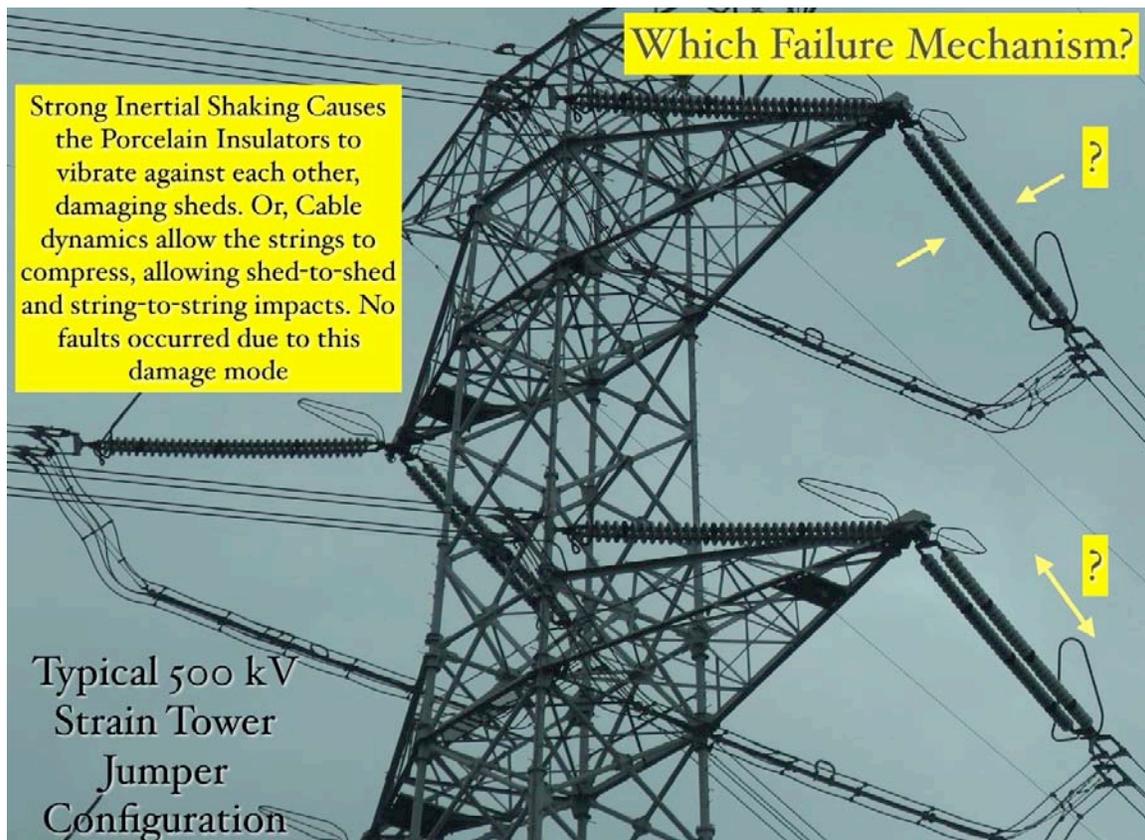
Figure 3-26. Typical 500 kV Tower Jumper Configuration, Angle Tower

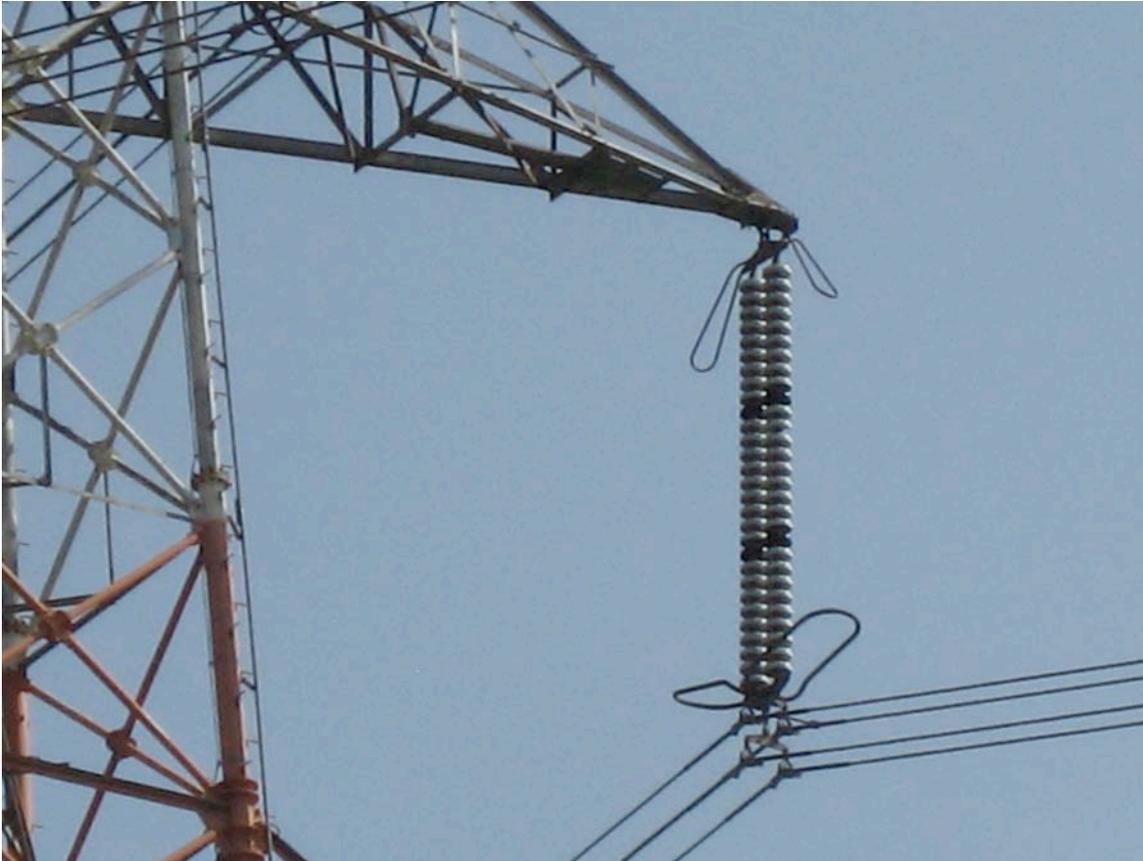
Figure 3-27. Typical 500 kV Tower Jumper Configuration, Suspension Tower

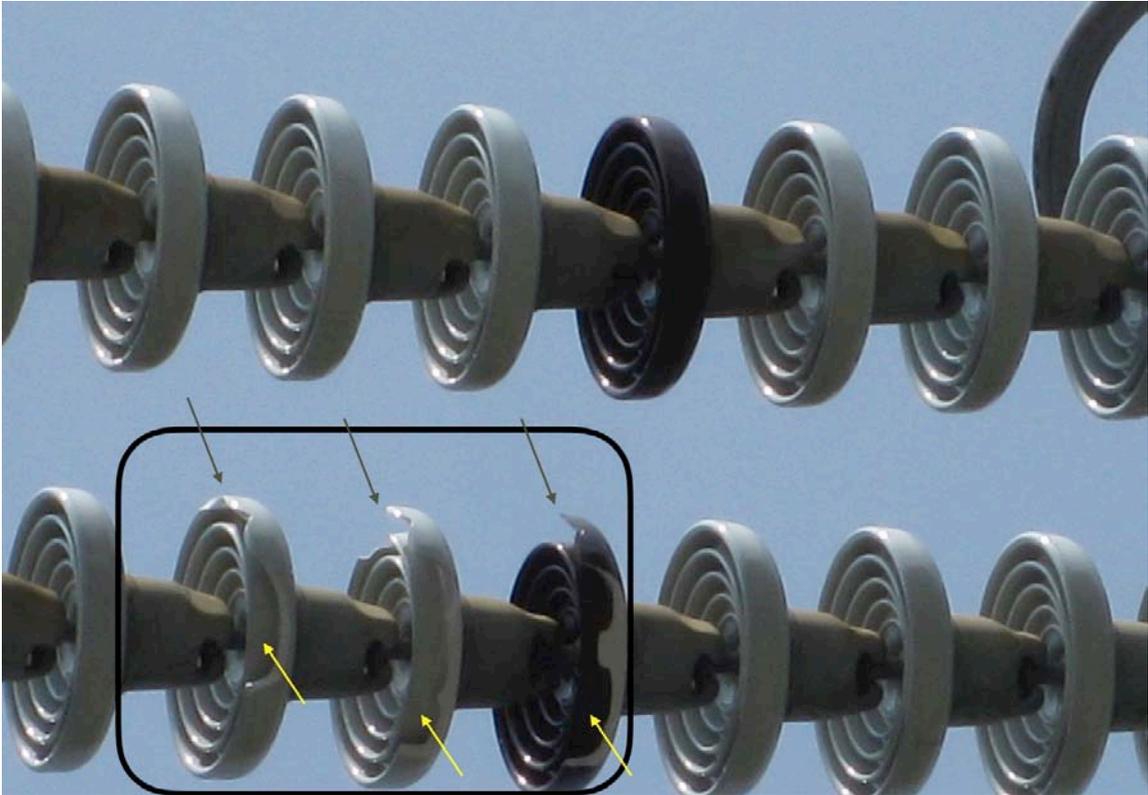
Figure 3-28. Damaged Porcelain Sheds on 500 kV Kumamoto Transmission Line 1, Angle Tower

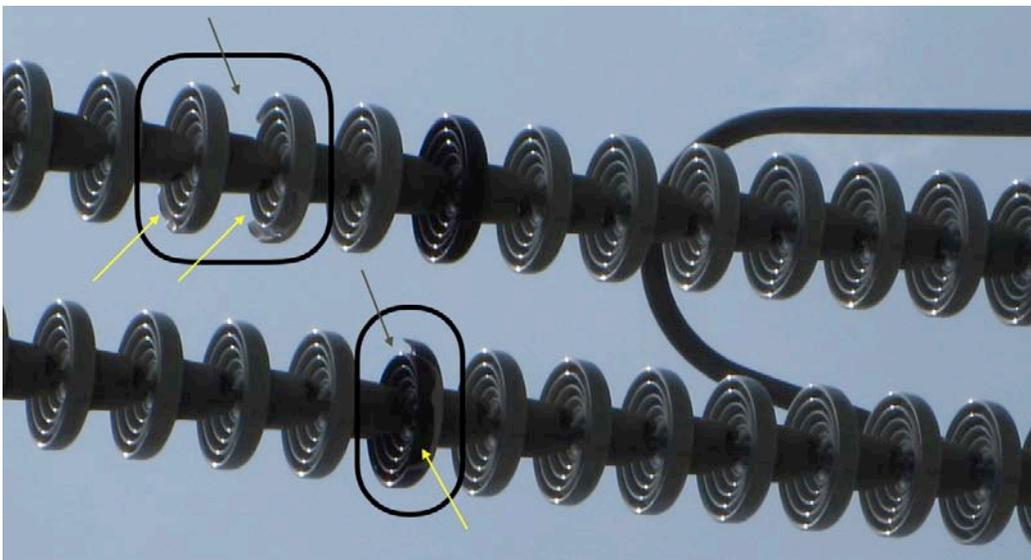
Figure 3-29. Damaged Porcelain Sheds on 500 kV Kumamoto Transmission Line 2, Angle Tower

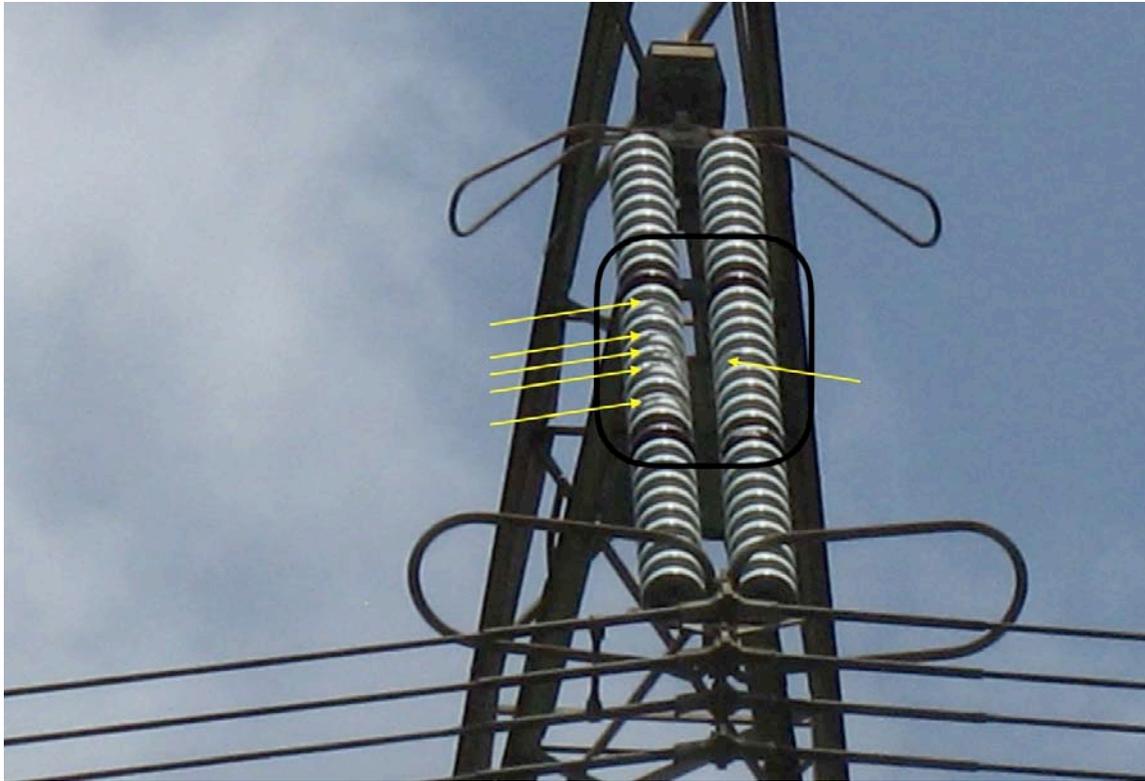
Figure 3-30. Damaged Porcelain Sheds on 500 kV Reihoku Transmission Line, Suspension Tower

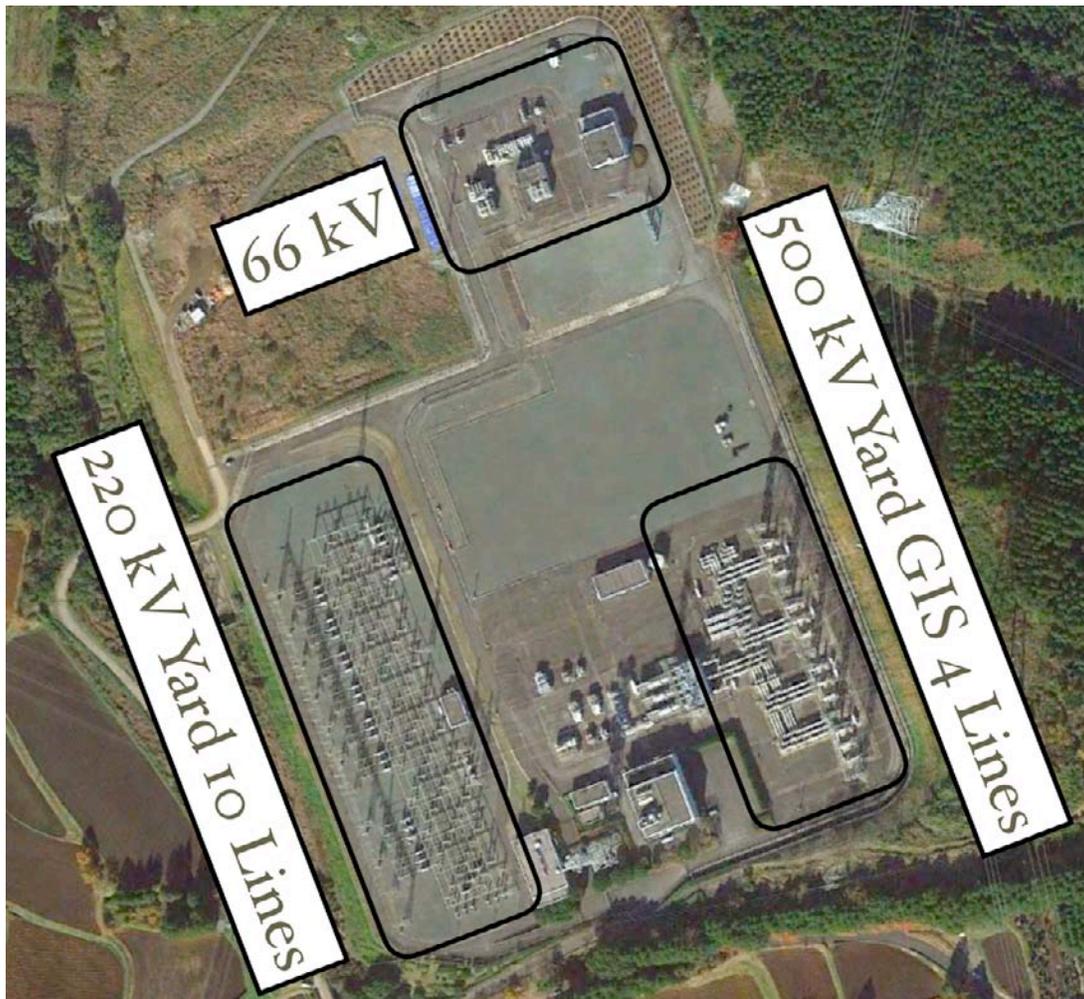
Figure 3-31. Kumamoto Substation

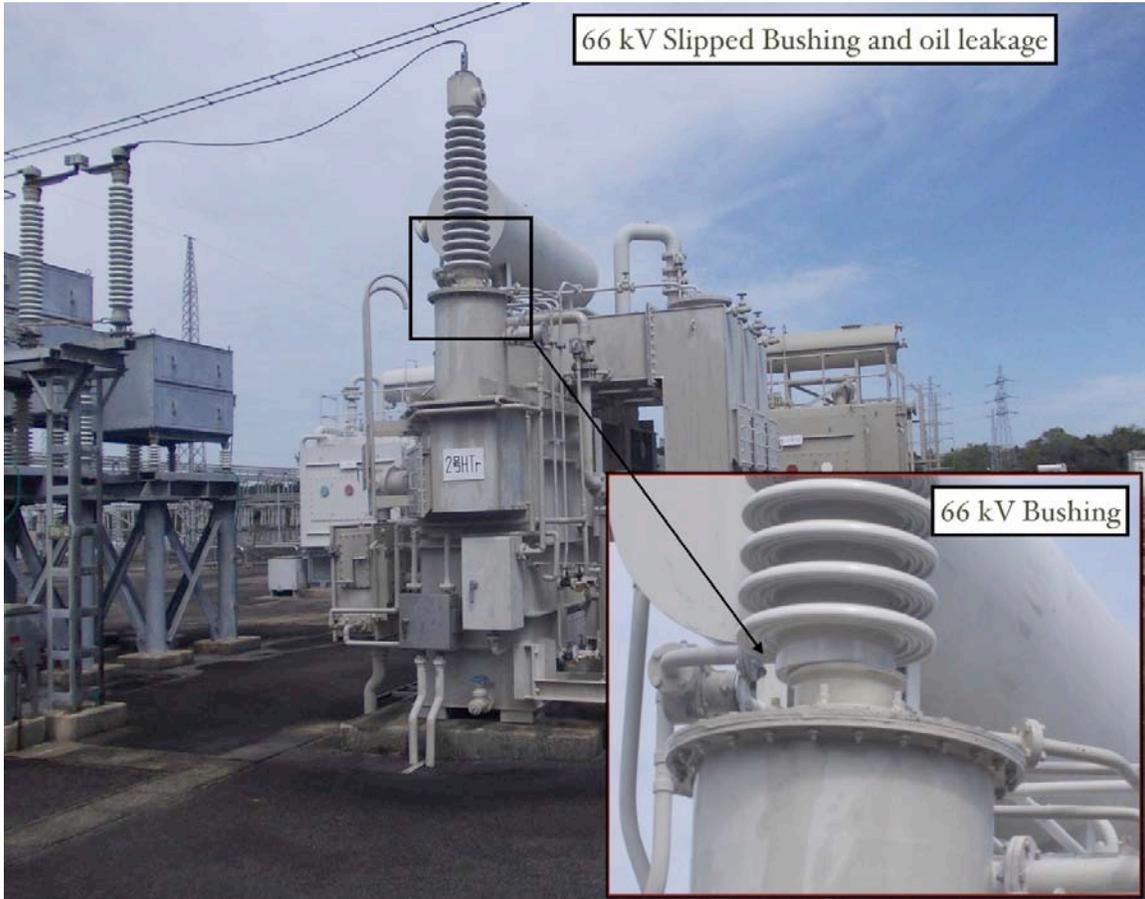
Figure 3-32. Slipped Bushing

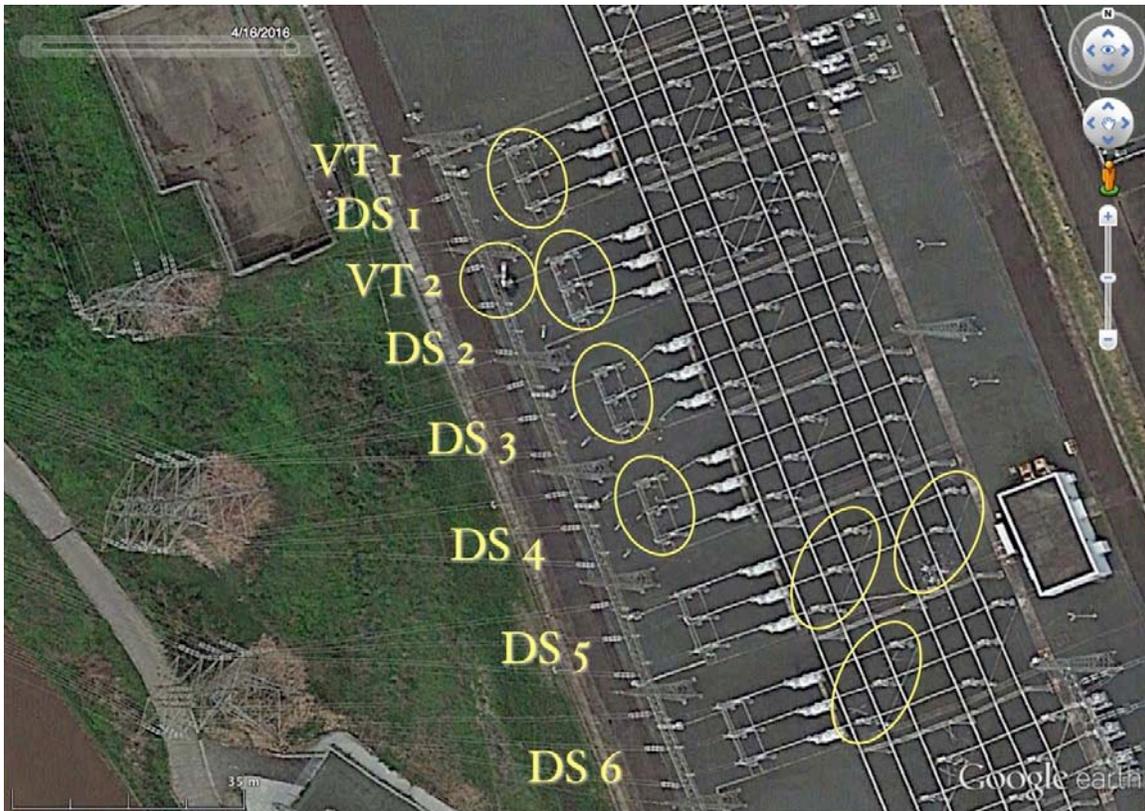
Figure 3-33. Damaged Equipment in 220 kV Yard

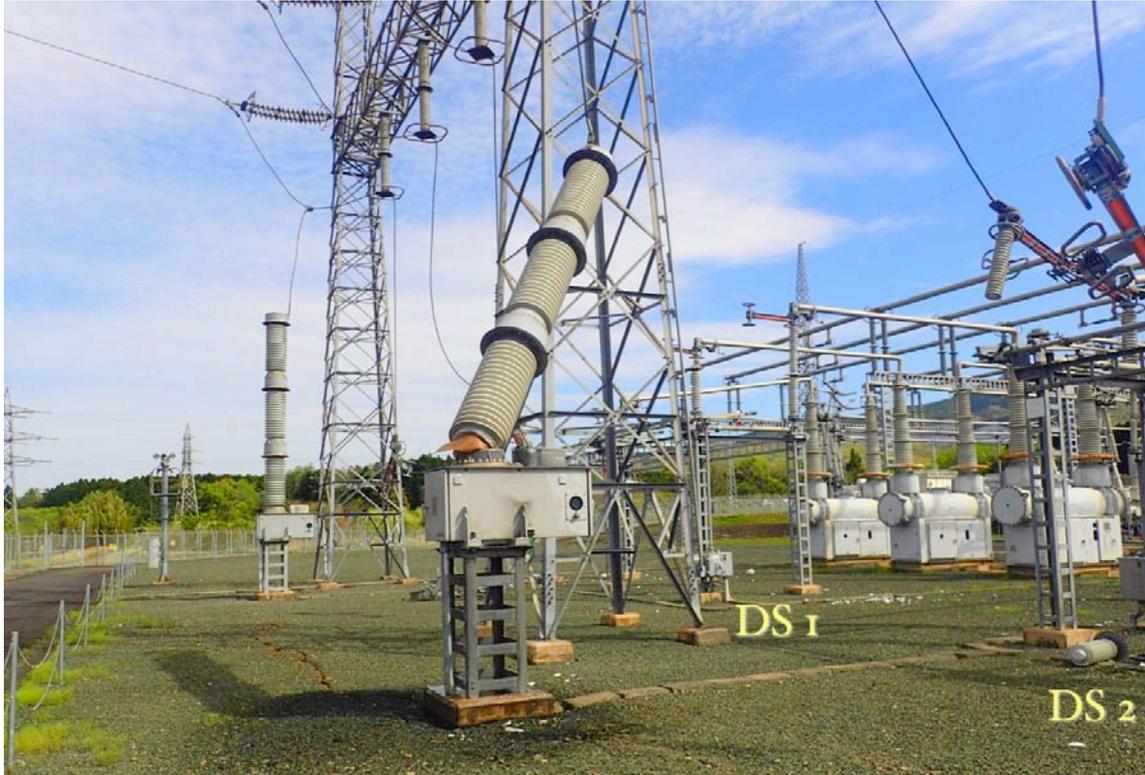
Figure 3-34. Damaged VT and DS 1 and DS2 in 220 kV Yard

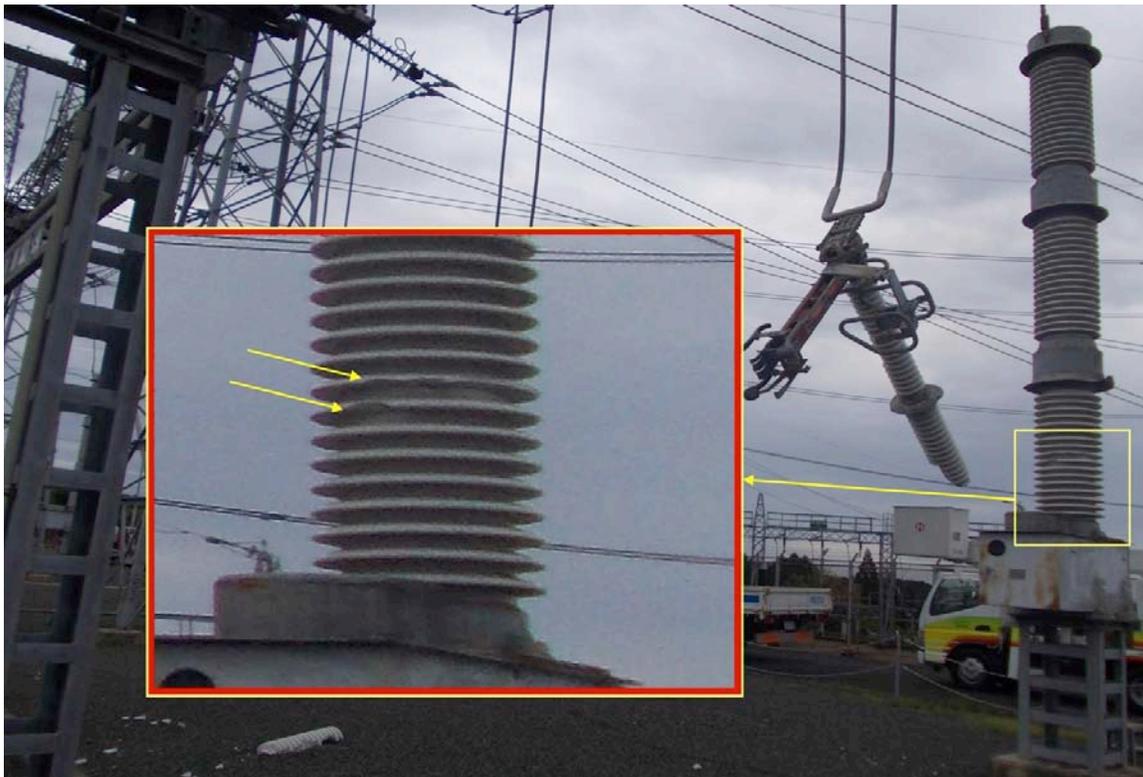
Figure 3-35. Damaged VT and DS 1 in 220 kV Yard

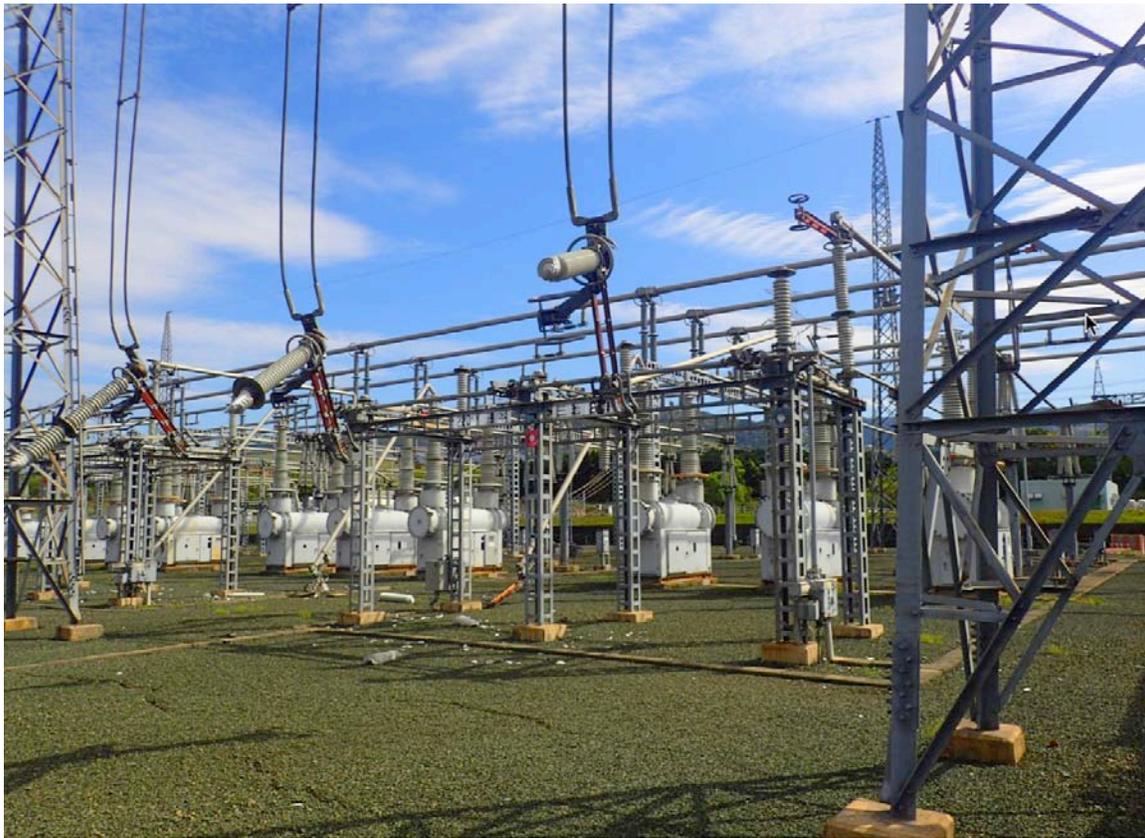
Figure 3-36. Damaged DS 4 in 220 kV Yard

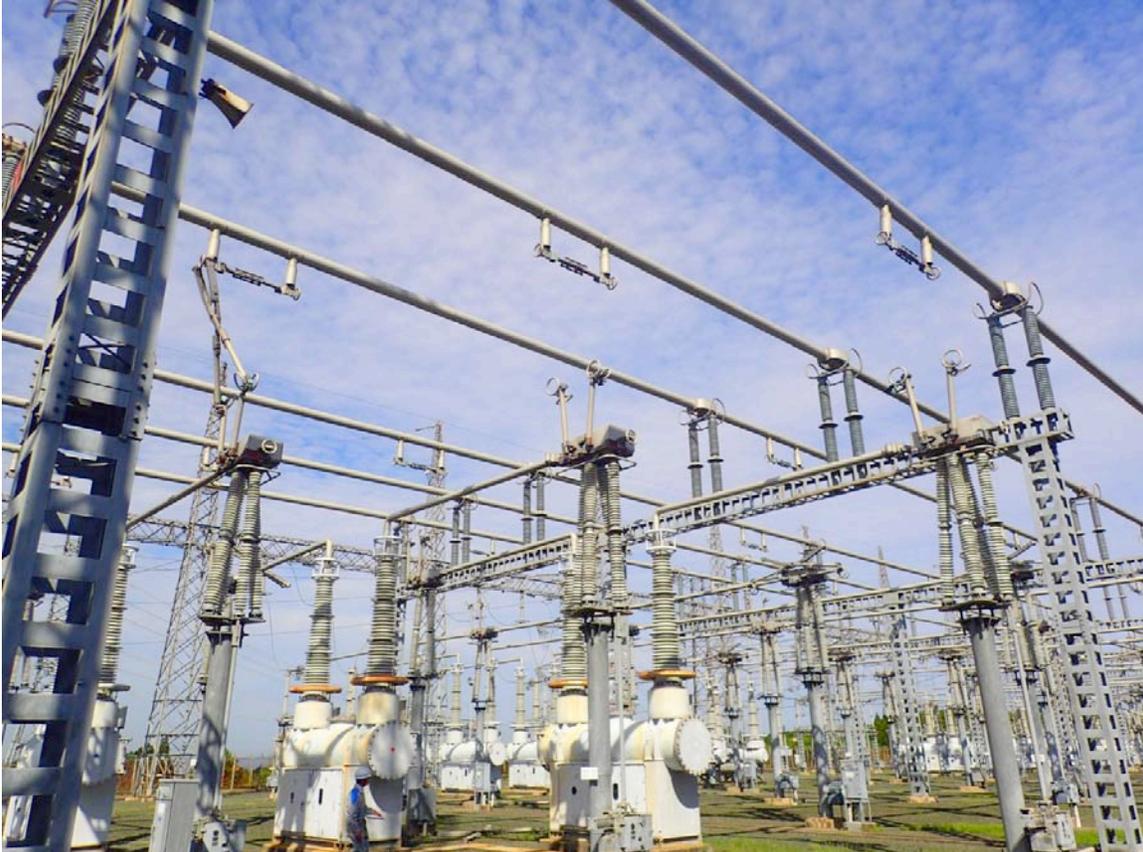
Figure 3-37. Damaged Pantograph Switch DS 5 in 220 kV Yard

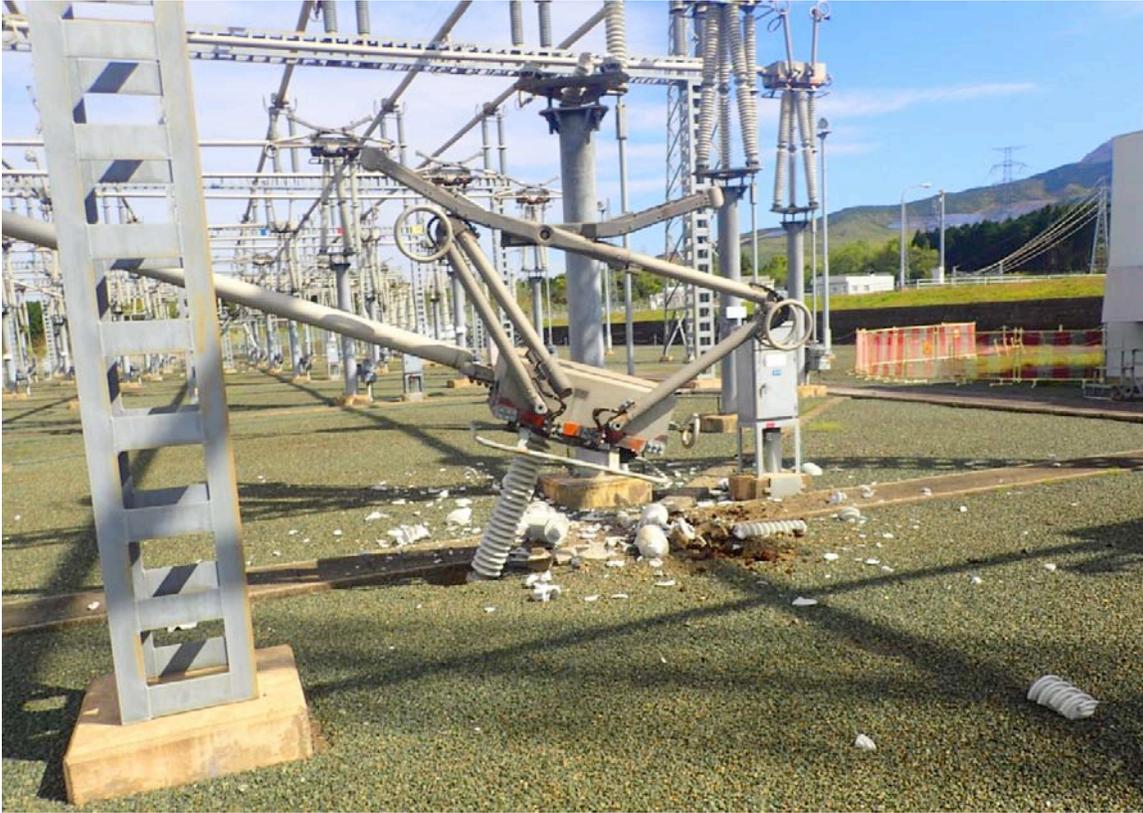
Figure 3-38. Damaged Pantograph Switch DS 5 in 220 kV Yard

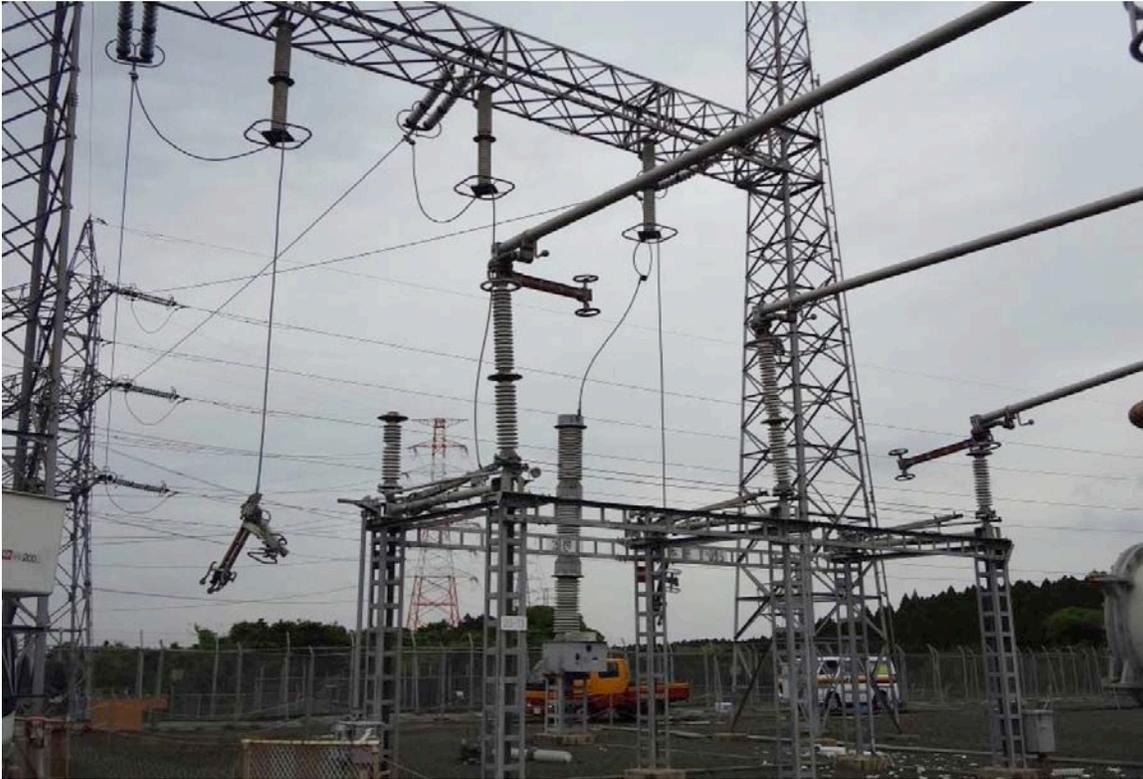
Figure 3-39. Damaged Switch DS 1 in 220 kV Yard

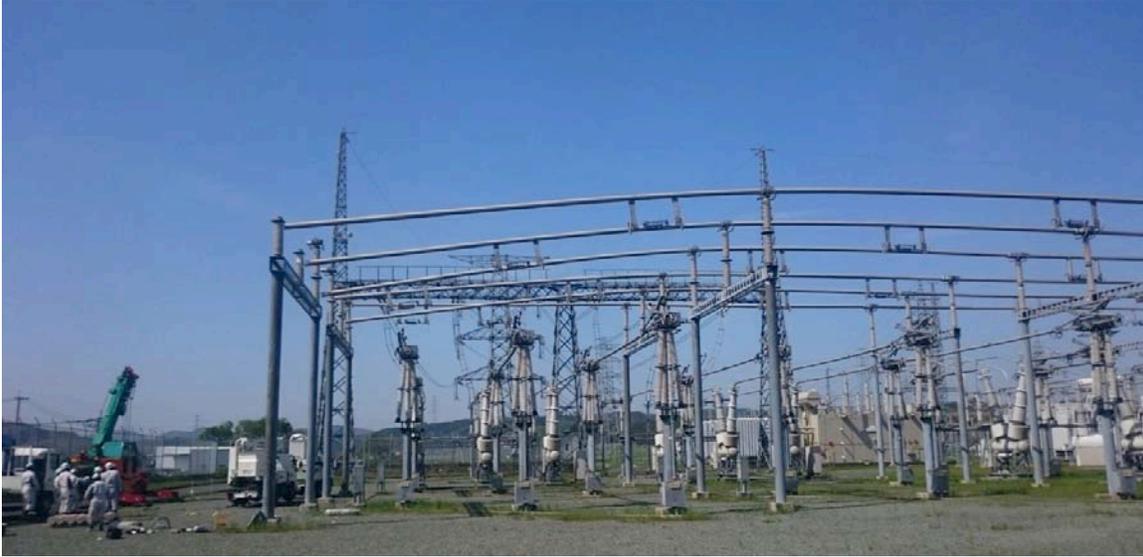
Figure 3-40. Damaged 220 kV Rigid Bus End Posts

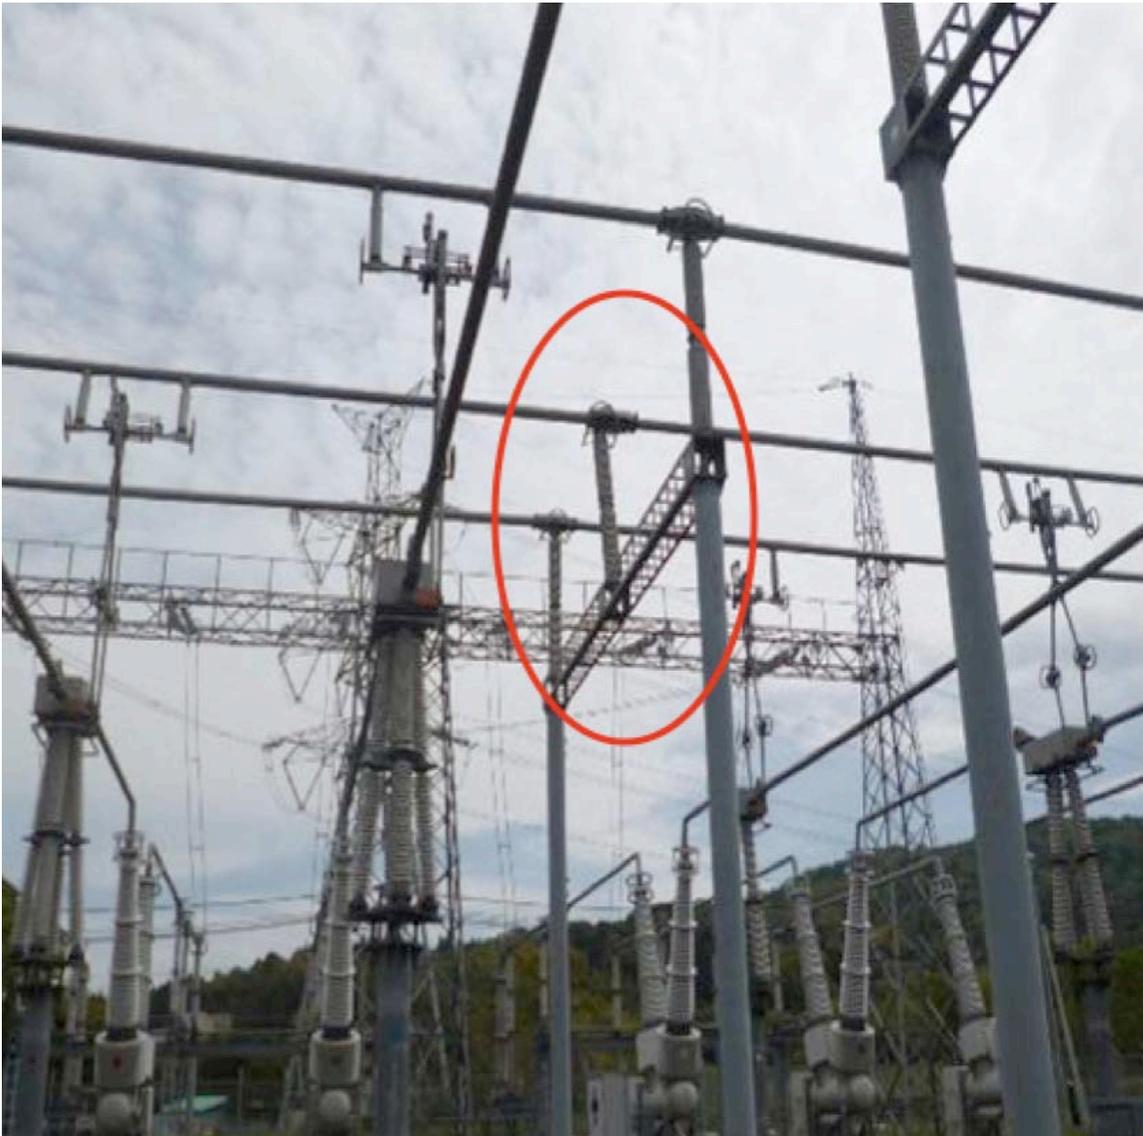
Figure 3-41. Damaged 220 kV Rigid Bus Post

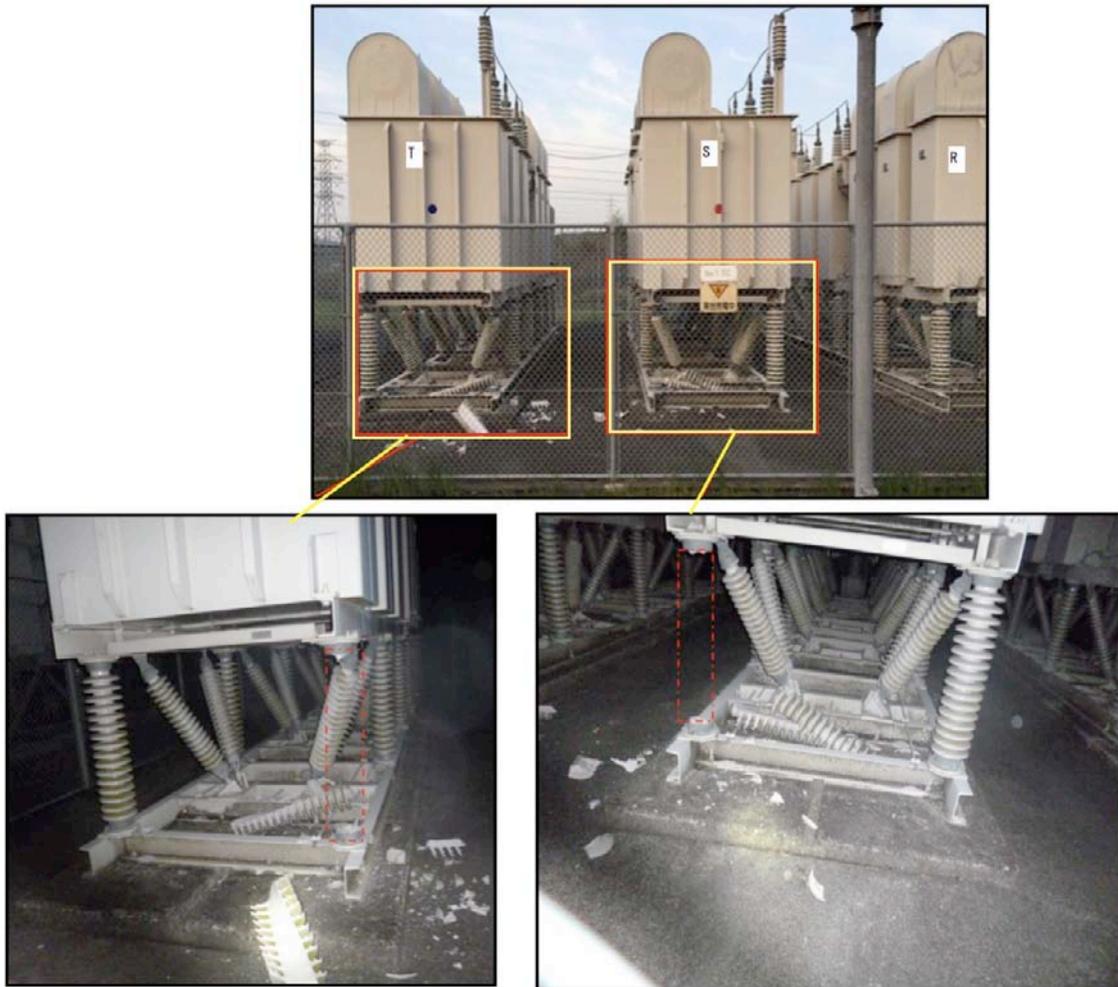
Figure 3-42. Damaged Post Supports for 66 kV Static Condensers

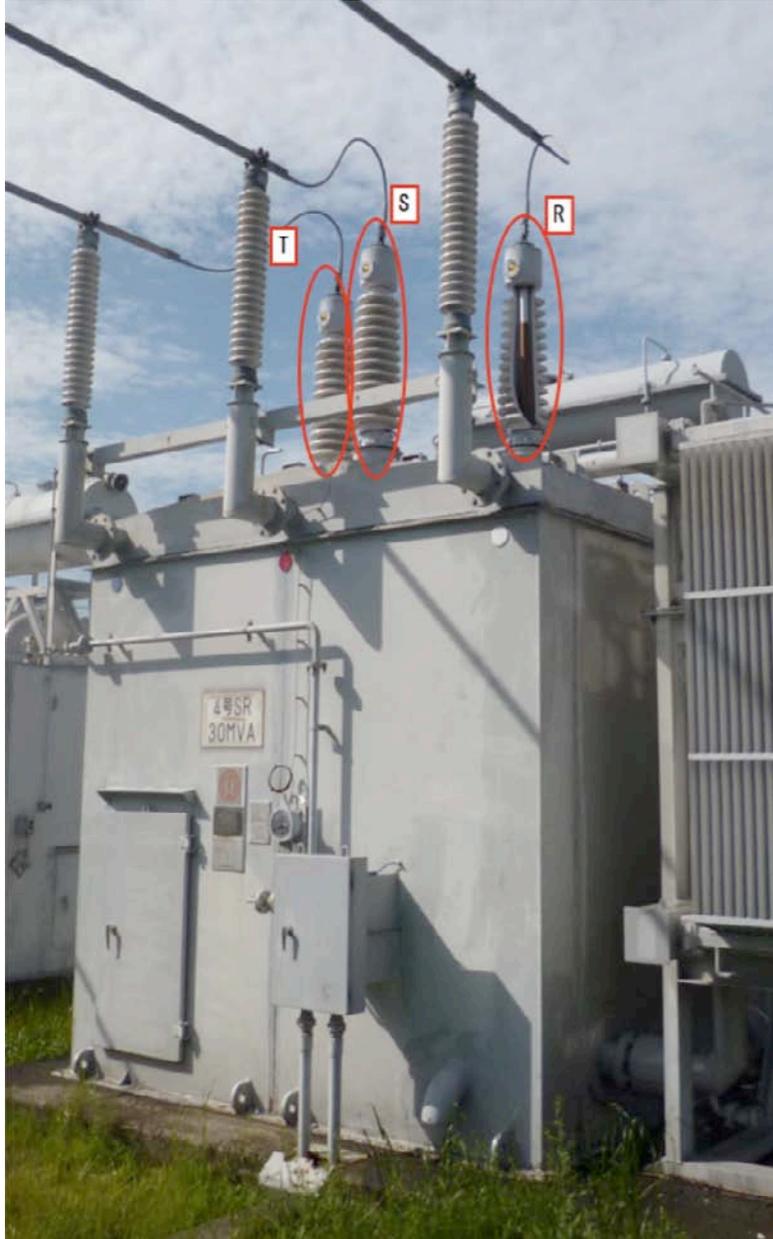
Figure 3-43. Damaged Bushings for 66 kV Shunt Reactor

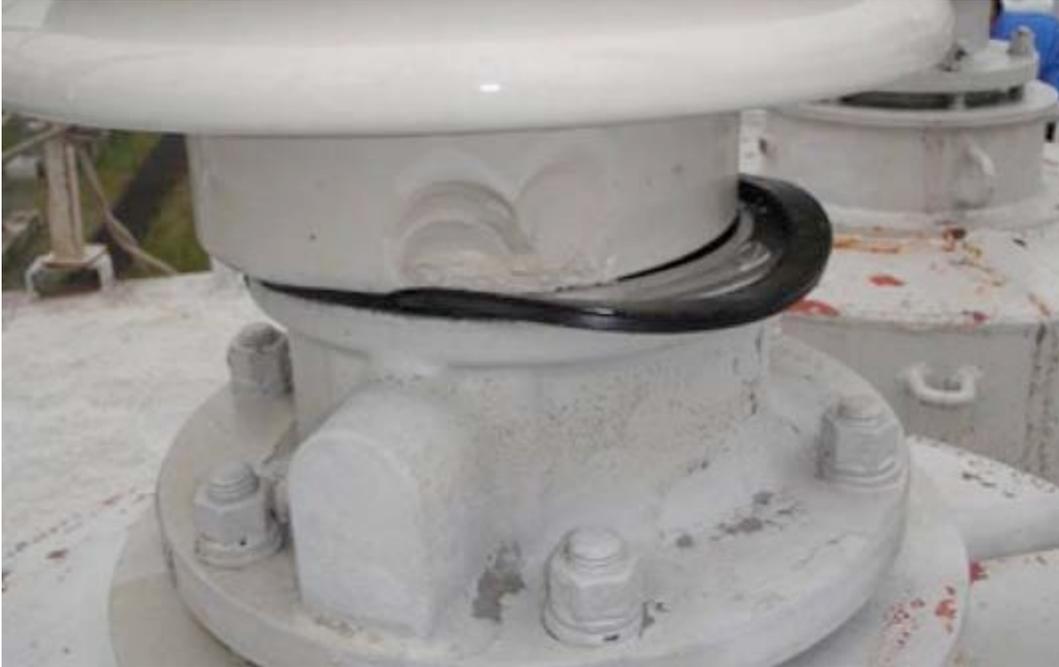
Figure 3-44. Damaged S Bushing for 66 kV Shunt Reactor in Figure 3-43

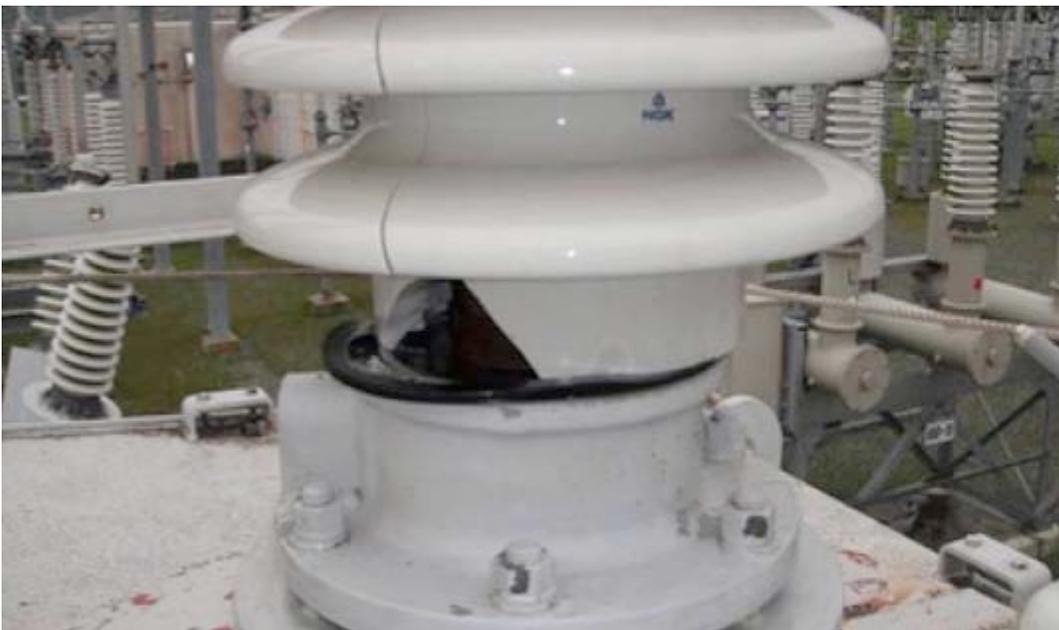
Figure 3-45. Damaged T Bushing for 66 kV Shunt Reactor in Figure 3-43

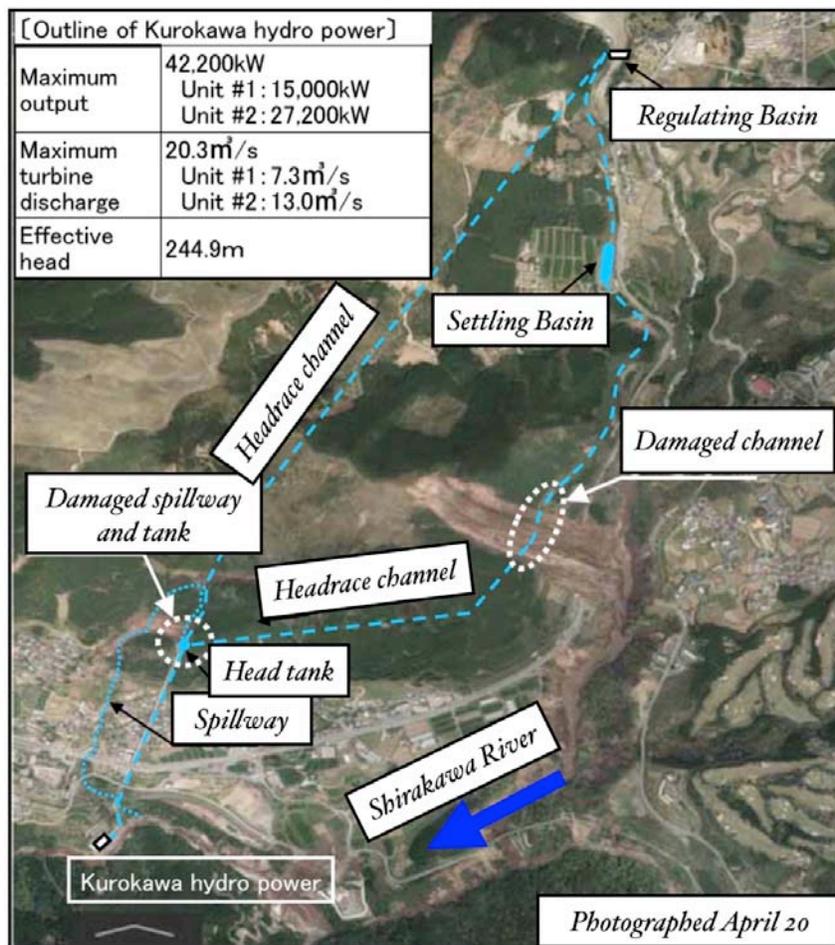
Figure 3-46. Kurokawa Hydroelectric Generation Facility

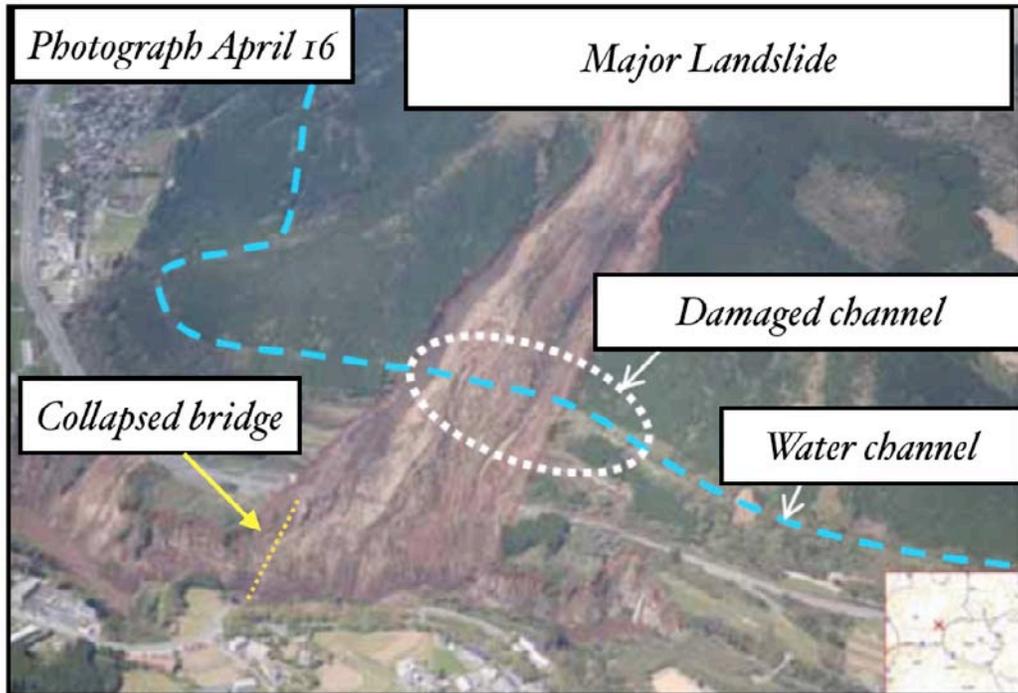
Figure 3-47. Damaged Headrace Channel

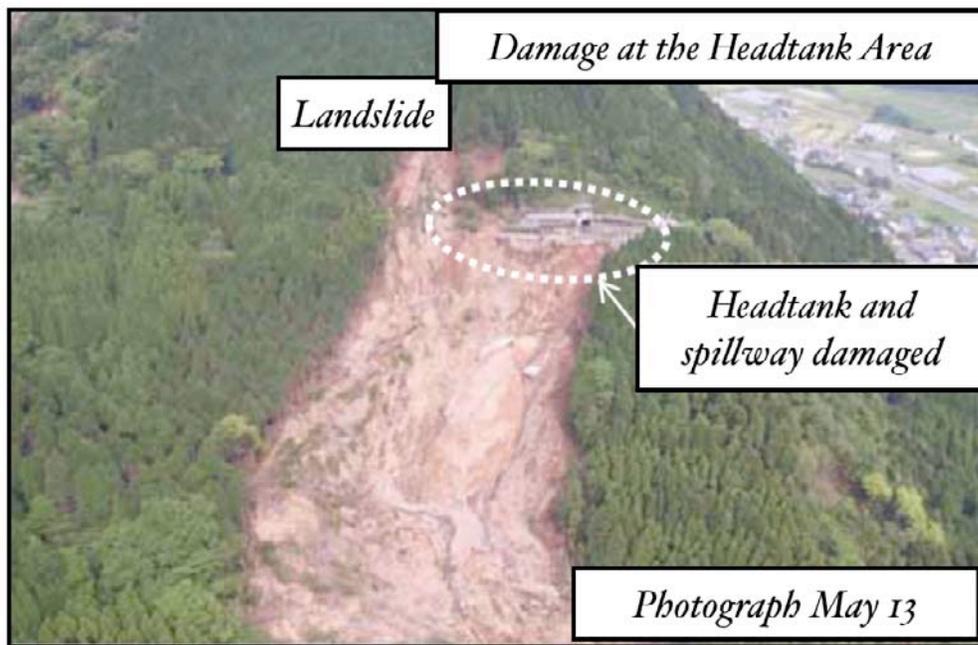
Figure 3-48. Damage at the Headtank Area

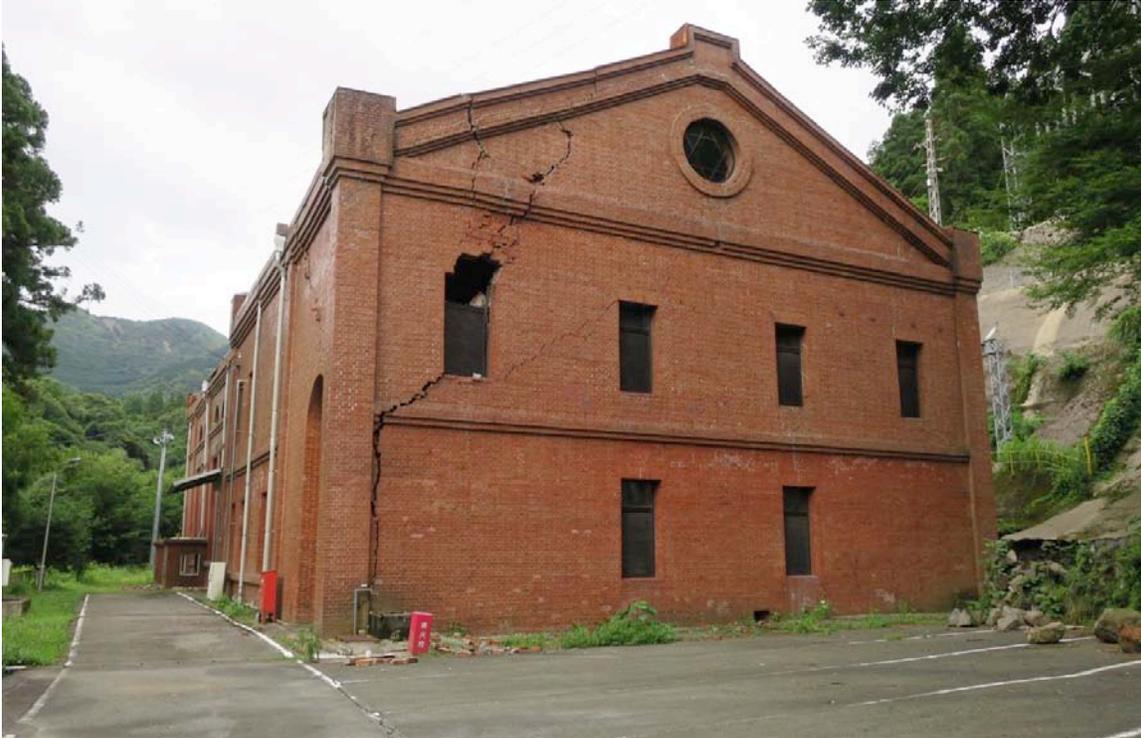
Figure 3-49. Damage at the JNC Hydroelectric Plant
