KUMAMOTO, KYUSHU, JAPAN, EARTHQUAKES OF M_w 6.0 April 14, 2016 M_w 7.0 April 16, 2016 LIFELINE PERFORMANCE

ALEX K TANG and JOHN M EIDINGER

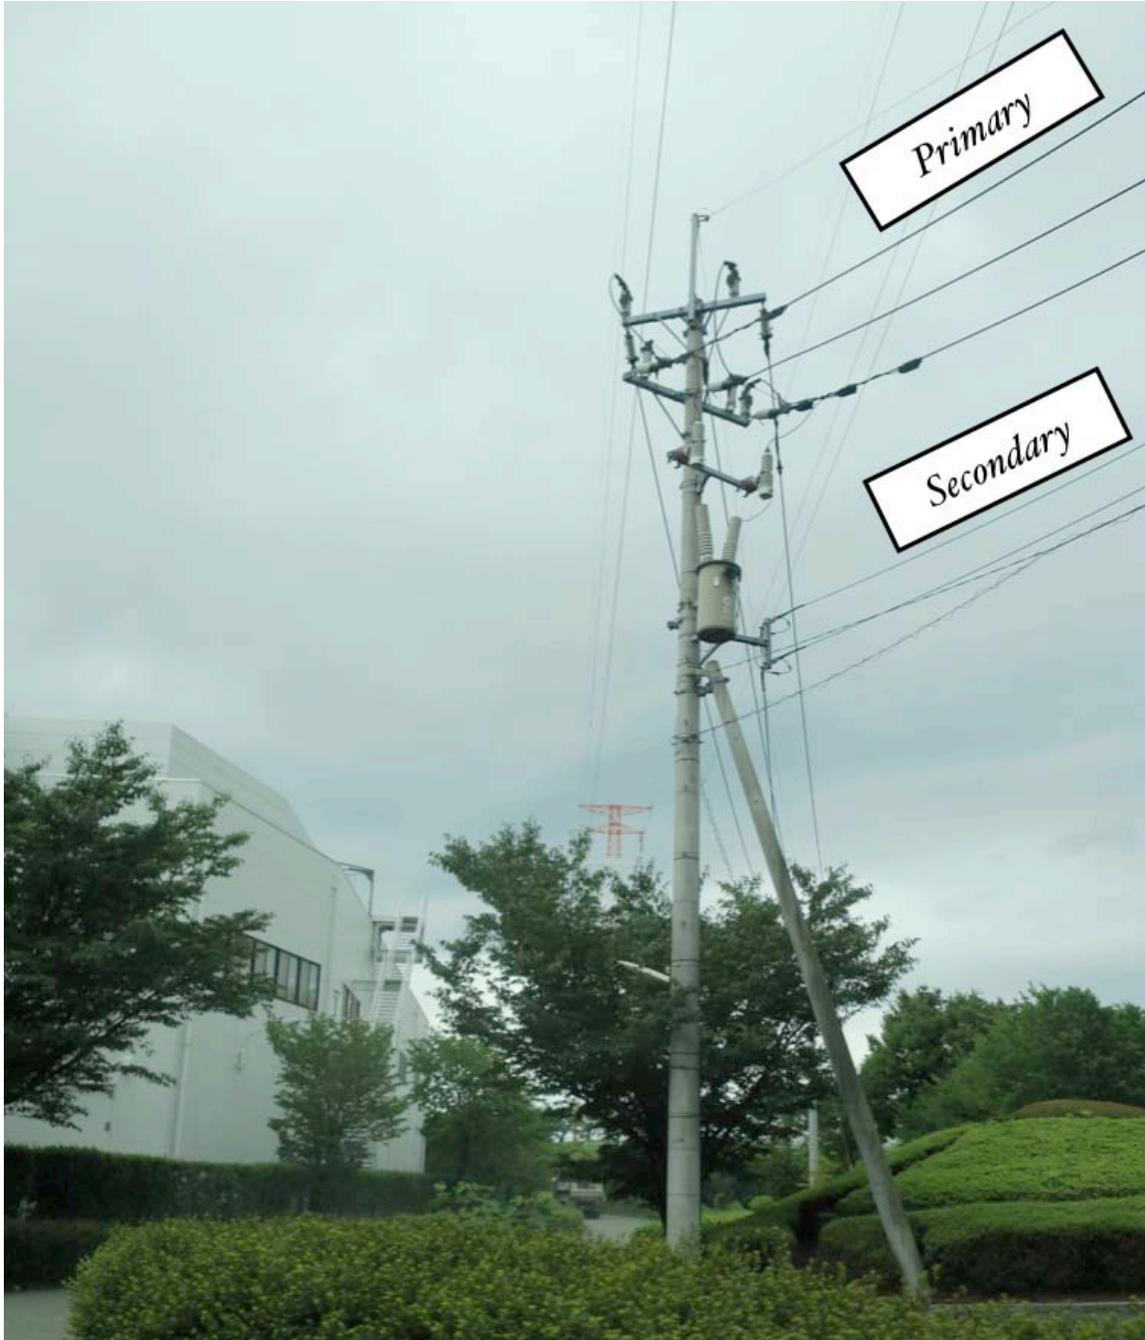
Figure 3-50. Common Distribution Pole

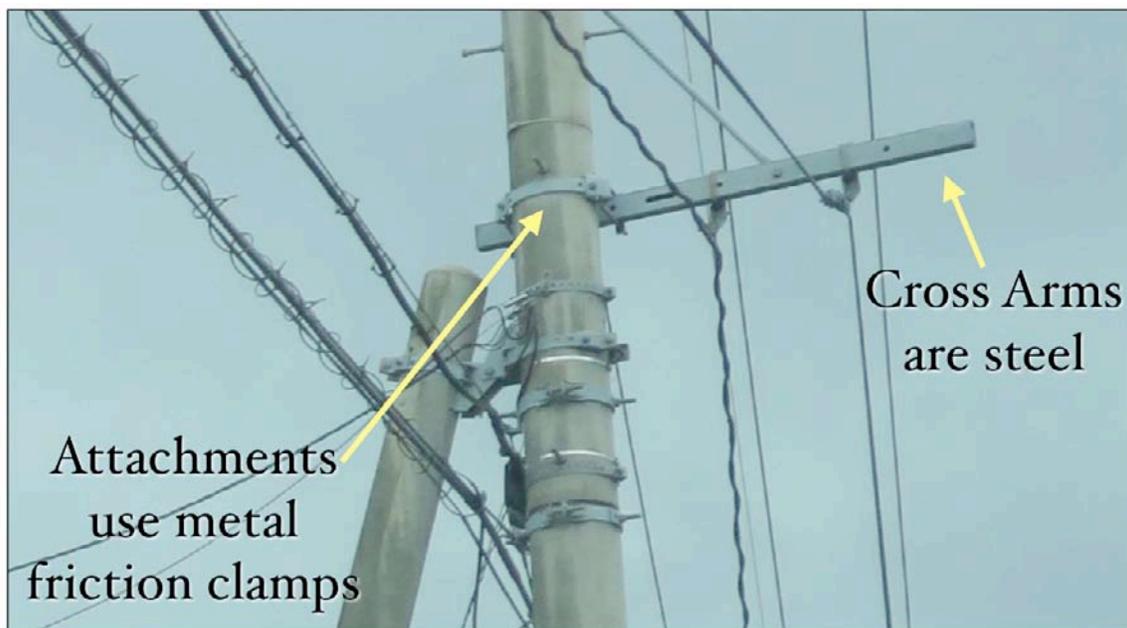
Figure 3-51. Common Cross Arm on Distribution Pole

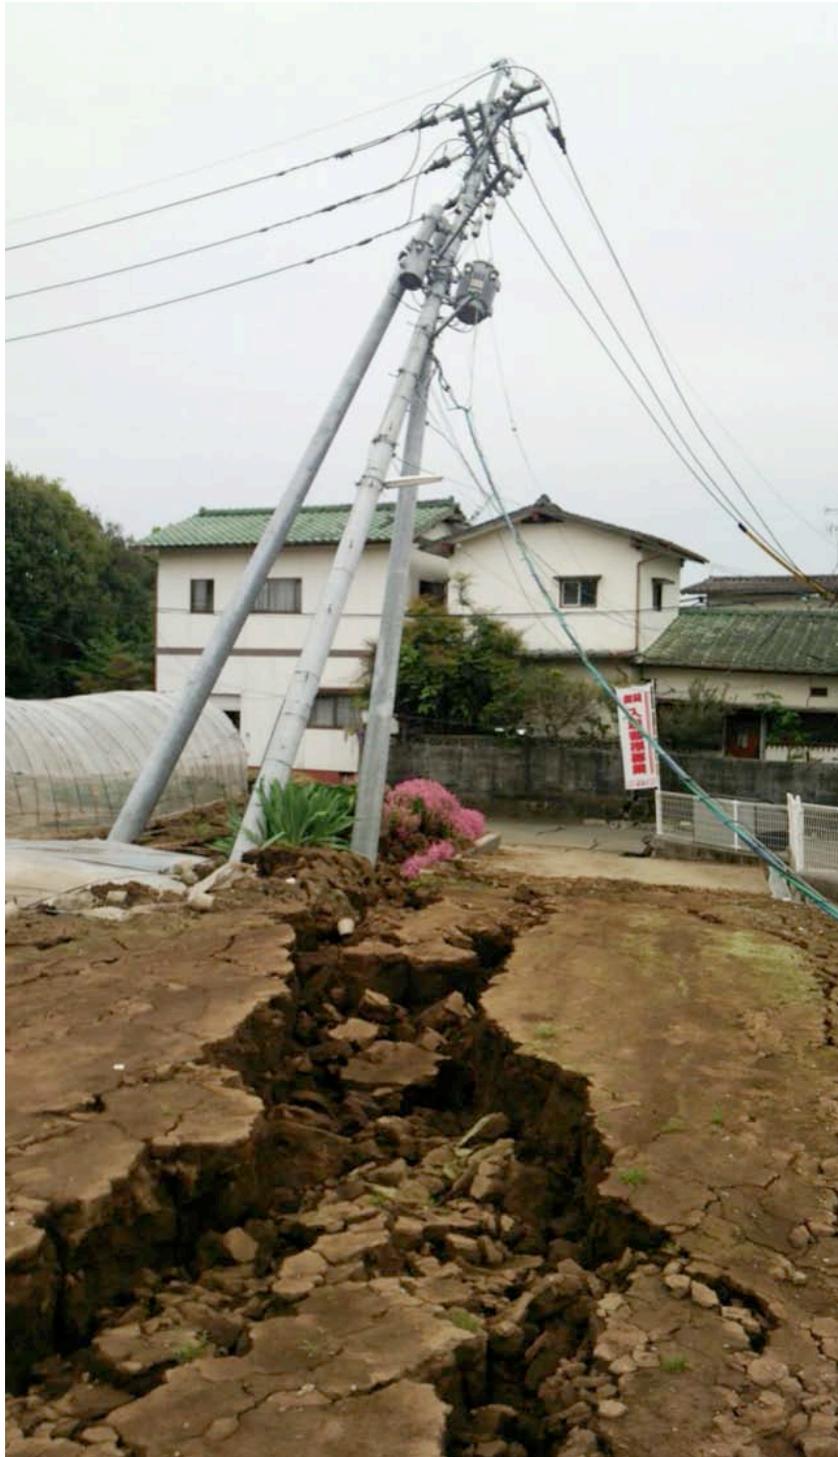
Figure 3-52. Distribution Pole Exposed to Surface Faulting

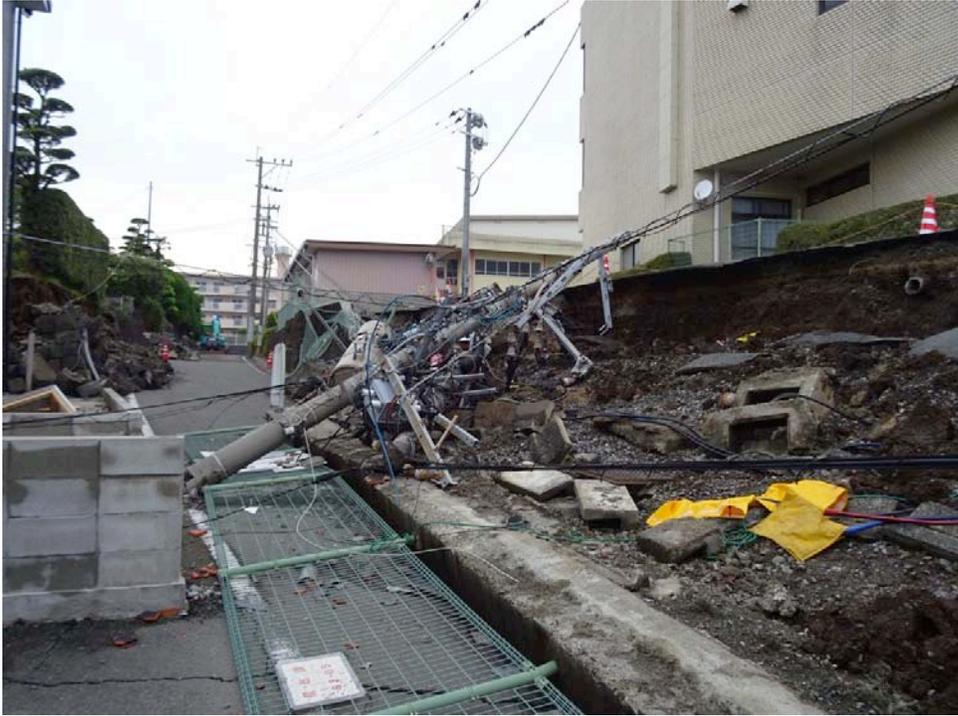
Figure 3-53. Distribution Pole Collapse

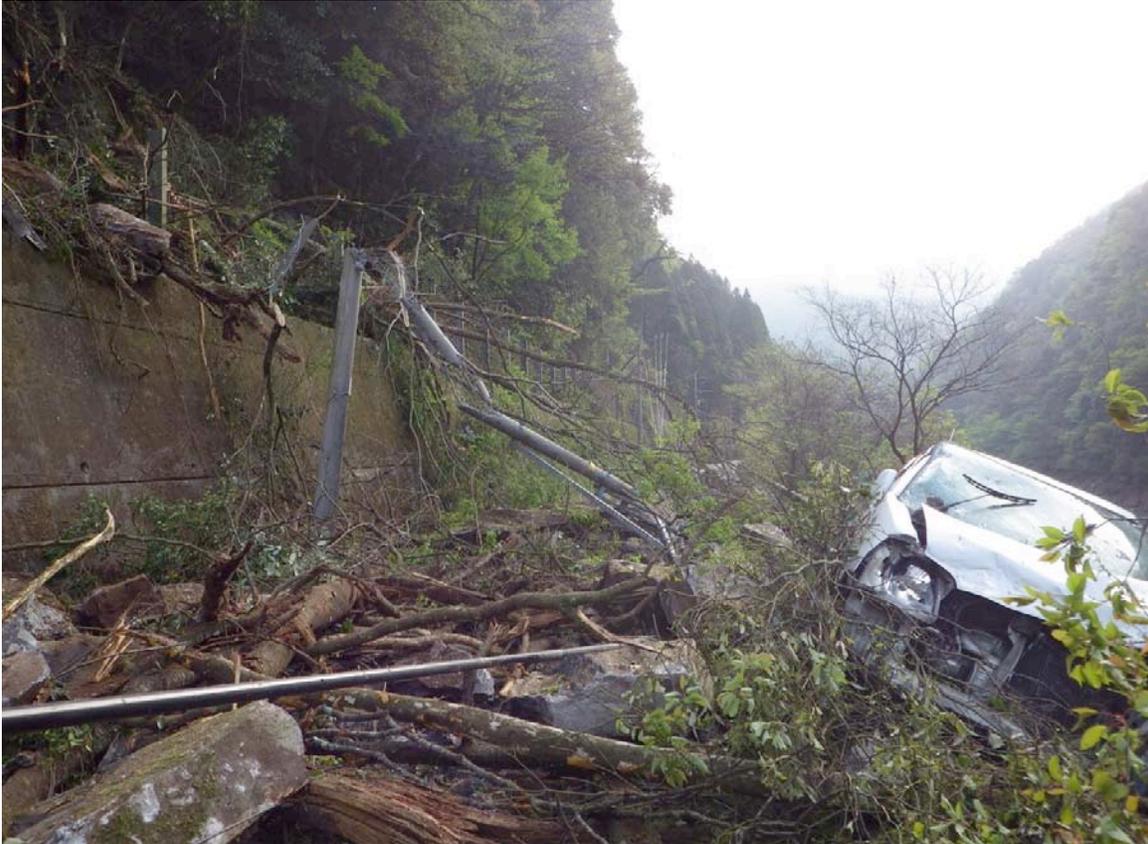
Figure 3-57. Distribution Pole Collapse

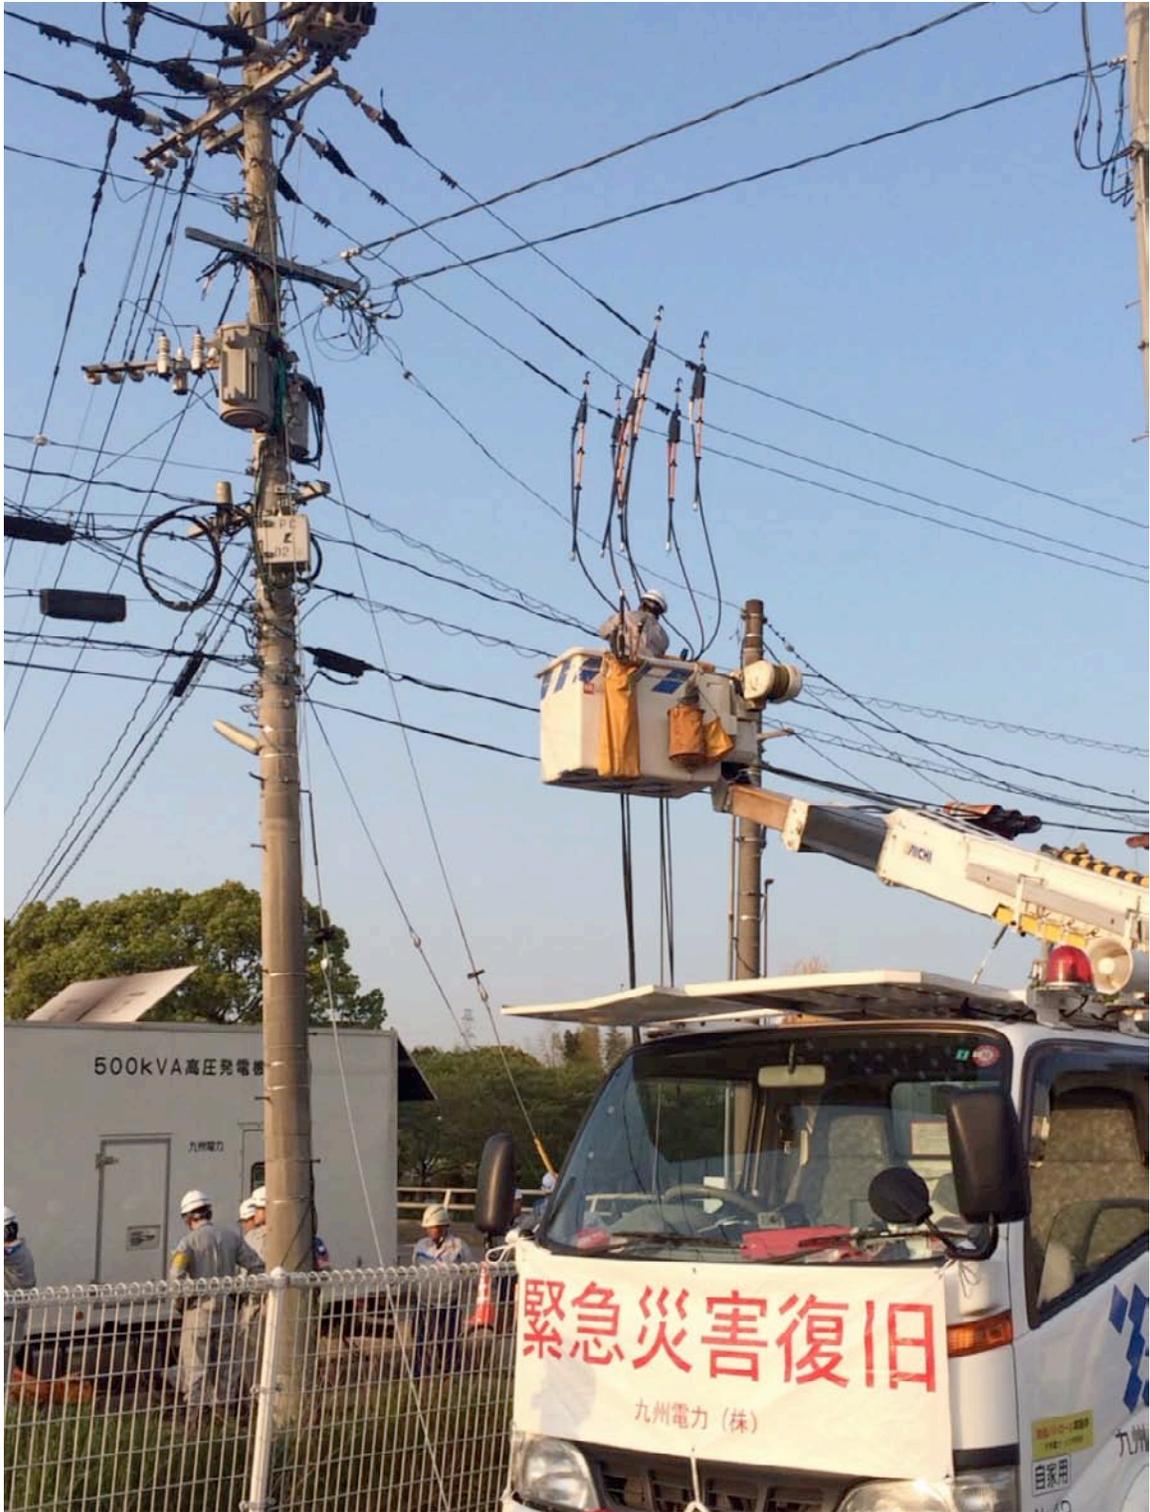
Figure 3-58. Hooking up an Emergency Generator to a Distribution Primary

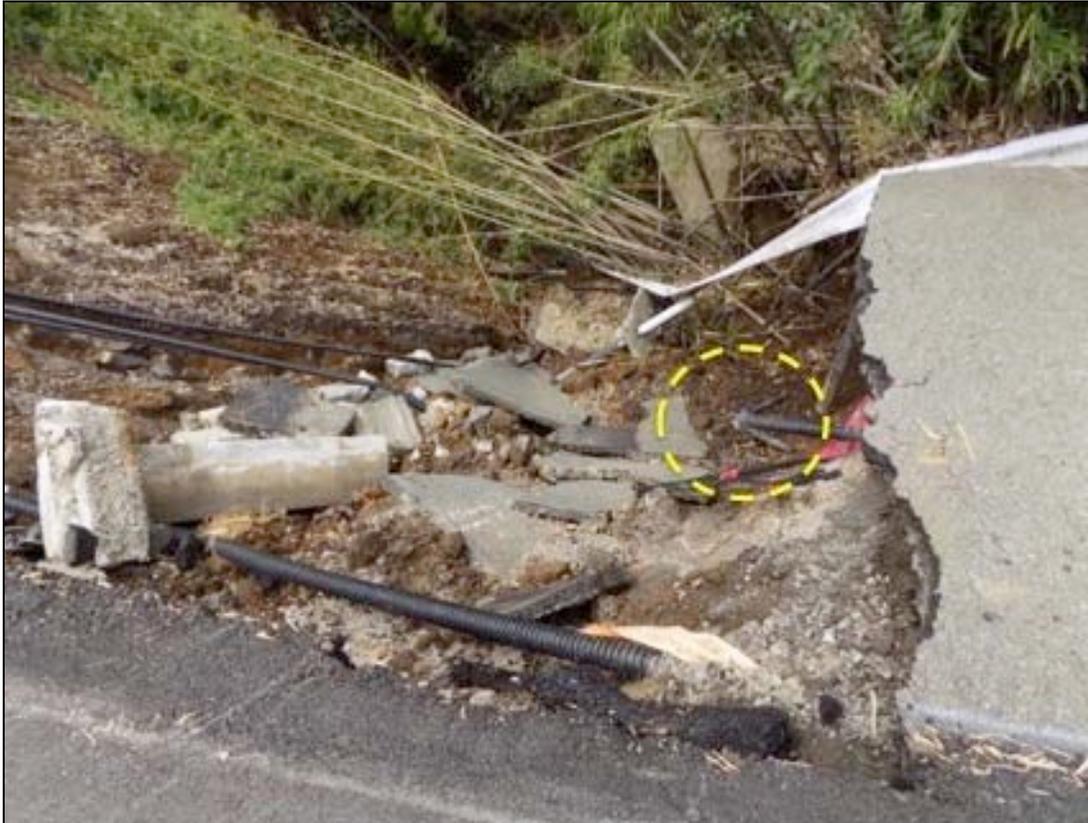
Figure 4-1. Buried cable with flexible conduit severed (Minami Aso)

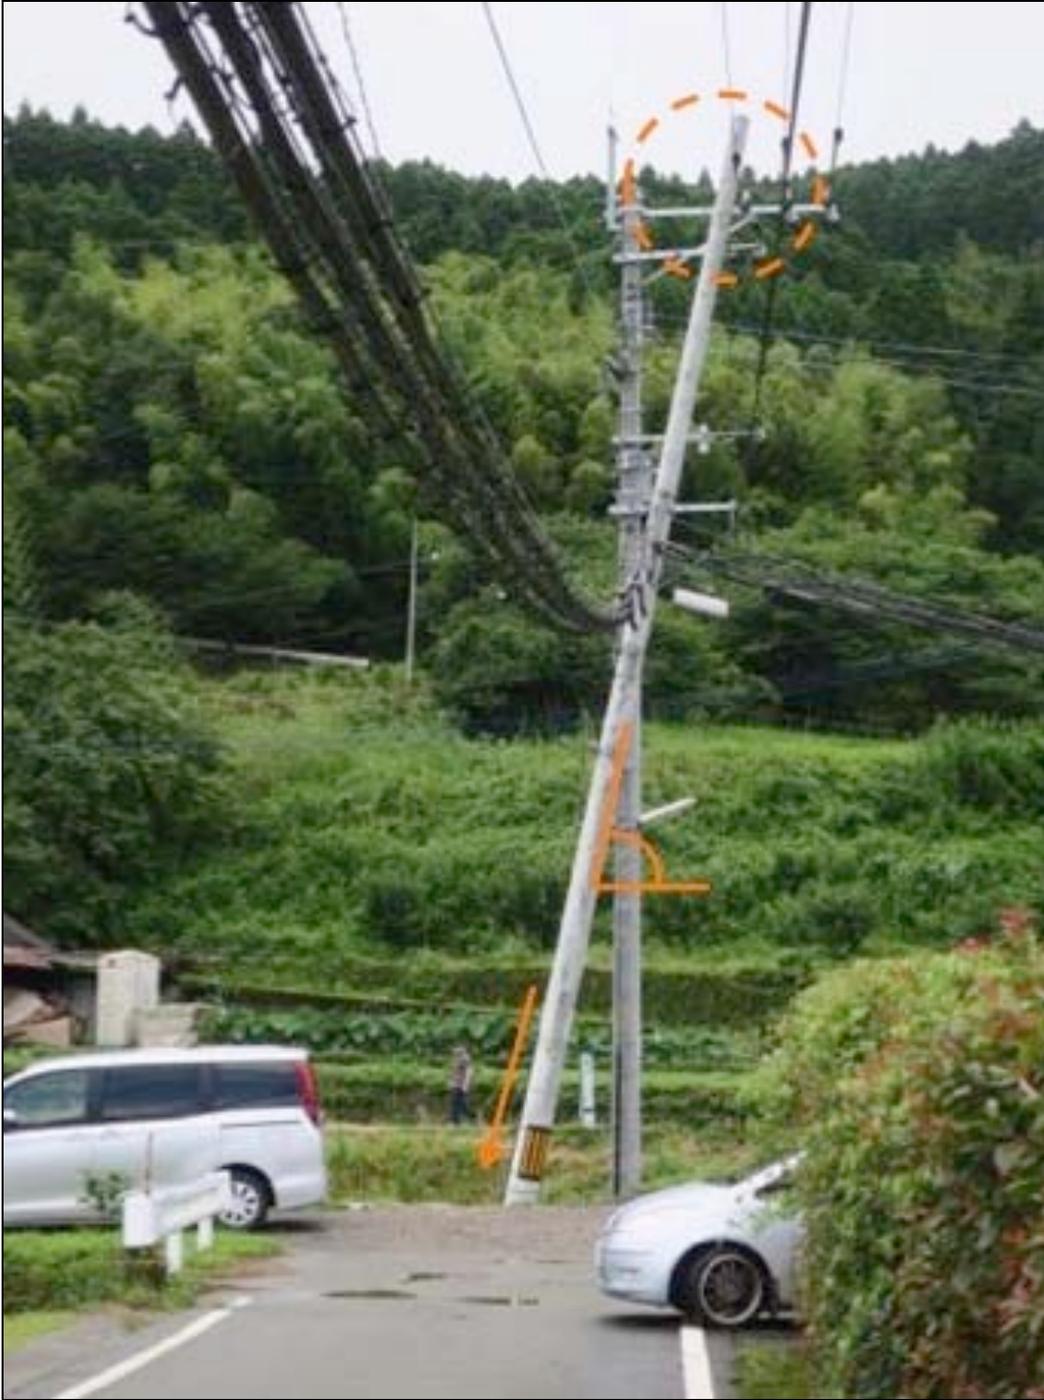
Figure 4-2. The utility pole carrying the telecom aerial cable bundles sustained ground failure damage. The top part of the pole was resting on the power cable isolator

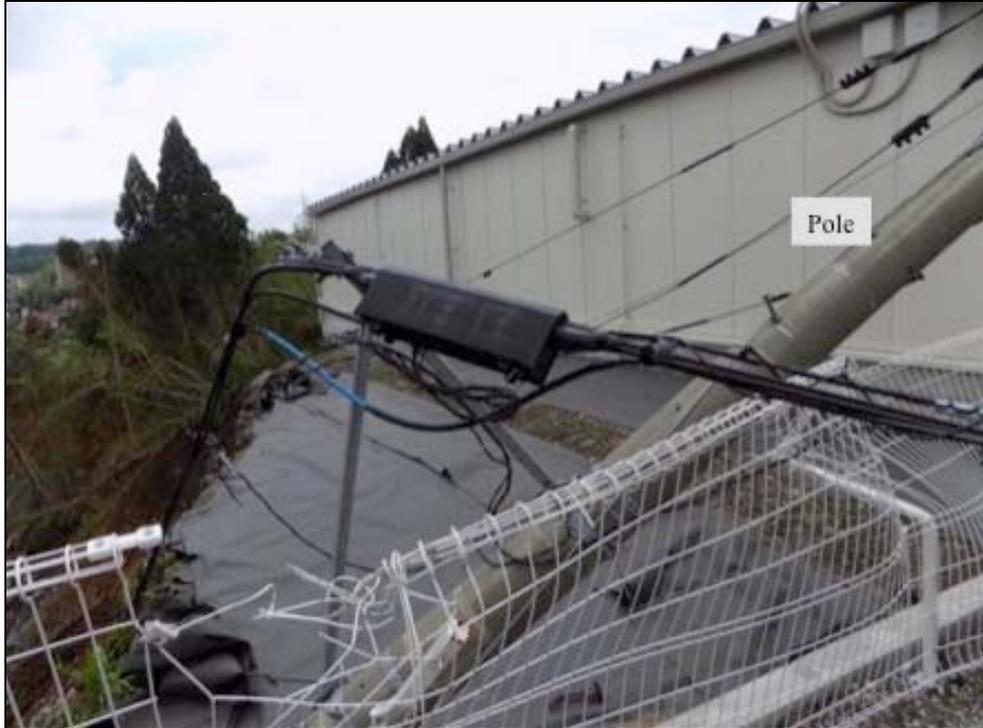
Figure 4-3. The telecom pole fell and resting on the side of the building

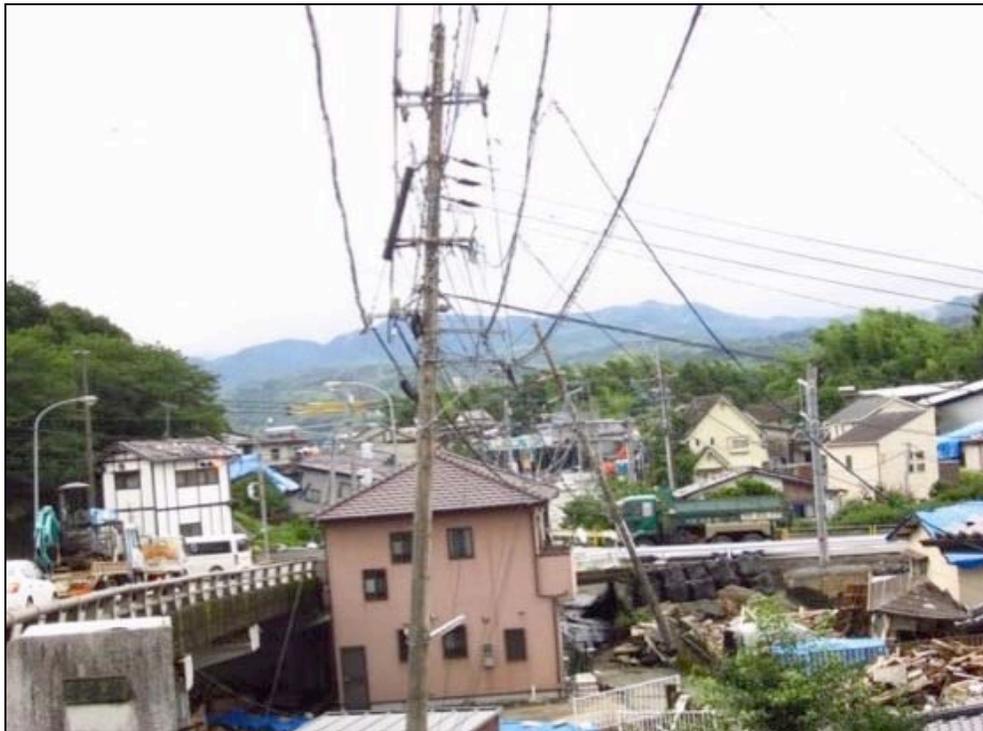
*Figure 4-4. Many telecom and power cable poles were damaged in Mashiki Town
(32.7901°N, 130.8209°E)*

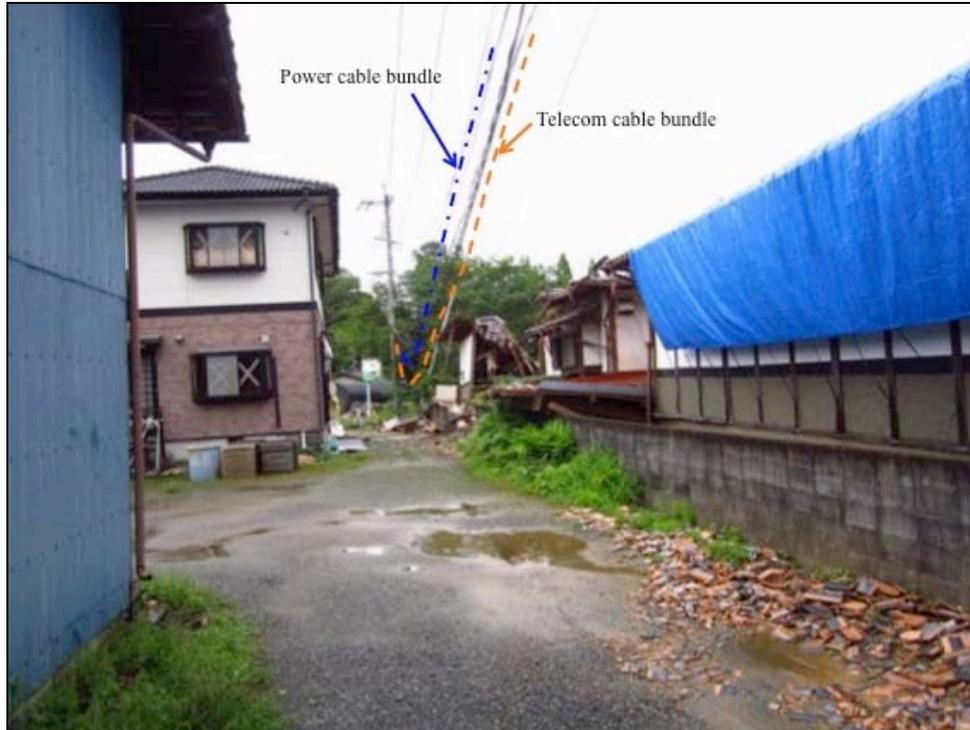
Figure 4-5. In Mashiki town these aerial cables (power and telecom) dropped almost to the ground and they were touching one another at the lowest point ($32.7888^{\circ}N$, $130.8205^{\circ}E$).

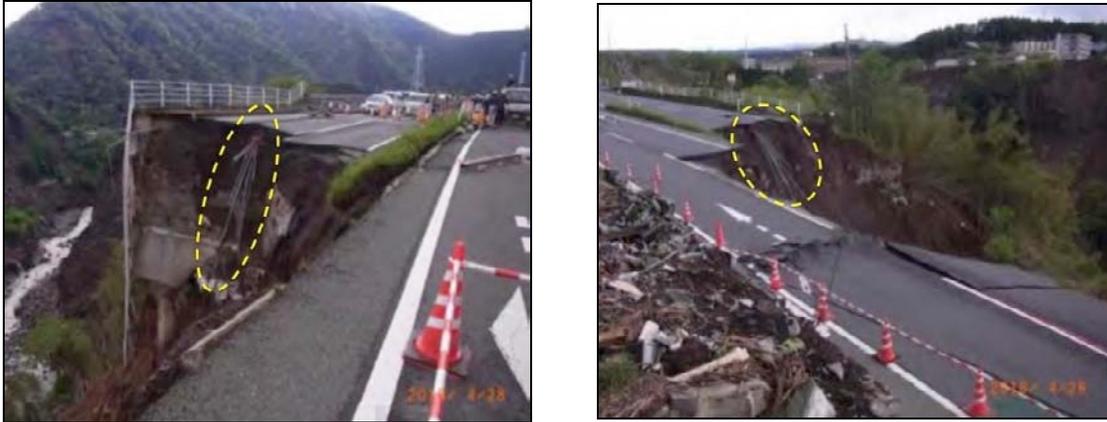
Figure 4-6. The two ends of the buried optical fiber cable bundles were severed by landslide (32.885°N , 130.9866°E). The distance was about 500 meters. (Courtesy: MLIT Kyushu)

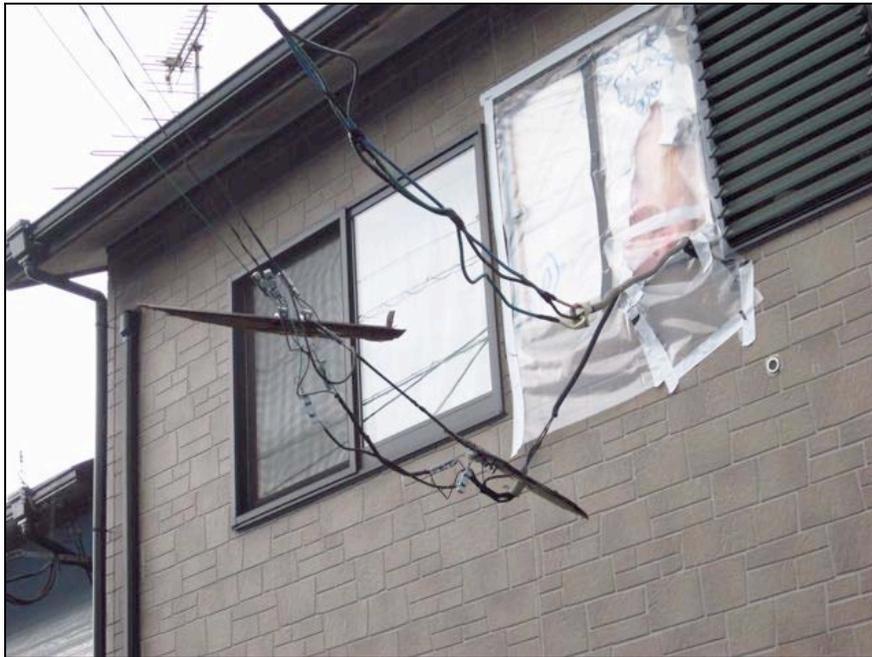
Figure 4-7. The drop wire connection was pulled from the exterior wall of this house in Mashiki town (32.7884°N , 130.8184°E). Note the proximity of the power drop wire.

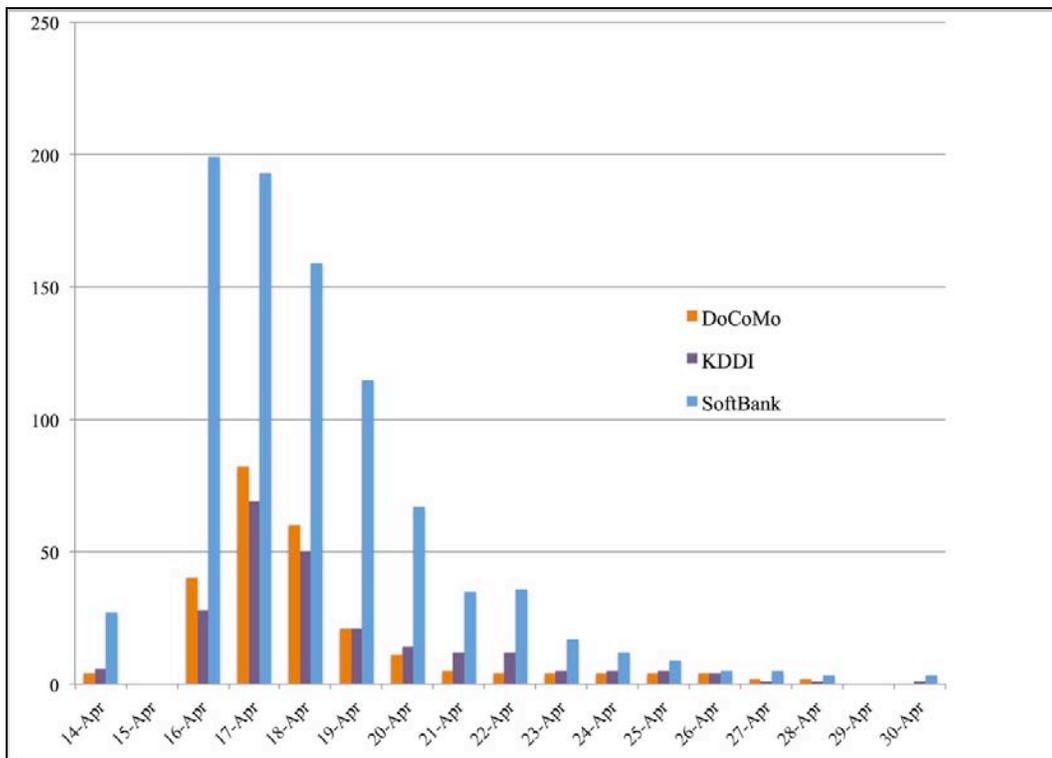
Figure 4-8. Cell site recovery progress after the earthquakes

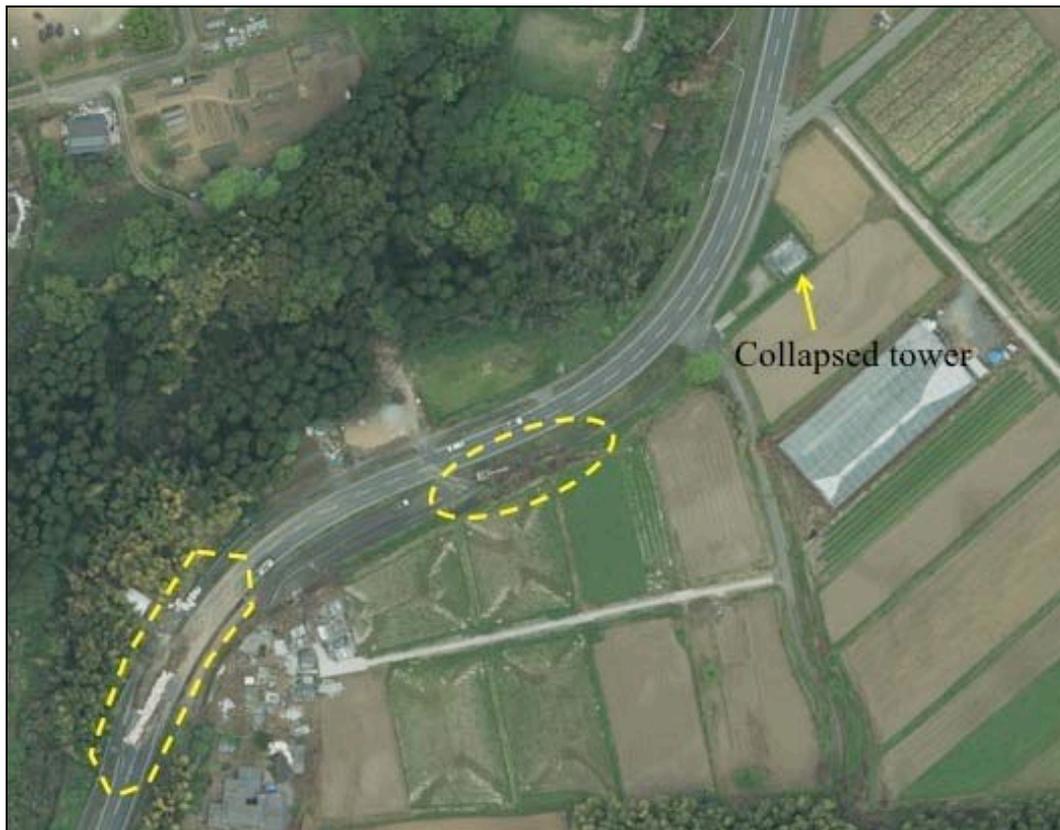
Figure 4-10. Aerial view of the area where the tower collapsed, Note the road damage (Auxiliary National Road 443) within the circled areas. (Courtesy: Aero Asahi Corporation)

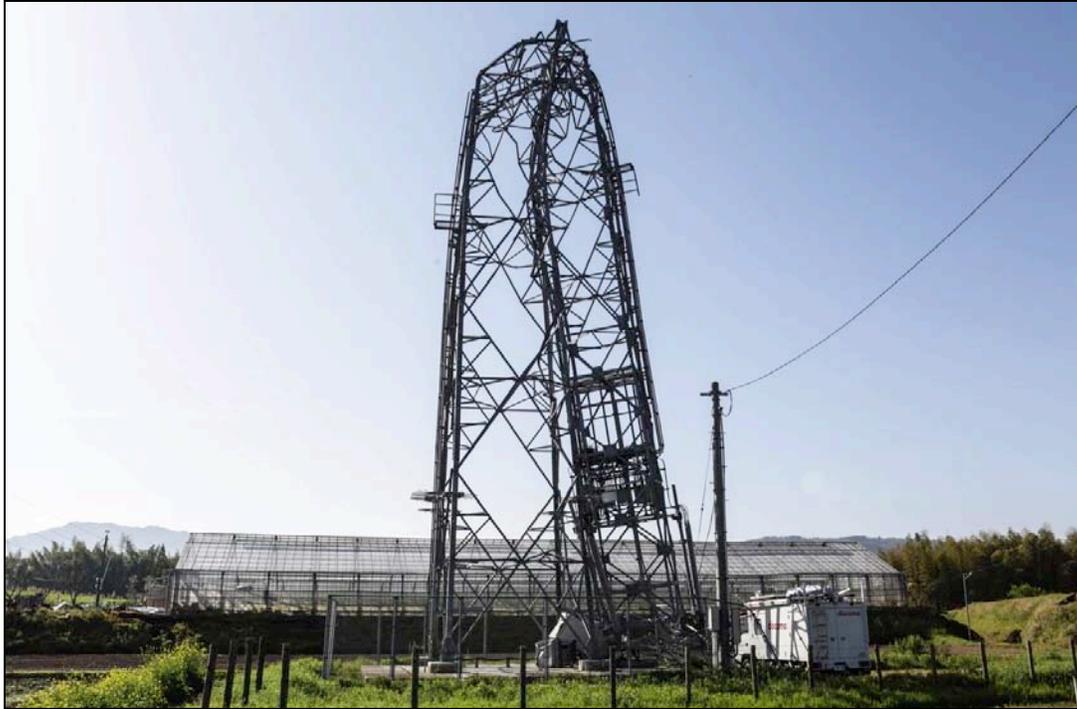
Figure 4-11. Collapsed cell tower (Courtesy: Guardian News & Media Ltd)

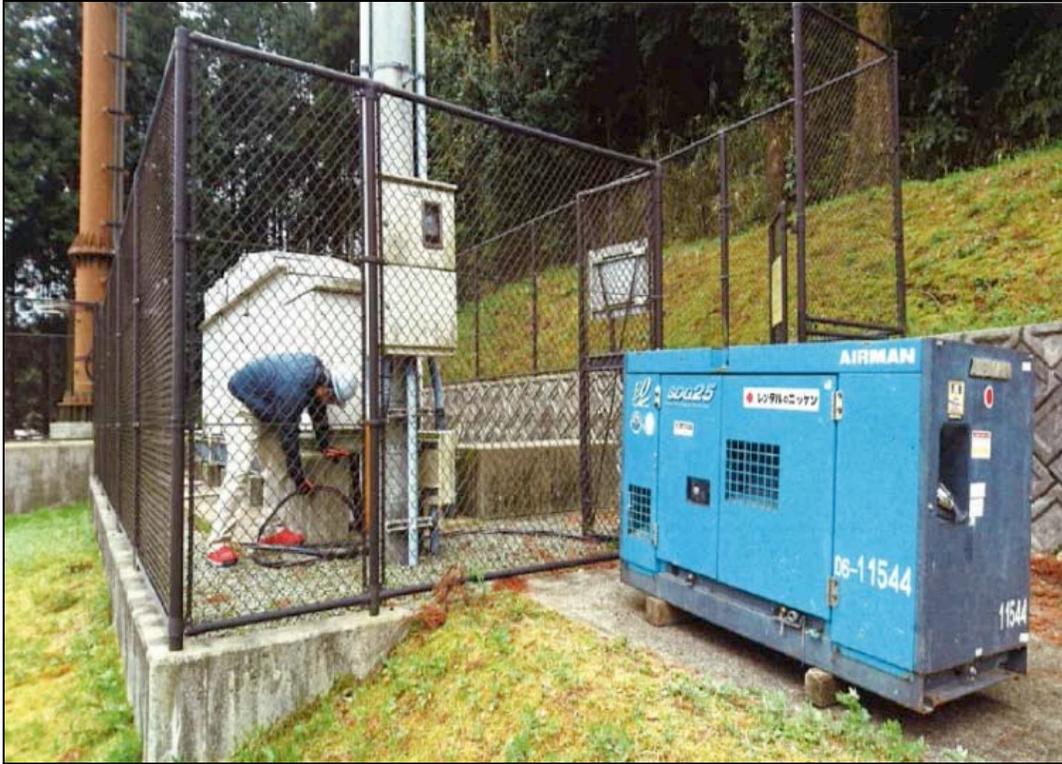
Figure 4-12. This DoCoMo Mid-zone Base Station had a power generator brought in to provide power to operate the base station. (Courtesy: NTT West)

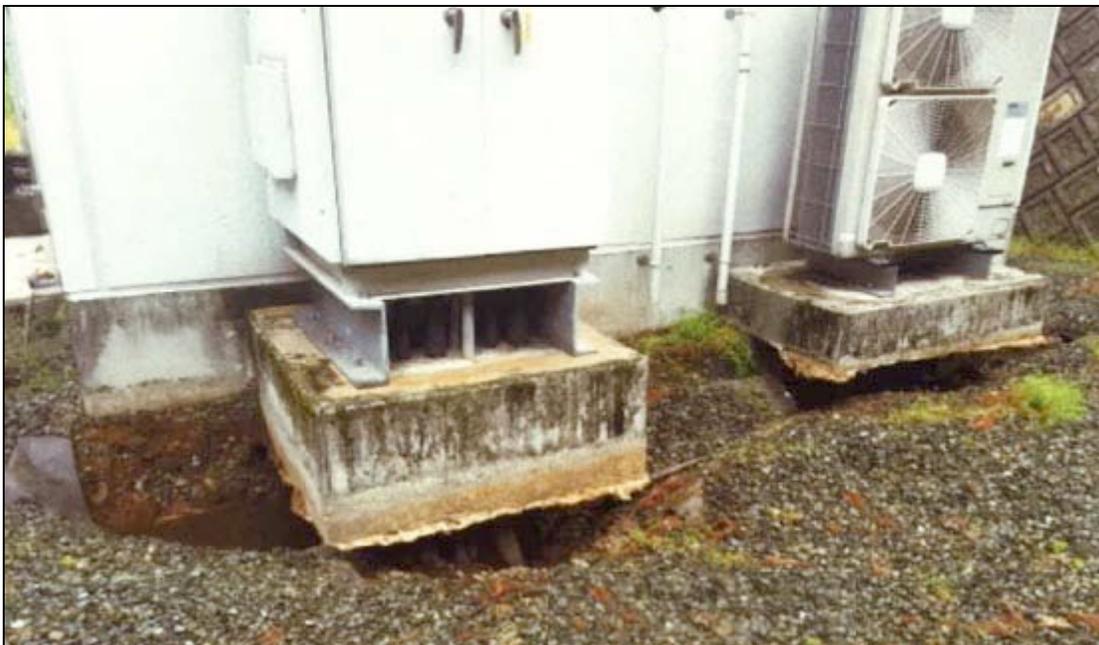
Figure 4-13. The transmission link at this cell site was damaged by the ground subsidence. (Courtesy: NTT West)

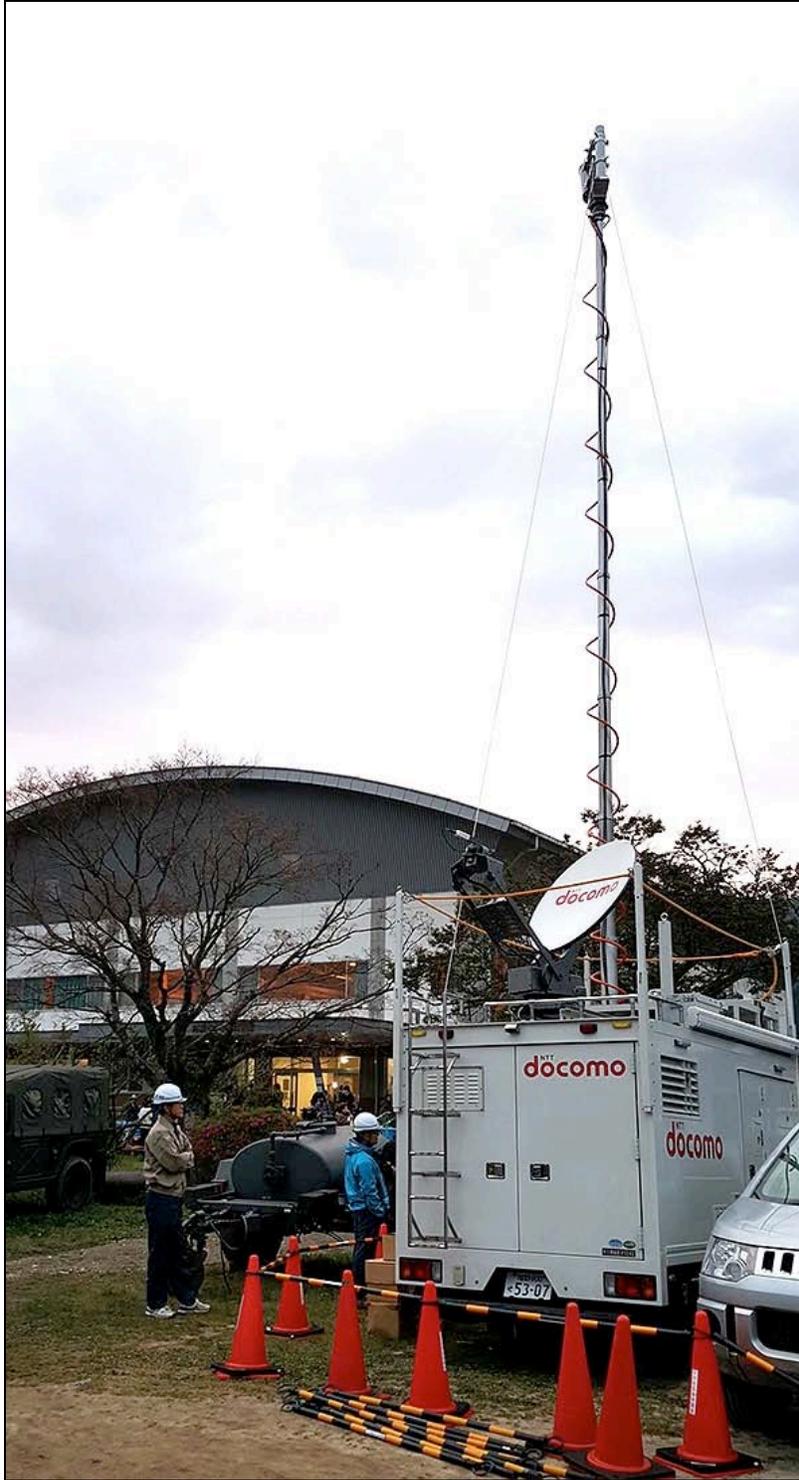
Figure 4-14. DoCoMo satellite truck outside of the Aso City Gymnastic Hall providing transmission link for damaged underground cable at cell sites

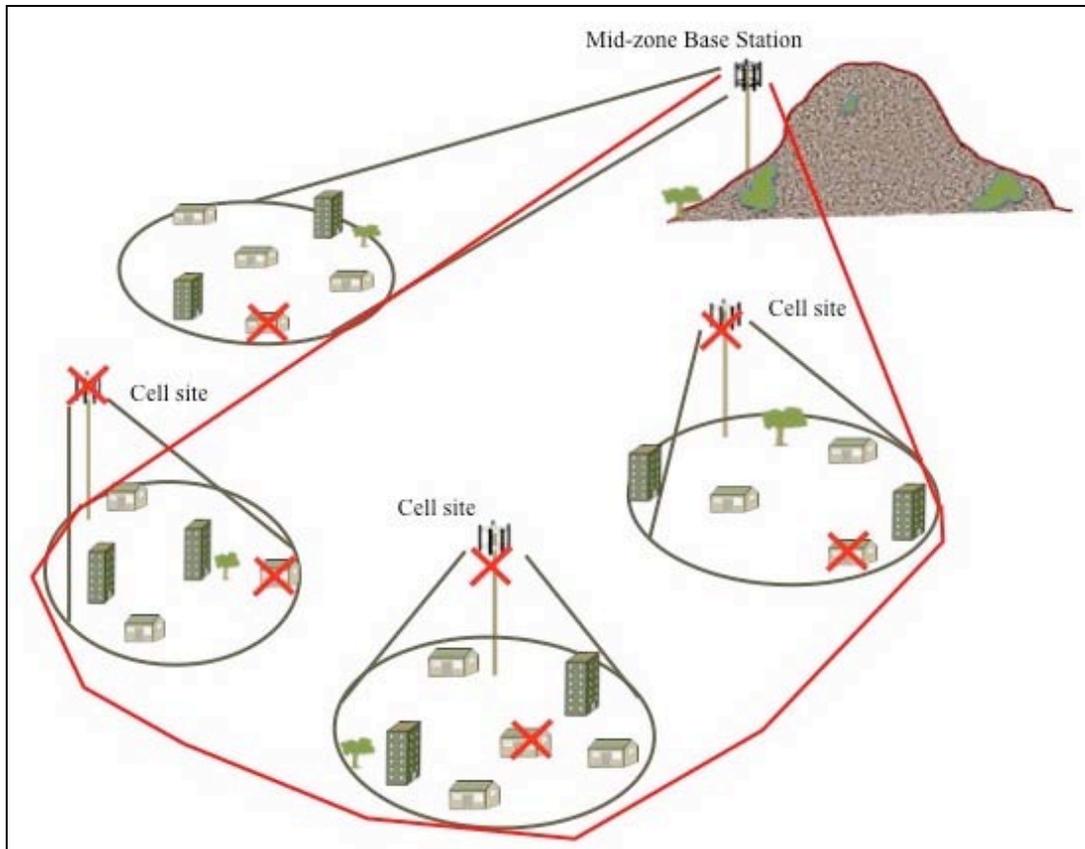
Figure 4-15. A graphical representation of a mid-zone base station (cell site) covering smaller cell sites that are off air due to any type of damage.

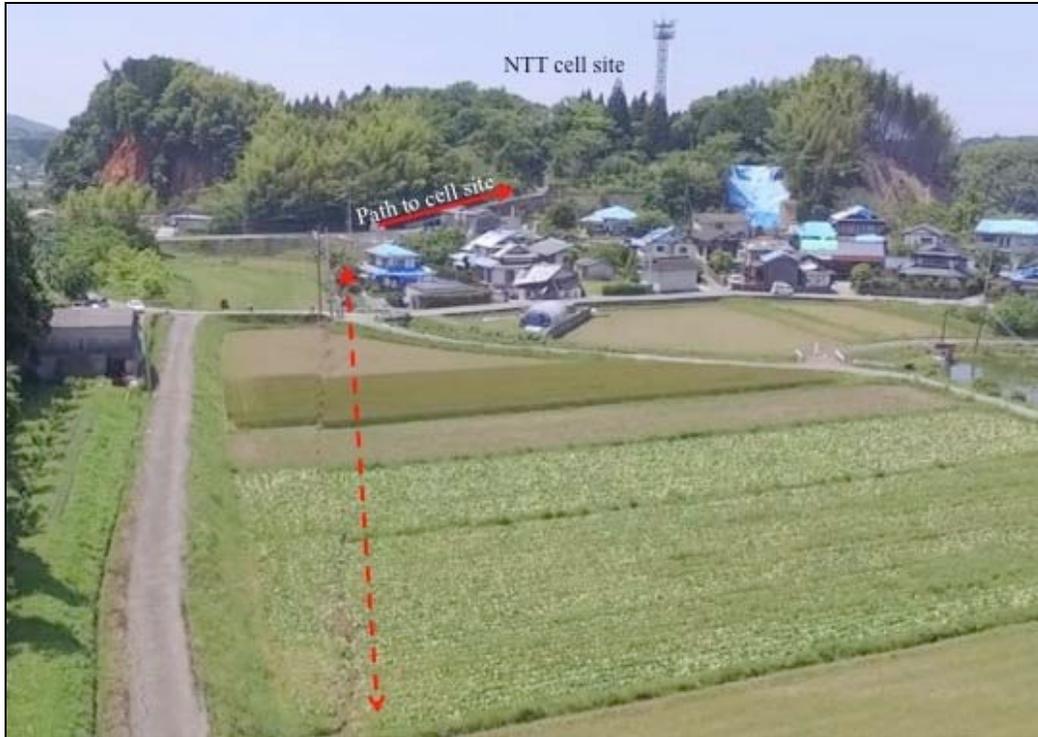
Figure 4-16. A landscape view of the location of NTT cell site with respect to the surface faulting. Figure 4.2 was taken at the end of the red line at the Y-intersection

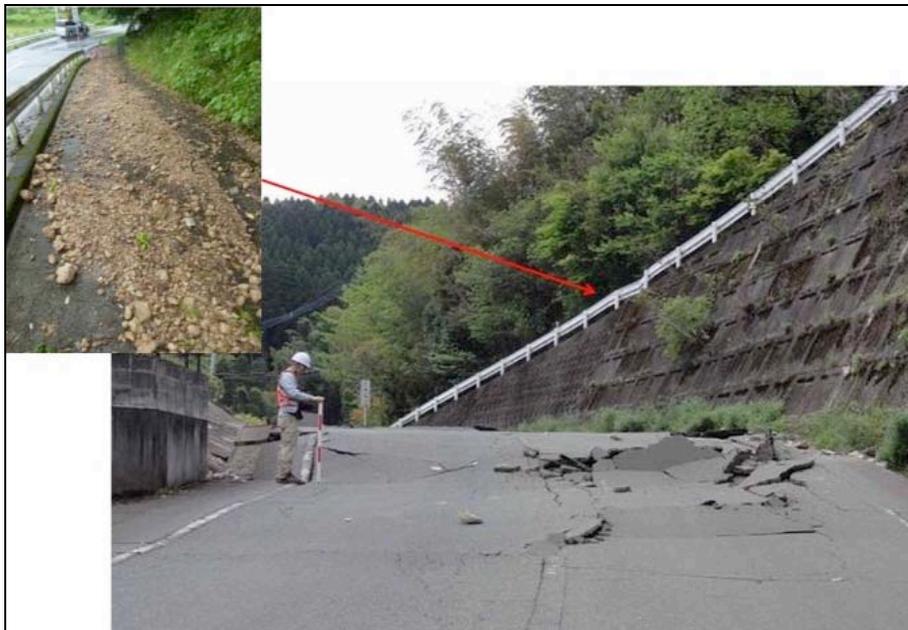
Figure 4-17. The insert on the top left corner shows the debris on the path leading up to the cell site (Investigation team photo). The road surface crack was most likely the end of the surface faulting (Courtesy: Geospatial Information Authority of Japan)

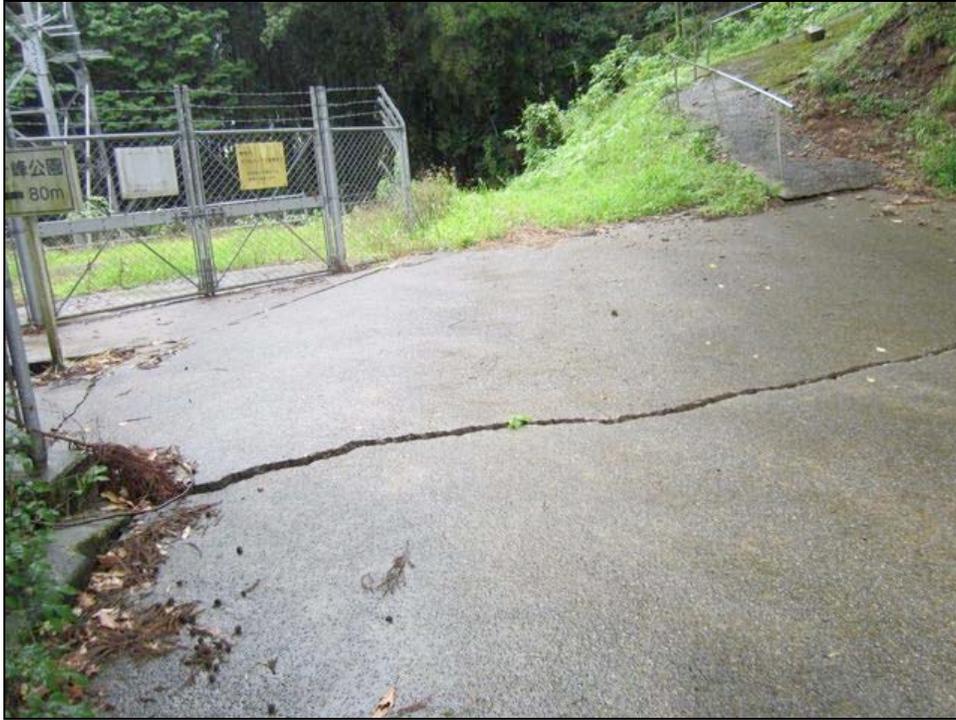
Figure 4-18. Two cracks were visible just in front of the cell site gate.

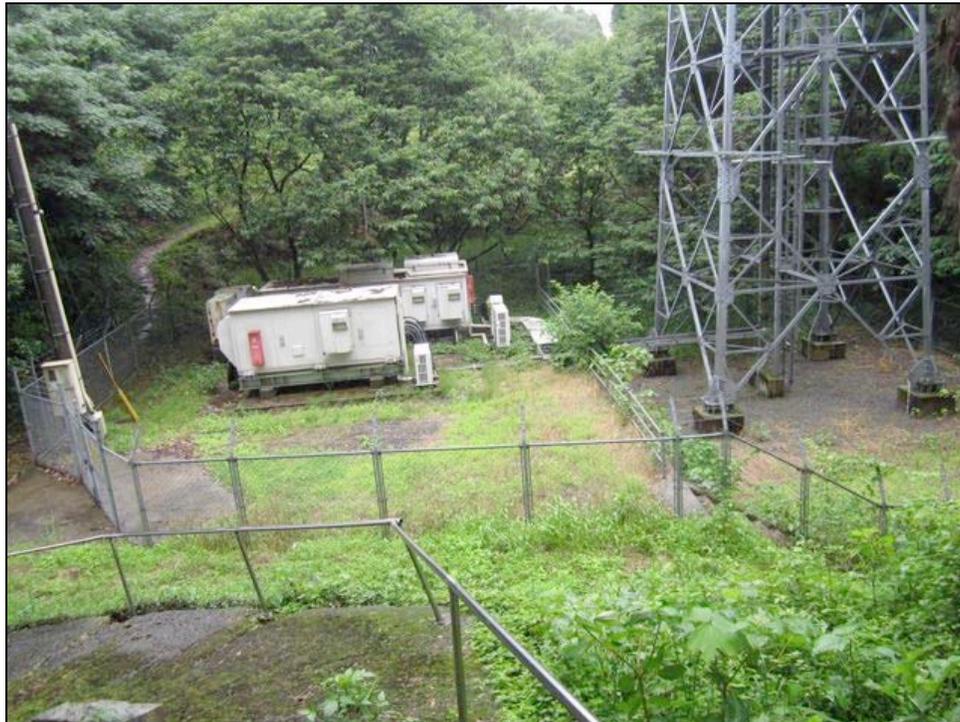
Figure 4-19. This aerial view of the cell site shows no visible damage on the outside of the huts and the tower footings

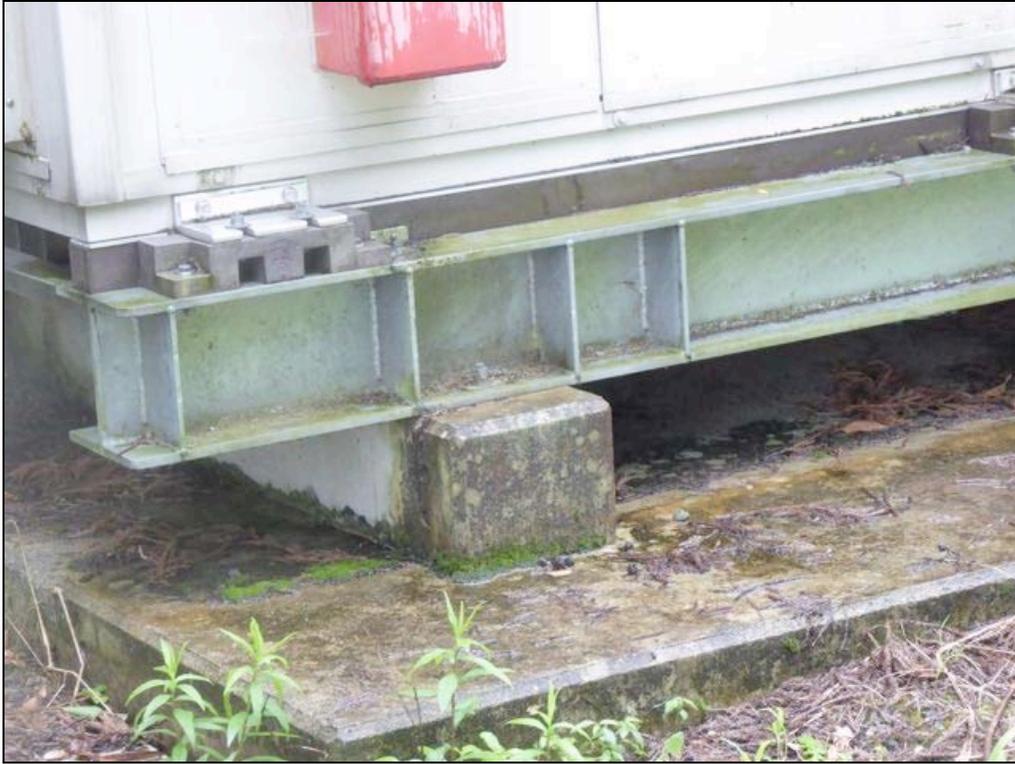
Figure 4-20. The equipment hut anchoring does not show any stress or deformation. The concrete pad was in good shape
