KUMAMOTO, KYUSHU, JAPAN, EARTHQUAKES OF M_w 6.0 April 14, 2016 M_w 7.0 April 16, 2016 LIFELINE PERFORMANCE

ALEX K TANG and JOHN M EIDINGER

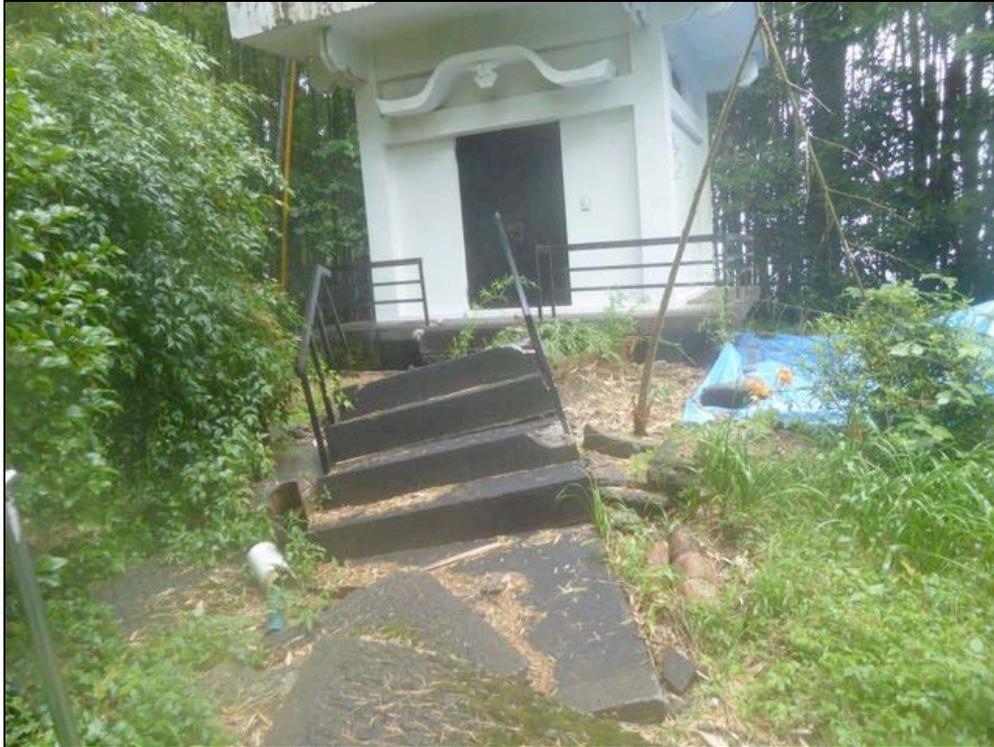
Figure 4-22. This concrete path with step to the small shrine sustained damage due to ground deformation. This shrine is about 10 meters above the cell site. The cell site aerial photo was taken from this point

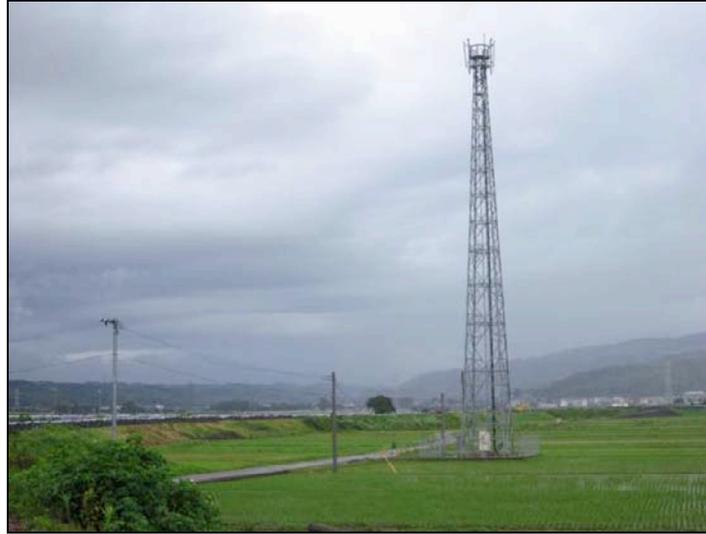
Figure 4-23. This cell site is in the middle of a large rice field. Note the height of the levee on the left of the cell site

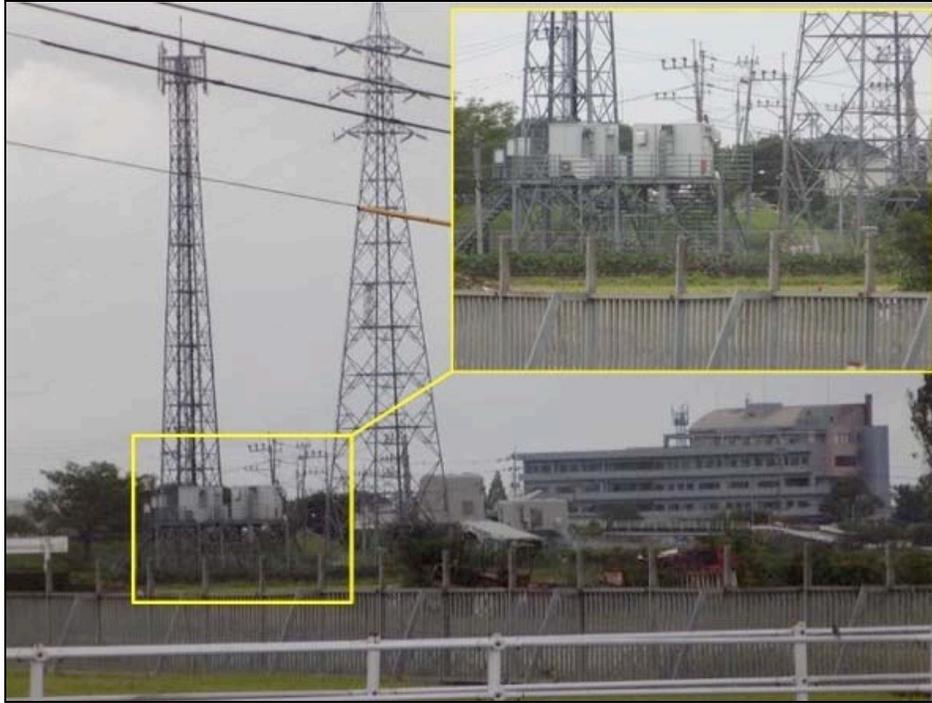
Figure 4-25. This cell site on the edge of the rice field is installed on a high steel platform. The equipment is installed with flood as one of the hazards

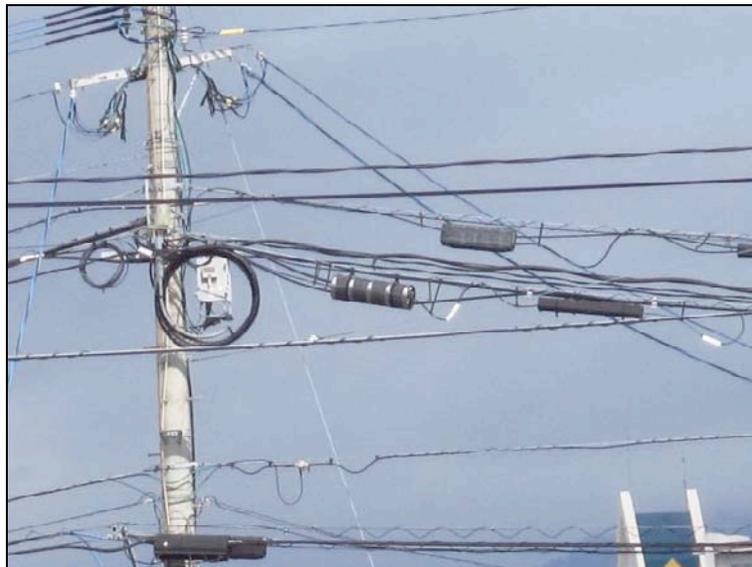
Figure 4-26. Aerial cable congestion on one pole

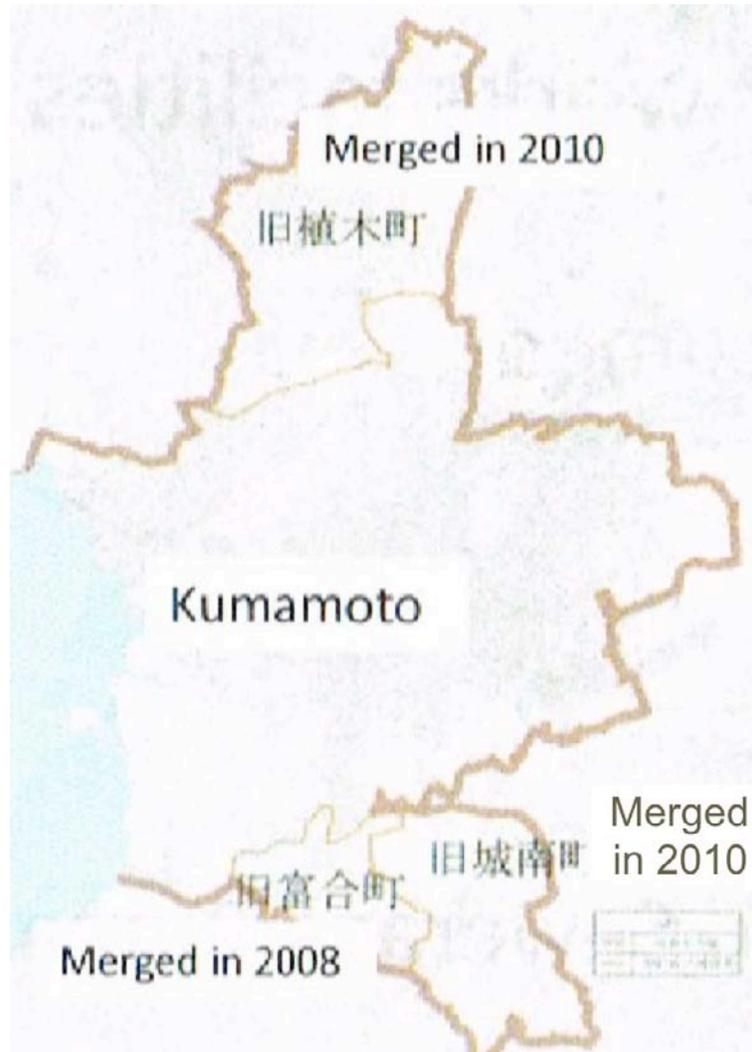
Figure 5-1. Kumamoto City Water System Service Area

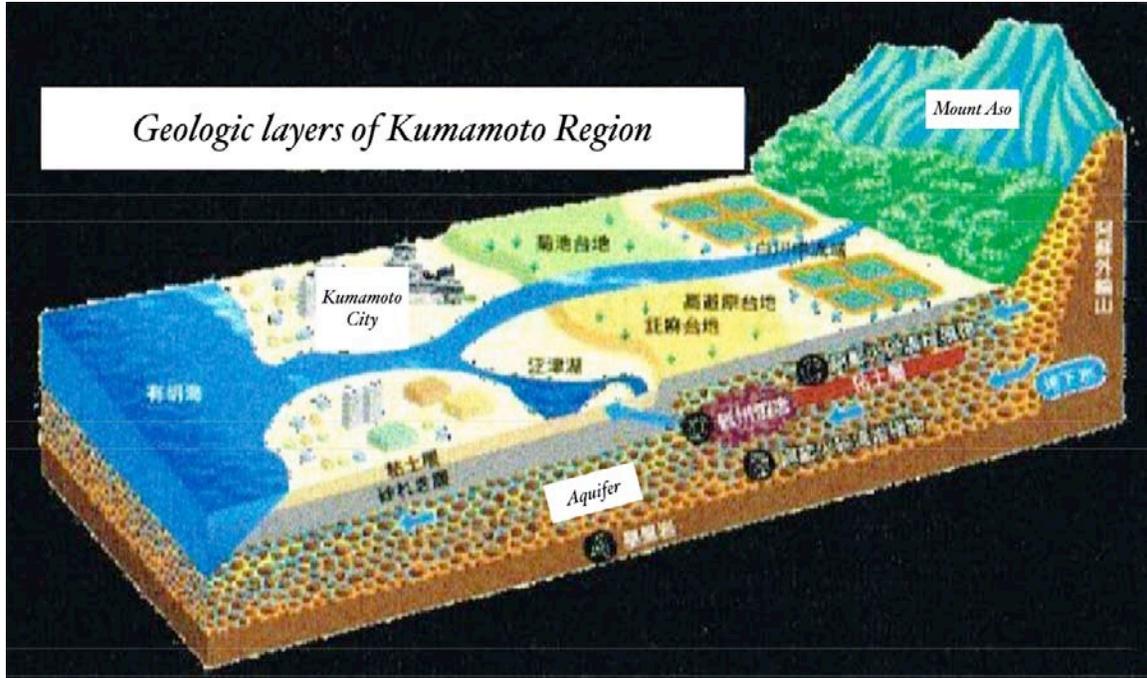
Figure 5-2. Kumamoto Region Geology

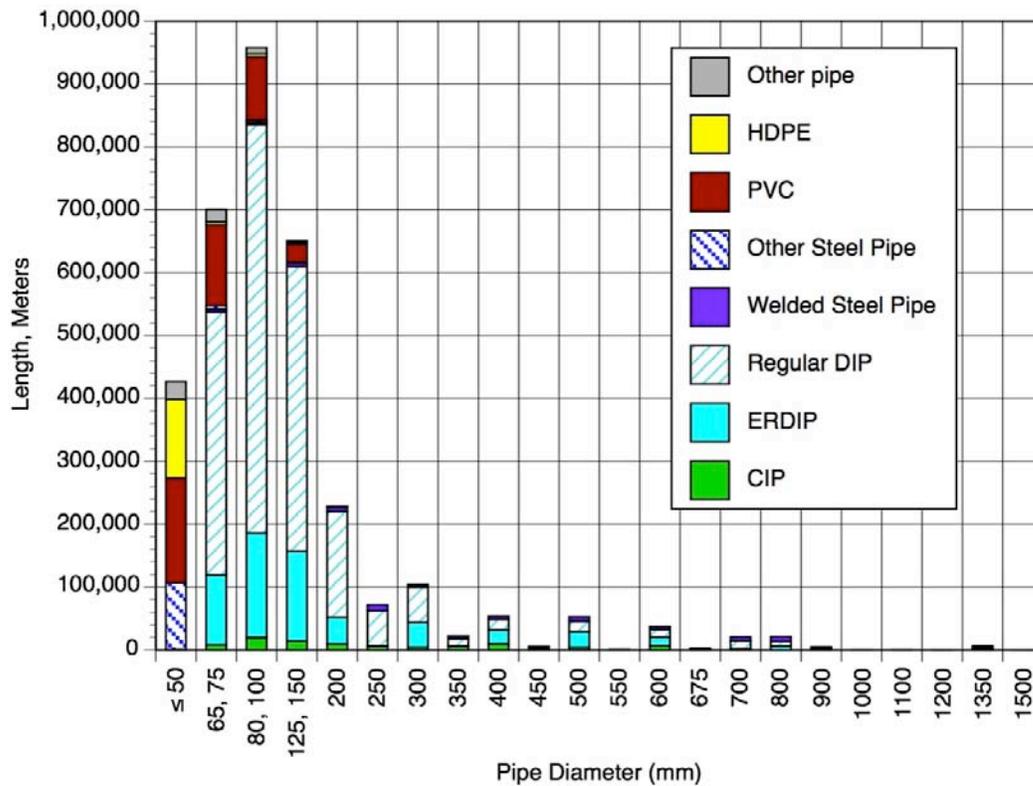
Figure 5-6. Pipe Length, by Material and Diameter (Kumamoto City)

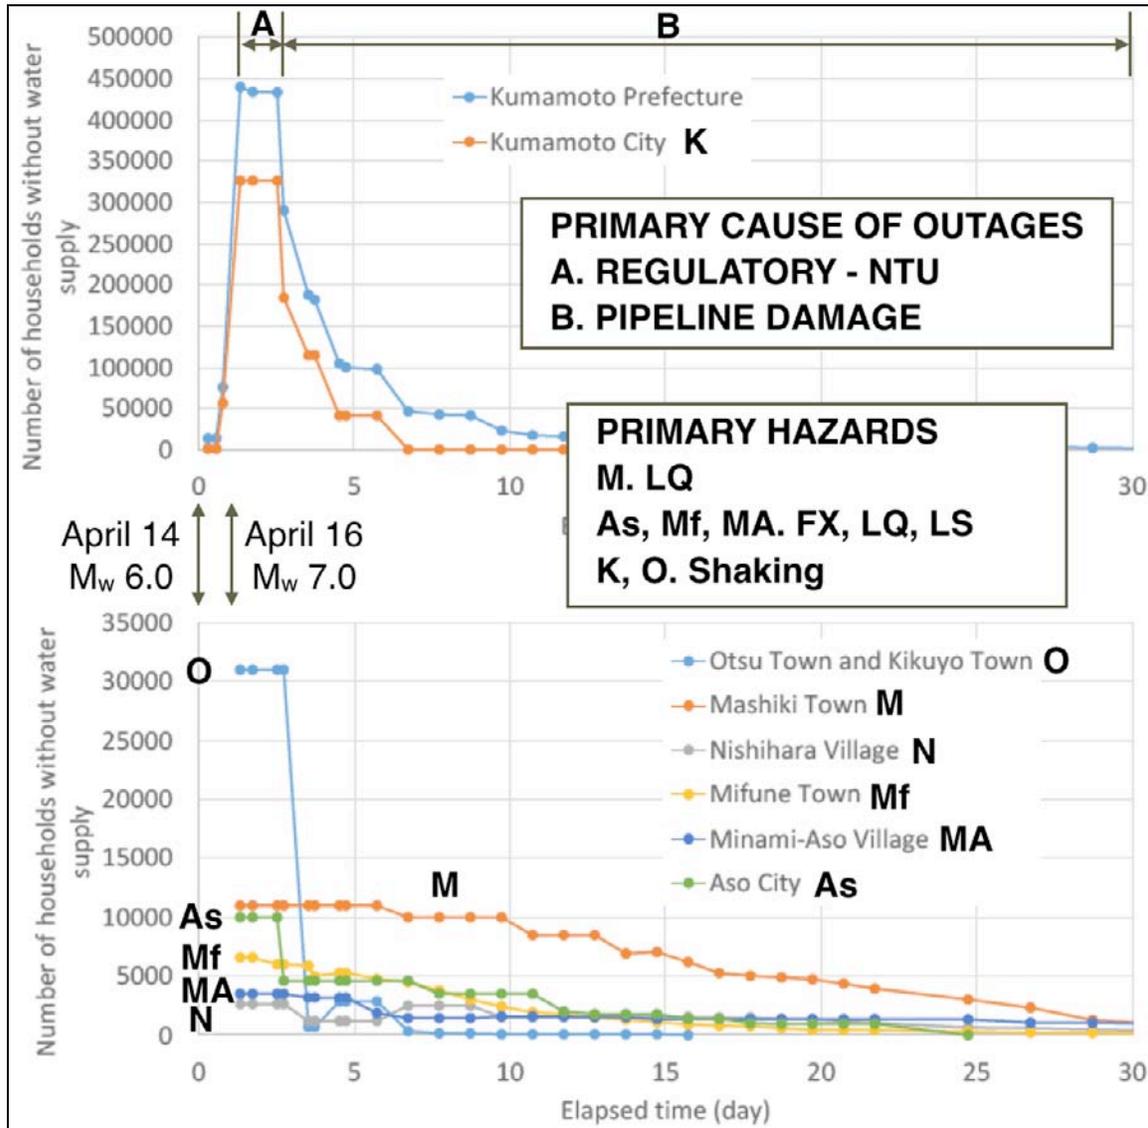
Figure 5-9. Water Outages (courtesy Maruyama)

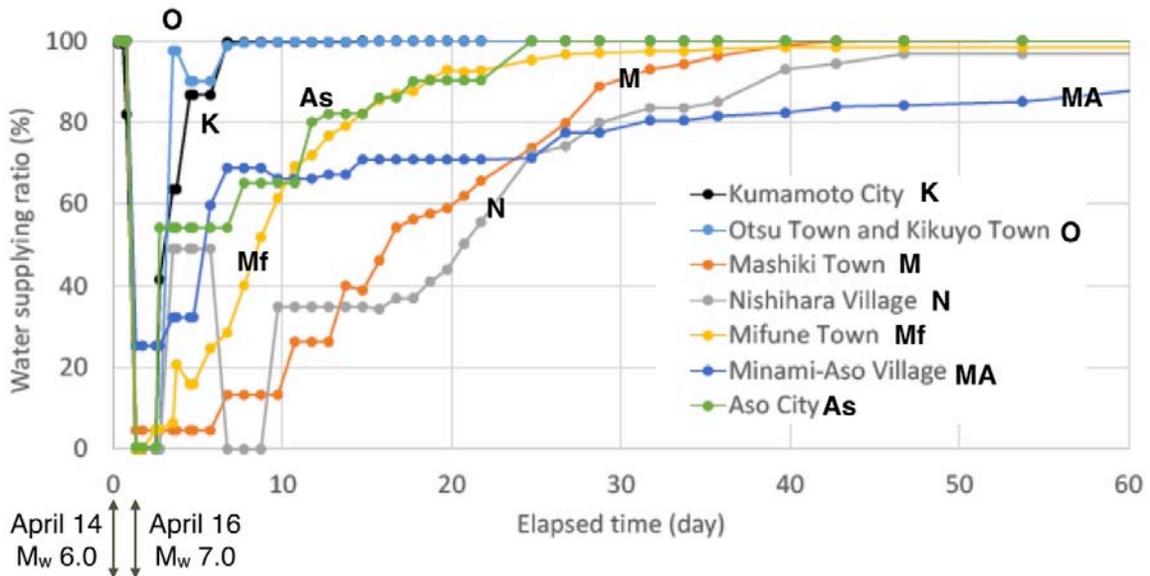
Figure 5-10. Percentage of Households with Water. Smaller towns had a much higher ratio of PGDs as compared to Kumamoto City (courtesy Maruyama)

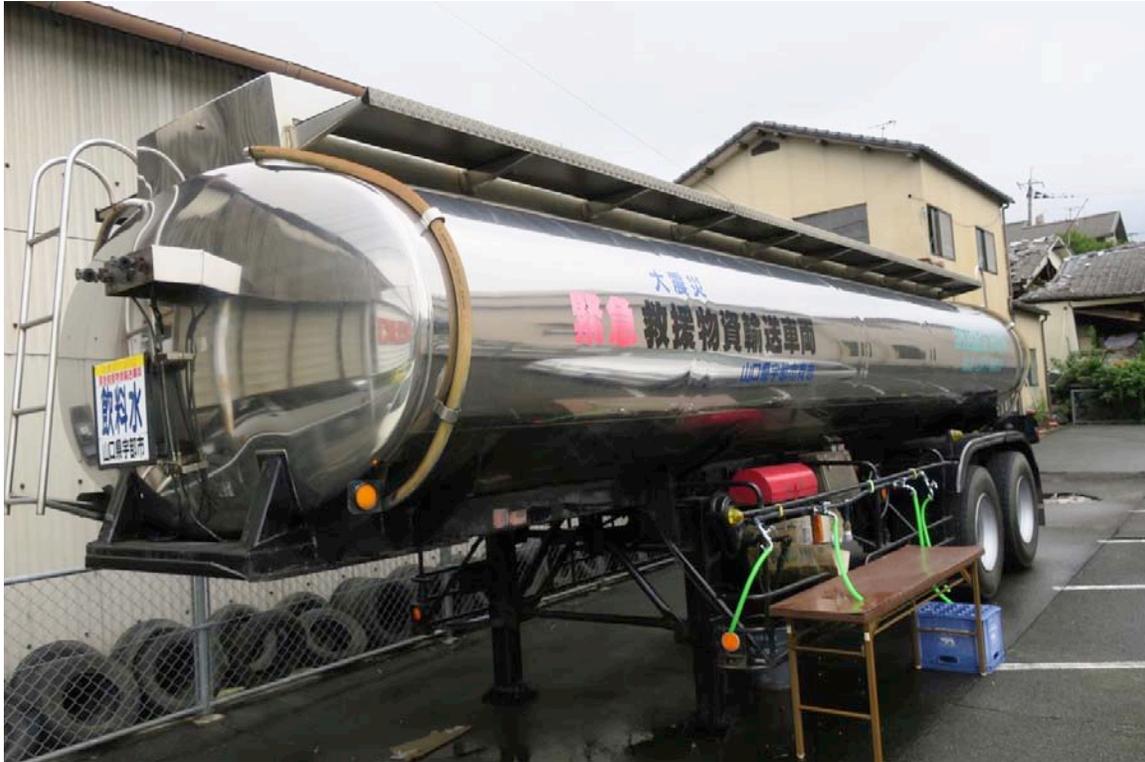
Figure 5-12. Water tank car in Mashiki Town, July 4 2016

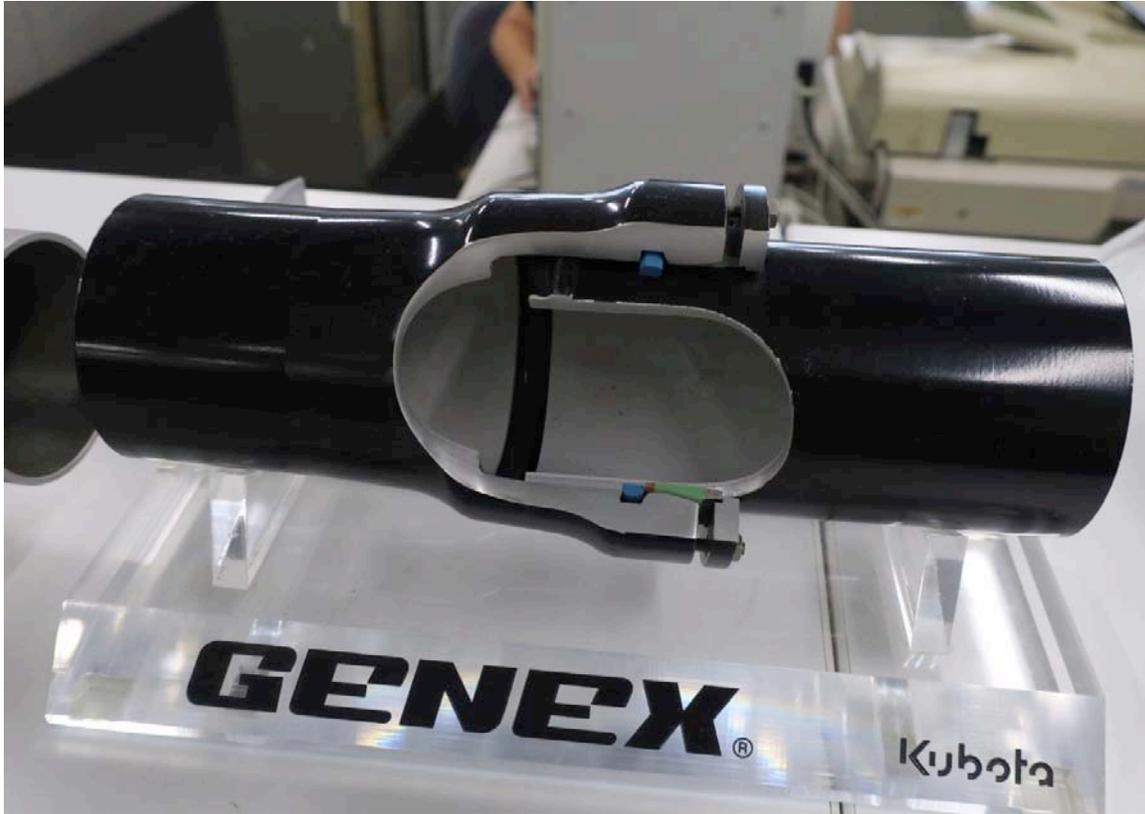
Figure 5-13. Kubota Chained Seismic Resistant Ductile Iron Pipe

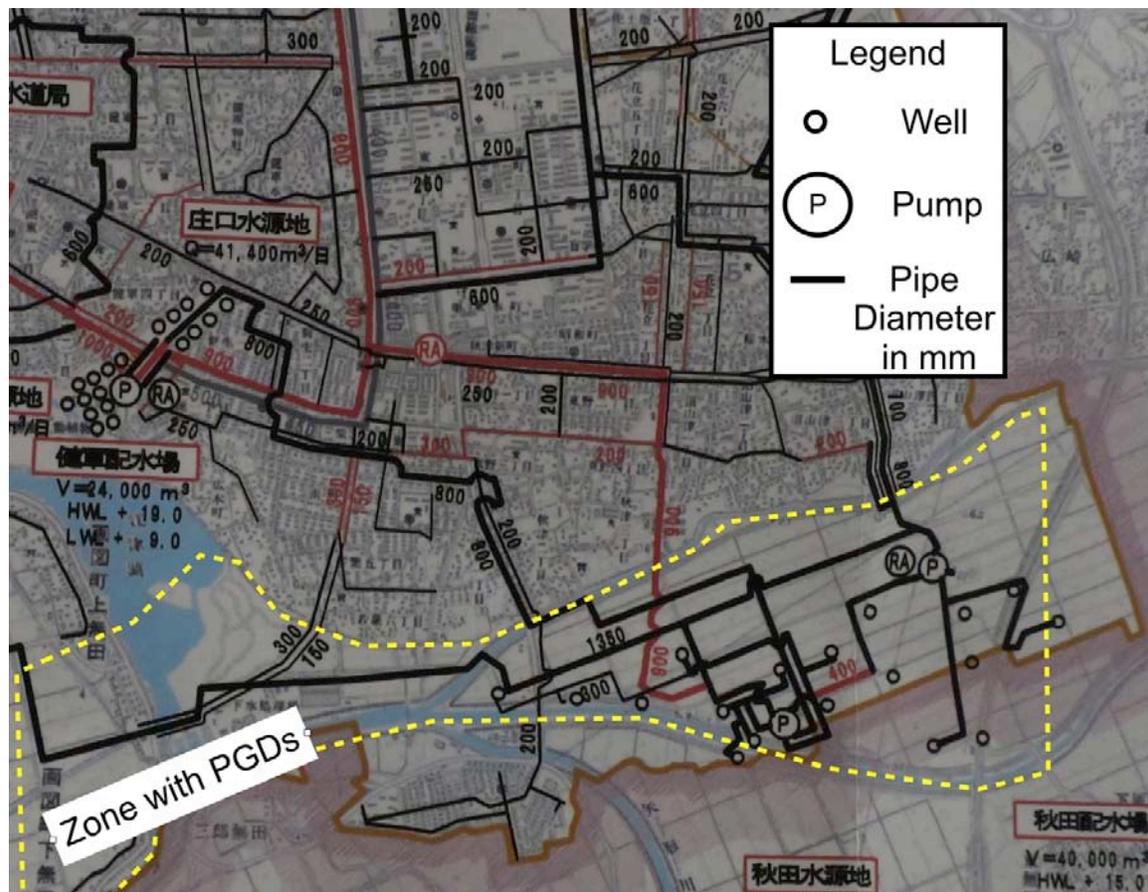
Figure 5-15. PGD Zone in southern Kumamoto City water system

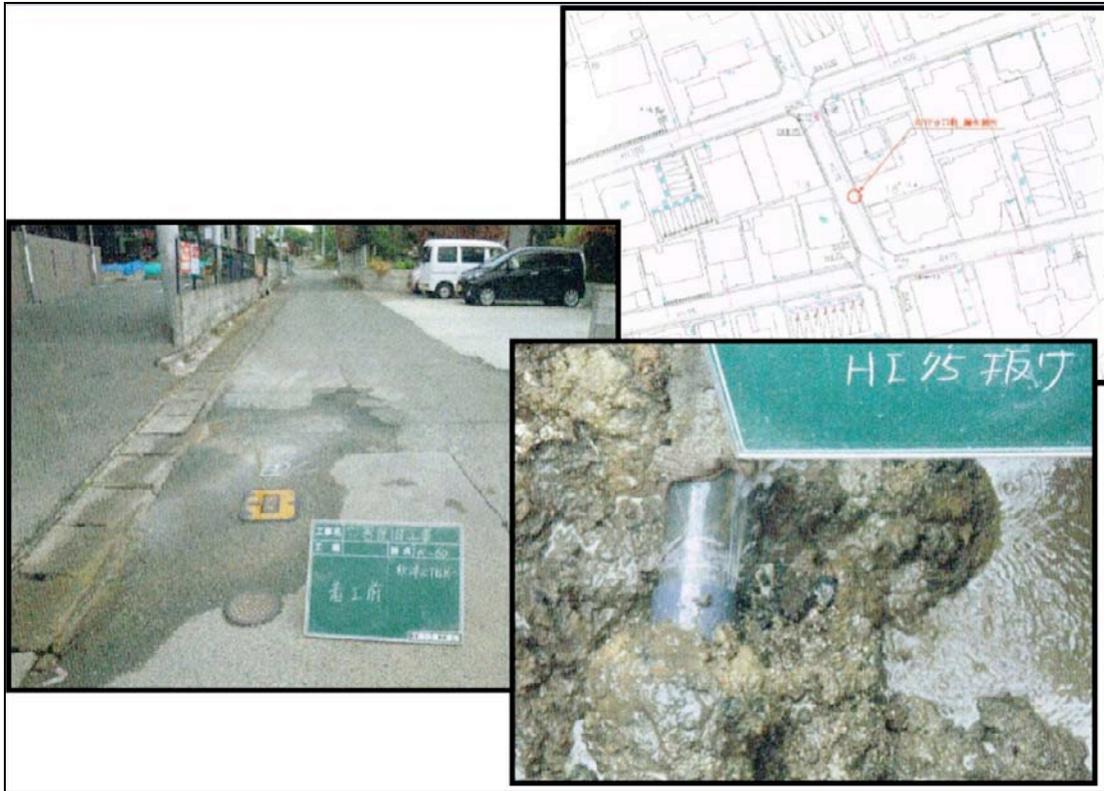
Figure 5-16. Leak of 3-inch High Impact PVC (HIVP) Pipe, near Nichome Akitsu

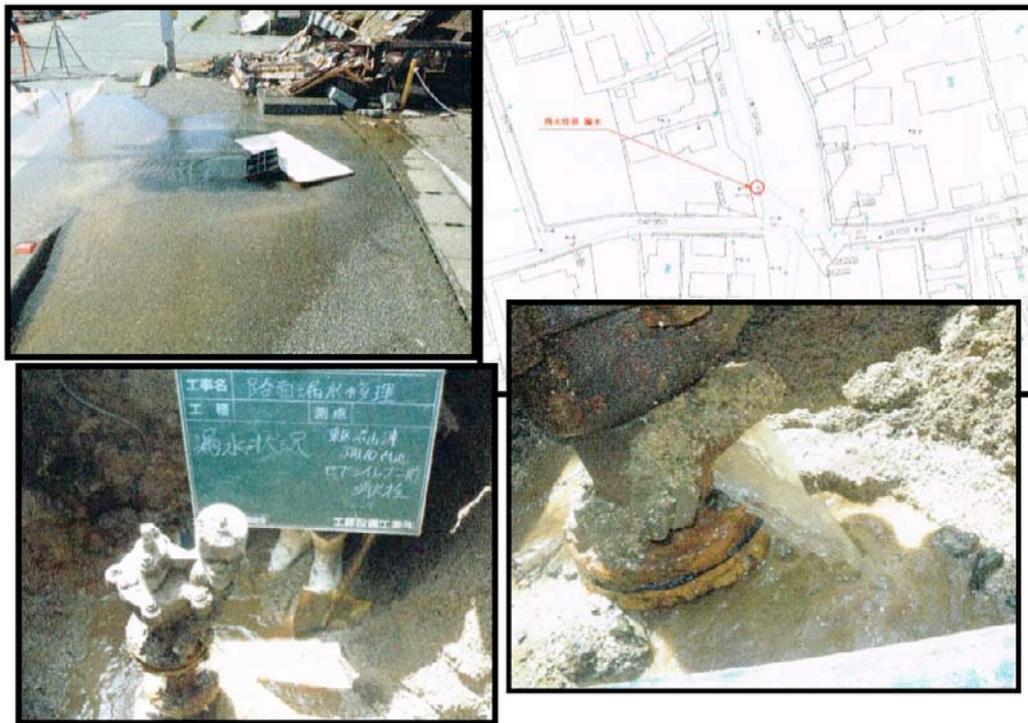
Figure 5-17. Leak of 150 X 75 mm (6x3-inch) fire hydrant, near Sanchome Numayamazu

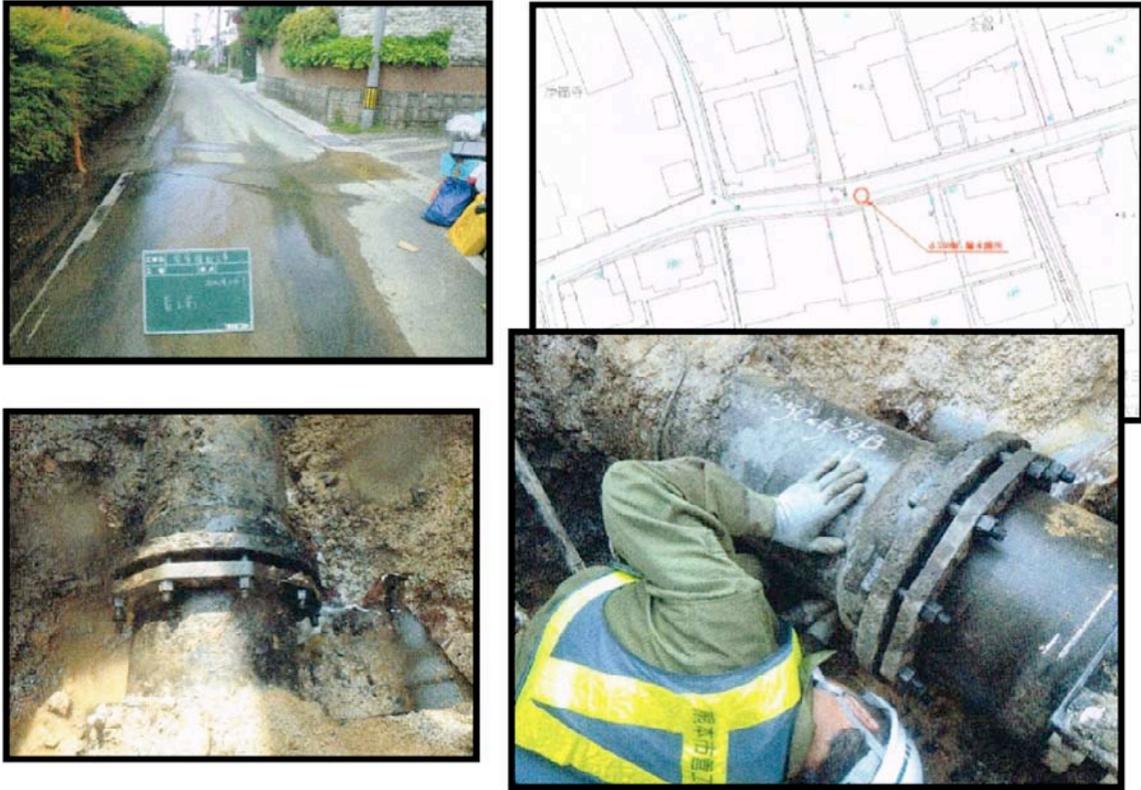
Figure 5-18. Leak of 350 mm (14-inch) cast iron pipe, near Sanchome Numayamazu

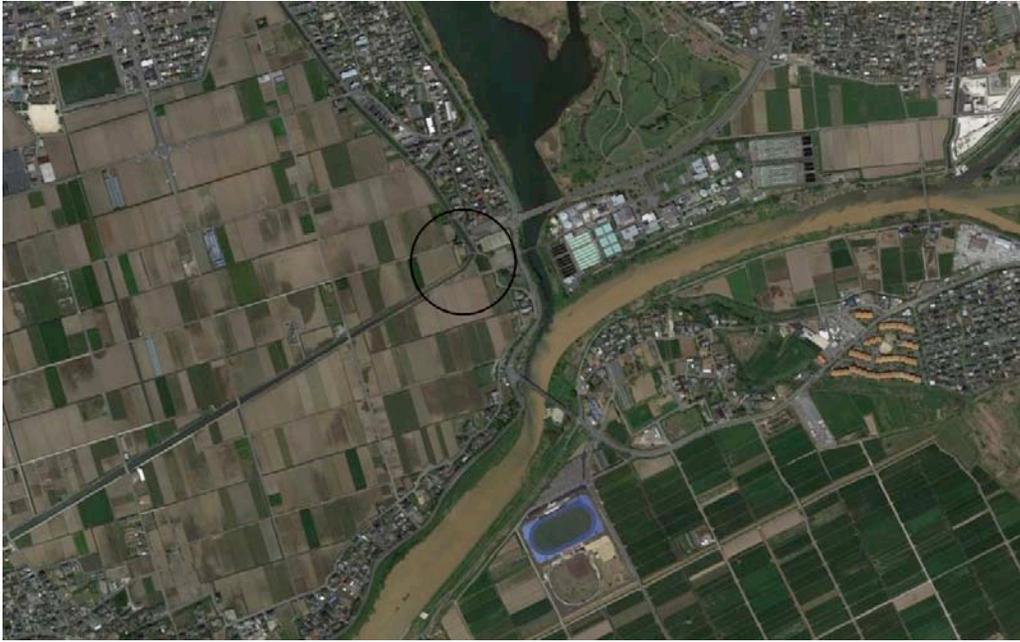
Figure 5-19. Location of 1350 mm Steel Pipe Repair near Ezumachishimomuta

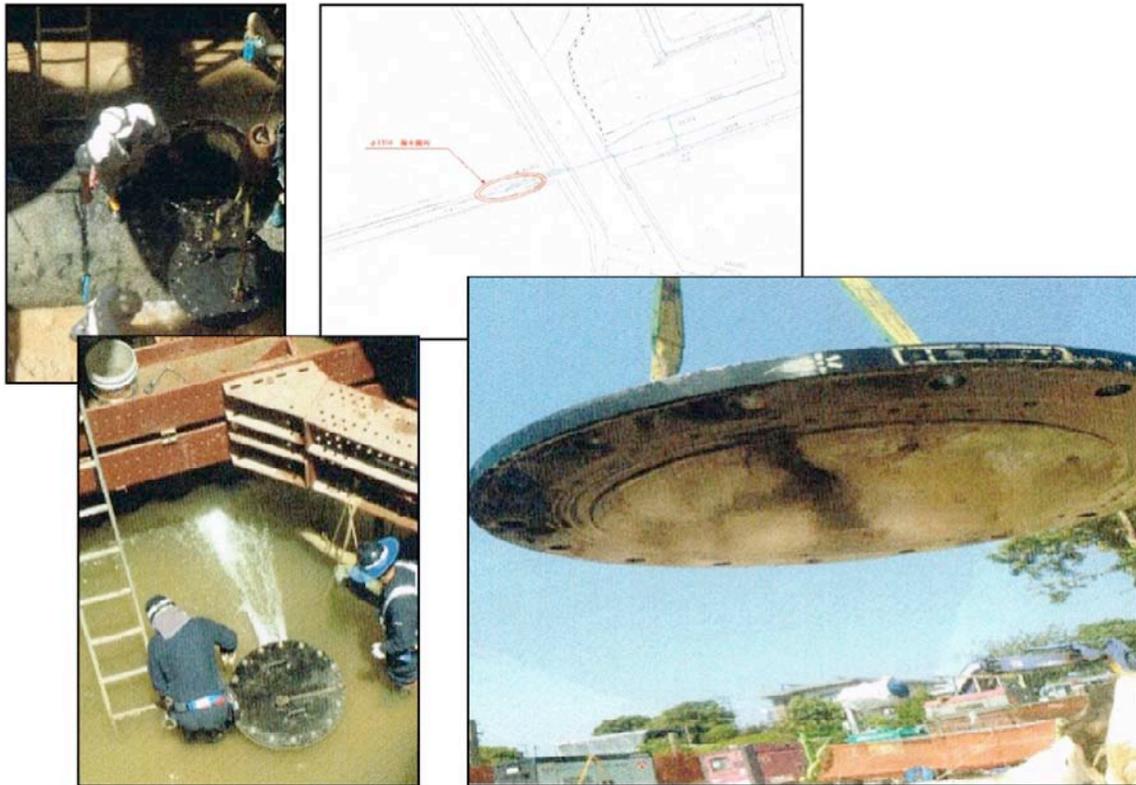
Figure 5-20. Excavation of 1350 mm Steel Pipe. Flange is bent and leaking

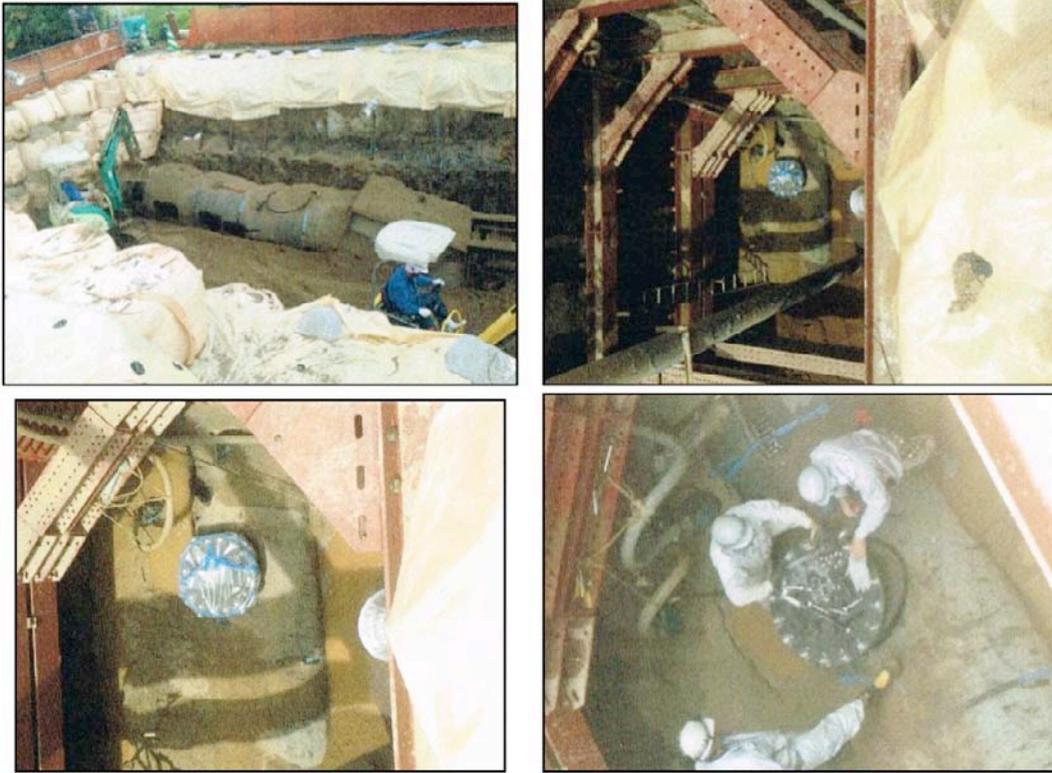
Figure 5-21. Repair of 1350 mm Steel Pipe

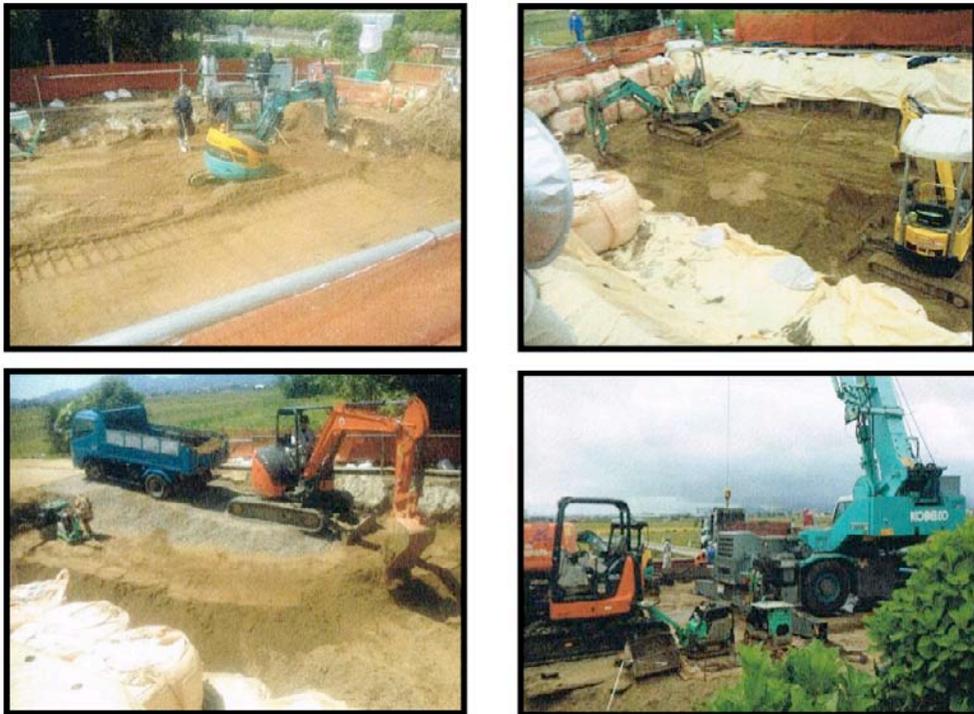
Figure 5-22. Completing Repair of 1350 mm Steel Pipe

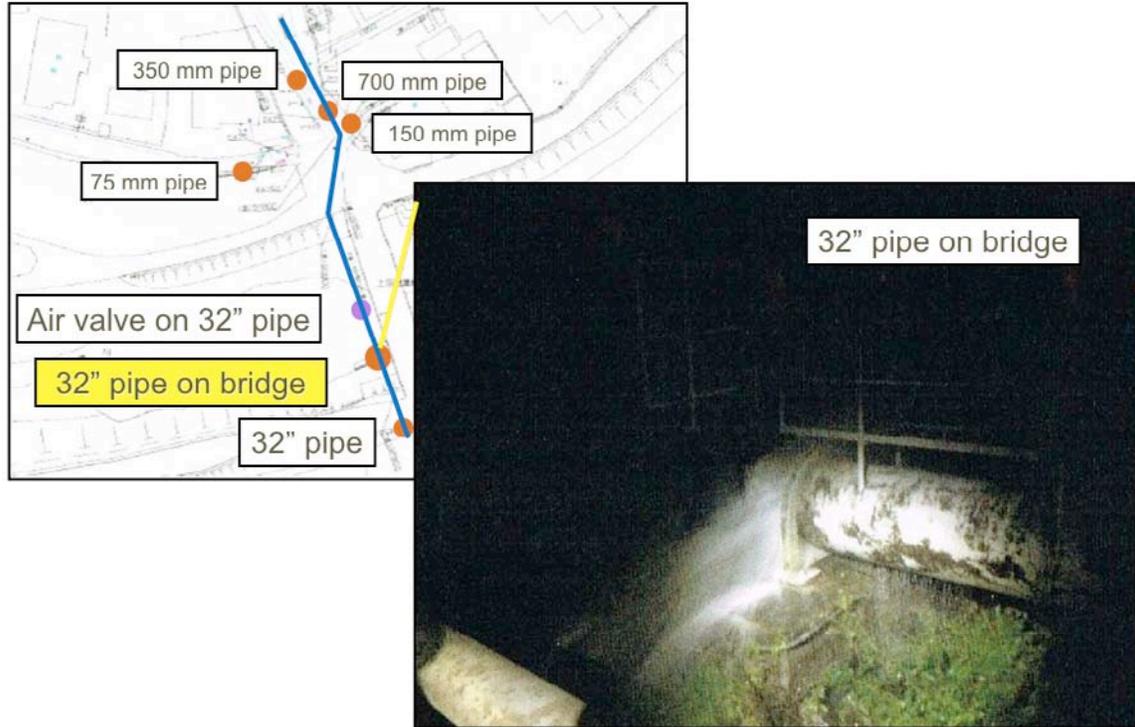
Figure 5-23. Repair of 32-inch steel pipe on bridge

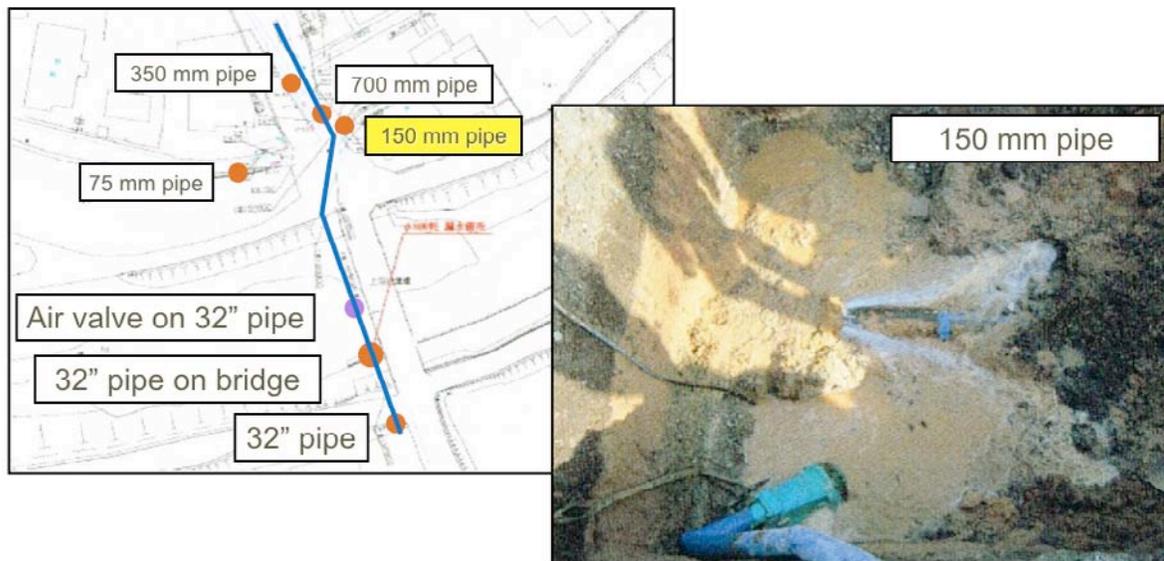
Figure 5-24. Repair of 150-mm ductile iron pipe (K-type joint)

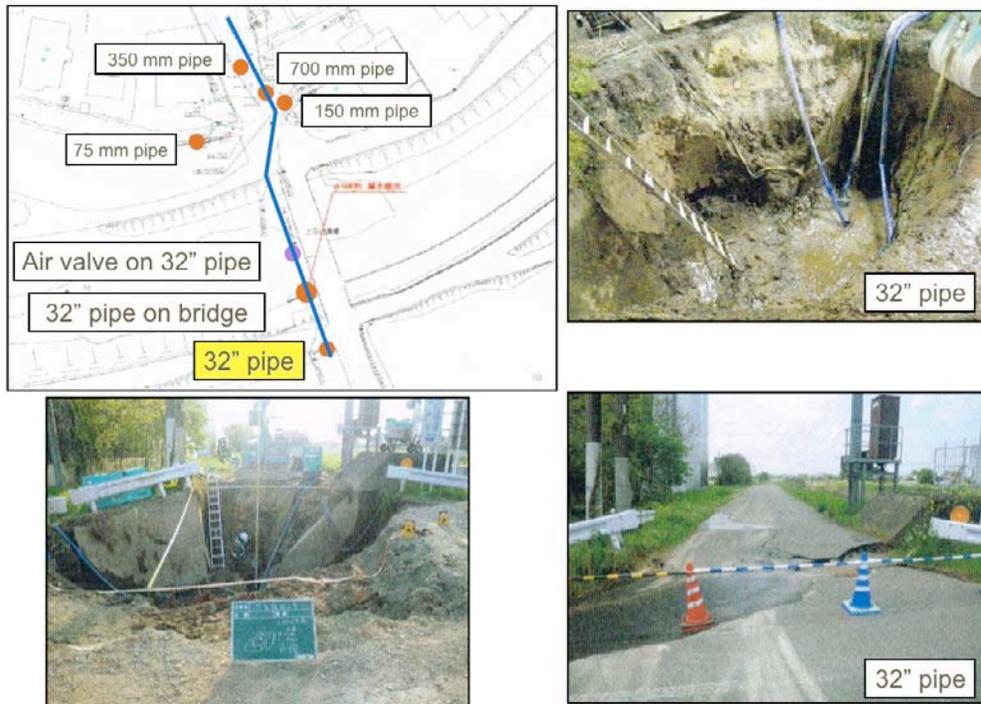
Figure 5-25. Repair of 800-mm steel pipe south of the bridge

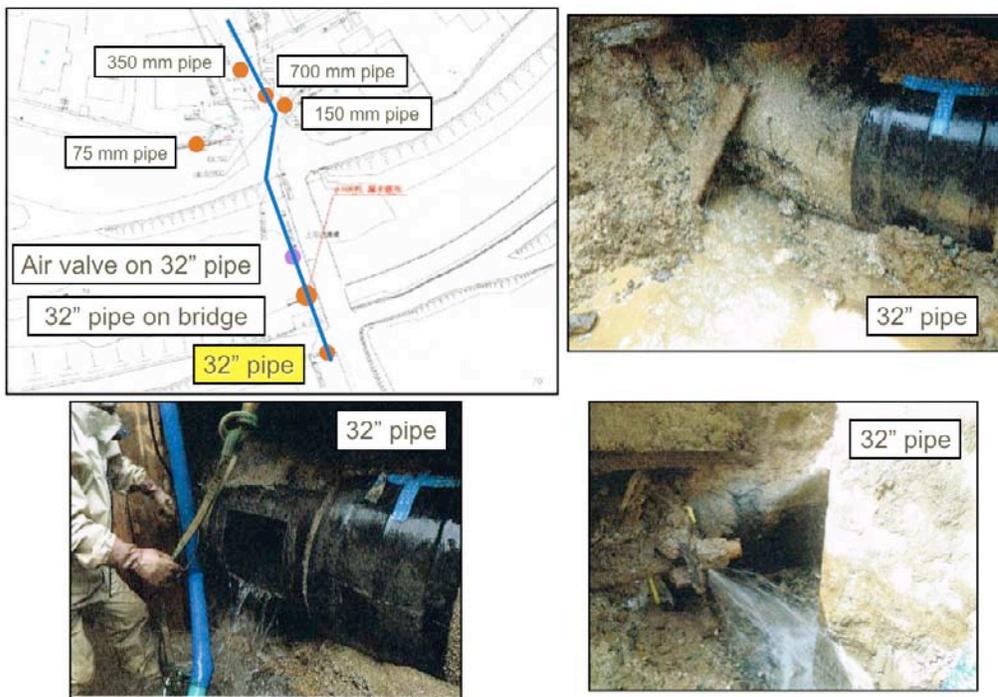
Figure 5-26. Repair of 800-mm steel pipe south of the bridge

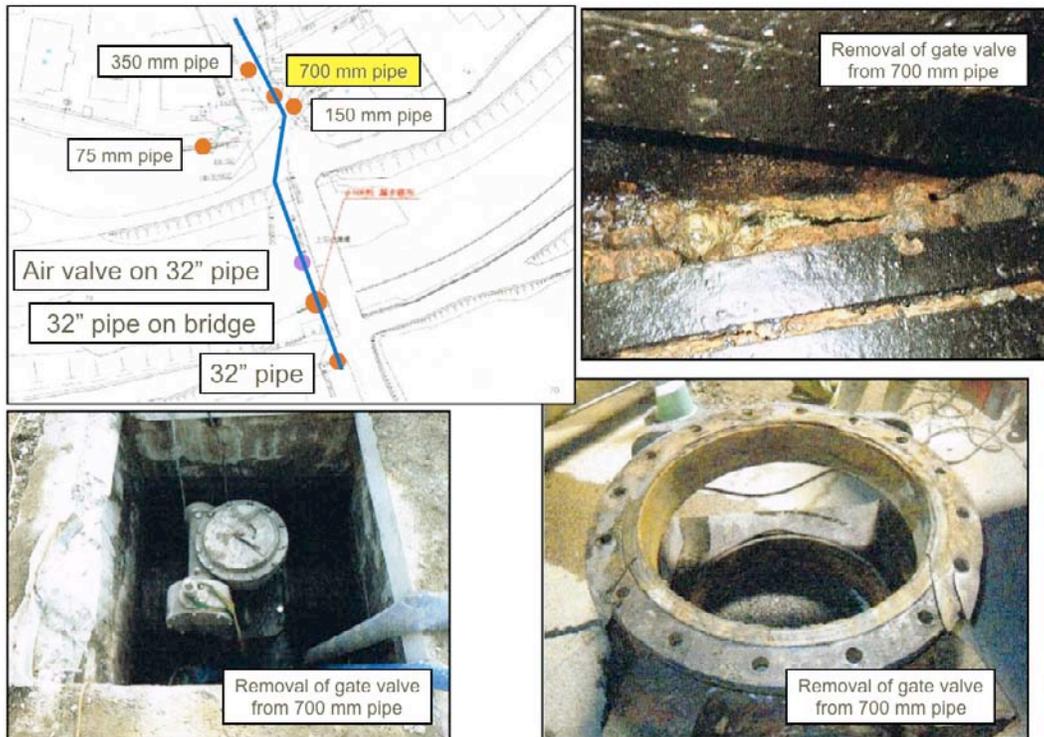
Figure 5-27. Repair of 700-mm steel pipe north of the bridge

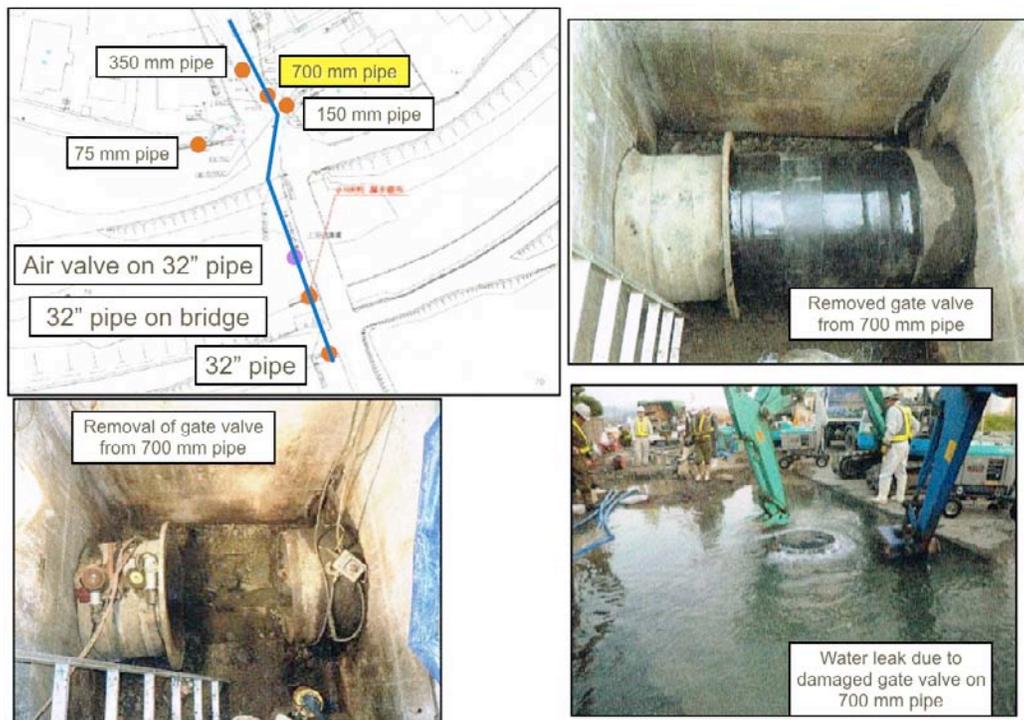
Figure 5-28. Repair of 700-mm steel pipe north of the bridge

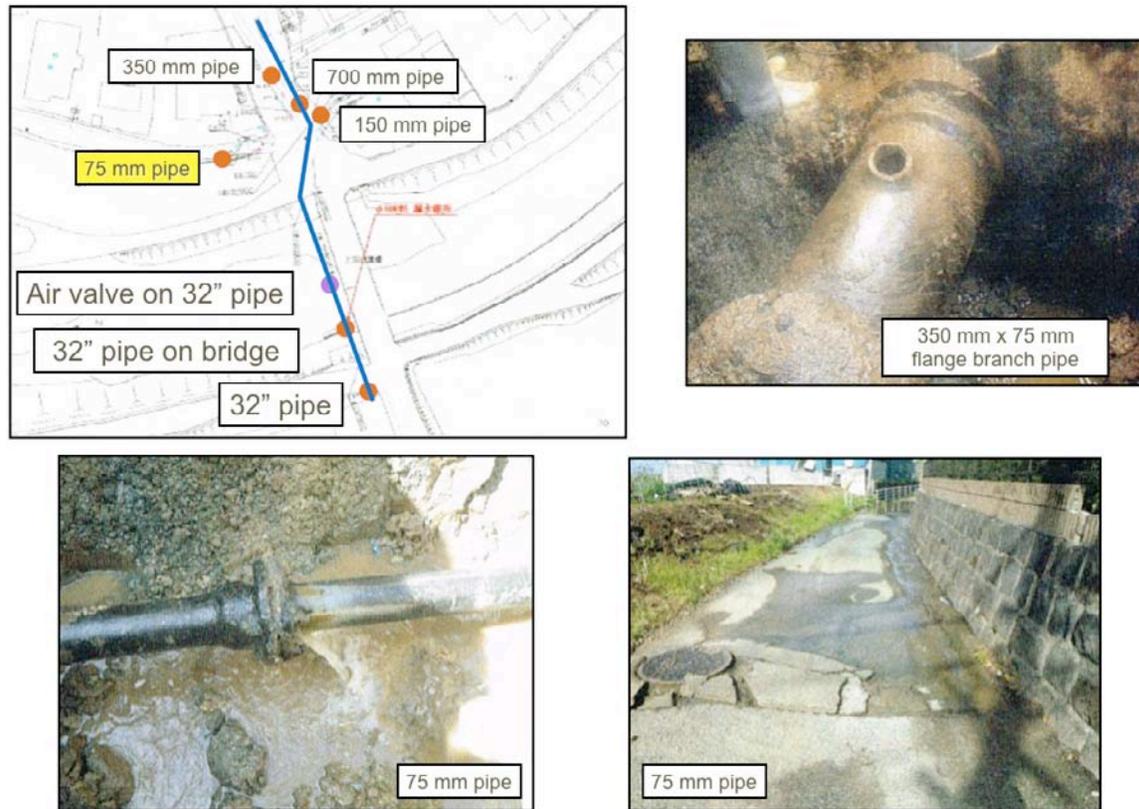
Figure 5-29. Repair of 75-mm DI pipe north of the bridge

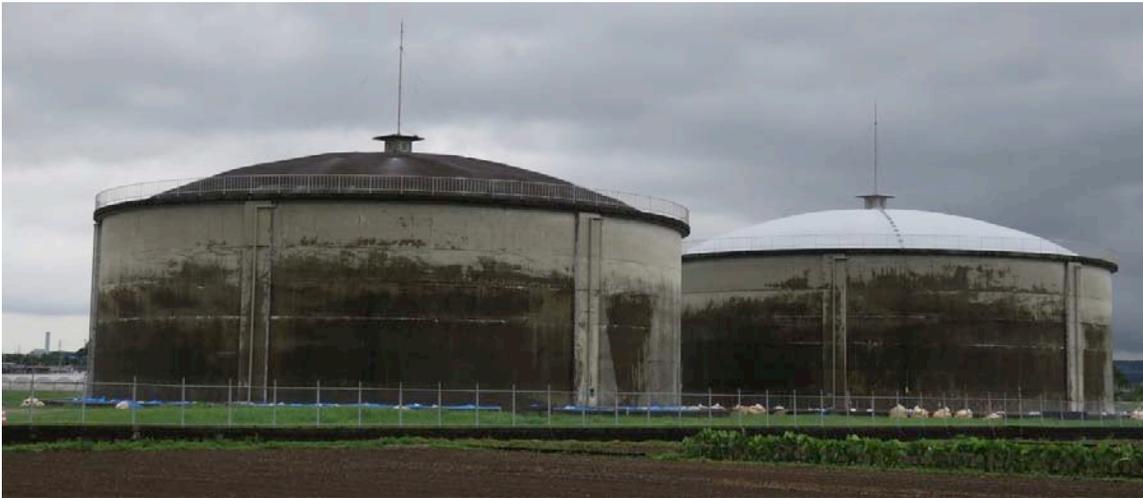
Figure 5-30. Two Pile-Supported Concrete Tanks

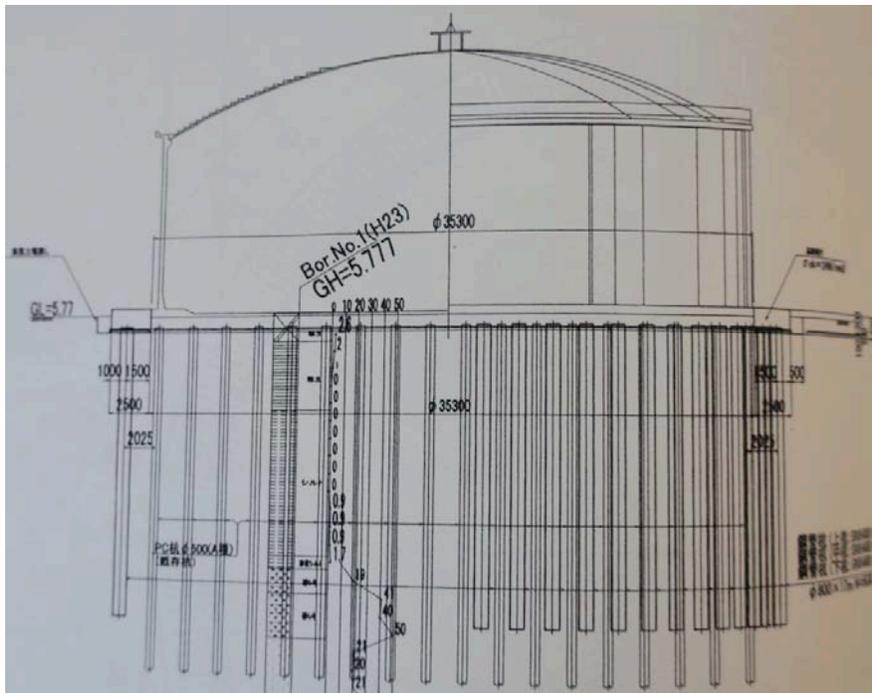
Figure 5-31. Piers and External Seismic Piers for Tanks in Figure 5-30

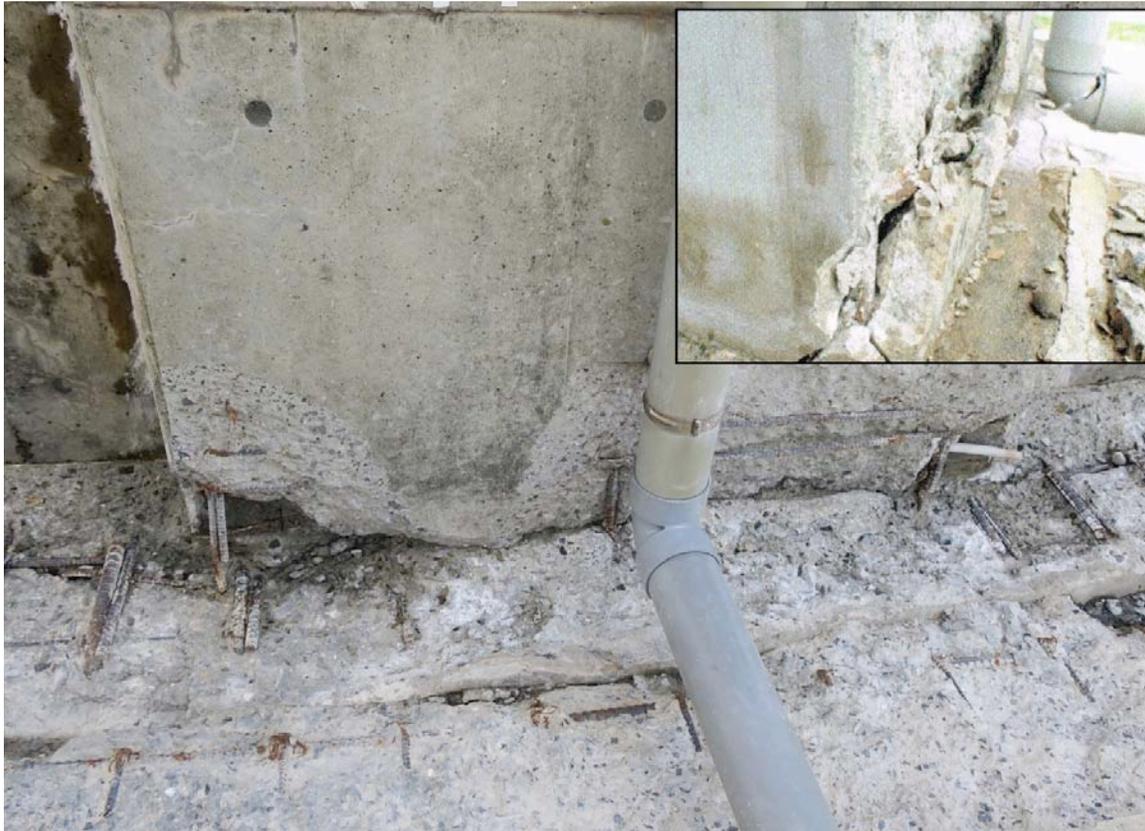
Figure 5-32. Damaged Tendon Anchor Point, with Gross Spalling
