KUMAMOTO, KYUSHU, JAPAN, EARTHQUAKES OF M_w 6.0 April 14, 2016 M_w 7.0 April 16, 2016 LIFELINE PERFORMANCE

ALEX K TANG and JOHN M EIDINGER

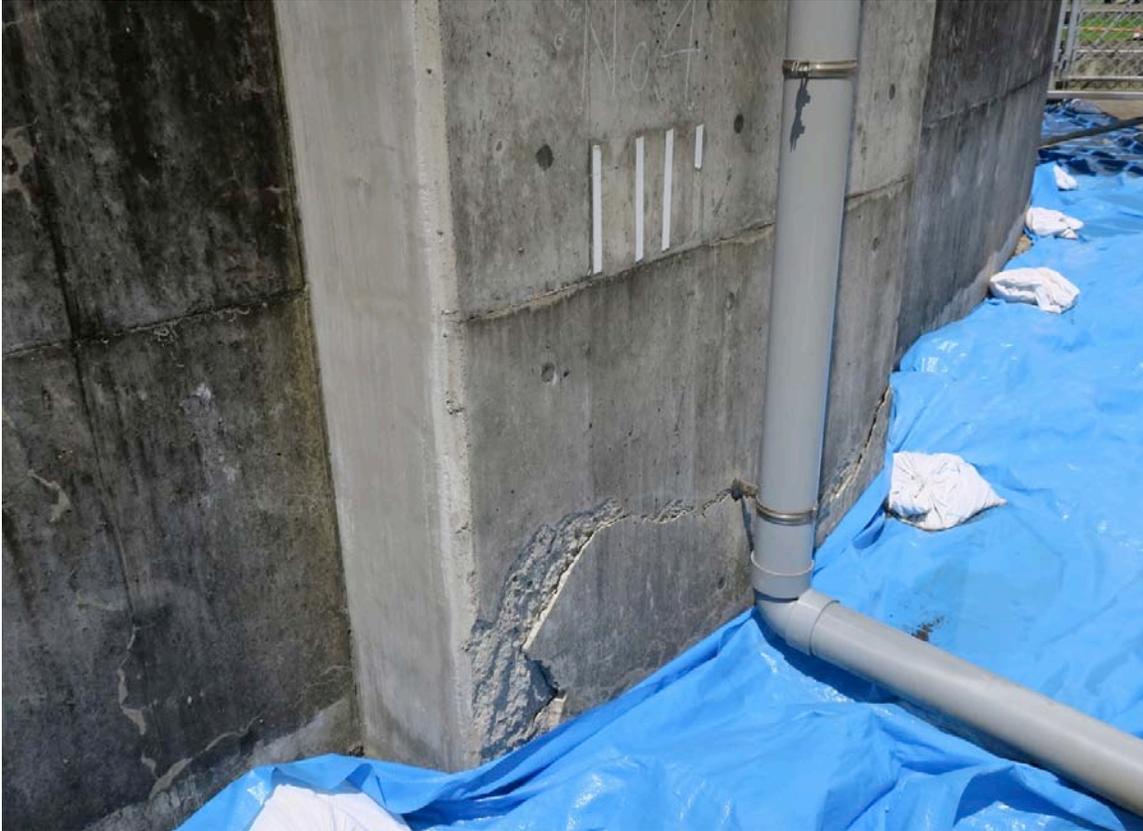
Figure 5-33. Damaged Tendon Anchor Point, with Incipient Spalling

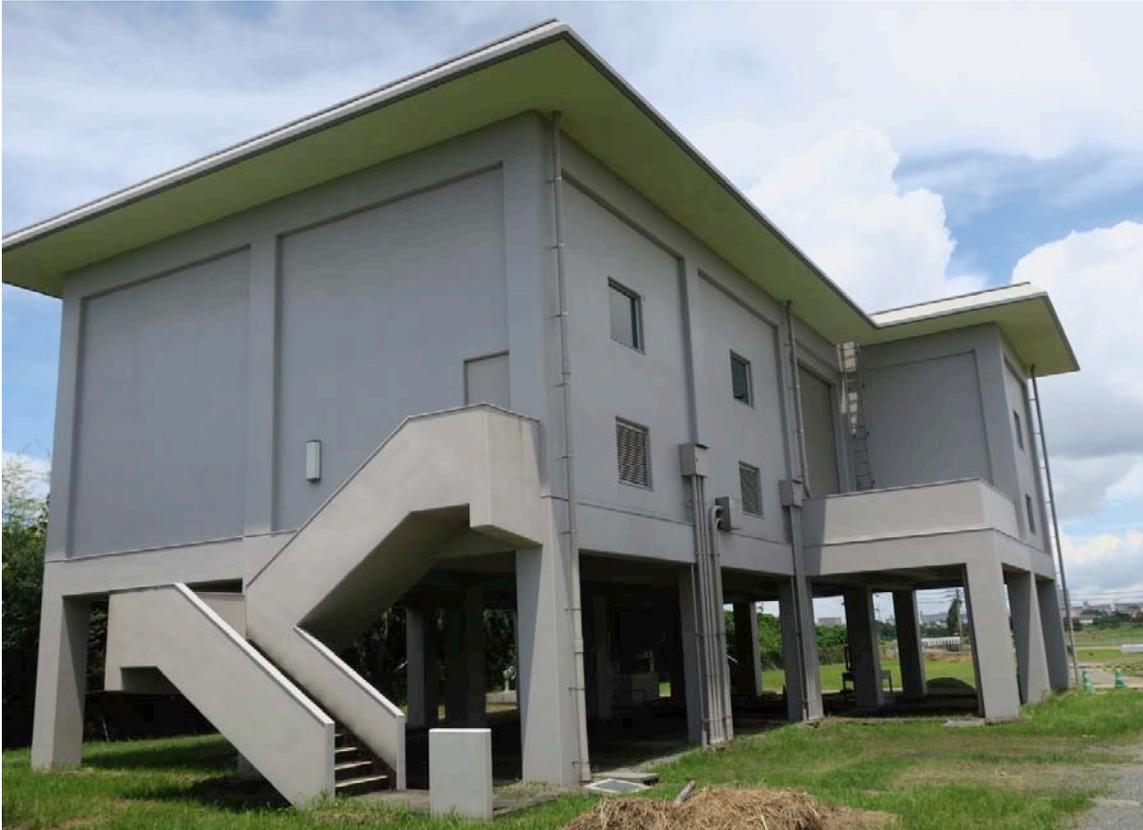
Figure 5-34. Pump Station Building

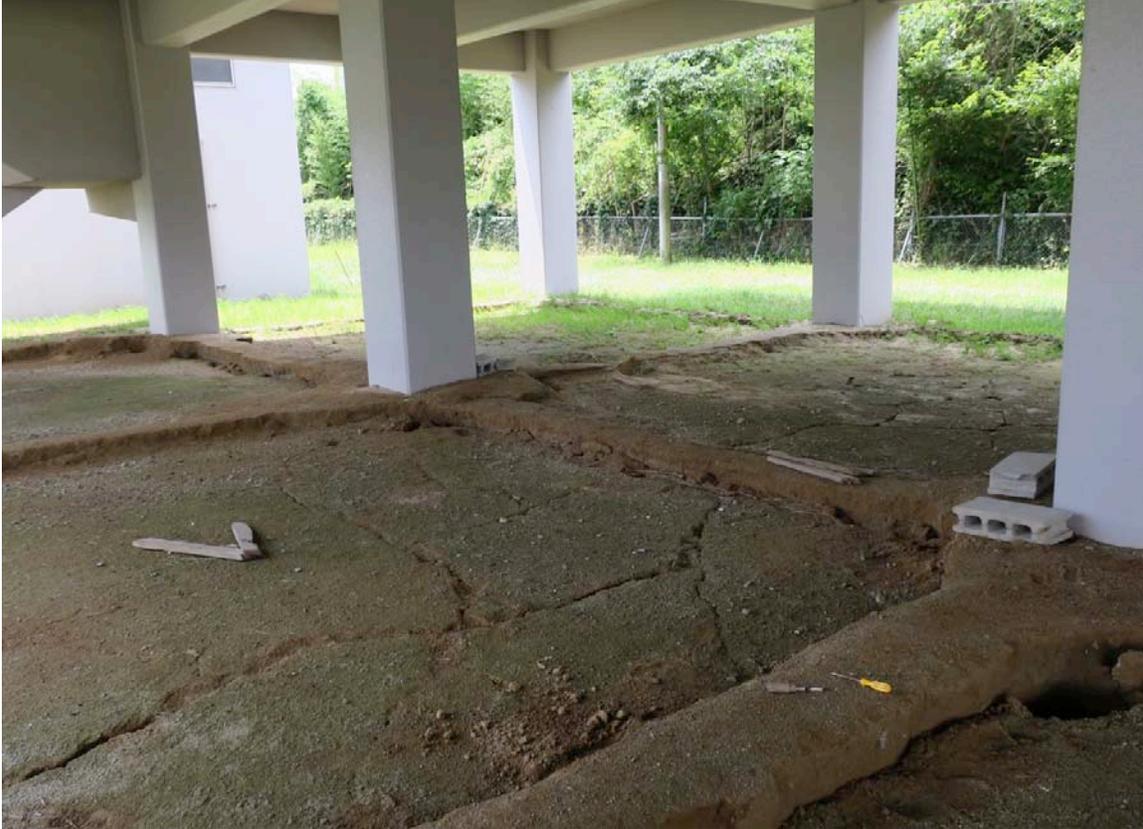
Figure 5-35. Pump Station Building Soil Settlement

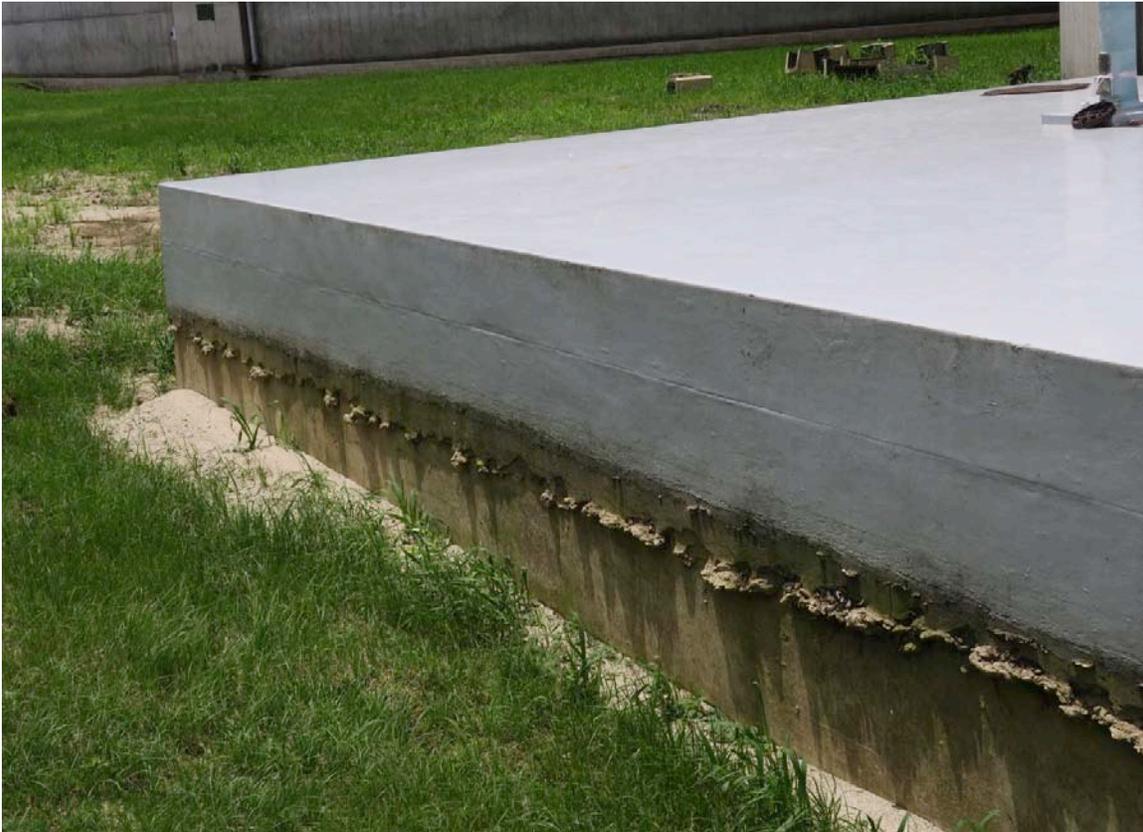
Figure 5-36. Buried Vault Soil Settlement

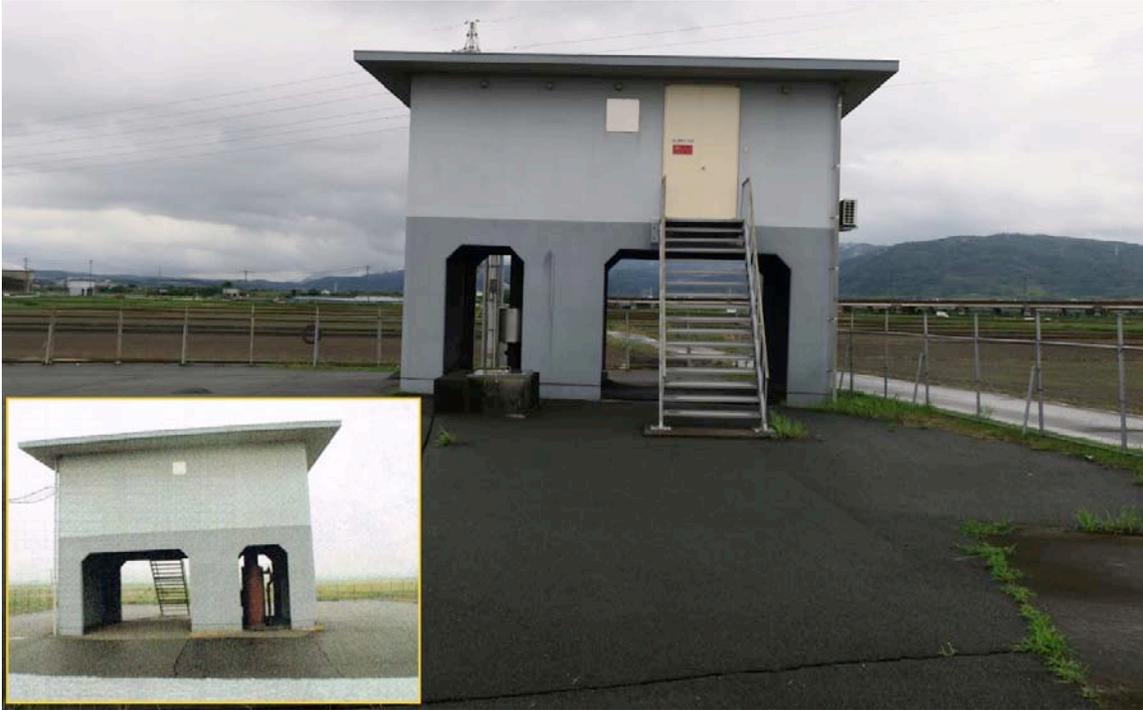
Figure 5-37. Numayamazu Well No. 8

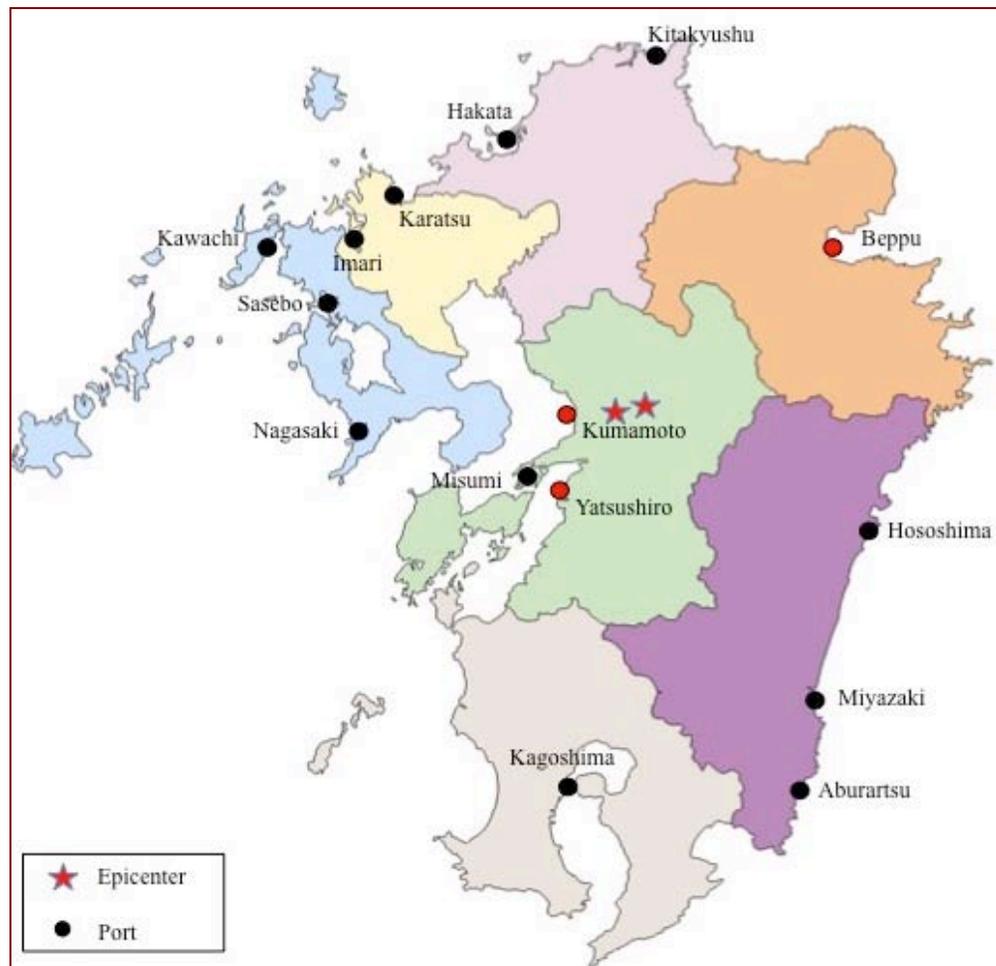
Figure 6-1. Location of Kyushu Ports, the Red Dots are the ports sustained minor earthquake damage to access roads.

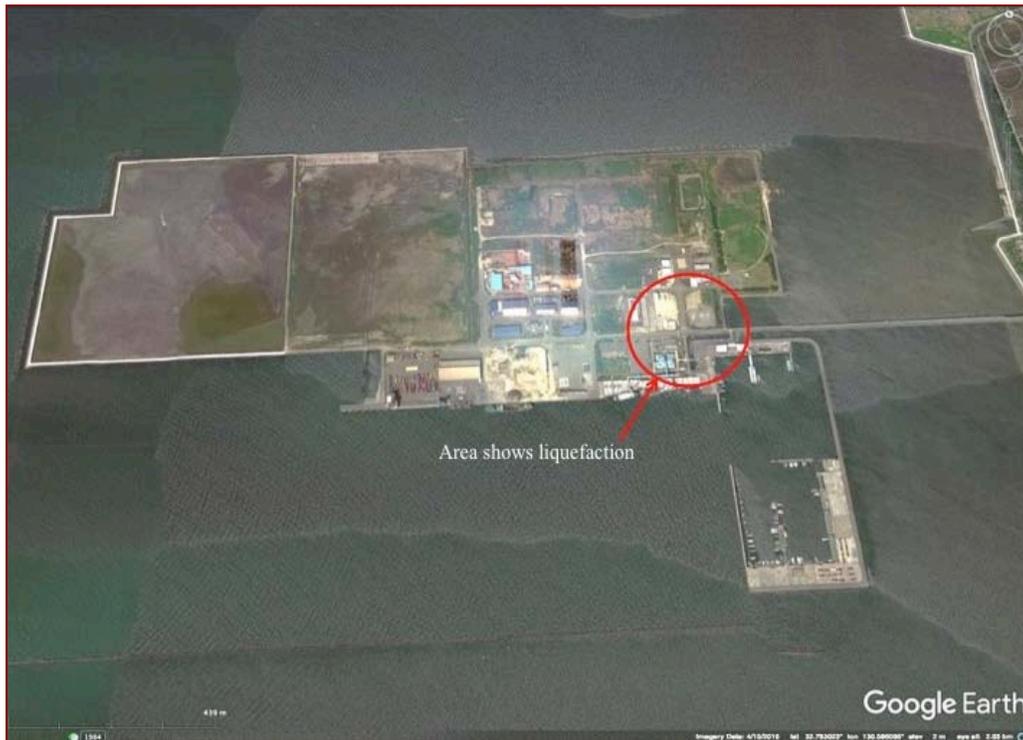
Figure 6-2. Aerial view of the Kumamoto Port (Source: Google Earth)

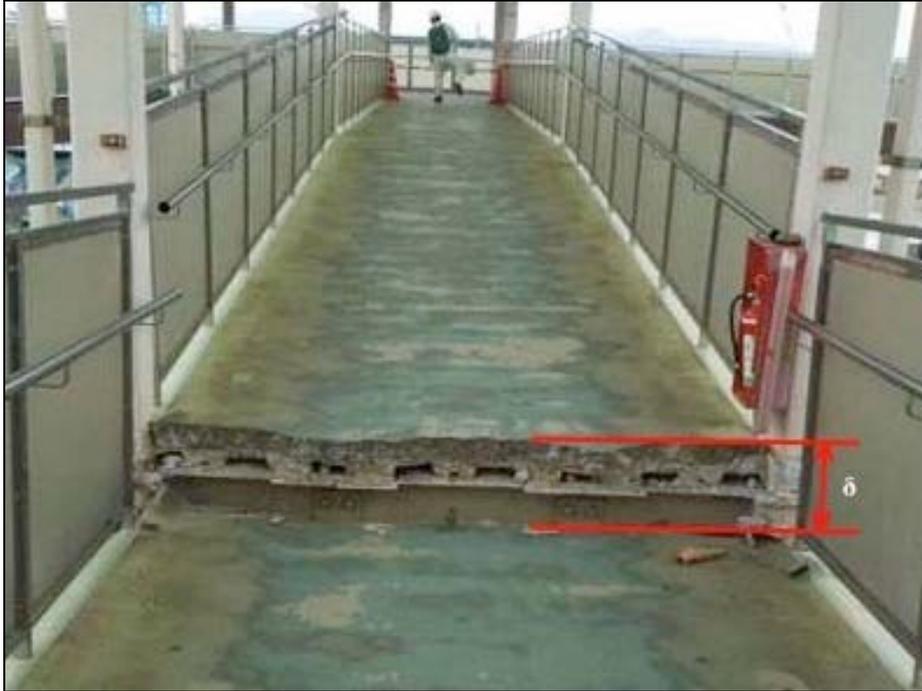
Figure 6-3. Bridge misaligned – Kumamoto Port (Source: Kumamoto Prefecture, Civil Engineering Department)

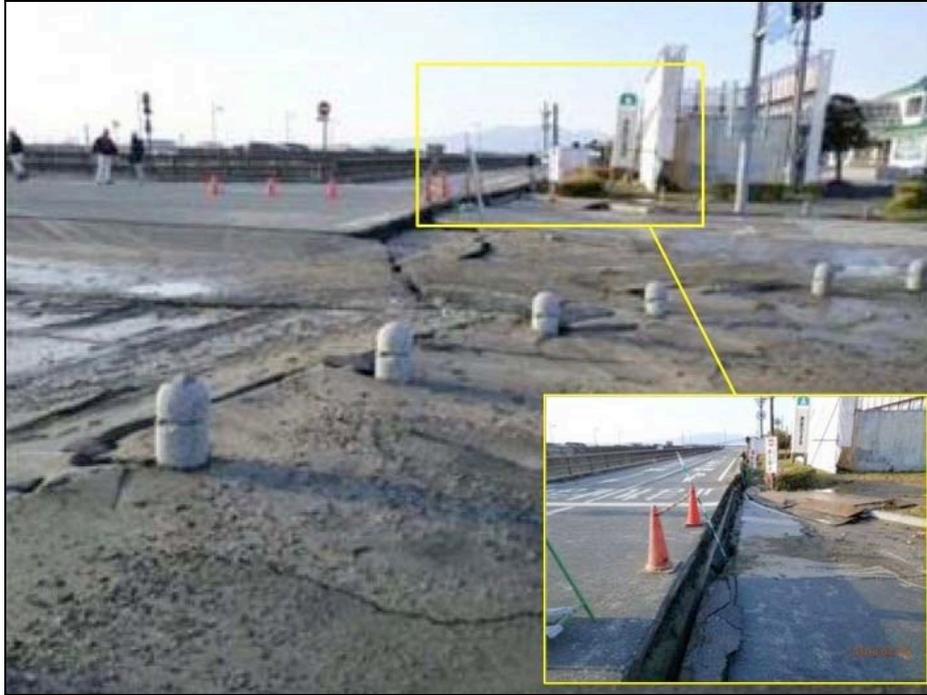
Figure 6-4. Road surface cracked and ground settlement – Kumamoto Port (Source: Kumamoto Prefecture, Civil Engineering Department)

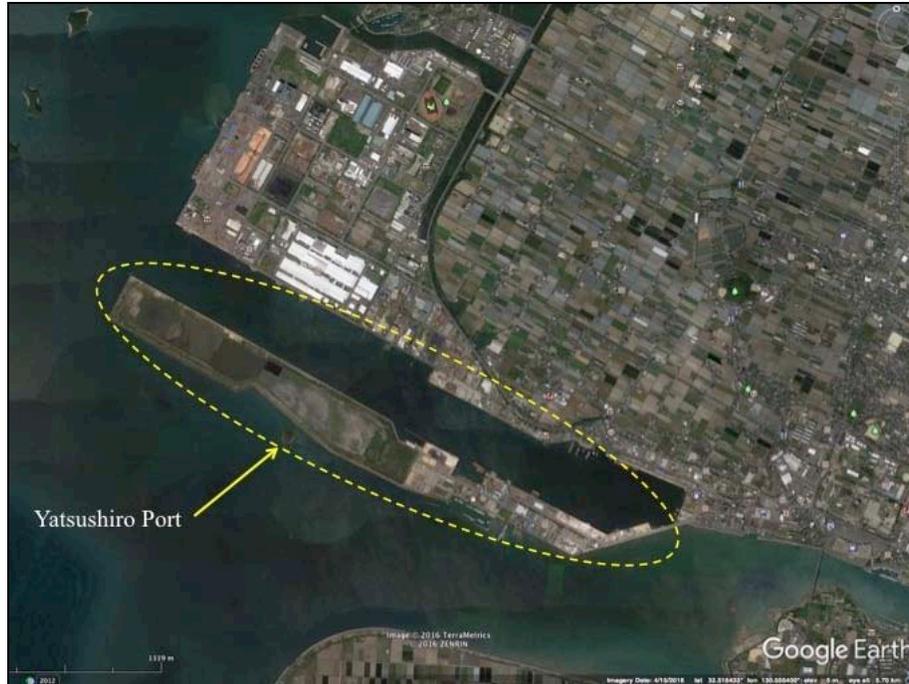
Figure 6-5. Aerial view of Yatsushiro Port

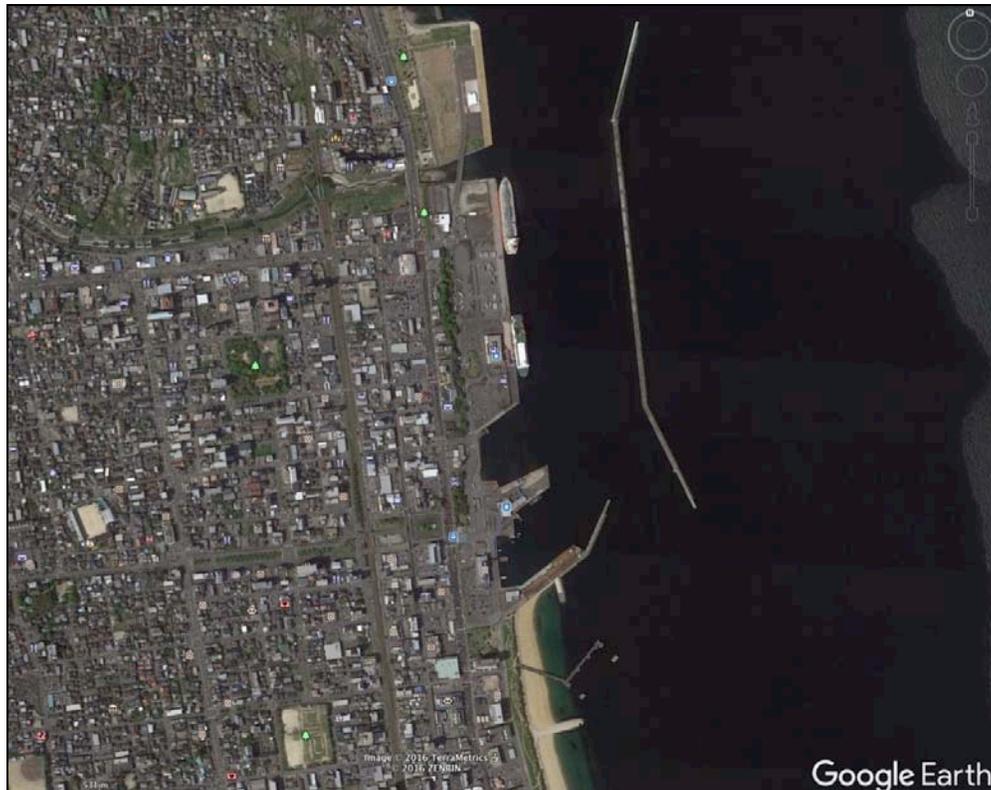
Figure 6-7. Aerial view of Beppu Port. (Source: Google Earth)

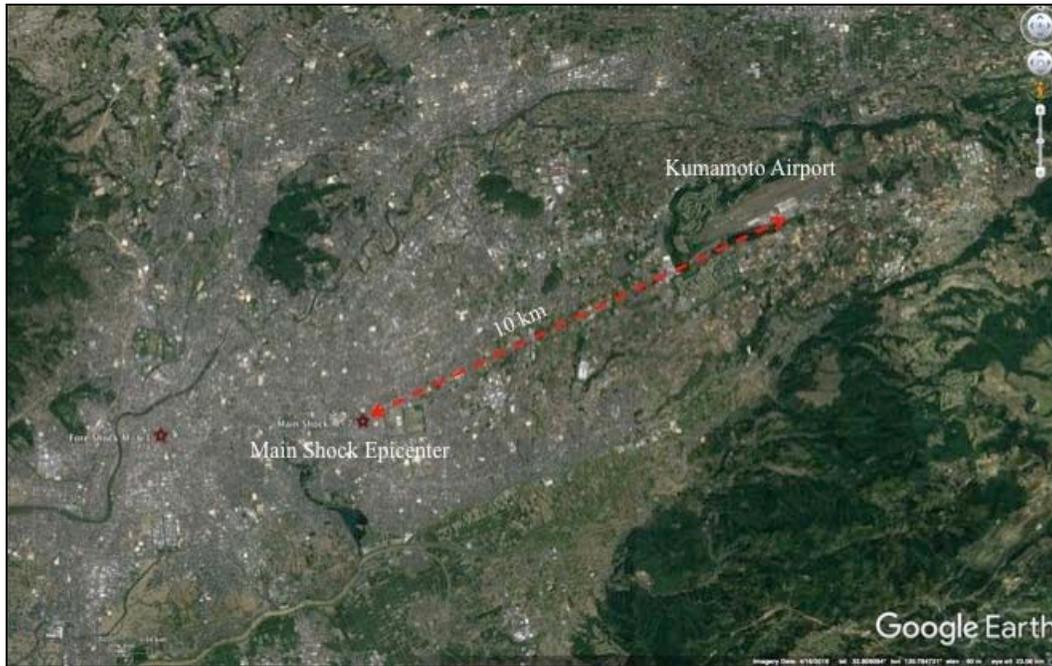
Figure 7-2. Location of Aso Kumamoto Airport with respect to epicenter of the 16 April 2016 M= 7.0 Main Shock.

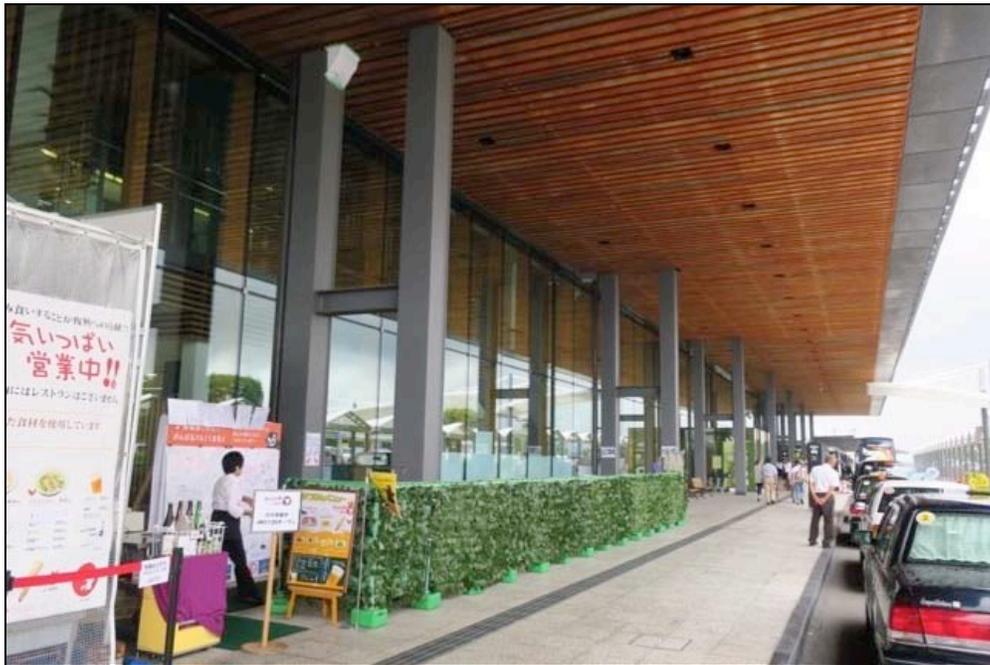
Figure 7-4. Exterior of Kumamoto Airport Domestic Terminal, the whole front wall is glass panel. There was signs of stress or displacement of the gasket around the glass panel.

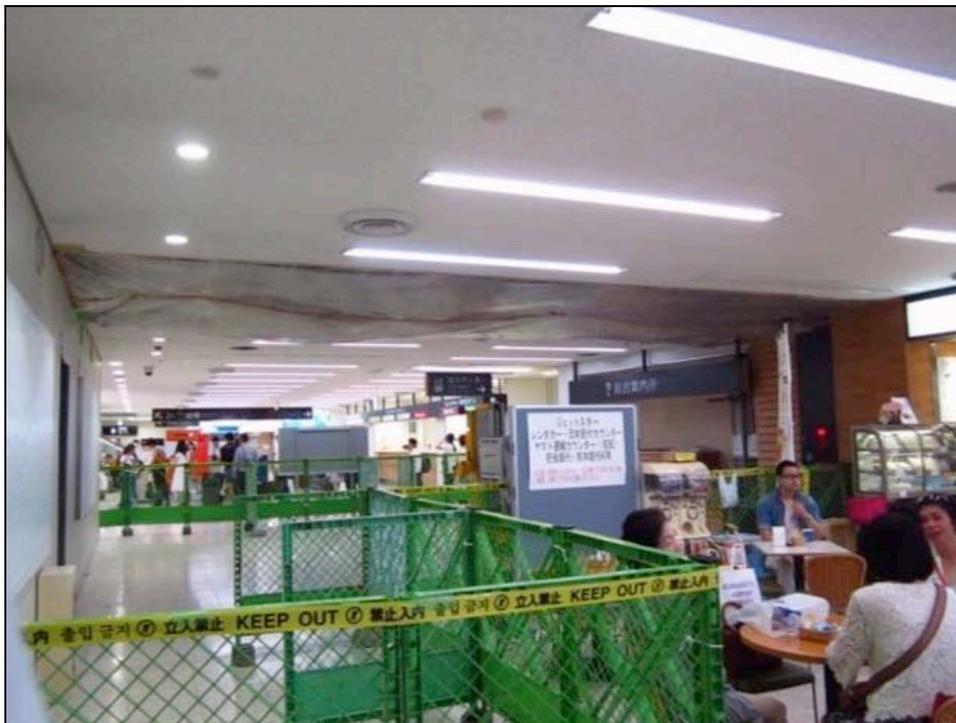
Figure 7-6. Ceiling damaged in the concession area, which was closed on July 3 2016

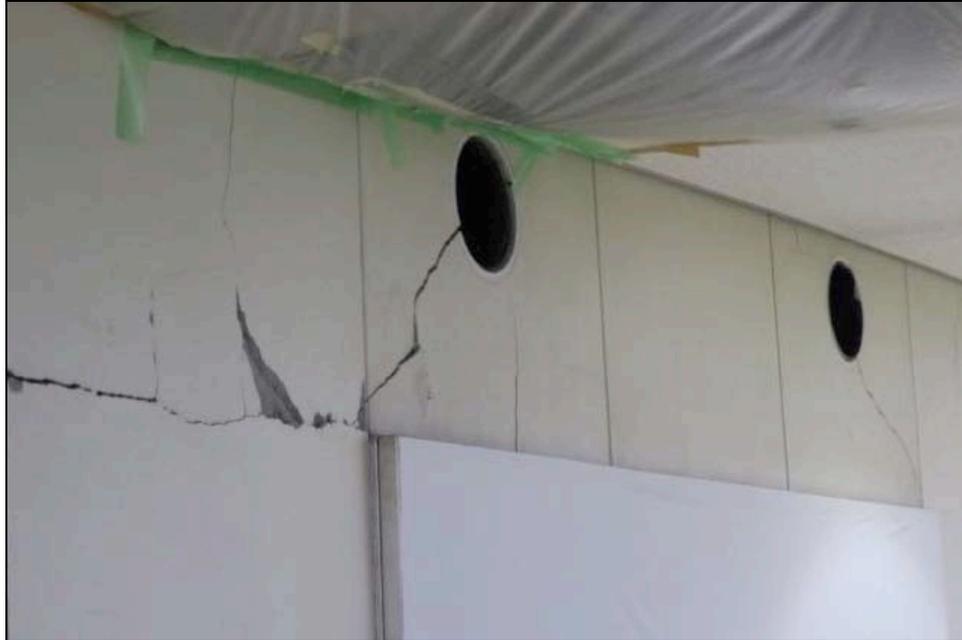
Figure 7-7. Cracks along the upper part of this dry wall

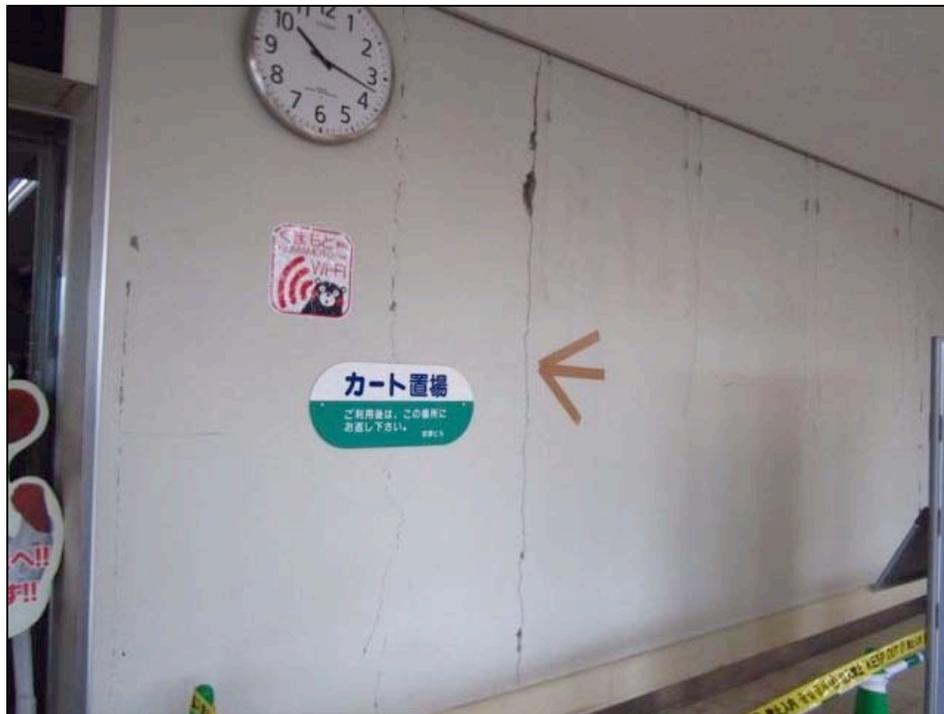
Figure 7-8. Cracked dry wall joints in the waiting area

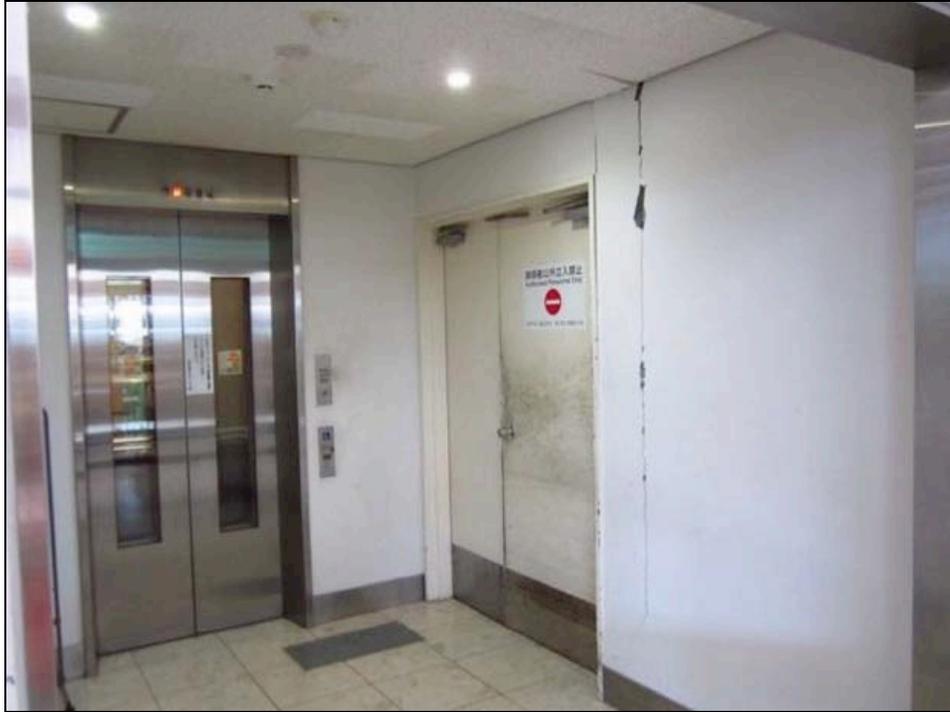
Figure 7-9. Cracks along the dry wall joints; the ceiling tiles were no damaged. The elevator was not damaged

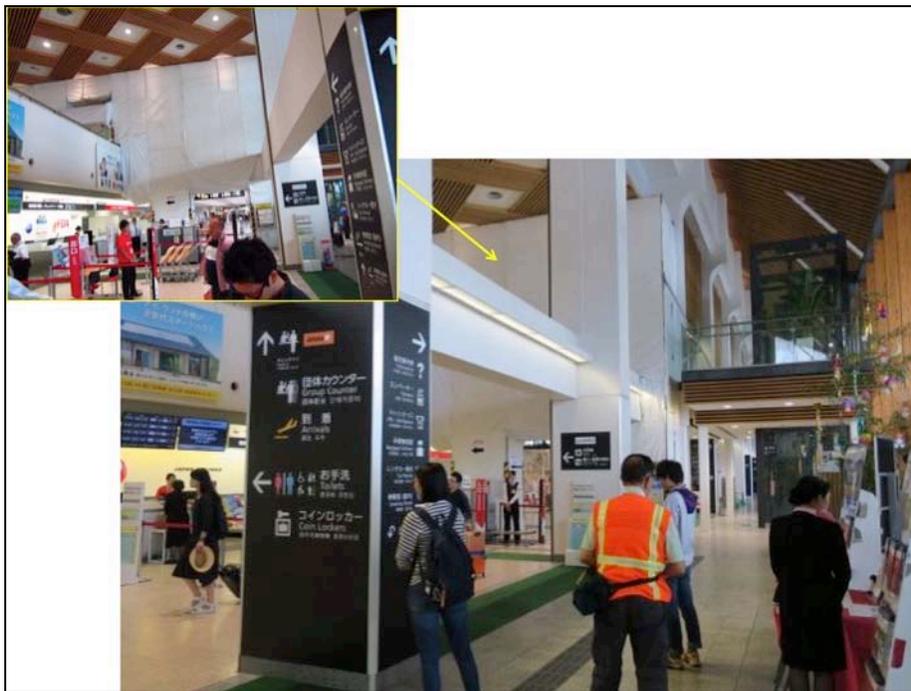
Figure 7-10. Inside Domestic Terminal with airline check-in counters on the left. The insert shows the covered walk way on the second floor, the departure level

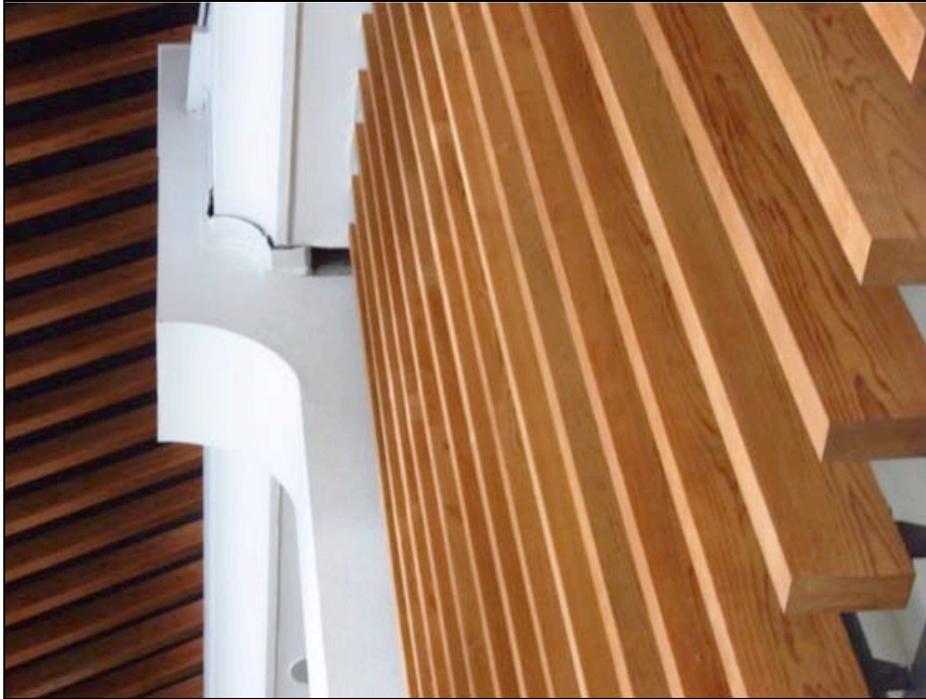
Figure 7-11. The column joint cover separated, no damage to the column.

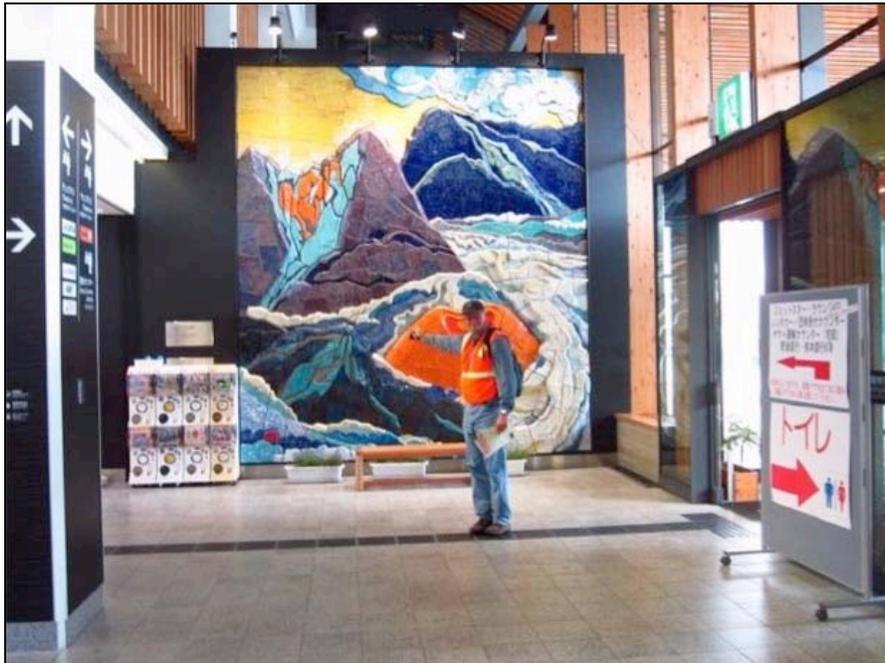
Figure 7-12. John Eidinger was standing in front of the mural, which had no sign of any strong shaking. Note also that the floor tiles had no cracks at all

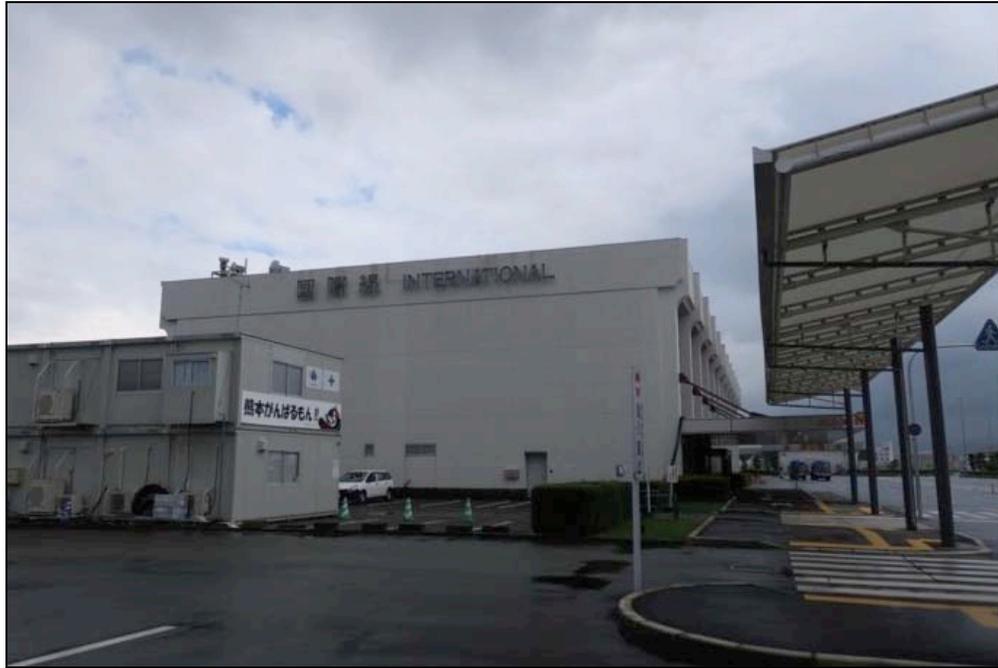
Figure 7-13. Exterior of the International Terminal

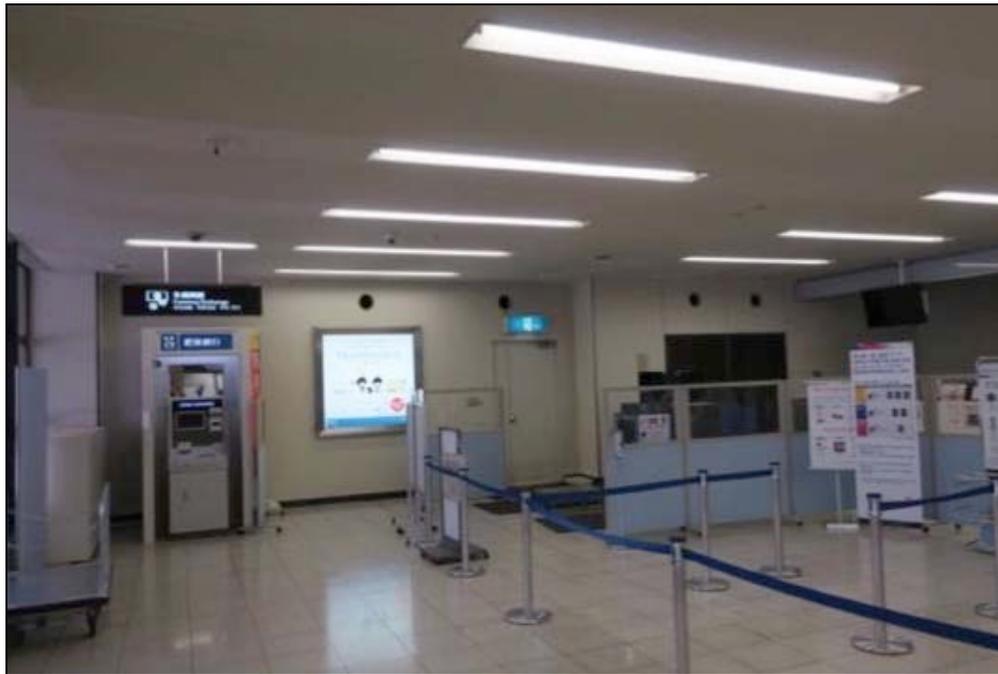
Figure 7-15. International Terminal security checkpoint of departing passengers

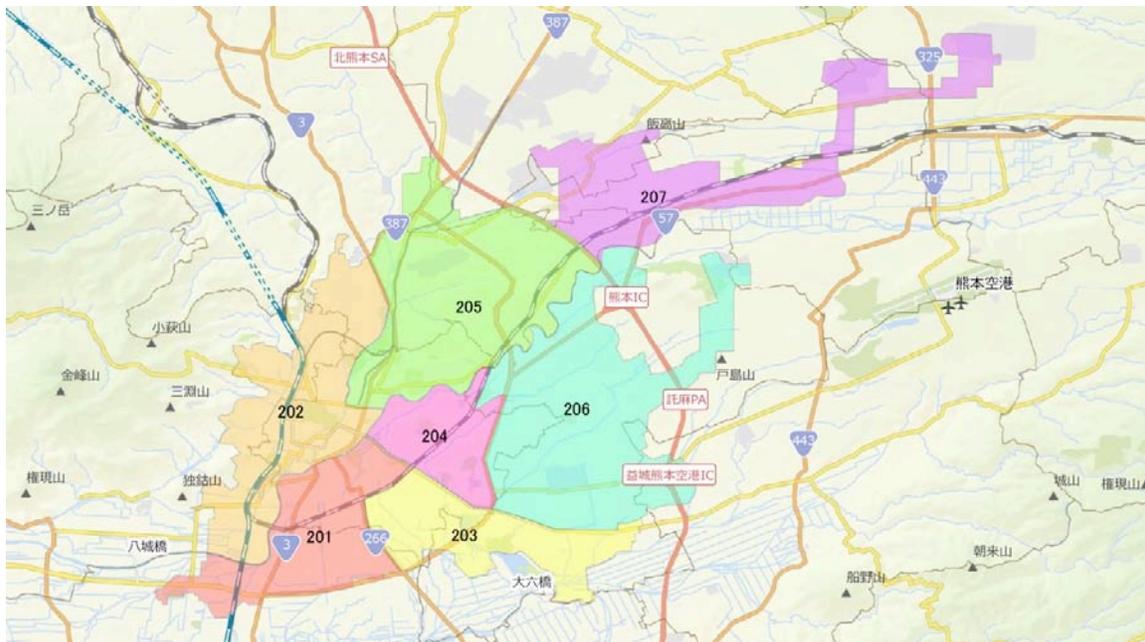
Figure 8-1. Gas Supply Blocks in Kumamoto Prefecture

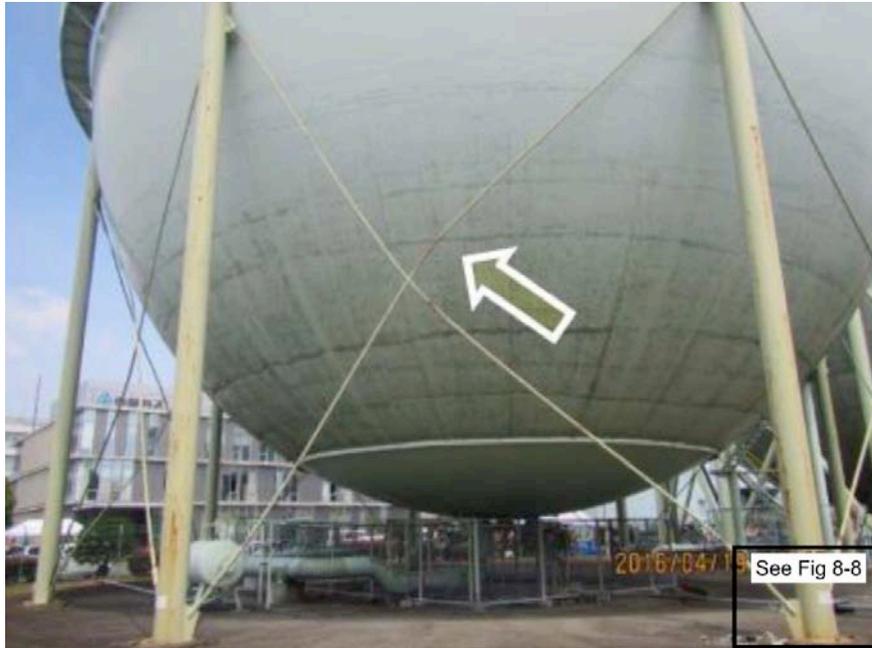
Figure 8-7. Gas Holder with Yielding Cross Braces

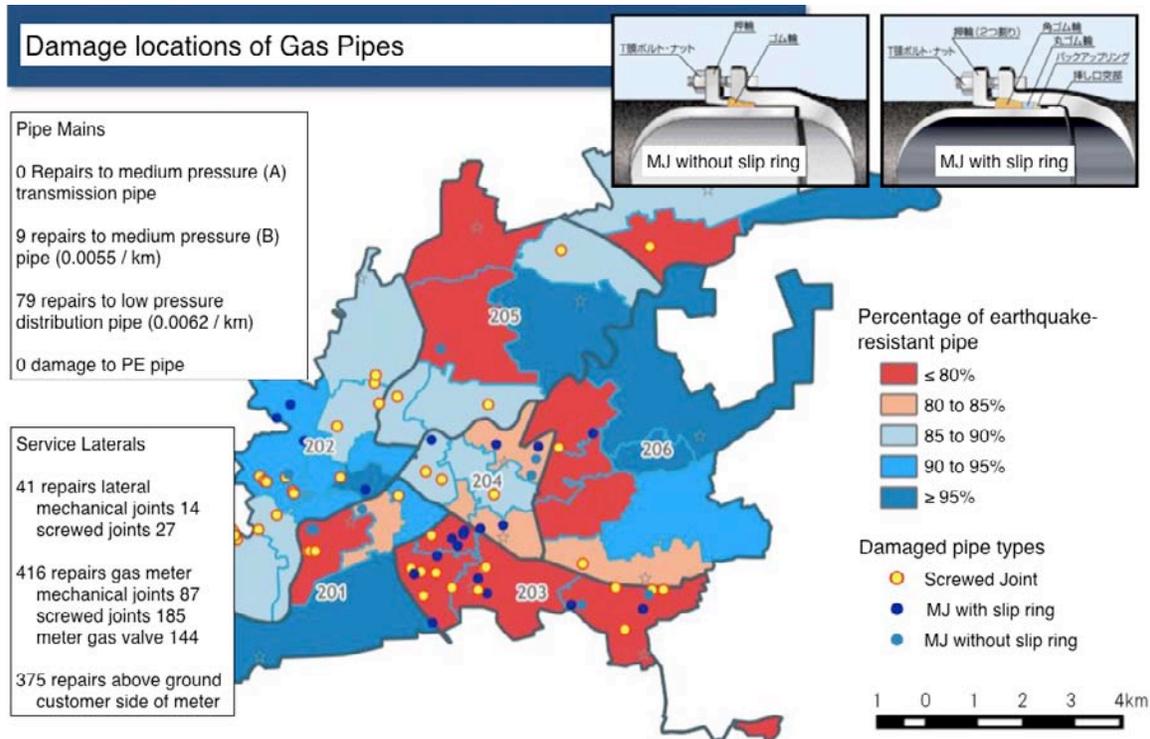
Figure 8-9. Location of Damaged Pipe Mains

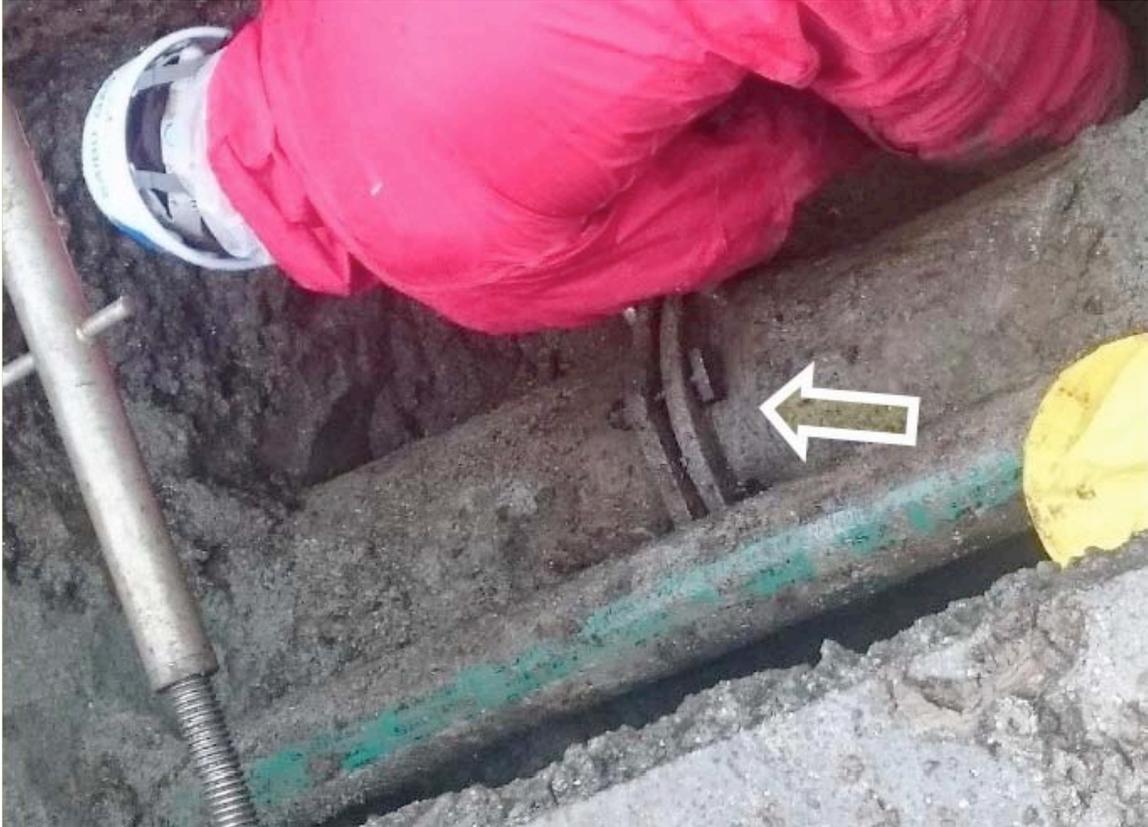
Figure 8-10. Repair to Median Pressure Class B Pipe. Repair was to tighten the mechanical joint (typical of 9 locations)

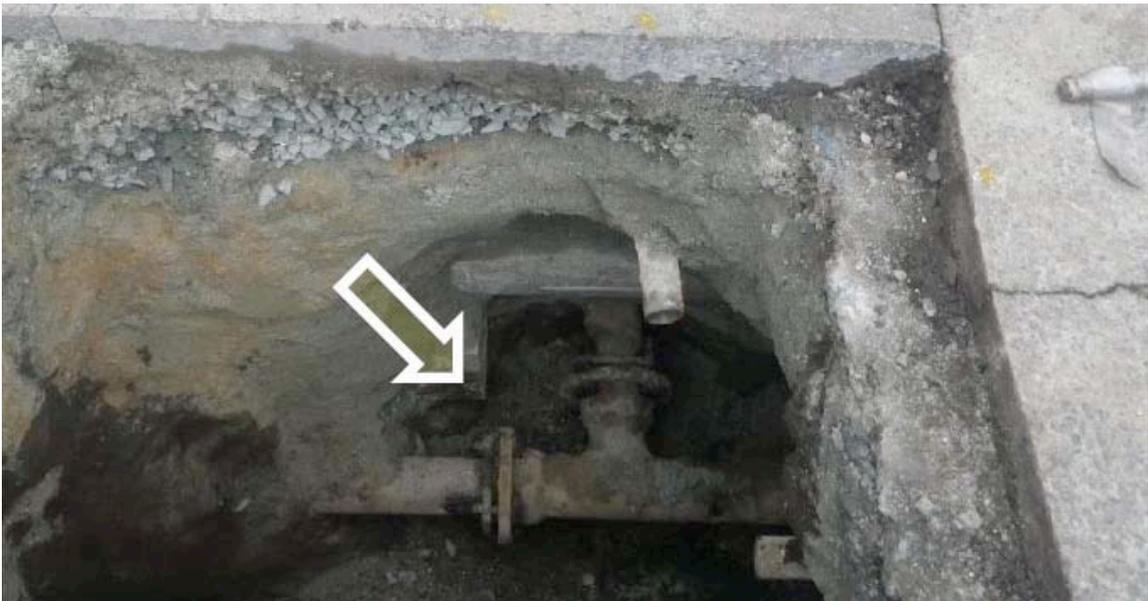
Figure 8-11. Repair to Low Pressure Distribution Pipe. Repair was to tighten the mechanical joint (typical of 23 locations)

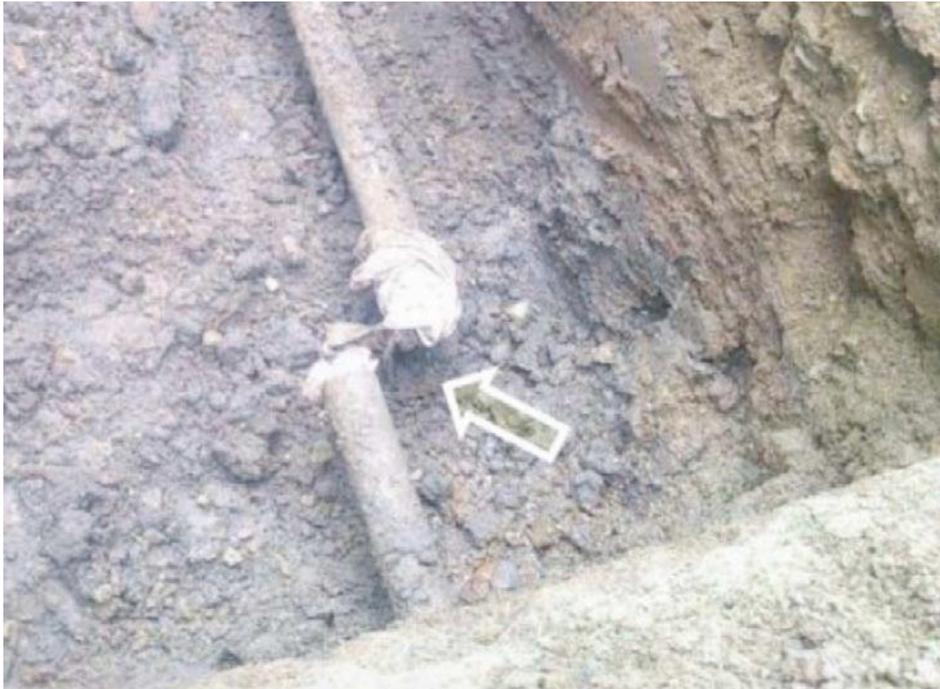
Figure 8-12. Damaged at Screwed Joint for Low Pressure Distribution Pipe (typical of 46 locations)

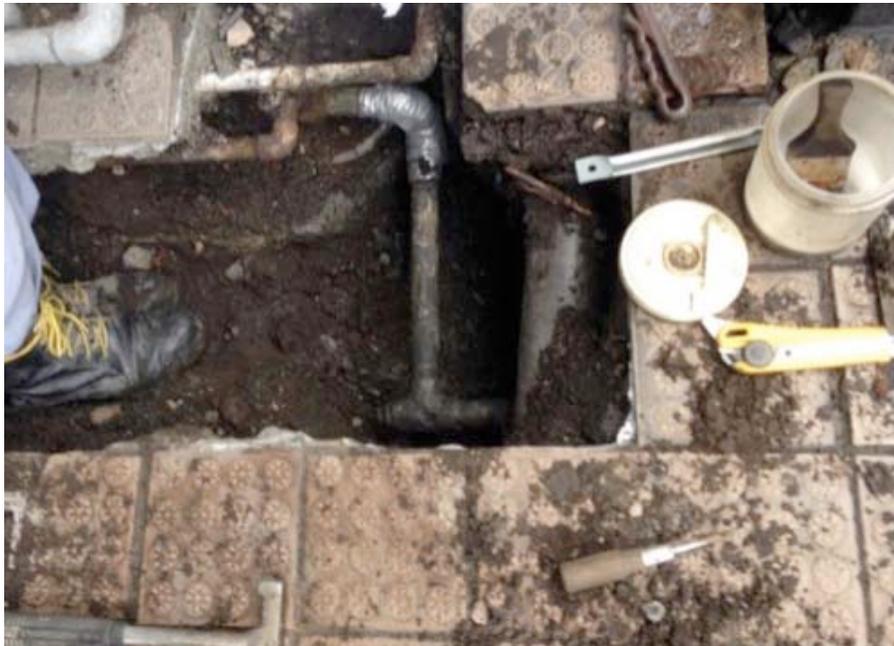
Figure 8-13. Damaged Low Pressure Pipe Customer Service Lateral

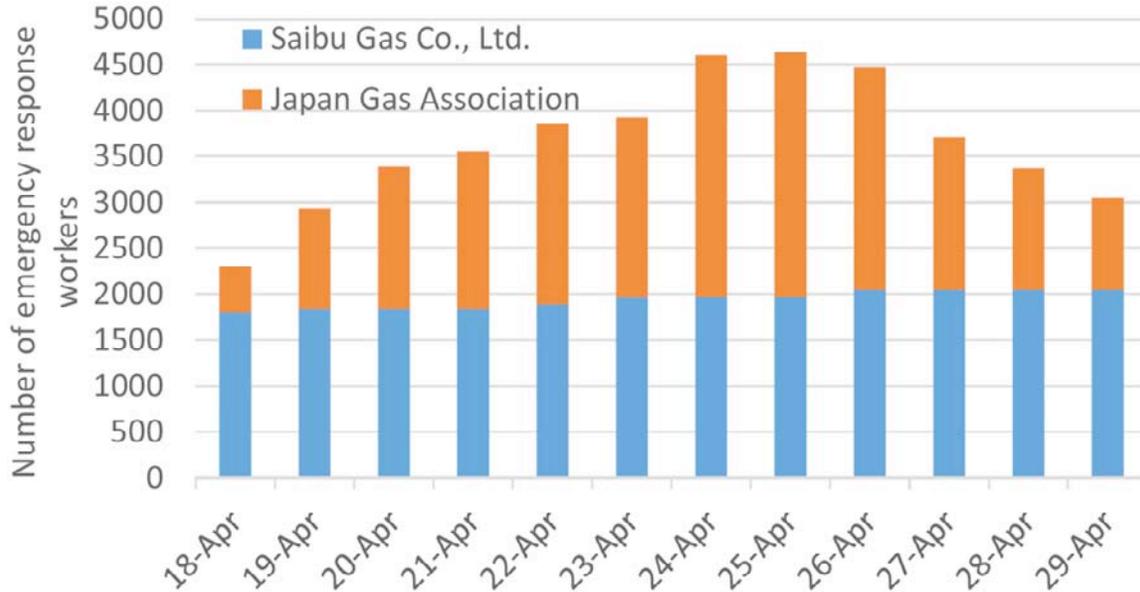
Figure 8-14. Gas Workers in Emergency Response
