KUMAMOTO, KYUSHU, JAPAN, EARTHQUAKES OF M_w 6.0 April 14, 2016 M_w 7.0 April 16, 2016 LIFELINE PERFORMANCE

ALEX K TANG and JOHN M EIDINGER

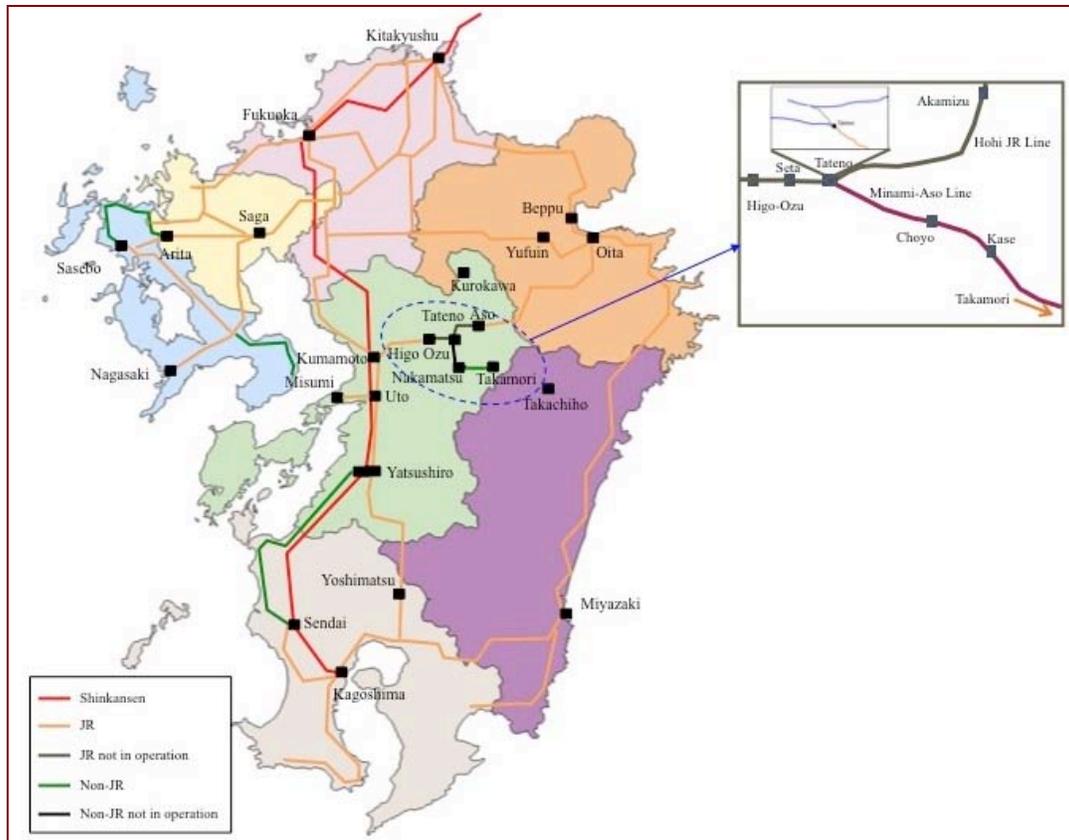
Figure 9-2. Rail Network within Kyushu. (Base map from Reference 1)

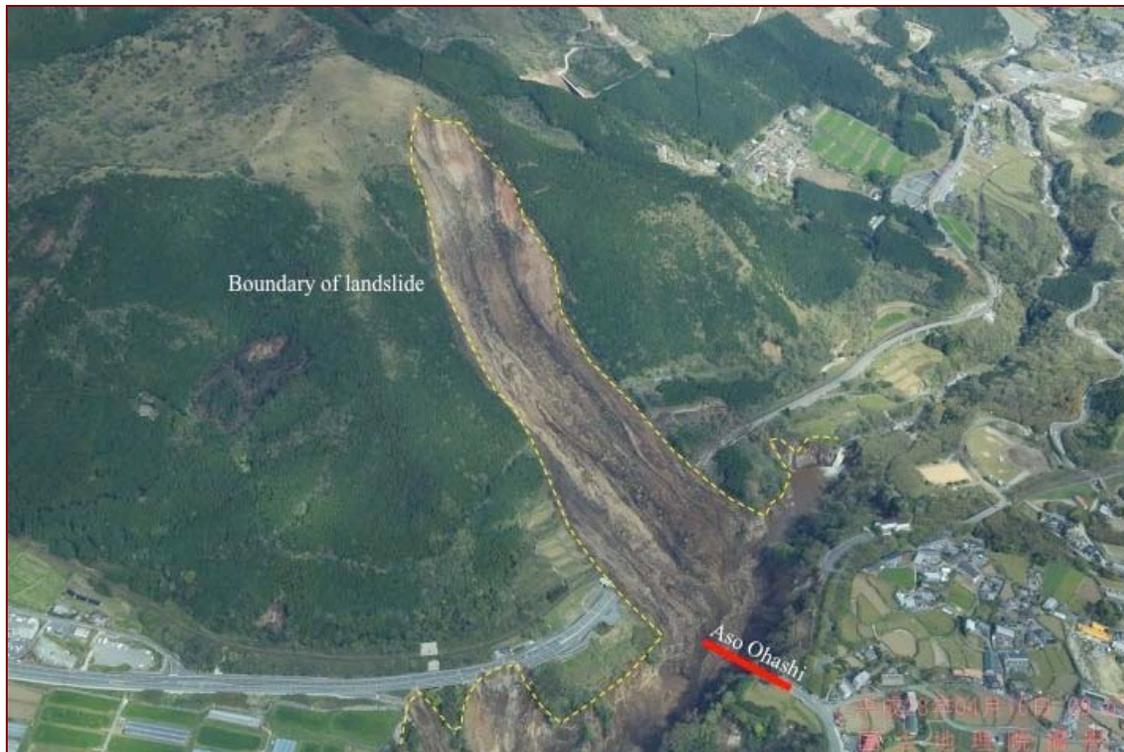
Figure 9-3. Aerial view of the landslide that caused the collapse of Aso Bridge (Source: Geospatial Information of Japan)

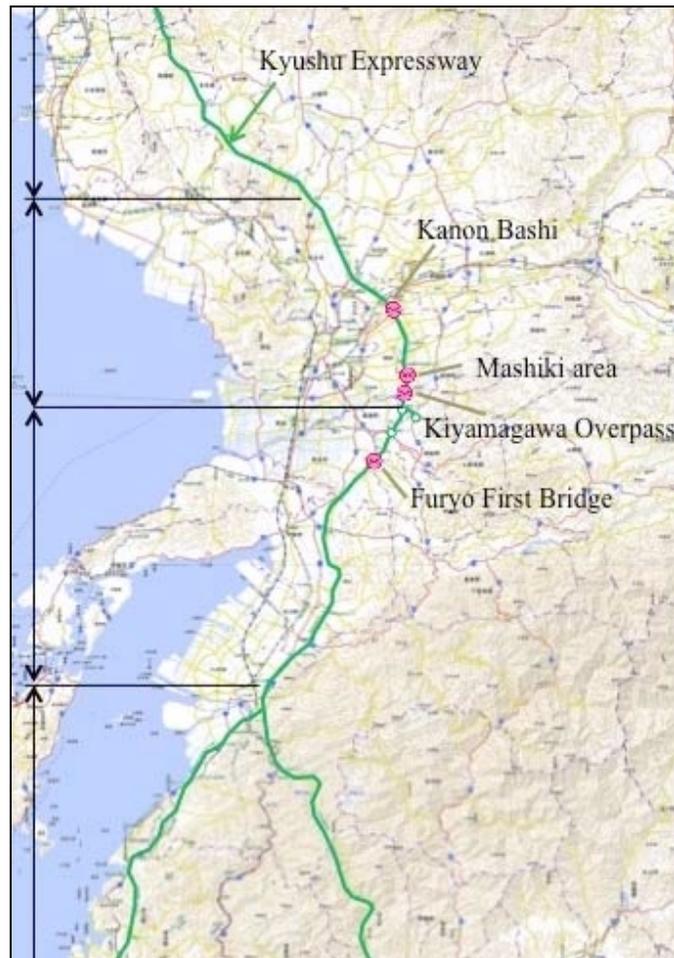
Figure 9-4. The four locations with significant impact to Kyushu Expressway are identified in red circles

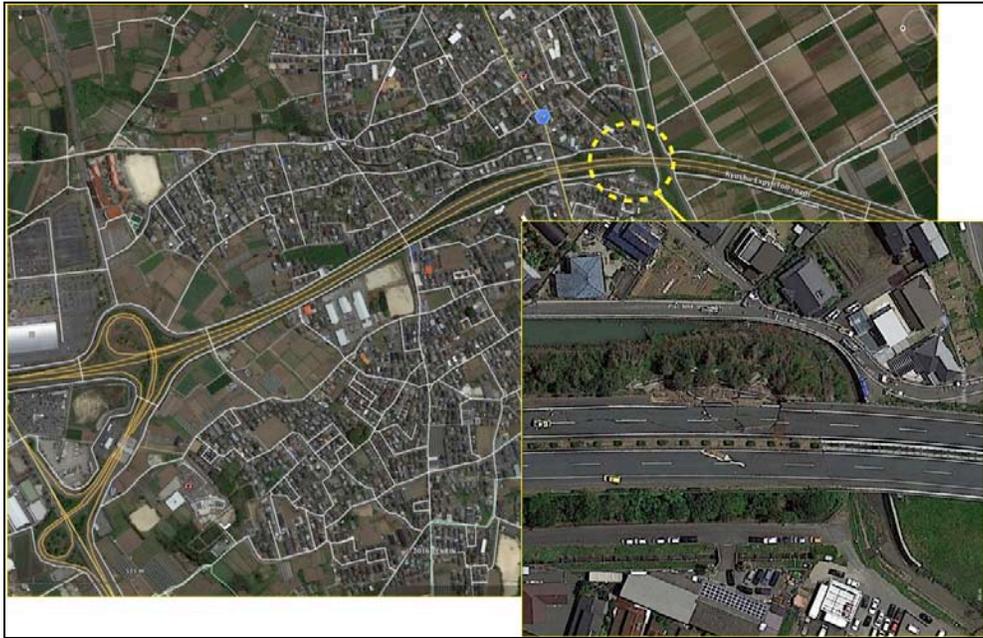
Figure 9-10. The road surface of the north bound lanes embankment collapsed

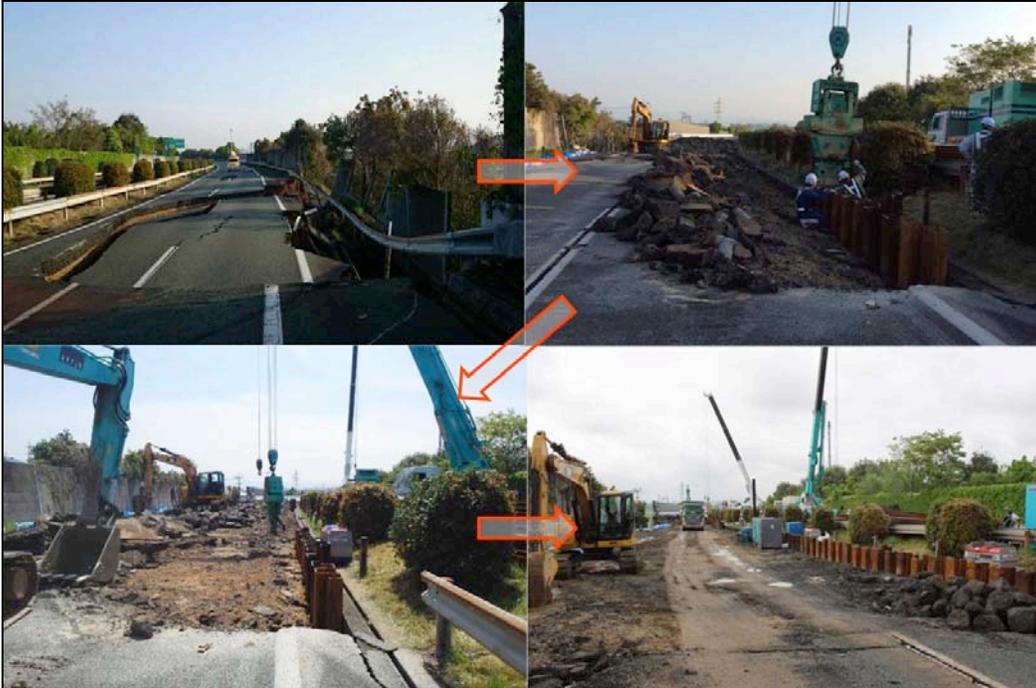
Figure 9-12. Repairs in progress

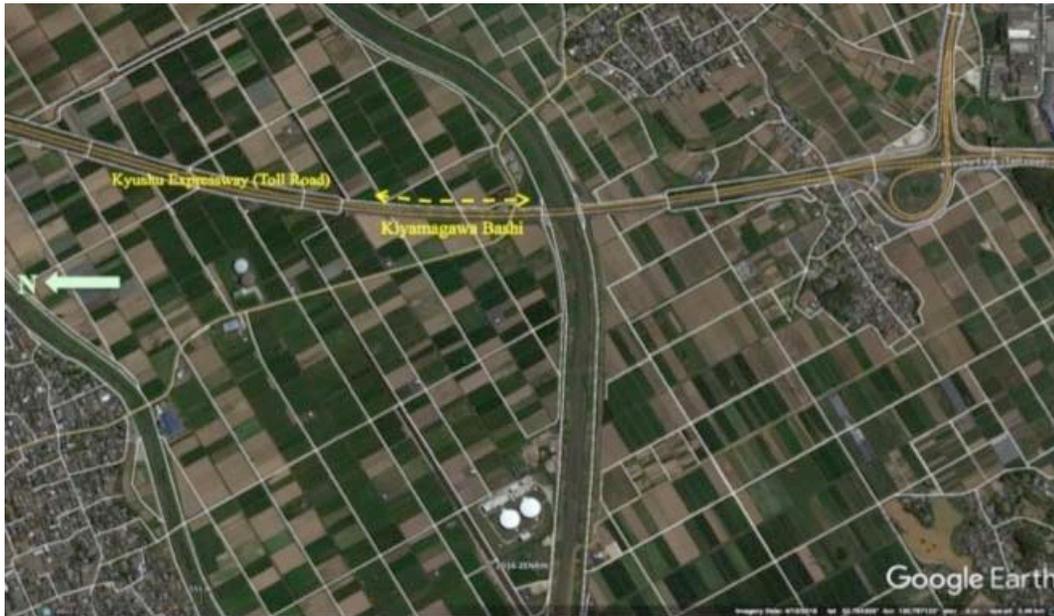
Figure 9-13. Location of the Kiyamagawa Bridge (Source: Google Earth)

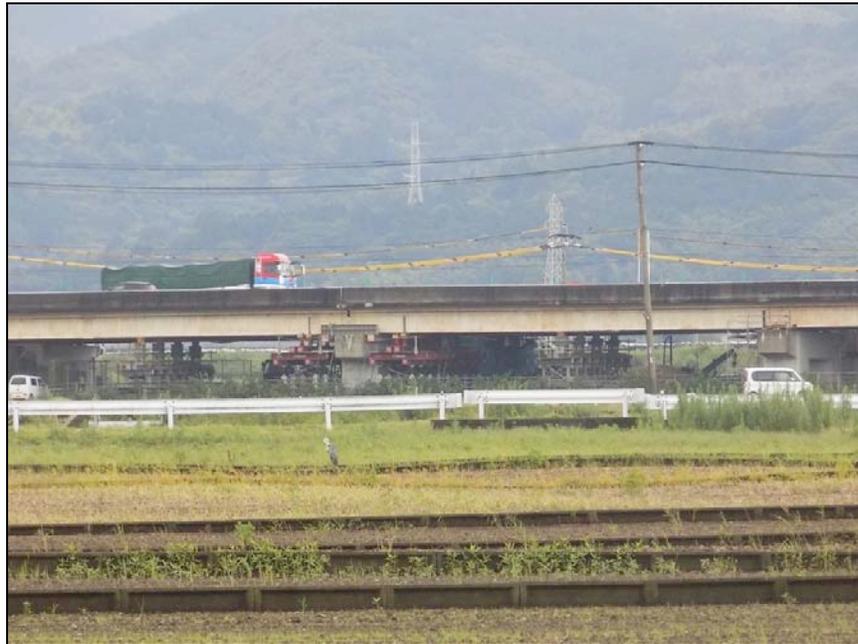
Figure 9-15. Some brace supports were needed to raised the deck to repair the bearings (Tang)

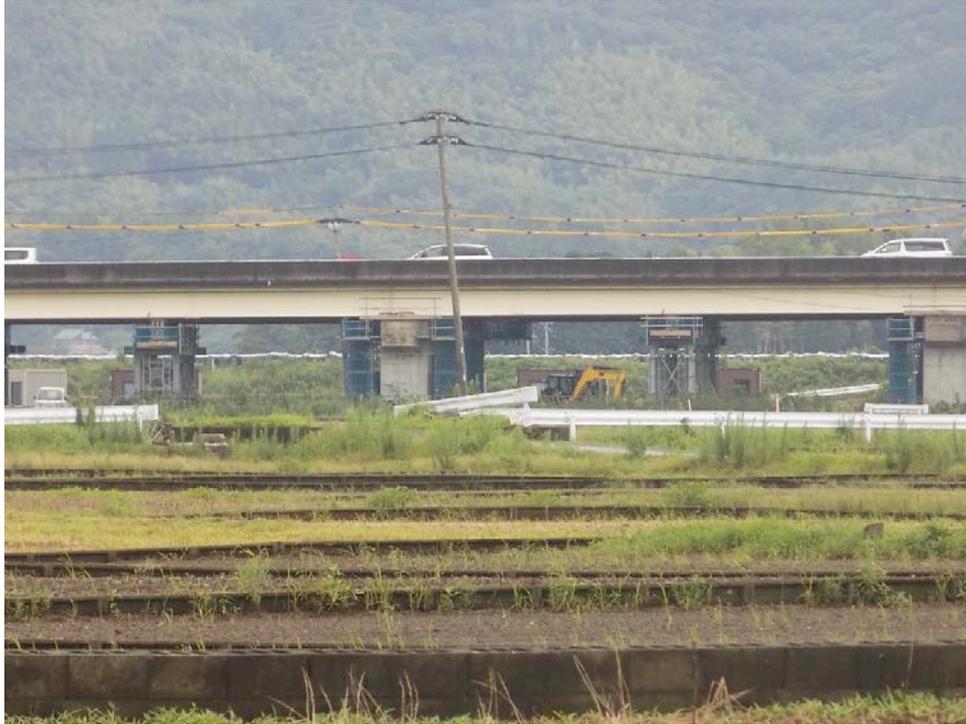
Figure 9-16. This shows another section of the bridge deck with shoring support (Tang)

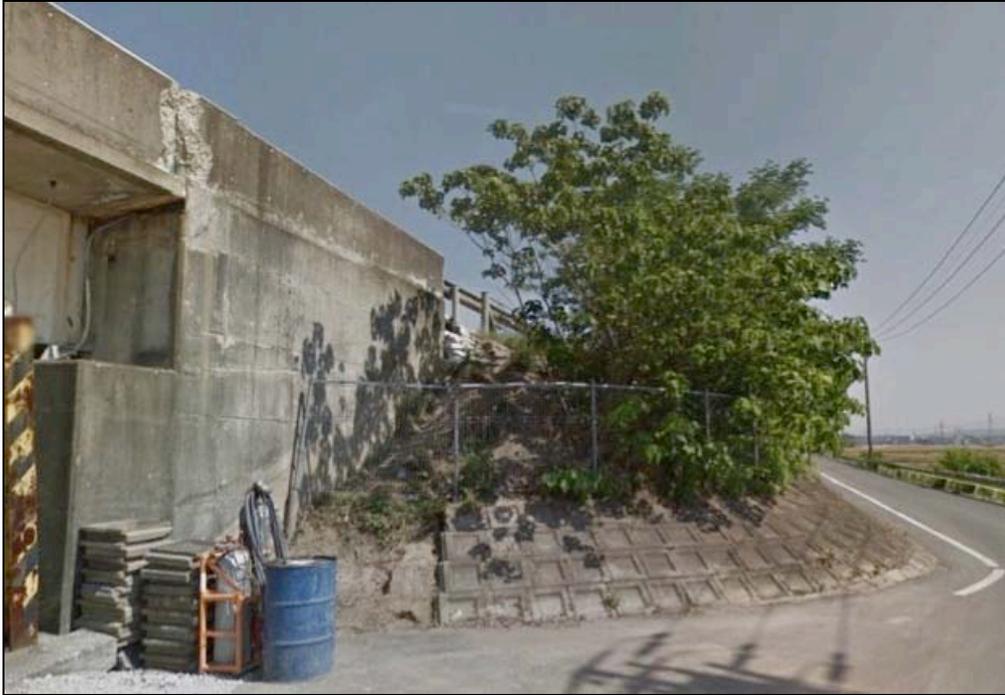
Figure 9-18. Pounding damage to side rail at the abutment (Tang)

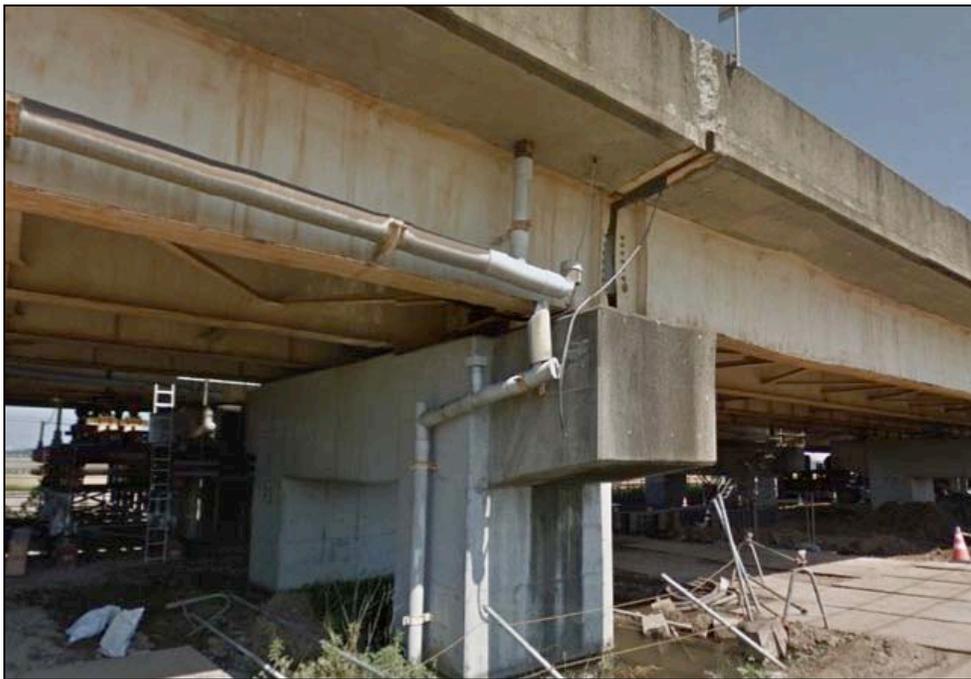
Figure 9-19. Pounding damage to both concrete side wall and junction plate of the steel girder (Tang)

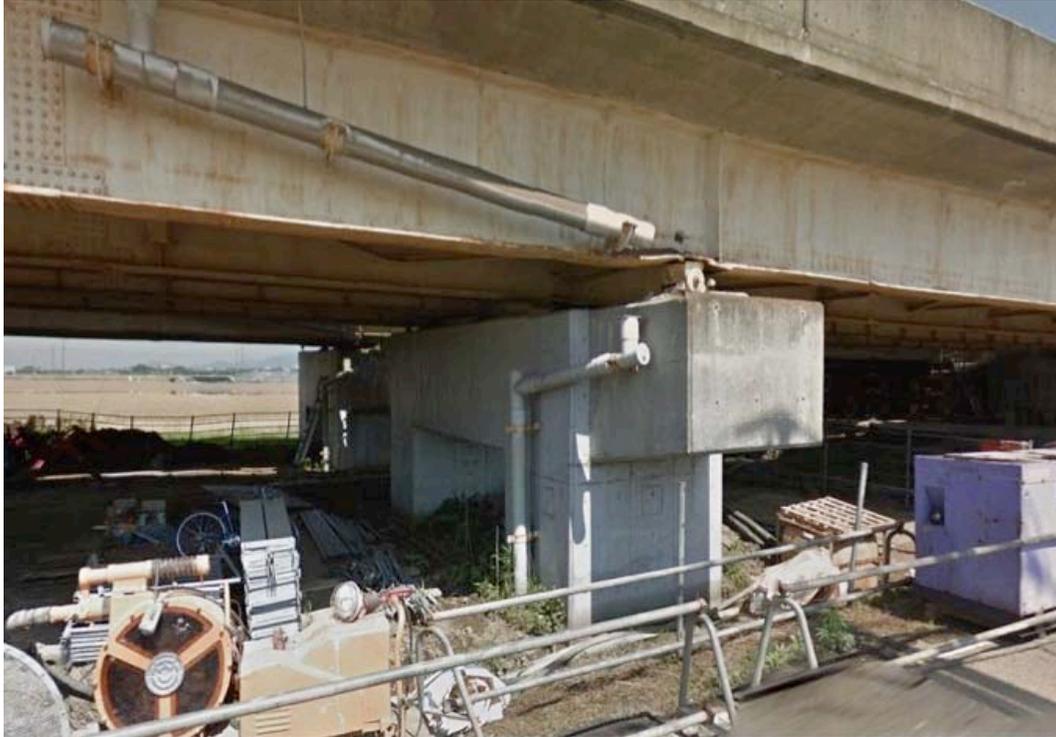
Figure 9-20. Drainpipe broken and the bearing rocker was pushed and damage the steel girder flange

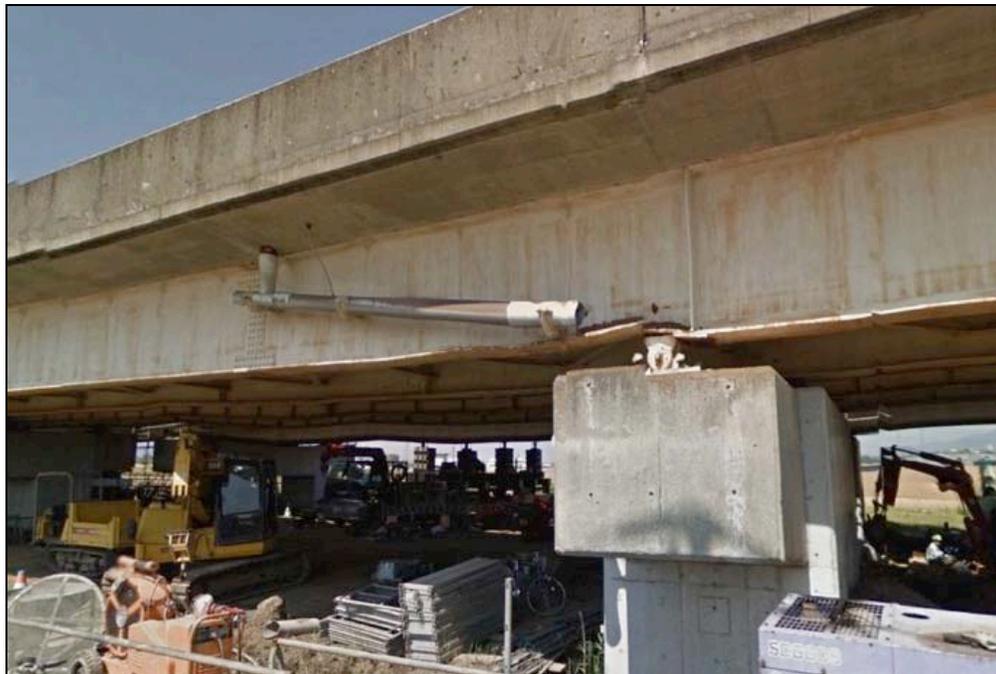
Figure 9-21. Broken drain pipe due to bridge movement

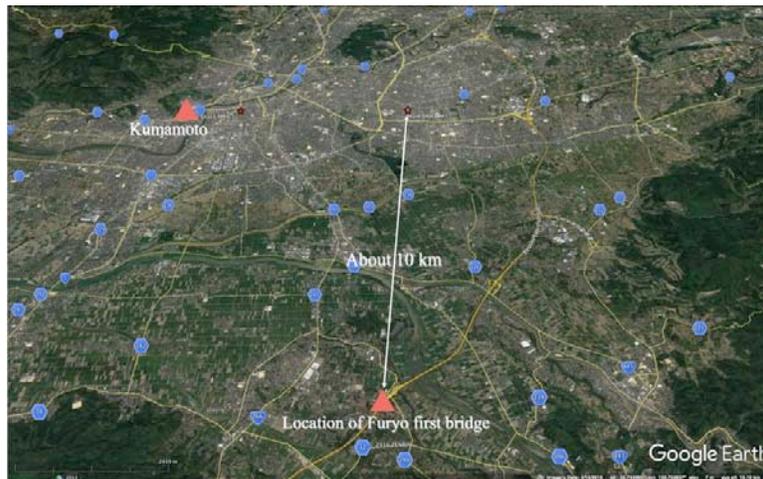
Figure 9-22. Location of Furoyo First Bridge with respect to epicenters. (Source: Google Earth)

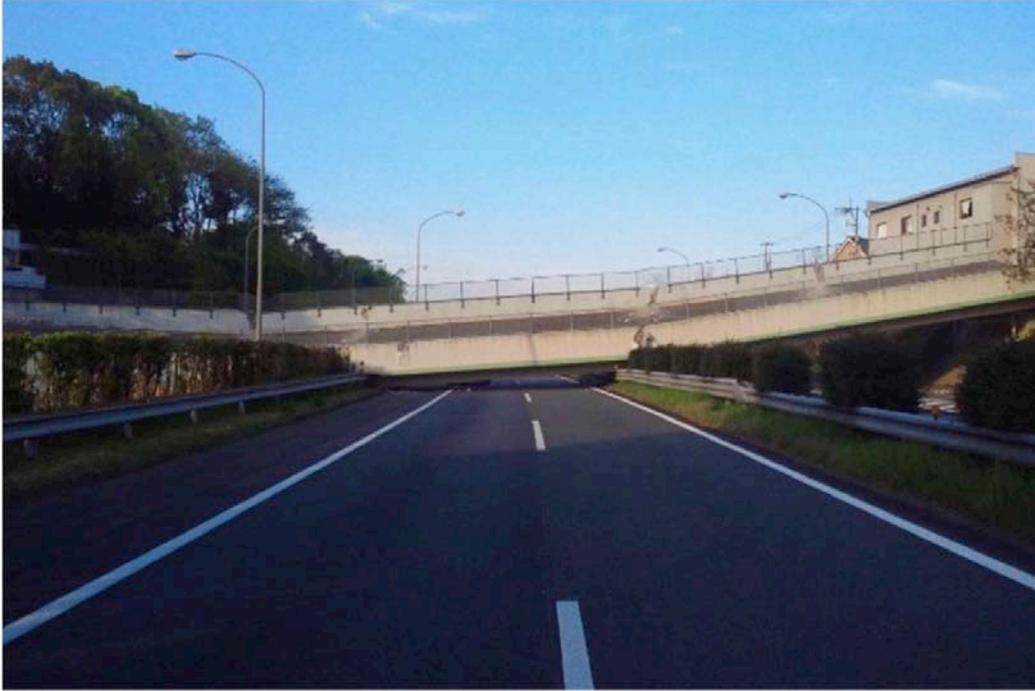
Figure 9-24. The collapsed bridge blocked the northbound traffic

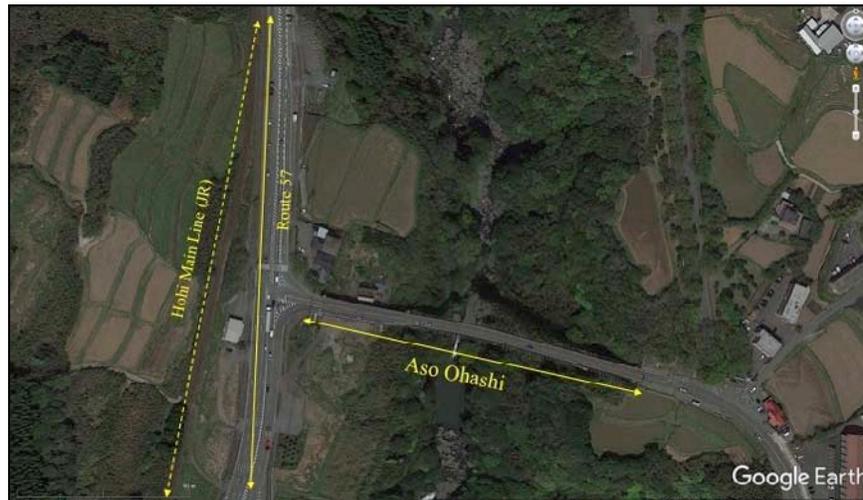
Figure 9-25. Aerial view of Aso Bridge before the Kumamoto earthquake. (Source: Google Earth)

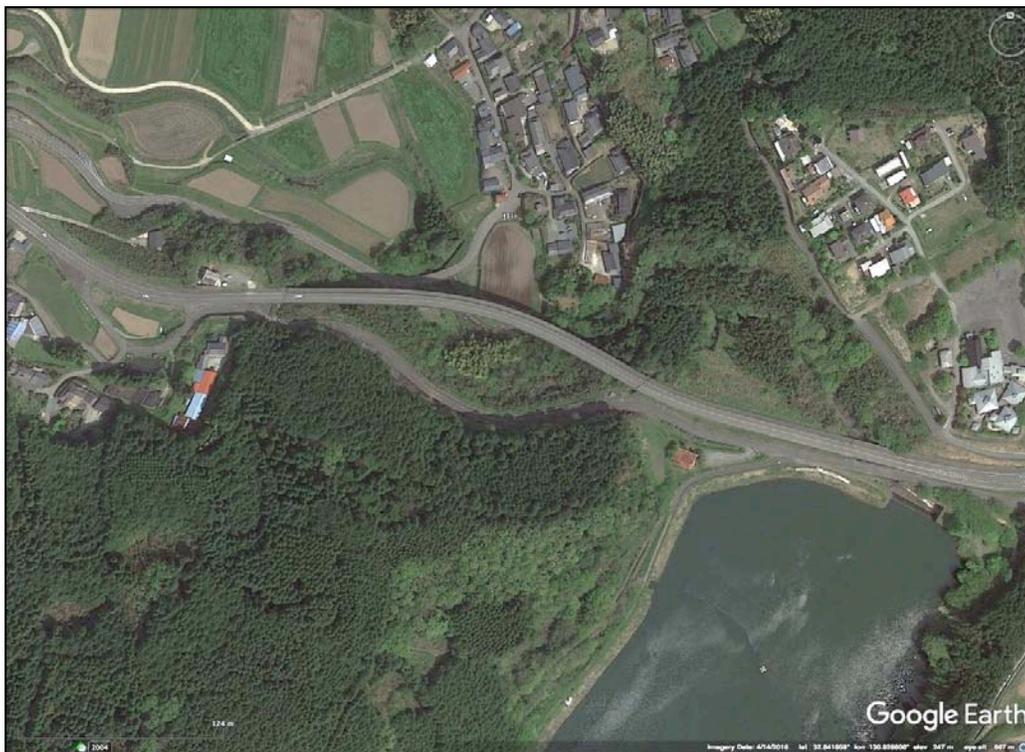
Figure 9-32. Aerial view of Oh Kirihata Bridge before the earthquake (Source: Google Earth)

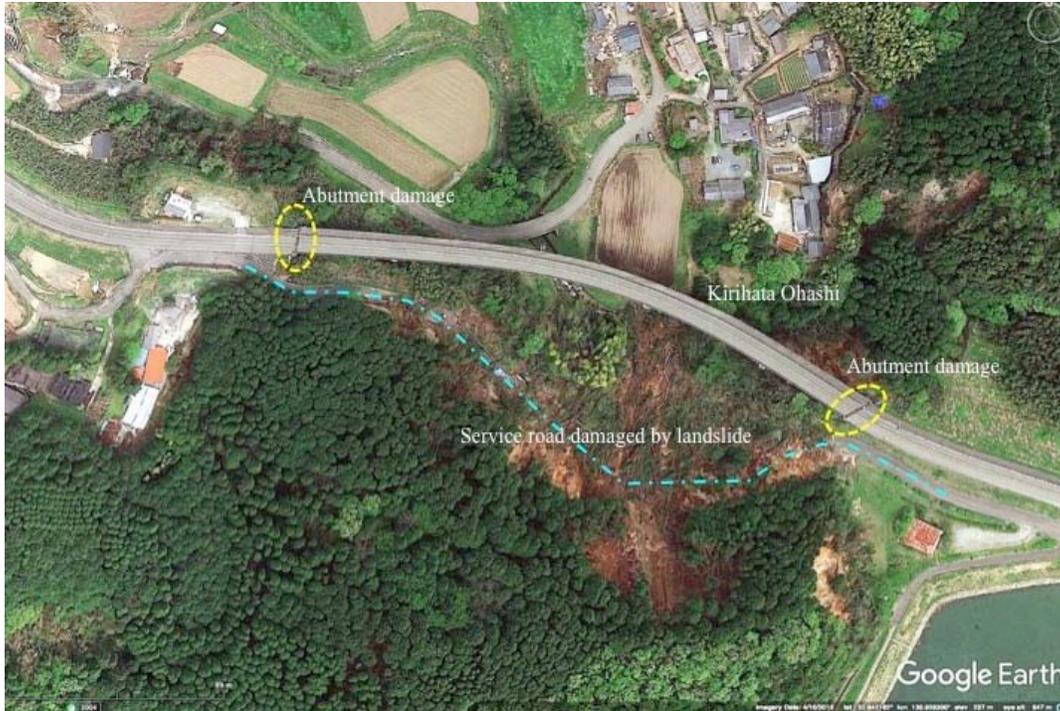
Figure 9-33. The circled areas were the damages observed. The blue color dashed line indicates the bypass road covered by landslide (Source: Google Earth)

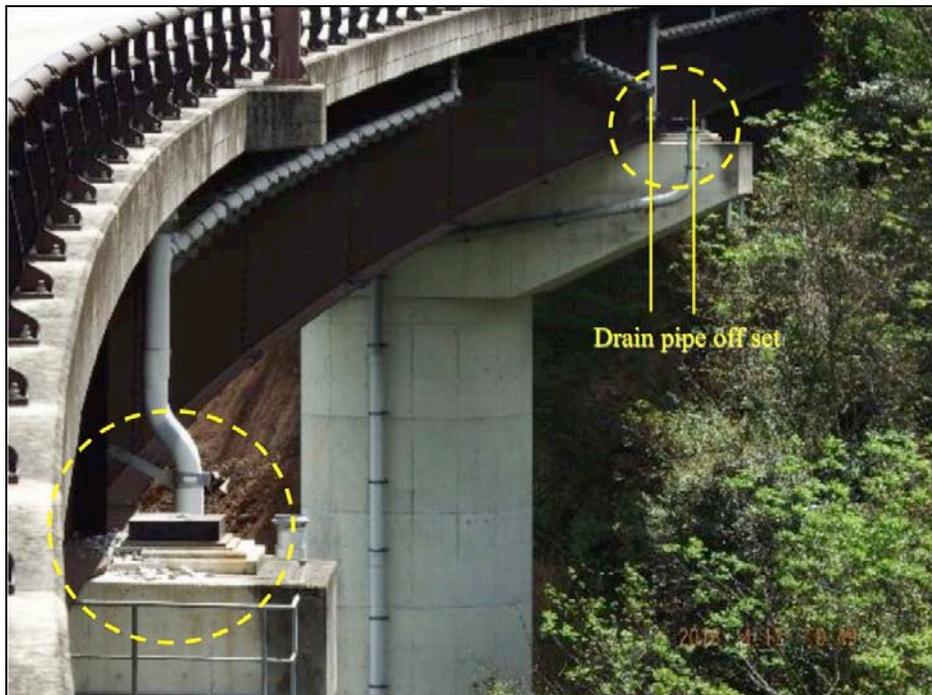
Figure 9-34. Relative movement between the deck and the support column demonstrated strong ground motion

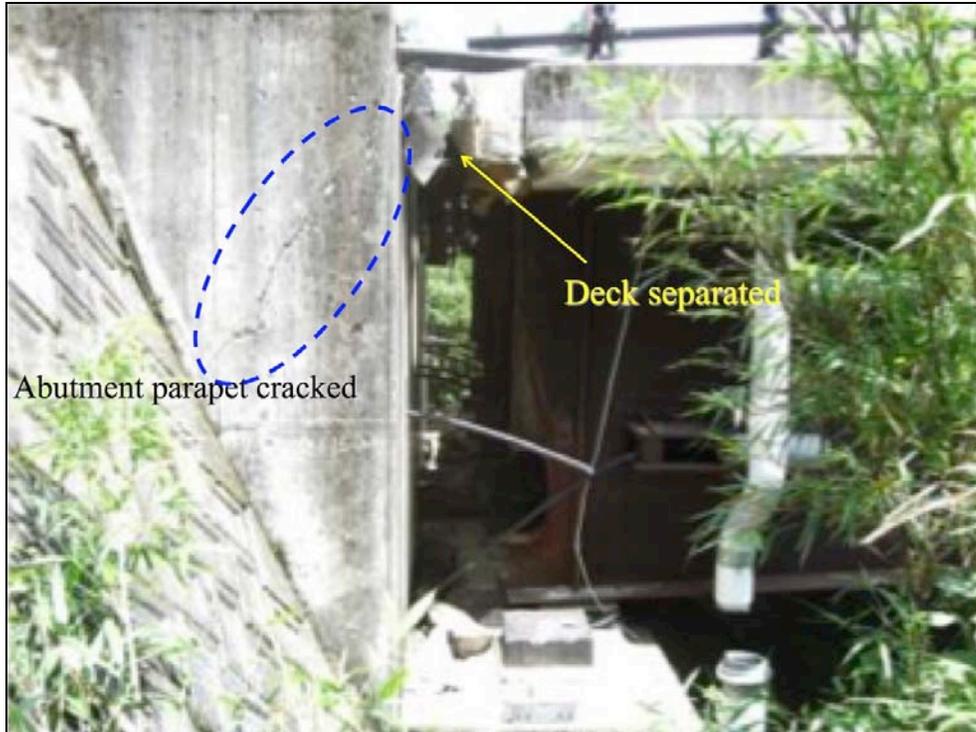
Figure 9-35. Abutment cracked and deck separation from abutment

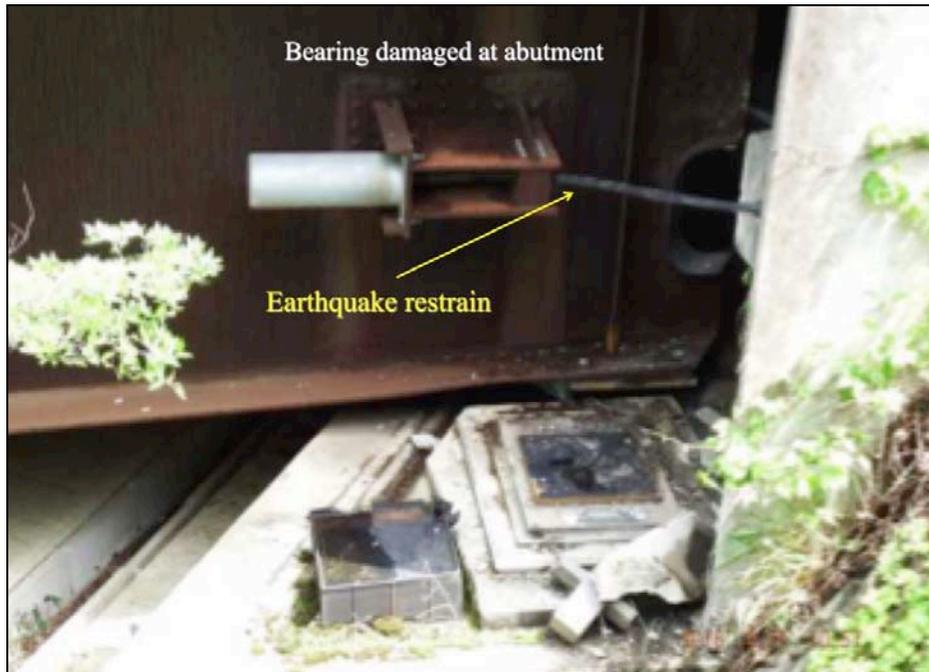
Figure 9-36. Bearing pad damaged the earthquake restraint mechanism restrained the bridge deck

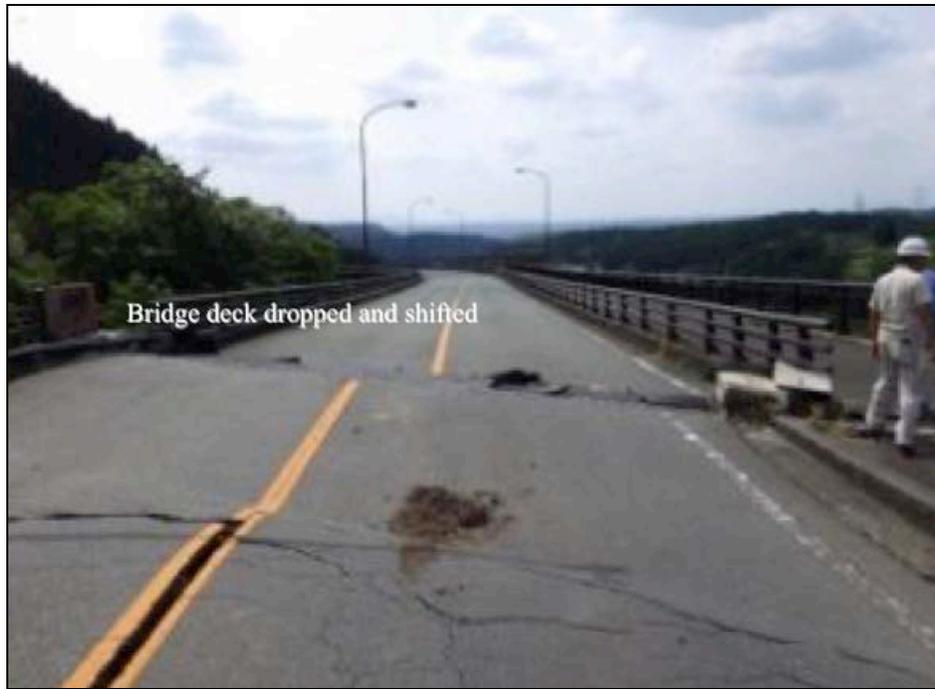
Figure 9-37. The abutment "appears" raised as the bridge deck shifted sideways off its rubber bearings and fell on the abutments

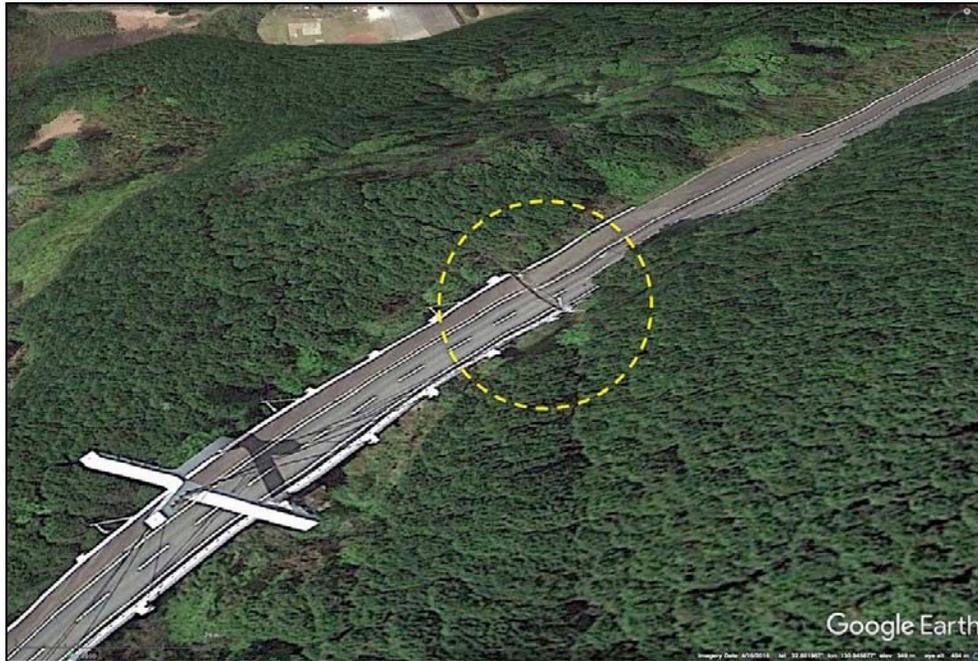
Figure 9-38. The circled area shows the abutment failure. (Source: Google Earth)

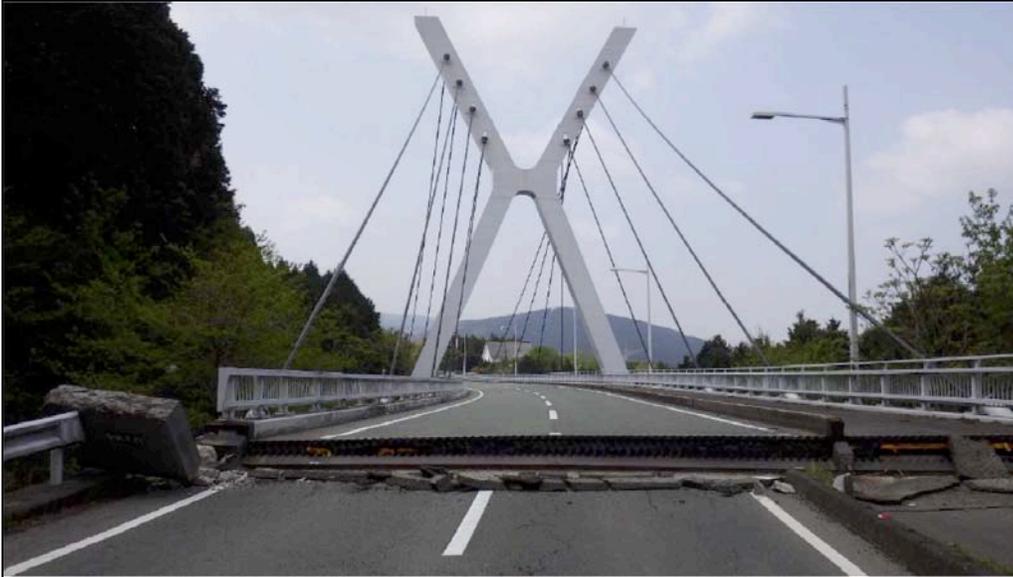
Figure 9-39. Close up view of the Northeastern abutment damage

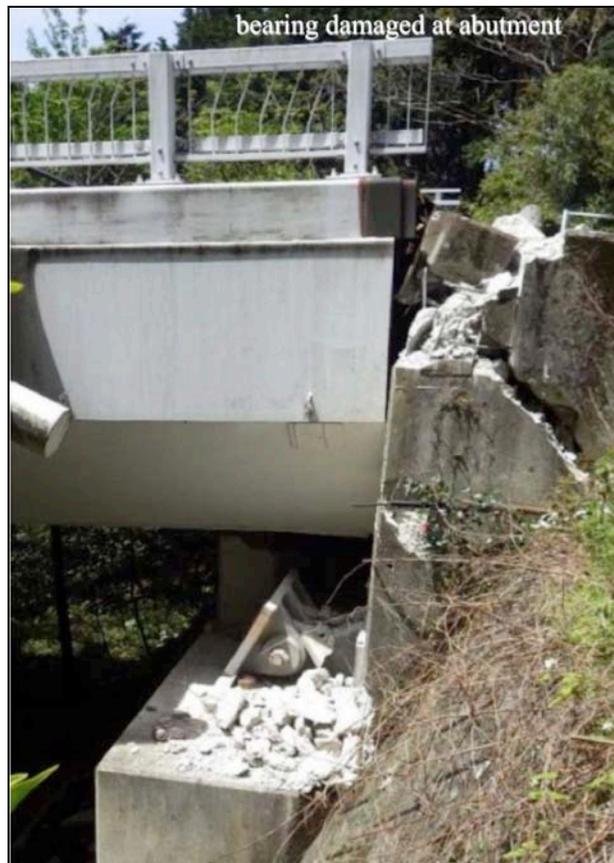
Figure 9-40. Due to pounding the bearing rocker broke off and the abutment concrete was shattered

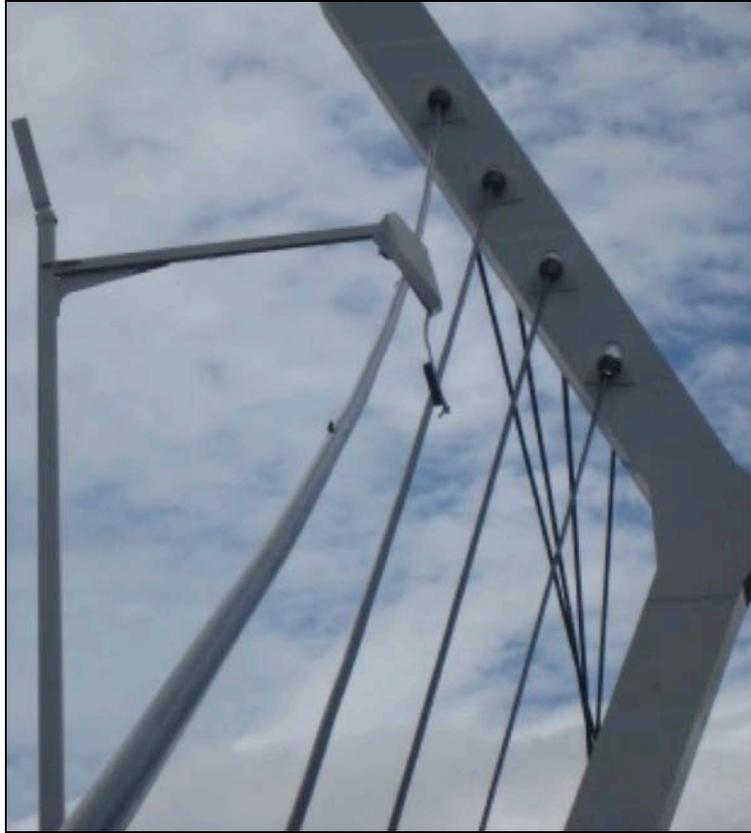
Figure 9-41. A few cables were loose

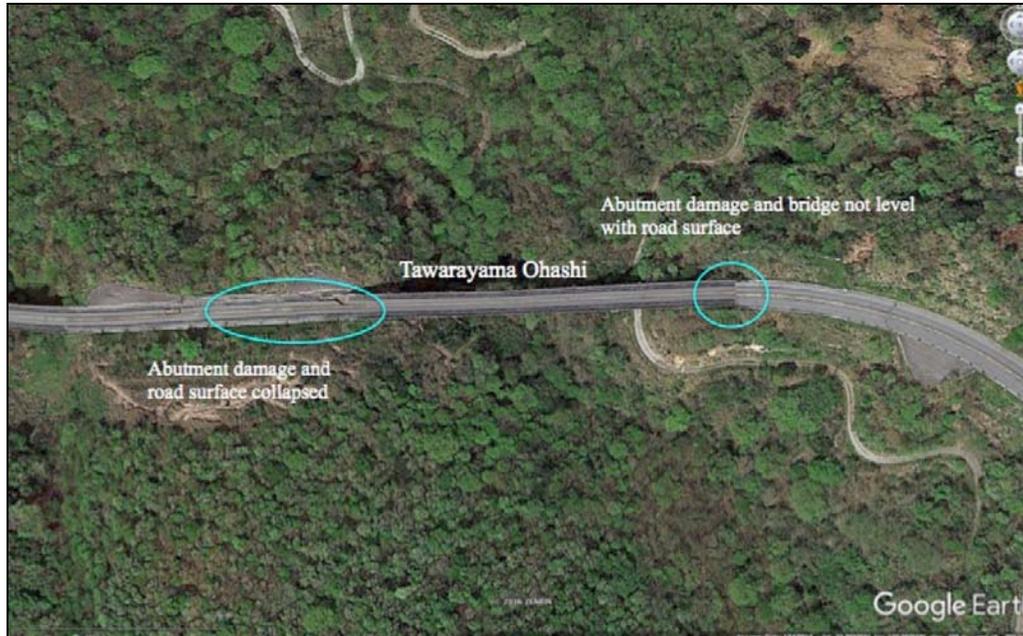
Figure 9-42. Aerial view of the failures of Tawarayama bridge. (Source: Google Earth)

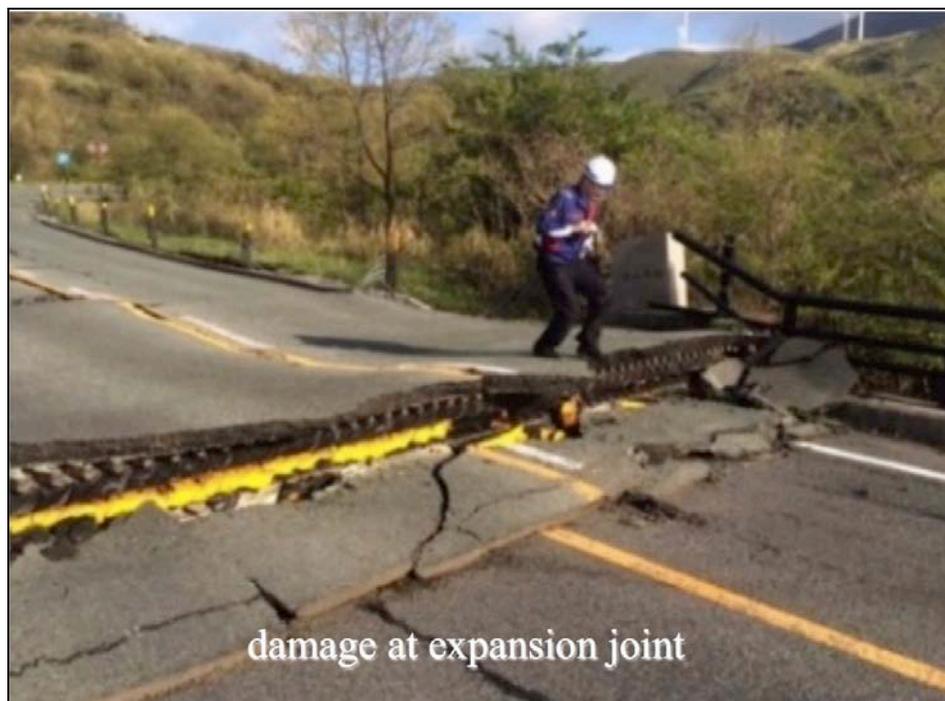
Figure 9-43. Close up view of the abutment damage at the expansion joint

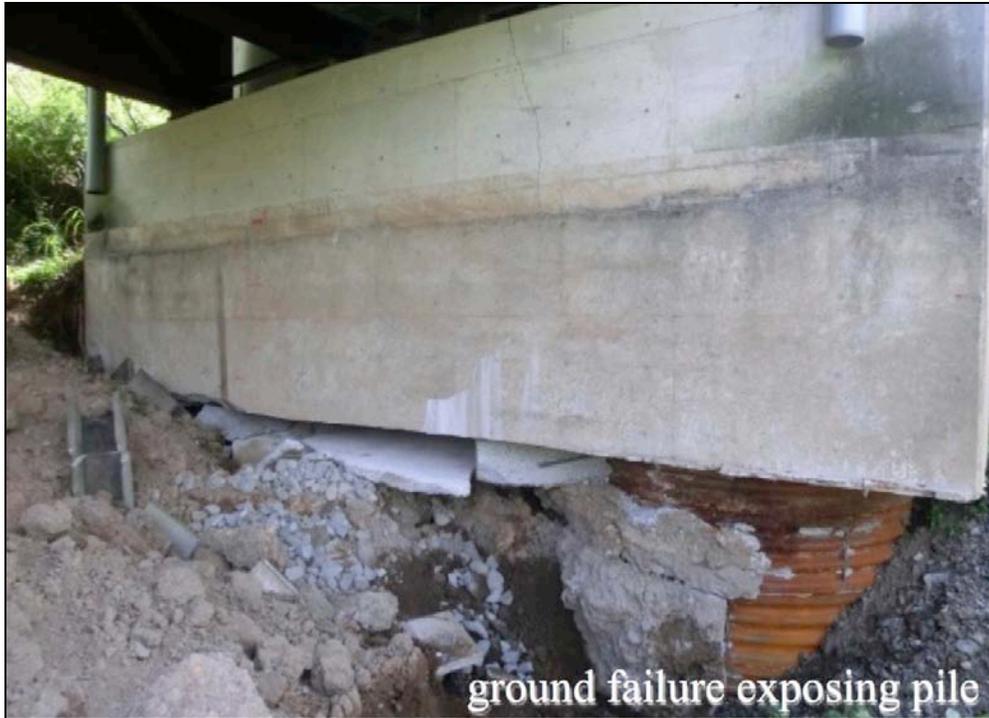
Figure 9-44. Ground failure close to the abutment support, the pile was exposed

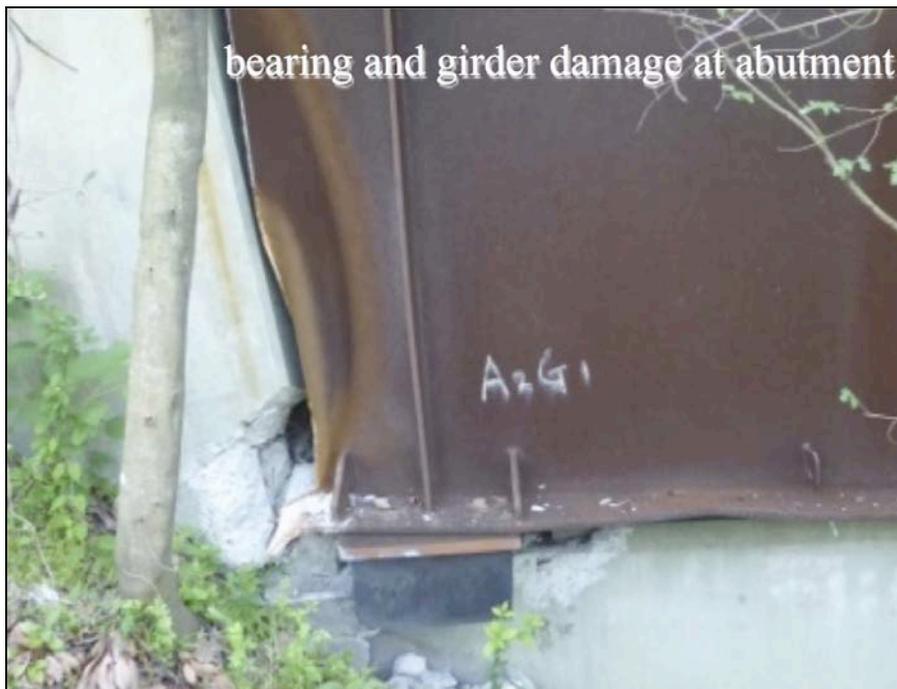
Figure 9-45. Damage to the abutment concrete and the bearing pad as well as the steel girder

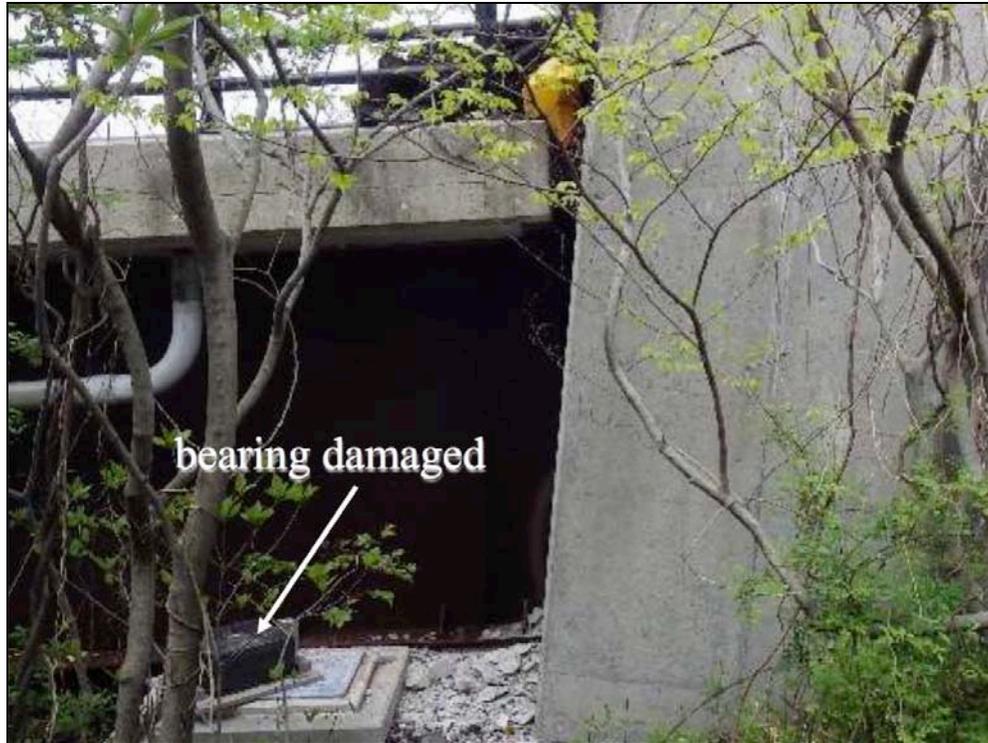
Figure 9-46. The steel girder slipped off the bearing pad

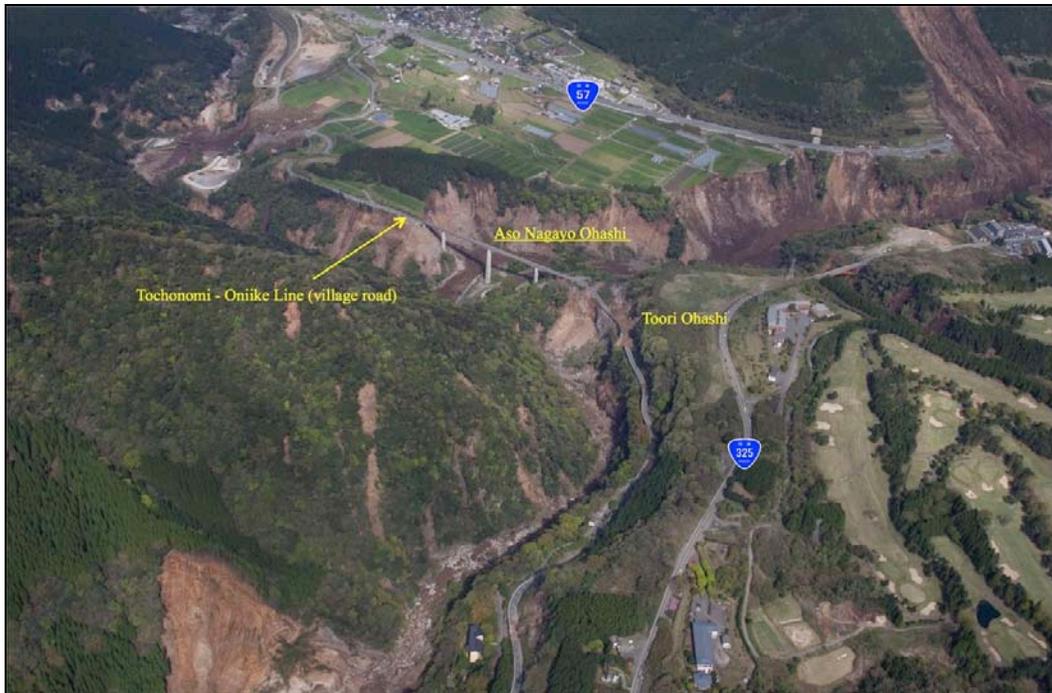
Figure 9-47. Locations of Aso Choyo and Toori Bridges, Aso Ohashi (collapsed) was on the top right hand corner

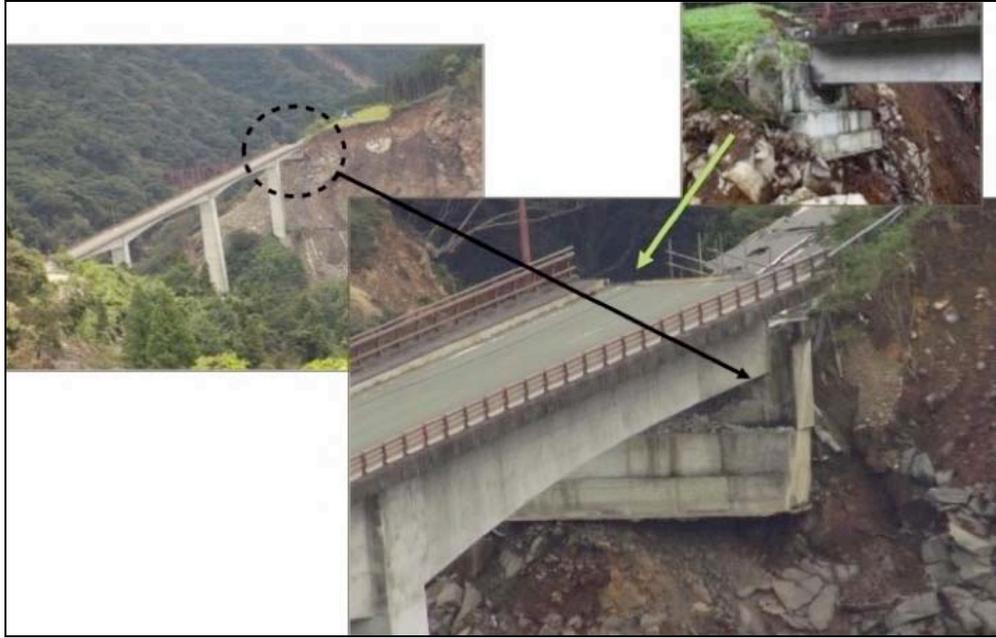
Figure 9-48. West end of the bridge, damage to the abutment and bridge deck

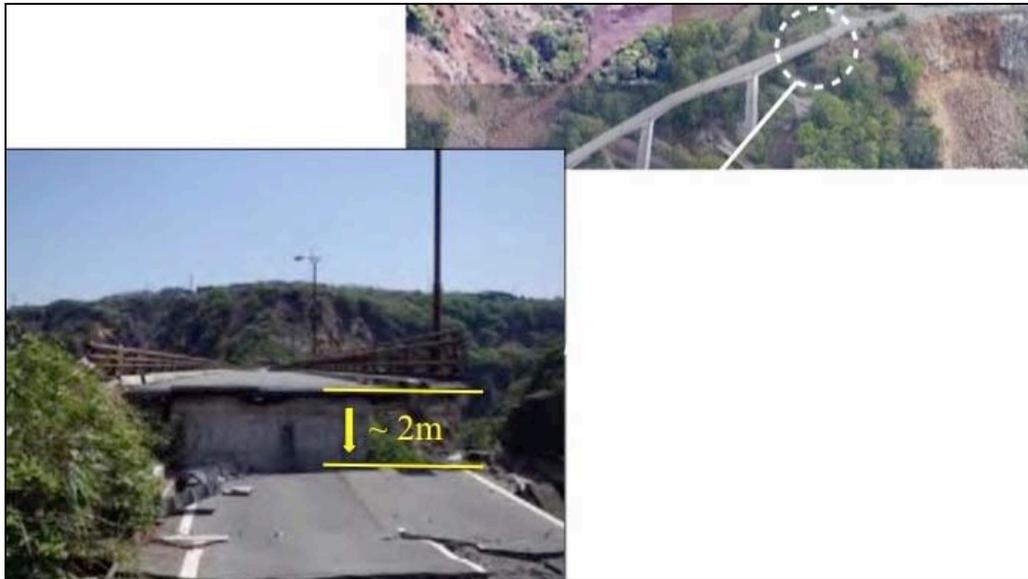
Figure 9-49. East end of the bridge, the abutment subsided about 2 meters

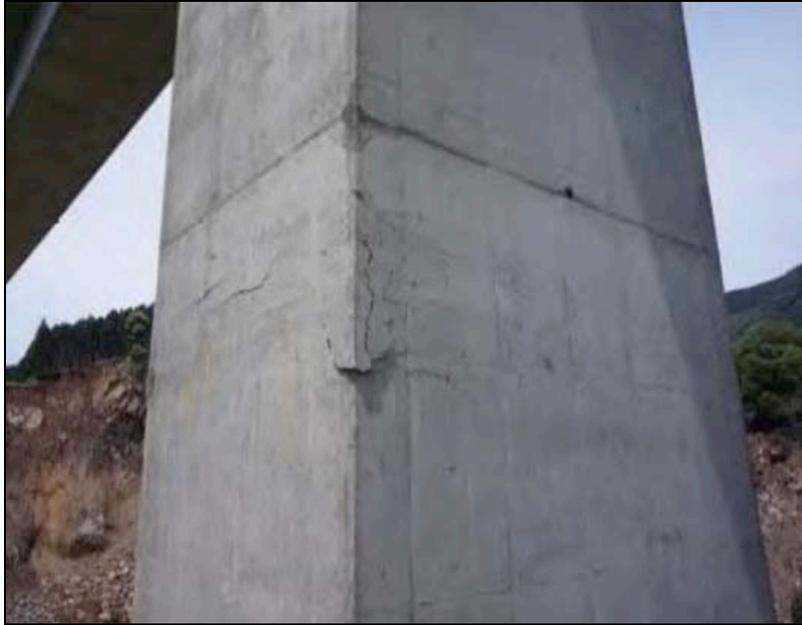
Figure 9-50. P2 pier close to the base showed concrete spalling
