KUMAMOTO, KYUSHU, JAPAN, EARTHQUAKES OF M_w 6.0 April 14, 2016 M_w 7.0 April 16, 2016 LIFELINE PERFORMANCE

ALEX K TANG and JOHN M EIDINGER

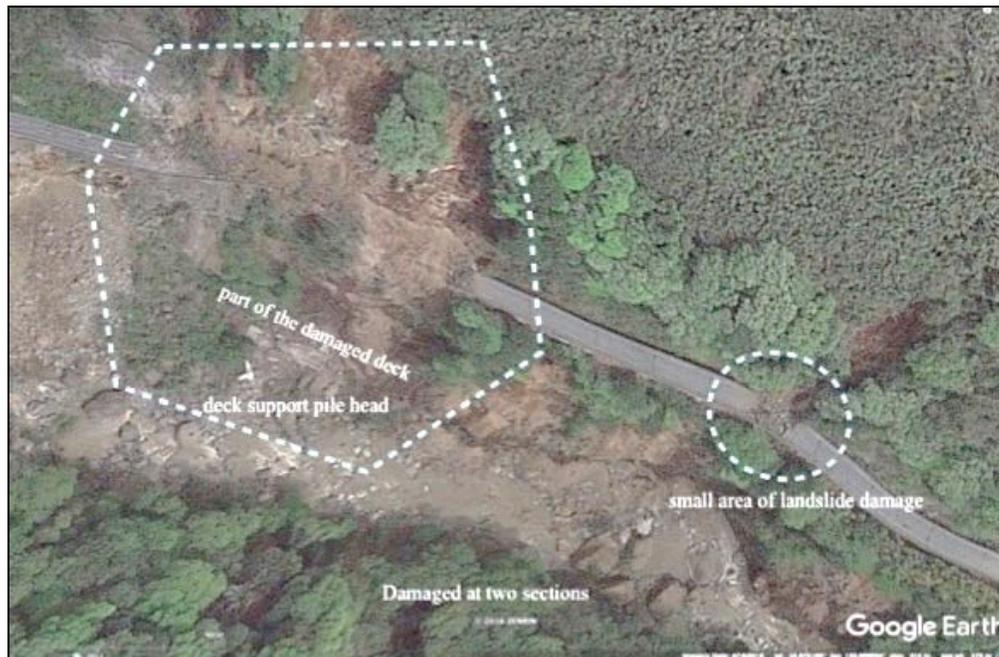
Figure 9-51. The bridge damage on the left hand side was about 60 m. The damage of the deck was small on the right hand side. (Source: Google Earth)

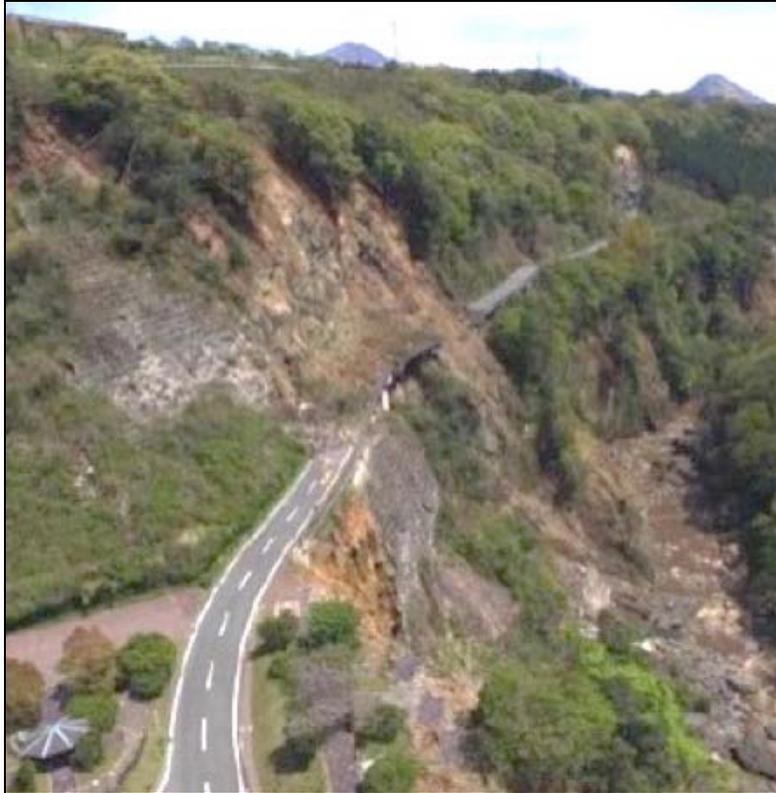
Figure 9-52. Aerial view (by MLIT drone) of destruction of this section of the bridge

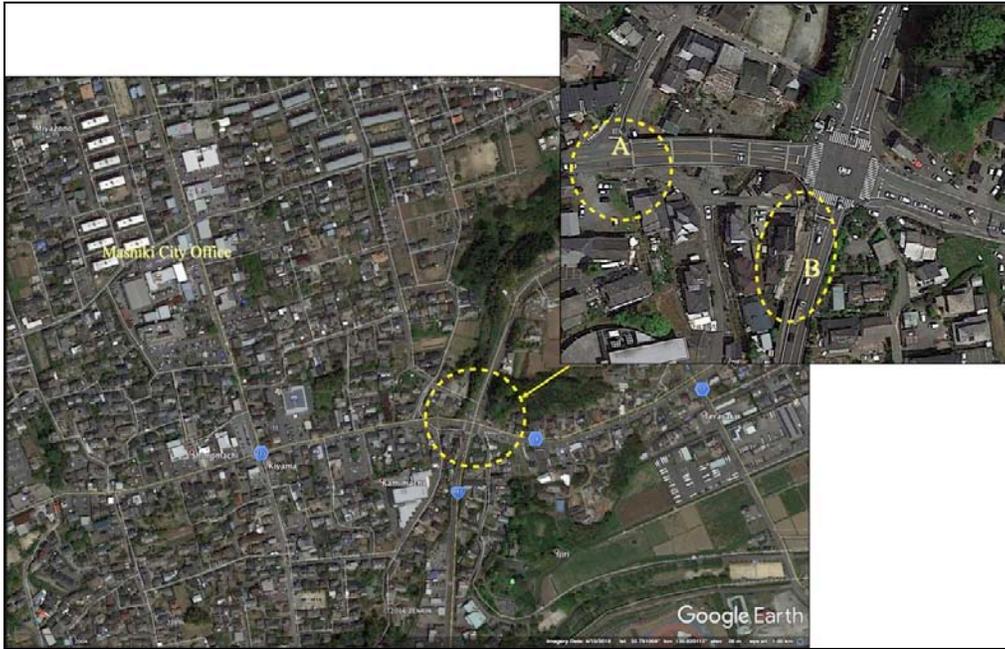
*Figure 9-56. Location of damaged bridge abutment (A) and the embankment failure (B)
(Source: Google Earth)*

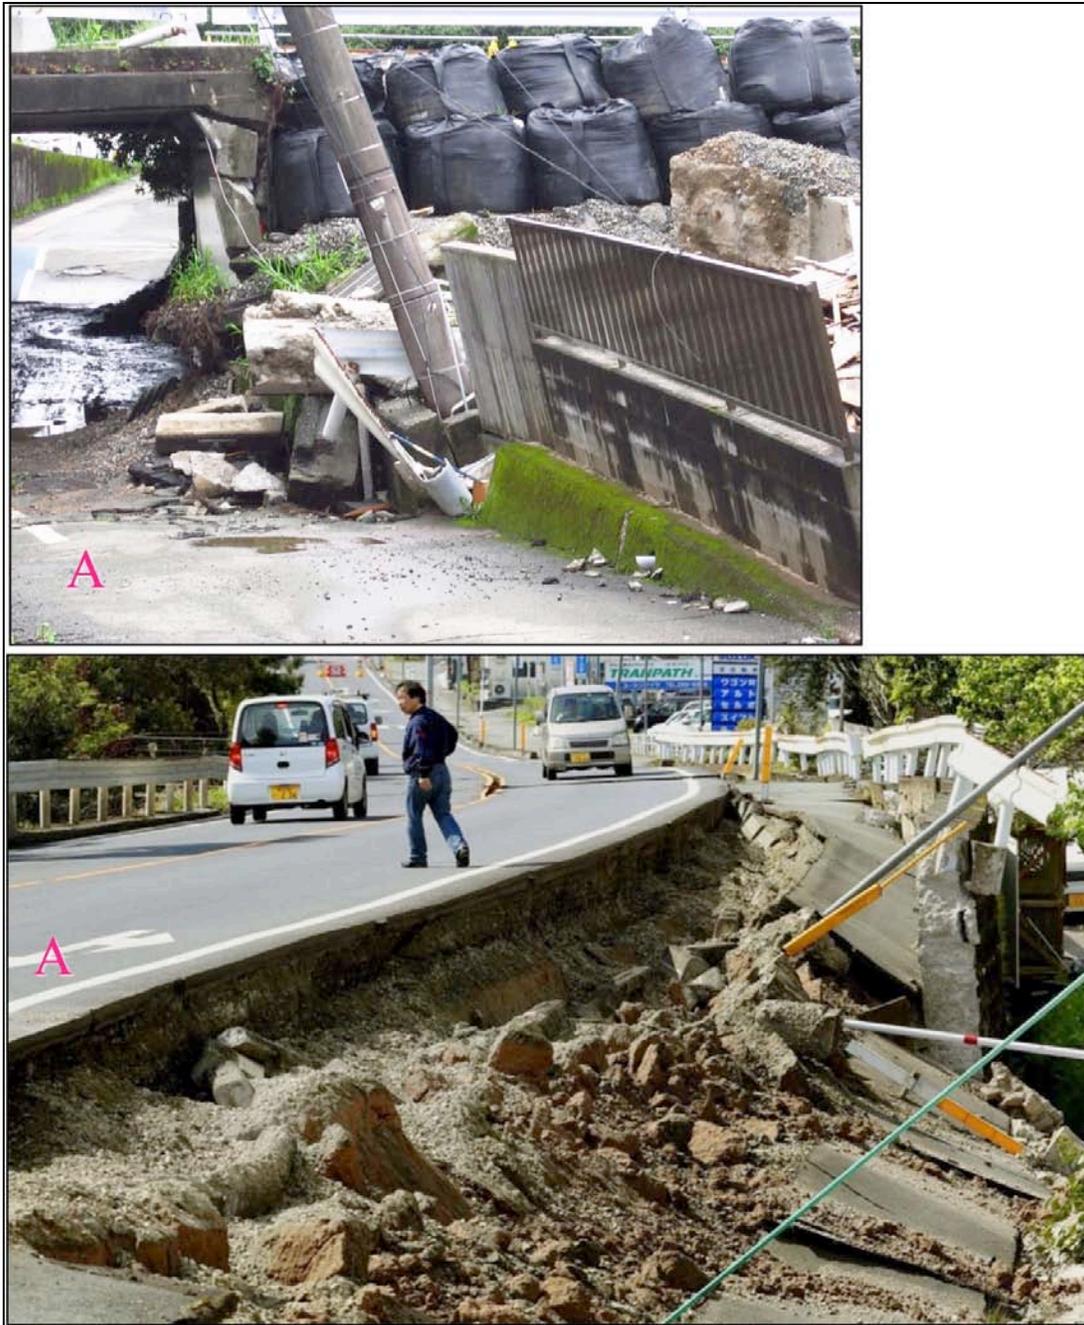
Figure 9-57. The embankment failure and temporary fix of (A)

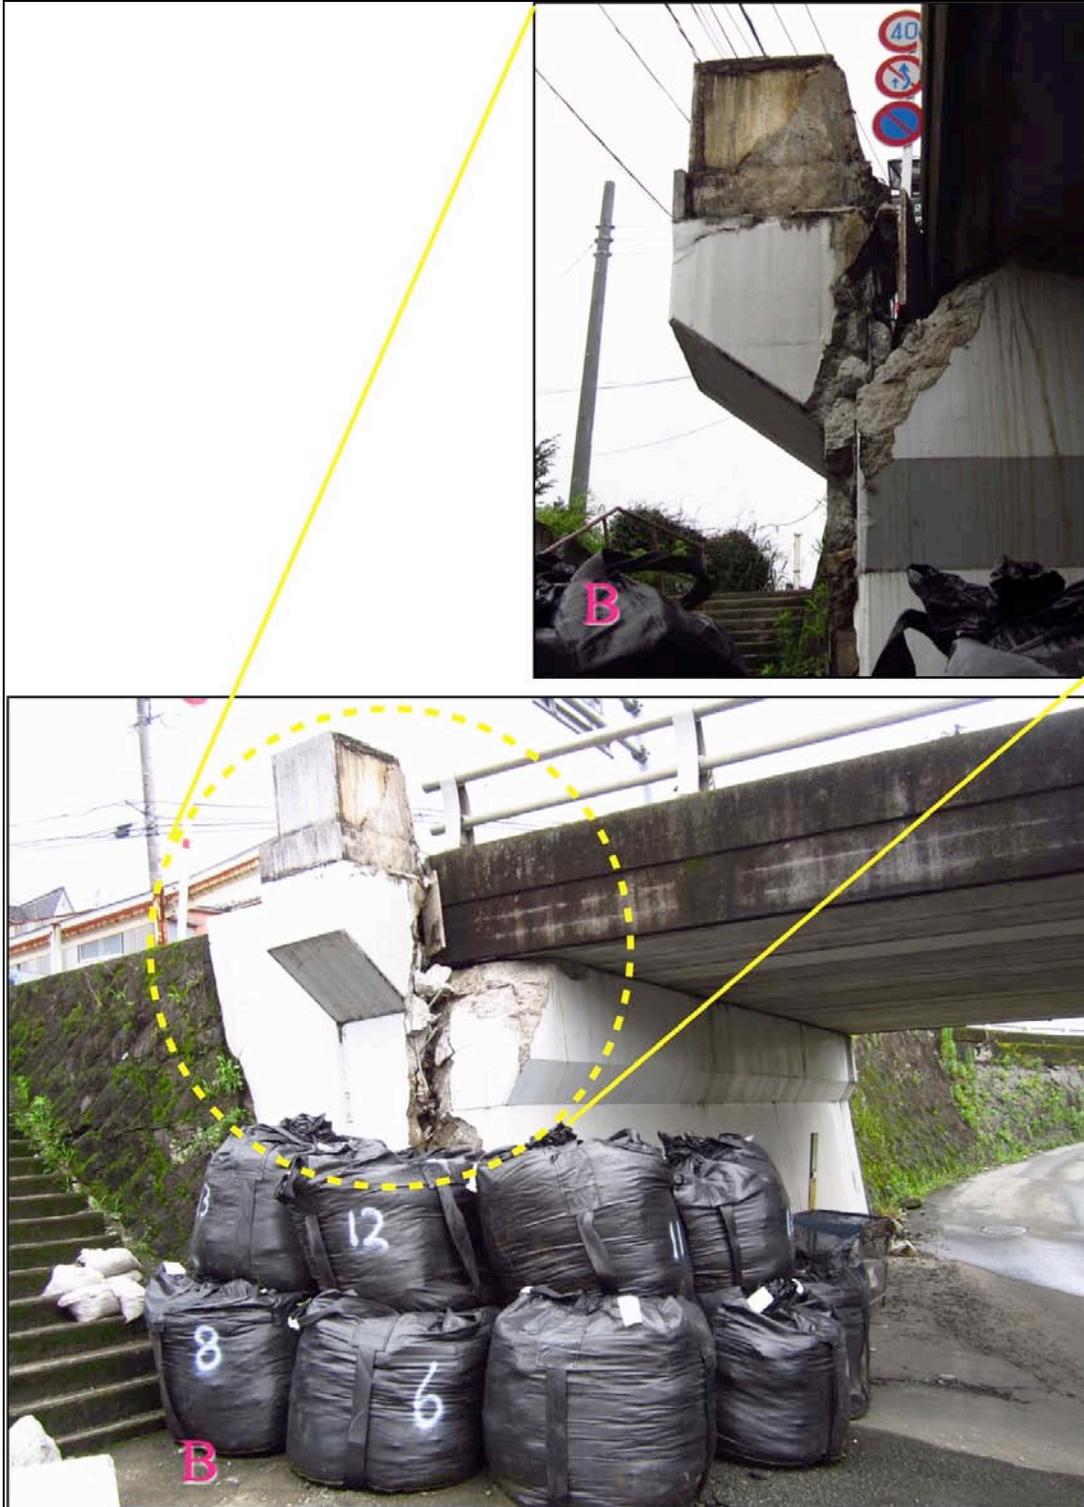
Figure 9-58. The bridge abutment failure at (B) and the temporary fix

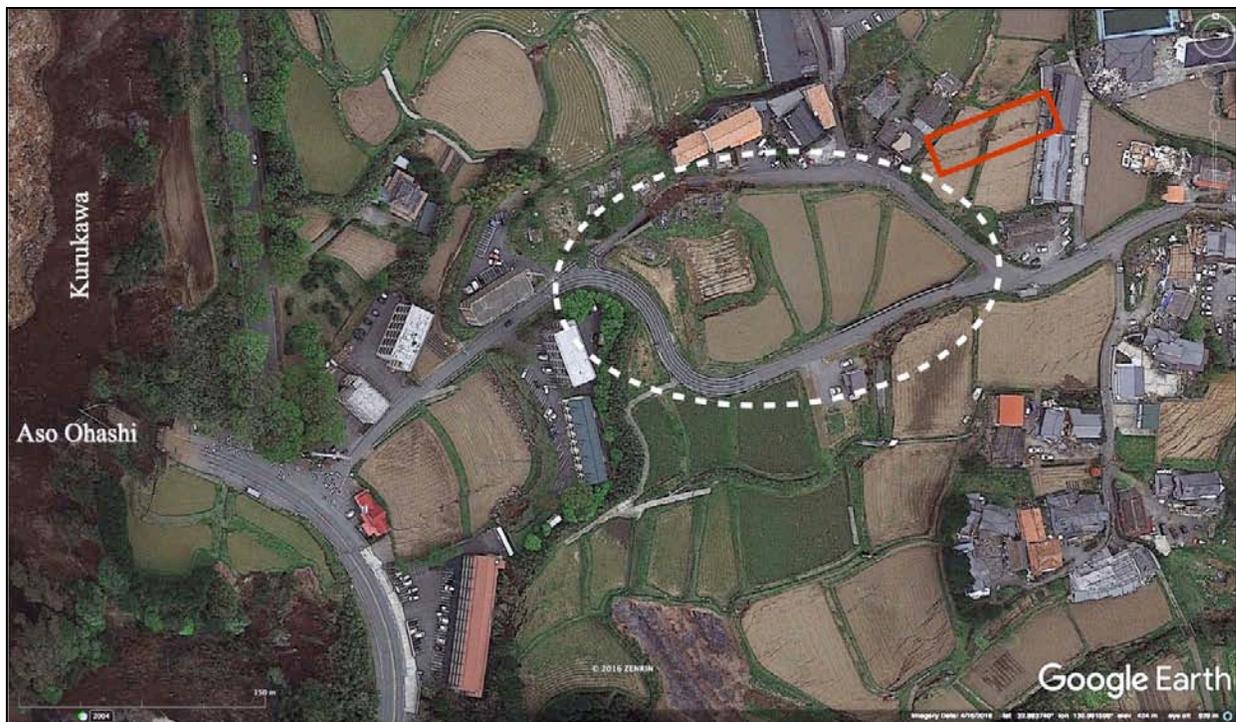
Figure 9-59. The circled area was explored by the investigation team. The red rectangle area shows the surface faulting. (Source: Google Earth)

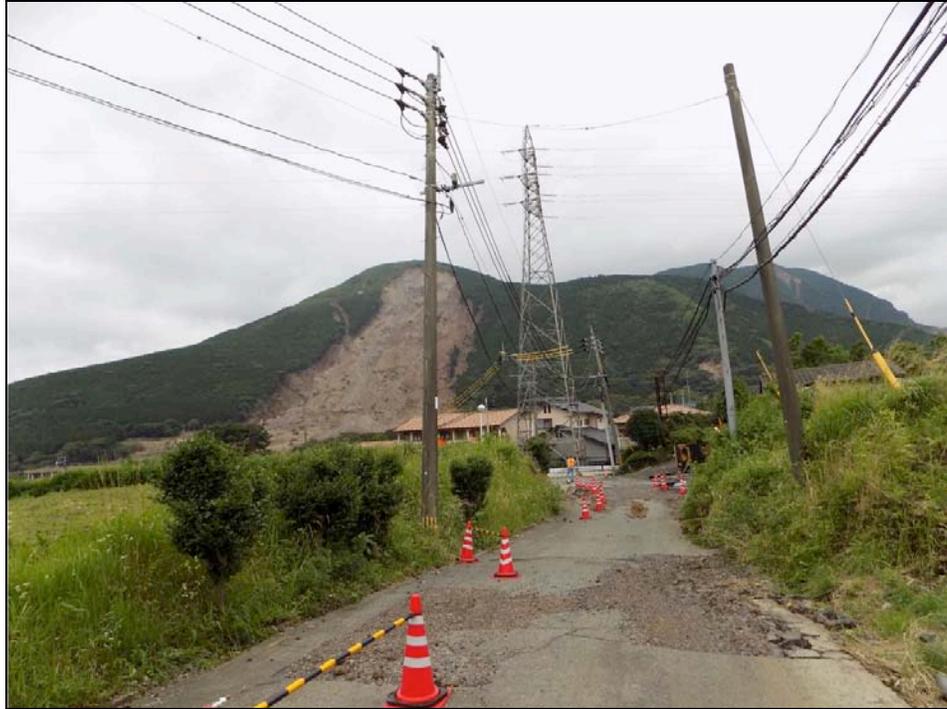
Figure 9-60. Slight road surface damaged. In the background is the major landslide described in Section 2. (Tang)

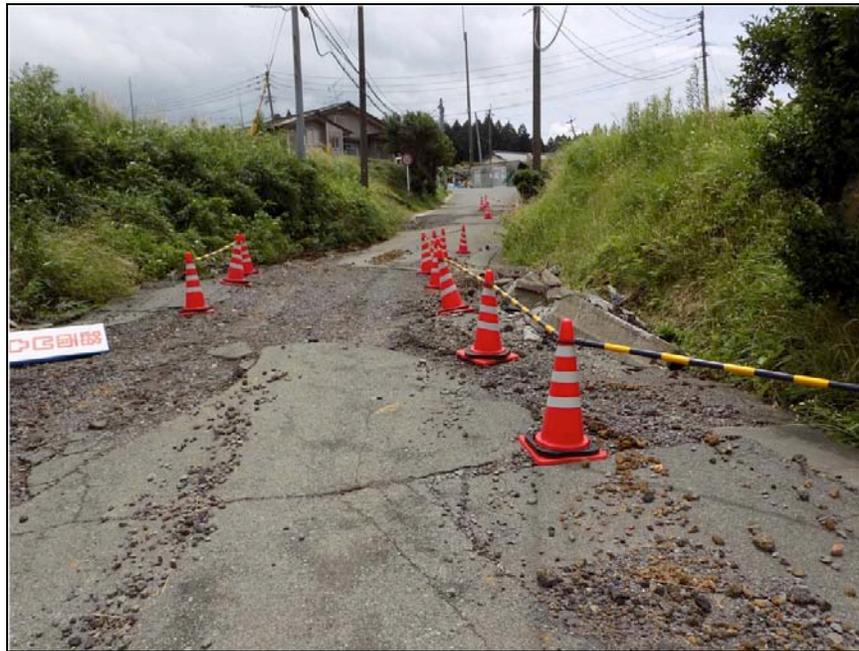
Figure 9-61. Road surface damaged but local traffic can still go around on this part of the road (Tang)

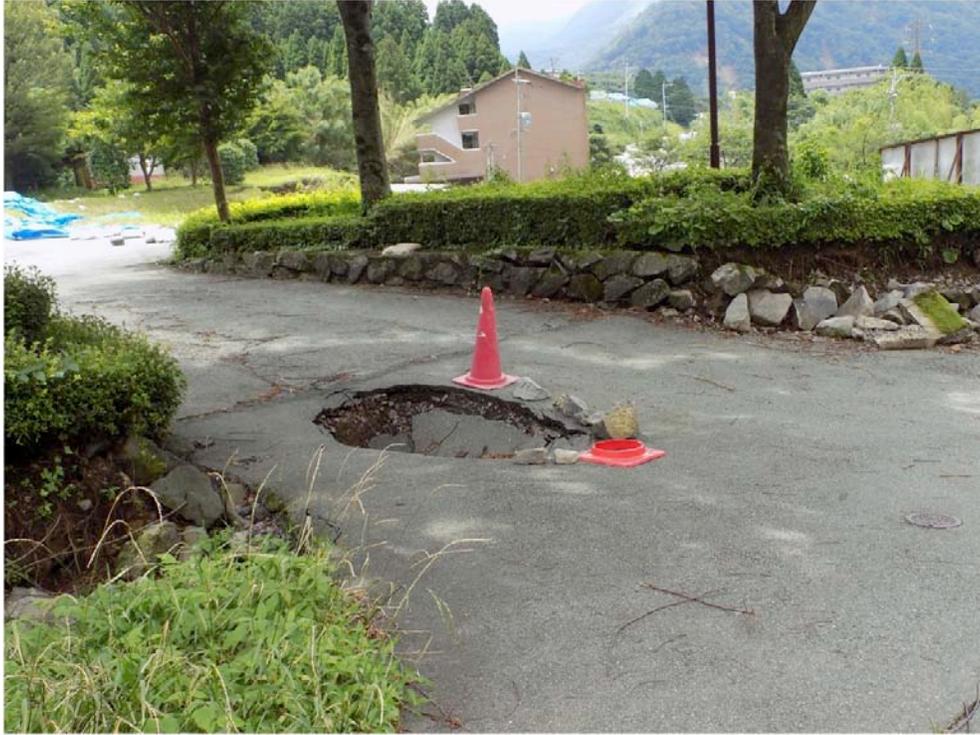
Figure 9-62. A sinkhole appeared here and it was not filled in when we were there in July (Tang)

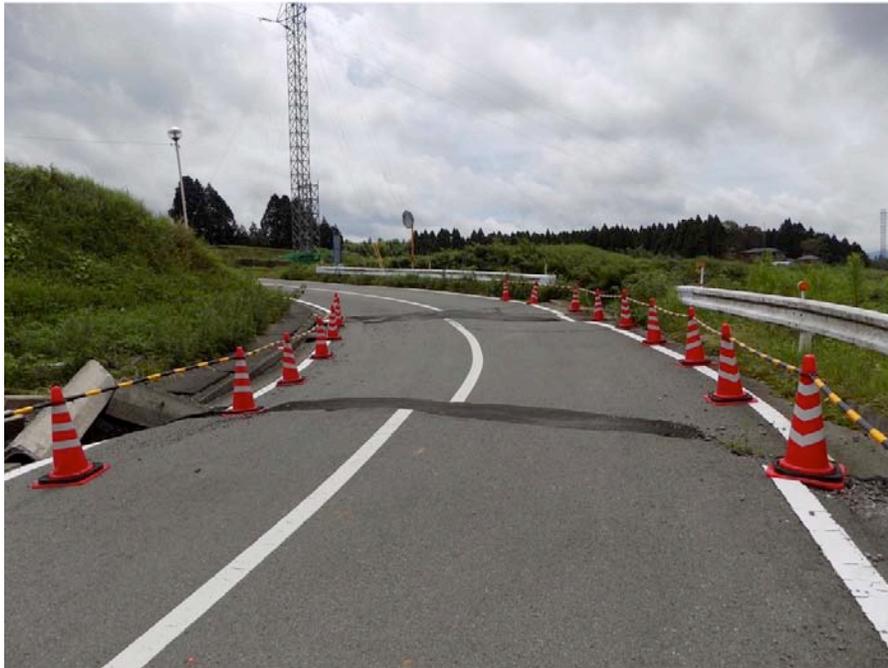
Figure 9-63. The cracks were filled with asphalt to allow traffic flow. This section of road was exposed to surface faulting. Note the destroyed surface water drain on the left side of the road has not yet been repaired. (Tang)

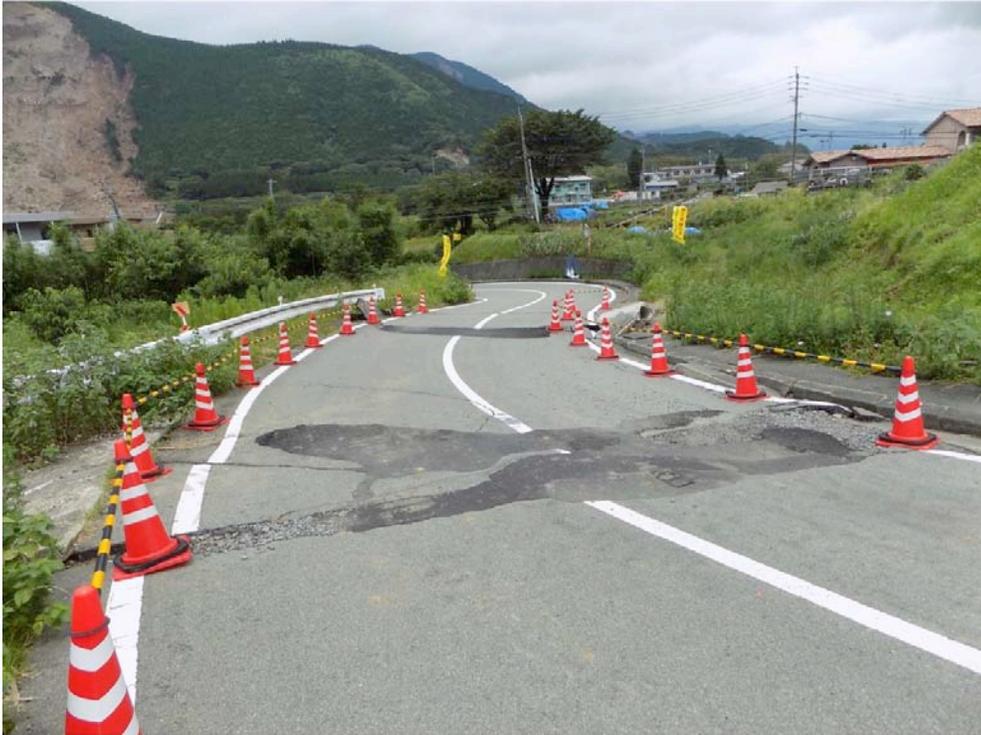
Figure 9-64. This part of road was temporarily paved to allow traffic flow (Tang)

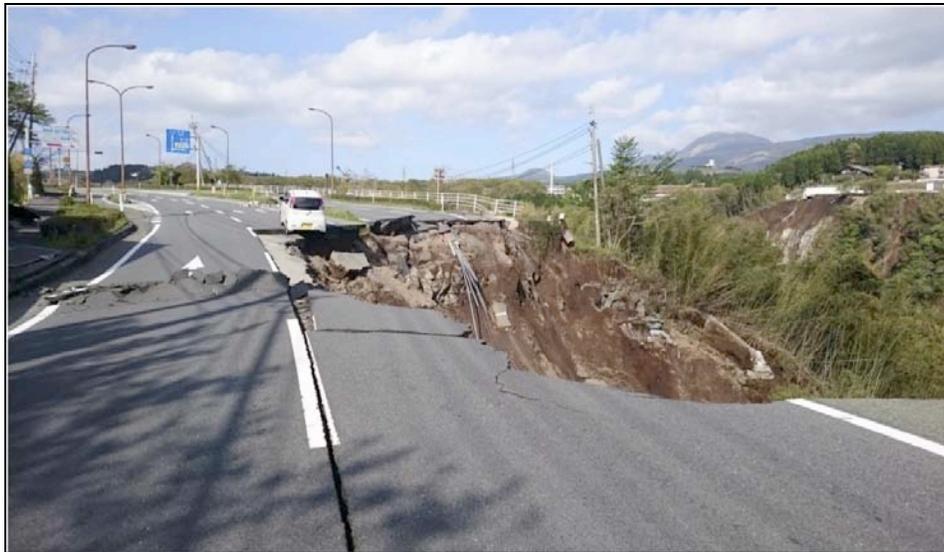
Figure 9-65. Slope failure took this part of the road (Route 57) down the slope

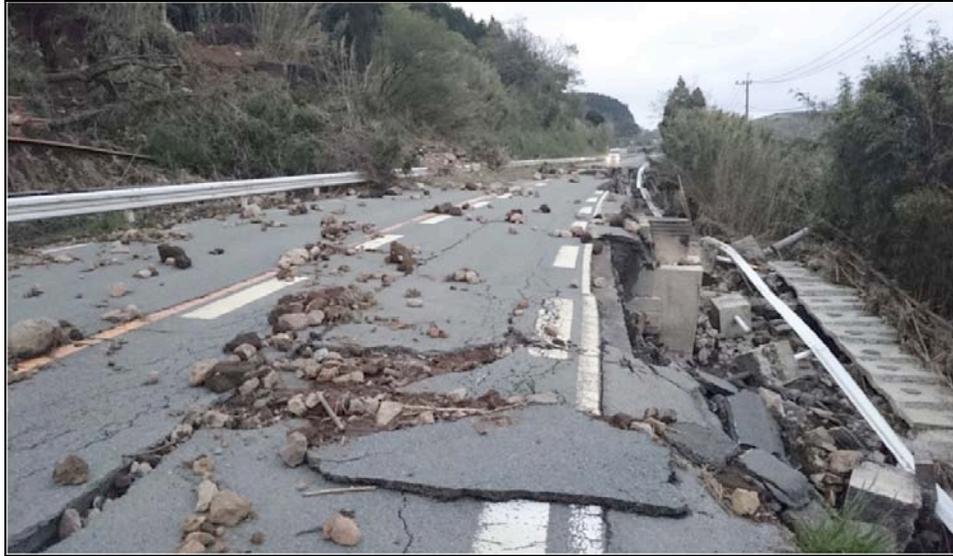
Figure 9-66. Embankment failure due to lateral spreading damage this part of Route 57

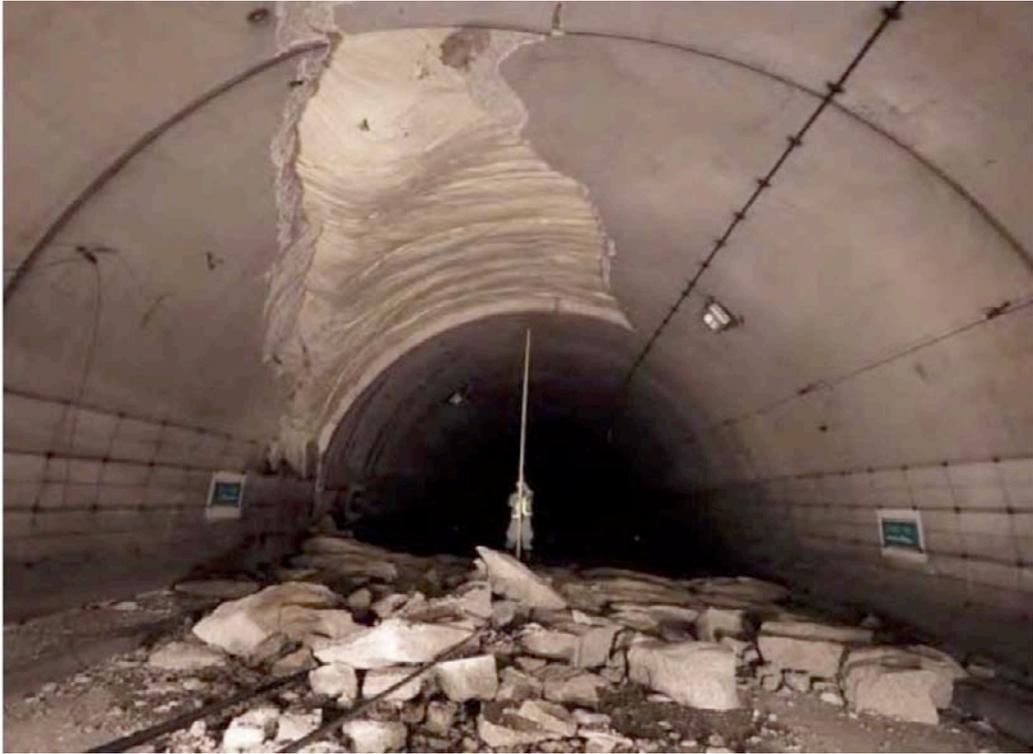
Figure 9-67. Tunnel cladding broke off, these were very large pieces of concrete

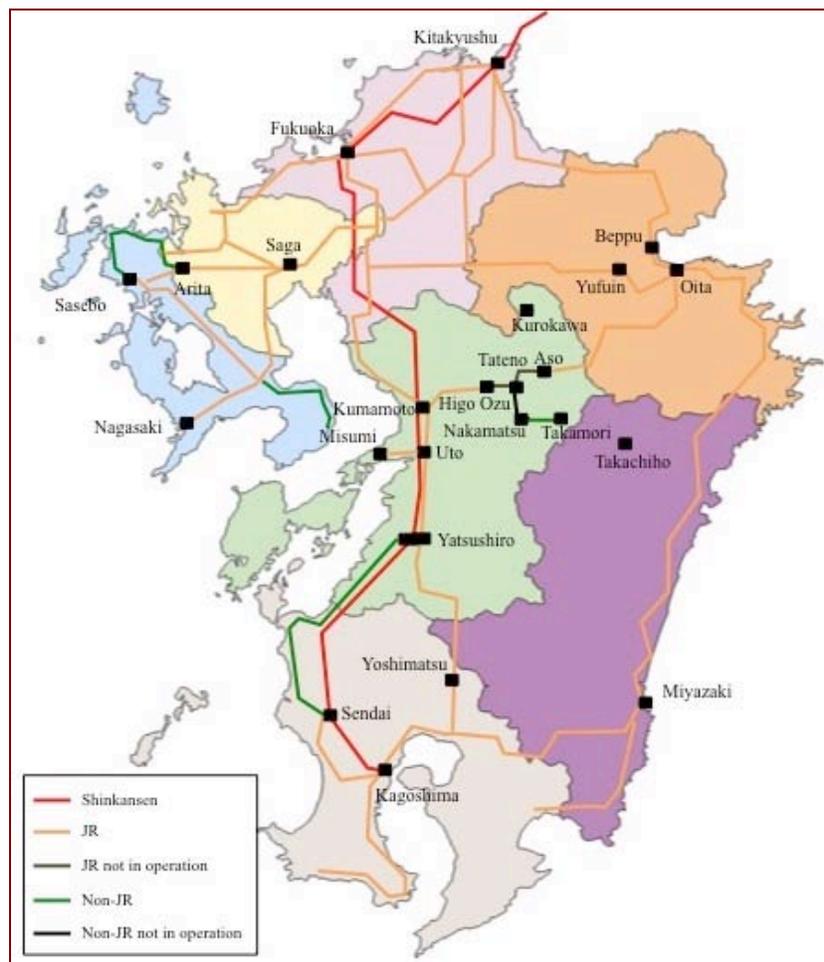
Figure 9-71 Kyushu Railway map (Base map from Reference 1)

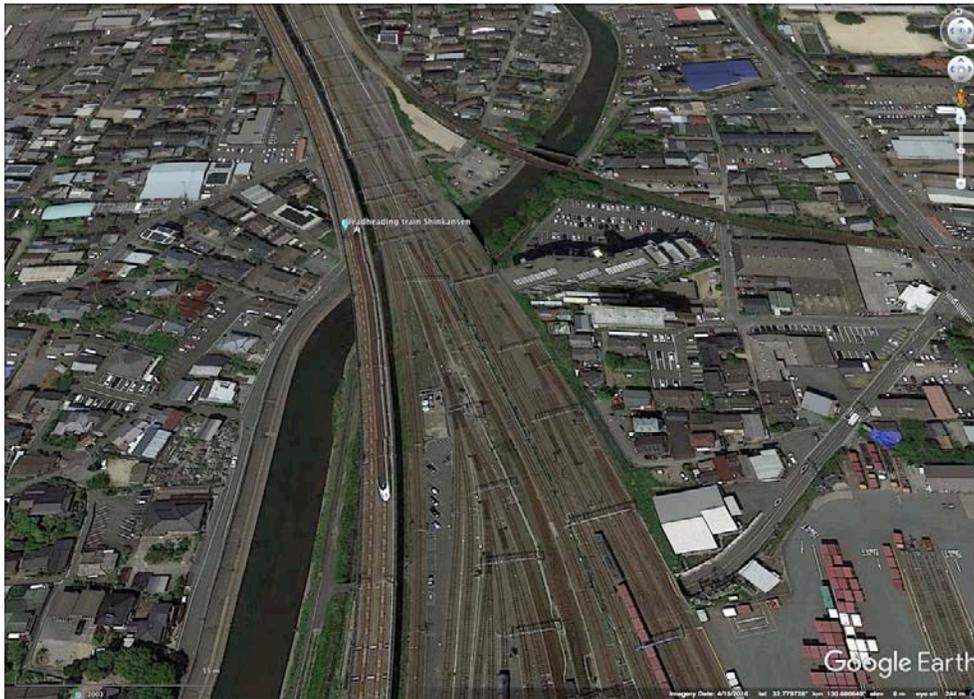
Figure 9-72. Aerial view of the location where the deadheading Shinkansen derailed. Kumamoto Station is about 1 km north of this location

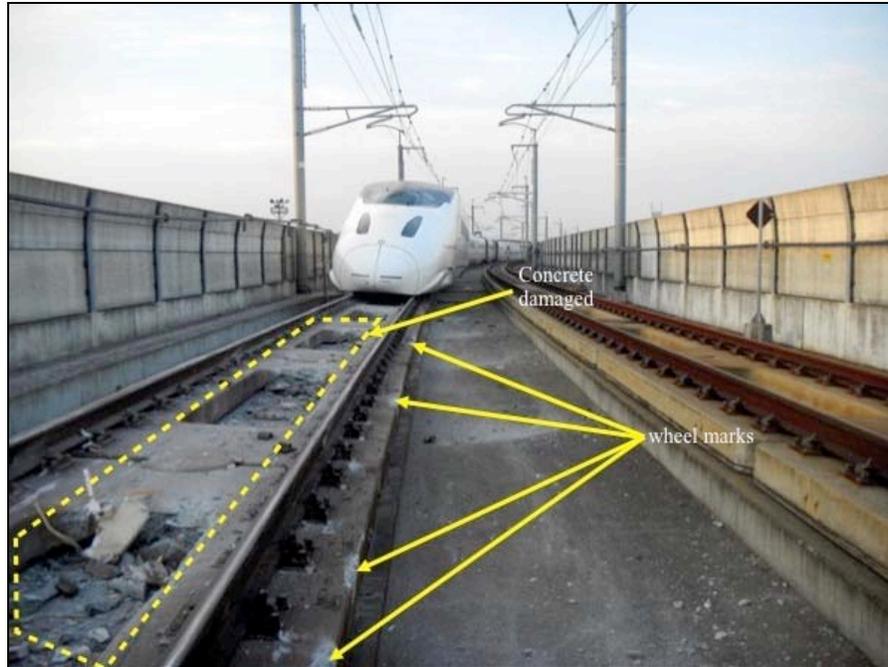
Figure 9-73 This deadheading Kyushu Shinkansen derailed closed to Kumamoto Station after the 14 April 2017 earthquake (the foreshock)

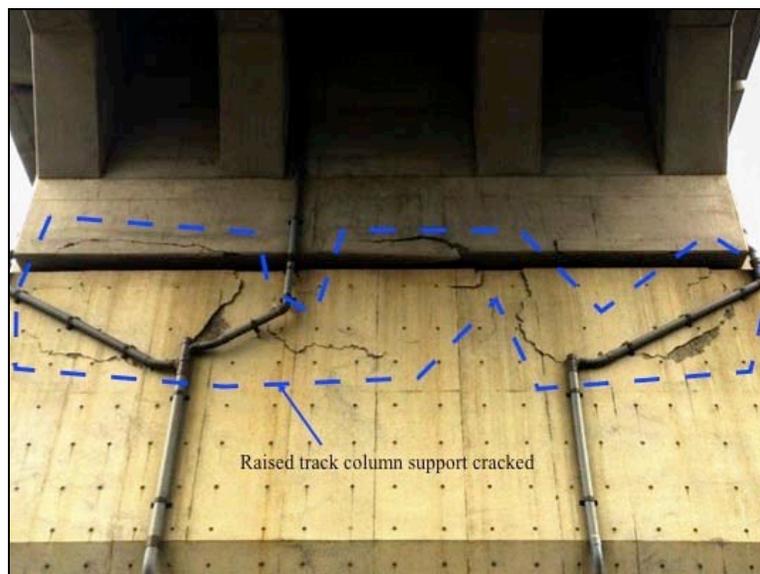
Figure 9-74 Raised track support column cracks

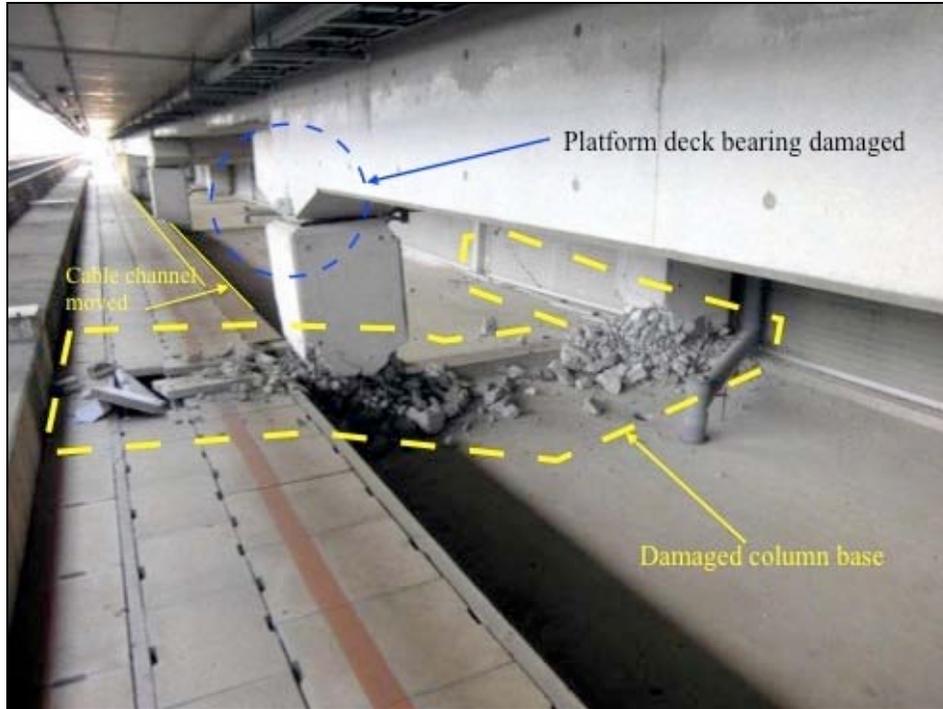
Figure 9-75. Bearing support column was damaged most likely due to the shifted cable duct structure

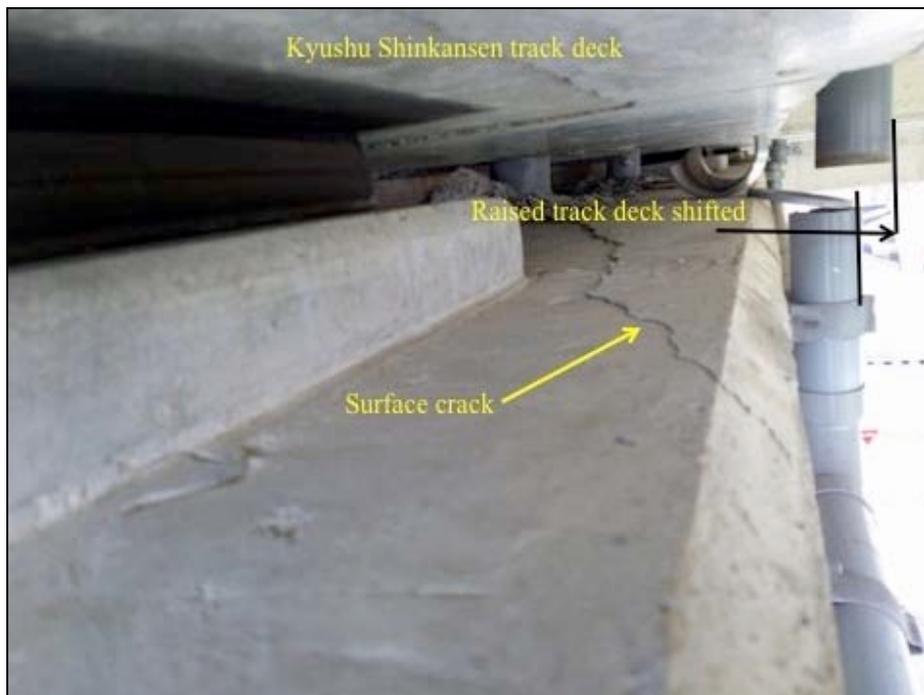
Figure 9-76. The rail platform shifted and broke the drain pipe. The concrete surface also showed cracks. Note the bearing is very close to the edge of the support

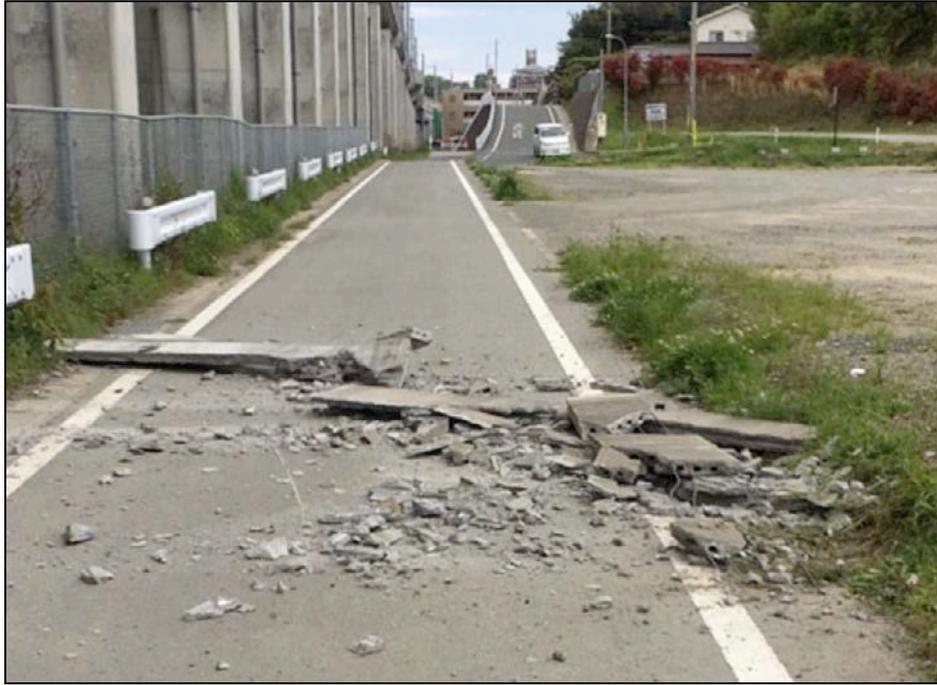
Figure 9-77 The sound barrier of the raised track fell to the ground

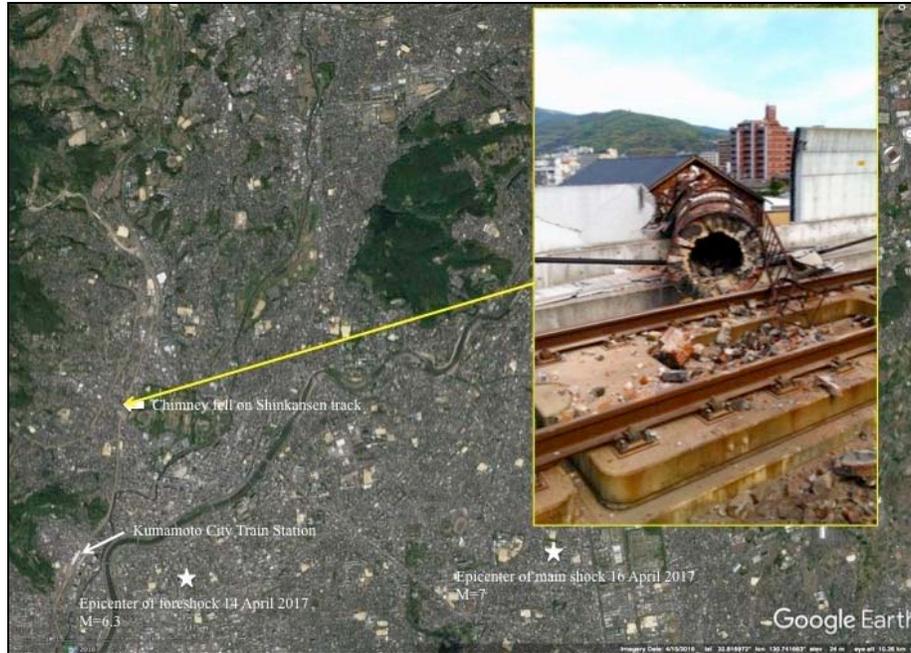
Figure 9-78. The chimney broke apart after falling on the raised track. Luckily it did not damage the rails; only the sound barrier was damaged. (Source: Google Earth and Fukuoka MLIT)

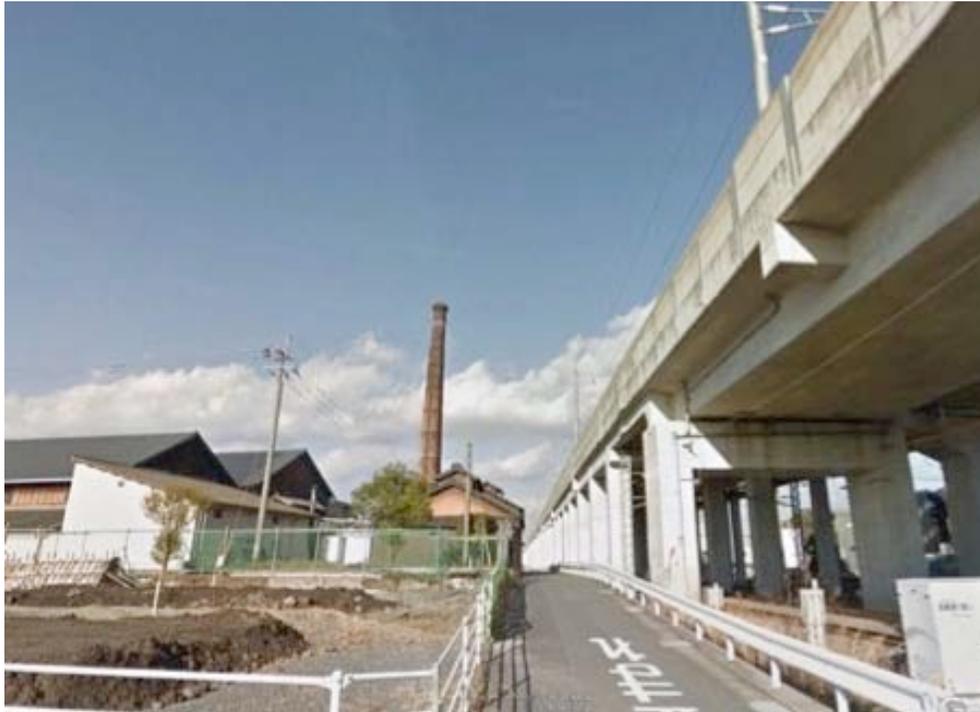
Figure 9-79. This photo shows the tall chimney before the earthquake, on the left side of the service road and the Shinkansen raised tracks

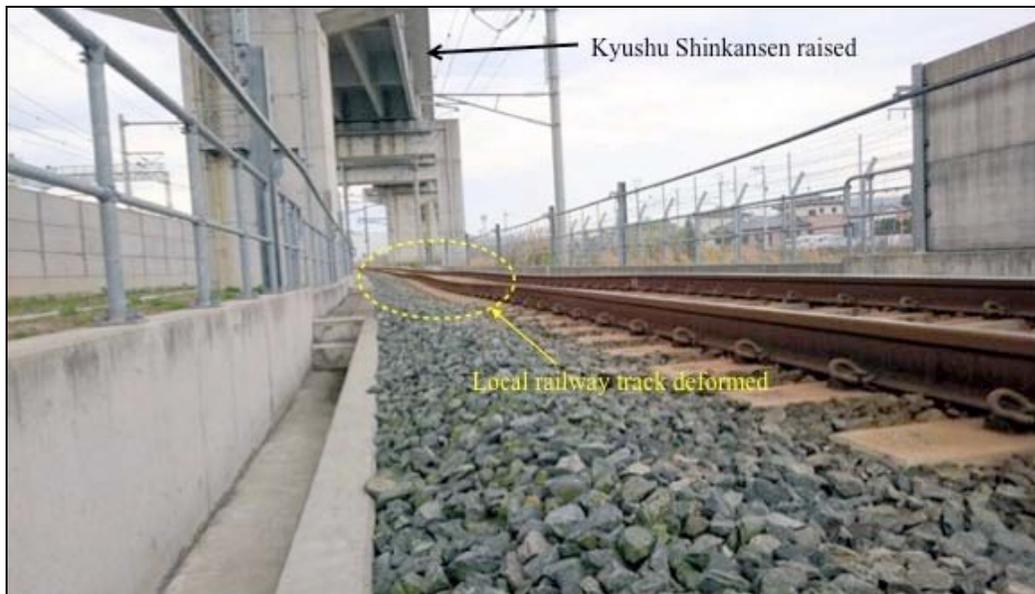
Figure 9-80. This section of JR tracks were deformed

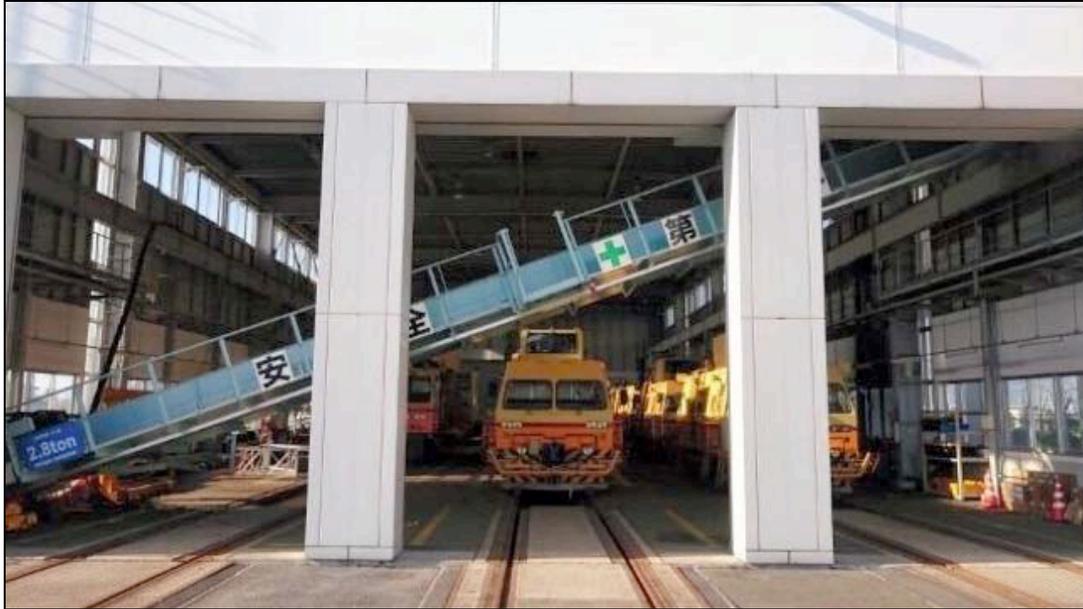
*Figure 9-81. The service crane was dislocated from the track along the sidewall.
(Source: Fukuoka MLIT)*

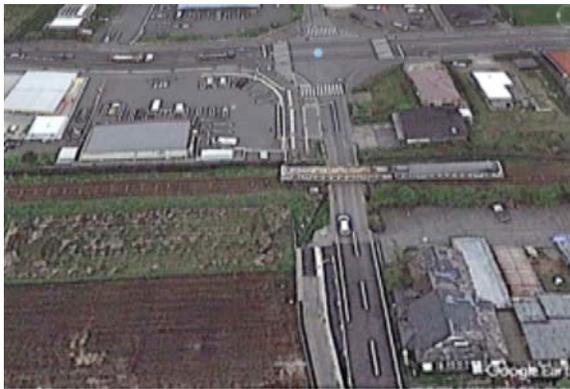
Figure 9-82. The train station is on the right this photo.

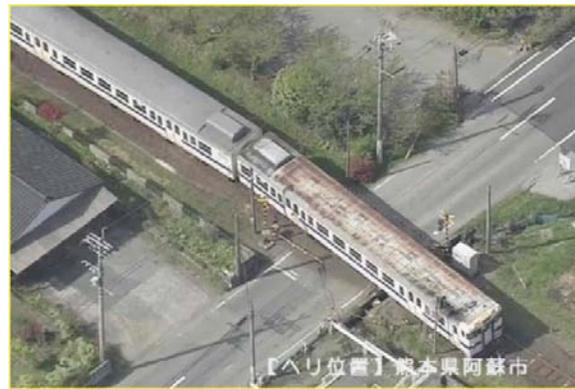
Figure 9-83. Aerial view of the derailment (Source: MILT Kyushu)

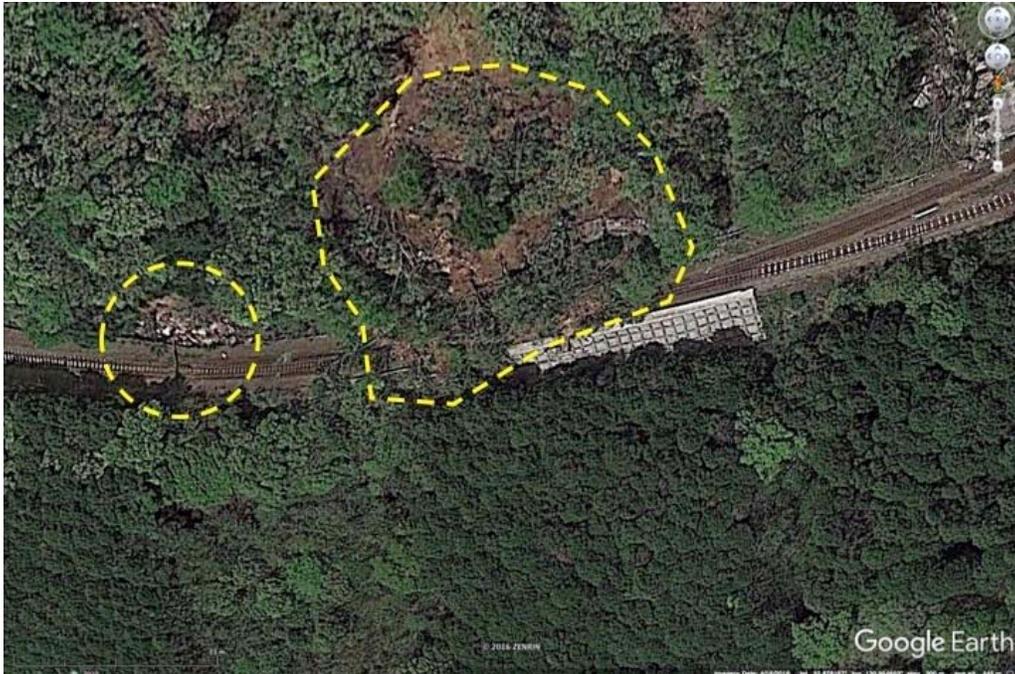
*Figure 9-84 Landslides damaged the train tracks at two places (N32.8782°, E130.9546°)
(Source: Google Earth)*

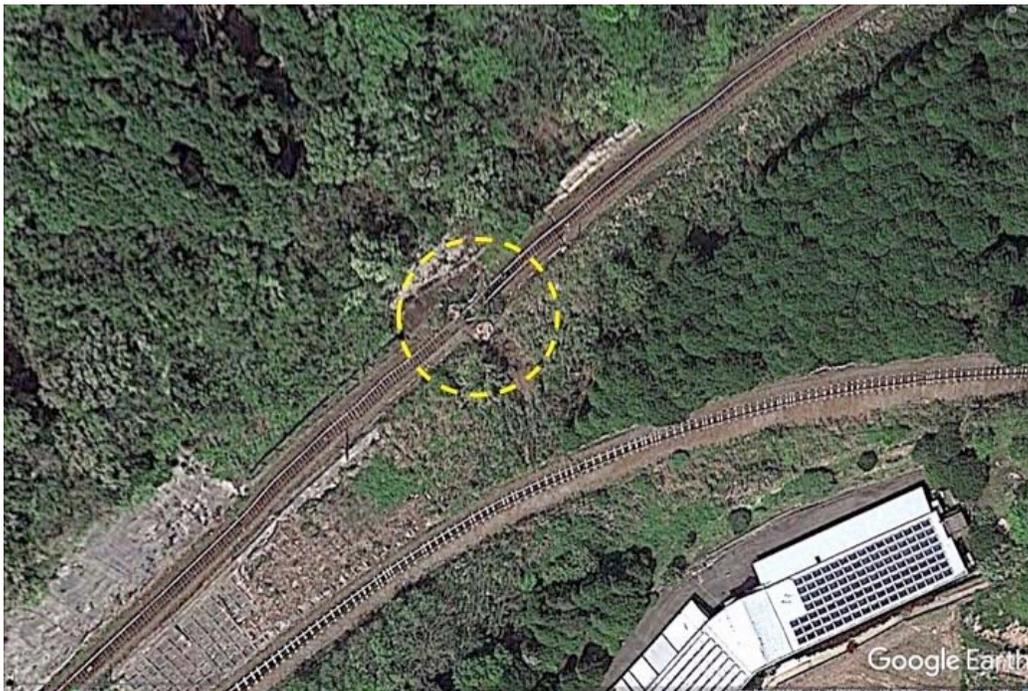
Figure 9-85. Rock fall damaged this section of the train track, located just east of Figure 8.1 (N32.879°, E130.9569°) (Source: Google Earth)

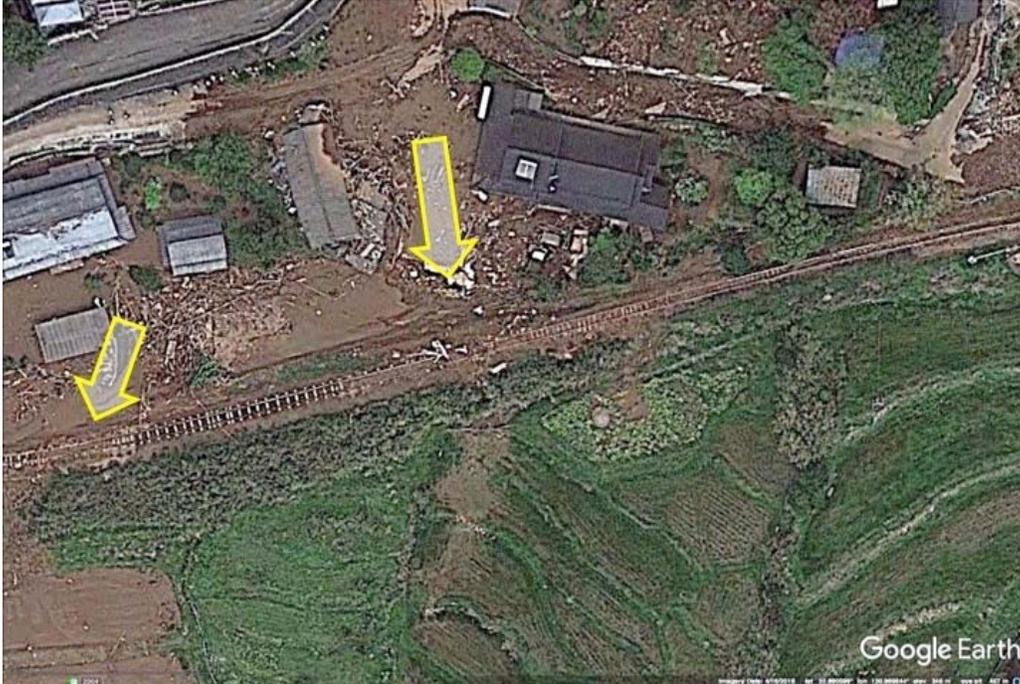
Figure 9-86. Debris flow on to the train track (N32.880°, E130.969°) (Source: Google Earth)

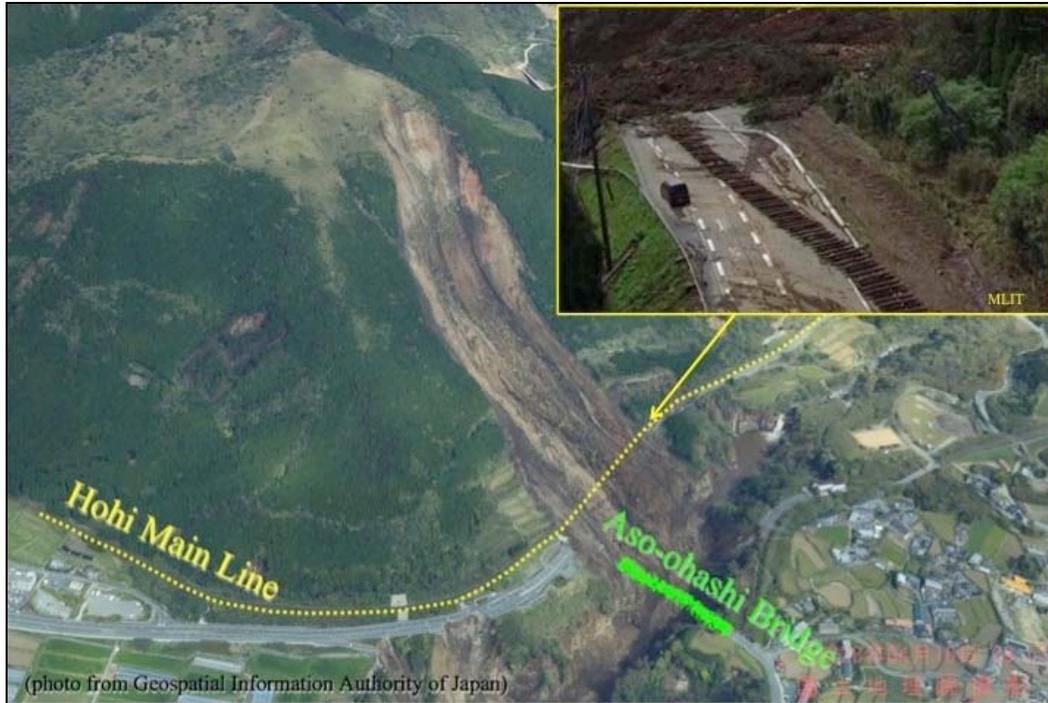
Figure 9-88. This is the great landslide site, the signature failure of this earthquake. A long section of the Hohi Main Line was damaged and covered under tons of mud and rocks. The insert shows the dislocation of the train tracks to route 57 below it, caused by the landslide. (N32.88387°, N130.98705°)

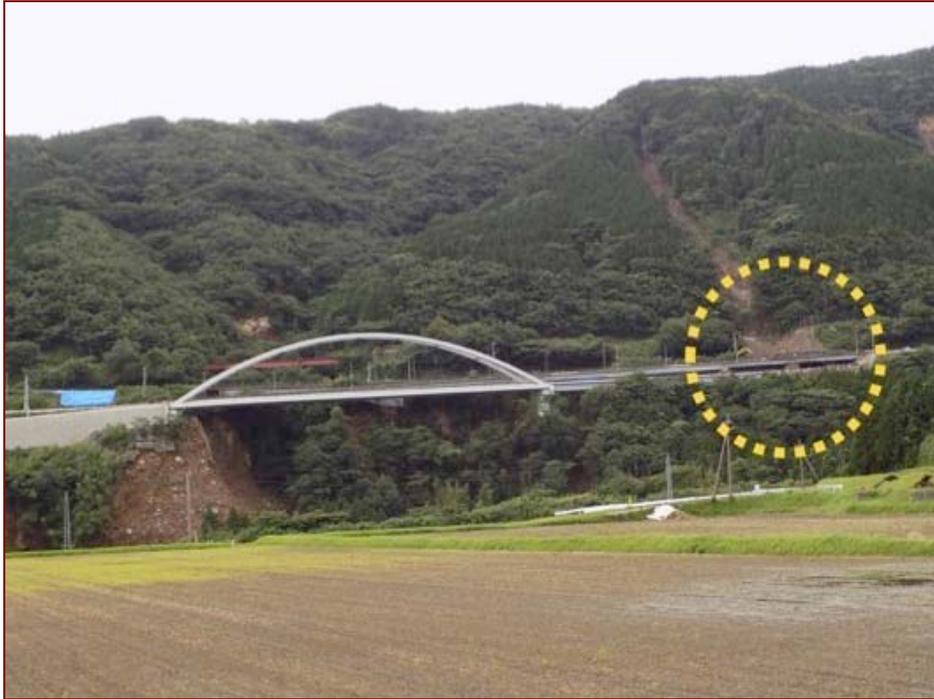
*Figure 9-89. Heavy rainfalls initiated this landslide that covered the tracks. (N32.87685°
E130.94996°)*
