KUMAMOTO, KYUSHU, JAPAN, EARTHQUAKES OF M_w 6.0 April 14, 2016 M_w 7.0 April 16, 2016 LIFELINE PERFORMANCE

ALEX K TANG and JOHN M EIDINGER

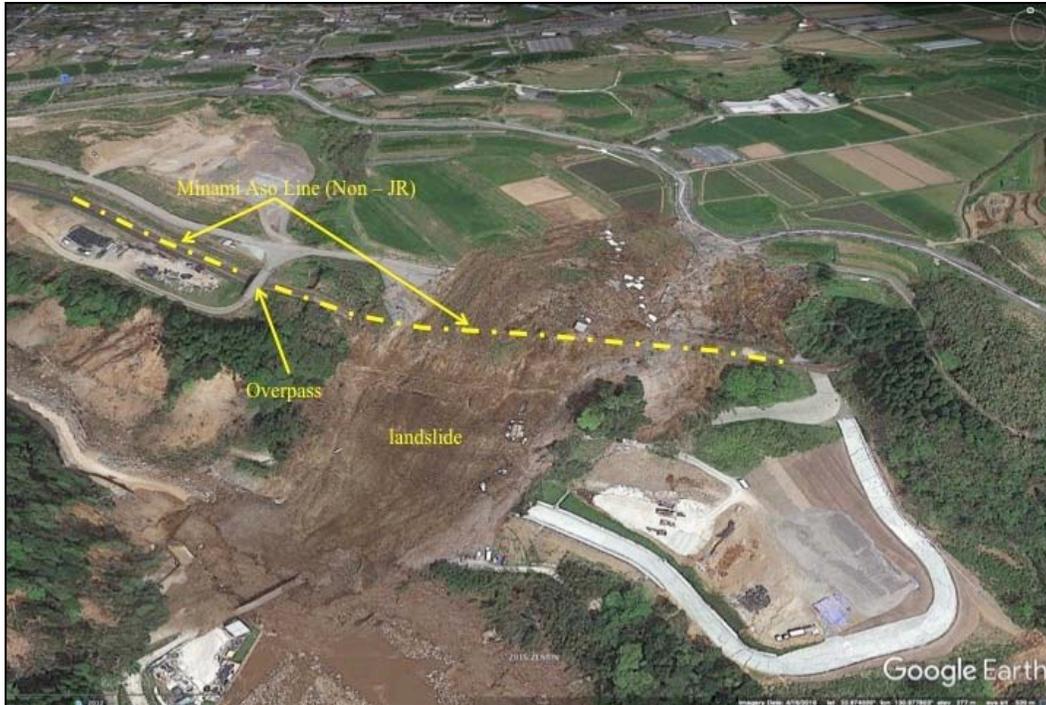
Figure 9-90. The landslide at this location is very large, it covered and damaged the train track as well as the county road below. (N32.87412°, E130.9778°). The landslide also covered a temporary construction office site. (Source: Google Earth)

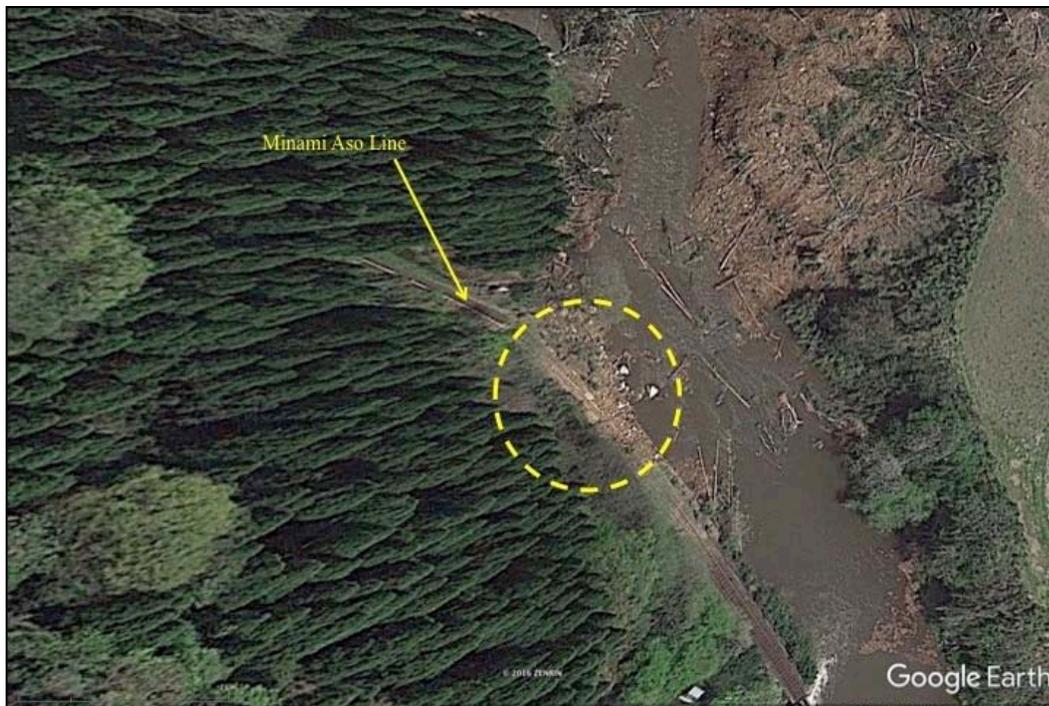
Figure 9-91. A combination of debris flow and landslide across the river caused the scouring of the ground under the track. (N32.86774°, E130.9909°) (Source: Google Earth)

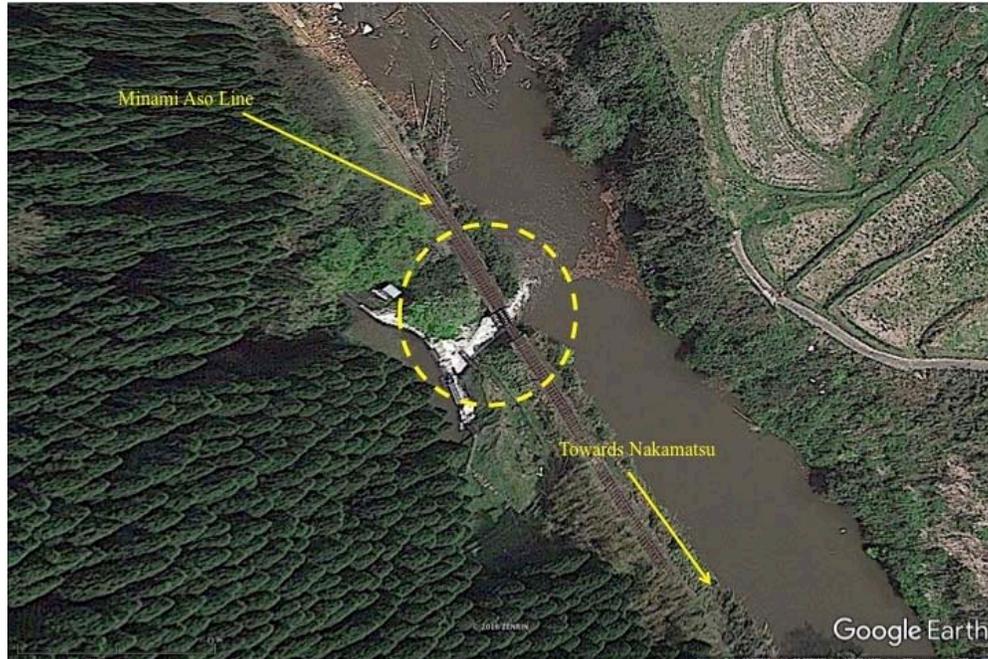
Figure 9-92. Part of the bridge that supported the tracks was damaged (N32.86712°, E130.9914°) (Source: Google Earth)

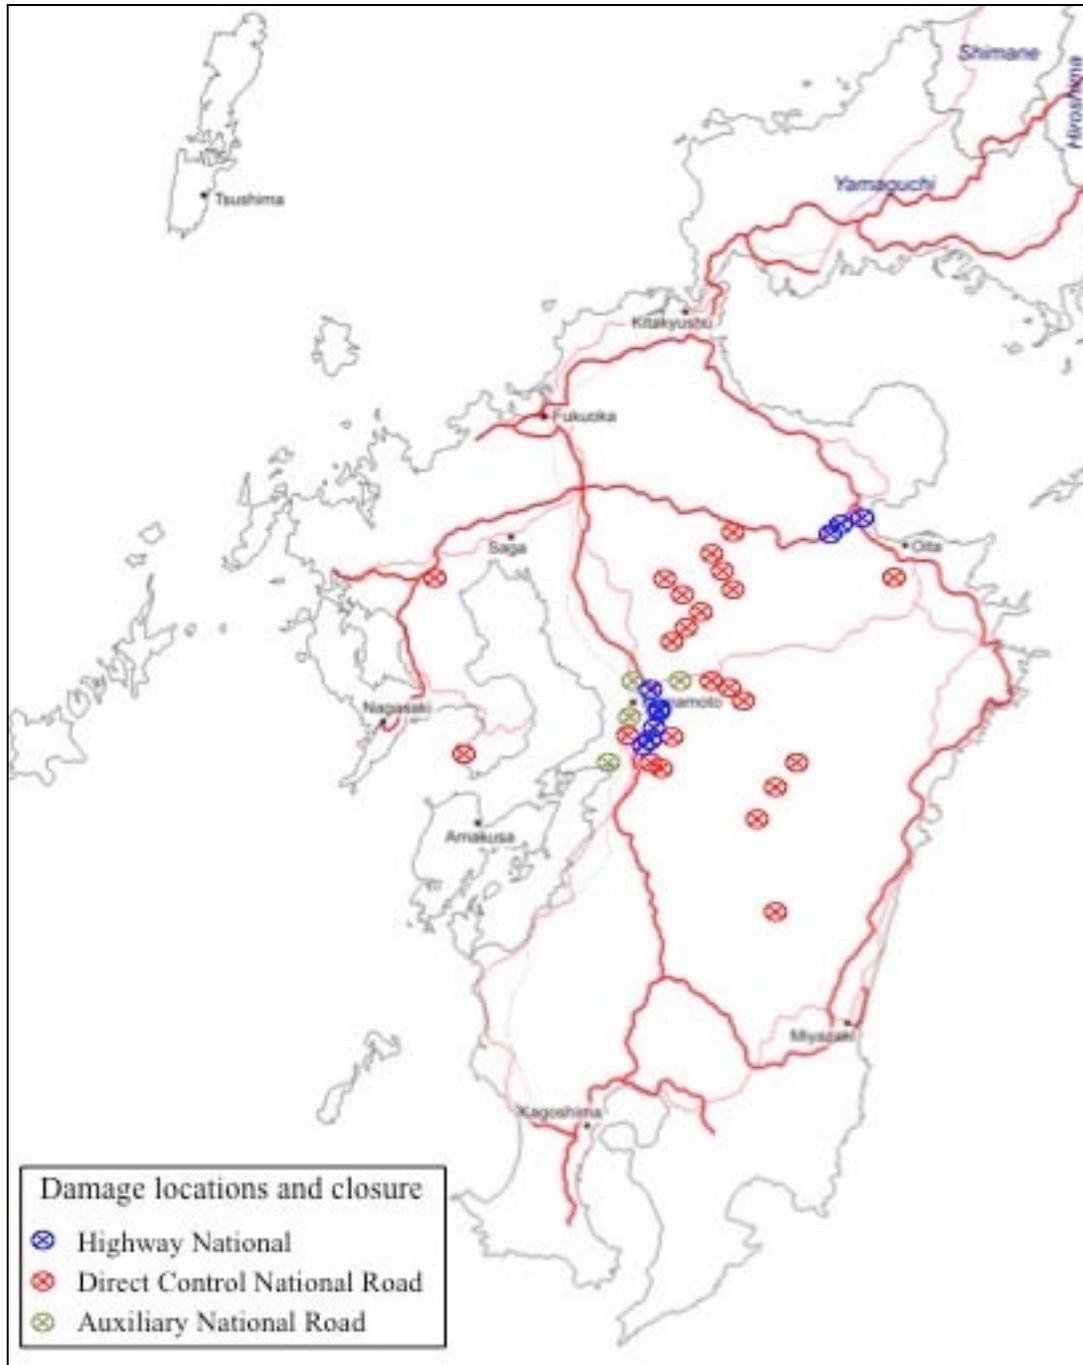
Figure 9-93. Map showing location of roads and bridges damage locations

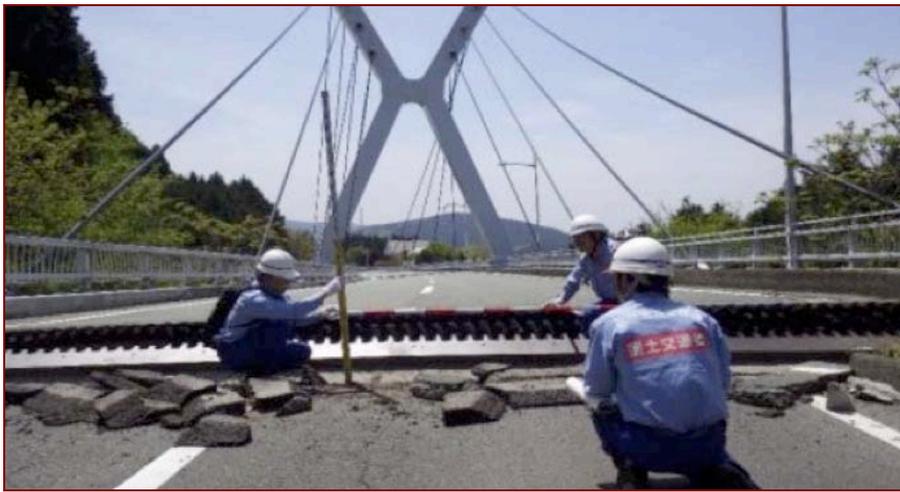
Figure 9-94. TEC-FORCE team at Kuwatsuru Ohashi

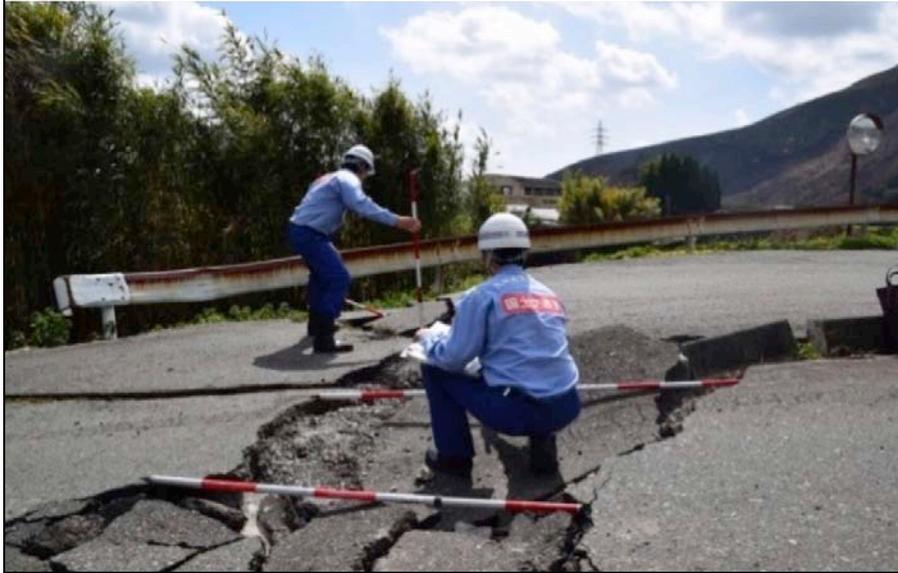
Figure 9-95 TEC-FORCE inspecting and recording damage to Prefecture Route 149 (N32.8924°, E130.9918°)

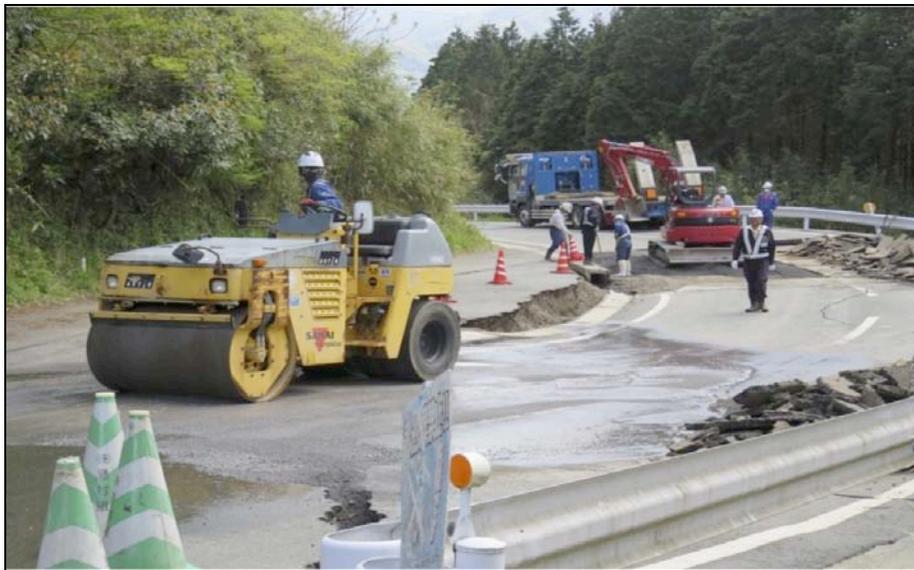
Figure 9-96. Prefecture Route 149 damage repairing in progress

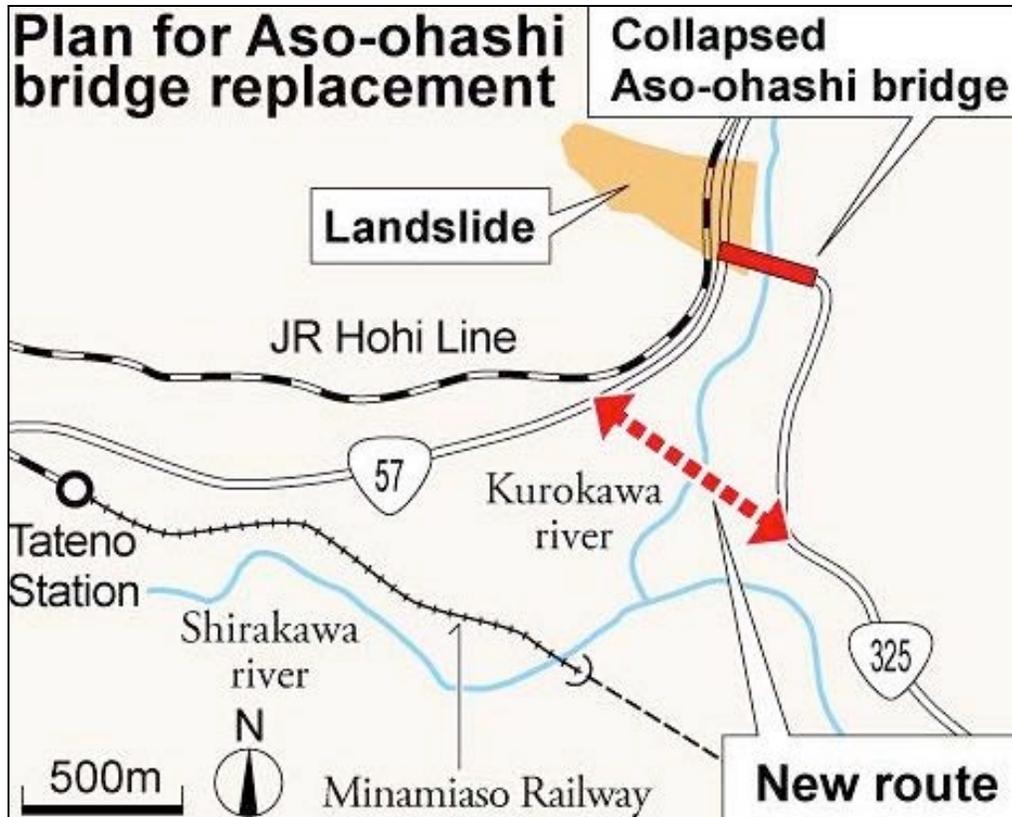
Figure 9-97 Location of the Aso Ohashi replacement connecting National Route 57 to National Route 325

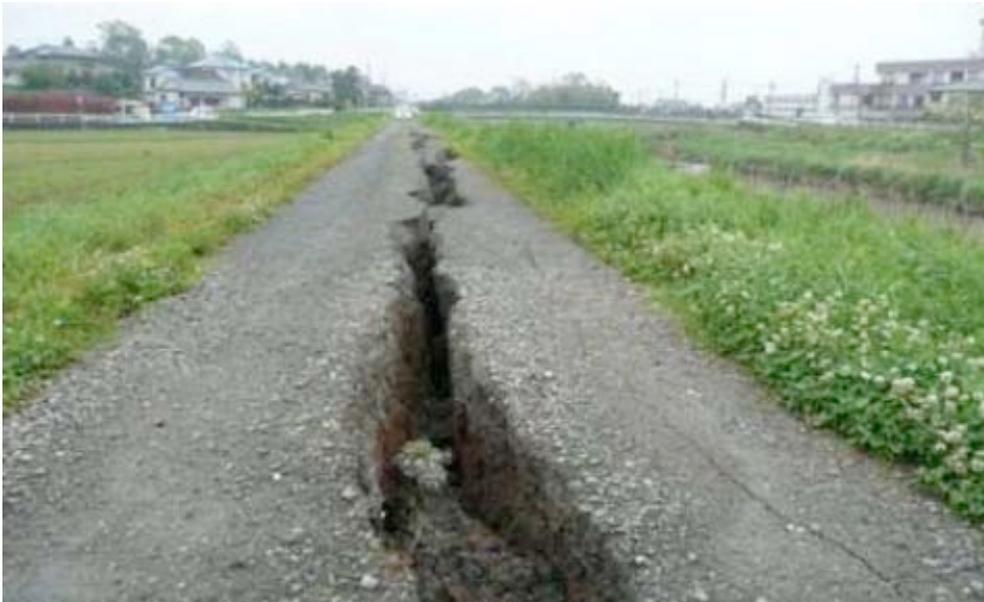
Figure 10-1. Levee Damage. Yagata River (Masuki-machi)

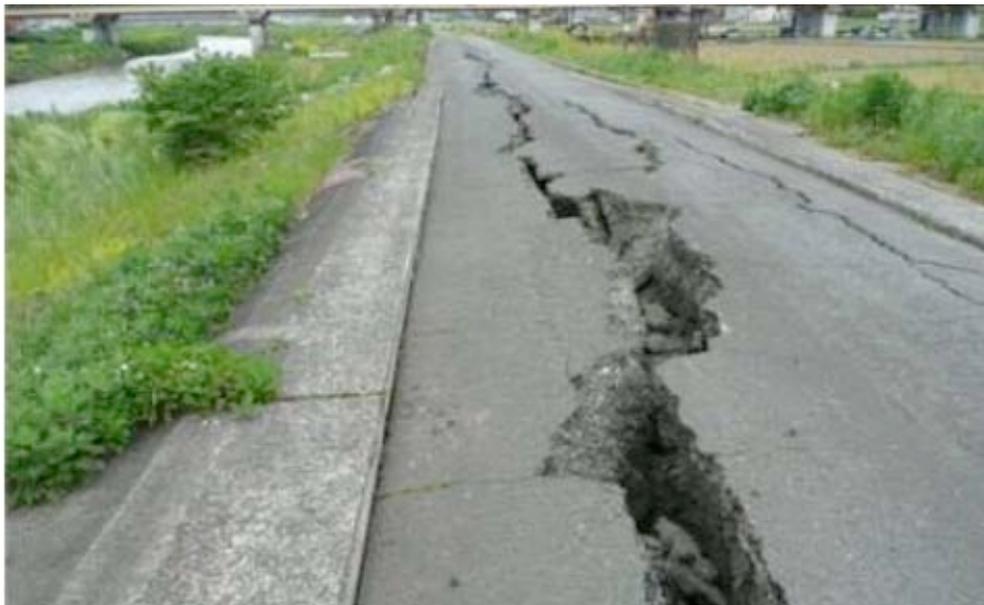
Figure 10-2. Levee Damage. Kiyamagawa River (Masuki-machi)

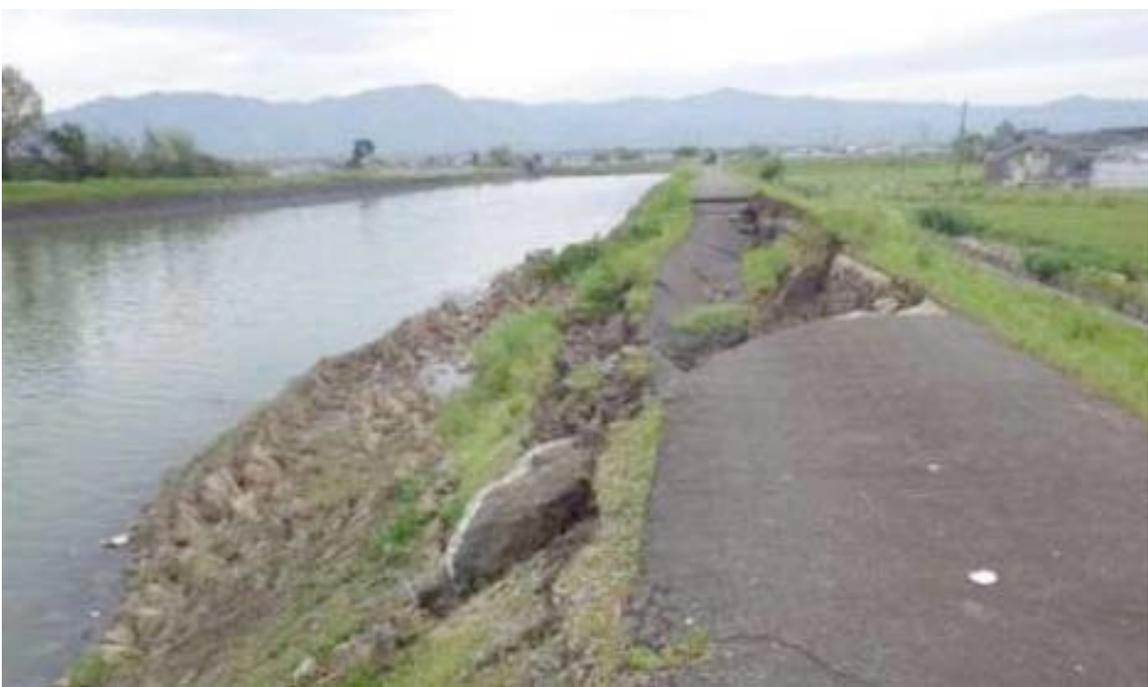
Figure 10-3. Levee Damage. Oosakawa River (Yatsushiro River). Masonry seawall collapse

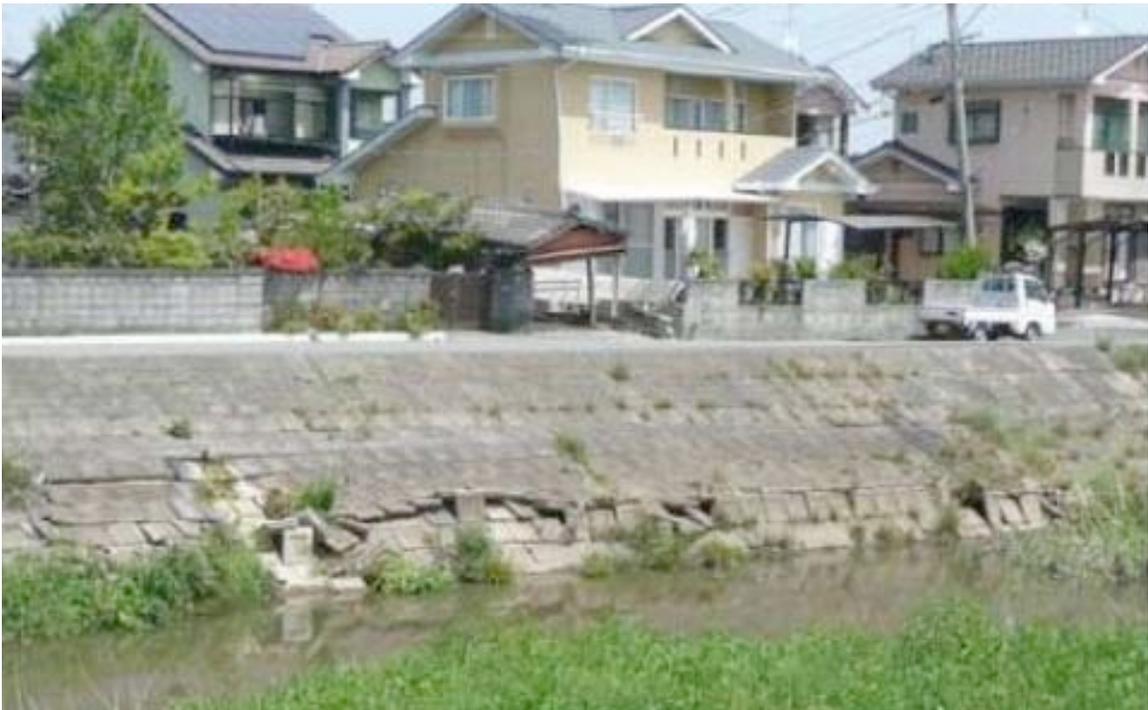
Figure 10-4. Levee Damage. Akitsugawa River (Masuki-cho). Seawall collapse

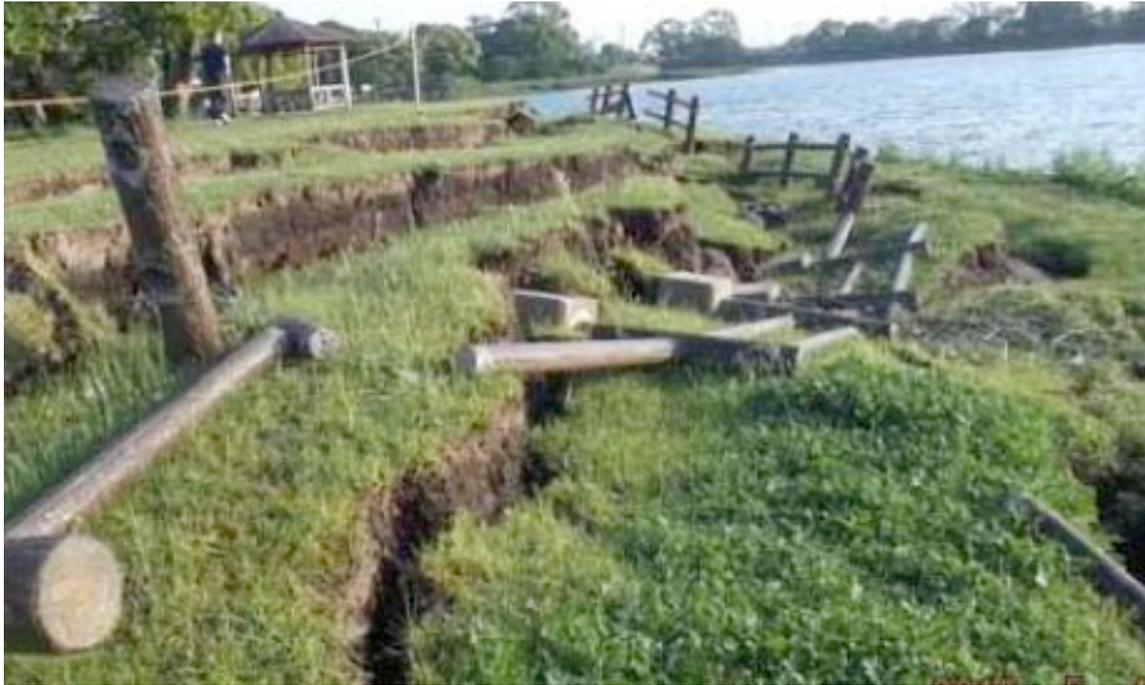
Figure 10-5. Shoreline Lateral Spread. Suizenji Ezu Lake Park, Kumamoto City
