Kumamoto M 6.0 and 7.0 Earthquakes of April 14, 16 2016

Electric Power
John Eiding
G&E Engineering Systems Inc.
September 15 2016

Electric Power

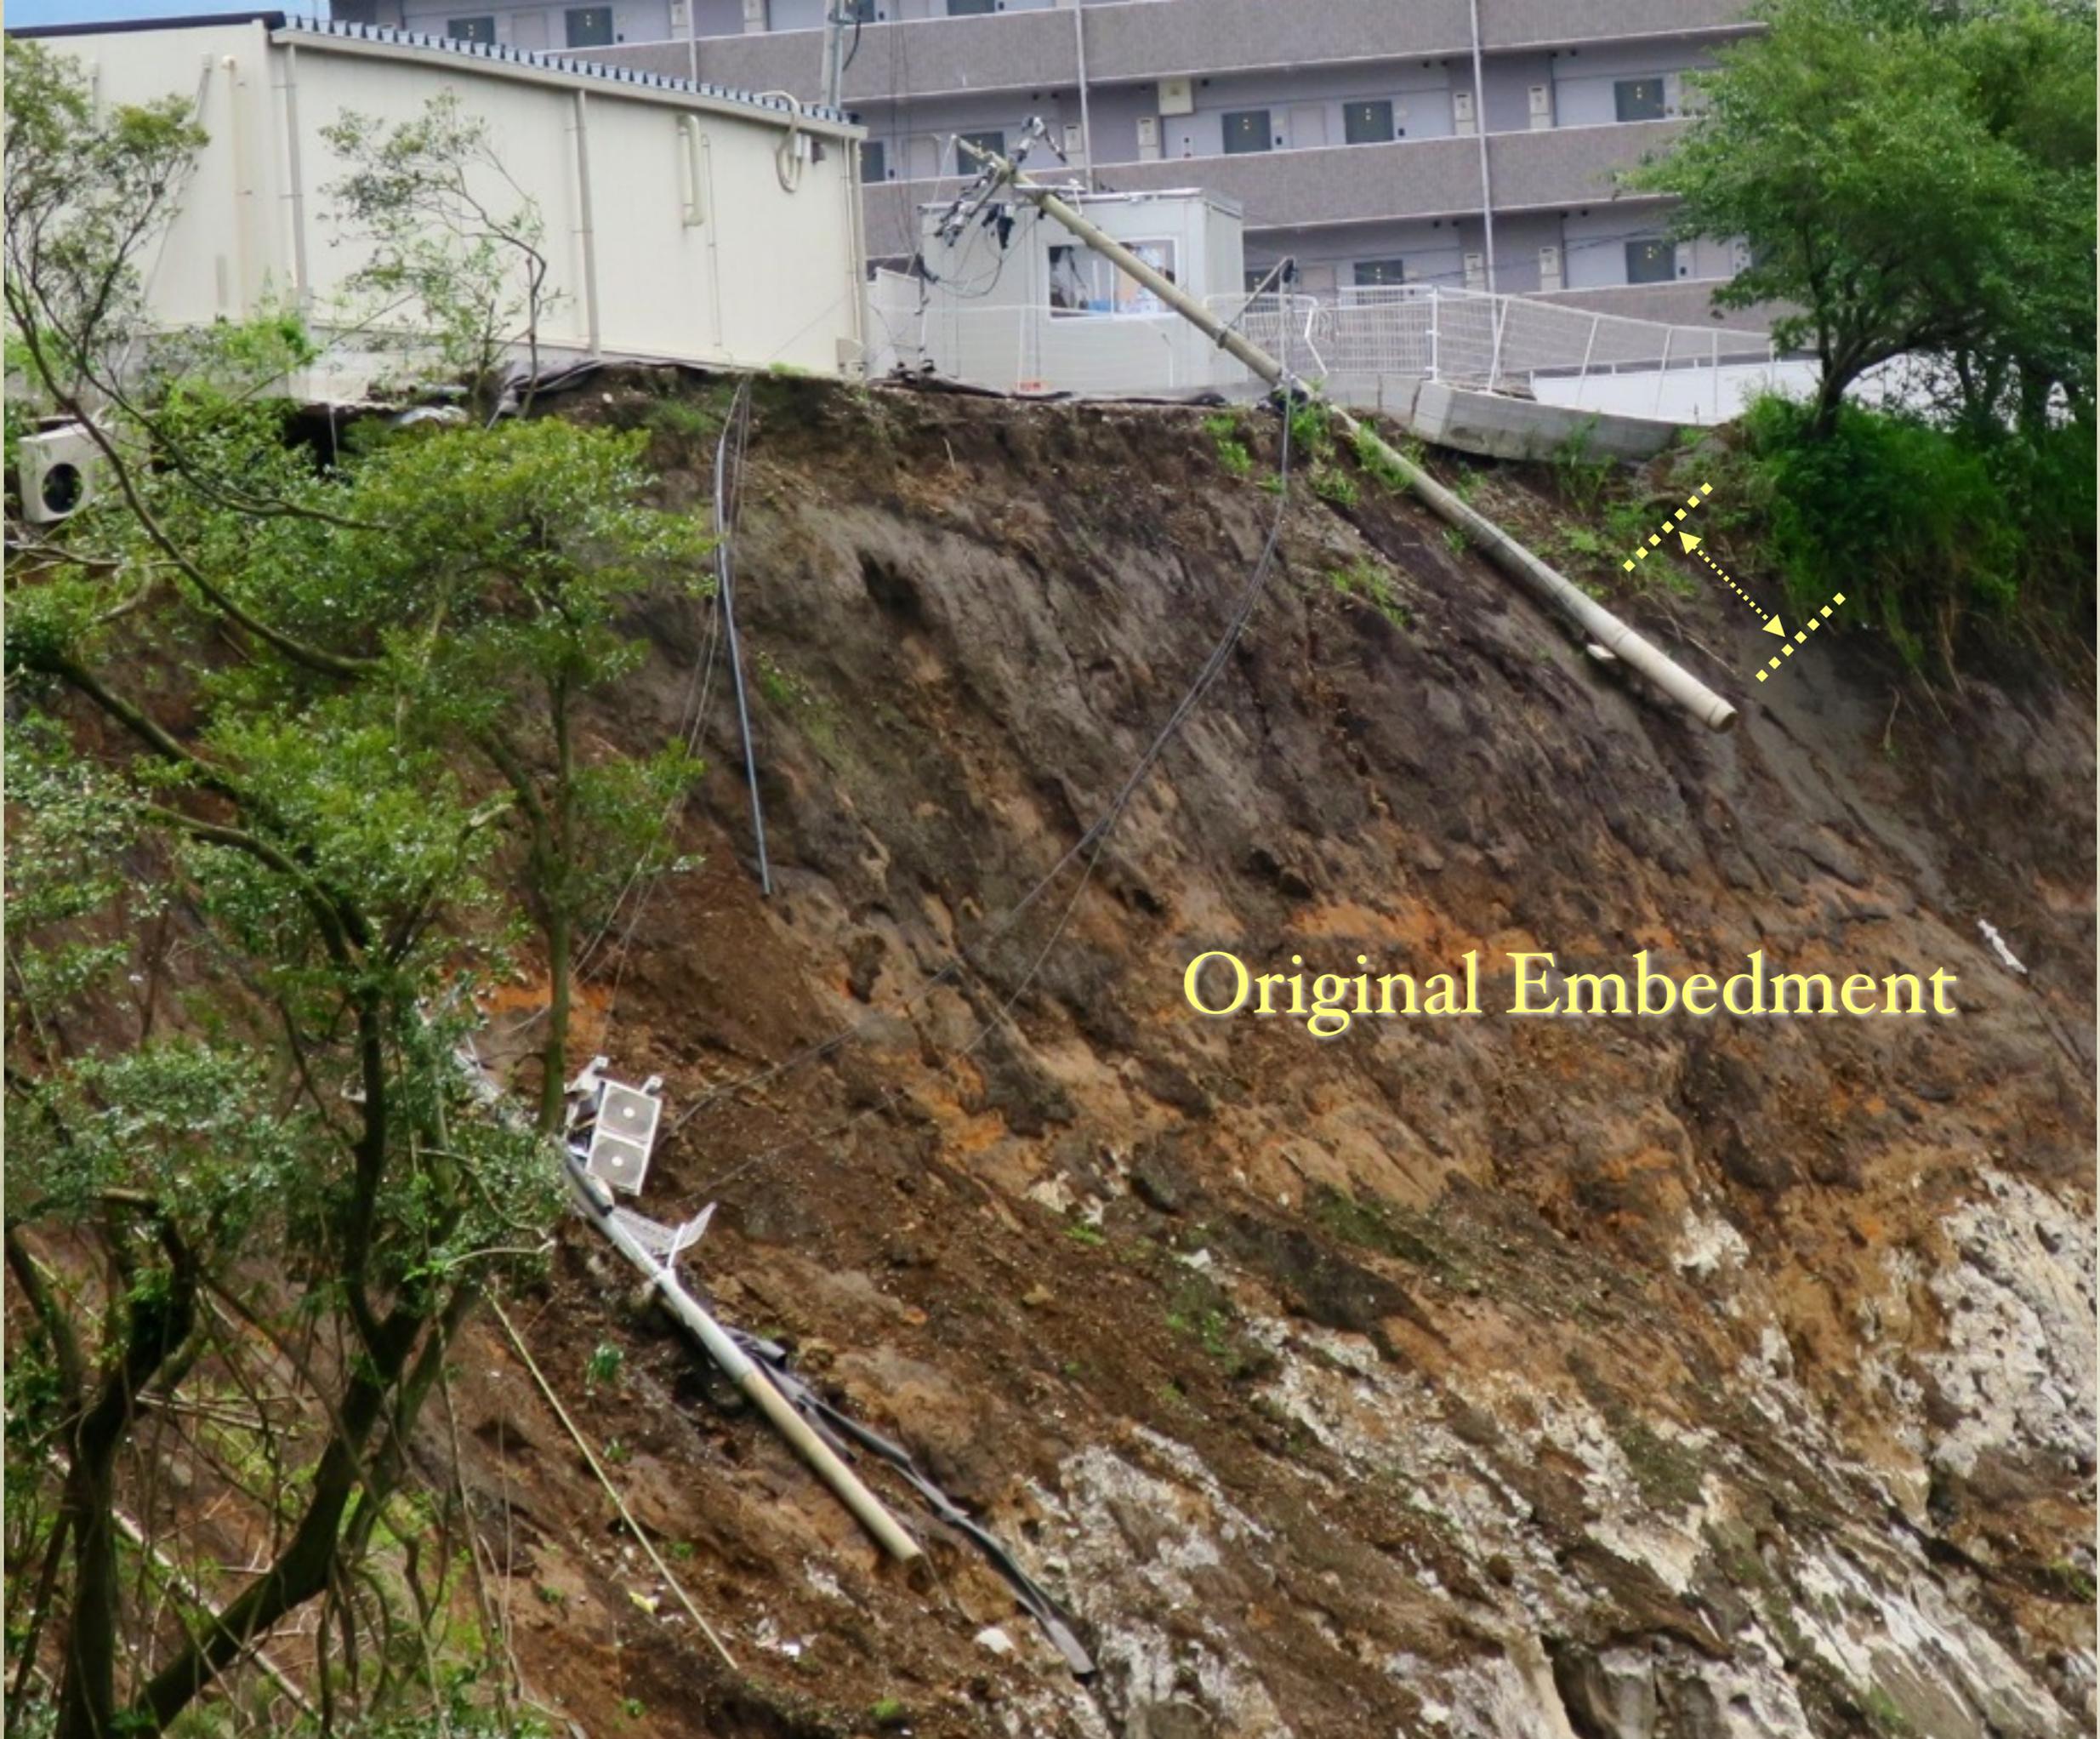
PGA $\sim 0.7g+$. Embankment failure

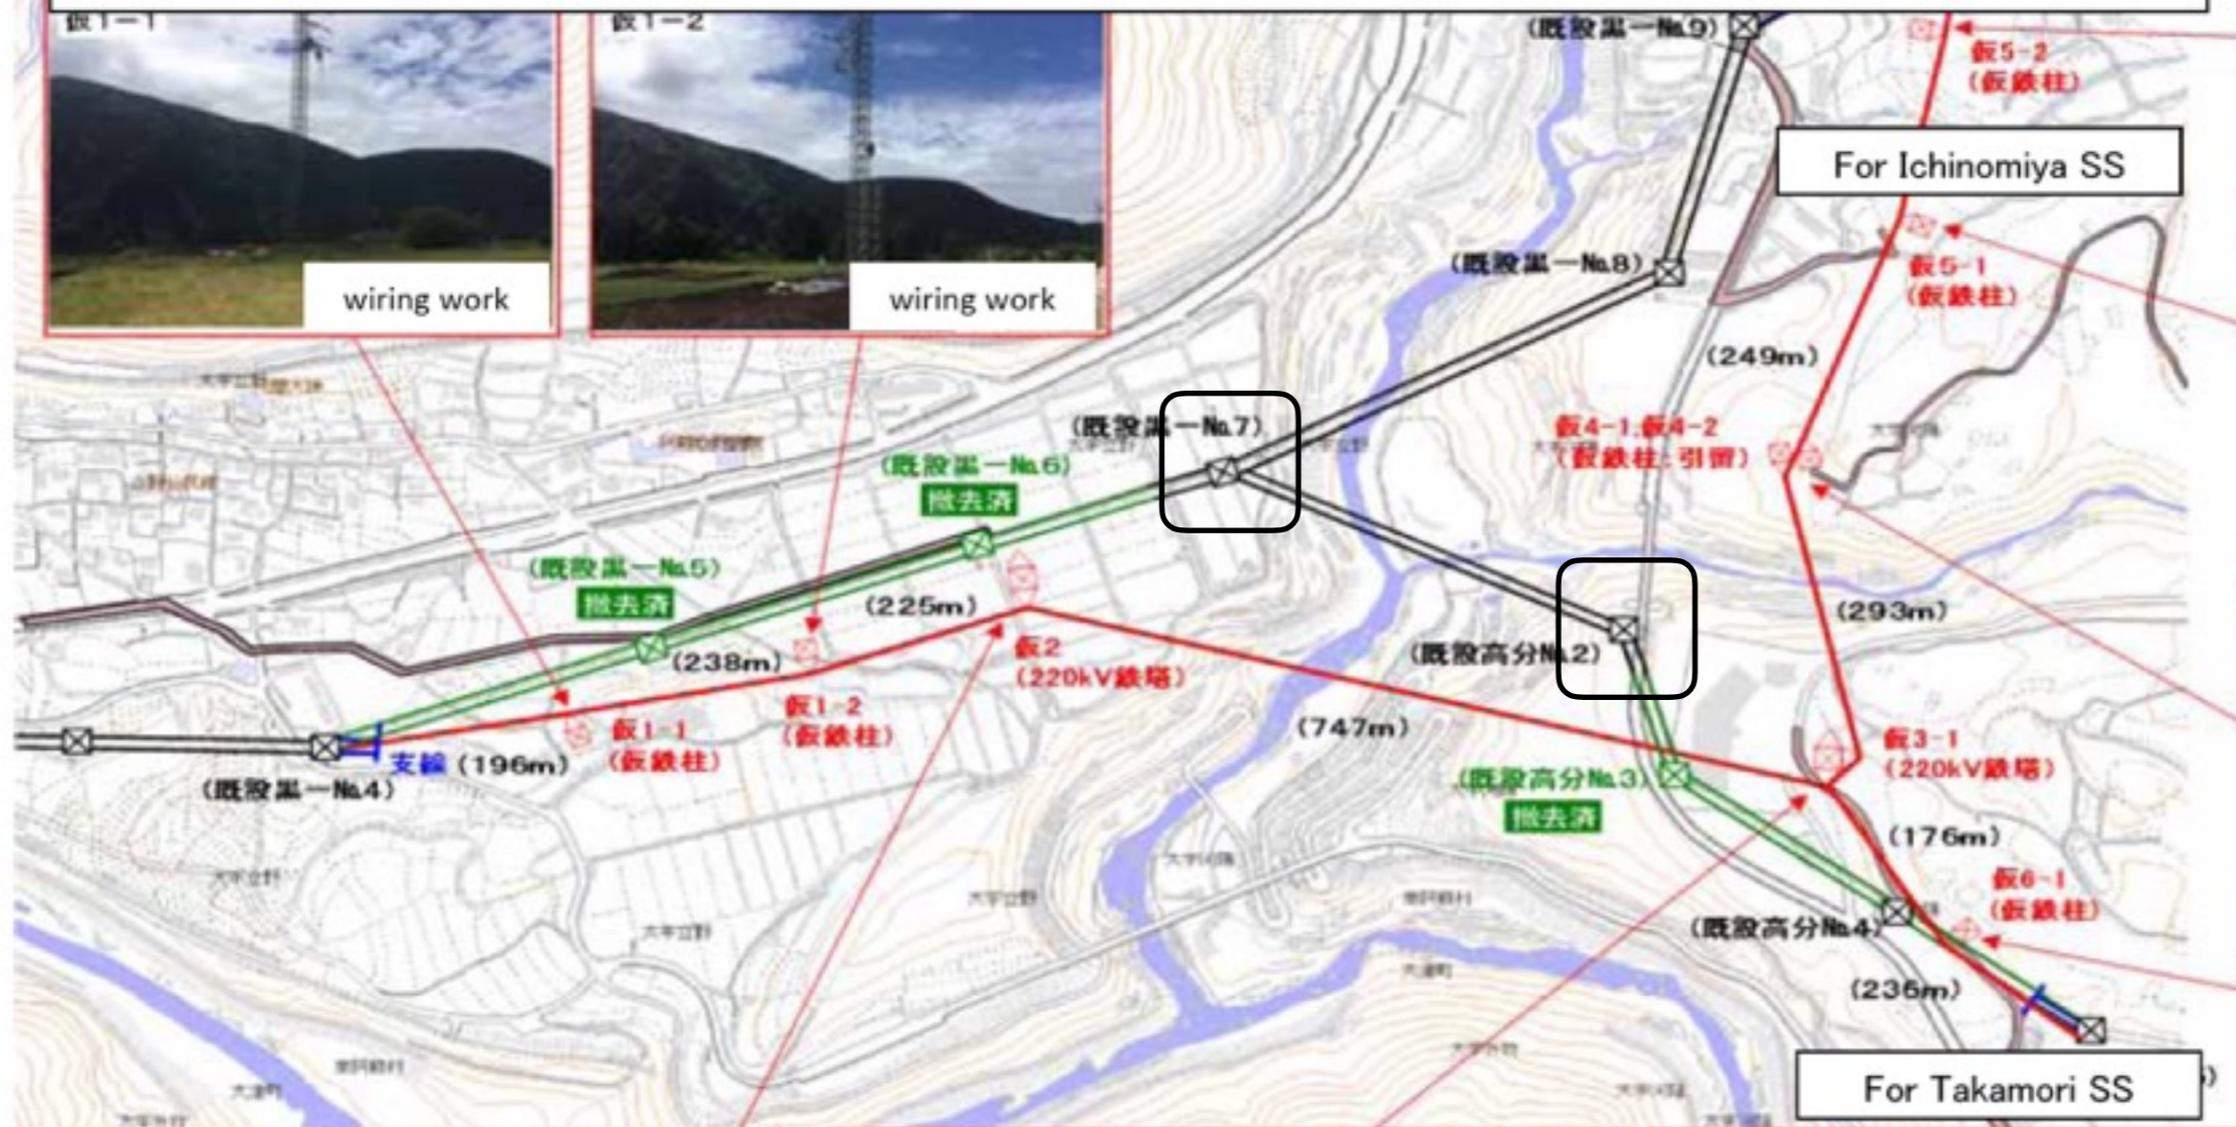
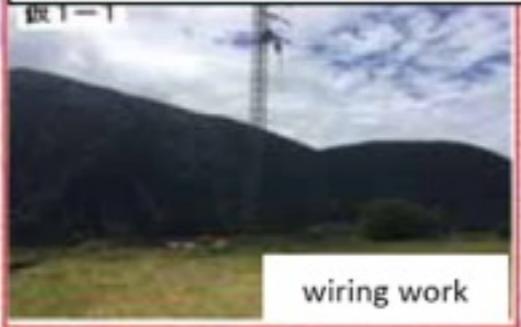
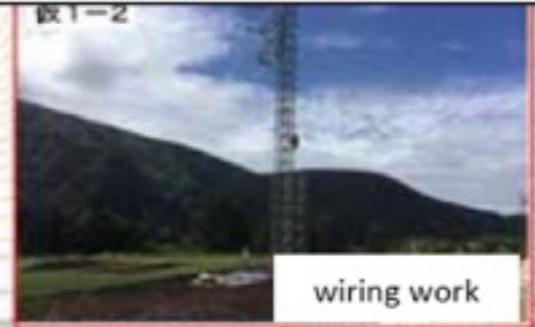
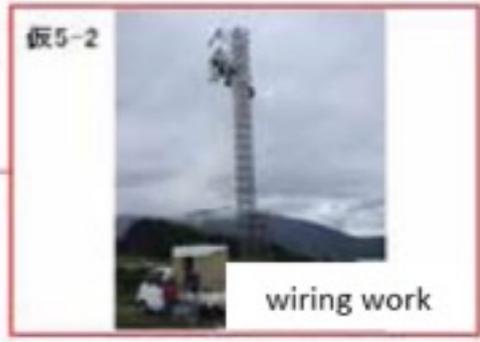
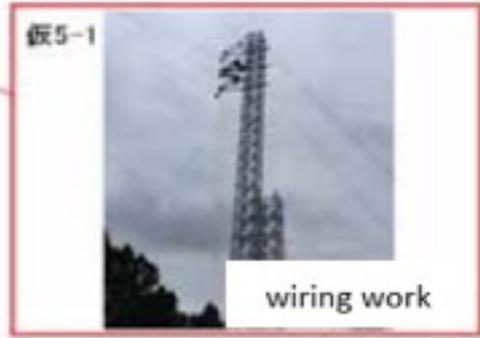
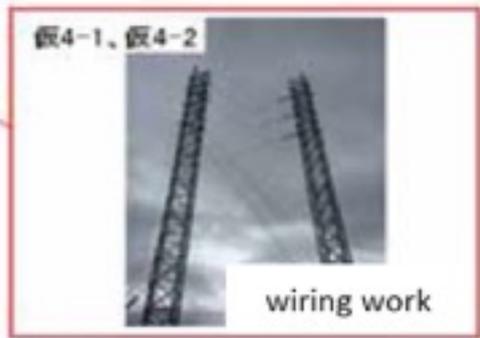
② 66kV Kurokawa-Ichinomiya Line in Tateno Area with the Temporary Route

Steel Tower
Minor Damage
(buckled brace)

Steel Tower
Major Damage
(2 foot PGD)

Steel Tower
Major Damage
(3 foot PGD)

Damaged Sites	Outline of Restoration
① Kurokawa-Ichinomiya Line around No.1 site	Restoration by Utilizing a Neighboring Steel Tower
② Around Kurokawa-Ichinomiya Line in Tateno area around No.7	2 Temporary Steel Towers and 7 Temporary Steel Poles 2.7m × 1 cct.
③ Around Kurokawa-Ichinomiya Line in Matoishi area around No.31	7 Temporary Steel Poles 2.0km × 1 cct.
④ Around Takamori branch Line in Nakamatsu area around No.35	Temporary Steel Tower 0.5km × 1 cct.

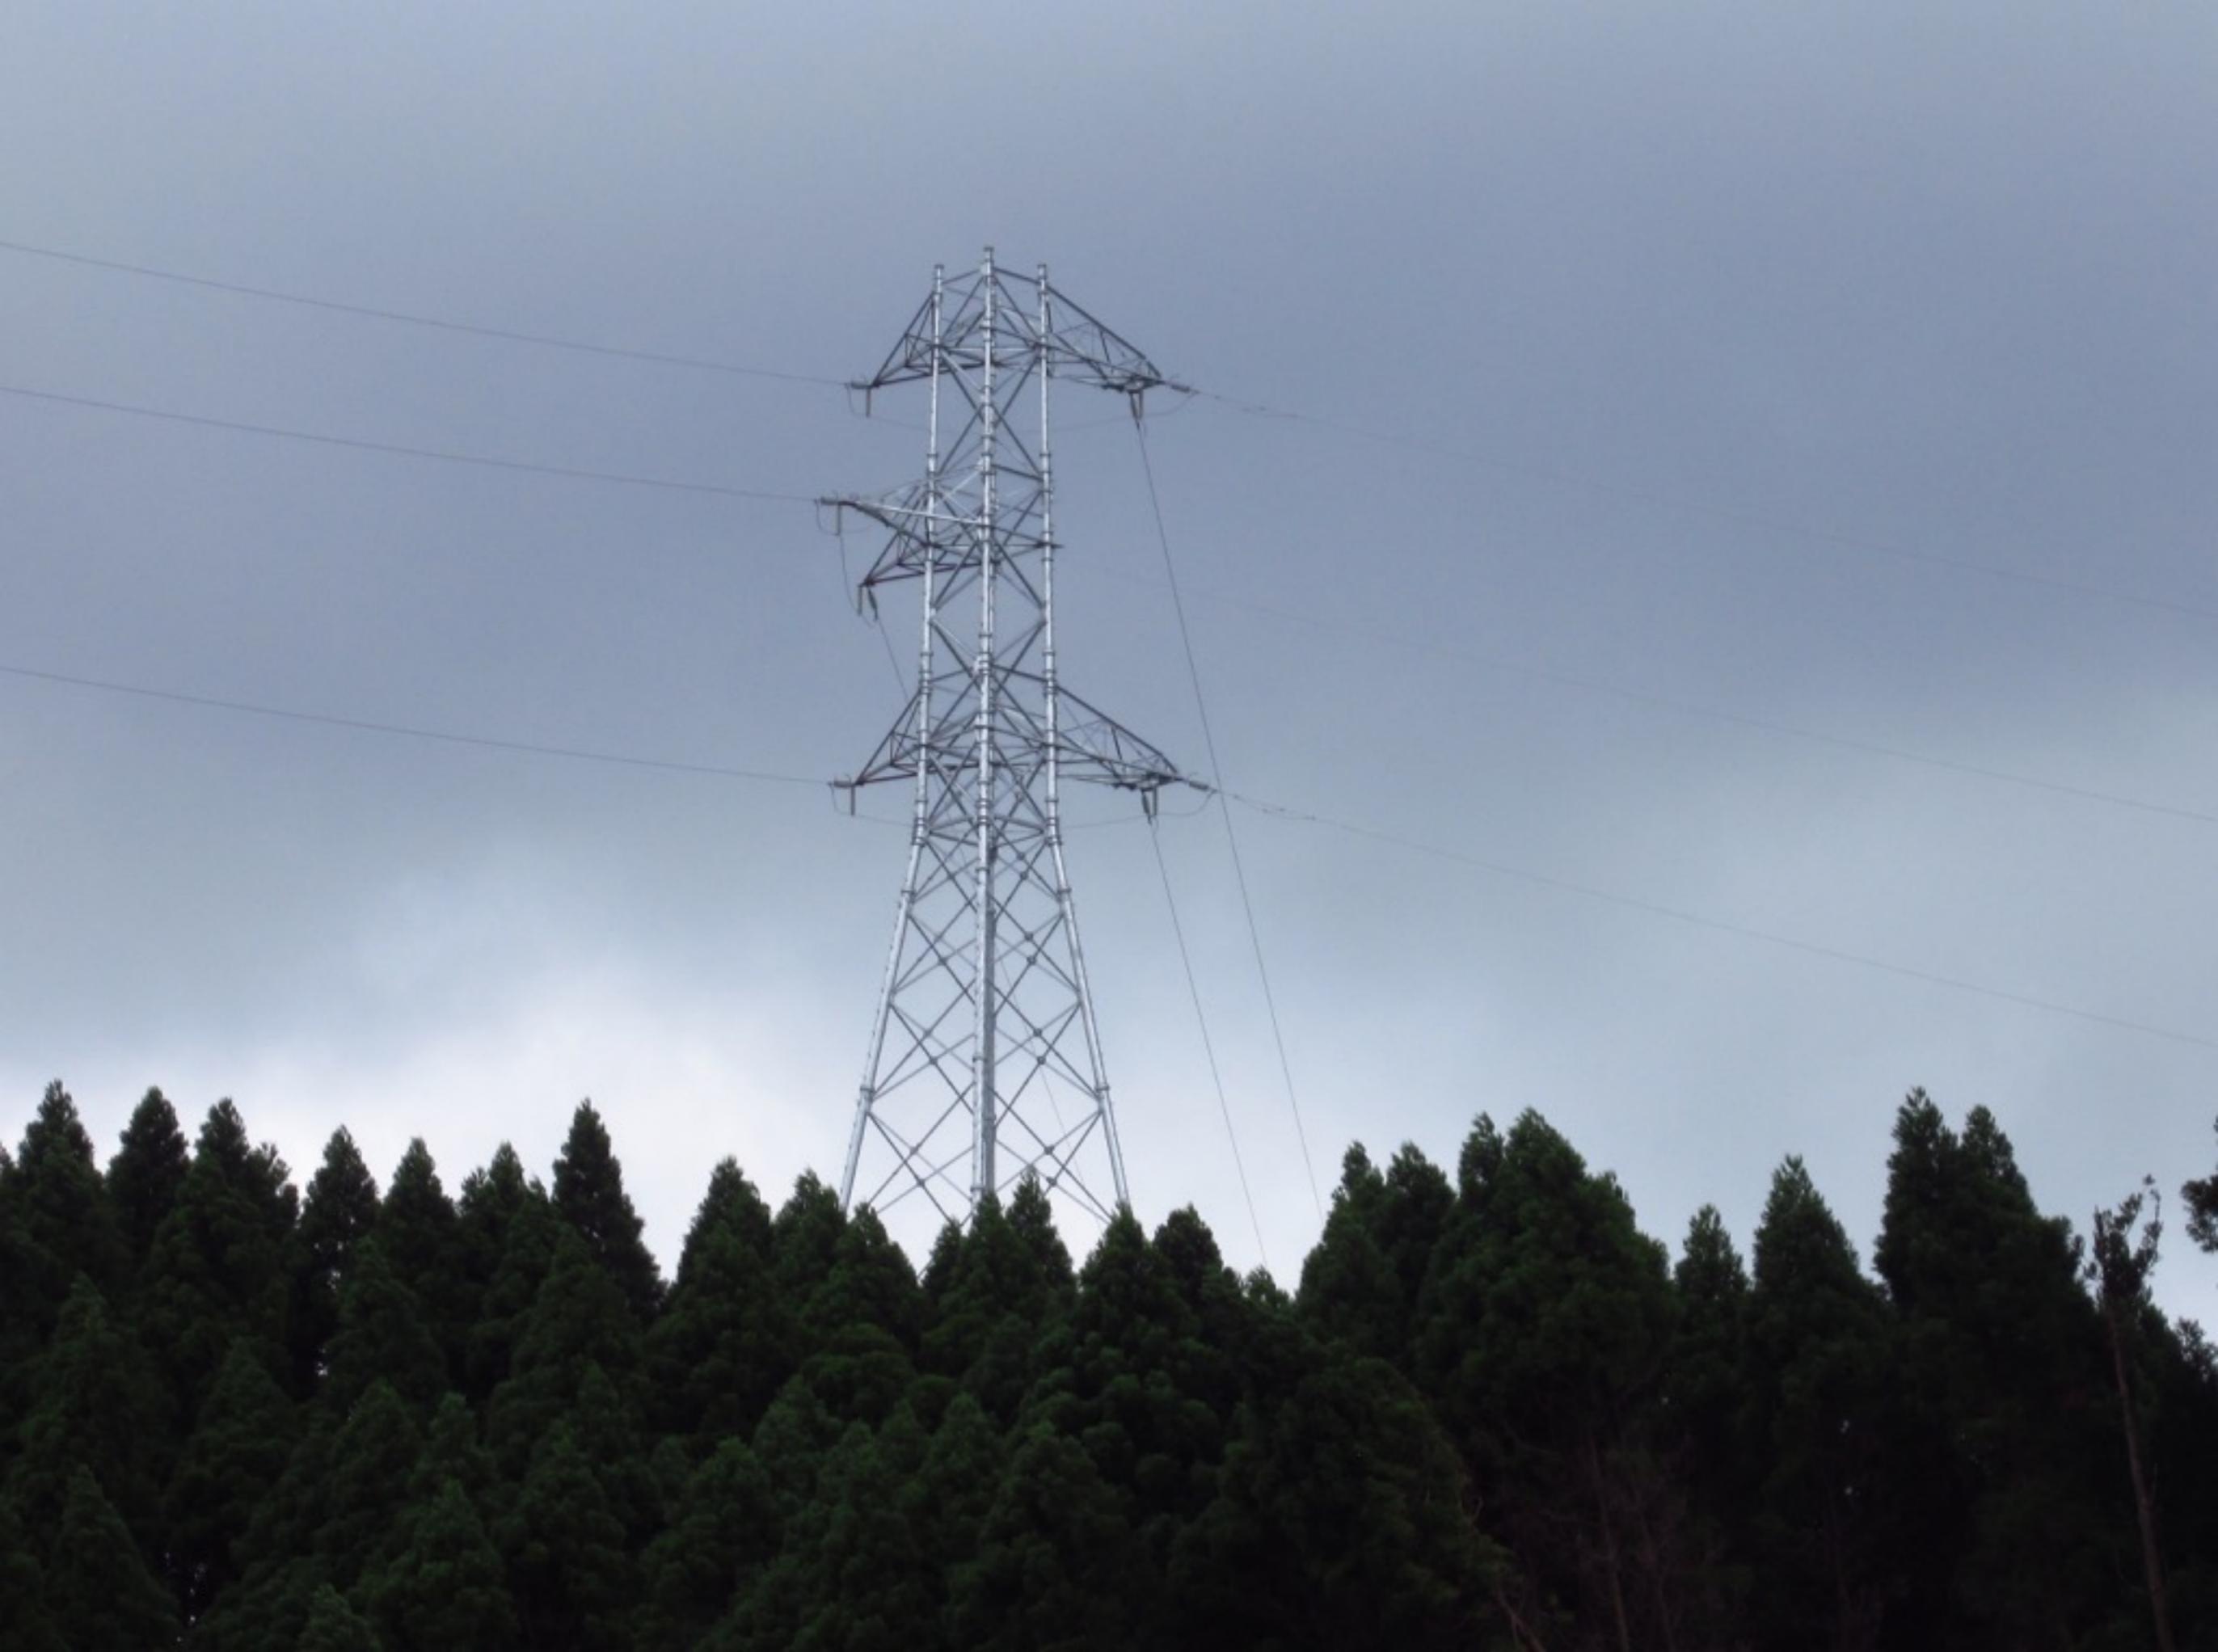
Steel Tower 10 Buckled Brace

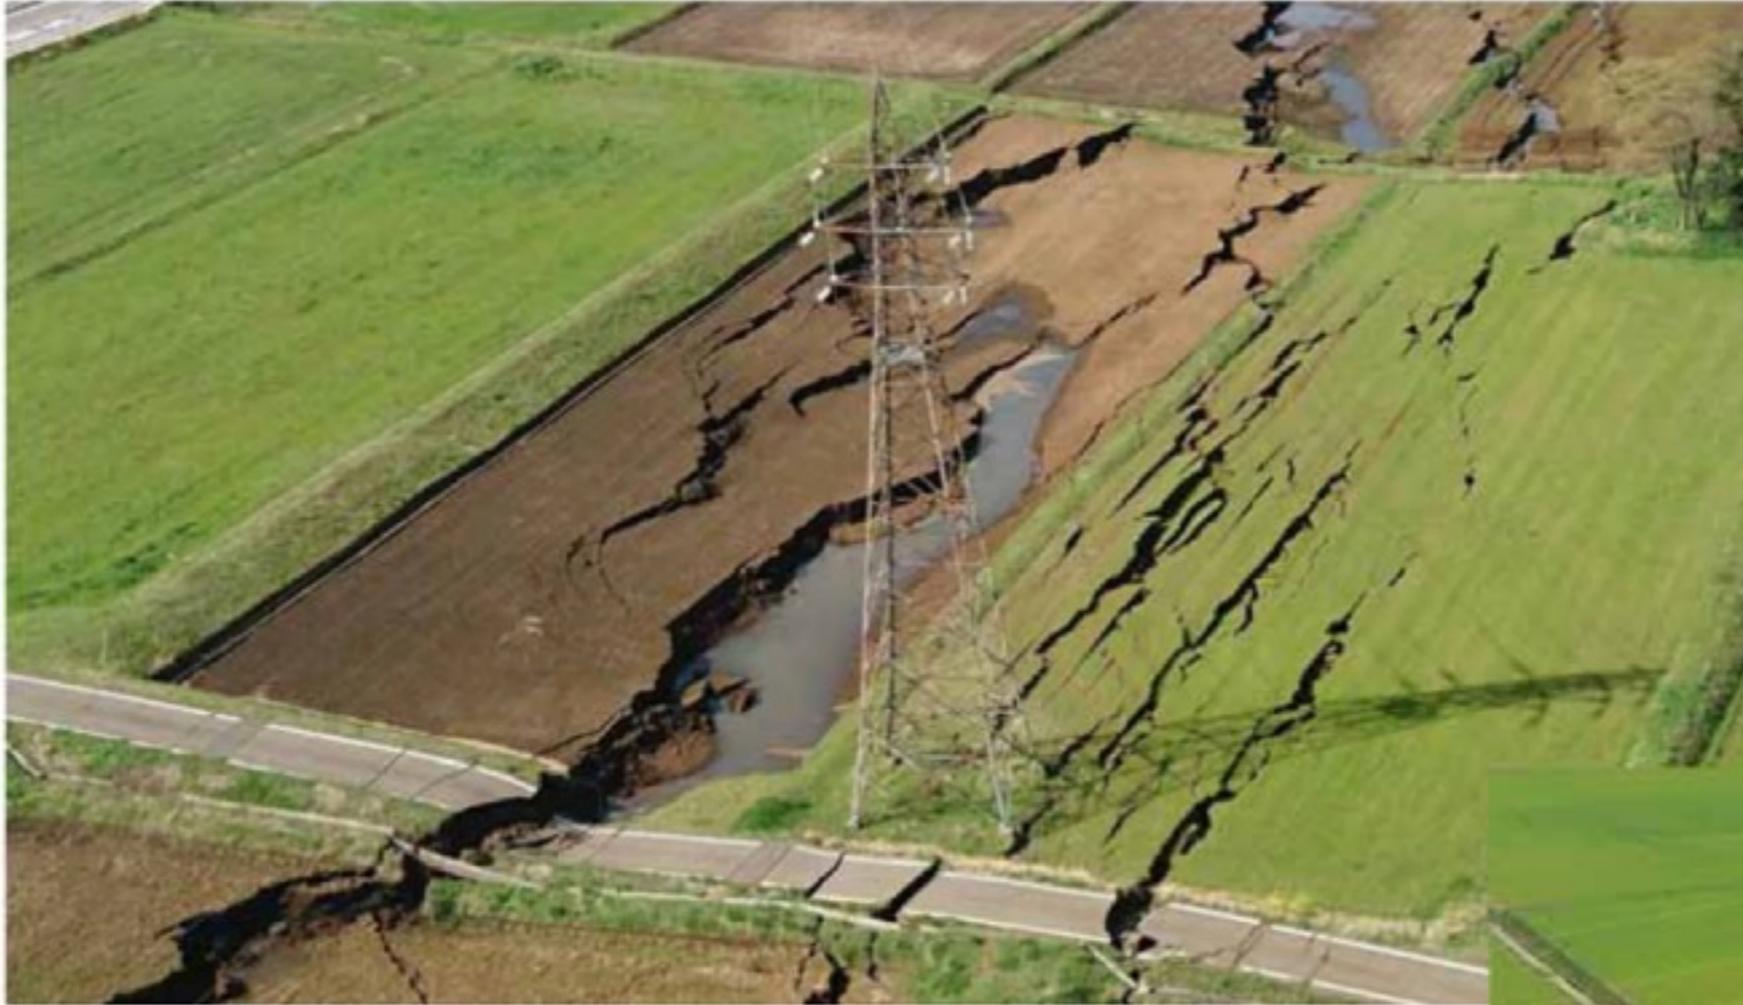
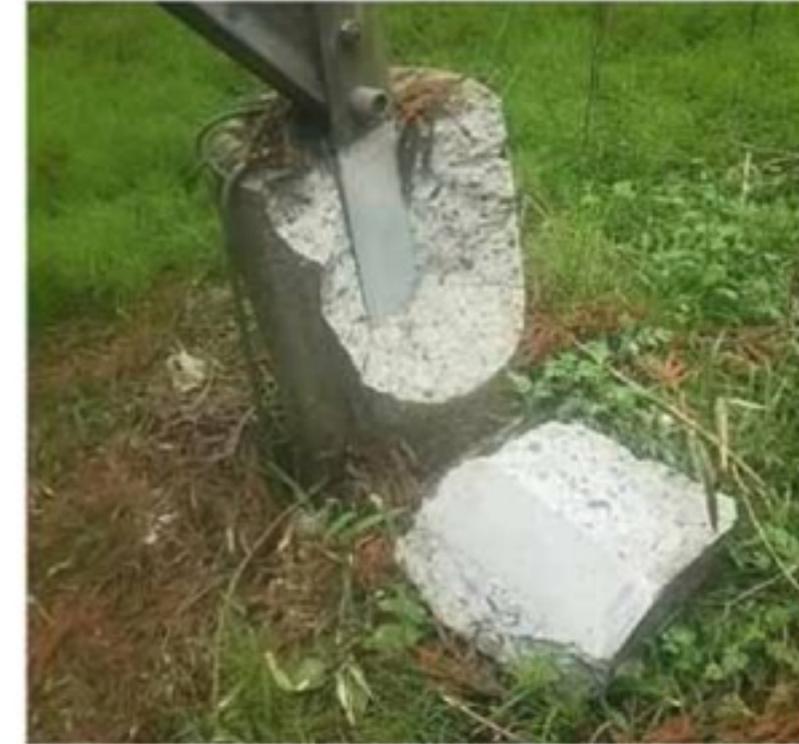
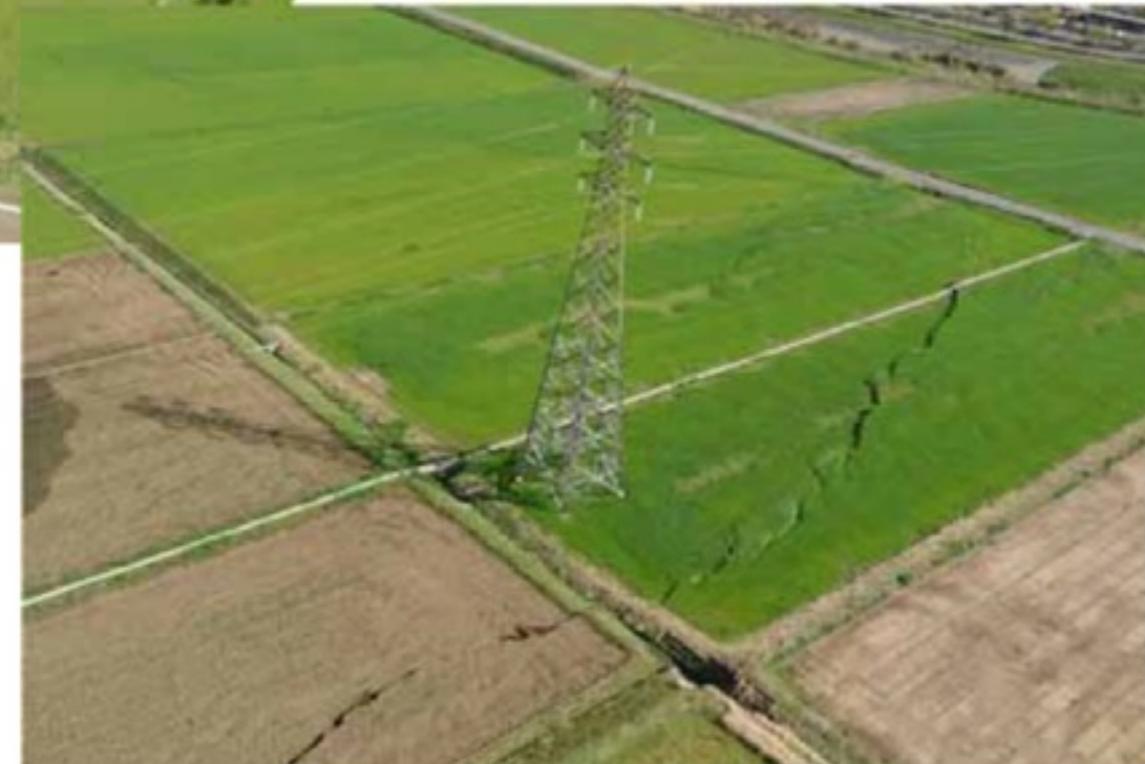
③ 66kV Kurokawa-Ichinomiya Line in Matoishi Area Affected by Extensive Cracks

Damaged Foundation of the Tower No.32

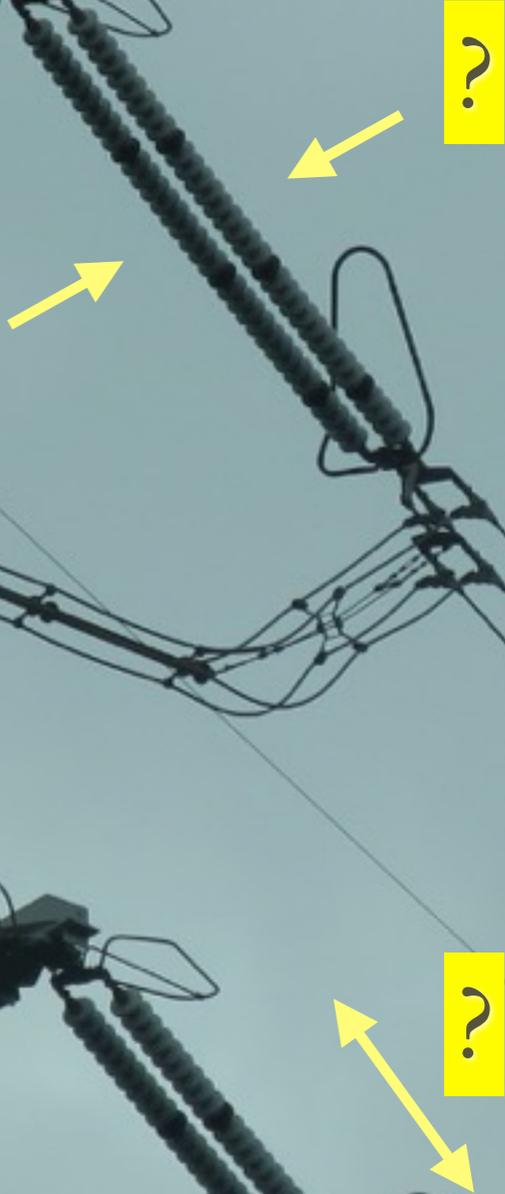
Typical 500 kV
Strain Tower
Jumper
Configuration

Strong Inertial Shaking Causes the Porcelain Insulators to vibrate against each other, damaging sheds. Or, Cable dynamics allow the strings to compress, allowing shed-to-shed and string-to-string impacts. No faults occurred due to this damage mode

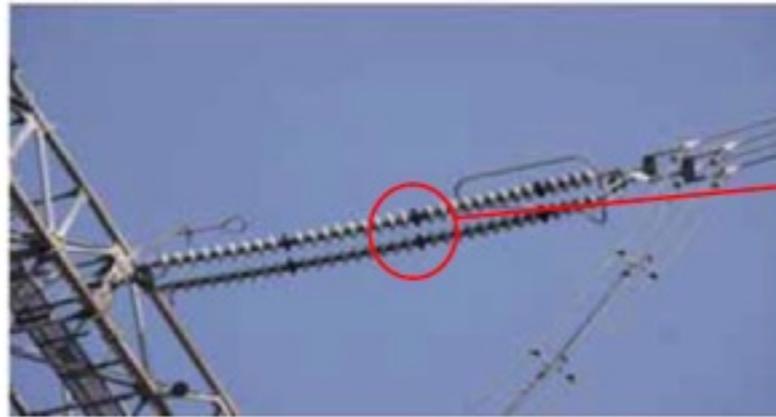
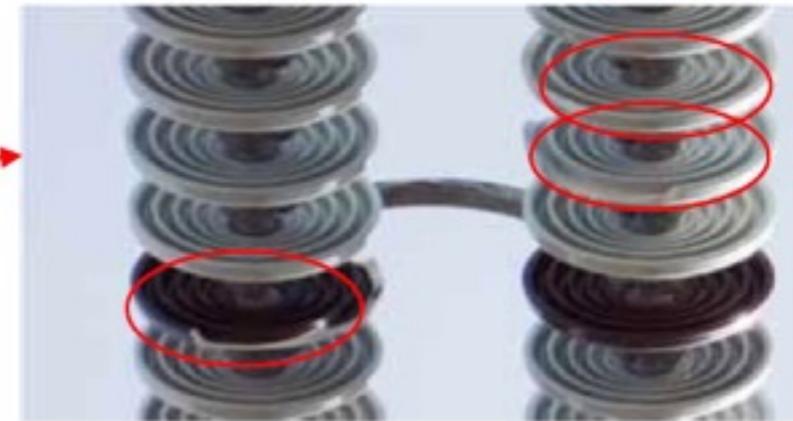
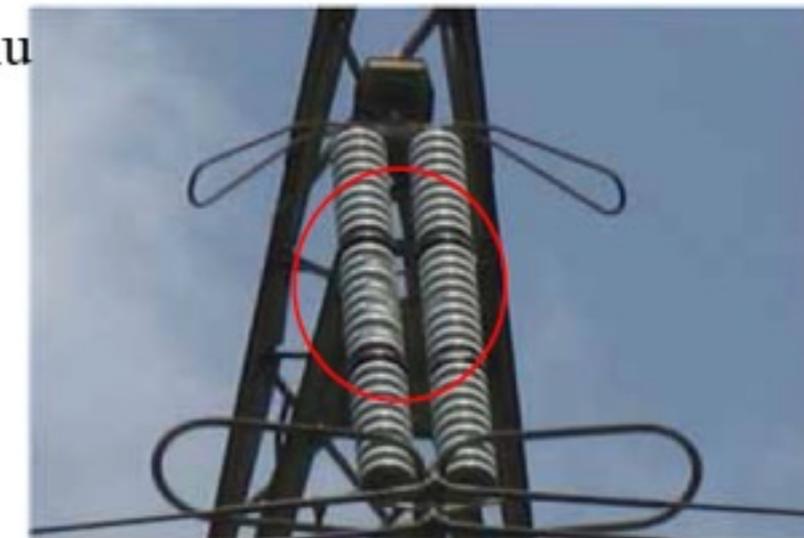
500kV Insulators Damaged

Solution: add spacers. Cause: vertical motions?
This damage did not cause faults

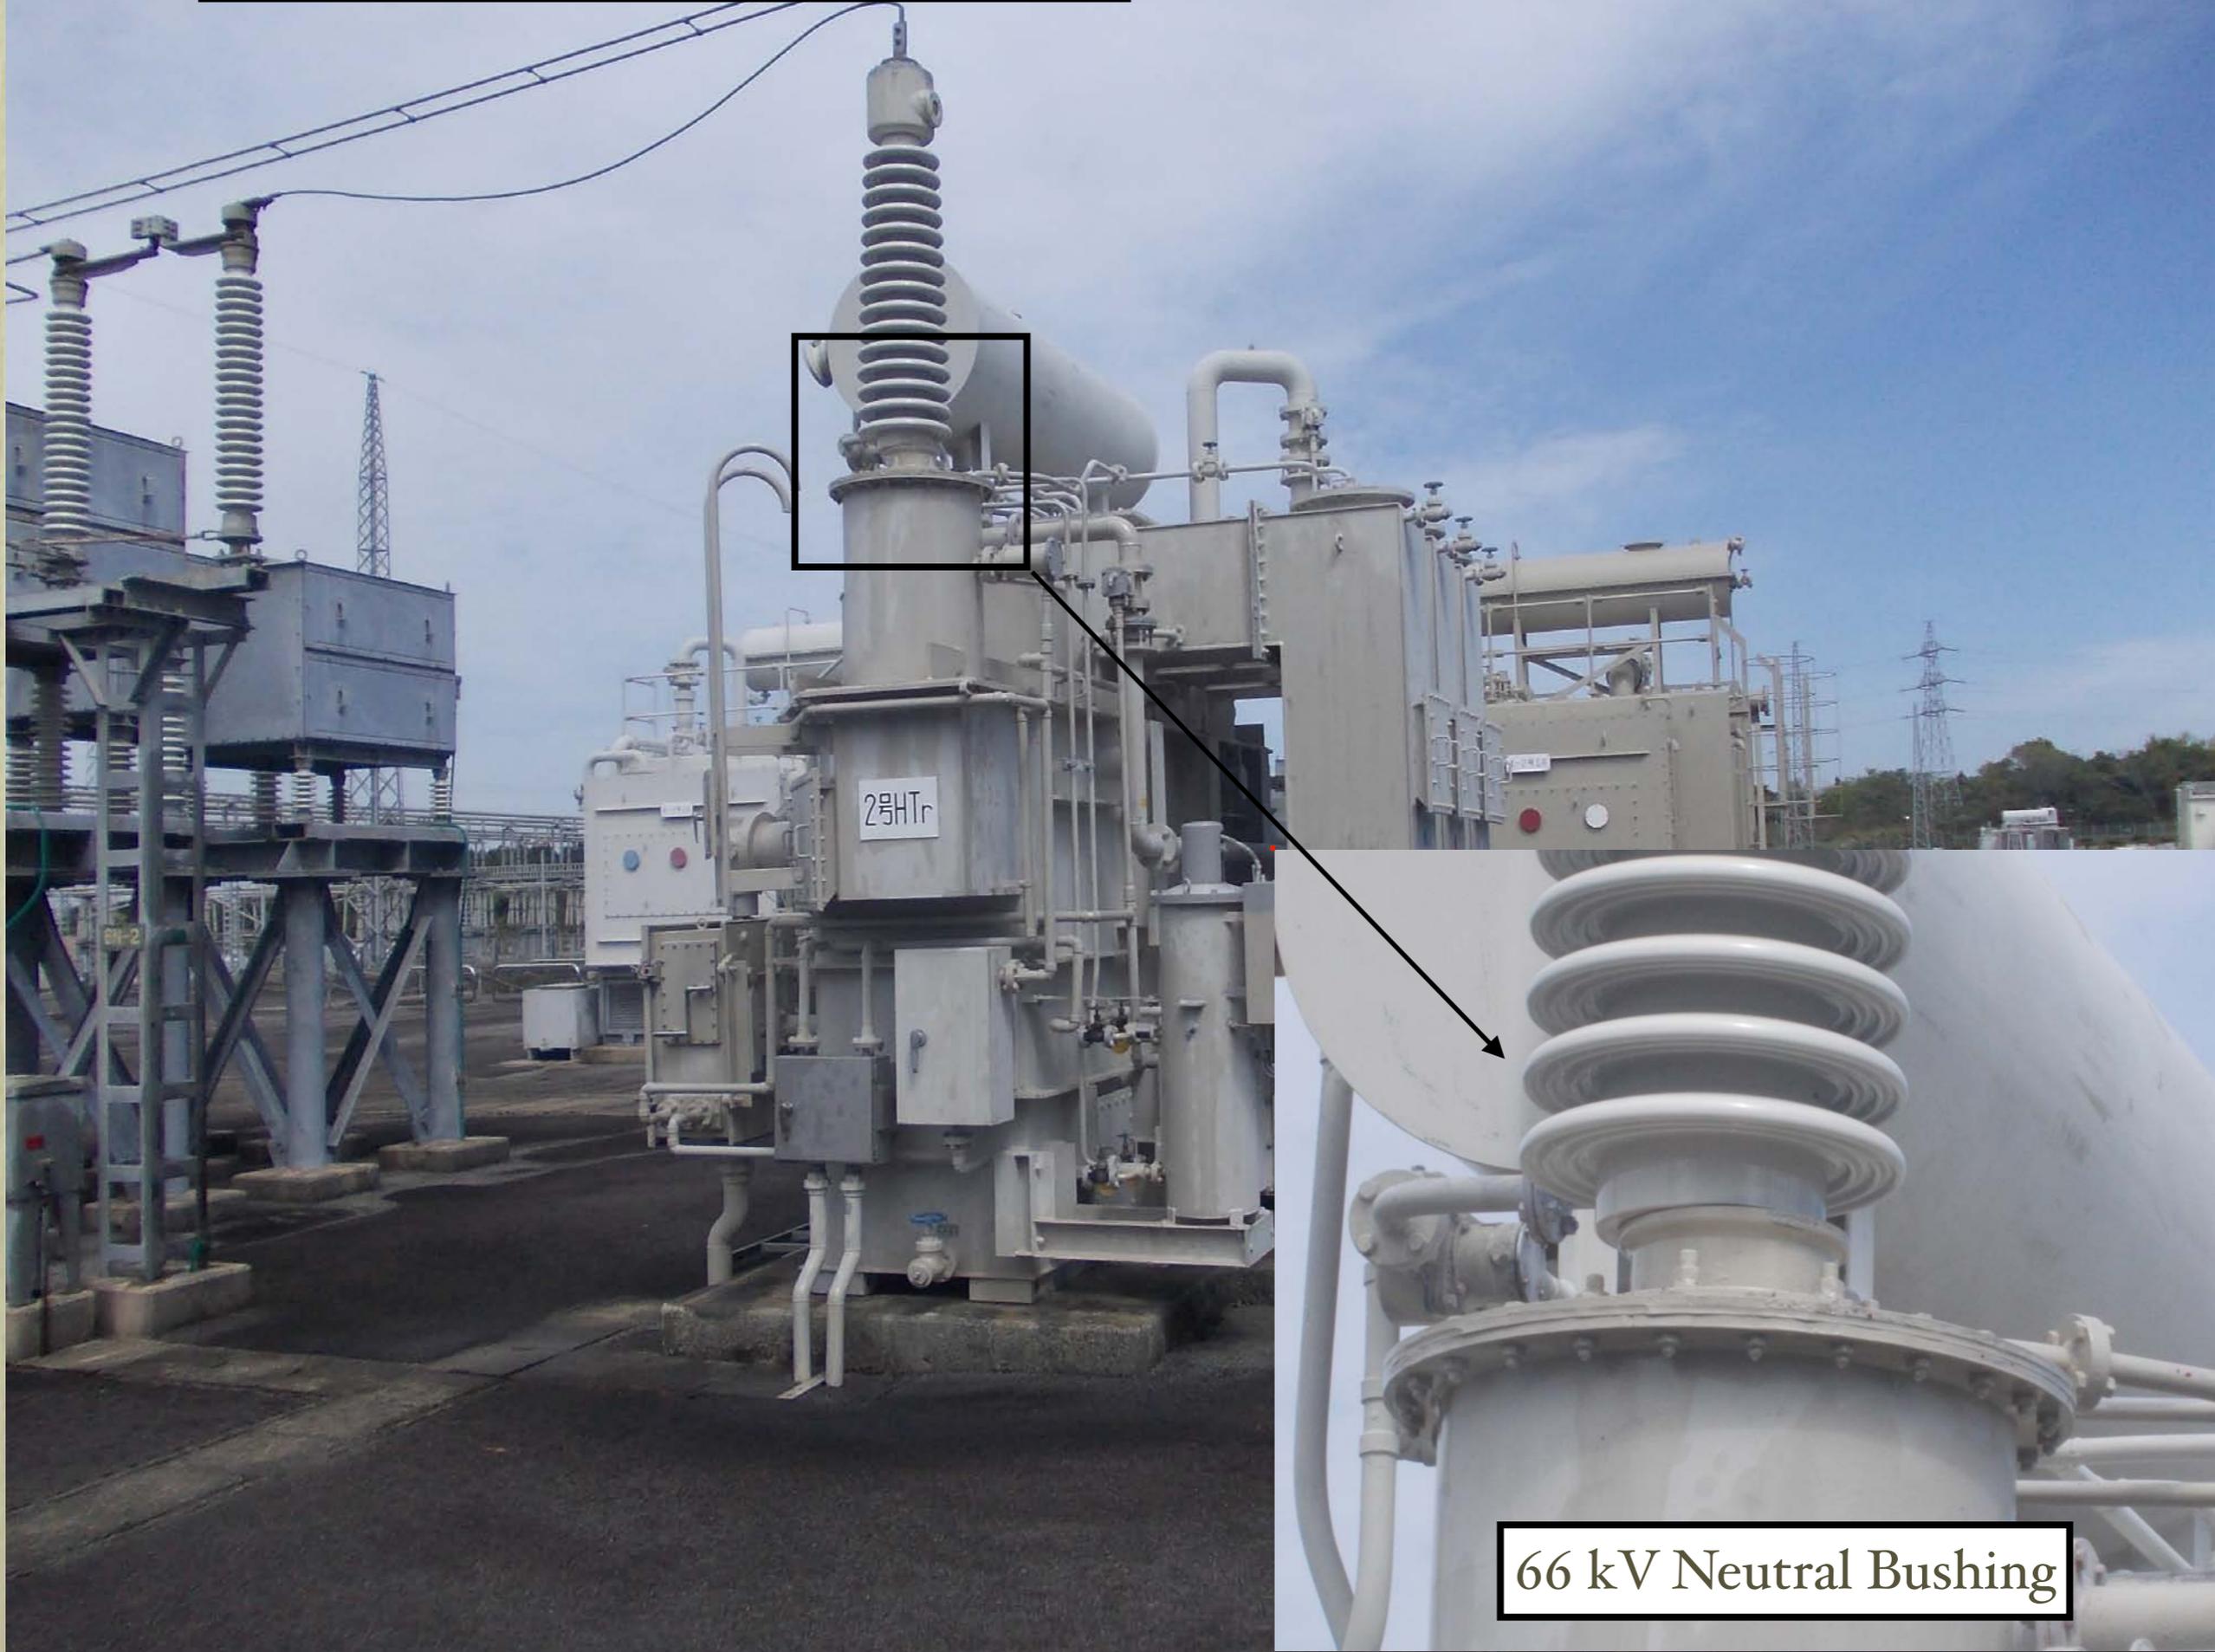
66 kV Slipped Bushing and oil leakage
