Kumamoto M 6.0 and 7.0 Earthquakes of April 14, 16 2016

Electric Power
John Eiding
G&E Engineering Systems Inc.
September 15 2016

Electric Power

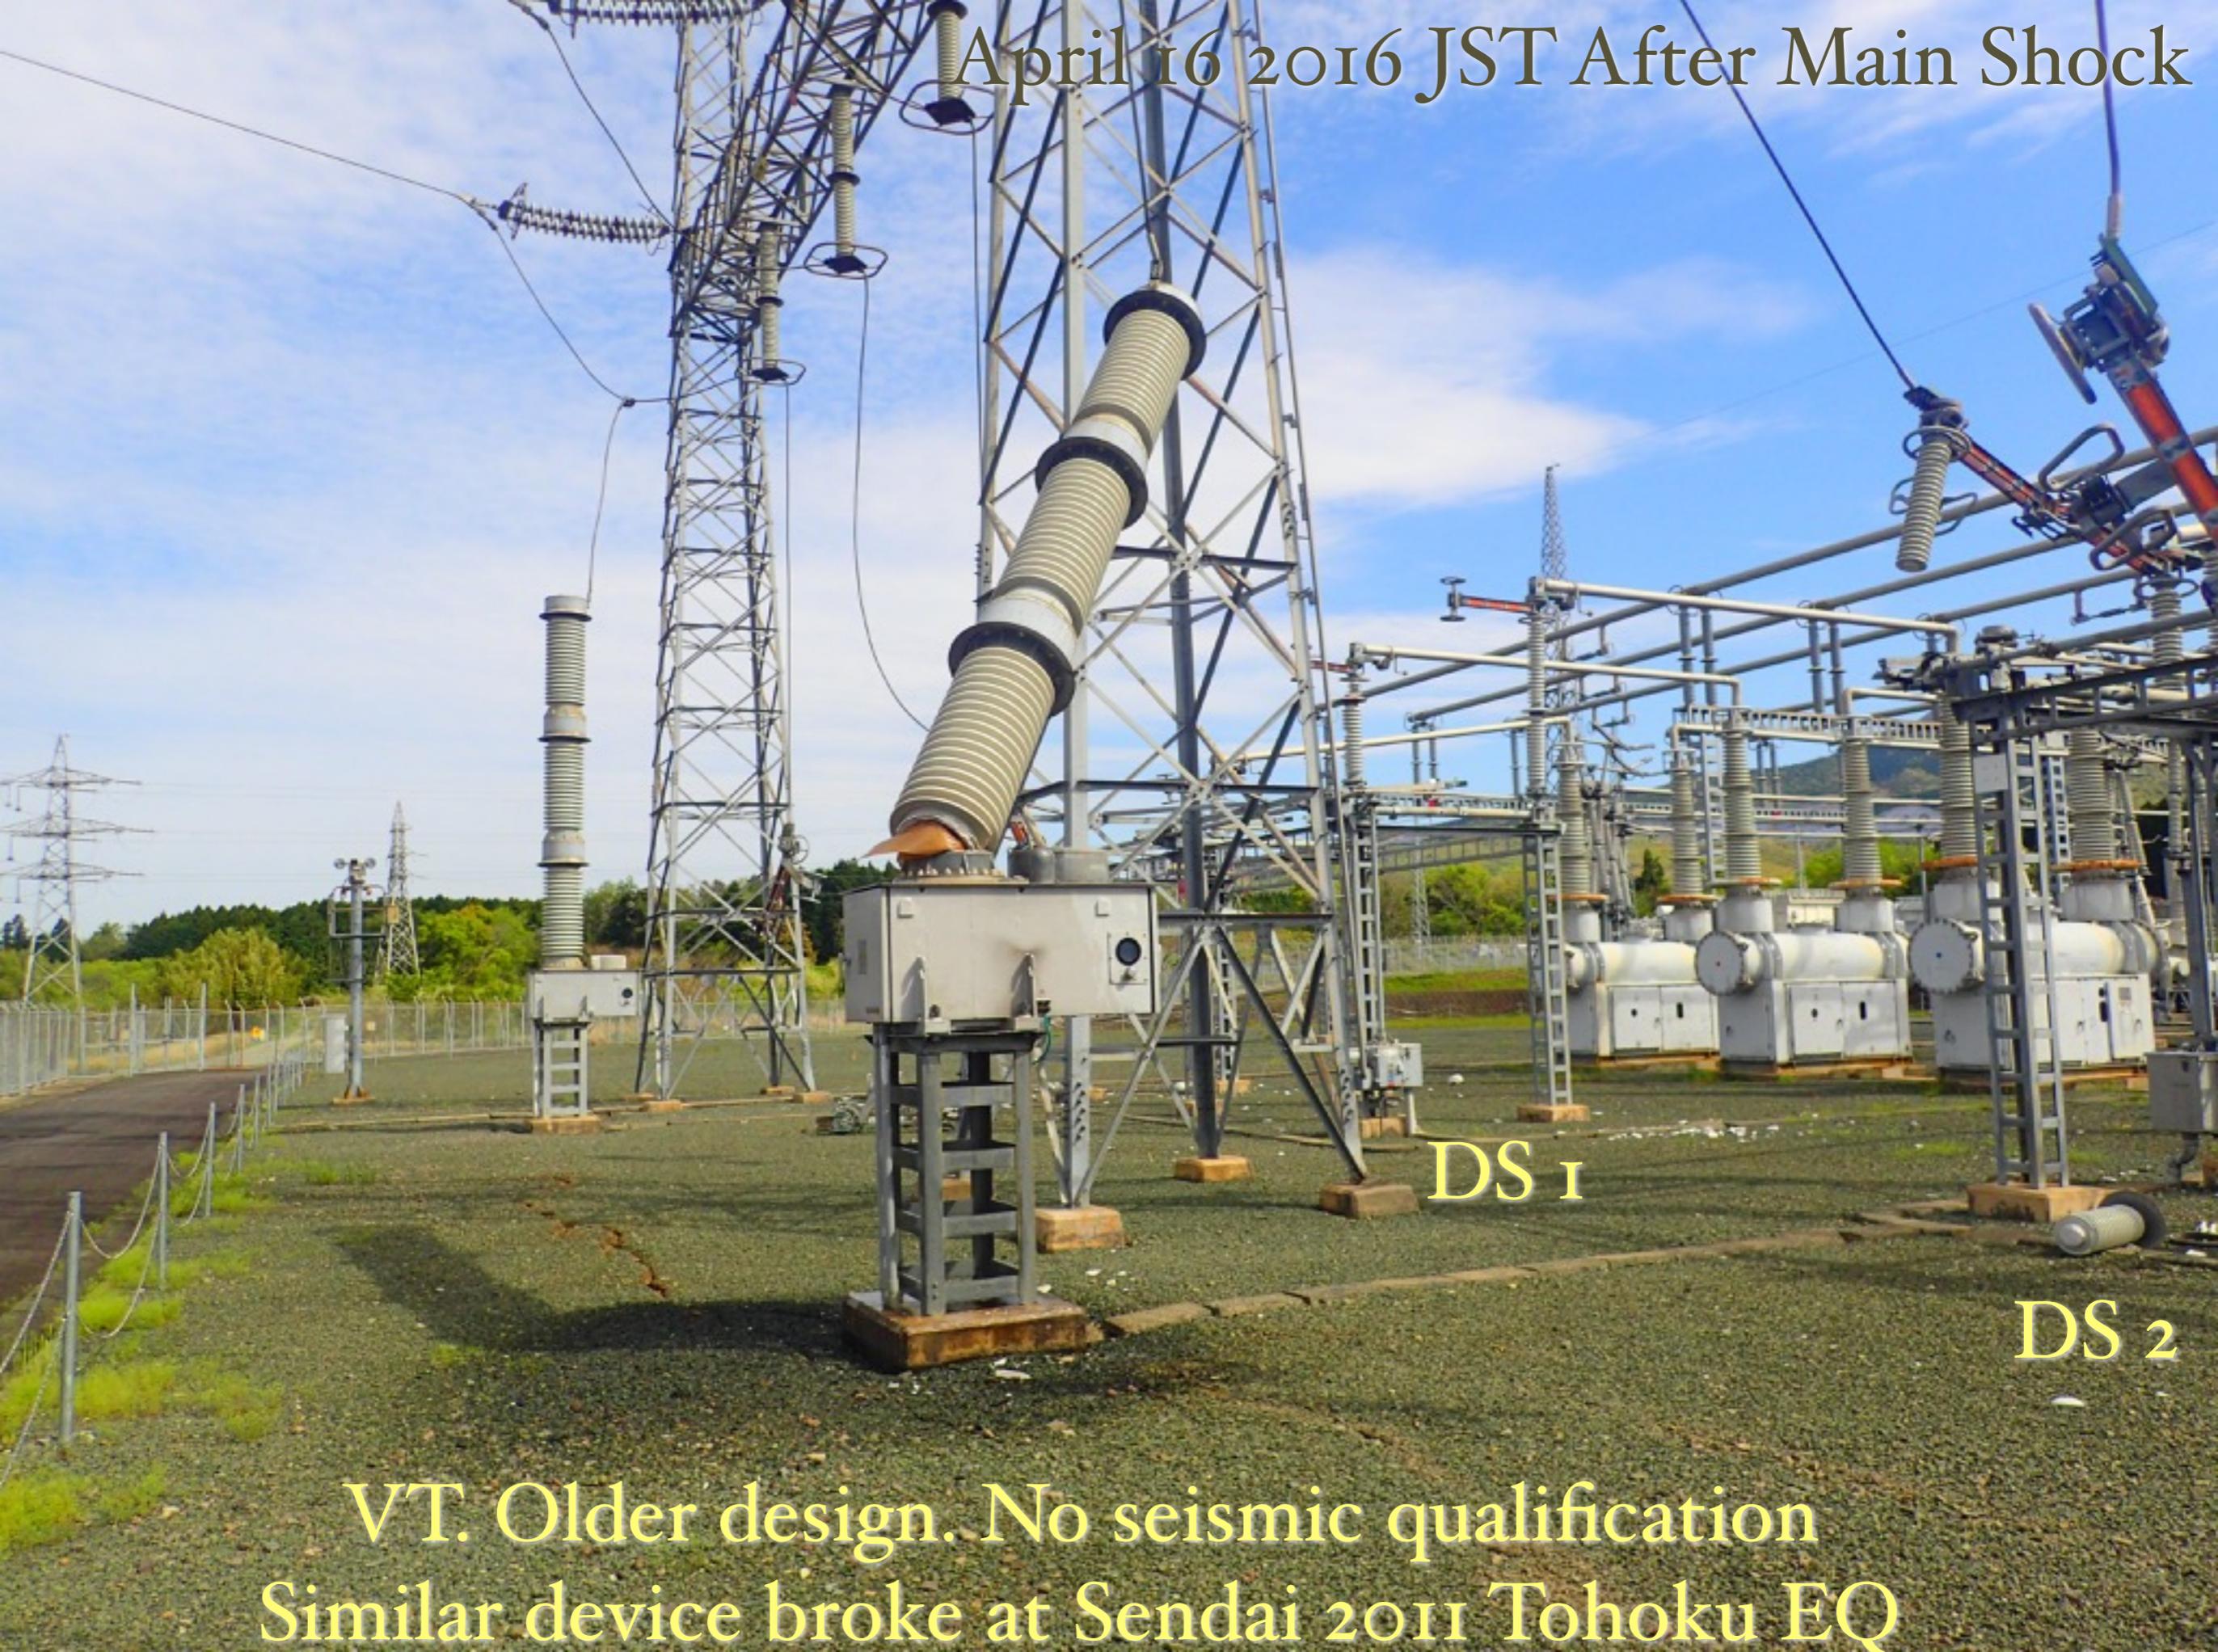
VT. Older design. No seismic qualification
Similar device broke at Sendai 2011 Tohoku EQ

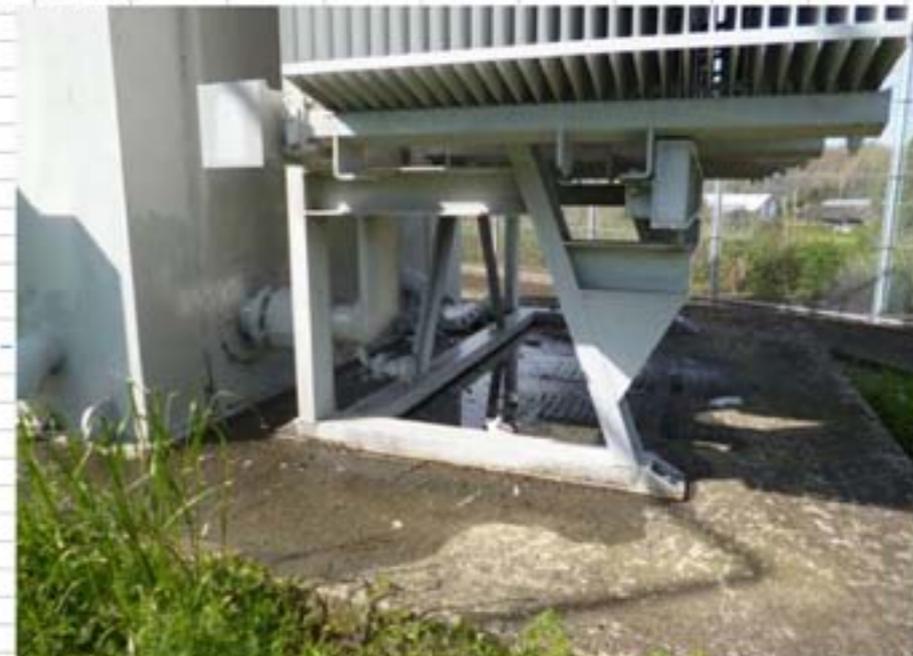
oil leakage

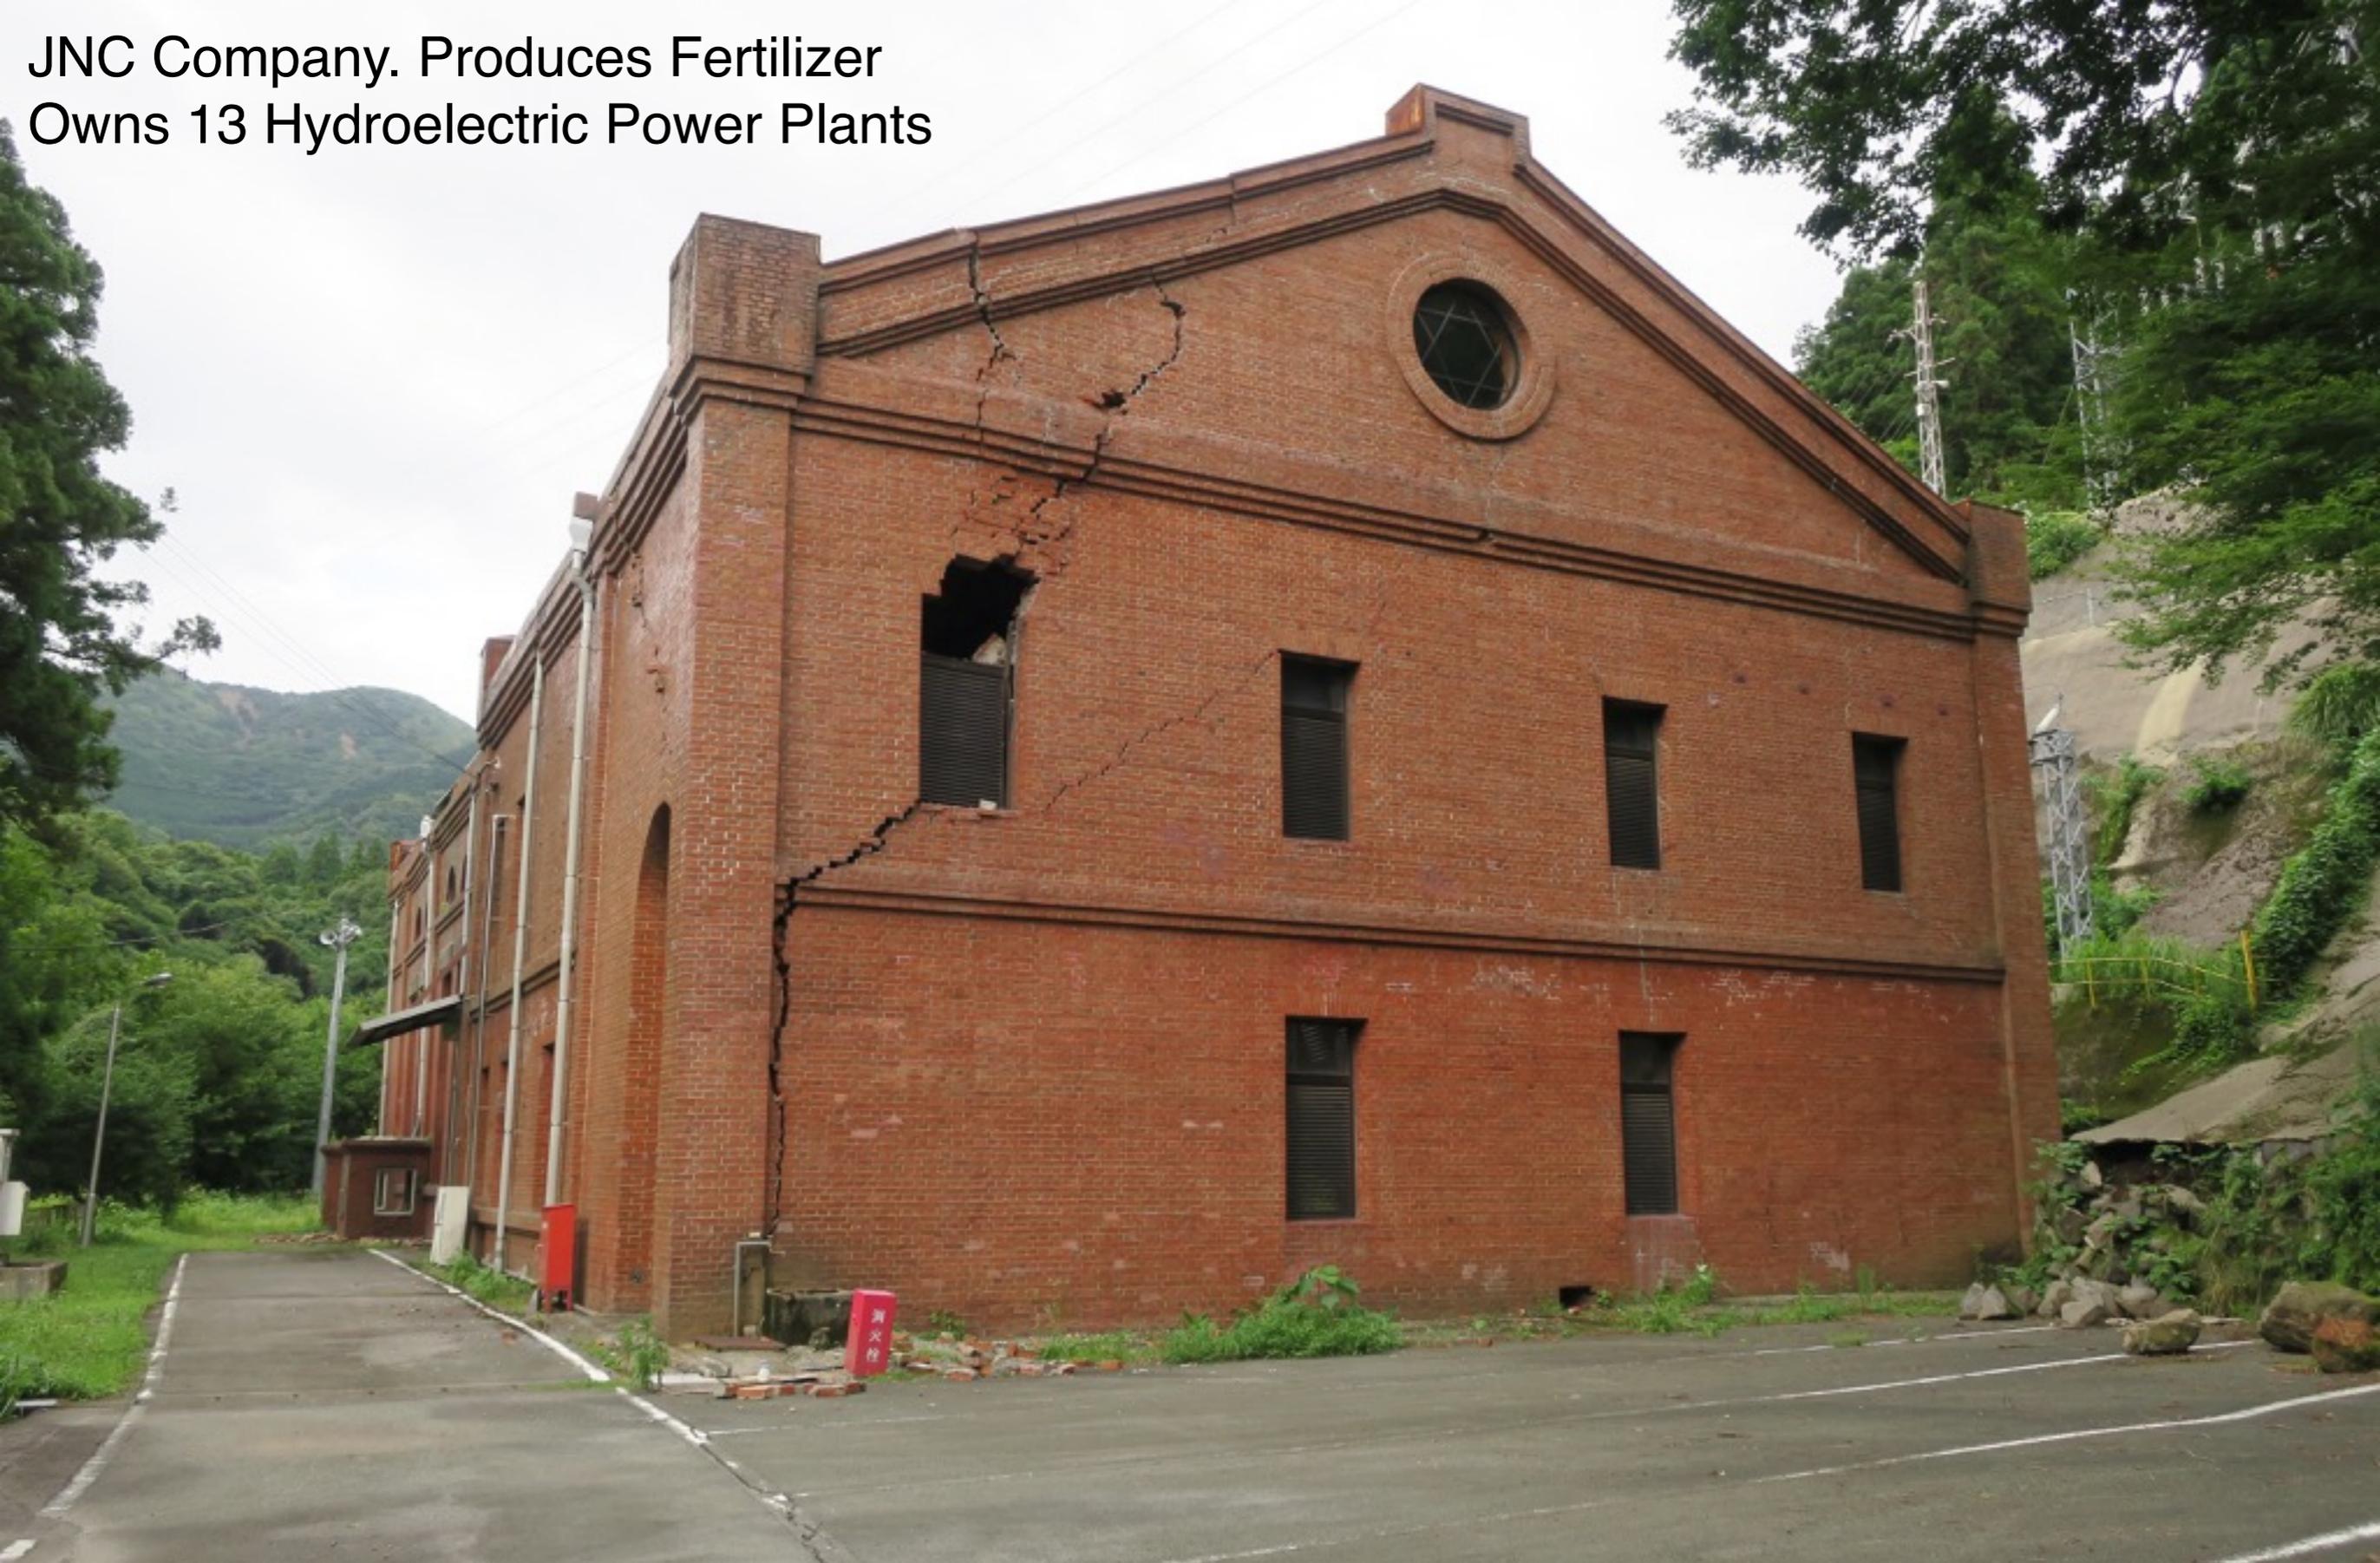
Turbine Building Failed. Repair after the landslide along the
access road is repaired (July 2 2016, t+77 days)
