1.0 Introduction

The Lushan earthquake occurred at 8:02 am local time, April 20, 2013. This earthquake is the result rupture on a nearby / adjacent fault segment from the great M 8.0 Wenchuan earthquake of May 12, 2008. The ruptured fault segment in 2013 was located south of the southern end of the rupture in the 2008 event. The distance between the Lushan EQ epicenter is about 83 km SSW of the Wenchuan EQ epicenter.

1.1 Key Findings

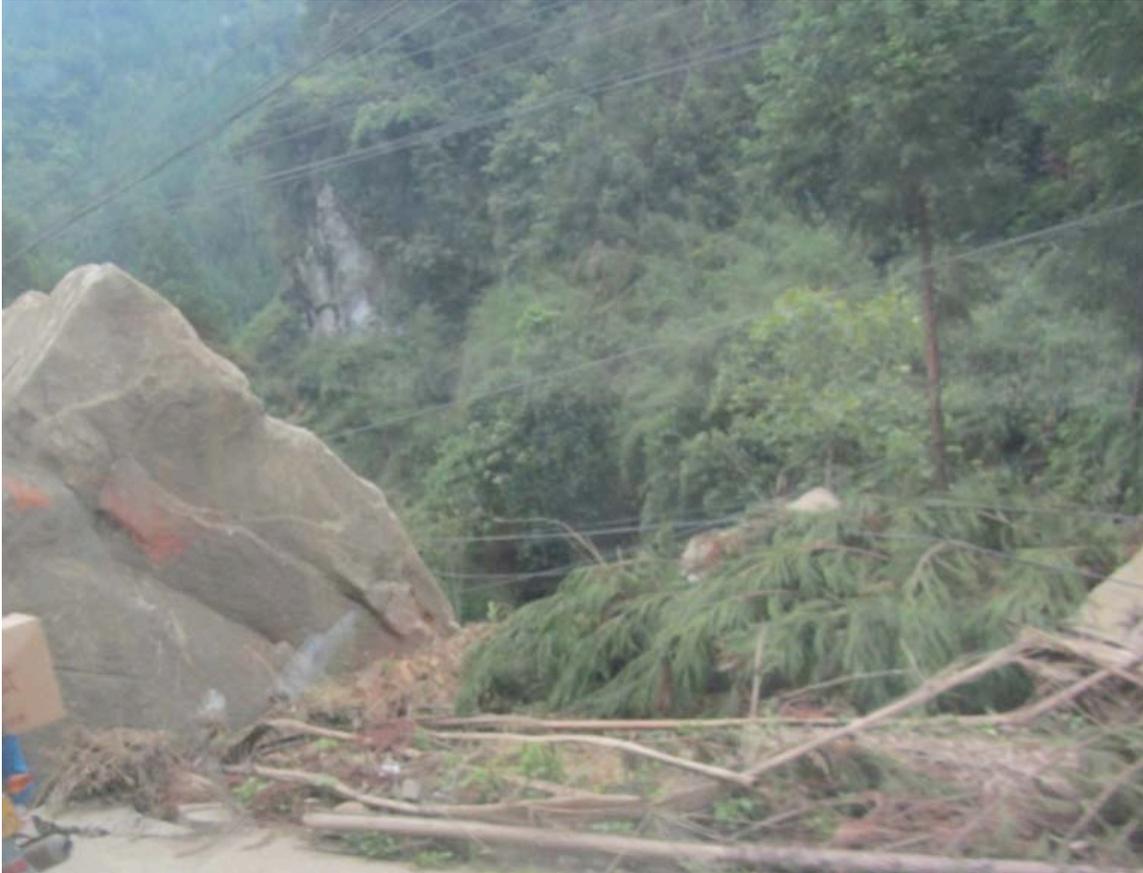
Figure 2-20. Rockfall into road and damage of power poles

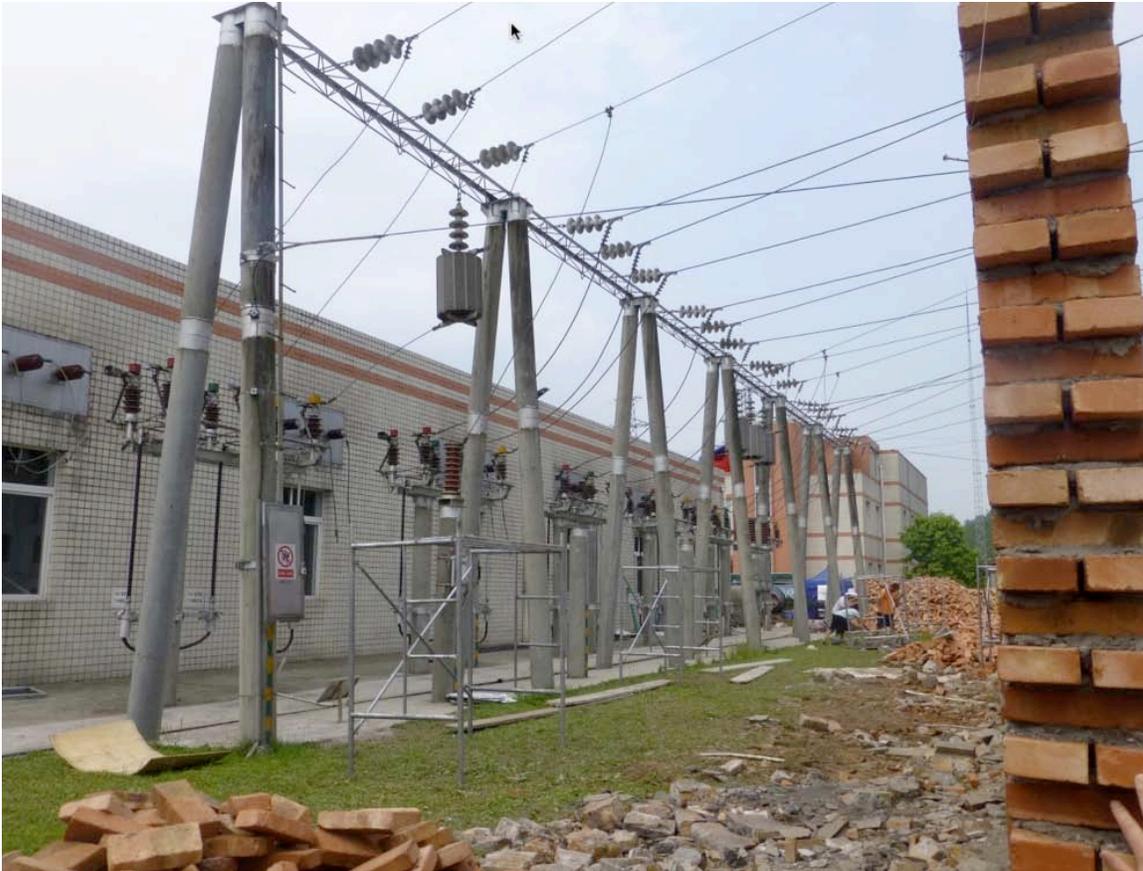
The site is surrounded by an unreinforced masonry wall. About a third of the wall was damaged due to inertial shaking, Figure 4-1. Also seen in Figure 4-1 in the control building (it had major x-cracks, see Figure 4-3) and dead end structure for low voltage feeder circuits (two of the disconnect switches were damaged). Unlike the gross failure of dead end structures at Ertishan substation (2008 earthquake), we did not see failure of the precast concrete – steel lattice dead-end structures in the 2013 earthquake; this "improvement" is likely because there were no 230 kV substations impacted by the 2013 event, and the Ertishan substation was subjected to higher shaking ($PGA \sim 0.60g$).

Figure 4-1. Damage to URM Wall, Cut Side. Some low voltage circuits were still not in service as of May 27 2013.

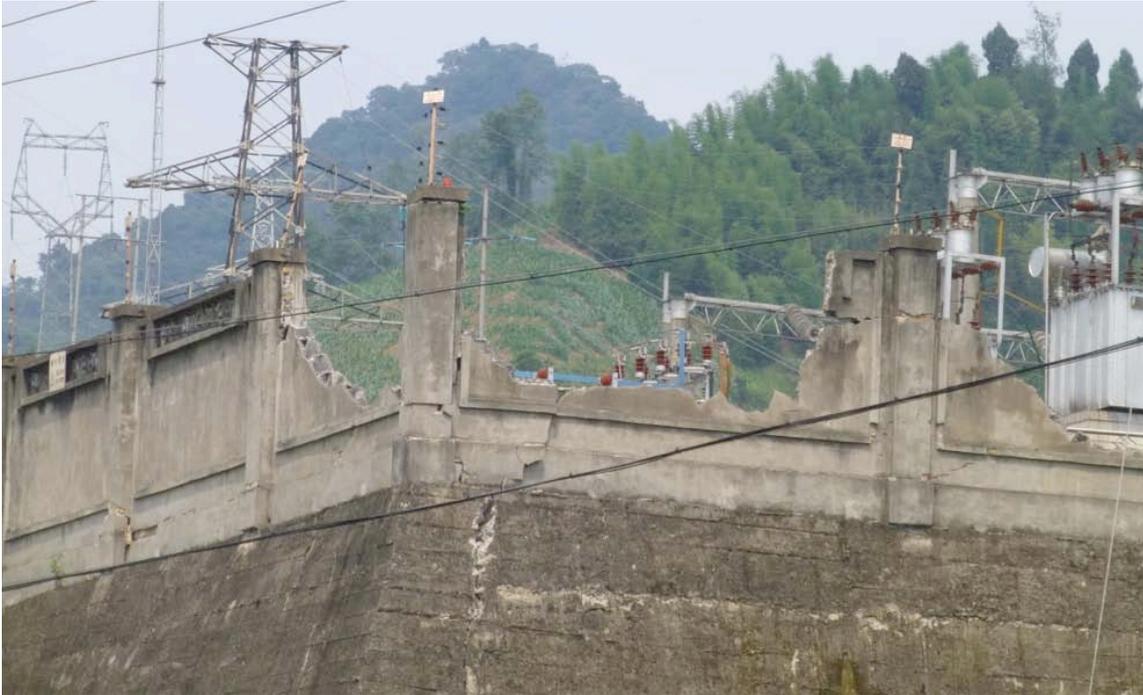
Figure 4-2 shows the damage to the exterior masonry wall at the corner of the substation on a gravity retaining wall. The damaged free-standing wall here was due to a combination of inertial loads, coupled movement of the gravity wall. The gravity wall movement resulted in about 2 to 4 inches of settlement and up to 6 inches of lateral movement at this corner of the yard. This corner of the yard included low voltage equipment only.

Figure 4-2. Damage to URM Wall, Fill Side

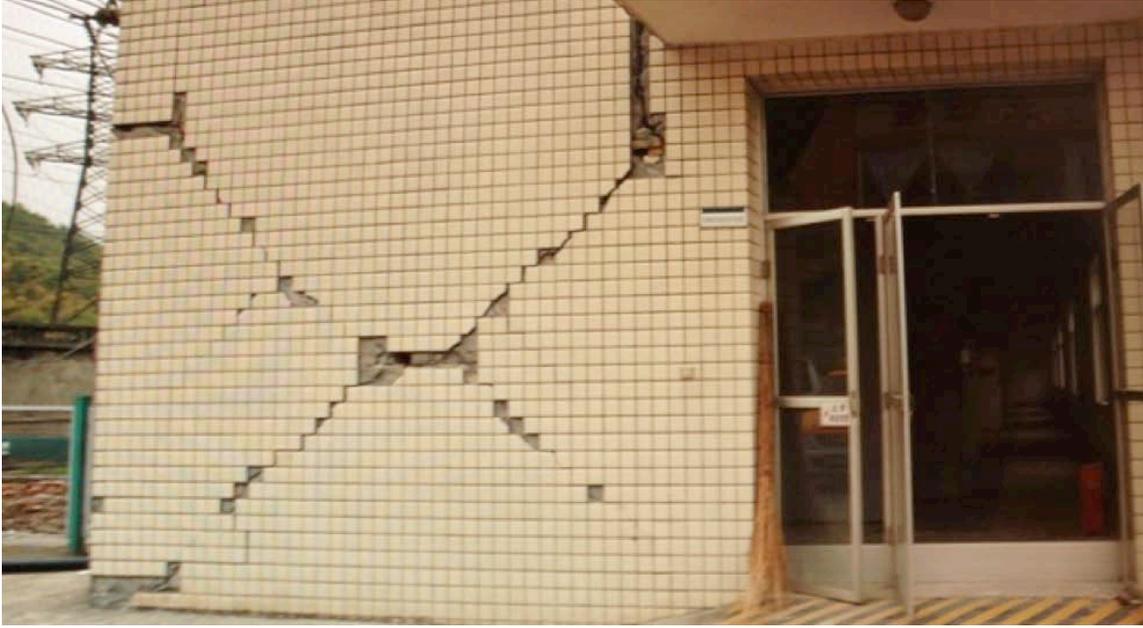
Figure 4-3 shows major x-cracks through a primary shear wall of the control building. The control building is normally occupied by several people, and remained in use a month after the earthquake.

Figure 4-3. Damage to URM Control Building (Also houses low voltage feeder equipment)

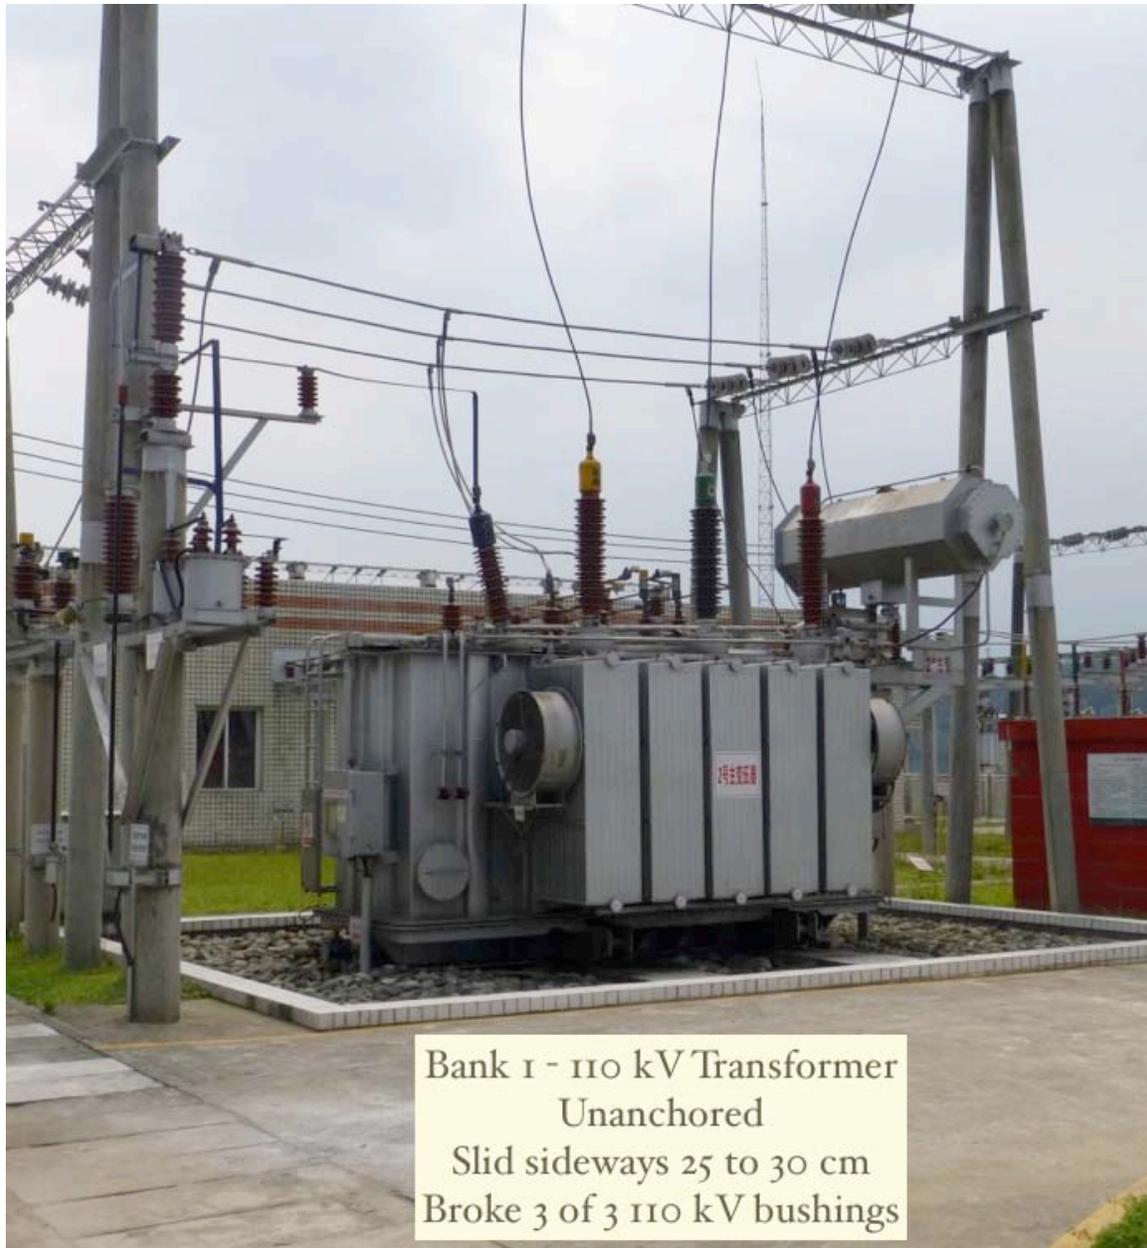
Figure 4-4. Bank 1 Transformer

Figure 4-4 shows one of the two three-phase 110 kV transformer banks in the yard. This transformer slide 25 to 30 cm in the earthquake, and broke all 3 of its 110 kV-side bushings. Figure 4-5 shows the sliding of the transformer. A crew of some 110 high voltage linemen repaired the yard within 3 days of the earthquake, and restored one transformer 28 hours post-earthquake. When asked if the oil for the transformer was treated, site staff replied that it was not.... Suggesting the urgency to restore power to Lushan, and also suggesting that there may be future reliability issues for the transformers.

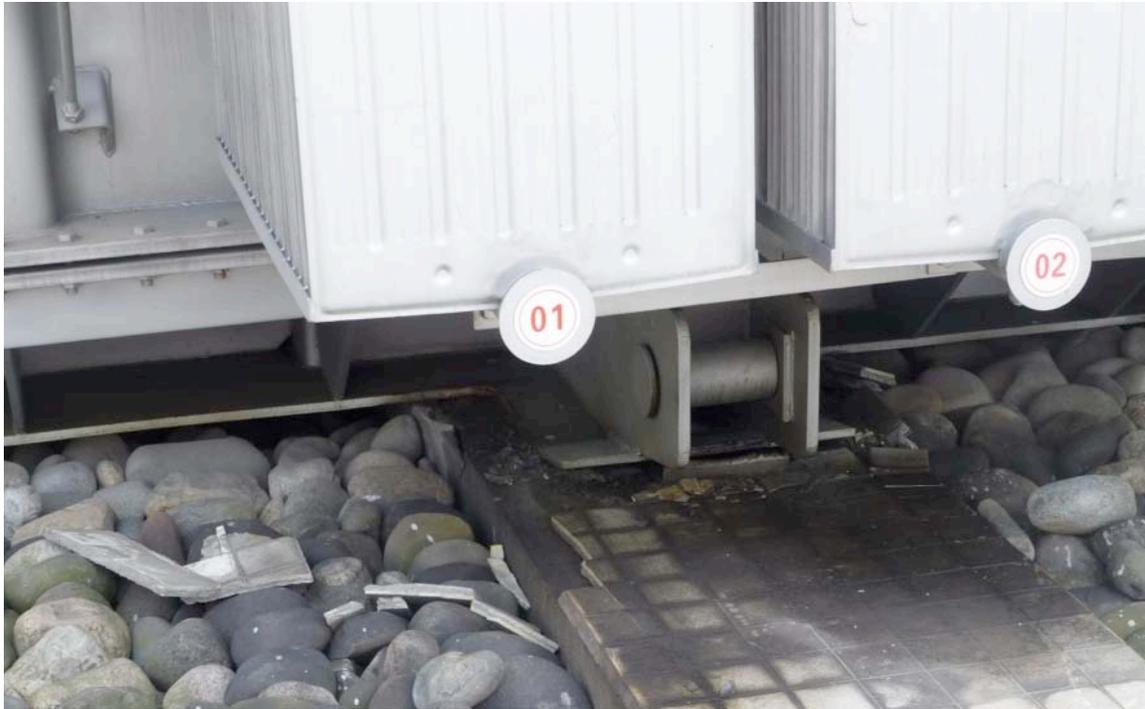
Figure 4-5. Bank 1 Transformer – Evidence of sliding (broken tiles over concrete foundation) and leakage of oil. The transformer was pushed back to its original position.

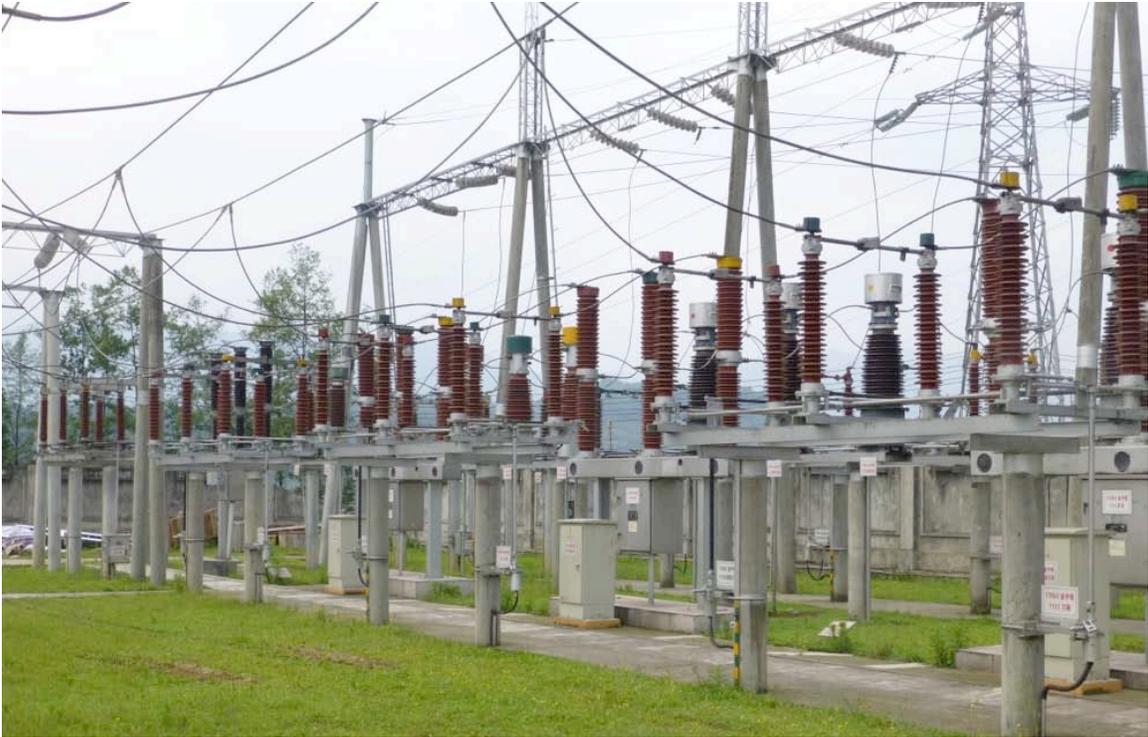
About 40 percent of all equipment in the 110 kV yard was damaged. Figure 4-6 shows the 110 kV yard, after it has been repaired. The 40% failure rate of the 110 kV yard is much higher than what would normally be expected at a seismically designed 110 kV yard in the US. The question is: why did this yard have so much damage?

Figure 4-6. 110 kV Yard (after repair)

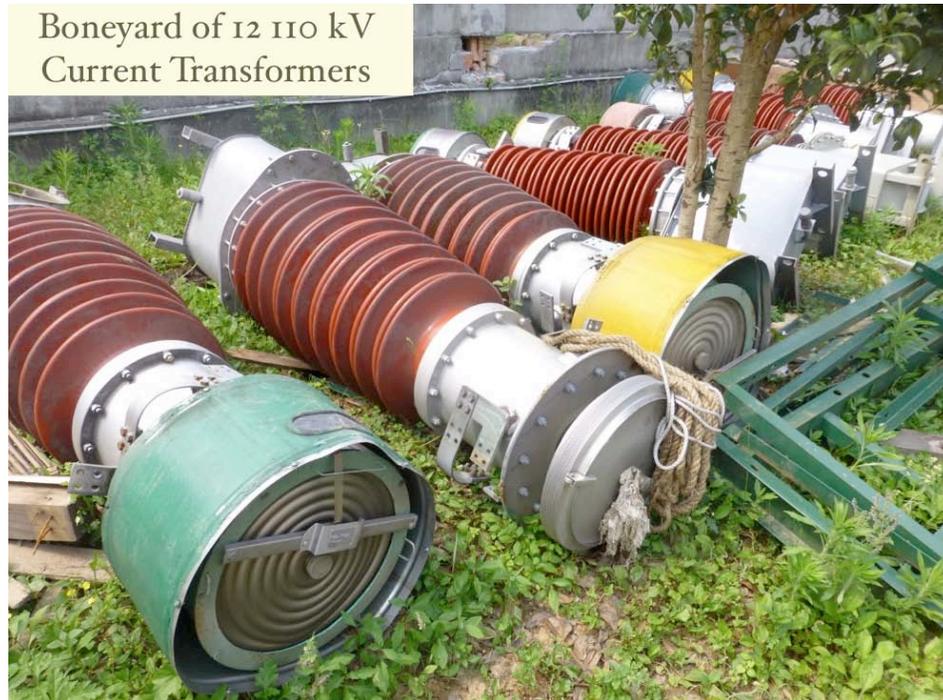
Twelve of the 110 kV current transformers were broken, Figure 4-7. When inspected, one damage mode was due to high tension forces applied to the terminations, leading to fracture of the porcelain, Figure 4-8. These high forces were likely due to inadequate cable slack between the current transformers and adjacent switches / circuit breakers, aggravated in large part by swinging wave traps.

Figure 4-7. 110 kV Broken Current Transformers

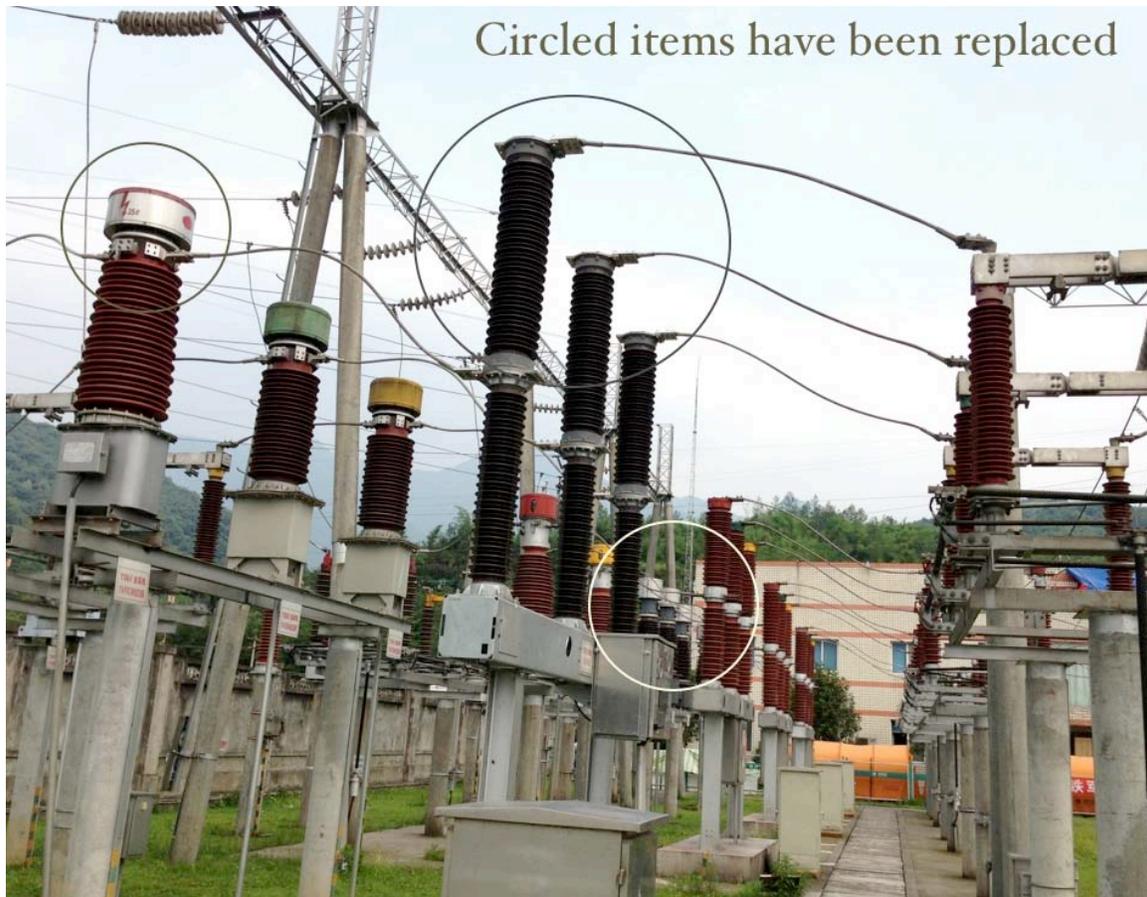
Figure 4-9 shows a portion of the 110 kV yard. Circled components are replacements for those damaged in the earthquake. The cable slack, after replacement, remains inadequate in many positions. One solution would be to increase the cable slack, or use stiffer components (steel beams, etc.) and increase the frequency of the components, to lessen the displacement demand. It appears that the original cables were used for the replaced equipment; there was no evidence of replaced cables. Damaged components in this photo include candlestick-type circuit breakers, horizontal-break disconnect switches, and current transformers.

Figure 4-9. 110 kV Yard – After Repair

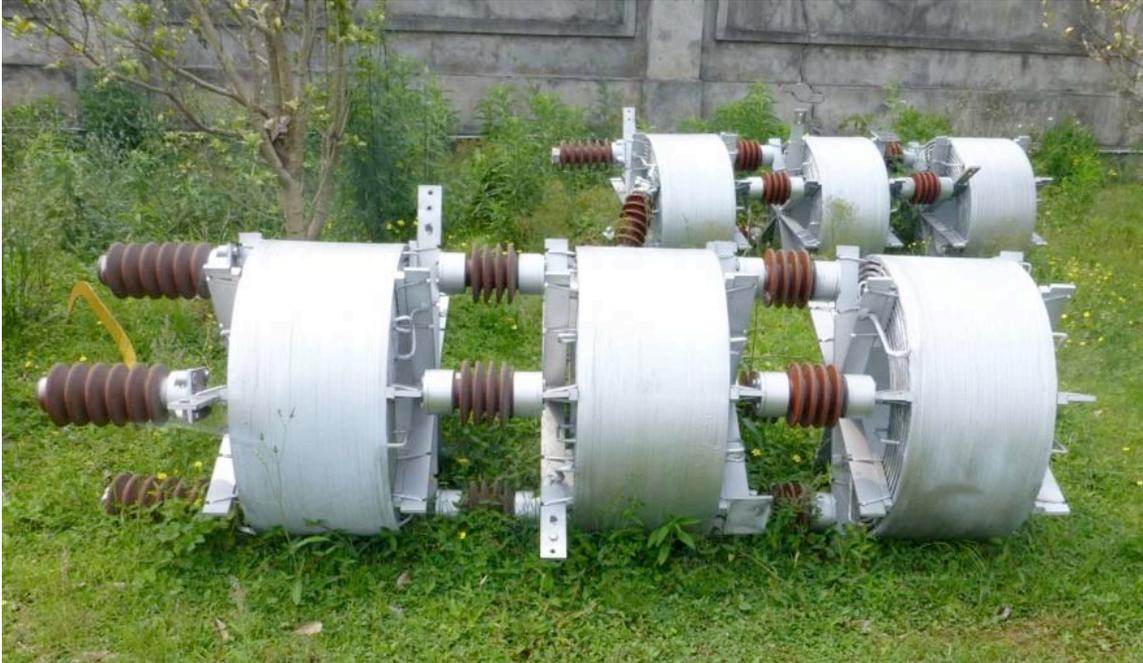
Figure 4-12. Damaged Air Core Reactors

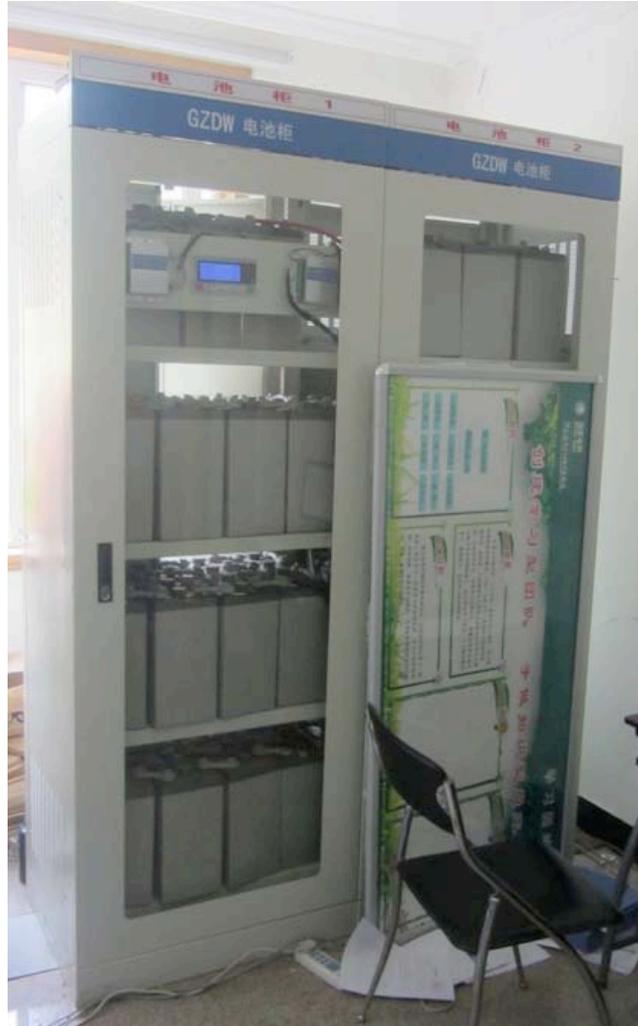
Within the control room, unanchored batteries slid, but did not topple, Figure 4-13. After sliding, the batteries continued to function. Even so, unanchored batteries are not considered to be an acceptable design practice; had the level of shaking been higher at this substation, the battery cabinets may have toppled.

Figure 4-13. Sliding Batteries within Cabinets (uneven spaces between batteries due to sliding)

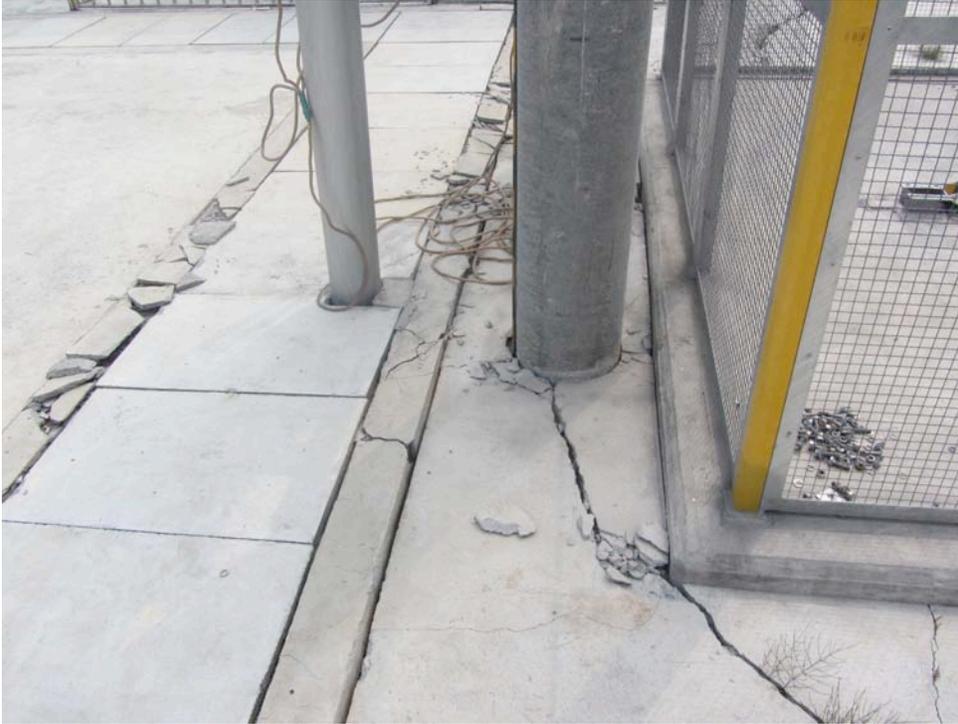
Based on our field observations, the damage in the low voltage part of the yard affected by these ground movements was caused by inadequate slack of the bus between adjacent pieces of equipment, coupled with completely unanchored pieces of equipment that allowed rocking (and hence increased demand on the slack of cables between the equipment). It appeared that the ground movements exacerbated the damage.

Figure 4-14. Cracks in the concrete pavement / cable trench due to the permanent ground movement

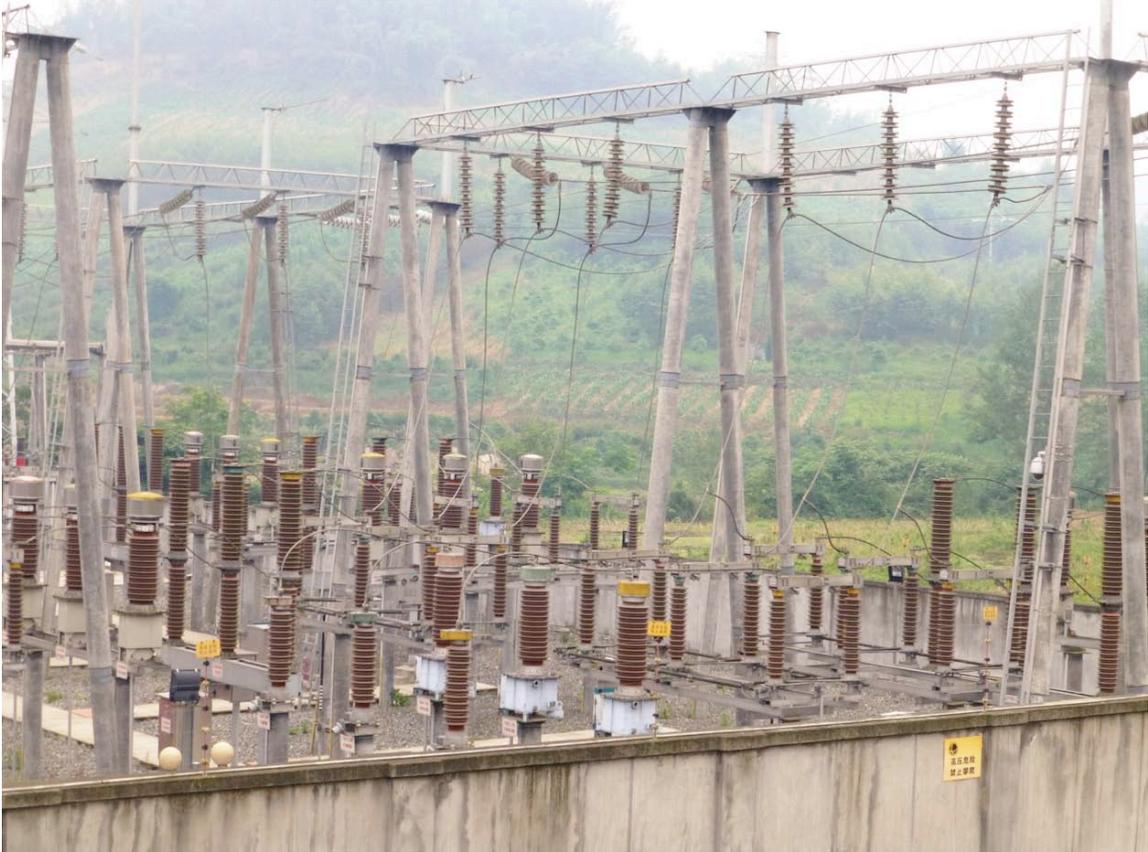
This substation uses the same type of 110 kV equipment as at the Jinhua Substation. However, the yard had little damage. Why? Based on initial observations, this substation does not use any hanging wave traps, as seen in Figure 4-14.

Figure 4-14. Undamaged 110 kV Yard at Substation 2

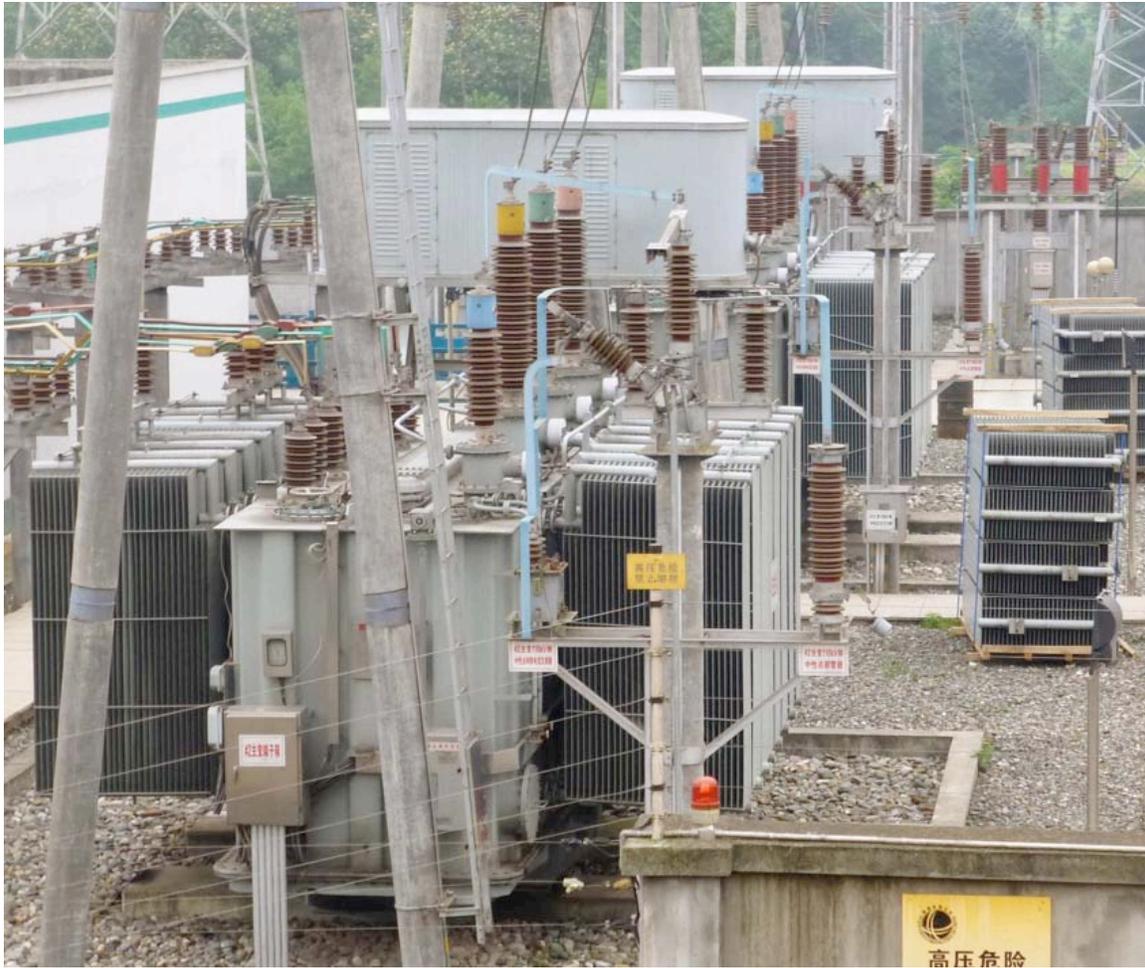
Even though Substation 2 had little 110 kV yard damage, it appears that the two 110 kV transformers had radiator failures. Figure 4-15 shows two radiators on wood skids, with replaced radiators on the transformers.

Figure 4-15. 110 kV Transformers and Radiators at Substation 2

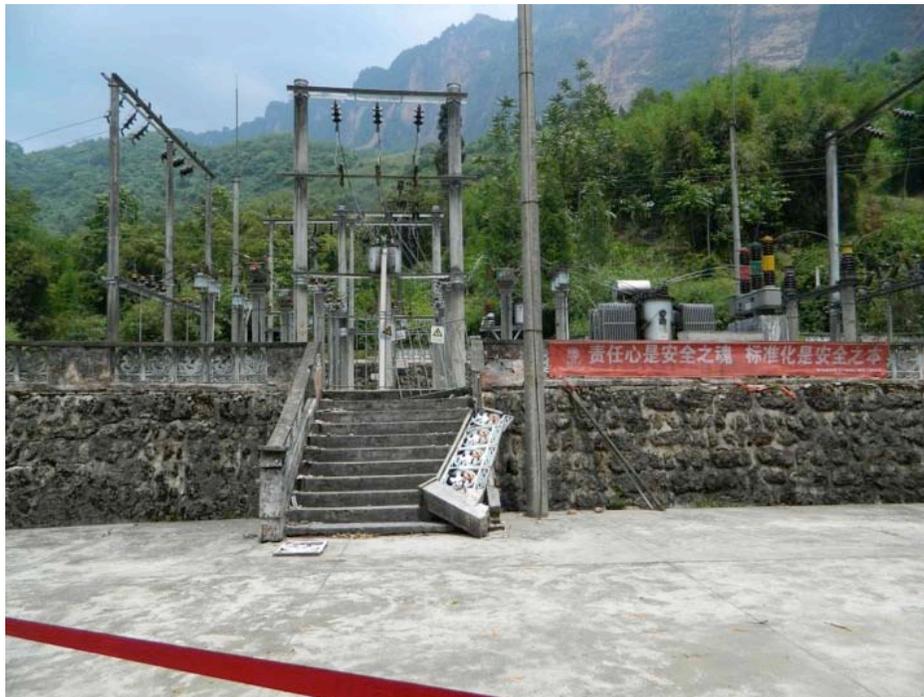
The other damage observed was the URM wall and the gate to the yard, Figure 4-19.

Figure 4-19 Entrance to the Dayanqiang (大岩腔) 35kV substation yard. Note the broken railing and part of the wall.

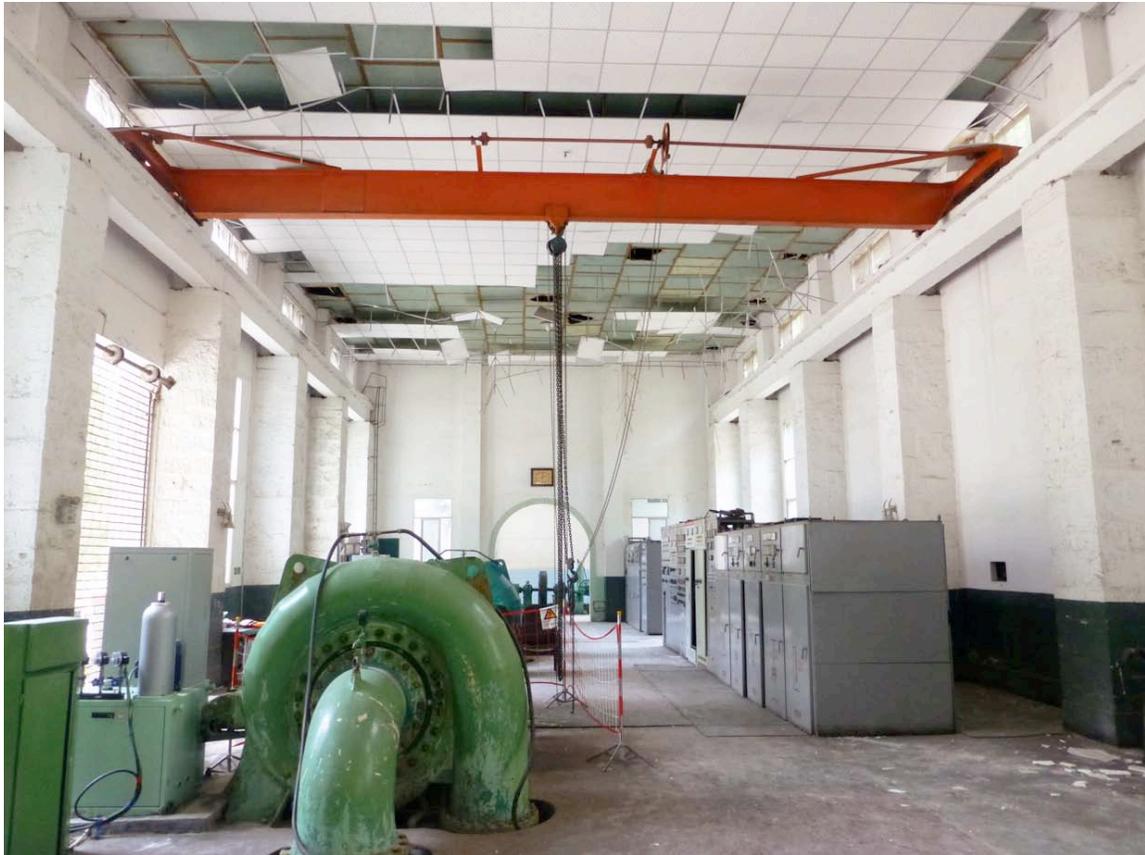
Figure 4-20 shows the generator hall in one of the power plants. Note the failure of the suspended ceiling. The traveling crane did not detail (it had no seismic restraints). Estimated level of ground shaking at this site was $PGA = 0.35g$. A few reinforced concrete columns at the window levels showed significant damage. The plant was not operational, owing to loss of the upstream water supply (flume and canal damage due to landslides).

Figure 4-20. Generator Hall, Hydro Power Plant

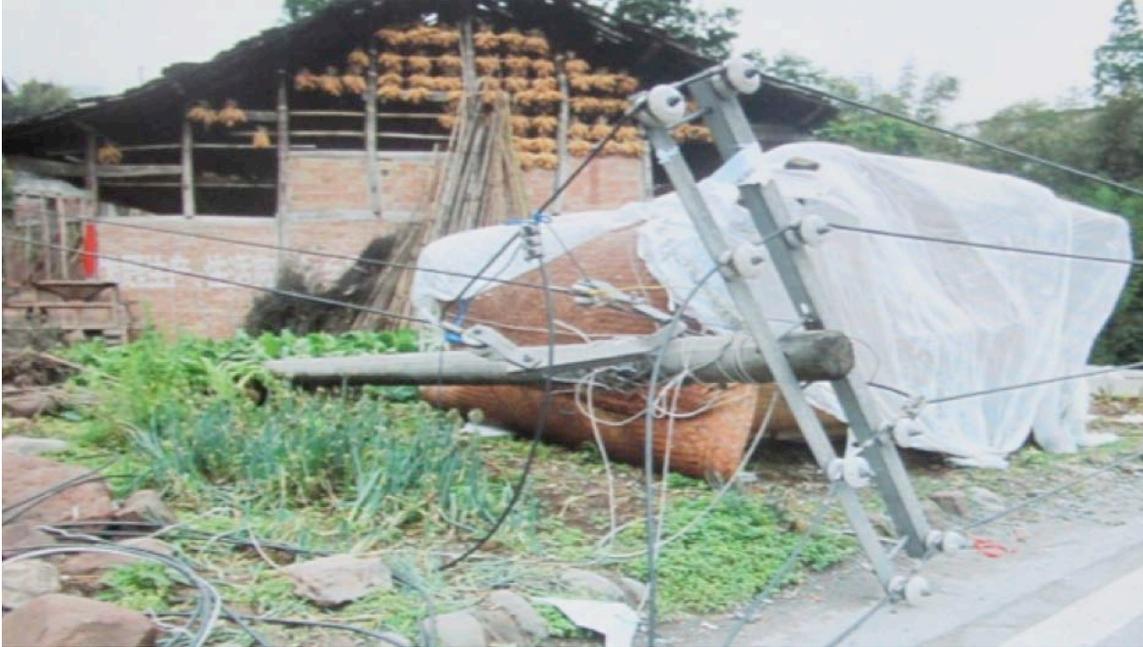
We observed many damaged power poles, either due to adjacent building collapse, or due to rockfall / landslide impacts, Figure 4-21.

Figure 4-21. Damaged Power Pole

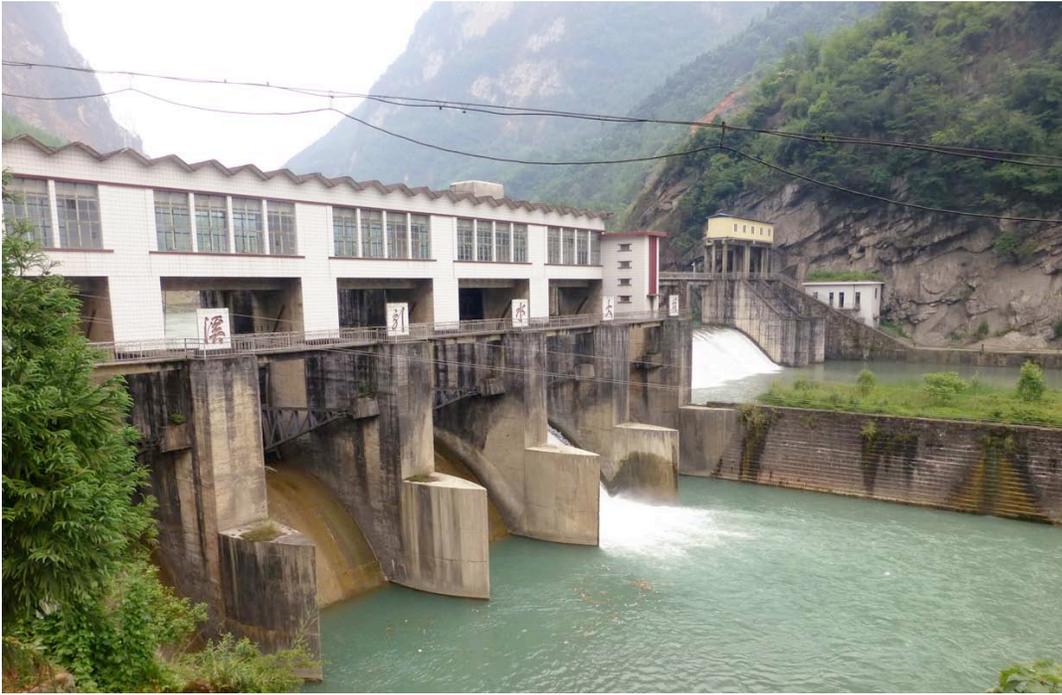
We visited one run-of-the-river concrete gravity dam, Figure 4-23, located immediately upstream of "bridge 1" (Figure 7-6). The operator of the dam reported that upon cessation of shaking, he immediately opened all radial and slide gates; all gates opened upon demand (no sticking). The dam included an emergency generator; we observed that the generator had an unanchored battery (Figure 4-24), and the dam operator confirmed that the generator failed to start on demand; but was quickly repaired.

Figure 4-23. Undamaged Dam (PGA ~0.35g)

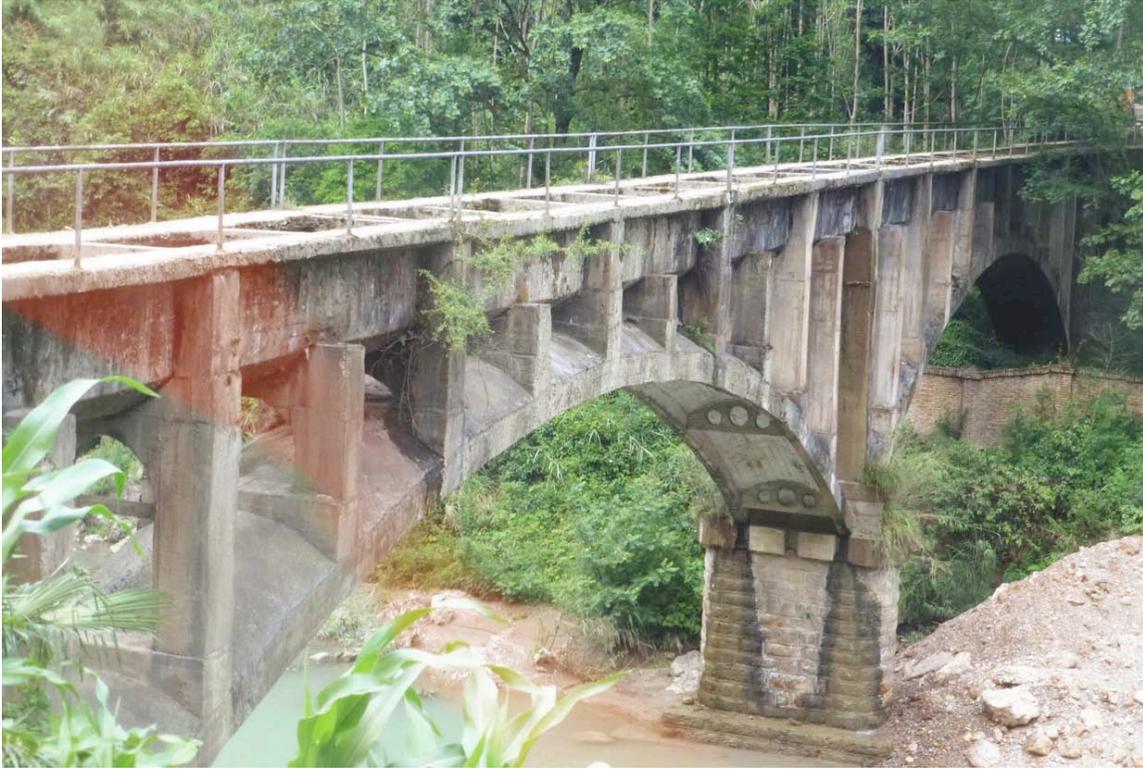
The reinforced concrete flume-bridge seen in Figure 4-25 seems to have had no damage. Still, there was no water flowing in the flume, due to upstream landslide-induced damage to the canals.

Figure 4-25. Undamaged Water Flume over River (PGA ~0.35g)

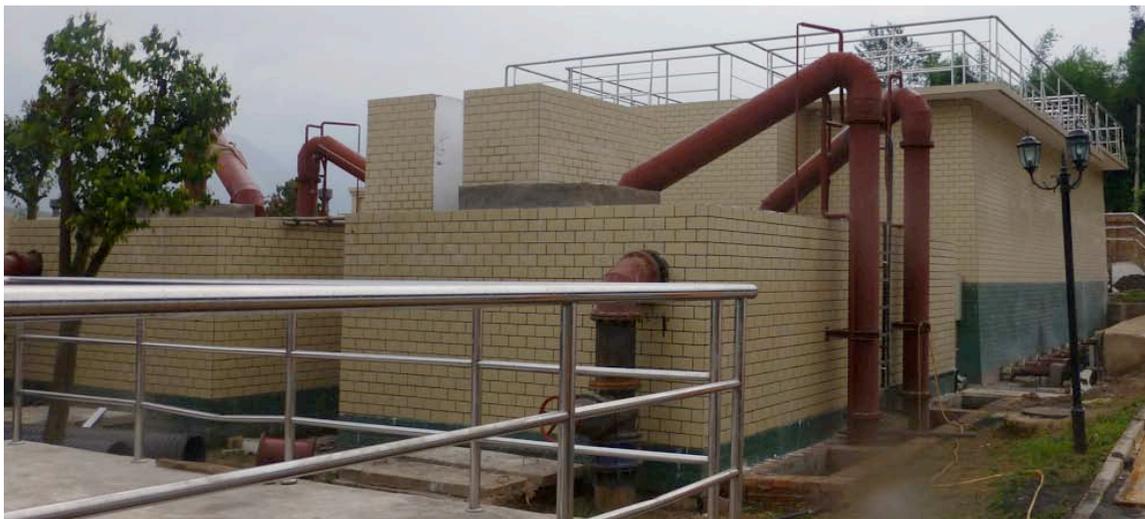
Raw water enters two sets of settling basins, flocculation basins and tube settlers, all in one rectangular reinforced concrete structure, Figure 5-2. We saw no evidence of damage to any part of this structure. Launderers over the filters were steel, anchored to the reinforced concrete walls; the launderers were undamaged.

Figure 5-2. Settling and Filter Basin Structures

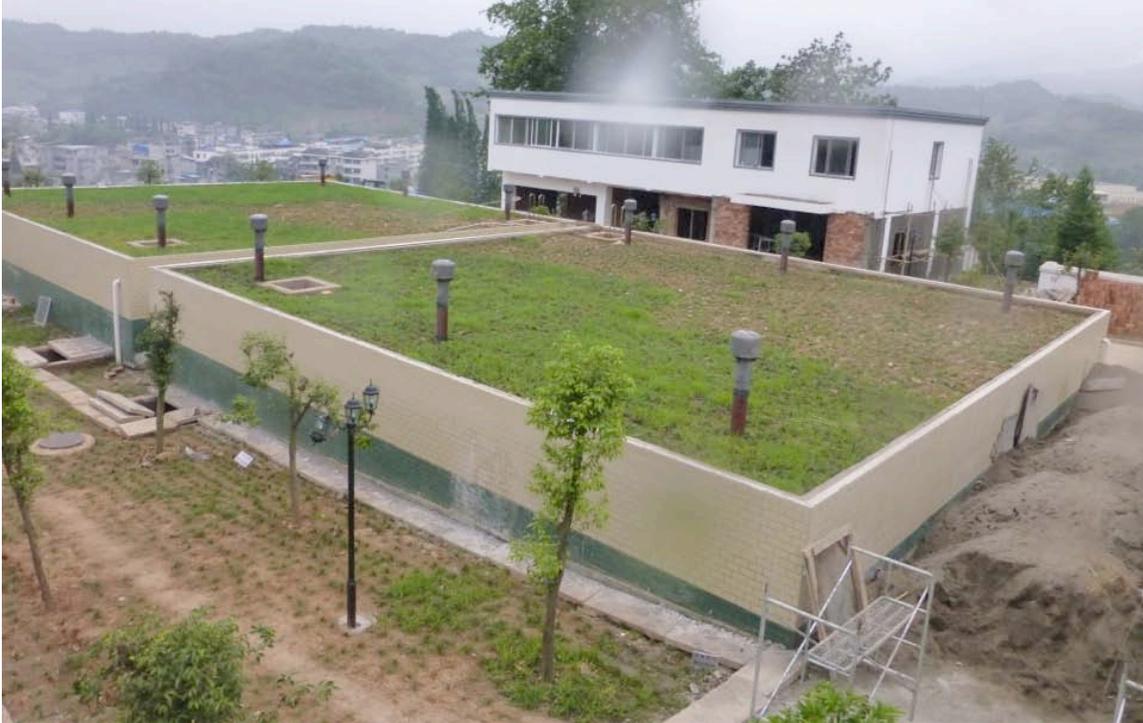
Water leaves the filters and enters two rectangular reinforced concrete clearwells, Figure 5-3. The clearwells appeared to be undamaged.

Figure 5-3. Two Partially Buried Clearwells

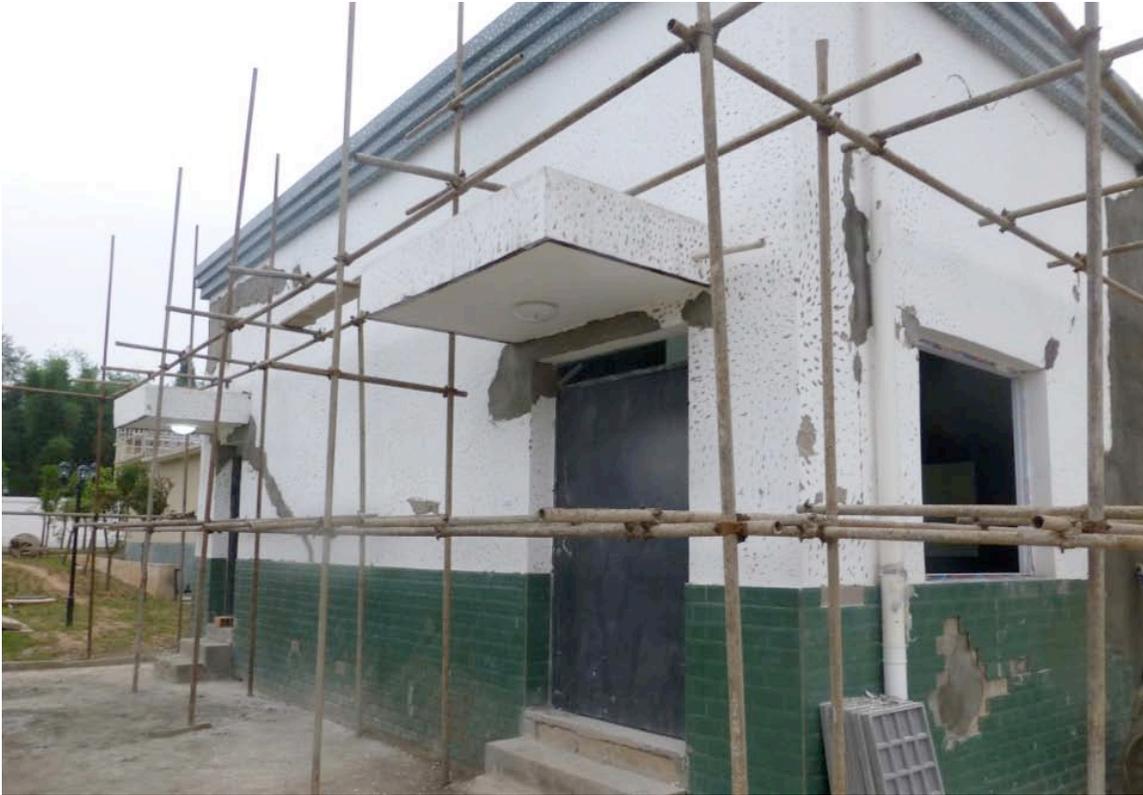
Several other facilities at the WTP were damaged. The control building is URM, and suffered large cracks (but did not collapse), Figure 5-4.

Figure 5-4. Damaged Control Building

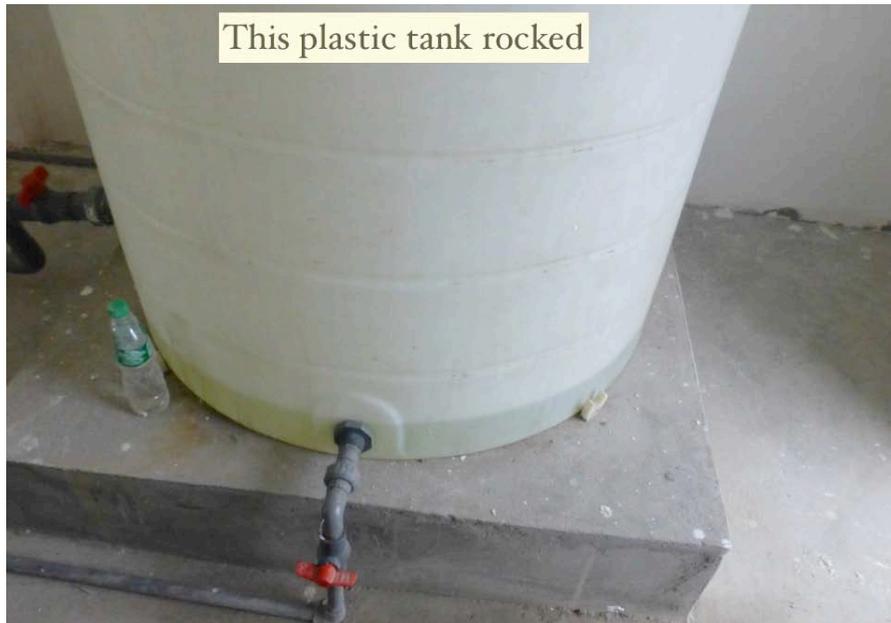
The chemical tanks rocked, Figure 5-5, leading to damage of attached PVC pipes, Figure 5-6. The small plastic stops (4 of them) did restrain the tank from sliding, but not rocking. The rocking led to damage of the attached restrained PVC pipe.

Figure 5-5. Plastic Tank for Chlorine Dioxide Disinfectant

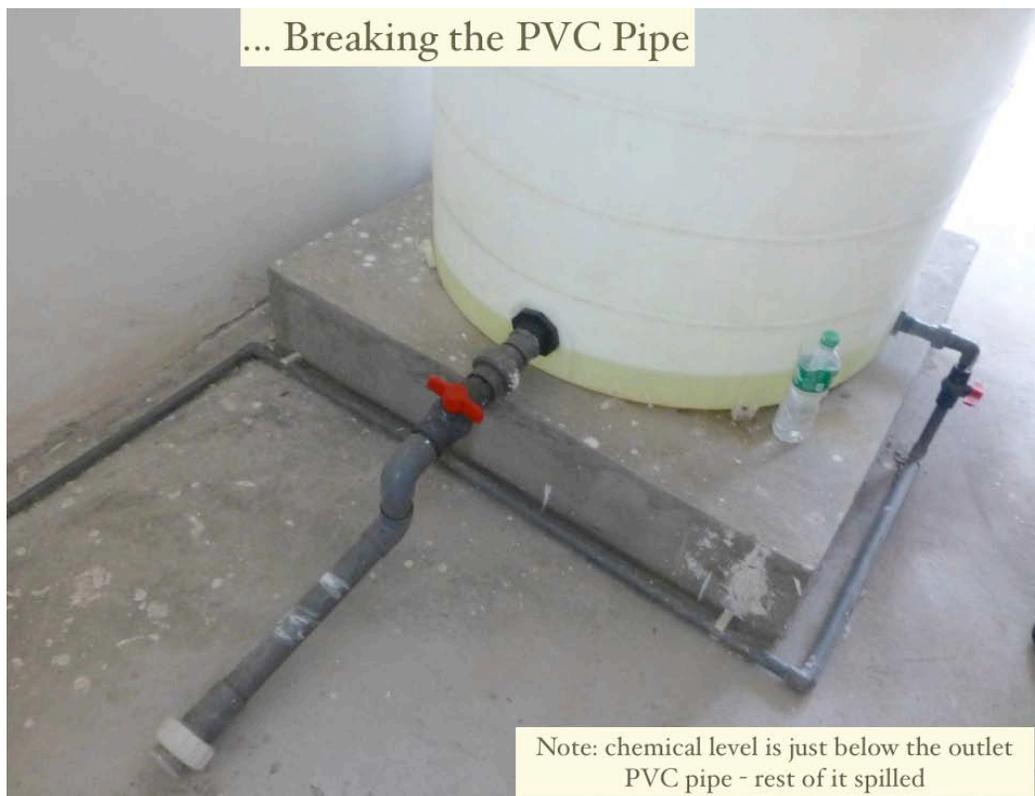
Figure 5-6. Broken PVC Pipe (the motor and pump also broke and have been removed)
