1.0 Introduction

The Lushan earthquake occurred at 8:02 am local time, April 20, 2013. This earthquake is the result rupture on a nearby / adjacent fault segment from the great M 8.0 Wenchuan earthquake of May 12, 2008. The ruptured fault segment in 2013 was located south of the southern end of the rupture in the 2008 event. The distance between the Lushan EQ epicenter is about 83 km SSW of the Wenchuan EQ epicenter.

1.1 Key Findings

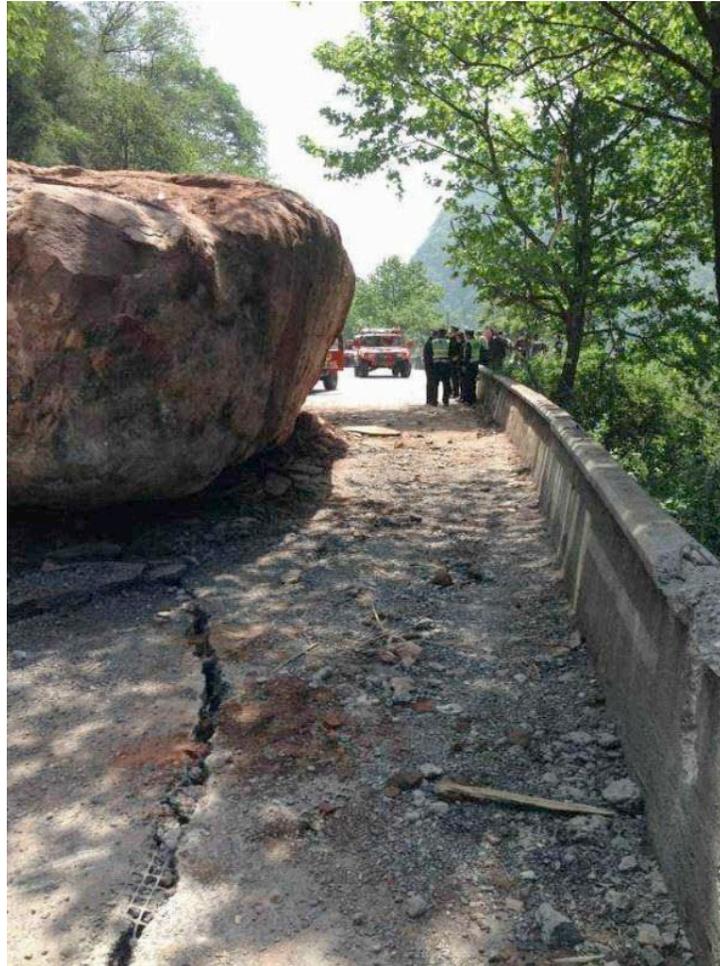
Figure 7-3. S210 damage on Feixianguan (飞仙关) Road by large boulders

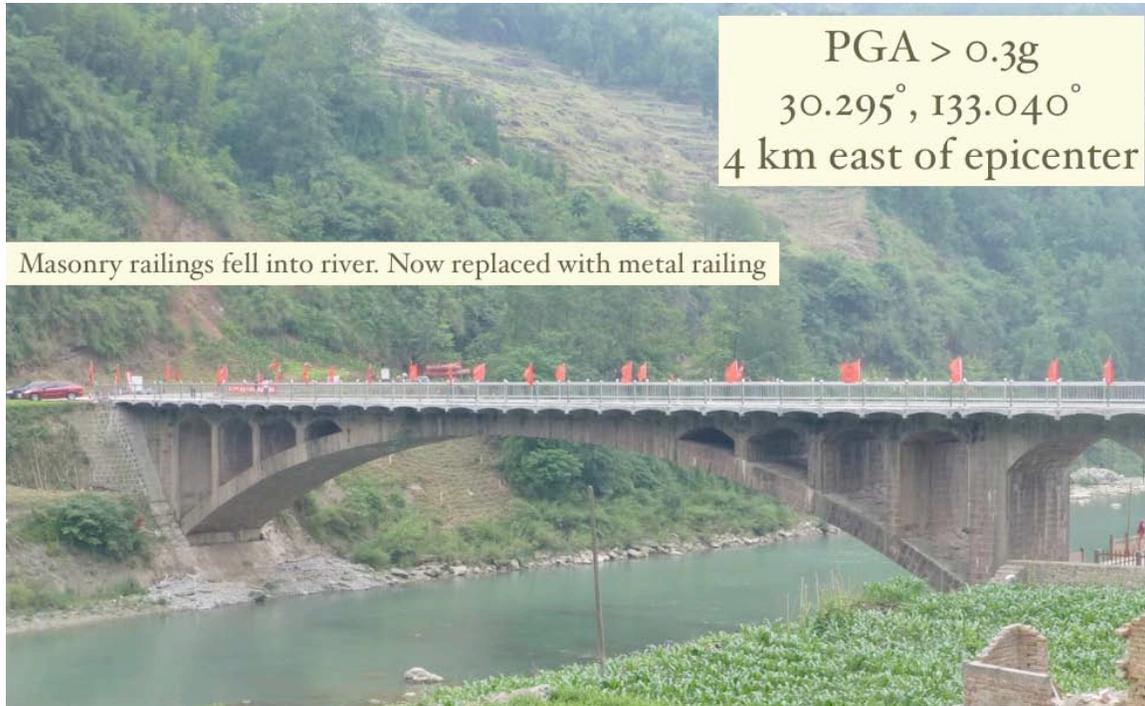
Figure 7-6. Damage to stone arch Bridge 1 in Lushan County (photo date May 31 2013)

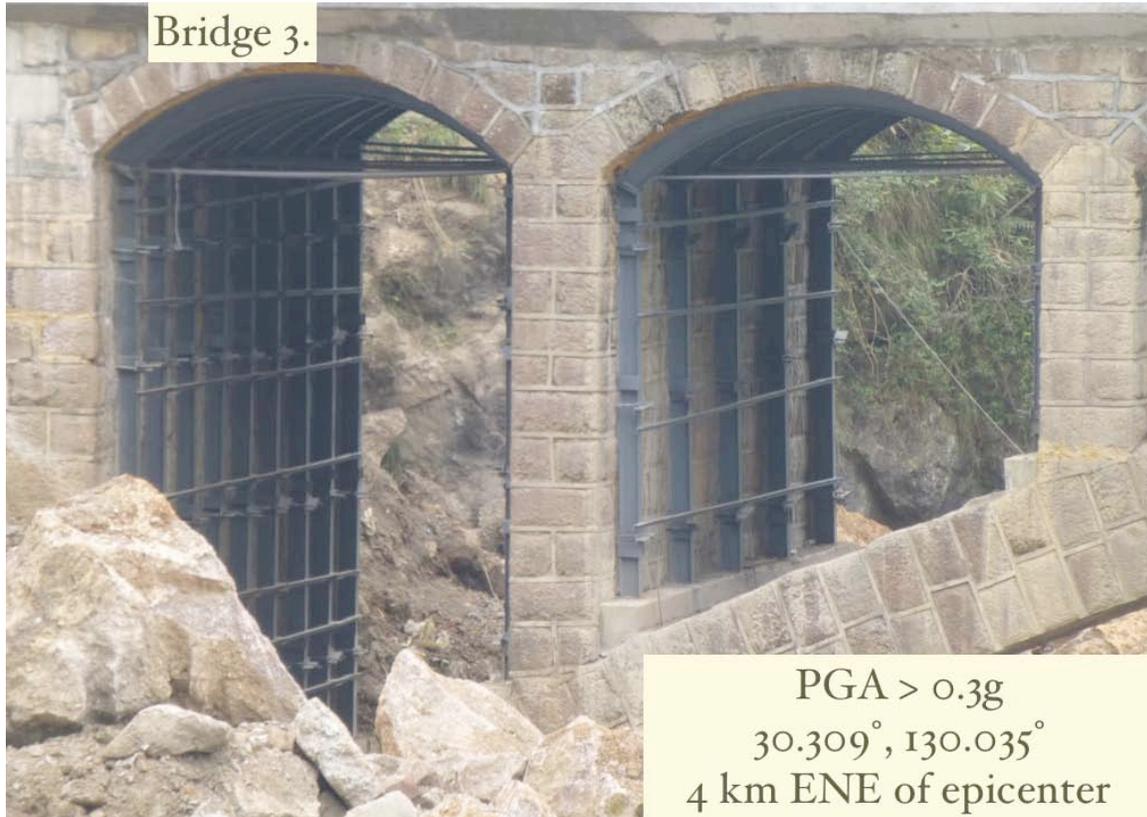
Figure 7-10. Steel Reinforcement Placed in Bridge 3 (May 31, 2013)

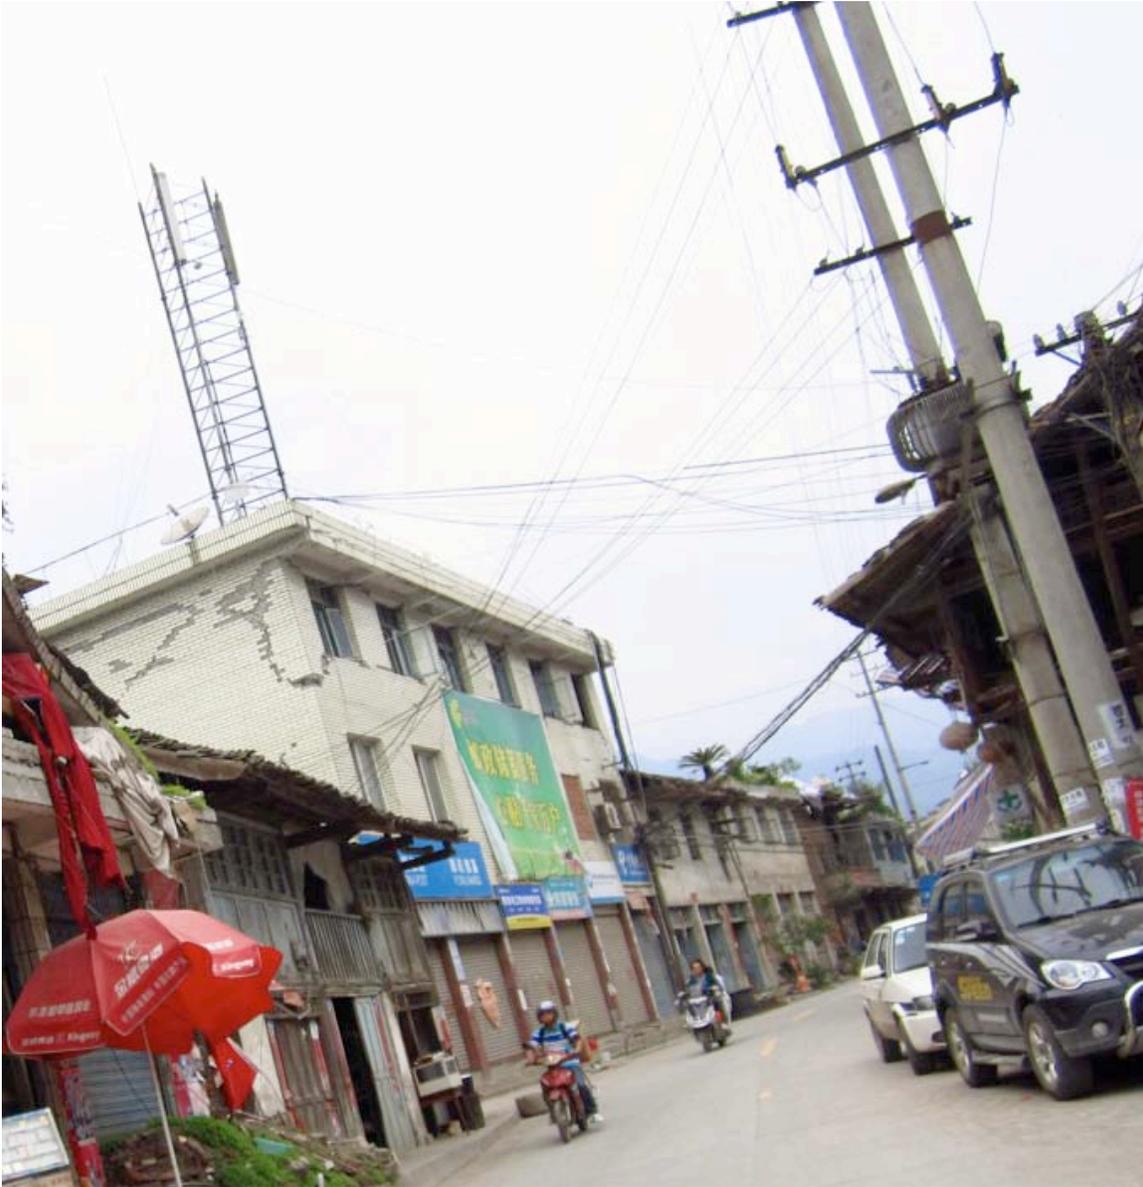
Figure 8-4a. The white building with the tower on top, showed large cracks on the wall. See Figure 8-4b for cable management issue.

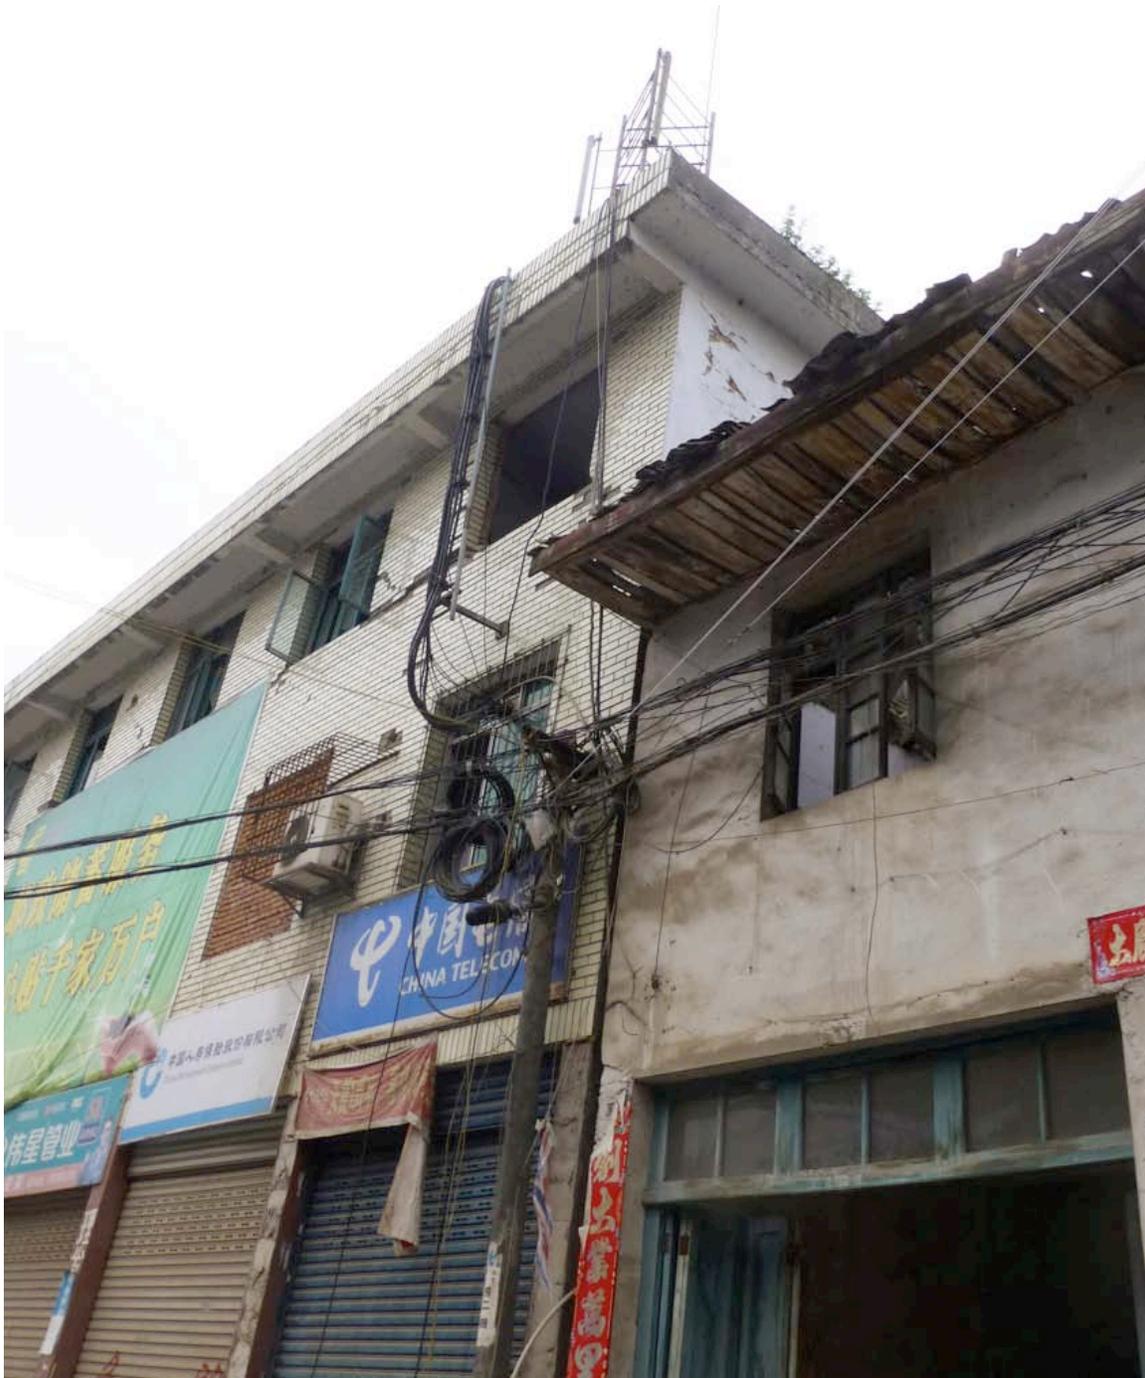
Figure 8-4b. Note that cable management is poor, the cables were dropped from the edge of roof to the head of the pole, site in Fig 8-4a.

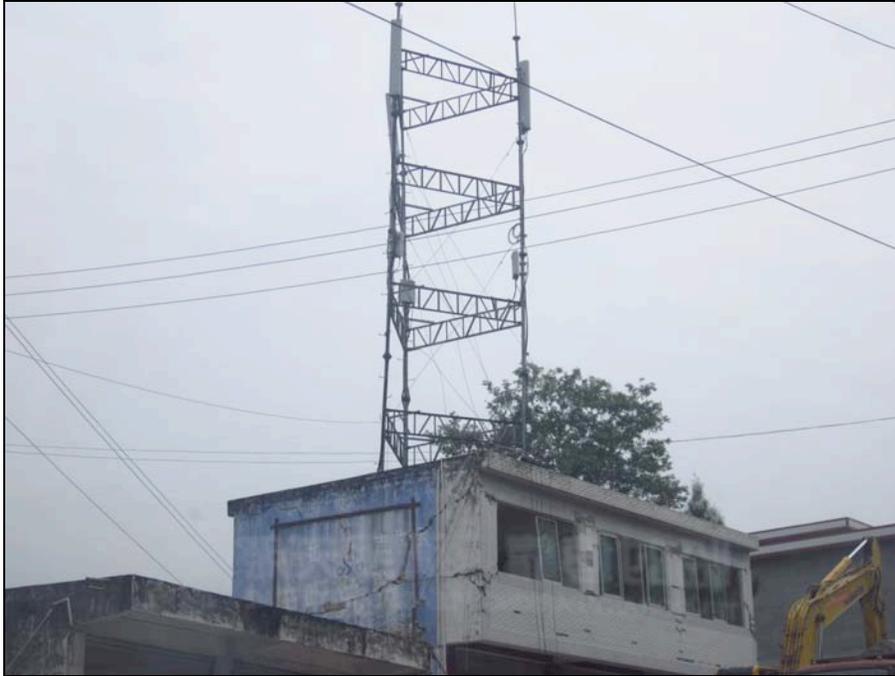
Figure 8-5. The cell tower at this site in Longmenxiang showed no damage, but the building showed large cracks on the side and front walls. Estimated PGA = 0.35g

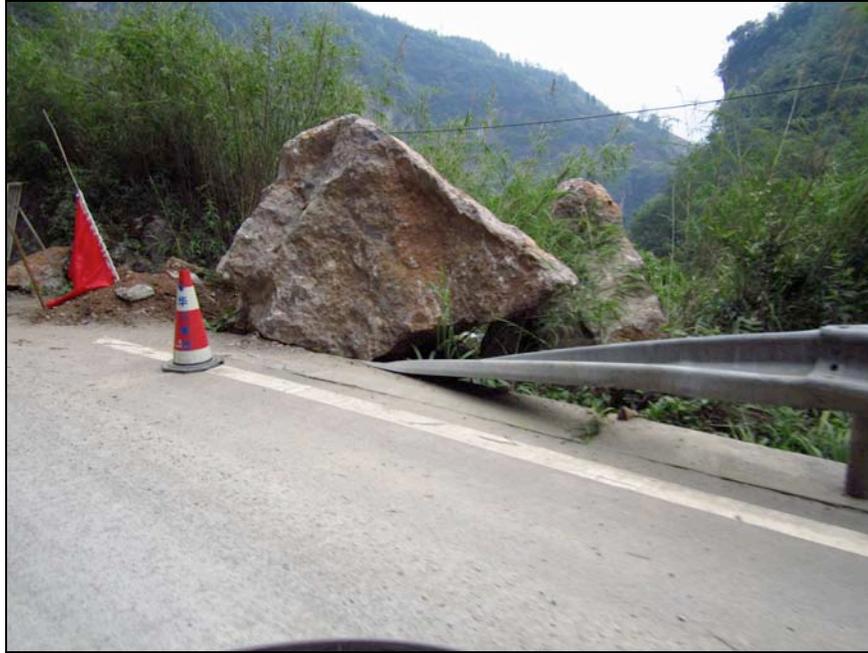
Figure 8-9. This road leading Taipingzhen (太平镇) had many sections of rock fall that destroyed the poles carrying the fiber optic cables.

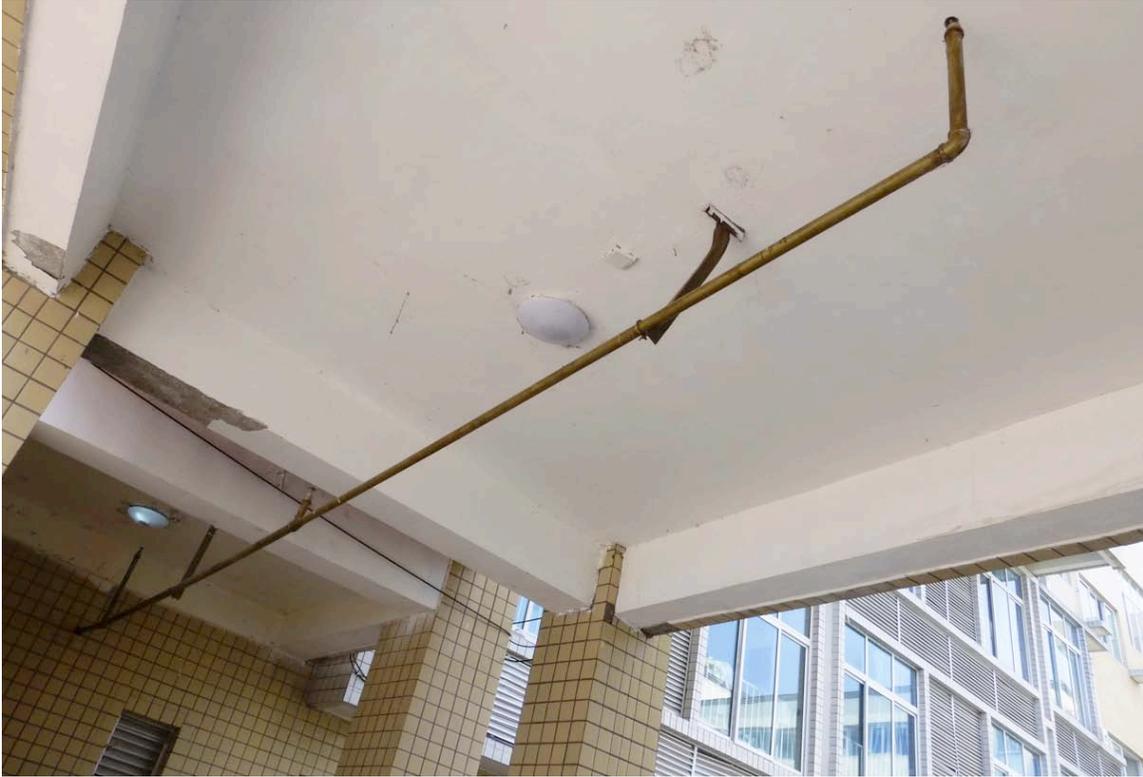
Figure 10-5. Damaged Sprinkler Pipe Support

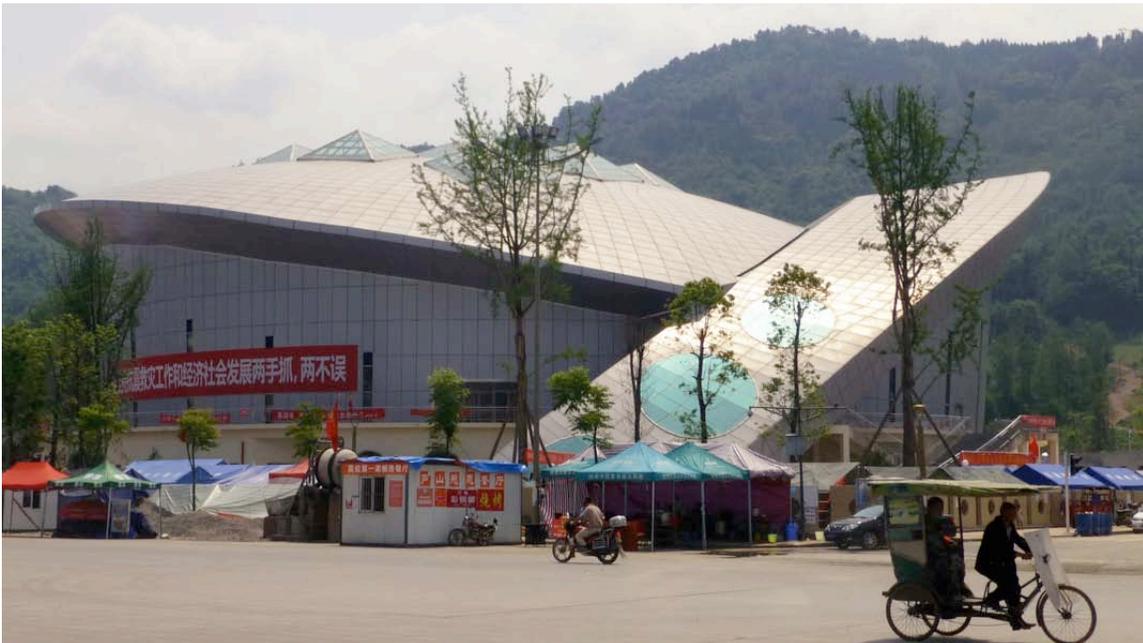
Figure 10-6. Post-2008-Constructed Building in Lushan (Red Tagged)

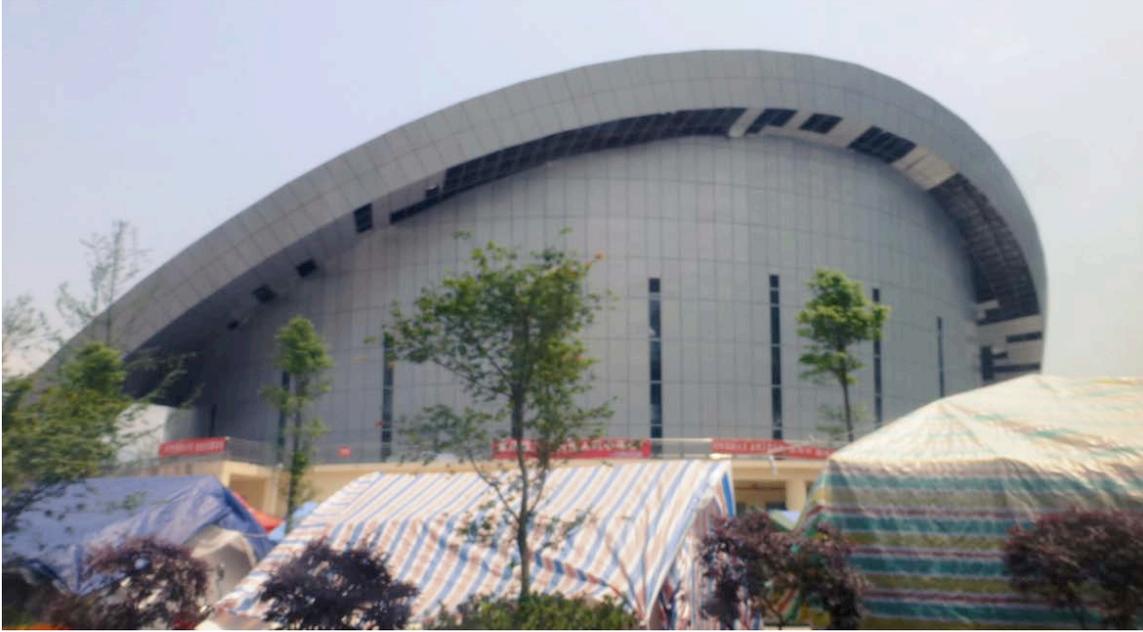
Figure 10-7. Post-2008-Constructed Building in Lushan (Dropped Exterior Panels)

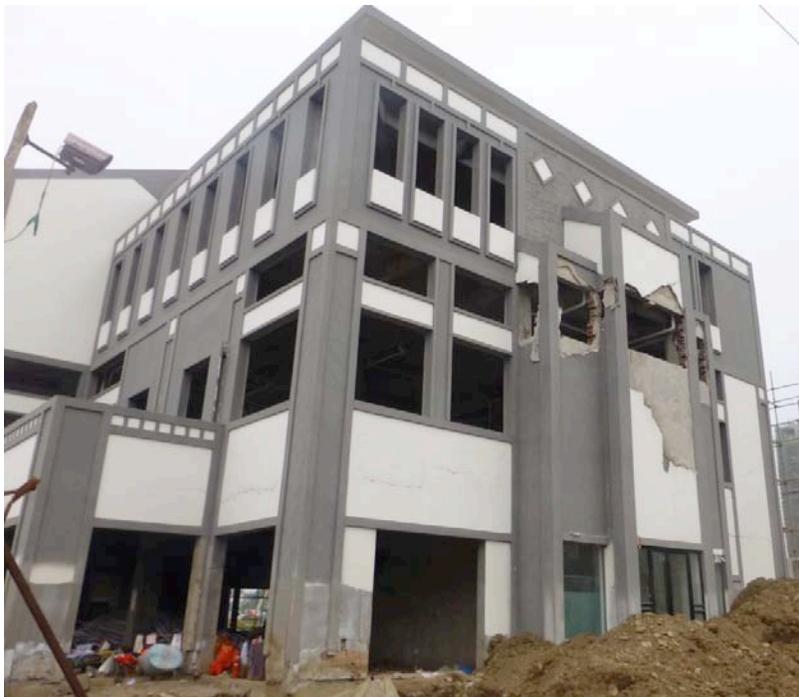
Figure 10-8. Post-2008-Constructed Building in Lushan (Failed Masonry Walls)

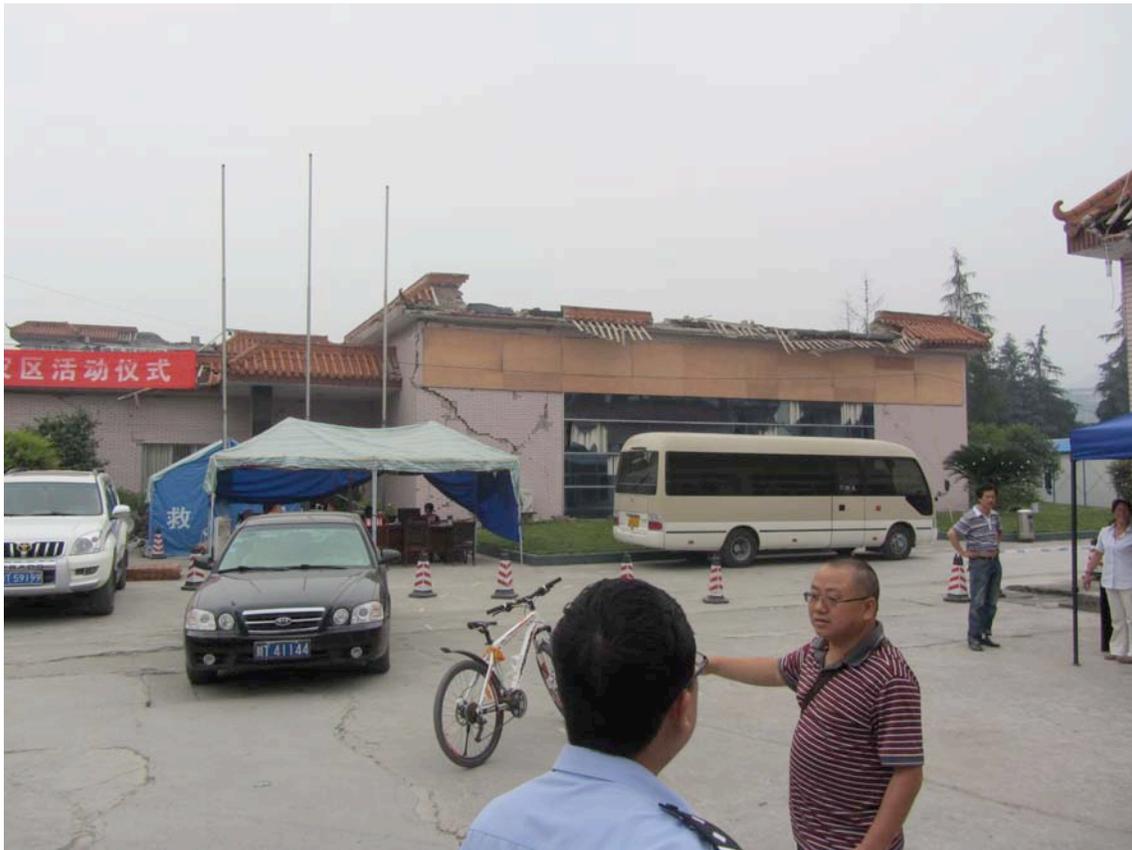
Figure 10-9. Damaged Lushan City Government Building

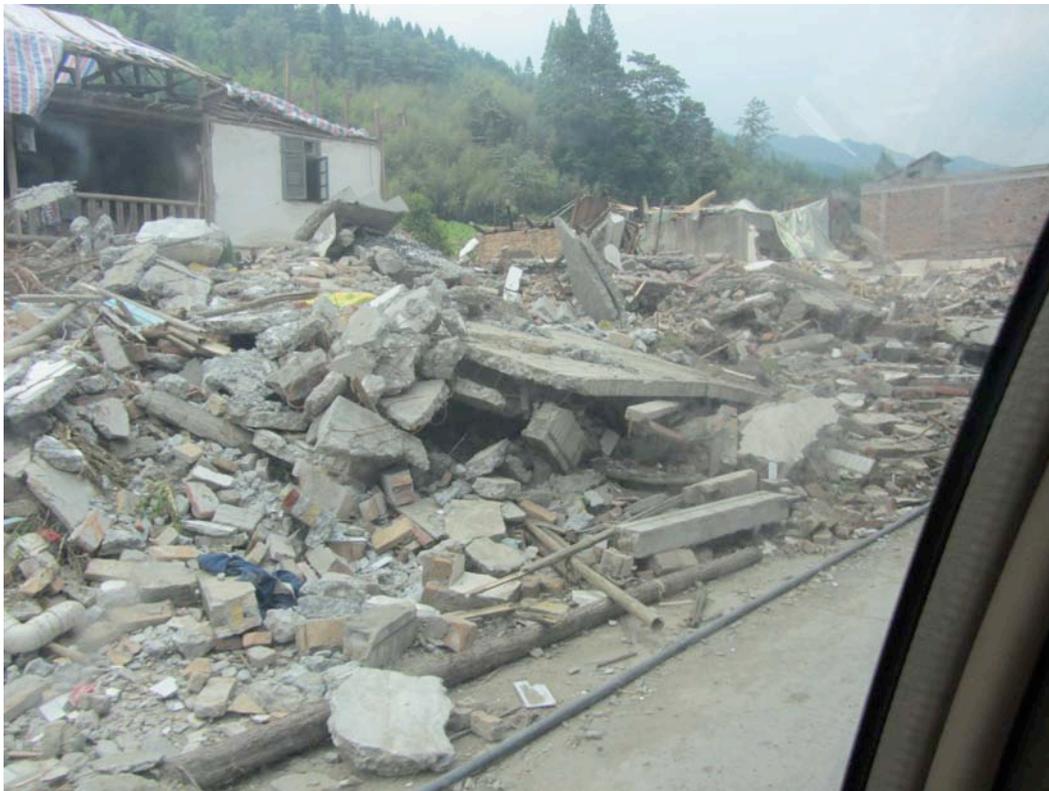
Figure 11-5. Severe Damage in Shuangshi Township (PGA ~ 0.5g).

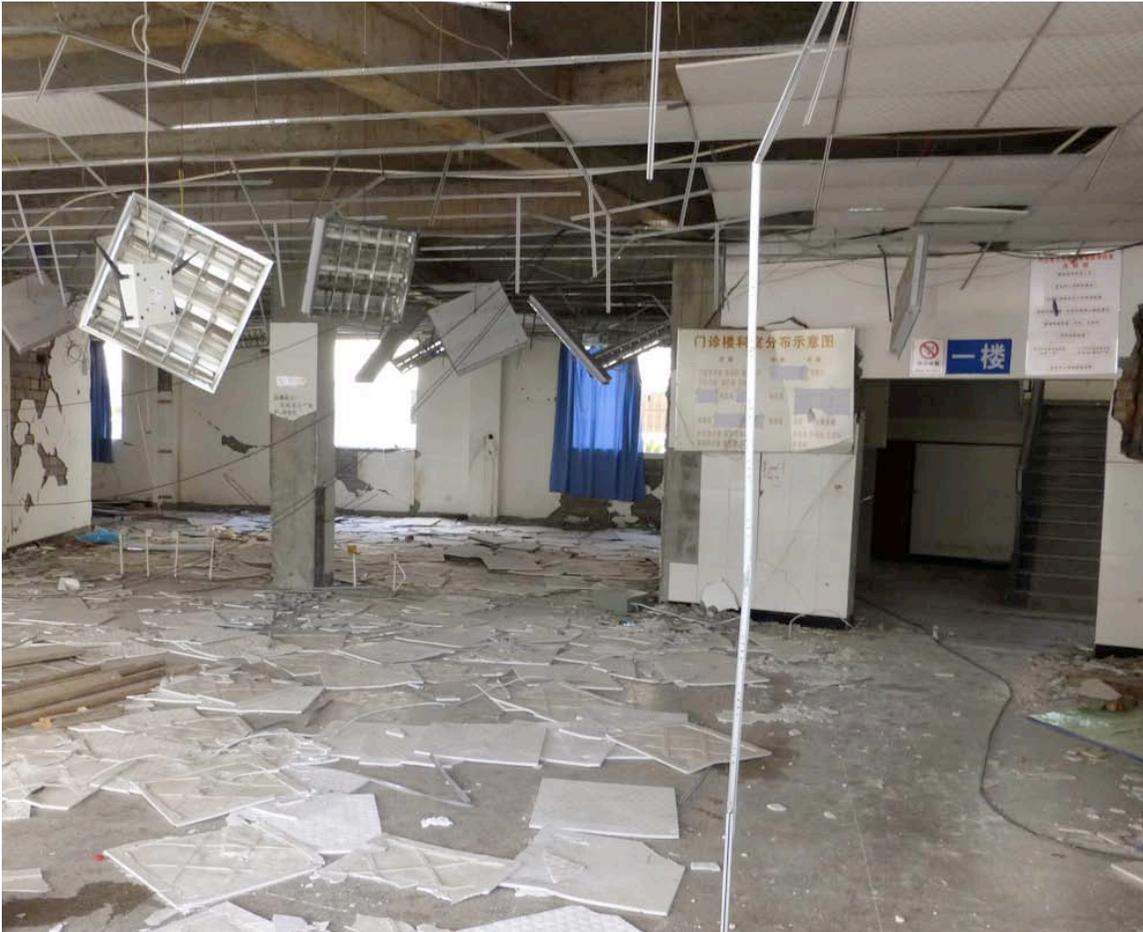
Figure 12-1. Suspended Ceiling at Lushan Hospital (PGA ~0.25g to 0.35g) (Non-base-isolated)

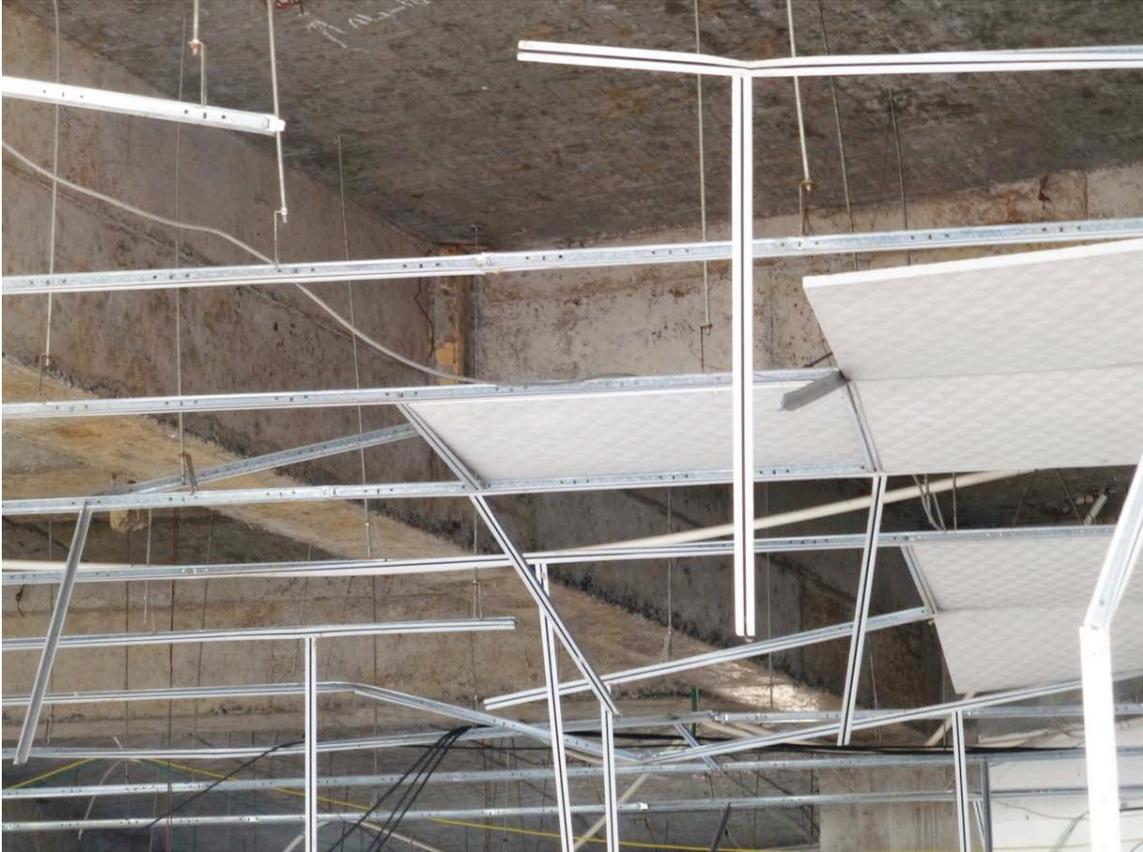
Figure 12-2. Suspended Ceiling at Lushan Hospital (PGA ~0.25g to 0.35g) (Non-base-isolated). About 60% of the area of the suspended ceilings were heavily damaged, with those over larger rooms being relatively in worse condition

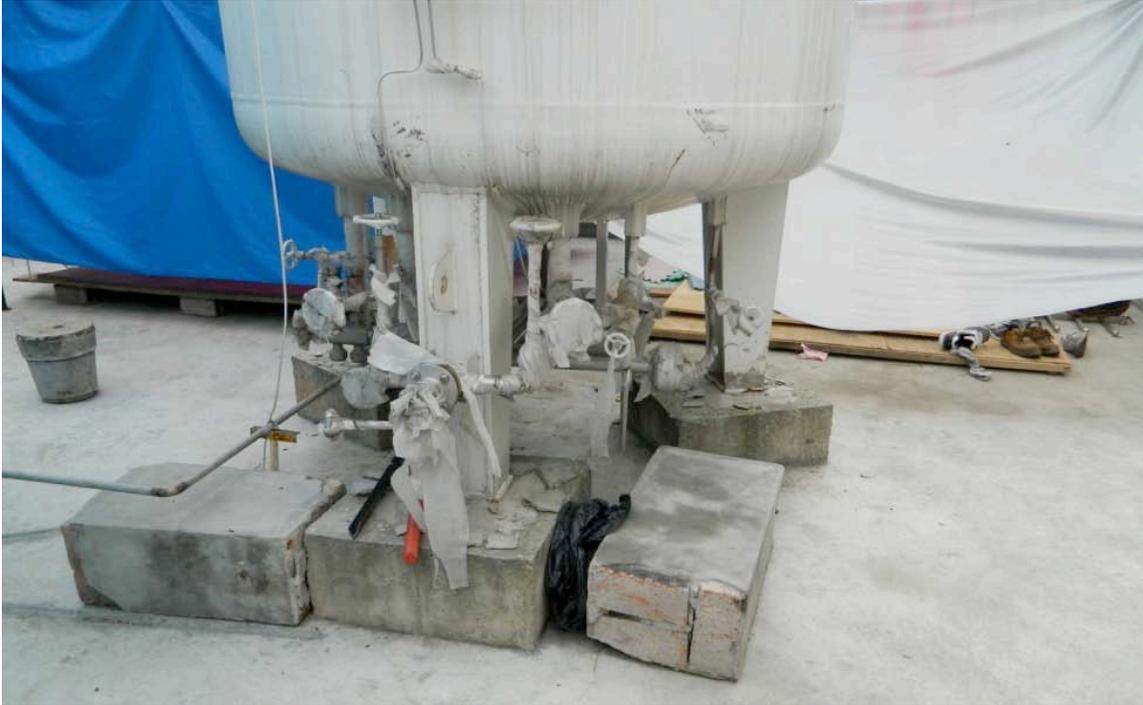
Figure 12-3. Unanchored Liquid Oxygen tank rocked at the hospital in Lushan. The rocking resulted in failure of the attached pipe. All liquid oxygen evaporated.

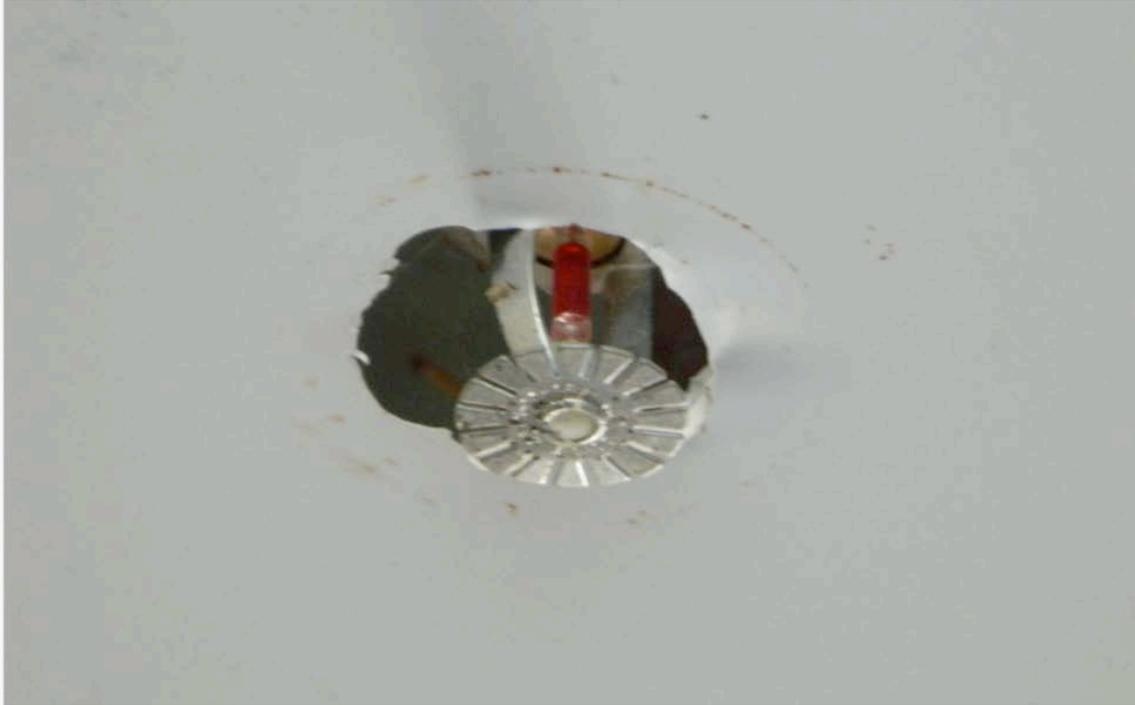
Figure 12-4. Sprinkler head moved sideways and impacted the suspended ceiling.
