The Performance of the Natural Gas System - Magna M 5.7 2020 Earthquake

The Council of Lifeline Earthquake Engineering
TCLÉE No. 6

April 7, 2021
Revision 0

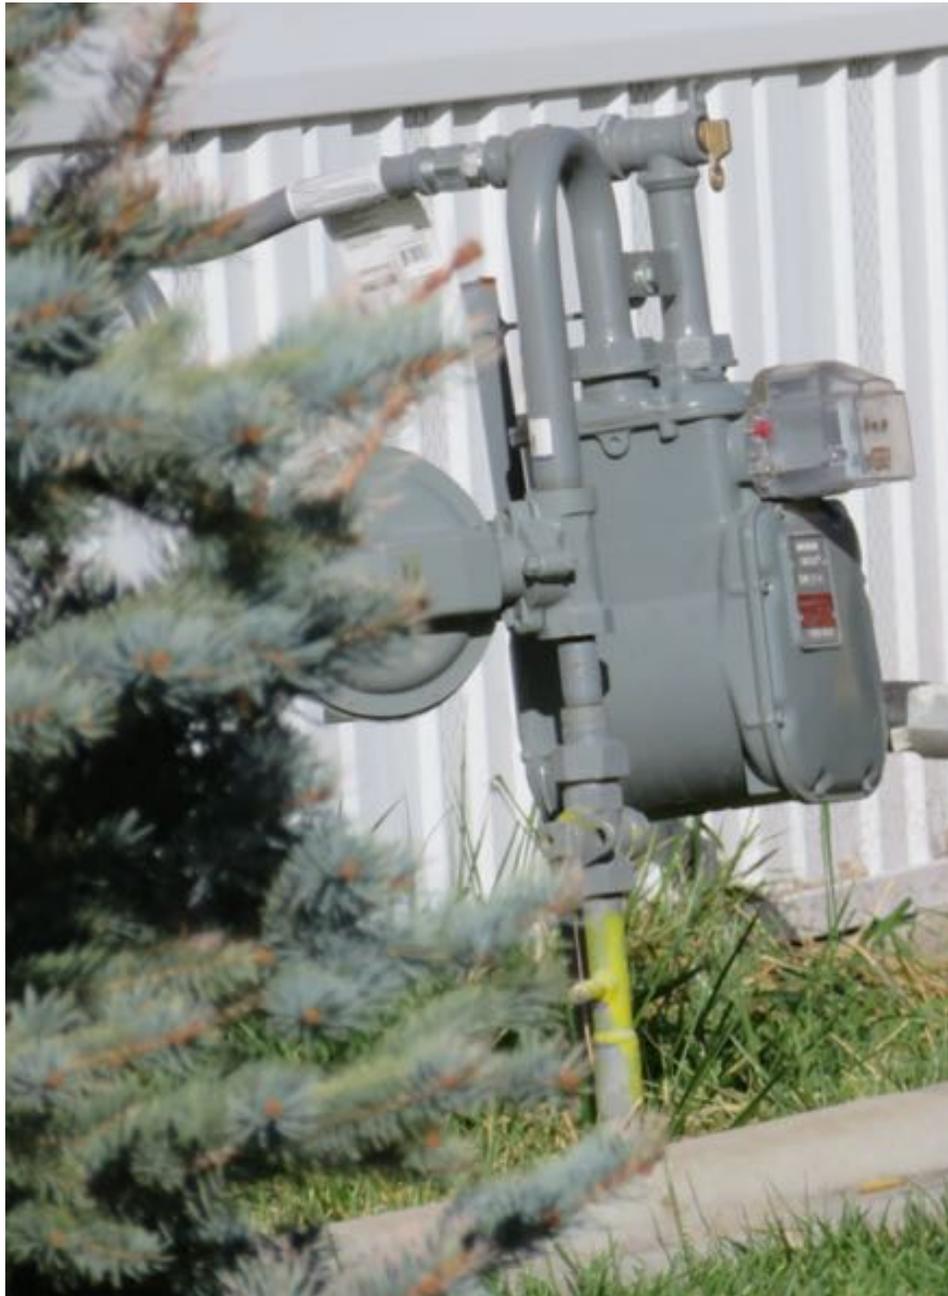
Figure 22. Structure 5. Meter tilted (towards structure).

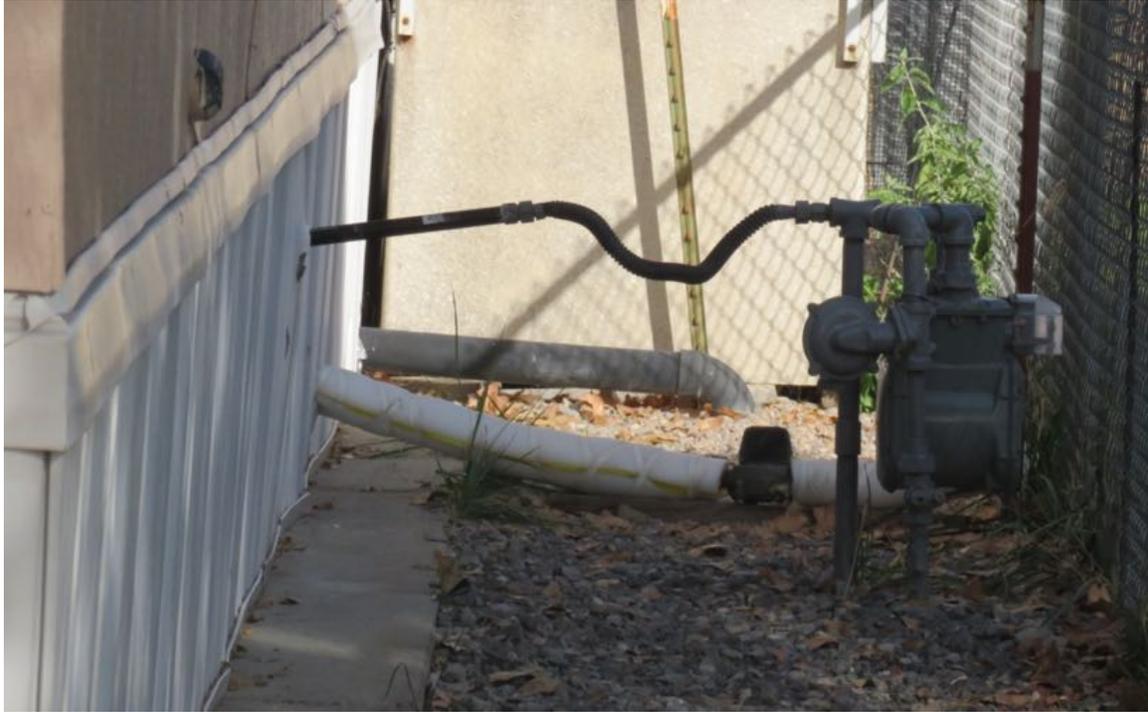
Figure 23. Structure 6. Original Meter. Tube-type supplementary support. No impacts.

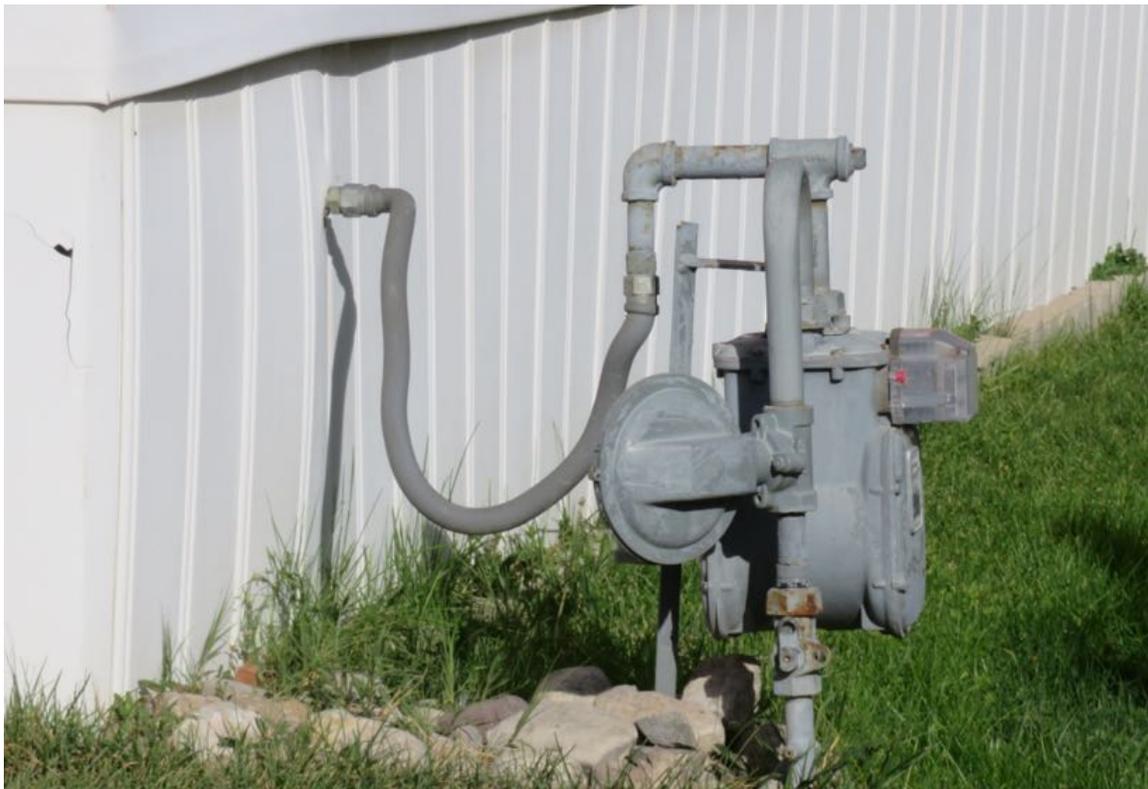
Figure 24. Structure 7. Original Meter. Post-type supplementary support. No impacts.

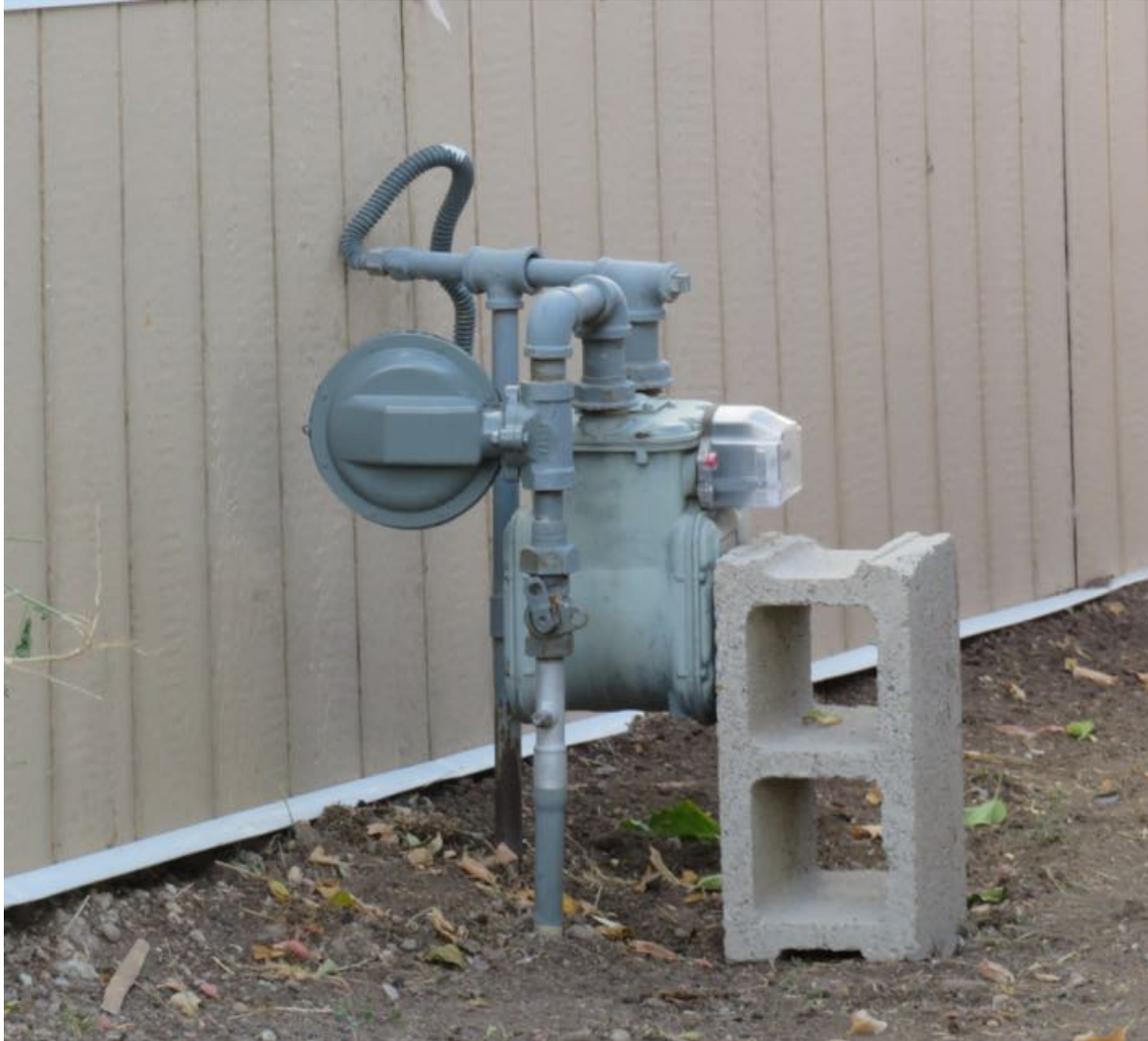
Figure 25. Structure 16. Original Meter. Tube-type support. Limited clearance D.

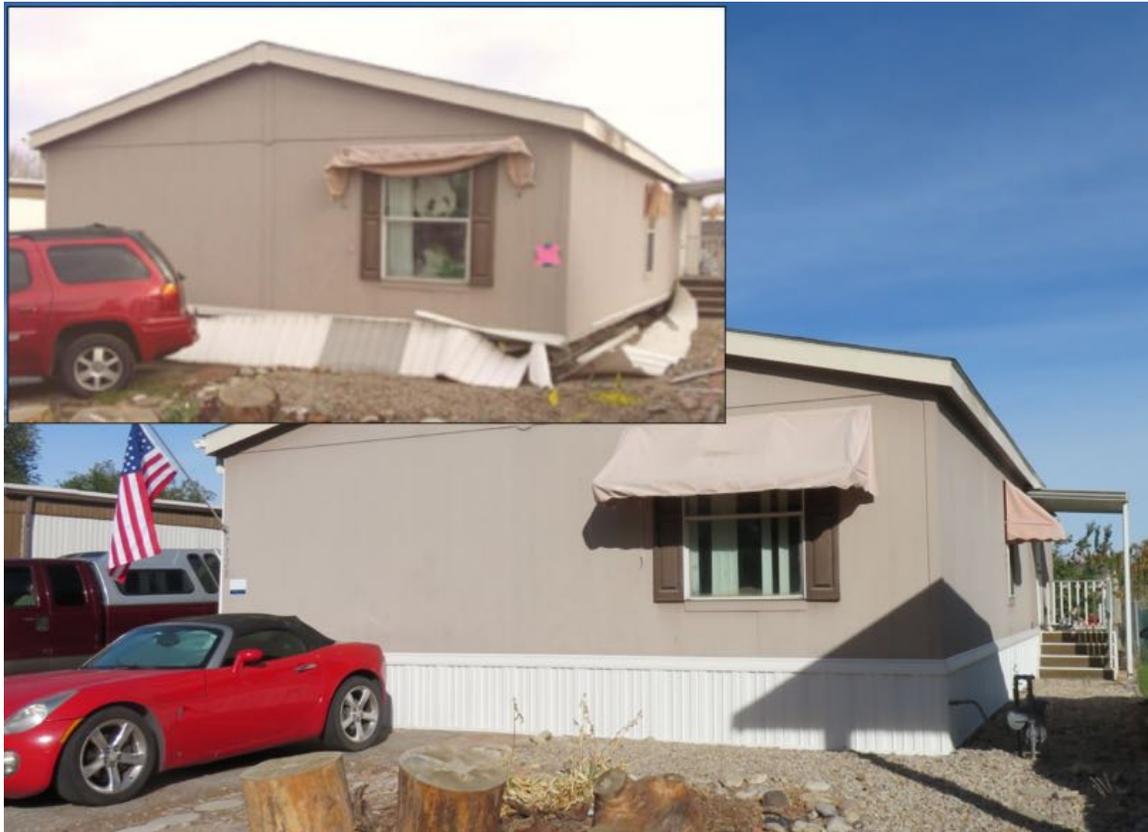
Figure 26-a. Structure 18. Inset Photo shows structure immediately post-earthquake. Main photo shows structure after repair. Inset photo indicates impacted gas meter set. See Fig 24b for meter.

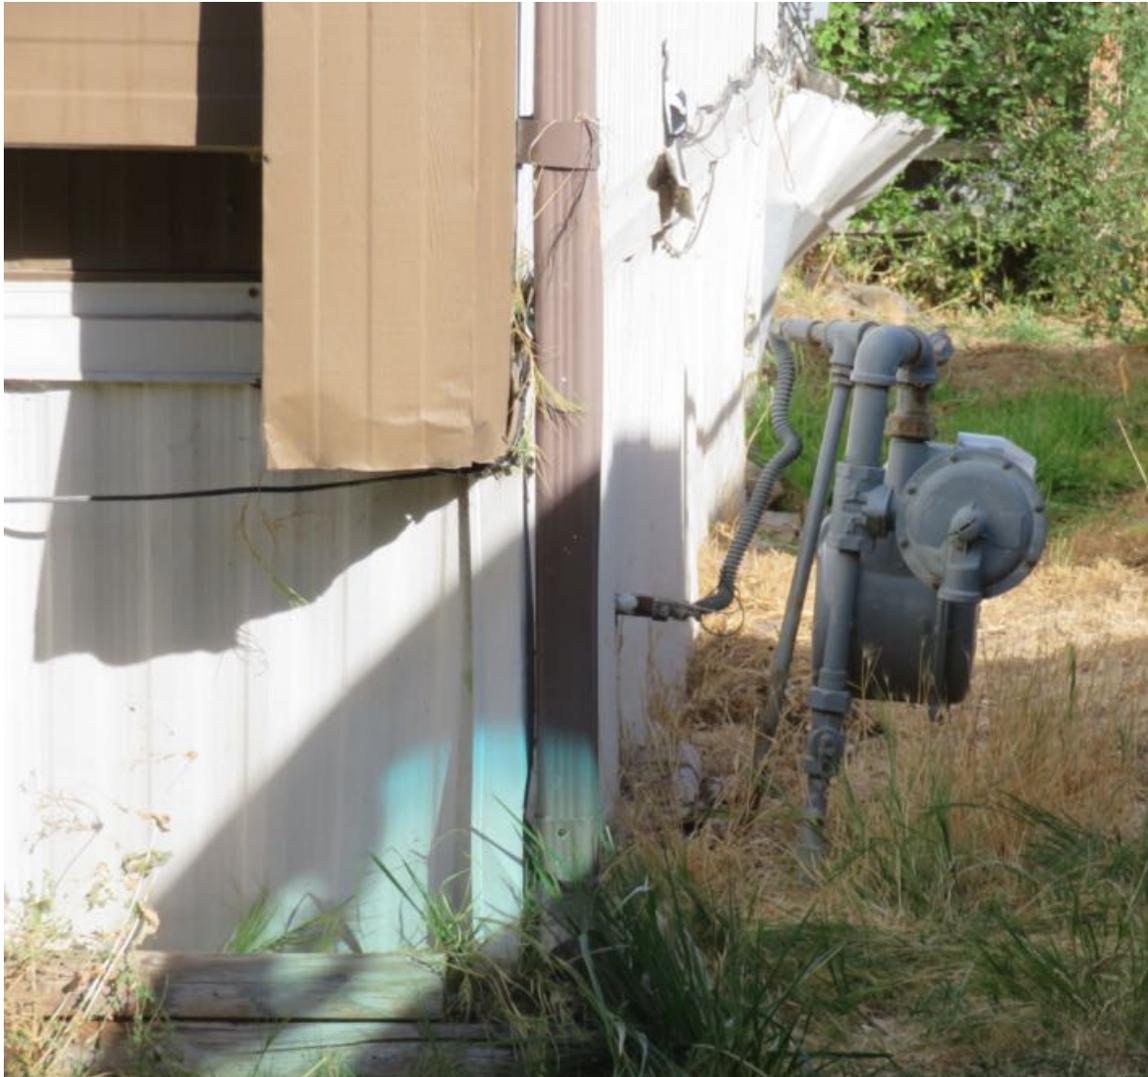
Figure 27. Structure 19. Tilted Gas Meter Set (Tube Support). Indication is that the MH impacted the tube type support

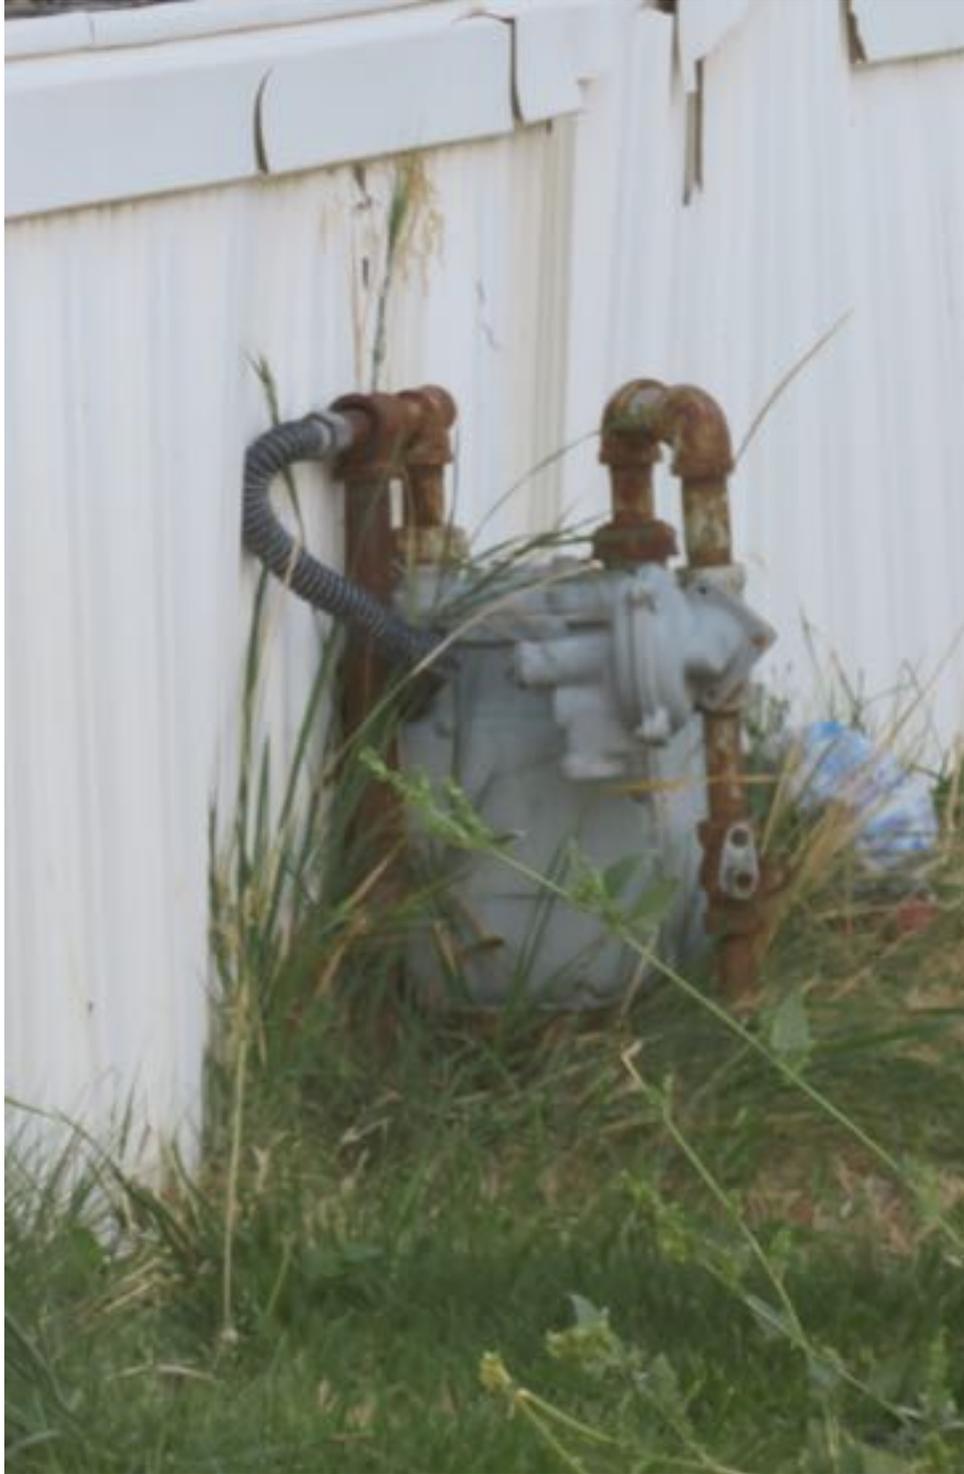
Figure 28. Structure 33. Original Gas Meter Set (Tube Support). Limited clearance D.

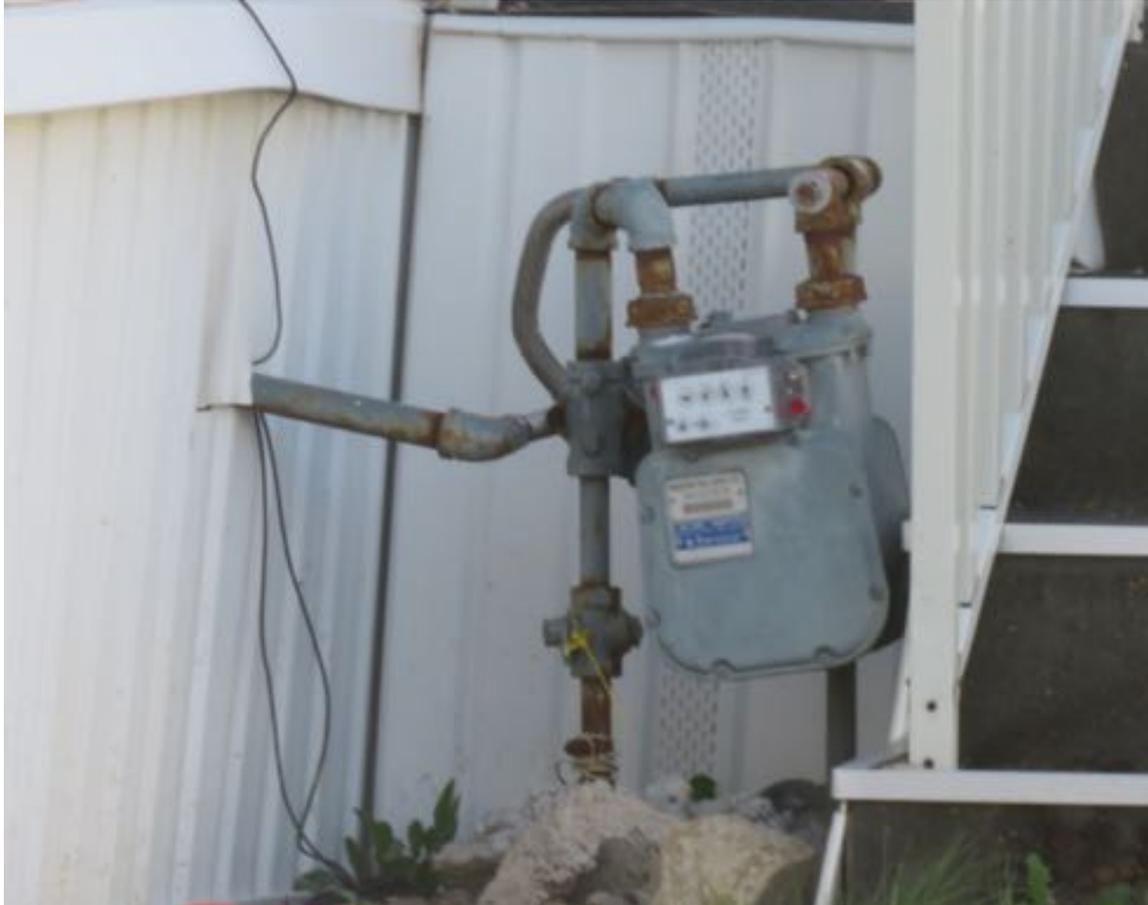
Figure 29. Structure 44. Original Gas Meter Set (Tube Support). Tilted

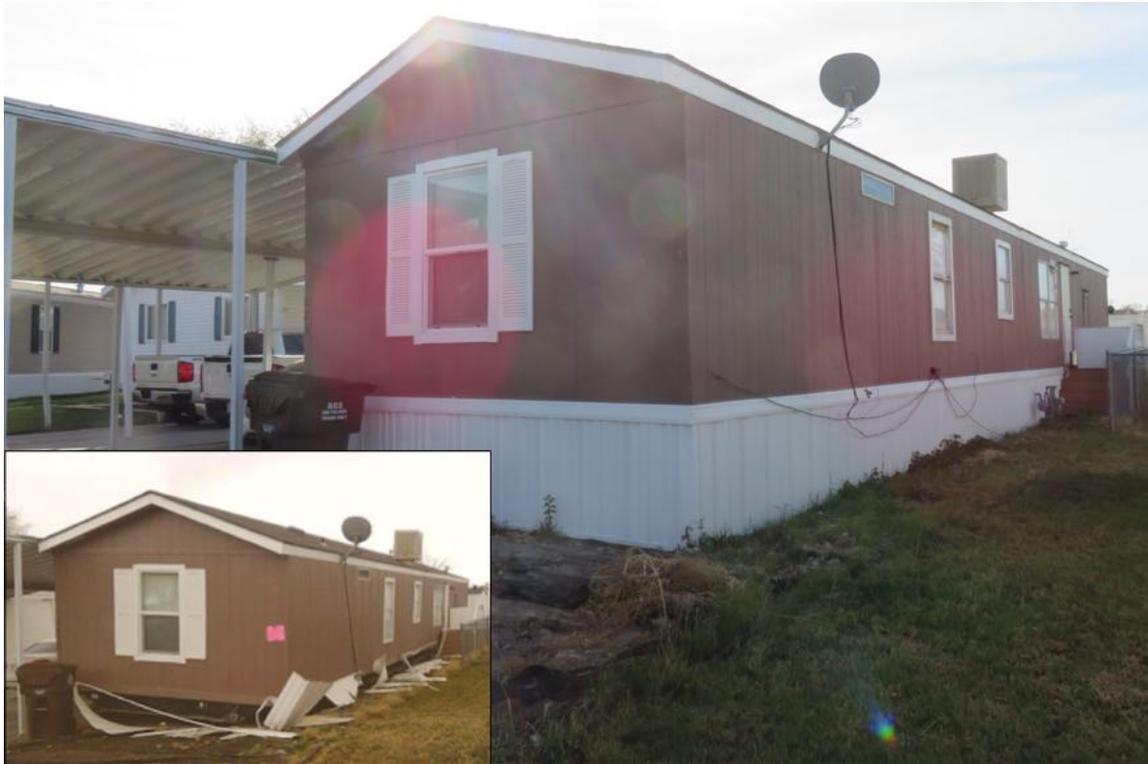
Figure 30-a. Structure 49. Inset Photo shows structure immediately post-earthquake. Main photo shows structure after repair. Inset photo indicates impacted gas meter set. Figure 30-b shows gas meter set after repair.

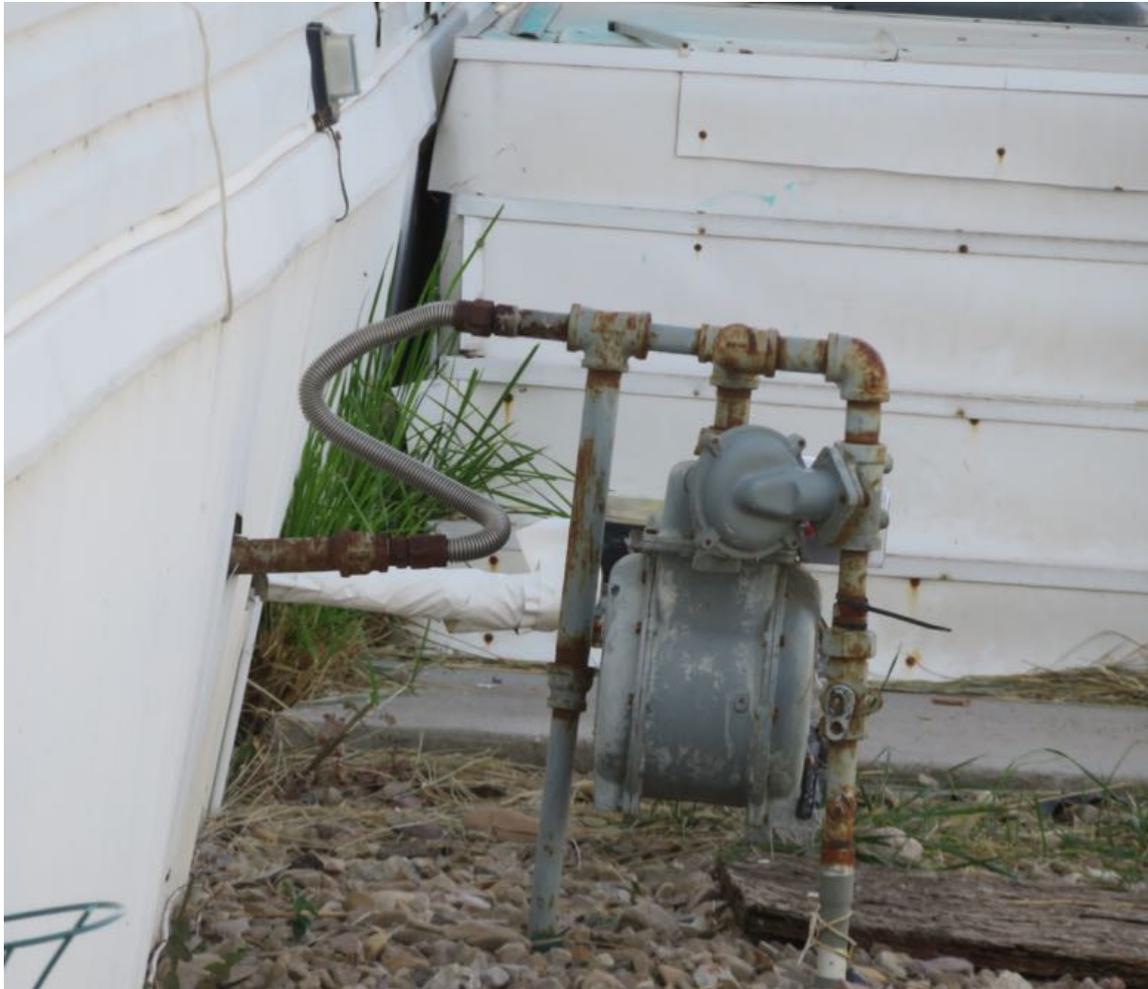
Figure 31. Structure 67. Tilted Gas Meter Set. Damage to MH suggests the meter was impacted during the earthquake.

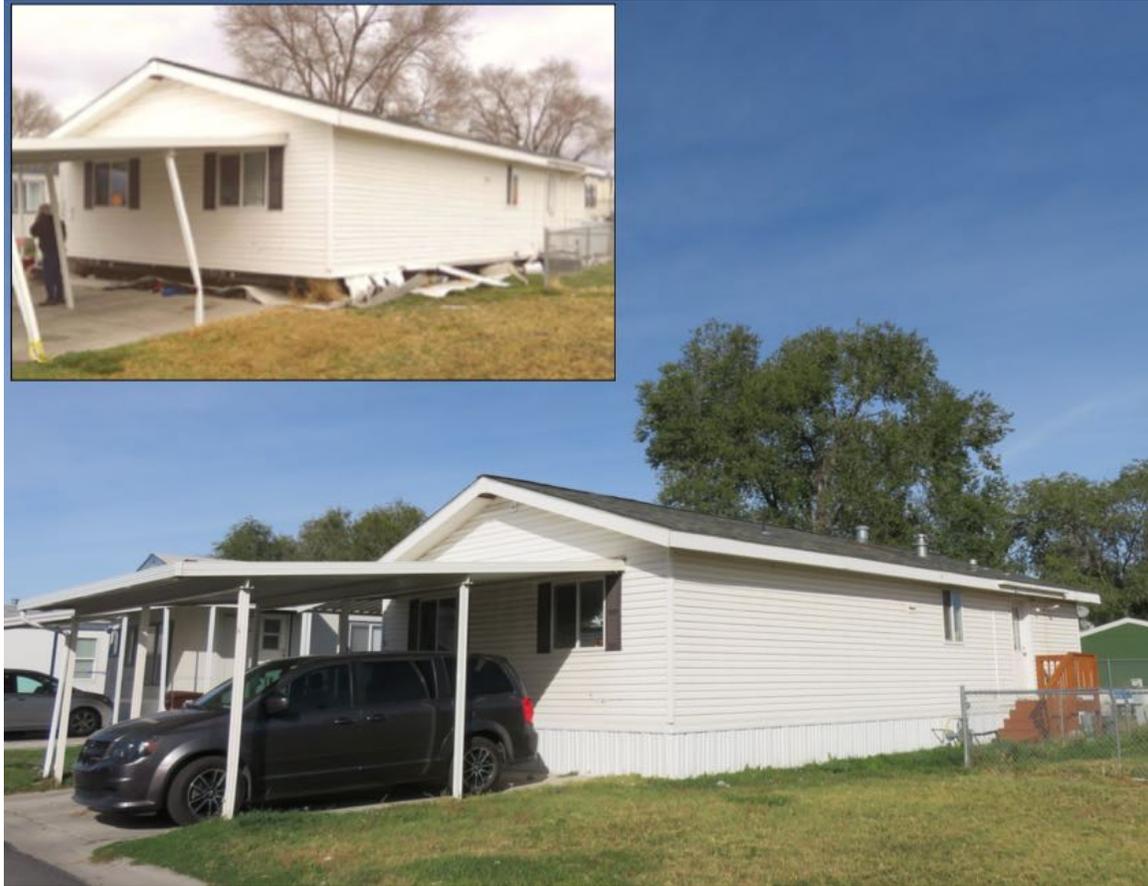
Figure 32-a. Structure 75. Inset Photo shows structure immediately post-earthquake. Main photo shows structure after repair. Figure 32-b shows gas meter set after repair.

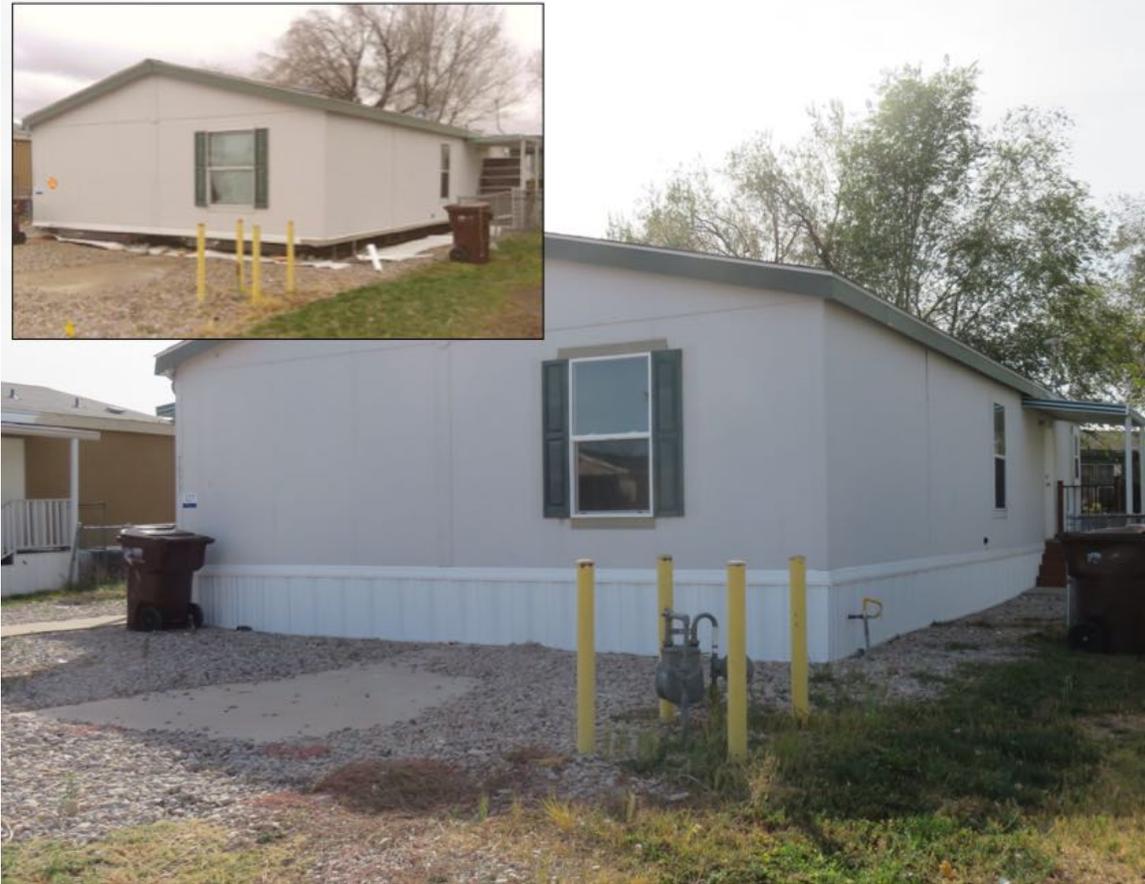
Figure 33-a. Structure 141. Inset Photo shows structure immediately post-earthquake. Main photo shows structure after repair. 4 yellow bollards (foreground) intended to protect meter from impacts from vehicles. Replacement meter set back from low pressure customer pipe with new yellow flex hose (Figure 33-b).
