South Napa M 6.0 Earthquake of August 24, 2014

Prepared by:

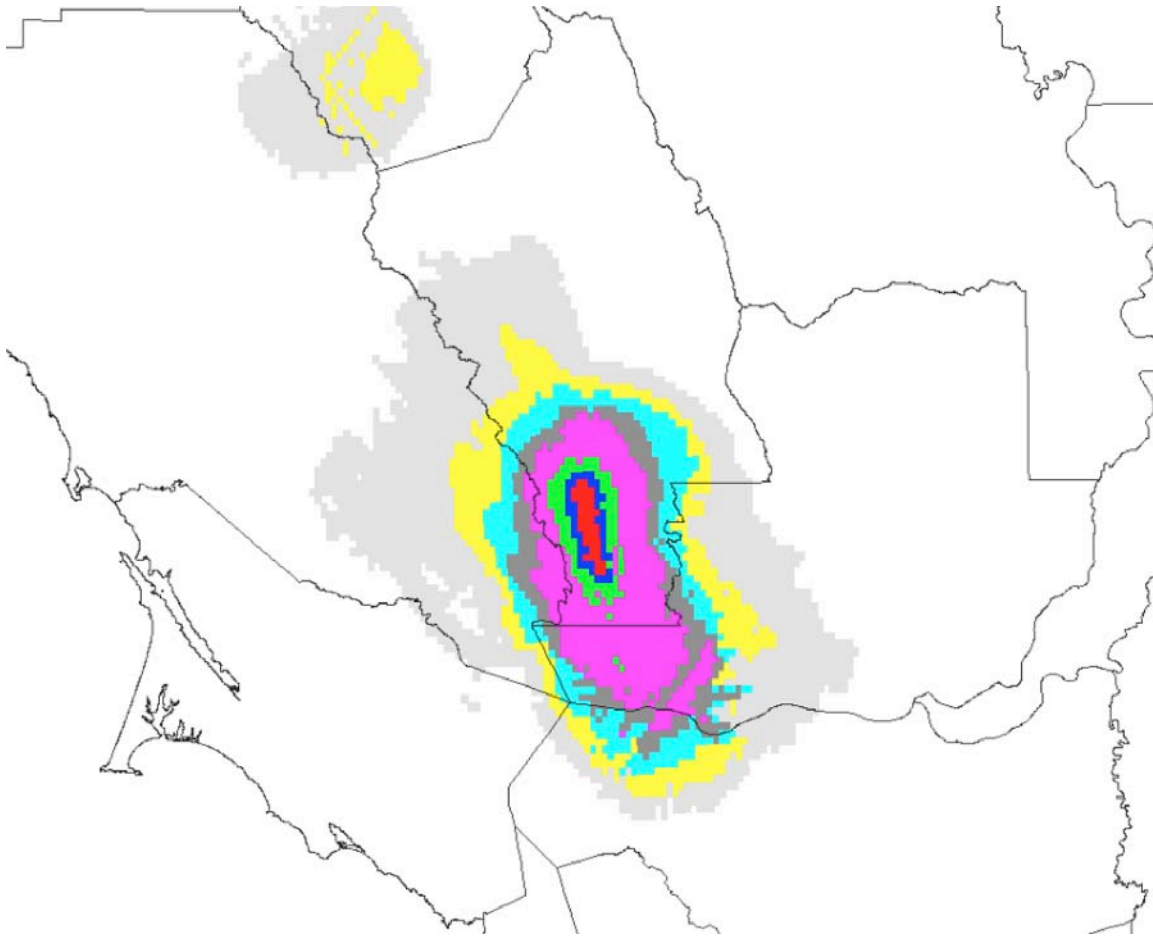
Figure 2-2b. Place Names and Populations, SERA ShakeMap-4 (PGA)

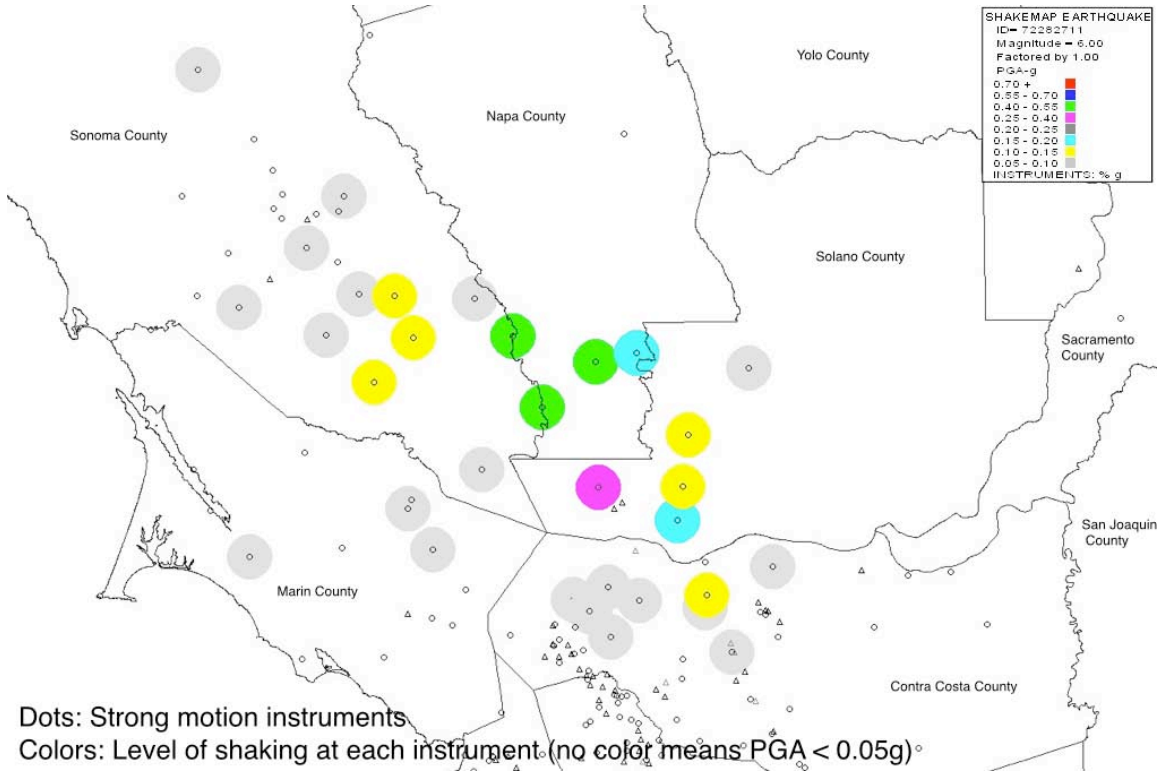
Figure 2-3. Strong Motion Instruments (PGA)

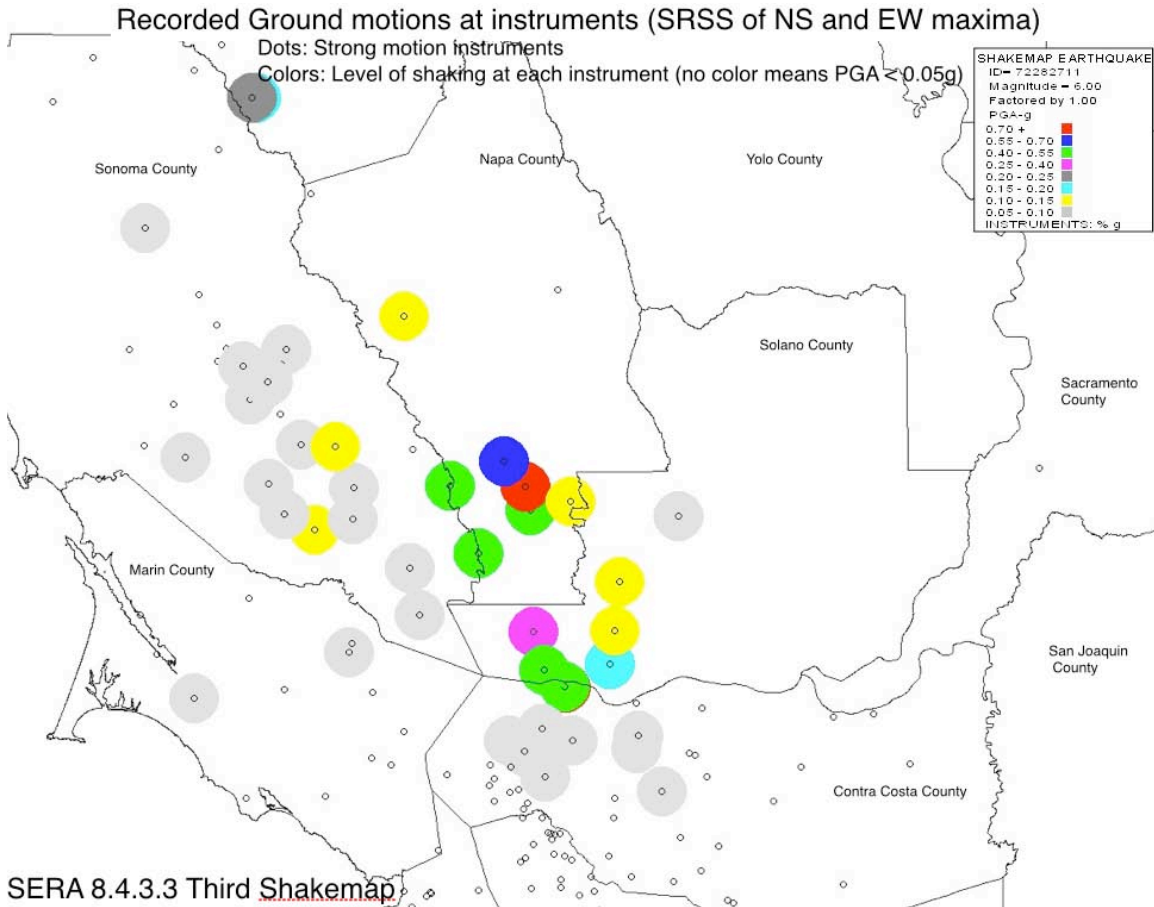
Figure 2-4. Strong Motion Instruments (version 3) (PGA)

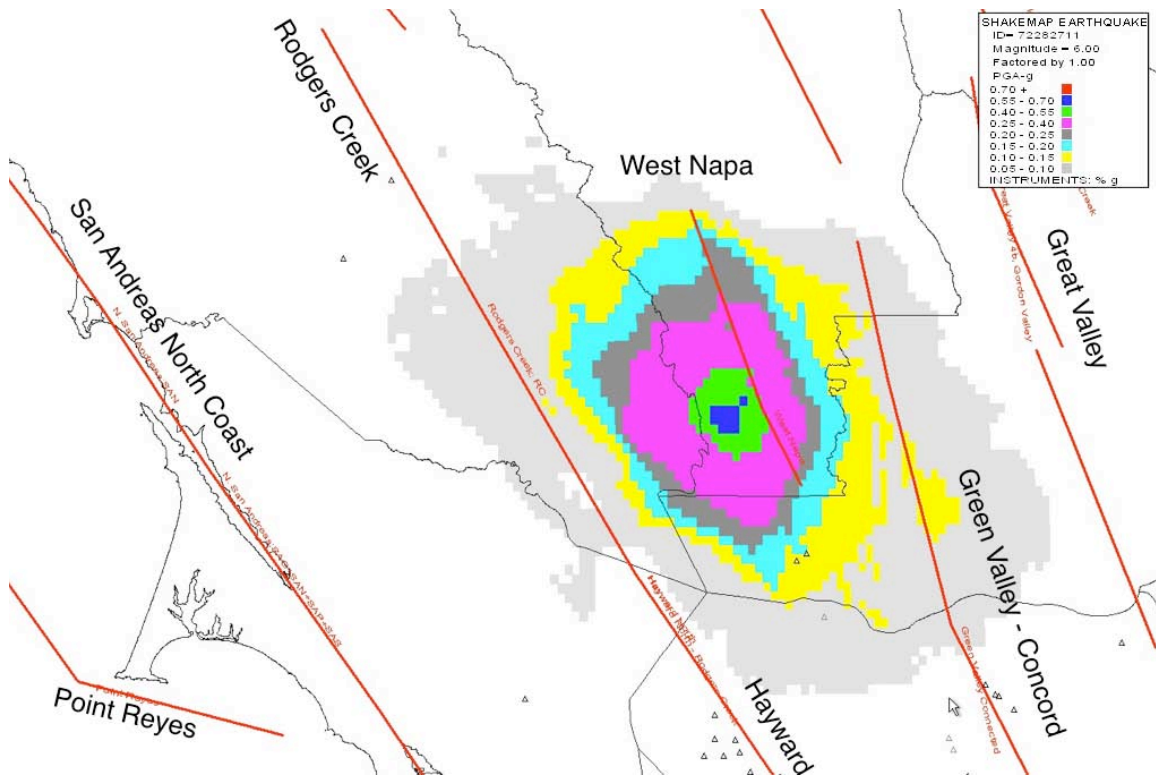
Figure 2-5. Nearby Active Faults

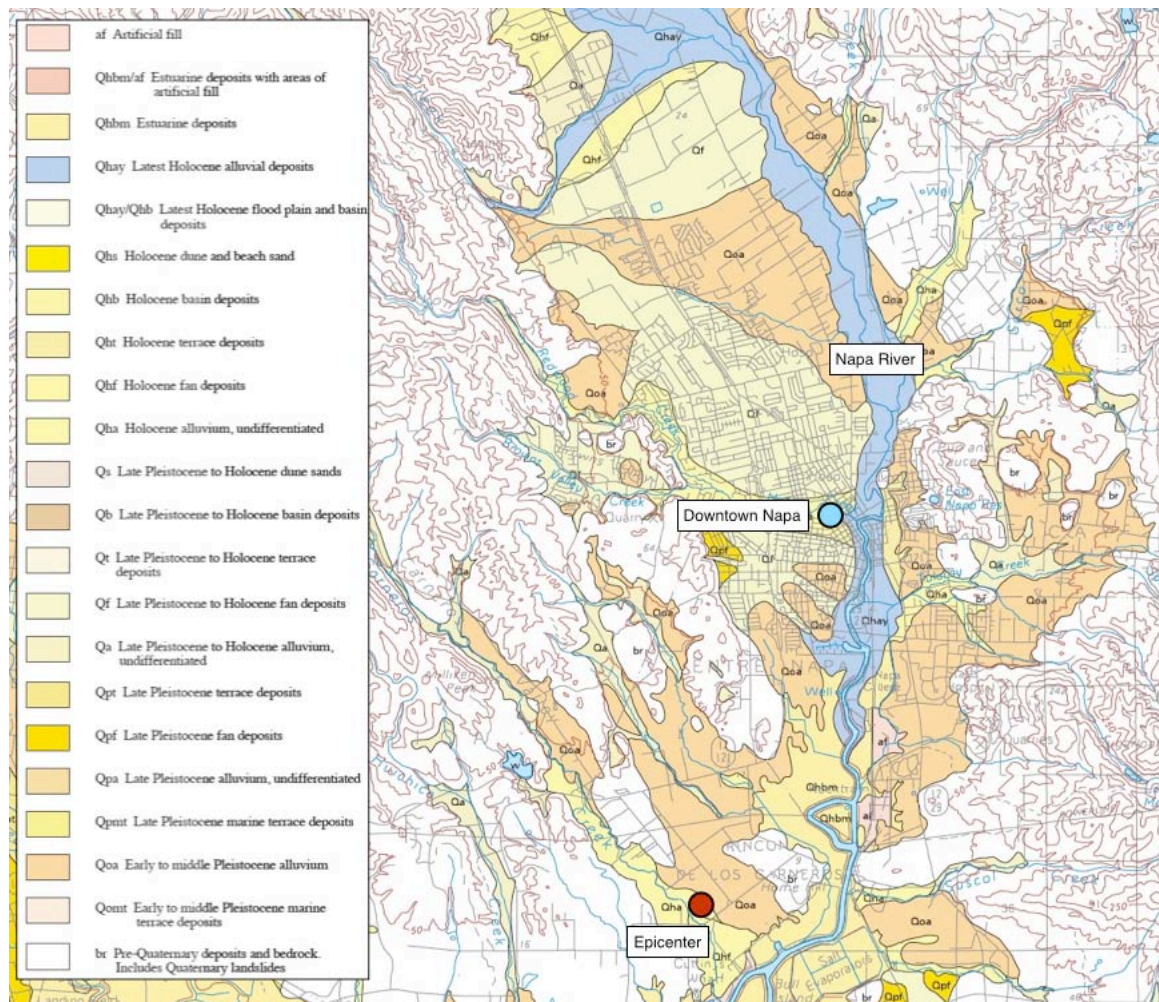
Figure 2-6. Geologic Map (After Sowers, 1998)

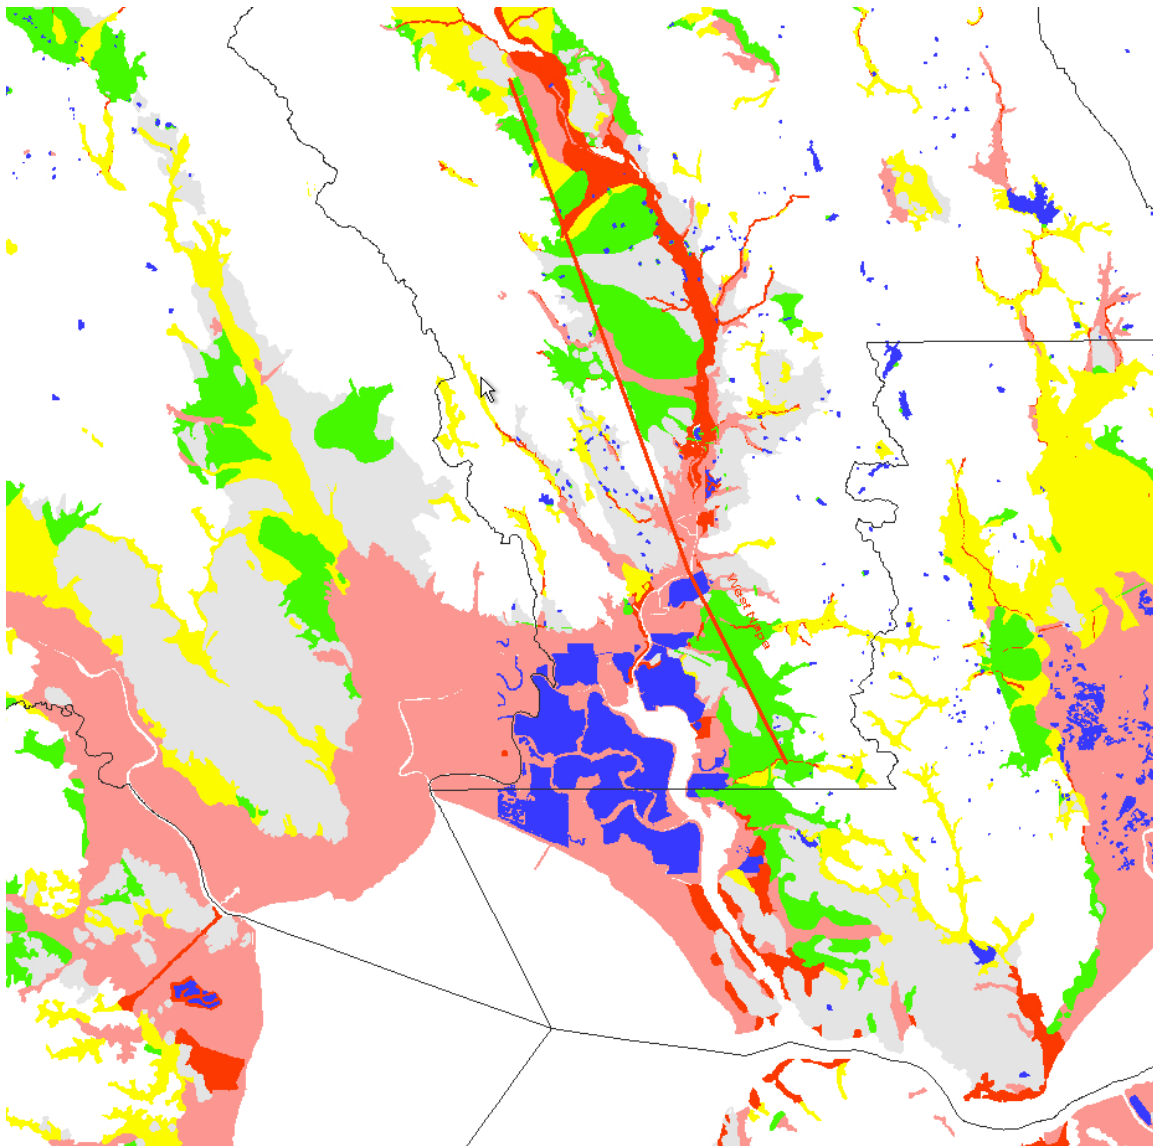
Figure 2-8. Liquefaction Susceptibility Map, Napa and Sonoma Valley Area

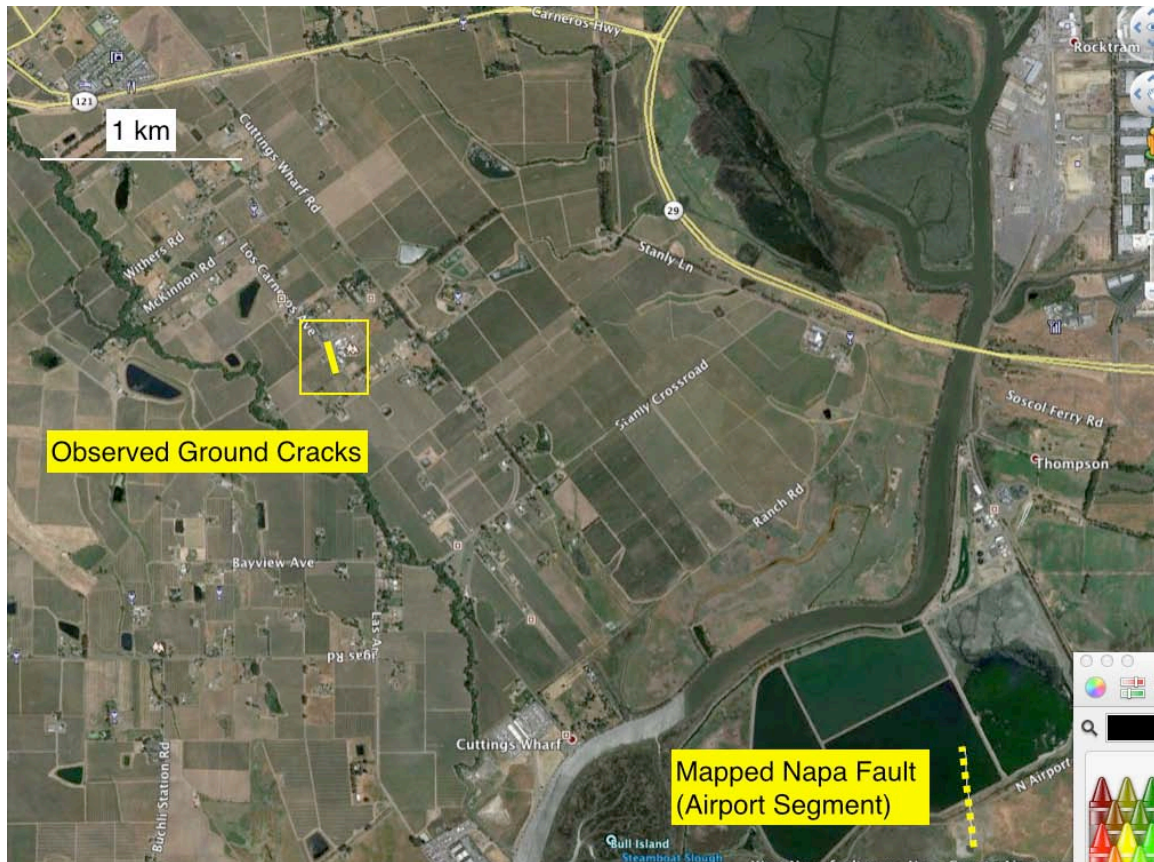
Figure 2-22. West Napa Fault Zone

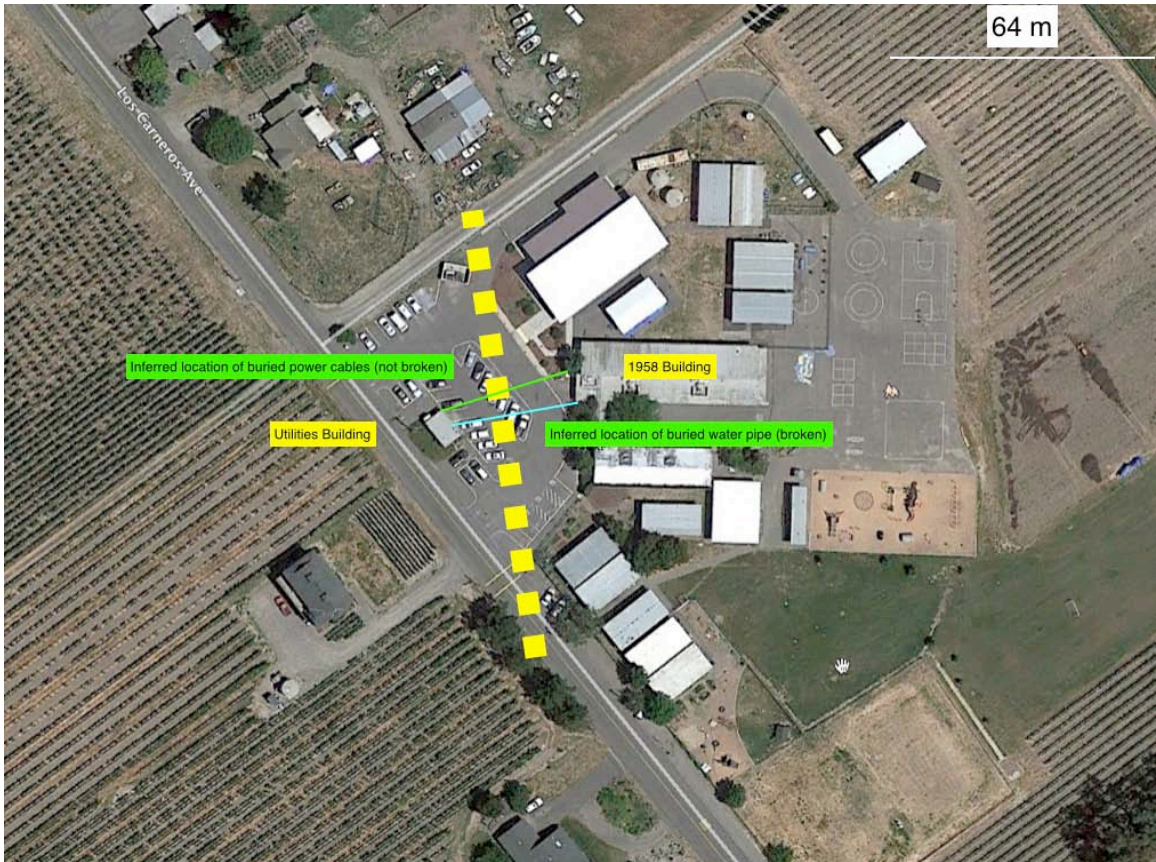
Figure 2-23. Aerial View of Fault Zone

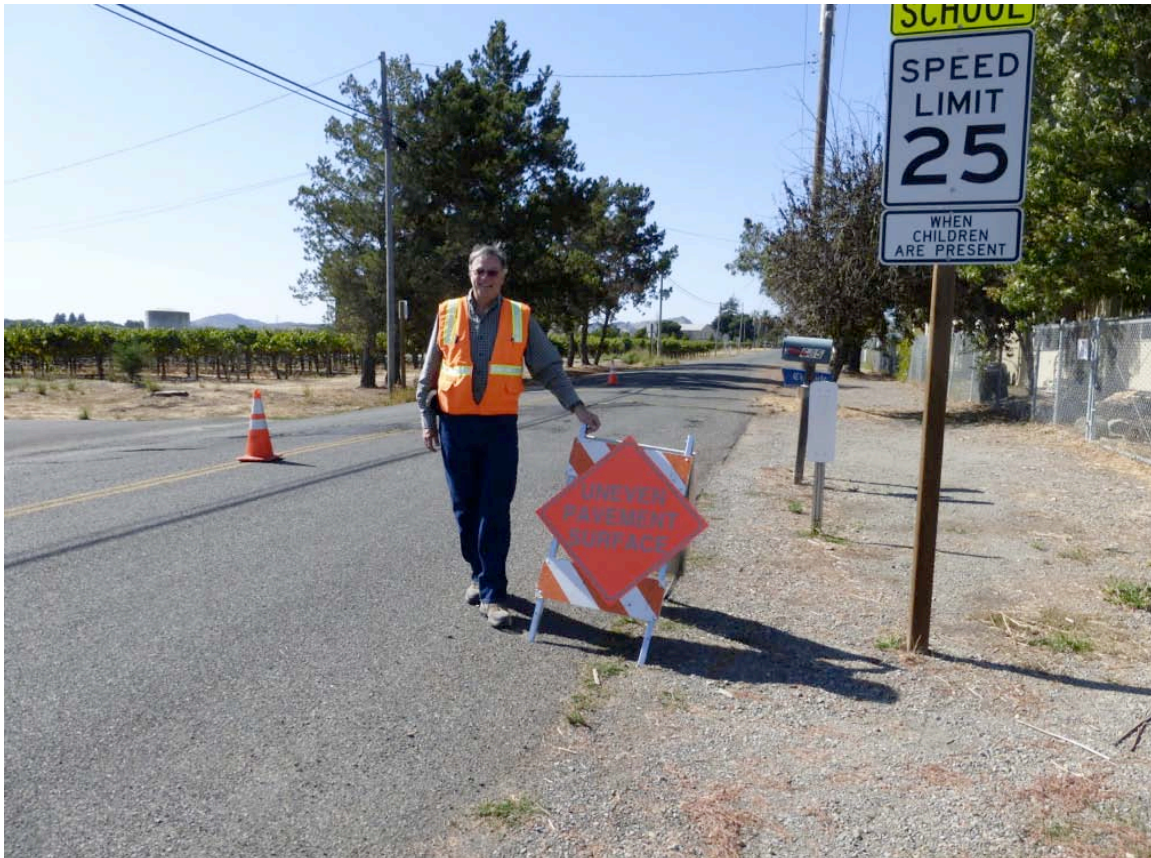
Figure 2-24. Repaired cracks in street

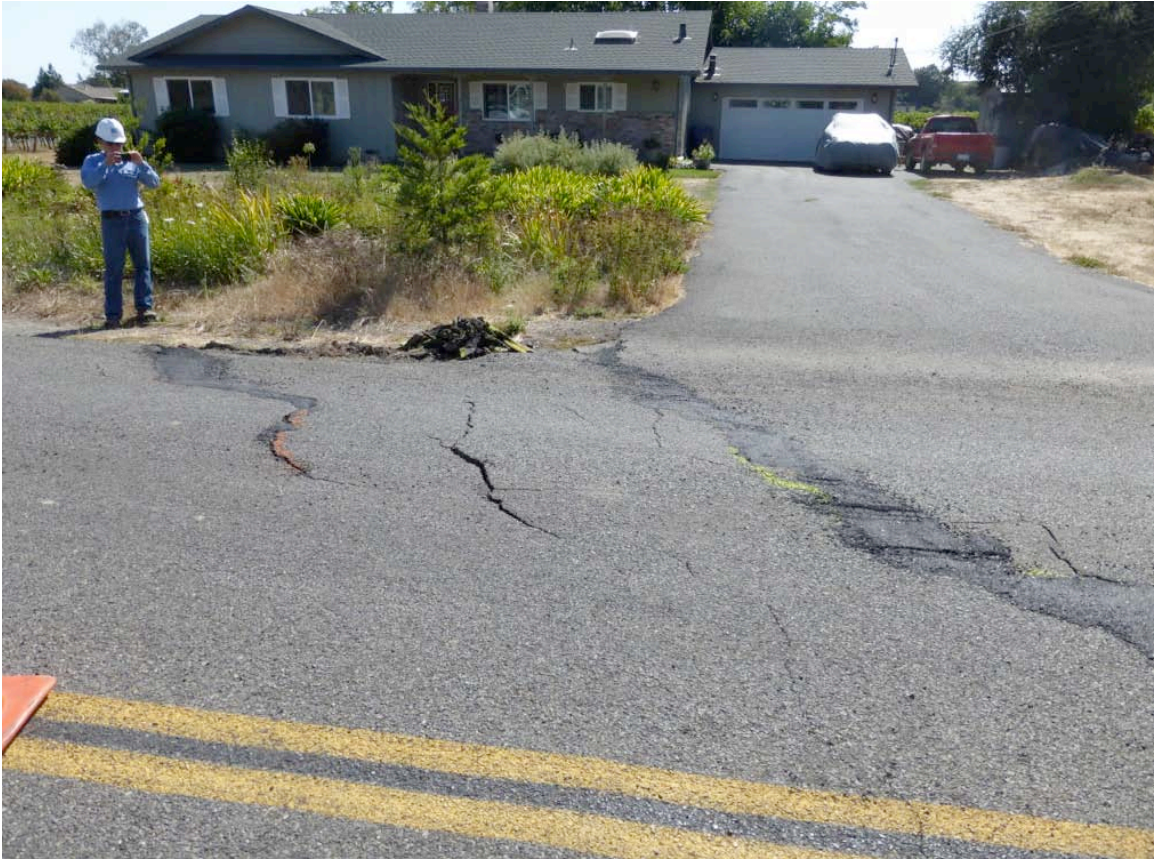
Figure 2-25. Repaired and newly formed cracks in street

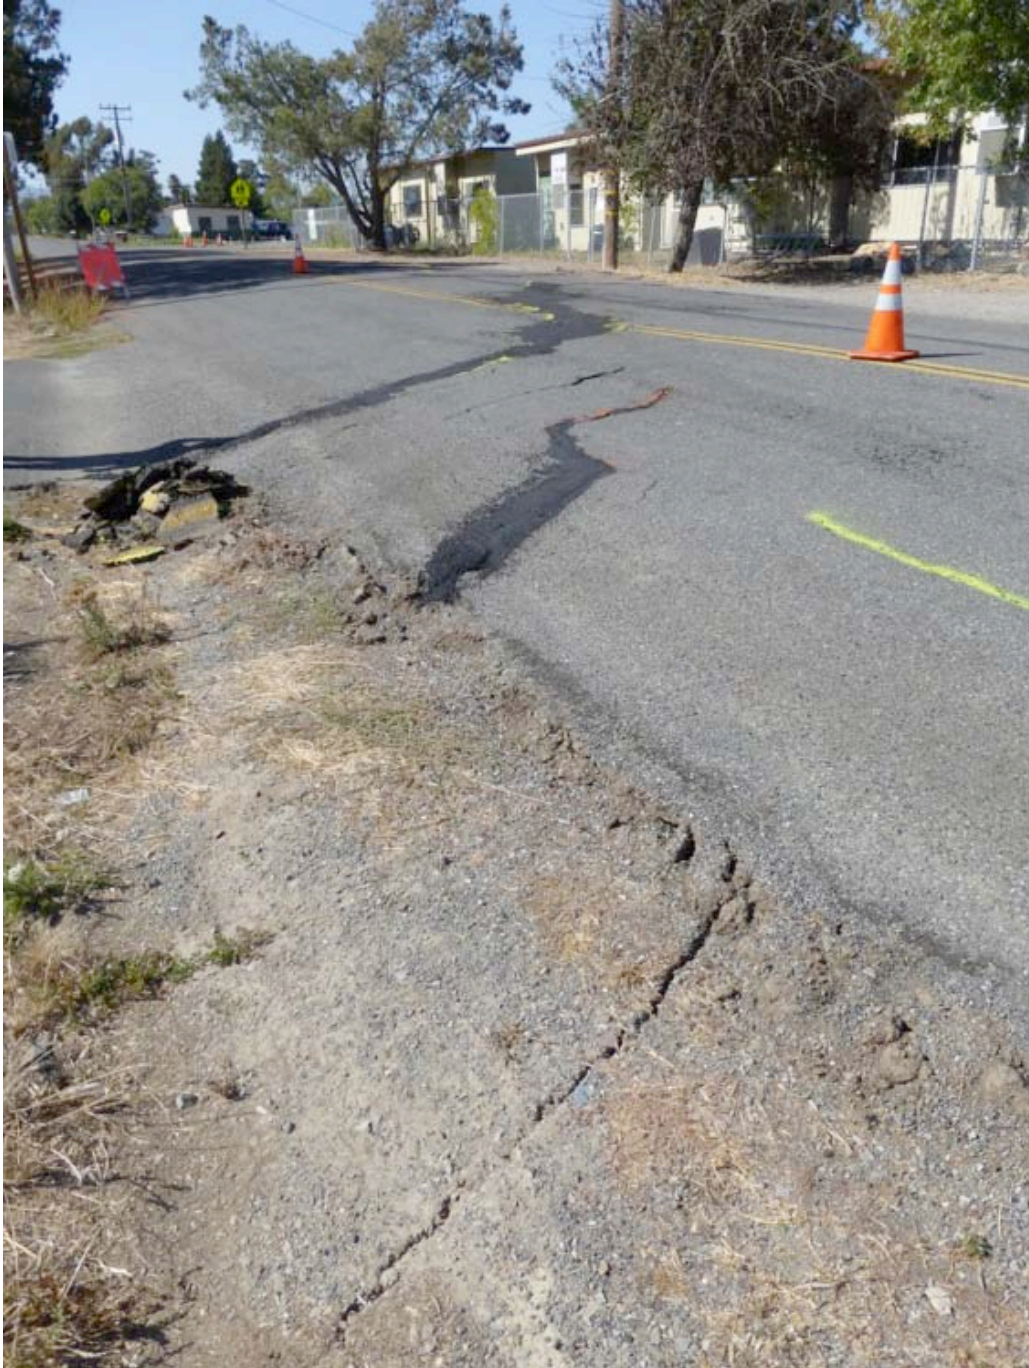
Figure 2-26. Road cracks (repaired and new), looking northerly

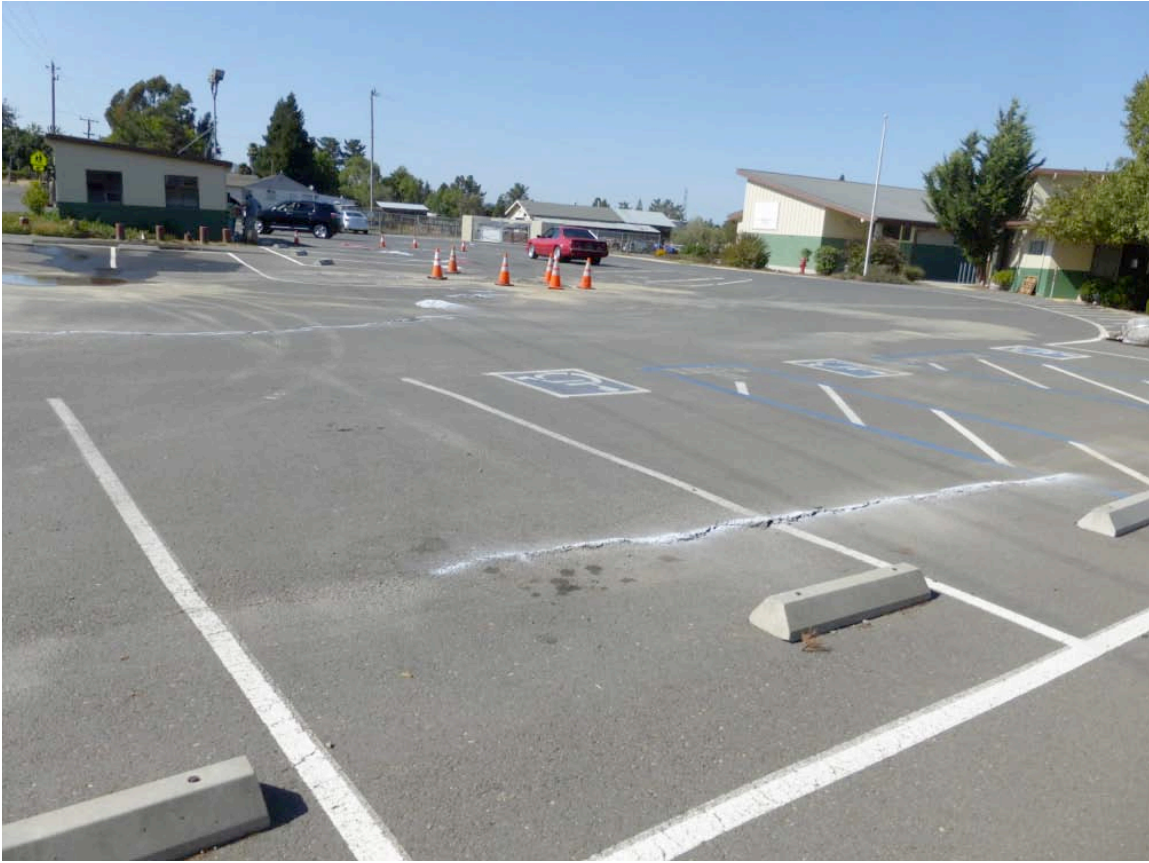
Figure 2-27. Parking lot cracks, looking northerly

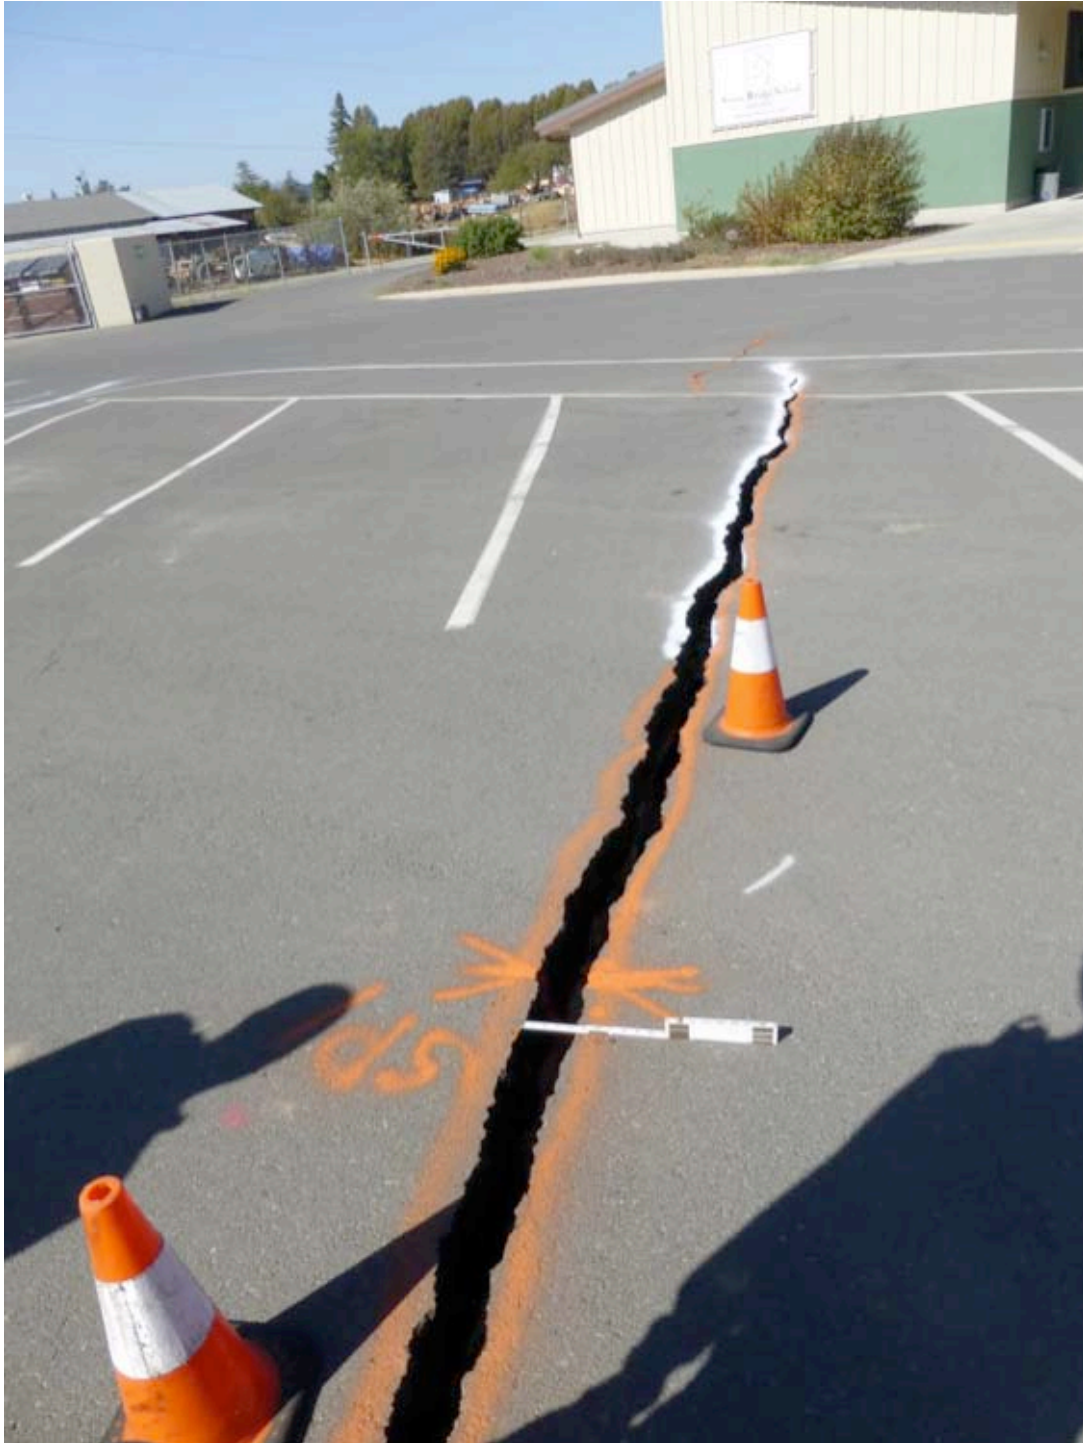
Figure 2-28. Parking lot crack, looking northerly

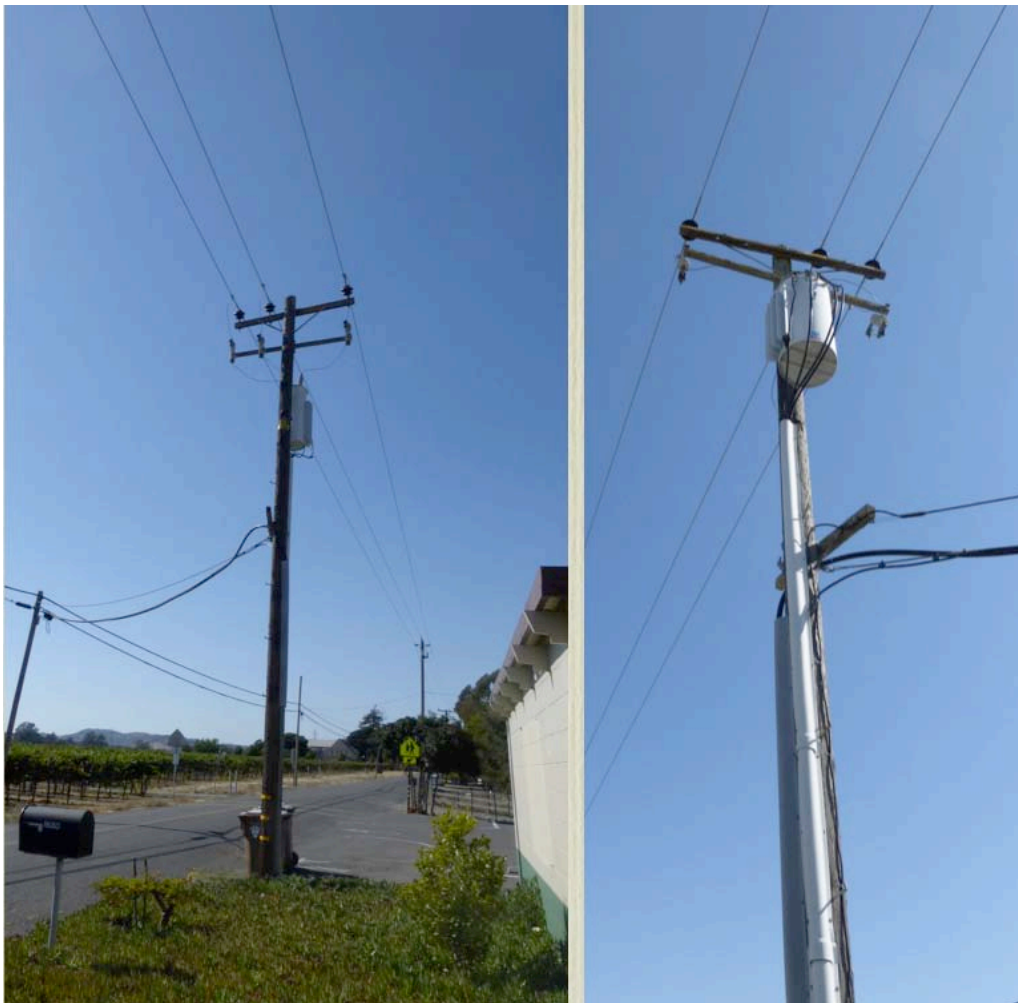
Figure 2-29. Power Pole, adjacent to fault zone (left side looking north, right side looking south)

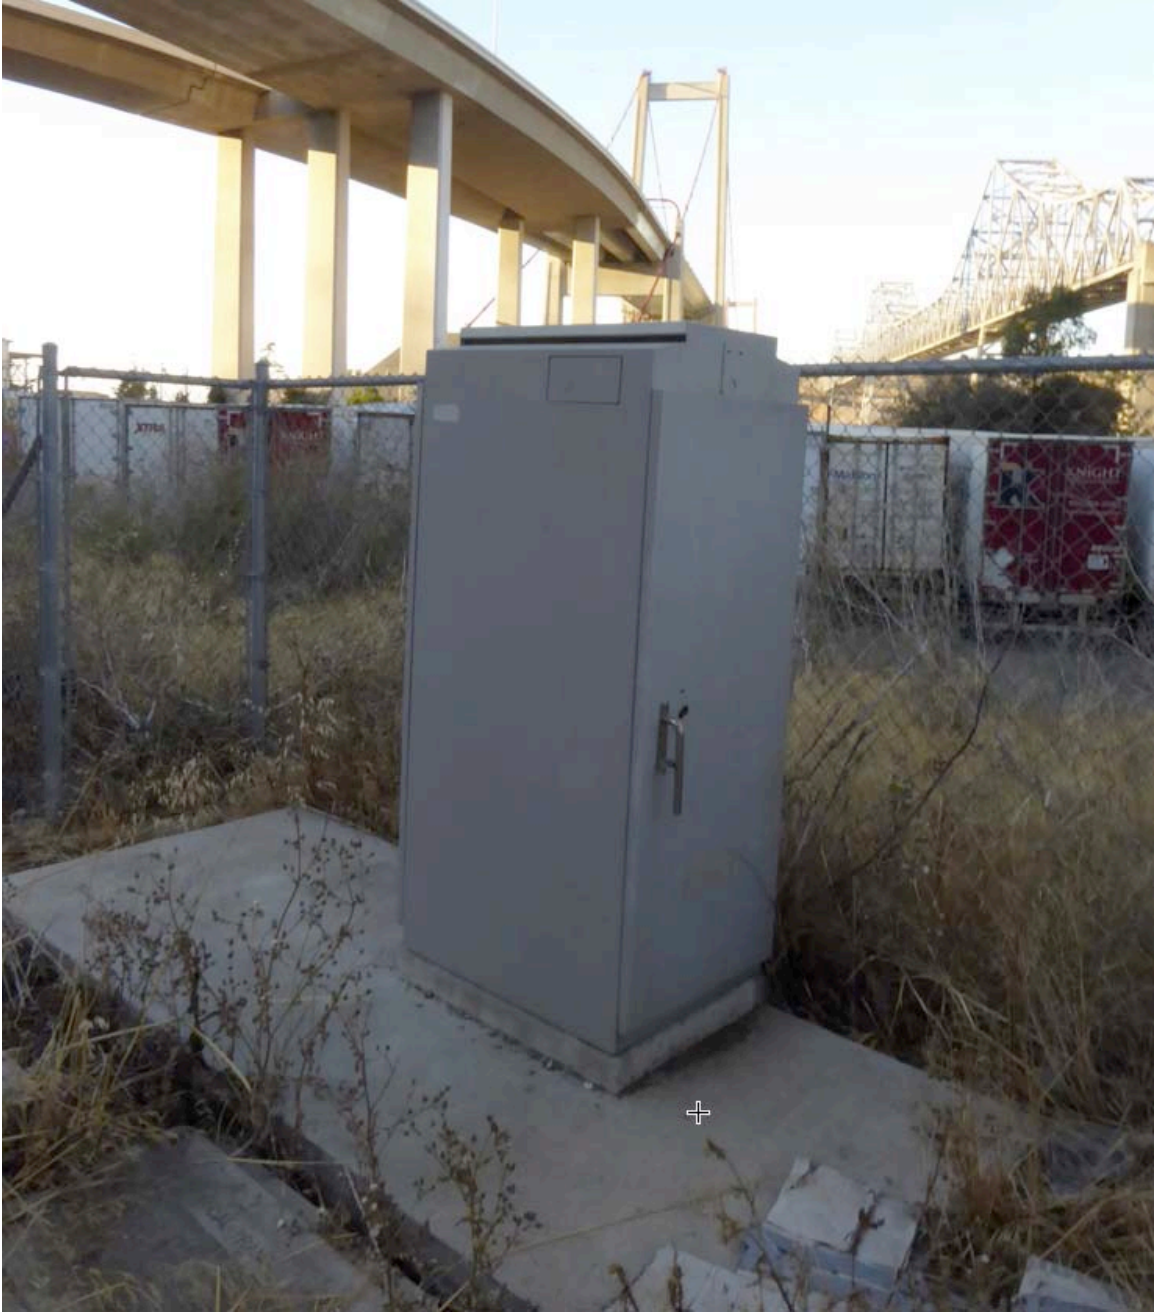
Figure 2-30. Instrument with New (Left) and Old (Right) Carquinez Bridges in Background

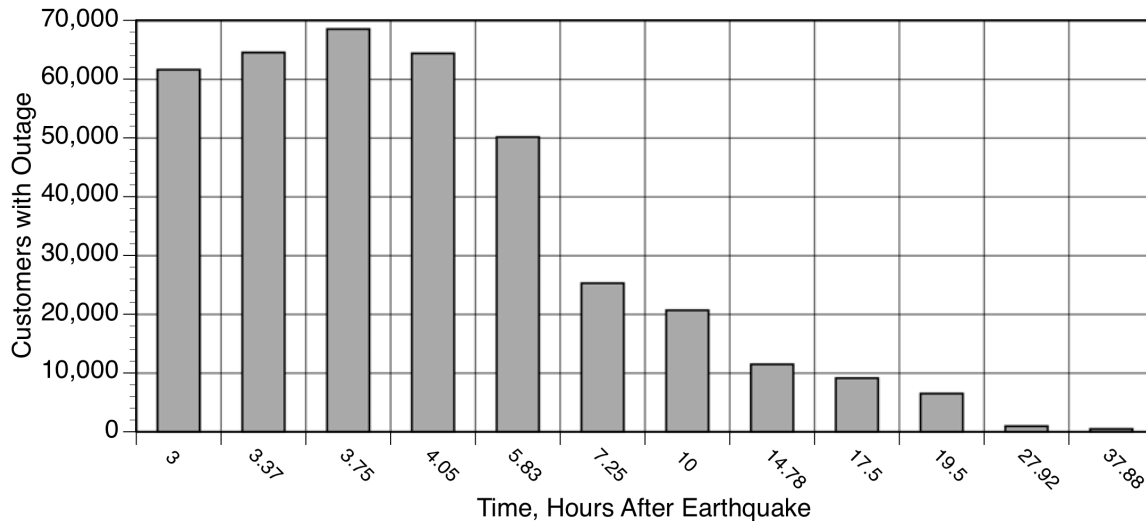
Figure 3-1. Power Outages

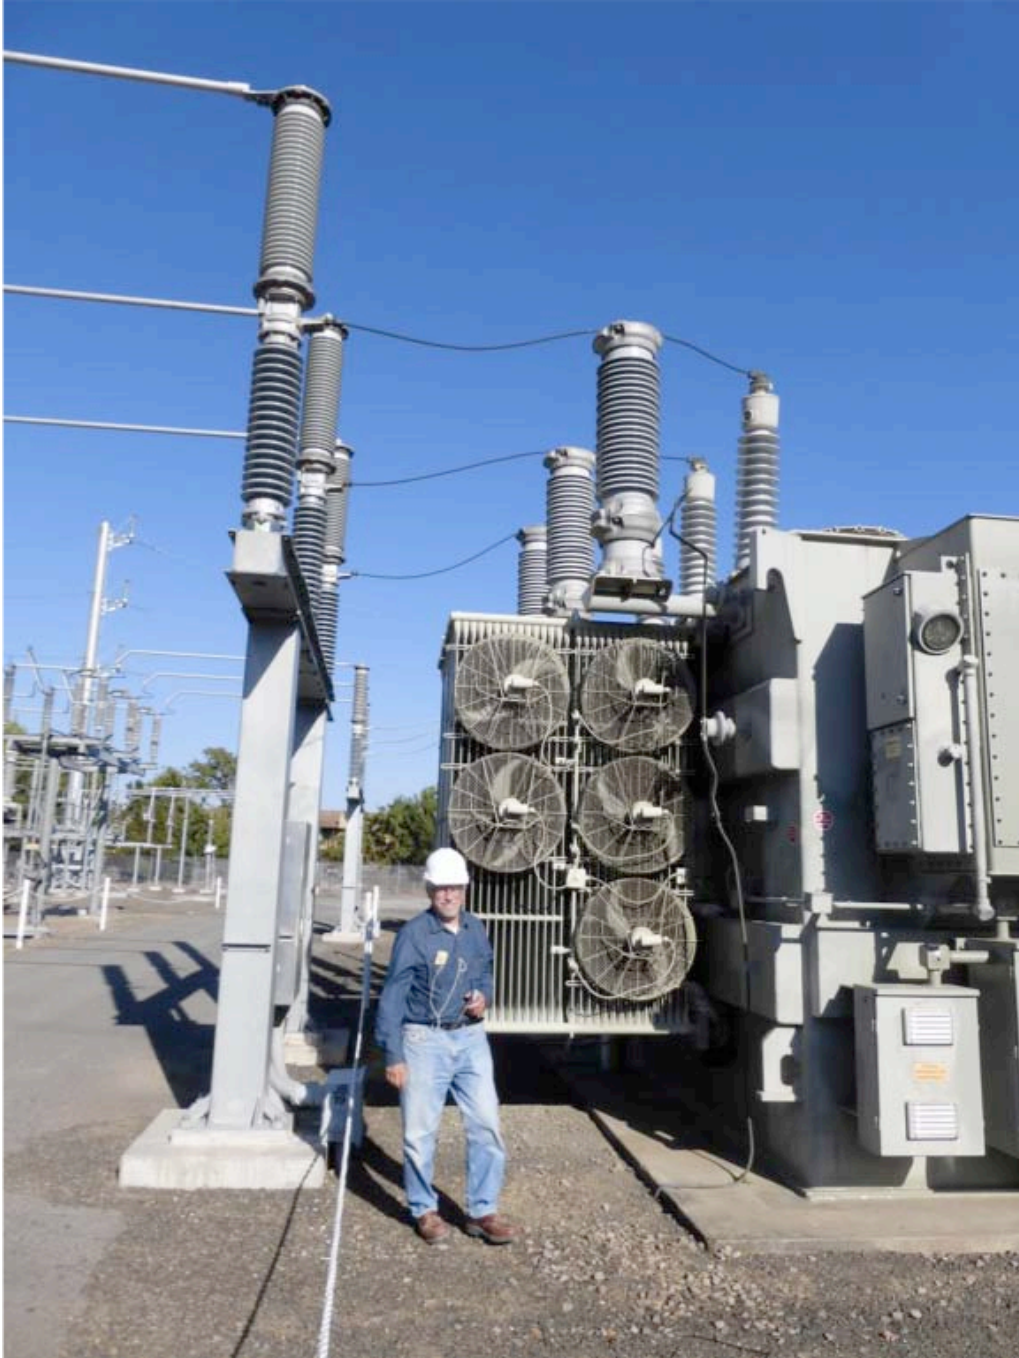
Figure 3-2. Power Transformer

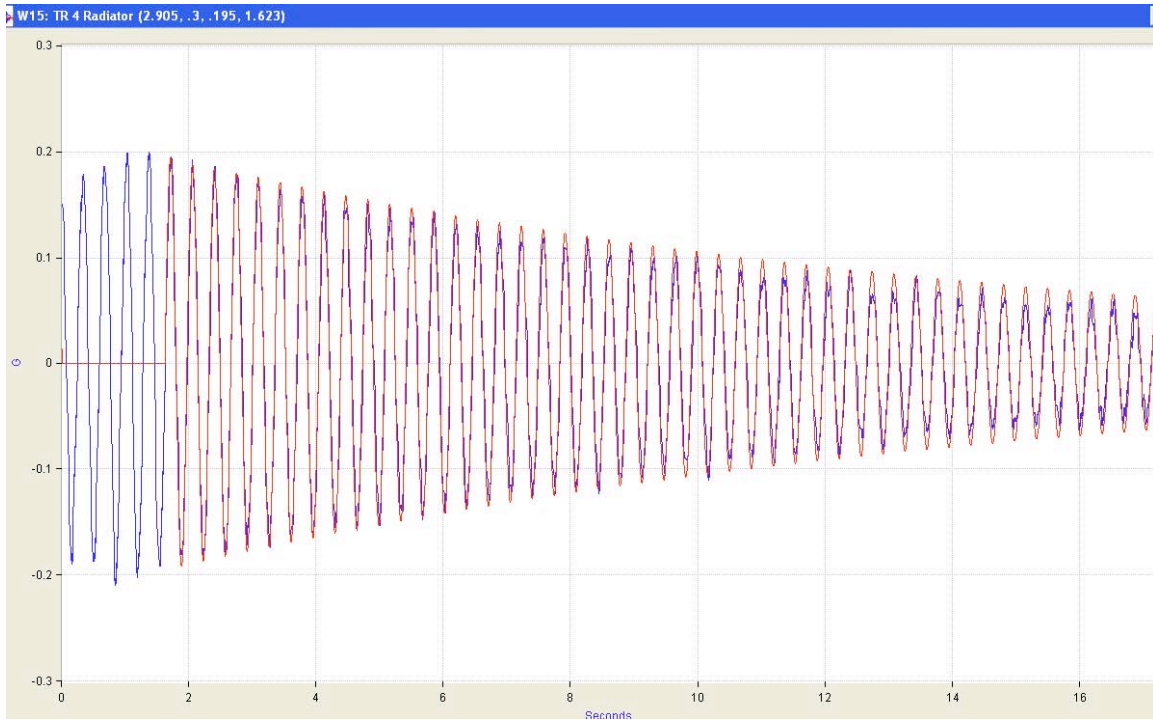
Figure 3-3. In Situ Test Vibration Response of Radiator (A. Schiff)

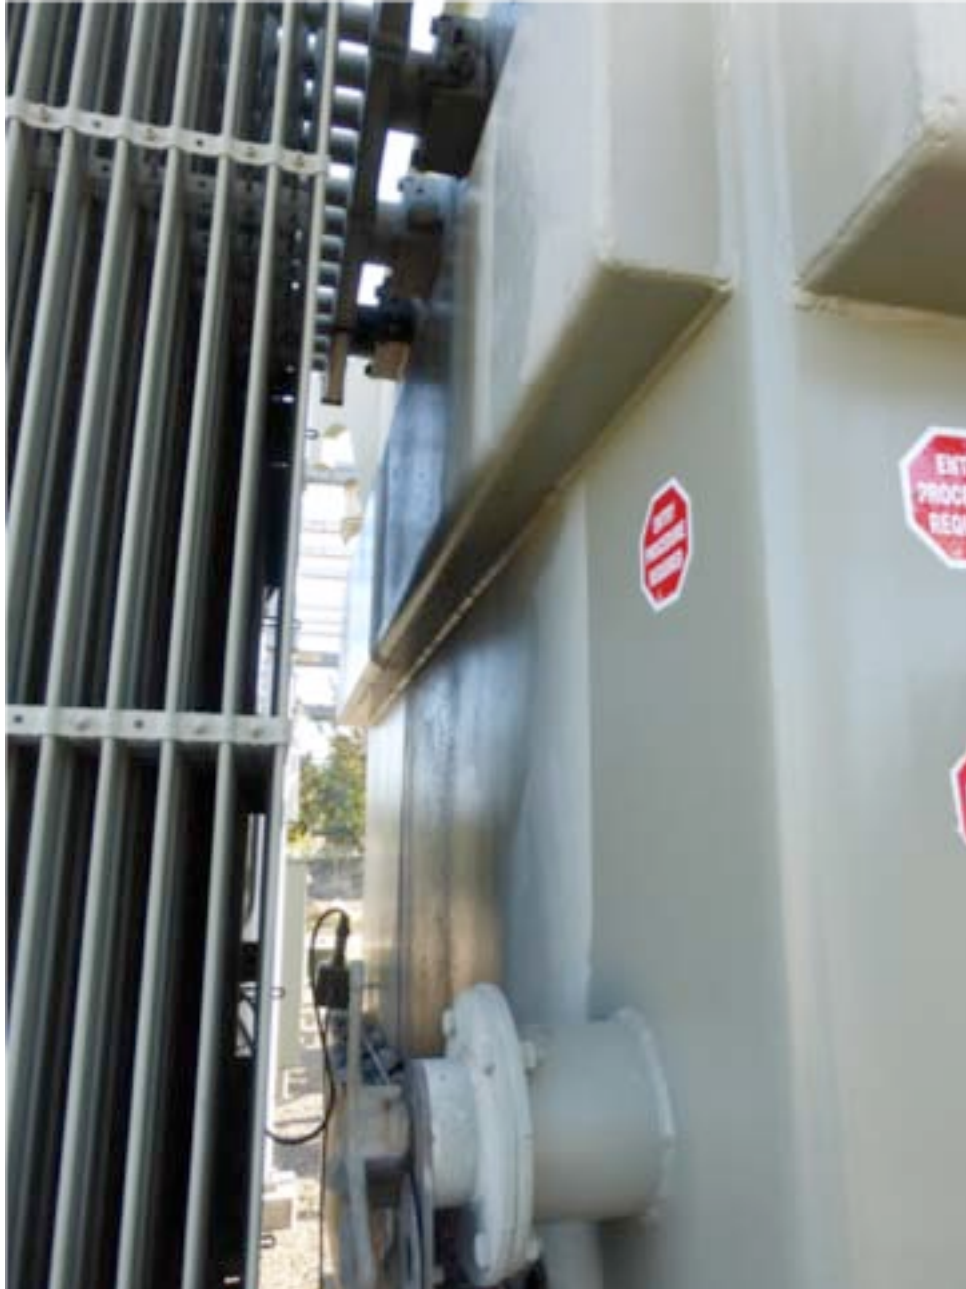
Figure 3-4. Transformer Oil Leak

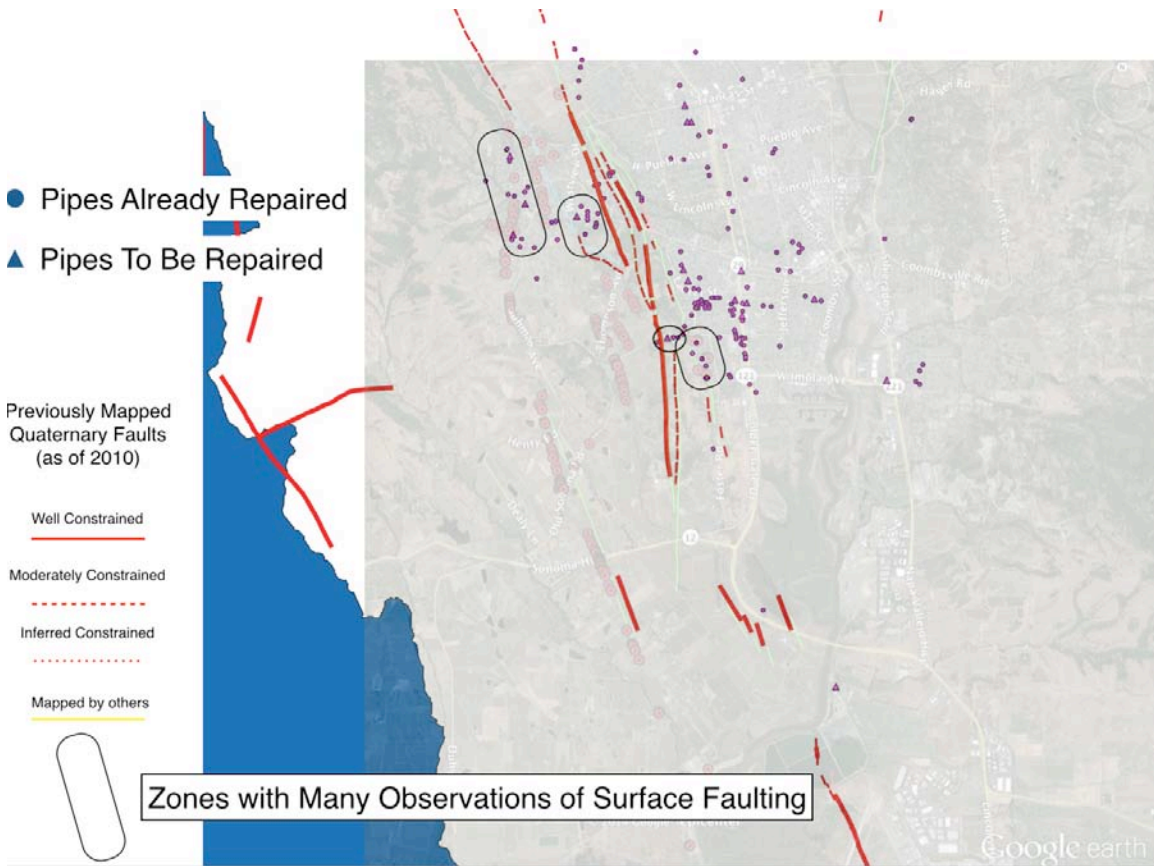
Figure 4-5. Overlay of Water Pipe Repairs and Zones with Surface Faulting

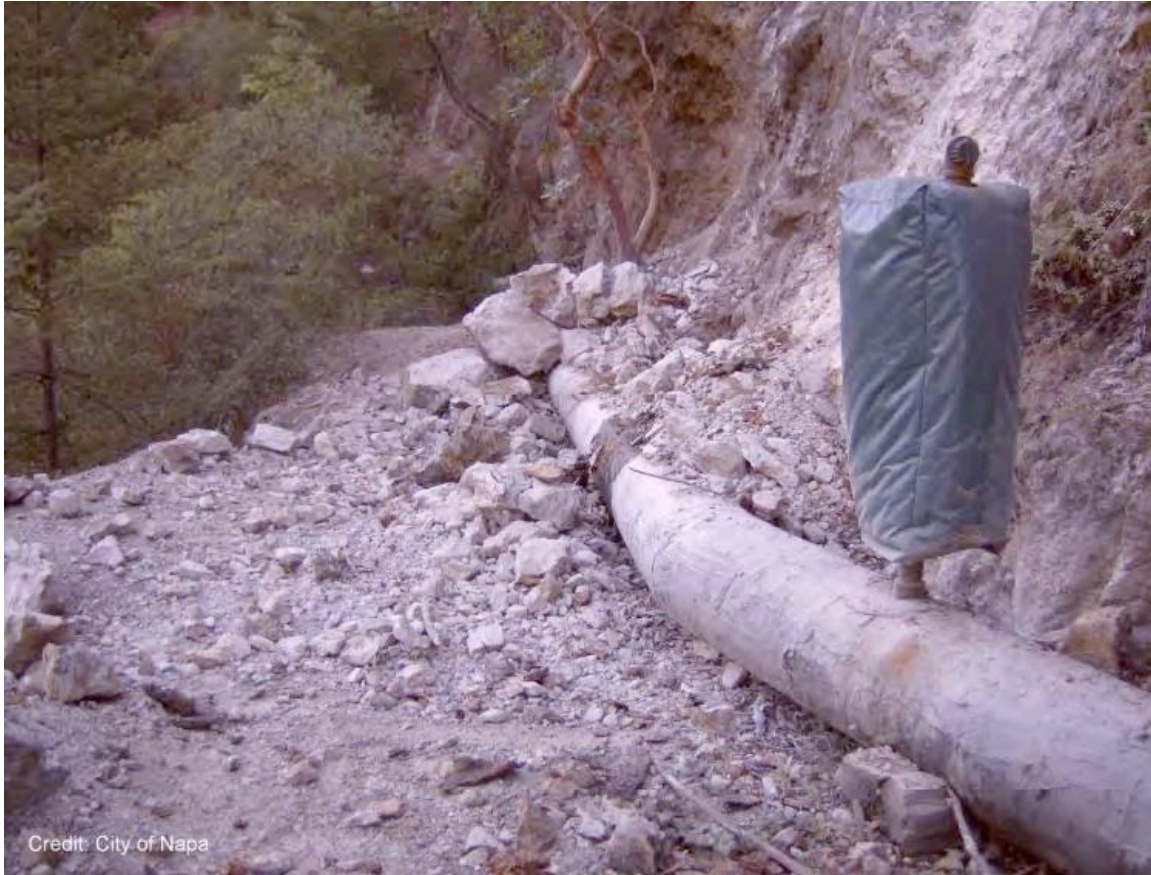
Credit: City of Napa
