South Napa M 6.0 Earthquake of August 24, 2014

Prepared by:

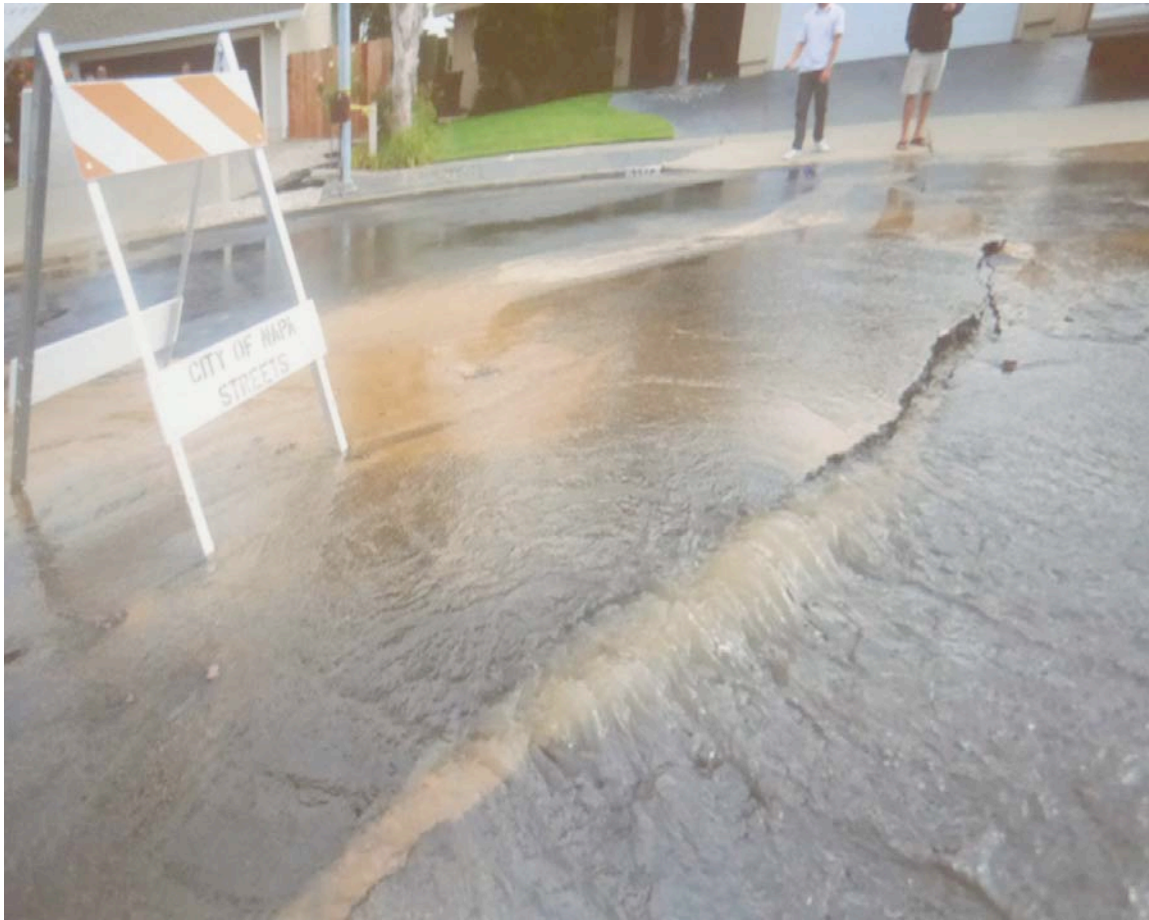
Figure 4-7. Water Leaking from a Damaged Distribution Pipe

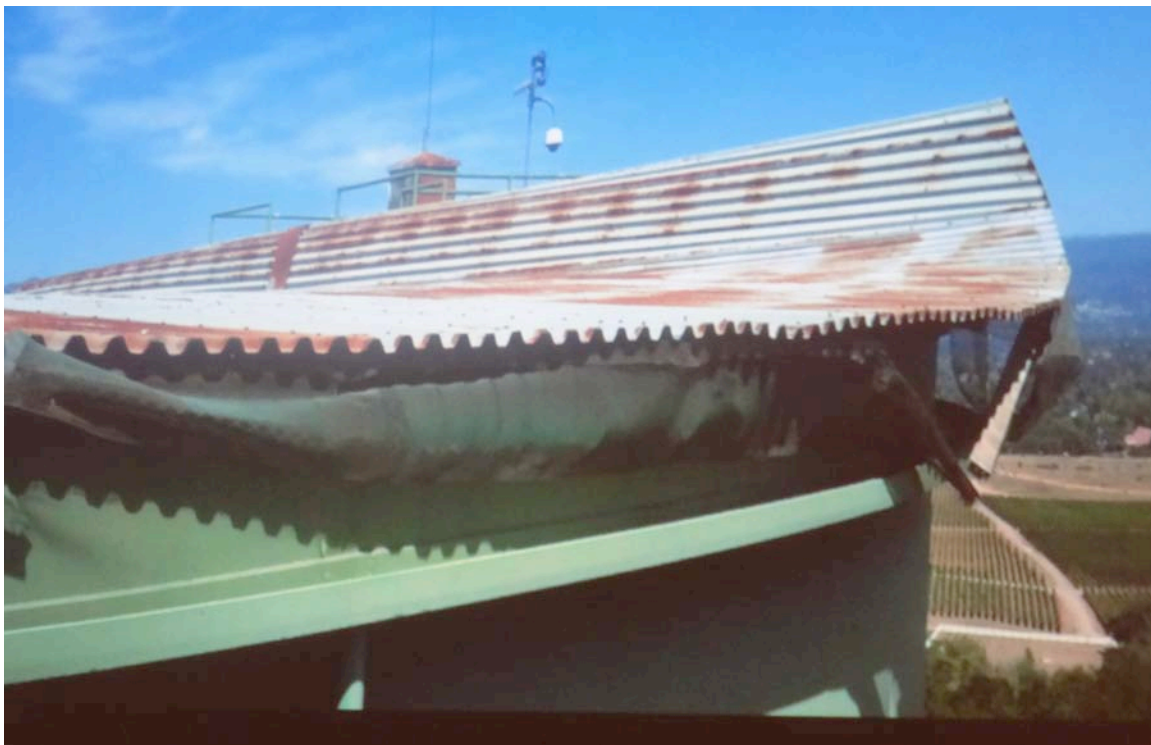
Figure 4-9. Damaged Roof of Steel Tank "B"

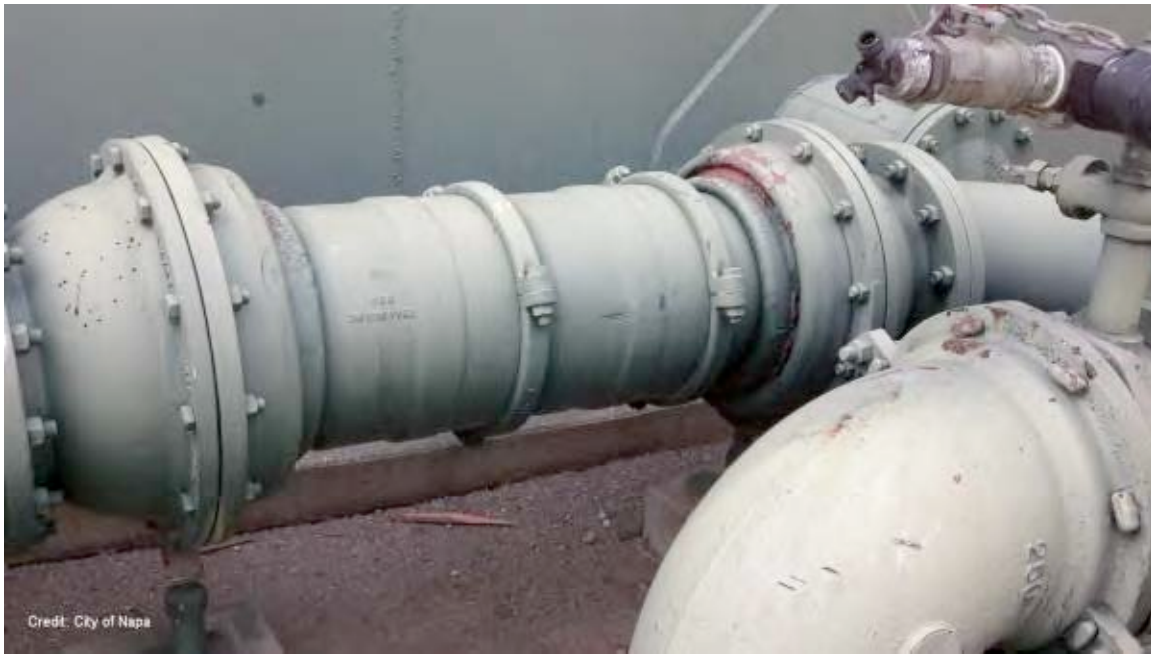
Figure 4-10. Movement of Attached Pipes

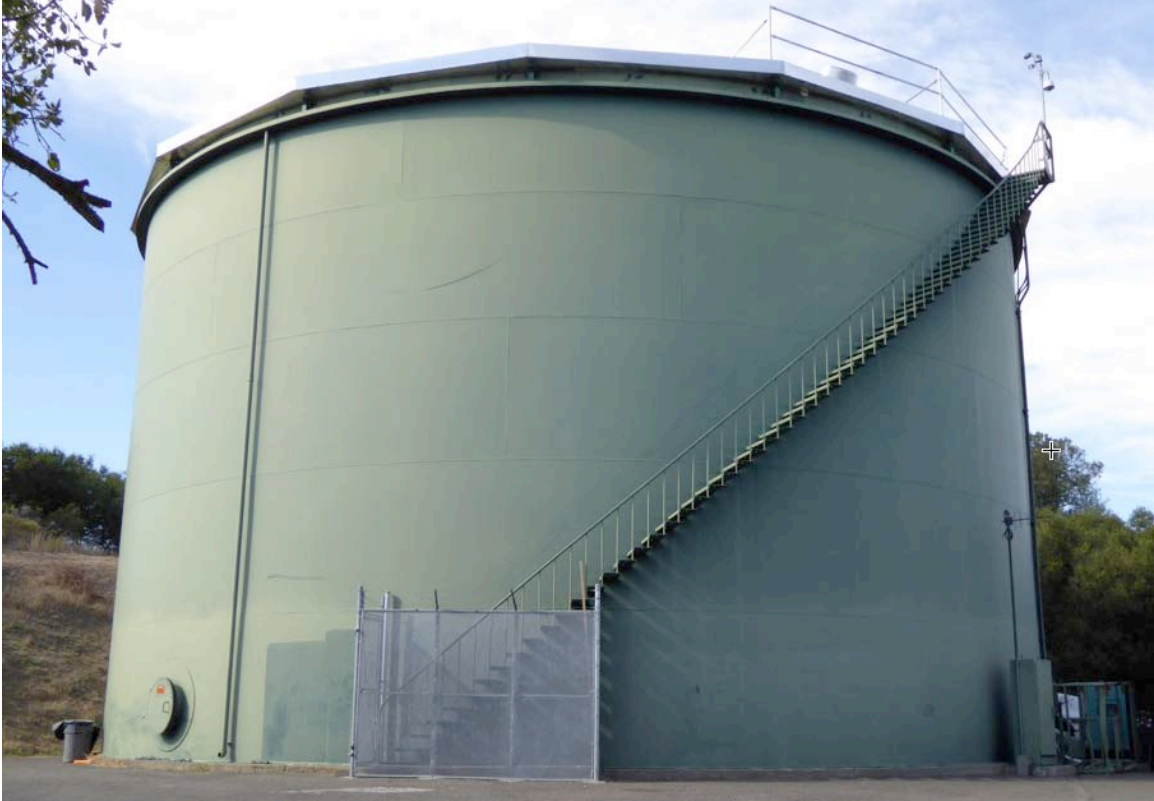
Figure 4-11. Tank B, with New Aluminum Dome Roof

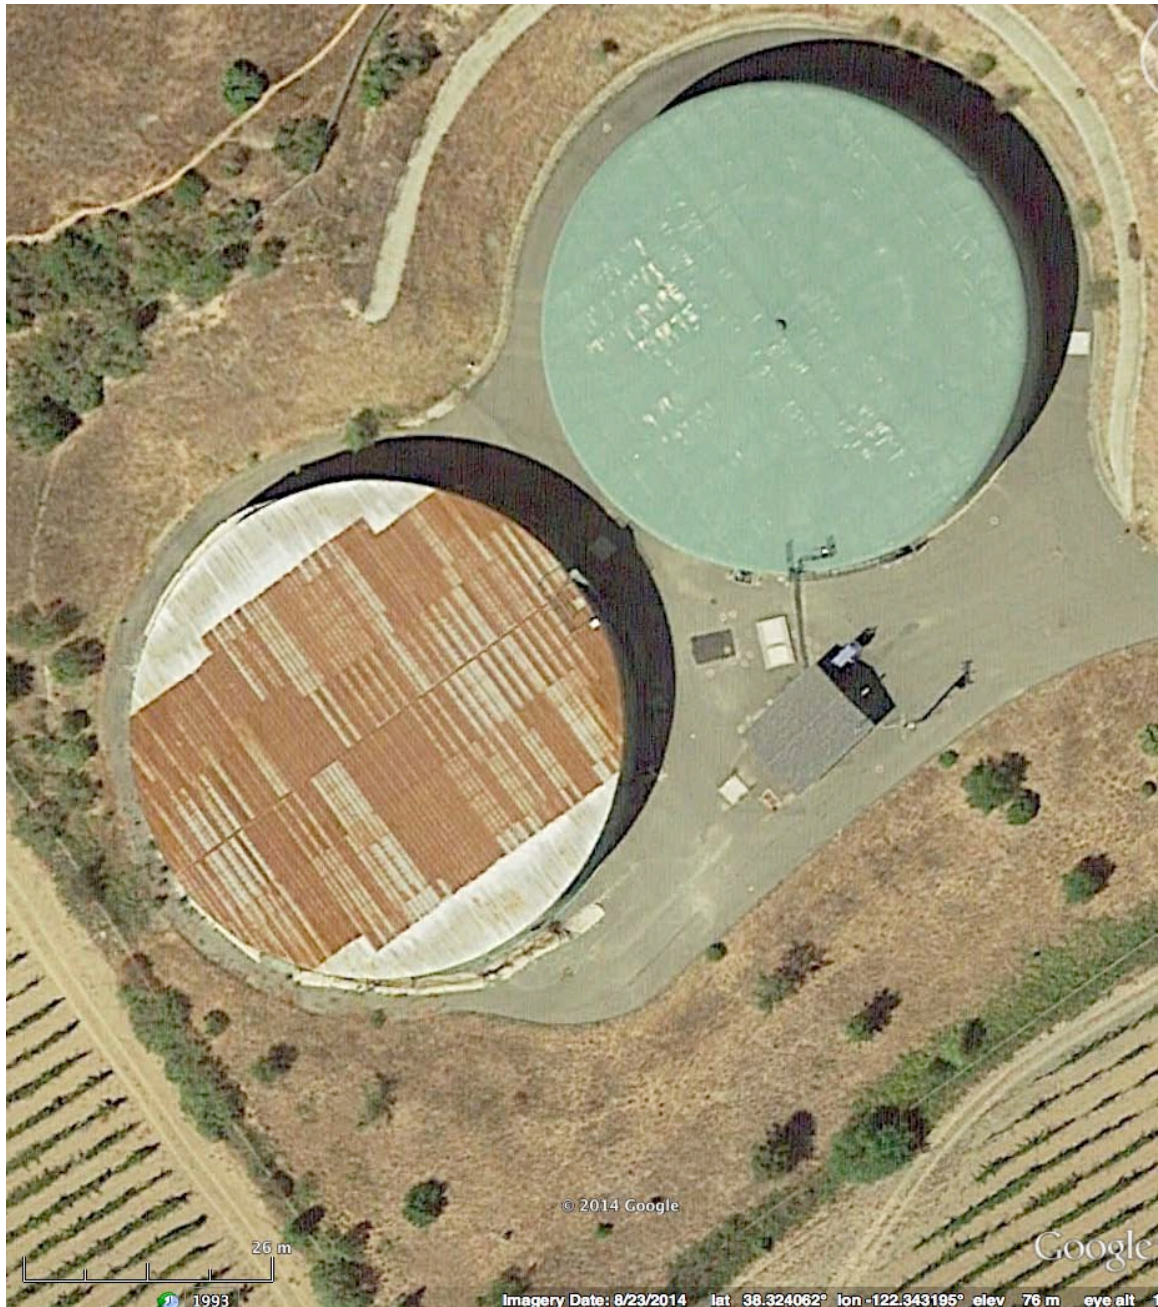
Figure 4-12. Two Tanks (38.2341, -122.3432)

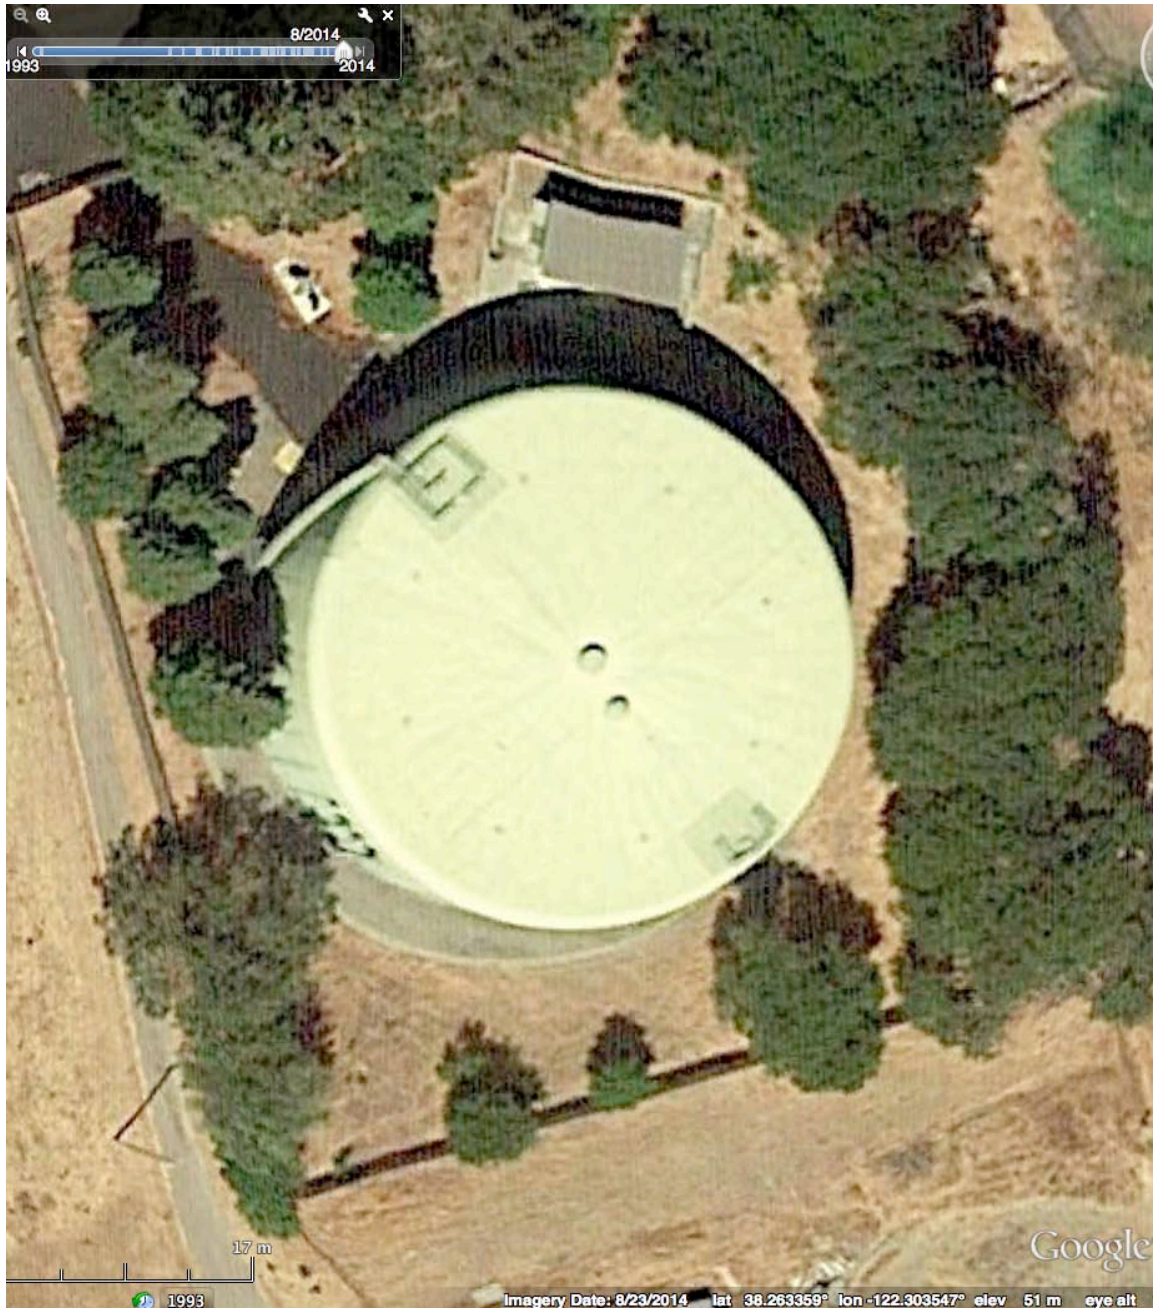
Figure 4-13. West Side Tank (38.2631, -122.3039)

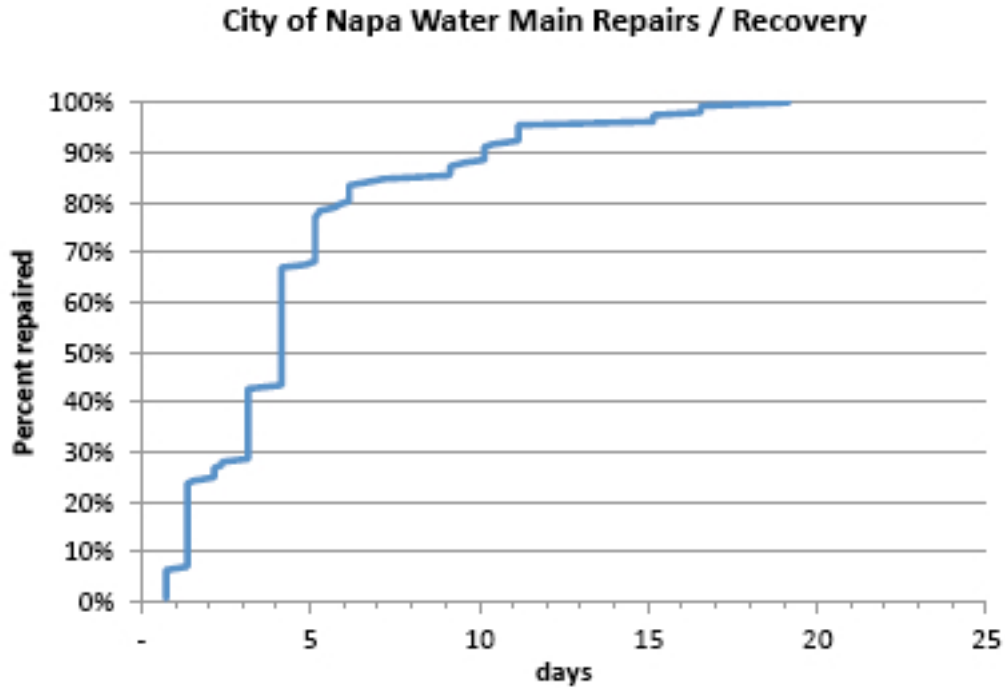
Figure 4-14. Napa Water Recovery

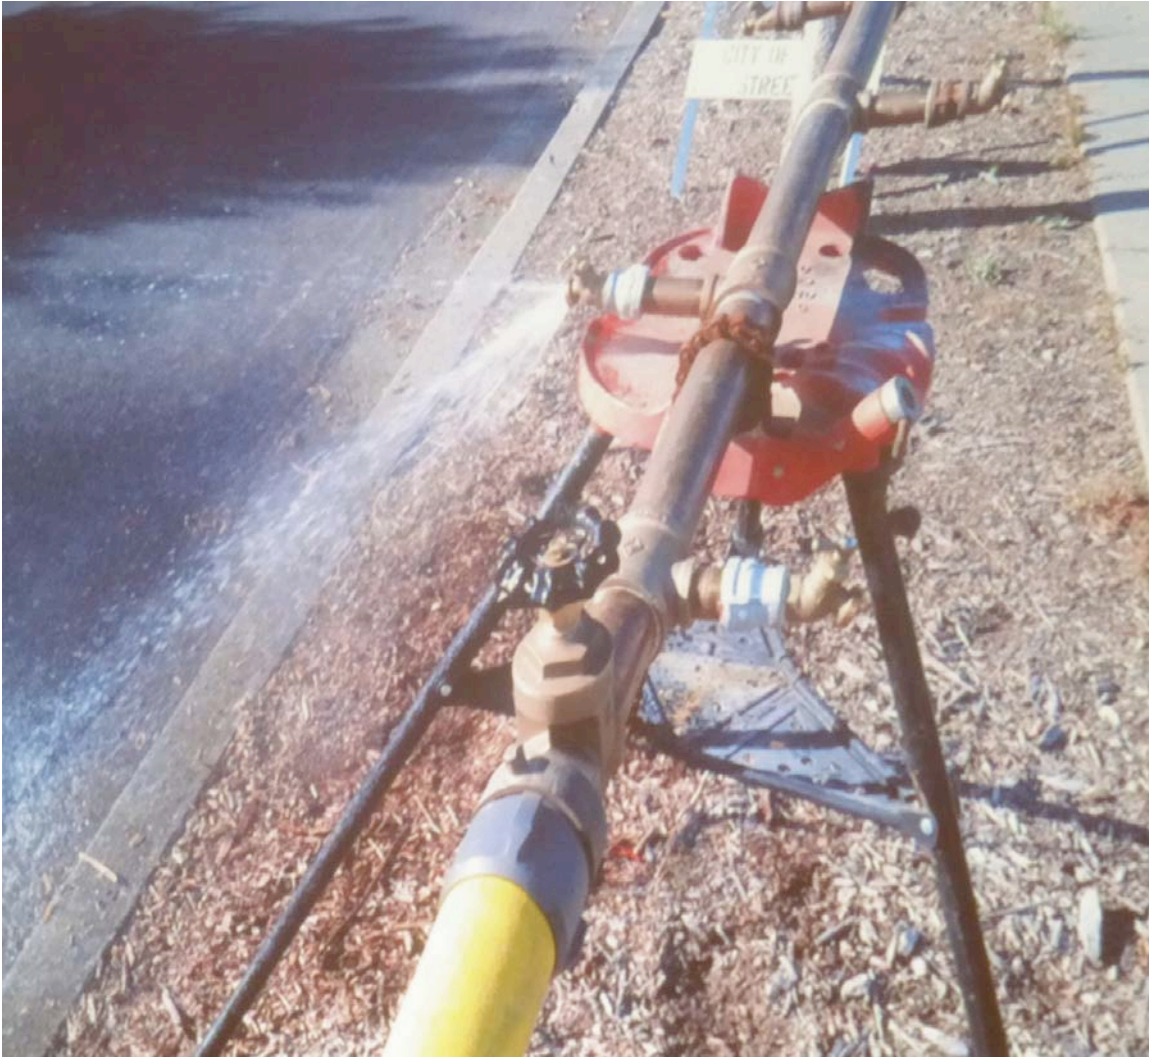
Figure 4-15. Hose Bib Used During Recovery

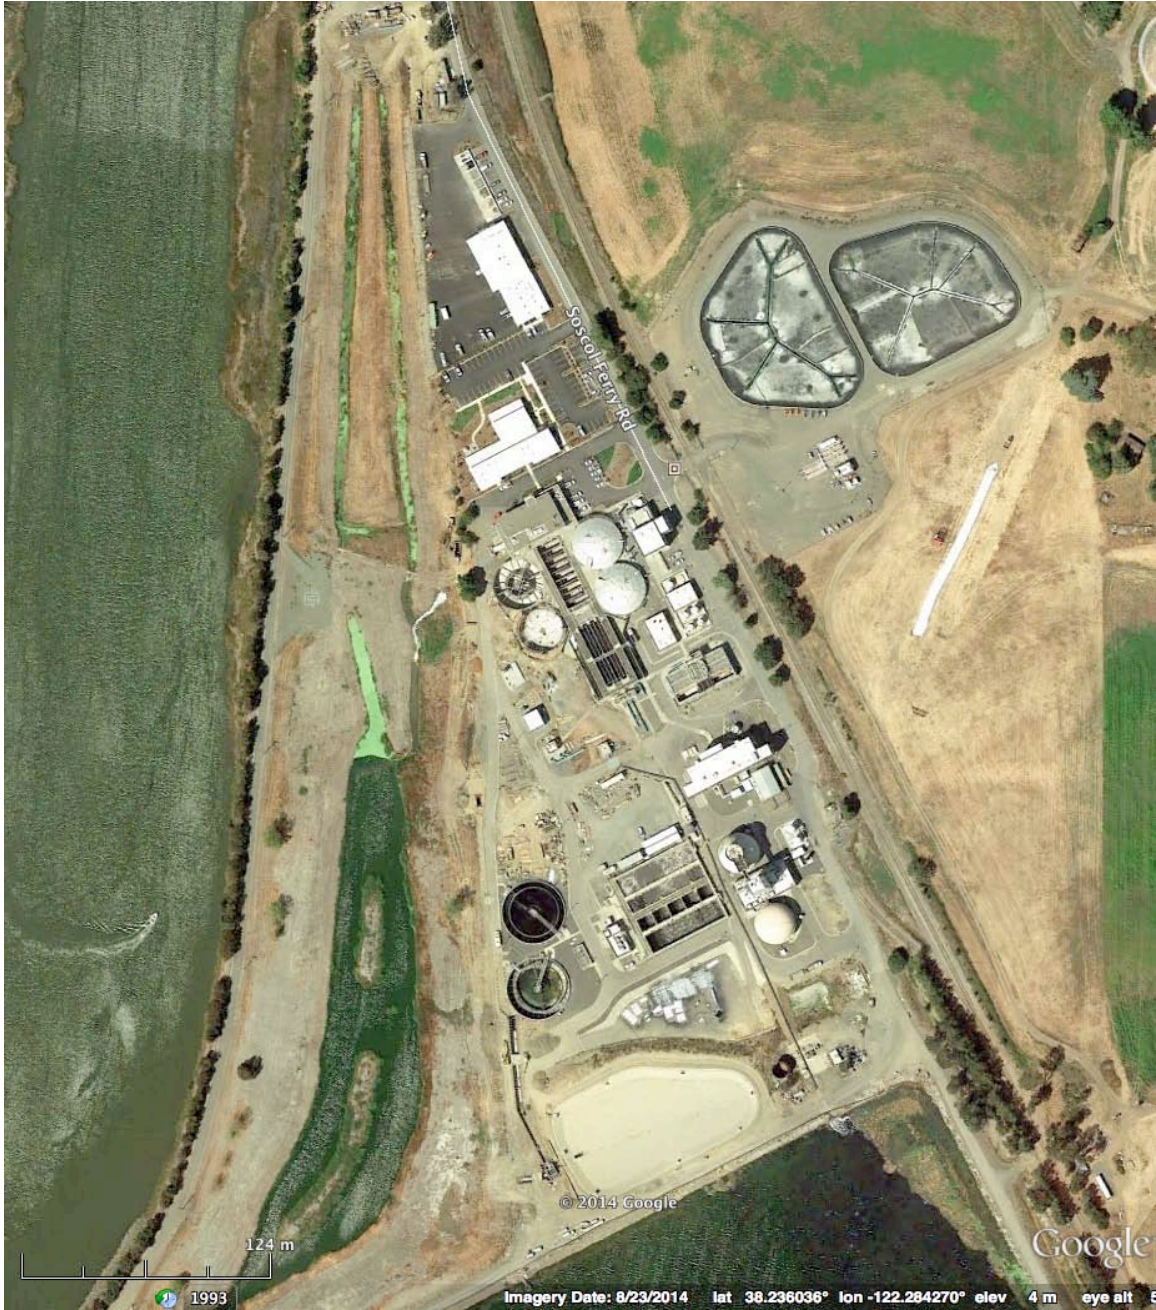
Figure 4-16. Suscol Wastewater Treatment Plant

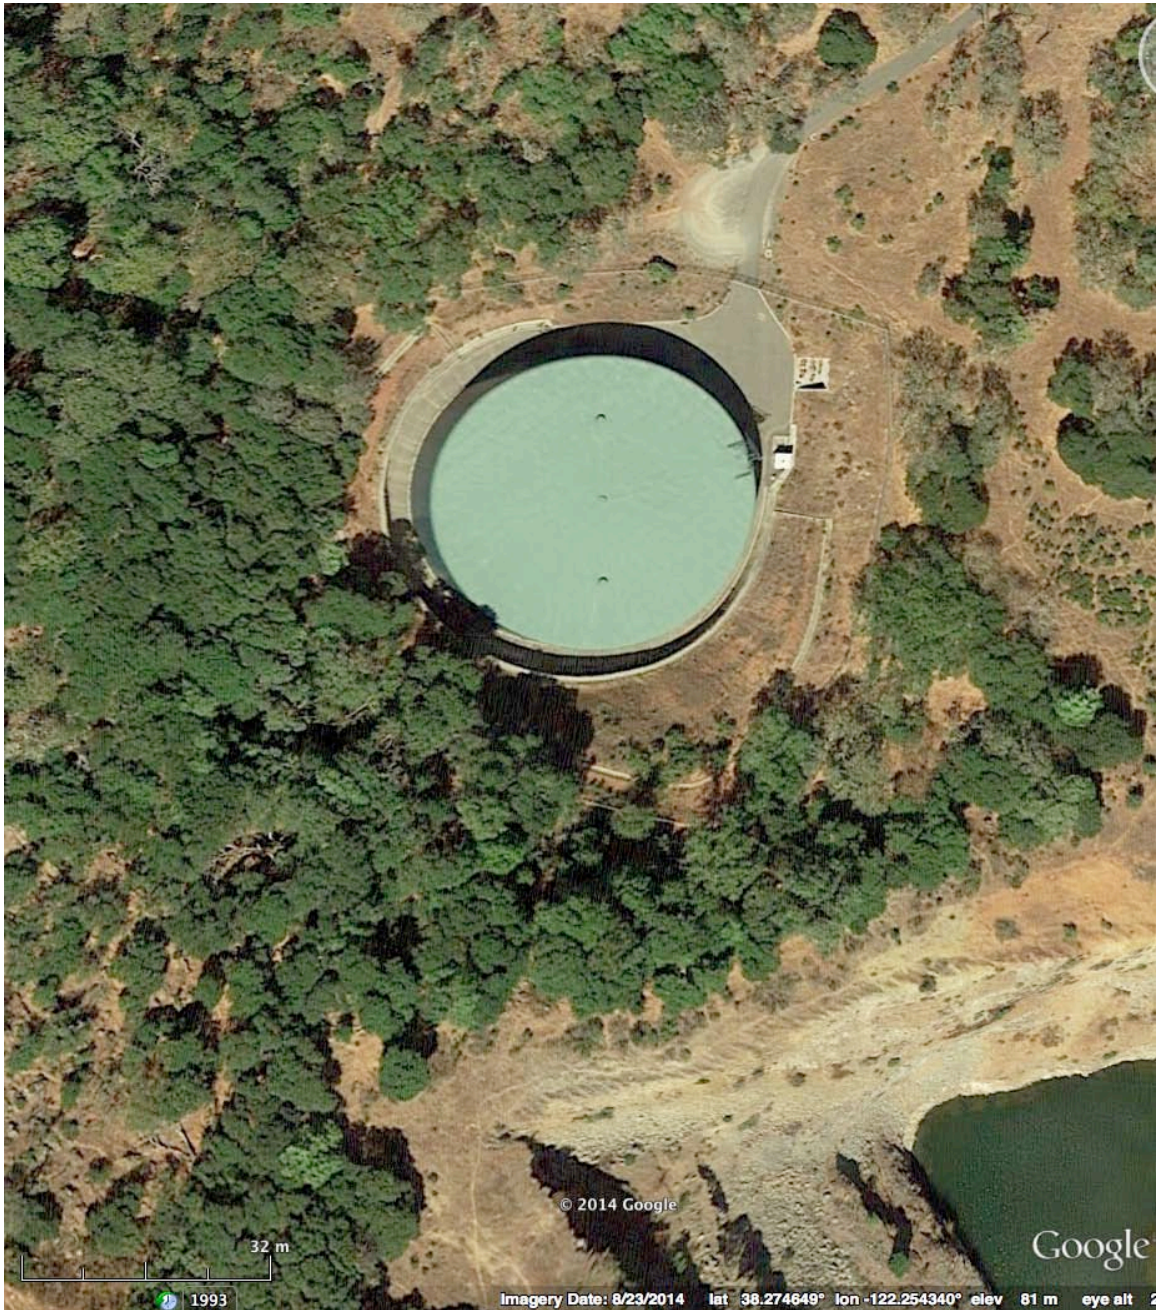
Figure 4-18. Recycled Storage Reservoir

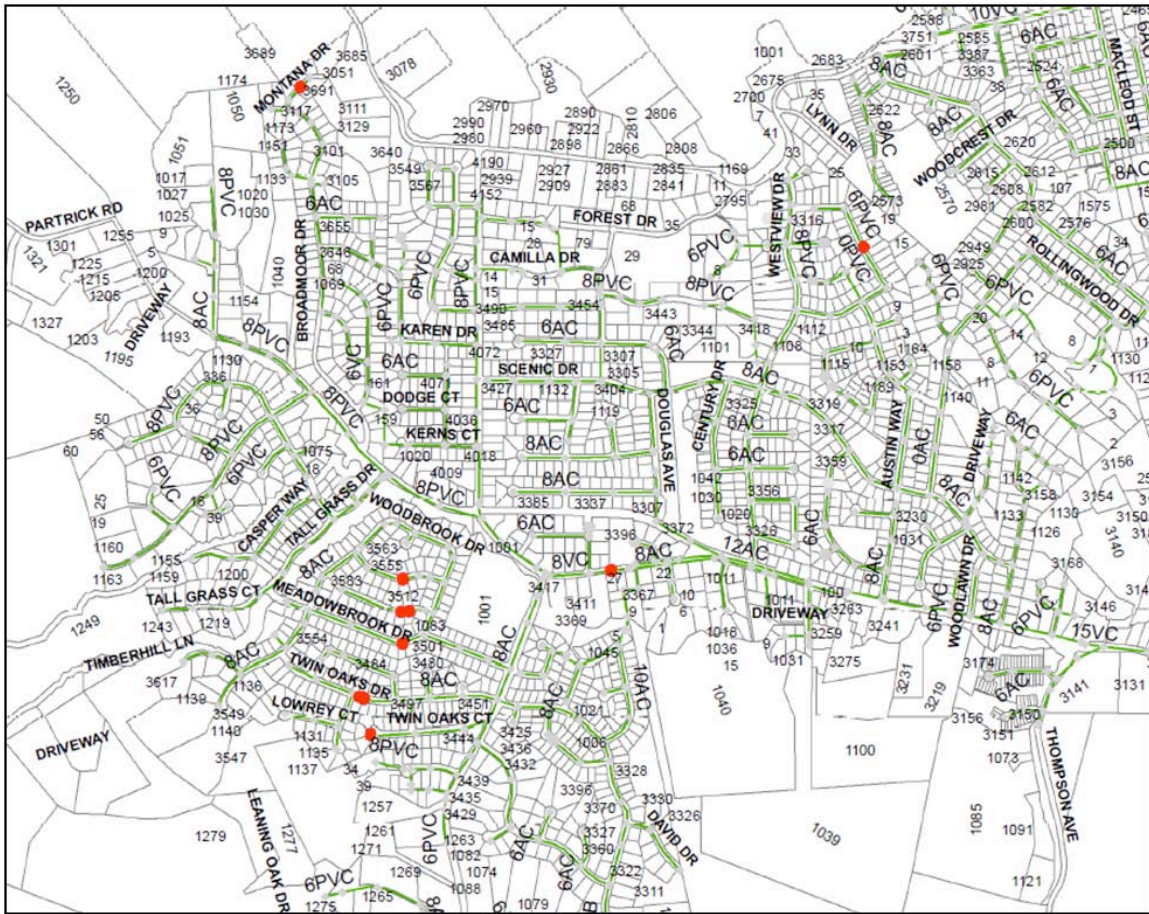
Figure 4-19. Location of Sewer Breaks

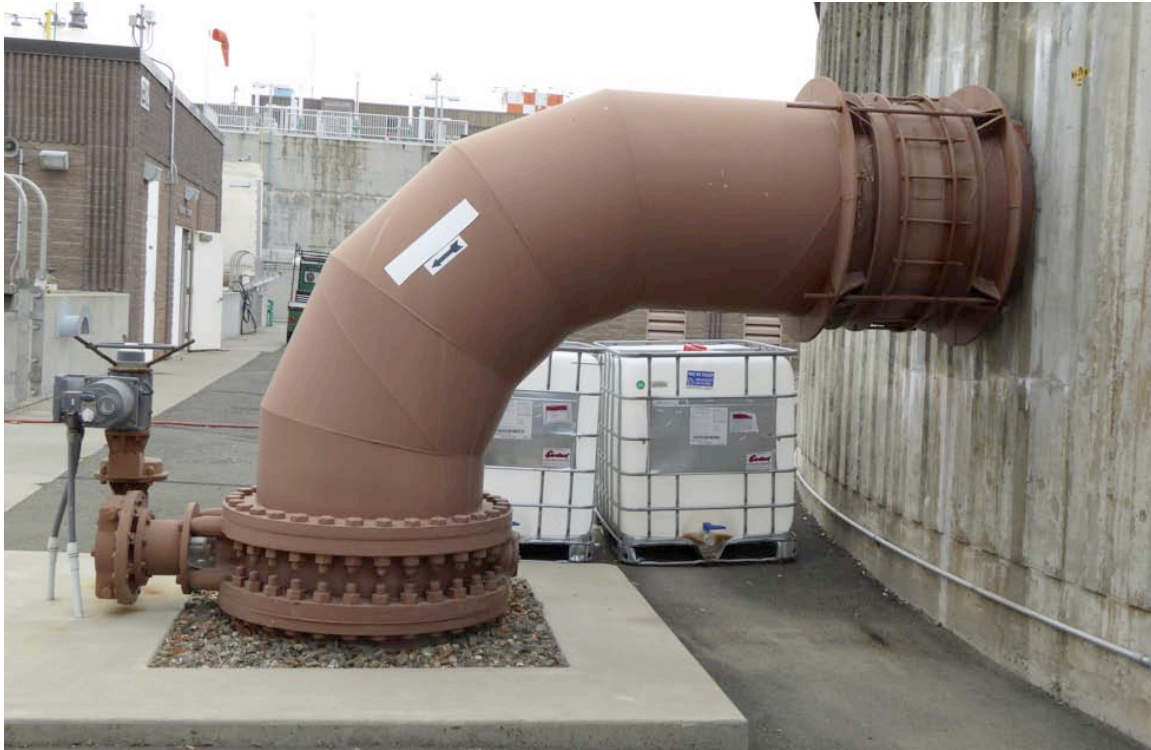
Figure 4-20. Steel Pipe with Dresser-Type Coupling

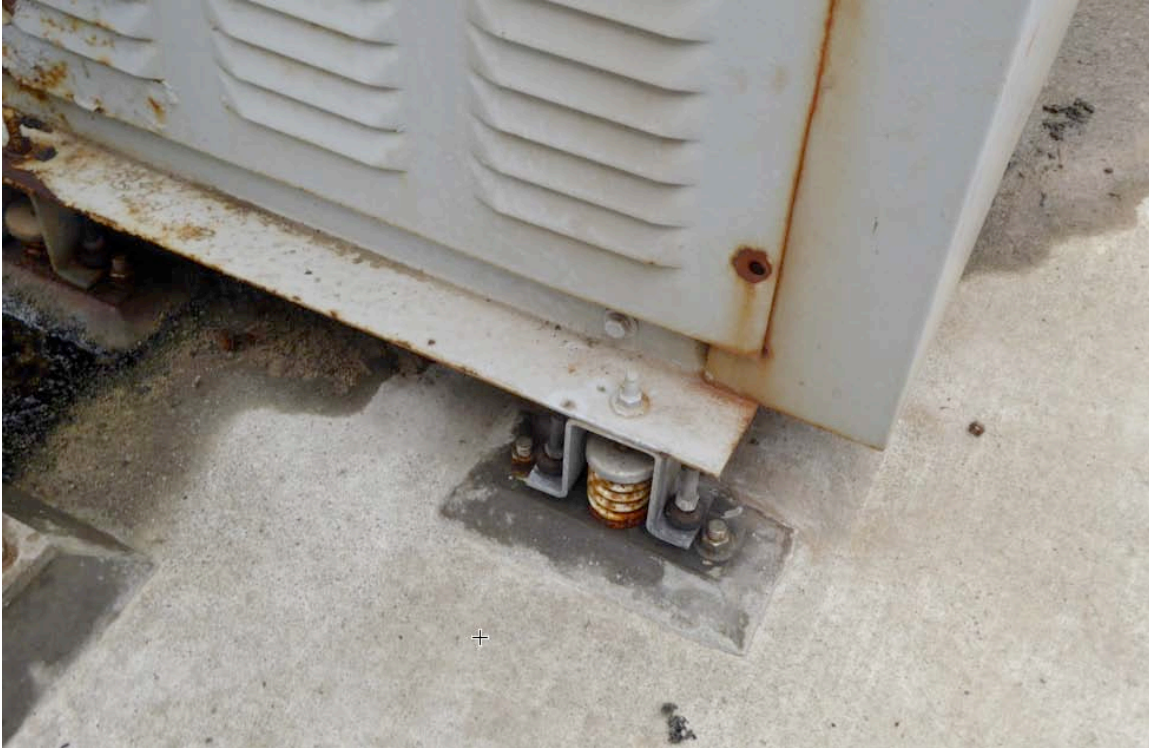
Figure 4-21. Spring-Mounted Motor Assembly

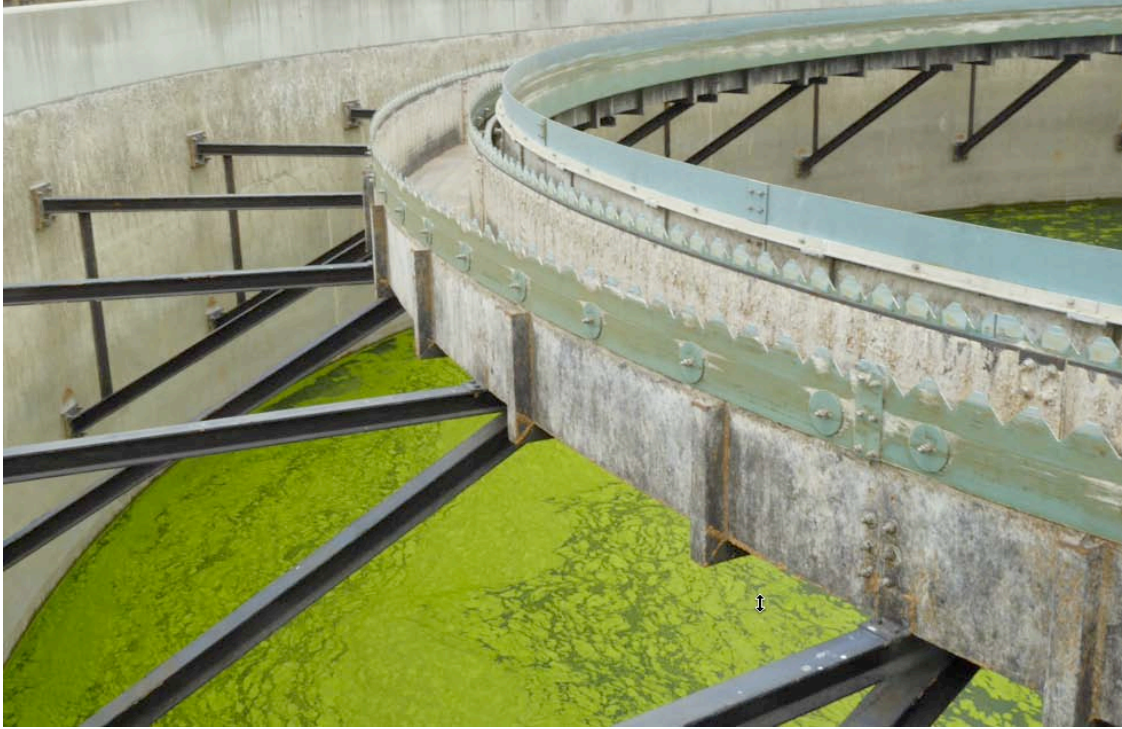
Figure 4-22. Empty Clarifier

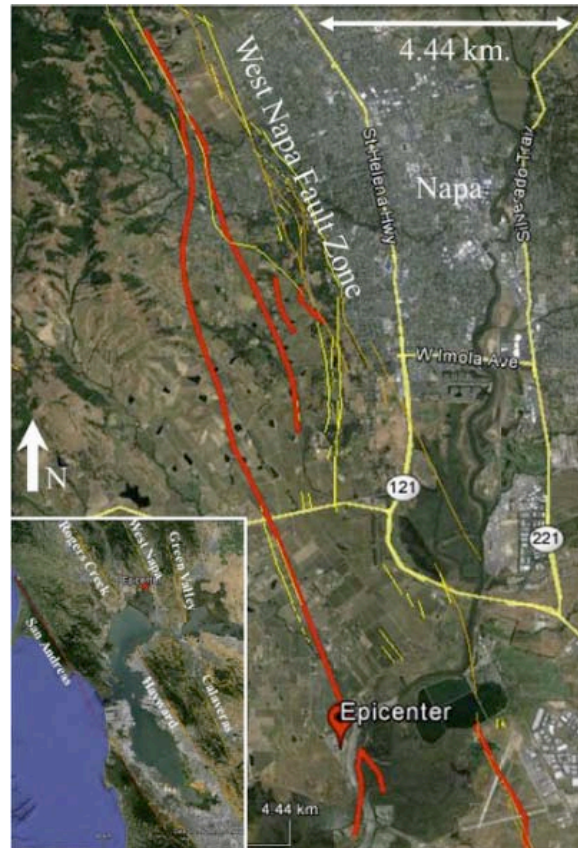
Figure 5-1. Aerial view showing epicenter of the South Napa earthquake and location of nearby faults

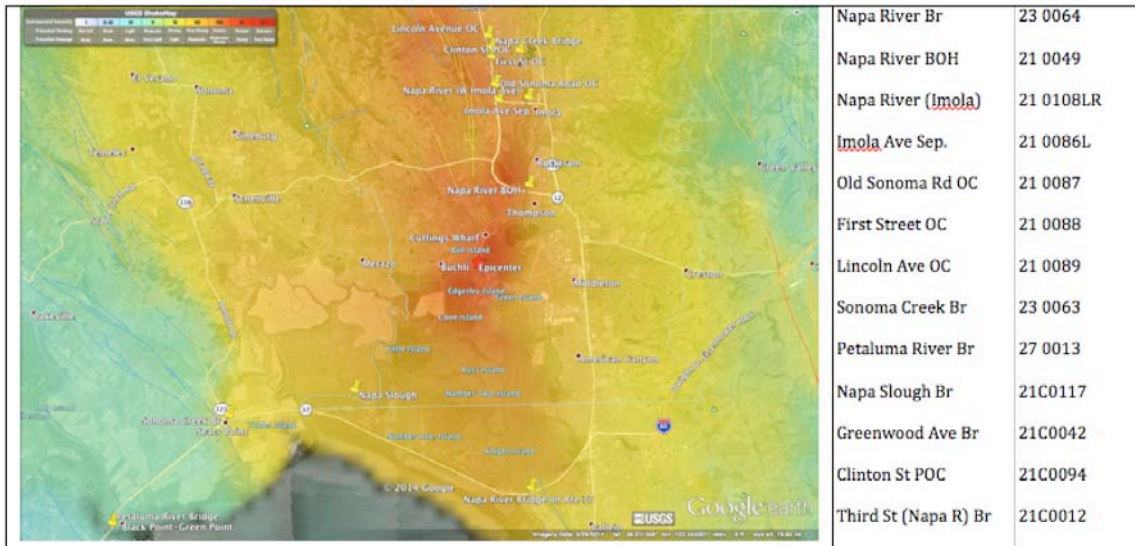
Figure 5-2. Bridges investigated after the August 24 2014 earthquake

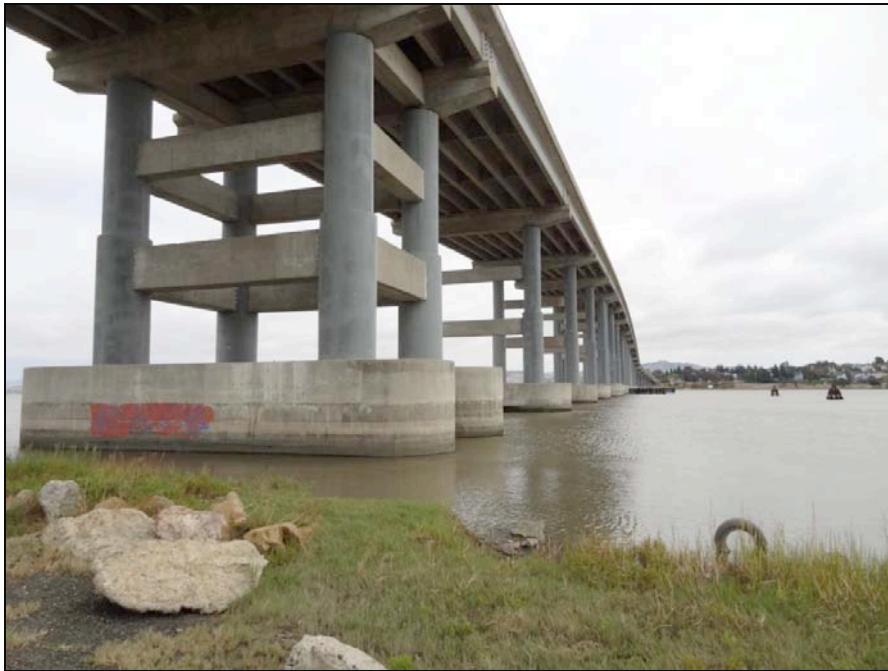
Figure 5-3. Napa River Bridge on Route 37 Br. #23 0064 (38.1203°, -122.2800°)

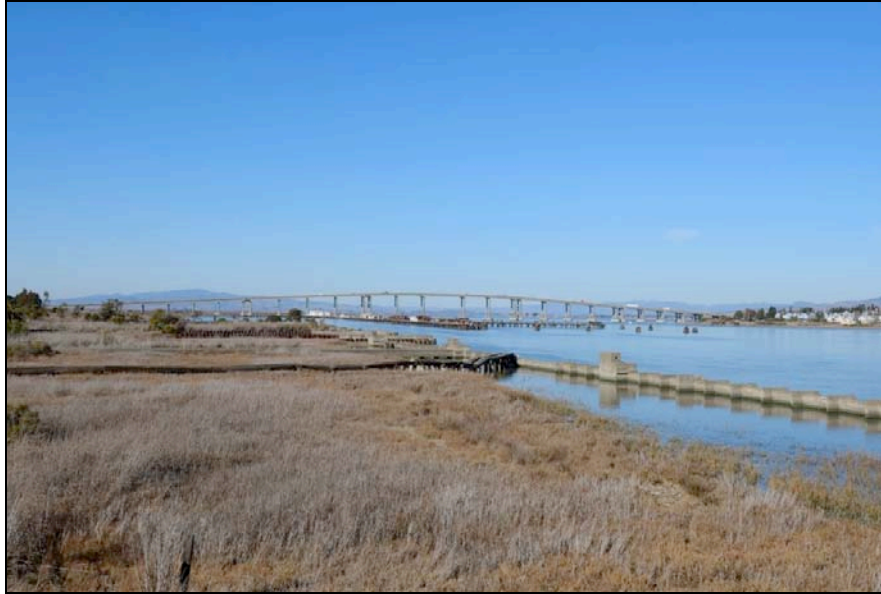
Figure 5-4. Napa River Bridge on Route 37 Br. #23 0064

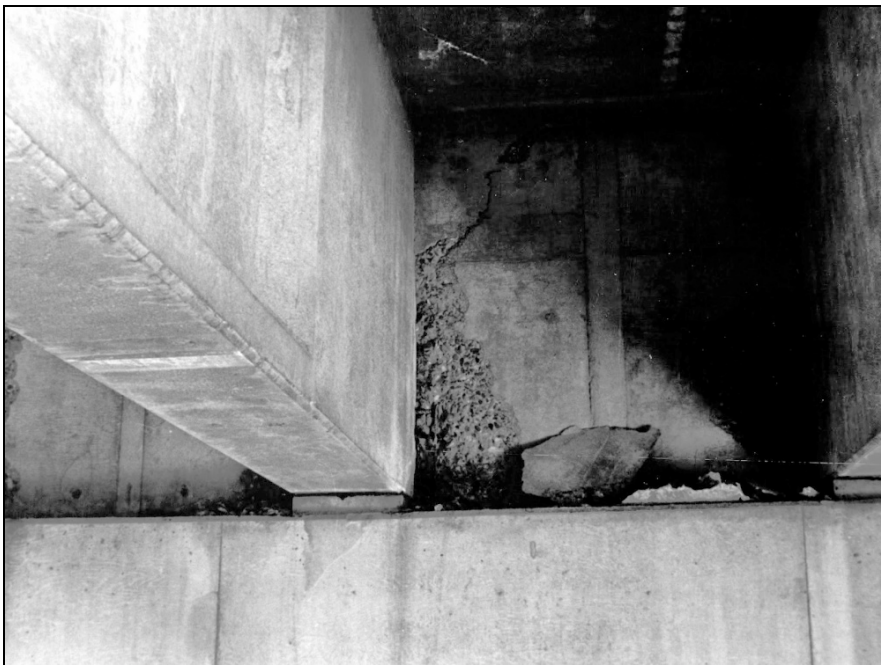
Figure 5-5. Damage to Napa River Bridge during the Loma Prieta 1989 Earthquake

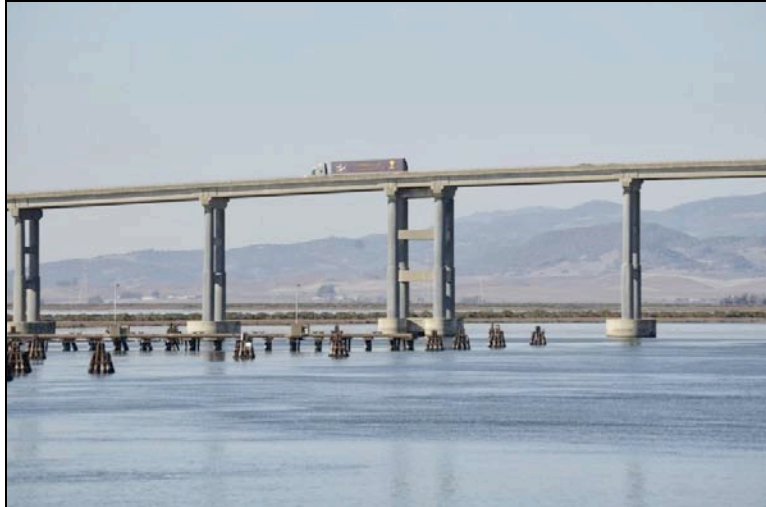
Figure 5-6. Retrofitted Napa River Bridge with Steel Column Casings and Enlarged Footings

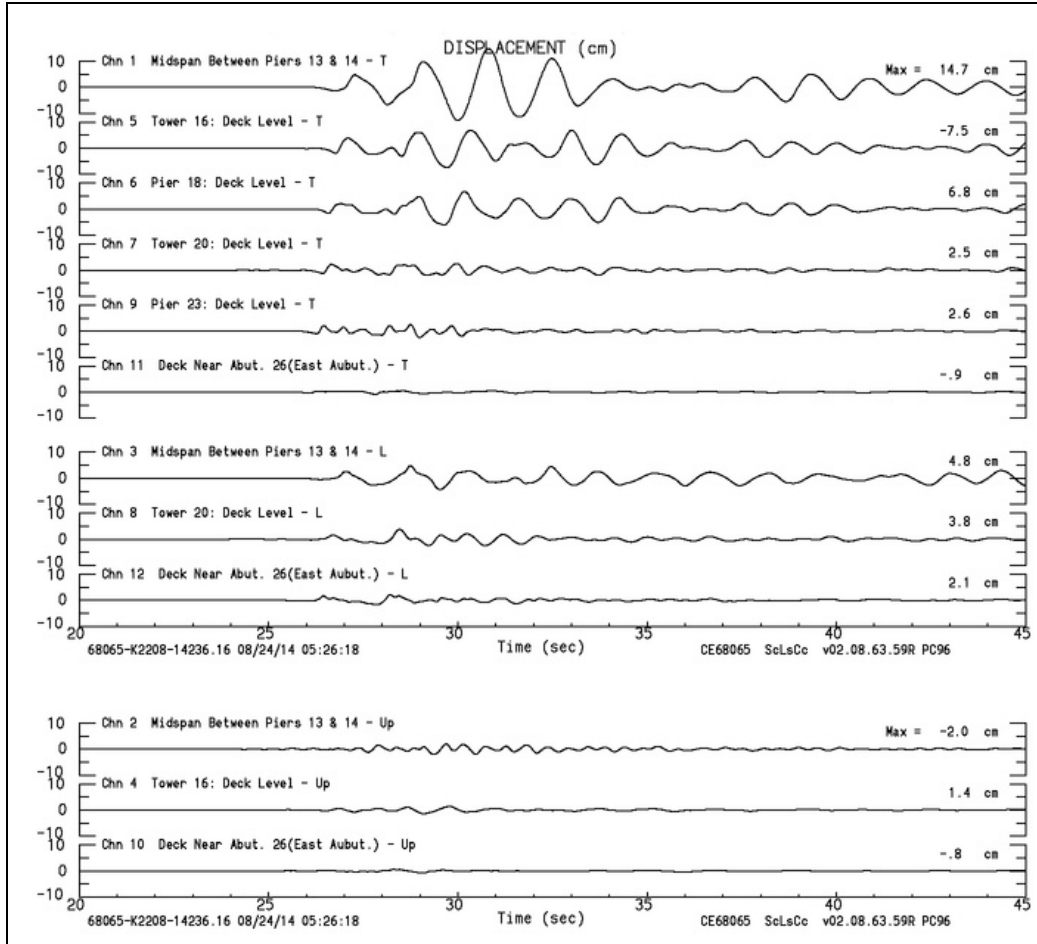
Figure 5-9. Displacement Records on Napa River Bridge on Route 37

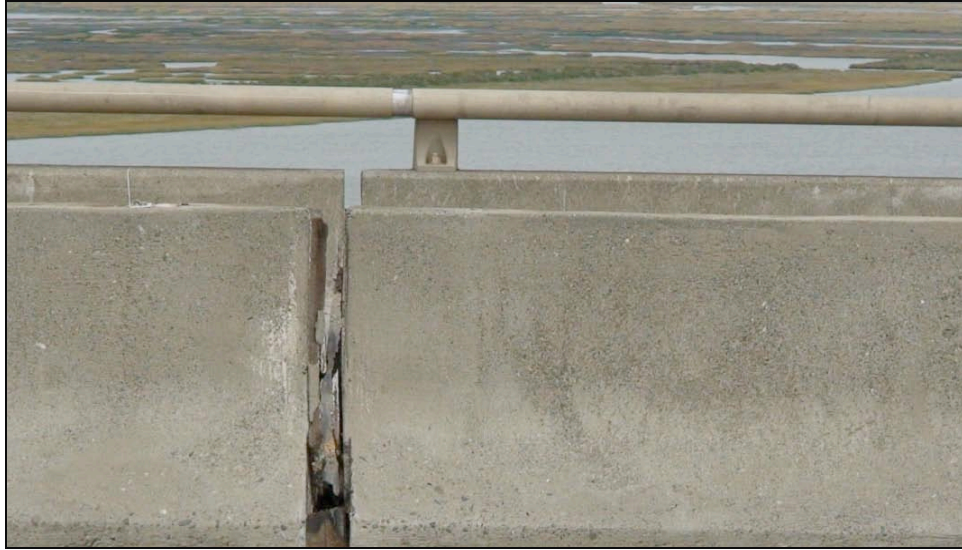
Figure 5-10. Damage to the Napa River Bridge was Permanent Longitudinal Displacement at the Expansion Joints

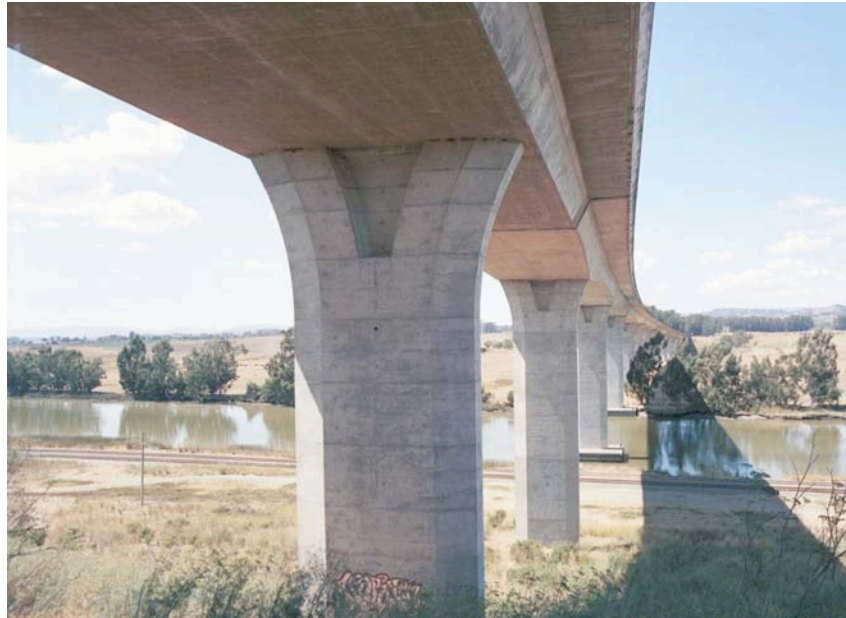
Figure 5-11. Napa River Bridge on Route 29 Br. #21 0049 (38.1245°, -122.285°)

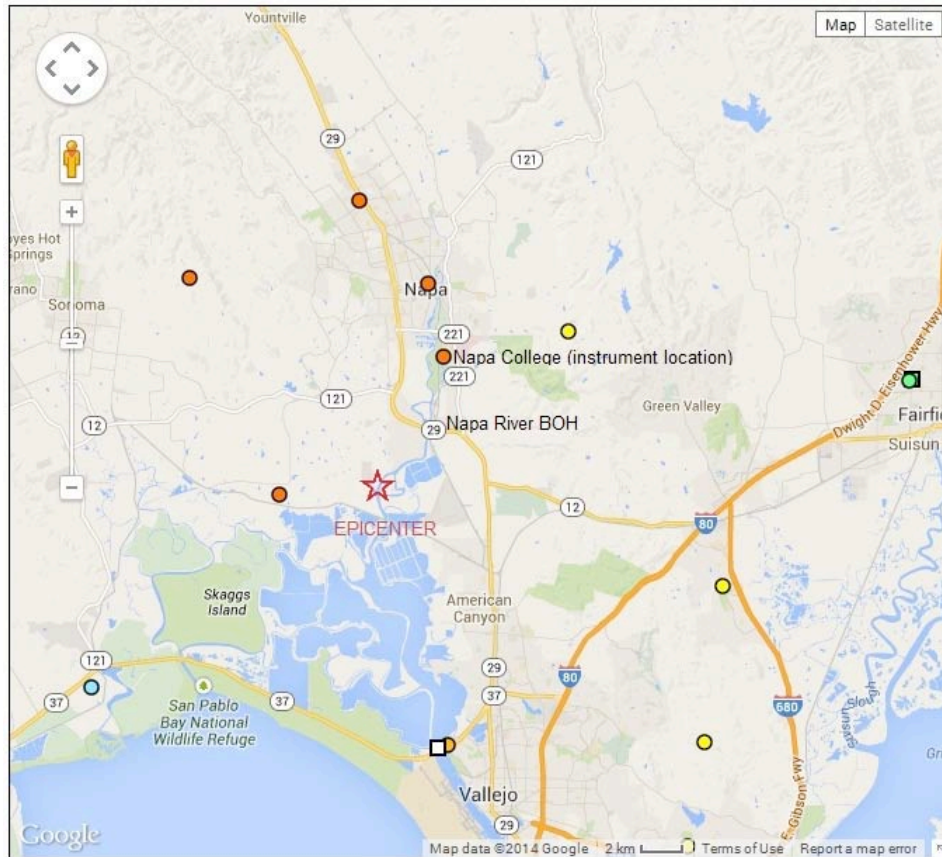
Figure 5-13. Map showing epicenter, bridge, and instrument locations

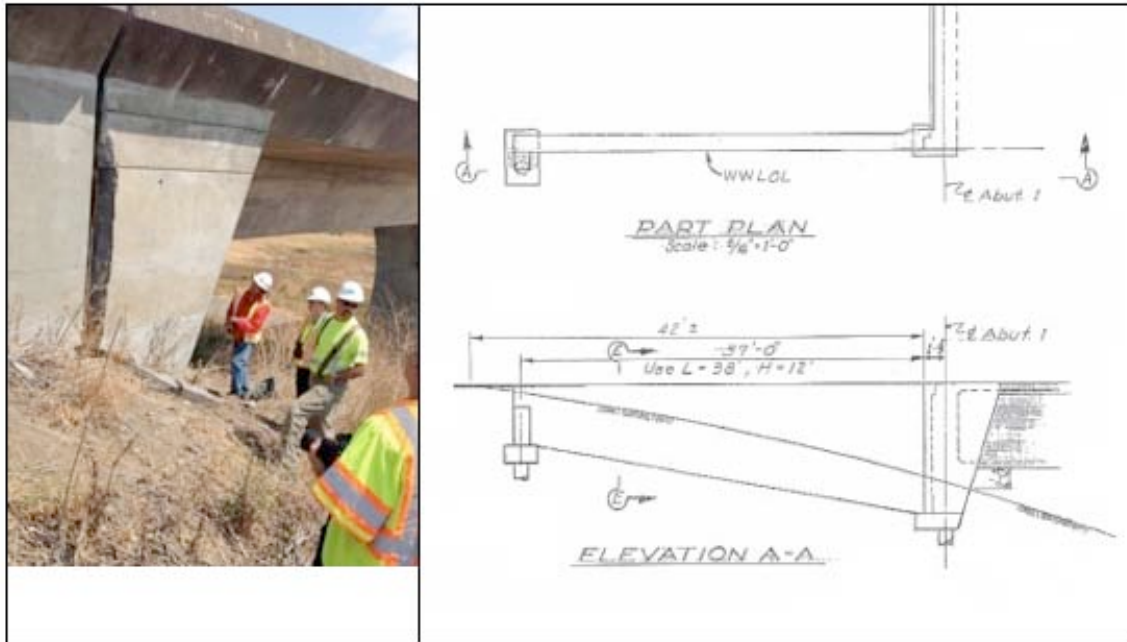
Figure 5-14. Abutment 14 concrete spall on the Napa River Bridge and Overhead

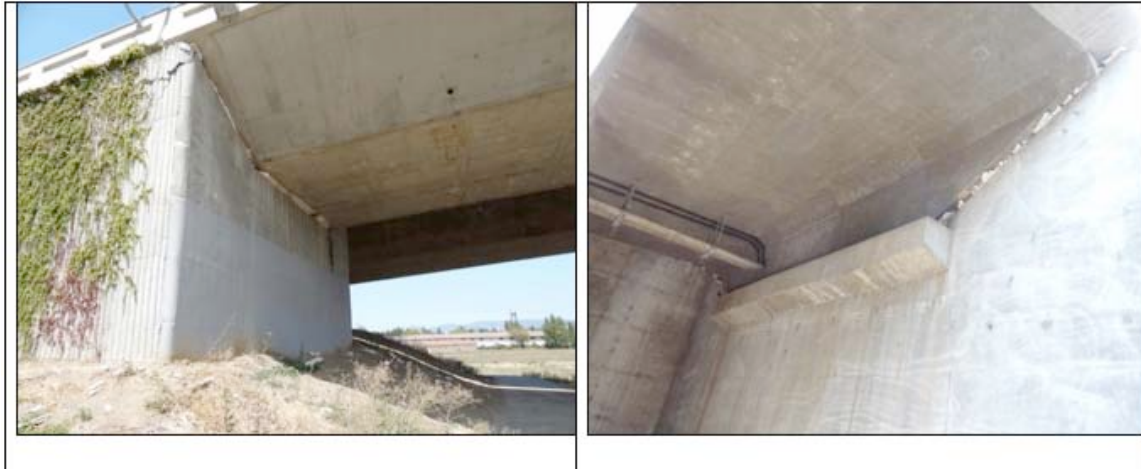
Figure 5-16. Outside and Inside of an abutment on the Napa River (West Imola Avenue) Bridges

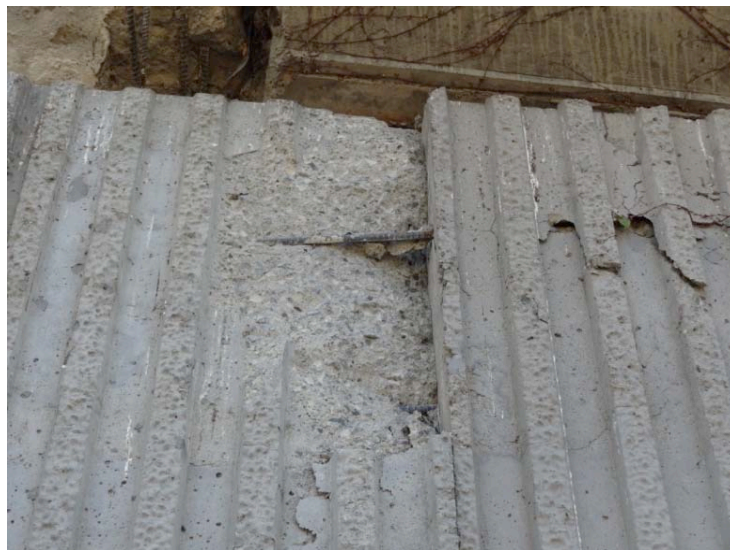
Figure 5-17. Close-up of damaged curtain walls on the Napa River (West Imola Ave) Bridge
