South Napa M 6.0 Earthquake of August 24, 2014

Prepared by:

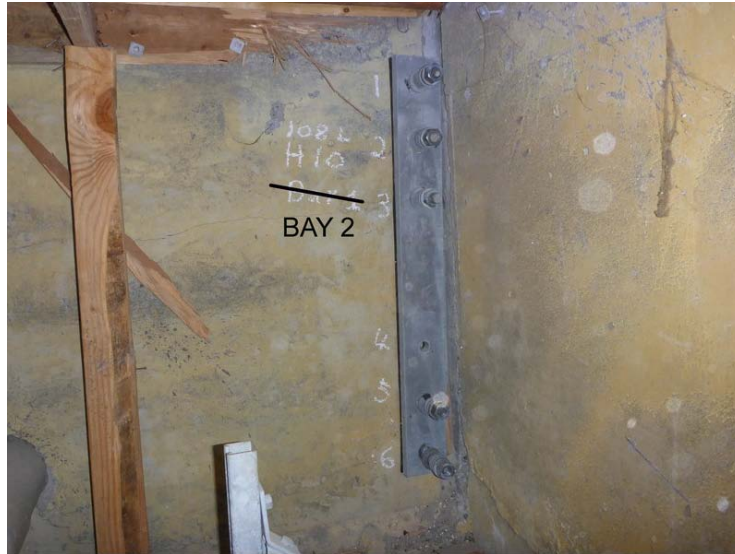
Figure 5-18. Restrainer damage at Hinge 10, Bay 2 of Napa River (W. Imola Ave) Bridge

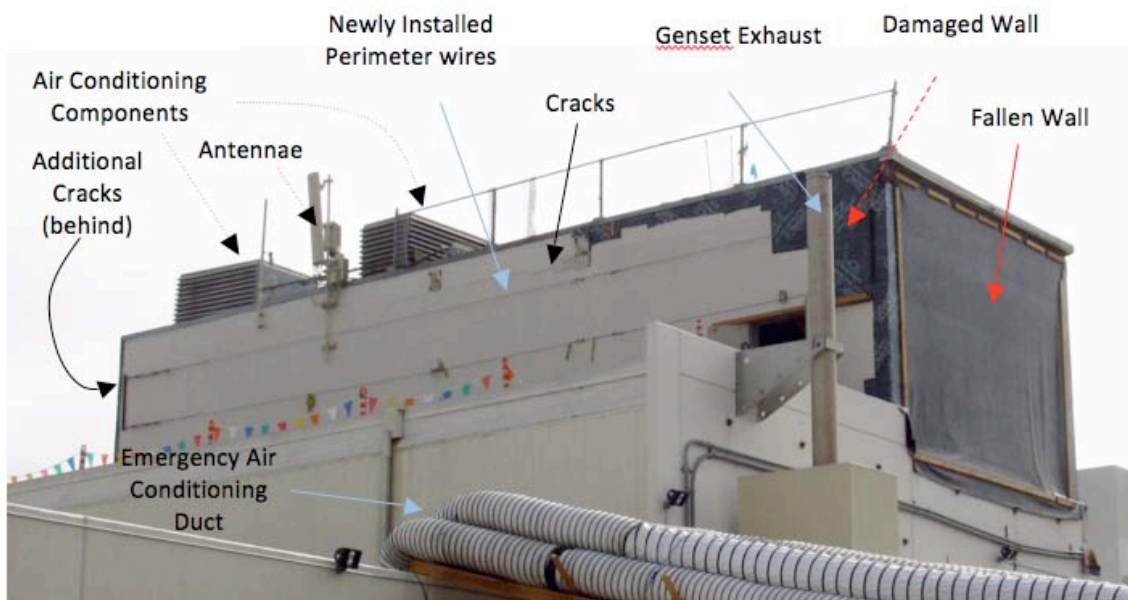
Figure 6-2. AT&T Building on Clay Street, Napa

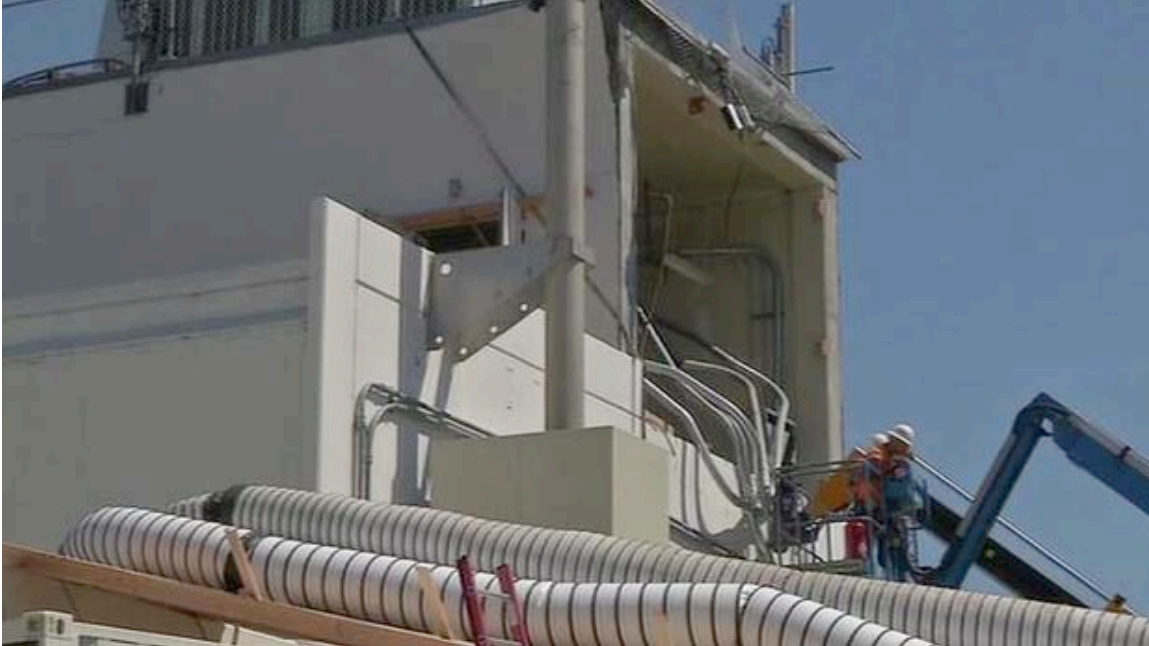
Figure 6-4. Providing External Services to AT&T Building

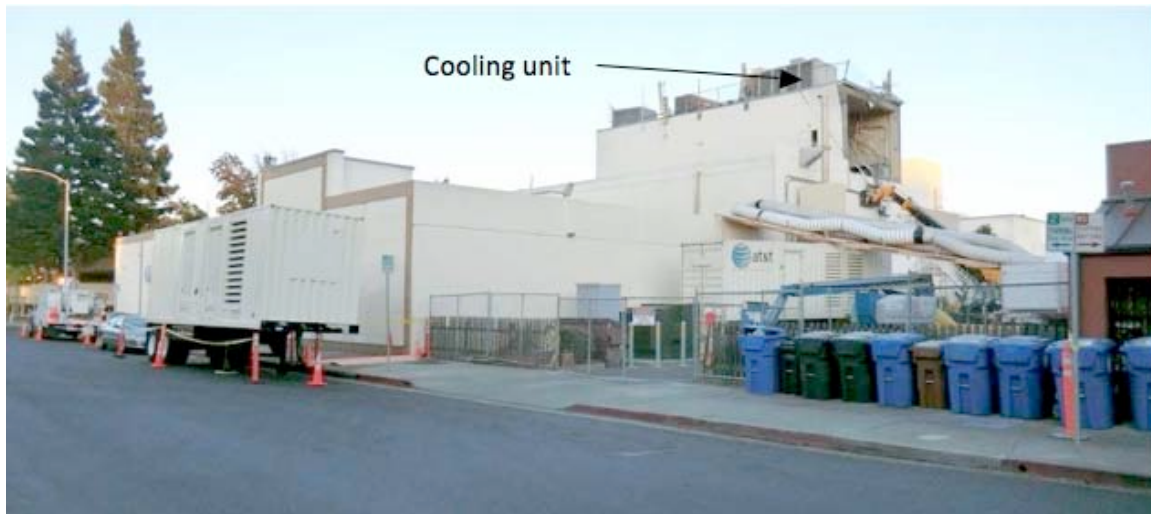
Figure 6-5. AT&T Building on August 25, 2014

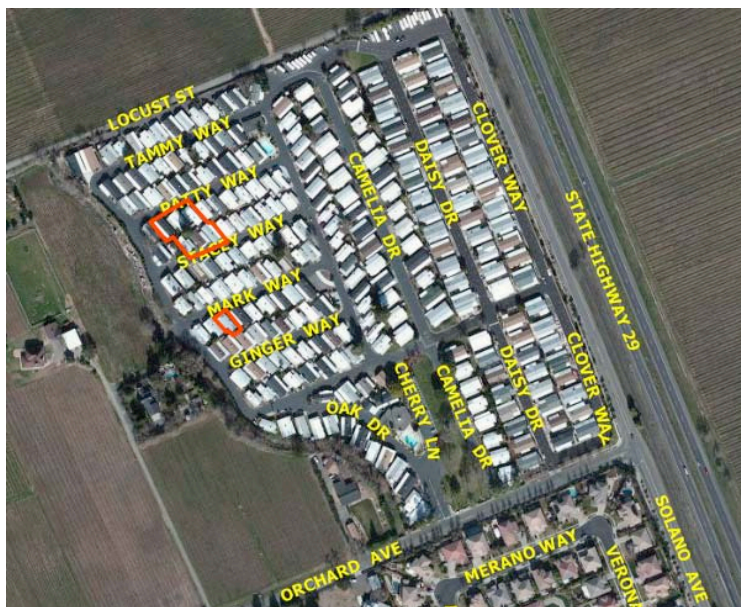
Figure 7-2. NVMHP Park and locations of fires, 24 Aug 2014 S. Napa M_w 6.0 Earthquake (damaged buildings outlined in red)

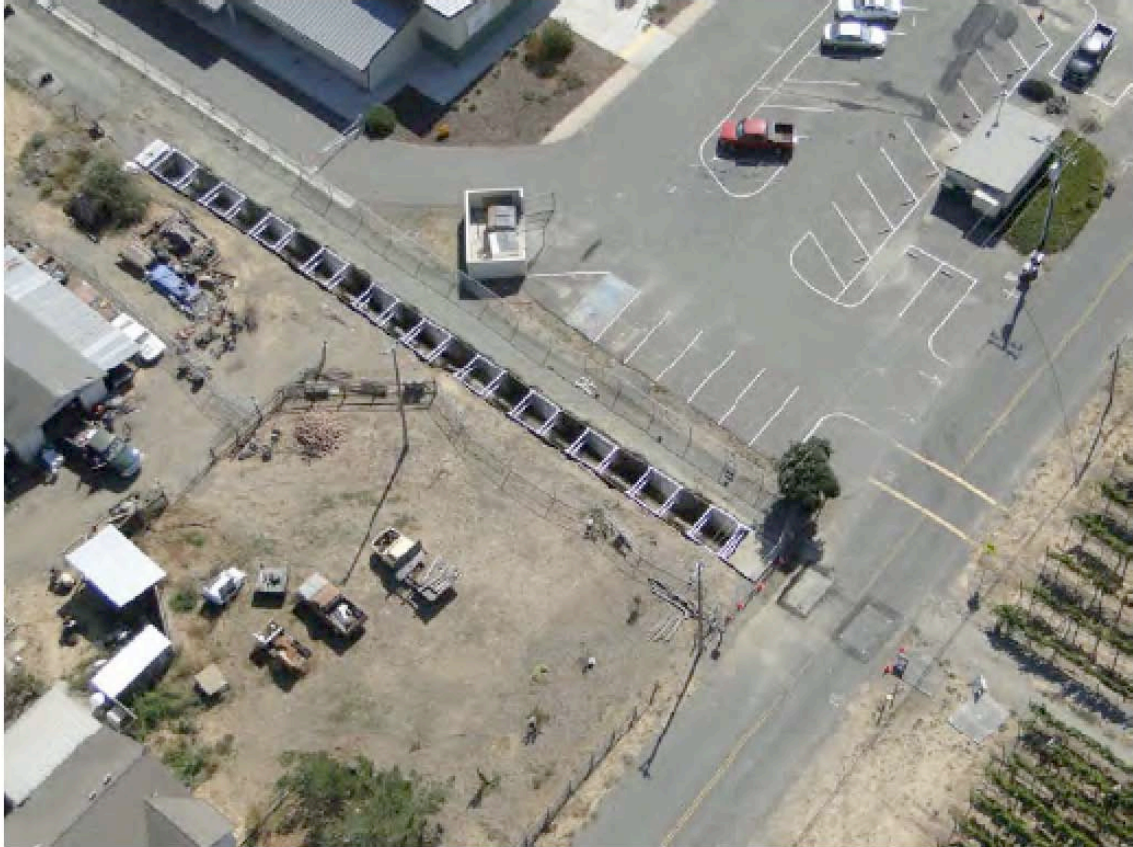
Figure 8-1. Location of PG&E Gas Pipe Trench Excavation
