South Napa M 6.0 Earthquake of August 24, 2014

Revision 1

March 17, 2015

This report describes the performance of lifelines systems due to the South Napa, M 6.0 earthquake of August 24, 2014.

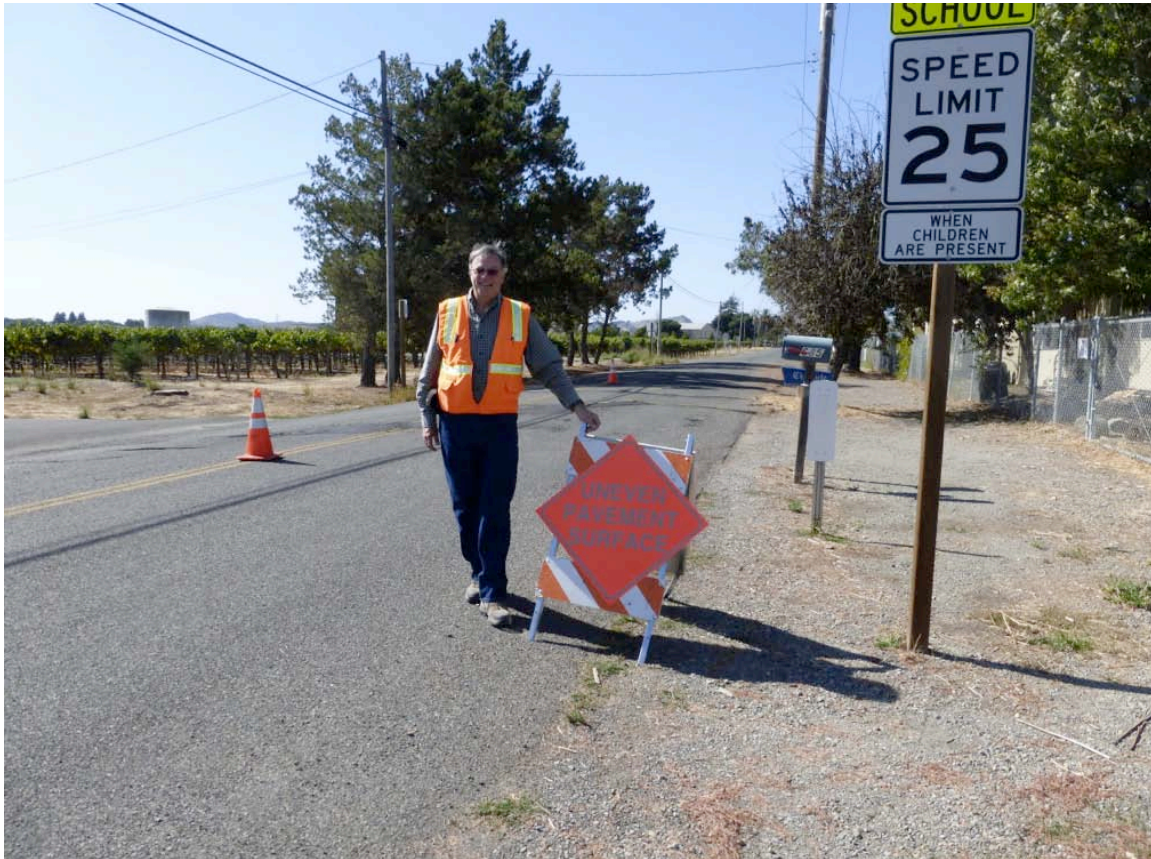
Figure 2-24. Repaired cracks in street

Figure 2-24 shows Los Carneros Avenue (and John Eiding), looking northerly, from a point just south of the fault offset zone. Photos taken around 4 pm local time, August 26 2014. Asphalt patches in the road pavement can be seen. To the west, the cracks in the ground are clearly seen on the westerly shoulder of the road. Note the overhead cable TV poles (west side of road) and overhead PG&E distribution poles (12 kV, east side of road).

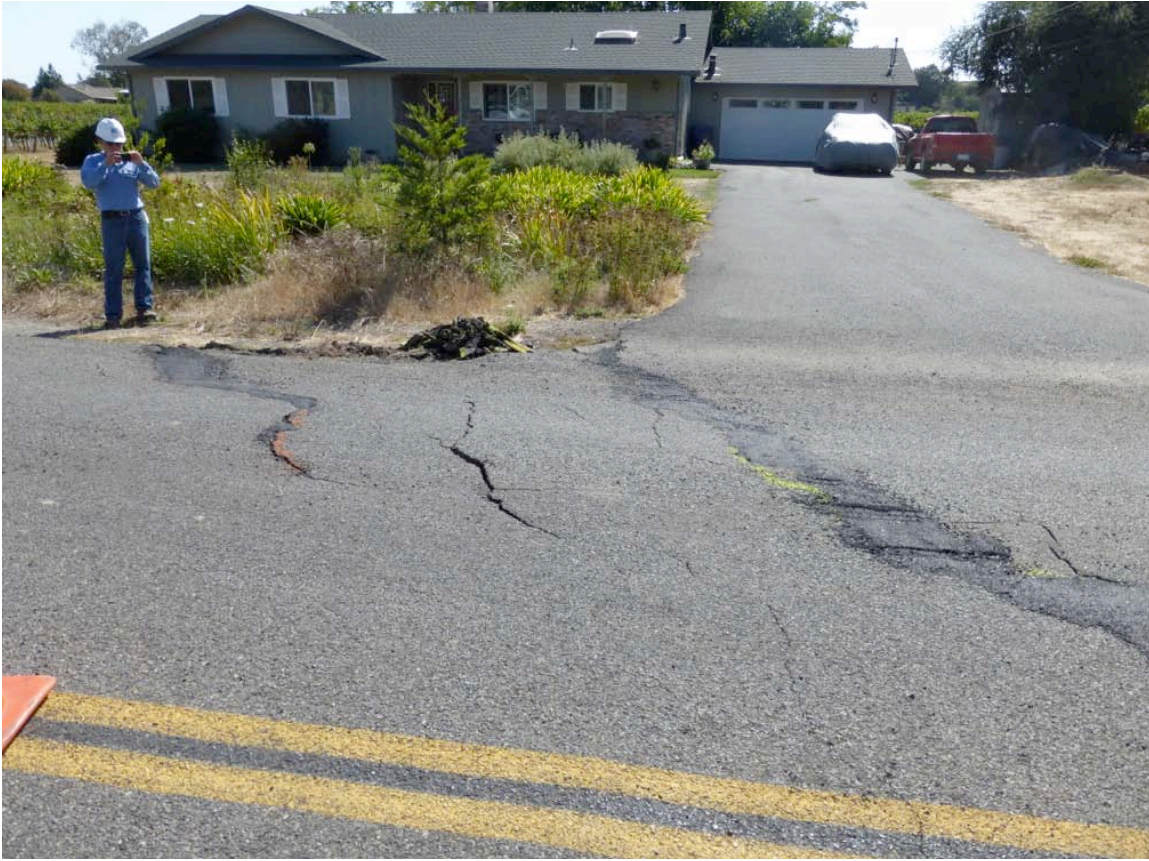
Figure 2-25. Repaired and newly formed cracks in street

Figure 2-25 shows the ground cracks that have been repaired by August 25 and some newly formed cracks (post-seismic "after-slip") (and Raymond Trinh).

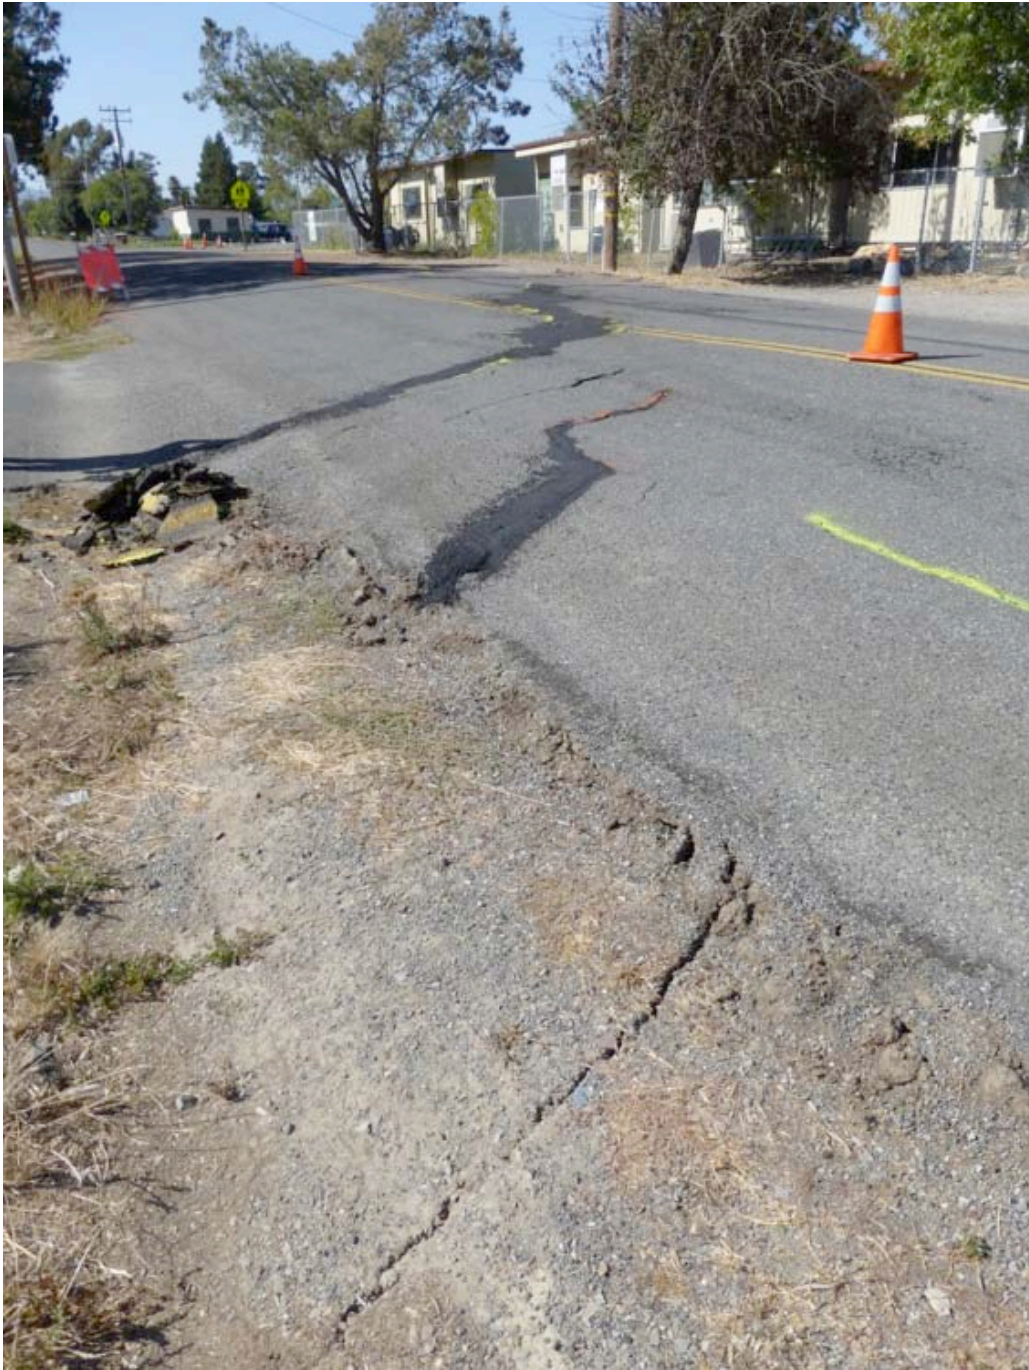
Figure 2-26. Road cracks (repaired and new), looking northerly

Figure 2-26 clearly shows the strike of the fault and the en echelon ground cracks. There appears to be about a 20° clockwise rotation of some of the en echelon cracks. One practical aspect is that for buried pipes crossing a fault, the fault offset might be along the strike, or perhaps rotation 20 to as much as 40 degrees or so (clockwise for right lateral, counterclockwise for left lateral).

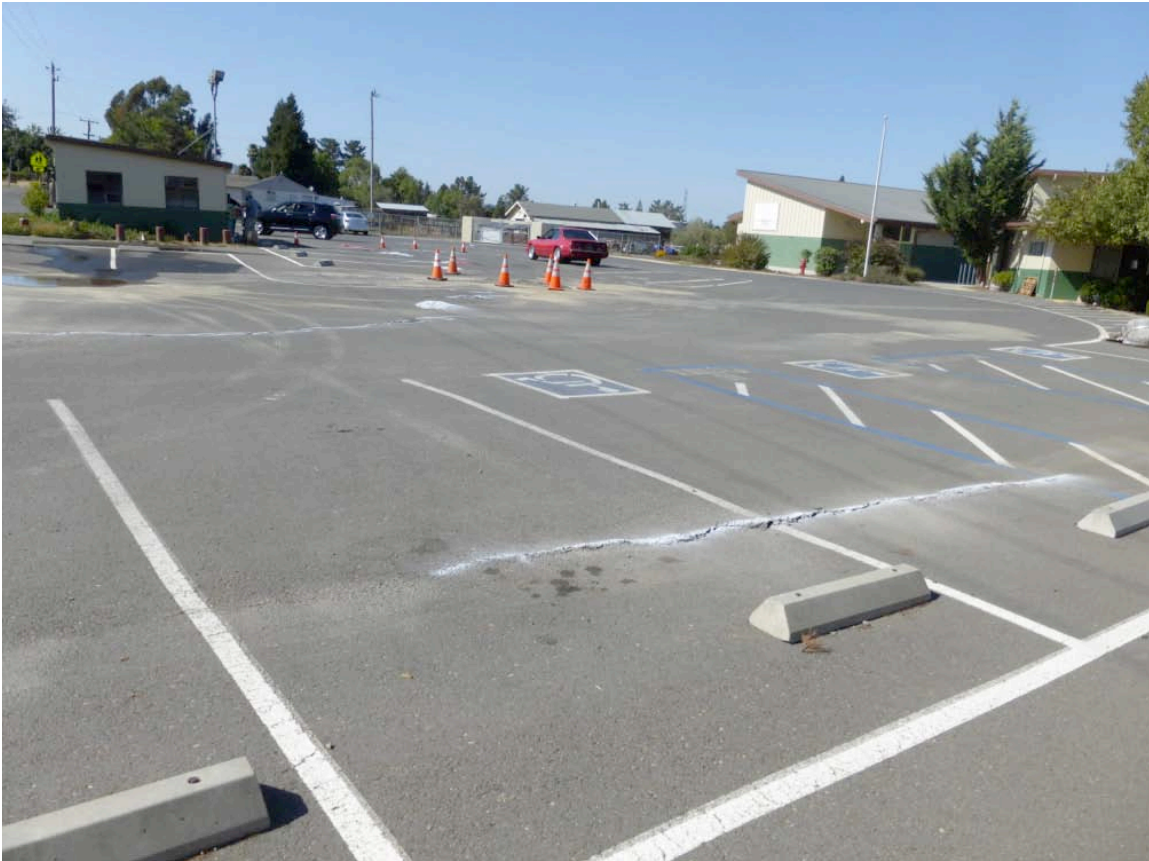
Figure 2-27. Parking lot cracks, looking northerly

Figure 2-27 shows the parking lot for the school, looking northerly. In the foreground, a crack (painted white after the earthquake to help identification) is seen, again oriented in an echelon clockwise direction as compared to the strike of the fault. In the center of the photo are several orange cones, surrounding where the water pipe (to-from well and the utility building on the left). The ejected sand at this location is from the sand surrounding the water pipe, that was ejected as part of the pipe break (not from liquefaction).

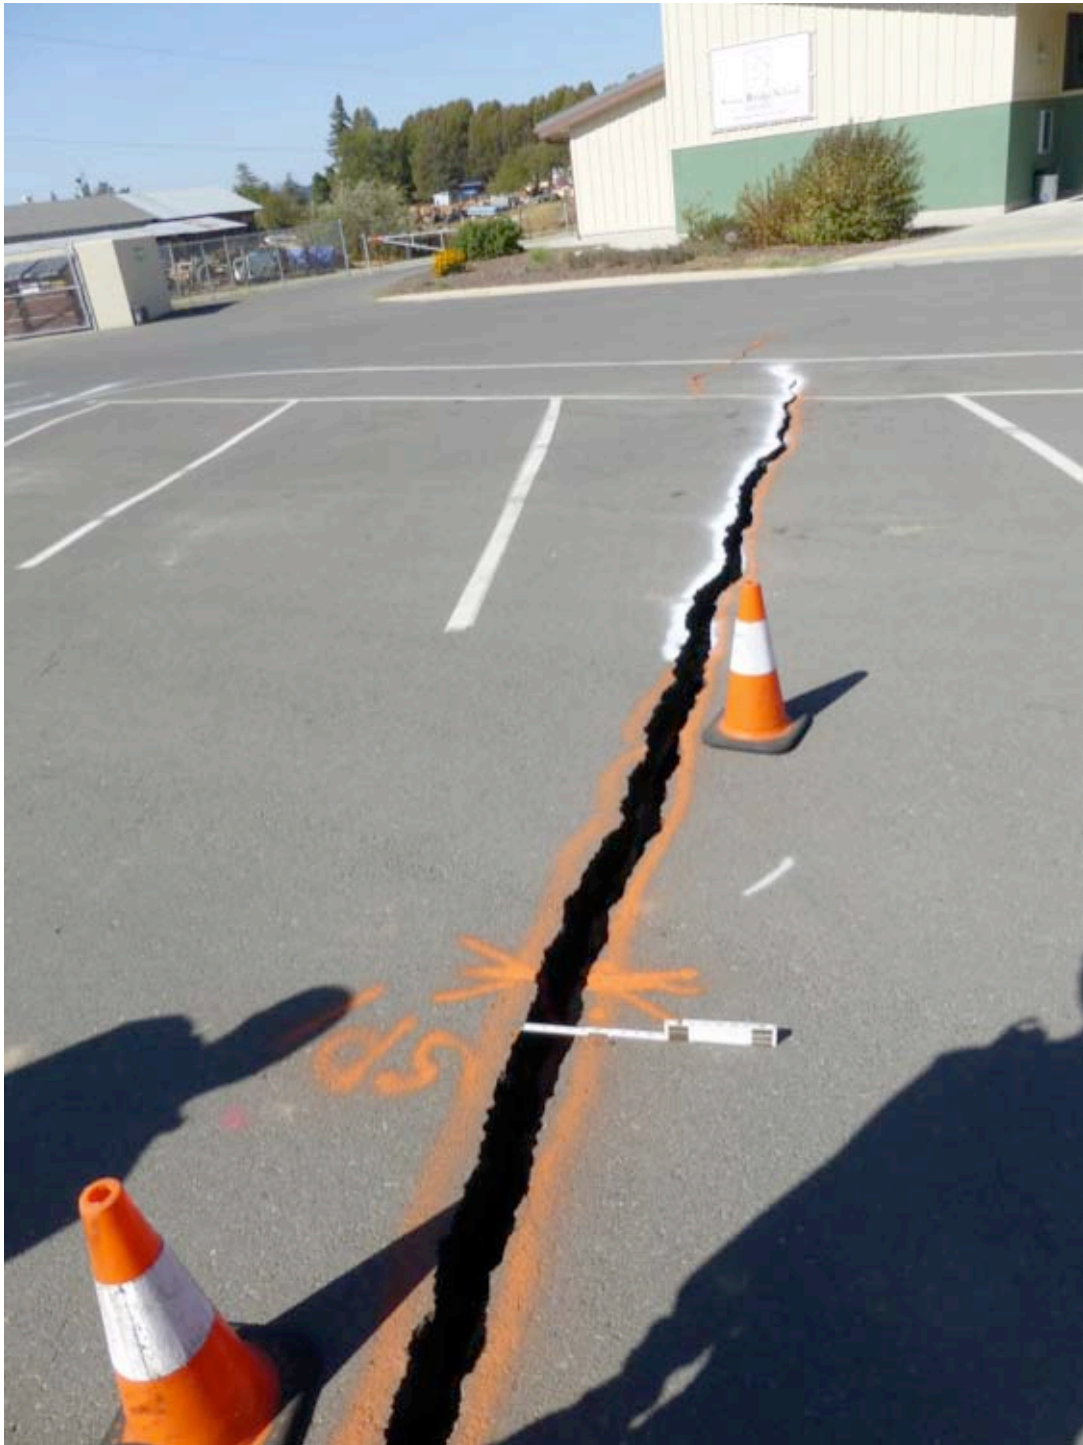
Figure 2-28. Parking lot crack, looking northerly

Figure 2-28 shows the largest crack in the parking lot, paring originally white, and then as the crack grew wider, orange. The ruler shows almost 4 inches of opening.

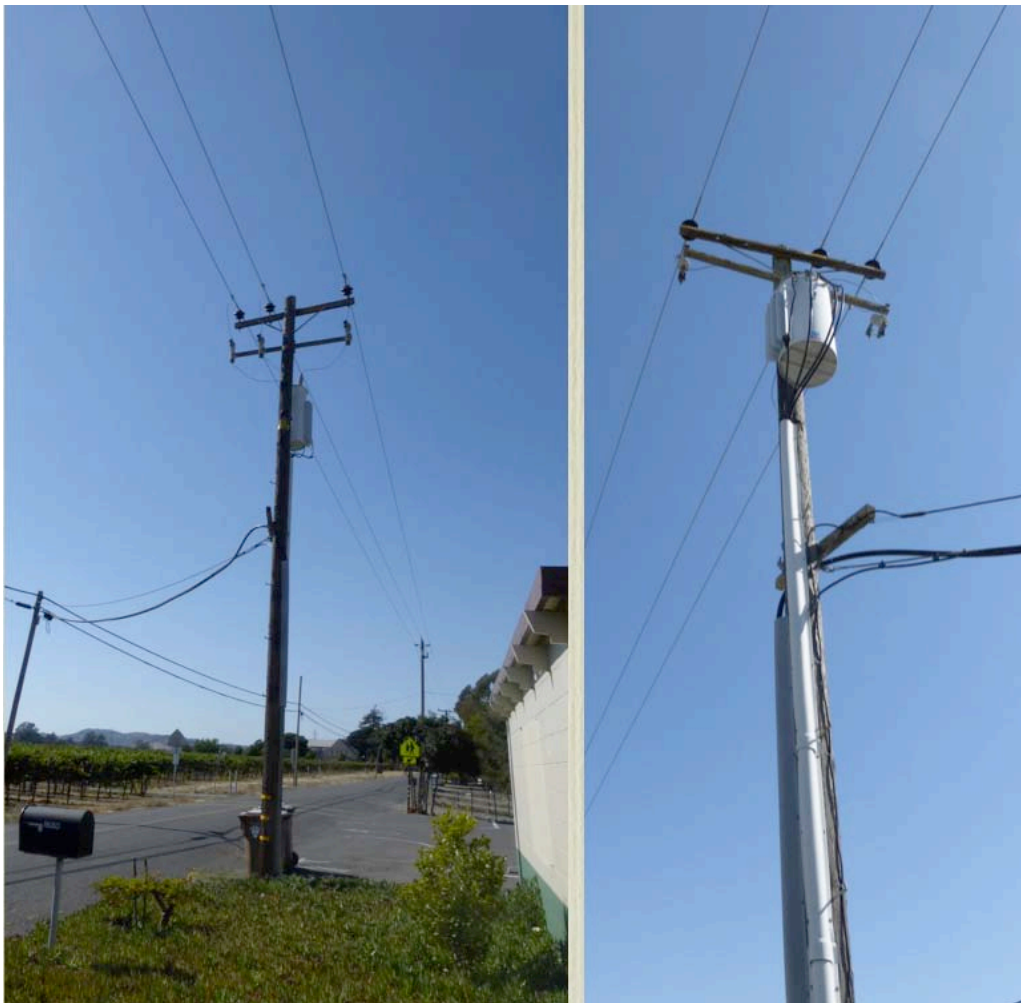
Figure 2-29. Power Pole, adjacent to fault zone (left side looking north, right side looking south)

there were no signs of oil leak. The pot head / line drop looks undisturbed. According to the school's staff, the power was out on Sunday (August 24) morning. Once power was restored at this location, the line drop into the utilities building worked, and the underground cables from the utilities building into the school buildings worked. In other words, the cable (school-owned) that crossed the fault was not damaged to the point of becoming non-functional. In other earthquakes around the world, short (commonly shorter than 200 meter) secondary buried power cables have had a much lower failure rate due to modest PGDs (on the order of several inches) than long (several km) direct buried cables. This superior performance, all other factors being equal, is attributed to the available slack at either termination of the short cable, that can be used up at the specific PGD zone; whereas any available slack in a very long cable is "too far away" and the soil can effectively anchors the cable preventing any available slack from being used at the PGD zone where it is needed. This analogy would have to be adjusted if the buried cable is within ducts (PVC or Transite are common) rather than in direct burial.

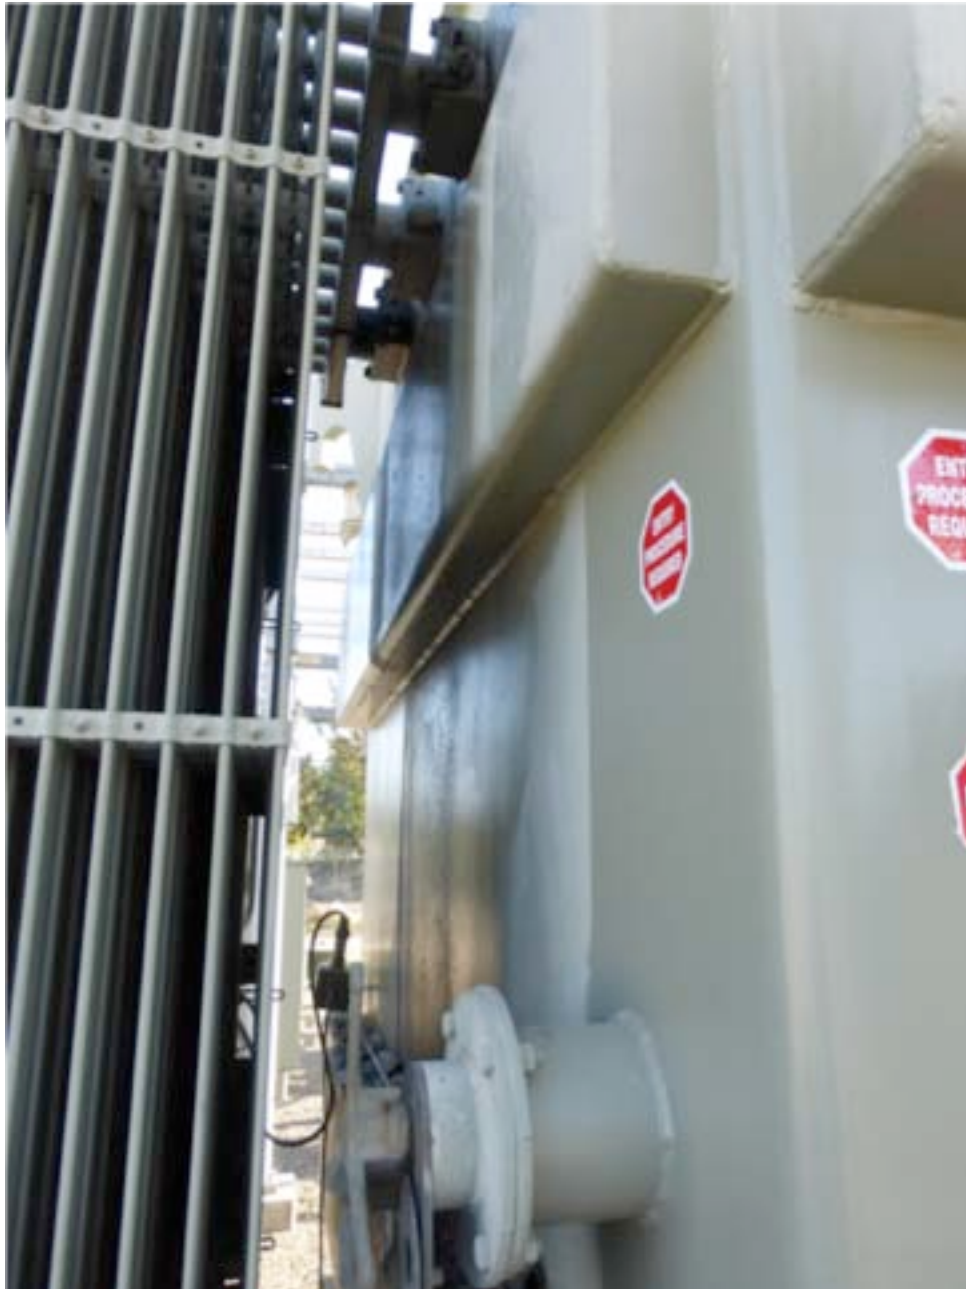
Figure 3-4. Transformer Oil Leak

There was evidence of oil leakage at this transformer, Figure 3-4.

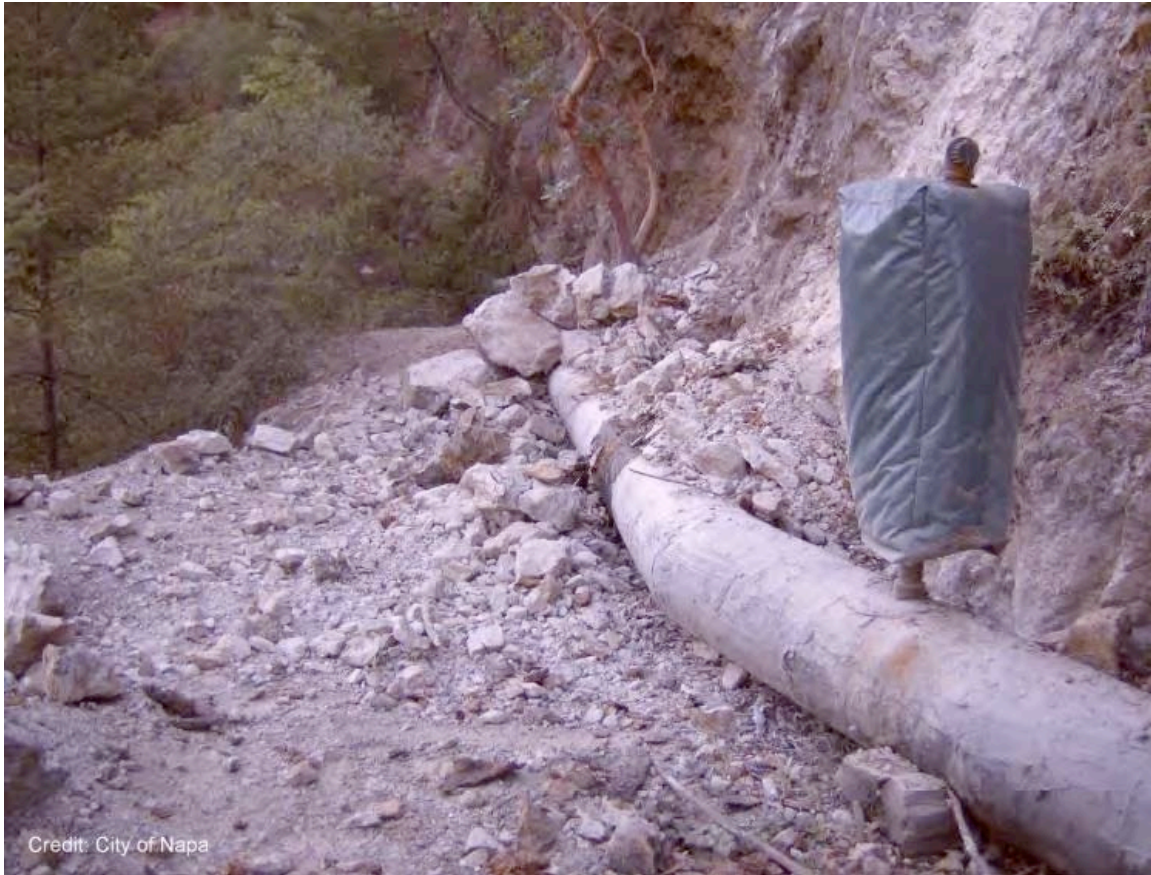
Figure 4-6 shows a damaged transmission line, due to rockfall (Milliken Transmission pipeline). Discussions with the City of Napa Water Department suggested that "perhaps it leaked".

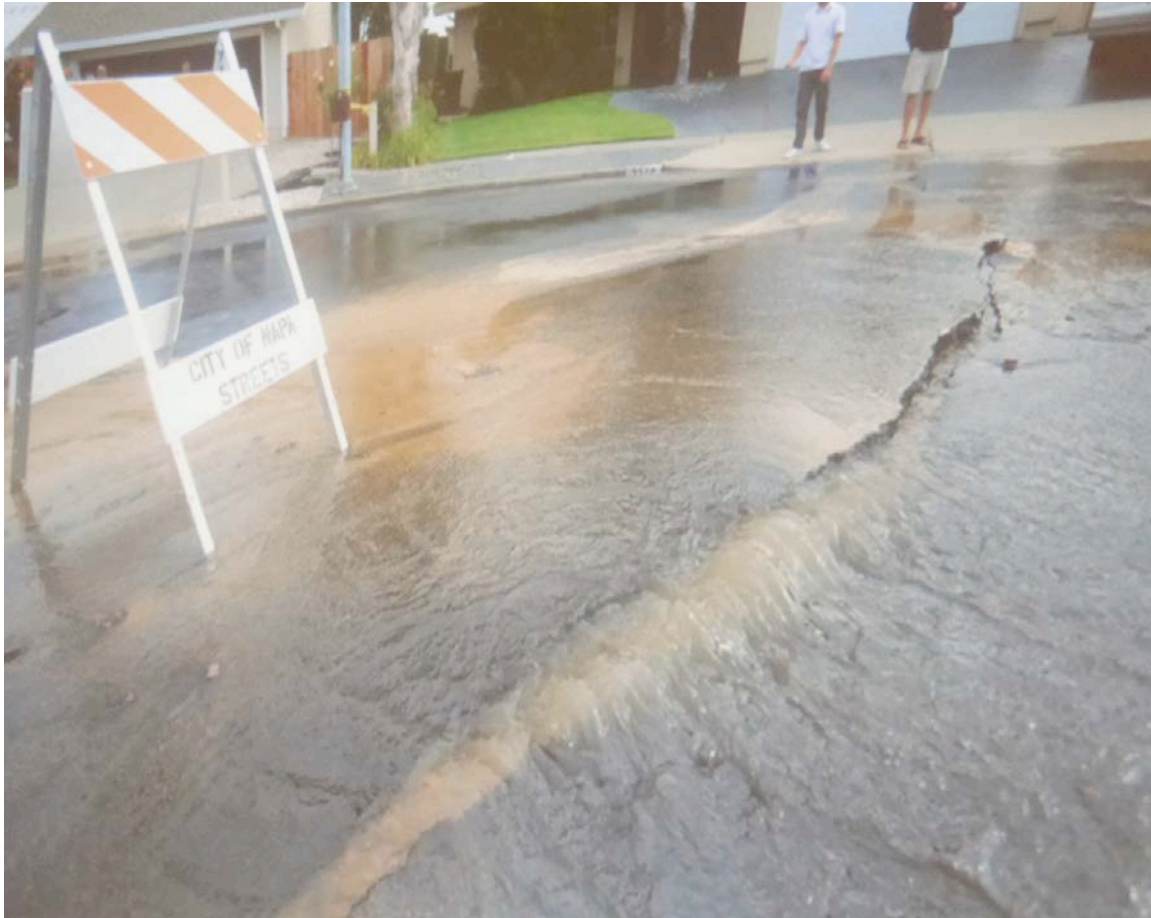
Figure 4-7. Water Leaking from a Damaged Distribution Pipe

Figure 4-7 shows water from a leaking distribution pipe.

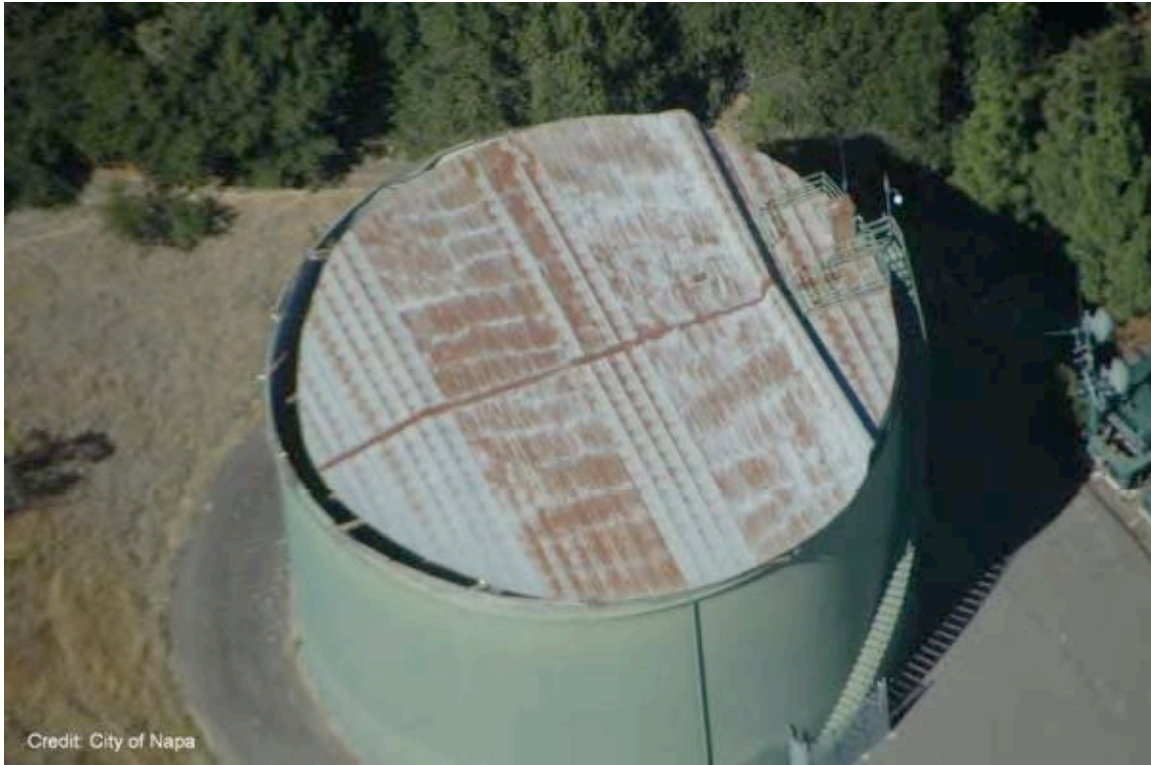
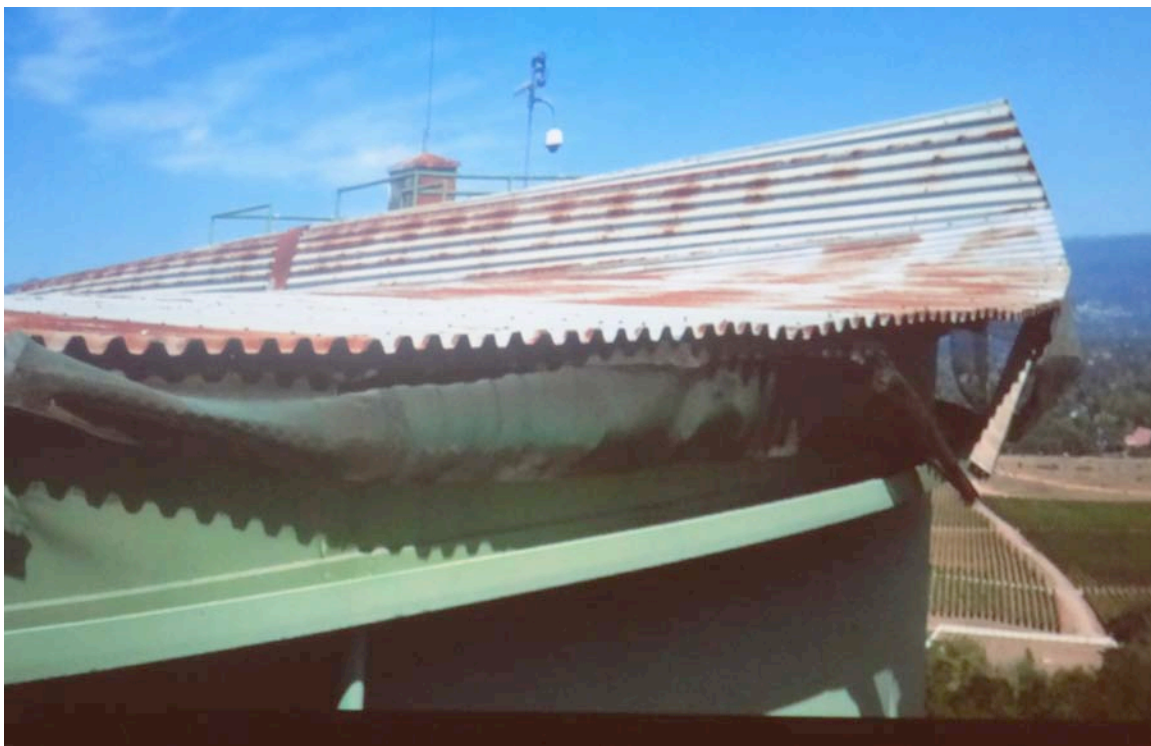
Figure 4-8. Damaged Roof of Steel Tank "B"

The tank did not lose its pressure boundary (likely some water was lost through the damaged roof / ventilation screens), but the tank drained rapidly all the same, owing to the damage to nearby broken pipes.

Within a month after the earthquake, the wood roof system for Tank "B" was removed, and replaced with a aluminum "dome" type roof. Figure 4-11 shows the tank on October 10, 2014. The City is considering further tank modifications, including raising the steel shell by several feet to provide more clear space for water sloshing in future earthquakes, as might be suggested by the current AWWA D100 code (2013 version). The cost effectiveness of this type of modification, as well as the AWWA code provision for providing several feet of clear space for sloshing, is uncertain, as the tank still performed (held water) in the earthquake.

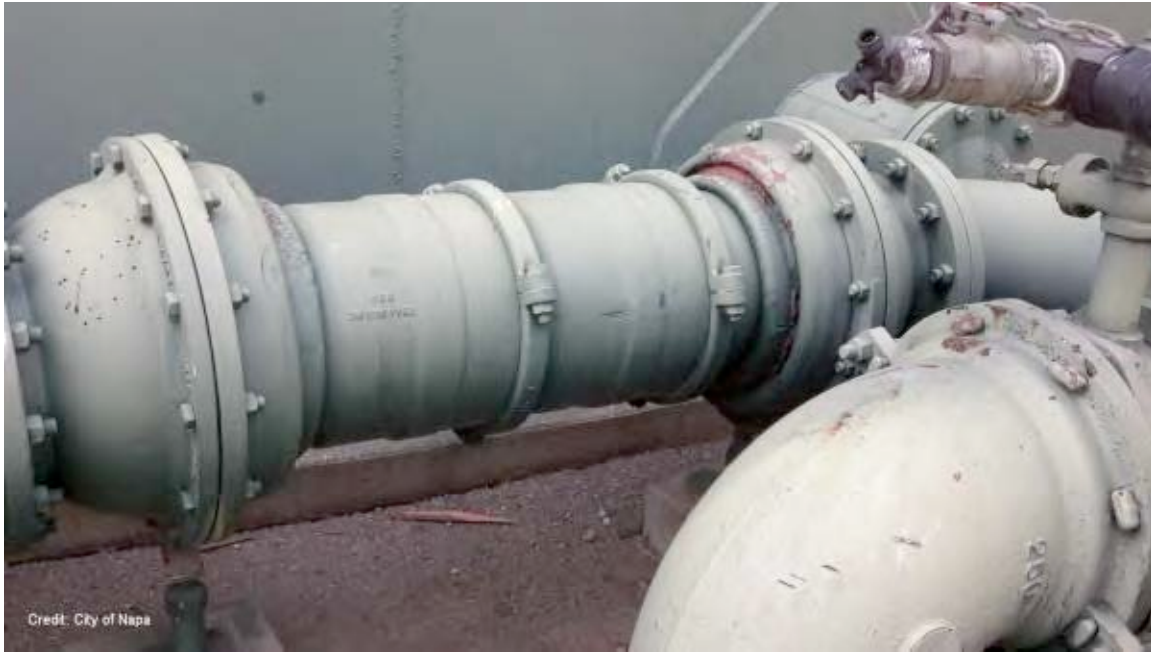
Figure 4-10. Movement of Attached Pipes

The outlet side-entry pipes used ball joint and slip joint hardware, capable of accommodating several inches of movement of the tank walls, Figure 4-10. The ball joints show evidence of rotation.

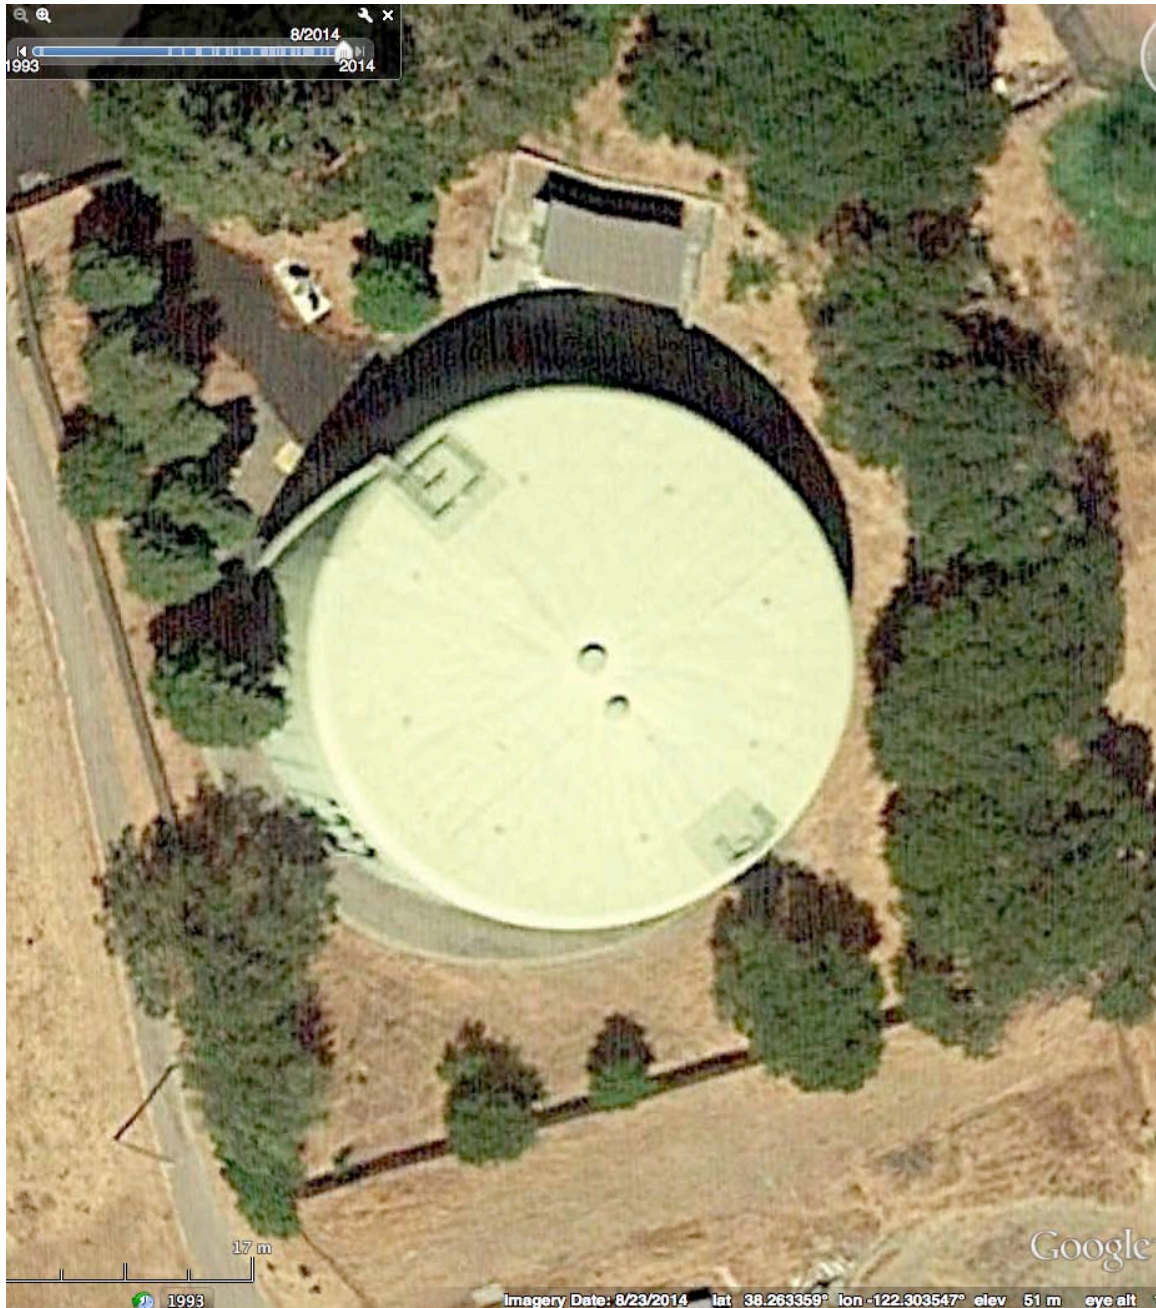
Figure 4-13. West Side Tank (38.2631, -122.3039)

Figure 4-13 shows a steel tank in the southwest part of Napa, built pre-1993. PGA at this location was likely around 0.4g. In mid-September 2014, it was reported that there was water observed near this tank, coming out of the ground; whether this water was from a leaking pipe, the tank, or some other source, remains unknown as of the time of writing this report.

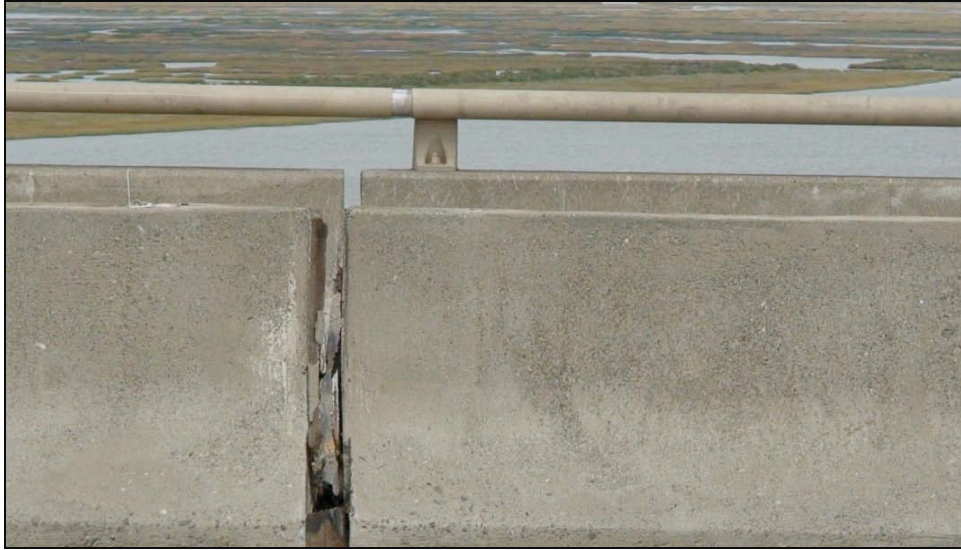
Figure 5-10. Damage to the Napa River Bridge was Permanent Longitudinal Displacement at the Expansion Joints

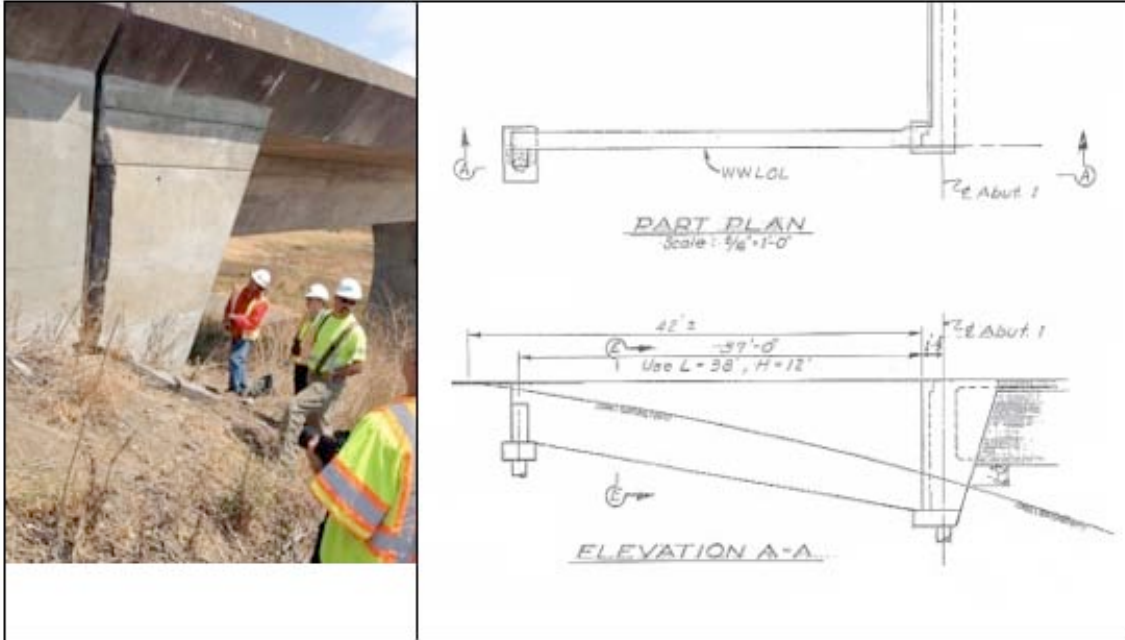
Figure 5-14. Abutment 14 concrete spall on the Napa River Bridge and Overhead

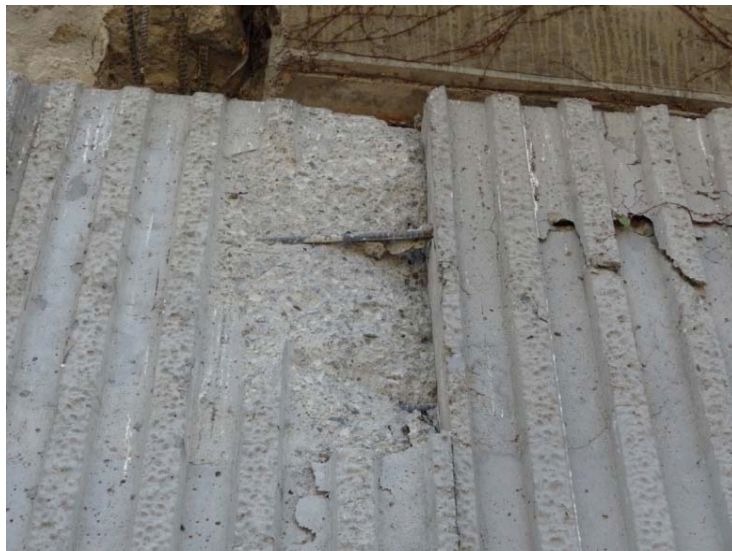
Figure 5-17. Close-up of damaged curtain walls on the Napa River (West Imola Ave) Bridge

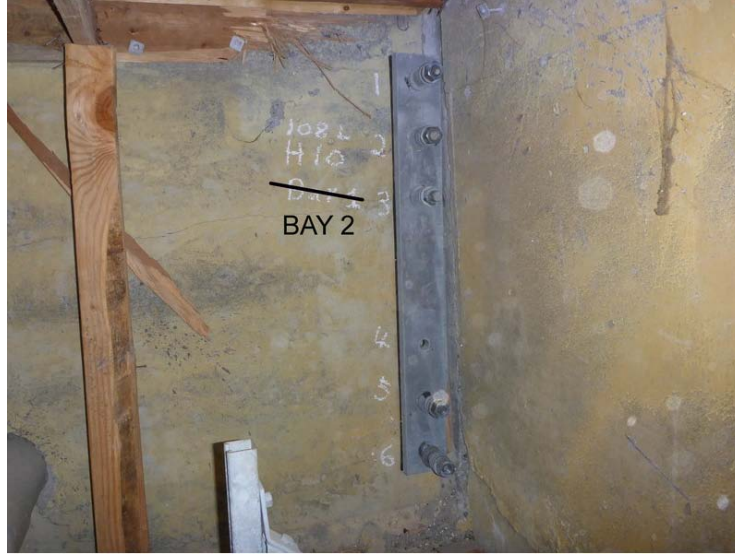
Figure 5-18. Restrainer damage at Hinge 10, Bay 2 of Napa River (W. Imola Ave) Bridge

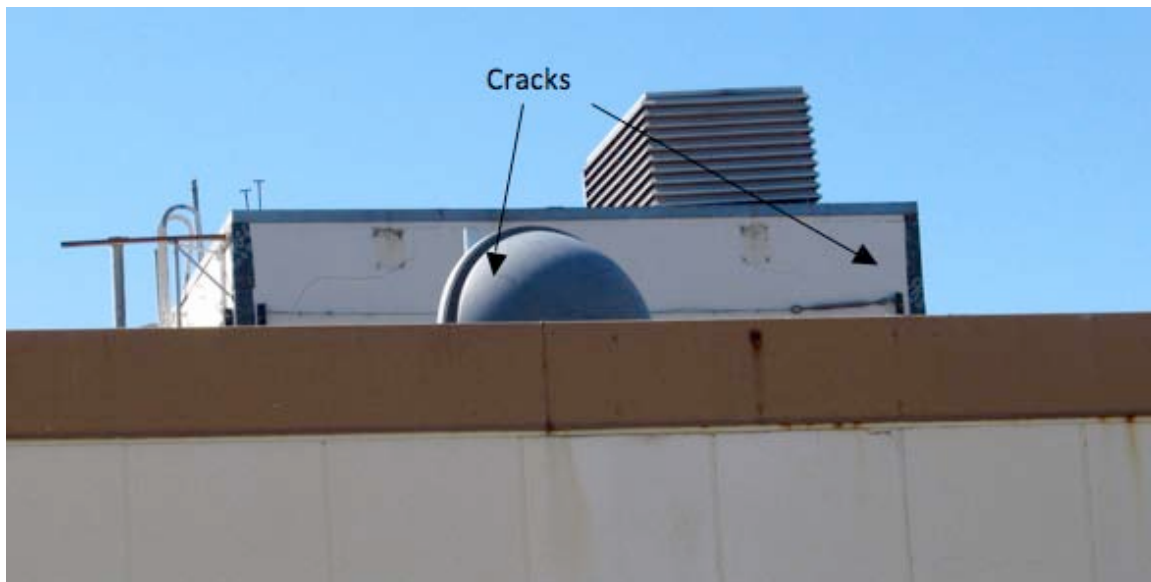
Figure 6-3. Additional cracks in the wall opposite to the one that fell
