South Napa M 6.0 Earthquake of August 24, 2014

John Eidinger – G&E Engineering Systems

Revision 2

March 12, 2016

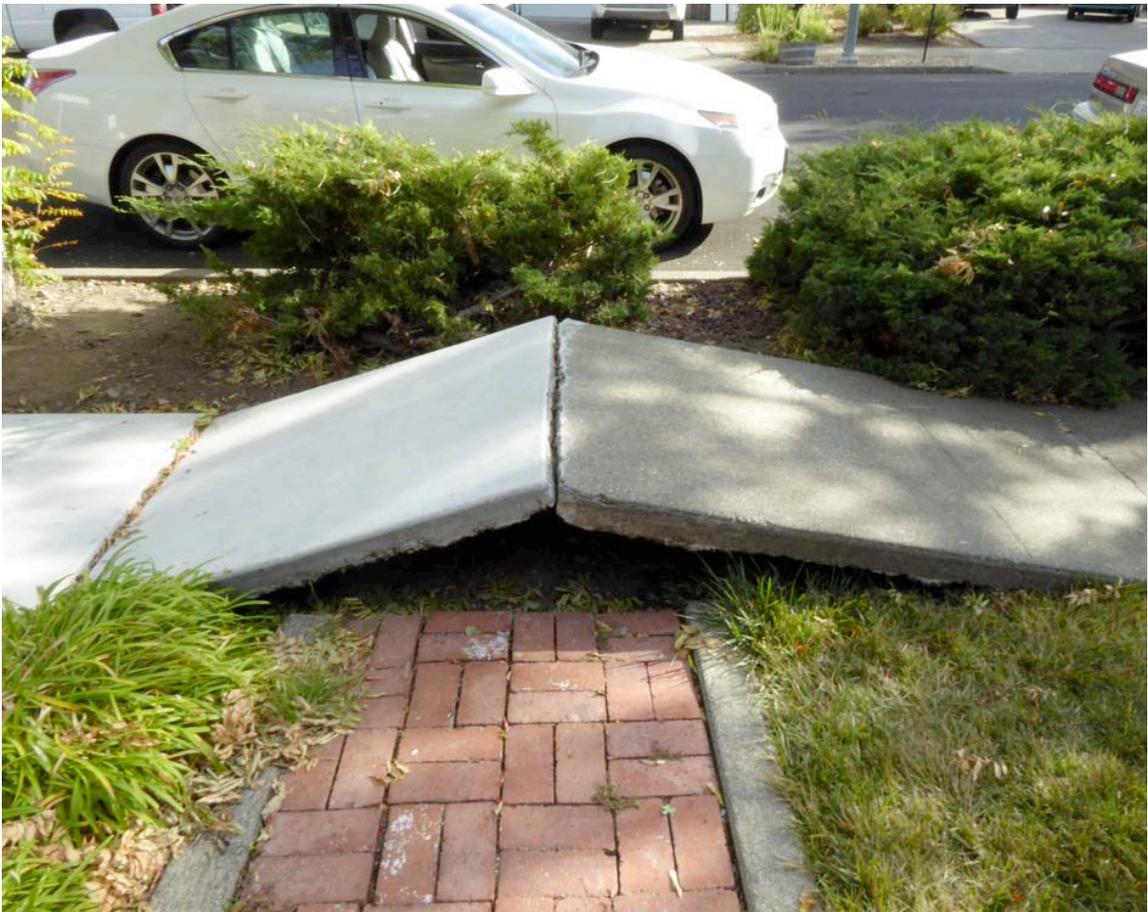
Figure 2-21. Buckled Sidewalk at Fault Offset Location

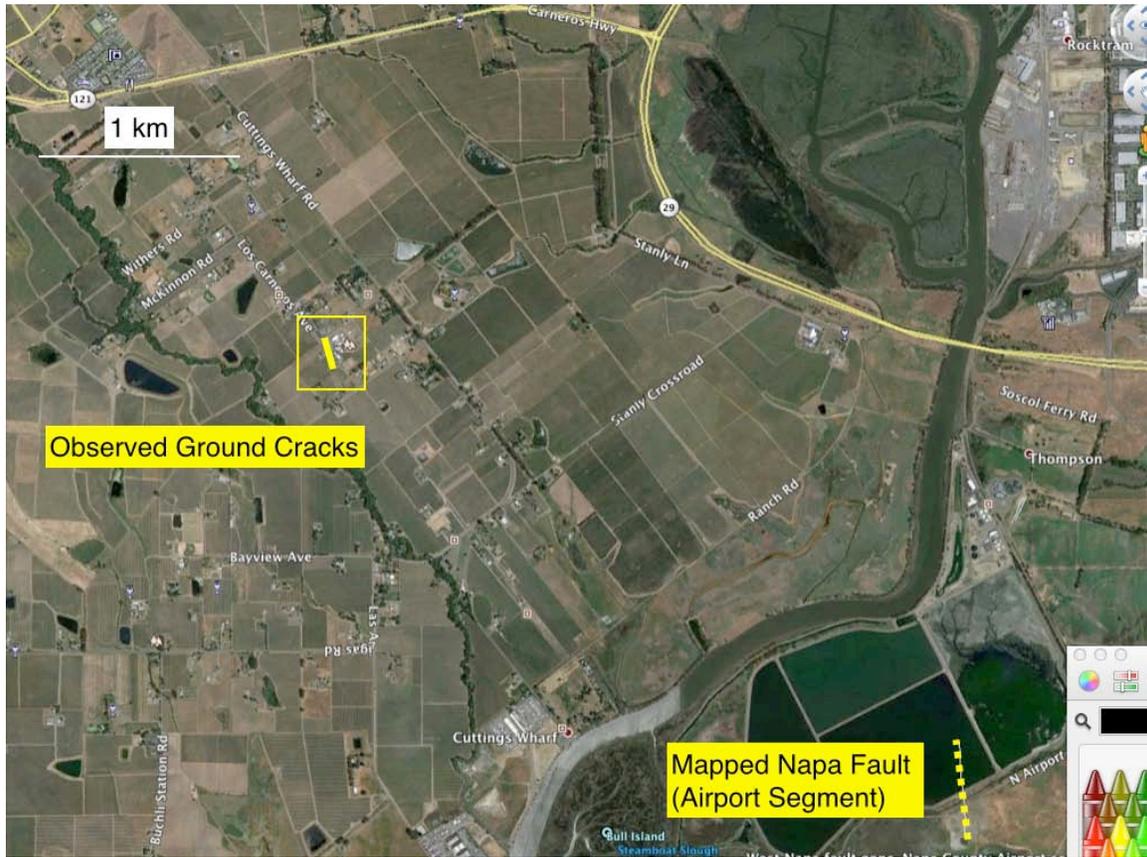
On August 26, 2014, some of the authors visited an area which shows ground failure, located by the solid yellow line in Figure 2-22. In Figure 2-22, the dashed yellow line shows the inferred location of the Napa fault zone, based on prior studies. In one projects this dashed line to the north, where it would connected up with the mapped Browns Valley segment of the West Napa fault zone, it is located about 2 km easterly of the solid yellow line, where (apparently) surface rupture was observed at this location.

Figure 2-22. West Napa Fault Zone

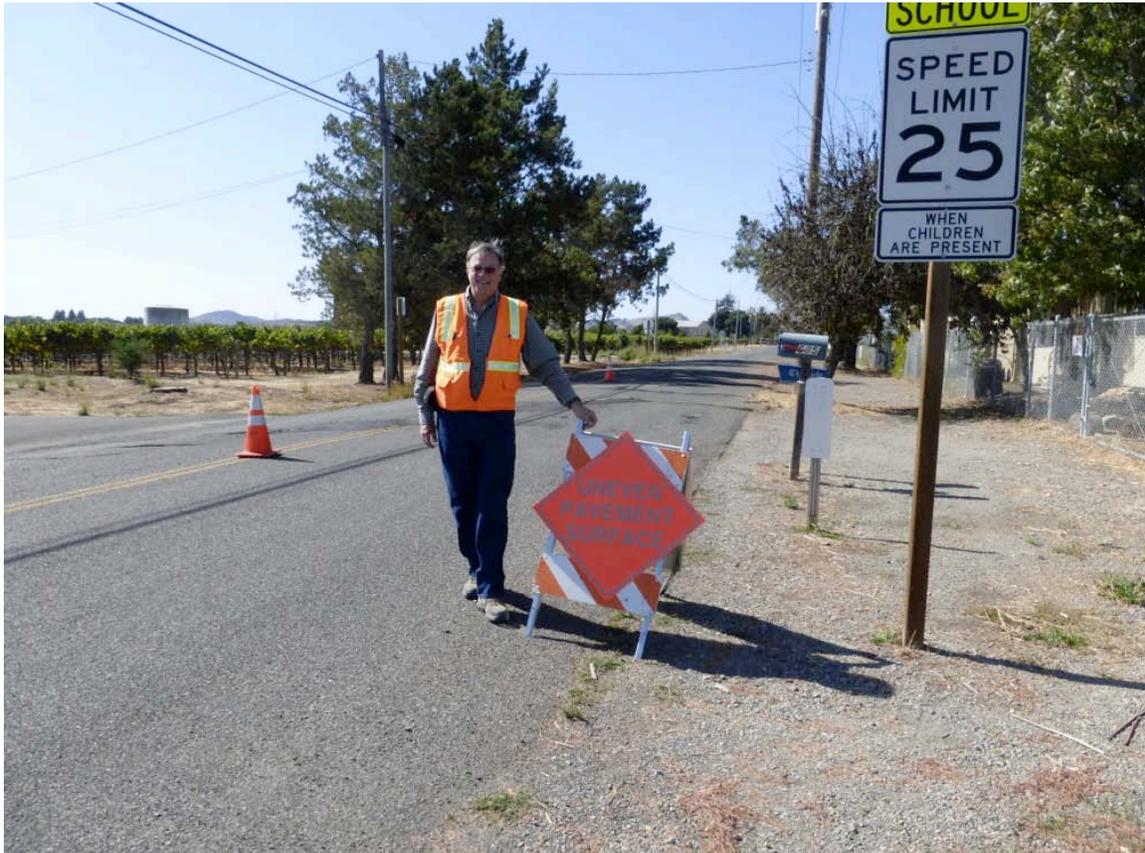
Figure 2-24 shows Los Carneros Avenue (and John Eiding), looking northerly, from a point just south of the fault offset zone. Photos taken around 4 pm local time, August 26 2014. Asphalt patches in the road pavement can be seen. To the west, the cracks in the ground are clearly seen on the westerly shoulder of the road. Note the overhead cable TV poles (west side of road) and overhead PG&E distribution poles (12 kV, east side of road).

Figure 2-24. Repaired cracks in street

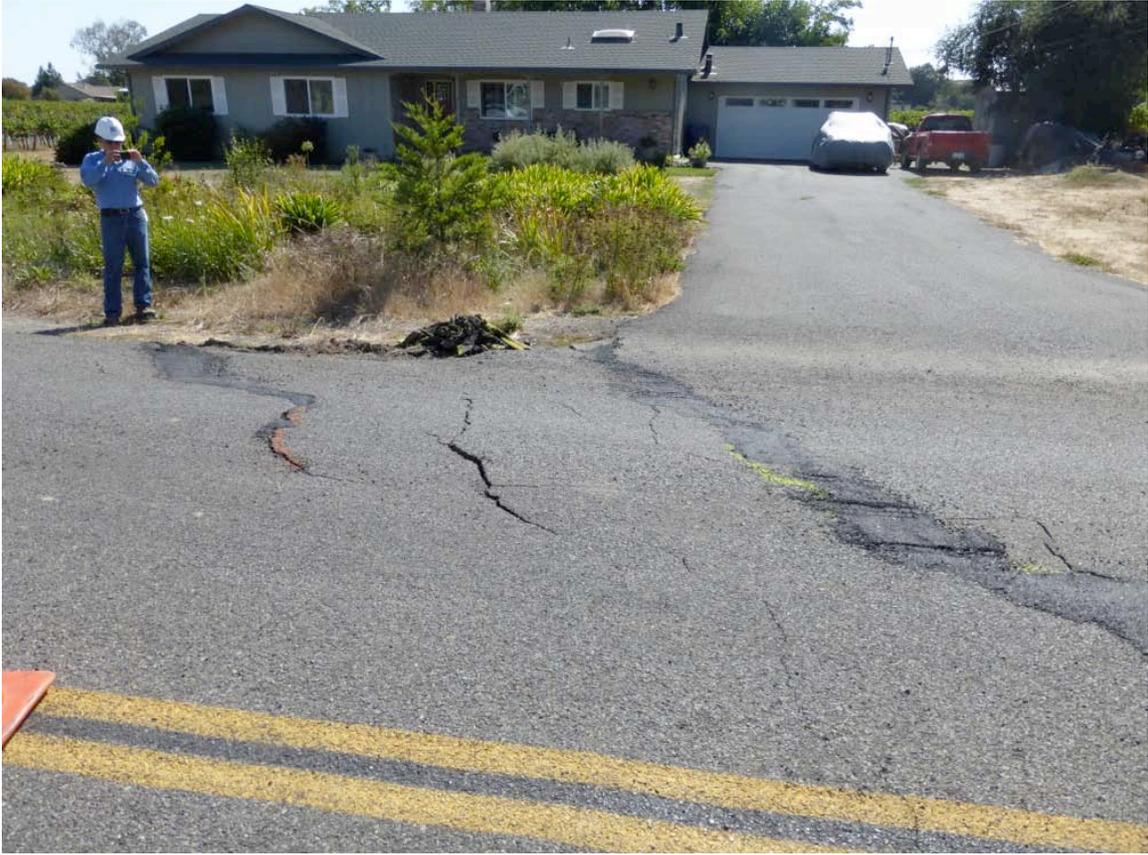
Figure 2-25 shows the ground cracks that have been repaired by August 25 and some newly formed cracks (post-seismic "after-slip") (and Raymond Trinh).

Figure 2-25. Repaired and newly formed cracks in street

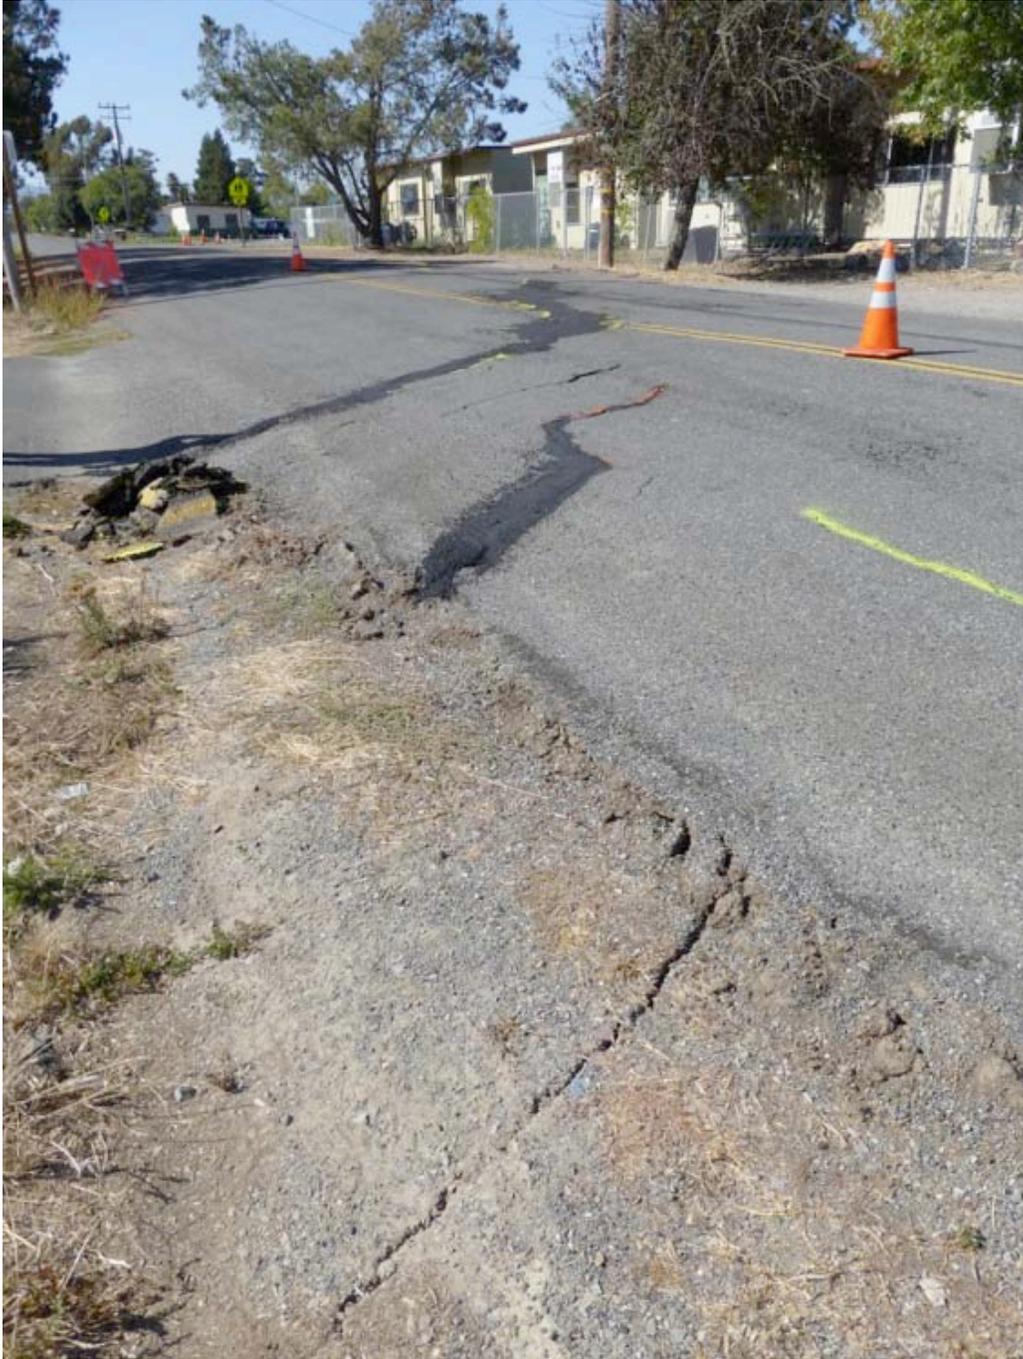
Figure 2-26 clearly shows the strike of the fault and the en echelon ground cracks. There appears to be about a 20° clockwise rotation of some of the en echelon cracks. One practical aspect is that for buried pipes crossing a fault, the fault offset might be along the strike, or perhaps rotation 20 to as much as 40 degrees or so (clockwise for right lateral, counterclockwise for left lateral).

Figure 2-26. Road cracks (repaired and new), looking northerly

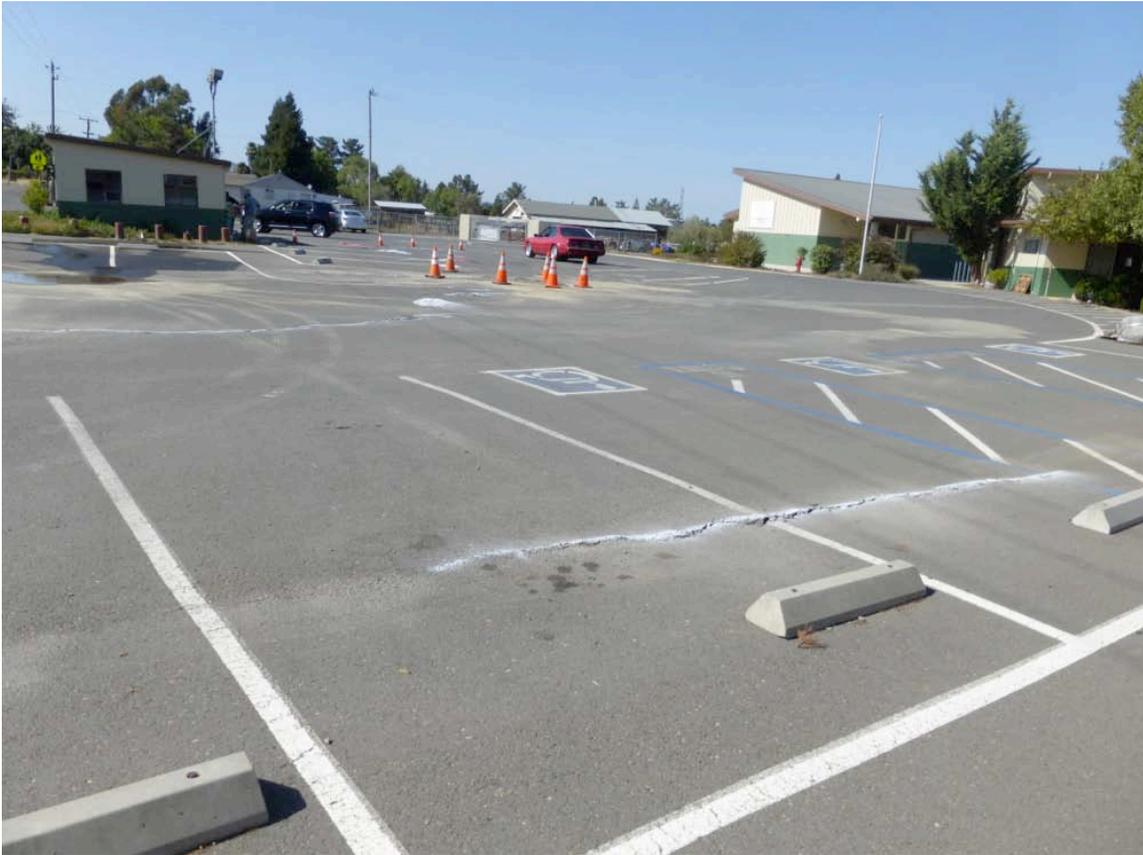
Figure 2-27 shows the parking lot for the school, looking northerly. In the foreground, a crack (painted white after the earthquake to help identification) is seen, again oriented in an echelon clockwise direction as compared to the strike of the fault. In the center of the photo are several orange cones, surrounding where the water pipe (to-from well and the utility building on the left). The ejected sand at this locations is from the sand surrounding the water pipe, that was ejected as part of the pipe break (not from liquefaction).

Figure 2-27. Parking lot cracks, looking northerly

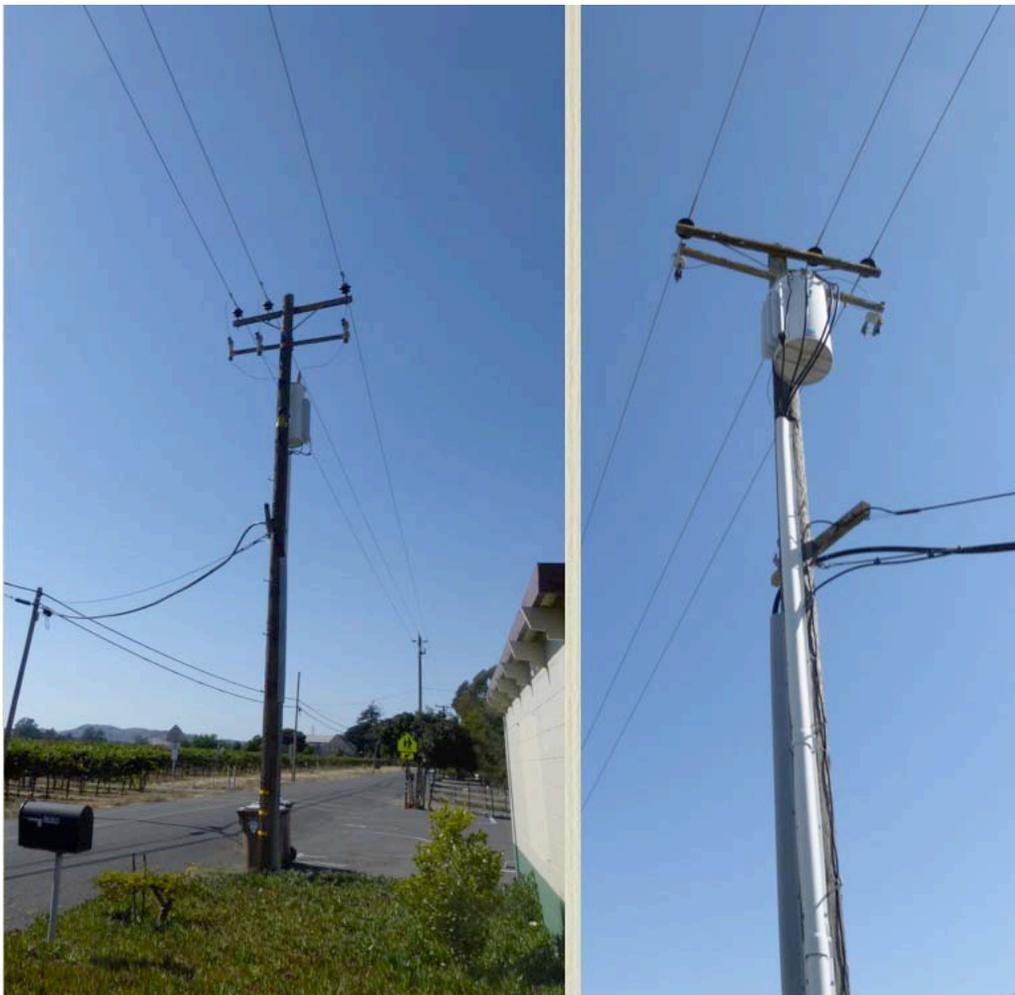
there were no signs of oil leak. The pot head / line drop looks undisturbed. According to the school's staff, the power was out on Sunday (August 24) morning. Once power was restored at this location, the line drop into the utilities building worked, and the underground cables from the utilities building into the school buildings worked. In other words, the cable (school-owned) that crossed the fault was not damaged to the point of becoming non-functional. In other earthquakes around the world, short (commonly shorter than 200 meter) secondary buried power cables have had a much lower failure rate due to modest PGDs (on the order of several inches) than long (several km) direct buried cables. This superior performance, all other factors being equal, is attributed to the available slack at either termination of the short cable, that can be used up at the specific PGD zone; whereas any available slack in a very long cable is "too far away" and the soil can effectively anchors the cable preventing any available slack from being used at the PGD zone where it is needed. This analogy would have to be adjusted if the buried cable is within ducts (PVC or Transite are common) rather than in direct burial.

Figure 2-29. Power Pole, adjacent to fault zone (left side looking north, right side looking south)

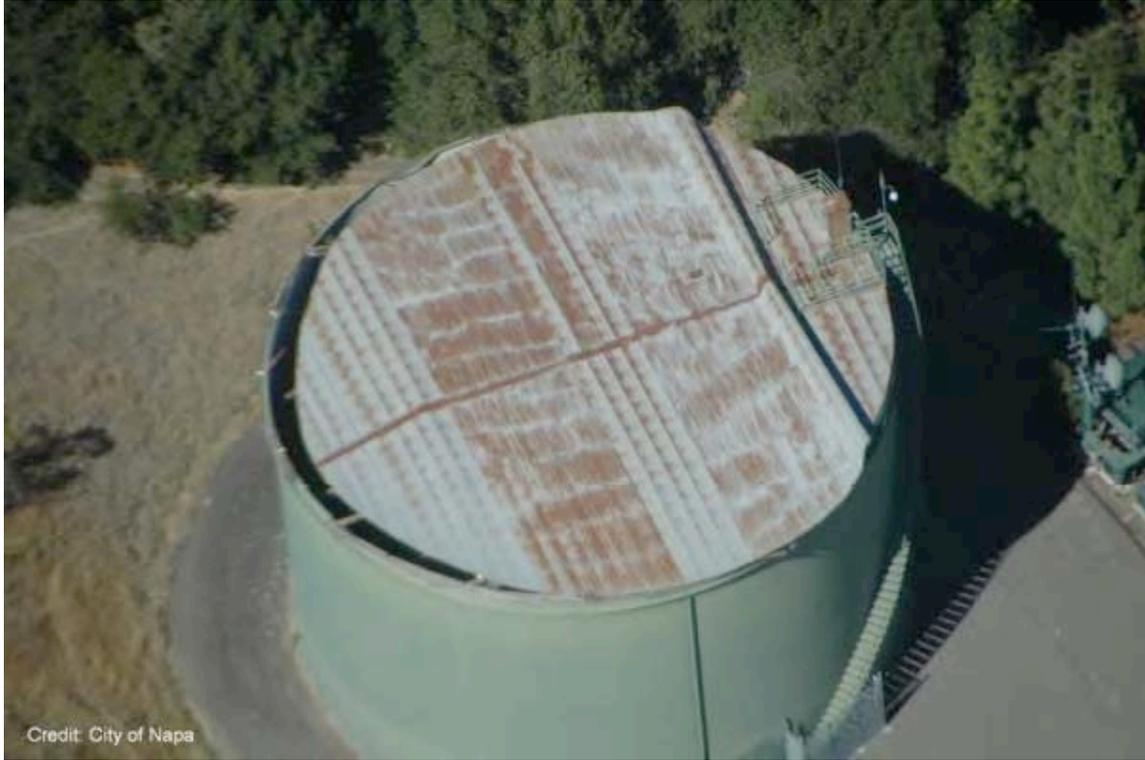
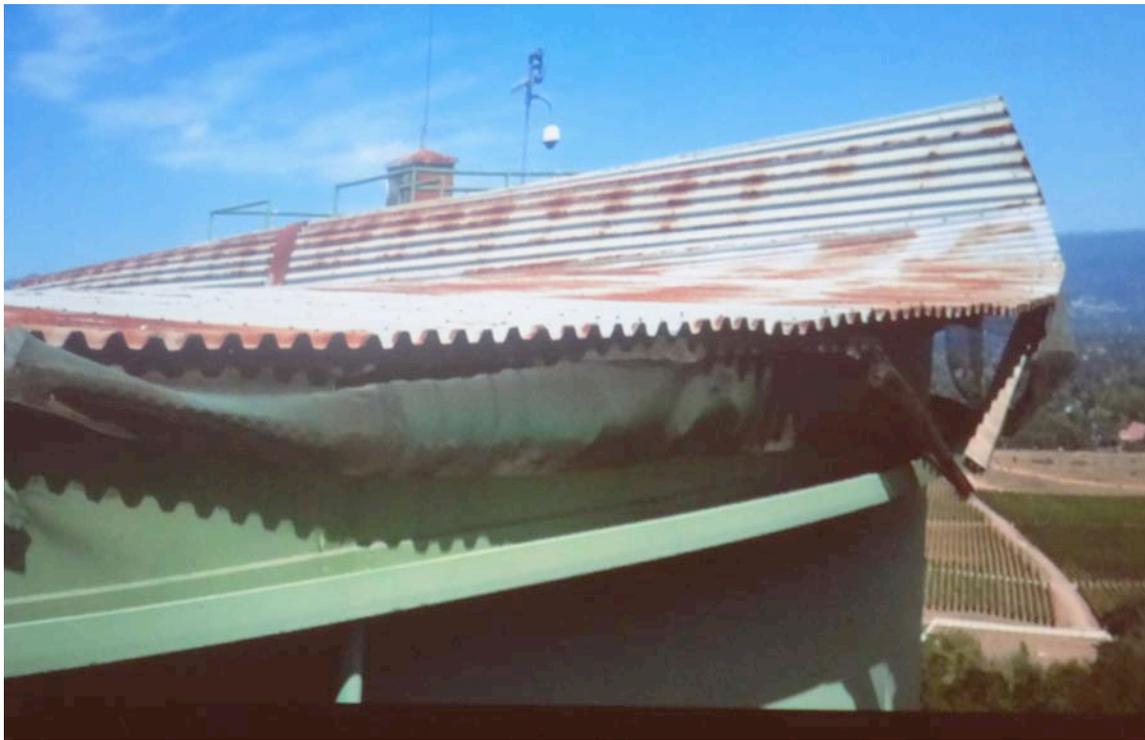
The tank did not lose its pressure boundary (likely some water was lost through the damaged roof / ventilation screens), but the tank drained rapidly all the same, owing to the damage to nearby broken pipes.

Figure 4-8. Damaged Roof of Steel Tank "B"

Figure 4-9. Damaged Roof of Steel Tank "B"

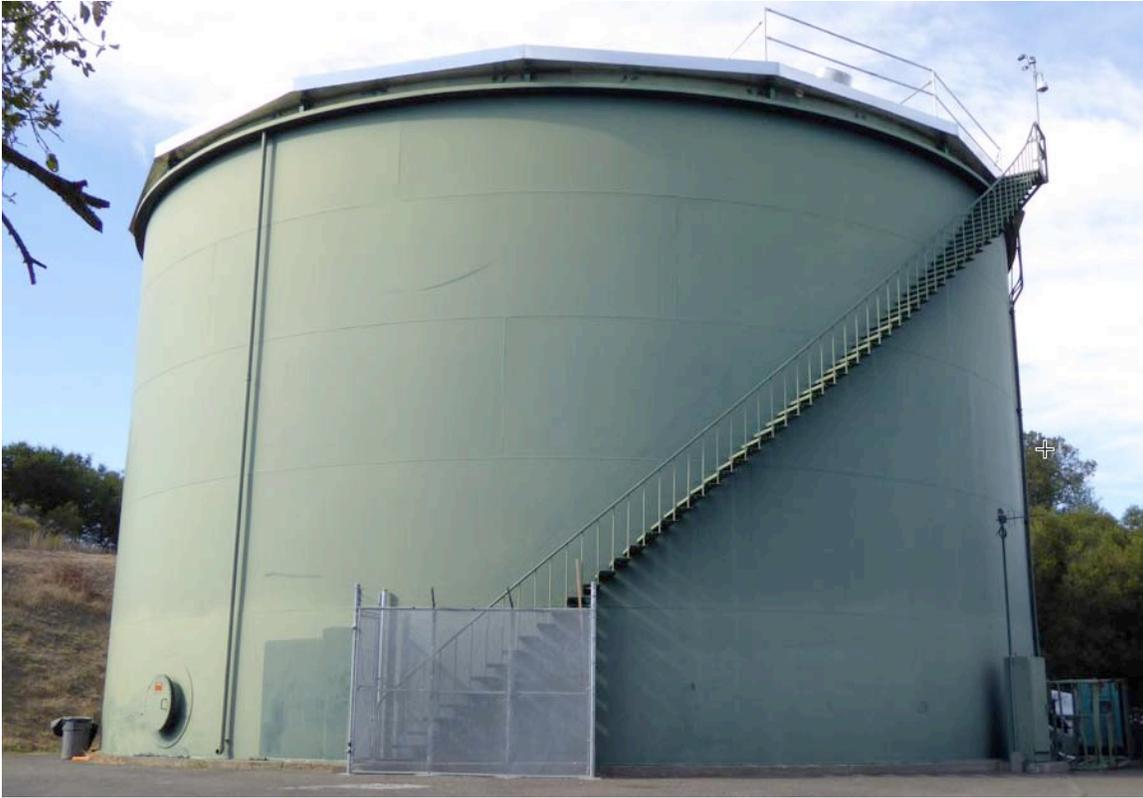
Figure 4-11. Tank B, with New Aluminum Dome Roof

Within a month after the earthquake, the wood roof system for Tank "B" was removed, and replaced with a aluminum "dome" type roof. Figure 4-11 shows the tank on October 10, 2014. The City is considering further tank modifications, including raising the steel shell by several feet to provide more clear space for water sloshing in future earthquakes, as might be suggested by the current AWWA D100 code (2013 version). The cost effectiveness of this type of modification, as well as the AWWA code provision for providing several feet of clear space for sloshing, is uncertain, as the tank still performed (held water) in the earthquake.

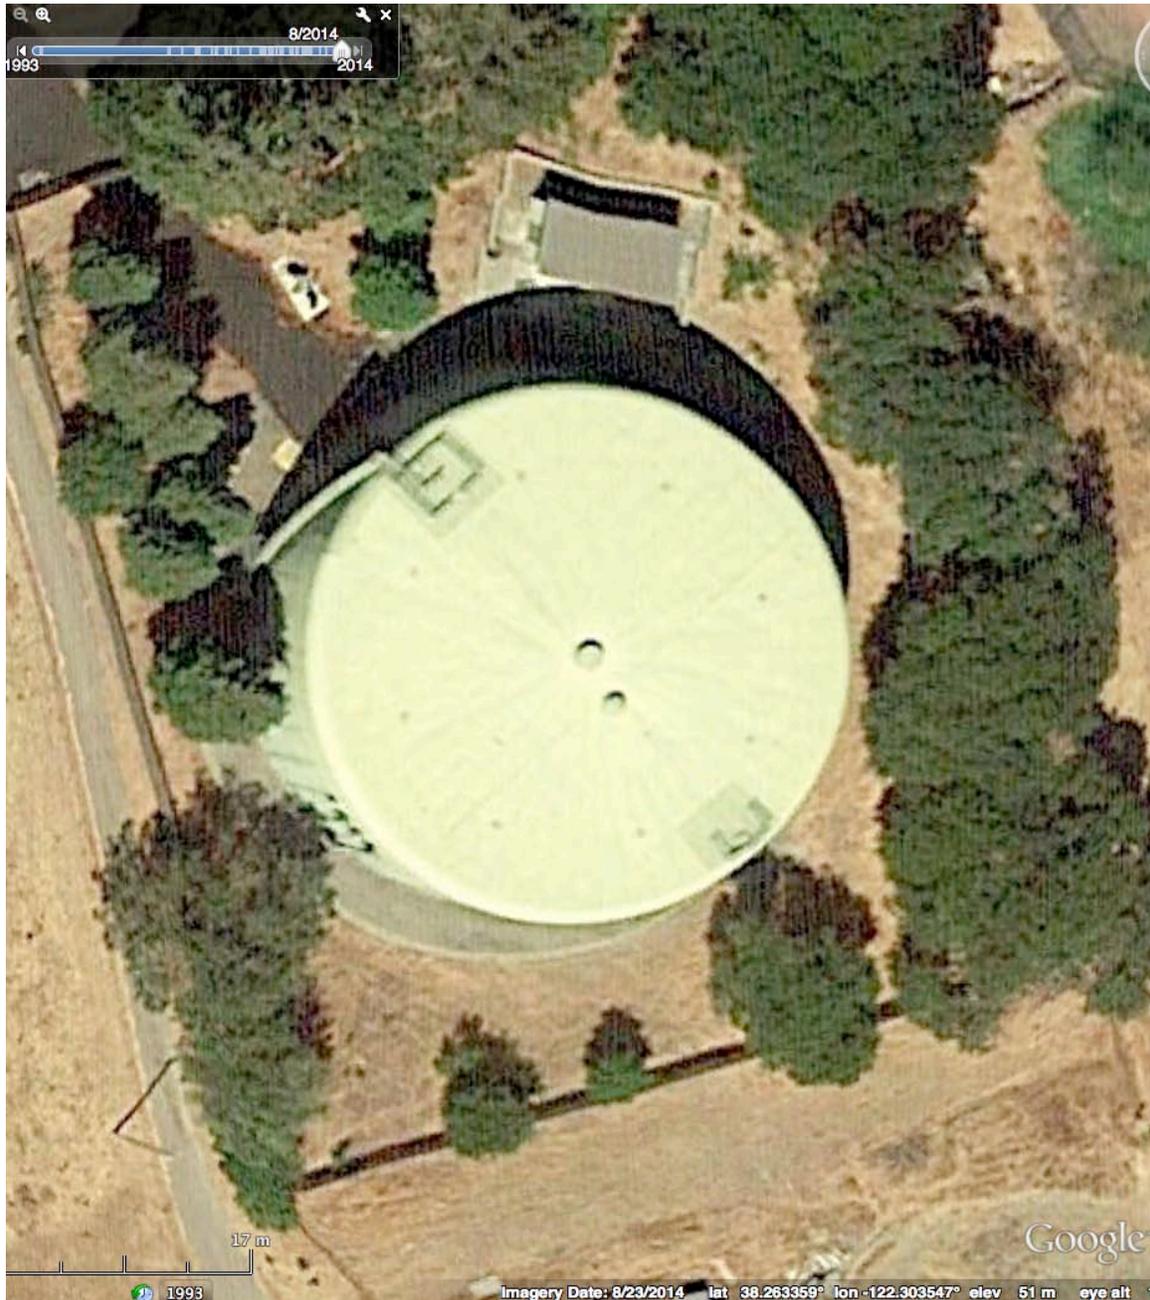
Figure 4-13 shows a steel tank in the southwest part of Napa, built pre-1993. PGA at this location was likely around 0.4g. In mid-September 2014, it was reported that there was water observed near this tank, coming out of the ground; whether this water was from a leaking pipe, the tank, or some other source, remains unknown as of the time of writing this report.

Figure 4-13. West Side Tank (38.2631, -122.3039)

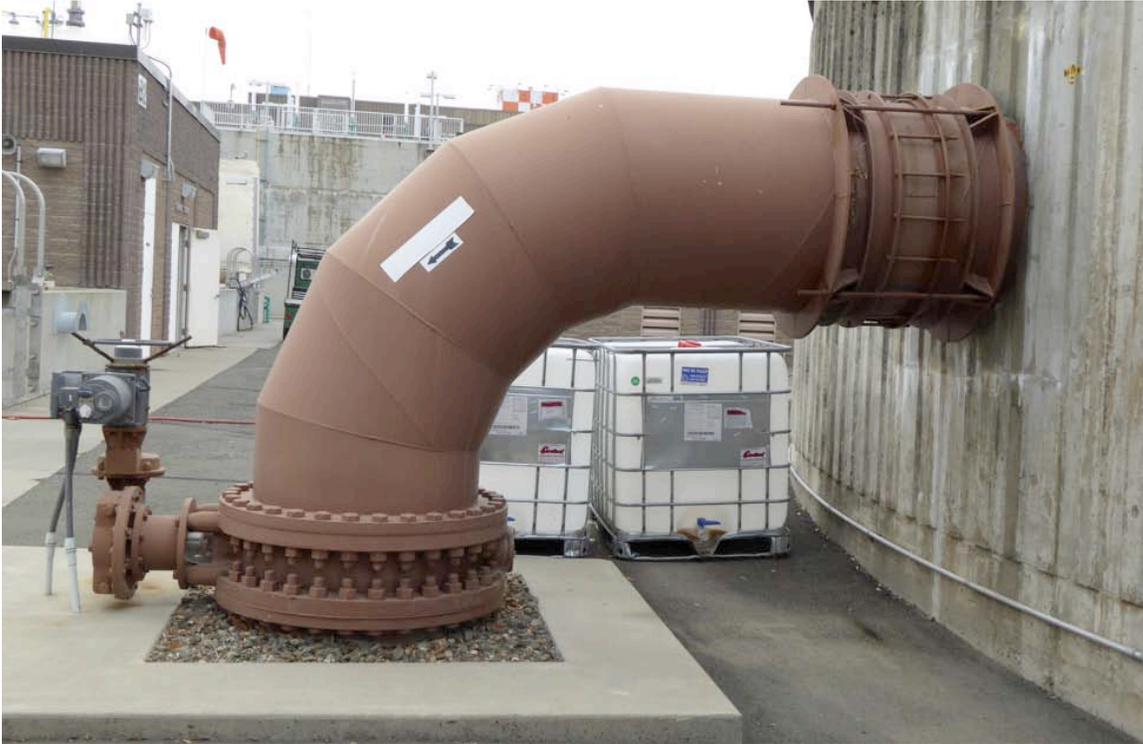
- At one location, a large pipe that enters a tank had a distressed Dresser-type coupler (slip joint). Figure 4-20 shows one of the two such pipes (the other pipe leaked); both have essentially the same details. This leak was attributed to high inertial ground shaking, rather than differential settlements. The shaking caused some movement at the slip joint. The leak was solved by re-tightening the bolts that make the connection (top right part in Figure 4-20).

Figure 4-20. Steel Pipe with Dresser-Type Coupling

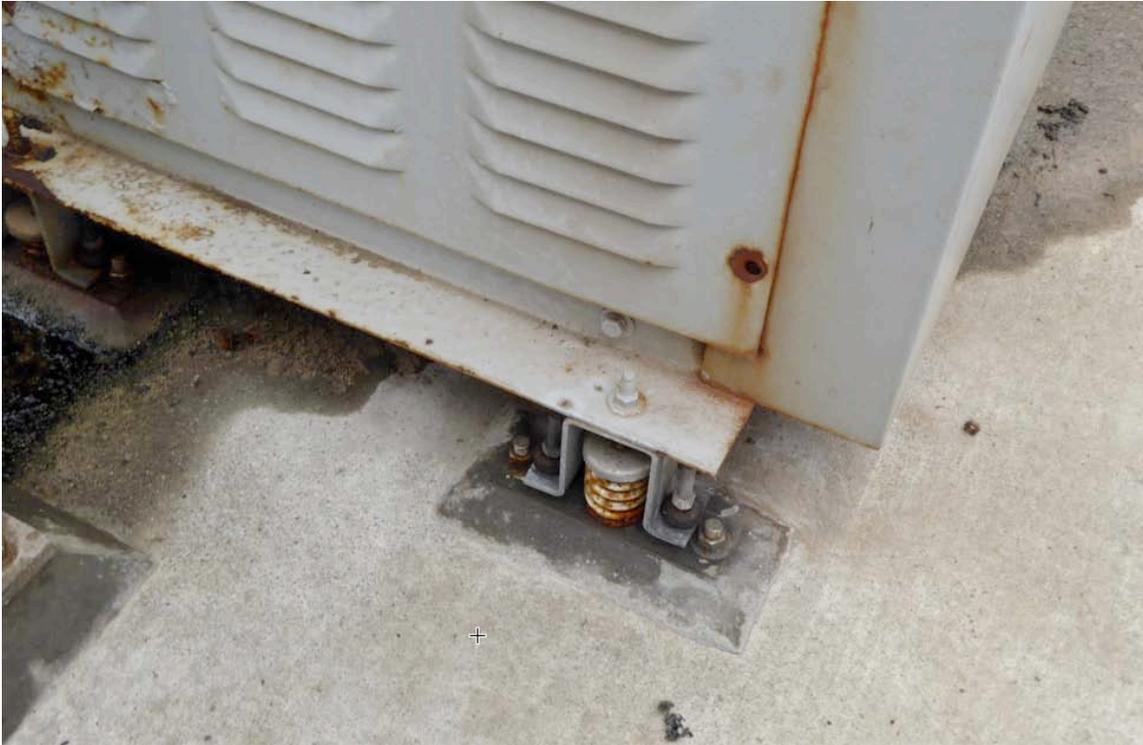
A spring-mounted motor system suffered some damage, Figure 4-21. This assembly is attached to an adjacent large diameter steel pipe. During normal operation, the spring mounts allow minor movements (commonly under 1/16th inch) of the motor assembly. To accommodate these movements, the attached pipe is supported on a concrete pedestal, and a rubber-type connector is used between the pipe and motor assembly. The earthquake broke the first pipe support. This pipe support had already sustained considerable damage due to corrosion, prior to the earthquake, and the incremental forces applied during the earthquake failed the support.

Figure 4-21. Spring-Mounted Motor Assembly

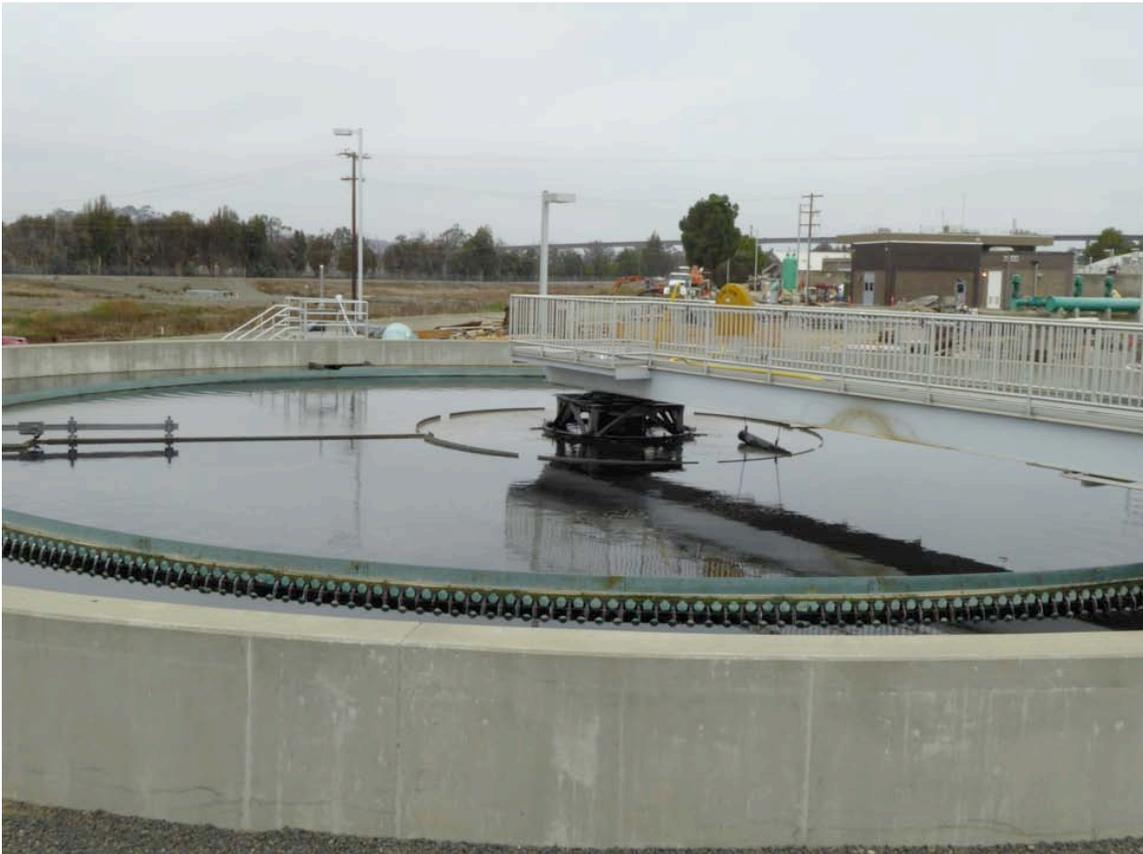
Discussion with plant staff indicate that there might have been some slight rocking of the central tower of the full clarifier in Figure 4-23, as the inside baffle (steel plate) seems to be slightly tilted; but as of 7 weeks post-earthquake, the clarifier had not been drained to verify the condition of the tower anchor system. While water sloshing as certain to have occurred, as the earthquake occurred during the night-time, there was no one there to observe the actual wave heights; there were no reported obvious solids on the ground adjacent to the clarifier.

Figure 4-23. Full Clarifier

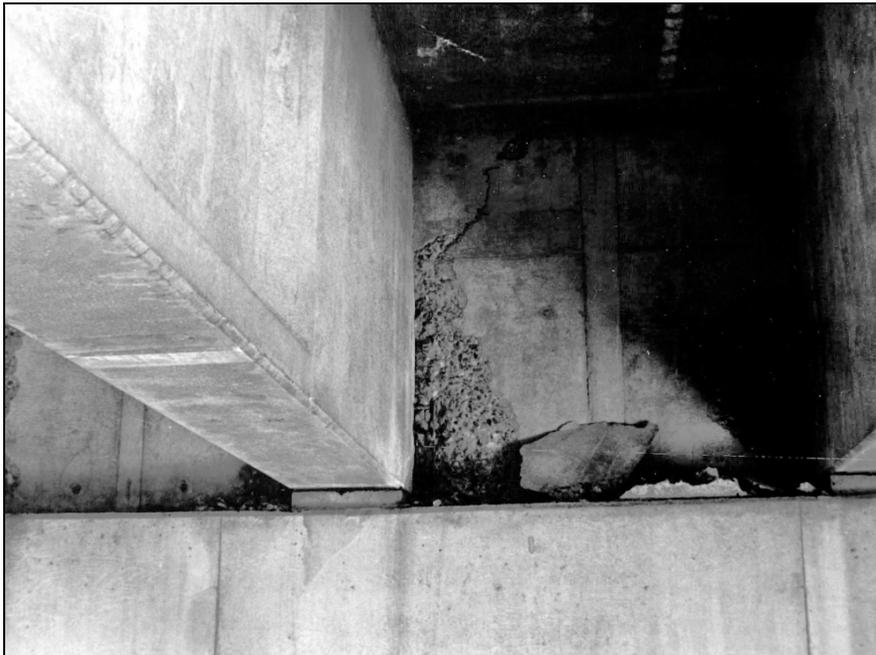
Figure 5-5. Damage to Napa River Bridge during the Loma Prieta 1989 Earthquake

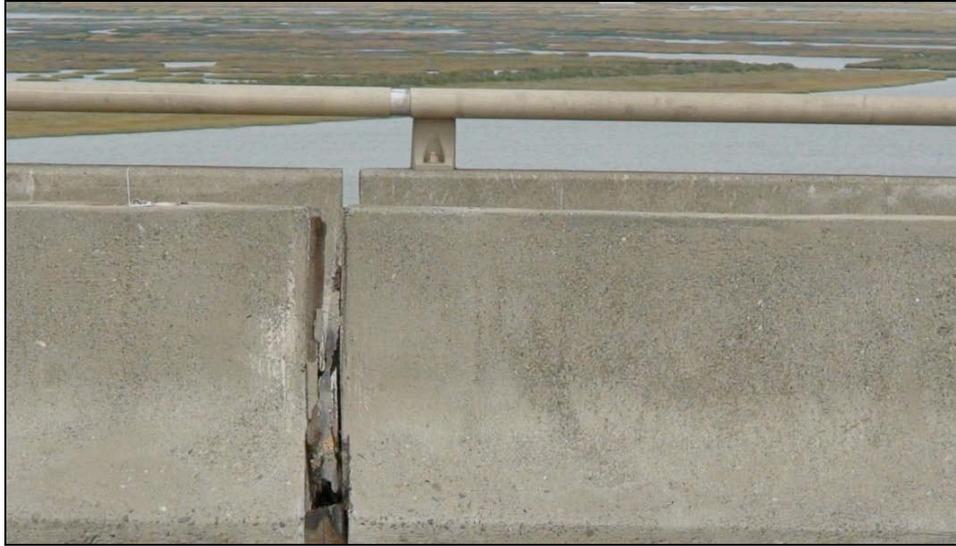
Figure 5-10. Damage to the Napa River Bridge was Permanent Longitudinal Displacement at the Expansion Joints

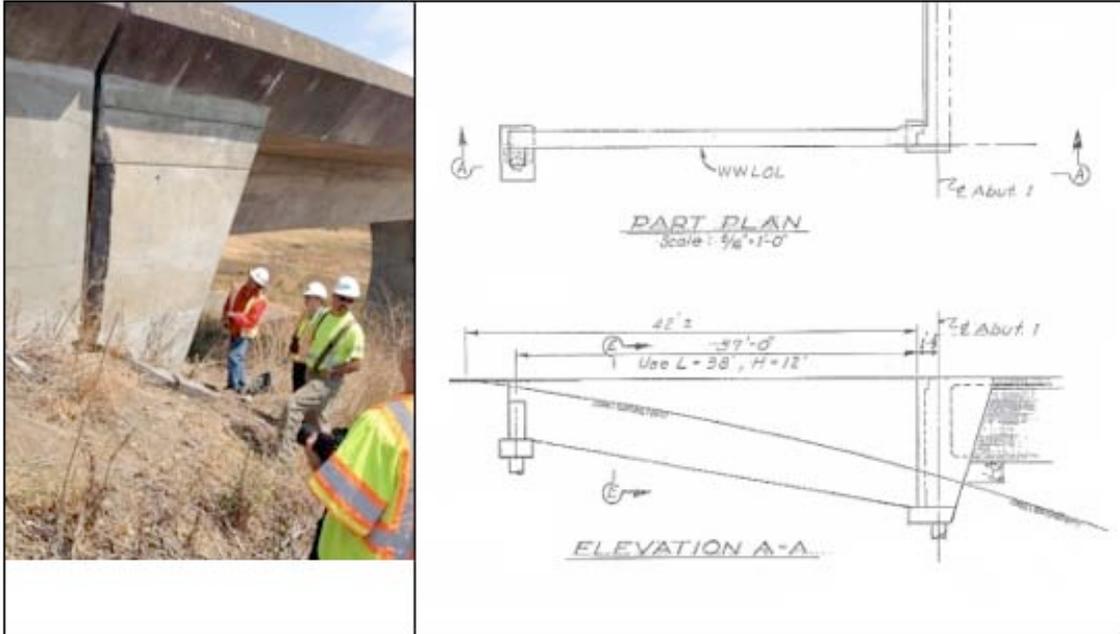
Figure 5-14. Abutment 14 concrete spall on the Napa River Bridge and Overhead

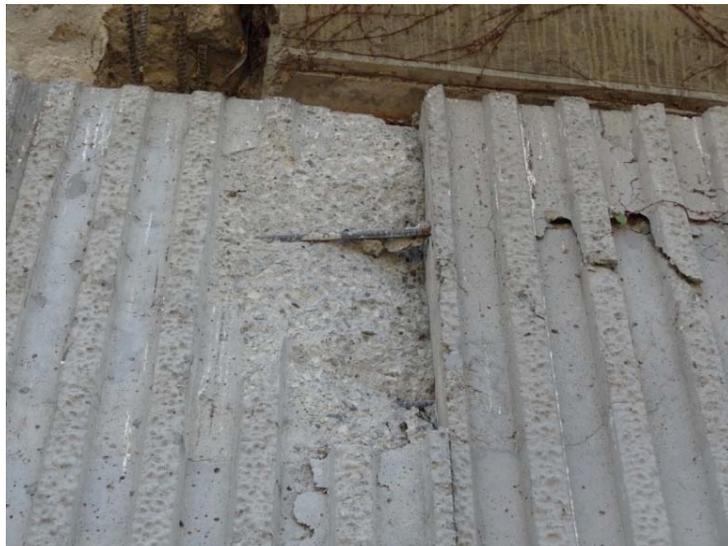
Figure 5-17. Close-up of damaged curtain walls on the Napa River (West Imola Ave) Bridge

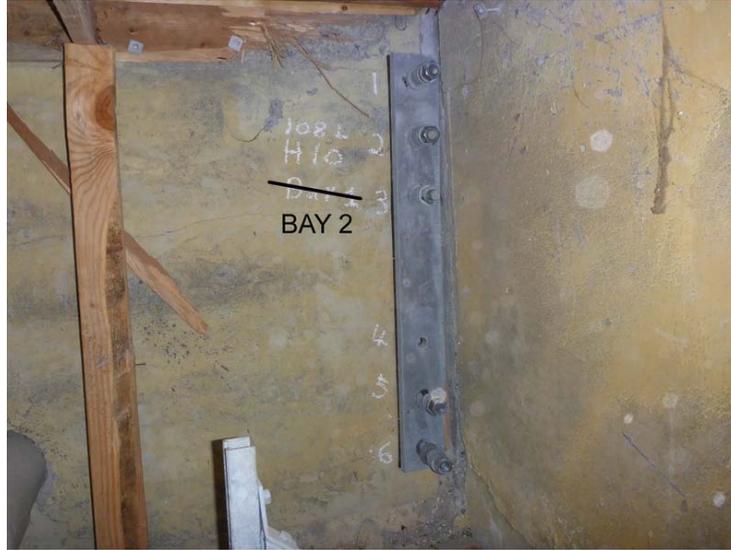
Figure 5-18. Restrainer damage at Hinge 10, Bay 2 of Napa River (W. Imola Ave) Bridge
