South Napa M 6.0 Earthquake of August 24, 2014

John Eidinger – G&E Engineering Systems

TCLEE No. 1

March 2016, Updated April 2017

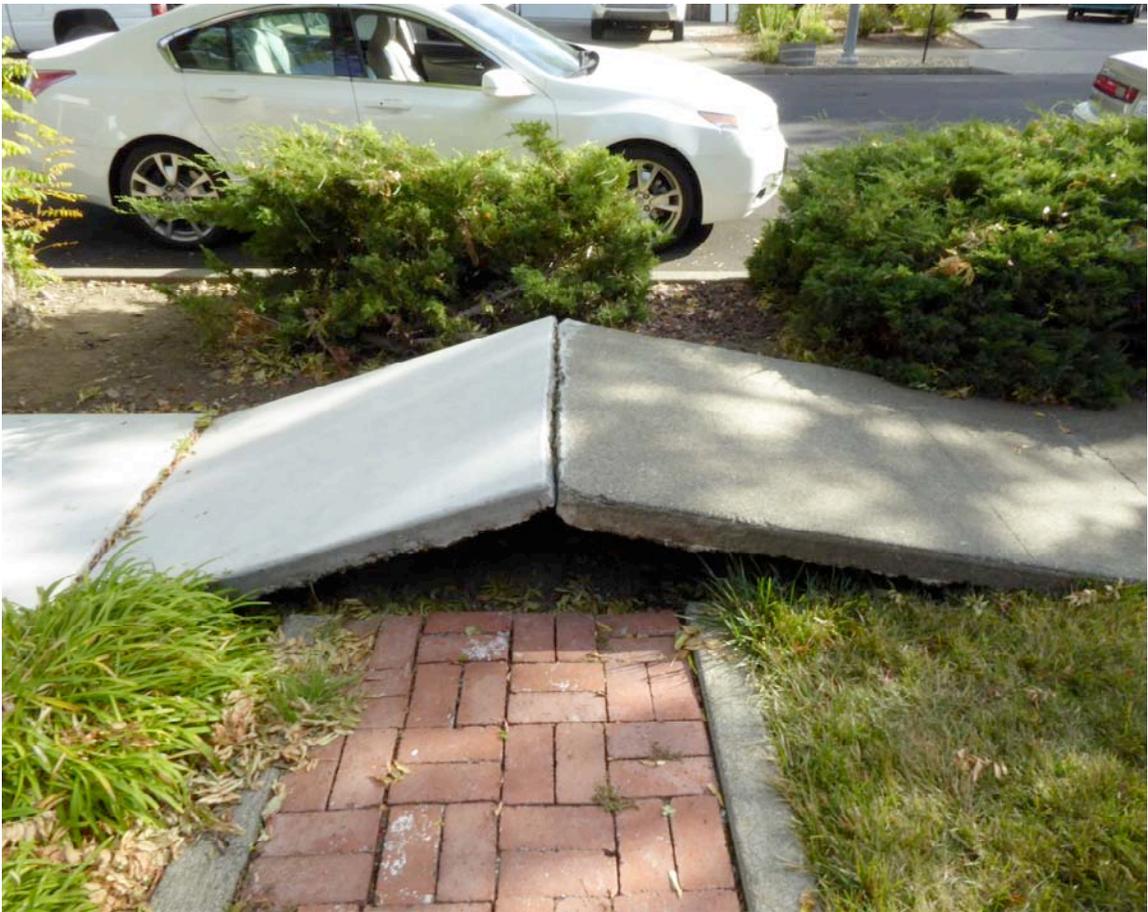
Figure 2-21. Buckled Sidewalk at Fault Offset Location

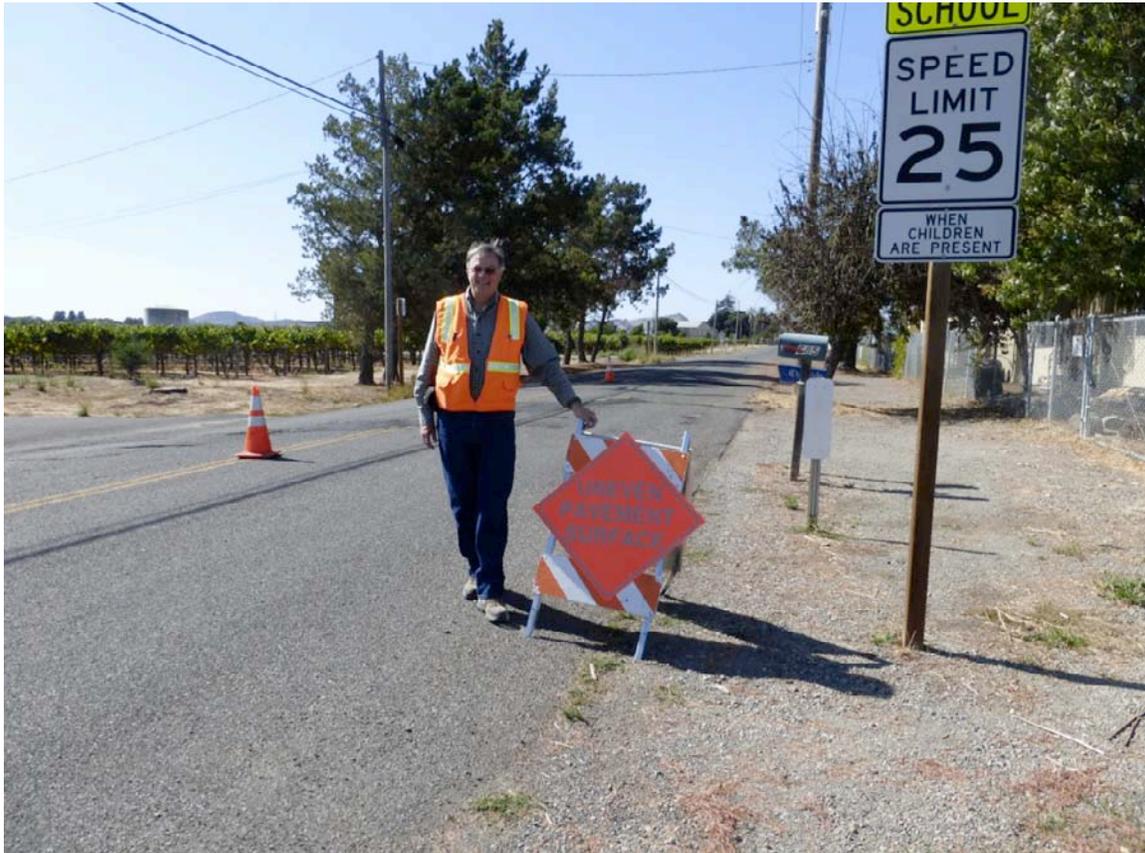
Figure 2-24 shows Los Carneros Avenue (and John Eiding), looking northerly, from a point just south of the fault offset zone. Photos taken around 4 pm local time, August 26 2014. Asphalt patches in the road pavement can be seen. To the west, the cracks in the ground are clearly seen on the westerly shoulder of the road. Note the overhead cable TV poles (west side of road) and overhead PG&E distribution poles (12 kV, east side of road).

Figure 2-24. Repaired cracks in street

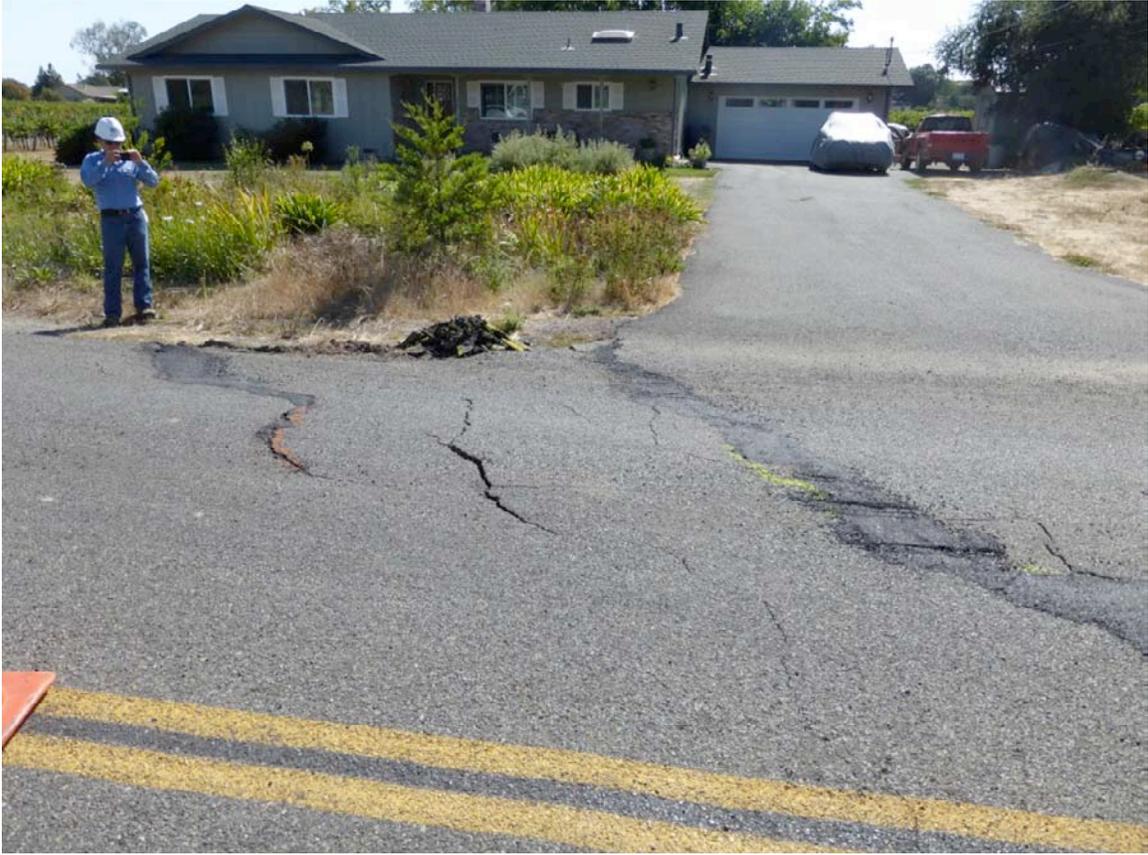
Figure 2-25 shows the ground cracks that have been repaired by August 25 and some newly formed cracks (post-seismic "after-slip") (and Raymond Trinh).

Figure 2-25. Repaired and newly formed cracks in street

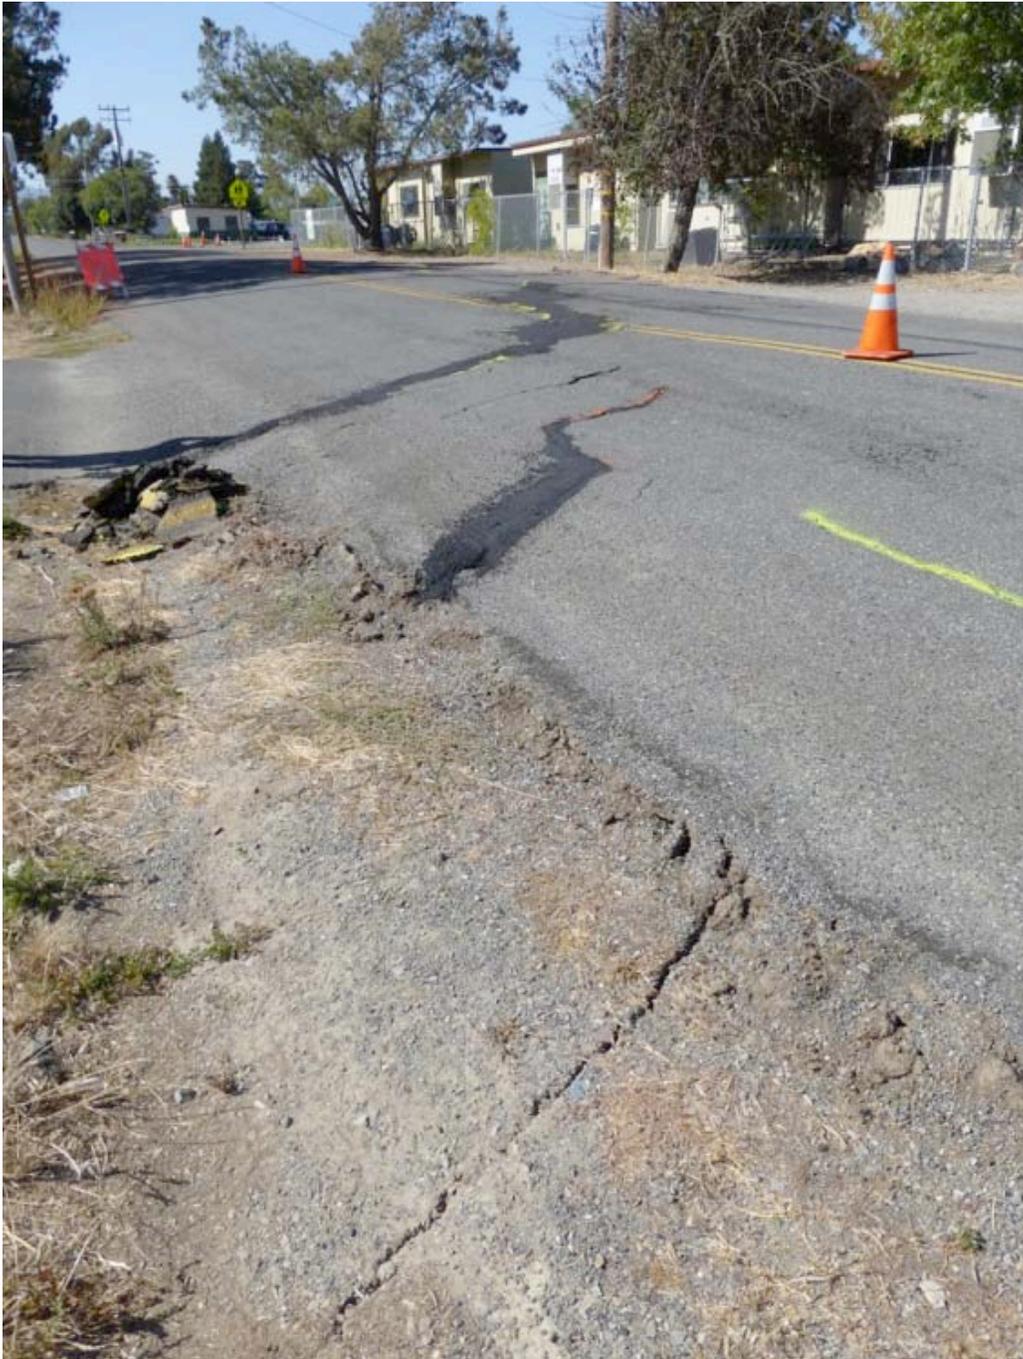
Figure 2-26 clearly shows the strike of the fault and the en echelon ground cracks. There appears to be about a 20° clockwise rotation of some of the en echelon cracks. One practical aspect is that for buried pipes crossing a fault, the fault offset might be along the strike, or perhaps rotation 20 to as much as 40 degrees or so (clockwise for right lateral, counterclockwise for left lateral).

Figure 2-26. Road cracks (repaired and new), looking northerly

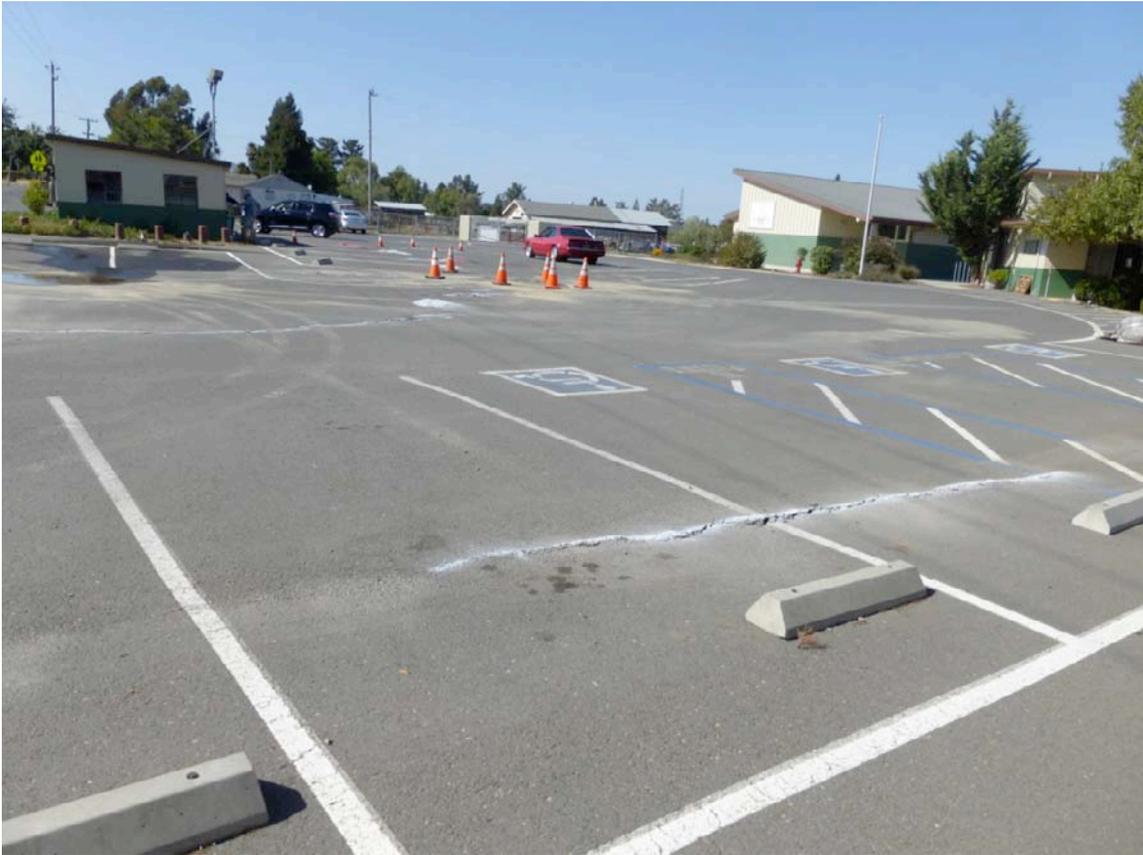
Figure 2-27 shows the parking lot for the school, looking northerly. In the foreground, a crack (painted white after the earthquake to help identification) is seen, again oriented in an echelon clockwise direction as compared to the strike of the fault. In the center of the photo are several orange cones, surrounding where the water pipe (to-from well and the utility building on the left). The ejected sand at this locations is from the sand surrounding the water pipe, that was ejected as part of the pipe break (not from liquefaction).

Figure 2-27. Parking lot cracks, looking northerly

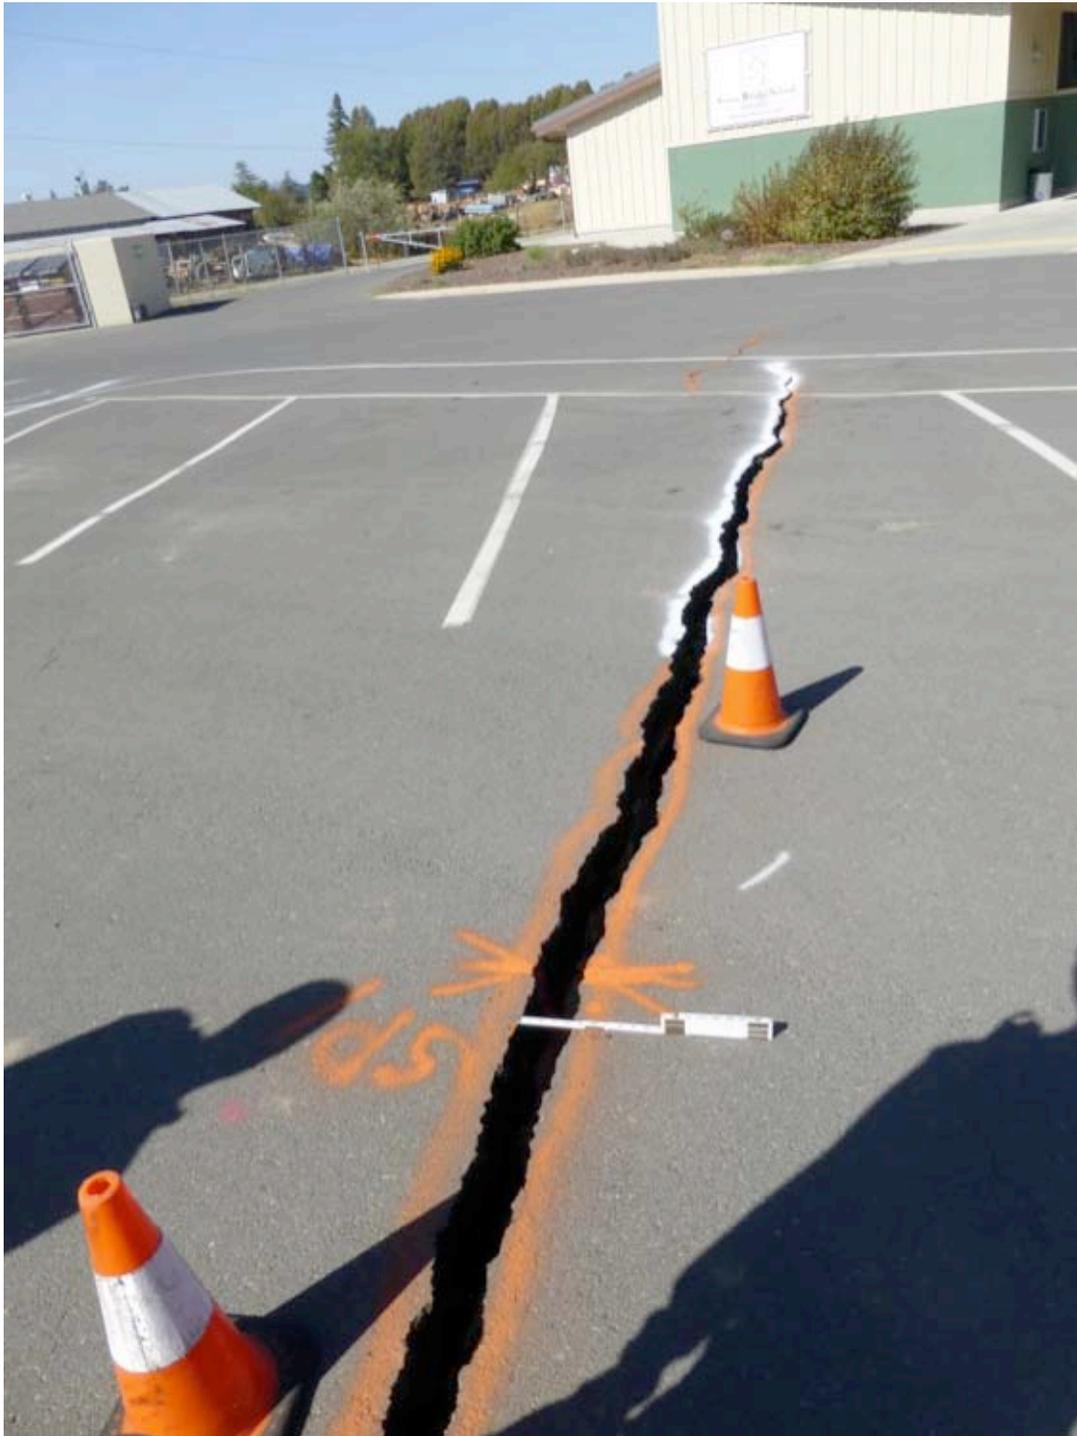
Figure 2-28 shows the largest crack in the parking lot, paving originally white, and then as the crack grew wider, orange. The ruler shows almost 4 inches of opening.

Figure 2-28. Parking lot crack, looking northerly

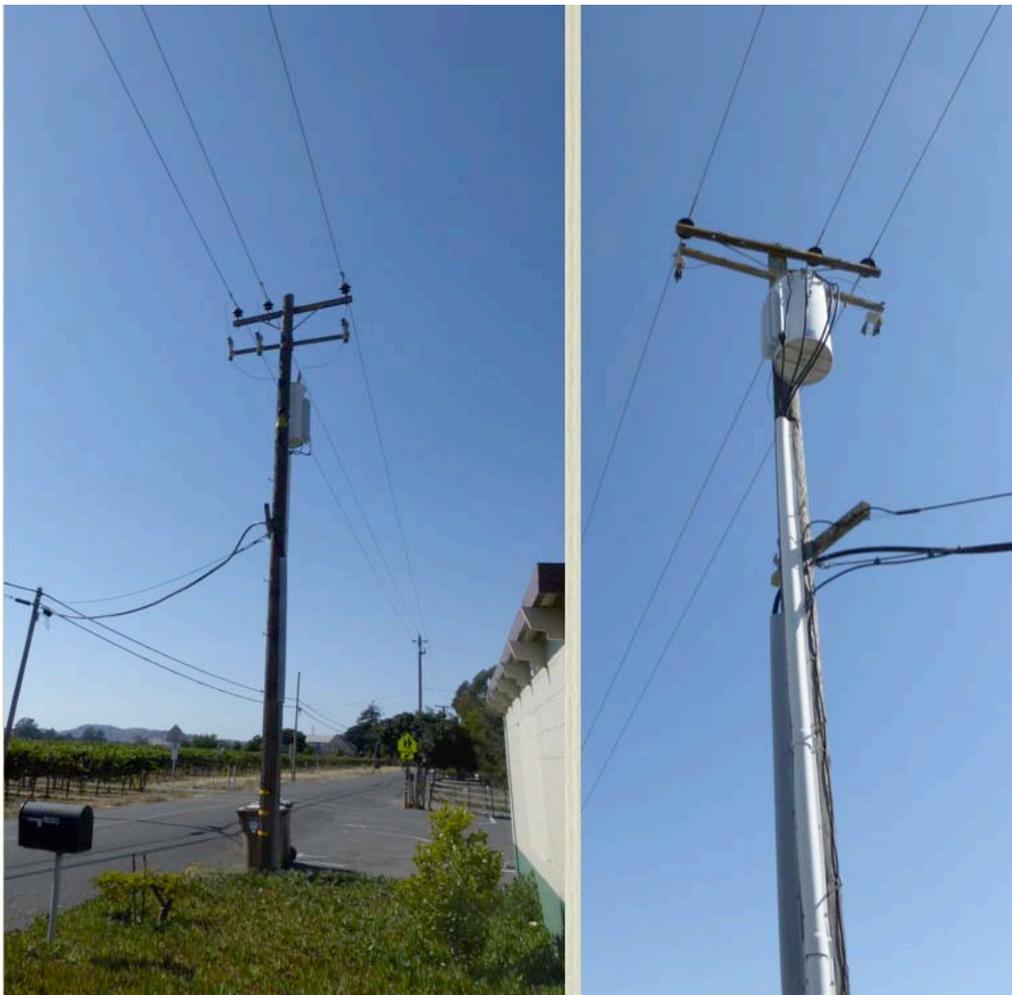
there were no signs of oil leak. The pot head / line drop looks undisturbed. According to the school's staff, the power was out on Sunday (August 24) morning. Once power was restored at this location, the line drop into the utilities building worked, and the underground cables from the utilities building into the school buildings worked. In other words, the cable (school-owned) that crossed the fault was not damaged to the point of becoming non-functional. In other earthquakes around the world, short (commonly shorter than 200 meter) secondary buried power cables have had a much lower failure rate due to modest PGDs (on the order of several inches) than long (several km) direct buried cables. This superior performance, all other factors being equal, is attributed to the available slack at either termination of the short cable, that can be used up at the specific PGD zone; whereas any available slack in a very long cable is "too far away" and the soil can effectively anchors the cable preventing any available slack from being used at the PGD zone where it is needed. This analogy would have to be adjusted if the buried cable is within ducts (PVC or Transite are common) rather than in direct burial.

Figure 2-29. Power Pole, adjacent to fault zone (left side looking north, right side looking south)

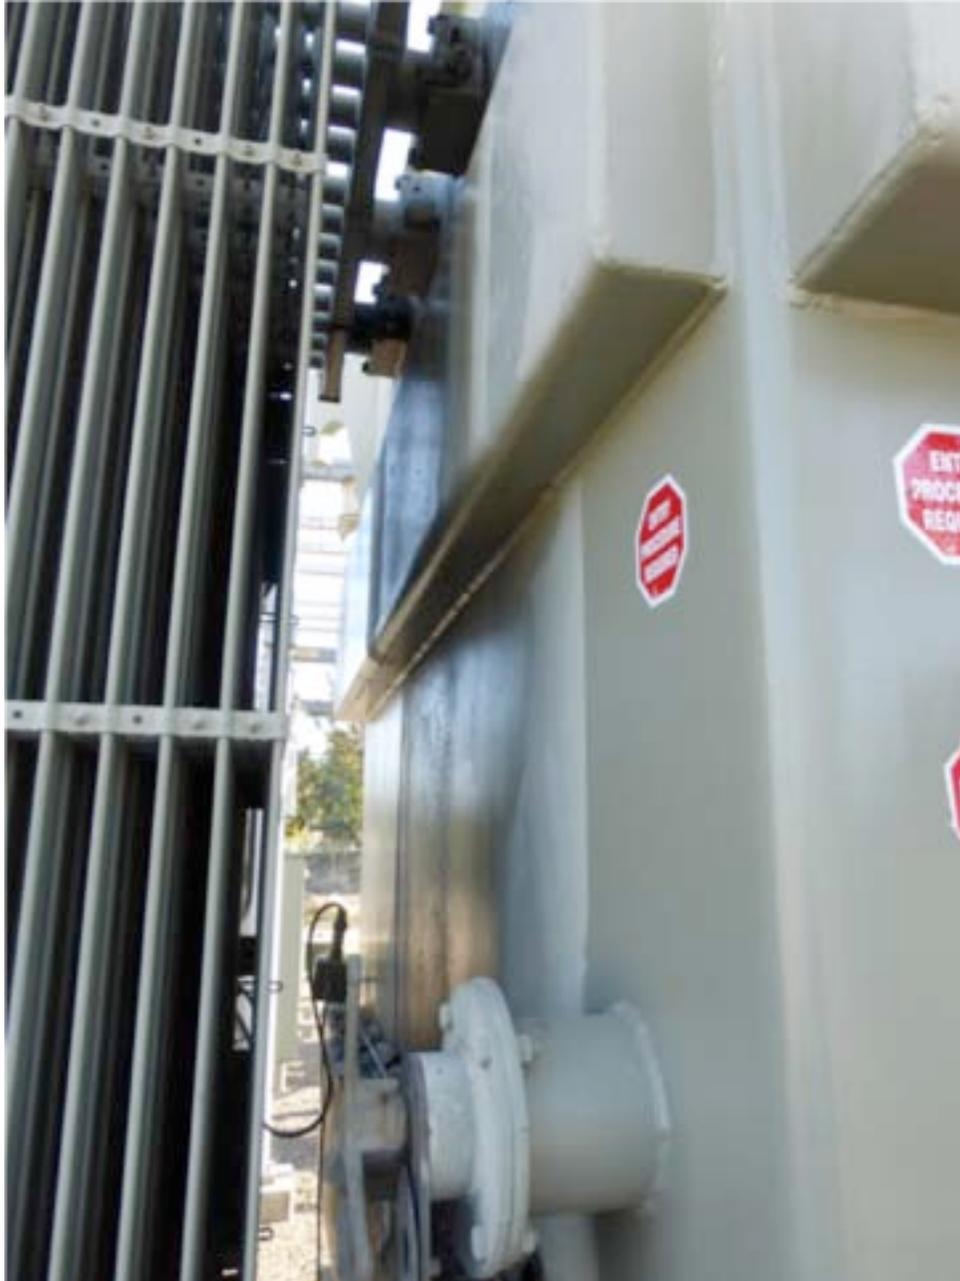
There was evidence of oil leakage at this transformer, Figure 3-4.

Figure 3-4. Transformer Oil Leak

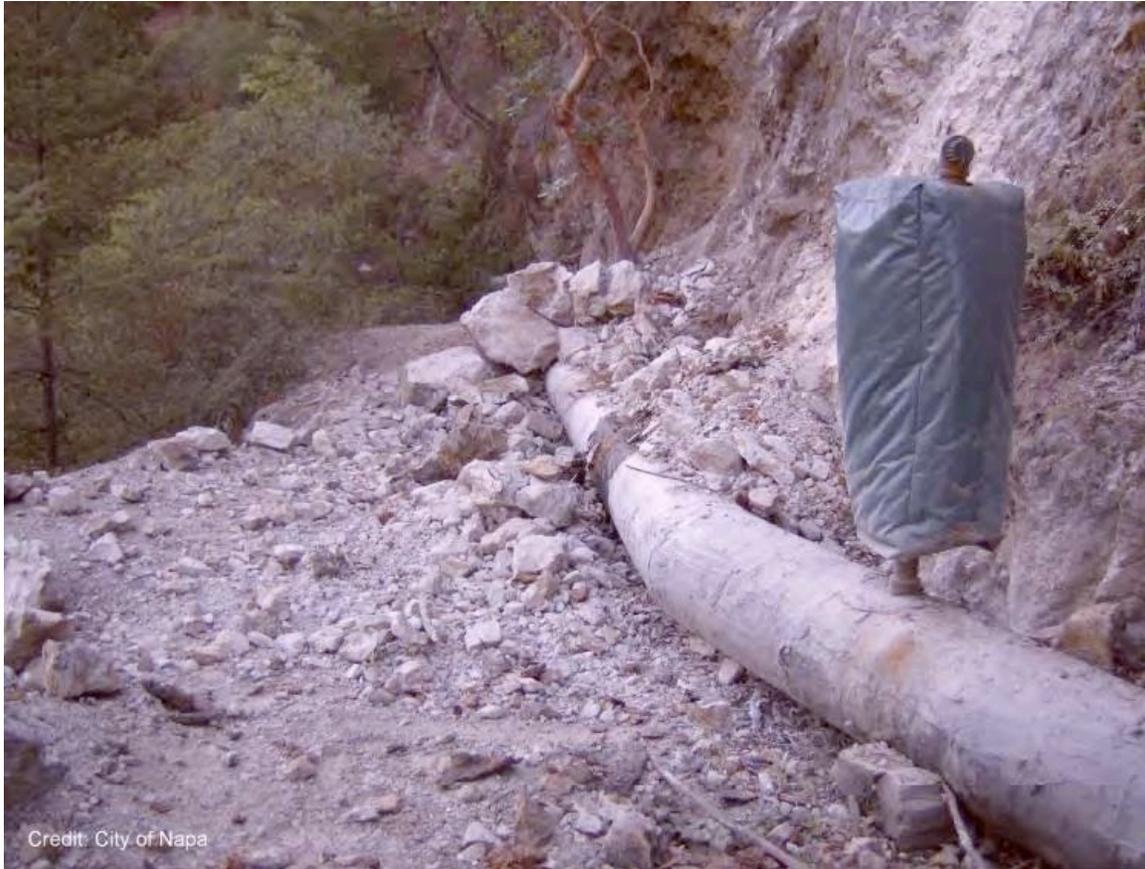
Figure 4-6 shows a damaged transmission line, due to rockfall (Milliken Transmission pipeline). Discussions with the City of Napa Water Department suggested that "perhaps it leaked".

Figure 4-6. Damaged Transmission Pipe due to Rockfall

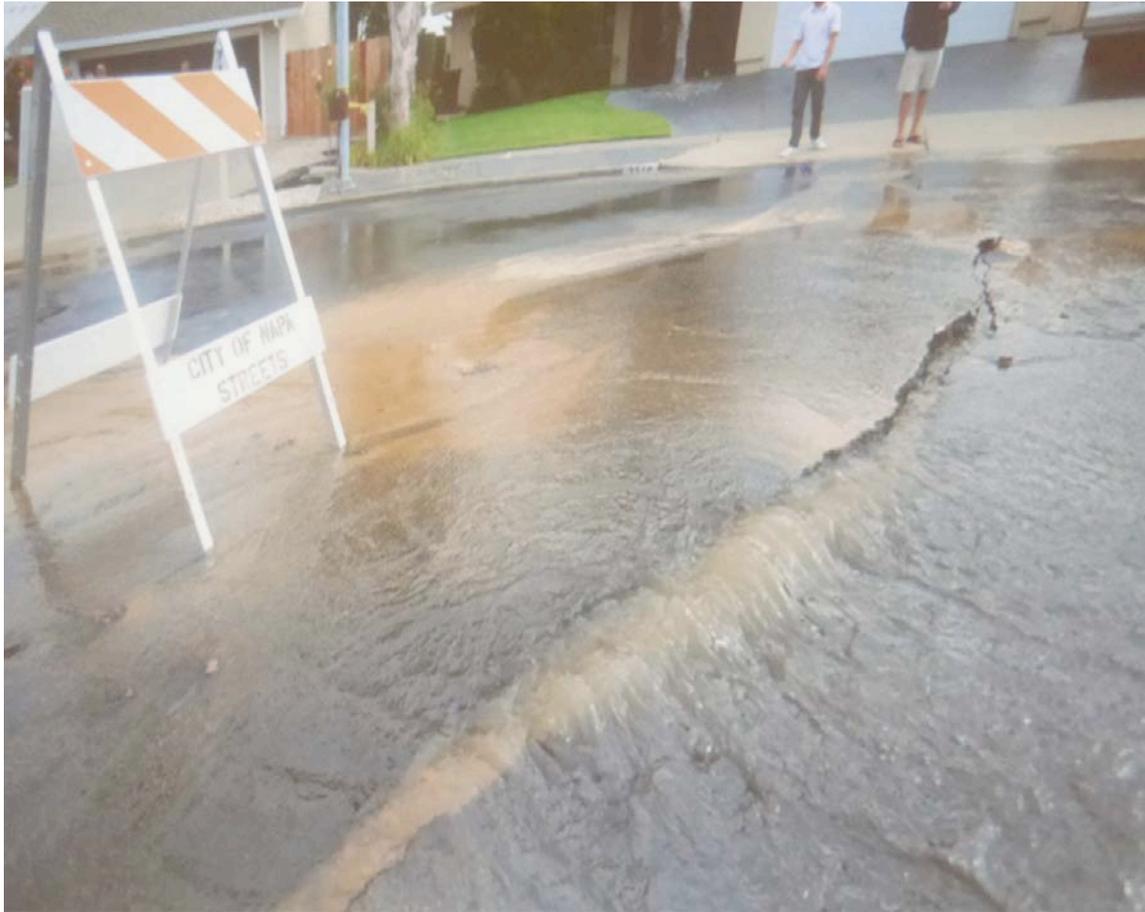
Figure 4-7 shows water from a leaking distribution pipe.

Figure 4-7. Water Leaking from a Damaged Distribution Pipe

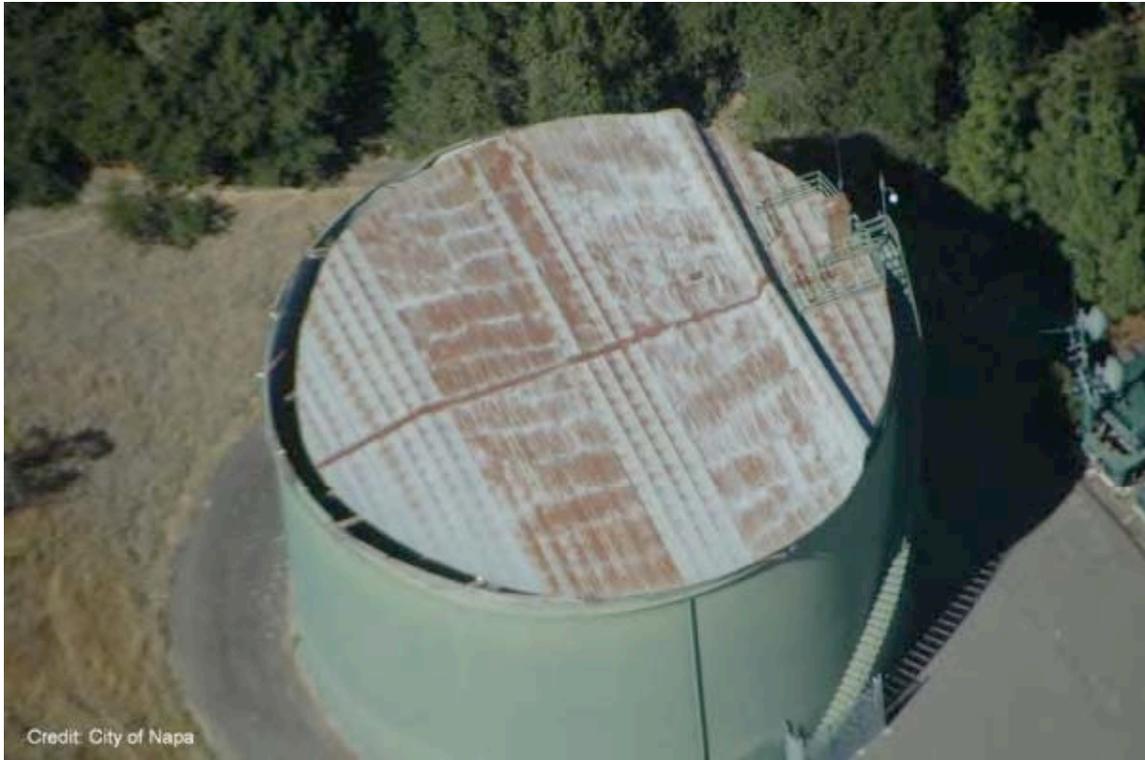
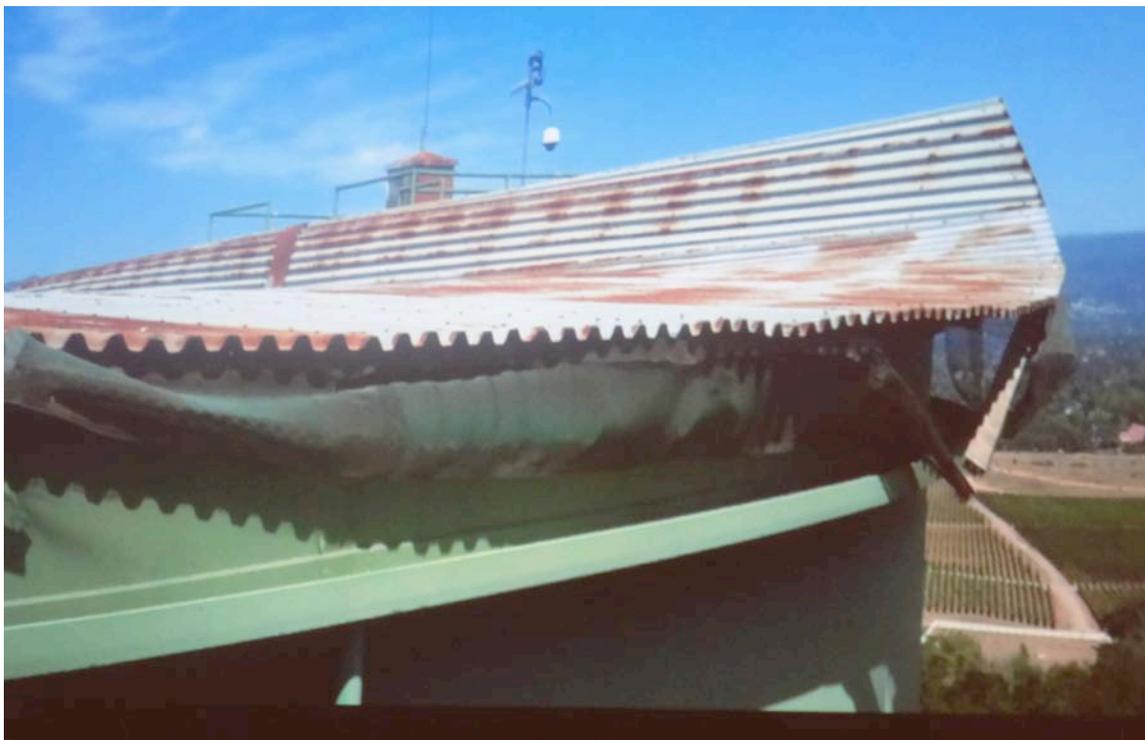
The tank did not lose its pressure boundary (likely some water was lost through the damaged roof / ventilation screens), but the tank drained rapidly all the same, owing to the damage to nearby broken pipes.

Figure 4-8. Damaged Roof of Steel Tank "B"

Figure 4-9. Damaged Roof of Steel Tank "B"

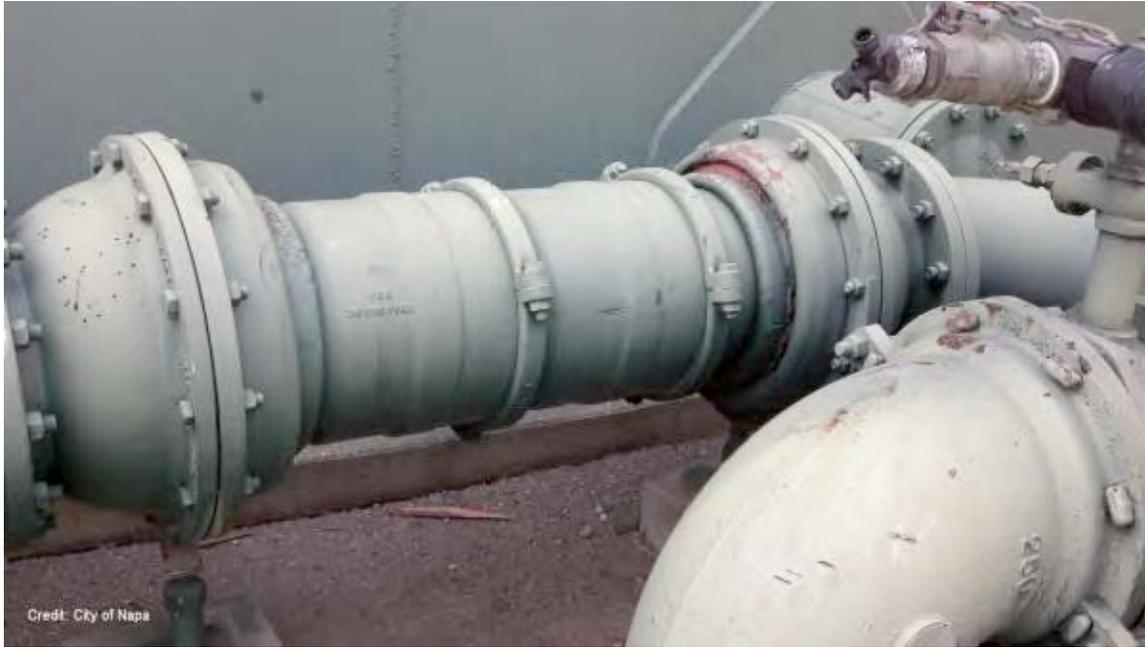
The outlet side-entry pipes used ball joint and slip joint hardware, capable of accommodating several inches of movement of the tank walls, Figure 4-10. The ball joints show evidence of rotation.

Figure 4-10. Movement of Attached Pipes

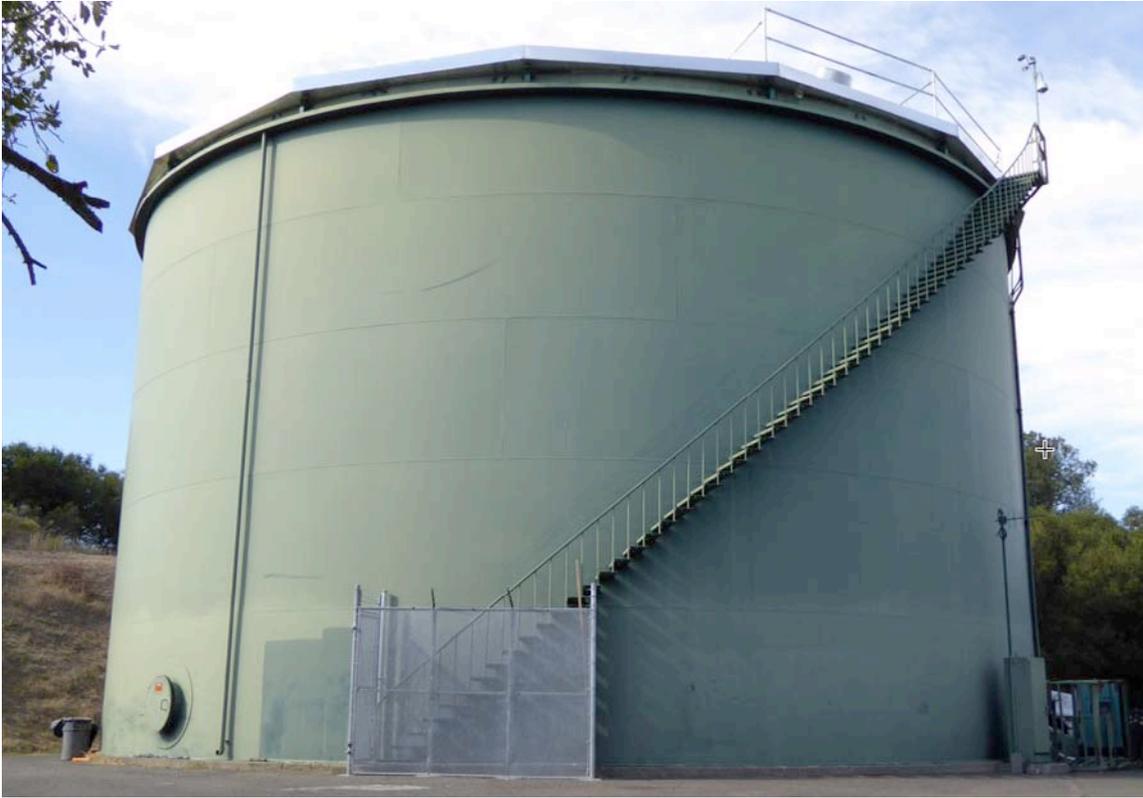
Figure 4-11. Tank B, with New Aluminum Dome Roof

Within a month after the earthquake, the wood roof system for Tank "B" was removed, and replaced with a aluminum "dome" type roof. Figure 4-11 shows the tank on October 10, 2014. The City is considering further tank modifications, including raising the steel shell by several feet to provide more clear space for water sloshing in future earthquakes, as might be suggested by the current AWWA D100 code (2013 version). The cost effectiveness of this type of modification, as well as the AWWA code provision for providing several feet of clear space for sloshing, is uncertain, as the tank still performed (held water) in the earthquake.

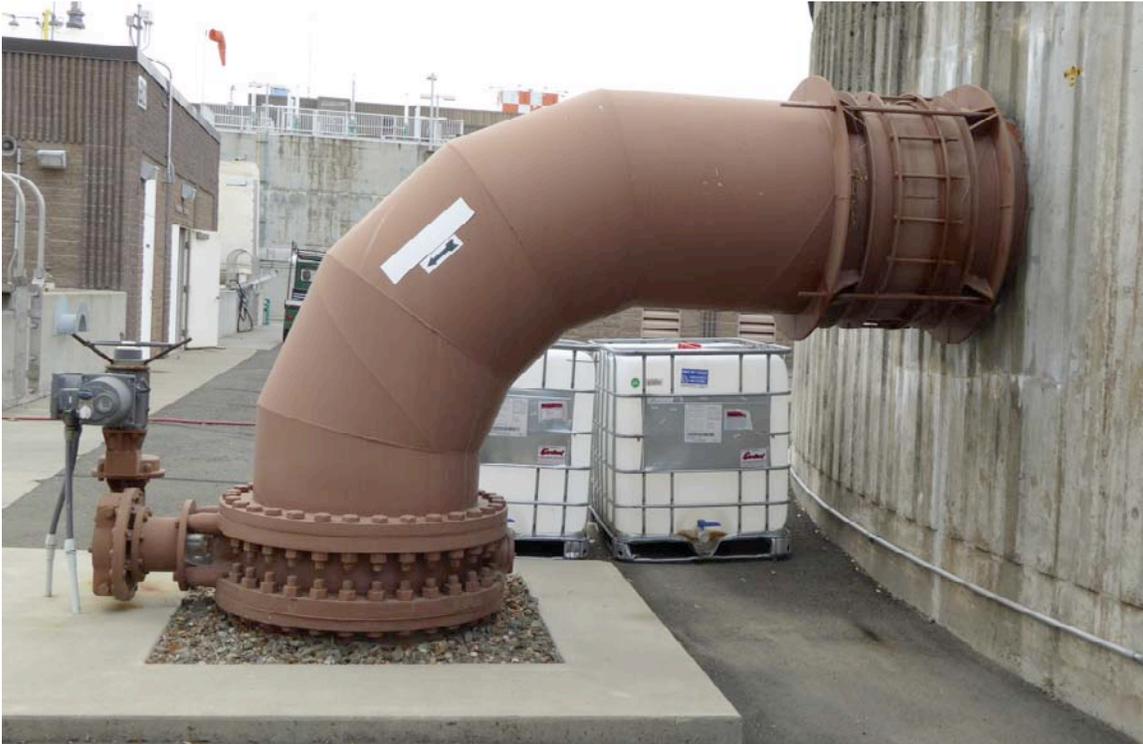
- At one location, a large pipe that enters a tank had a distressed Dresser-type coupler (slip joint). Figure 4-20 shows one of the two such pipes (the other pipe leaked); both have essentially the same details. This leak was attributed to high inertial ground shaking, rather than differential settlements. The shaking caused some movement at the slip joint. The leak was solved by re-tightening the bolts that make the connection (top right part in Figure 4-20).

Figure 4-20. Steel Pipe with Dresser-Type Coupling

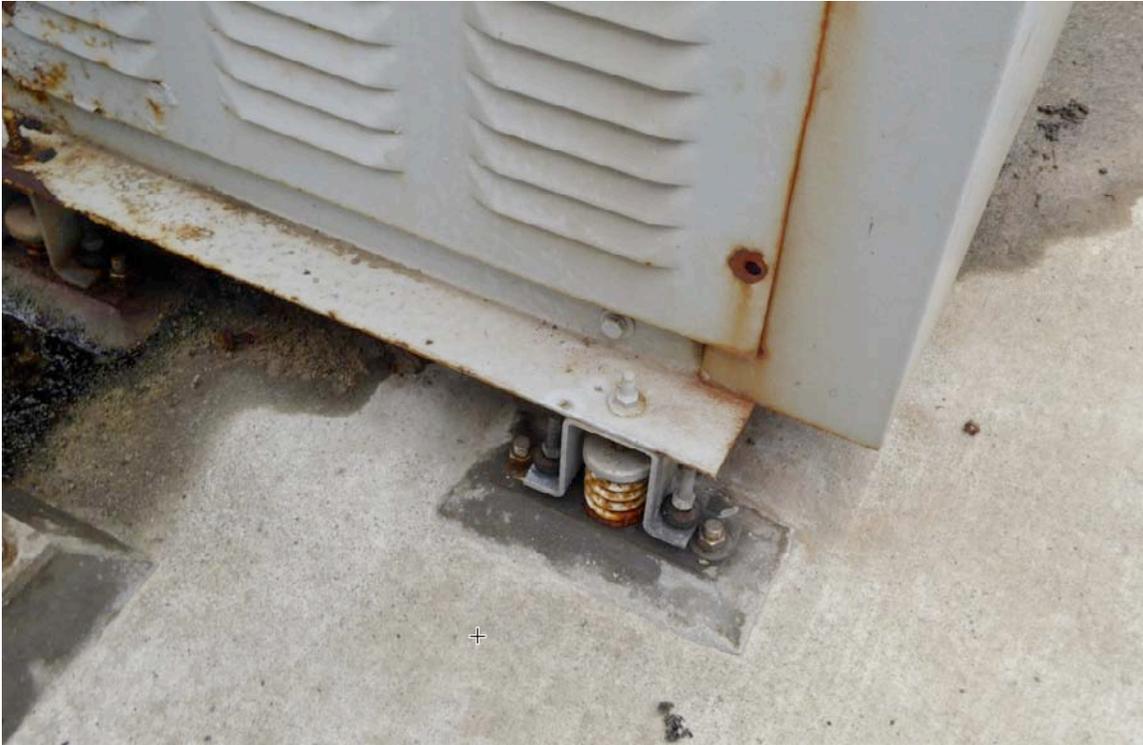
A spring-mounted motor system suffered some damage, Figure 4-21. This assembly is attached to an adjacent large diameter steel pipe. During normal operation, the spring mounts allow minor movements (commonly under 1/16th inch) of the motor assembly. To accommodate these movements, the attached pipe is supported on a concrete pedestal, and a rubber-type connector is used between the pipe and motor assembly. The earthquake broke the first pipe support. This pipe support had already sustained considerable damage due to corrosion, prior to the earthquake, and the incremental forces applied during the earthquake failed the support.

Figure 4-21. Spring-Mounted Motor Assembly

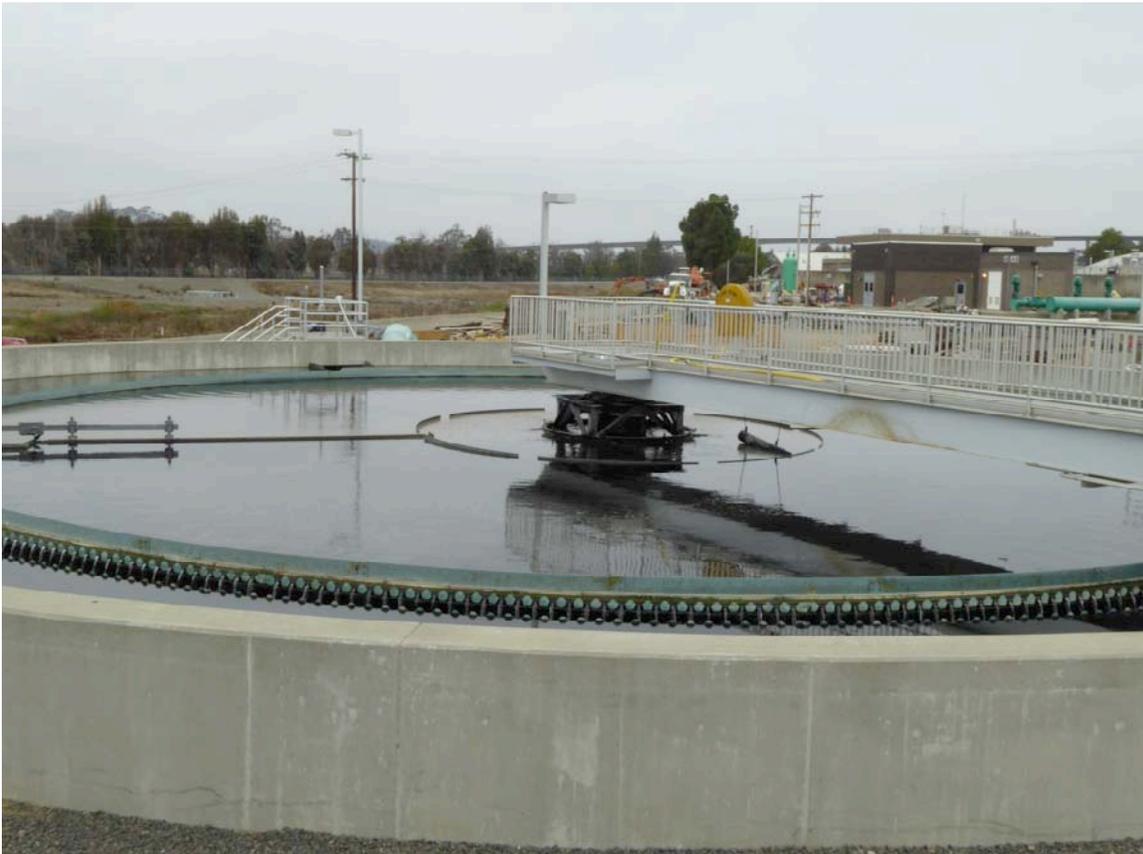
Discussion with plant staff indicate that there might have been some slight rocking of the central tower of the full clarifier in Figure 4-23, as the inside baffle (steel plate) seems to be slightly tilted; but as of 7 weeks post-earthquake, the clarifier had not been drained to verify the condition of the tower anchor system. While water sloshing as certain to have occurred, as the earthquake occurred during the night-time, there was no one there to observe the actual wave heights; there were no reported obvious solids on the ground adjacent to the clarifier.

Figure 4-23. Full Clarifier

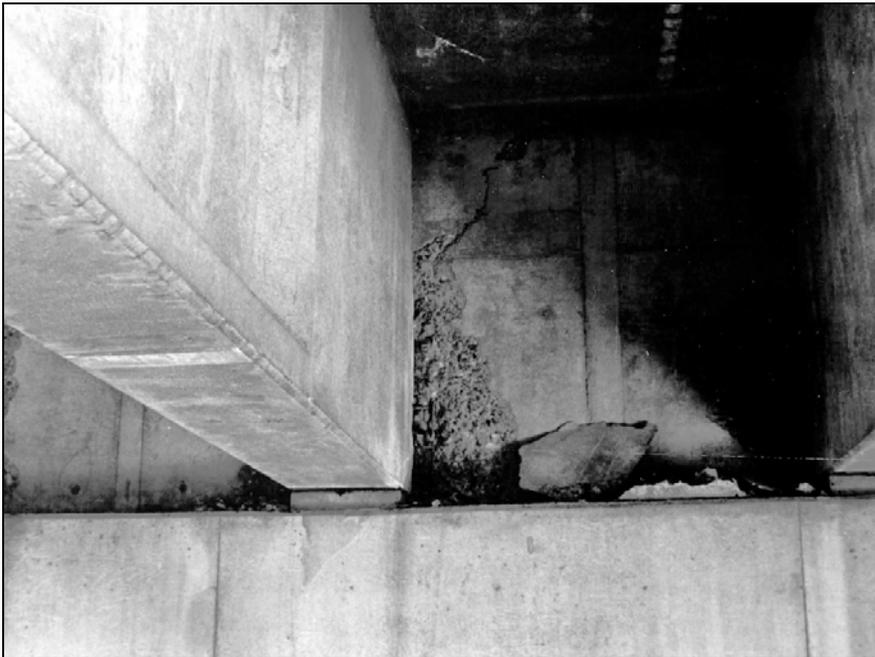
Figure 5-5. Damage to Napa River Bridge during the Loma Prieta 1989 Earthquake

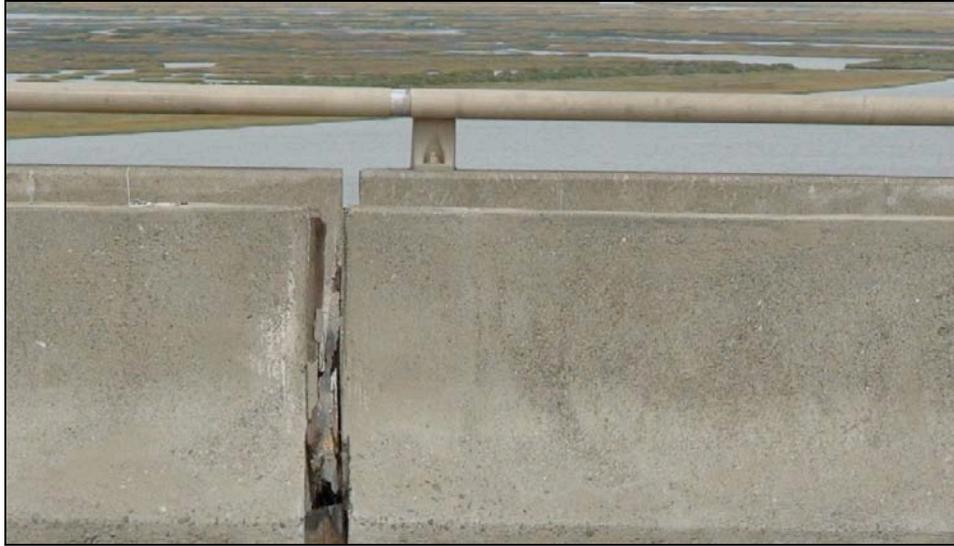
Figure 5-10. Damage to the Napa River Bridge was Permanent Longitudinal Displacement at the Expansion Joints

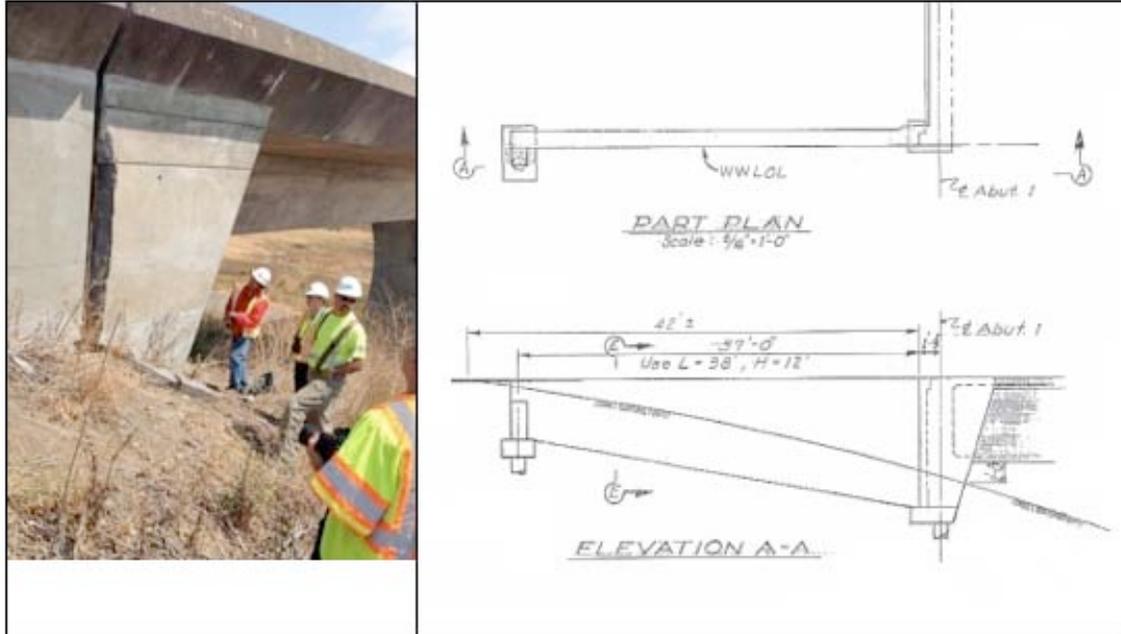
Figure 5-14. Abutment 14 concrete spall on the Napa River Bridge and Overhead

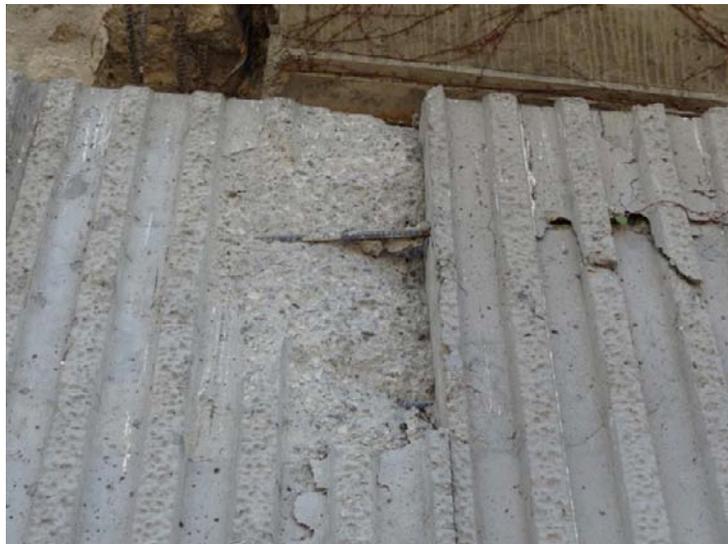
Figure 5-17. Close-up of damaged curtain walls on the Napa River (West Imola Ave) Bridge

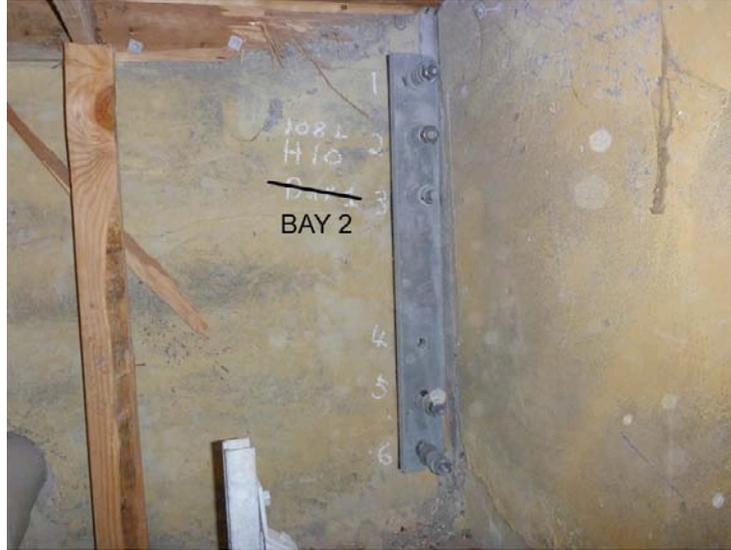
Figure 5-18. Restrainer damage at Hinge 10, Bay 2 of Napa River (W. Imola Ave) Bridge

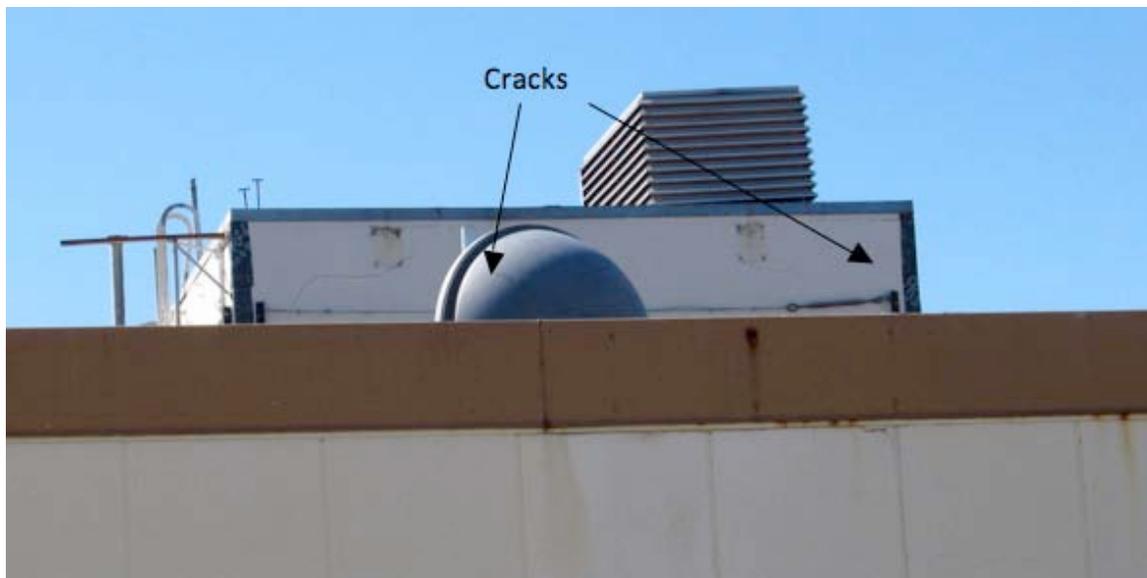
Figure 6-3. Additional cracks in the wall opposite to the one that fell
