FRAGILITY OF ELECTRIC POWER DISTRIBUTION SYSTEMS

J. Eidinger⁽¹⁾

Abstract

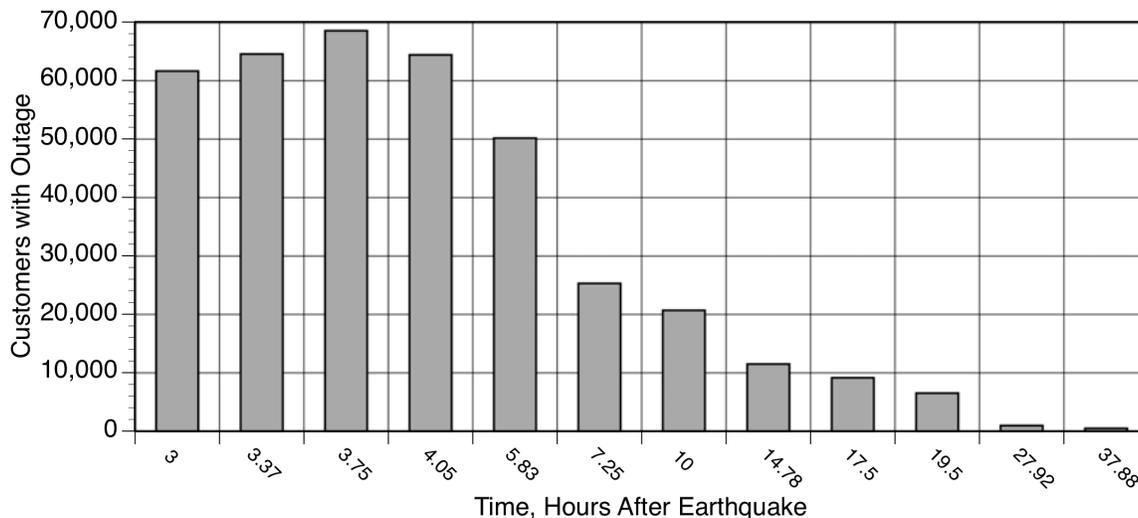
Fig. 1 - Power Outages

Over the past two decades, PG&E has upgraded and replaced most of the older equipment and control buildings at six high voltage substations (69 kV to 230 kV) located within 30 km of the August 24 2014 epicenter. These efforts were successful, as there was zero damage that resulted in any outages, to any piece of PG&E high voltage equipment at the six high voltage substations in the Napa area, even though each of these substations having experienced PGA between 0.20g and 0.30g (and possibly somewhat higher). All the 70,000 customer outages was due to damage of low voltage distribution lines (11 kV to 22 kV primaries and low voltage secondaries).

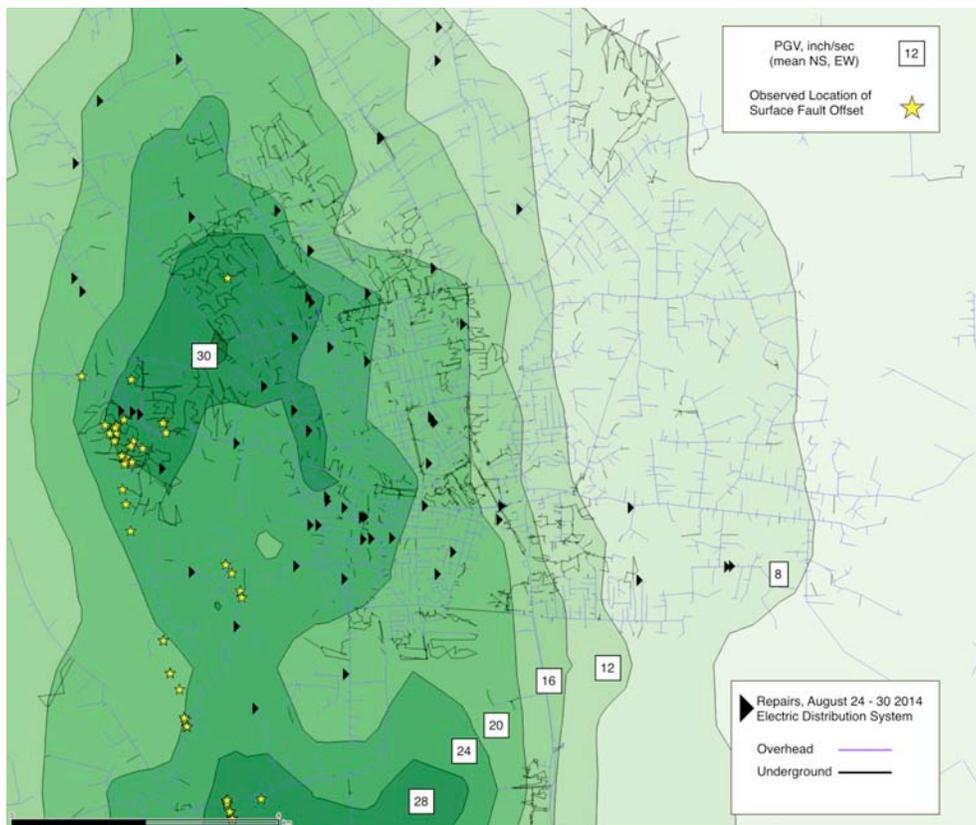
Fig. 5 - Electric Distribution System Repairs near the City of Napa

Fig. 5 highlights the location of repairs (black triangles) in and near the City of Napa with respect to overhead (purple lines) and underground (black lines), along with the PGV levels (green shaded contours) and locations of observed surface faulting (yellow stars). There is a strong correlation of overhead repairs with higher PGV; and very little (if any) correlation of damage of overhead or buried circuits with surface faulting location. There was no damage to buried feeders due to surface faulting that occurred at the locations indicated by the yellow stars in Fig. 5; this strongly indicates that PG&E's design practice to place buried feeders in PVC (or similar) ducts, leaves enough slack in between the conductor cable and the PVC duct to accommodate about 10 to 20 cm of PGD.

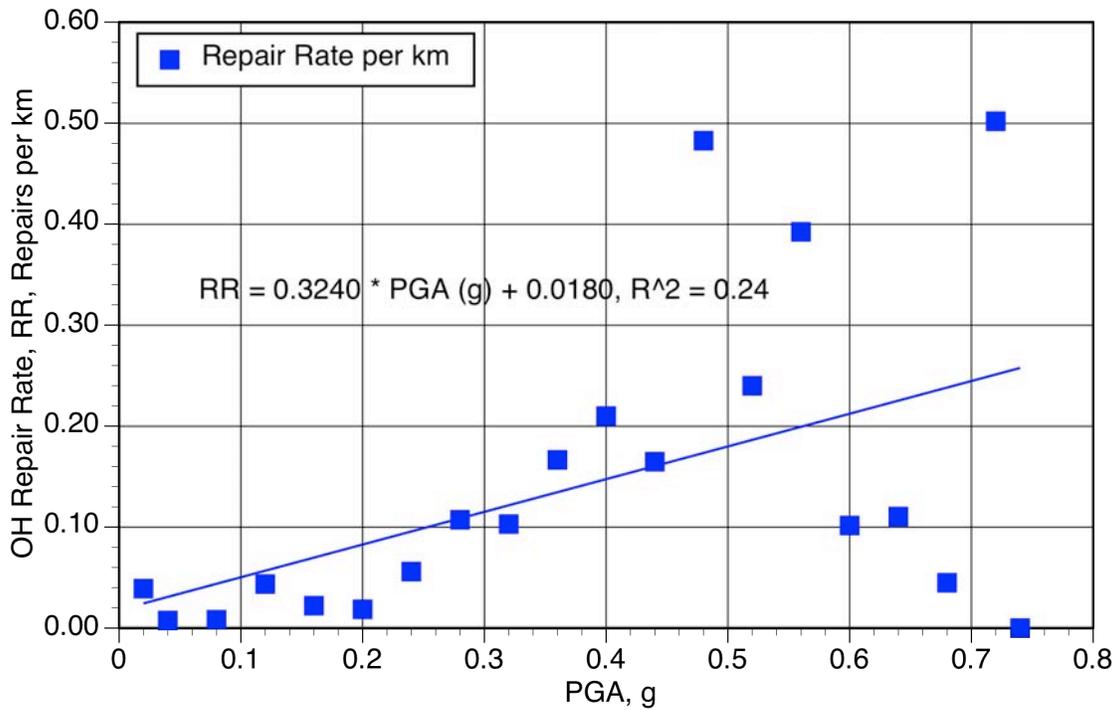
Fig. 6 - Repair Rate, Overheads, Using PGA

The results using PGA and PSA(T=3.0 seconds) are presented in Figs. 6 and 7. These figures show that there is a clear trend of increasing repairs with increasing seismic hazard. The regression R^2 value for PGA (0.24) is much lower than for PSA (T=3 seconds) (0.96). This suggests that PGA is not a very good predictor. The R^2 value for PSA (T = 3 seconds) is very high. Mostly, we think that the better goodness-of-fit for long period motion is because the overhead poles and wire systems are mostly long period structures and the level of damage is largely due to the differential movements between overhead poles that lead to high cable "snapping" forces if the available slack is insufficient to accommodate the relative movements between poles or between poles and the customer's buildings.

At the highest levels of PGA (0.6g or higher), Fig. 6 shows that there is a very large increase in scatter in the damage data; either there was very little damage or very large damage. This seems "counter-intuitive", but in fact, if one assumes that long period motions drive motion of the conductors, and hence loads due to insufficient slack issues, as well as wire-slapping issues, this trend might not be unexpected as there is not much correlation of PGA with longer period pulse-type earthquake motions.

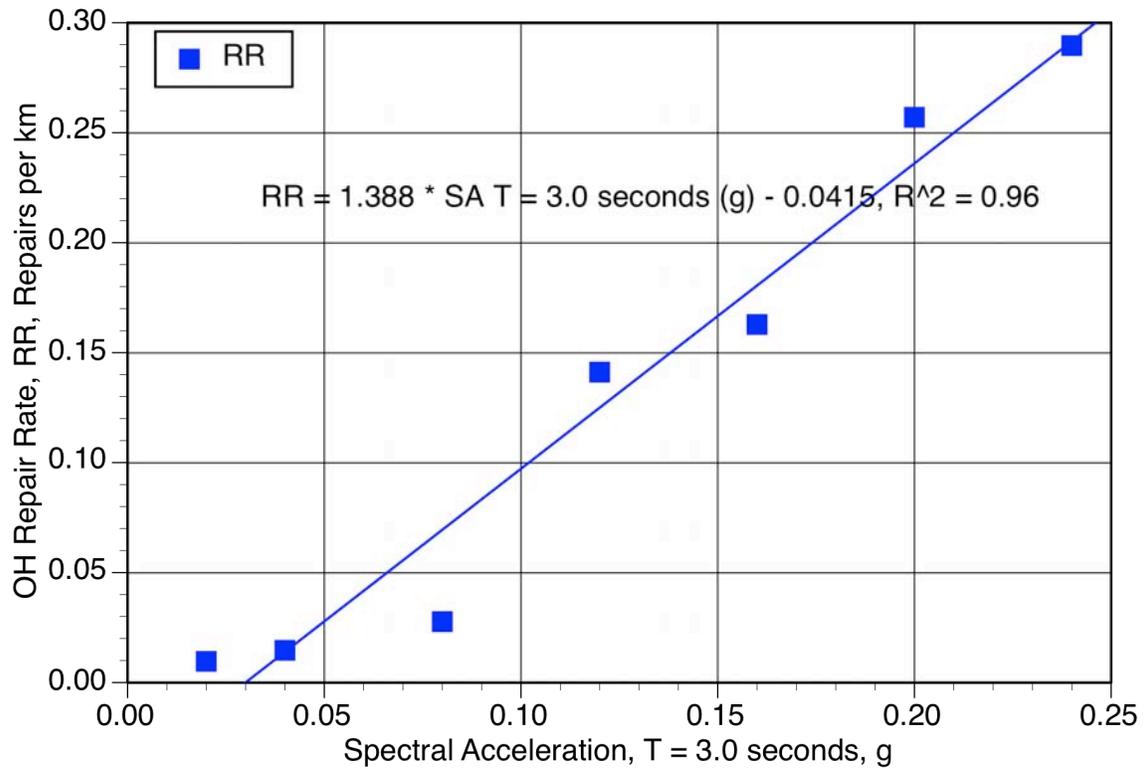
Fig. 7 - Repair Rate, Overheads, Using PSA (T = 3.0 seconds)

Based on these findings, we think that use of PGA (or short period spectral accelerations) for predicting damage to overhead distribution systems is inferior. Use of the PSA (T = 3 seconds, 5% damping) value appears to be best, and reflects the likely range of periods of combined pole and wire systems. If one needs to forecast overhead damage in a "near real time" situation, (like within a few minutes post-earthquake, as soon as instrument recordings can be processed), if the long period information (T = 3 Spectra value) is not yet available, then use of PGV with equations (3) and (4) can be used with reasonably good results.
