Report on the
Napa - American Canyon Earthquake of 8.24.2014
Mw 6.0 - Performance of Lifelines

Bay Area Center for Regional Disaster
Resilience

Dublin, CA, February 20 2015

John Eiding
G&E Engineering Systems Inc.
eidinger@geEngineeringSystems.com

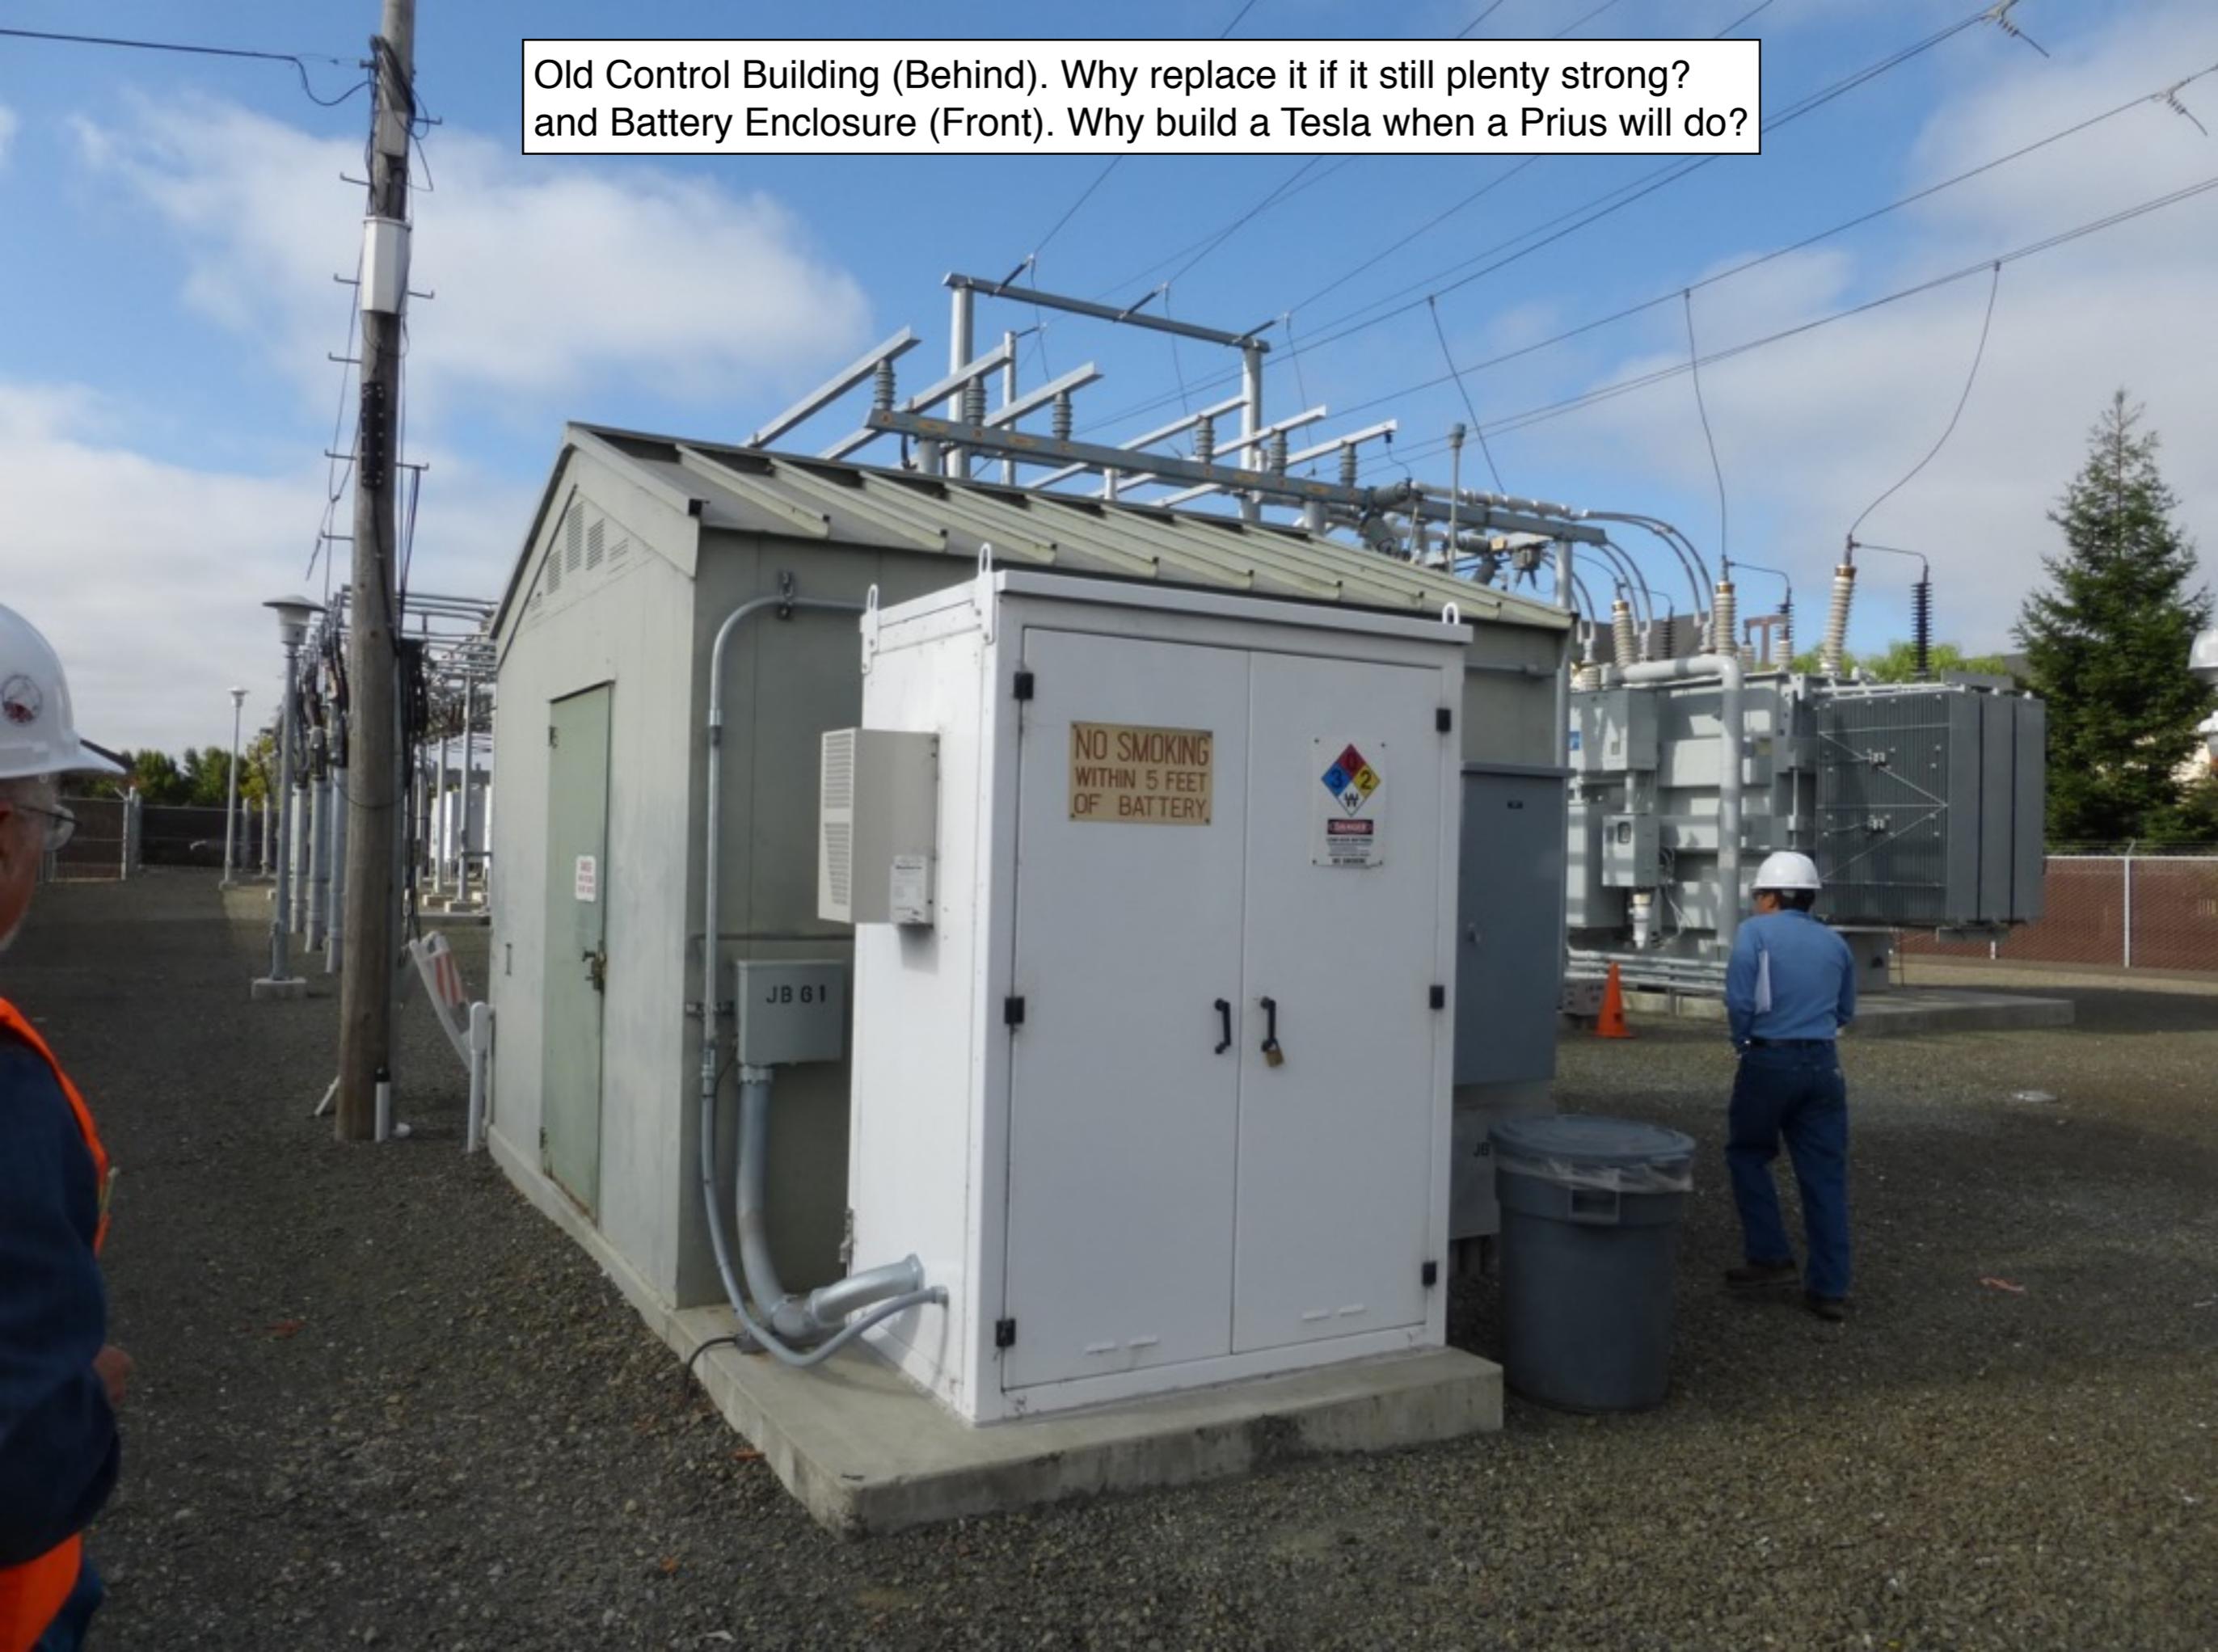
Everything OK at PGA = 0.30g.

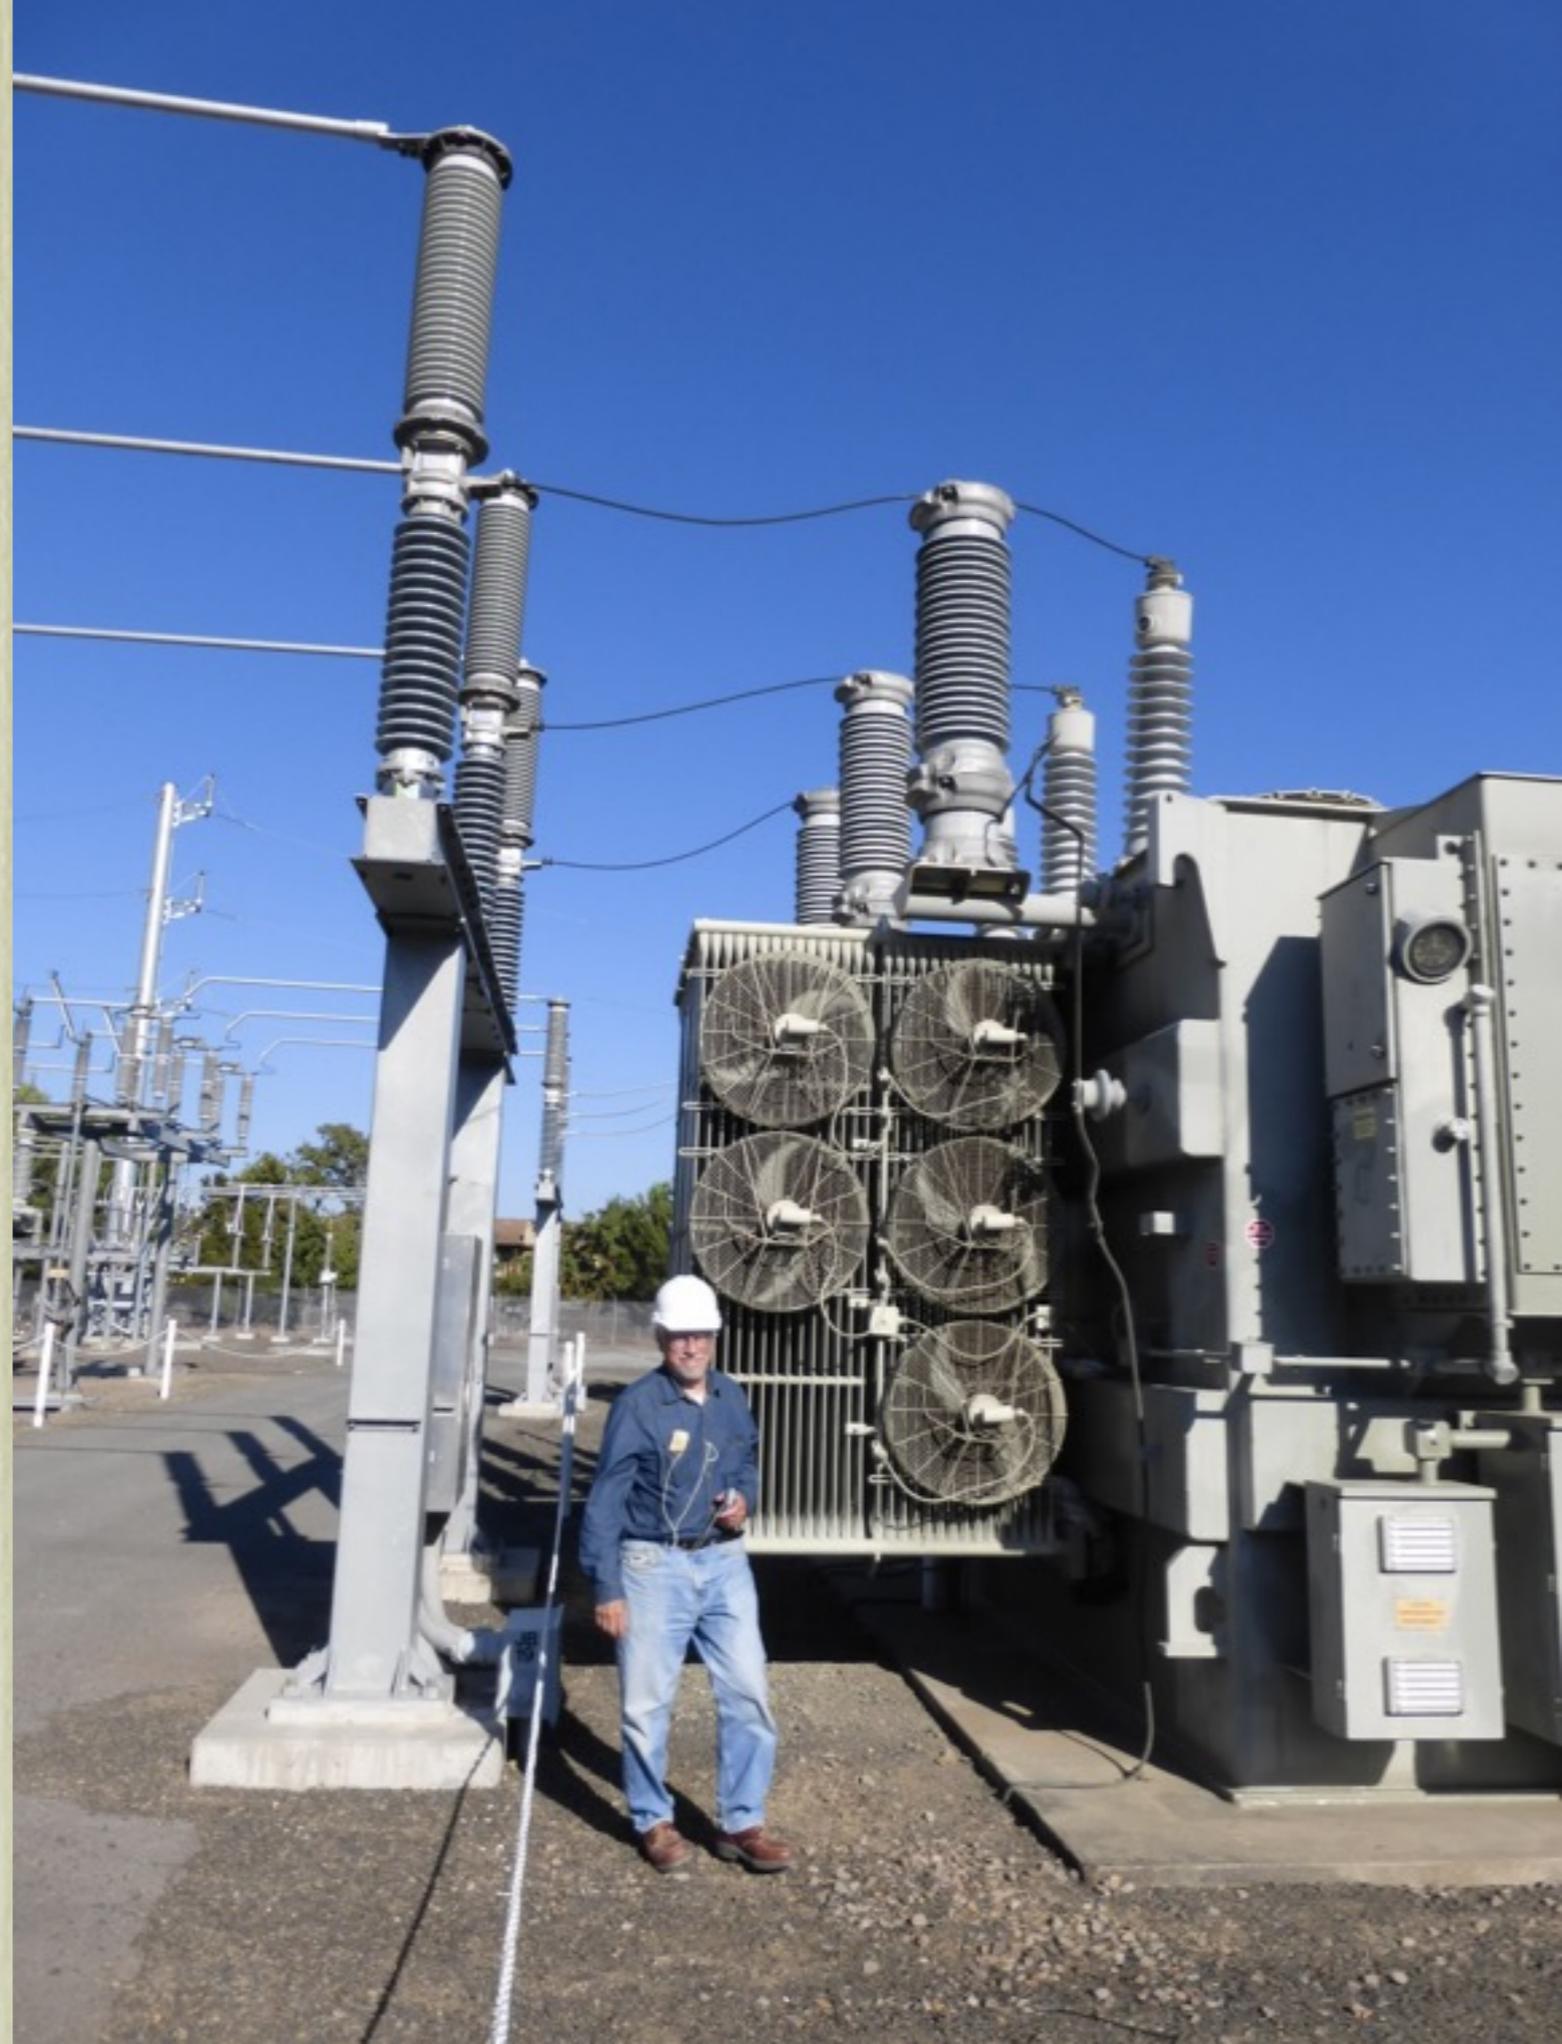
115 kV - 12 kV Bank 1

Oil leaks appears to be from top pipe connections (as expected / common)

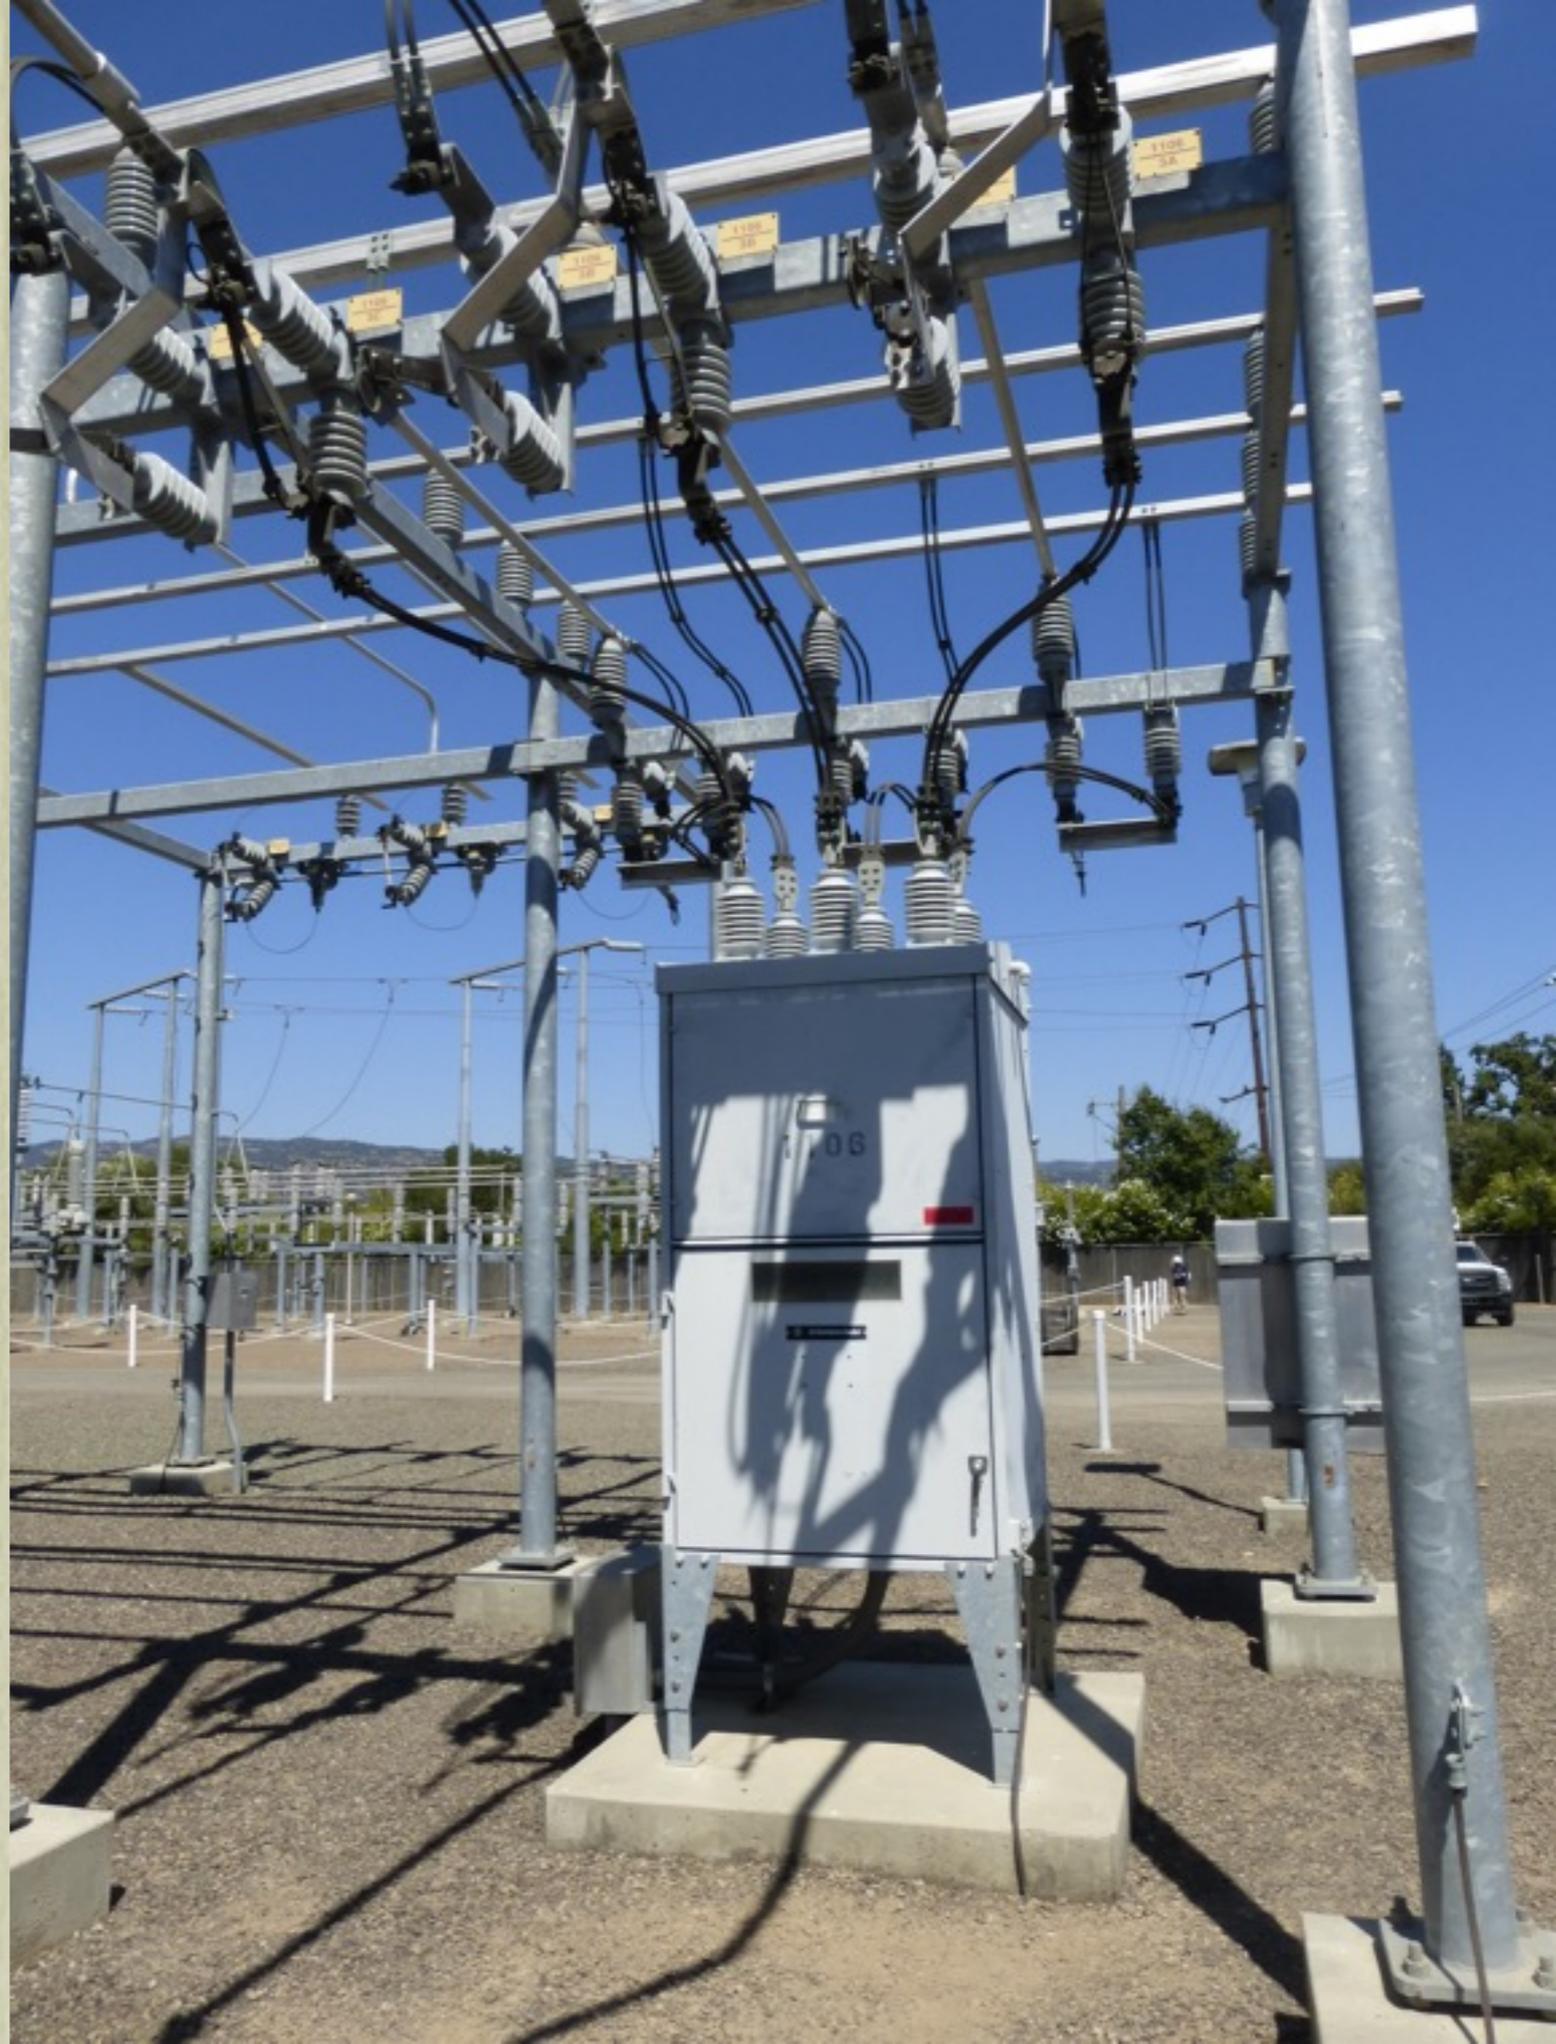
12 kV Circuit Breaker and switches
some settlement

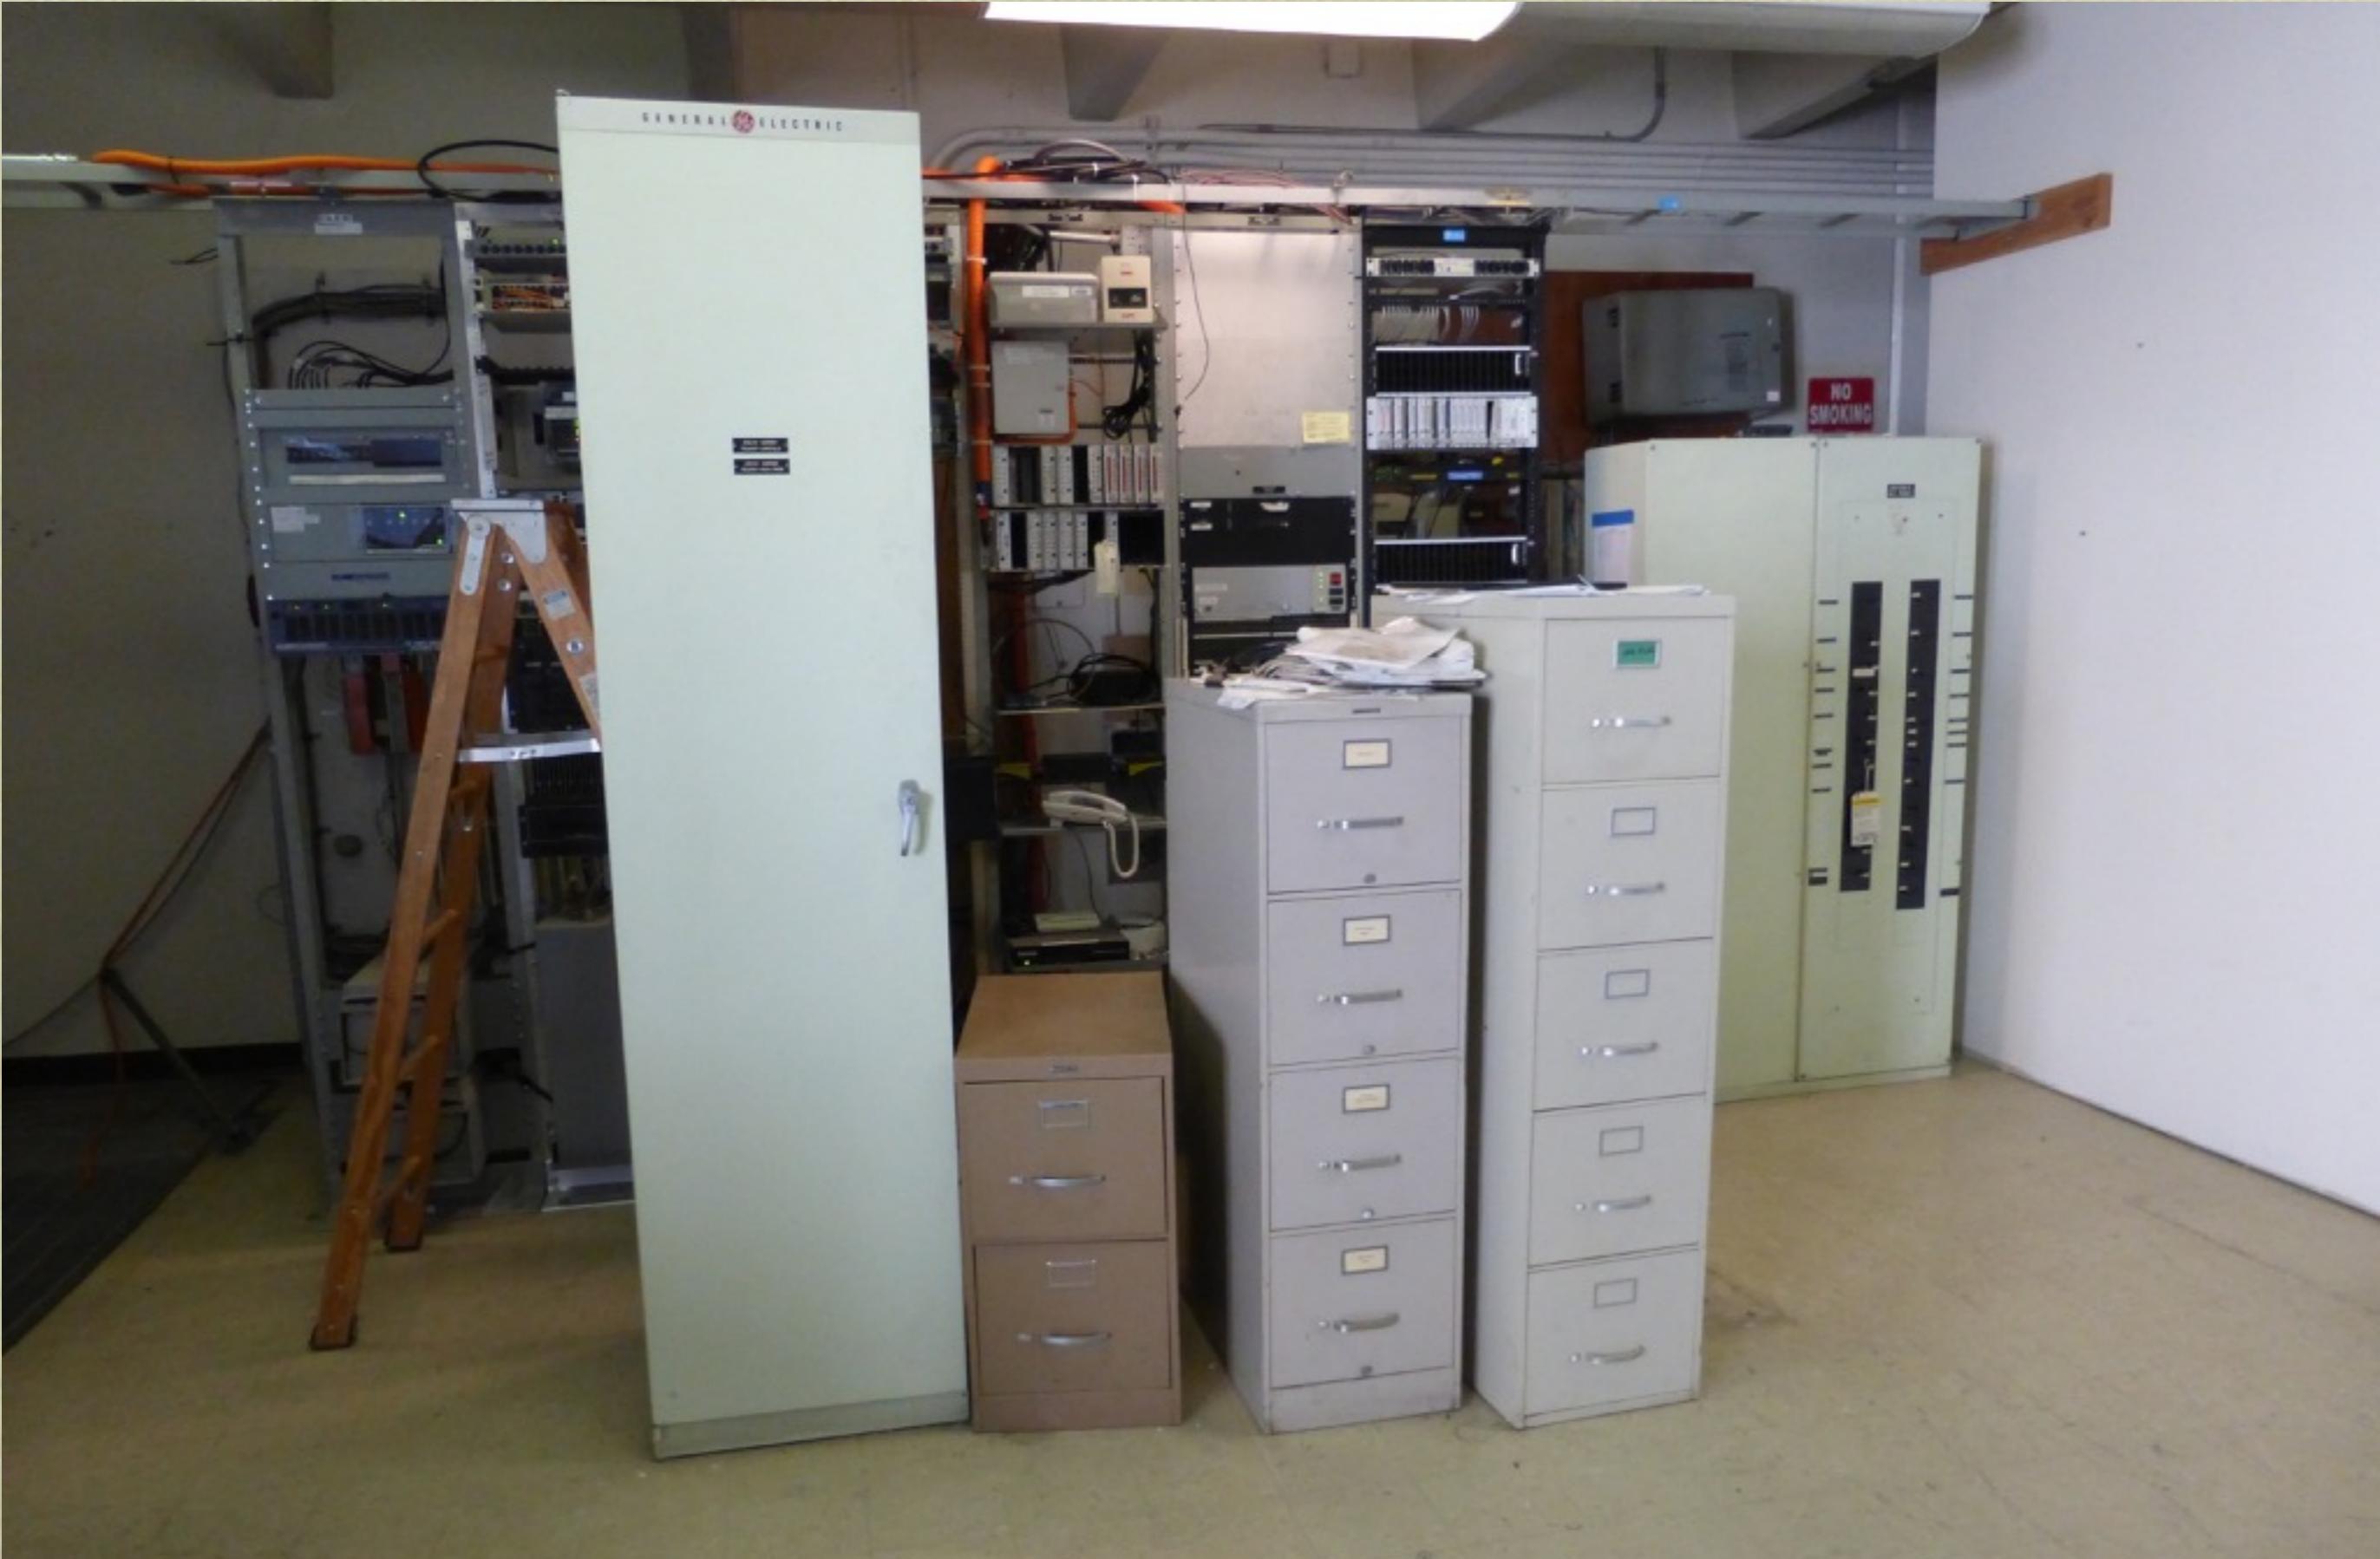
Unanchored Cabinets rocked to these positions (formerly cabinets were tight against each other).

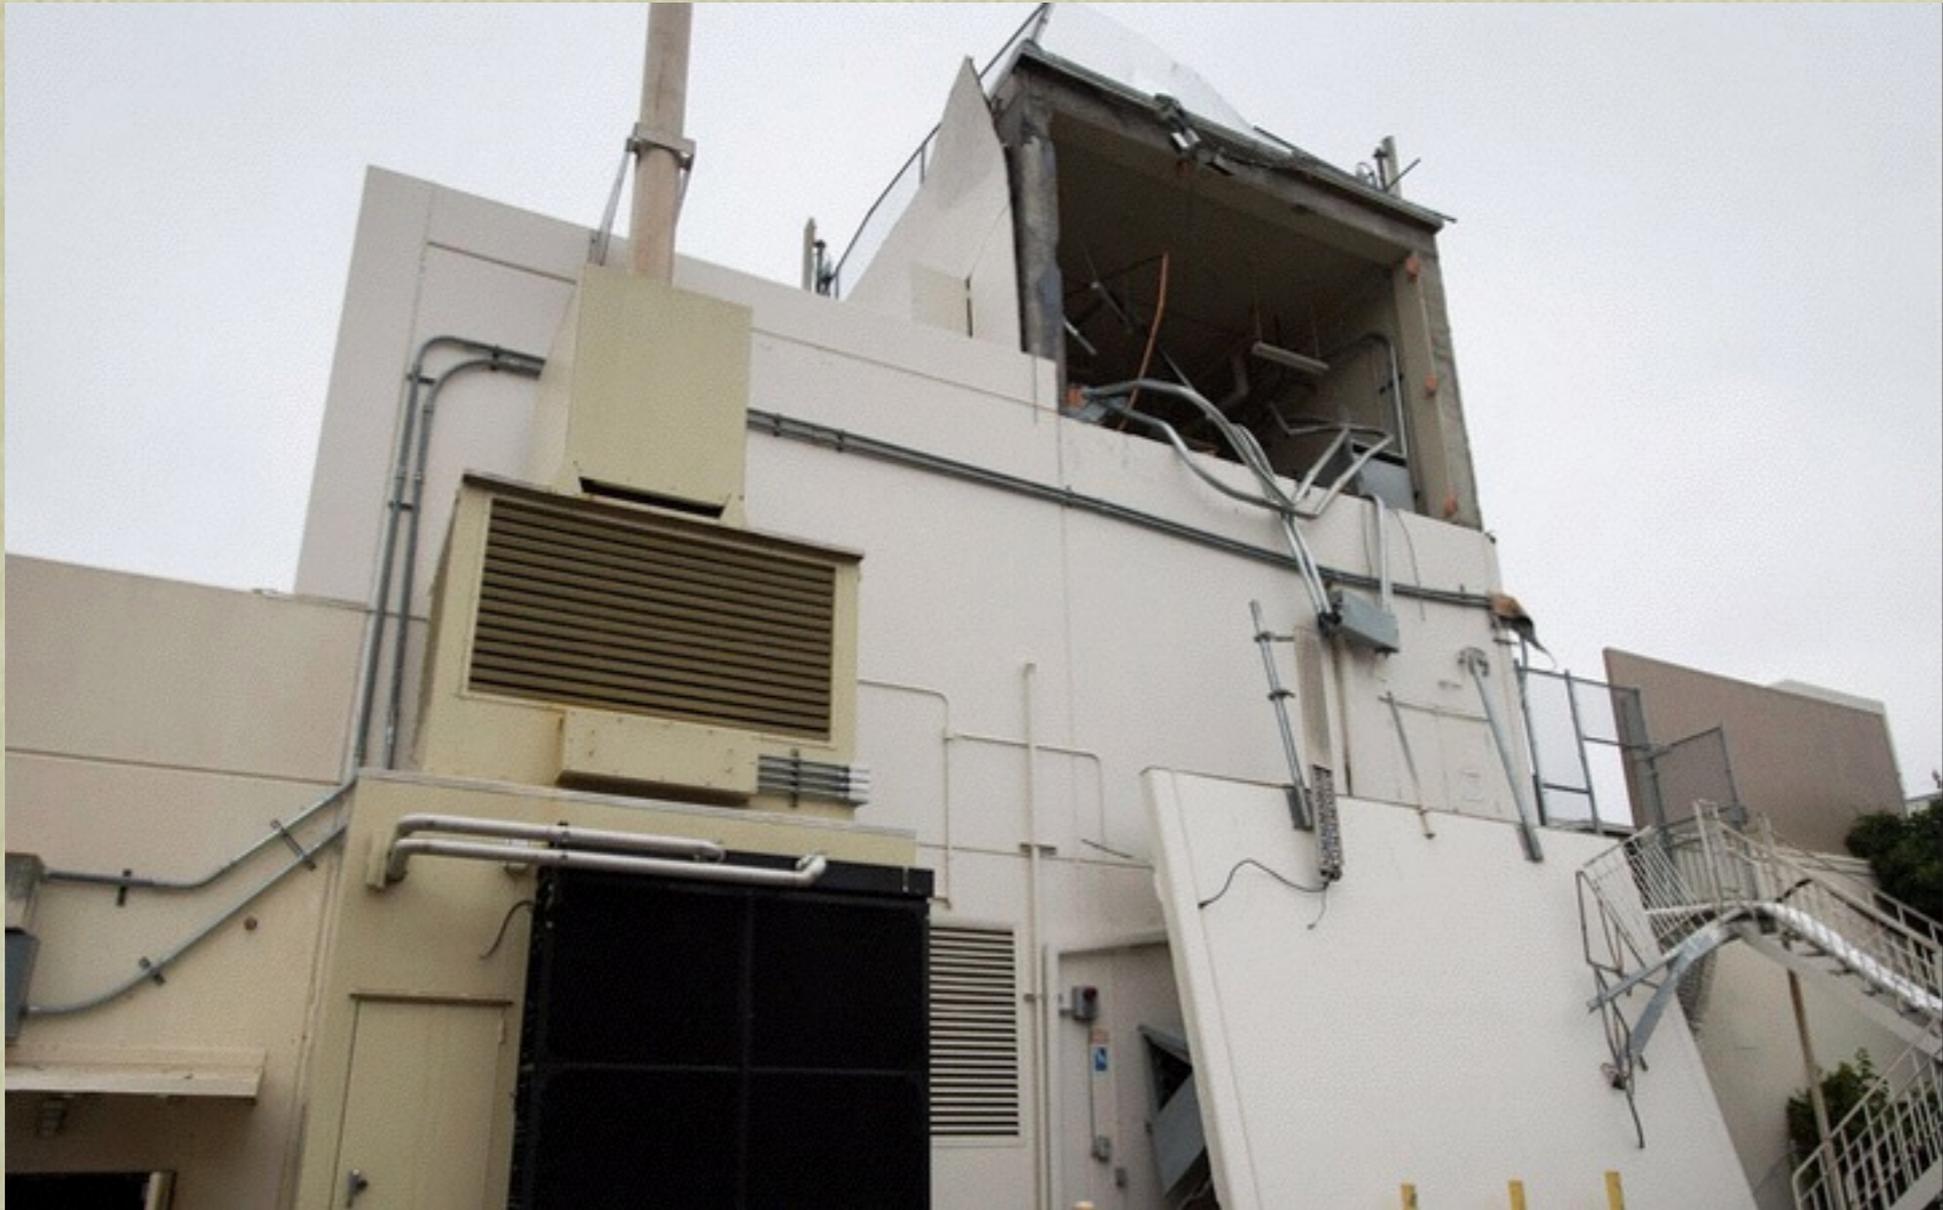
Wall Panel Fell. Was held by 4 tabs, for future expansion. Building racking damaged the tabs. Panel fell onto HVAC equipment, damaging cooling system. PG&E power equipment was also damaged by the falling wall. Emergency generator failed to start. Back up batteries worked well. But, batteries need to be recharged.... a priority to get a generator to recharge the batteries. No real loss of service, as AT&T was able to respond.

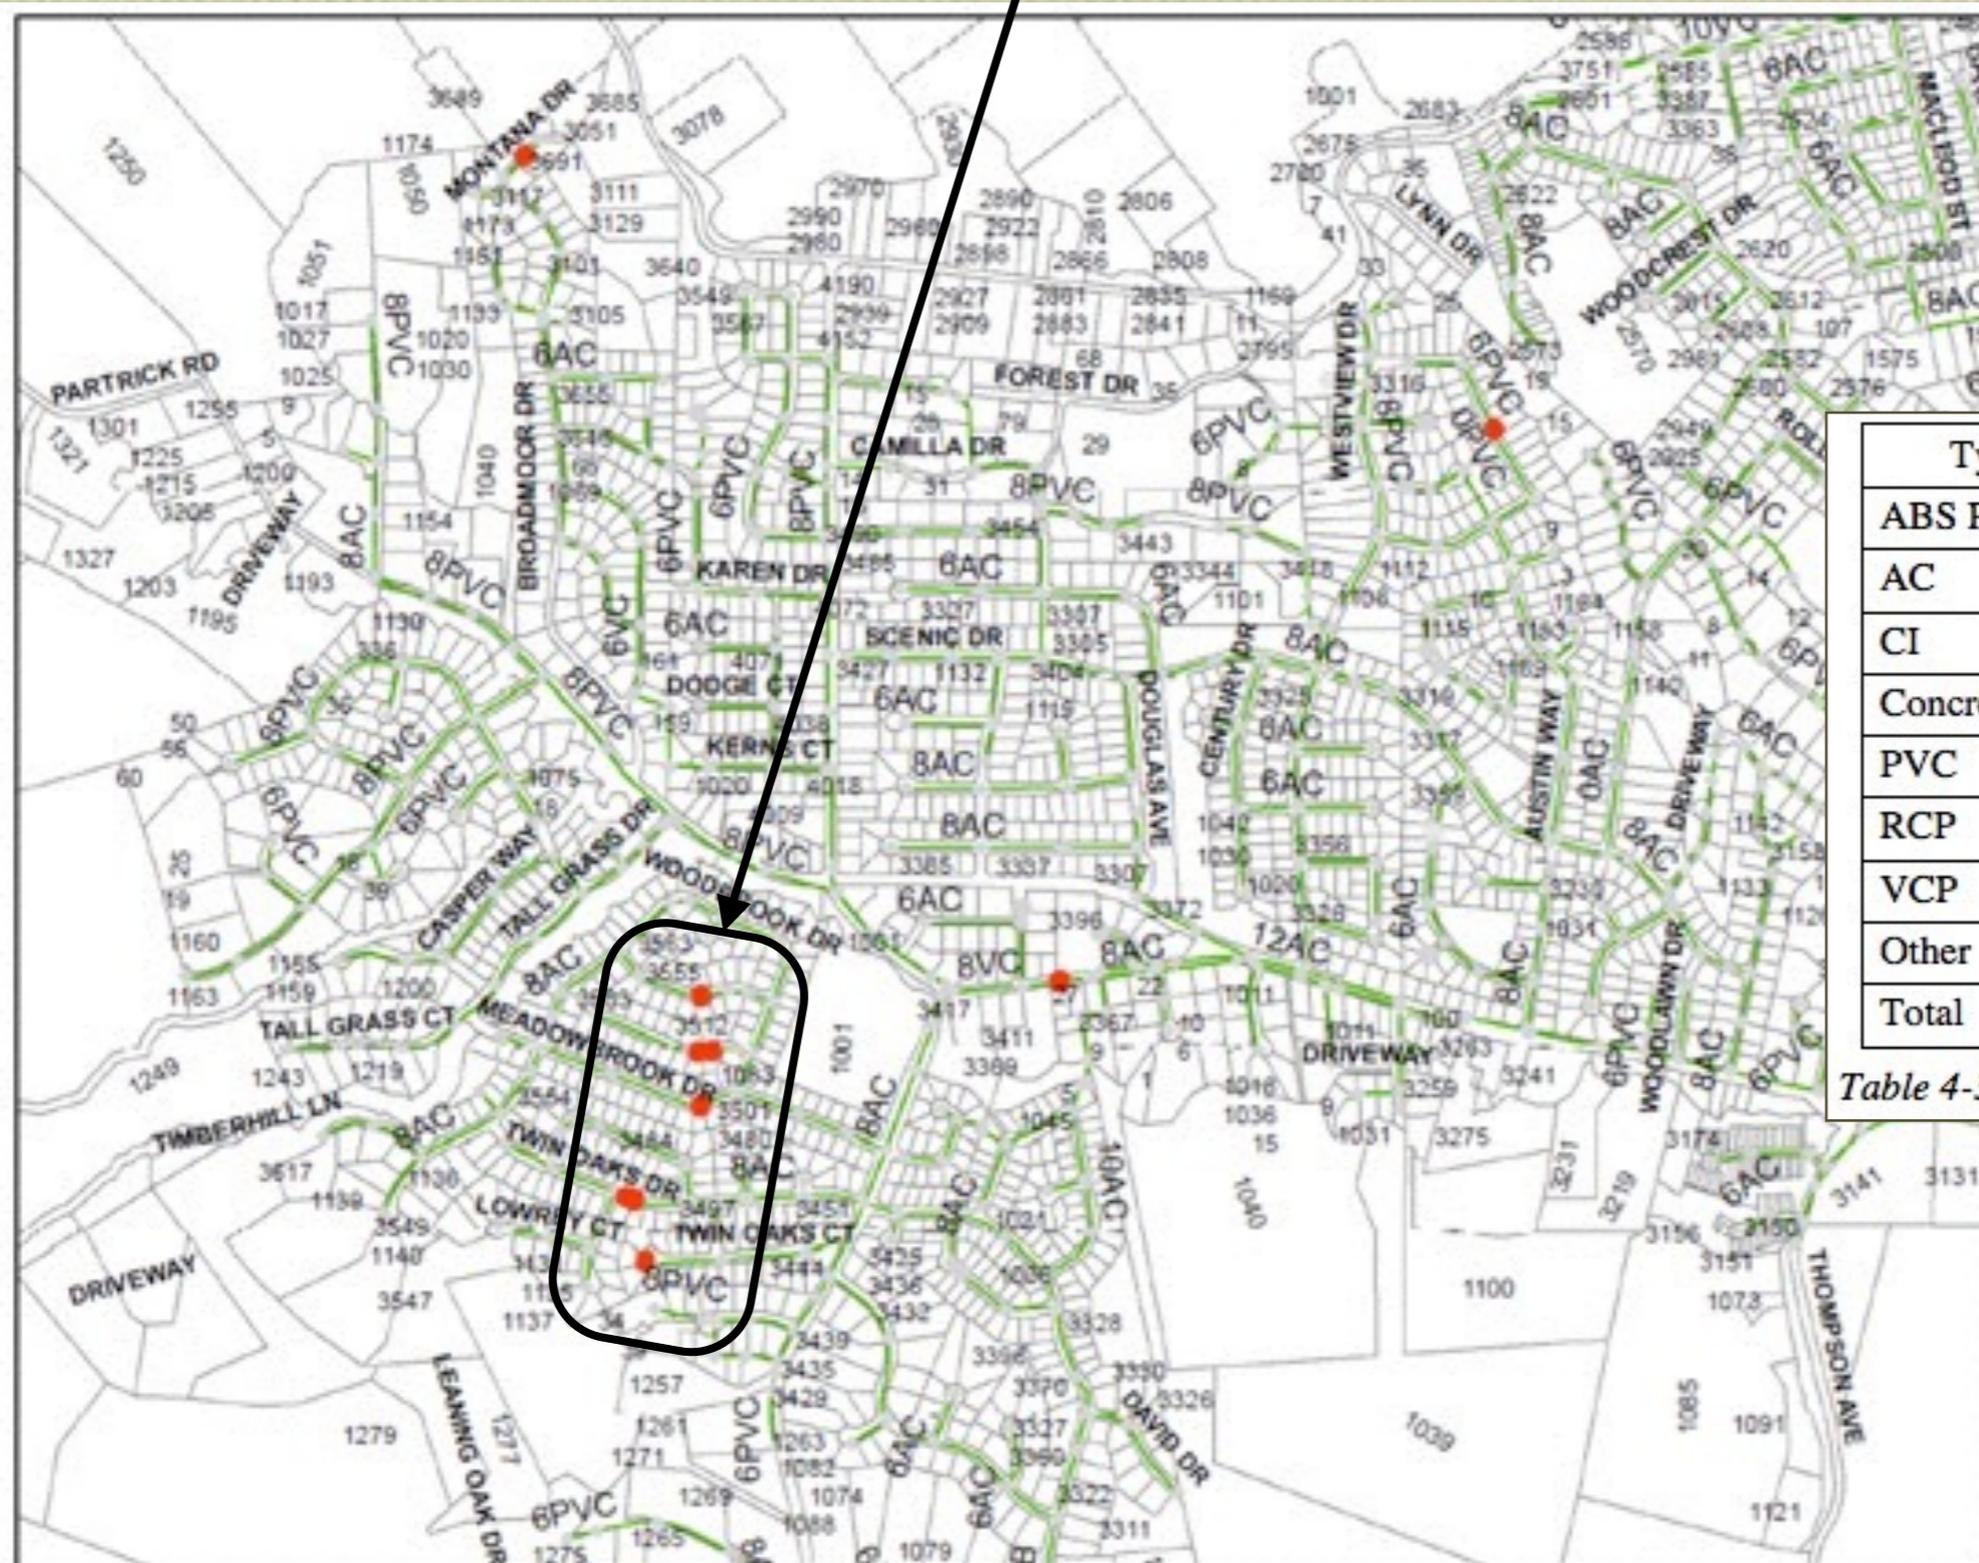
Figure 4-16. Location of Sewer Breaks

Zone with Concentrated Sewer Pipe Breaks

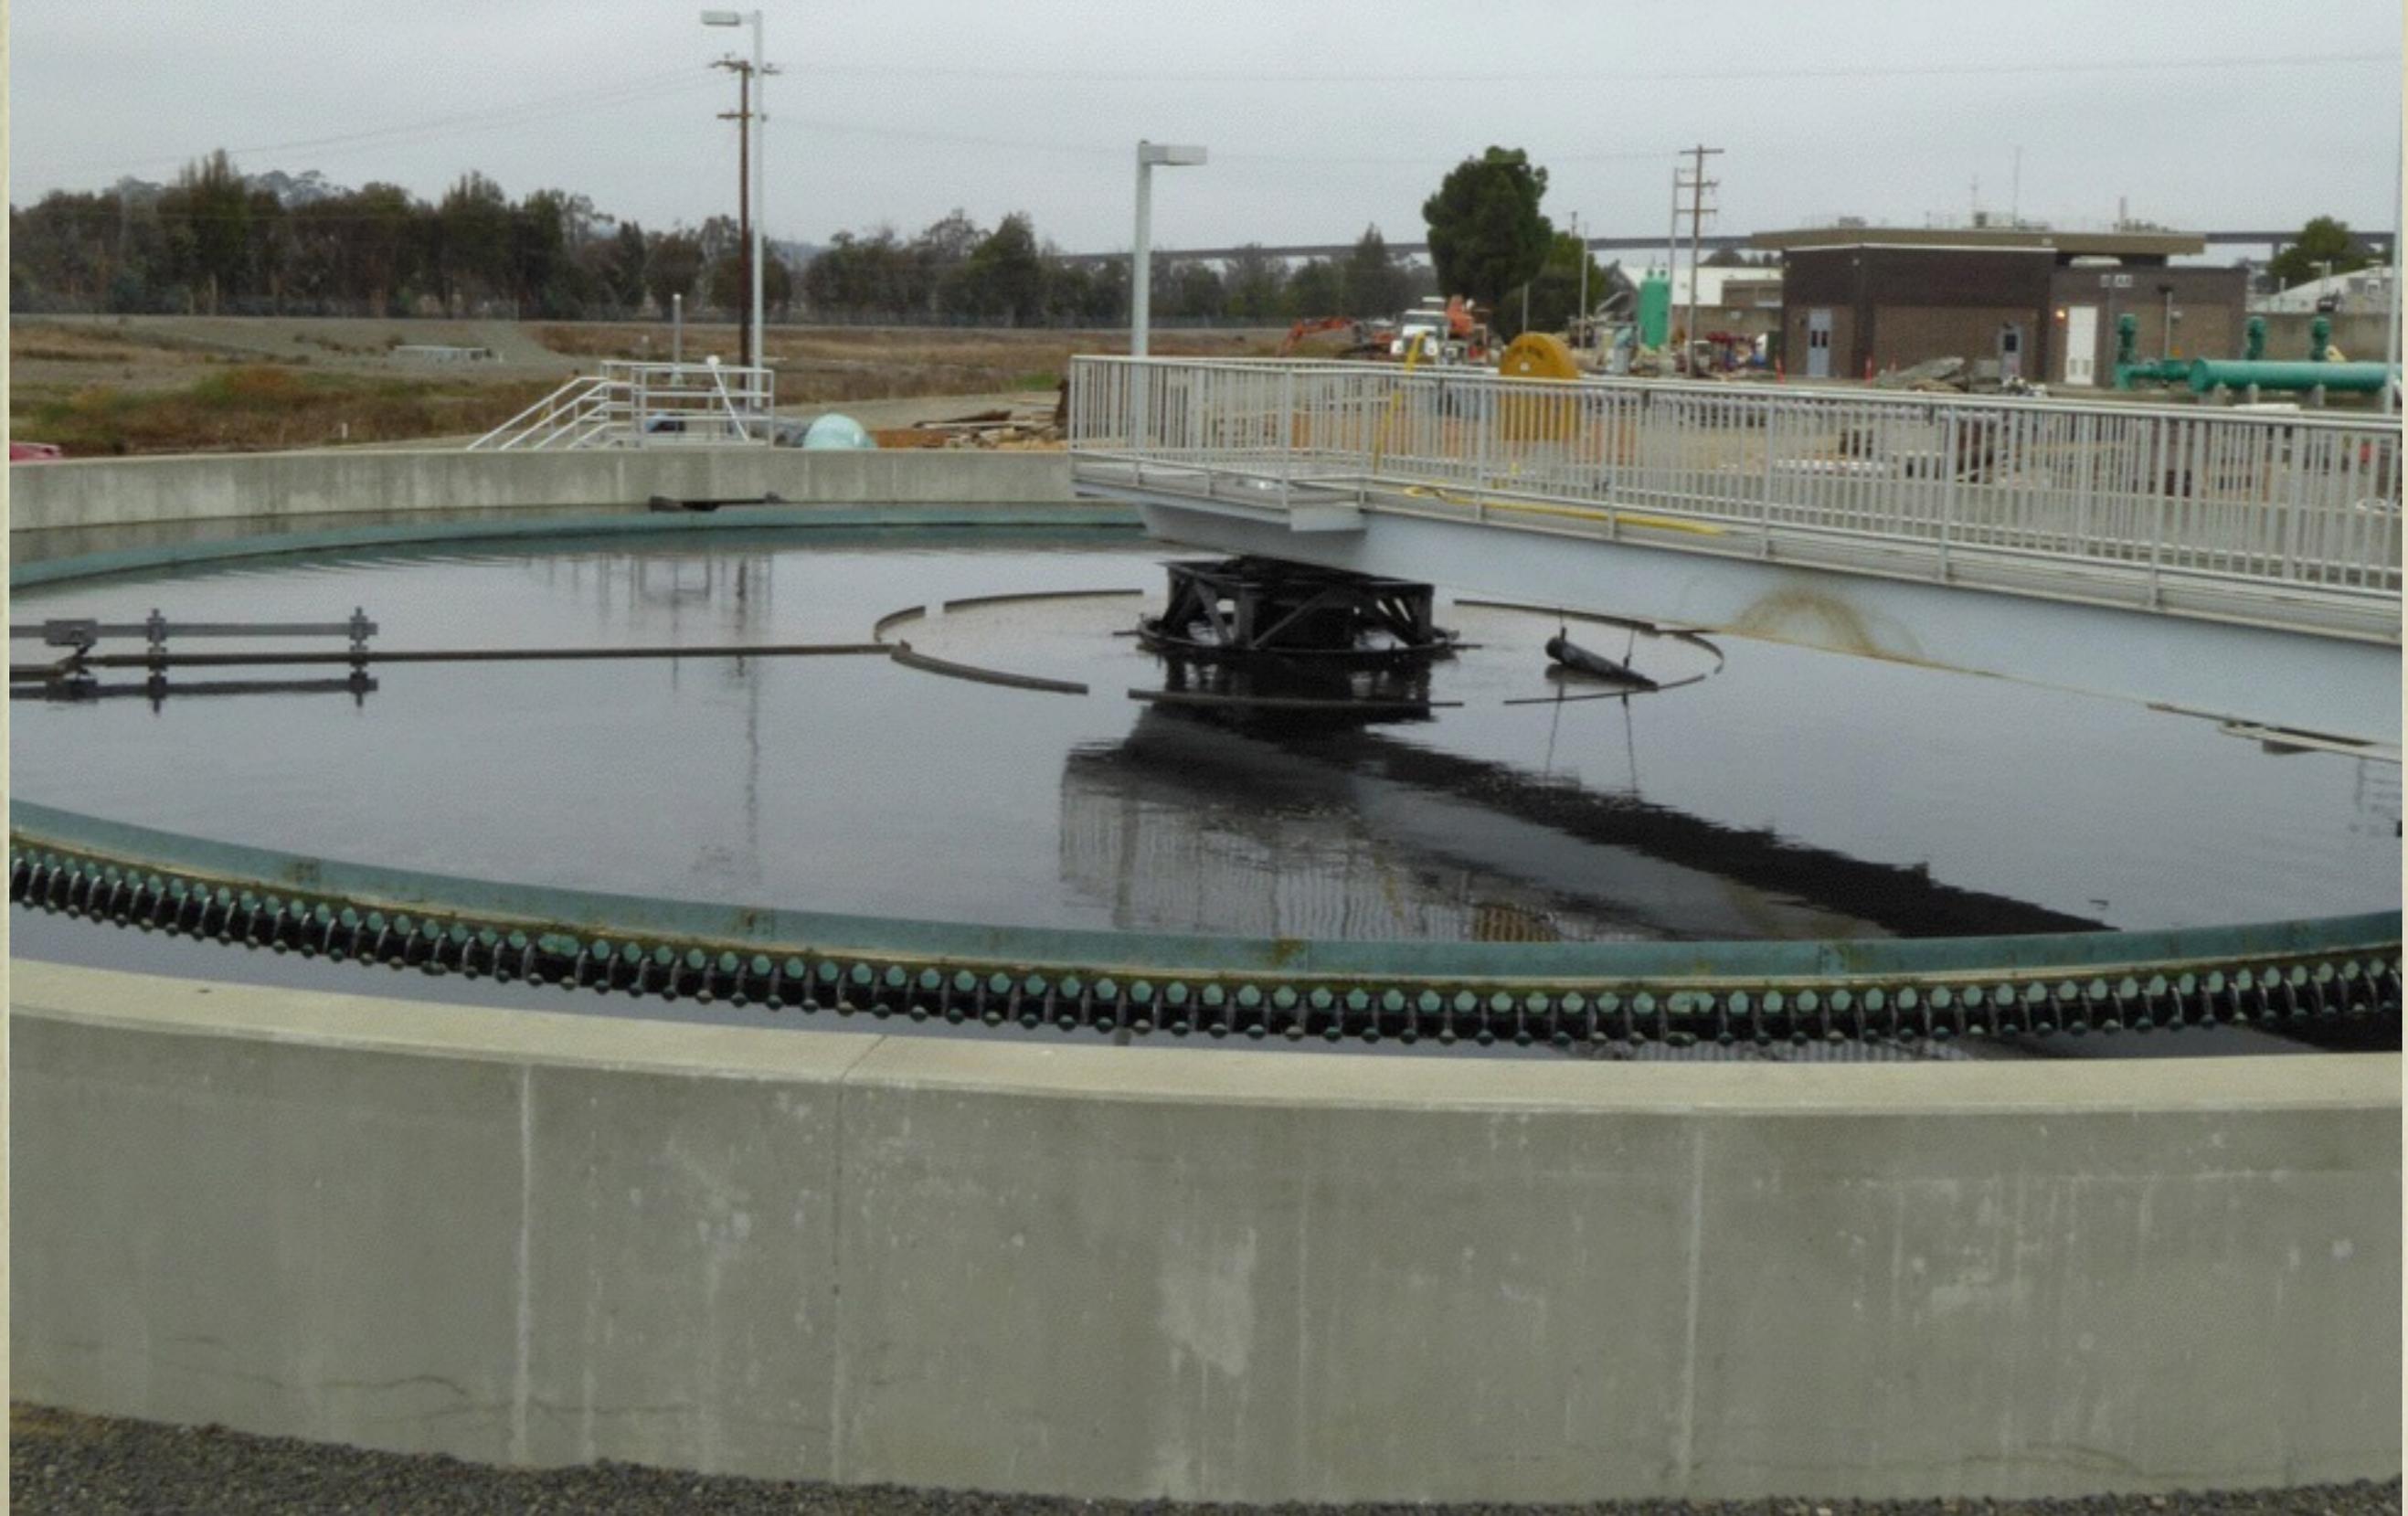
Possible Rocking of Center Tower in Clarifier
