Napa Earthquake of 8.24.2014 Performance of Lifelines

Water, Power, Gas, Fires

City and County Engineers Association of
San Mateo County

South Napa M 6.0 Earthquake of August 24, 2014

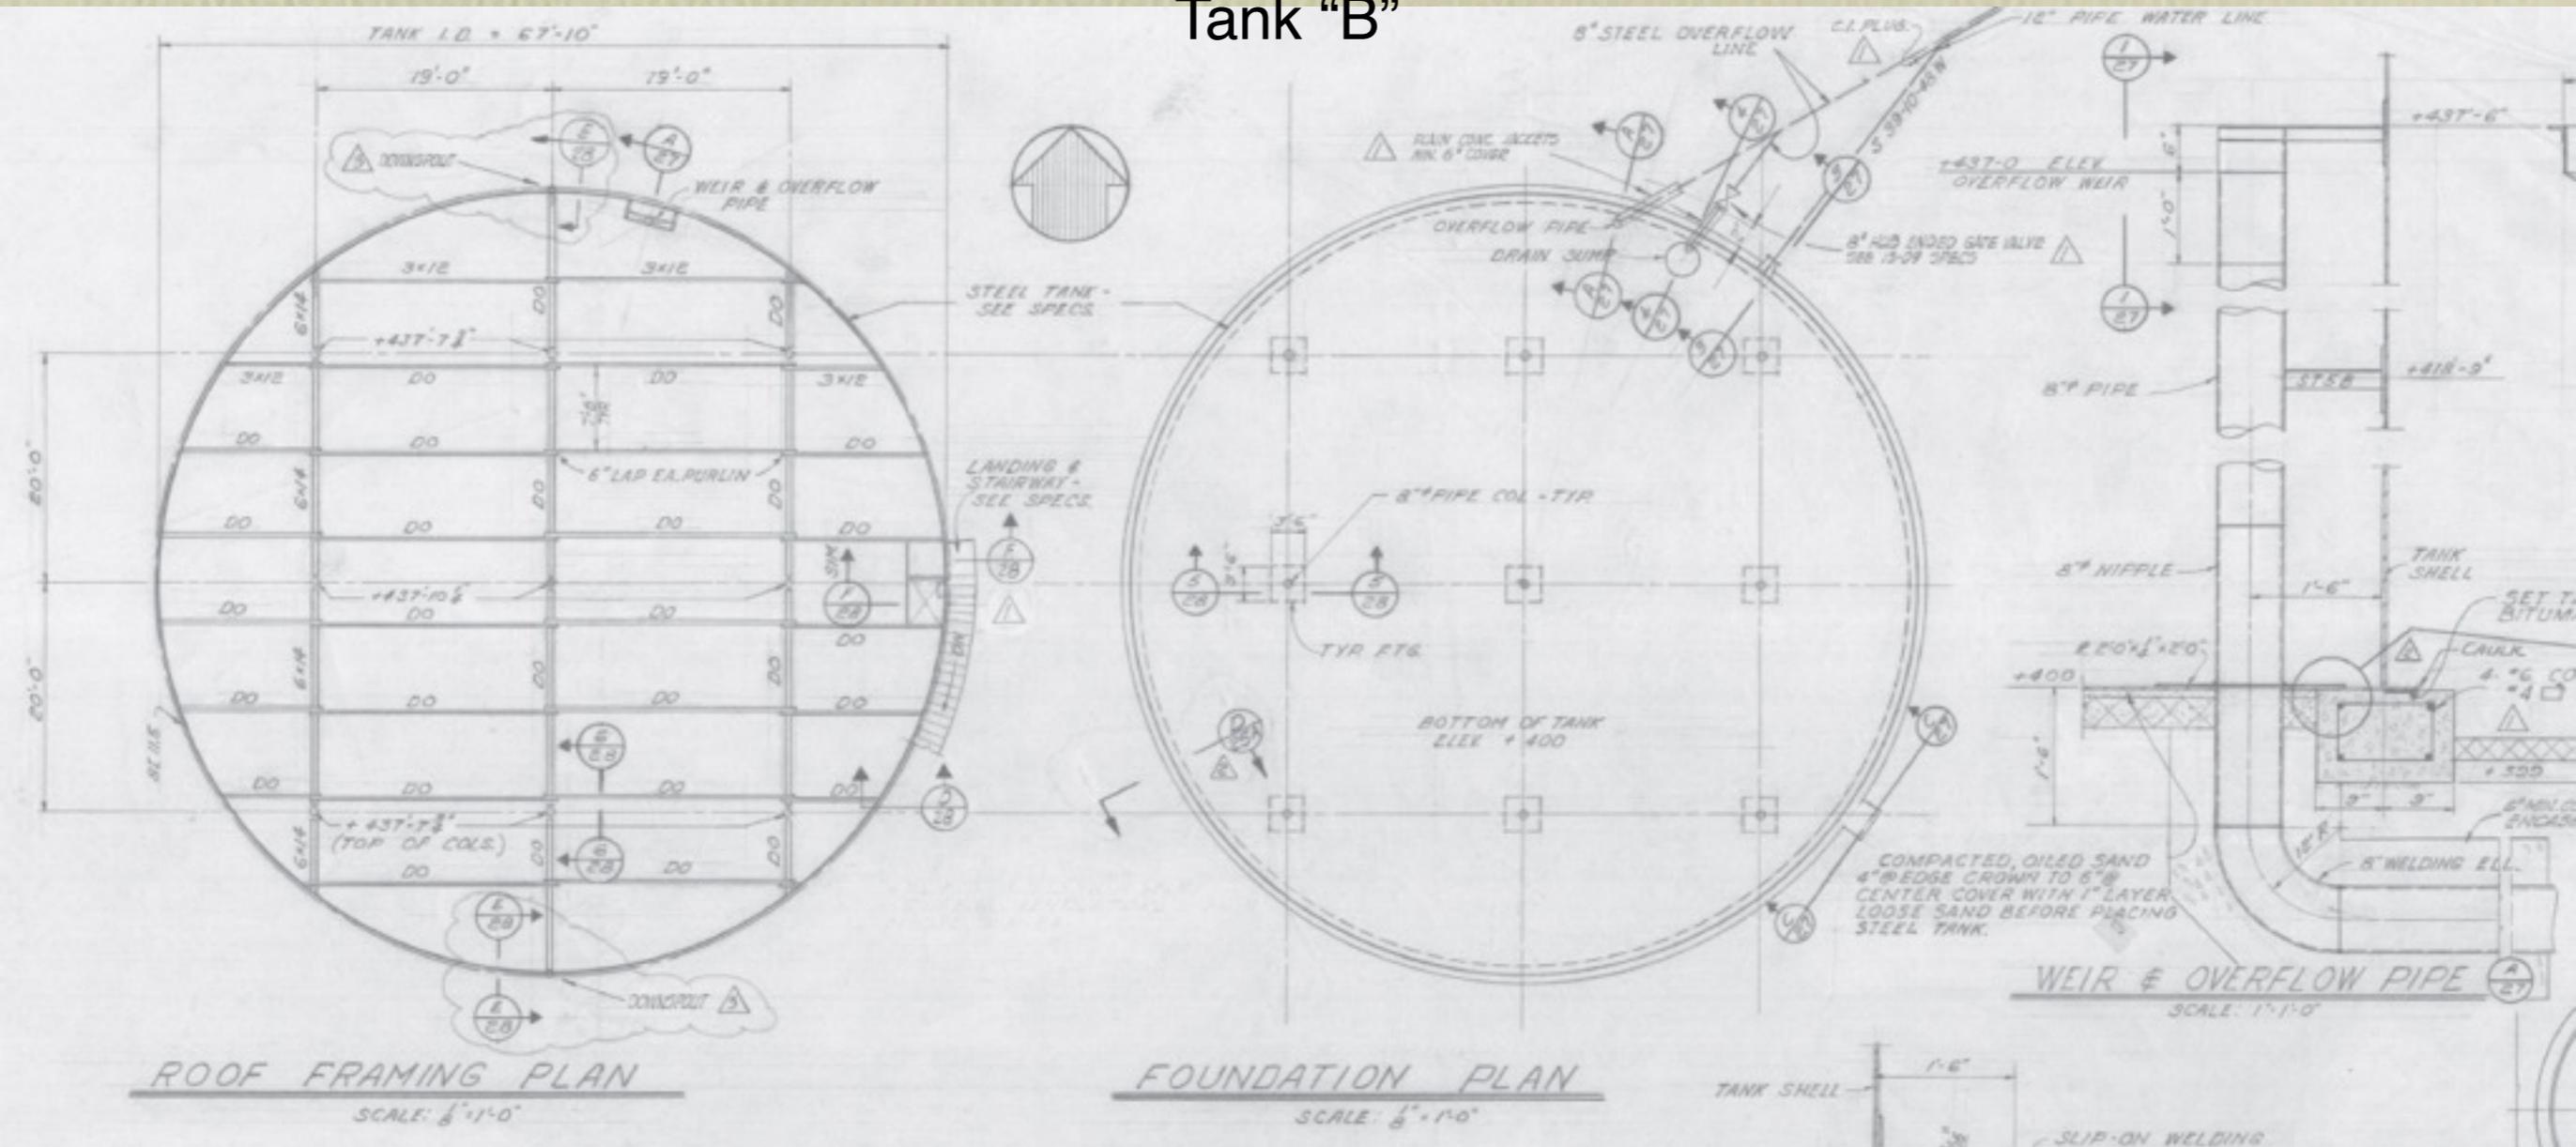
Unanchored Steel Tank

Design by Pat Creegan, 1960 of Creegan and D'Angelo. C&D SF Office closed in 2015, RIP.

No Seismic Design Concepts

EBAA Flextend had been previously installed for Inlet-outlet pipe (good thing, BUT...)

The outlet pipe broke in the street, so the tank drained anyways (missed the big picture)

The Roof was damaged due to water sloshing and tank wall uplift (who cares, FEMA pays)

Napa replaced the roof

Then, Napa wanted to "raise" the roof top prevent future roof damage (IMHO, a waste of \$\$)

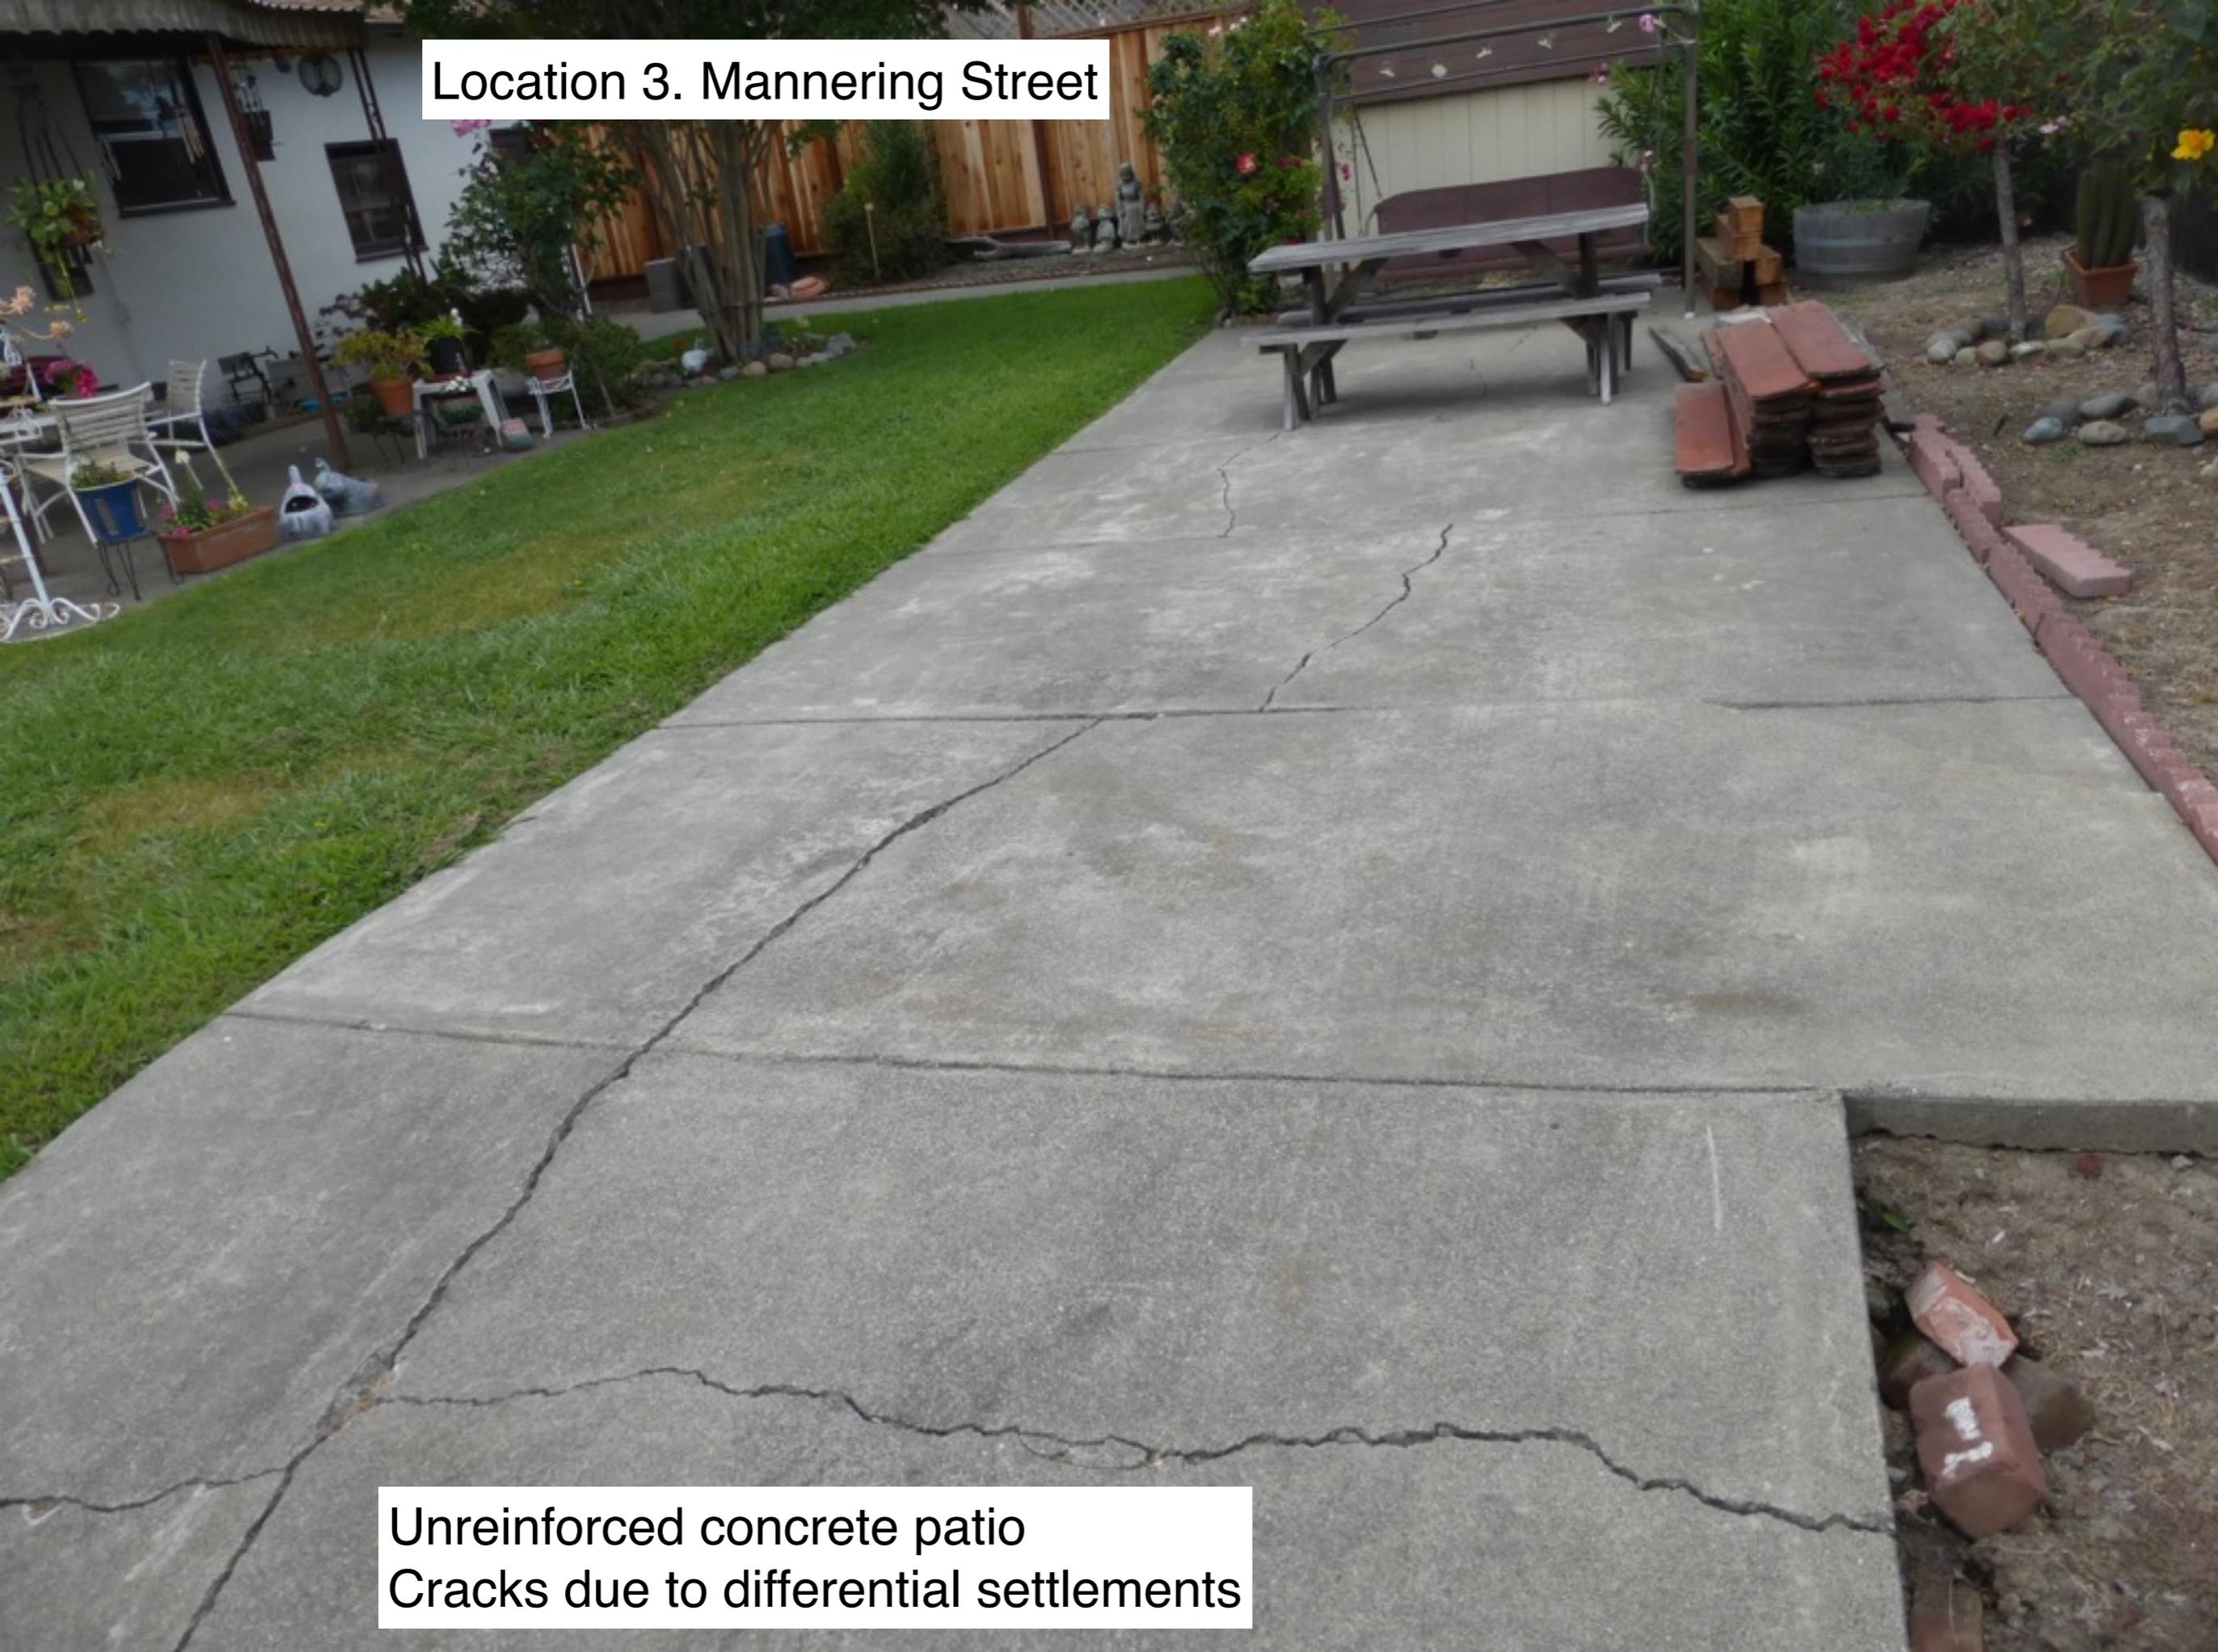
Location 3. Mannering Street

Unreinforced concrete patio
Cracks due to differential settlements

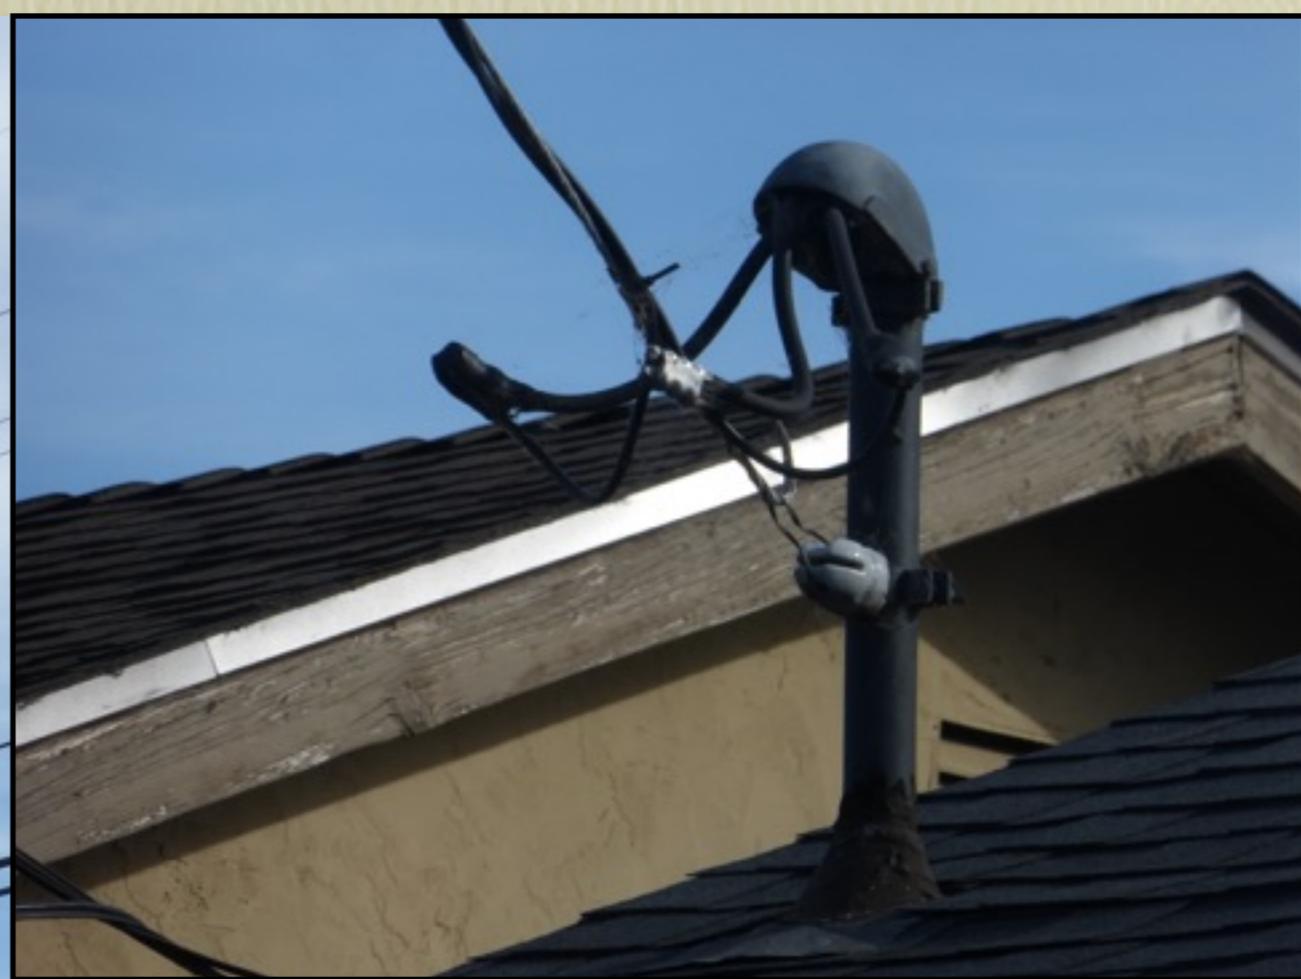
Swaying of pole and inadequate slack on secondary line drop to house led to failure of the insulator connection on the house.

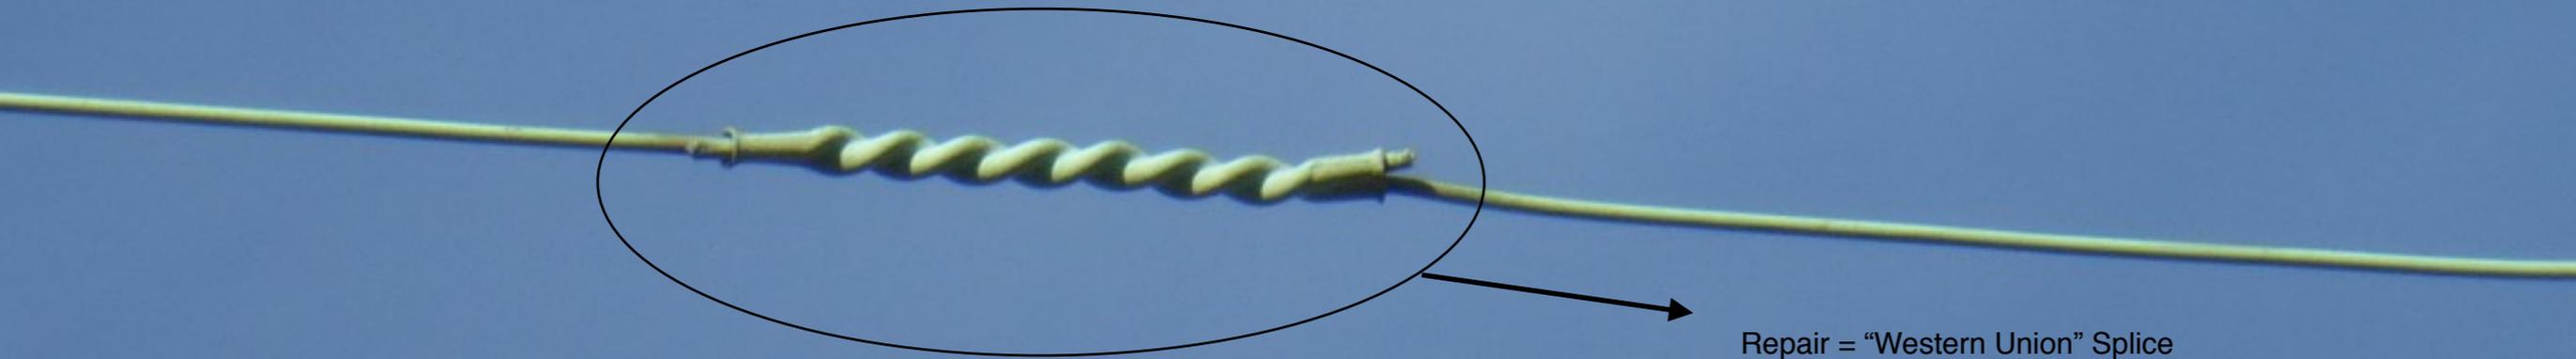
Repair = "Western Union" Splice
Nearby cross arm was replaced.
Possible burn marks on conductors

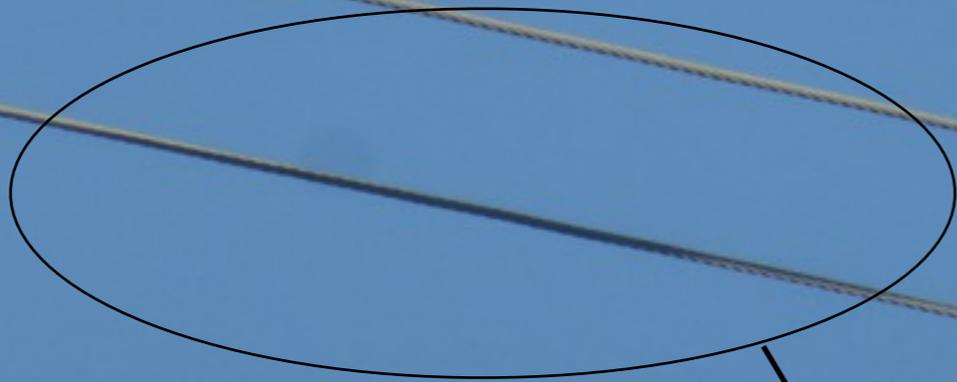
Wire burn marks.
This failure mode can be prevented with “smart” de-energization at the substation.

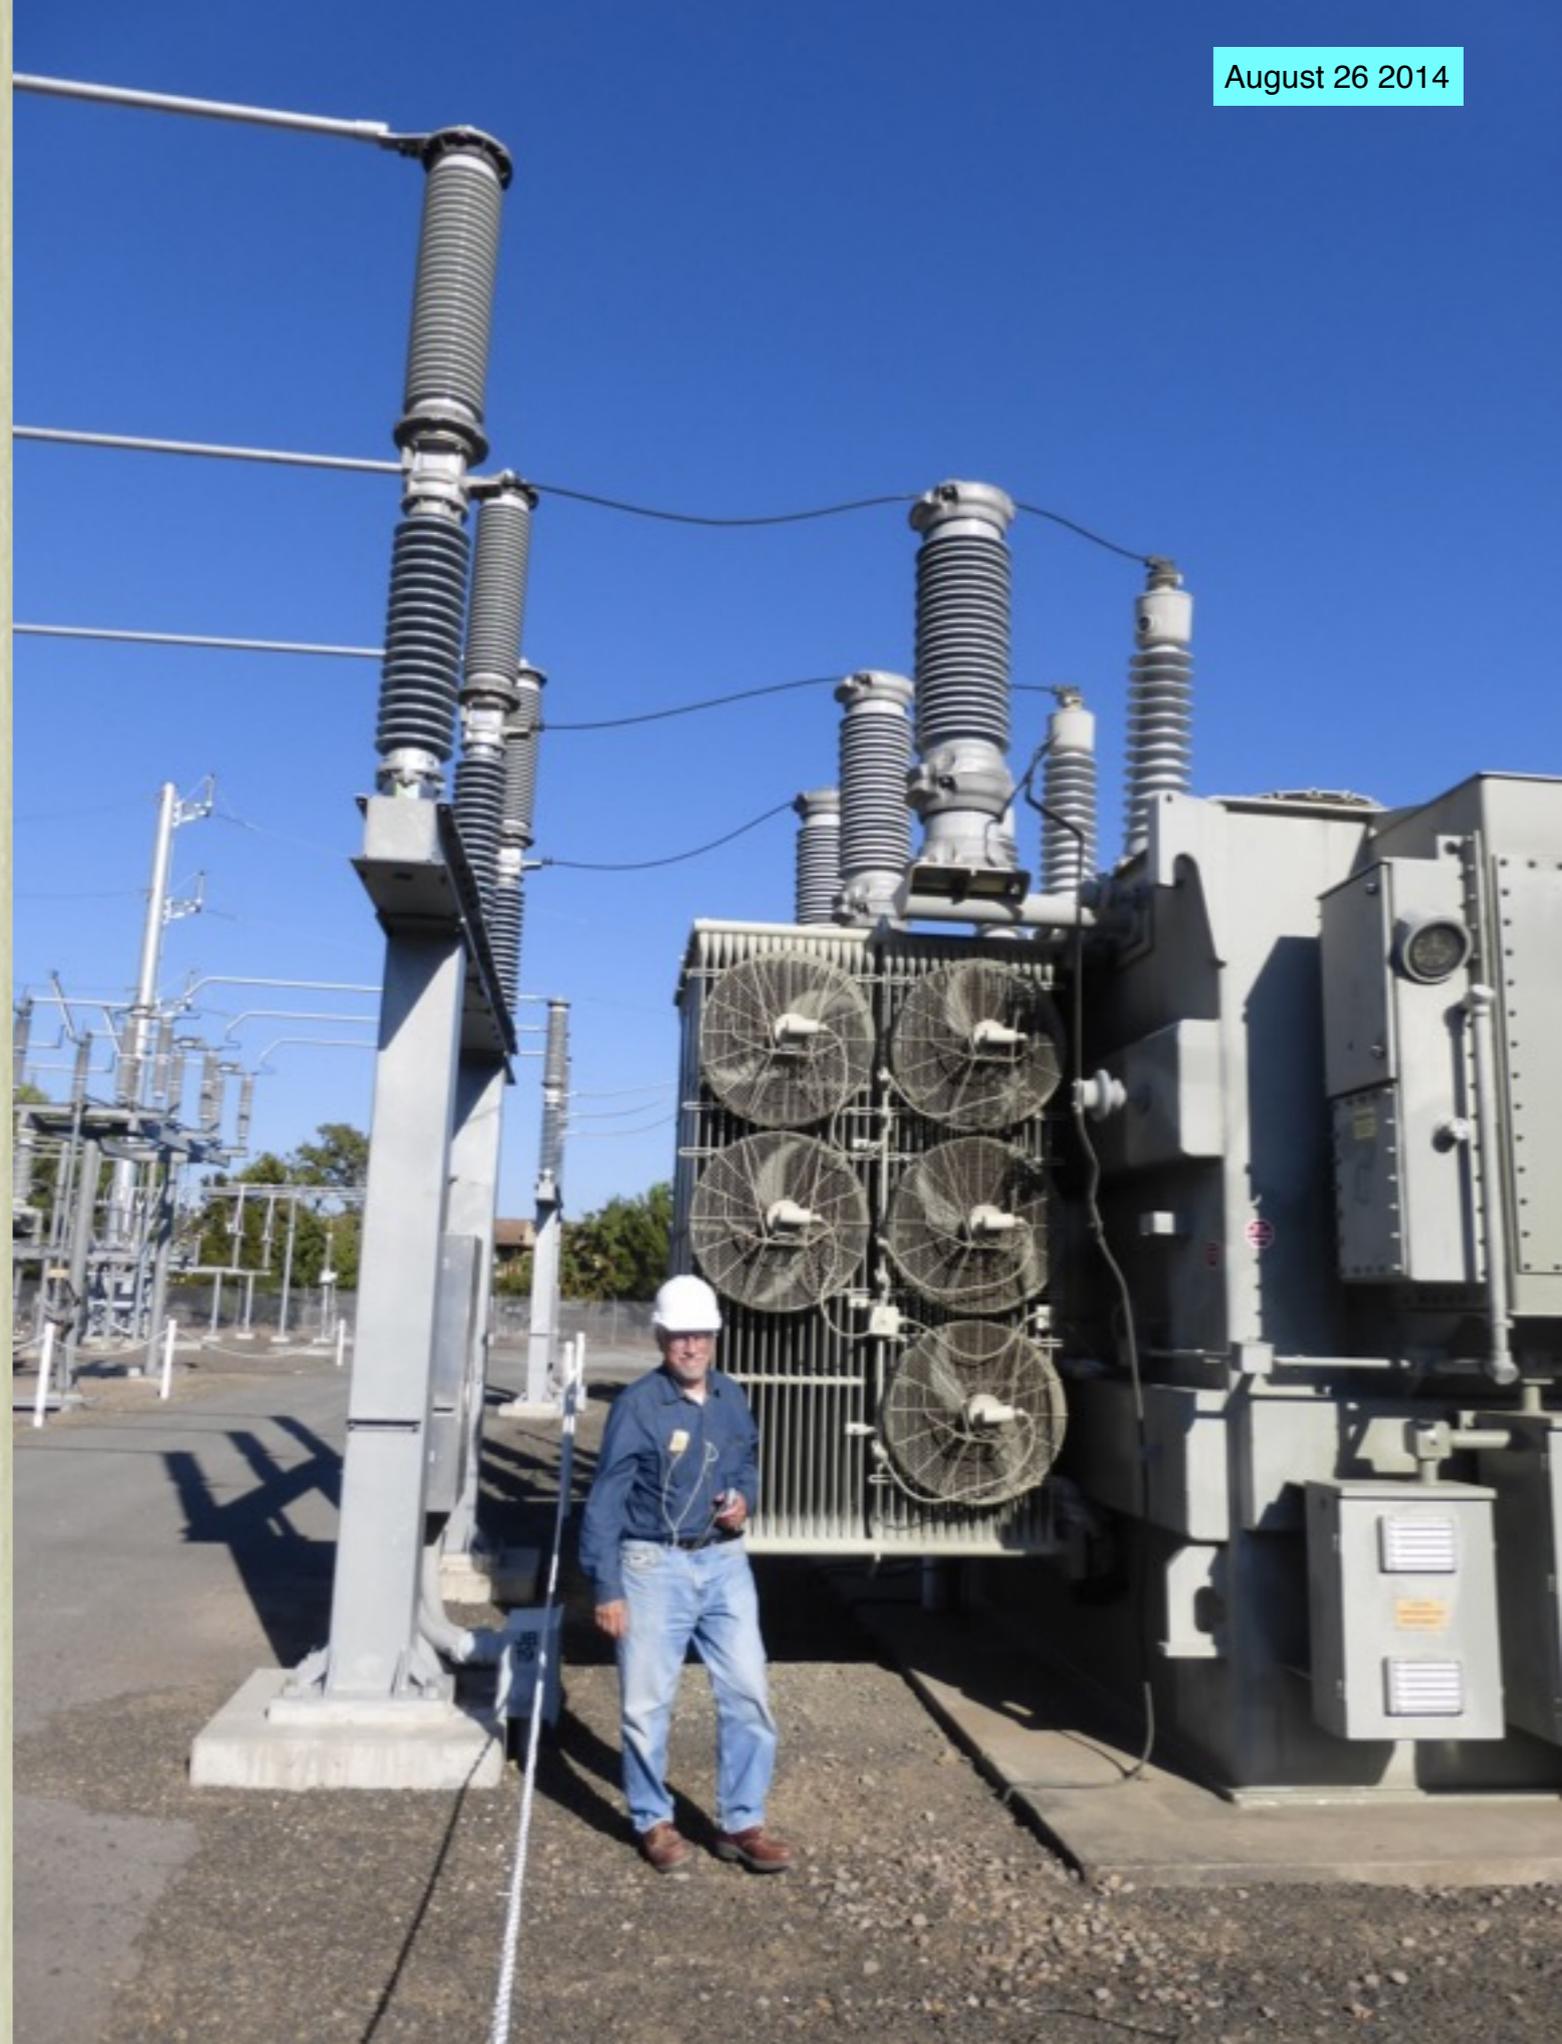
115 kV - 12 kV Bank 1

Oil leaks appears to be from top pipe connections (as expected / common)

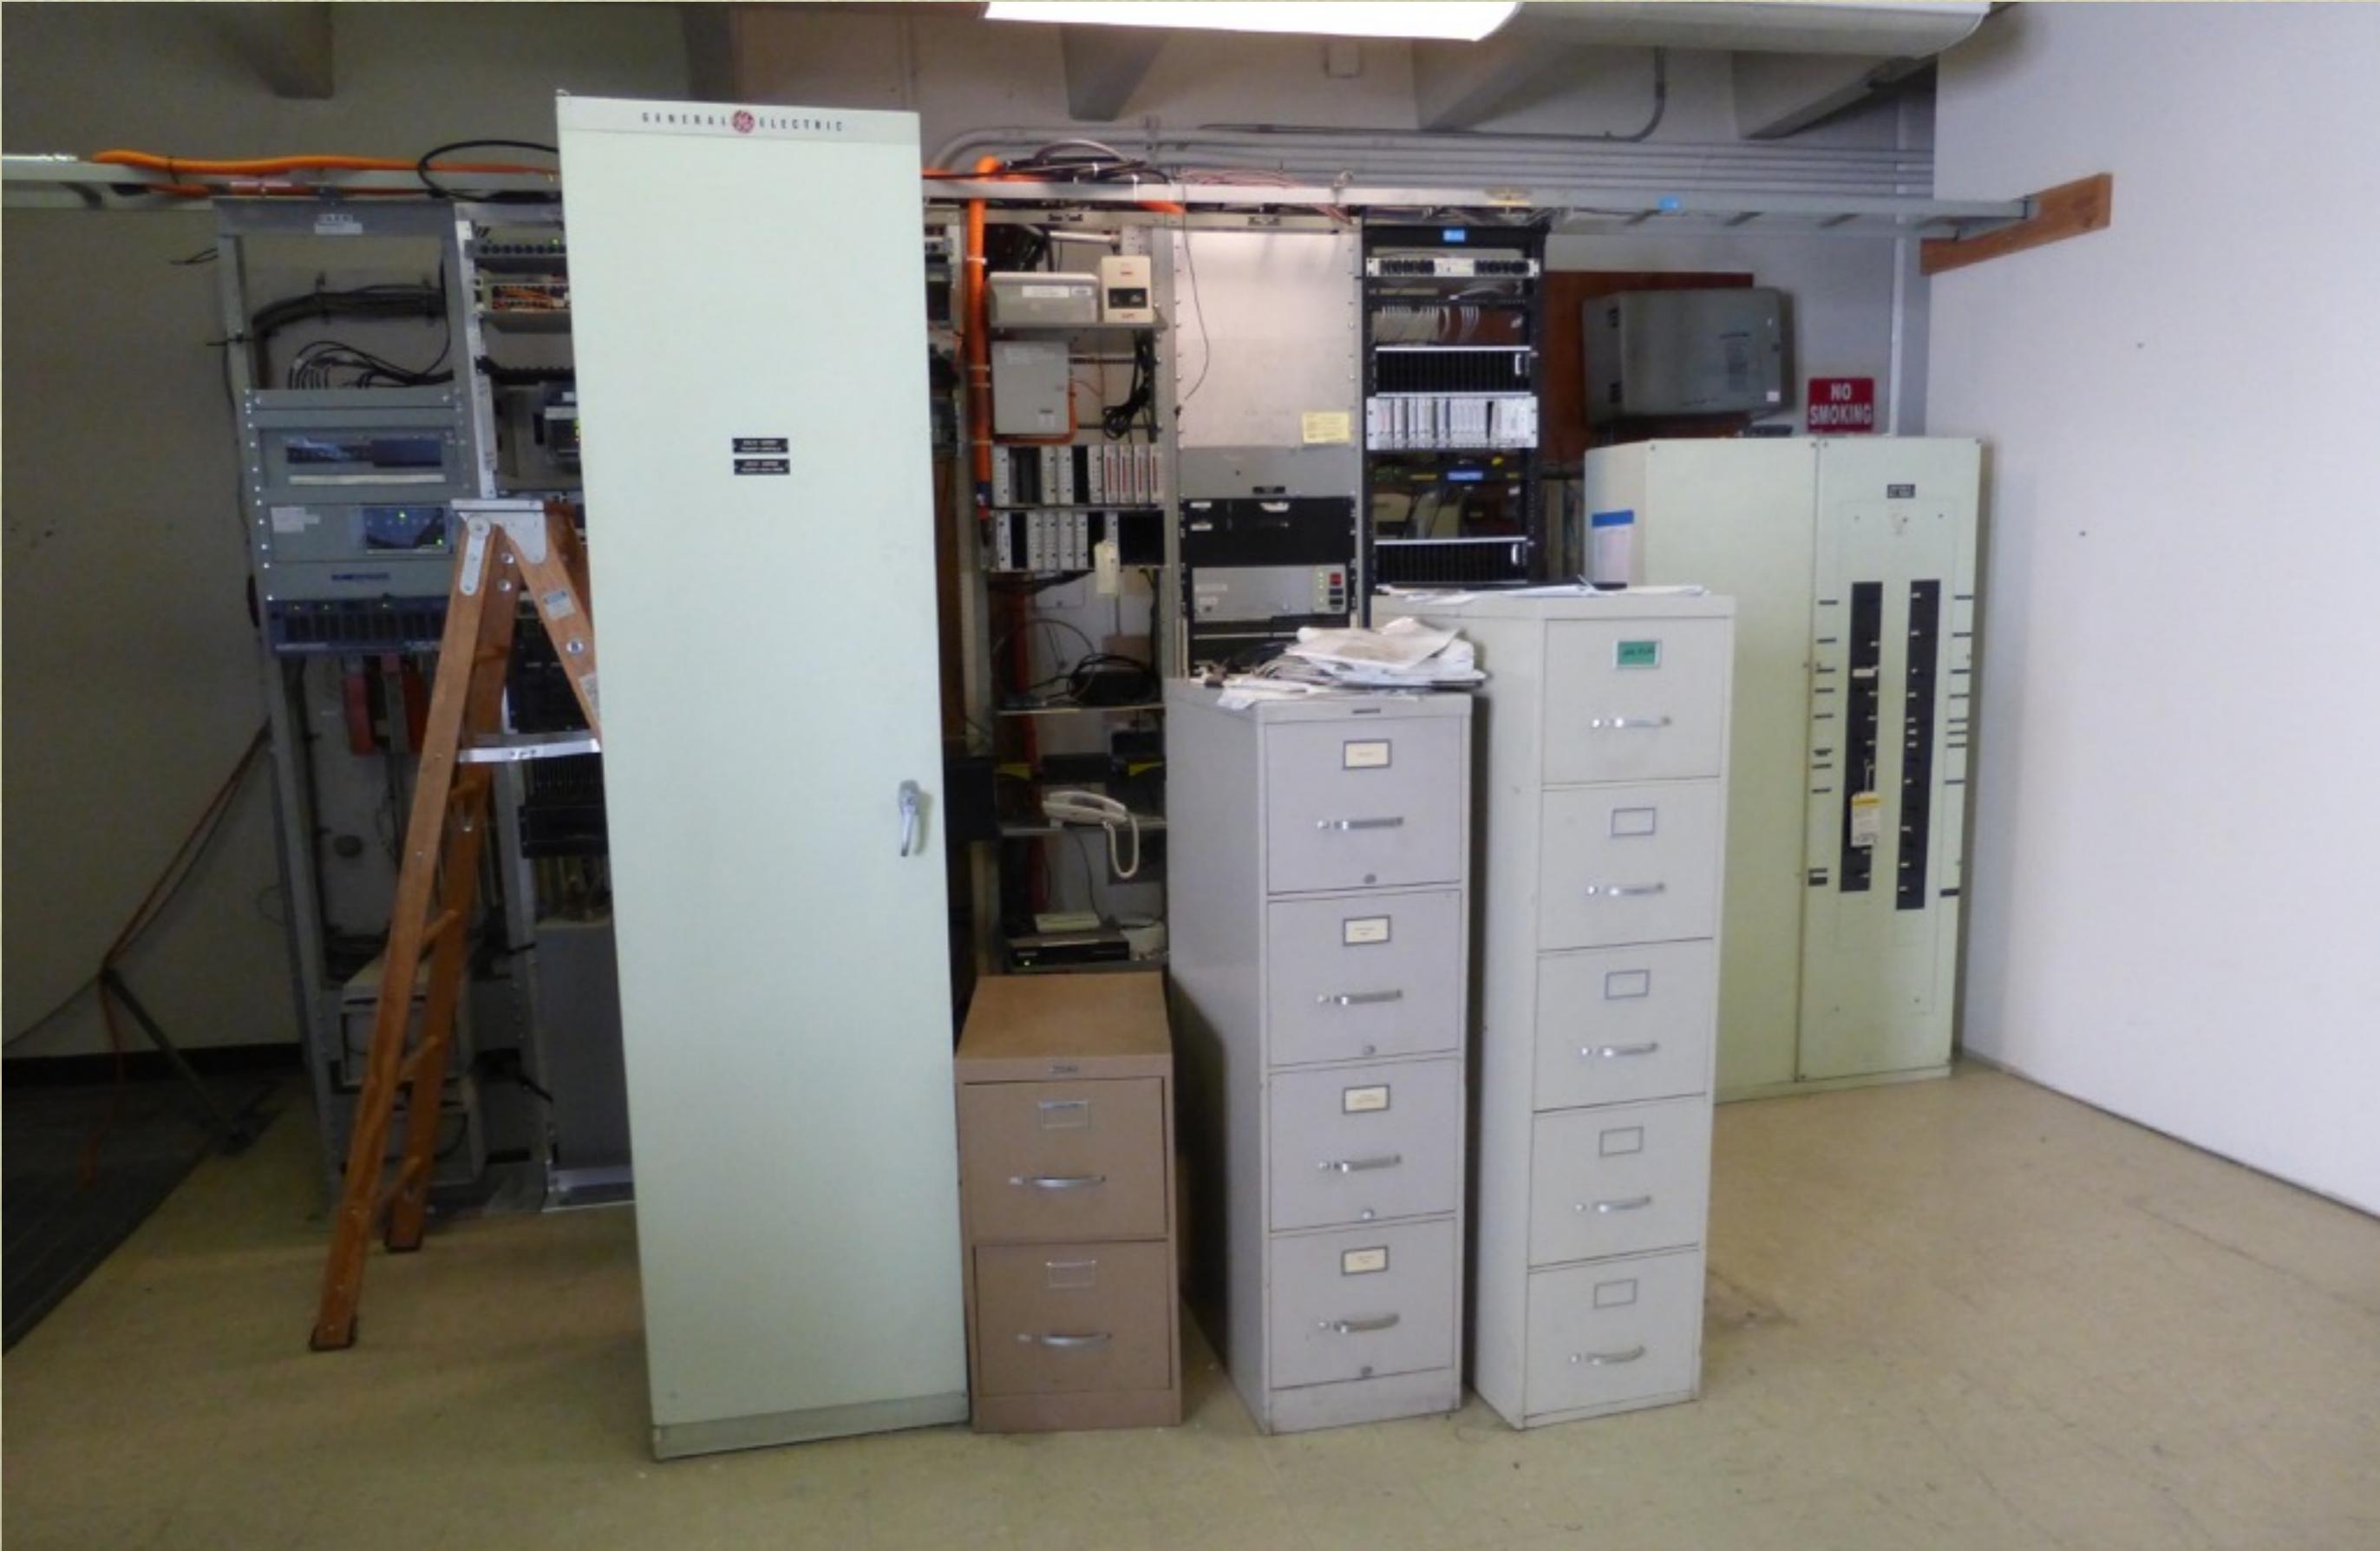
Unanchored Cabinets rocked to these positions (formerly cabinets were tight against each other). Mitigating this “housekeeping” weakness is an ongoing process.

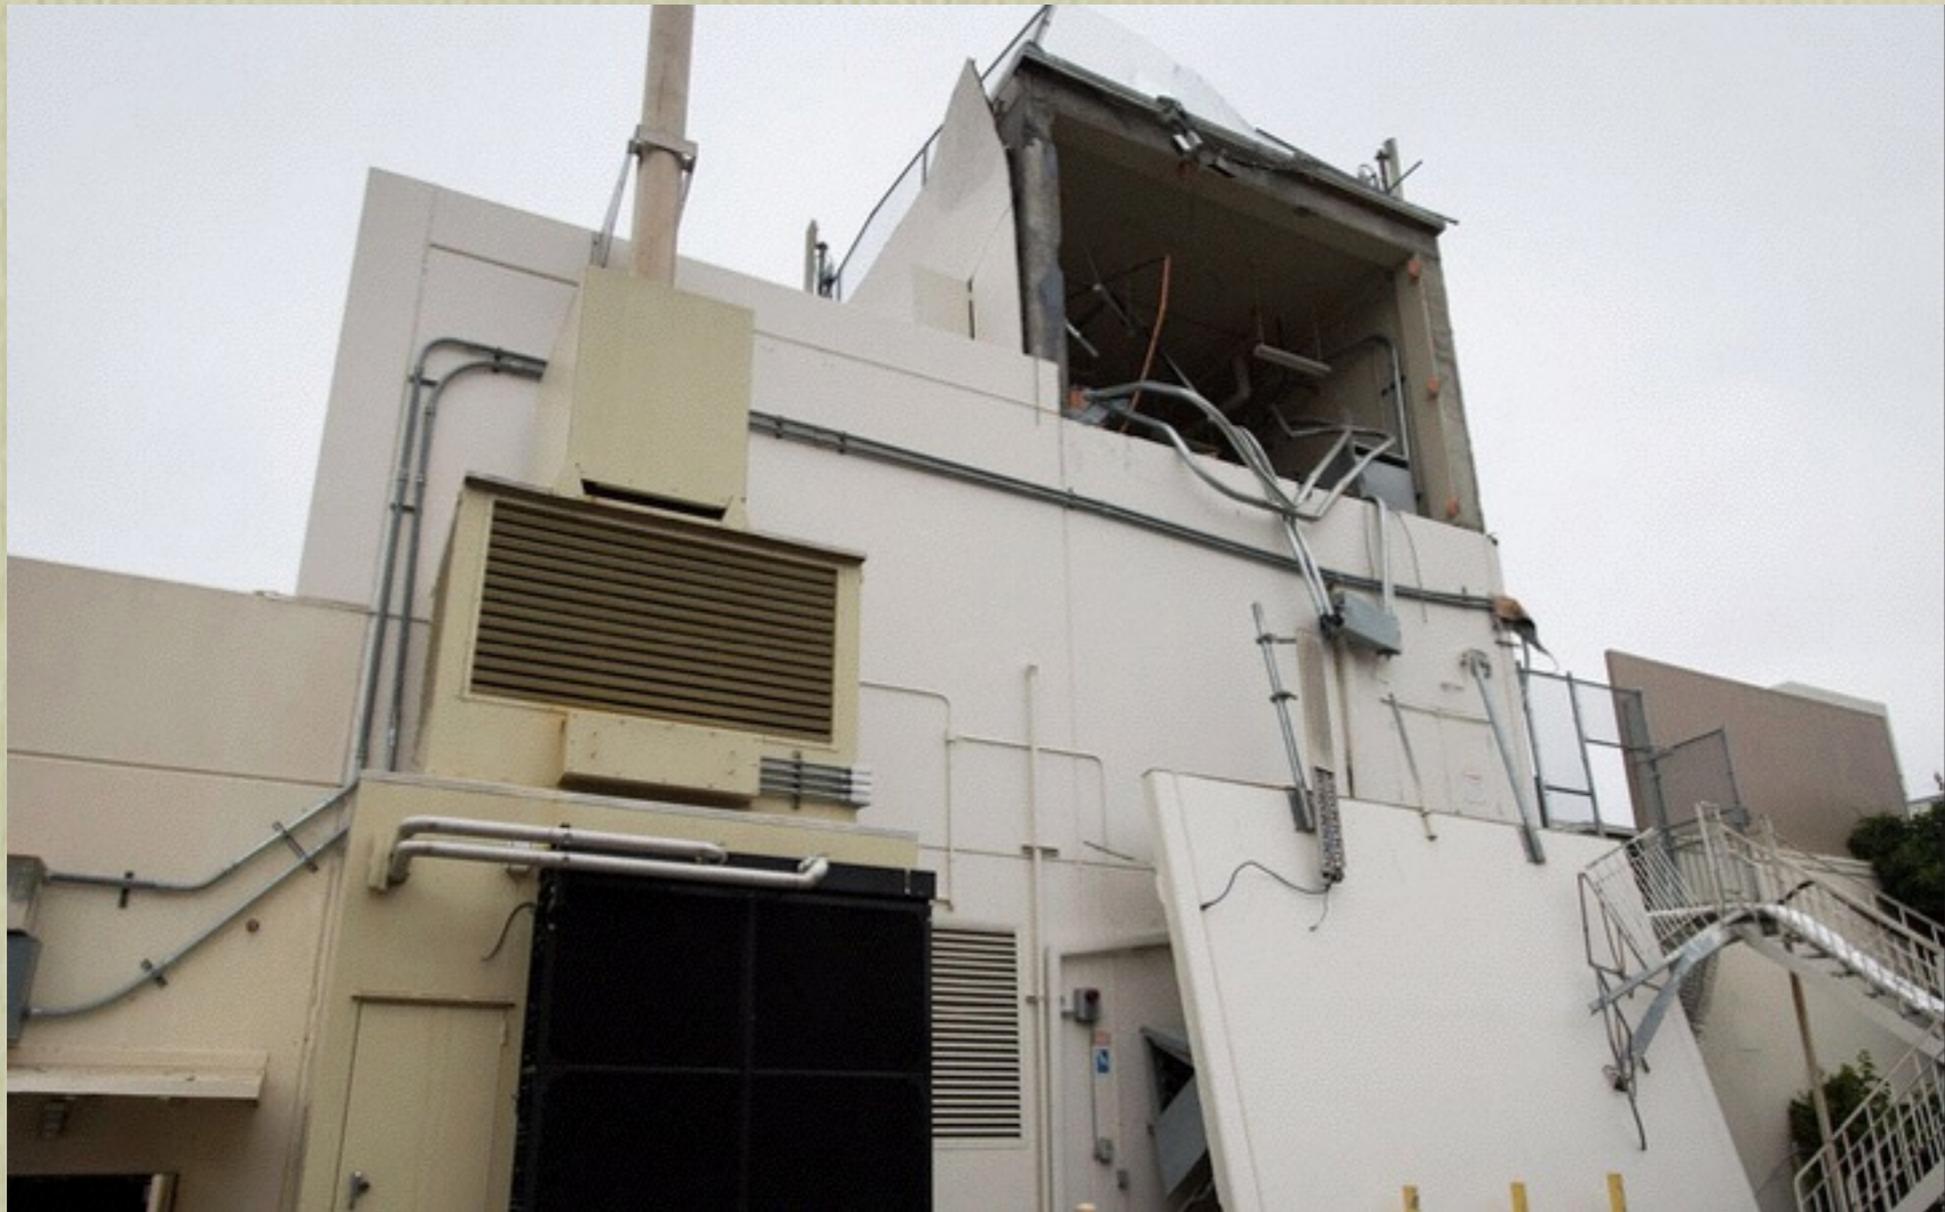
AT&T - Communications

Wall Panel Fell. Was held by 4 tabs, for future expansion. Building racking damaged the tabs. Panel fell onto HVAC equipment, damaging cooling system. PG&E power equipment was also damaged by the falling wall. Emergency generator failed to start. Back up batteries worked well. But, batteries need to be recharged.... a priority to get a generator to recharge the batteries. No real loss of service, as AT&T was able to respond.
