Napa Earthquake of 8.24.2014 Performance of Lifelines

Water, Power, Gas, Fires

City and County Engineers Association of
San Mateo County

South Napa M 6.0 Earthquake of August 24, 2014

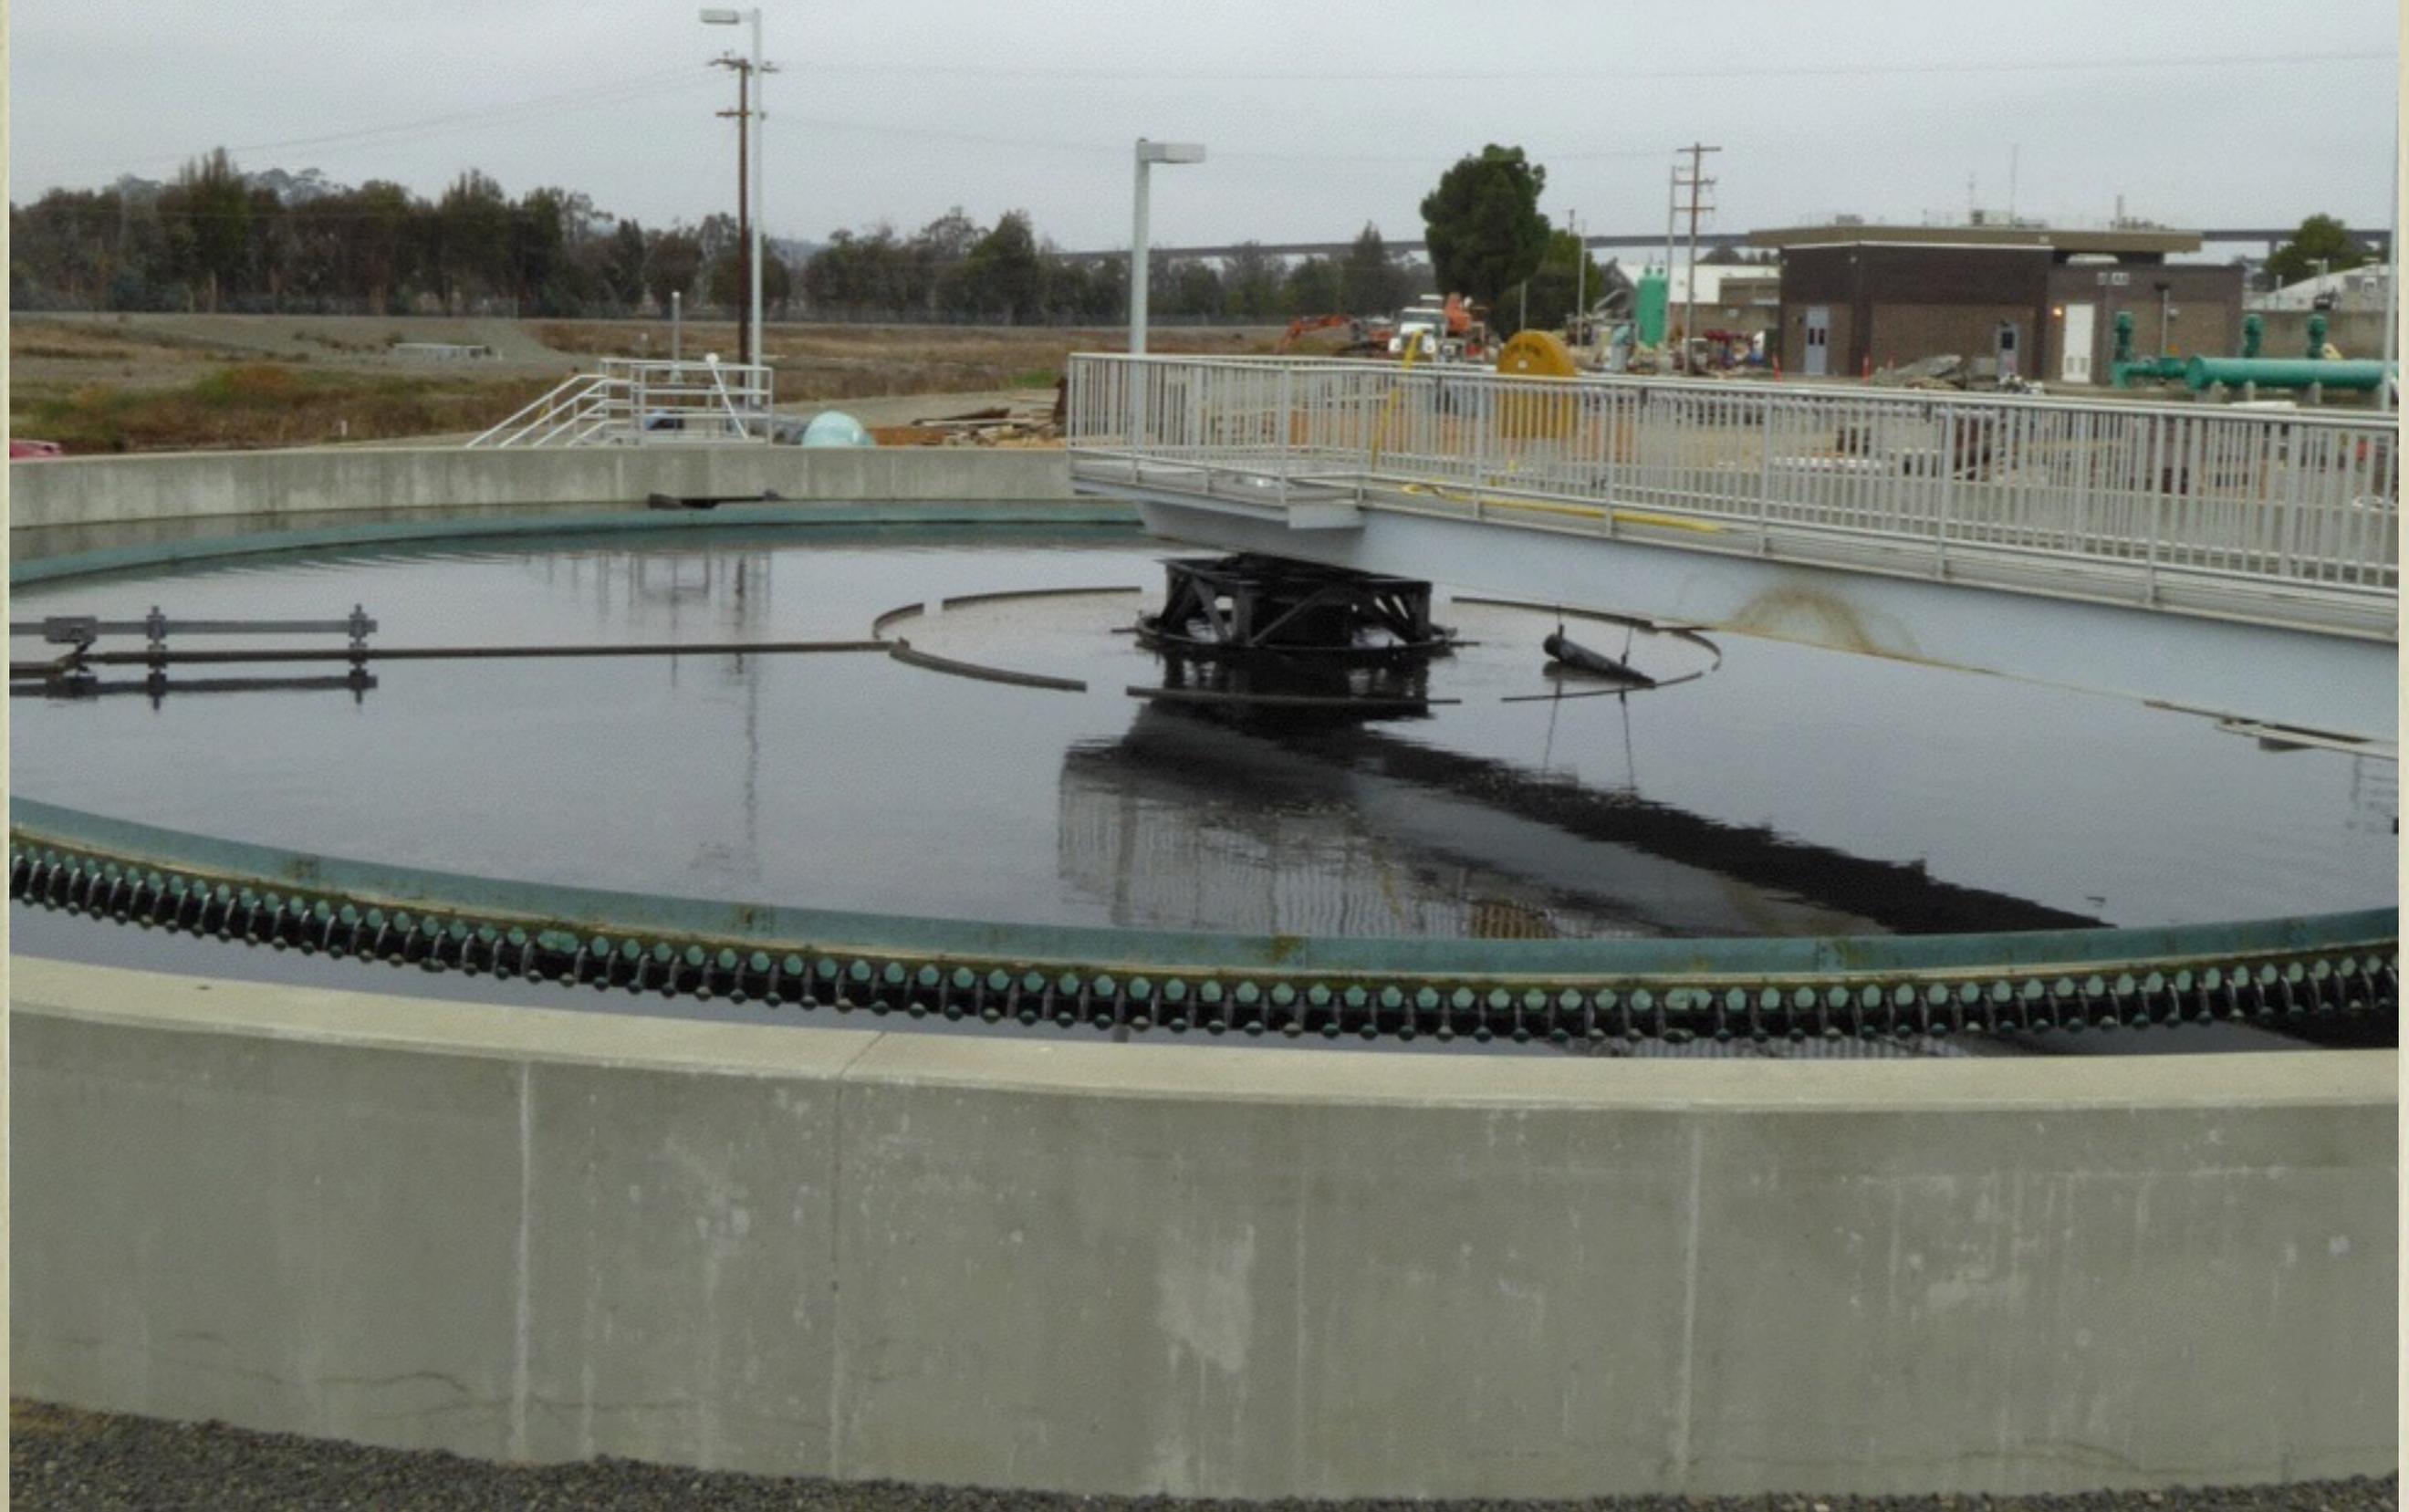
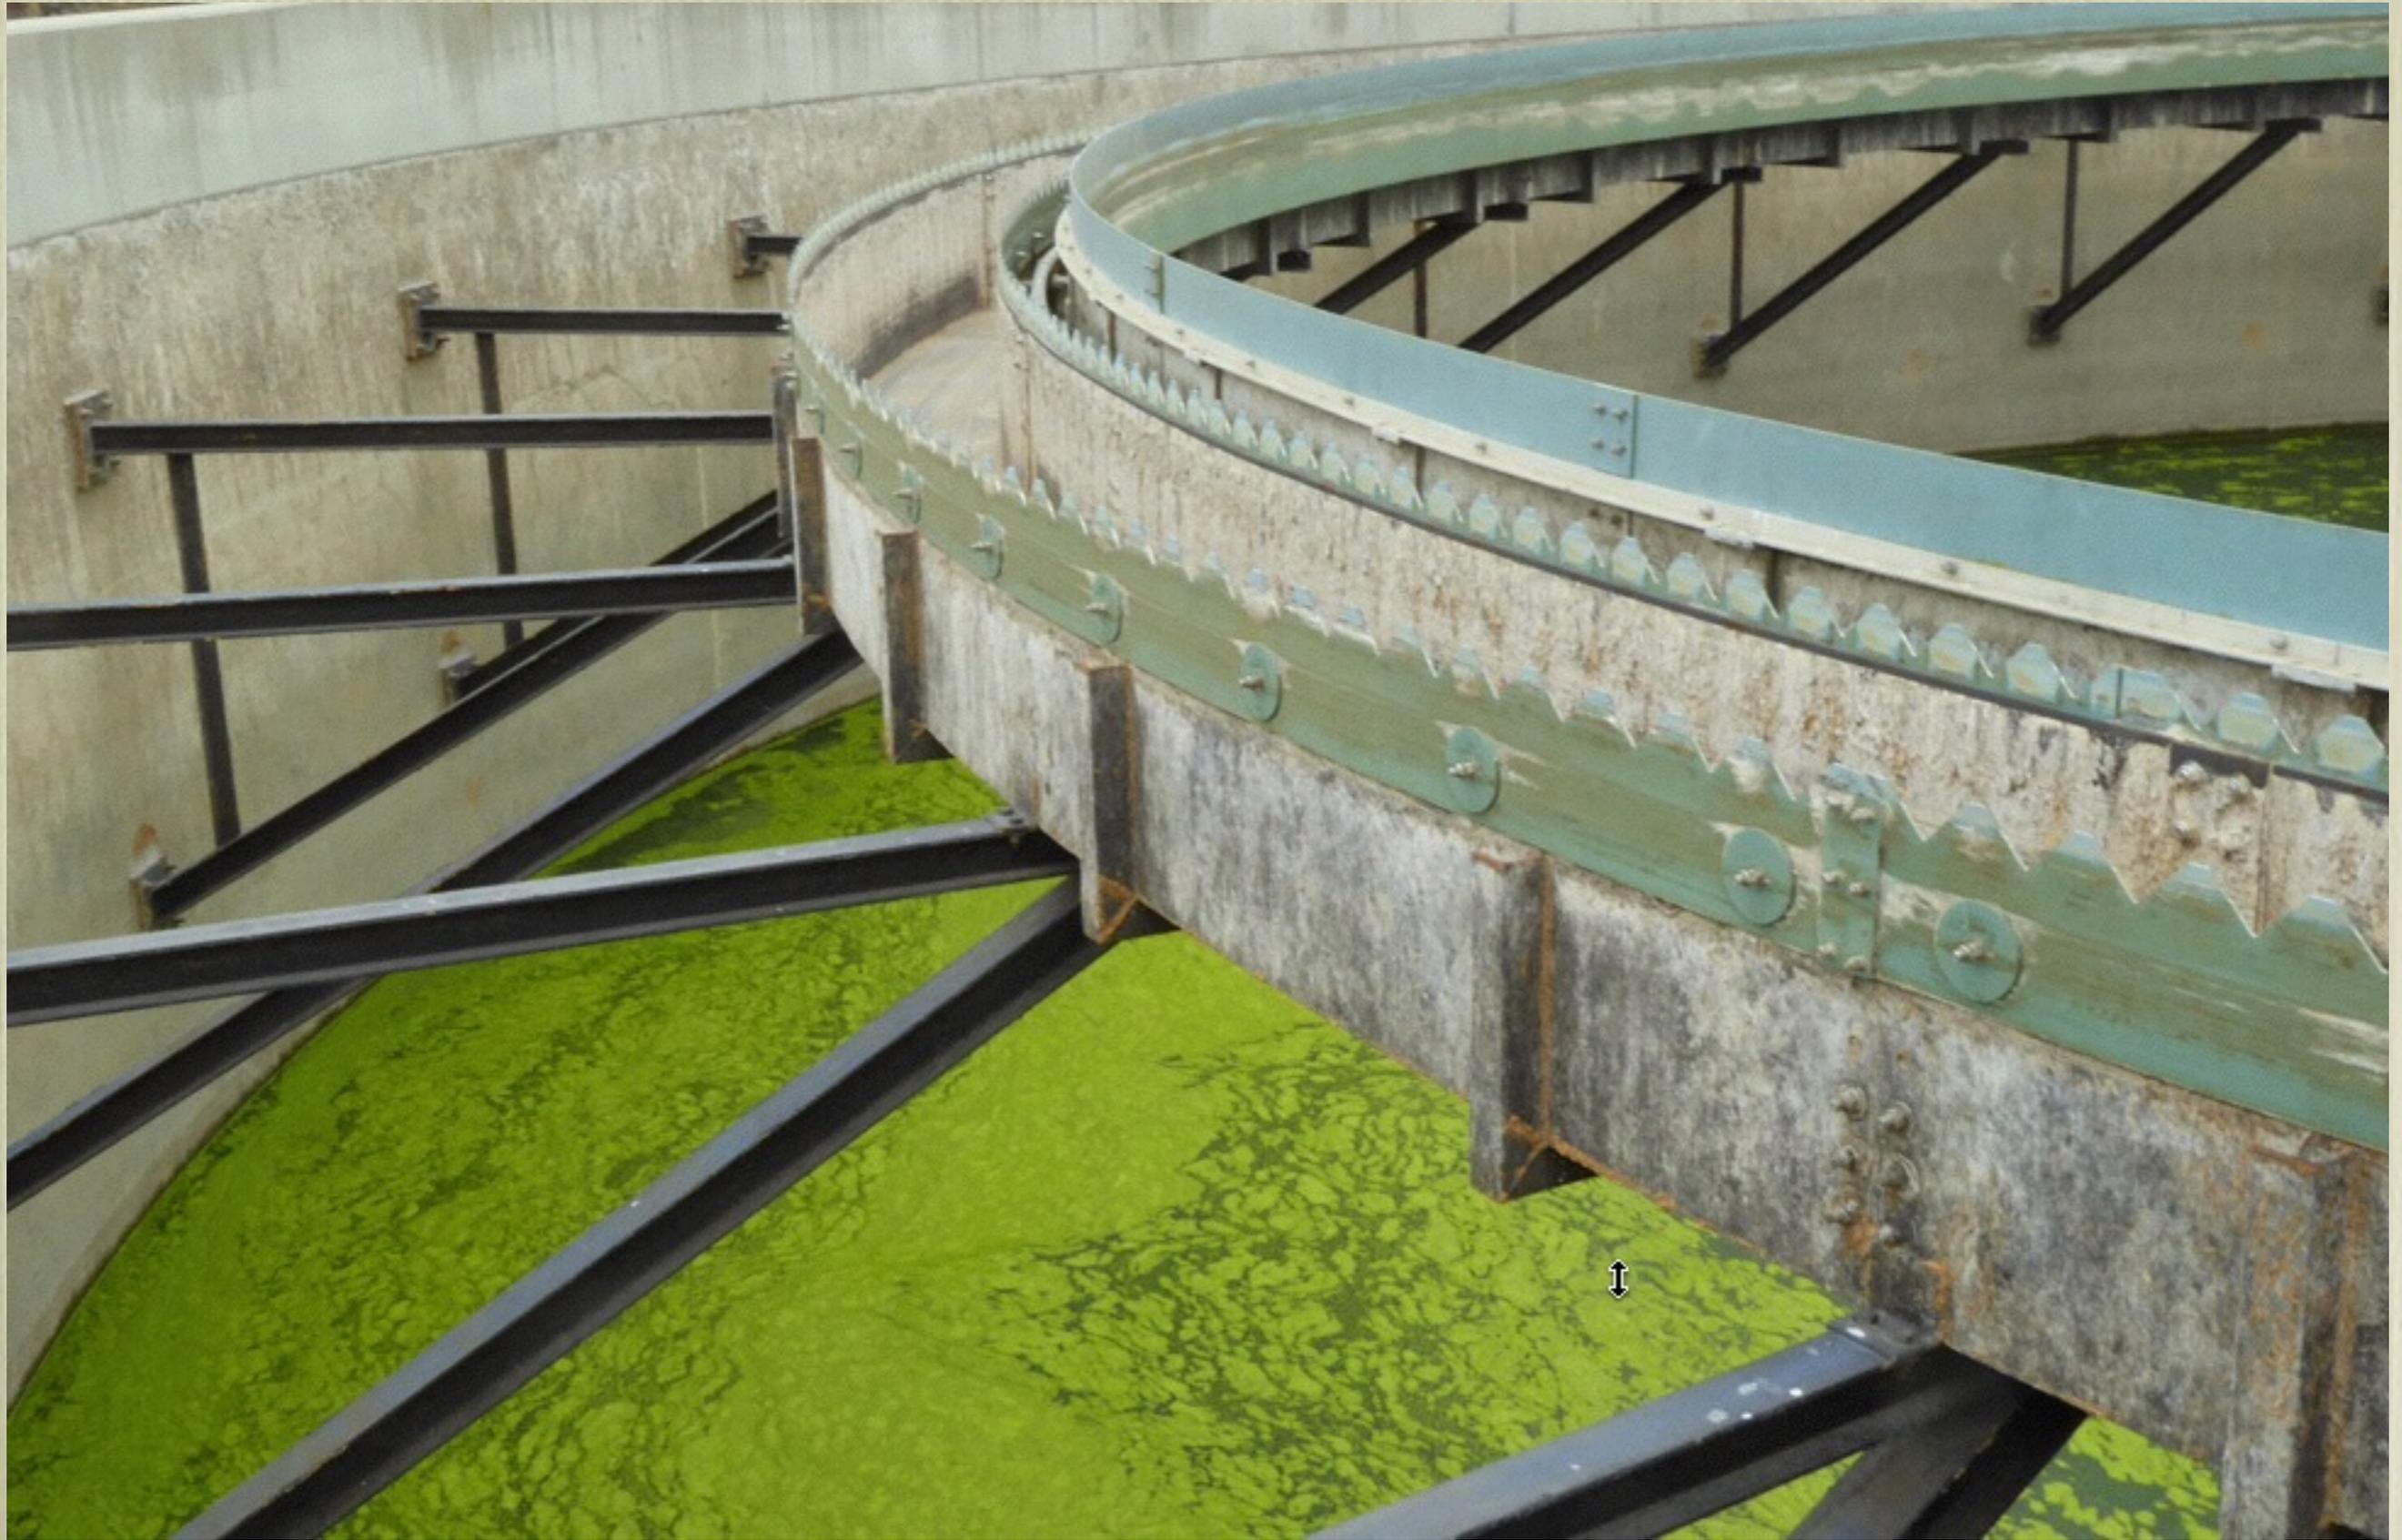
Possible Rocking of Center Tower in Clarifier
