# Napa M5.2 Earthquake of September 3, 2000

## Evaluation of Lifeline Performance

**John Eidinger<sup>1</sup>**  
**Mark Yashinsky<sup>2</sup>**  
**Anshel Schiff<sup>3</sup>**

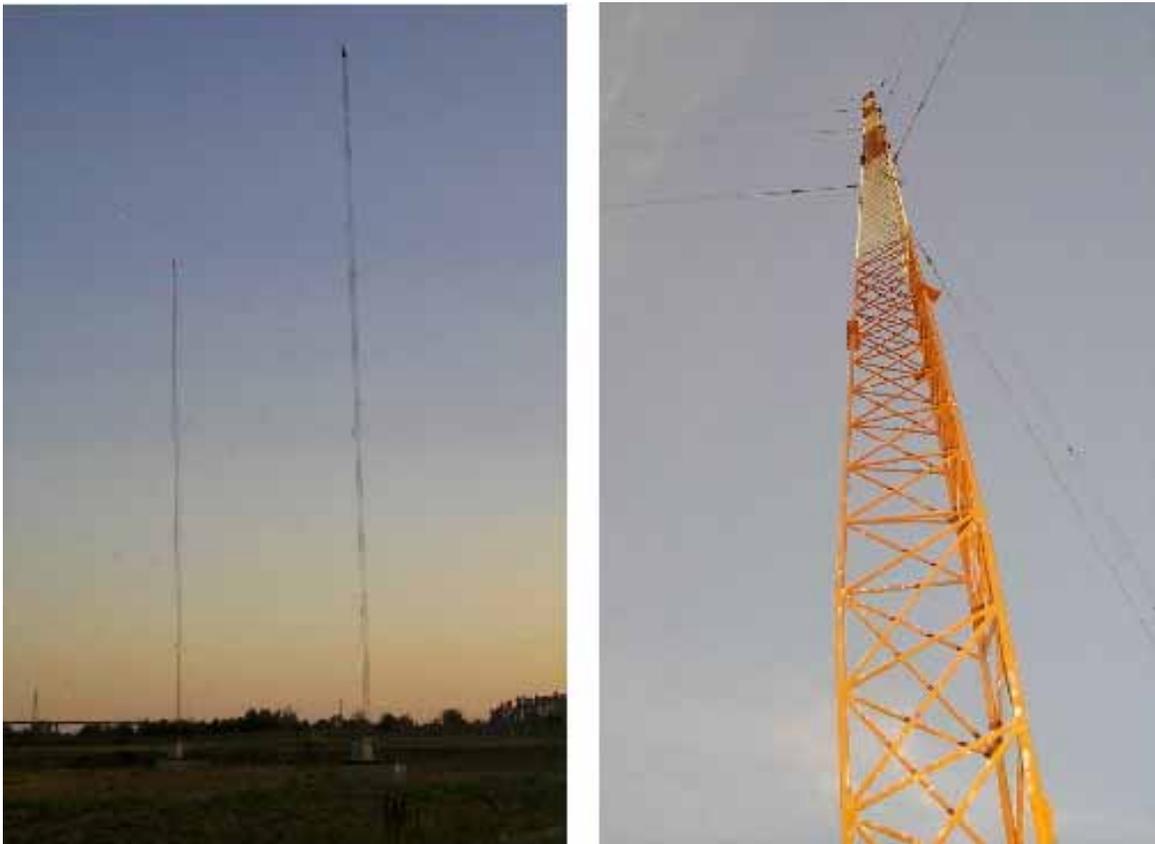
**Figure 3. AM Transmission Towers - Guy Wires and Mast**

Other than some minor items falling on the floor, the radio station had no other ground-shaking-induced damage at the broadcast studio. At the AM transmission site, the radio station operates four towers. Each tower is a steel truss with guy lines (Figure 3). Apparently, the guy lines experienced high loading during the earthquake, and three of the four towers were displaced sufficiently such that their signals were no longer being broadcast in optimal directions. The fourth tower experienced some damage to the central tower itself, which will need to be replaced. As of 5 days after the earthquake, the transmission towers were not yet repaired, but remained operable with signals going off in non-optimal directions. The exact cause for the tower damage is not clear, but could be due to settlements of some of the guy wire anchors; and/or high transient loading of the guy wires during the earthquake.

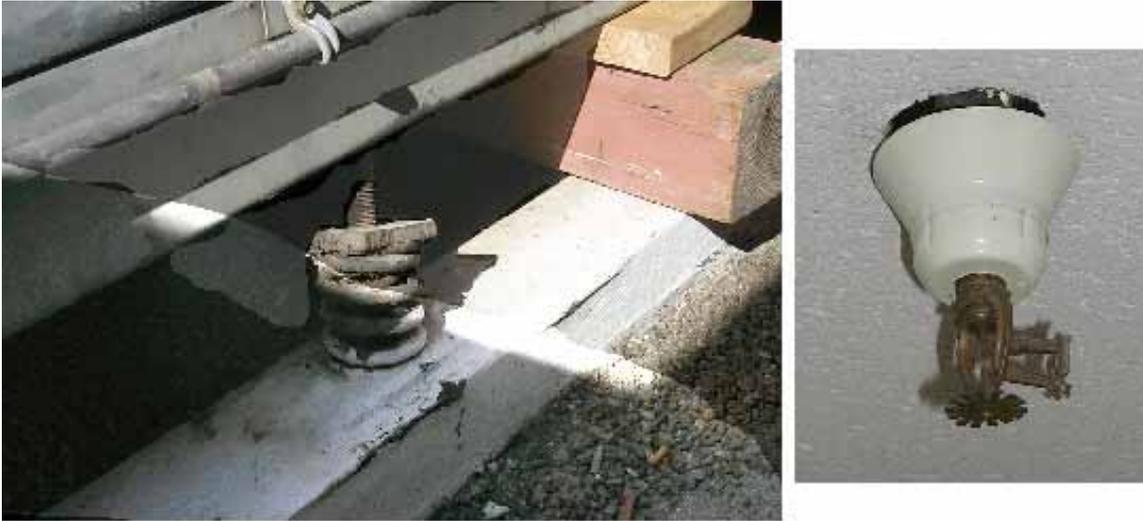
- Fire sprinklers. The hospital has an extensive sprinkler system. No sprinkler heads were damaged to the point where they went off. However, many sprinkler heads had moved sufficiently to knock off / dislodge the metal annulus caps around the sprinkler heads and the suspended ceiling tiles (Figure 4). Dozens of these caps were being replaced 5 days after the earthquake. In one case, the sprinkler head had lifted up through the suspended ceiling, and ended up resting atop the suspended ceiling.

- Air chiller. One air chiller unit located at a rooftop fell off its vibration isolation mounts. When it fell off its mounts, it also broke the inlet/outlet water pipes. This air chiller unit served the administration building, and was thus not "critical" to hospital operations. It was temporarily repaired within days following the earthquake (see Figure 4) by mounting the unit on wooden blocks and repairing the attached pipes.

**Figure 4. Hospital - Air Chiller Isolator, Sprinkler Head**

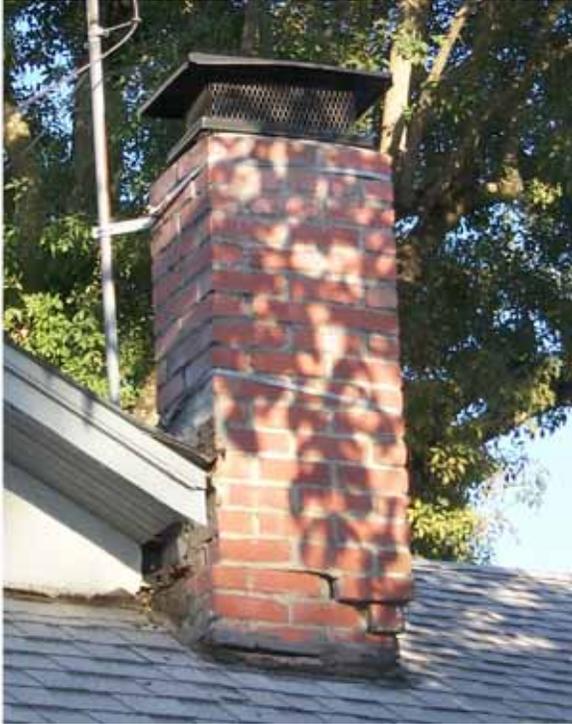
Figure 5. Damaged Chimney.

As previously mentioned, the most prominent feature of this earthquake was the number of chimneys that were damaged or fell. There was a lot of other damage including broken plumbing, broken windows, and in one case a house fell off of its foundation. We saw many houses with yellow ribbons and some office buildings in downtown Napa wrapped in blue plastic and closed due to moderate damage. Estimates of the cost to repair this damage are still sketchy but public officials are suggesting between \$50 to \$100 million dollars, largely based on a HAZUS, computer-generated risk analysis. Based on field observations, the bulk of the direct damage could be attributed to chimney failures (200 to 400 of these), a few structural failures, various non-structural failures, and various lifeline damages; this would suggest (very roughly) total direct losses due to this sort of damage in the \$15,000,000 range. Repairs or maintenance for cosmetic or other non-structural damage (cracks in paint, repair of water heaters, etc.) may amount to substantially higher total losses. There were no fatalities and few injuries, however the Red Cross was busy providing temporary shelters to families, surveying the damage, and providing counseling as well as food, clothing and medicine. City inspectors are also busy due to the estimated 3,000 to 5,000 buildings that are thought to be damaged. Inspecting and recording damage is important to the City because they need to document

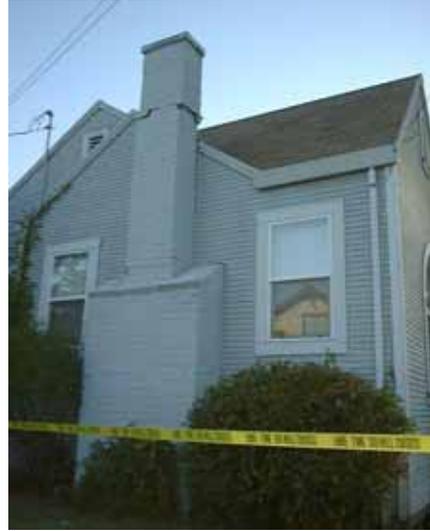
Figure 6. Broken Chimney.

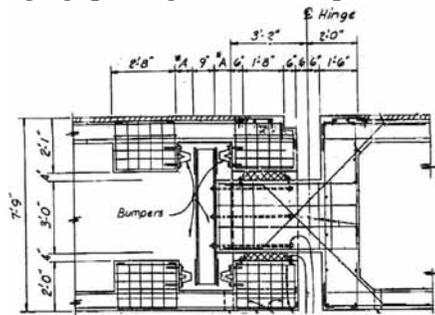
- **The Napa River Bridge and Overhead** (Br. #21-0049) was built in 1977. It is a 13 span precast, segmentally constructed, concrete box girder bridge that carries State Route 29 over the Napa River (see Figure 1). The bridge is supported on tall single-column bents and end-diaphragm abutments; all on pile caps that were retrofitted in the 1990’s. The structure is composed of four frames separated by three unusual hinges. Instead of a bench for the longer cantilevered span to rest on, they are supported by concrete pistons with steel stoppers (Figure 7). The earthquake widened the hinge openings (and moved the bearings) an inch or two, but the very large gaps (Figure 8) are a pre-existing condition.

Figure 7. Hinge Detail.

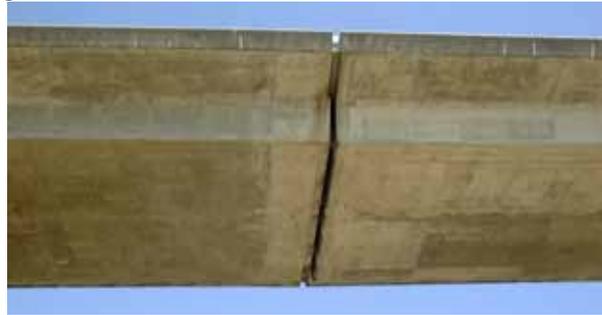
Figure 8. Hinge Opening at Napa River BOH.

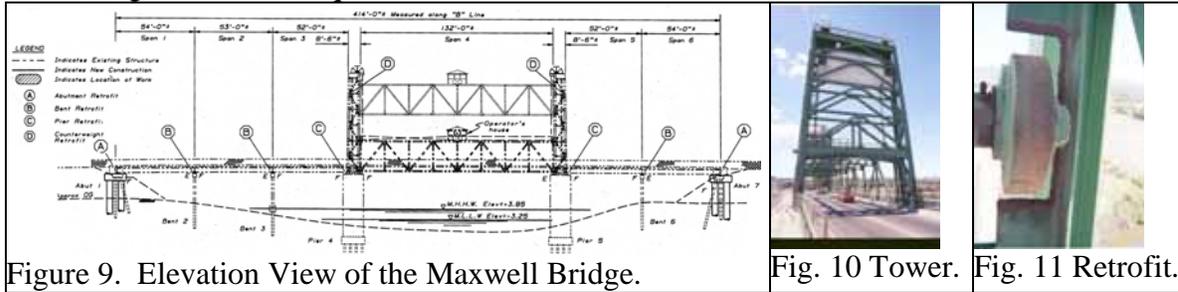
Figure 9. Elevation View of the Maxwell Bridge.

- **The Maxwell Bridge** (Br. #21-0075) is a two-lane vertical lift bridge (with a main span of 130 ft) that was built in 1949 (Figures 9 and 10). It was recently retrofitted to provide greater seismic resistance for the maximum credible earthquake. This retrofit included some work to the towers that carry large concrete counterweights to lift the bridge. The main vertical tower members are ‘double (back-to-back) angle sections from which small squares were (almost completely) gas-cut out to allow the counterweight to move freely both transversely and longitudinally after knocking out the cut pieces (instead of banging against the tower legs during the earthquake). The metal squares were left in so the guides on the counterweight wouldn’t bind against the holes. During the earthquake, the retrofit worked perfectly, with the guides knocking out the cut metal squares, thus allowing it to swing without hitting the tower legs (Figure 11). However, the metal squares fell onto the roadway, which could have banged up a vehicle or even endangered a driver if the earthquake had occurred when someone was on the road. Therefore, the designer has asked that the plates be tack-welded back onto the channels (to help guide the counterweight) and

that little chains should be attached to keep the plates from falling onto the roadway during the next earthquake.
