PERFORMANCE OF WATER SYSTEMS IN THE M_w 8.4 ATICO (PERU) EARTHQUAKE OF JUNE 23, 2001

John Eidinger¹

This report describes the performance of water systems in the Atico, Peru M_w 8.4 earthquake of June 23, 2001.

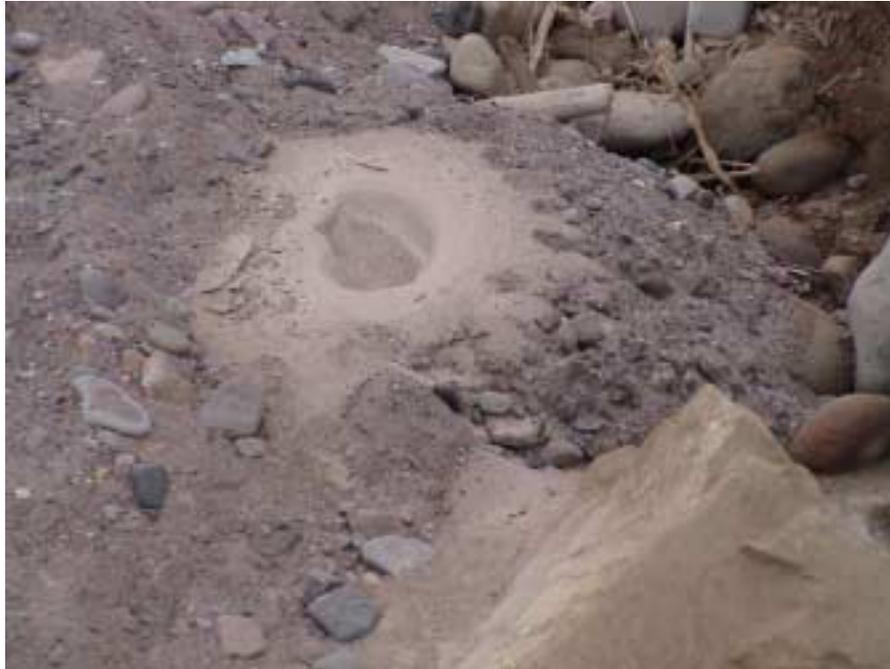
Figure 3-2. Sand Boil in river bed. The boil measures about 6 inches in diameter.

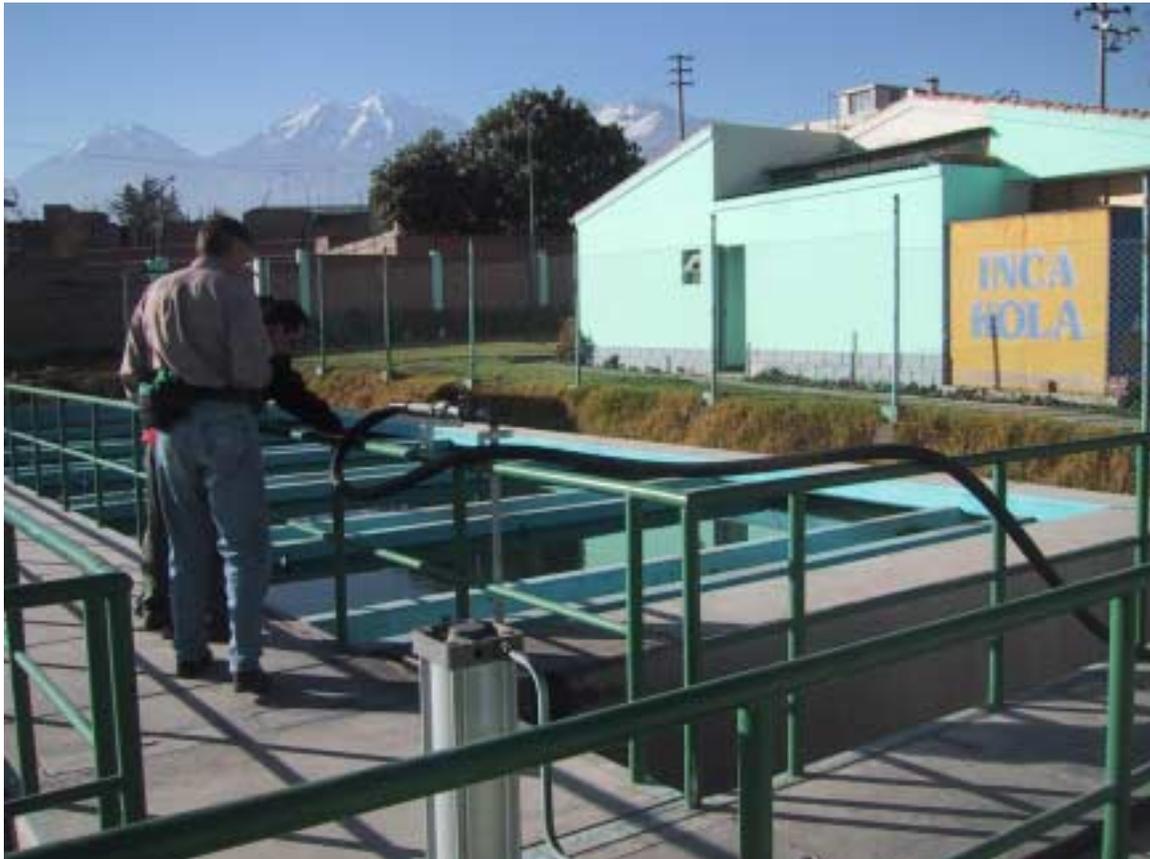
There was no damage to the reinforced concrete rectangular basins; nor to the concrete troughs in these basins. According to the plant manager, there was wave sloshing in these basins, but the slosh height did not exceed the height of the freeboard in the tanks (Figure 4-2). The sedimentation basins use tube settlers, and some of these (near wall edges) had tilted over in the earthquake, presumably due to water sloshing forces; the settlers had not been repaired 34 days after the earthquake.

Figure 4-2. Arequipa WTP. No damage to concrete troughs, no sloshing over freeboard

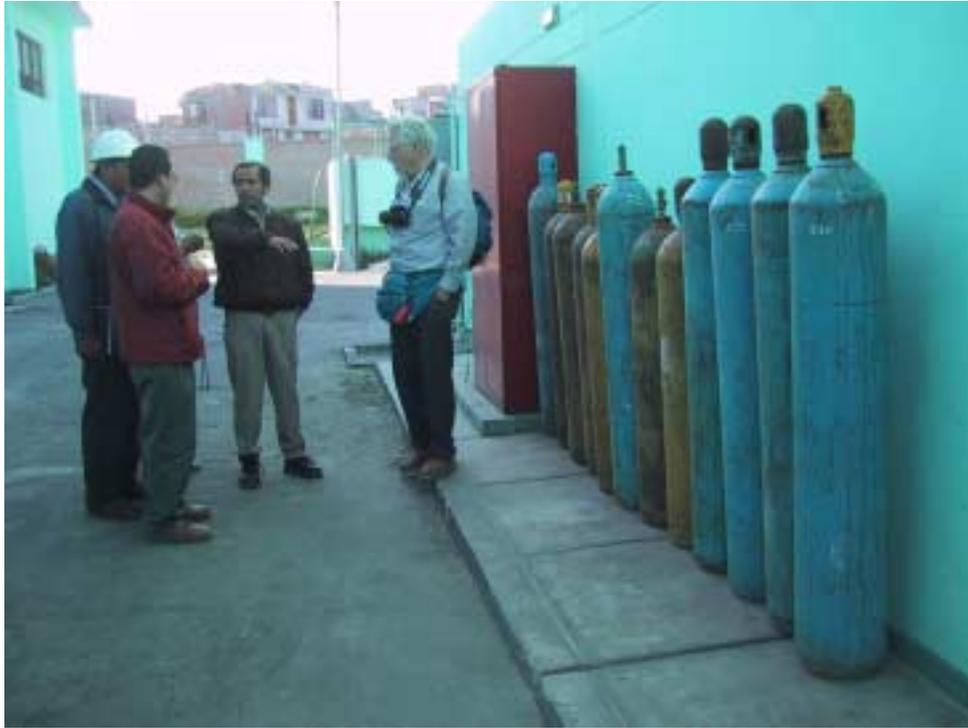
Figure 4-3 shows about a dozen small chlorine tanks at the Arequipa WTP. These tanks are used for rechlorination at remote reservoir sites, and are often stored at the WTP. As can be seen these tanks are not anchored or chained in any way. During the earthquake, all the tanks tipped over and fell onto the ground. The pressure regulator for one of the tanks broke, and there was a chlorine gas release at the plant. In the cabinet seen in the background of Figure 4-3 are respirators; these were used during the cleanup process.

Figure 4-3. Arequipa WTP. Small Chlorine Tanks

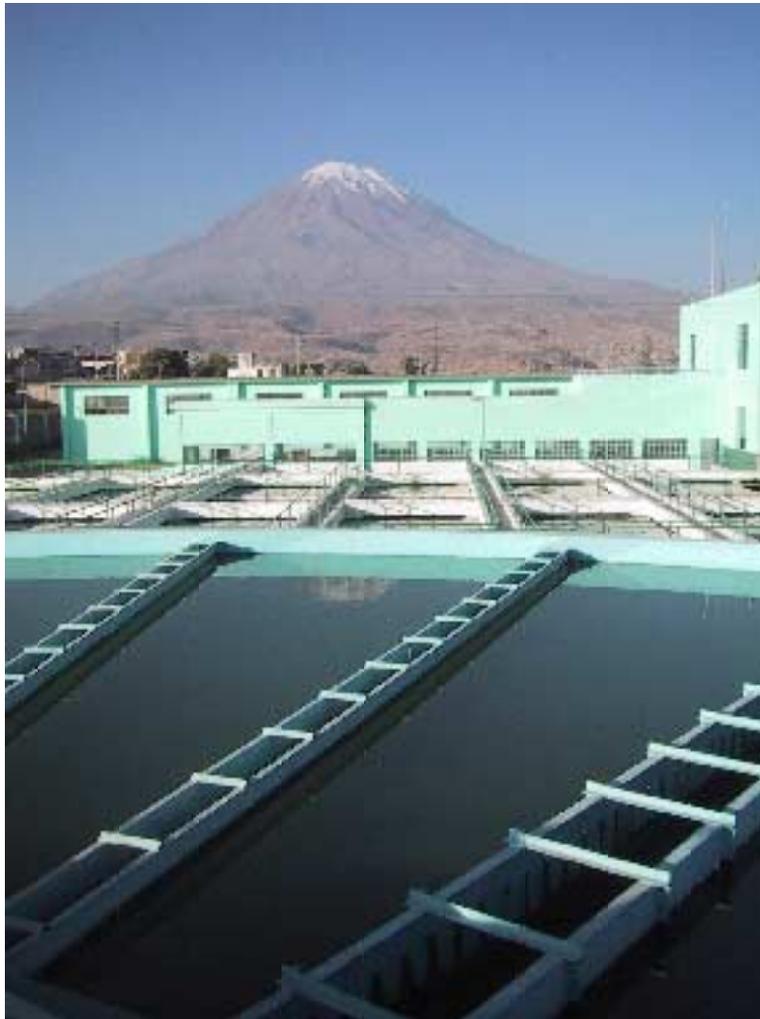
The circular clarifier did experience a moderate amount of damage. Figure 4-5 shows the radial metal troughs, going from the center column of the clarifier to the outer concrete walls. The volcano in the background is "El Misti" with summit elevation of over 5,800 meters (19,100 feet). The metal troughs were clearly out of alignment after the earthquake, as evidenced by most of the weirs being too far above or below the water line (although this is difficult to see from the picture). This suggests that the steel center column rocked during the earthquake, causing some permanent offsets. Coupled with the other damage to the clarifier, we proposed to the plant manager that the clarifier should be drained and inspected for additional damage from within. The plant manager reported that this was not feasible, as draining the clarifier would reduce plant capacity to below the level of water demand; and seeing as the water demand in July is at the annual low, the plant manager did not have a plan as to how to address the damage to the clarifier.

Figure 4-5. Metal Troughs – Out of Alignment (El Misti in background)

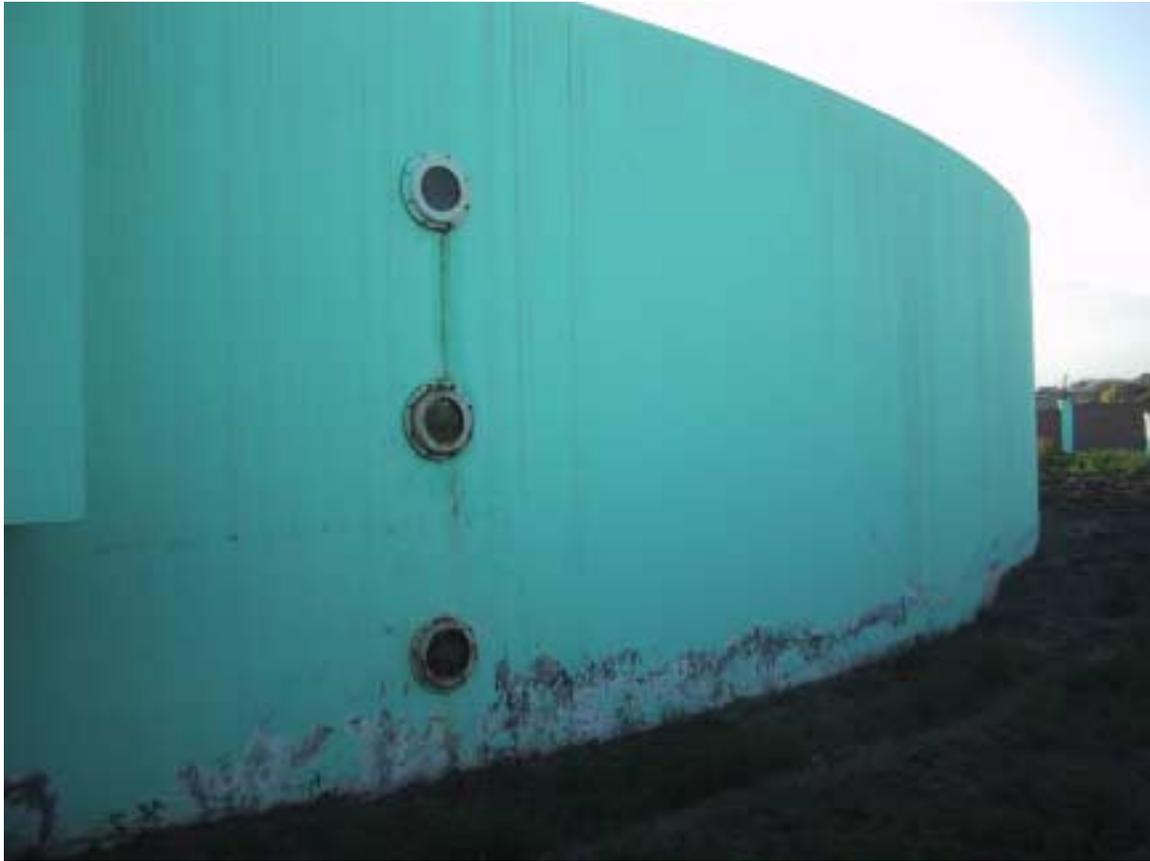
Figure 4-6 shows the exterior wall of the clarifier at the Arequipa WTP. There is a horizontal crack about 4 feet above the ground level, which runs almost entirely around

the tank. There are additional cracks near the ground level. These cracks were freshly made by the earthquake, but were not leaking. The three viewing ports seen in Figure 4-6 indicated that the media (clay and sand layers) within the tank were upset, according to the plant manager. Again, as noted previously, taking the clarifier out of service for detailed inspections was not deemed feasible by the plant manager.

Figure 4-6. Clarifier Wall at Arequipa WTP

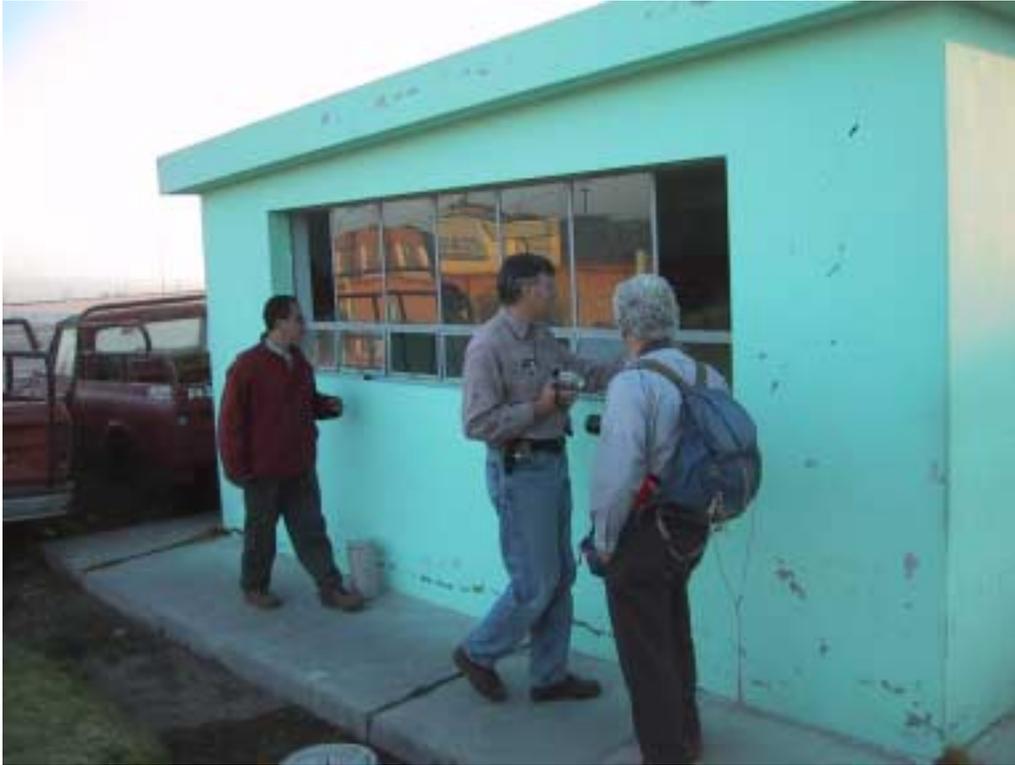
Figure 4-7 shows the pumping plant building at the Arequipa WTP. About half of the windows (1/4" thick annealed glass panels) were broken; all the glass had been held in place by stiff cement mortar, which explains the high damage rate. Many cracks can be observed in the walls; most of the cracks are located at the interface between the reinforced concrete frame columns and the non-reinforced interior infill walls. The extent of cracking was considered moderate, not indicative of a possible collapse, but warranting either replacement of the infill walls (preferred approach) or a "painting over" (a not unlikely outcome). The extent of the damage suggests that the non-reinforced infill masonry approach yields moderate damage at PGA about 0.15g to 0.2g, and potential collapse at PGA of 0.4g. There was similar types of glass breakage in other plant buildings which had similar levels of damage to infill walls – this suggests that once the infill walls crack, the remaining reinforced concrete frame system becomes flexible enough to cause sufficient story drifts to crack cement-grouted regular glass panes.

Figure 4-7. Pumping Plant Building at Arequipa WTP

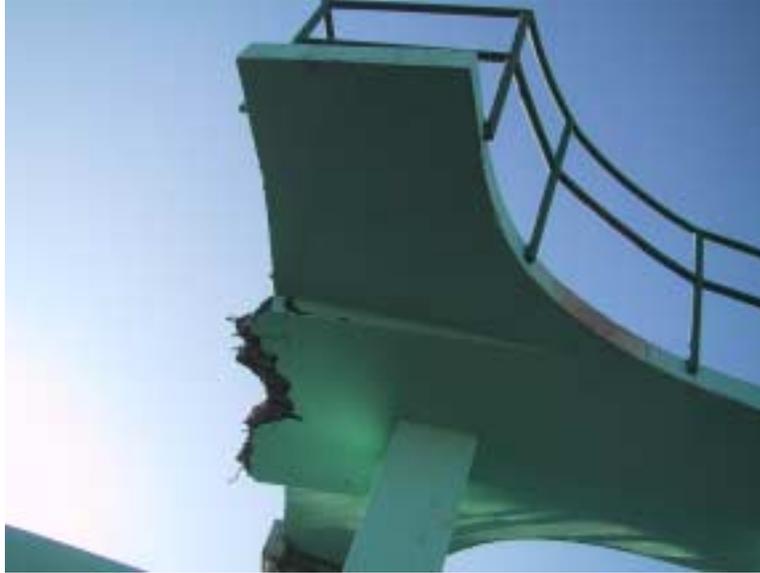
Figure 4-8 shows the damage to a reinforced concrete walkway leading to the clarifier operating deck. Small reinforcing bars can be seen at the failure location. Figure 4-9 shows the piece of the walkway which has fallen to the ground level.

Figure 4-8. Damage to Reinforced Concrete Walkway

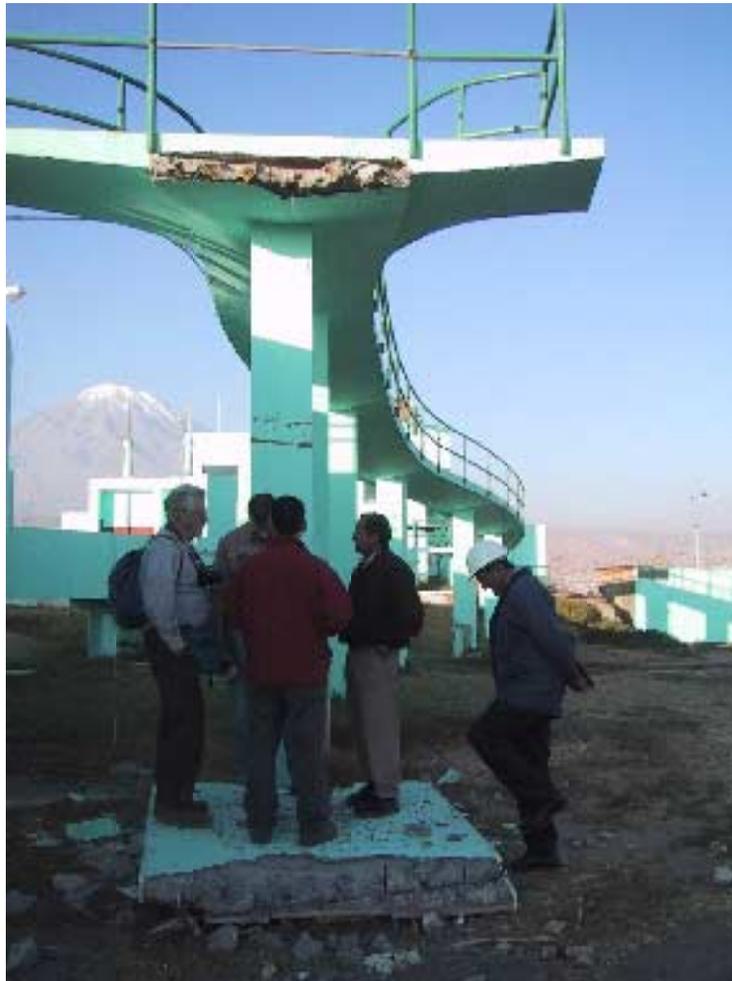
Figure 4-9. Damage to Reinforced Concrete Walkway

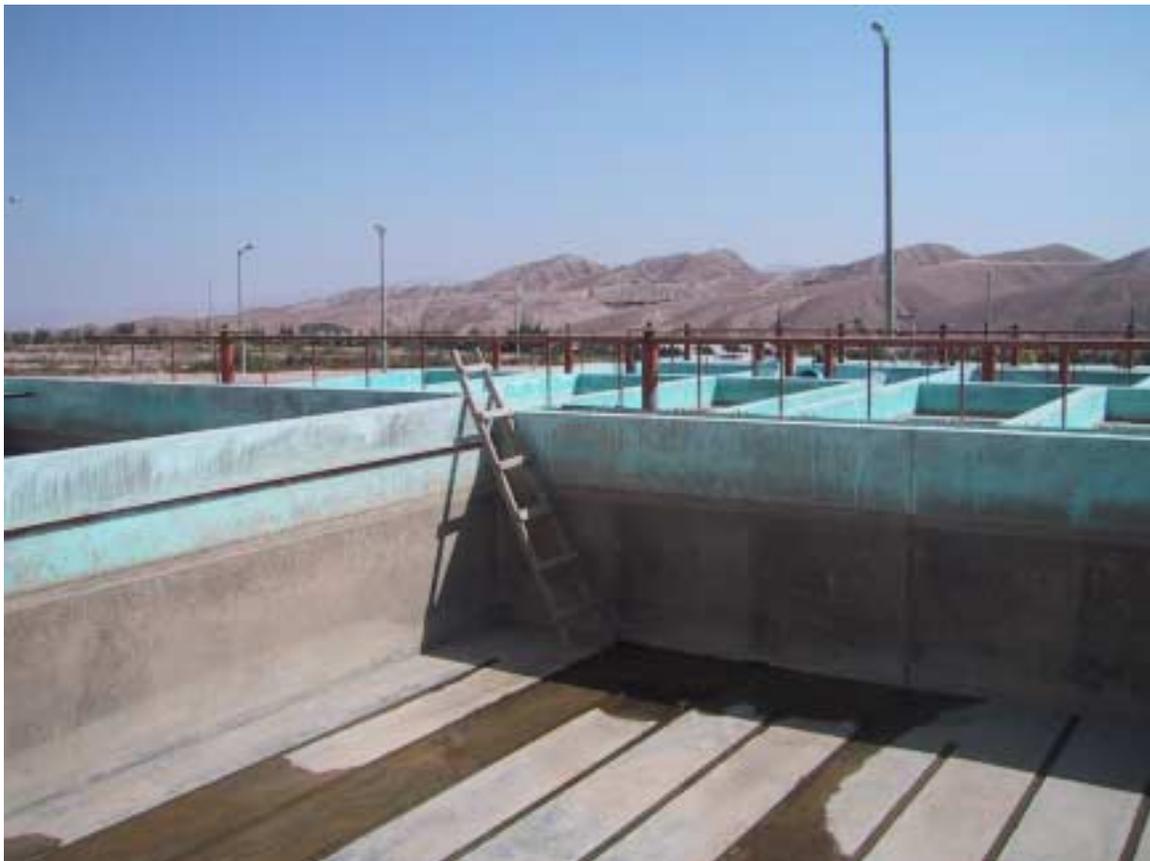
Figure 4-11 shows the empty floc basins, as seen during the plant inspection. The longitudinal "grooves" at the bottom of the tank form the bottom channels used to maintain position of the baffles (all the baffles have been removed from the tank).

Figure 4-11. Primary Flocculation Basin, Moquegua WTP

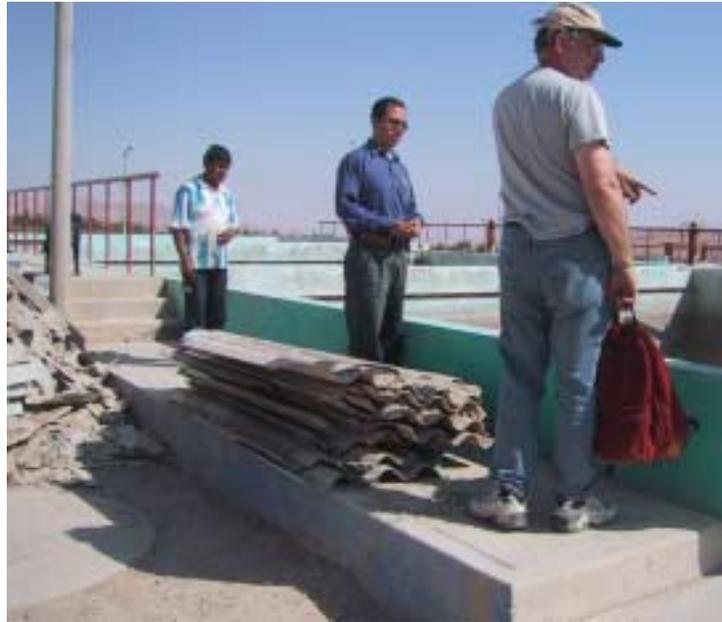
Figure 4-12 shows the broken baffles resting next to the flocculation basin. These baffles appeared to be either corrugated lightweight fiberglass or asbestos sheets. These baffles had been hung in the basin from steel channels. Most of the baffle sheets showed damage to their edges, where they had been bolted to the steel channels. The steel channels in turn had been bolted to steel angles on either side of each concrete basin. At the time of the

inspection, all the channels (Figure 4-13) and broken baffles (Figure 4-12) were resting near the basin. The bulk of the damage was to the baffles. It appeared to the inspection team that it might have taken a workforce of about 4 men about 2 days to replace all the baffles and channels, but it was reported that there was neither manpower, material or money available to make the repairs.

Figure 4-12. Broken Baffles, Moquegua WTP

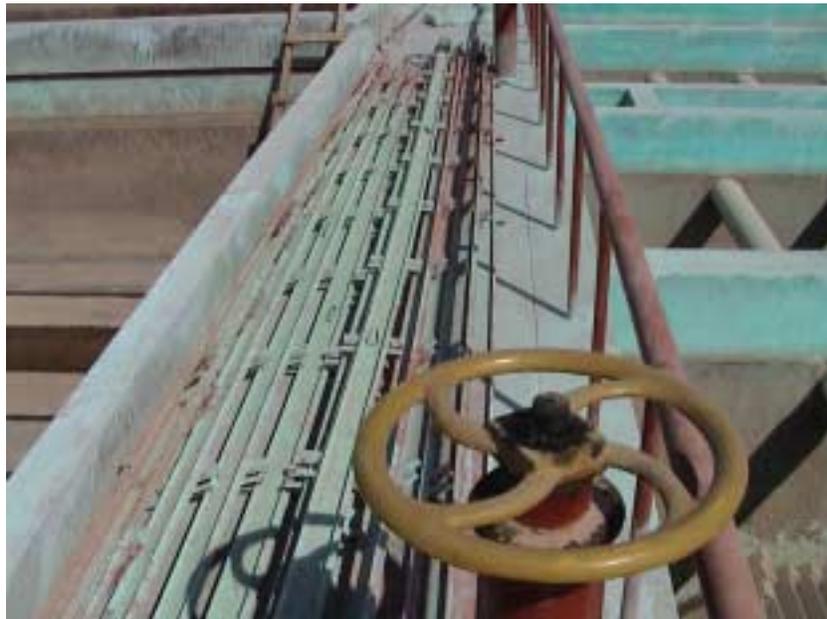
Figure 4-13. Baffle Support Channels – Removed from Service, Moquegau WTP

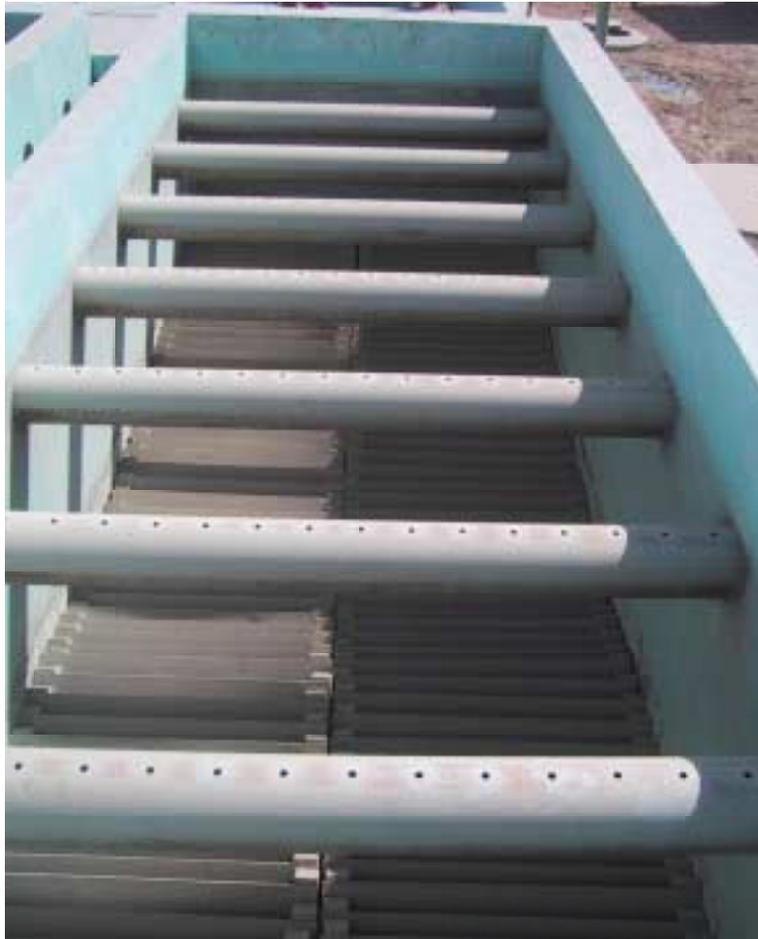
All settling basins were empty of water during the inspection (Figure 4-14). In the bottom half of the basins were diagonal settlers. About 10% of these settlers were tilted away from their natural angle, which would modestly negate their effectiveness. The settlers had not yet been realigned to their proper configuration. None of the enclosed water troughs at the top of the basin appeared to be damaged.

Figure 4-14. Settlers at Moquegua WTP

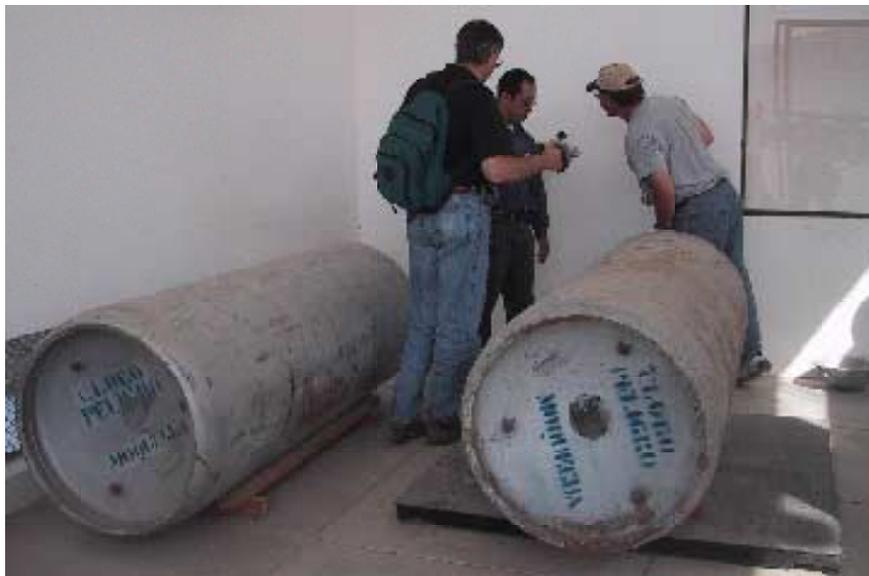
The chlorine one-ton tanks were located in small building. This building had a chain link fence as one wall. Figure 4-15 shows the tank configuration. The tank on the left is the spare tank and rests on a wooden "2x4" skid system; this tank was empty at the time of the earthquake. The tank on the right is the active tank, with a "pig-tail" type of hose system attached to the tank at the far side (unseen in this photograph). The empty tank at the left rolled off its supports, coming to rest about 1.5 feet to the right near the active chlorine tank. but as it was not connected, it broke no attached hoses. The active tank at the right did not roll off its supports (note that it is resting on a scale), but showed evidence that it pushed its supports by about an inch or so. It is possible that the sloshing of the chlorine fluid within the tank acted as a "active mass damper", to partially alleviate the dynamic motions of the in-service tank; or possibly it is just luck that this tank did not also roll off its supports; had that happened, it is possible that the attached pig tail hose would have been broken, leading to a substantial chlorine gas release; fortunately, this

did not occur. A plant watchman noted that there was a lack of confidence in the chlorine system, and he preferred to use a manual approach of adding chlorine bleach to the finished water. As to the structure of the chlorine building itself – it was moderately damaged (reinforced masonry frame structure with infill non-structural masonry), with through wall cracks (1/16 to 1/8 thick cracks) running diagonally through several of the walls.

Figure 4-15. Chlorine Tanks – Moquegua WTP

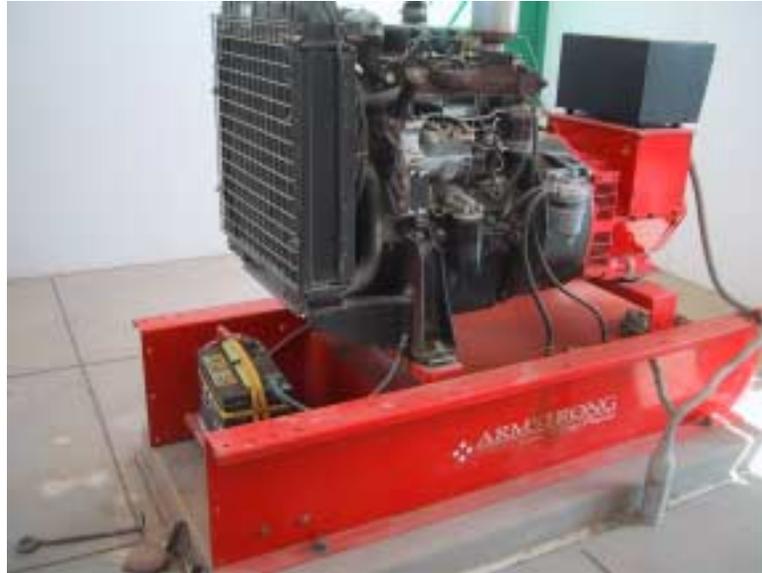
The earthquake caused a loss of offsite power to this WTP. The WTP has a standby diesel generator, seen in Figure 4-16. With the exception of the battery, the generator was otherwise well anchored. The battery fell over in the earthquake, and spilled acid on the floor. The generator was presumed not to be operational immediately after the earthquake. Reportedly, offsite power was restored to the WTP prior to repairing the emergency generator, and it is not known if this generator was ever used during or after the earthquake. The battery remained unanchored in its repaired state.

Figure 4-16. Emergency Generator – Moquegua WTP

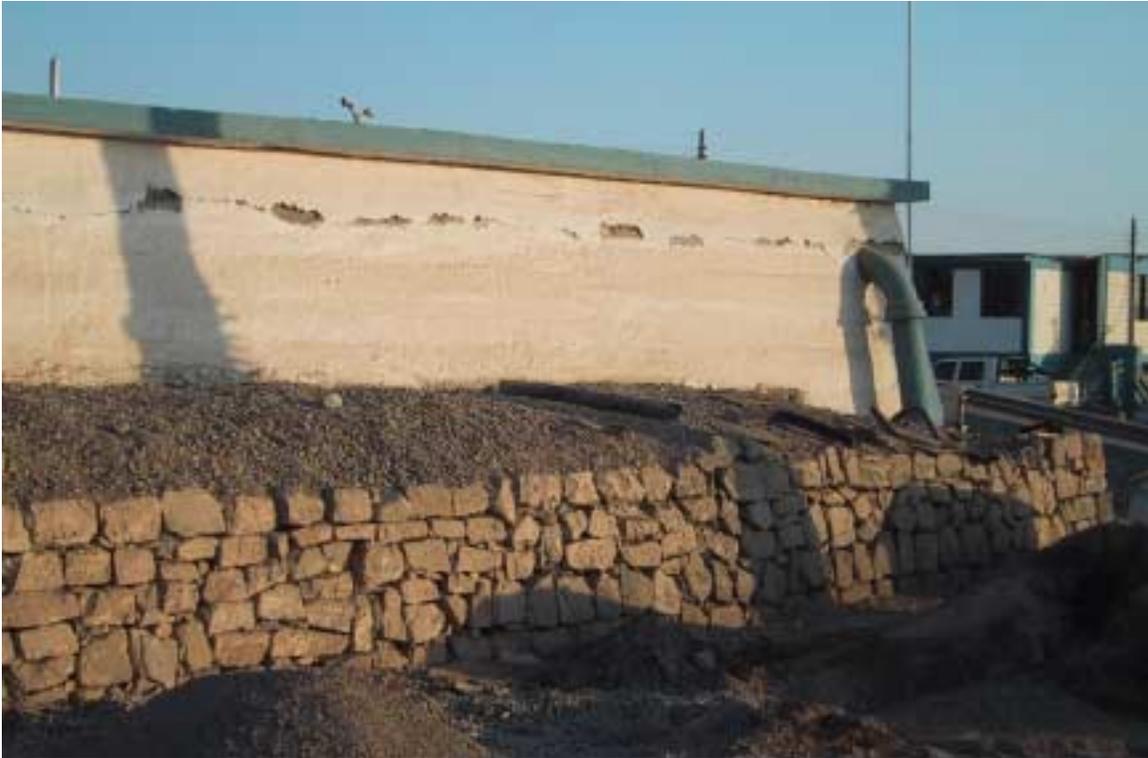
A partially buried reinforced concrete clearwell (Figure 4-17) at one of the water treatment plants was inspected from the outside. This reservoir used a heavy concrete roof system, support on interior columns, with lateral resistance provided by exterior concrete walls. The bottom of the reservoir used a concrete lining. It was evident from the outside that the roof system had been damaged, likely from sloshing wave action on the inside, coupled with modest inertial forces (PGA at the side was in the $0.10g$ range). There were several portions of the roof system which had visible settlements on the order of 4 to 12 inches. The outside reservoir walls, above the ground surface, were cracked, likely from excessive shear forces during the earthquake. Outside the reservoir, there was a pile of remnants of liner damage (about 100 pieces, total volume about 2 cubic yards). The water utility had yet to make a comprehensive inspection of the reservoir from the inside, although they expressed concern about the damage.

Figure 4-17. Tacna WTP – Damage to Walls of Reinforced Concrete Clearwell

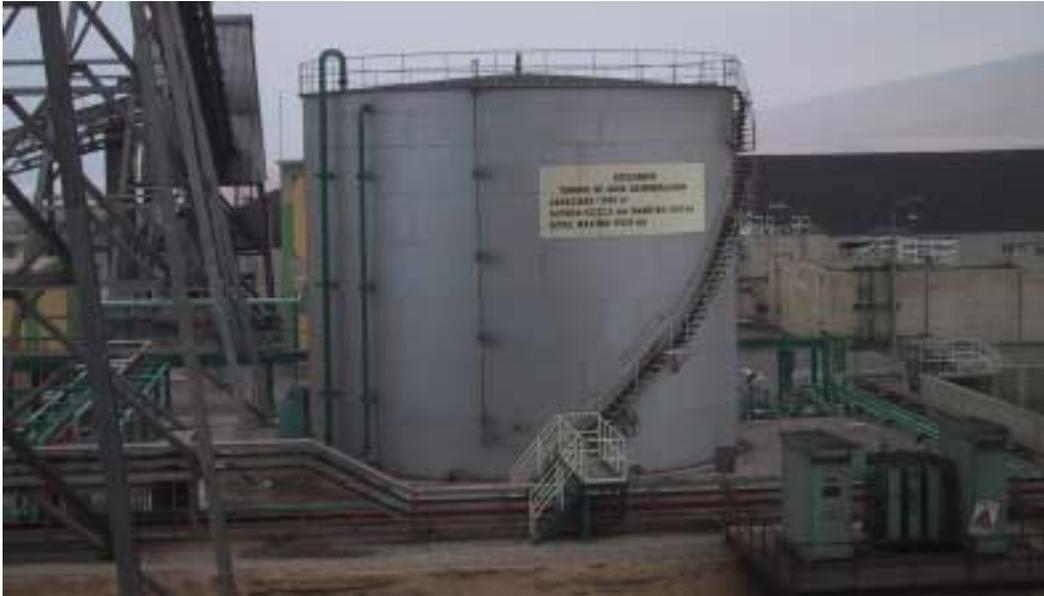
anchor bolts. Figures 4-18 and 4-19 show one of these three tanks, along with a typical anchor bolt. This tank had capacity of about 1,500,00 liters of water, and was full at the time of the earthquake. The tank dimensions were height 12.2 meters, diameter 14.5 meters, water level at the time of the earthquake 11.6 meters. Each of the 8 anchor bolts stretched out of the foundation by about 1.5 to 2 inches. None of the attached pipelines (side entry) were damaged, although each pipe was long enough before its first support to likely be able to accommodate a few inches of vertical movements. There was no evidence of elephants foot buckling on this tank.

Figure 4-18. Water Tank Near Ilo

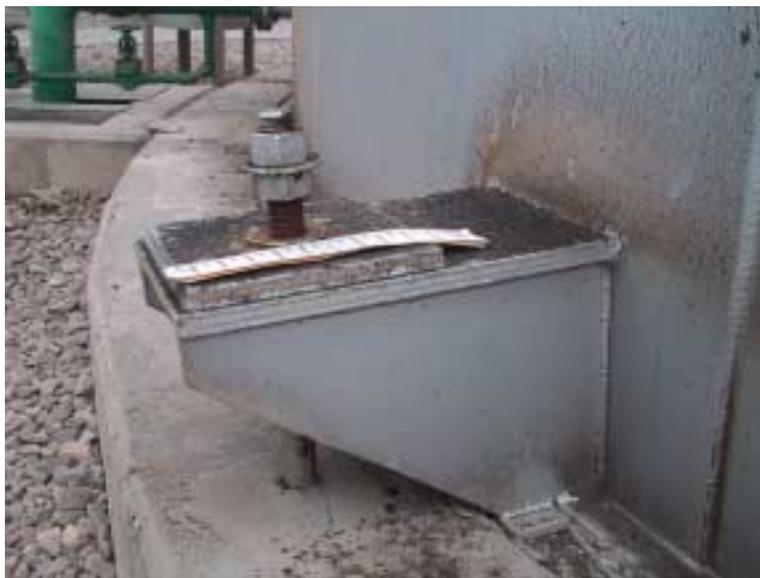
Figure 4-19. Stretched anchor bolt – 1,500,000 tank near Ilo

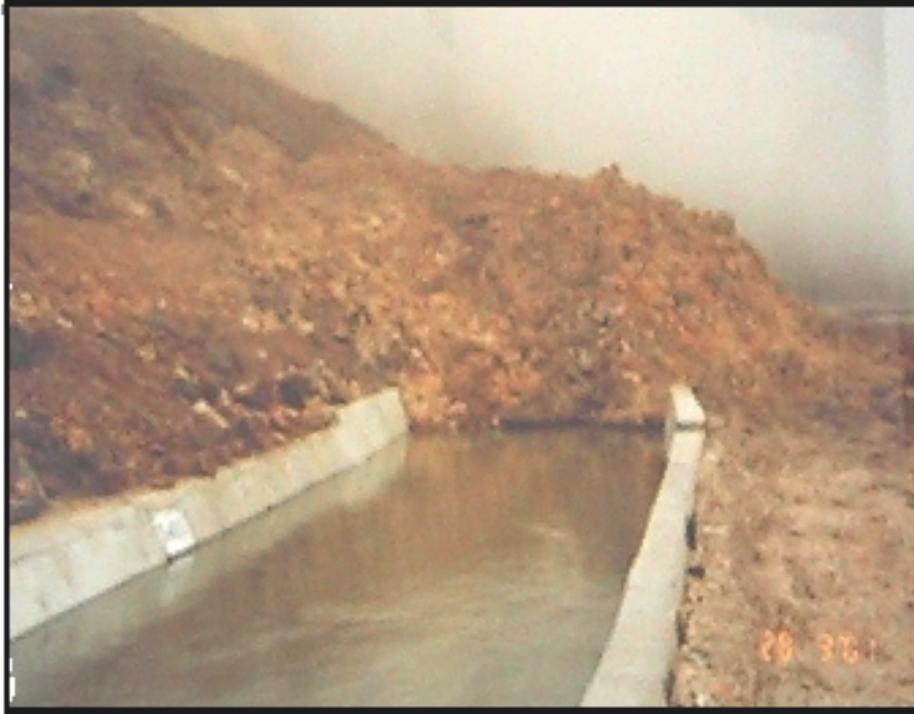
There was no reported damage to the tunnels; although these had not yet been inspected, and PGA values were likely in the 0.01g to 0.05g range. However, the Otoratorata and other canals suffered serious damage, including about 106 locations where landslide debris entered the canals (Figures 5-1 through 5-4). Substantial lengths of canals were exposed to ground shaking levels in the PGA = 0.10 to 0.30 (or higher) range. In at least a few locations, the landslide debris also damaged the reinforced concrete canal walls. It required a workforce of 60 men a total of 35 days to perform emergency repairs to the canal system and restore water flows.

Figure 5-1. Landslide Debris in Canal Near Moquegua

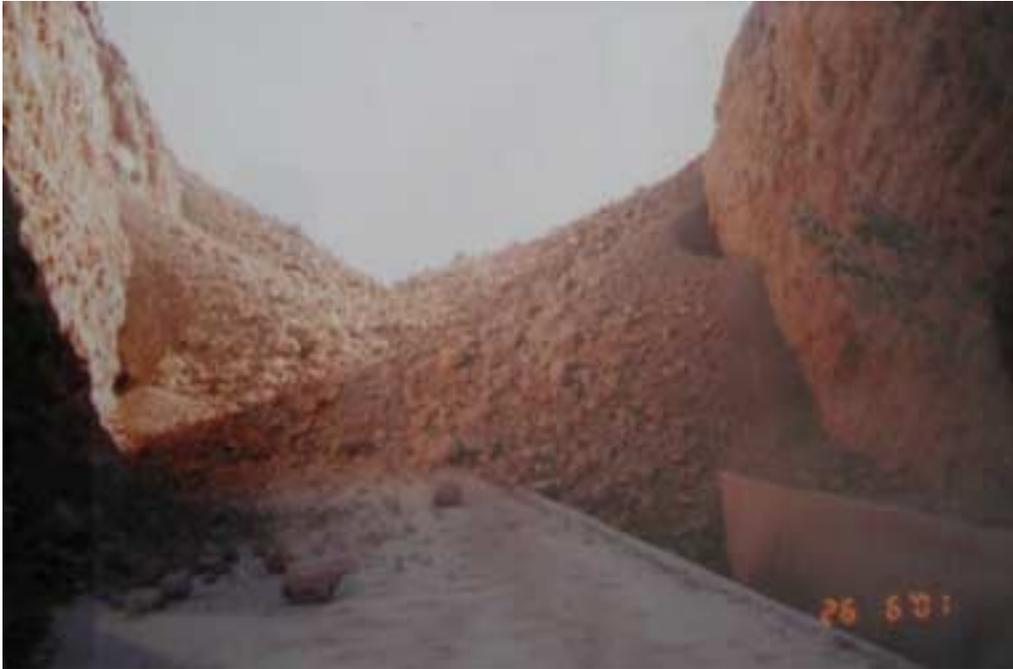
Figure 5-2. Landslide Debris into Canal Near Moquegua

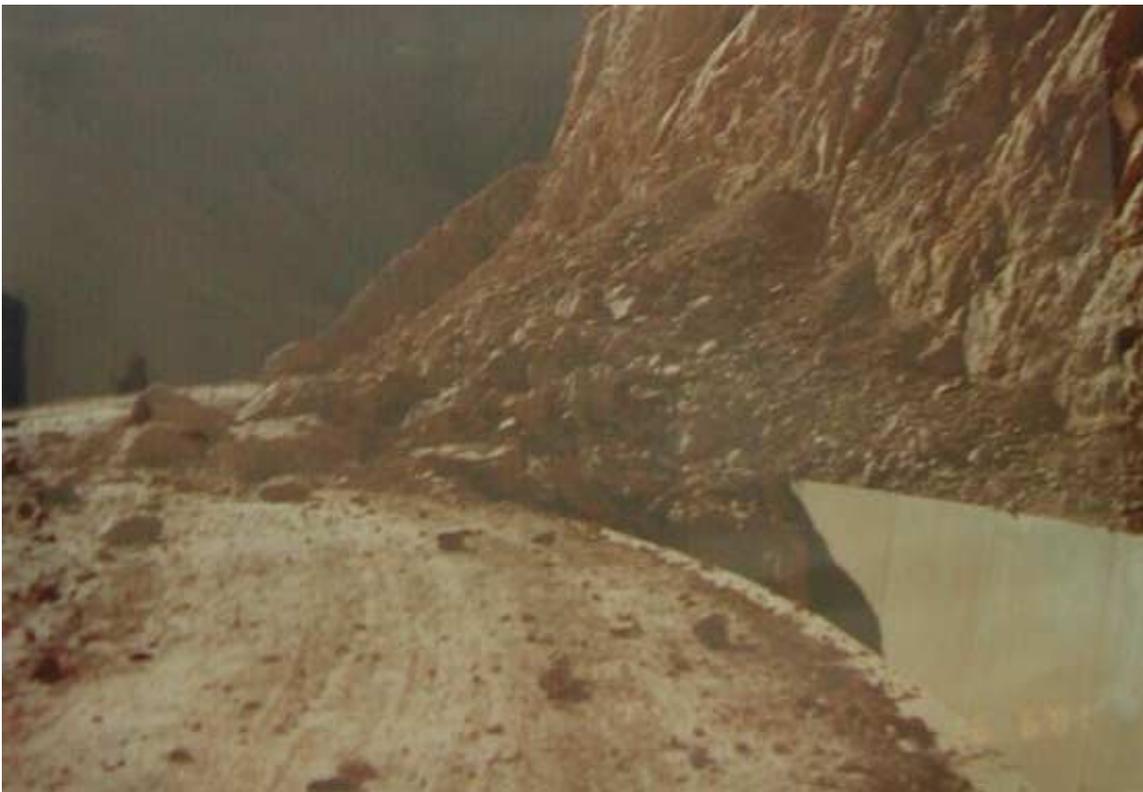
Figure 5-3. Landslide Debris into Canal Near Moquegua

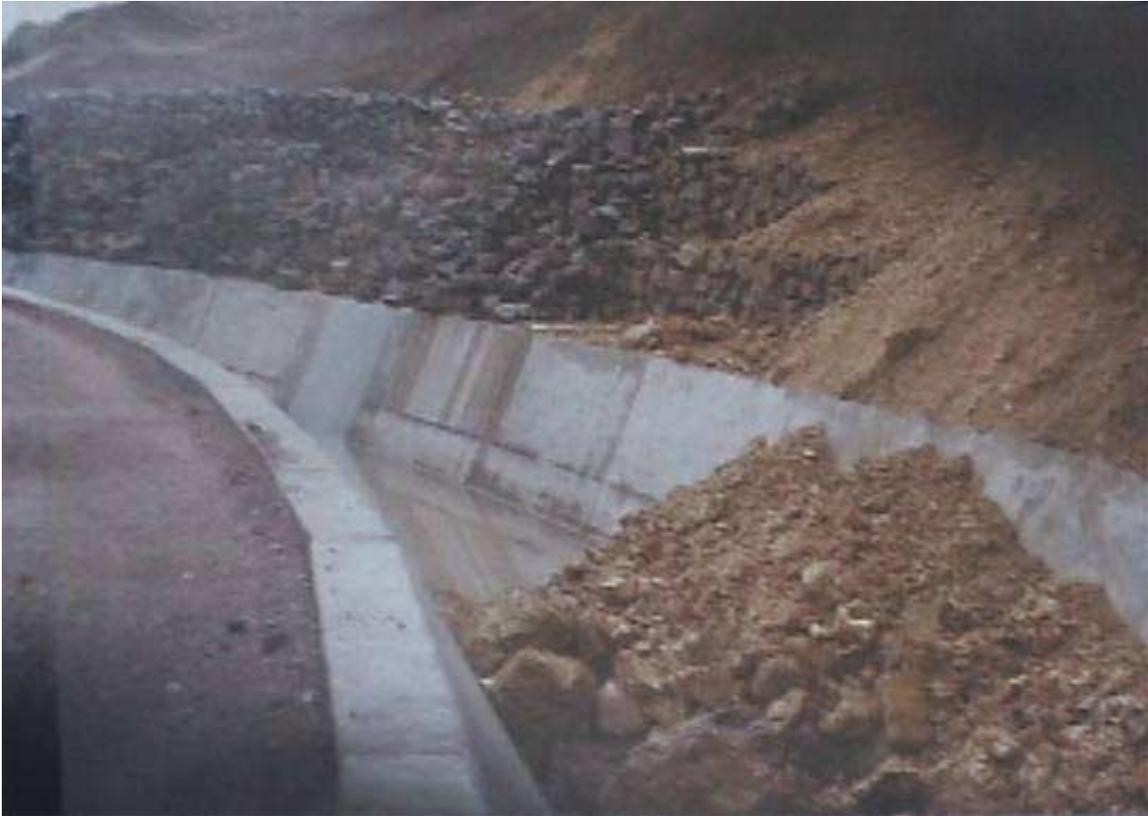
Figure 5-4. Landslide Debris into Canal Near Moquegua
